**FINAL REPORT**  
**PHASE TWO ARCHAEOLOGICAL IMPACT ASSESSMENT**  
**ERF 110460, CAPE TOWN -**  
**PREVIOUSLY THE GARDEN WELGELEGEN**

(HWC Ref No C13/3/6/2/1/1/1/A1 Permit No 2006-10-002)  
Permit extended 1 October 2008 and renewed 3 November 2009

**14 December 2011**

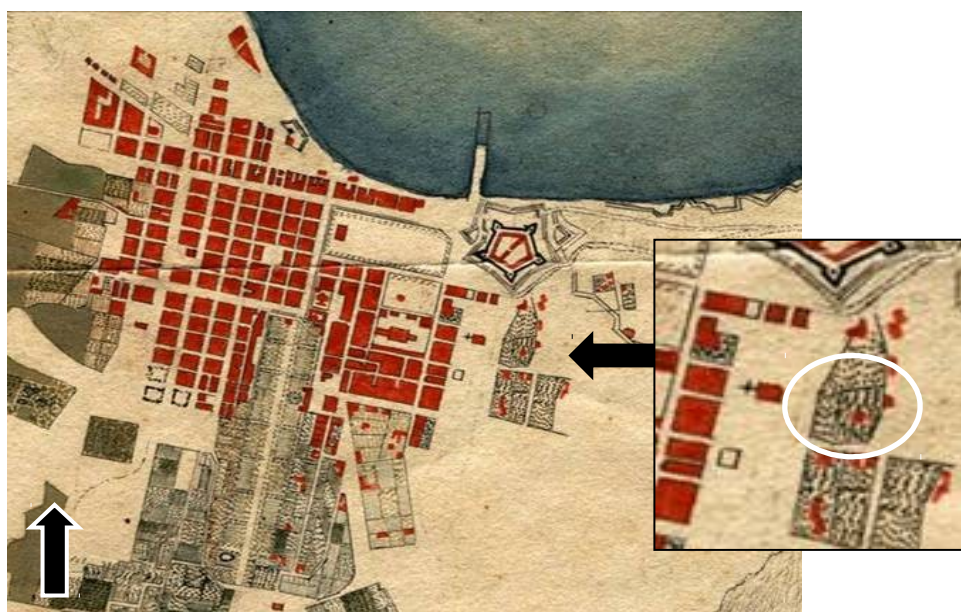
Figure 2: Detail of map of Cape Town (CA M1/388). The date of the map is in dispute, as while the Commercial Exchange appears on the Parade (c1822), the New Market to the east of the Castle (c1814) is not shown. The insert shows the detail of the area in the vicinity of the Welgelegen garden, and possibly the actual market garden boundary (See Figure 3).

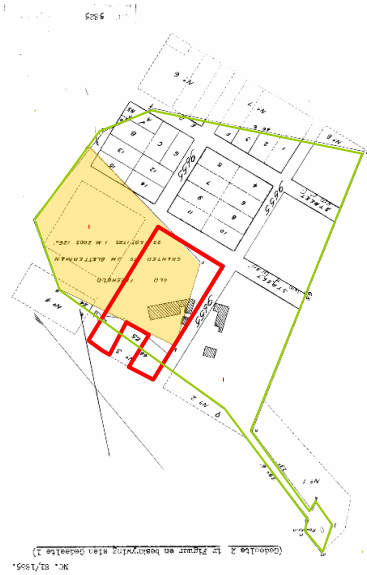
Figure 3: Survey diagram 81/1865 c1865 showing the subsequent subdivisions of Erf 5825. The Welgelegen farmhouse is situated on the original Bletterman grant (shaded yellow), while the extensive outbuildings are situated on the surrounding land granted to Wernich in 1805 (outlined in green). Erf 114060, Cape Town is outlined in red.

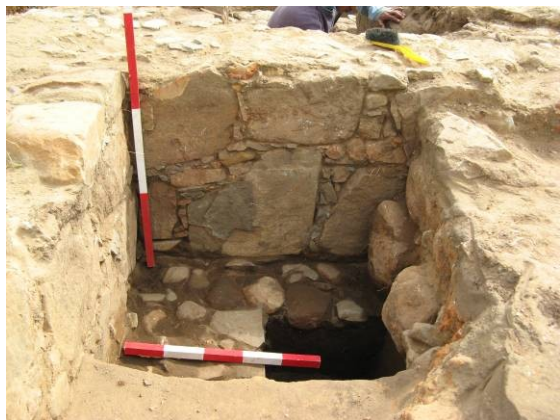
Figure 5: NW corner of Room 3 Wall IV.

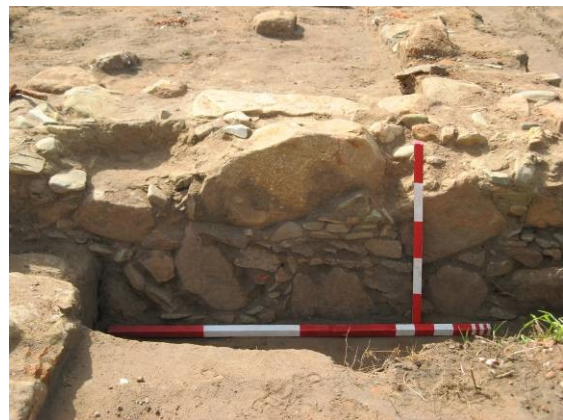
Figure 6: Wall V, 'exterior' Room 3

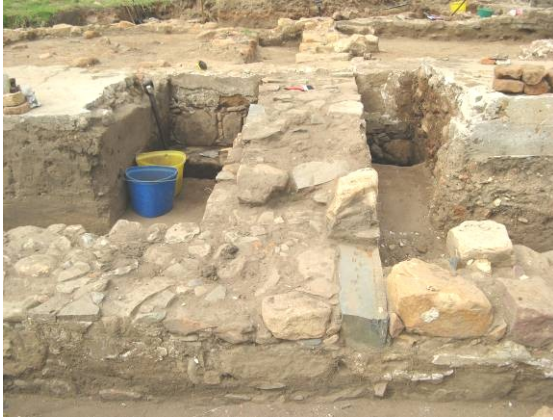
Figure 7: The construction method used in the stoeep is similar to that used in the original core, but with a brown clay mortar. NW corner.

The stoep was added to the three-roomed core subsequent to its completion. Traces of lime plaster are visible between the exterior of the walls and the stoep walls (Plate 4 and 5). The walls of Stoep I vary between 680 and 750mm thick, with a foundation of 840 - 900mm. The wall is constructed of a combination of large cobbles and some slate set in a brown clay mortar (Plate 4 and 5). This wall is only plastered on the 'exterior'.

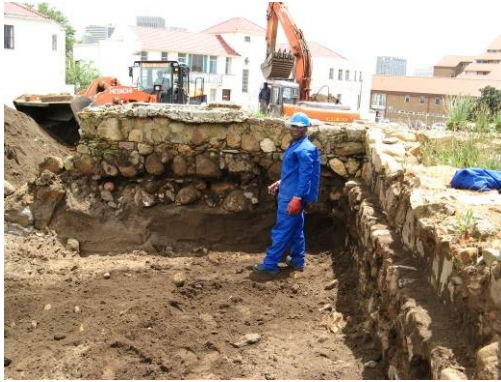
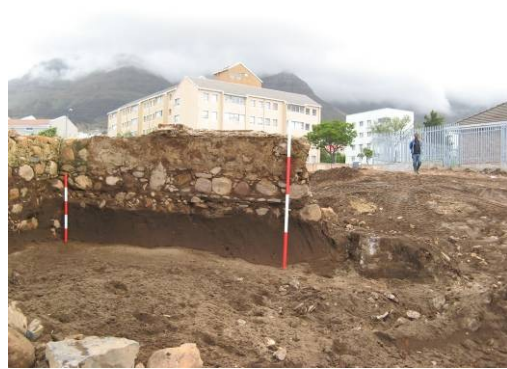
Figure 9: Views of Wall 4A. Note the similar construction method to the core. Varying depths of foundation is very clear in the image on the right. (Image on the left is taken facing N. Image on the right was taken facing SE).

The extensions to the east and west of Wall IV have a similar construction method, but lack the wide foundations of the core, suggesting that they may have been lower,

non-weight bearing walls eg wmf walls. Wall 4B ranges in width between 480-650mm. Wall 4A is 600mm wide. These walls were altered during the subsequent alterations and their terminal points were not found.

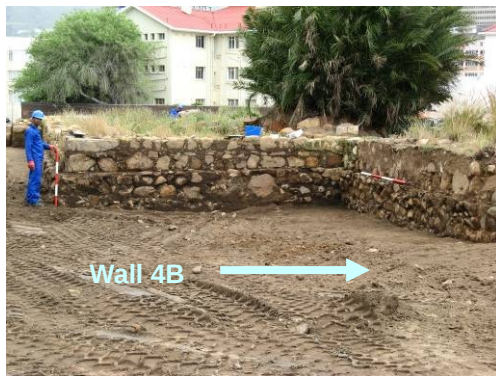
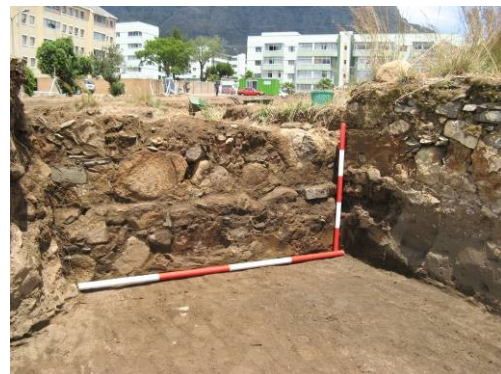
Figure 10: Views of Wall 4B. The depth of the foundation of this extension wall is deeper than the corresponding wall to the west of the core and reflects the natural slope of the ground. Lime plaster on the southern side of Wall 4B stops about 300mm below the level of the cobble floor; the ground surface at the time, is shown to slope fairly steeply towards the north and east (Clift 2006). (Image on the left is taken facing W, after the foundation of the CB2 had been removed. Image on the right was taken facing SW. Stoeep extension is visible on the right. Remains of collapsed support wall visible on the left).

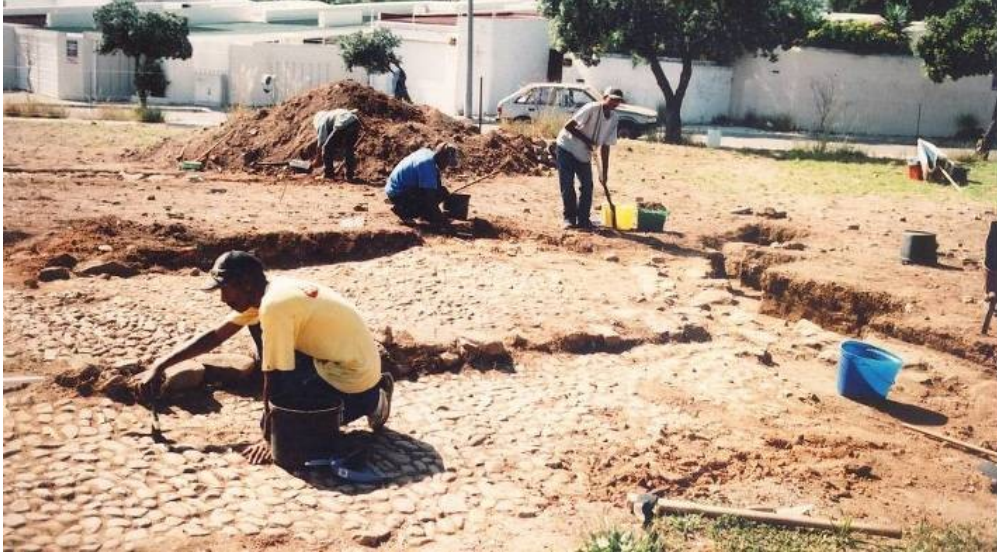
Figure 12: Clearing of the surface rubble, exposing the cobbled stable area. Although not clear in the photo, the cobbles are packed so as to facilitate the drainage of liquid to a central drain, as one would expect in stables or animal sheds. (Photo taken facing vd Leur Str)

The cobbled surfaces CB1 and CB2 are the remains of a stable/animal stall. While the pattern of the cobbled floor suggests two structures, no evidence was found during excavation or the monitoring brief of foundations which would support this suggestion. (The wall bisecting the cobbled area is a later alteration). Plaster on the exterior walls of the original core, as well as on Wall 4B, situated below the cobbled surfaces confirmed that the cobbled floor surfaces were later additions/alterations to the structure (Clift 2006). During the monitoring phase, the lower courses of the foundation of the eastern end wall was uncovered.

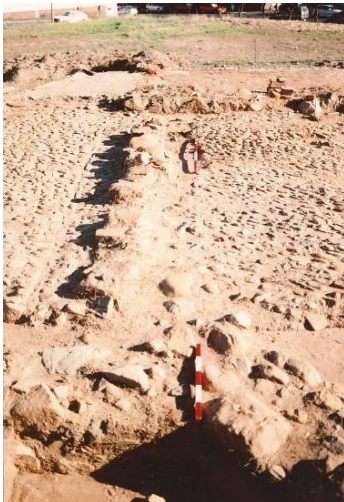
Figure 13: View of the CB1 and CB2. Cobbles of CB1 are packed perpendicular to the drainage row to the left of a later dividing wall. Cobbles of CB2 are packed on the diagonal; suggesting that this may have been a subsequent addition to the original stable. However, no foundations were found supporting this theory.

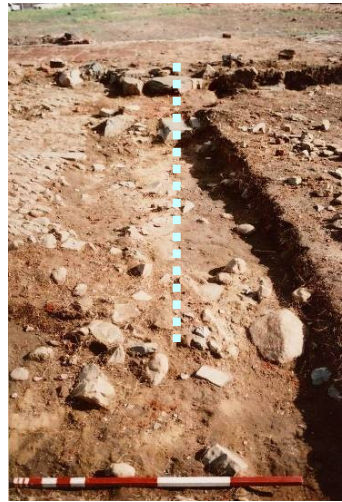
Figure 14: The remains of a plaster line, indicated by the dashed line, shows the position of the external wall of CB2. The stones of this wall were removed and reused in subsequent construction. During the monitoring phase, some evidence of this wall was uncovered.

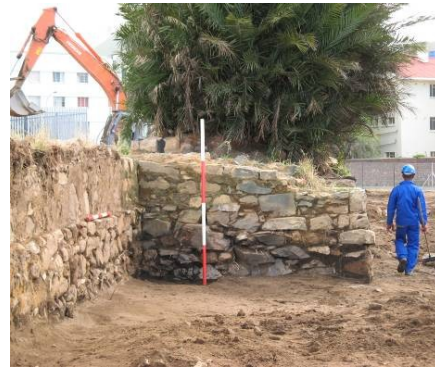
Figure 16: View of the east face of the support wall during the monitoring brief. Wall 4B is to the left of the image (the support wall abutting this wall had collapsed and was removed).

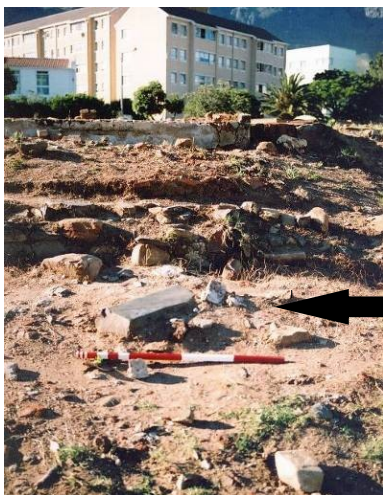
Figure 17: Slate step associated with the earlier period of the dwelling was found in 2006 among the surface rubble towards the eastern half of the site.

No clear evidence of the late 18<sup>th</sup>/early 19<sup>th</sup> century stairway to the stoep was found, with the exception of one well worn slate step found in a secondary context in the first field season. During the monitoring phase, it became clear that the position of the stairway had remained constant, it had just been modified at least twice.

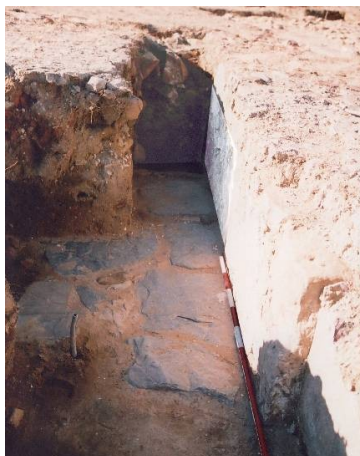
Figure 19: Slate paved area to the east of the extended Stoep Area 1 (Figure 18). (Photo taken facing south). The paving did not extend northwards beyond Wall 2B. It is possible that the paving extended along the front of the dwelling, but was removed and reused in the back courtyard area.

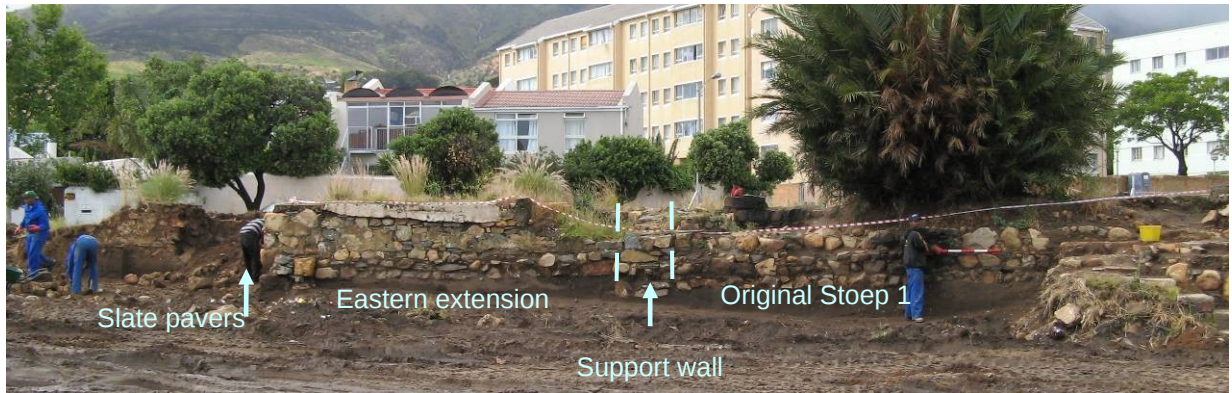
Figure 20: Eastern section of the front wall of the older core, once the late 19<sup>th</sup> century stoep had been removed. The predominantly slate constructed support wall is shown abutting the original stoep wall. The eastern extension probably dates to the early decades of the 19<sup>th</sup> century and is associated with slate paving stones which were found along the eastern edge of this extension. (Photo taken after the support wall shown in Plate 16 had collapsed).

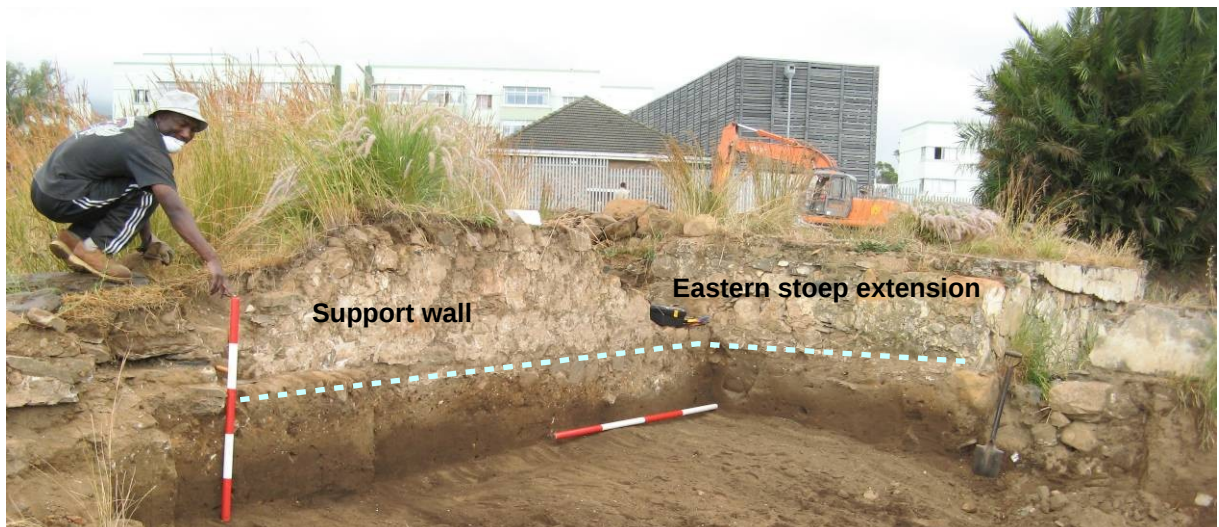
Figure 21: The blue dotted line shows the level of the mid 19<sup>th</sup> century ground surface. This level is confirmed by the remains of a cobble layer (just to the west of the 1m measuring rod) and the extent of the plaster mark. The slate pavers shown in Plate 14 were also located at this level.

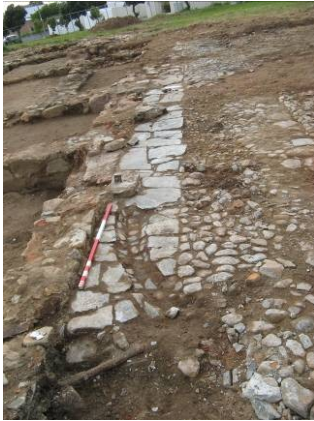
Figure 22: View of cobbled walkway between courtyard and house. Note the drain feature. (Photo taken facing east.)

The cobbled courtyard to the south of the dwelling also dates to this period. Lead water piping was found underneath undisturbed portions of the cobbling, suggesting that the water supply pipes were laid at the same time the cobbling. According to Hennie Vos (2006 pers comm.) lead piping was already in common usage by the 1860s. A slate walkway separated the dwelling and the cobbled courtyard (Plate 17-18).

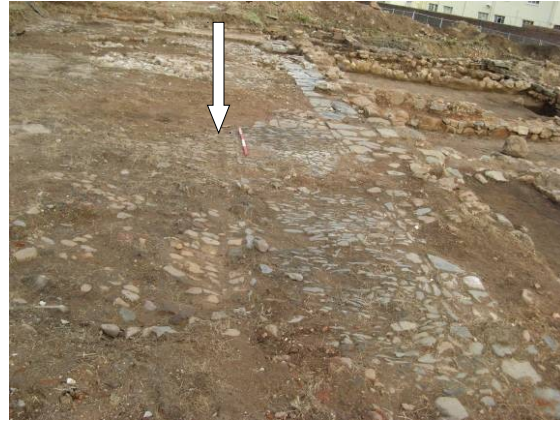
Figure 23: View over the courtyard. Remains of a cobble packed drain visible in foreground. (Photo taken facing west.)

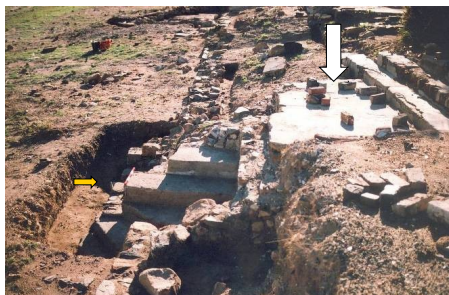
Figure 24: Earlier set of stairs underneath the cement slab is indicated by the white arrow. (Photo taken facing eastwards).

The stairway giving access to the dwelling was initially covered in layers of cement, as was the surface of Stoep area. Underneath the cement slab (Plate 19) was evidence of a tiled stairway giving access to the dwelling. During the monitoring brief, an additional slate paved area was uncovered between the end of the tiled stairway and the stairwell shown in Thom's Survey of 1898.

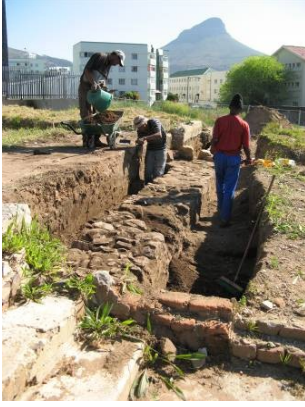
Figure 25: The cement stairway. Wall II of Stoop I visible in background.

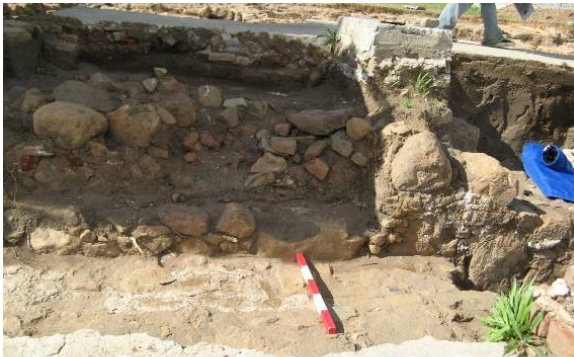
Figure 27: Plaster mark in the fill showing the position of the steps.

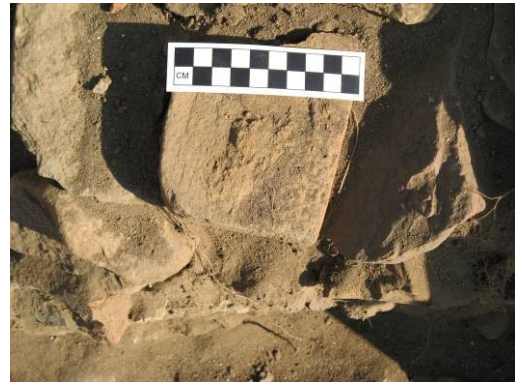
Figure 28: Detail of an edge tile.

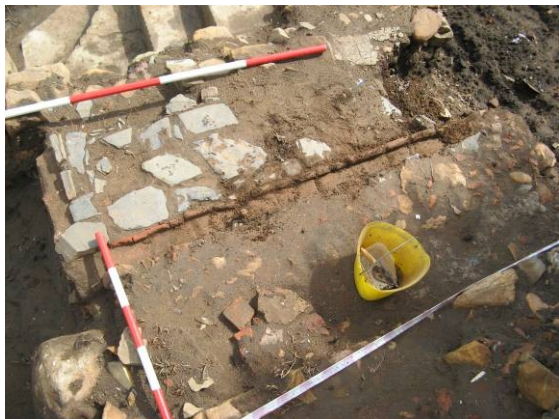
Figure 29: Abutting the end of the tiled stairway, was a layer of slate pavers, perhaps linking with the remains of the slate pavers to the east of the extended stoep (Figure 19). (Photos taken during the monitoring brief, after Wall III had been removed). The slate paved area represents the ground level of the mid 19<sup>th</sup> century.

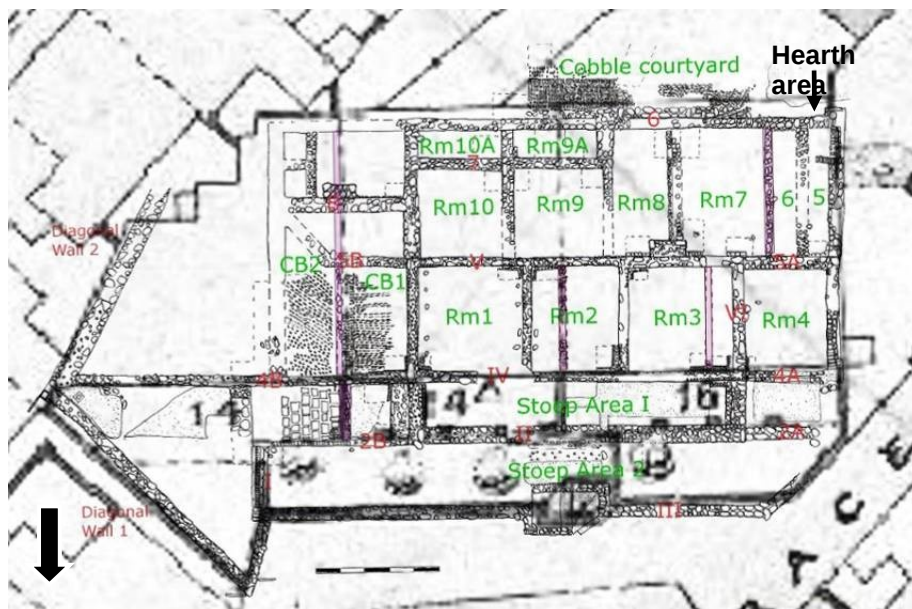
Figure 30: Overlay of the site plan on Thom's survey c1898. Late 19<sup>th</sup> century foundations are shaded purple. A hearth/cooking area was uncovered in the SW corner of the dwelling.

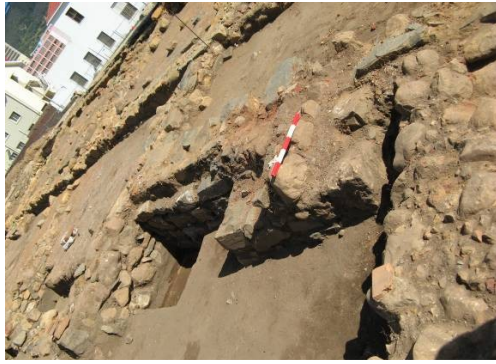
Figure 31: The 500mm measuring stick marks the position of a later 19th century crosswall which aligns with the crosswall bisecting the Stable (Plate 26). (Photograph taken facing north.)

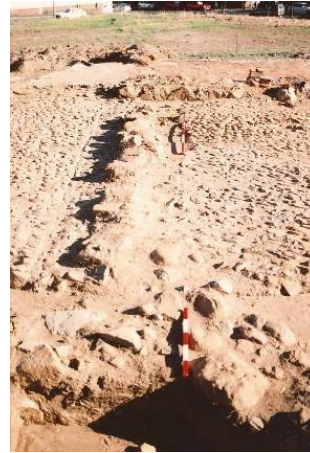
Figure 32: Crosswall bisecting Stable area. October 2006.

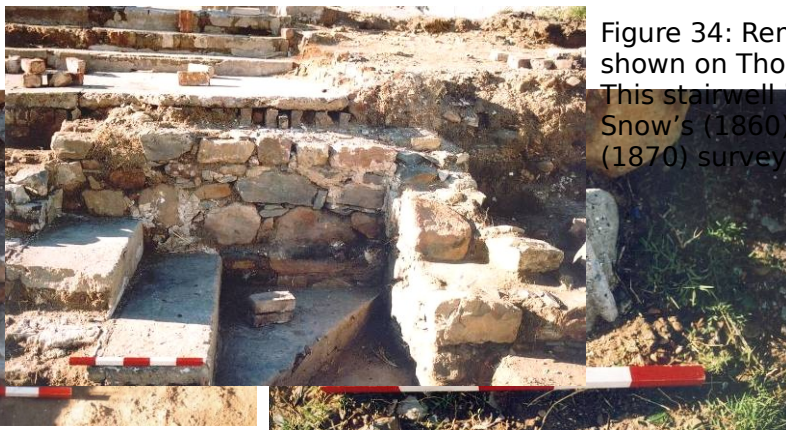
Figure 34: Remains of stairwell shown on Thom's survey of 1898. This stairwell is not shown on Snow's (1860) nor on Wilson's (1870) surveys of the same area.

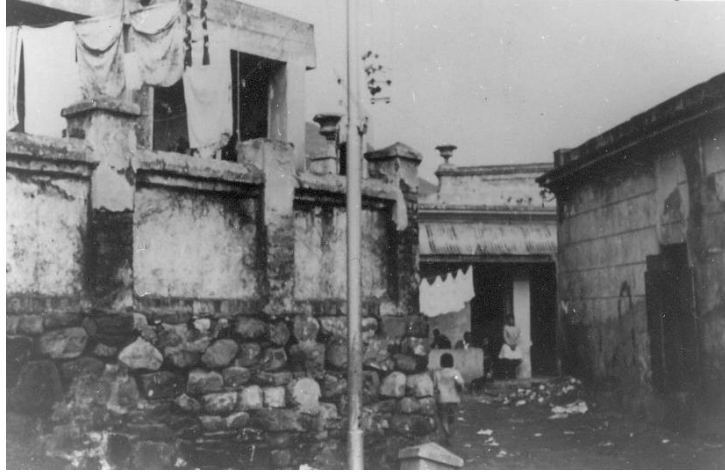
Figure 37: Oblique view of the NW corner of the Welgelegen dwelling. The stone walling of the Stoep Area II is shown with its brick and mortar walling. The building in the background is part of a row of semi-detached cottages facing onto a lane giving onto Mount Street. (Cape Archives AG17606).

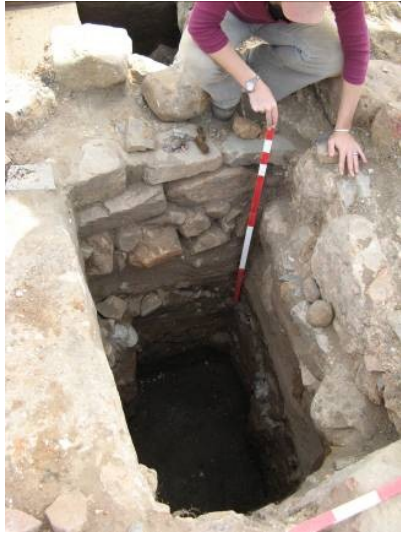
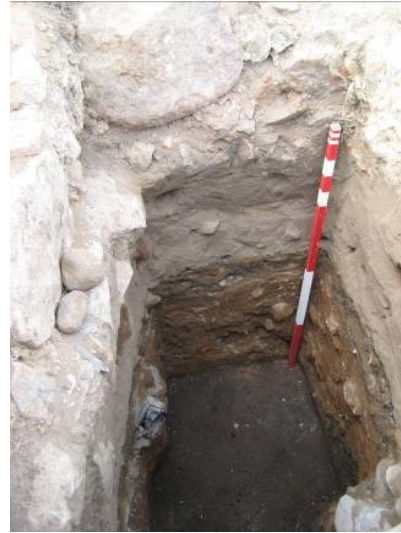
Figure 39 and 40: Northern and southern sections of the test pit respectively. The dump continues to the east, the south and the west, but was not found in any of the test pits to the north of Wall 7.

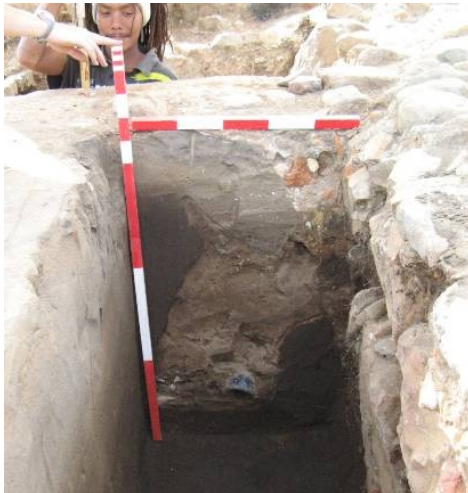
Figure 41: Eastern section of the test trench to locate the western most extent of the dump. The edge of the pit is clearly visible in the section.

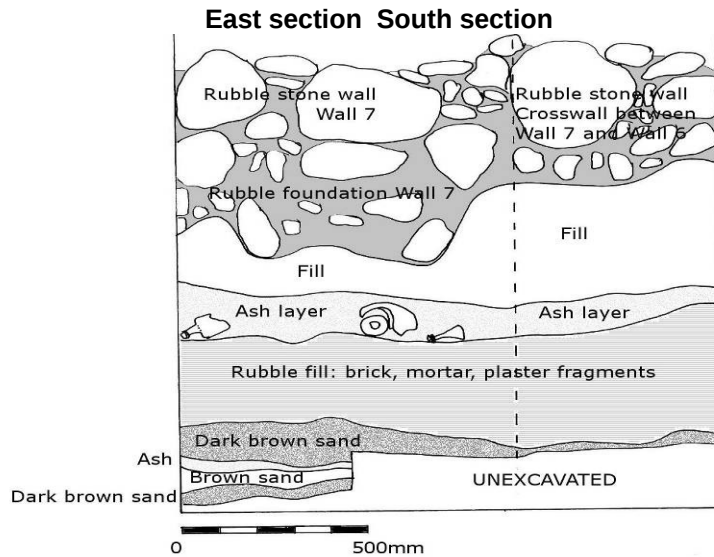
Figure 42: Section drawing of the eastern and southern sections of the test pit in Rm9A

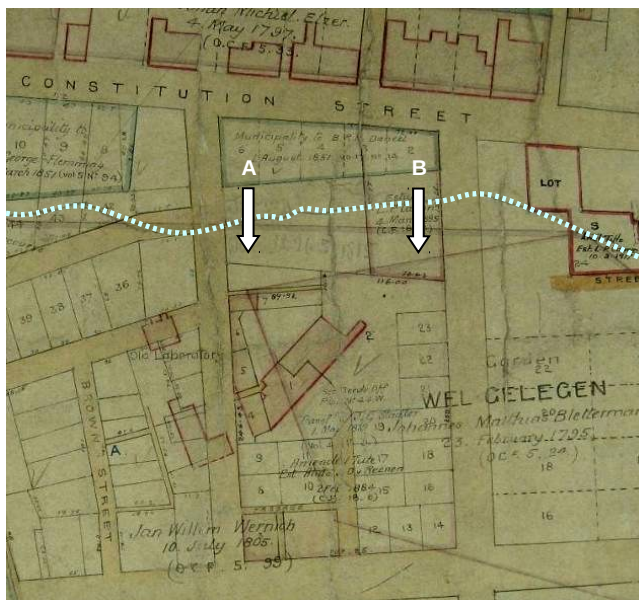
Figure 43: Detail of a map of Cape Town c1910 showing the subdivision history of the town (CA M4/12).

The alignment of the stream/furrow is highlighted. A more regular watercourse was shown in Snow's survey of 1860, but is not shown on Thom's survey c1898. The drain is situated just to the SW of the furrow.

Test trenches were dug on either side of the substation to try and locate the remains of this water feature. These test trenches were dug using a mechanical excavator and then by hand. The location of the test trenches are shown on Figure 43.

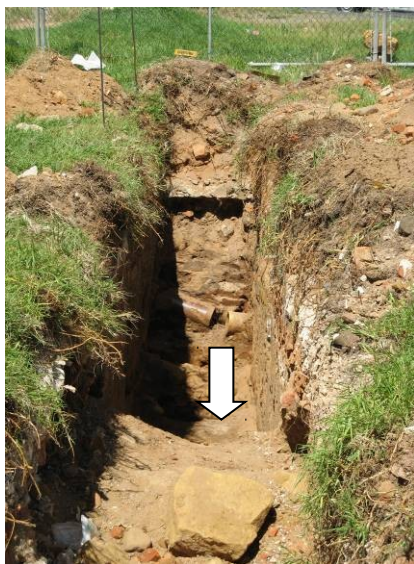
Figure 44: Test Trench A: the arrow shows the position of the streambed, and the position of the test into the cobble bed (Photo taken facing west/southwest).

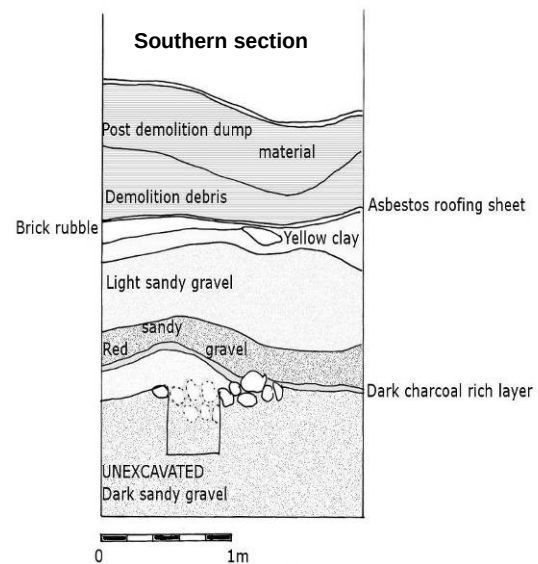
Figure 45: Section drawing of a section of the Test Trench A. The asbestos roofing sheet marks the surface level at the time of the demolitions in the 1970s. Ceramics in the sandy gravels appear to date to the early half of the 19th century. The lack of water wear on the ceramics in this test particularly suggests that the stream may have come down very strongly in winter, washing out the debris.

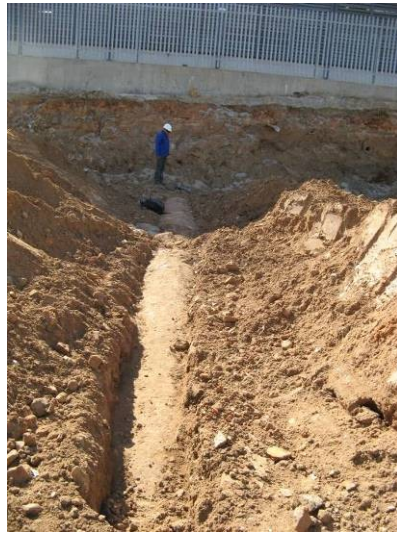
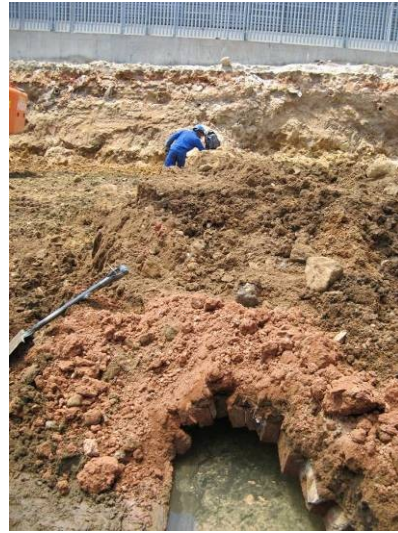
Figures 46 and 47: View of the uncovered drain to the north of the substation (Photos taken facing south). The drain sloped towards Mount Str: this section still containing water ).

During the 2009 monitoring brief, it became clear that the water course shown in Snow's Survey of 1860 was not in fact the remains of the streambed discovered during the course of the 2007 field season, but a constructed drain. The drain was located in the *in situ* yellow clays lying closer to Constitution Str and was just missed

during the test trenching of 2007. The drain continues NW direction underneath the present Mount Str. A section is also preserved intact underneath the electric substation.

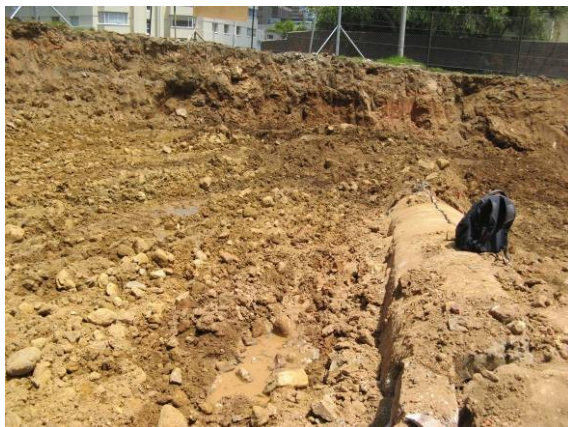
Figure 48: View of drain to the north of the substation (facing towards cnr Mount and Constitution Streets). The in situ yellow clay is clearly visible. The ground water is very high, possibly a result of the spring water no longer draining naturally nor through the constructed drain.

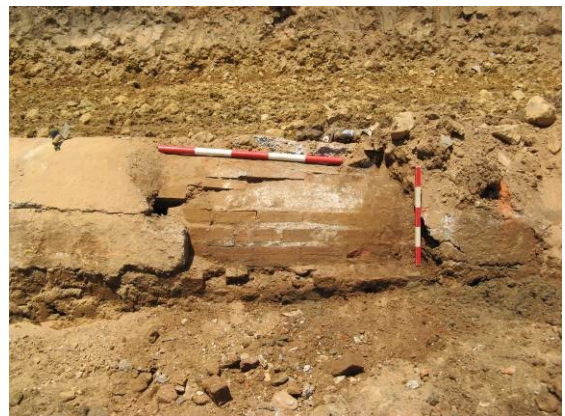
Figure 49: Detail of the drain to the north of the substation. 19th century brick with clay mortar, covered by a thick layer of coarse cement characterises the drain.

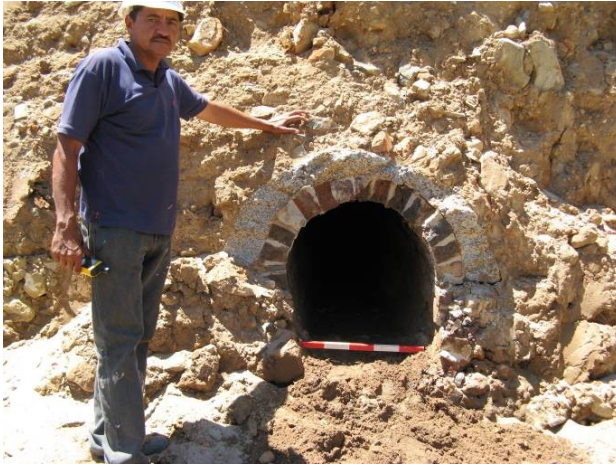
Figures 50 and 51: Detail of the drain to the north of the substation. Image on the right showing detail of the interior of the drain.

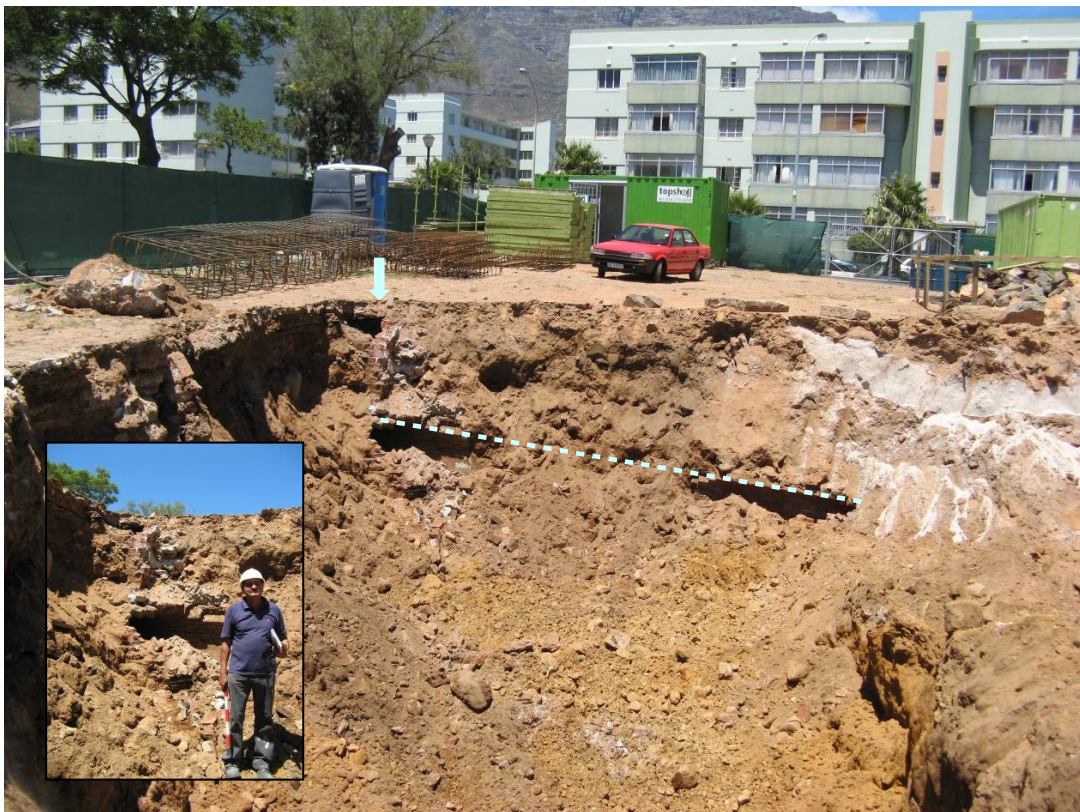
Figure 52: Location of the drain on the southern side of the substation. Top of the drain is highlighted by dashed line. The arrow shows the location of a stop point in the line (Detail shown on insert and Figures 53 and 54).

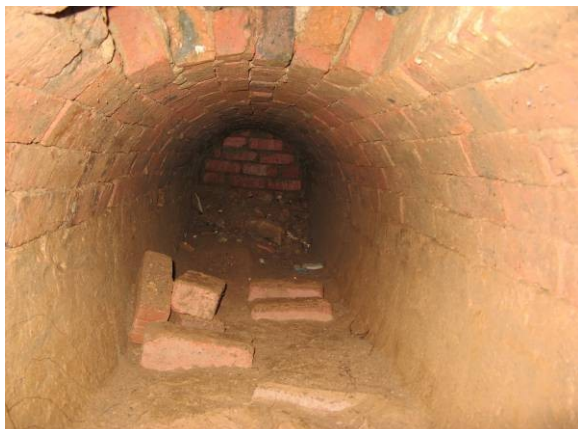
Figure 53: Detail of the stop point.

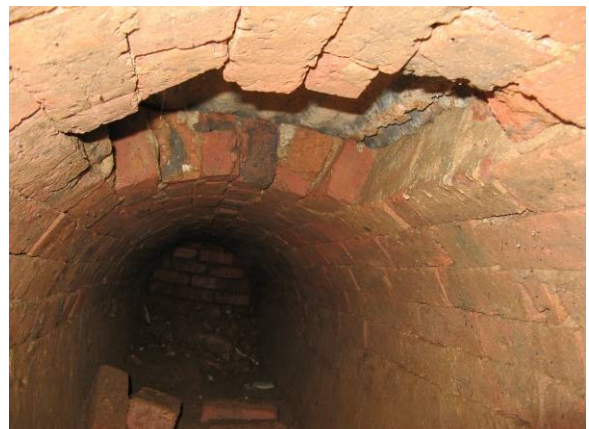
Figure 54: Repair in the same section of the drain in the form of a corrugated iron patch on the exterior.

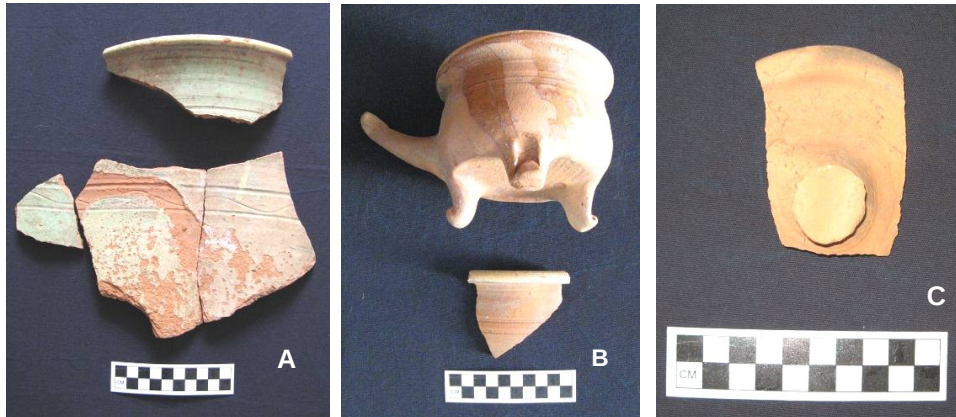
Figure 55: Examples of European coarse earthenwares. 'A' is a possible water storage container, which was found in the kitchen midden. 'B' was found in the fill of Stoep 1. 'C' was found in the test trench along Wall II.

A very small sample of coarse earthenware was recovered from the site, and consisted of the remains of small cooking pots, a small bowl and what appears to be a water storage container. According to Jane Klose (pers comm. 2009), the earthenware appears to be European made and dates to the 18<sup>th</sup> century.

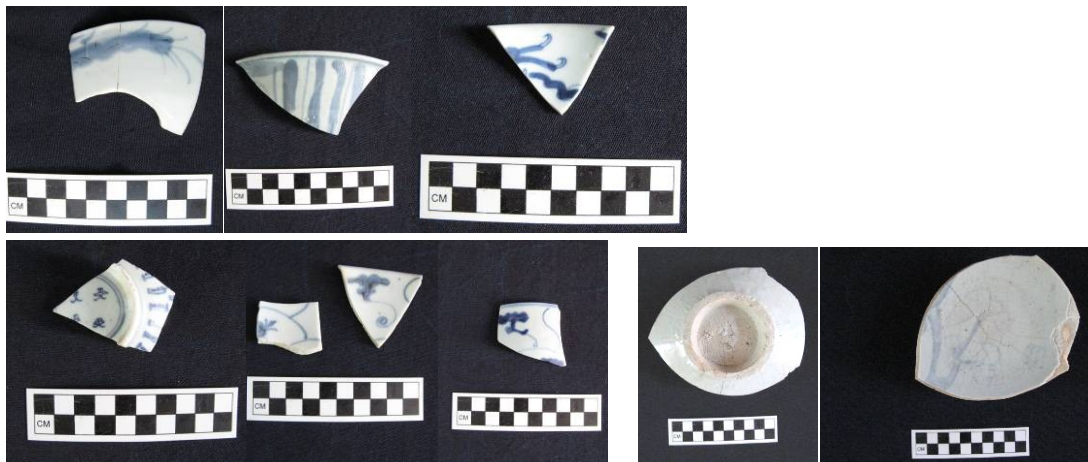
Figure 56: Asian market porcelain bowls/cups and a platter. In Cape contexts, these are usually, but not exclusively, associated with the poorer classes (servants or slaves). The first three examples are typical of an 18<sup>th</sup> century assemblage, the following three of a 18<sup>th</sup> to 19<sup>th</sup> century assemblage. The last two plates are the different sides of the same platter.

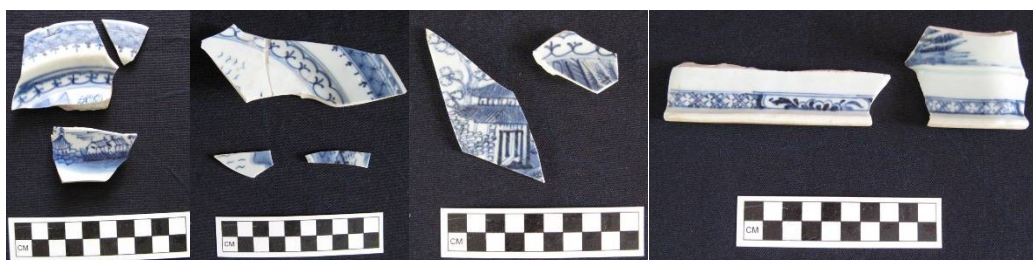
Figure 57: Export market Asian porcelain. First three examples are of plates, while last is of a serving dish/tureen.

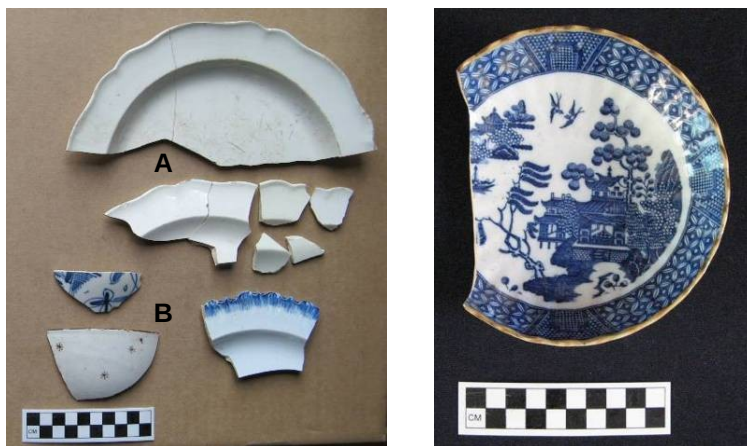
Figure 59: British refined earthenwares from the kitchen midden. (A) identifies the creamware collected during the monitoring brief, while (B) identifies the pearlware. Image on the right is a pearlware Willow Pattern saucer/small plate with a gilt edge (unmarked).

Pearlware and Creamware (late 18<sup>th</sup>/early 19<sup>th</sup> century) were only found in the kitchen midden; confirming a late 18<sup>th</sup>/early 19<sup>th</sup> century deposition date. During the monitoring brief, additional material was collected from the midden site (deposit run through a sieve).

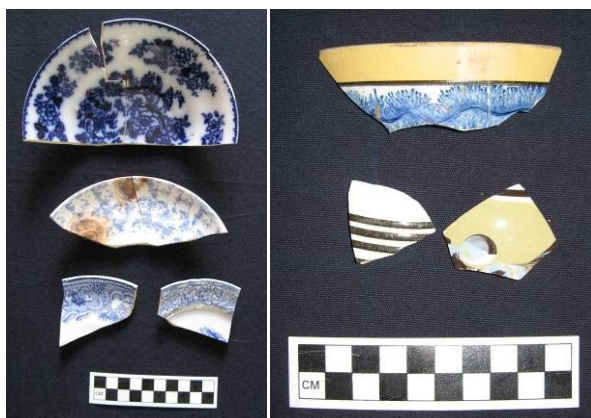
Figure 60: REW single colour transfer print and Industrial slipware (Banded and Cat's eye) were found in primary context in the remains of the stream bed uncovered in Trench A (Figure 45).

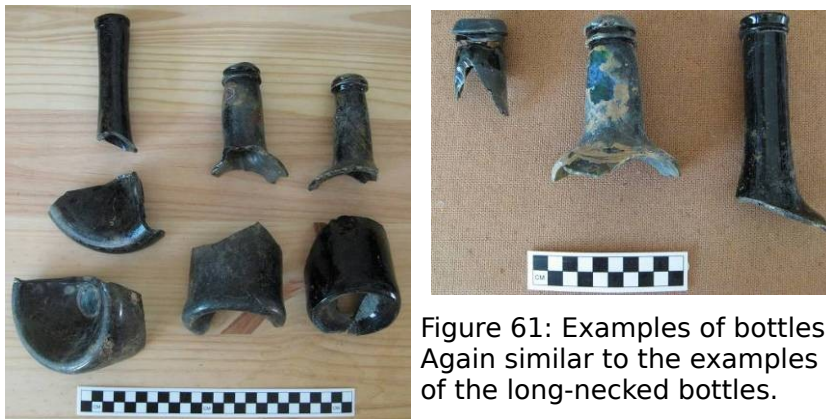
Figure 61: Examples of bottles from the kitchen midden. Again similar to the examples above, but with 2 examples of the long-necked bottles.

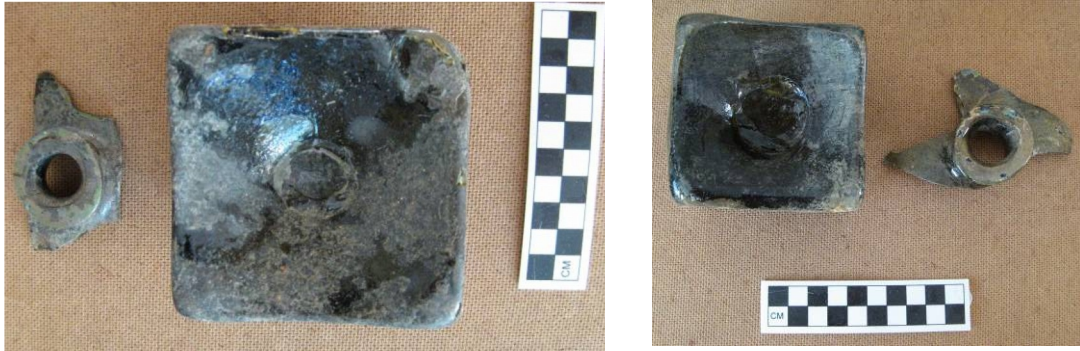
Figure 62: Examples of casement/ginger bottles. The example on the left is from the kitchen midden, and the example on the right from the area to the west of Stoep 1.

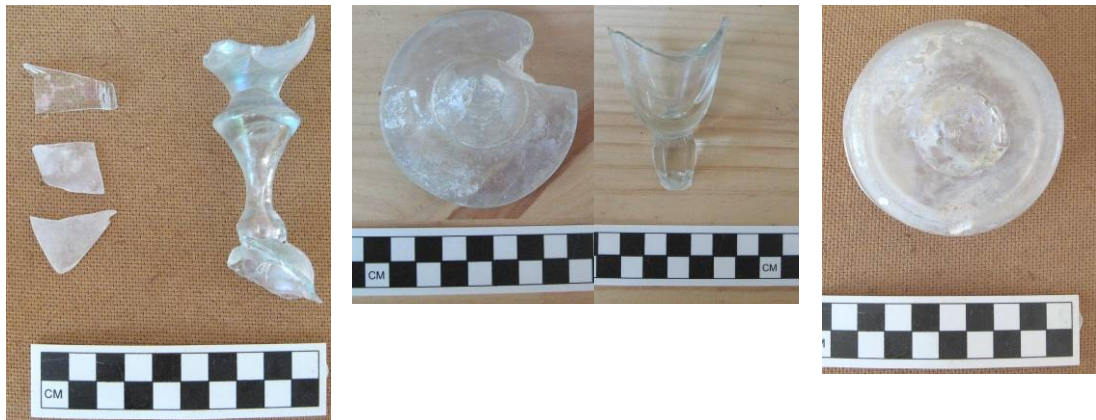
Figure 63: Examples of tableware (essentially wine glasses) from the kitchen midden, the area to the east of Stoep 1 and the area to the west of Stoep 1 (from left to right). The tableware from these locations have been exclusively wine glasses.

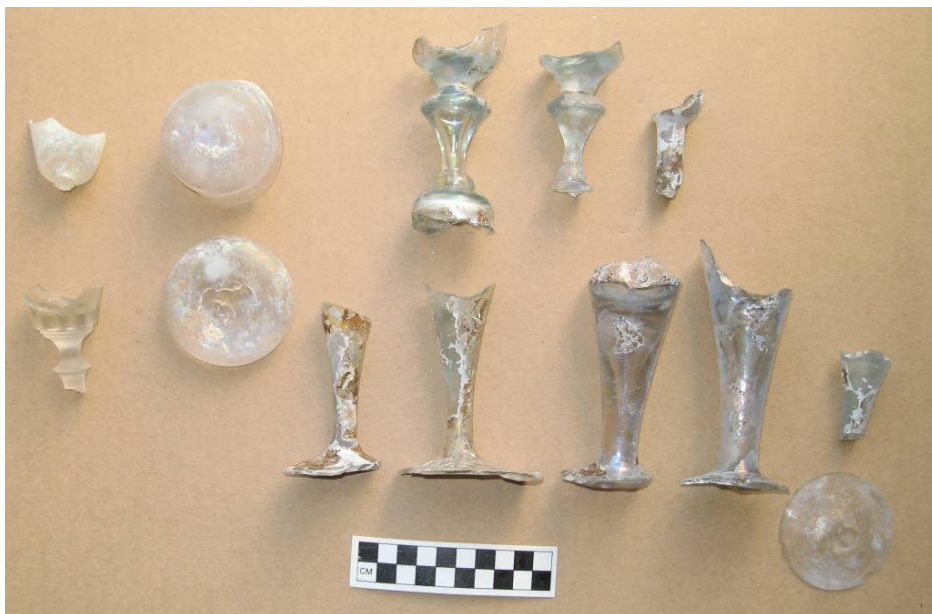
Figure 64: Additional tableware collected during the monitoring brief. With the exception of the fragments of the two glasses on the far left, all the glass in this image was found in the kitchen midden.

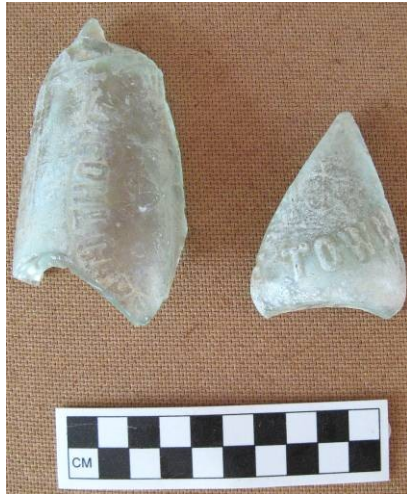
Figure 65: Fragments of Codd mineral water bottles. The bottle on the left was manufactured by Thomas Mullival, a Cape Town based firm established in 1850. The trademark clover leaf is visible. The bottle on the right faintly shows the embossed anchor of the Neptune trademark of Daly & Day, another Cape Town based firm established in c1880 (Lastovica 1990:82-83).

These fragments were found in the upper layers of the test pit in Rm9A (location of the kitchen midden). They were most likely introduced into the deposit during the construction of the southern portion of the dwelling. These shards are considerably younger than the other artifacts found in the kitchen midden.

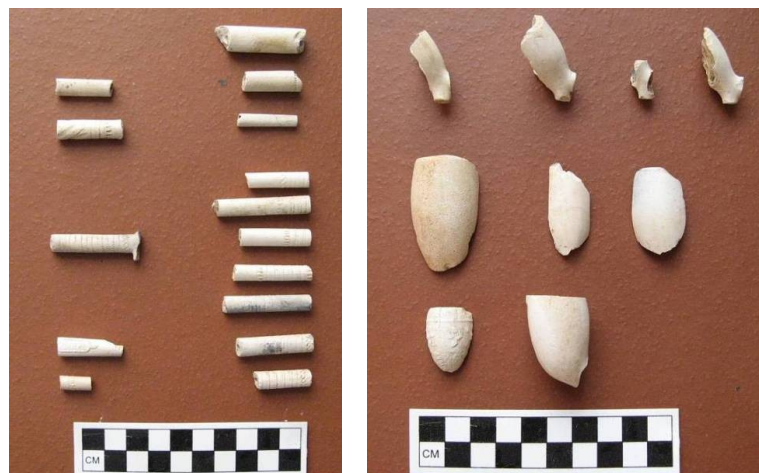
Figure 66: Clay tobacco pipes. Selection of decorated stems on the left and the range of bowls on the right. The pipe stem second from the bottom left was made by White

of Glasgow<sup>5</sup>. The top row of pipe bowls are typical 17<sup>th</sup>/18<sup>th</sup> century Dutch bowls, while the remainder are more typical of the British period (19<sup>th</sup> century).

The clay tobacco pipe assemblage for this site is relatively small, the total number of artefacts being 115 (plus 52 fragments collected from the kitchen midden during the monitoring brief). Three fragments with heel marks were recovered, all of these associated with the original core of the house: two interior and one exterior (Plate 50). Two fragments with marks of the side of the heel were recovered during the monitoring brief (Plate 51). Relative dating with such a small sample is problematic, but the evidence does point to the core of the structure being constructed during the first half of the 18<sup>th</sup> century.

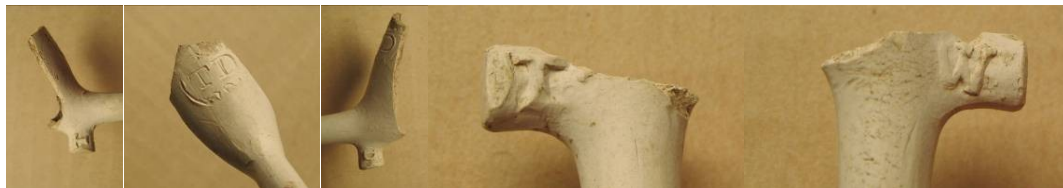
Figure 68: English manufactured clay tobacco pipes from the ash midden. The example of the left (TD). The shape of the bowl is consistent with the typology identified for the period 1780-1820 for British manufactured pipes, and can possibly be associated with the pipe maker Thomas Duggan. Duggan operated in the period 1805 - 1825 (Pearce pers comm. 2010).

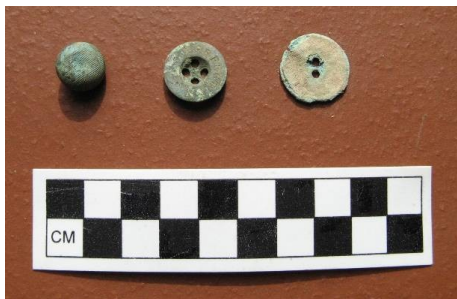
Figure 71: Metal buttons.  
Relatively few metal buttons were un-covered. The button, far right, appears to have been covered with fabric.

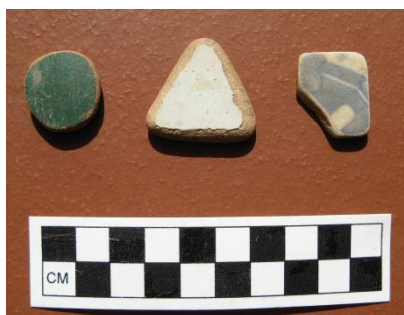
Figure 72: Modified ceramics.

In addition to scores of marbles (stone, Codd bottle stoppers and traditional glass) and the shells discussed in Section 3.3.6, a number of gaming tokens have been recovered. These modified ceramics (Figure 72) were not found in primary contexts. The gaming pieces are found commonly in the archaeological record into the late 19<sup>th</sup> century (Jordon 2005). A number of small white stones were also found, and which may also have been 'gaming tokens' used a game called 'klippies'<sup>7</sup>, still played today. The domino and checkers pieces probably need no explanation (Plates 73 and 74). The Shell airline insignias (Figure 75) was a promotional gimmick of the 1970s.

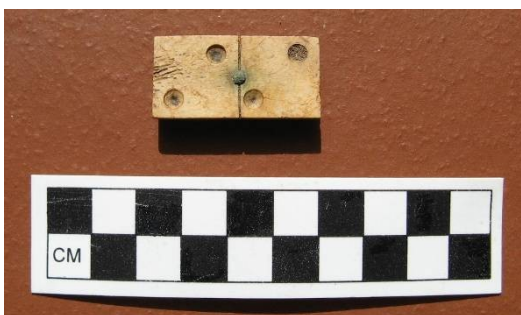
Figure 73: Domino

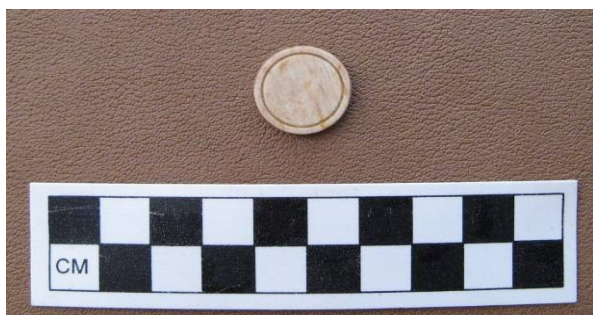
Figure 74: Checkers insignias.

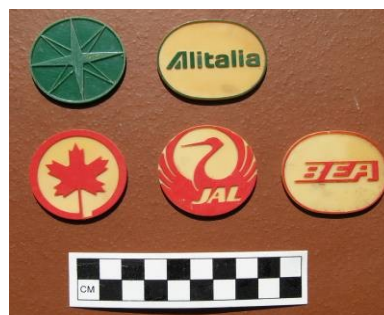
Figure 75: Shell collectables: Airline

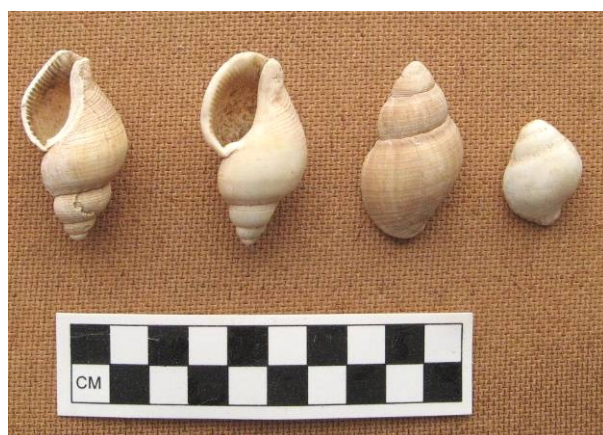
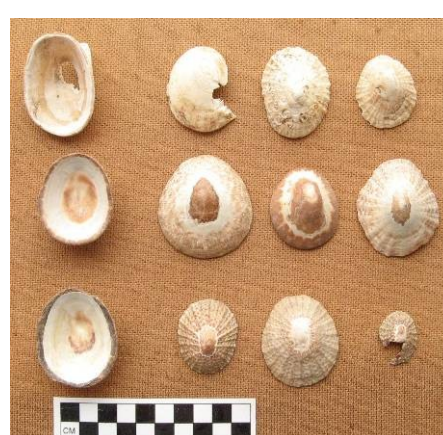
Figure 77: Wear on shell suggesting use as gaming pieces.

Some modified shell was found in the fill above the slate paved surface to the east of the early/mid 19<sup>th</sup> century dwelling. Wear on the base of the shells suggests that they may have been used as pieces for a board games such as checkers: whelks vs limpets. The limpets were found in the deposit nested one inside the other.
