**FINAL REPORT**  
**PHASE TWO ARCHAEOLOGICAL IMPACT ASSESSMENT**  
**ERF 110460, CAPE TOWN -**  
**PREVIOUSLY THE GARDEN WELGELEGEN**

(HWC Ref No C13/3/6/2/1/1/1/A1 Permit No 2006-10-002)  
Permit extended 1 October 2008 and renewed 3 November 2009

**14 December 2011**

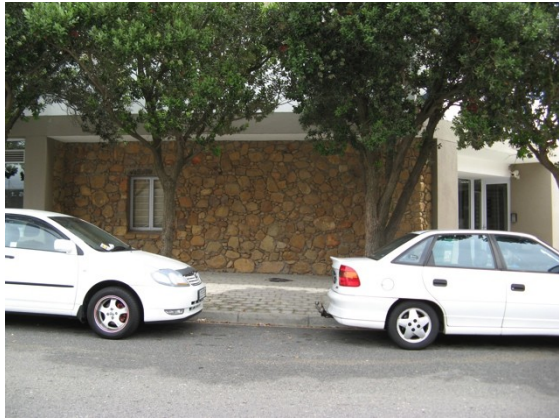
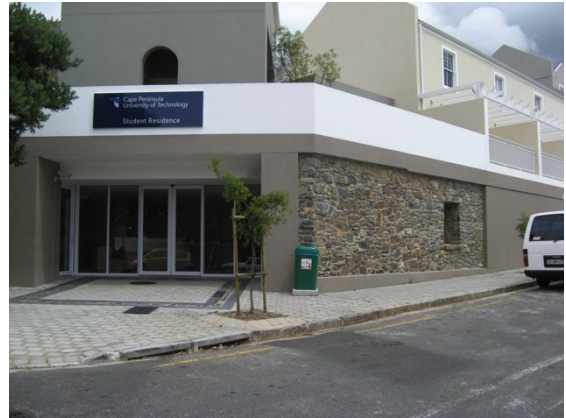
Figure 78: The entrance on the corner of Caledon and Primrose Streets.

The cobble/rubble wall (although not coursed) represents the 18<sup>th</sup> century historic core of the Welgelegen dwelling, with its distinctive large cobbles and smaller filler stones. The slate wall on the Primrose Street represents the 19<sup>th</sup> century additions.

The main entrance has two flanking walls which mimic the historic stone building styles (Figure 78).

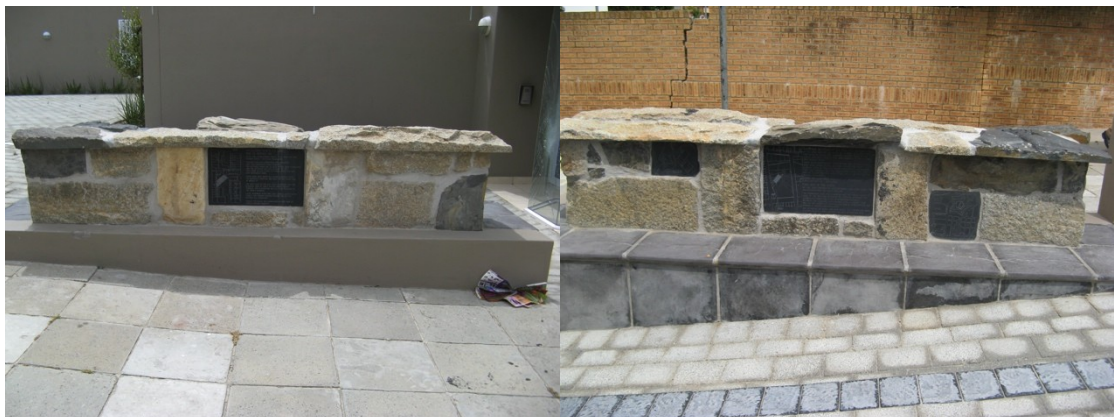
Figure 80: Engravings at the Constitution Street entrance set in plinth constructed from

stone from the site: granite curbstones from the old Vernon Terrace and slate blocks from the 19<sup>th</sup> century stoep extension. The text boxes are shown in Figure 82.

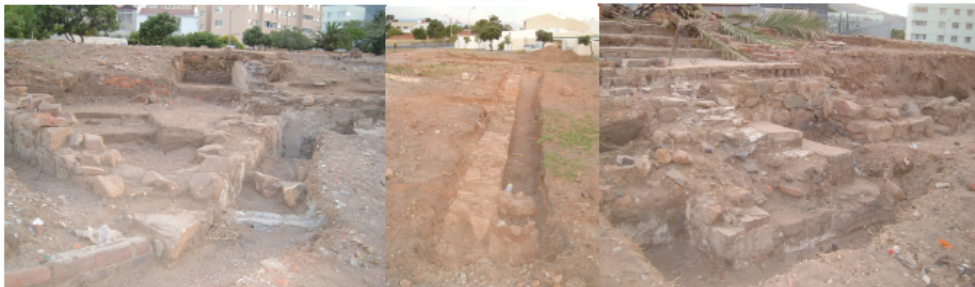
Photographs taken during the archaeological excavation (colour references refer to coloured map above).

From L to R: corner coloured purple, wall between yellow and green areas (looking to Vernon Terrace st), steps and two stoep walls (Skyways RHS of background)

Figure 83: A3 poster to be located in the basement parking area. The footprint of the building was marked in the basement floor surface at the exact location where it stood prior to demolition.

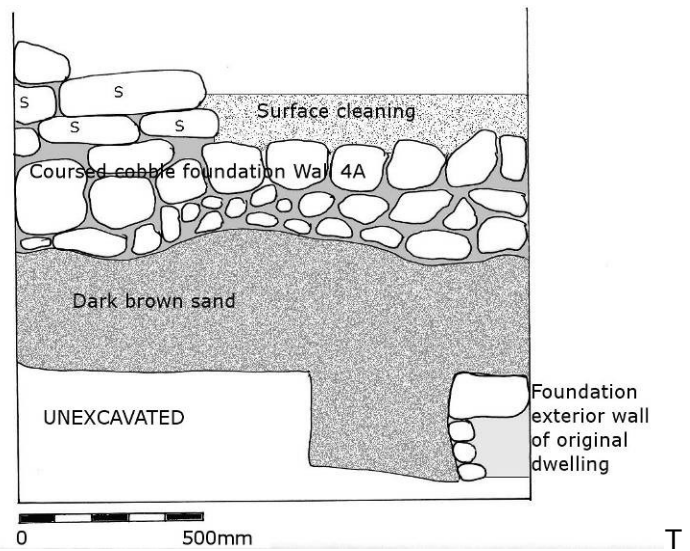
Test pit Rm4 NE cnr - northern section (S = T)

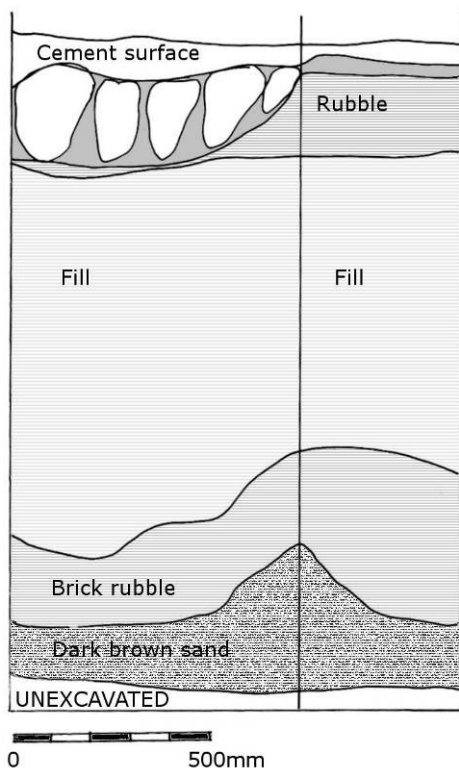
Test pit (2) under cobble courtyard (northern and eastern sections)

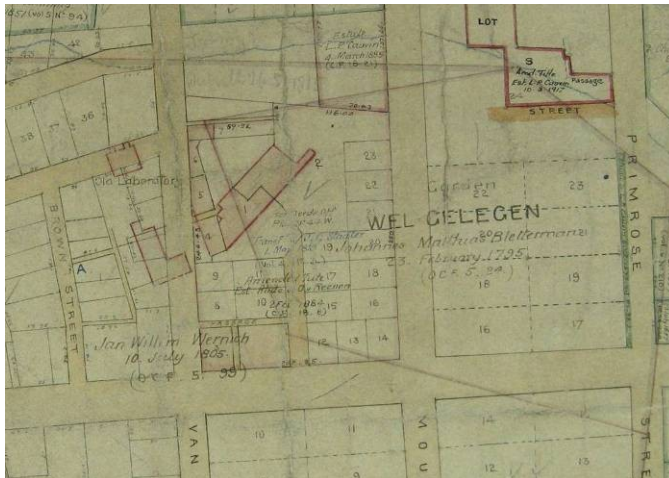
Detail of map of Cape Town (CA M4/12 c1910) showing the city grid onto the earlier cadastral boundaries of the market gardens. The homestead is shown divided into two portions, while Thom's survey shows the homestead divided in three portions.

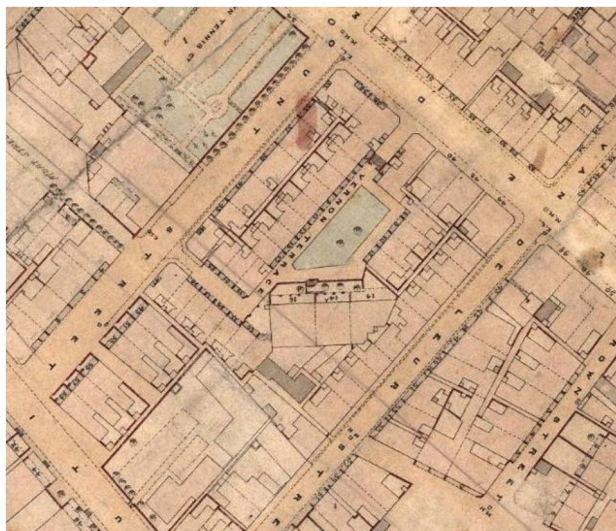
Detail of Thom's survey of Cape Town c1898, showing the block on which the Welgelegen farmhouse was situated. By 1898 the area is densely developed.
