**HERITAGE BASELINE AND SENSITIVITY
ASSESSMENT, CATO RIDGE, ETHEKWINI
MUNICIPALITY, KWAZULU-NATAL**

March 2021

**FOR: Zutari (Pty) Ltd
 Jeanne-Louise Wiese**

**AUTHOR: JLB Consulting
 Jean Beater**

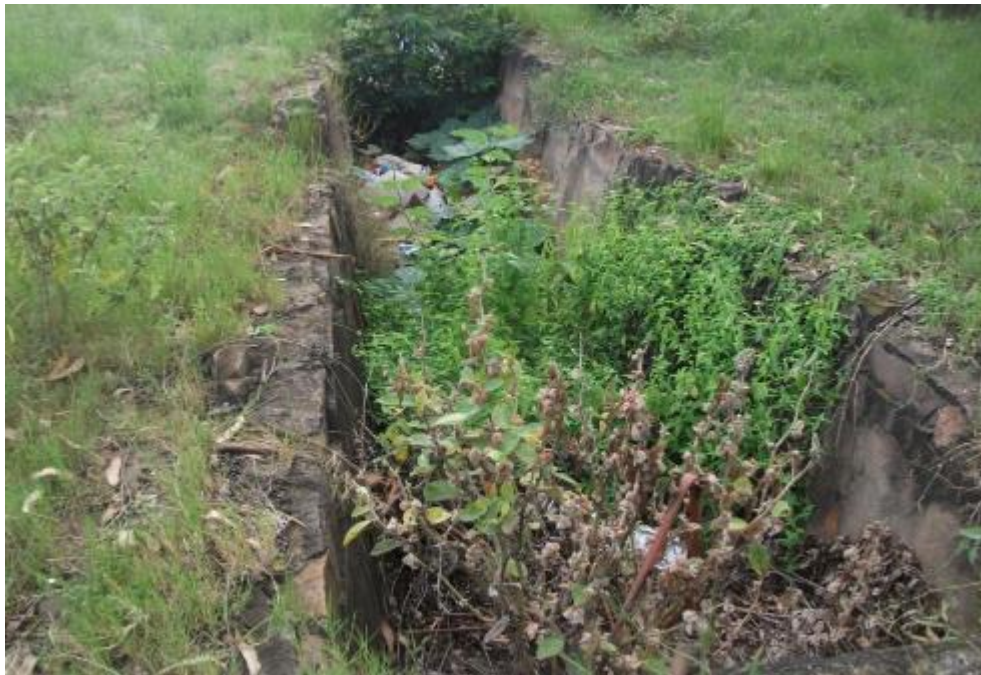
Figure 5: Cattle dip

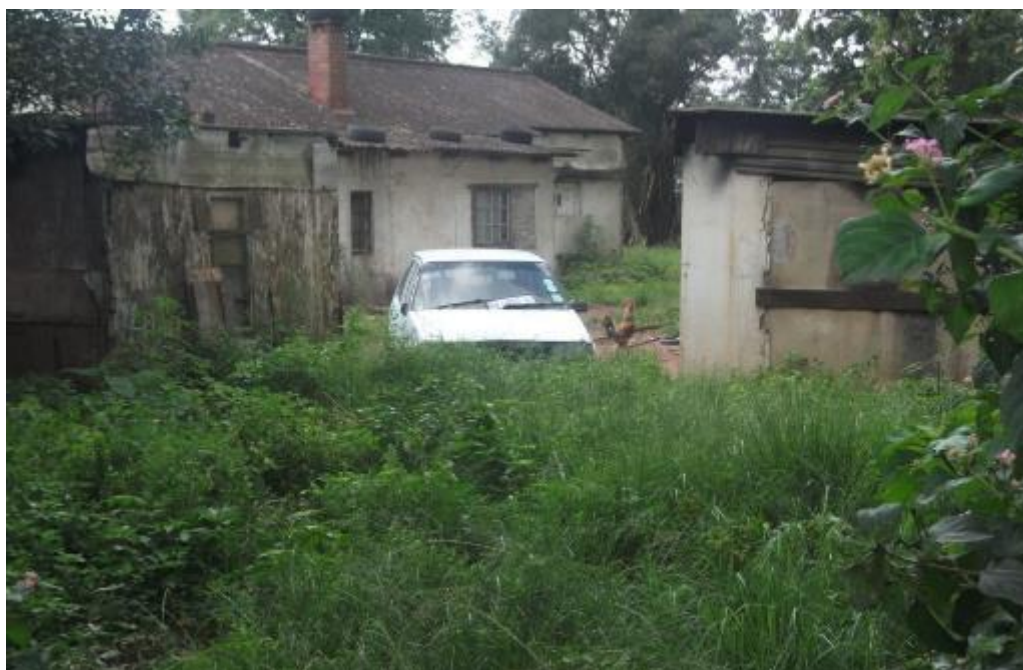
Figure 6: Farmhouse and associated buildings

Description	Coordinates	Significance	Mitigation
Farmhouse and other structures (Figure 5)	29°42'06.3" S 30°37'46.6" E	>60 years, high heritage significance, the structures are occupied & there is high potential of graves associated with the structures	Leave structures & graves <i>in situ</i>
Remains of structure, could be associated with farmhouse	29°42'05.4" S 30°37'45.5" E	>60 years; low heritage significance unless graves found in area	Can be demolished once permit received from Amafa once it is established that there are no graves in the surroundings
Remains of structure, could be associated with farmhouse	29°42'05.0" S 30°37'45.3" E	>60 years; low heritage significance unless graves found in immediate area	Can be demolished once permit received from Amafa once it is established that there are no graves in immediate surrounds
Remains of floor of structure	29°42'19.4" S 30°37'31.3" E	>60 years as 1953 aerial map shows buildings that appear to be a farmstead; low heritage significance but if there are associated graves then high heritage significance.	Can be demolished once permit received from Amafa once it is established that there are no graves in the surrounding area

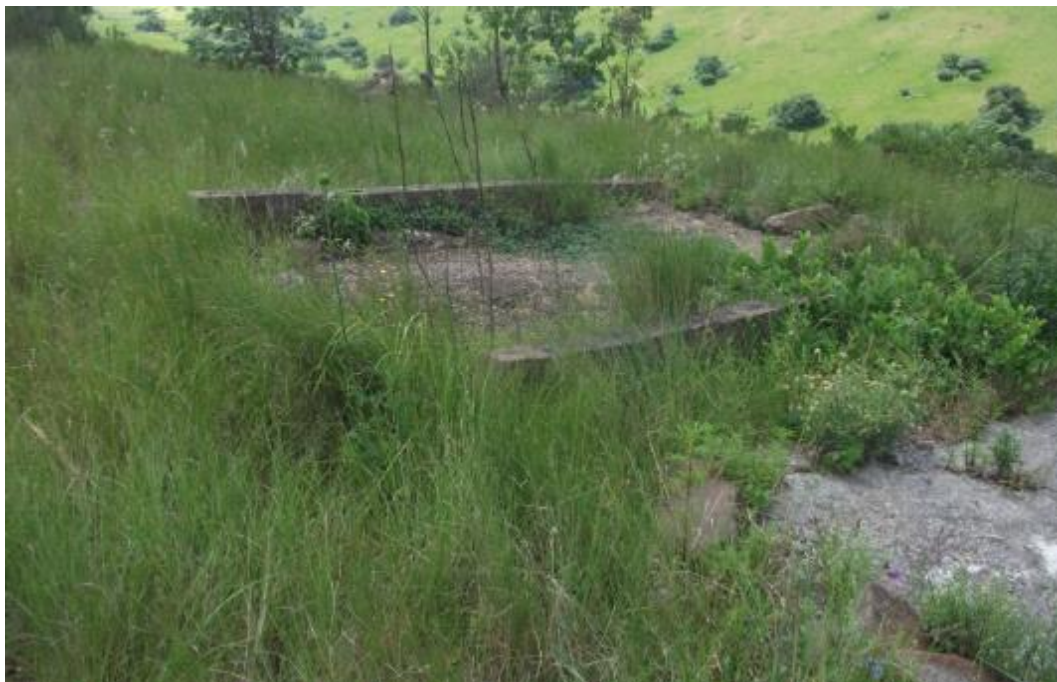
Figure 7: Graves

- It is recommended that a buffer of at least 10m be placed around heritage sites of high heritage sensitivity such as graves, structures, etc., to ensure that during construction and maintenance activities these sites are not disturbed.

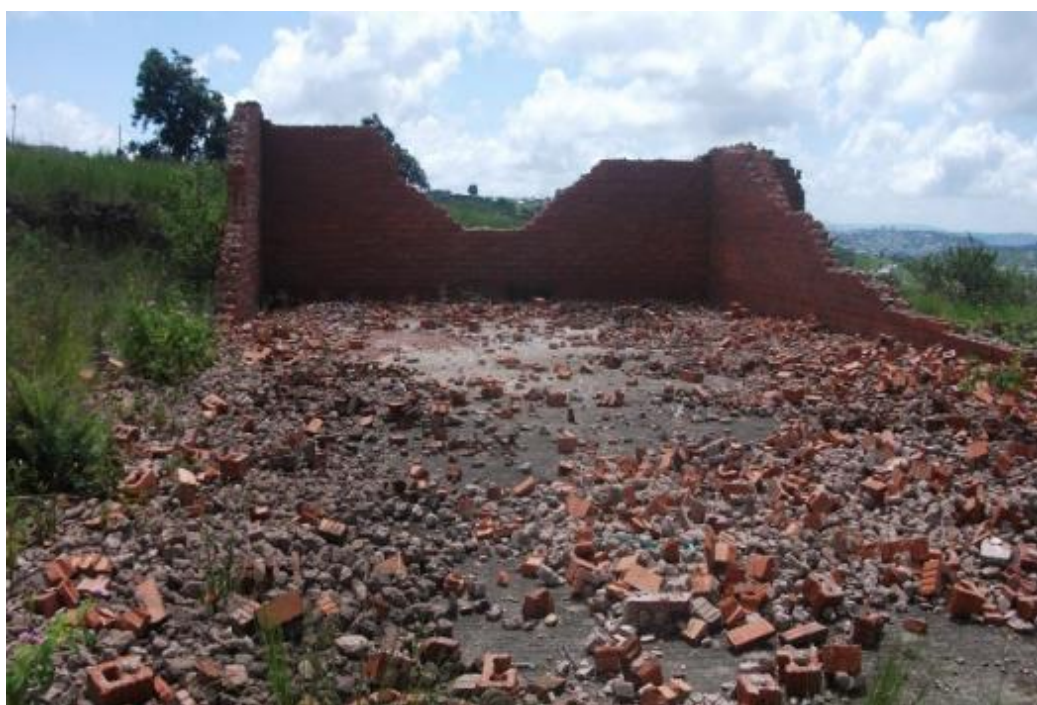
Figure 8: Remains of homestead associated with above graves

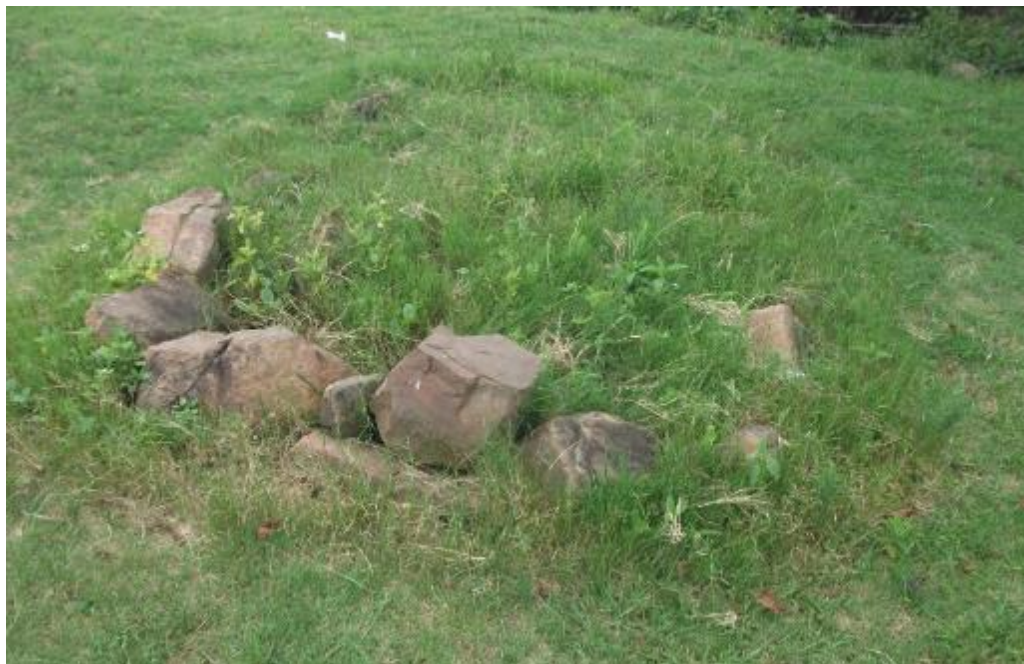
Figure 9: Grave within homestead complex

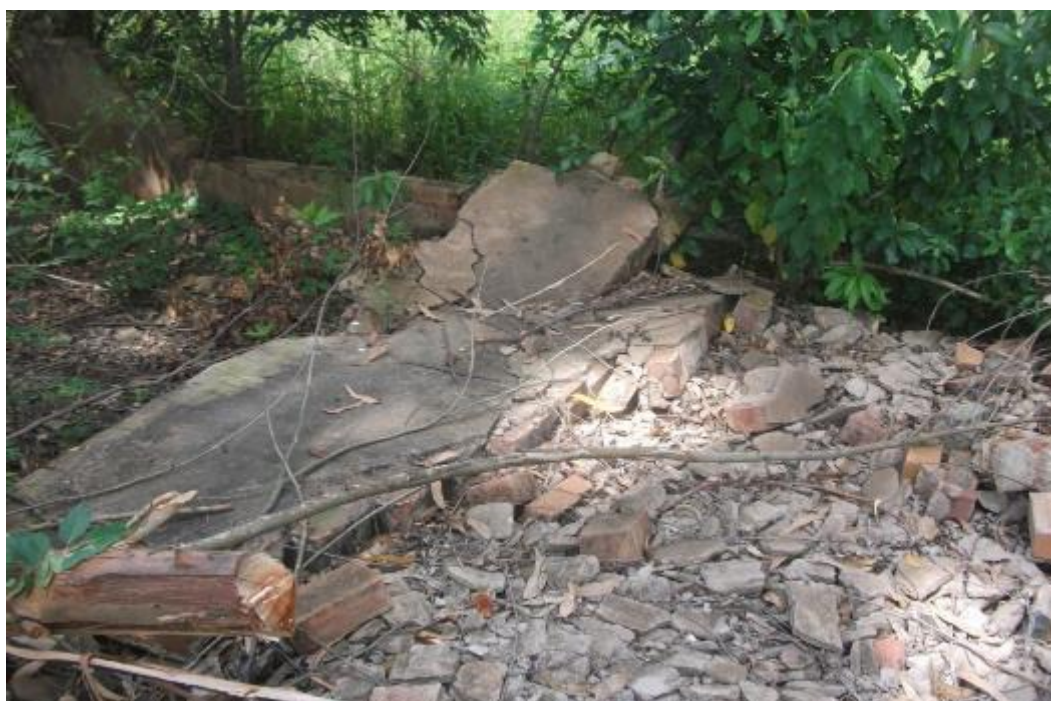
Figure 10: Remains of structure/dwelling
