**Rescue excavation and recording at Erven 1258 and 1263,
Simonsplein, Stellenbosch
September/October 2003**

HWC Permit No: 2003/09/APM 001

April 2004

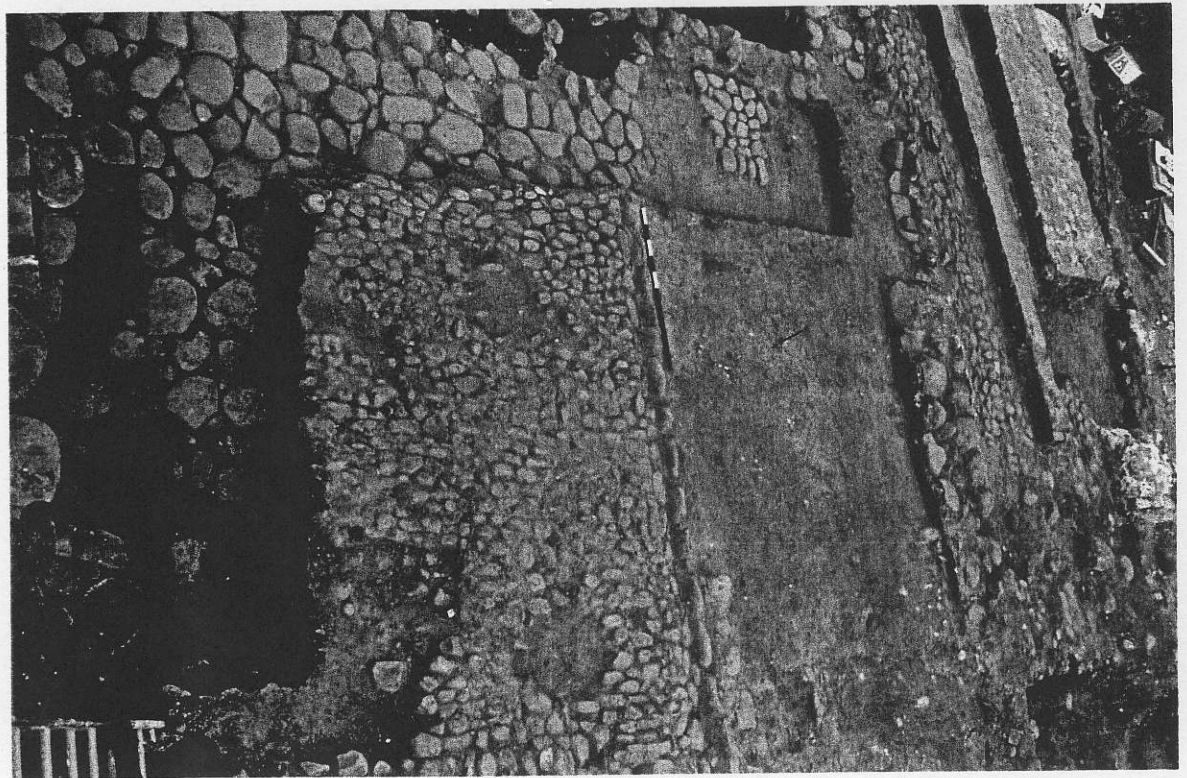
Photograph 4: Detail of the cobbled floor surfaces in Room 2

The remains of two cobbled floor surfaces were uncovered in Room2. A large cobble floor, about 0.55m below the surface, seemed to be contemporary to the late 18th century foundations which enclosed it (Photograph 4). A small test section dug underneath the large cobble floor unearthed some Chinese porcelain, but no refined earthenware, confirming this date.

A floor surface, consisting of smaller cobbles packed in a distinct linear pattern was situated above the large cobble floor, 0.3m below the surface (Photograph 4). The inclusion of pearlware and cream coloured ware in the ceramic assemblage sandwiched between these two floor surfaces suggests that the second floor surface was laid down in the early half of the 19th century.

Well S6 (to the right of the wheelbarrow in Photograph 4), also cobble lined, contained a large proportion of bottles, mostly mineral water bottles. The northern section of the well had collapsed at some stage and may provide the reason for its use as a dump.
