Bethlehem, Dwarsrivier valley, Farm 153 Stellenbosch:
Archaeological exploration of secondary werf and
outbuildings

Prepared for
Reside Properties Pty Ltd
c/o Karin Koep
Farmfrance
Simondium

19 August 2011

Prepared by
Harriet Clift
7 Pypies Plein
Devils Peak
Cape Town, 8001

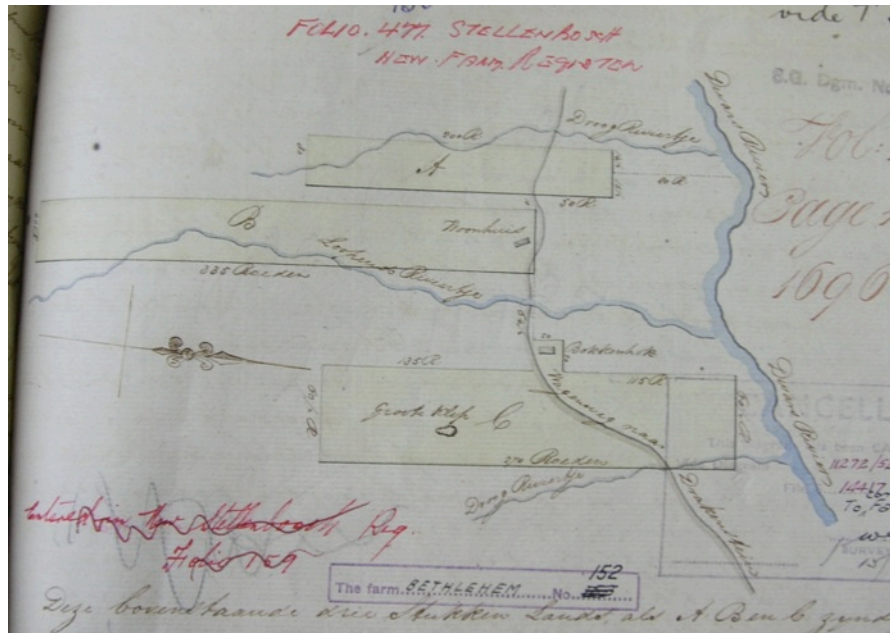
Figure 3: Survey diagram 5/1696 showing the three portions of land included in the Bethlehem grant (OSF 2.421). The diagram shows a *bokkenhok* on Portion C and a dwelling on the northern extent of Portion B. Note the location of the wagon route with regards to the position of the dwelling and the goat shed. The three portions of land roughly align with mountain streams draining into the Dwars River. (North is to the right of the image)

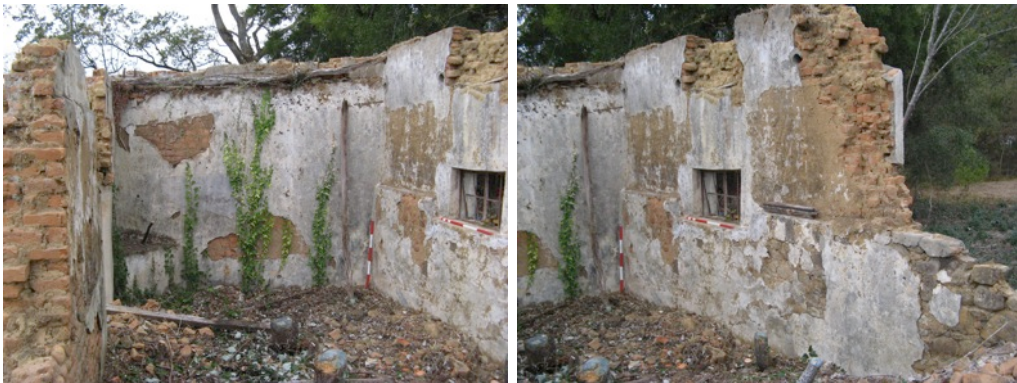
Figure 6: View of eastern room of Cottage 1. The height of the stone walling is clearly visible.

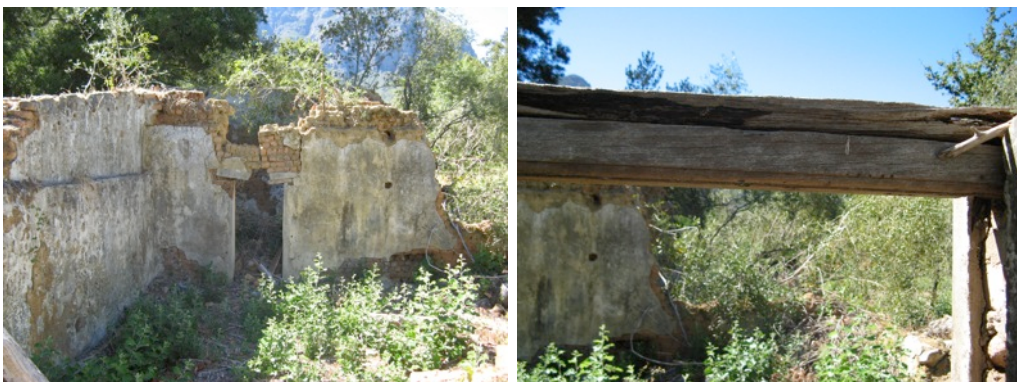
Figure 7: View of northern room of Cottage 1. Again the height of the stone walling is clearly visible. The image on the right shows the detail of the remains of one of the wooden window frames with quarter round moulding.

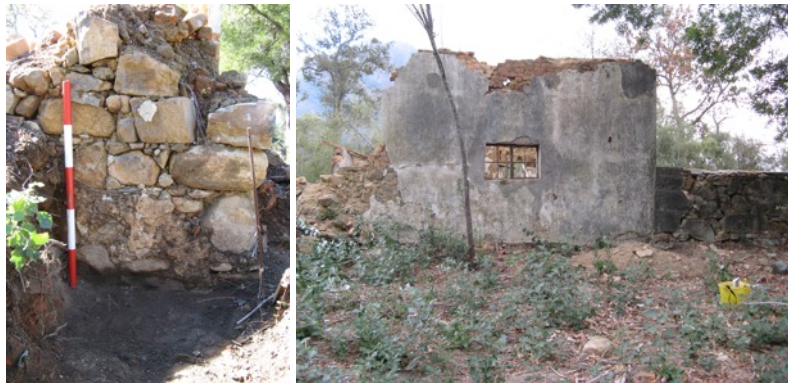
The stone of the foundation/footing extends to a height of 1.3m above the present ground level and approximately 1.5m above the base of the foundations. The foundation appears to be a simple rubble layer. The width of the stone coursing is 500mm. The style of construction (roughly coursed cobbles with mud and lime mortar) is very similar to that of the outbuildings of the historic werf and the werf wall.

Figure 8: Details of the SE elevation of Cottage 1. Image on the left shows the construction style of the stone coursing. Image on the right shows the junction of the foundation of the cottage and that of the abutting stone kraal.

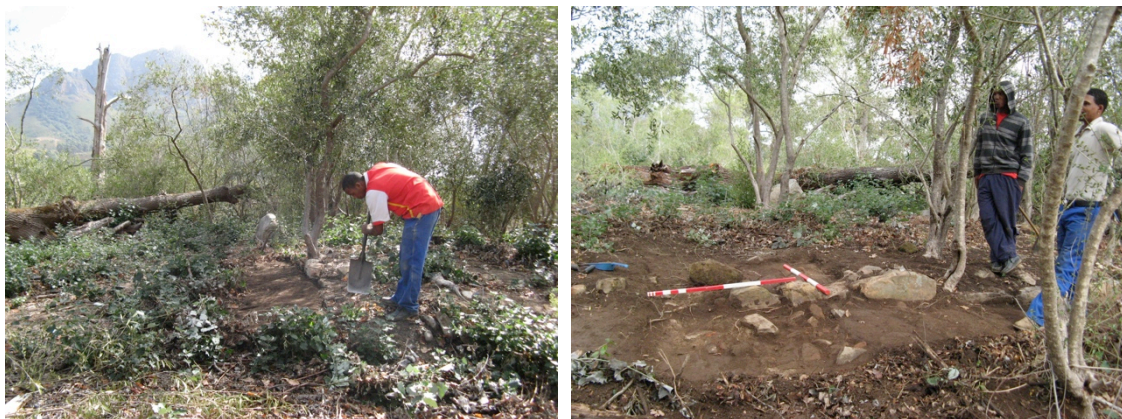
Figure 10: Exposing the footprint of Cottage 2 by Franklin Venneal and Denver Jones. Note the young trees growing over the archaeological remains.

The site of Cottage 2 should be considered a no-go area until further archaeological investigations have taken place and a more complete understanding of this site has been acquired.

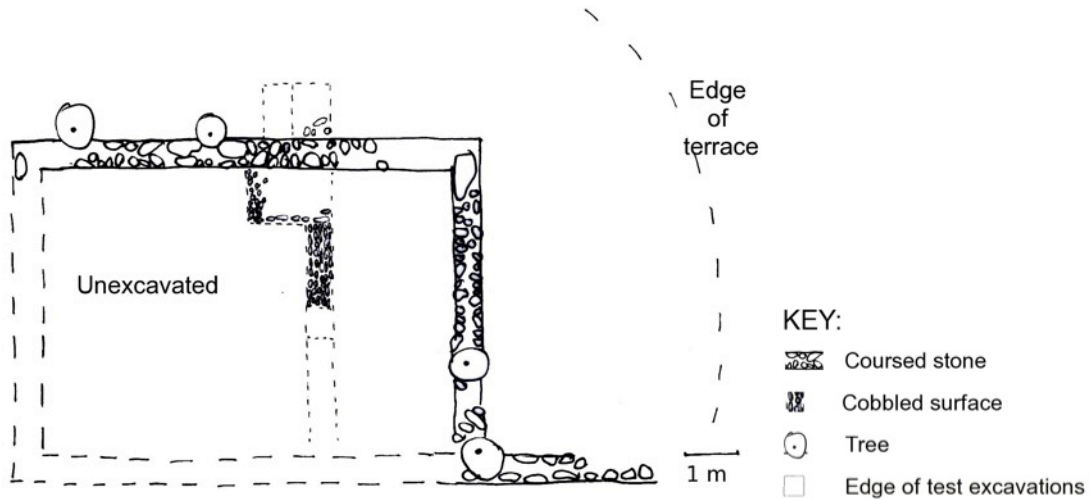
No walls of the cottage have preserved, although some brick fragments are to be found in the surrounding deposit. The foundations are of roughly coursed rubble; larger stones on the outer edge, with smaller stones on the interior. Some of the stones are dressed. The foundations are 550mm wide and extend to a depth of 800mm.

Figure 11: Sketch plan of Cottage 2. (North is to the top left of the figure).

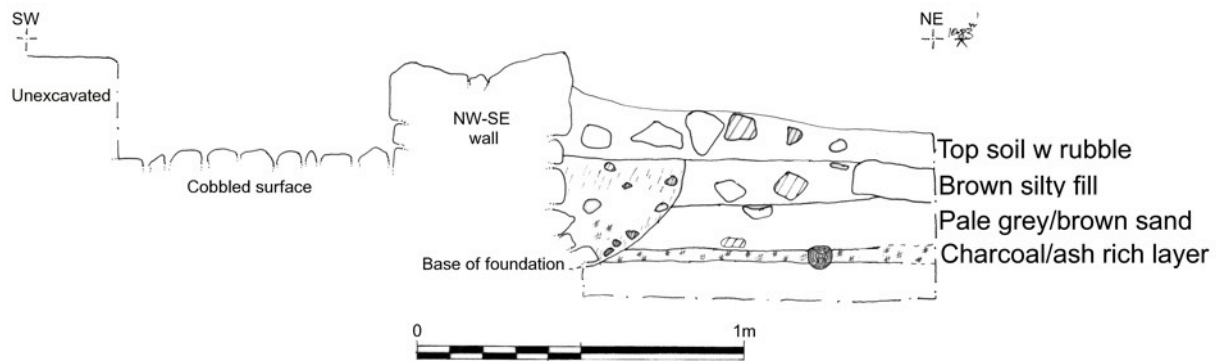
The foundation trench is visible in section (Figure 12) and extends into the natural soil (yellow/brown compact clay-like). The foundation trench cuts through a charcoal/ash rich layer, a pale grey/brown sand layer and a brown silty fill layer with some brick rubble inclusions.

Figure 12: NE facing section across the NW/SE wall of Cottage 2 showing the level of the cobbled floor surface relative to the foundation and construction stratigraphy.

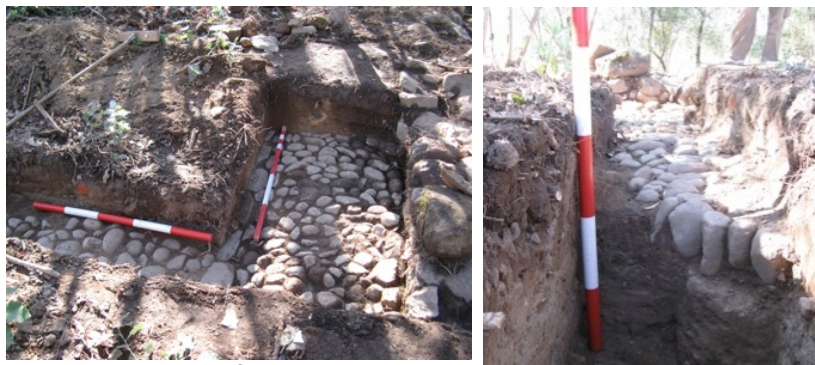
The remains of a cobbled floor surface were found in the interior of the cottage. A packing pattern is visible (Figure 13). There were no artefacts recovered from the deposits below the cobbled flooring, suggesting that this floor was contemporary to the construction of the cottage.

Figure 13: The packing pattern of the cobbles is visible in the image on the left. The image on the right shows detail of the packing method.

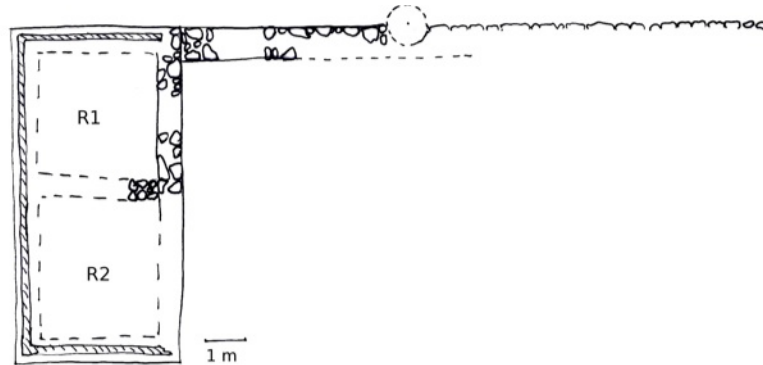
Figure 14: Sketch plan of Cottage 3 (North is to the top right of the image)

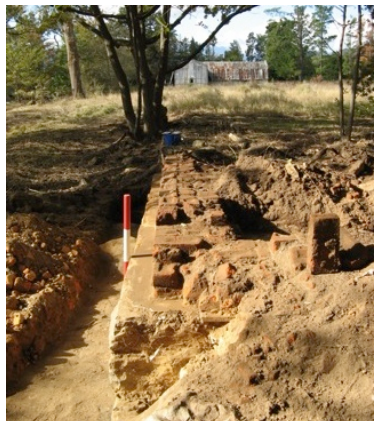
The cottage appears to be constructed on the remains of an old boundary wall, similarly to Cottage 4. It extends for approximately 14m towards the T-shaped wine cellar before traces of it disappears. Only the lower courses of this wall are still visible and it is on the same depth as the foundations of the cottage.

Figure 15: View from the corner of Cottage 3 towards the T-shaped wine cellar.

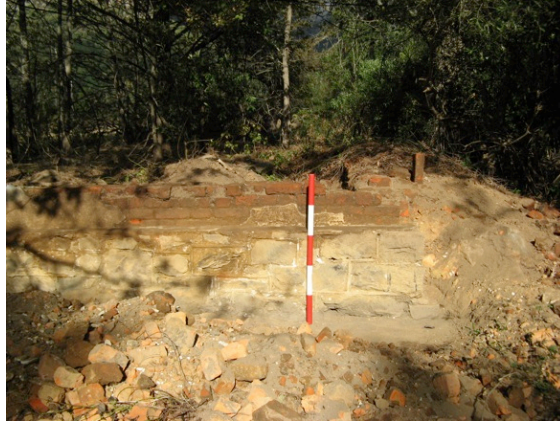
The walls are constructed of soft baked brick with yellow mud mortar on a stone foundation. The brick walling has collapsed and remaining brick is in a poor condition. Bricks are frogged, suggesting late 19th /early 20th century date of construction. The mock pointing dates to 1909.

Figure 16: Mock pointing on Cottage 3. It appears as if the foundation consists of one course of stone. Mock pointing is visible on the remainder of the stone, which would have been exposed above ground level.

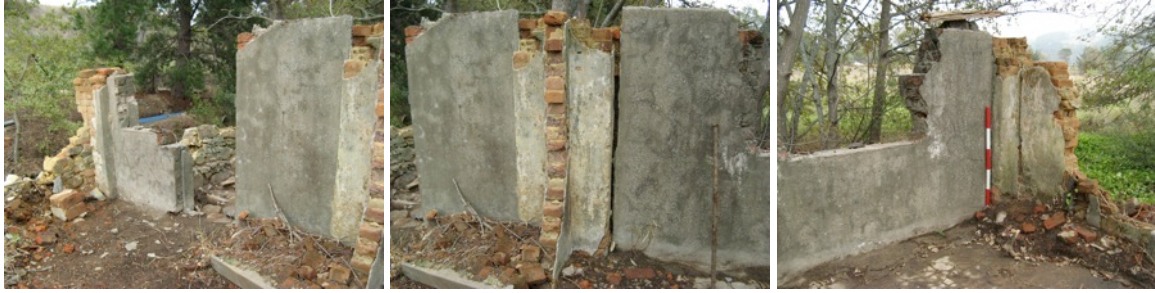
The cottage is a simple 2 roomed structure constructed in part on the remains of stone walling (boundary wall) which ran parallel to the irrigation furrow along the main access route. It would seem as if the structure was used as an animal enclosure prior to its conversion: the southern side consisting of three pillars and subsequently filled in with brick and cement mortar.

Figure 17: Brick columns forming the southern wall of the structure. The infill between the columns is of modern pink/red brick and cement mortar. The structure was probably converted to a dwelling in the early 20th century.

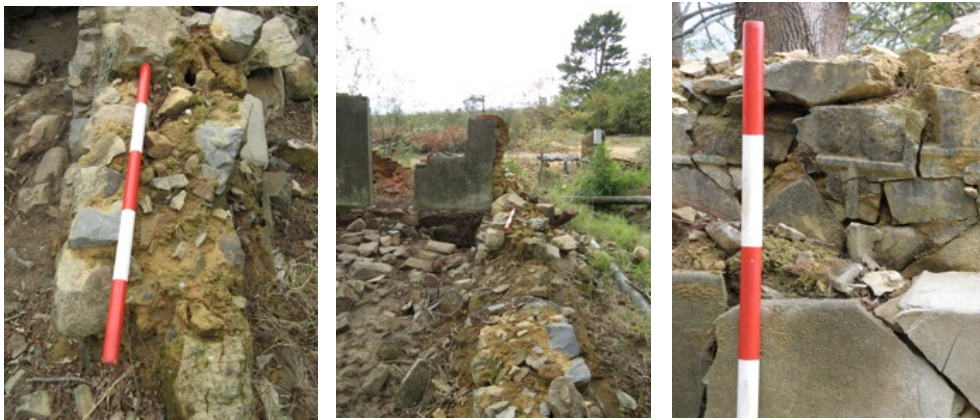
The remains of a stone wall are visible along the northwestern edge of the old irrigation furrow. The wall extends >1500mm northeast-wards and >900mm southwest-wards from the structure. The walls are constructed of roughly coursed stone blocks forming the exterior edges of the wall, with stone rubble and yellow mud filler in the centre. The walls are 500mm thick. The foundation of the wall measures 830mm in width.

The stone wall has the same mock pointing as the stone kraals and sections of the historic werf. Dates on the stone kraal as well as on one of the outbuildings on the historic werf, dates the mock pointing to the early 20th century (1909).

Figure 18: Stone boundary wall associated with Cottage 4.

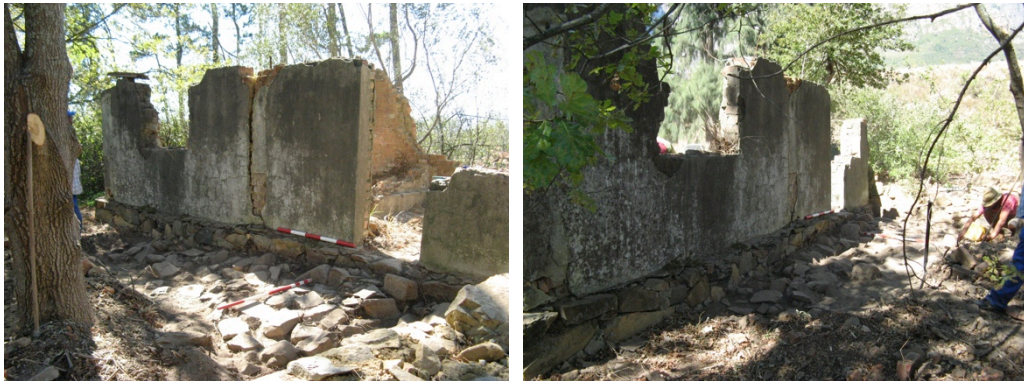
Packed stone rubble outside the door of the cottage provided a levelling surface and perhaps also served to provide an improved walking surface during the winter months.

Figure 19: Stone rubble surface to the south of Cottage 4.

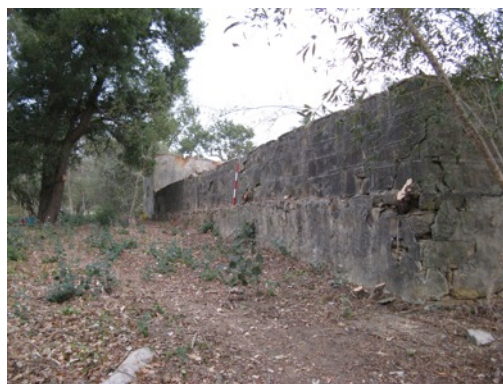
This is the smaller of the two kraal structures. It is constructed using roughly dressed stone. Mr du Plessis remembers this kraal being used for the horses and the mules. It would appear as if the kraal was built after the cottage, with the cottage forming its western end.

Figure 20. View of Kraal 1 with Cottage 1 visible in the background. The old olive tree associated with Cottage 1 is located to the left - off photograph.

The secondary werf is an important feature of the farm and represents the diversification of the farm in the late 19th/early 20 century. The stone kraals are relatively well preserved, but in need of maintenance and repair. It is recommended that Kraal 1 and Kraal 2 be retained and reused appropriately.

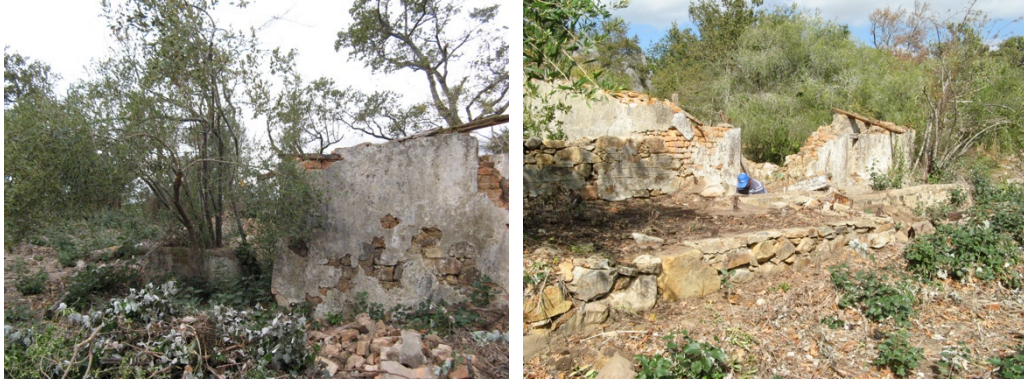
A sheep dipping trough and platform is situated to the east of the small kraal. Constructed of stone and cement, this feature is a 20th century addition, possibly built with stone reused from elsewhere in the complex.

Figure 21: View of the sheep dipping trough from the western end of the structure (corner of Cottage 1) and facing southwards with Cottage 1 in the background.

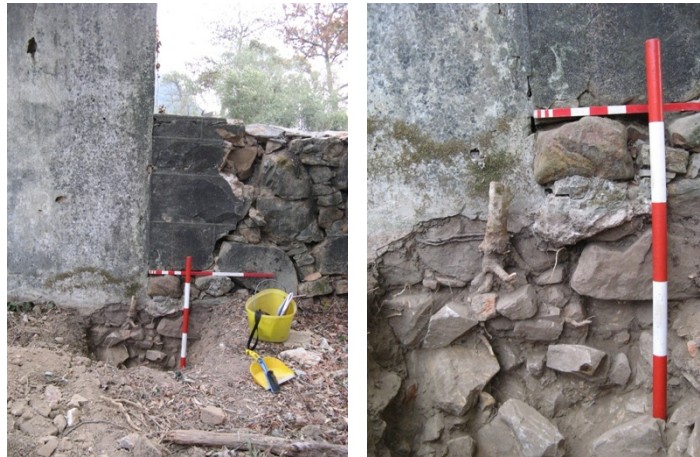
Figure 22: Detail of the junction of Cottage 1 and Kraal 1 showing the rubble foundation of the cottage contrasted with the more regular coursed rubble foundation of the stone kraal.

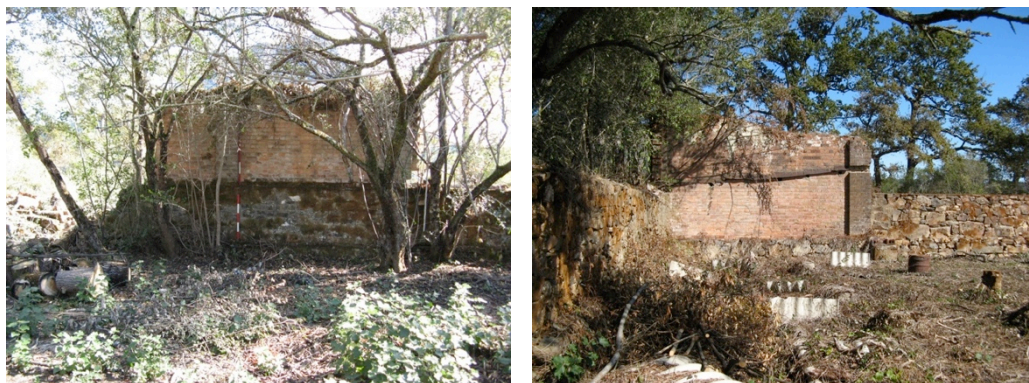
The remains of brick animal stalls are clearly visible. Recent additions to these stalls are evident in the remains of cement-cast bases for metal posts for corrugated asbestos roofing. Damage to the western extent of this structure suggests that it had been demolished mechanically. Piles of stone and rubble are evident.

Figure 23: Brick enclosures (cow sheds) on the western end of Kraal 2 viewed from the outside of the kraal (left) and the interior of the kraal (facing westwards). The asbestos roof sheeting is visible in the foreground of the image on the right.

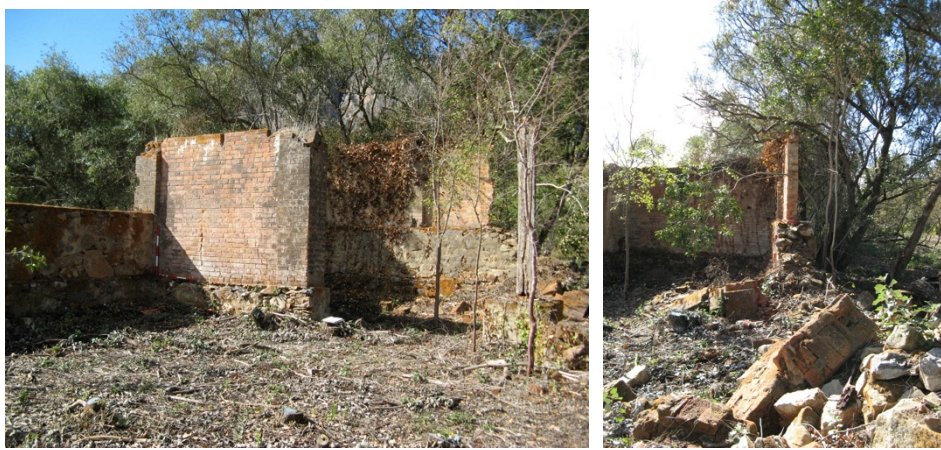
Figure 24: Brick enclosures viewed from the western extent.

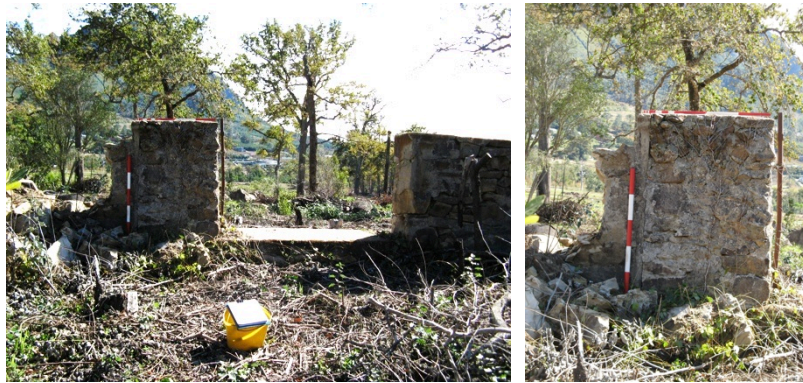
The structure had also been altered in the recent decades e.g. openings made smaller.

Figure 25: Modification of the entrance into Kraal 2.

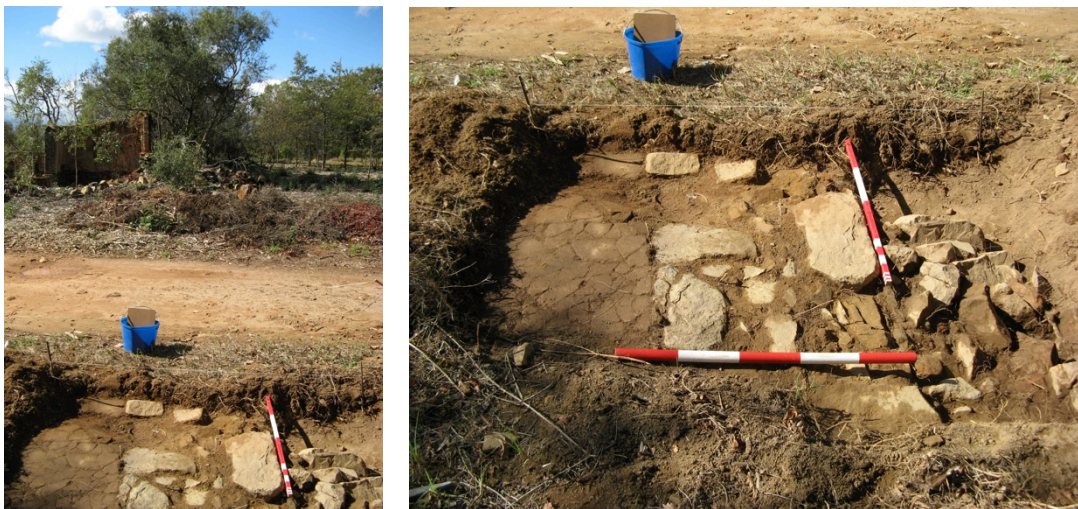
The road dividing the structure was formalised in the 1980s, but according to Mr du Plessis, prior to that there was a footpath leading to Kylemore. The footpath is not shown on the 1938 aerial photograph. It would appear as if the southern wall joining the cow shed to the present pigsties was still standing.

Figure 26: Foundations of the wall extending under the present road towards the remains of the brick enclosure shown in Figures 23 and 24 linking Kraal 2 cow sheds and the pigsties. Evidence of a cement surface to the west of the wall is visible.

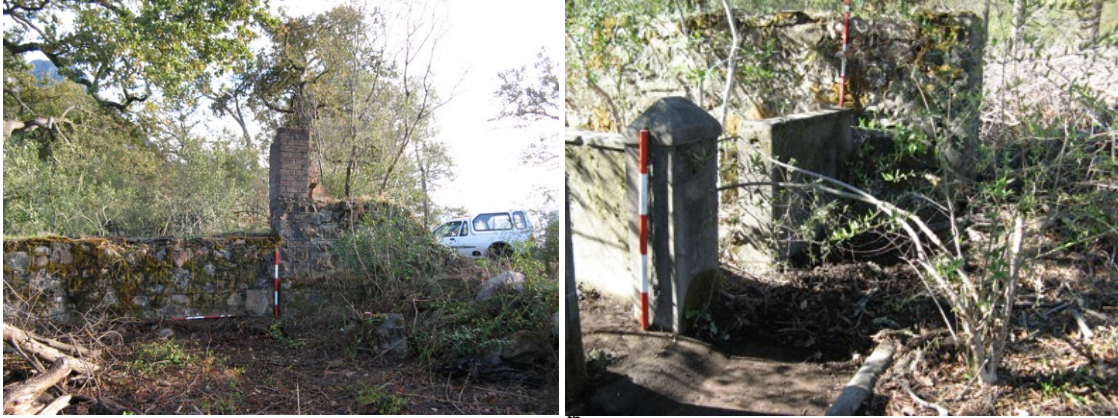
Brick and cement pigsties are evident on both sides of the remains of a stone wall. The remains of a flat corrugated iron roof are still visible. According to Mr du Plessis, the sows were kept in the smaller enclosures

Figure 27: Early 20th century pigsties.

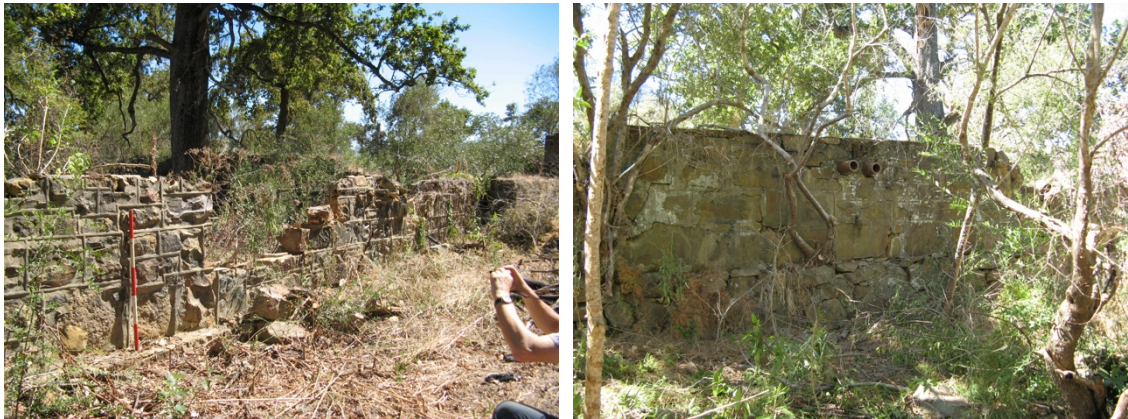
Figure 28: Southern and northern stone walls associated with the pigsties.

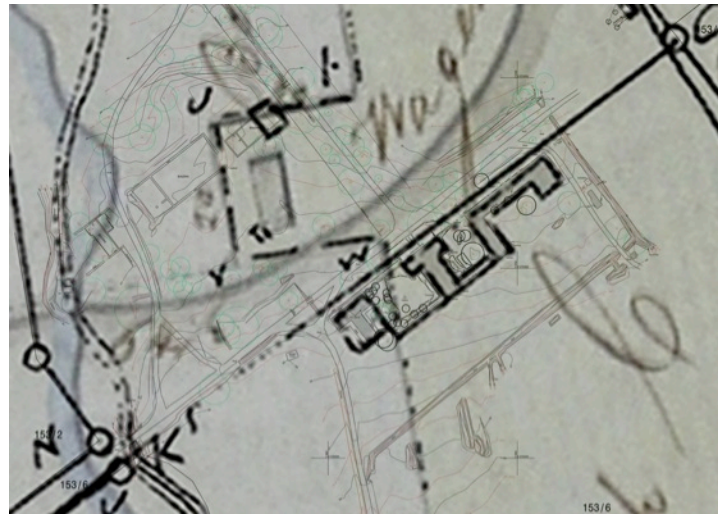
Figure 29: Overlay of the Friedlaender, Burger & Volkmann survey with the 1755 and 1952 survey diagrams. Note the relative position of the bokkenhok to the historic werf and the stone kraals. The scale of the 18th century survey diagram is distorted: this is clearly apparent when the size of the woonhuis (centre left) is compared to the dwelling house and the T-shaped wine cellar of the historic werf.

The overlay of the survey diagrams, place the position of the old Bokkenhok in the area between the smaller stone kraal and the T-shaped wine cellar. A possible crop mark in the area also suggested the presence of subsurface features.

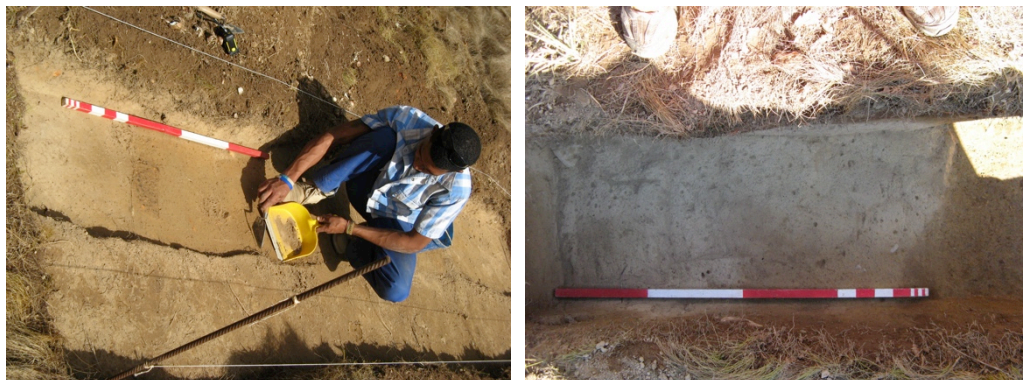
The test excavations (1m wide) showed a concentration of hard compact yellow clay across the entire section tested. Towards the northern end of the test trench, a very compact, hard concentration of yellow clay was recorded. This clay resisted water absorption, suggesting the presence of lime in the mixture. The feature had a roughly linear appearance and may have been the remains of the outer wall of the *bokkenhok*. However, the extreme compactness of the surrounding clay layer did not allow for the further exploration of this feature. No cultural material was uncovered.

Figure 30: Test excavations in the vicinity of the bokkenhok. Hard compact yellow clay differing from the surrounding clay in that it resisted water absorption suggested the presence of a wall. The image on the left shows Denver Jones uncovering what appeared to be the remains of a decomposed brick. The image on the right shows the difference in water absorption of the clay wall in comparison to the surrounding clay.

Should any development be approved for the area in front of the historic homestead, in the vicinity of the Bokkenhok, any earth moving activities would need to be monitored in order to try and determine and/or confirm the extent of the structure.

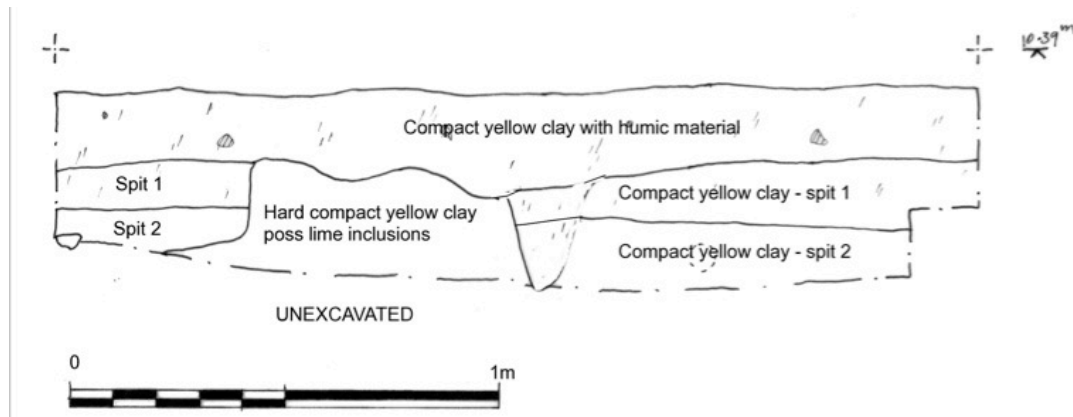
Figure 31: South facing section of a portion of the test trench in the vicinity of the *bokkenhok*.
