Assessment of the historic dwelling
Jonkersdrift – previously Mount Happy
(Farm 1444, Stellenbosch)

25 May 2011

Introduction

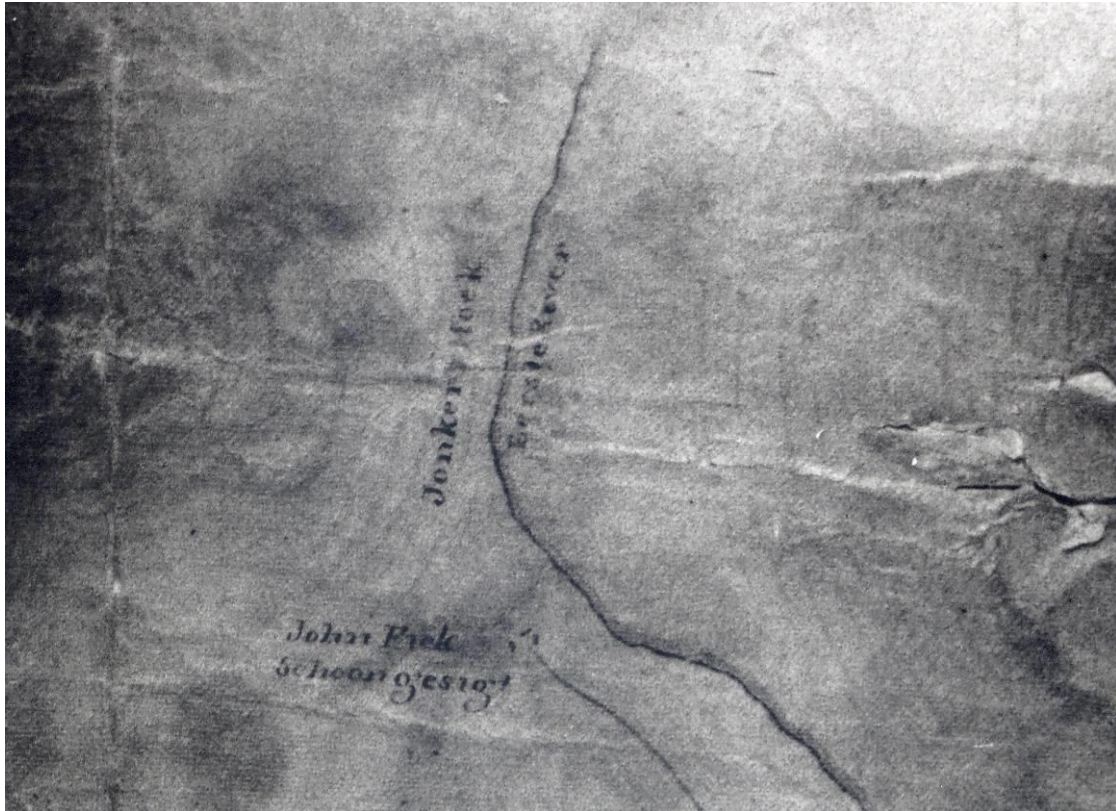
Figure 1: Detail of an 1808 survey of the area between Stellenbosch and Franschoek (Cape Archives M3/405). The farmstead at Schoongezicht/Lanzerac (owned at the time of the survey by Johan Fick) consisting of the dwelling and two outbuildings are shown. The survey appears not to have extended into the Jonkershoek Valley.

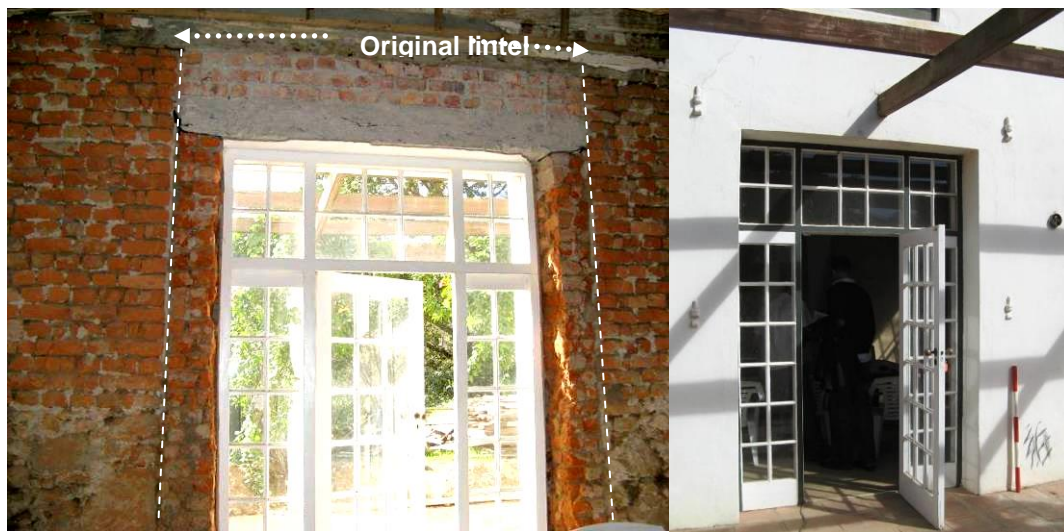
Figure 4: Door opening in eastern flank. Originally accommodating a wider double barn door (iron hinges are still visible on the outside), this is the only opening in the structure that has not been punched through existing stone walling, but built in place. The image on the right shows the same door from the exterior: note the position of the hinges.

The opening in the eastern end of the structure (Figure 4) as well as the opening beneath the gable (Figure 5) is original. The wooden lintel has quarter round beading, which according to Hennie Vos is most typically associated with the 18th century. Both these openings originally gave access to utility rooms (the usual pattern would be wagon room/store and stable/stall).

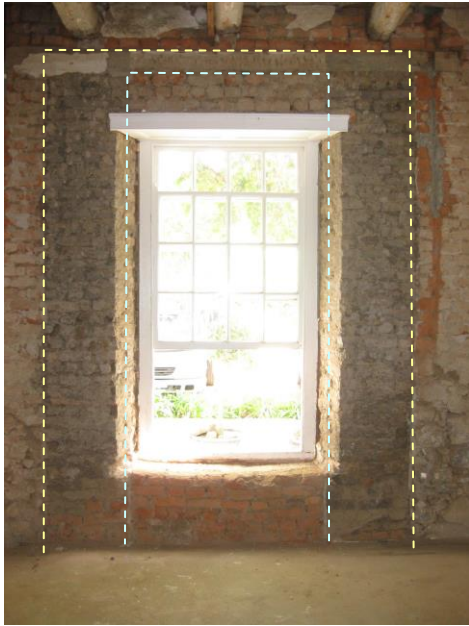
Figure 5: Door opening in northern flank beneath gable. Two alteration phases are clearly visible: 1) the narrowing of the space to accommodate a single door with fanlight and the replacement of the door with the present sash window.

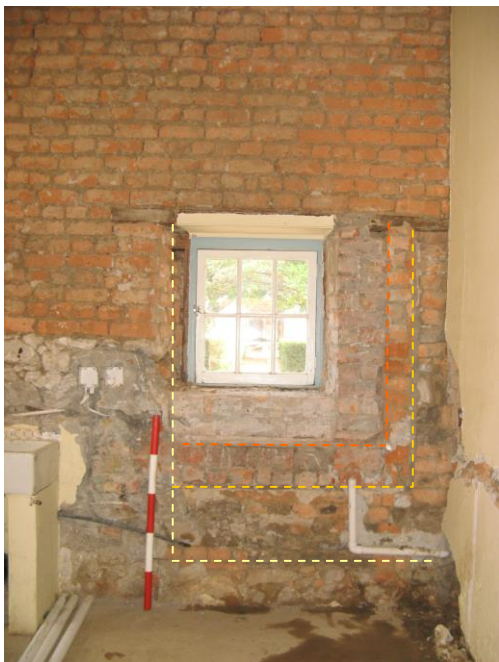
Figure 6: 18th century casement window in kitchen, northern façade. An 18th century lintel spans the dividing wall, suggesting a double casement was initially inserted in this position.

Two subsequent alterations in the size of the window (width and height) are evident, prior to the insertion of the present window in the 20th century.

The window in the kitchen (northern façade) has a lintel which extends beyond the wall into the room adjoining. A number of alterations are visible (Figure 6).

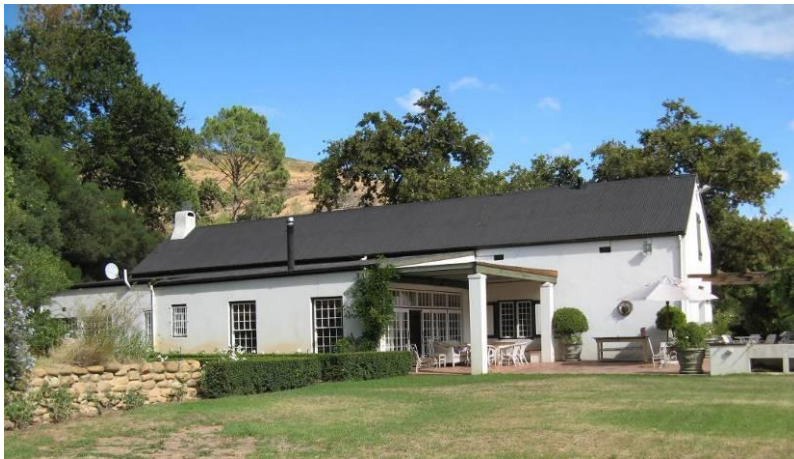
Figure 9. View of the southern flank of the dwelling with the modern additions still intact (2010). The iron stove pipe is visible near the eastern end of the roof.

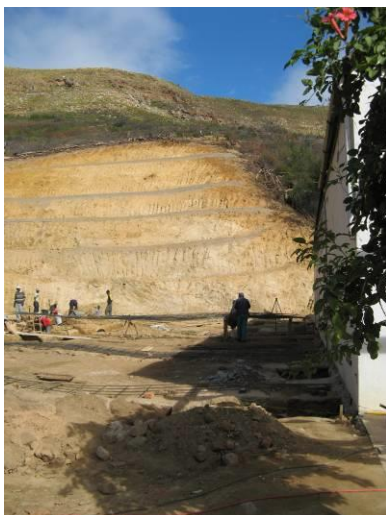
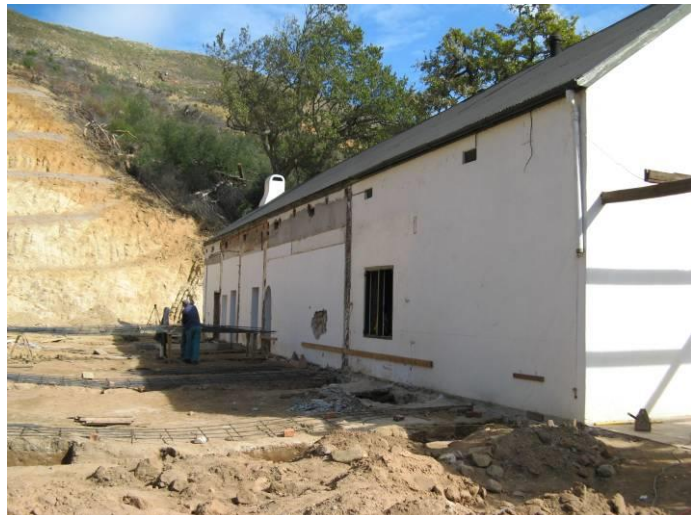
Figure 10: Present view of the southern flank of the dwelling. The 20th century additions have been removed and extensive excavations have been undertaken for the new additions.

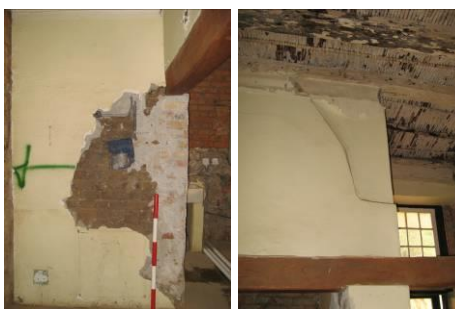
B:

The northern hearth end wall is constructed with brown unbaked brick with brown mortar. The wall is 390mm wide. It is likely that this wall was inserted when the kitchen was formalized and the present backdoor was required.

The end of the wall supporting the hearth beam has been rebuilt with brick and cement mortar. The detailing above the northern hearth wall appears to be decorative and the degree to which it aligns with the flue at attic level has not been confirmed (owing to access limitations due to safety and light).

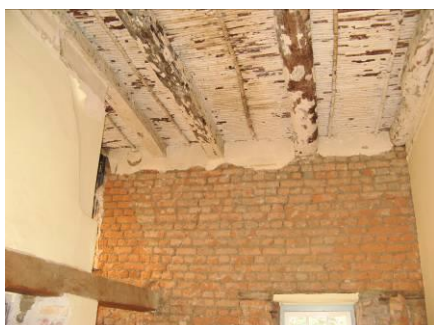
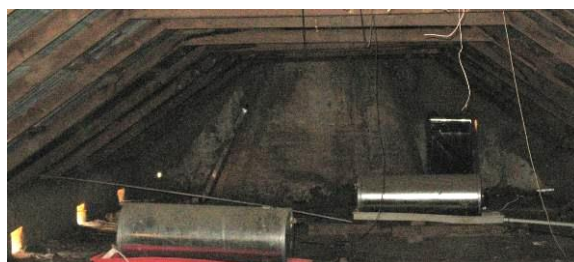
Below is a shot of the flue, alteration to the end gable associated with the raising of the eaves is also visible.

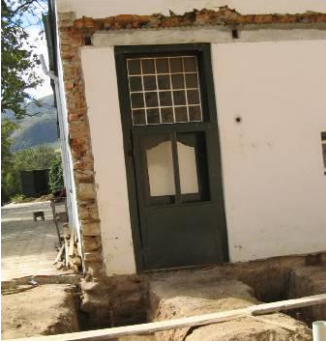
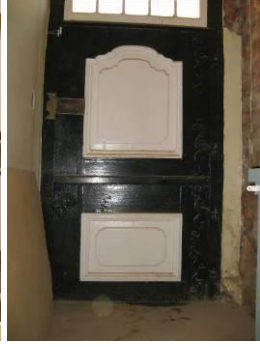
C:

The kitchen backdoor has been reused from elsewhere (very fine 18th century, front door). Views of the door from the outside and from the interior (brass fittings have been removed, presumably for safe keeping).

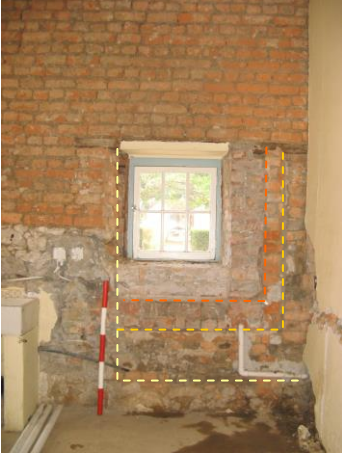
D:

The lintel of the window extends behind the dividing wall, and into the room beyond. The dimension of the window suggests a double casement (light yellow).

The dashed lines on the image shows subsequent resizing. The fill associated with the dashed yellow line differs from the current dividing wall. The orange dashed line indicates another resizing of the opening.

The latest alteration (insertion of the current window) dates to the 20th century and is probably contemporary with the alterations to the hearth area.

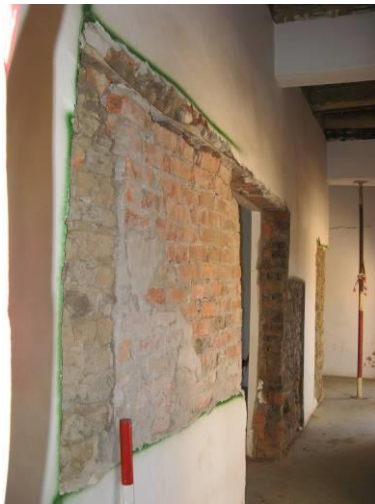
E:

Internal wall:

The internal walls are constructed from brick; lower layers constructed with soft fired brick, while upper layers with unbaked brick and mud mortar. An earlier door opening was bricked closed during the 20th century.

The present opening is modern, the earlier opening having been closed with brick and cement mortar.

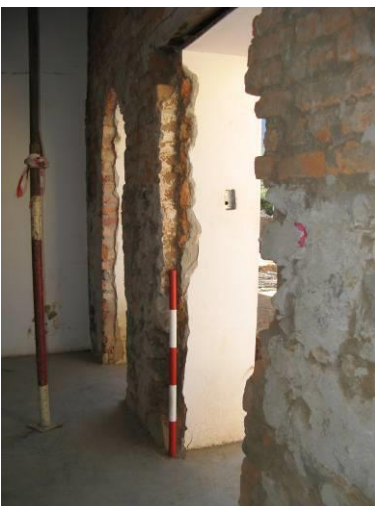
External wall:

4 door openings are visible in this stretch of walling – in all cases they have been punched through the original structure.

The western-most door is modern.

Immediately to the east of this door is an opening which has been bricked up recently: it is visible as recessed shelving on the exterior side of the wall (which prior to the demolitions of the modern additions would have been an internal shelf space).

The opening shown in the image to the left is of the 18th century opening. The original coarse grained lime plaster is still visible on the eastern edge of the opening. A more recent lintel was inserted directly below the older lintel and the jambs refinished in brick.

The eastern-most door of the passage (opposite the present front door is modern).

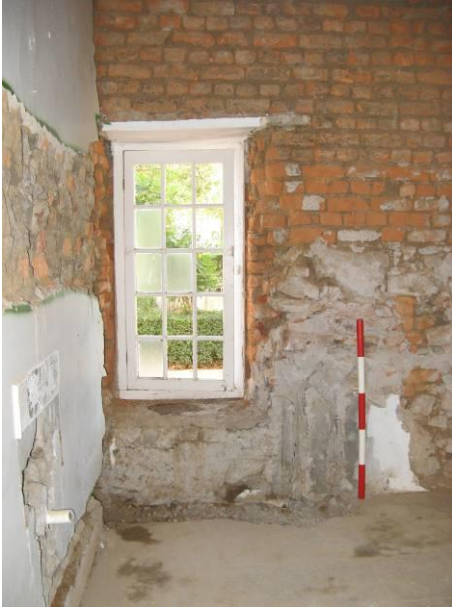
F:

Room A is a narrow room, presently serving as an *en suite* bathroom to Room B. The lintel of the window is at the same height as the contiguous window in the kitchen, shown in D and appears to be part of the same (18th century) double casement window.

The wall dividing the kitchen and this room is constructed with a mixture of soft fired and unbaked brick, set in a yellow/brown mortar. The width of the wall is 250mm.

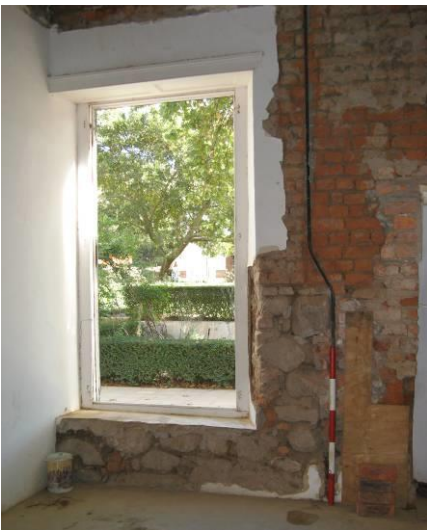
G:

Sash window with moulding detail on upper edge – predates the dividing wall.

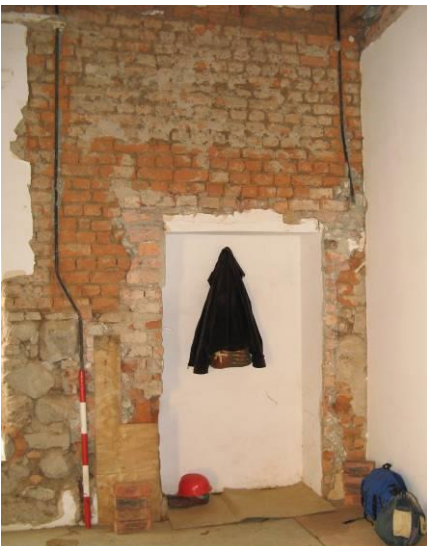
H:

To the east of the window is a closed door opening. The opening appears to have been made narrower and closed as a recessed nook. The use of brick and cement mortar places this alteration within the 20th century.

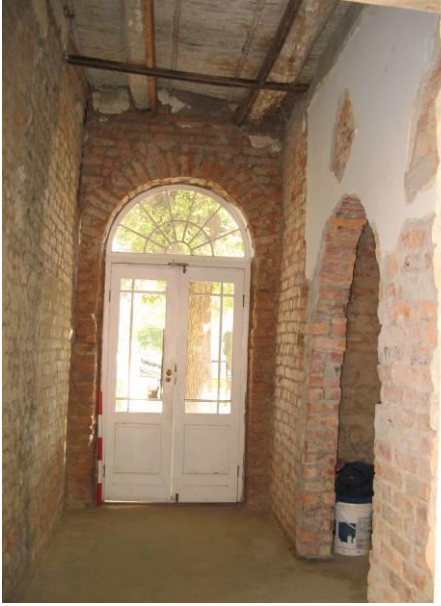
J:

One of two features in the structure constructed using brick relieving arches with semicircular fanlights inserted. The opening has been inserted into the original wall, punching through the stone and the edges rebuilt with soft fired brick and brown mortar.

The wall dividing Room B from the entrance hall is the only wall built with a stone foundation. Measured at the point where the wall has been cut away and joined with the dividing wall forming the passage way to the kitchen (E), the wall measures 350mm in width. The section of the wall closest to the external wall has no stone foundation and appears to have been rebuilt from the floor upwards and no evidence of a lintel is visible

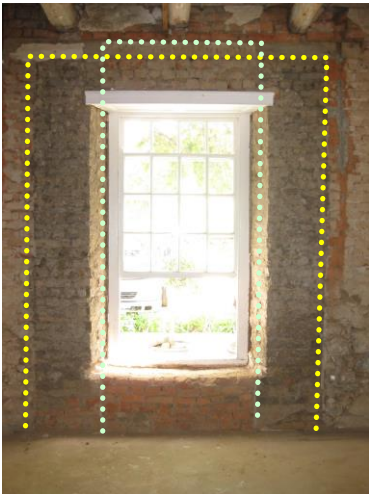
K:

Originally a double door opening underneath the gable (yellow dashed line), this feature shows evidence of being altered to accommodate a single door and fanlight (white dashed line). The door opening was reduced by 500mm on either side and again red/orange soft baked brick is used for support purposes as a foundation level.

The final phase was the insertion of the sash window. The

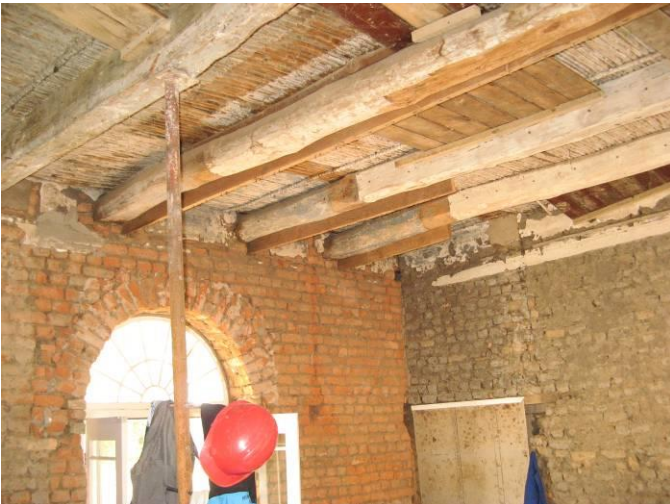
L:

The second feature with relieving arch and semi circular fanlight. The photograph shows the imprints of the demolished walls.

The wall dividing Room D1 and Room E is constructed with unbaked bricks and brown mortar. The door opening has an older lintel (18th century quarter round beading) which may have been reused. The remains of an iron stove pipe is visible where it enters into the attic space, and its associated chimney is visible on the roof.

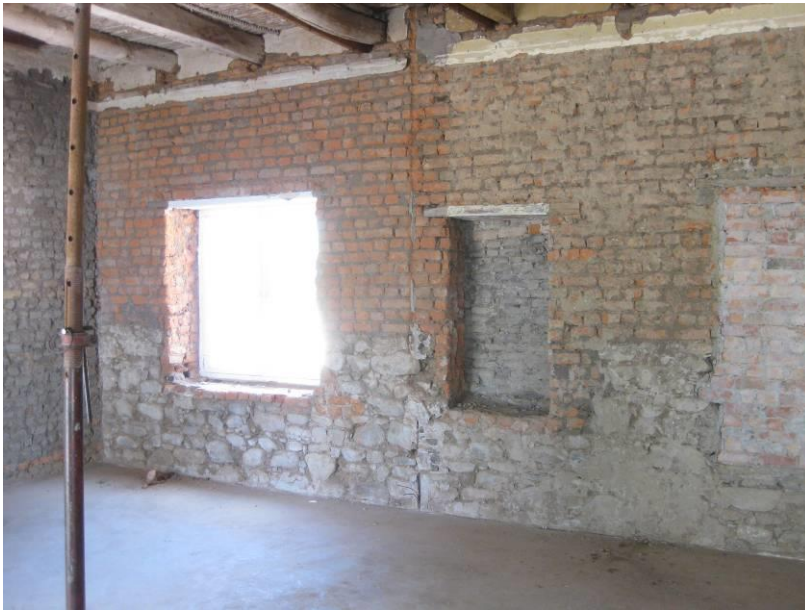
Three features are visible in the southern external wall of Room D/D1 (Right to Left): A closed window with 18th century quarter round beading on the lintel; a recessed nook/window with 19th century beading on the lintel and an existing double casement window (M).

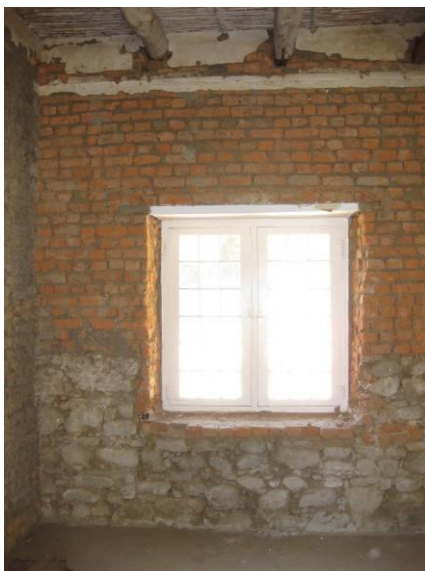
M:

Double casement window in Room D1. The window has been moved from its original position and inserted in its current position. Its dimensions match those of the window in the adjoining Room (See P).

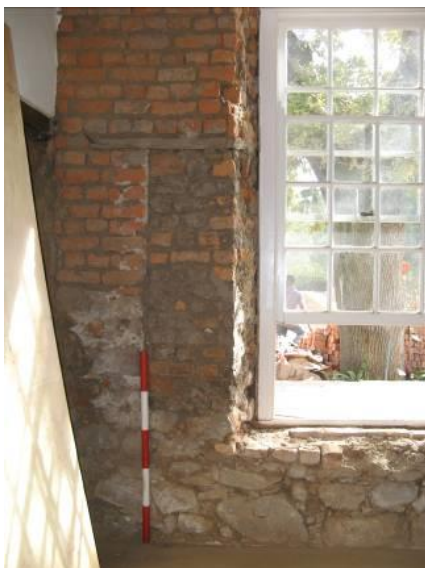
N:

A 18th century double casement window predates the sash window. The 18th century window itself was inserted after the structure was built. Evidence of this is visible in the brick work (compare to O where the brick coursing makes allowance for the finishing off of the wall, creating a neat edge).

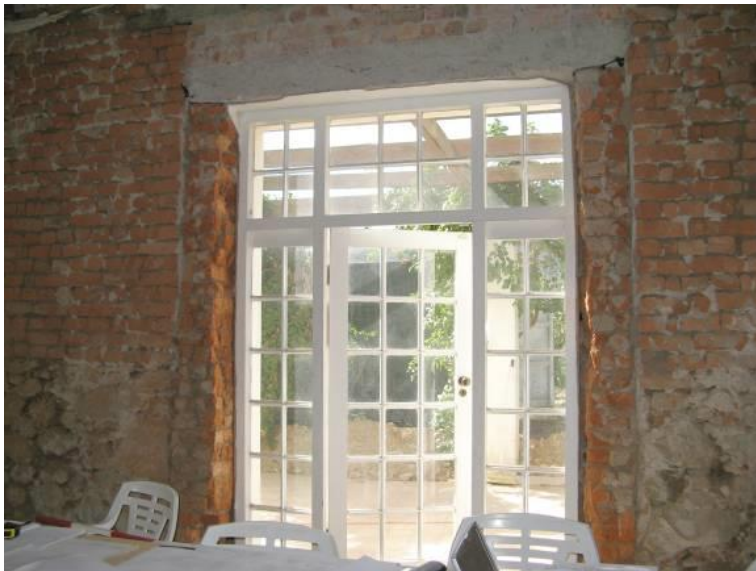
O:

The original dimension of the double barn door is clearly visible. The opening was made narrower, possibly retaining the original height.

The chopped up nature of the bricks flanking the present door suggests that the opening was widened again when the present door was inserted. The modern brick and cement infill and concrete lintel is associated with the present door.

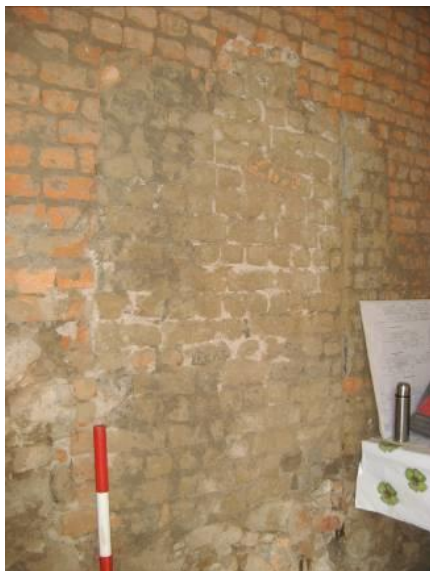
P:

A window opening showing first a reduction in width and then a complete closure. Both construction episodes are executed in unbaked brick and brown mortar.
