# UNDERWATER ARCHAEOLOGICAL IMPACT ASSESSMENT FOR THE PROPOSED MARINE SERVITUDES FOR THE COEGA SEZ

**UNDERWATER ARCHAEOLOGICAL IMPACT ASSESSMENT FOR THE PROPOSED MARINE SERVITUDES FOR THE COEGA SEZ, PORT ELIZABETH**

**Report #:** 2020/PE/001  
**Status:** Final  
**Revision #:** 3  
**Date:** 20 October 2020

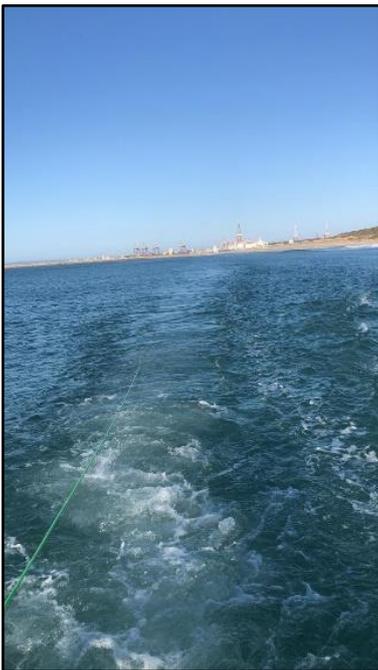
Figure 1: Deployed magnetometer (Maitland, A 2020)

A Geometrics G-882 cesium-vapor marine magnetometer was towed behind a 7.8m fibreglass rigid inflatable boat (RIB), with a layback of 15 meters, at an average speed of 3 - 6 knots/hour, utilising 15m run-lines. The magnetometer data collected by MagLog® software was analysed twice. The first or field analysis is performed as the magnetometer is towed (Figures 1- 3). Possible sites are tabulated and analysed according to the environmental conditions in the field. The post-field analysis was interpreted with geophysical software (Surfer), with knowledge of the environmental conditions. The analyses were compared and a final analysis completed.

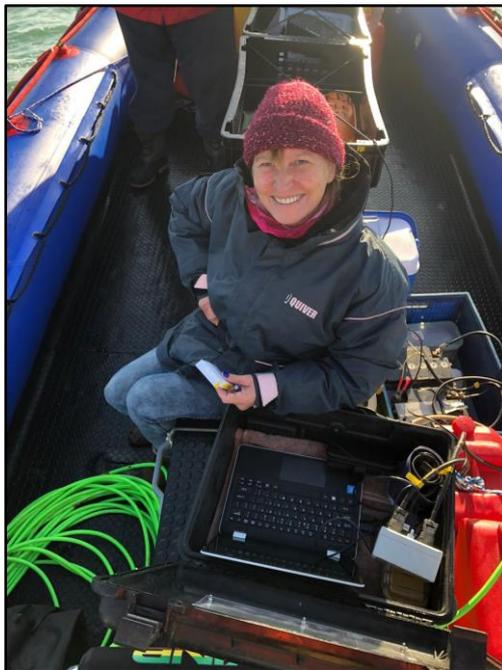
Figure 2: Magnetometer data capture (Maitland, A 2020)

The magnetometer data collected by MagLog® software was analysed twice. The first or field analysis is performed as the magnetometer is towed. Possible sites are tabulated and analysed according to the environmental conditions in the field. The post-field analysis was interpreted with geophysical software (Surfer), with knowledge of the environmental conditions. The analyses were compared, and a final analysis completed.

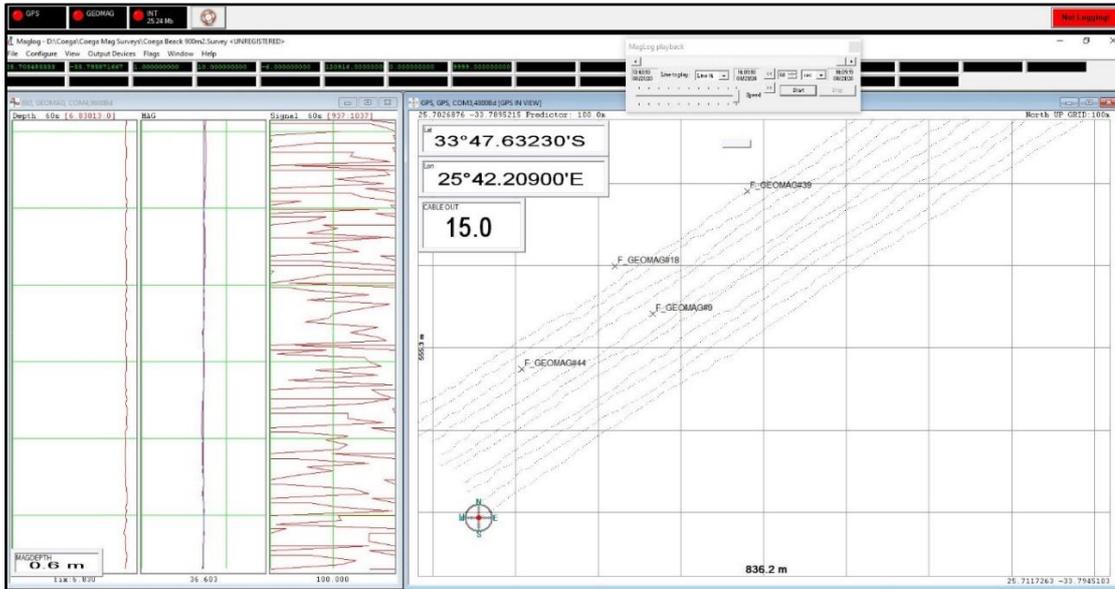
Figure 3: Field Analysis (Maitland 2020)

The magnetometer data collected by MagLog software was analysed twice. The first or field analysis is performed as the magnetometer is towed (Figure 3). This analysis observes real time spikes within the magnetic field. Possible sites are tabulated and analysed according to the environmental conditions in the field. These conditions include:

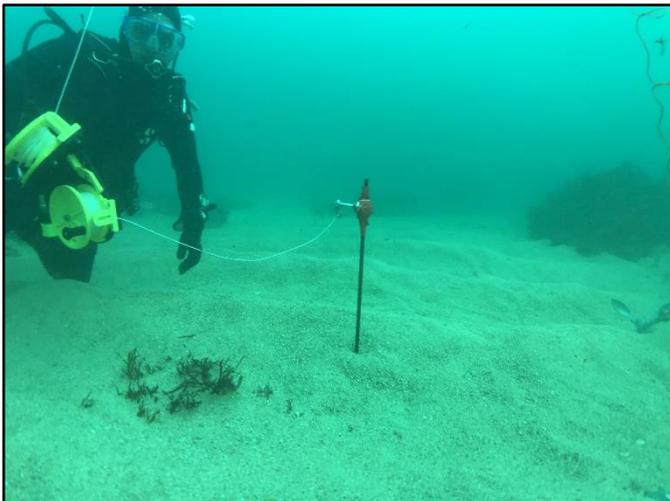
Figure 4: Marker buoy and attached search reel (Maitland 2018)

From the analysis of the magnetic data, anomalies are plotted. These need to be investigated by divers. A marker buoy is dropped on the coordinates and a circular search is conducted from this central point (Figure 4 and Figure 5). Results are recorded. A buoy with a handheld GPS attached is held by the diver, this tracks the location of the search (Figure 24).

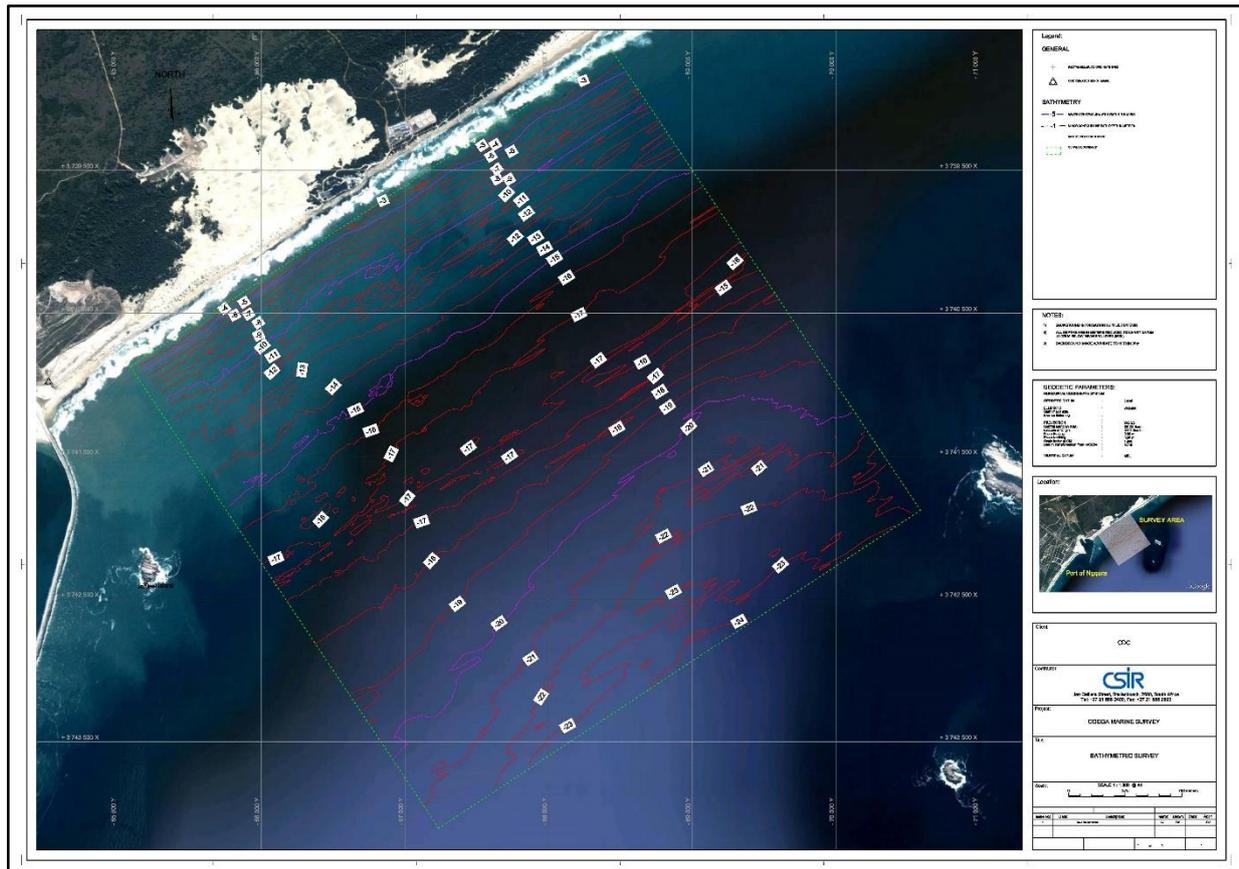
Figure 7: Bathymetric survey, east of the breakwater (CSIR: 2010)

“The bathymetry shows a uniformly sloped bottom of gradient of 1/120 to 1/140. The bathymetry steepens in the shallow water from about -10m to shoreline. The surf zone and beach are also fairly steep. The bathymetry shows an undulated rough seafloor, indicative of the absence of a sandy bottom. The bathymetry shows undulations of 10 to 60cm of the seafloor. Rock reefs run mostly parallel to the coastline.

The bathymetry shows a prominent rock reef, 2 km from shoreline and running from left to right across the survey area. This reef has a steep landward slope of about 2 to 3m rise in the east, and a less pronounced slope towards the western part of about 1 to 1.5m rise. On the seaward side the reef has a gentle slope. In the South west quadrant there is an area that has a somewhat less undulated seafloor indicative of a sandier bottom. This area is from the -17m to -22m contours. The bathymetry is otherwise fairly uniform over the survey area” (CSIR 2010: 3-4) (Figure 7).

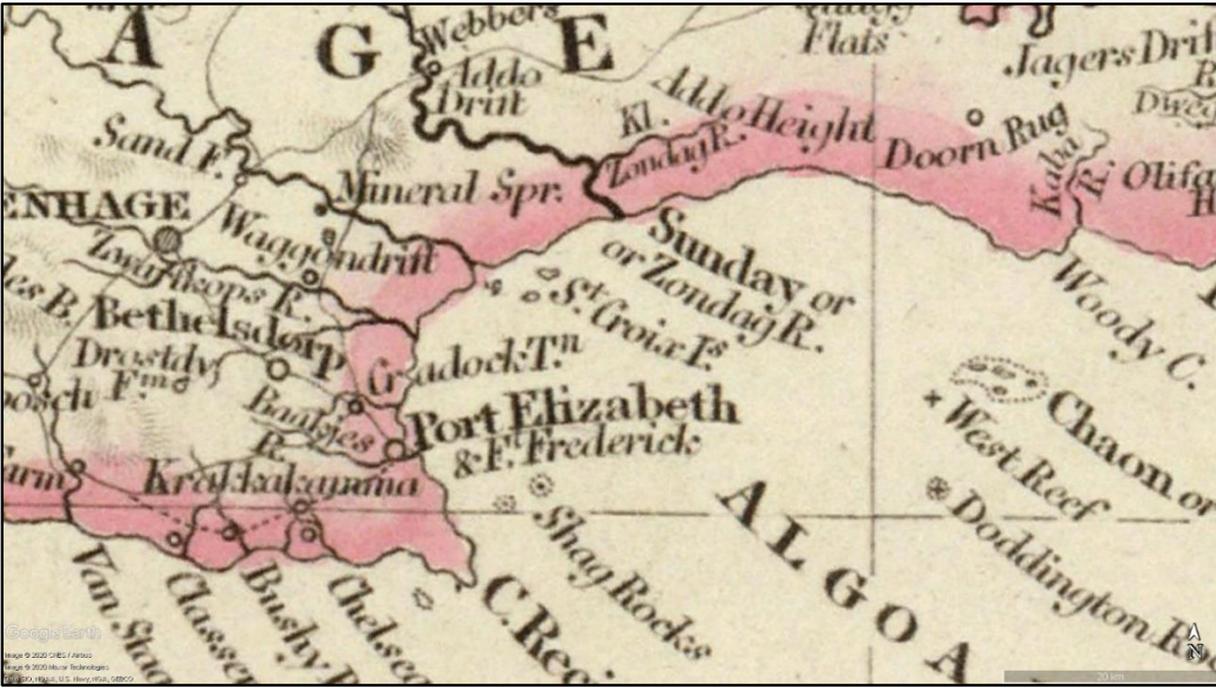
Figure 9: 1844 Map of Algoa Bay (Arrowsmith)

In van Keulen's map of 1778 (Figure 8), the islands and some of the other rivers are represented but not the Coega River. In the Arrowsmith map of 1844 (Figure 9), the Coega River is drawn in. The British Admiralty map of 1856 (Figure 10) is very accurate and includes depths soundings. The historical anchorage in Algoa Bay was outside the modern-day harbour of Port Elizabeth, protected by Cape Recife. Although, Purdey (1822) mentions vessels anchoring in the lee of St Croix during certain weather conditions (Figure 11).

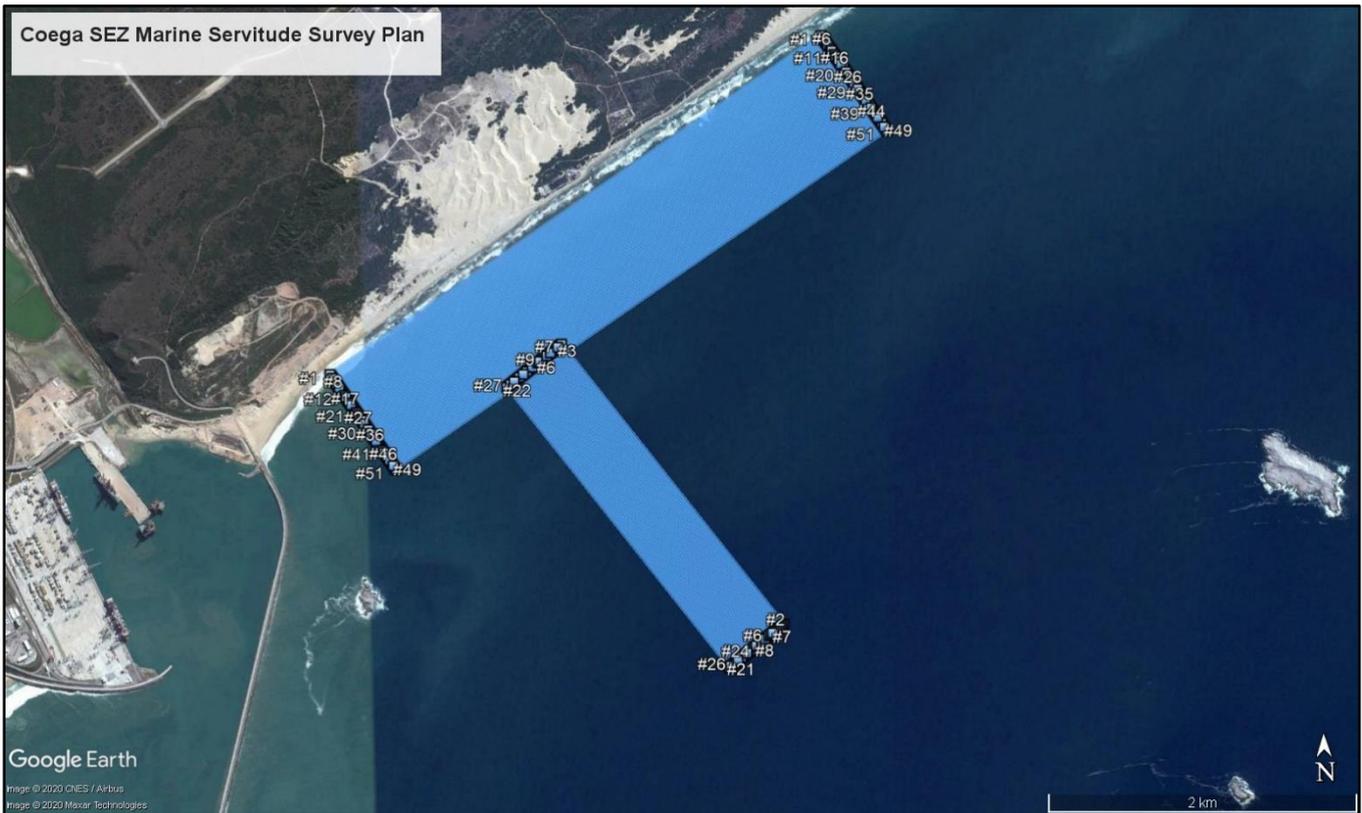
Figure 17: Coega SEZ Marine Servitude Survey Plan

The closer the magnetometer is to the seabed, the better the data. In shallow areas, the mag is towed from the nose, this tows the mag about 0.5 m below the surface. As the depth increased, we switched to a top tow, which drops the mag to about 3 m below the surface. At -12 m, we added a lead wing to the mag, this allows the mag to be towed at 7-8 m below the surface. Speed of the survey was also variable, if the mag is required to go deeper, the speed needs to be reduced.

As mentioned in Section 5.1, the bathymetry of the Impact Zone is -3 near the shore to -23 at the end of the Impact Zone. This dramatic change in bathymetry required a different survey plan. The shallower inshore area was surveyed parallel to the shore. The deeper area of the Impact Zone was surveyed vertical to the shore (Figure 17).

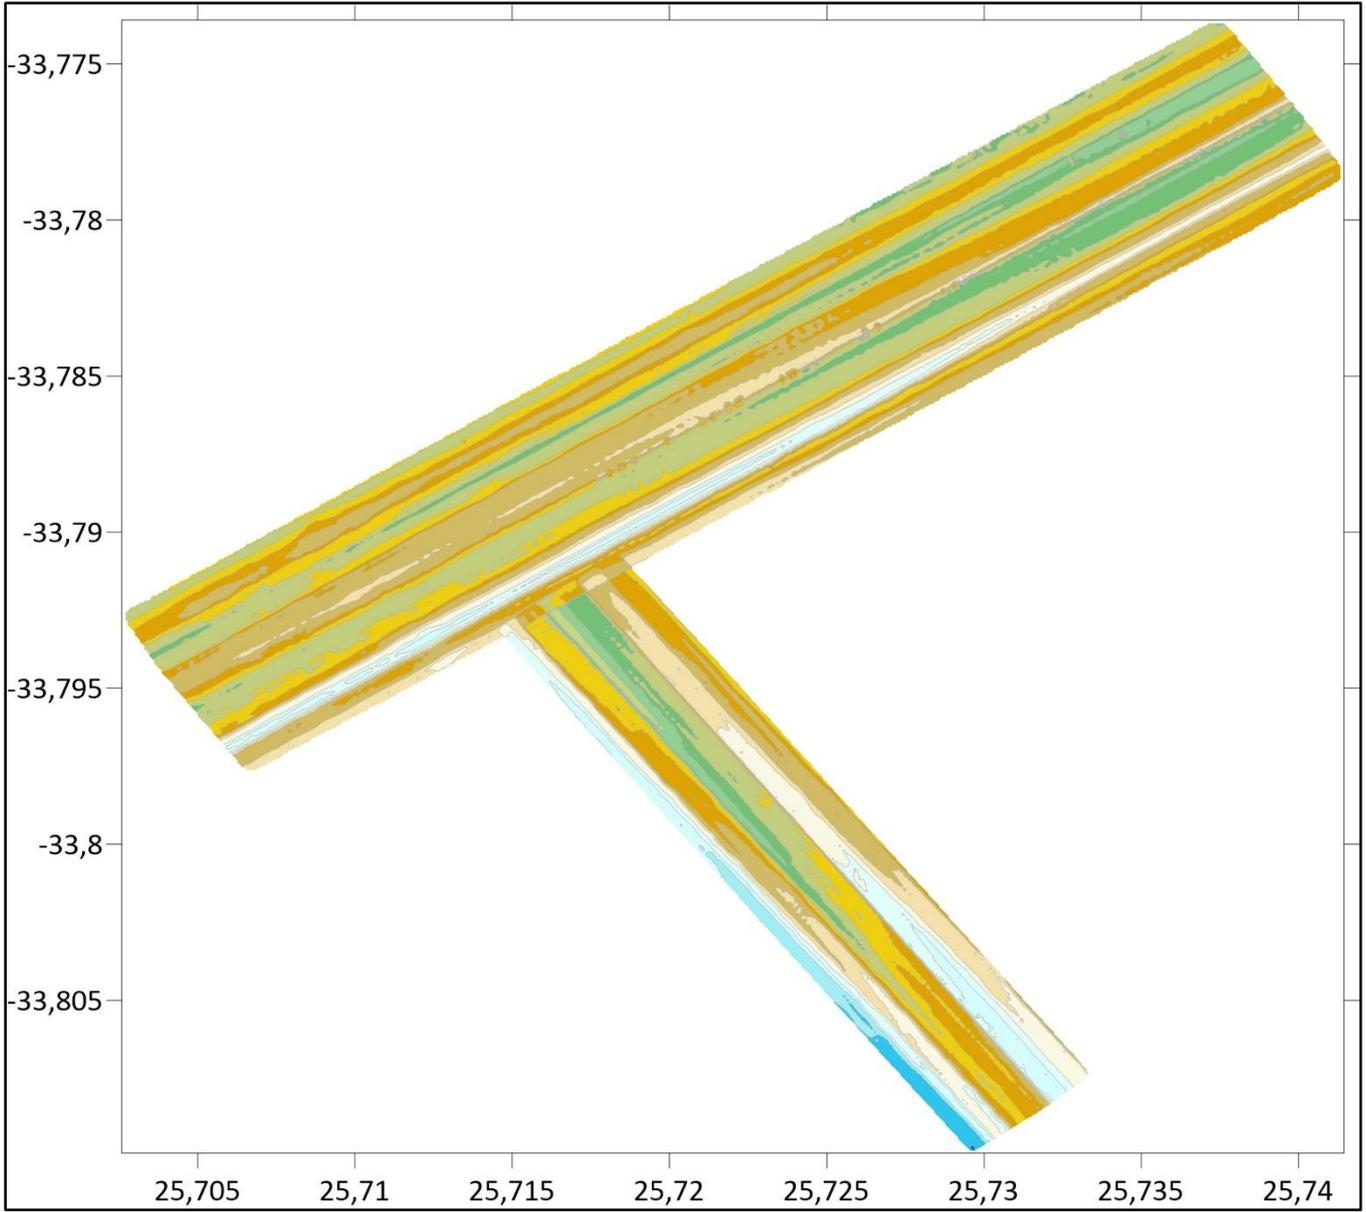
Figure 18: Surfer Survey Plot using contour intervals of 2 nT

The post-field analysis was interpreted with Surfer geophysical software, ignoring the environmental conditions (Figure 18 and Figure 19). However, the Surfer analysis did not show the field observed anomalies. Therefore, the coordinates of the field anomalies was plotted into Google Earth (Figure 20).

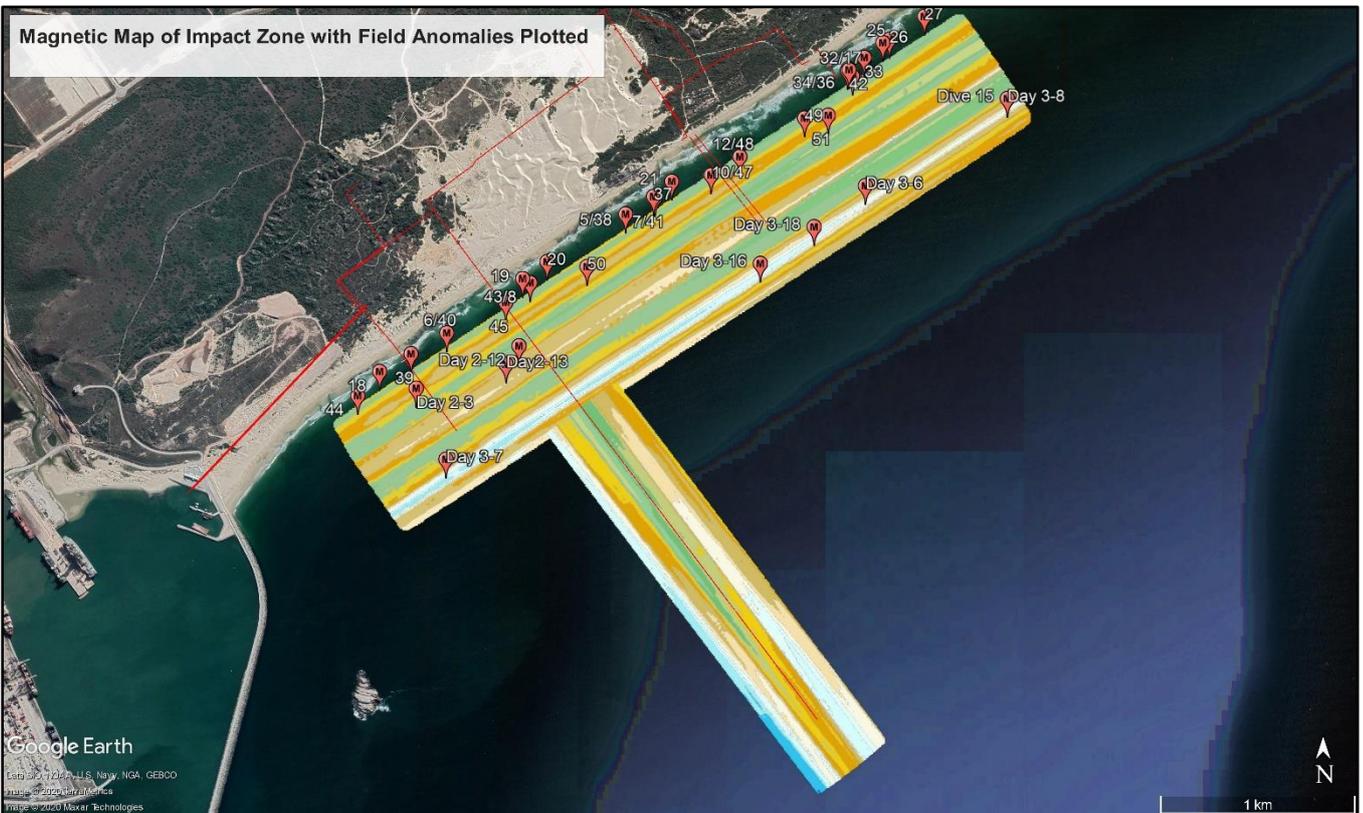
Figure 20: Magnetic map of Impact Zone with field anomalies plotted

A number of small magnetic anomalies were identified during the magnetometer survey. The majority of these were in the surf zone. Generally, shipwrecks, even wooden ones represent as larger magnetic signatures. However, in the interests of thoroughness, dives were undertaken on those sites that were accessible. Only one metal object was found, a metal pipe.

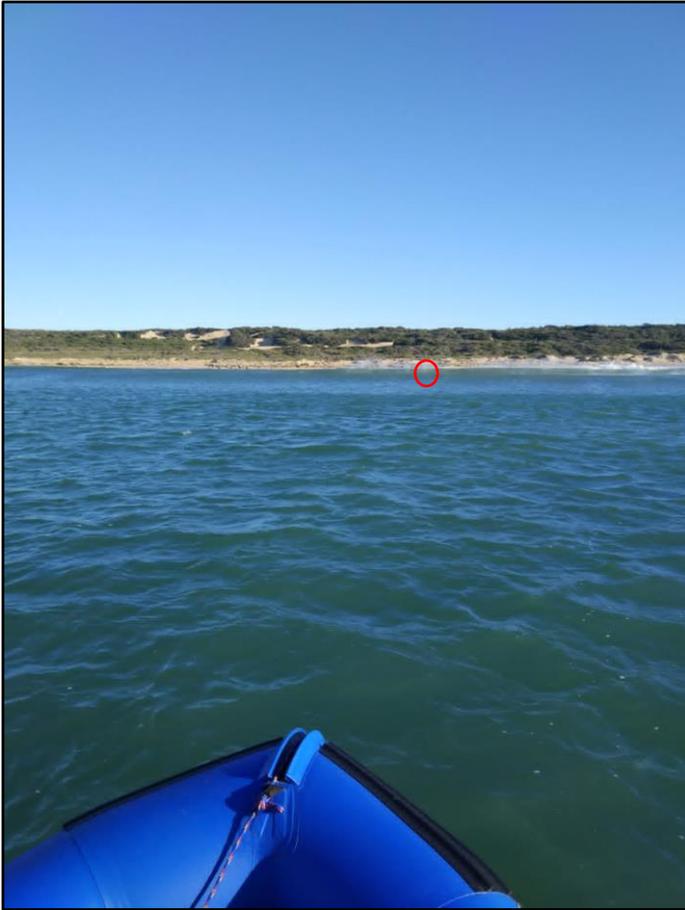
Figure 22: Marker Buoy on Dive 3

Dives were planned for the next open weather window, which was 31 August 2020. We dropped the marker buoy on Dive 3, and then watched the sea conditions to ascertain if it was safe to dive, it was not (Figure 22). Thereafter the first two dives (Dive 11 and 12) were a bit further offshore. Figure 23 is the GPS track for Dive 12, and Figure 24 is the metal pipe found at that location. Three further dives were undertaken. Dive 5 was closer inshore, but the underwater surge filled the water column with sediment creating zero visibility. Two further dives at the deeper locations were undertaken on Dive 13 and 14. However, the underwater surge and visibility was the same as the shallower dives (Figure 25).

Dive #	Latitude	Longitude	Comments
1	33° 46.627'S	25° 43.874'E	Too close inshore; swell too high
2	33° 46.595'S	25° 43.928'E	Too close inshore; swell too high
3	33° 46.646'S	25° 43.888'E	Buoy dropped; too close inshore; swell too high (Figure 22)
4	33° 46.870'S	25° 43.514'E	Too close inshore; swell too high
5	33° 46.921'S	25° 43.418'E	Dived – No visibility, high surge, no visible MUCH
6	33° 47.209'S	25° 42.791'E	Too close inshore; swell too high
7	33° 47.221'S	25° 42.816'E	Too close inshore; swell too high
8	33° 47.275'S	25° 42.735'E	Too close inshore; swell too high
9	33° 47.418'S	25° 42.420'E	Too close inshore; swell too high

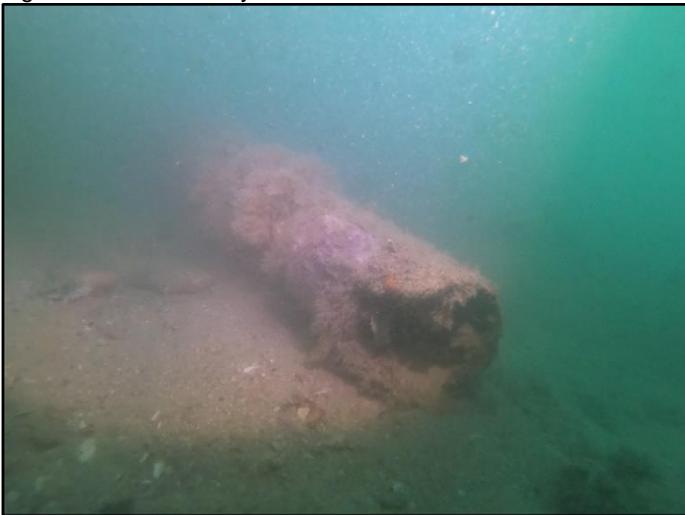
Figure 24: Metal pipe at Dive 12

It is my belief that, due to the small size of the anomalies, their location close to the shoreline and what was found on the diver searches, that the anomalies probably represent construction debris from the old oyster farm on the beach (Figure 15) and from the port's construction.

While there is an extremely low probability that shipwrecks will be found underwater, there exists a chance that shipwreck material and/or pre-colonial sites (shell middens and stone tools) may be found in the dunes during construction. If such materials are found, the steps in Section 10 must be followed.
