HERITAGE IMPACT ASSESSMENT: PROPOSED GRANITE MINE, NAMAKWALAND MAGISTERIAL DISTRICT, NORTHERN CAPE PROVINCE

Required under Section 38(8) of the National Heritage Resources Act (No. 25 of 1999)
as part of a Heritage Impact Assessment.

10 February 2021

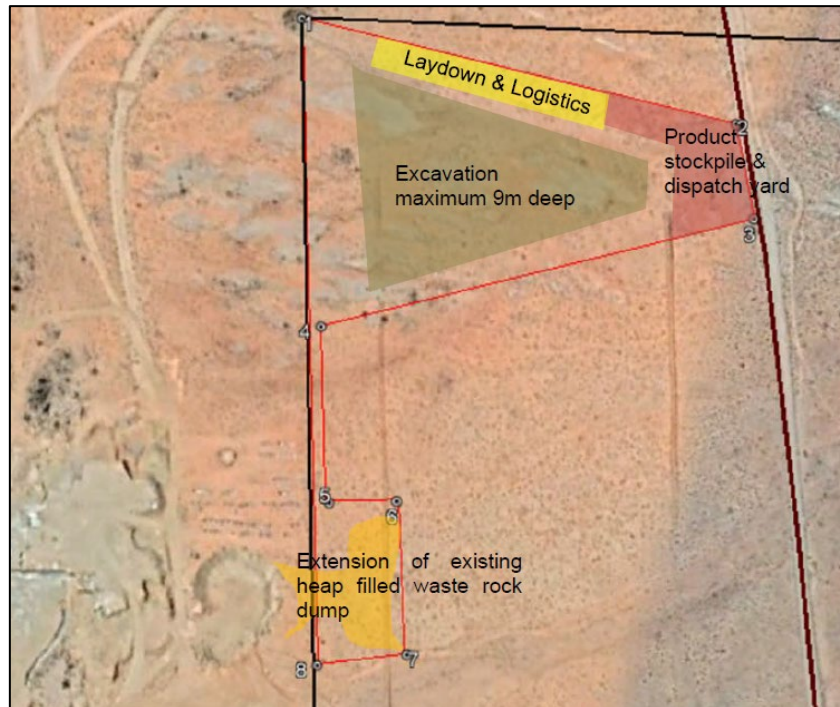
The mine will be an open cast mine working from the surface into the buried granite outcrop. Blocks of granite will be cut from the outcrop which is located in the northern part of the application area and waste rock will be dumped in the southern part as an extension to the neighbouring rock dump to the west. A laydown and logistics area will be placed along the northern edge of the application area, while a product stockpile and dispatch yard will be established in the east, adjacent to the existing public road through the area (Figure 3).

Figure 3: Plan of the proposed mine adjacent to the existing granite mine.

Although it is not essential, it is preferred that the small historical kraal in the north-western corner of the study area be avoided and protected. On the current layout plan (Figure 3) the site is completely avoided. It is best that the site be fenced into the mining area (this will reduce the ongoing littering) and a small fence be erected around the kraal to indicate its presence and preclude accidental damage to the walling. A buffer of 5 m from the walling is sufficient.

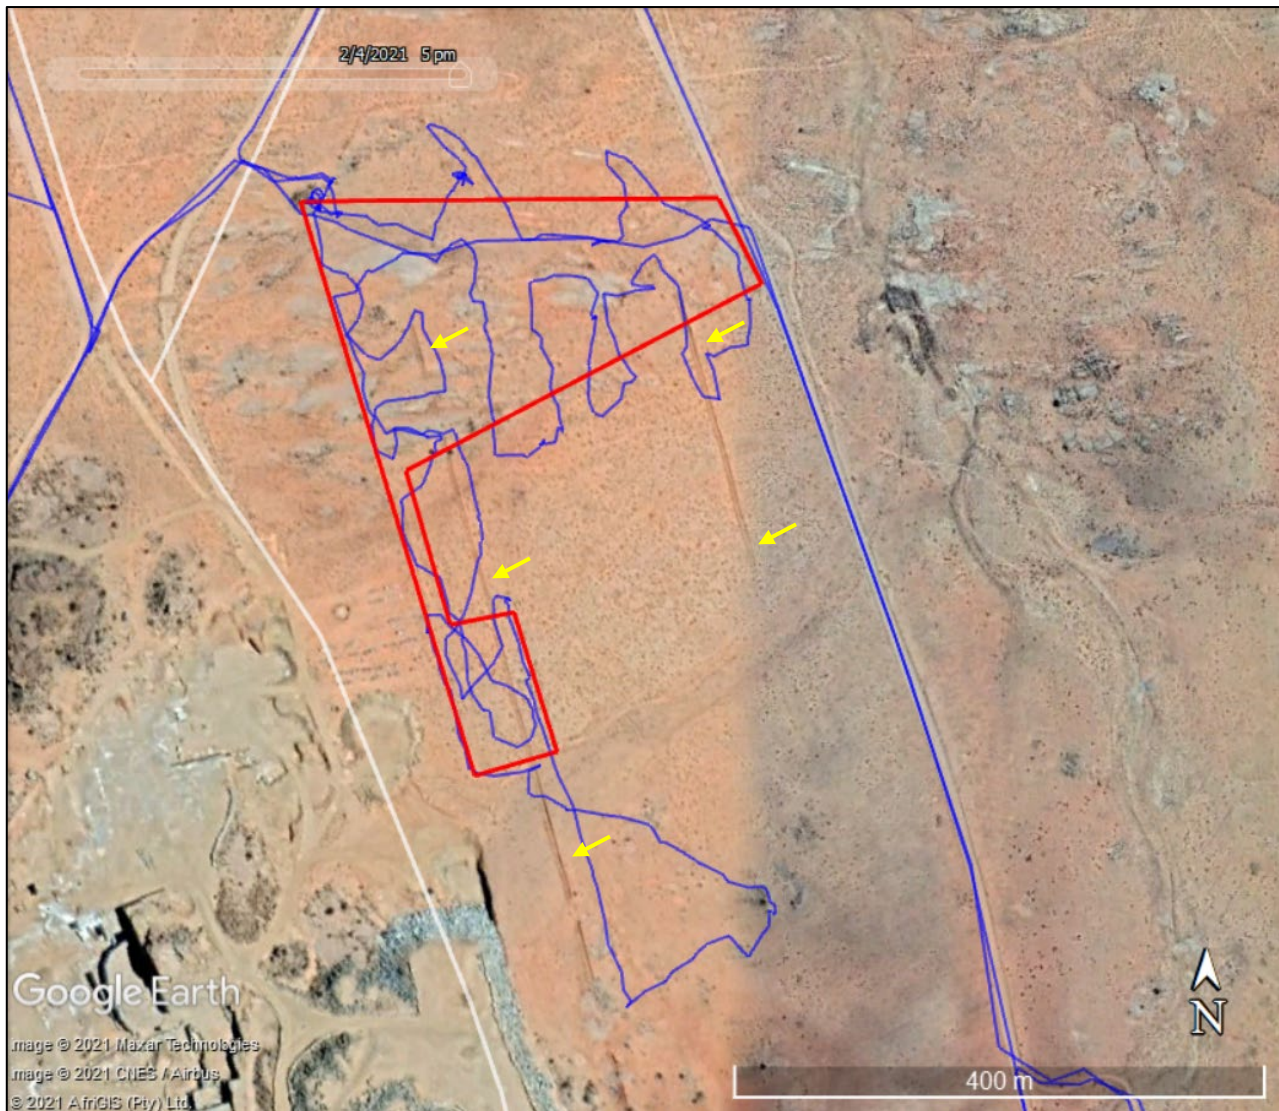
Figure 3: Aerial view of the study area showing the survey tracks (blue lines). Note the two shallow test trenches (yellow arrows). The north-eastern one continues towards the southeast but due to stitched images on Google Earth an older image in the east does not show the trench.

clear from the two shallow trenches visible on Figure 3 that weathered granite lies just below the surface virtually throughout the site – hence the choice of the site for granite mining.

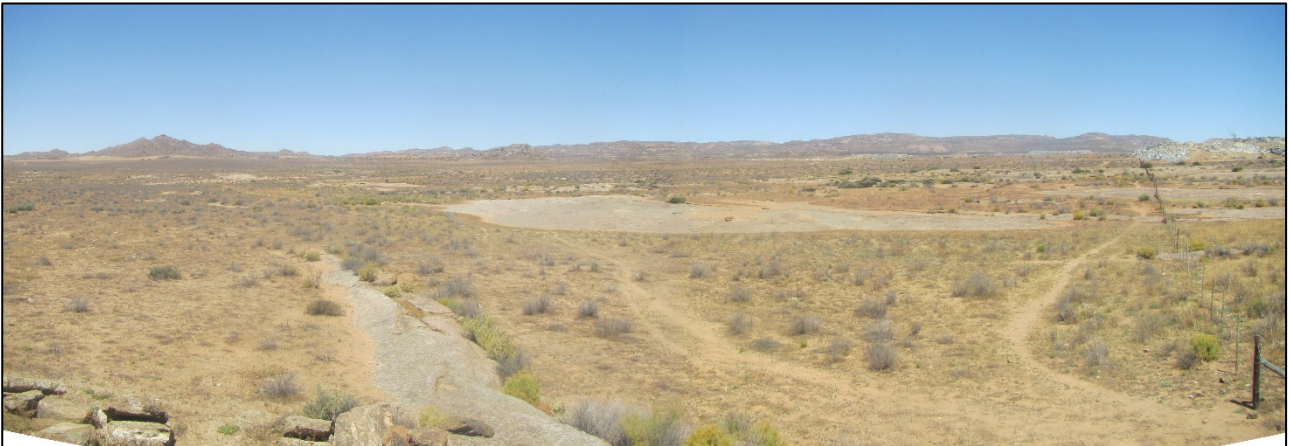
The site is fairly flat with many areas of exposed bedrock (Figures 4 to 6). These areas are generally less than about 0.5 m high. A small granite hill occurs right at the north-western corner of the study area (Figure 7). Elsewhere the surface has a coarse granitic sand cover (Figures 8 & 9) but it was

Figure 4: View towards the southeast (left) and south (right) from the small rocky hill at the northwest corner of the application area. The existing mine fence can be seen at the right hand side, while the exposed bedrock outcrops are visible running towards the back left of the photograph.

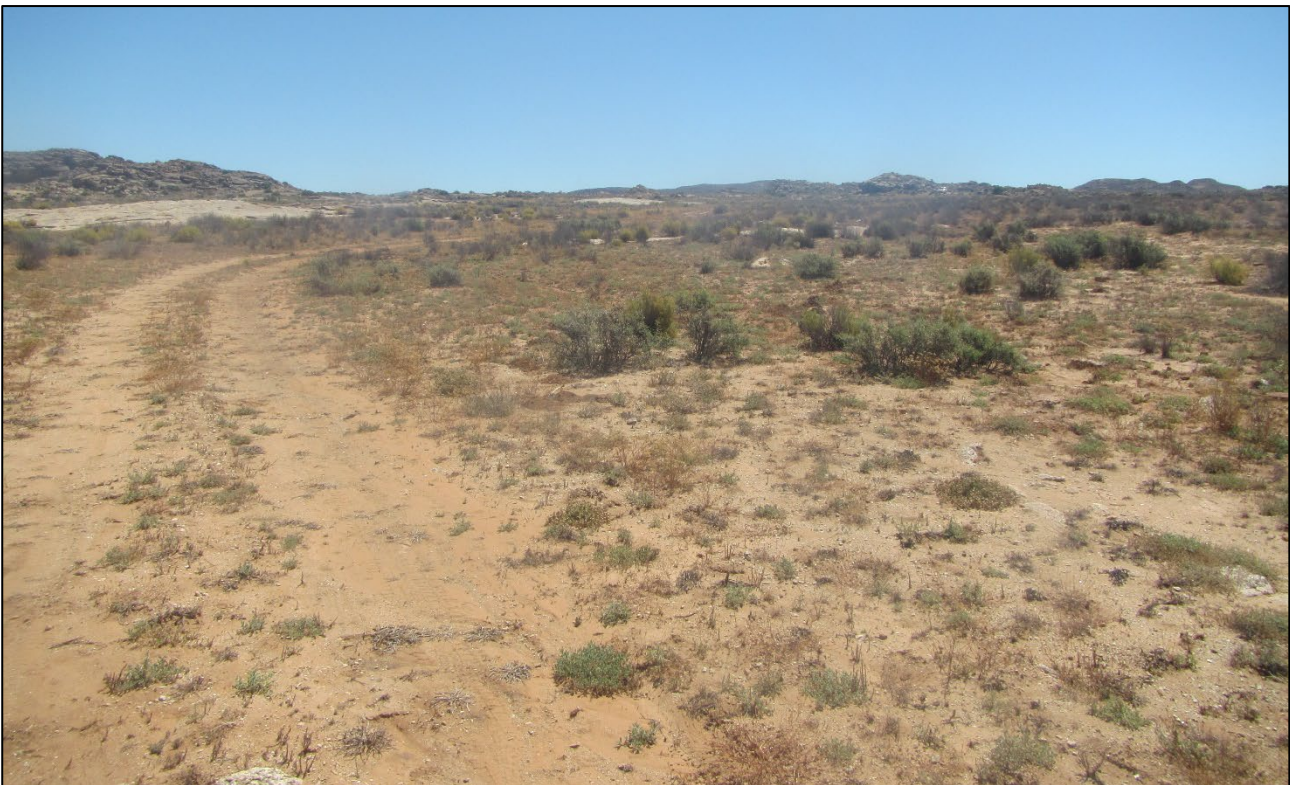
Figure 5: View towards the west through the northern part of the study area.

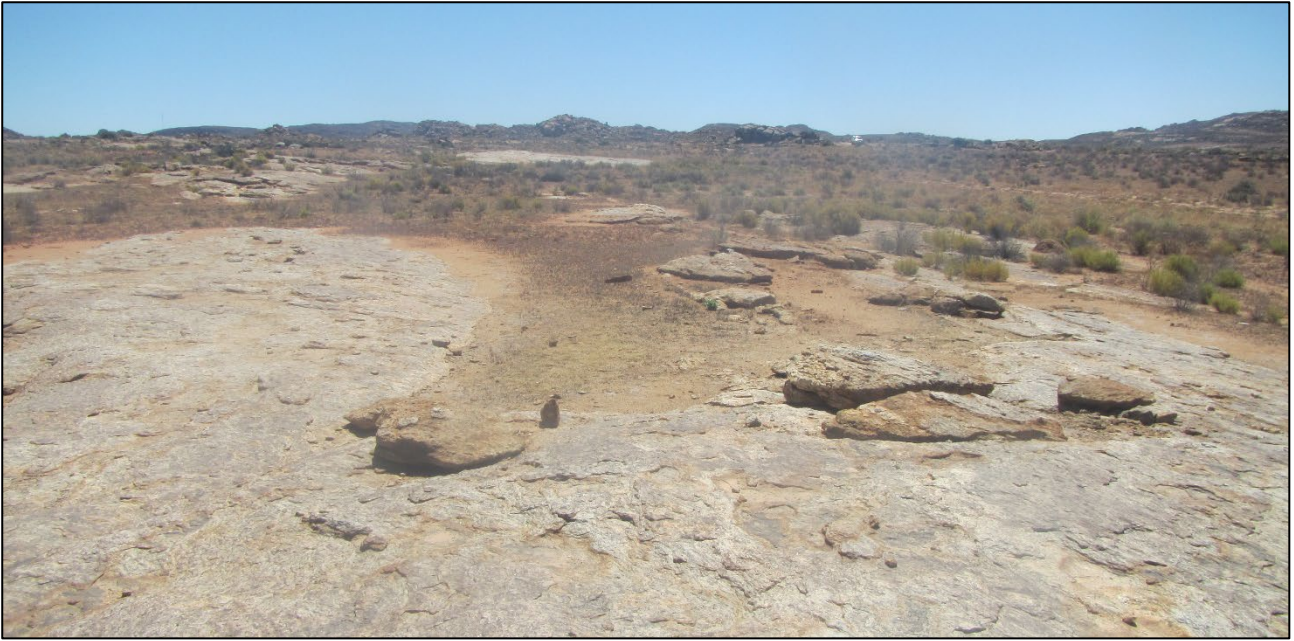
Figure 6: View towards the west through the northern part of the study area and showing one of the several large granite bedrock exposures there.

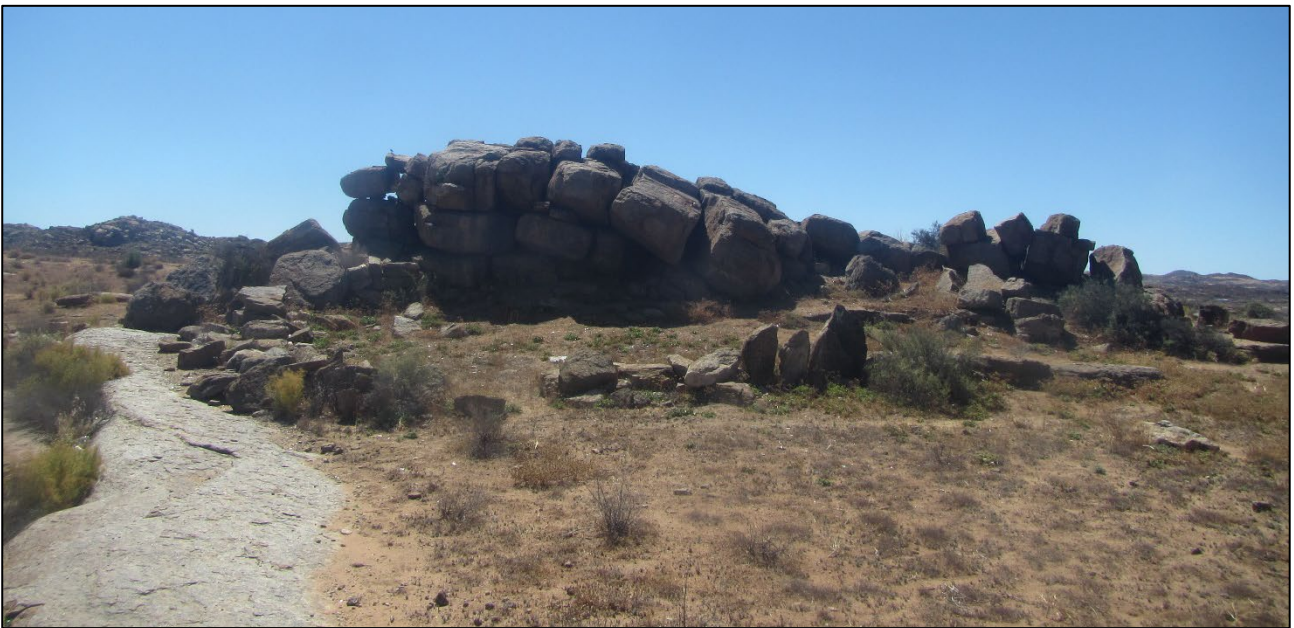
Figure 7: View towards the south through the southern part of the study area.

A small historical kraal was seen on the south-eastern side of the small granite hill at Waypoint 961 (S29 33 25.9 E17 57 06.5; Figures 7 & 11). It was built up with granite blocks surrounding a space of about 9 m by 12 m although the north-eastern side di not have any walling present (Figure 11). The inside of the kraal had large numbers of broken modern beer bottles in it. However, a careful search amongst the debris showed that historical materials were also present (Figure 12). The ceramics included lined industrial slipware, transfer-printed ware and sponge-printed ware, all typical of the second half of the 19th century.

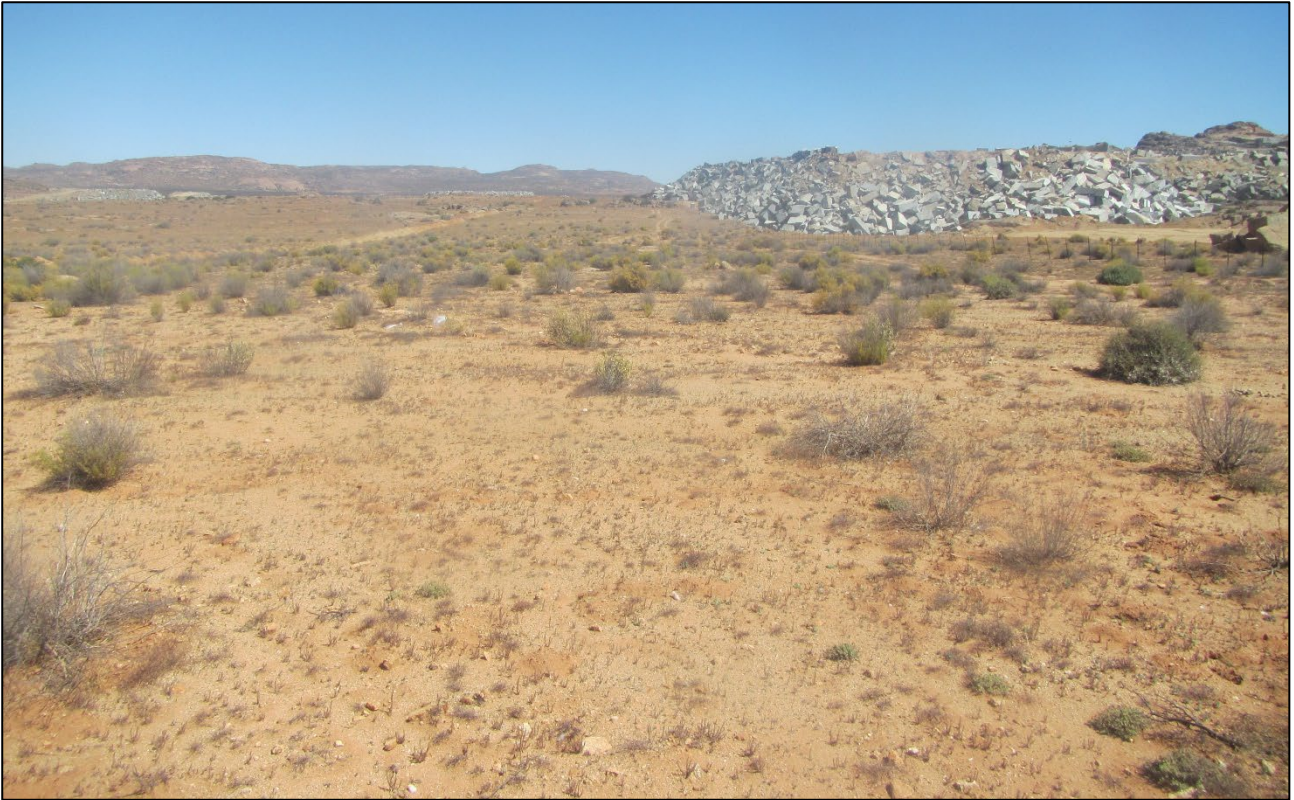
Figure 8: View towards the south through the southern part of the study area.

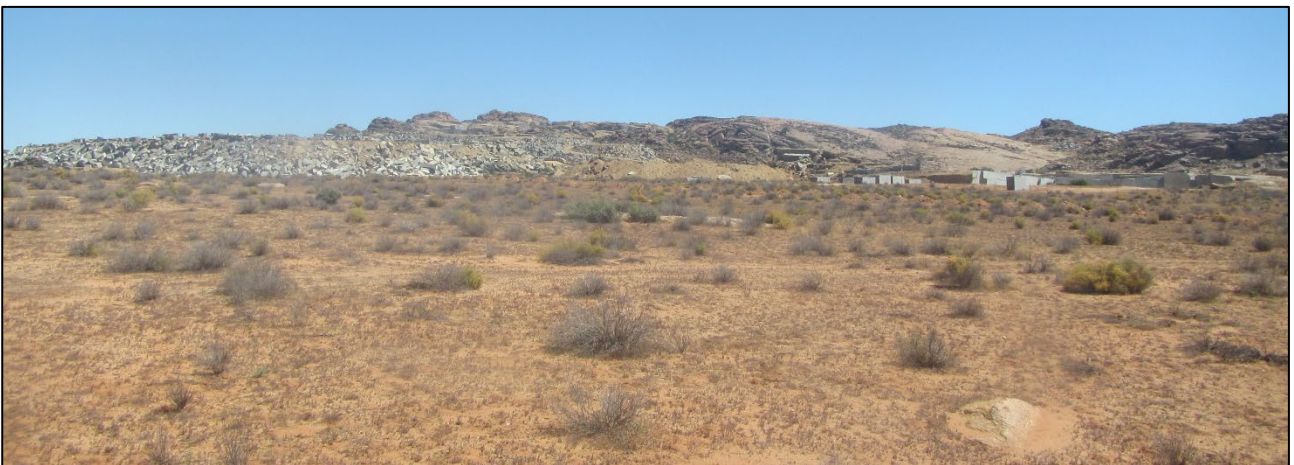
Figure 9: View towards the southwest through the northern part of the study area showing the existing mine alongside the present application area.

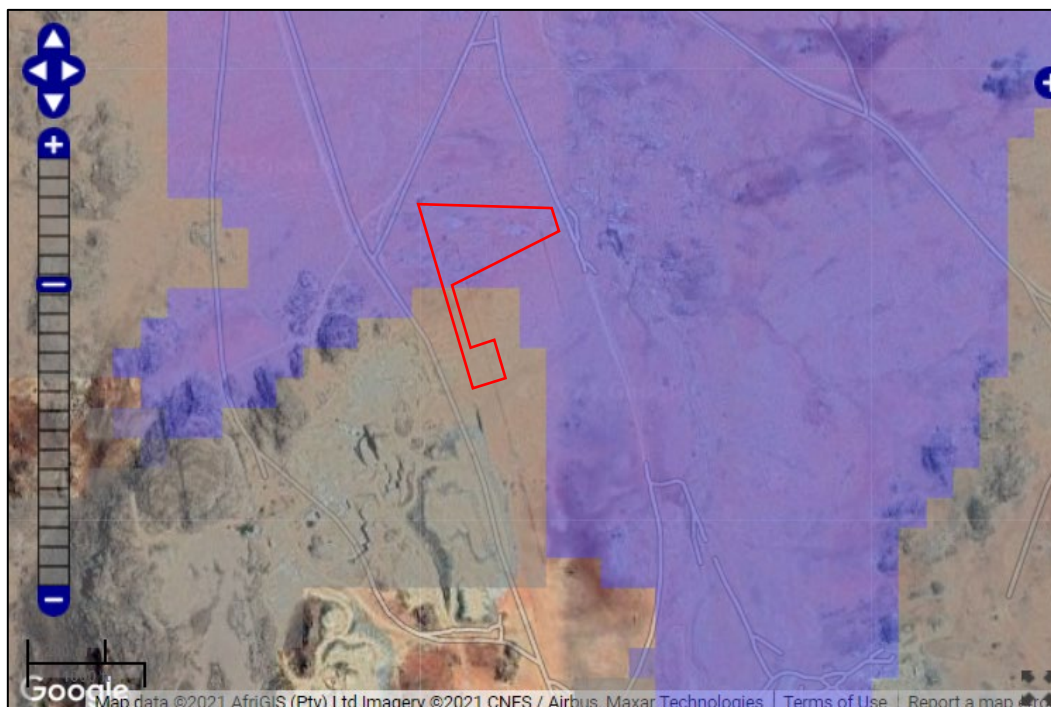
Figure 10 shows an extract from the SAHRIS Palaeosensitivity map. The study area is shown as being of zero (grey shading) and low (blue shading) palaeontological sensitivity. The field survey showed the northern part of the study area to have much granite exposed at the surface, while two trenches excavated across the area showed that weathered bedrock was present just beneath the surface virtually everywhere. The entire area should thus be rated as being of zero sensitivity.

Figure 10: Extract from the SAHRIS Palaeosensitivity map showing the site to be rated as of zero (grey shading) and low (blue shading) palaeontological sensitivity.

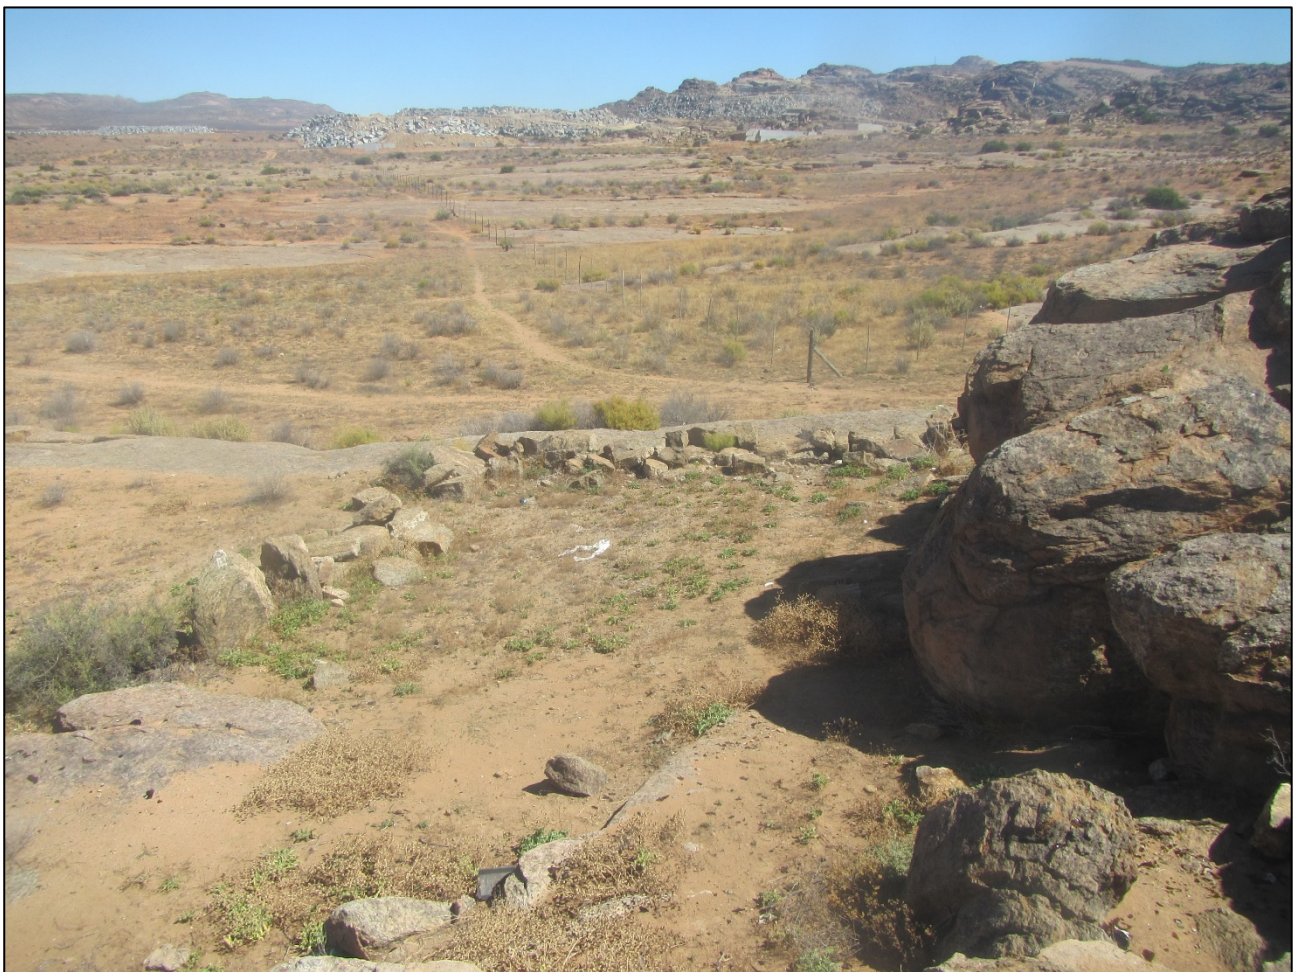
Figure 11: View towards the southwest of the kraal at waypoint 961. Walls are evident on the southwest and southeast but not along the north-eastern side which would be in the foreground. The existing mine fence is visible in the background.

- The small kraal in the north-western corner of the application area should be avoided and protected from harm by a small fence running 5 m from the stone walling;
- All exposed fresh bedrock (mine faces and rock dump) must be rehabilitated during mine closure so as to reduce the visual contrast between weathered and fresh rock; and
- If any archaeological material or human burials are uncovered during the course of development then work in the immediate area should be halted. The find would need to be reported to the heritage authorities and may require inspection by an archaeologist. Such heritage is the property of the state and may require excavation and curation in an approved institution.

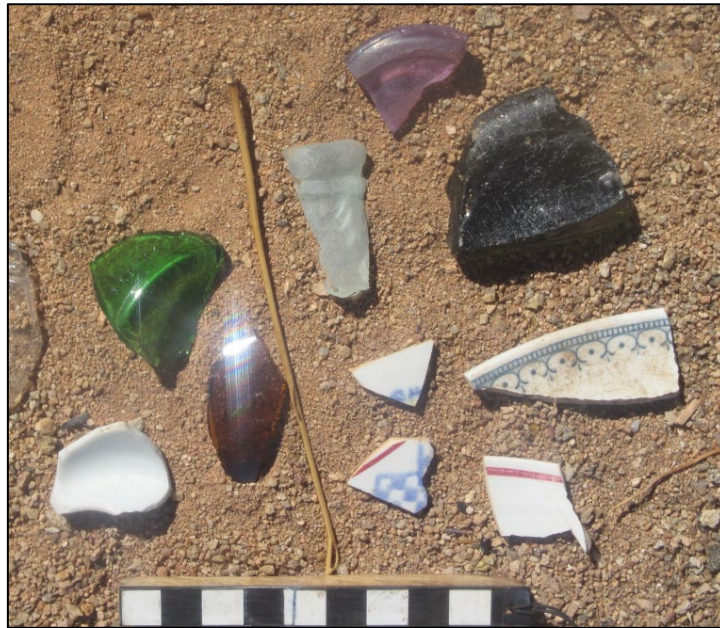
Figure 12: Modern (left) and historical (right) glass and ceramic fragments in the kraal at waypoint 961. Scale in cm.

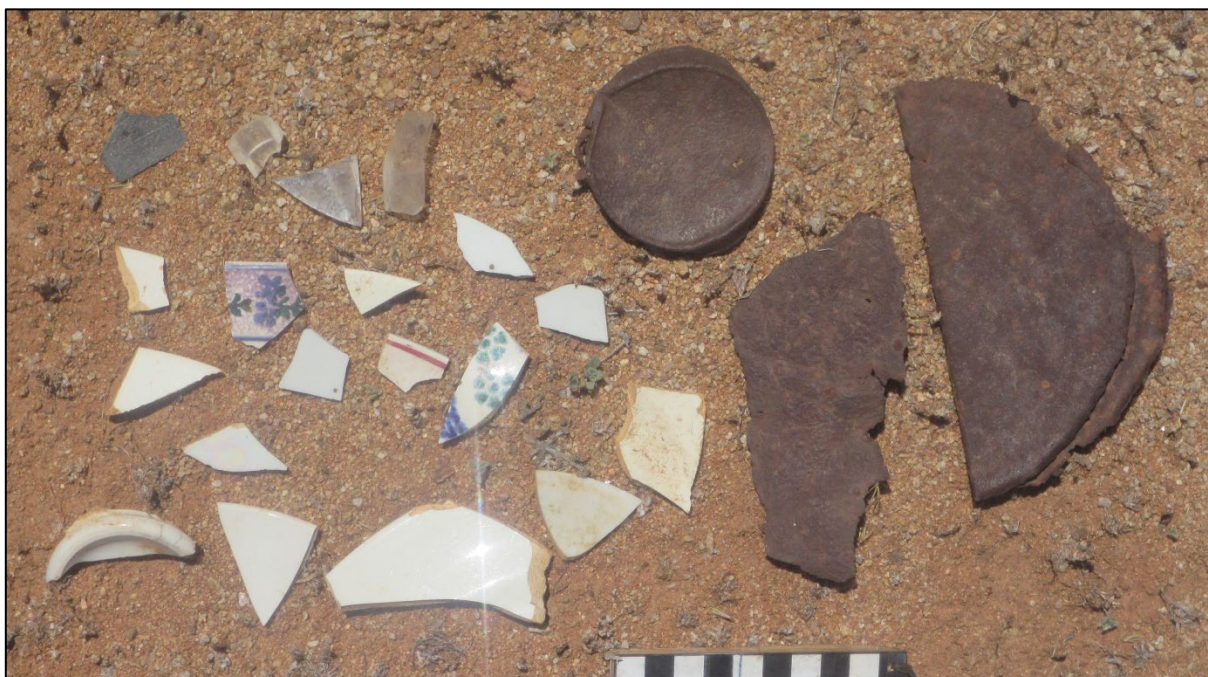
A scatter of historical glass and ceramics and one small piece of writing slate was seen at waypoint 960 (S29 33 25.3 E17 57 10.5; Figure 13). This was in an open area about 100 m east of the small kraal. There were no other features in this area. The scatter again included typical late 19th century materials such as lined industrial slipware and sponge-printed ware. Rare stone artefacts (all in quartz and all adiaagnostic) and other fragments of historical material (including one more piece of writing slate) were seen in various places (Figure 15).

Figure 13: Glass, ceramic and metal items from waypoint 960. A small fragment of writing slate is at the top left hand corner. Scale in cm.

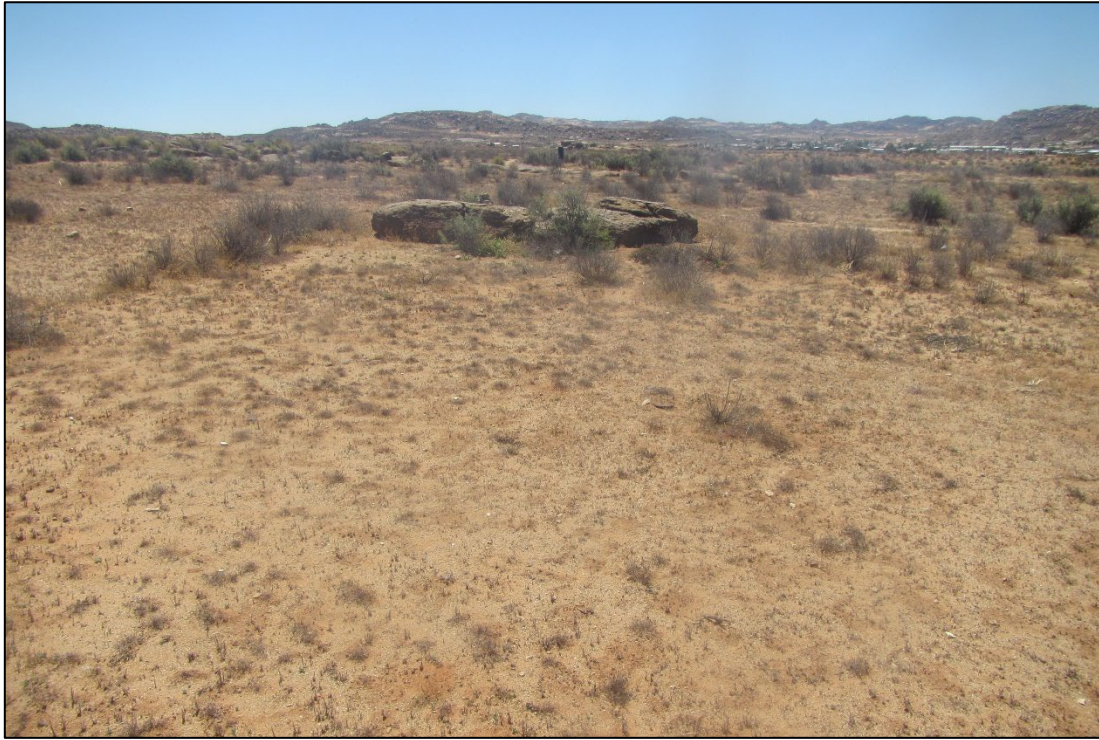
Figure 14: The context of the finds at waypoint 960. This view is towards the northwest and the town of Concordia is visible in the background.

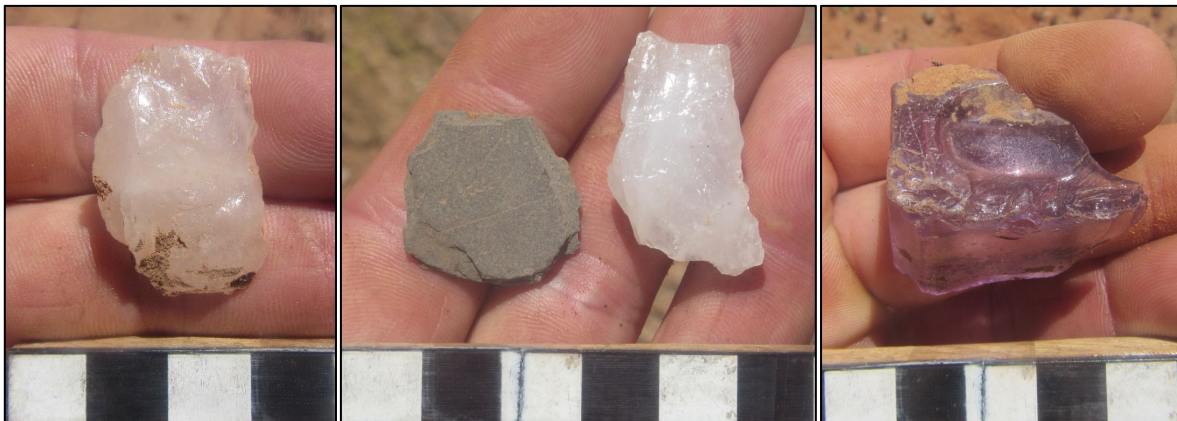
Figure 15: Isolated quartz stone artefacts, a writing slate fragment and the base of a pink glass bottle (probably a medicine bottle).

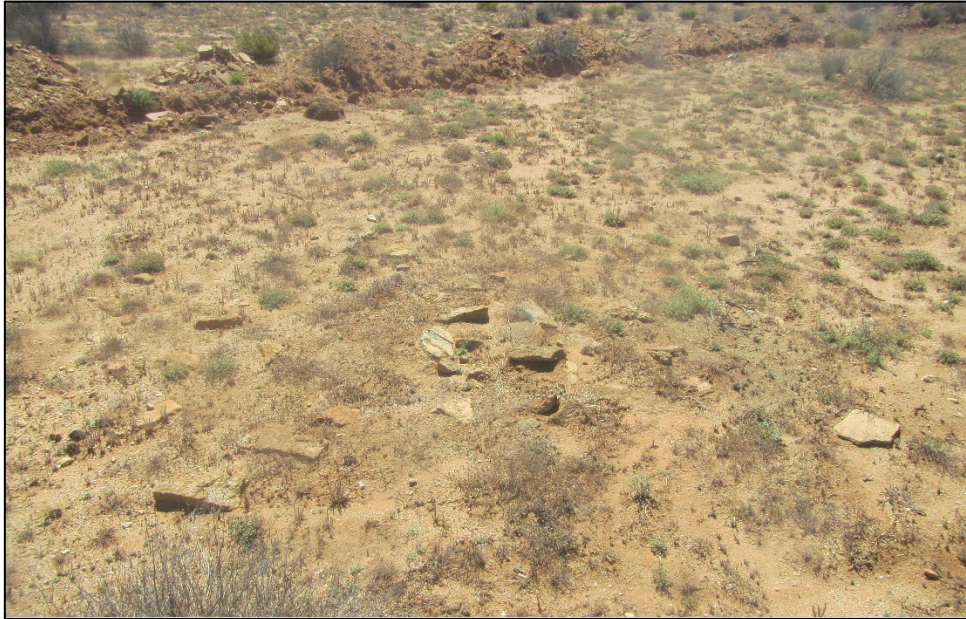
A small cluster of granite rocks and slabs was seen at waypoint 960 (S29 33 25.3 E17 57 10.5). While they could be there naturally they were noted because the surrounding area tended to not have such pieces of stone on the surface. The rocks were far too small for gravestones and, given the fact

that weathered bedrock occurs just below the surface, this feature is not a grave. Given the extensive historical use of the area, these rocks could easily have been assembled for a multitude of purposes.

Figure 15: *The vague collection of small slabs at waypoint 960.*

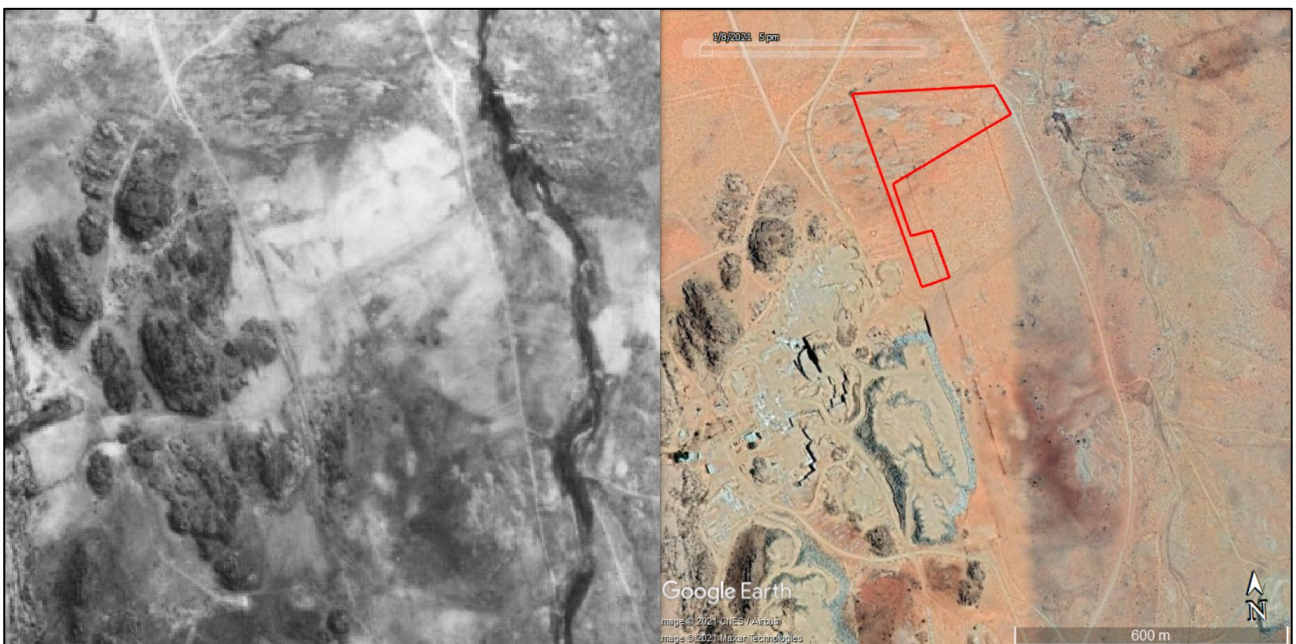
Figures 17 and 18 show historical aerial views from 1958 and 1964. There was cultivation in the area around then and the far greater clarity of the river to the east shows that far more water was available. The agriculture has long since been abandoned.

Figure 18: 1964 (Job 525_028_03062) and modern (Google Earth) aerial photographs clearly showing the southern part of the study area to have been cultivated in 1964. Note how clear the river was in 1964, a sign of far more rainfall.

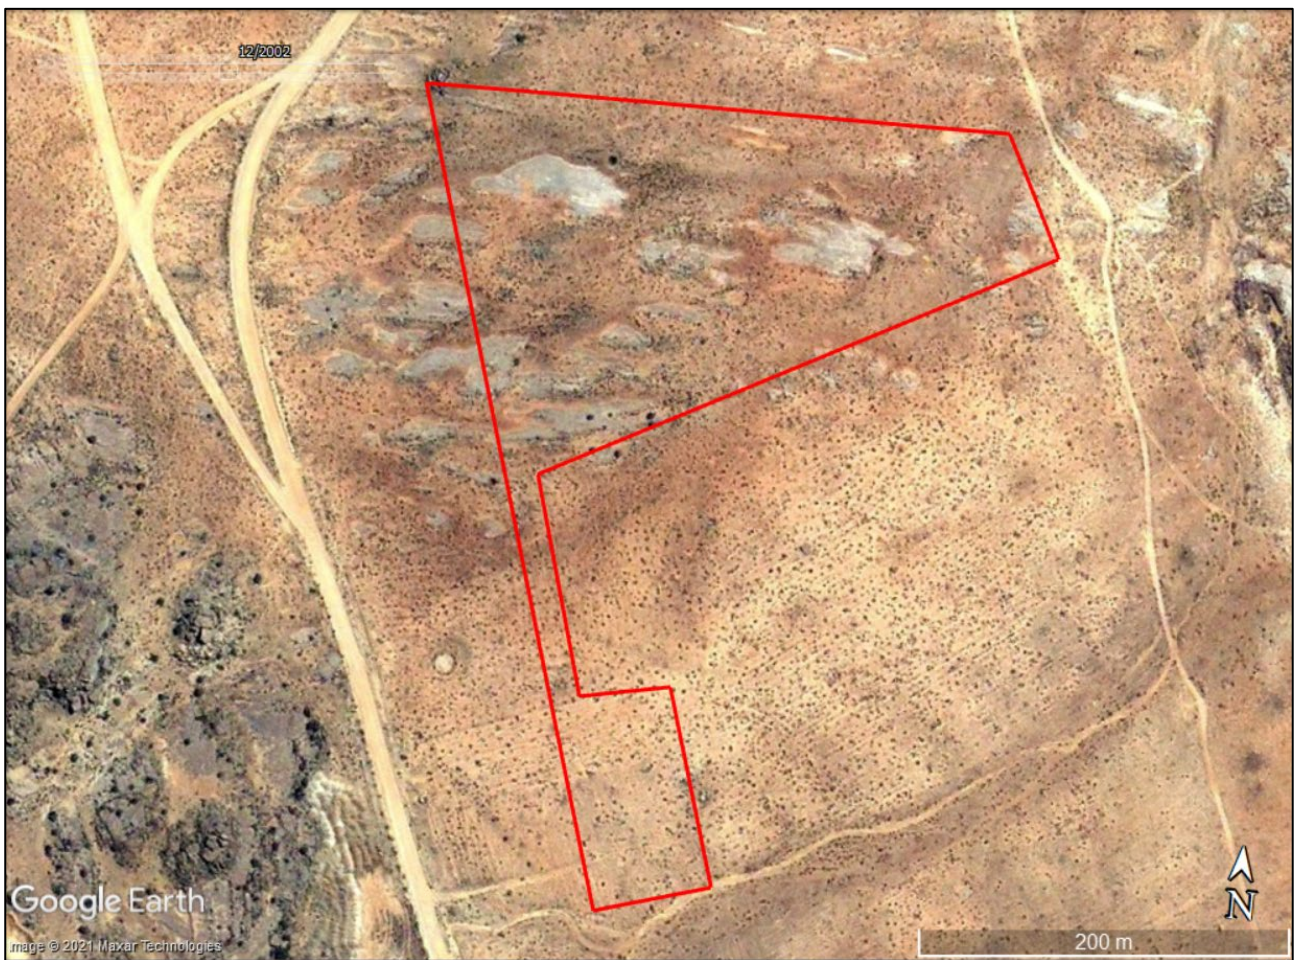
Figure 20: October 2002 aerial photograph showing lines on the ground which show that, despite the shallow soil, much of the southern part of the area was cultivated in the past.
