# MANAGEMENT PLAN

<b>HERITAGE KWAZULU NATAL</b>

<b>SITE</b>	<b>PREPARED BY</b>	<b>DUE FOR REVIEW</b>
<b>COW CAVE on the farm Ptn. 3 Rood 14899</b>	CELESTE ROSSOUW Senior Rock Art Officer (SRAO) and Mr. Siyabonga Mbatha Rock Art Monitor (RAM)	June 2017

### 1.1. Survey and base-line documentation of Cow Cave

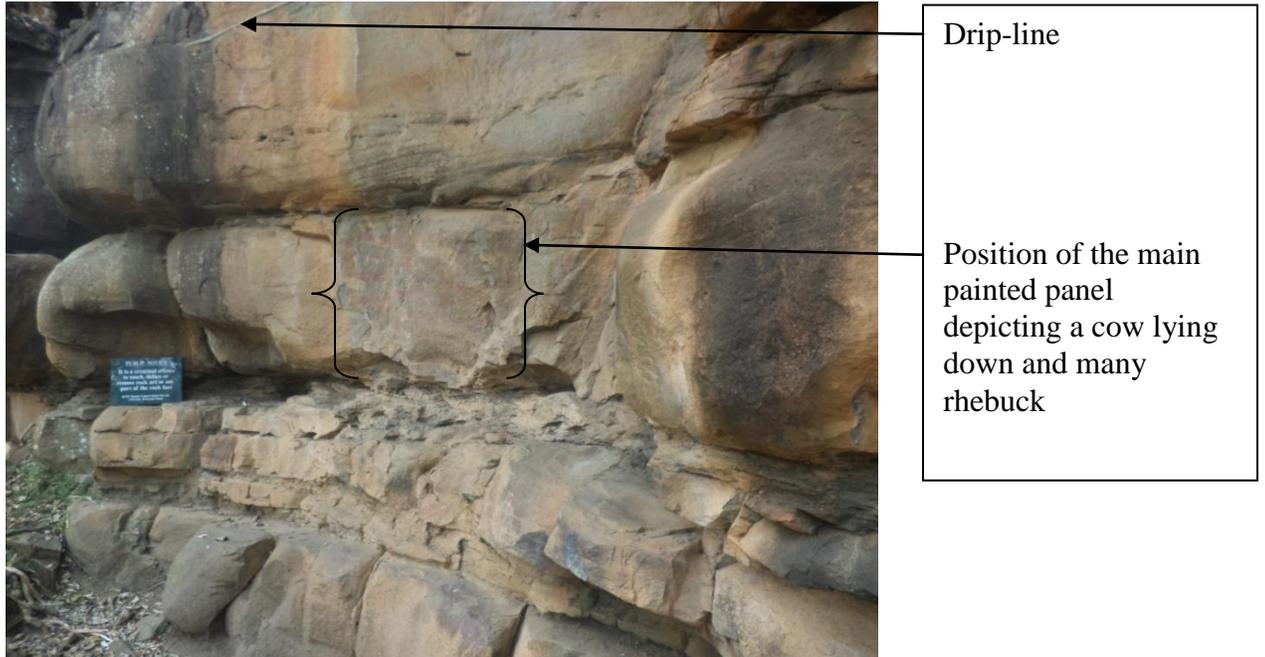
Figure 1 Parent rock of Cow Cave to contextualize the position of the main panel and the position of the drip line, above.

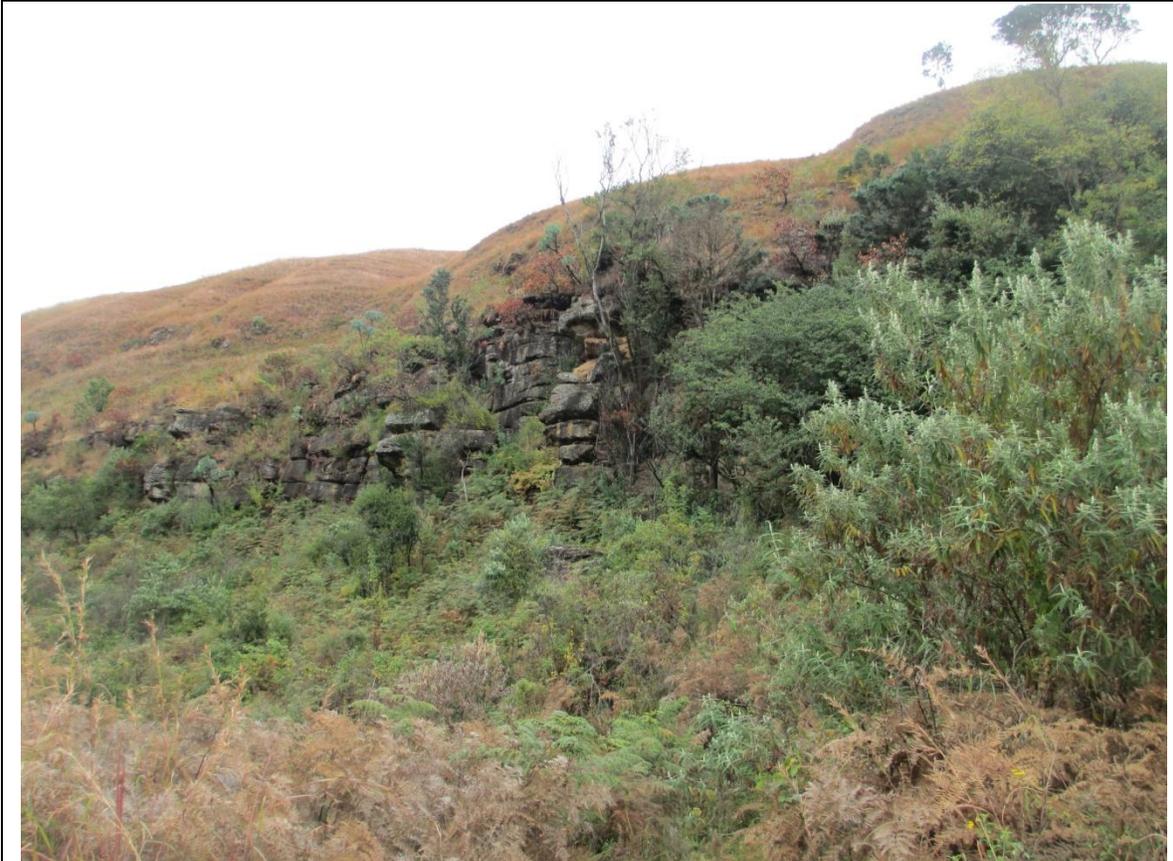
Figure 4 Cow Cave is located in a small shelter measuring 14,5m screened by thick vegetation. The cave is facing south and it is not known whether an archeological deposit is present.

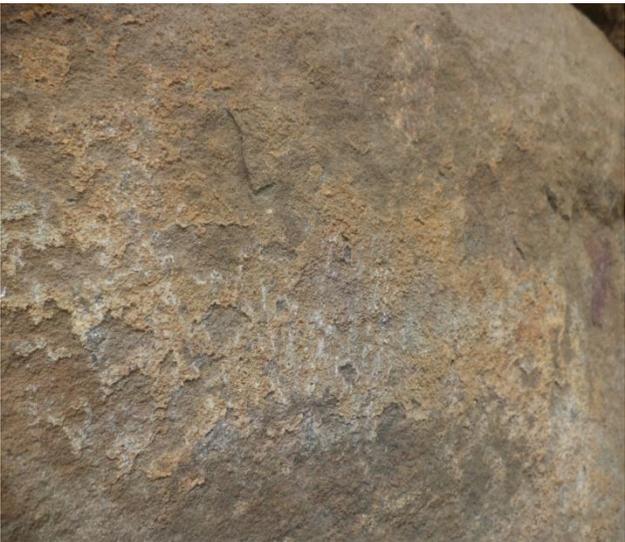
Have the paintings or rock shelter been damaged by graffiti?	Yes, there are some new scratches visible.

Figure 5 Some vertical scratches are visible.

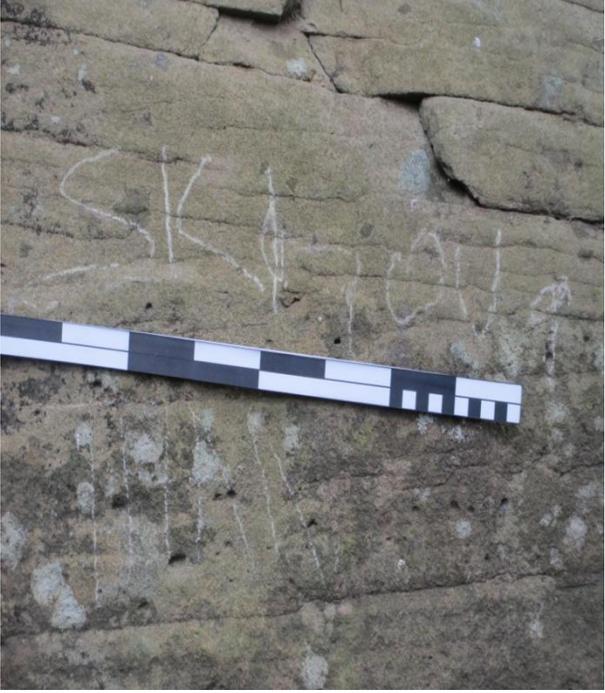
<p>Figure 6 shows new engraved graffiti measuring approximately 35cm by 15cm. Underneath the “SKHOLE” HM was also engraved measuring 20cm by 20cm.</p>
Approximate number of paintings: 30	Red: Black: White: Yellow: Bichrome: Polychrome:
Number of human figures: 2	Male: Female: Indeterminate: 2
Number of animals: 27	Indeterminate antelope: 3 Cow: 1 Rhebuck: 15 Eland: Leopard: Baboon: 1 Hartebeest: 2 Impala: Giraffe: Buffalo: Gemsbok: 1 Dik-dik: 5
Number of handprints: None	Plain: Patterned:
Number of non-representative patterns: None	Dots: Lines: Grids: U-shapes: Smears: Zigzags: Y Shapes: Finger paint:
Describe unusual images: 1	White painted animal portraying a large and fat mammal, this might represent a rain-animal and is accordingly of ritual significance
Is the cave floor rocky or sandy or ashy?	Sandy
Location of the site (on top of mountain, in stream bed, half way up a mountain?)	Halfway up a koppie.

New graffiti was documented at the site and reports from Buffalo Guides mentioned the problem of illegal access to Cow Cave. Proposal: Mr. Mbatha and I should go and see the owners or the Hospitality/Entertainment Manager of Dragon's Peak Hotel who were directing their guests to the site illegally based on complaints by Buffalo Guides.

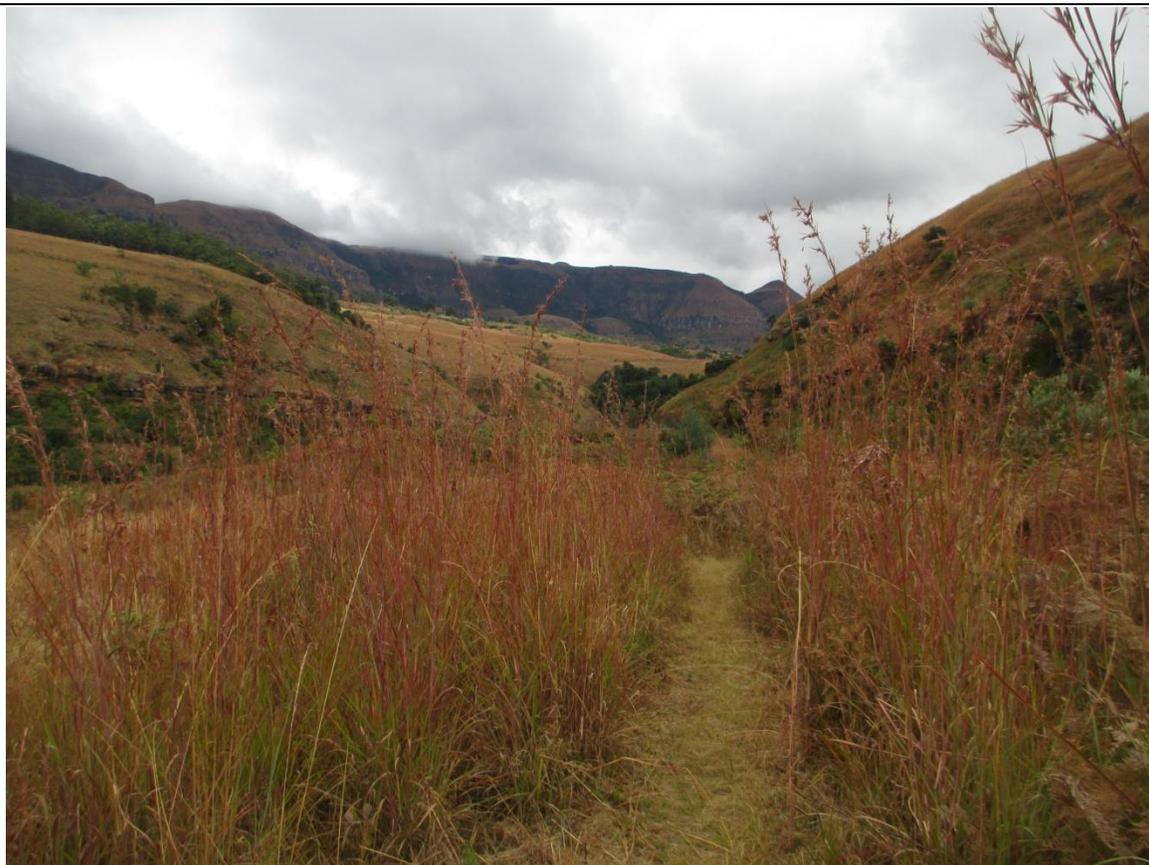
Figure 7 shows that the trail to Cow Cave is well maintained. A gate is also in place to allow for better access control, however, sometimes the gate is not closed and people from the neighbouring Dragon's Peak Hotel may access the property of Mr. Mackintosh and go to the site alone.

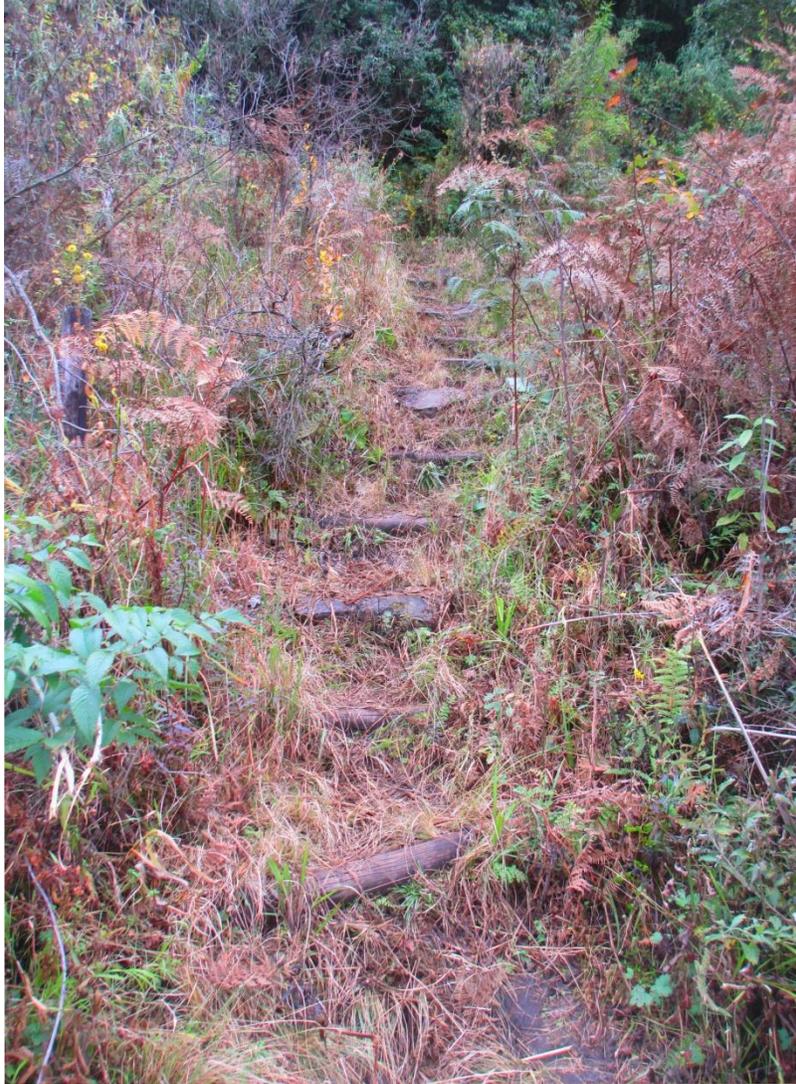
Figure 8 shows the pathway up the slope to Cow Cave, no soil erosion is visible and the trail is clear.

During the rainy seasons the pathway must be checked for soil erosion and should be rehabilitated as soon as possible. This would be the responsibility of the owner of the site.

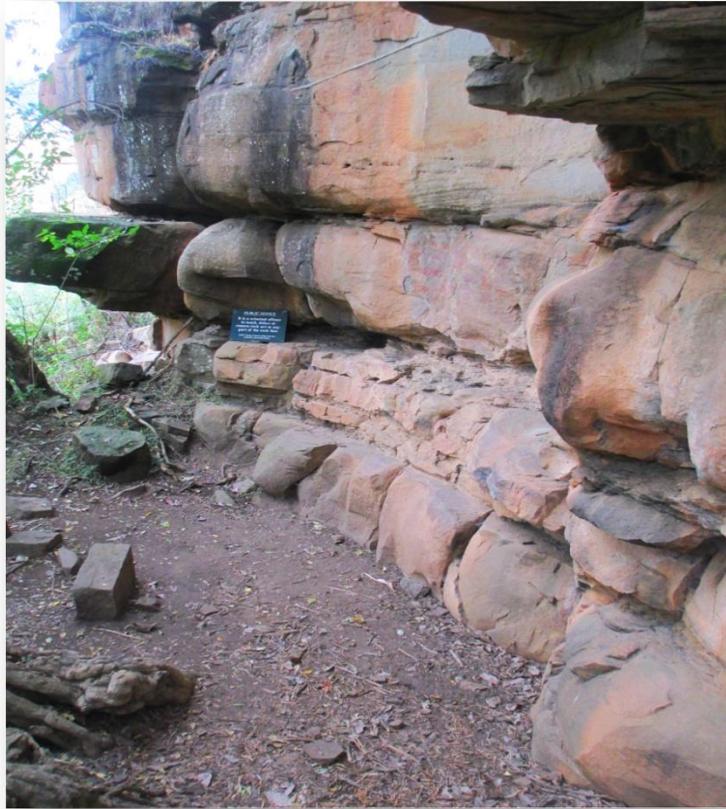
Figure 9 shows part of the shelter floor and parent rock with the drip-line.

- a. Taken into consideration that the area in front of the cave is very narrow, it is recommended that only five guests enter the cave at once, the custodian included. Guests must also be informed to be careful not to stir dust or to accidentally rub or touch the parent rock or paintings.
- b. A maximum of two site visitations may occur and the time frame specified will be at 9am and 11am daily.
