**CREIGHTON BULK WATER SUPPLY SCHEME, HARRY  
GWALA DISTRICT MUNICIPALITY,  
KWAZULU-NATAL**

**Phase 1 Heritage Impact Assessment**

**June 2022**

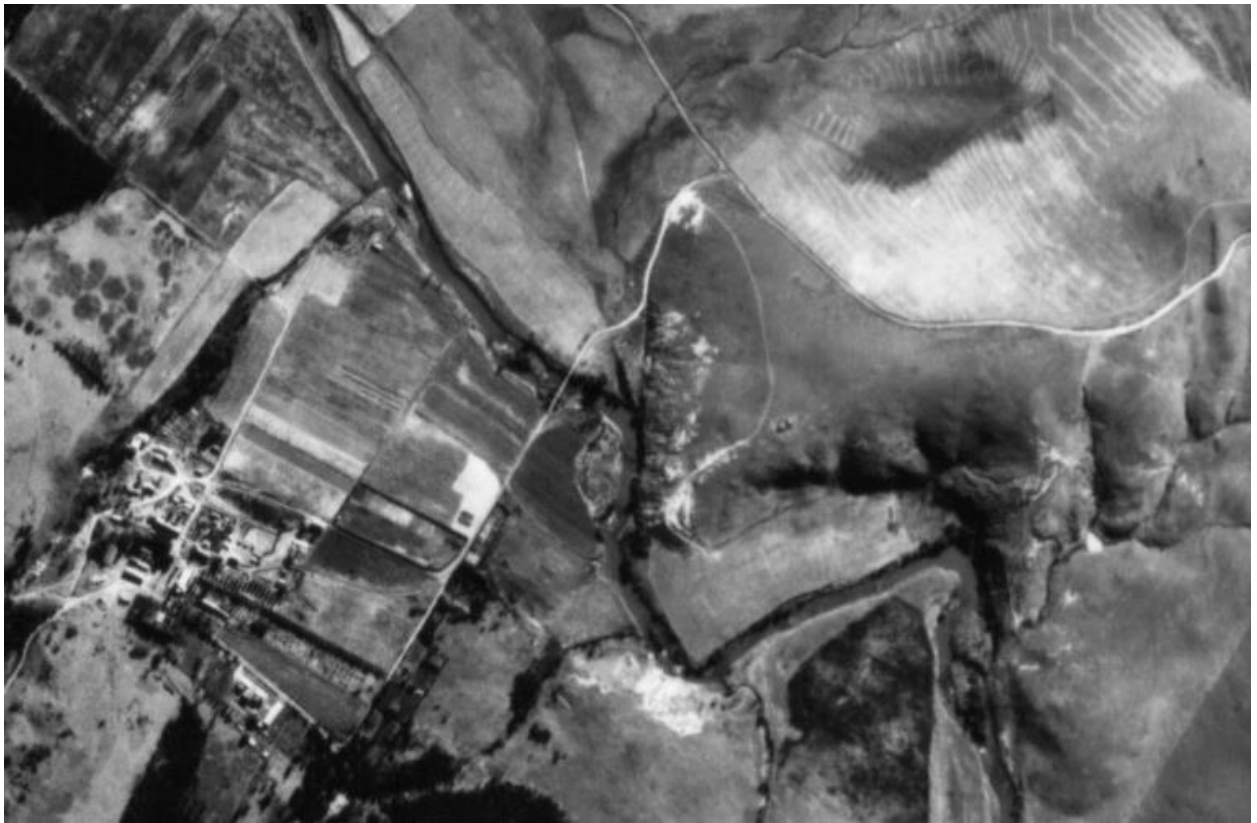
**Figure 2: 1954 aerial photograph of Centocow and surroundings**

The 1954 aerial image of Centocow area shows the mission buildings, cultivated land between the mission and the Mzimkhulu River and abstraction point, the road out of Centocow and cultivated land on the northern side of the road to Creighton.

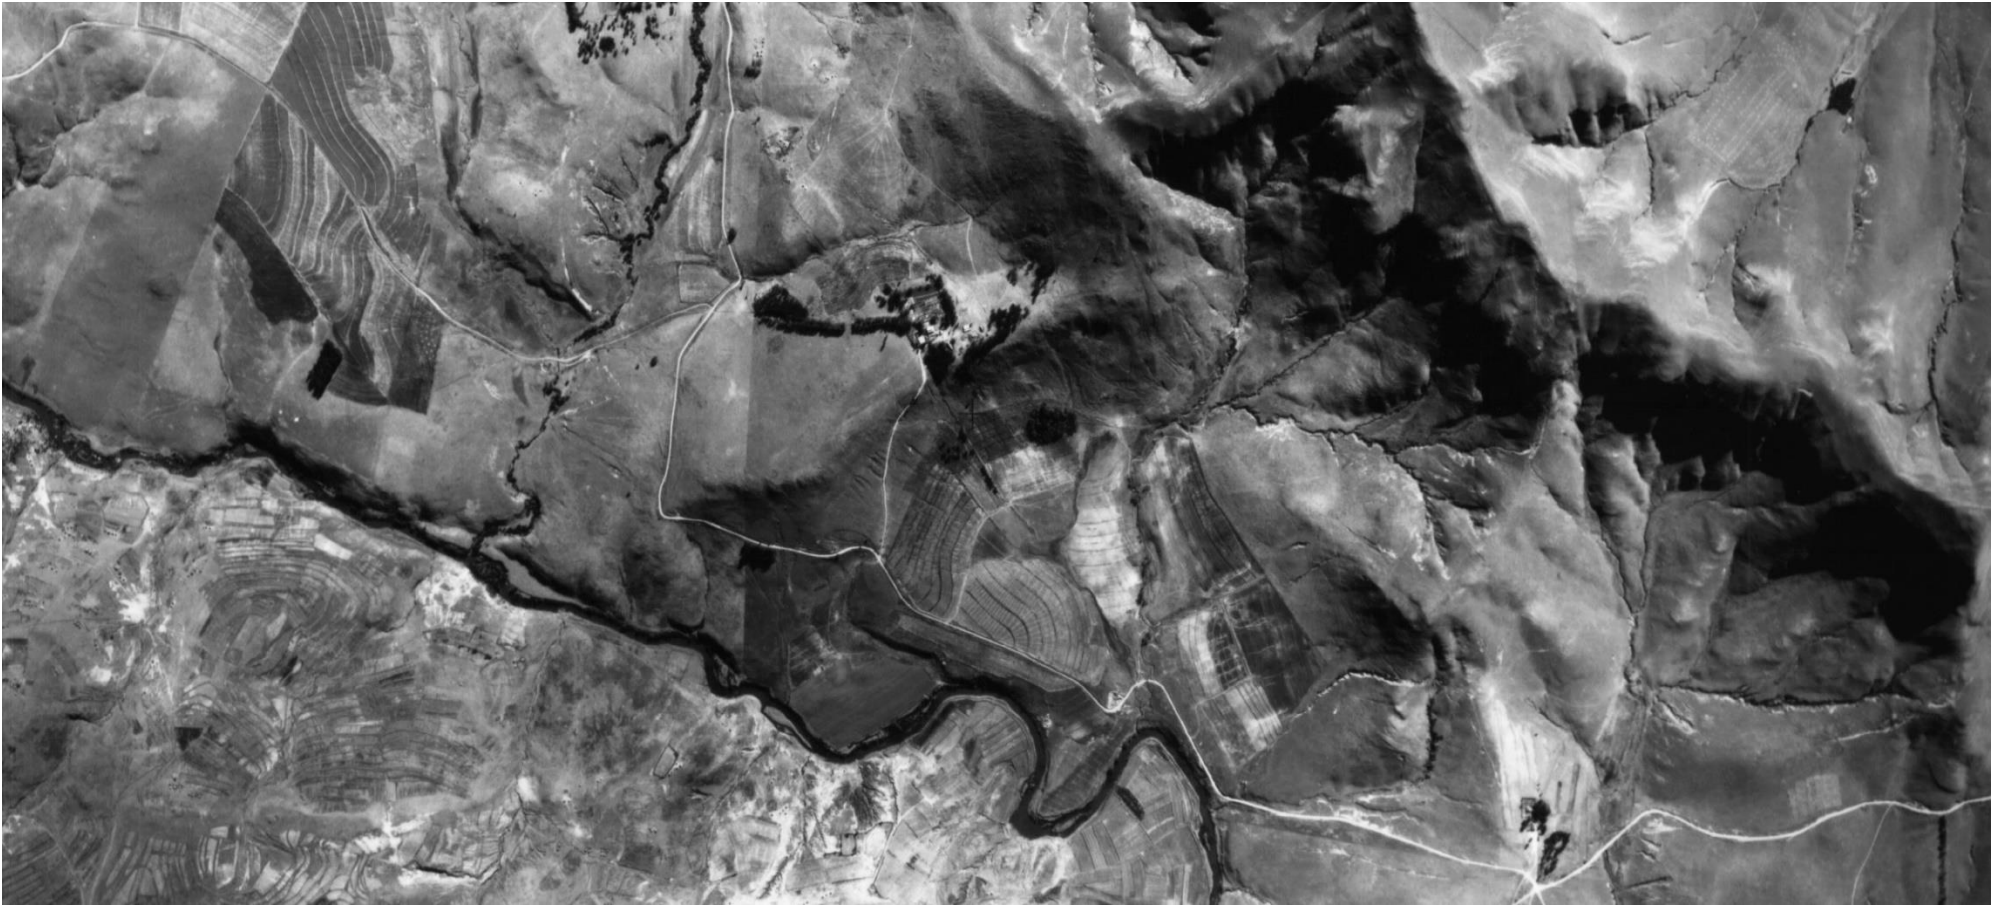
**Figure 3: 1954 aerial image of road and surroundings between Centocow and Creighton**

The 1954 aerial photograph of the road between Centocow and some distance from Creighton shows cultivation of on either side of the road as well as the uMzimkhulu River with little evidence of structures and homesteads.

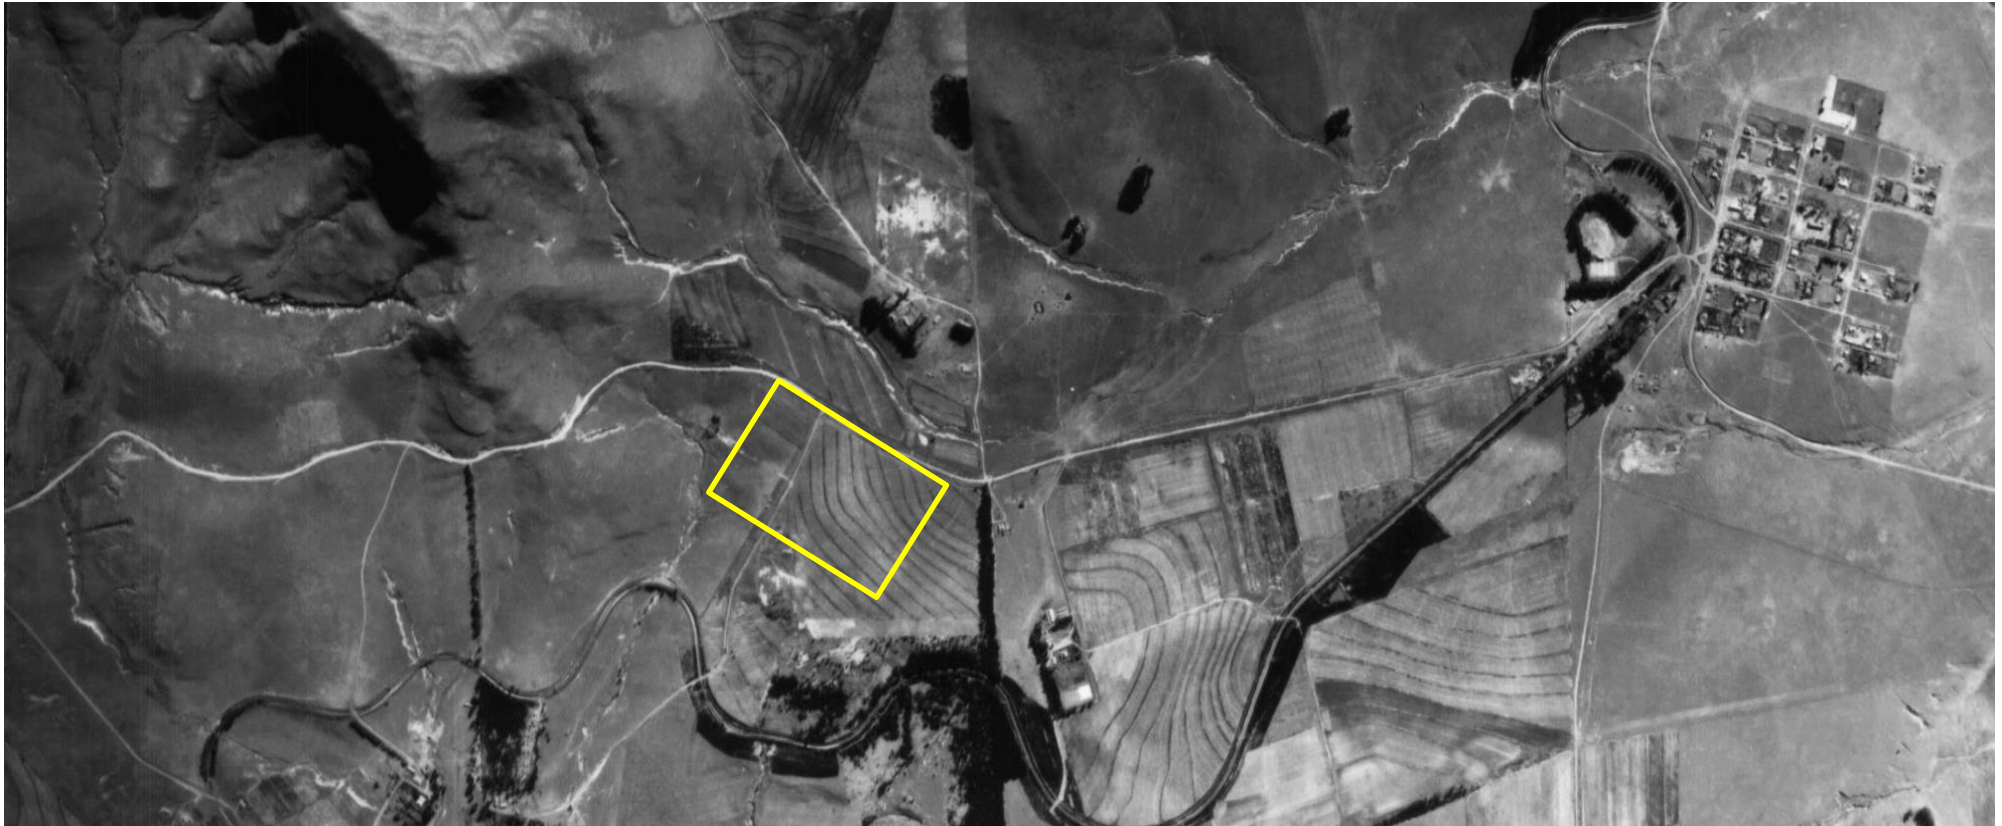
**Figure 4: Aerial image of proposed reservoir site and town of Creighton**

The 1954 image below of the proposed reservoir site (outlined in yellow) and of Creighton shows the area to be partly cultivated with some farmsteads located off the road.

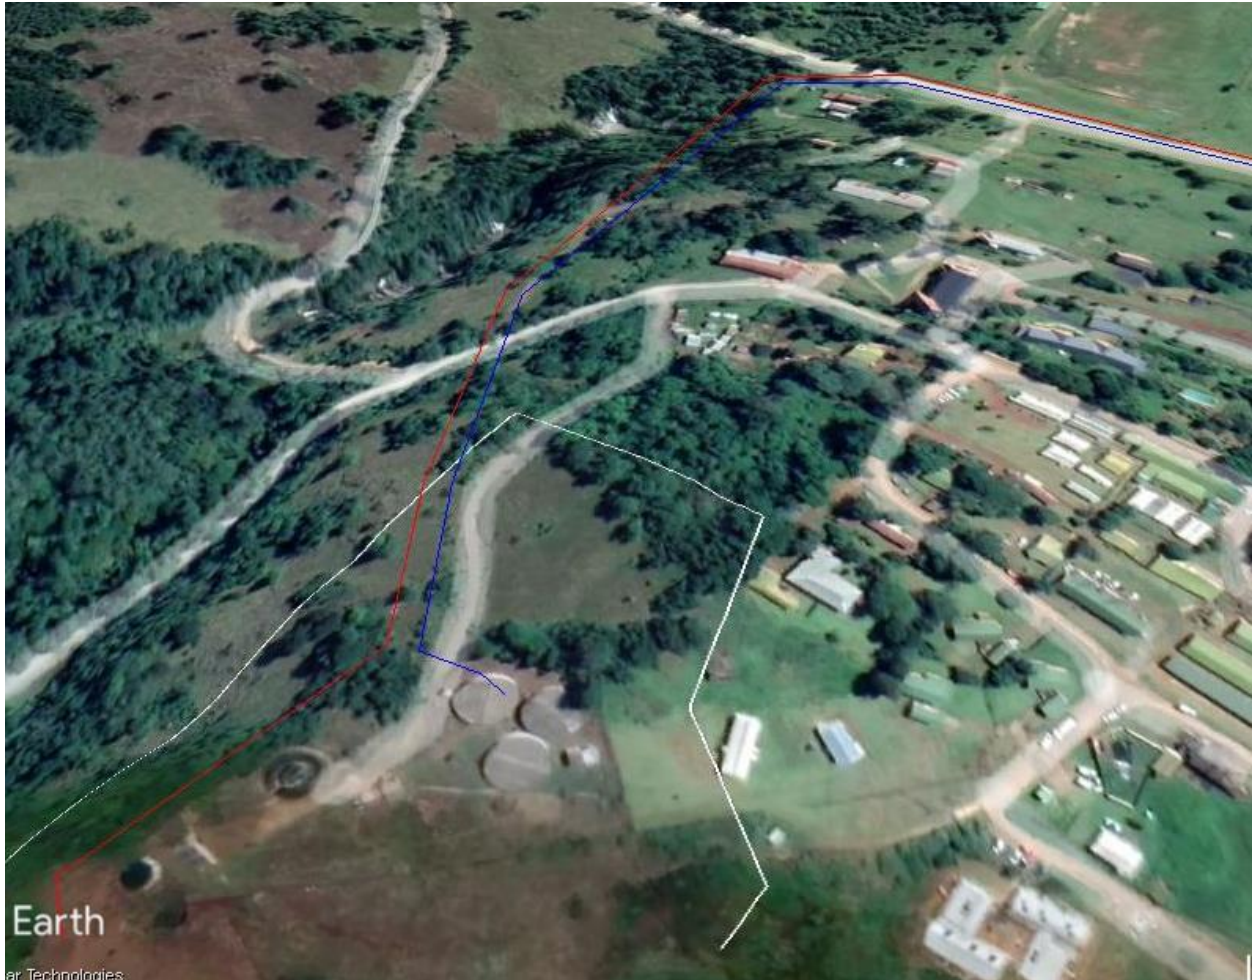
**Figure 5: Pipelines depicted in blue and red from WTP to abstraction works**

The site inspection started at the Centocow WTP. The area was investigated on foot as well as the two proposed pipeline routes between the WTP and the abstraction works that are indicated in blue and red in **Fig. 5** below.

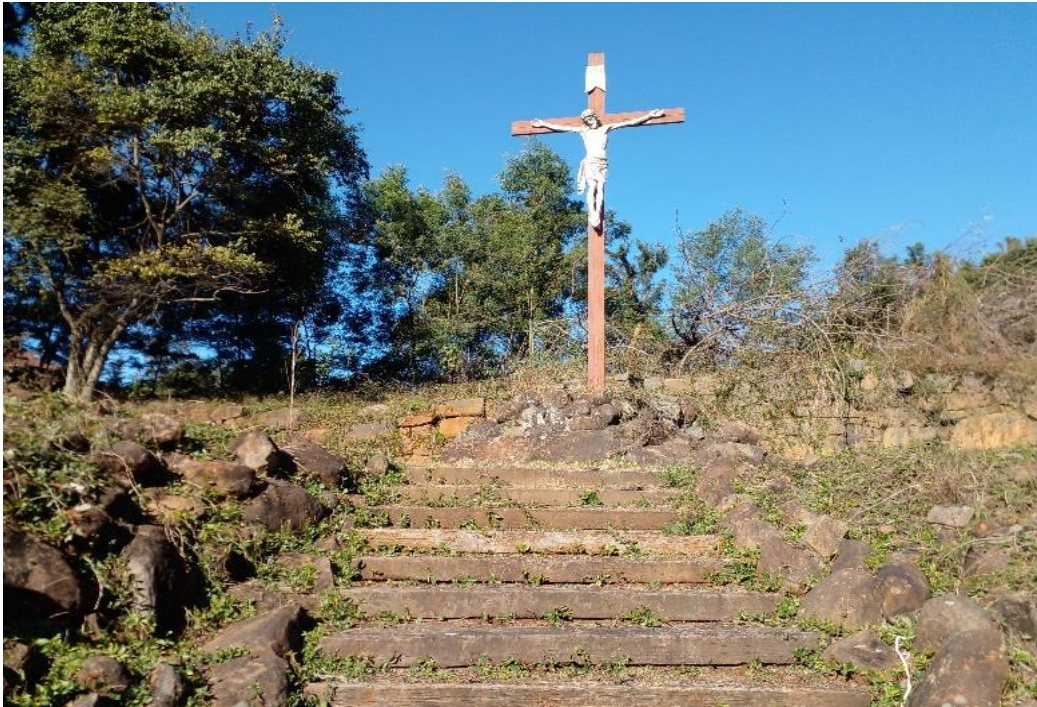
**Figure 8: Crucifixion cross**

Both pipelines from the abstraction point are located to the west of the Centocow mission station and thereby avoid impacting several protected structures that form part of the mission station as

well as a number of memorials that depict the stages of the crucifixion of Jesus as well as a cross depicting the crucifixion with steps leading up to it.

- *The structures associated with the mission should be left intact as they comprise the history of the mission as a holistic entity.*
- *A buffer of at least 5m must be placed around all protected structures located near the pipeline routes to avoid damage to the structures. The buffer must be visible and made from durable material or fencing.*

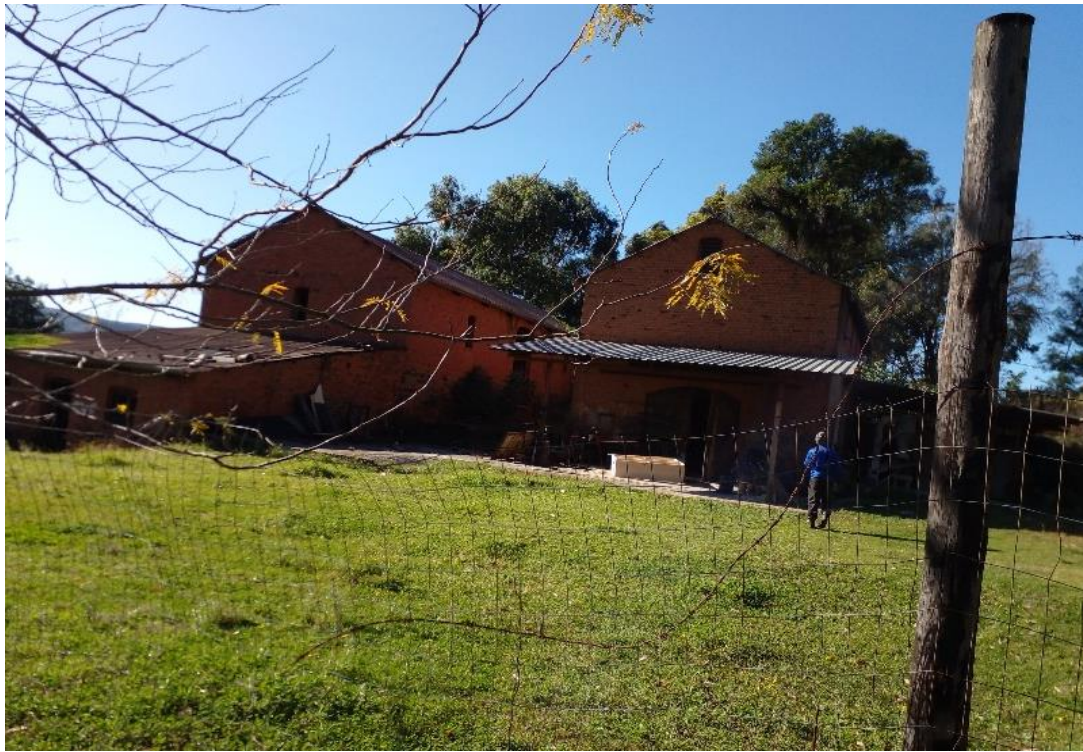
**Figure 12: Protected structures close to pipeline route**

However, the pipelines are located within 10m of protected structures where the pipelines turn eastwards to reach the road that runs along the northern boundary of the Centocow settlement. This complex of structures is fenced and appears to be used for carpentry purposes.

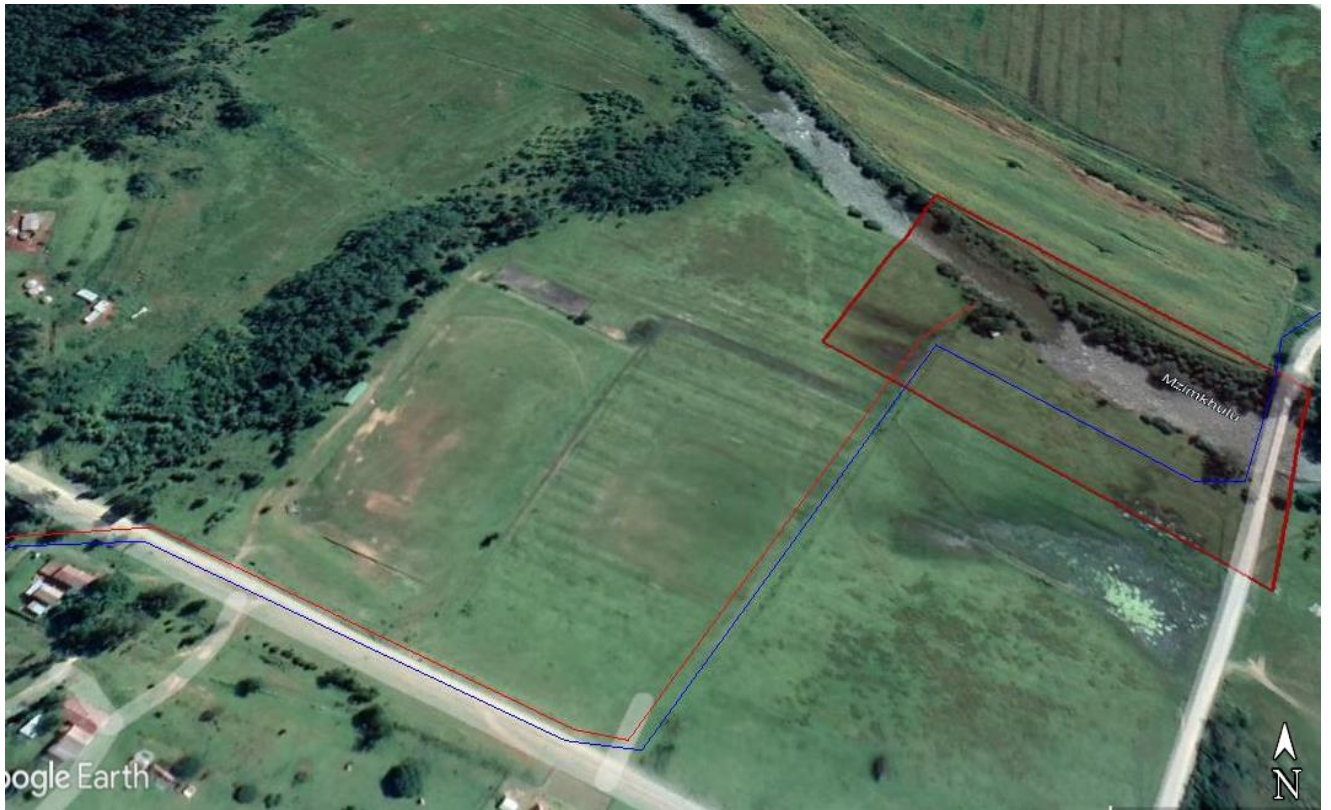
**Figure 14: Abstraction point and associated pipelines**

The pipeline routes below the mission to the abstraction point cross fallow land and a sports field (**Fig.14**). There is an existing pipeline that is close to the proposed pipeline route. Near the proposed abstraction point are the existing abstraction infrastructure as well as an abandoned structure (**Fig. 16**) which was a pump station with the original abstraction pipes still going into

the Mzimkhulu River. The structure appears to be less than 60 years but if the structure is to be demolished then a built heritage specialist should confirm the age of the structure.

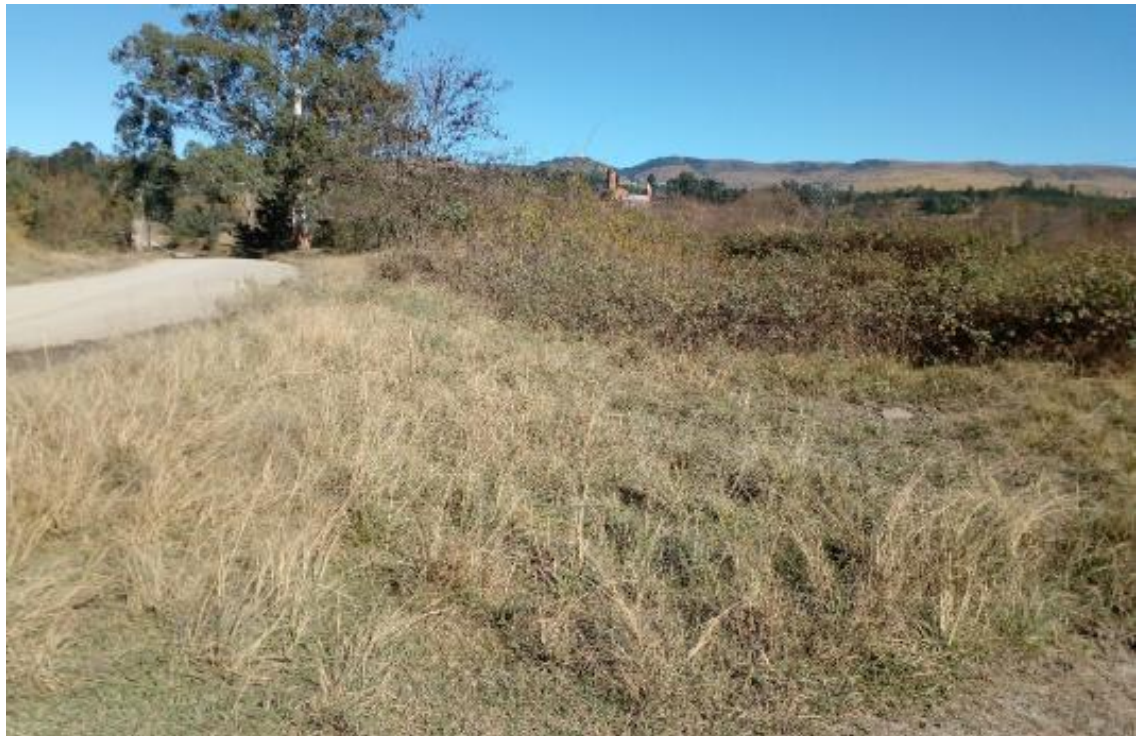
**Figure 17: Pipeline route towards road intersection with Mission structures in background**

From the abstraction point the pipeline then crosses the access bridge to Centocow and runs up to the road intersection before turning towards Creighton on the northern side of the road.

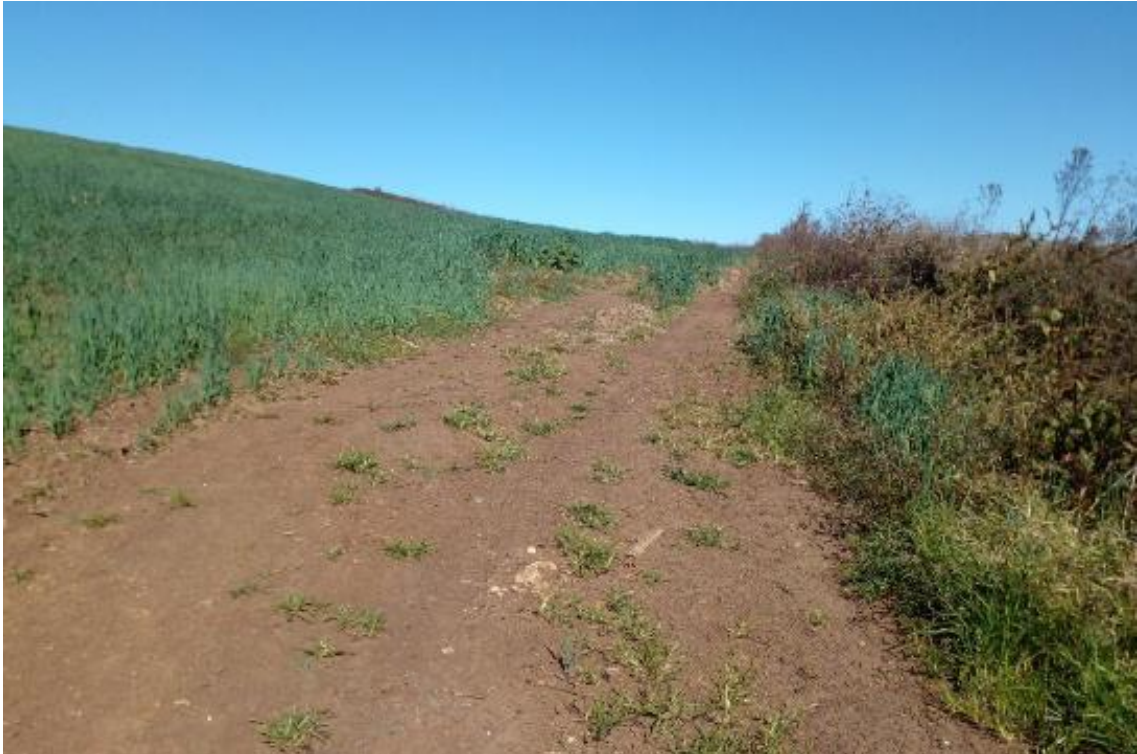
**Figure 18: Rye fields along pipeline route**

The pipeline route runs on the northern side of the road through cultivated farm land, tree plantations and a very small number of undeveloped areas. There are also power lines and farm dams along the route and a number of roads are crossed. No heritage sites were found during the inspection.

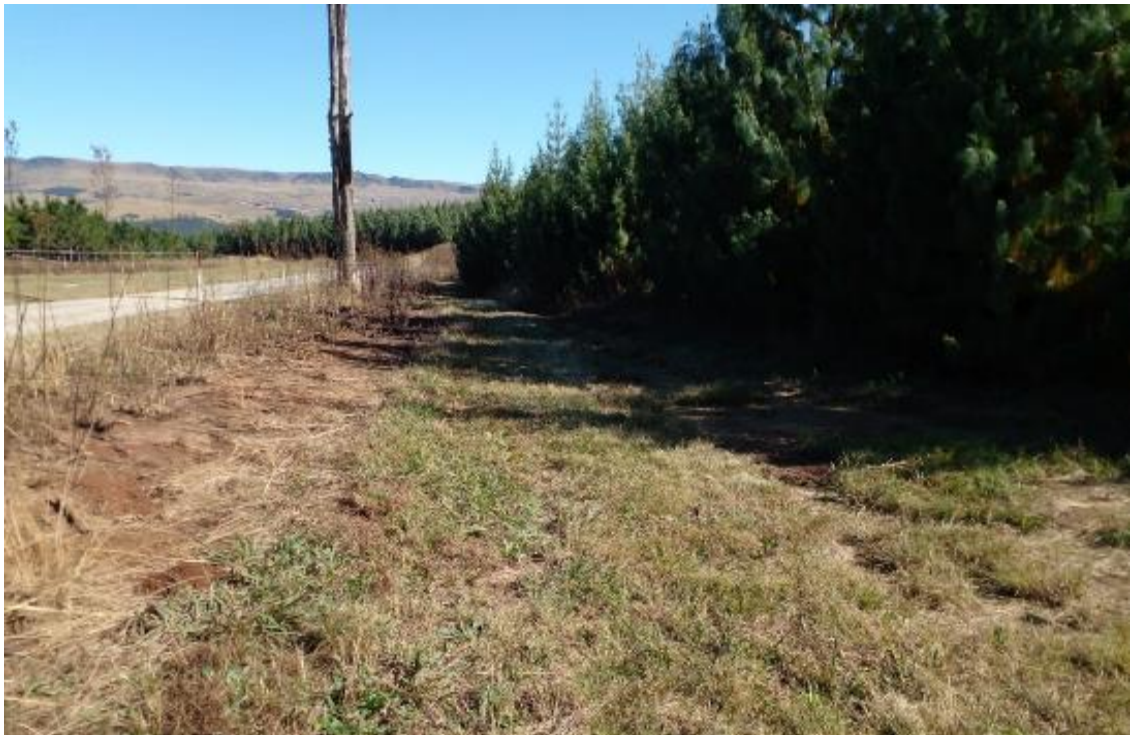
**Figure 21: Pipeline route next to plantation of trees**

During the inspection, the specialist spoke to Sipiwe Zulu and Nhlanhla Mkhize who said that to their knowledge there were no graves along the pipeline route as people buried their dead near their homesteads. There were no homesteads in the vicinity of the pipeline.

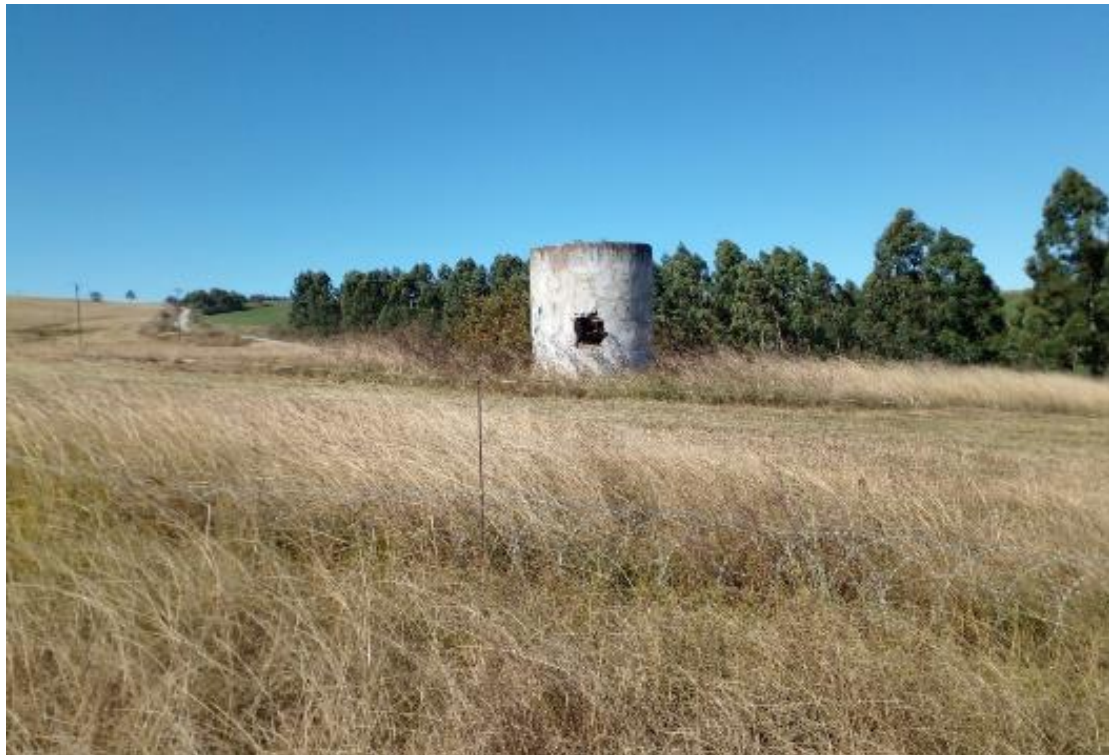
**Figure 23: Dilapidated silo on pipeline route**

During the inspection a dilapidated crop silo was found close to the pipeline route. The silo is not a protected structure.

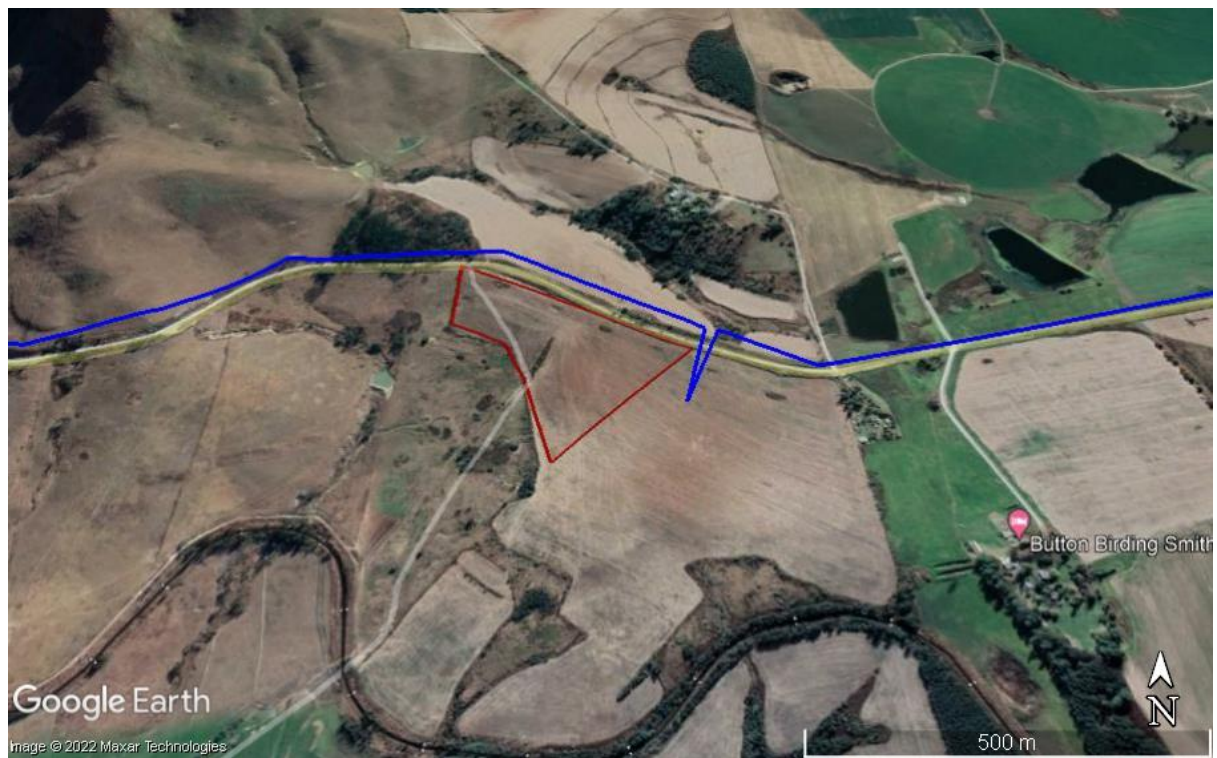
**Figure 24: Site of proposed reservoir outlined in red**

The site of the proposed reservoir is currently used to grow maize and rye with a power line crossing it. It is highly disturbed and no heritage sites were found.

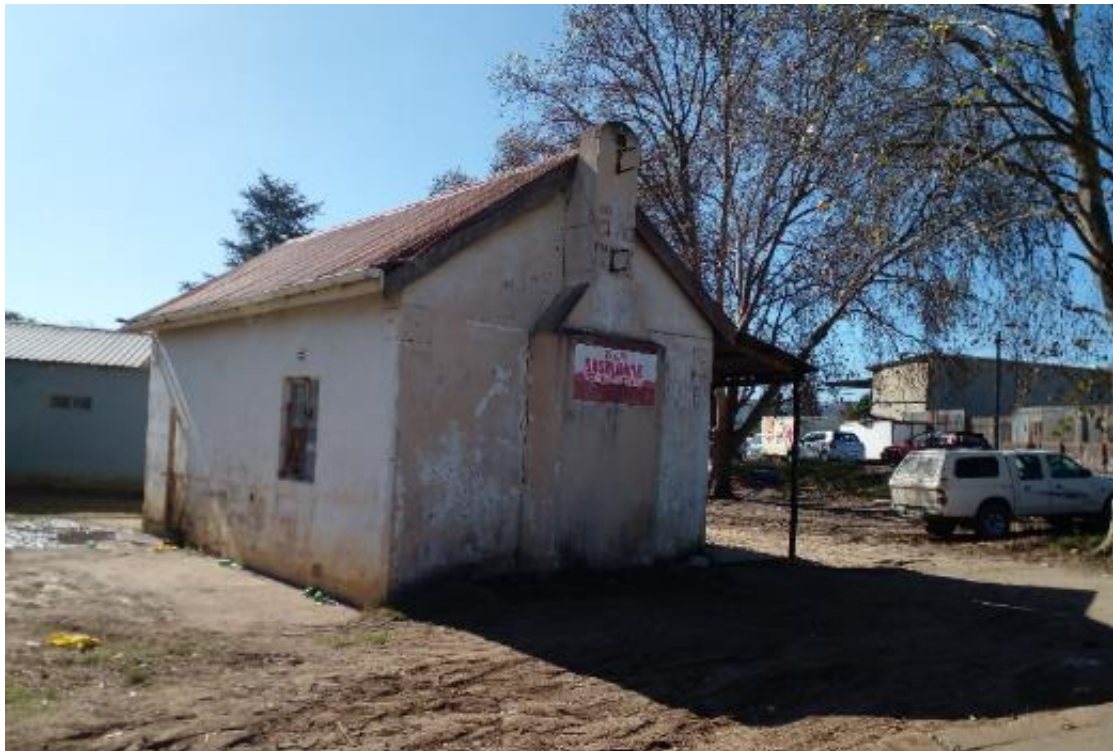
**Figure 27: Protected structure in Creighton**

The pipeline route through Creighton does not pass protected structures apart from a structure at the end of the pipeline route. It is located 10m north of the pipeline (see **Fig. 27**).

The inspection of the pipeline route between Centocow and Creighton revealed no heritage resources apart from a protected structure that is located 10 m from the end of the pipeline in Creighton. A buffer of at least 5m must be placed around the structure to avoid impacts to it by the construction of the BWSS.

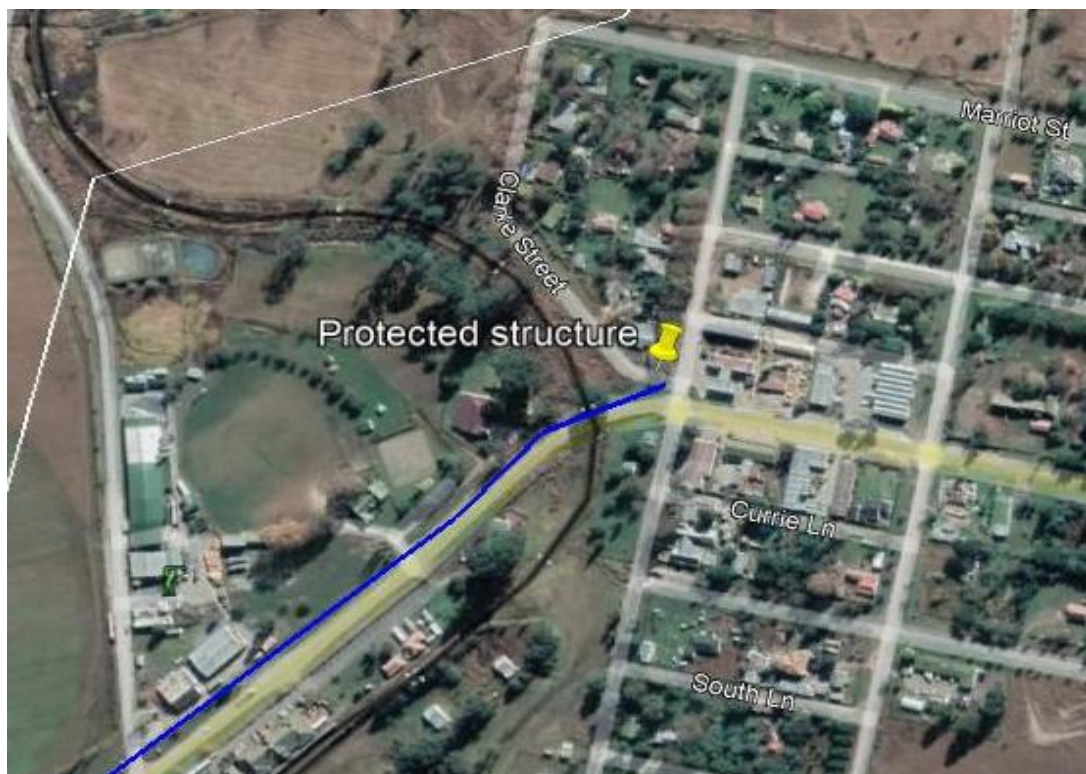
**Figure 29: Creighton structure**

The Creighton structures is indicated below.
