**Phase 2 Cultural Heritage Documentation:**

**DOCUMENTATION OF FOUR CONCRETE ROAD BRIDGES ON SECTION 13 OF THE N11 NATIONAL ROUTE NORTH OF MOKOPANE, LIMPOPO PROVINCE**

**Report No:** 2023/JvS/006

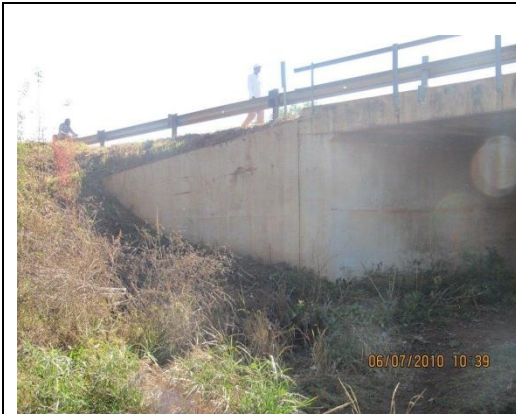
The walls are constructed from concrete that was cast in slabs. The abutment walls are currently below water level and most likely going down to the bedrock. The height of the abutment walls (to water level) is 3 m and it is 12 m wide.

Abutment wall, north-eastern side

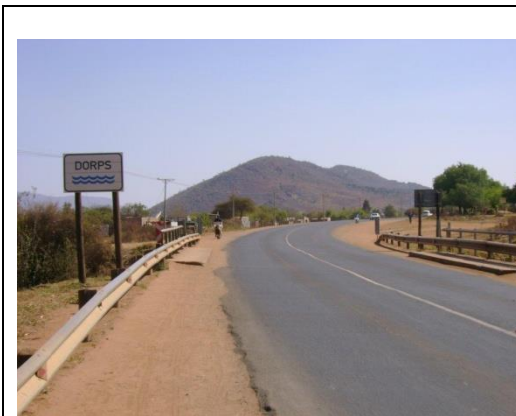
The approach road runs between Mokopane and the Botswana border and carries a large volume of traffic.

Approach road, travelling north

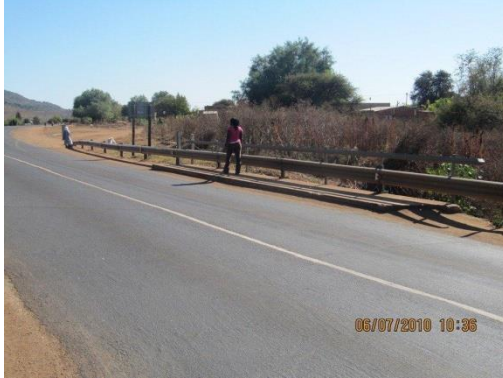
The bridge deck consists of concrete, which is also part of the construction of the bridge and is then covered with a layer of tarmac. The total length of the bridge deck is just over 12 m.

Bridge deck seen from the top

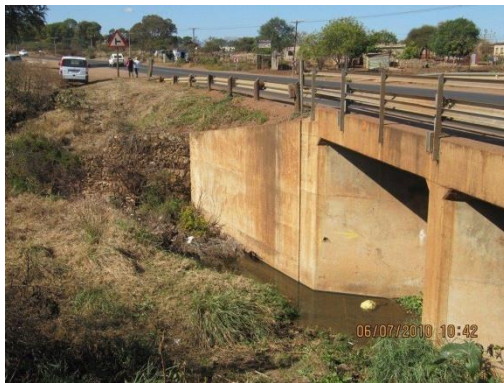
A single column supports the bridge deck. It is from cast concrete and is set at a slight angle to the bridge deck in order to be parallel to the stream bed.

The location of the column

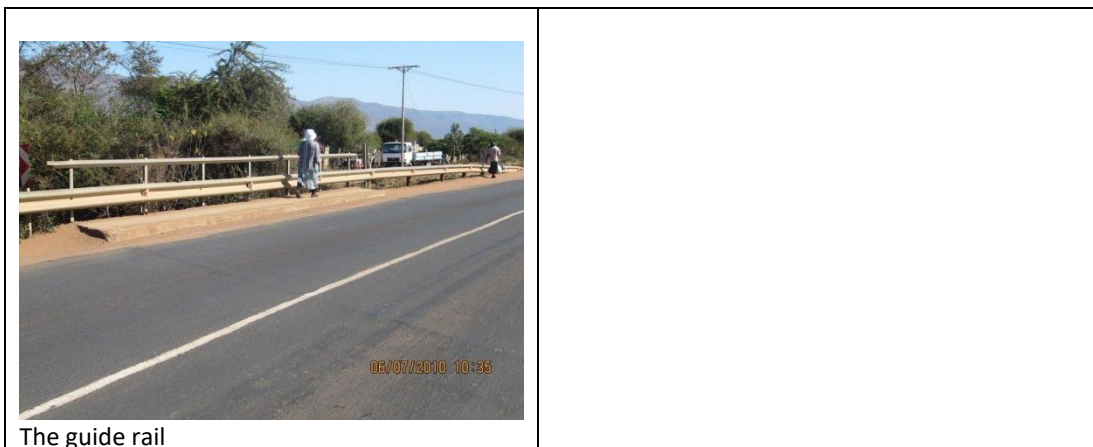
The guide rail is a raised platform of concrete, edged with angle iron that runs the length of the bridge. It is about 10cm high and about 30cm wide.

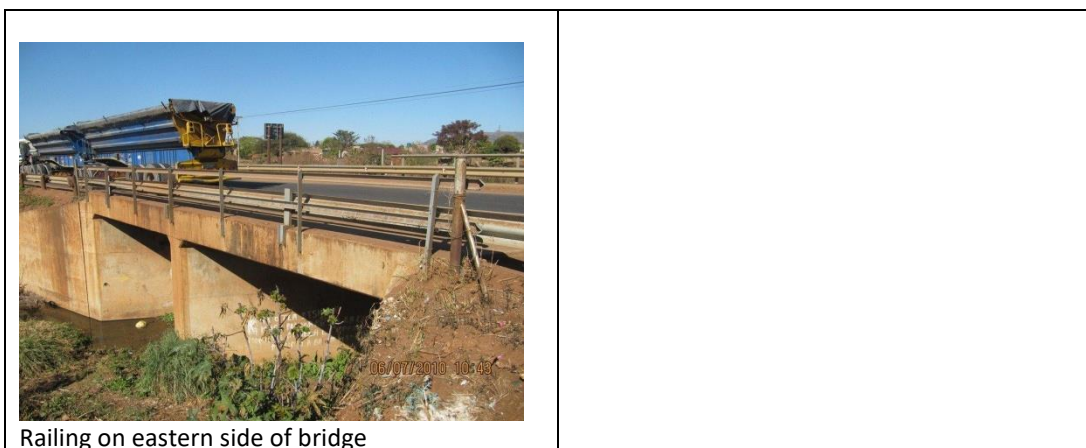
The original railings are made of six upright sections of pipe which supports two horizontal bars running the length of the bridge. The railings are now supported by Armco barriers

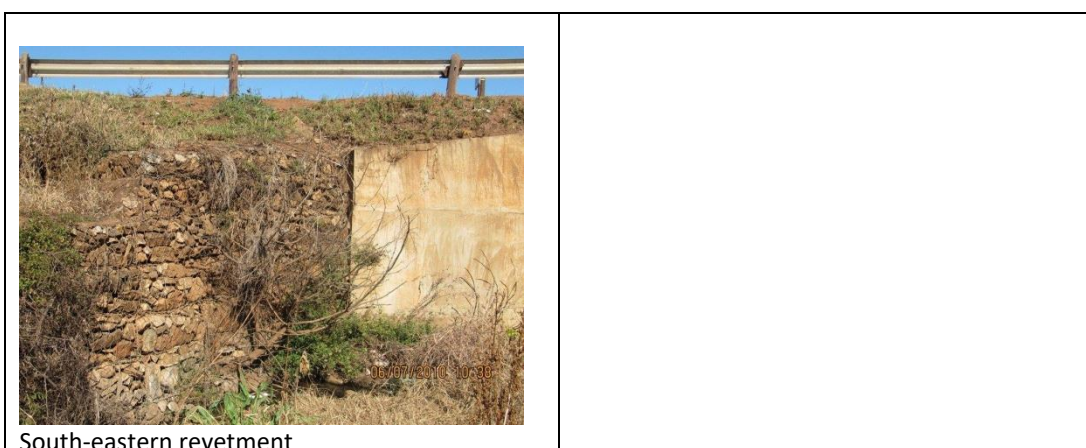
In the case of this bridge the revetments have at a later stage been strengthened by the installation of gabions.

Apart from the embankments that had to be strengthened by the installation of gabions, this structure is still sound.

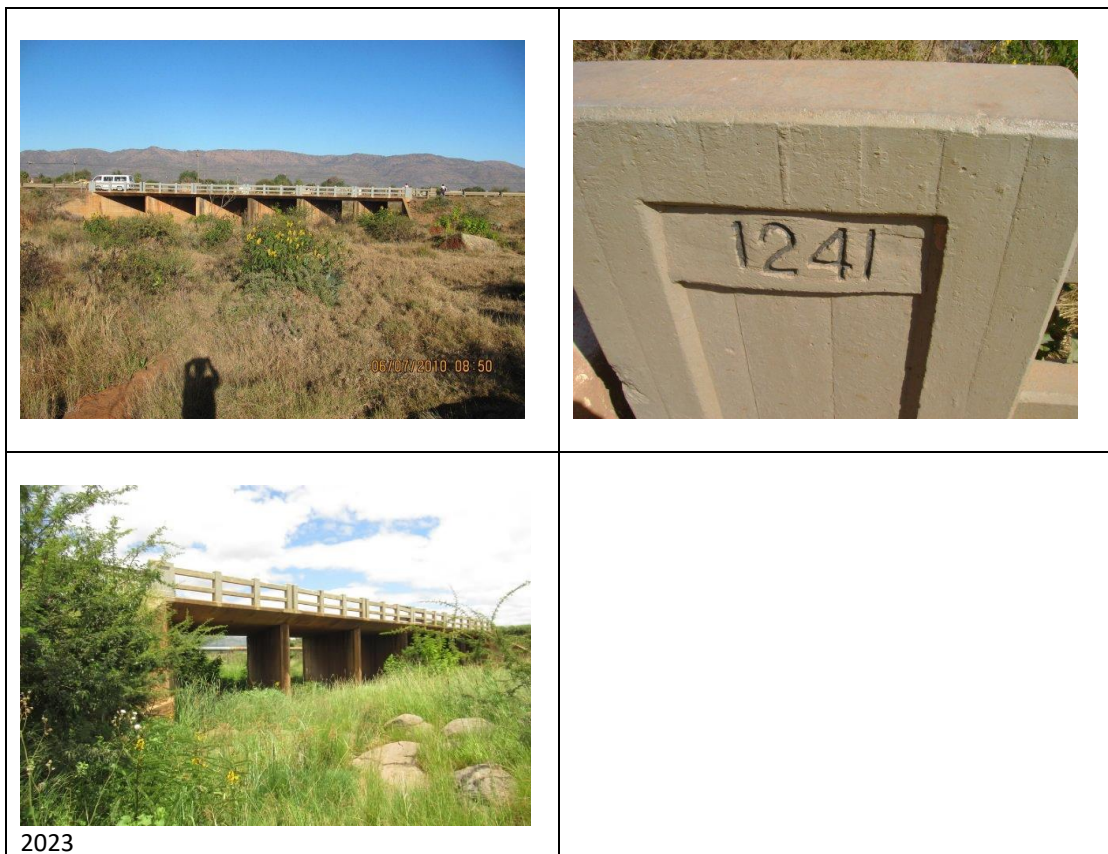
Fig. 10. Side-view of the bridge and its identification number.

This is a six span bridge of cast concrete. The bridge deck is supported by a five concrete columns. The abutment and wing walls are all of concrete, although the upstream side of the walls have been strengthened with stone revetments that were cemented in. The railings are of prefabricated cement and were probably added at a later date. A date of 1953 was found on one of the pylons of the bridge.

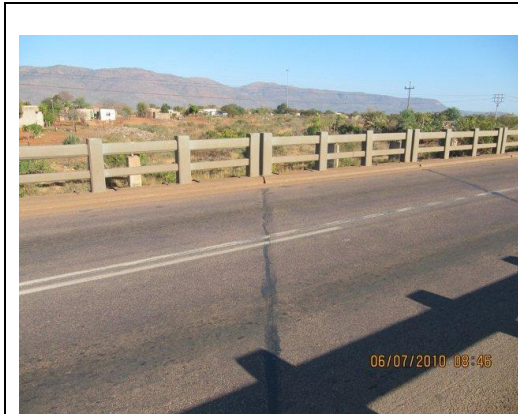
The bridge deck consists of six concrete sections reinforced by girders, which is also part of the construction of the bridge and is then covered with a layer of tarmac. The total length of the bridge deck is approximately 34 m.

Bridge deck seen from the top

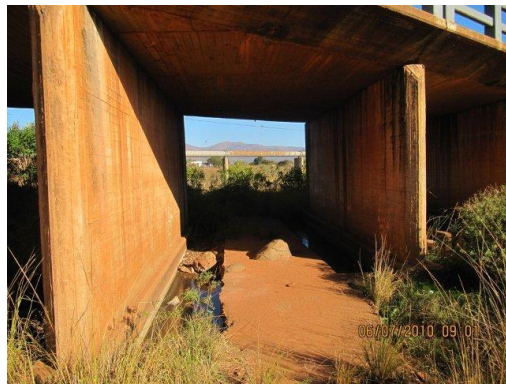
Five columns support the bridge deck. It is from cast concrete and is set at a slight angle to the bridge deck in order to be parallel to the stream bed. The foundation of the column is boat shaped to accommodate the flow of water.

The location of the columns

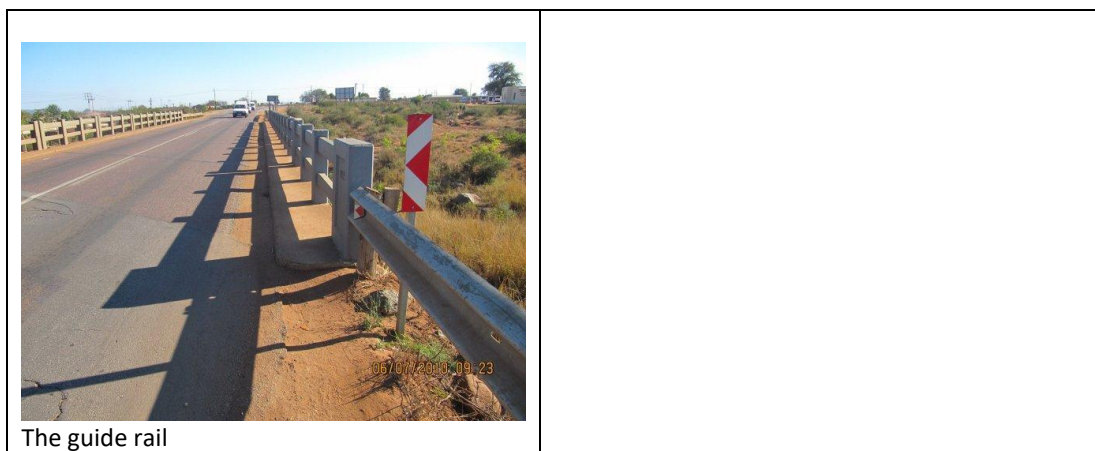
The guide rail is a raised platform of concrete, edged with angle iron that runs the length of the bridge. It is about 10cm high and about 30cm wide.

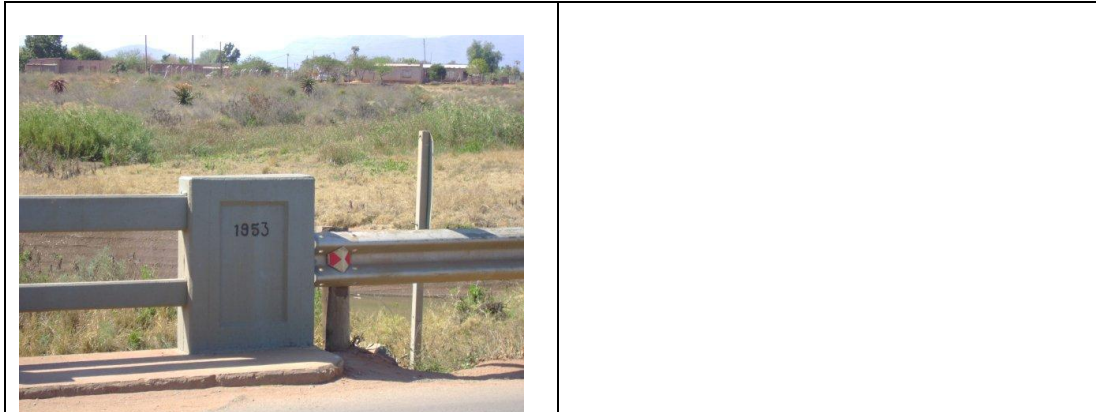
This bridge has four similar pylons – one on each corner of the bridge. They have either the date or the number of the bridge on them. They are 75 x 55 cm in size.

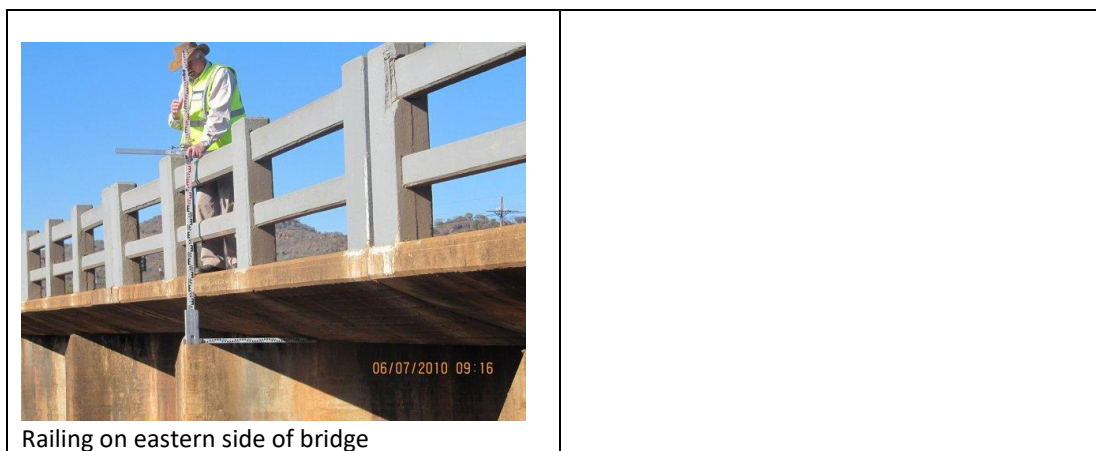
The railings consist of a number of uprights and two horizontal bars attached to them. The railings are cast in solid concrete and forms an integral part of the bridge deck.

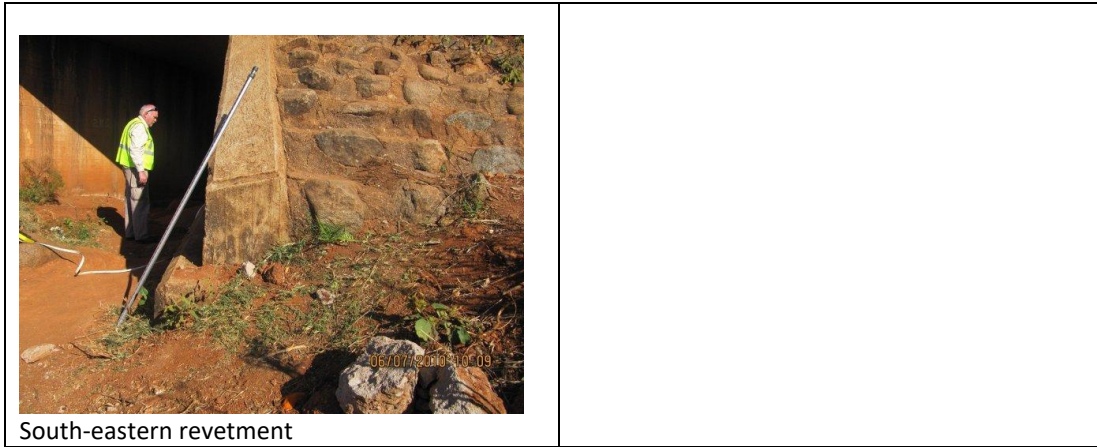
The revetment walls are constructed from large stones that have been cemented into place.

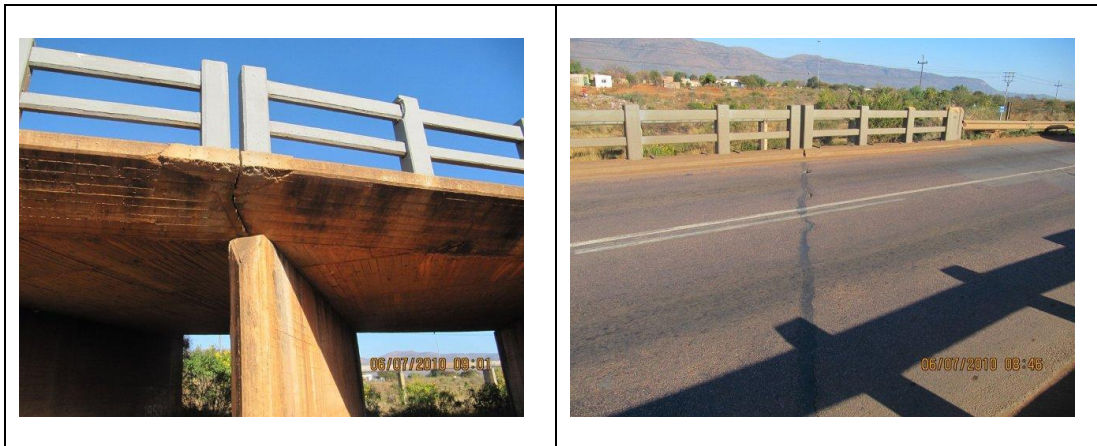
The joints where the various spans come together show signs of damage and consequent repairs.

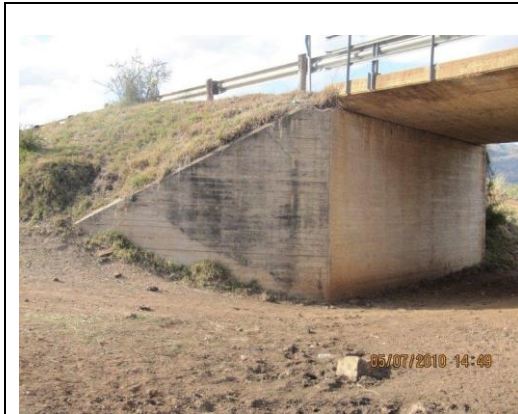
The walls are constructed from concrete that was cast in slabs. The abutment walls are currently below water level and most likely going down to the bedrock. The height of the two abutment walls (to water level) is 4 m and it is 8 m wide.

Abutment wall, north-eastern side

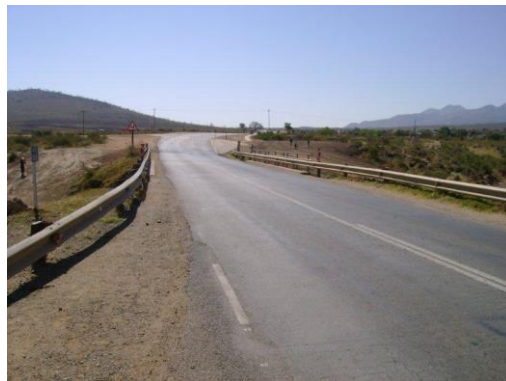
The approach road runs between Mokopane and the Botswana border and carries a large volume of traffic.

Approach road, travelling north

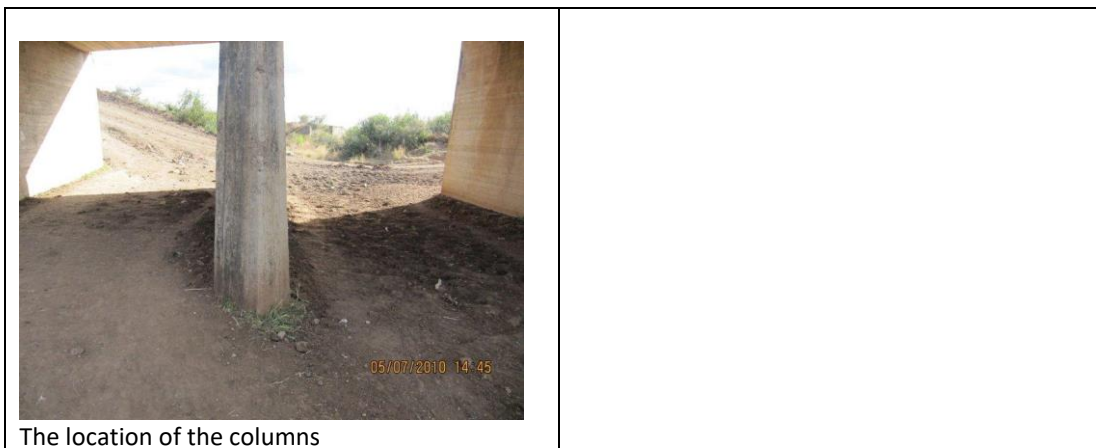
Three columns support the bridge deck. It is from cast concrete and is set at a slight angle to the bridge deck in order to be parallel to the stream bed.

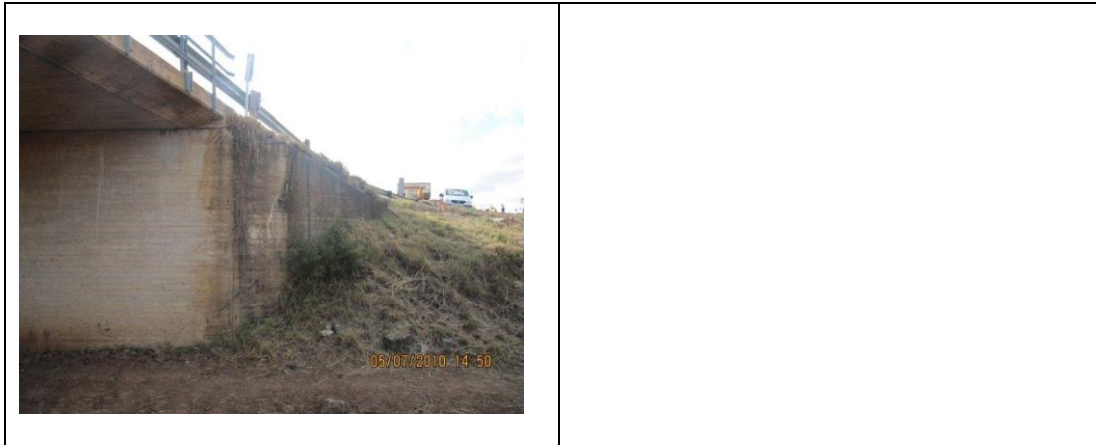
Formed by packing down soil to achieve the necessary height and then sloping down gradually the further away one moves from the river.

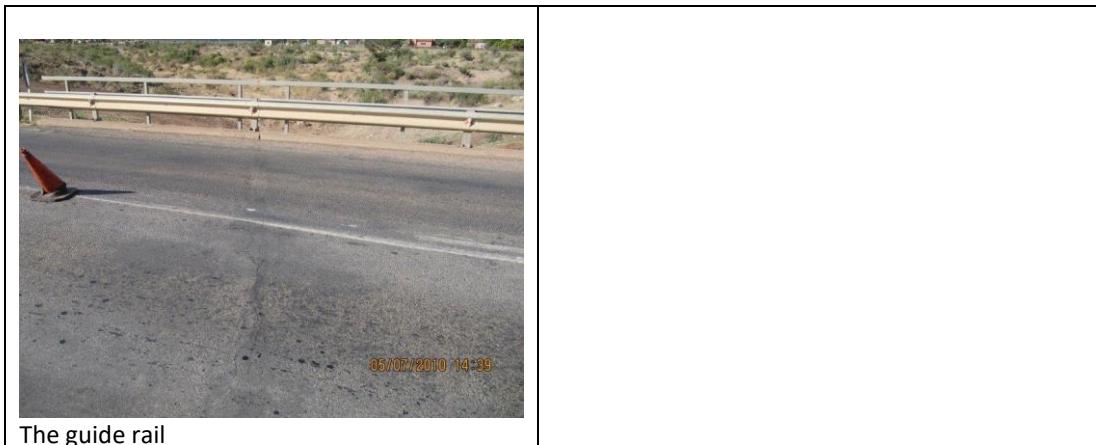
The guide rail is a raised platform of concrete, edged with angle iron that runs the length of the bridge. It is about 10cm high and about 30cm wide.

The guide rail

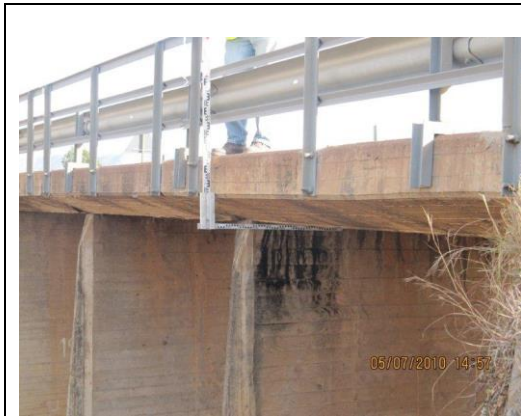
The original railings are made of ten upright sections of steel which supports two horizontal bars running the length of the bridge. The railings are now supported by Armco barriers.

Railing on eastern side of bridge

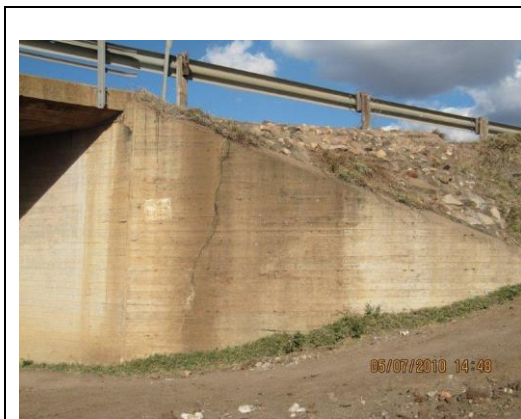
The bridge shows large cracks in the abutment wing walls.

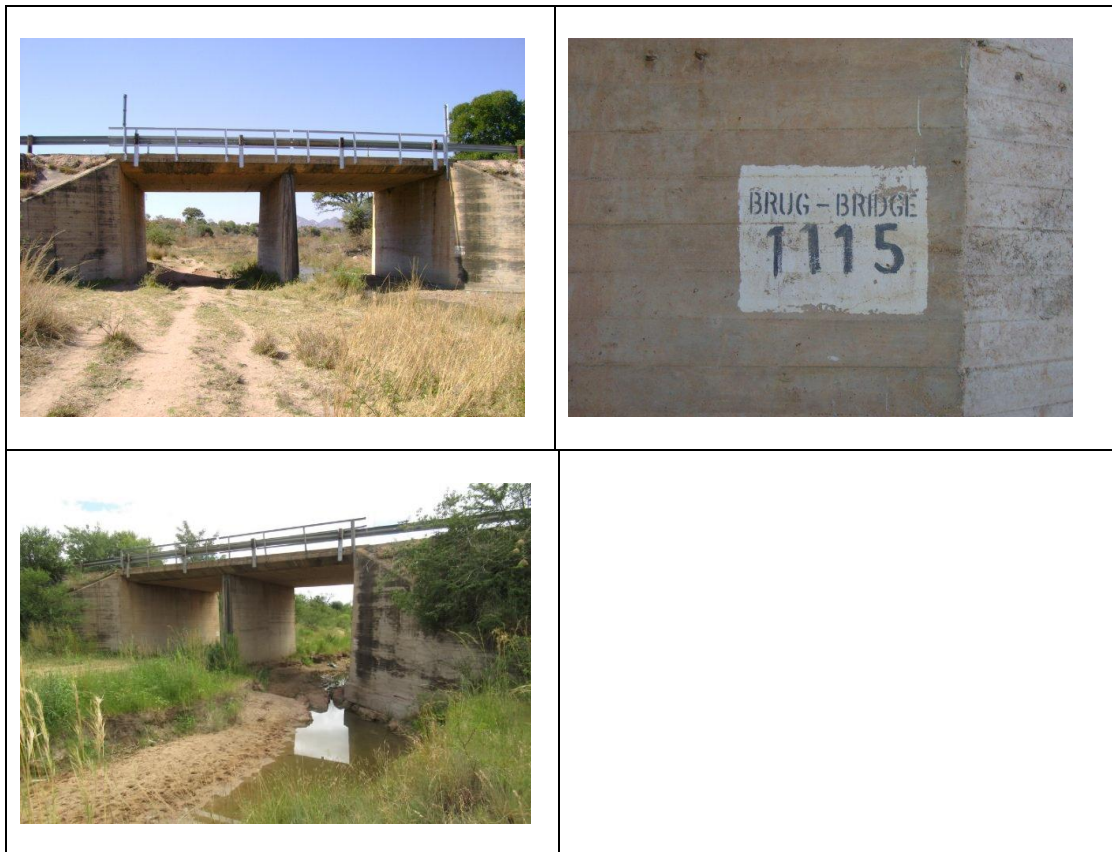
Fig. 16. Side view and identification number of the bridge.

This is a two span bridge of cast concrete. The bridge deck is supported by a single concrete column. The abutment and wing walls are all of concrete. The original railings are still in place and are now supported by Armco barriers. No date could be found on this bridge, but it is assumed to be in the same time-frame (1950s) as that of the other bridges.

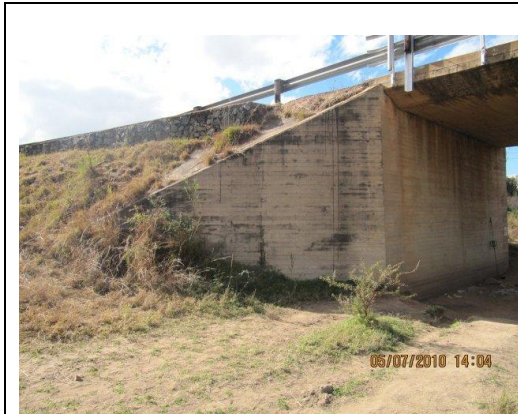
The walls are constructed from concrete that was cast in slabs. The abutment walls are currently below water level and most likely going down to the bedrock. The height of the two abutment walls (to water level) is 4,6 m and it is 7 m wide.

Abutment wall, north-eastern side

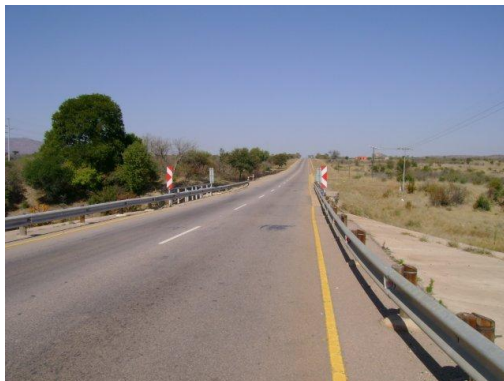
The approach road runs between Mokopane and the Botswana border and carries a large volume of traffic.

Approach road, travelling north

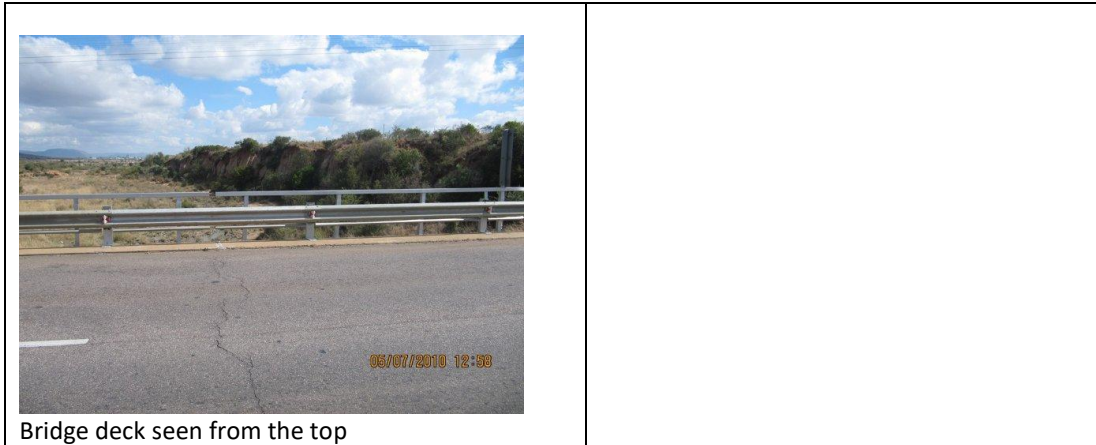
The bridge deck consists of two concrete slabs reinforced by girders. The top layer of the bridge deck consists of concrete, which is also part of the construction of the bridge and is then covered with a layer of tarmac. The total length of the bridge deck is approximately 13 m.

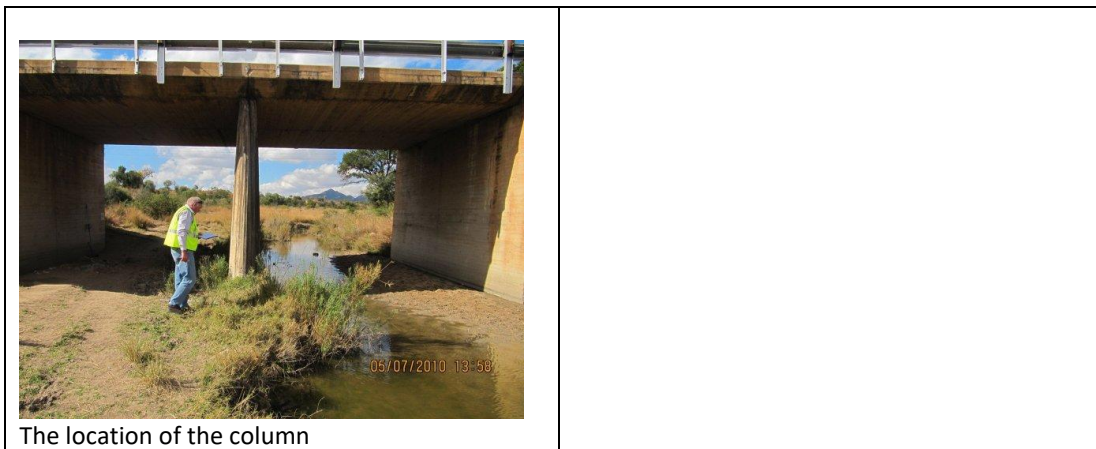
One columns support the bridge deck. It is from cast concrete and is set at a slight angle to the bridge deck in order to be parallel to the stream bed. The foundation of the column is boat shaped to accommodate the flow of water.

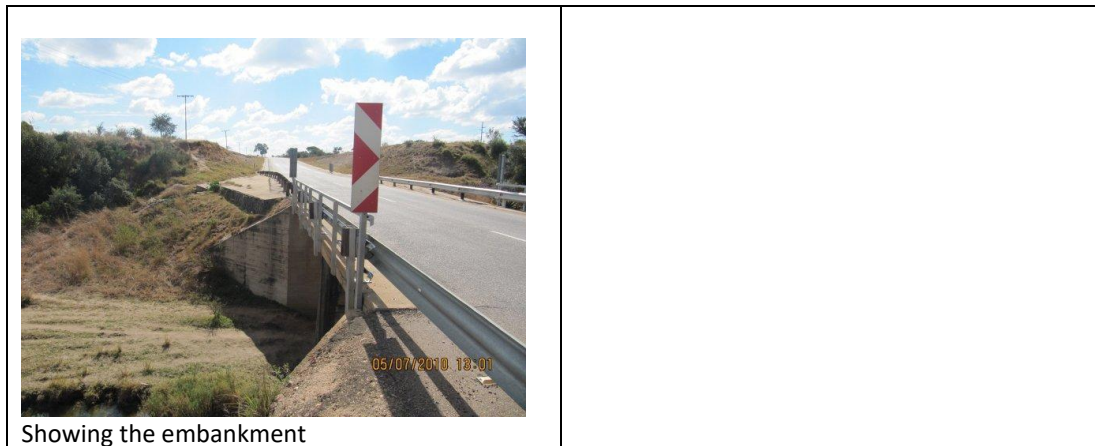
Formed by packing down soil to achieve the necessary height and then sloping down gradually the further away one moves from the river.

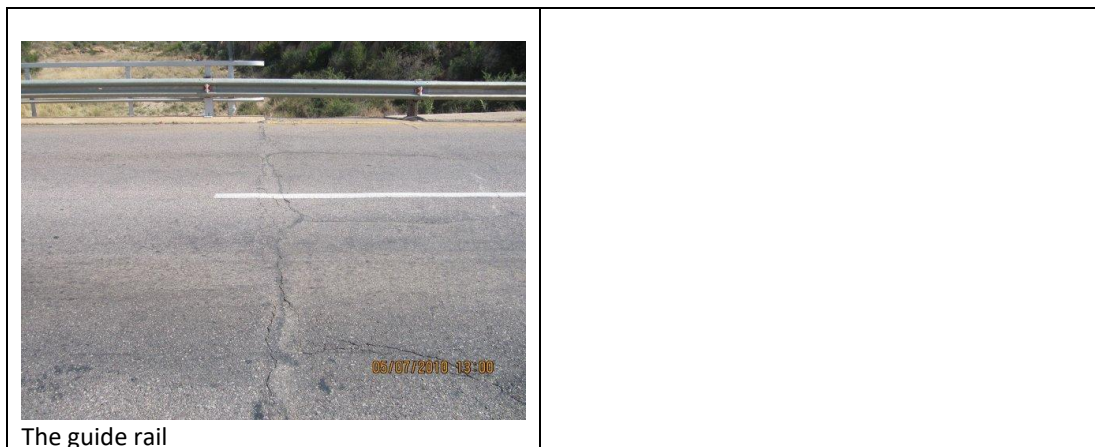
The guide rail is a raised platform of concrete, edged with angle iron that runs the length of the bridge. It is about 10cm high and about 30cm wide.

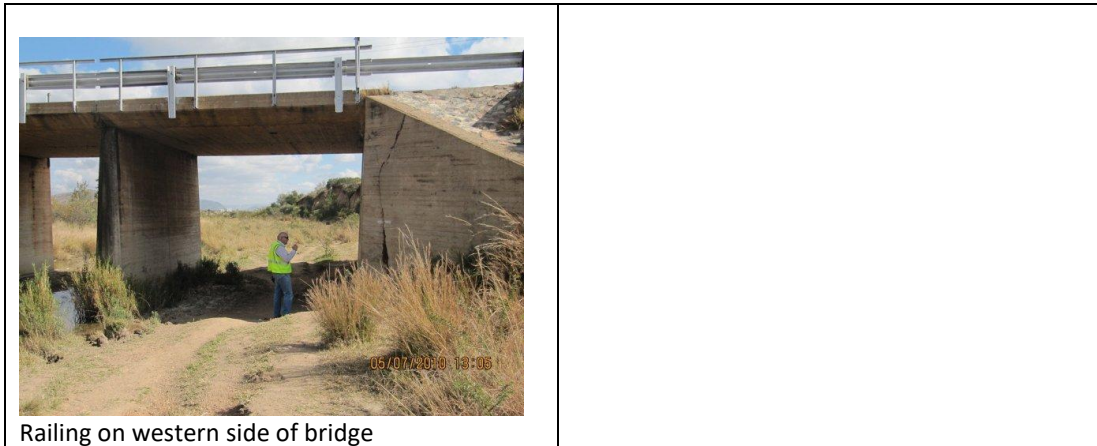
The original railings are made of ten upright sections of steel which supports two horizontal bars running the length of the bridge. The railings are now supported by Armco barriers.

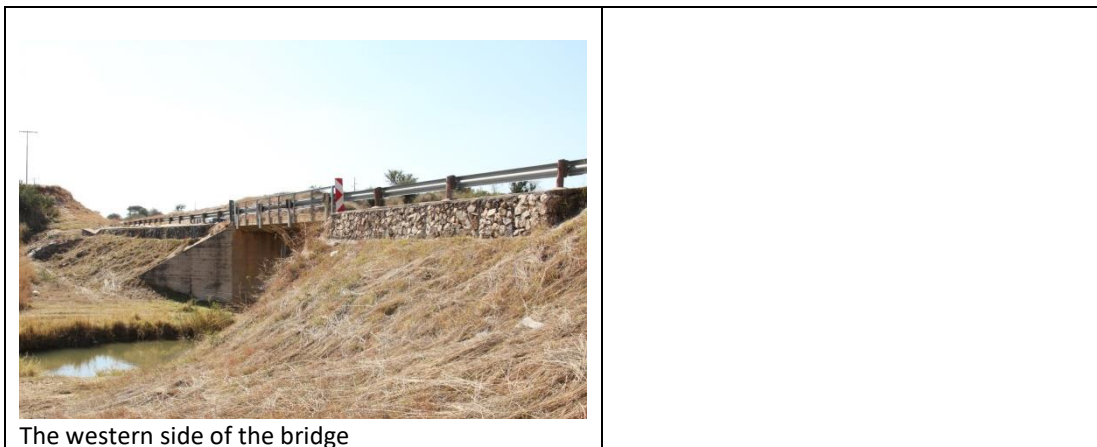
The revetments on this bridge have recently been strengthened by the installation of gabions.

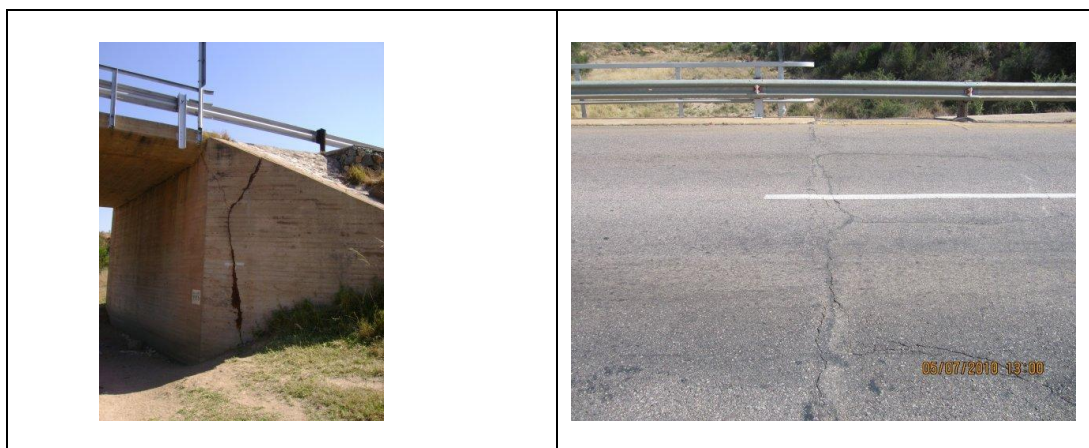
The bridge shows large cracks in the abutment walls as well on the bridge deck.
