# ARCHAEOLOGICAL IMPACT ASSESSMENT: PROPOSED CONSTRUCTION OF HUMANSRUS SOLAR PV ENERGY FACILITY 2 ON THE REMAINDER OF THE FARM HUMANSRUS 147 NEAR COPPERTON, NORTHERN CAPE

(Assessment conducted under Section 38 (8) of the  
National Heritage Resources Act No 25 of 1999)

November 2014

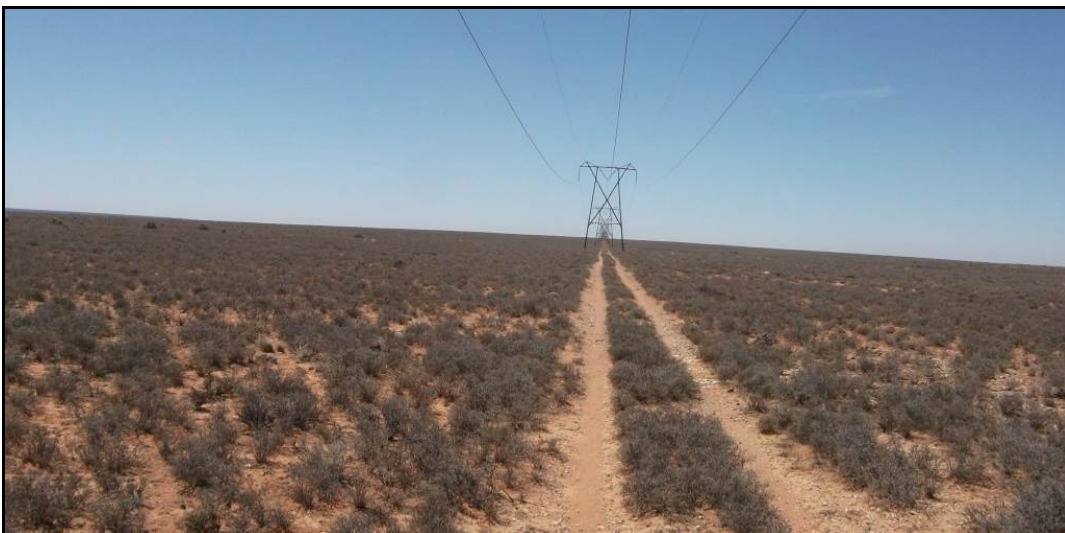
**Plate 2:** There are two sets of powerlines (and servitudes) which cross the property at right angles.

The Remainder of the farm Humansrus comprises a generally flat landscape, with knee-high vegetation and a substrate which varies between thick red soils, calcrete surfaces and gravel patches. The northern border of the property is bounded by the R357. There are two powerlines which run diagonally across the study area (Plate 2). The “pans” observed on RE Capital 13 do not occur on the southern portion of the farm.

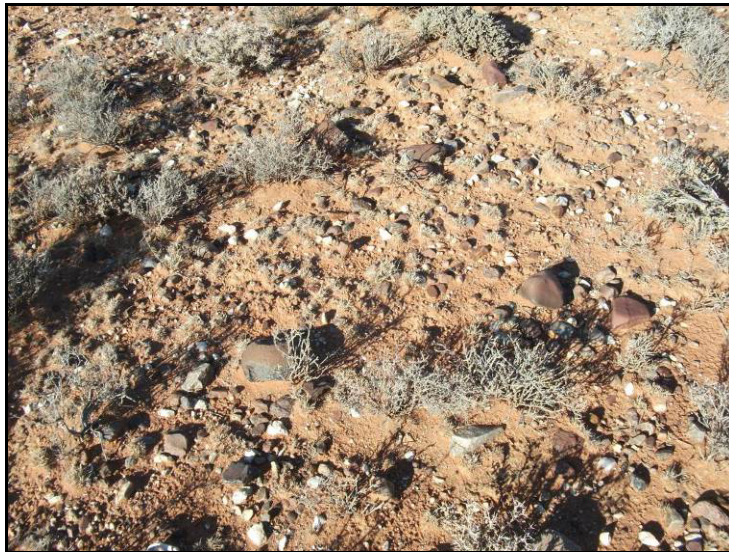
**Plate 3:** View of the soil surface indicating the presence of large, worn hornfels artefacts.

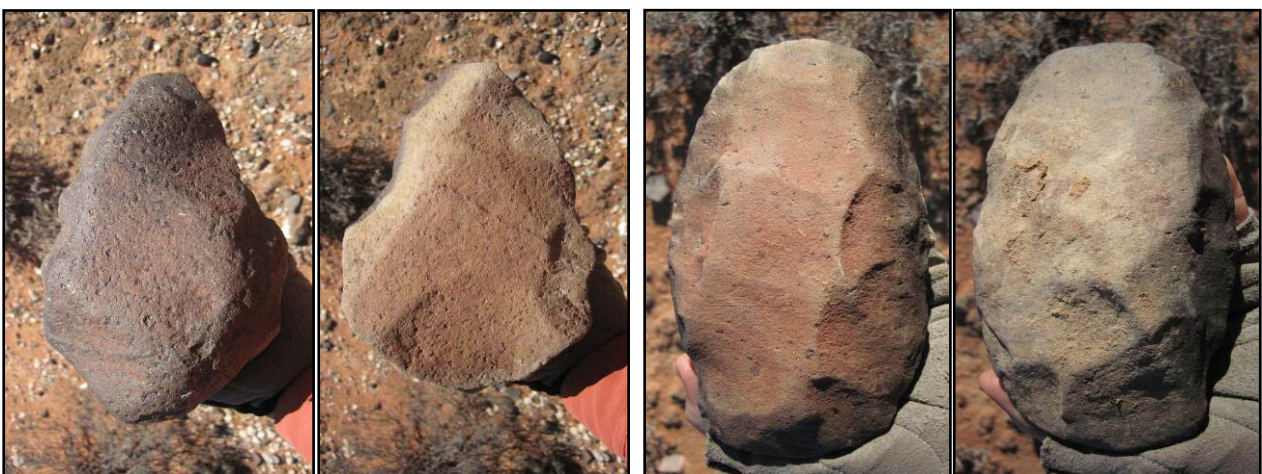
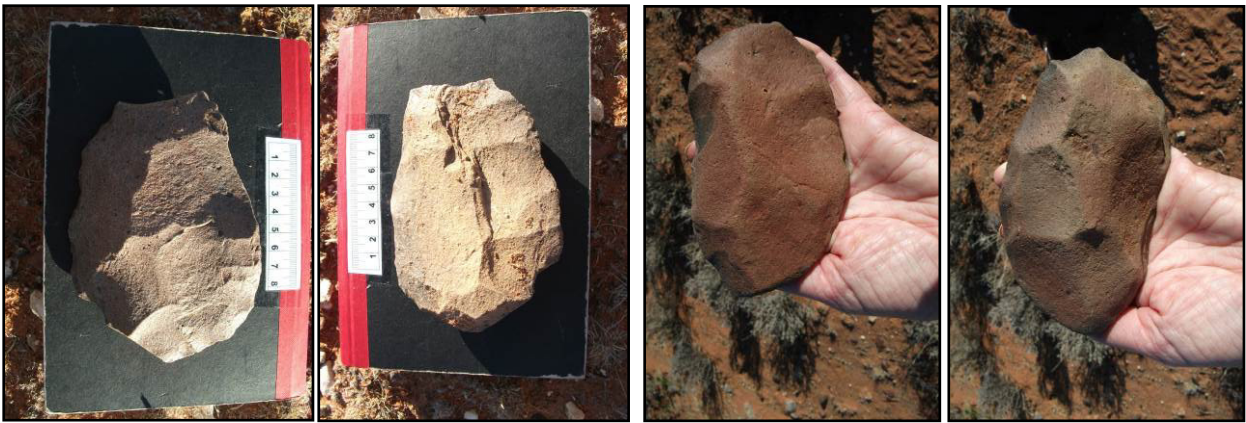
The handaxes were predominantly made on indurated shales and on quartz. The shale (or hornfels) handaxes were often very weathered and it was often difficult to be sure that they were handaxes. Large worn flakes were also recorded.

**Plate 4:** A selection of large bifacial tools, the majority are on indurated shale and very weathered.

**Plate 4 (contd):** A selection of large bifacial tools, the majority are on indurated shale and very weathered.

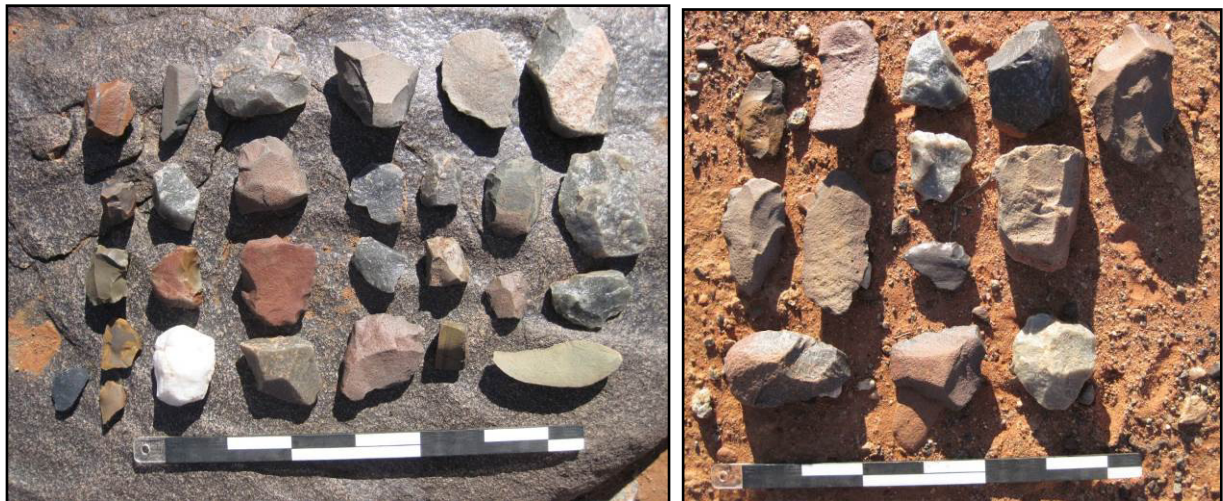
The majority of the MSA artefacts are made on quartzite, although some banded ironstone is also present. There are occasional chunks of red jasper, some with evidence of being flaked. Quartz appears in certain areas and usually in small chunks. There are no apparent outcrops of quartz. Chunks and flakes are common (Plates 5 and 6). Cores tend to be irregular. There is no obvious sign that cores were specifically prepared for blade production although there is a blade element present (Plate 7) in the stone scatters. A fair percentage of the blade artefacts showed signs of retouch. The shorter, wider convergent flakes are not common.

**Plates 5 & 6:** The range of Middle Stone Age artefacts typically found in an area of higher artefact concentration.

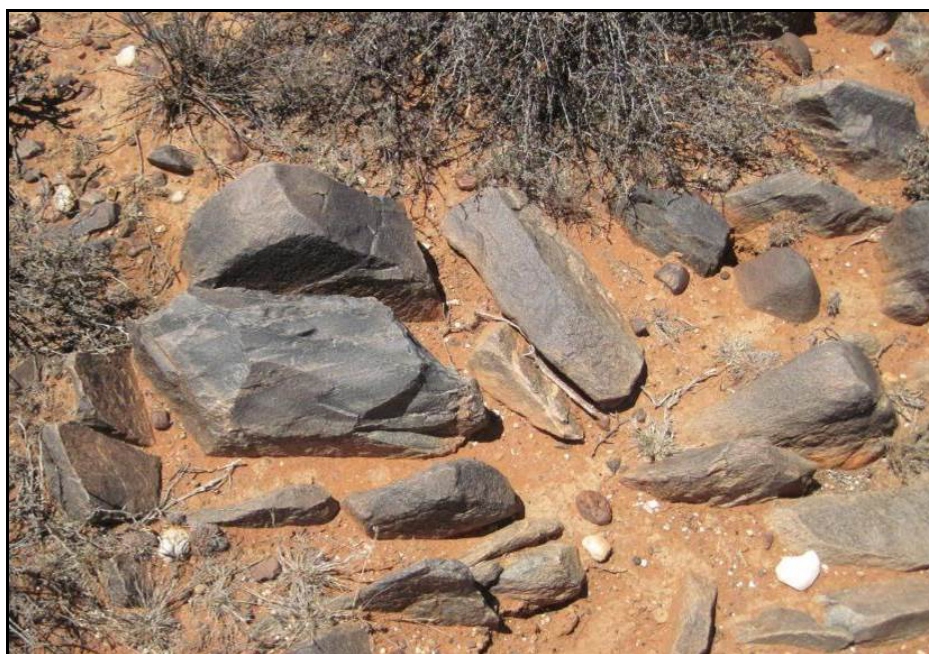
**Plate 8:** Evidence that the quartzite bedrock was quarried as a source of raw material.

- The outcrops of grey and black quartzite show some signs of knapping – the occasional outcrop has a coherent scatter of material around it which suggests some *in situ* material. In addition, these outcrops appear to have served as some type of foci on the landscape, and often there is evidence for the flaking of other raw material in the vicinity;
- Detailed measurements and recording of stone artefacts, such as handaxes, may provide an indirect form of dating through comparison with similar industries documented elsewhere;
- Due to potential cumulative impacts in the area, some limited sampling of artefactual material should occur.

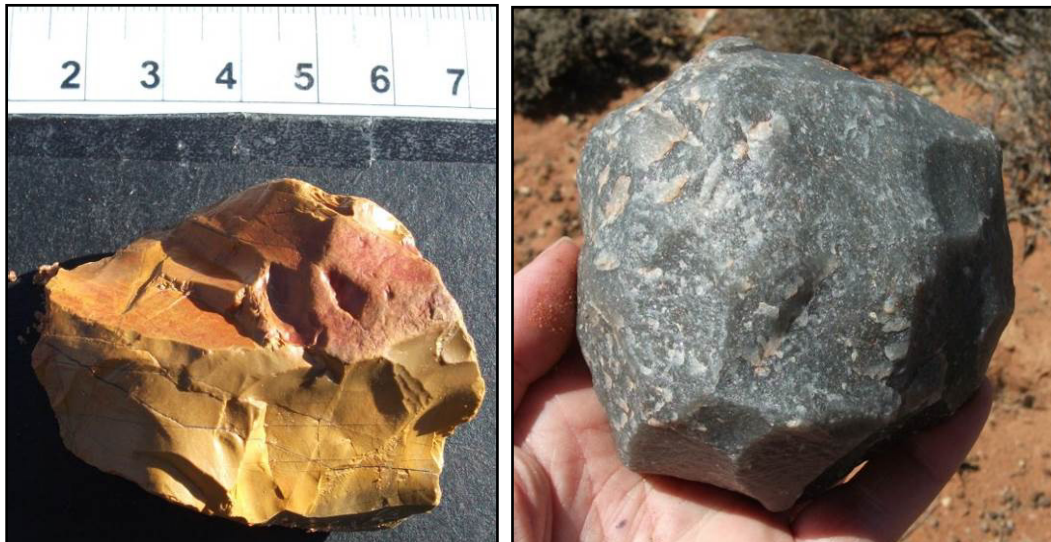
**Plate 9:** A banded ironstone core (left) and quartzite core (right).
