REPORT ON ARCHAEOLOGICAL MONITORING OF RUBBLE REMOVAL

submitted in terms of Section 35 of the NHRA (1999) for
DISTRICT SIX PHASE FOUR DEVELOPMENT ON PARCEL N,
DISTRICT SIX, CAPE TOWN,
ERVEN 177646, 10010 AND 117891-117898

Prepared by Katie Smuts, Archaeologist at Rennie Scurr Adendorff for Delta BEC
on behalf of the Department of Land Reform and Rural Development

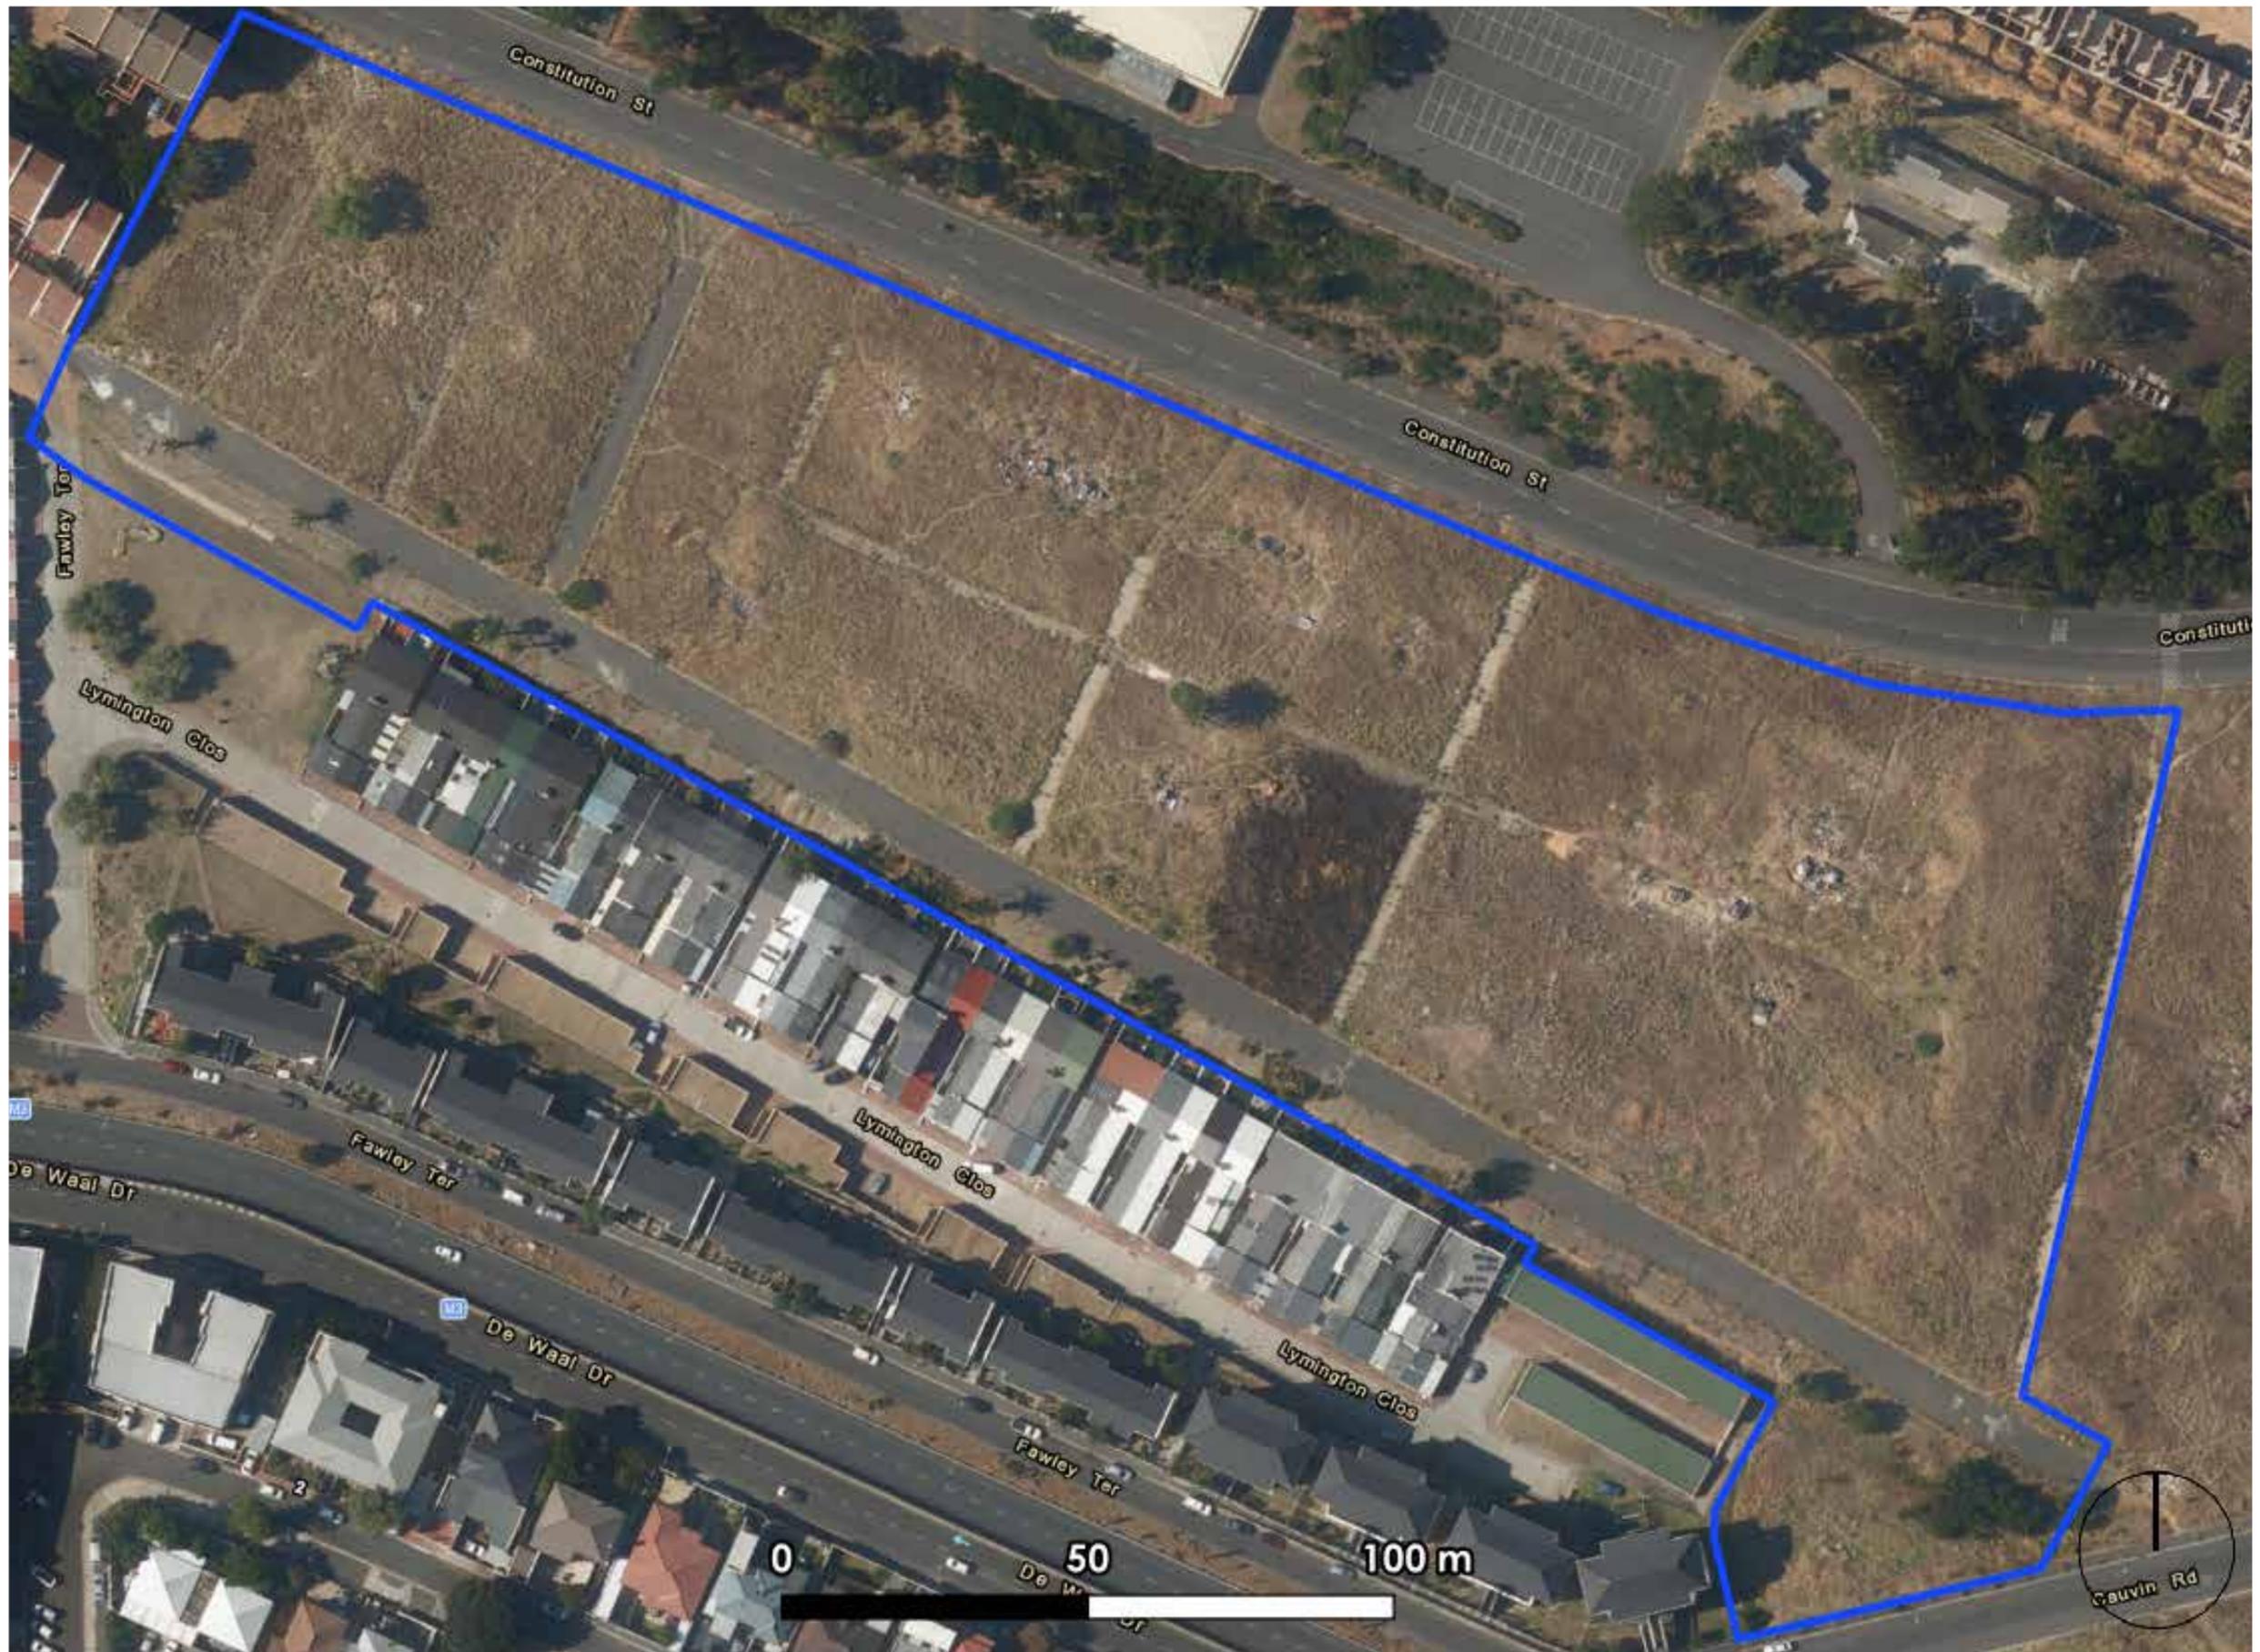
The area subject to clearance, Parcel N comprises erven 10010, the majority of the area, as well as erven 117891, 117892, 117893, 117894, 117895, 117896, 117897 and 117898. It is bounded to the north by Constitution Street, and to the south by Justice Walk (Figure 3). It lies to the west of Y2K College, which was formerly the Upper Ashley Street Preparatory School and to the east of a housing development built in the 1980s. Historically this parcel was bounded to the east by Horstley Street, to the south by Upper Constitution Street, west by Smart Street, and north by Roos Street.

Parcel N is a steeply sloping site, with variable evidence for preservation and some clear signs of disturbance, although it displays fairly good preservation of the historic street system throughout (Figure 3 to Figure 11).

Figure 3. Detail of Parcel N; note the road alignments still clearly visible and the two mature trees on the site (RSA, 2020).

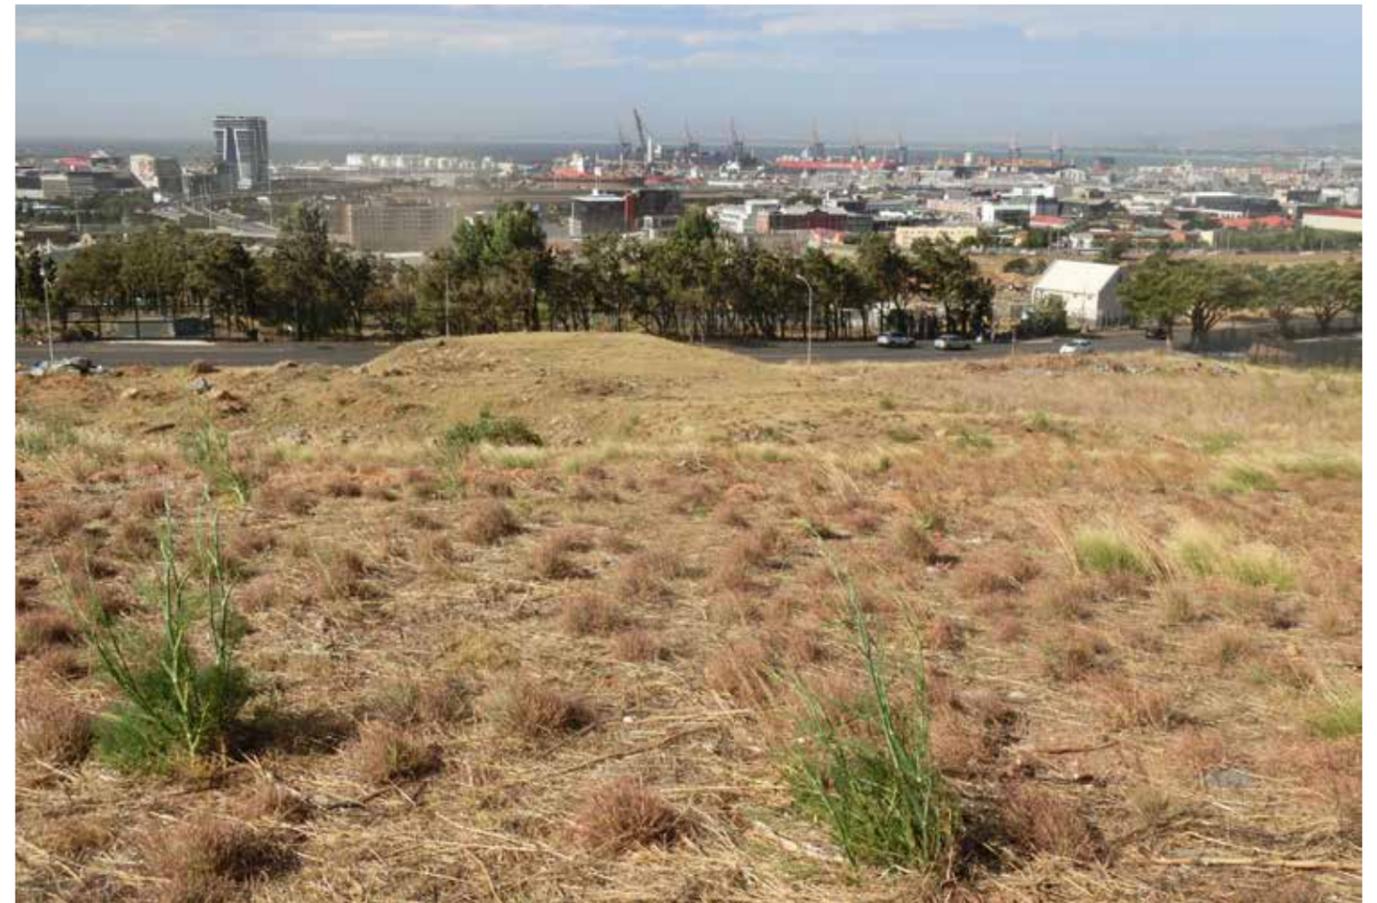
The site retains evidence for past earthmoving activities, particularly to the east, near Horstley Street, where there is a large, regular mound that appears level on top as though it were utilised by dump trucks for depositing large quantities of rubble (Figure 7 to Figure 9). This could reflect 1960s activities related to clearance of the wider site, or be evidence for more recent activity. Squatters have erected shacks across the central portion of site (Figure 8). Shacks are particularly erected where topography provides shelter from the southeaster, and it looks as though some digging activity has occurred to create such shelter where there was none.

Figure 7. View across Parcel N from west of Horstley Street, view to north east (RSA, 2020).

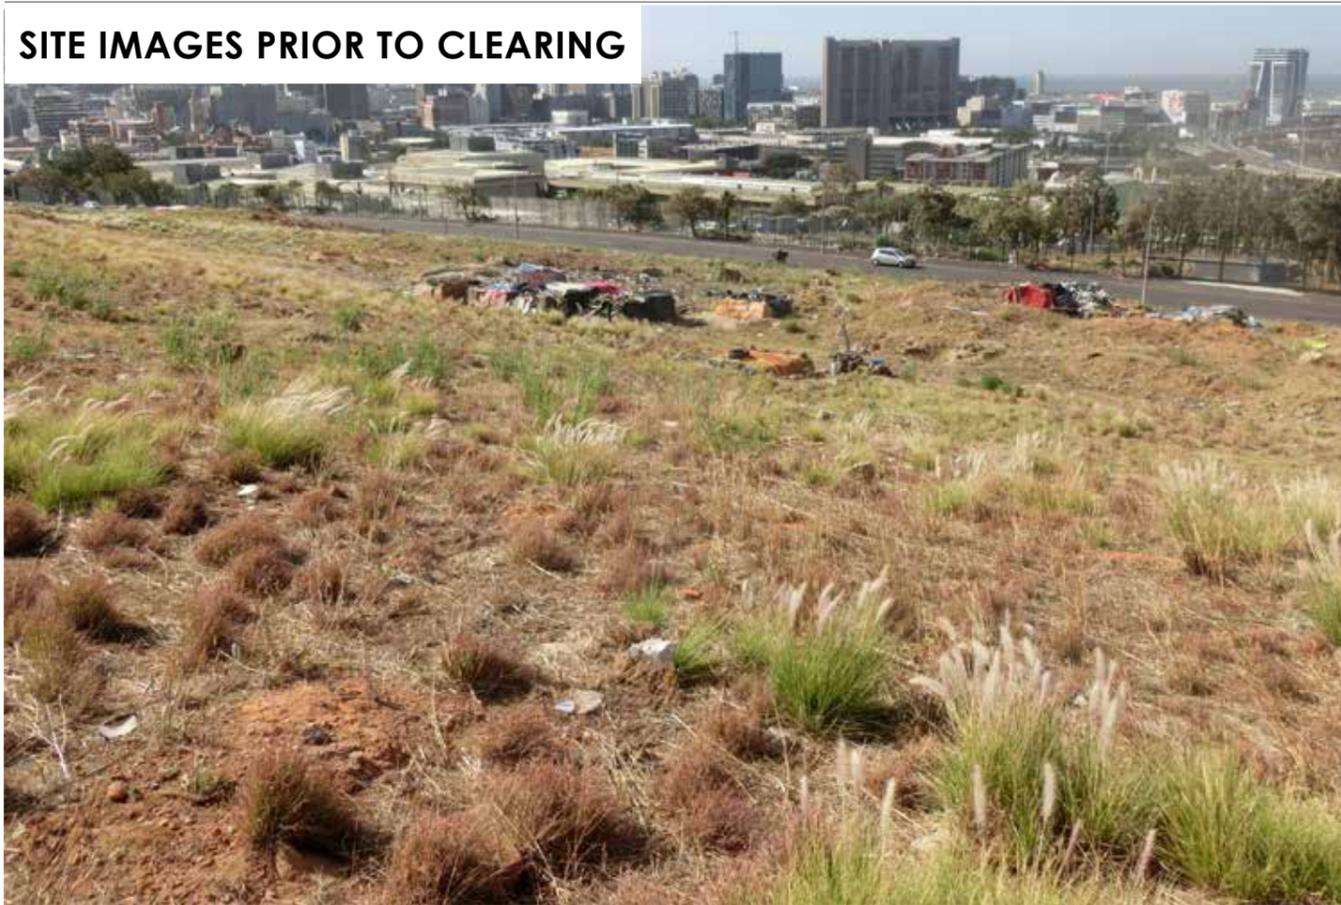
Figure 8. View across shacks erected on Parcel N, view to north (RSA, 2020).

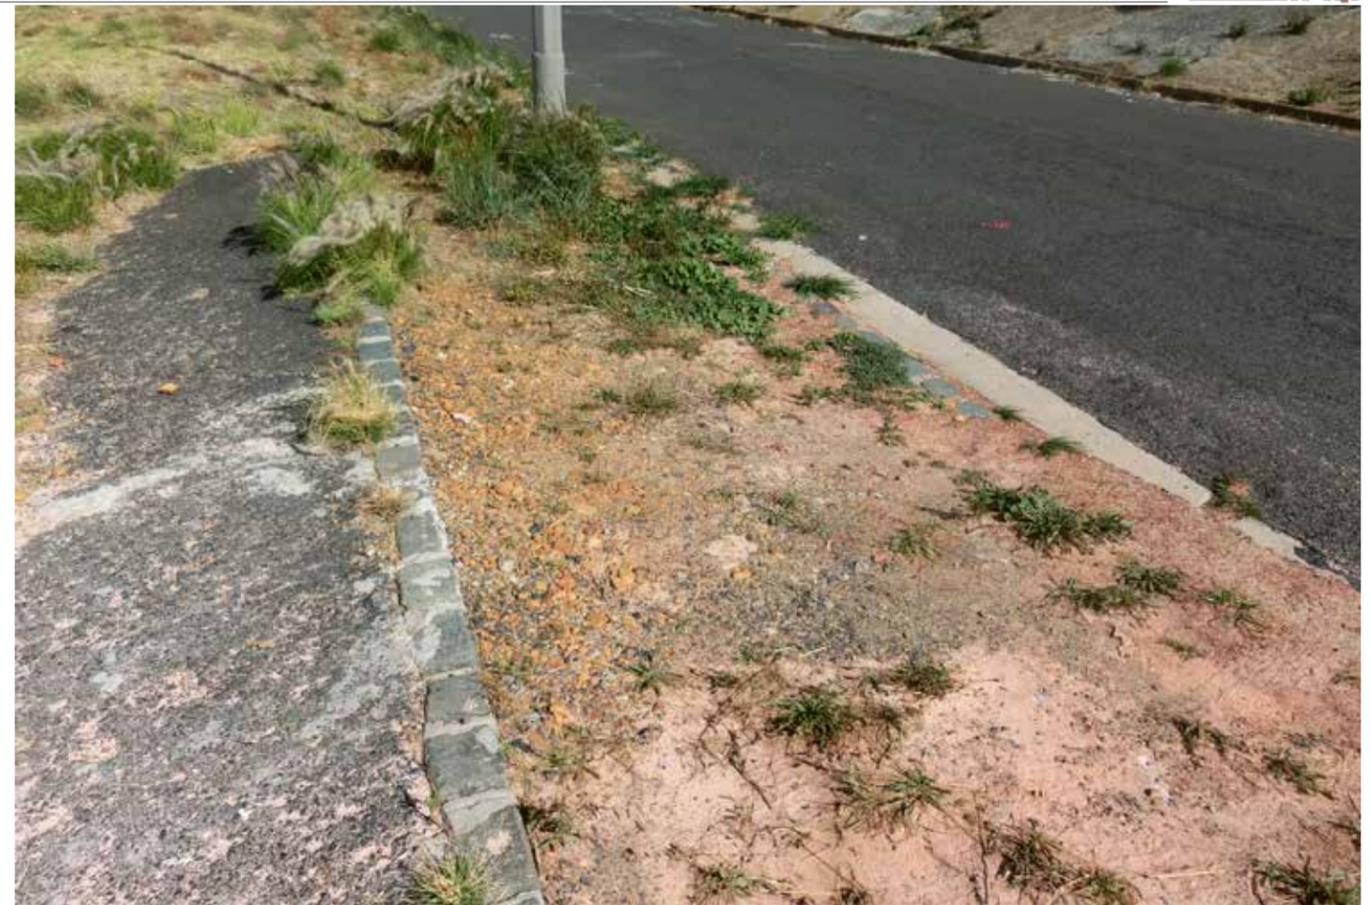
Figure 10. Old street edgings and alignments with preserved pavement levels, presumably of Upper Constitution Street, along Justice Walk, view to east (RSA, 2020).

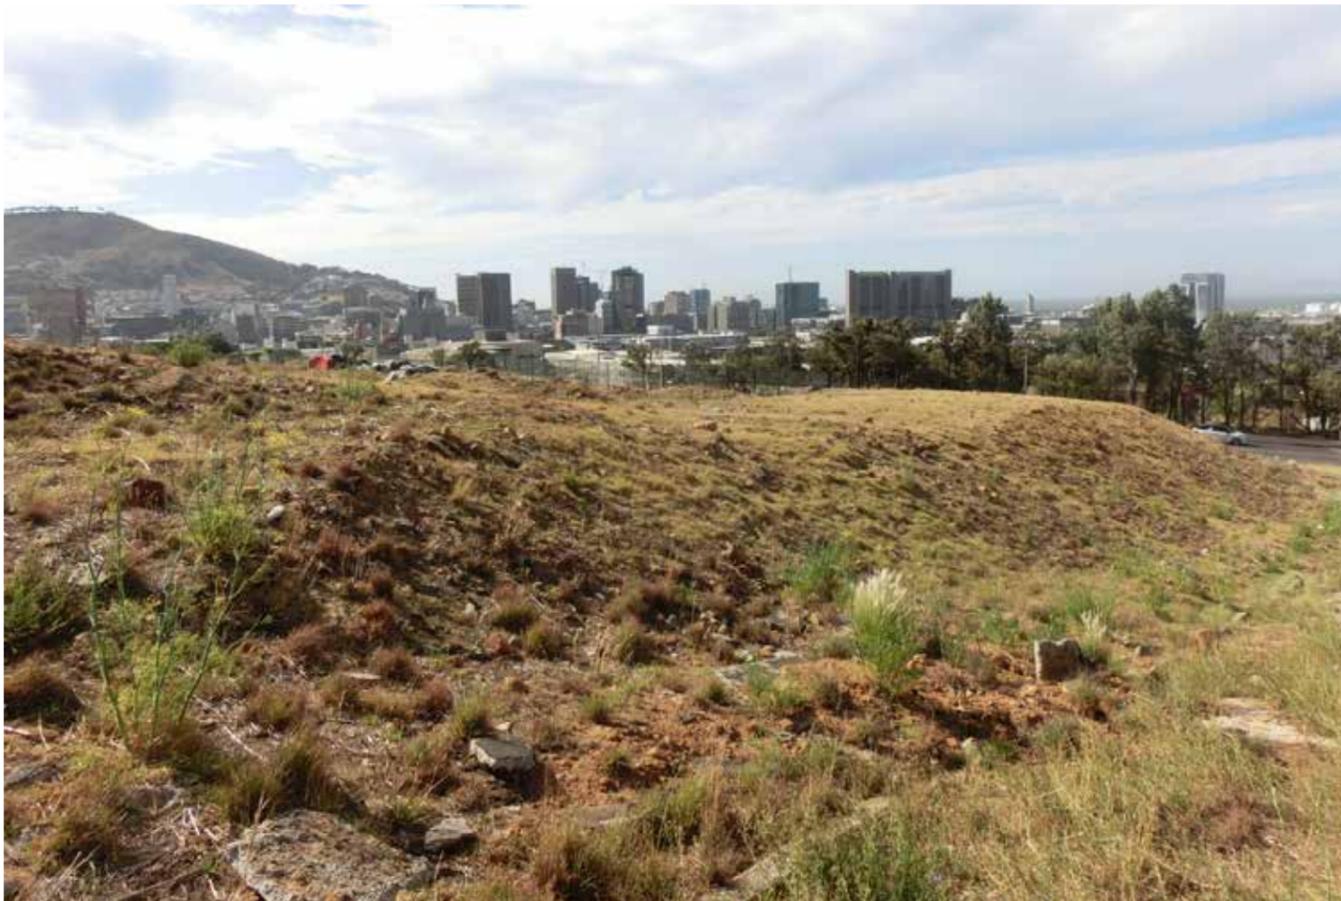
Figure 9. Evidence for past dumping and earthmoving across site (RSA, 2020).

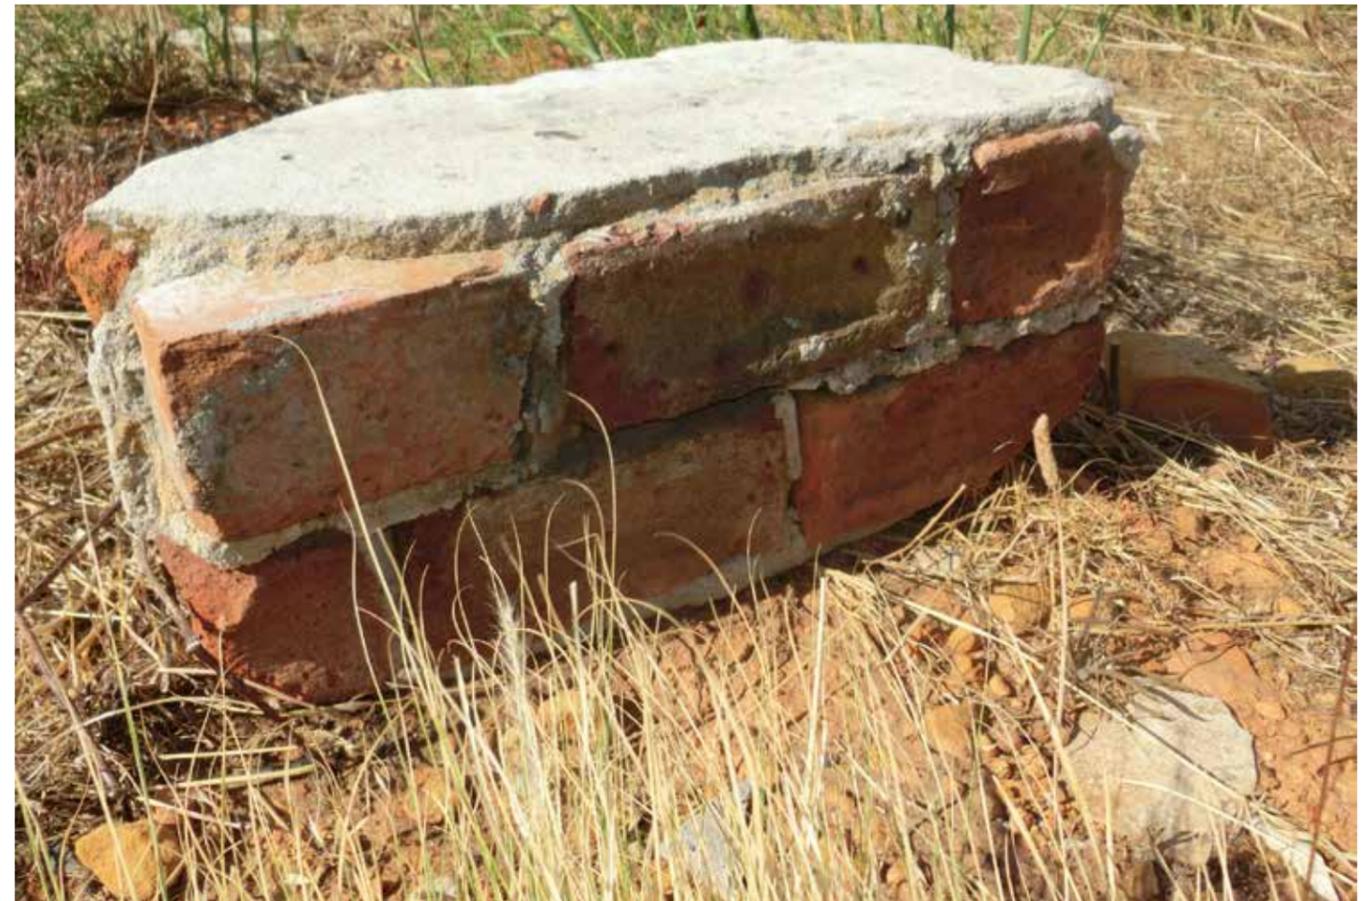
Figure 11. Historic building debris, with frogged bricks, likely early C20th (RSA, 2020).

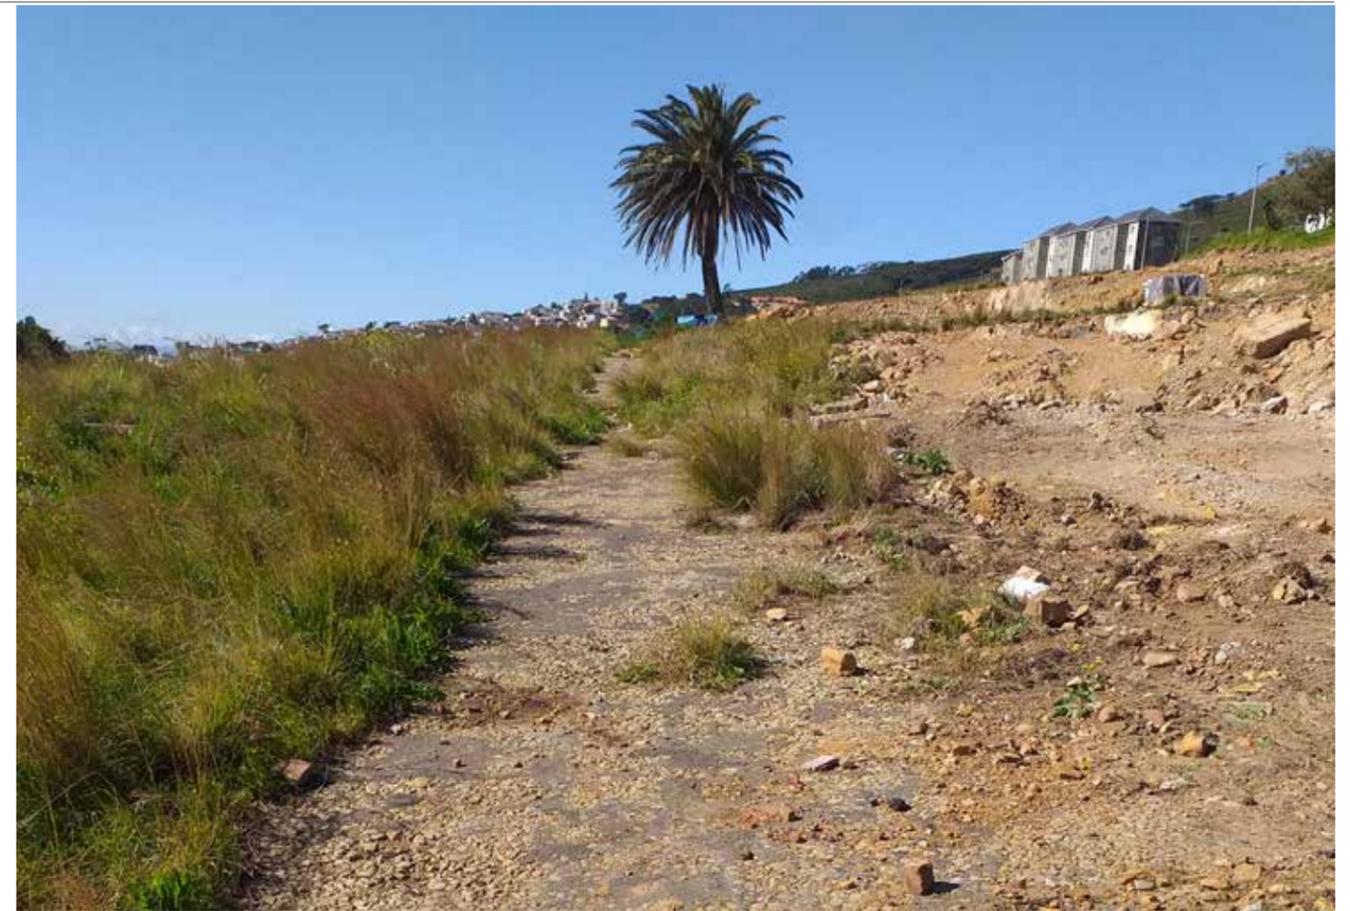
Further resources of significance include the two mature trees, one a palm tree between 13 and 15 Milton Street (Figure 22), and the other a belhambra at 23 Albert Street (Figure 23).

Figure 22. View to east along Milton Street towards the palm tree (RSA, 2020).

The palm tree and belhambra remain intact, and were avoided by all earthmoving activities. Both appear to still be in excellent condition. The stories regarding the palm tree, as related by various members of the public visiting site support the reading of this tree as highly significant in the landscape.

The palm tree is highly visible on the site, and is used for shelter by homeless people who have live under tarpaulin and tents at its base. While the tree looked healthy, it appears to exhibit some damage at the base of the trunk: this could reflect the attempts to uproot it during the forced removals, but could also reflect damage or disease from another source.

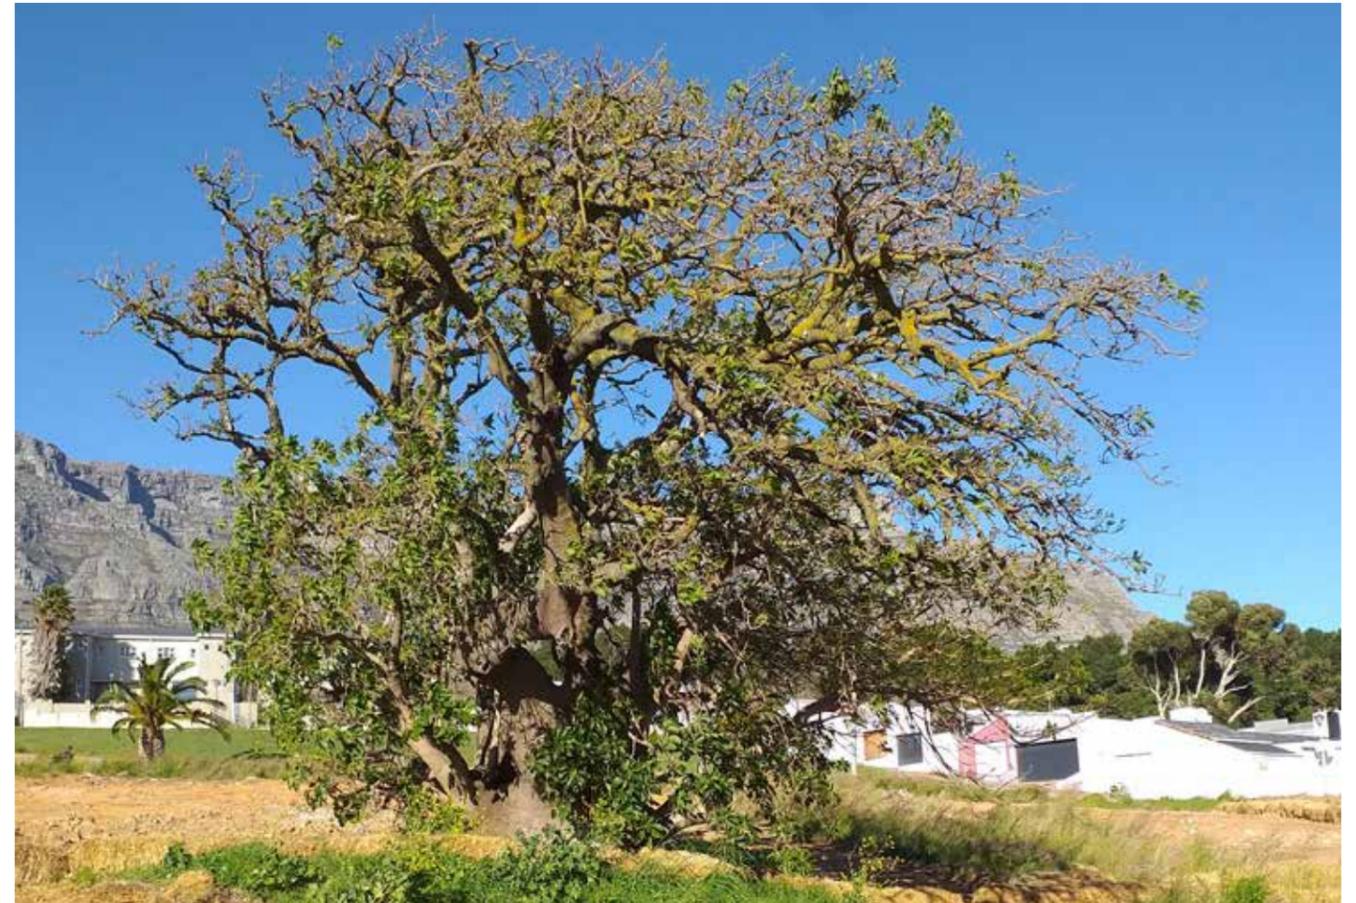
Figure 23. The belhambra, view to west (RSA, 2020).

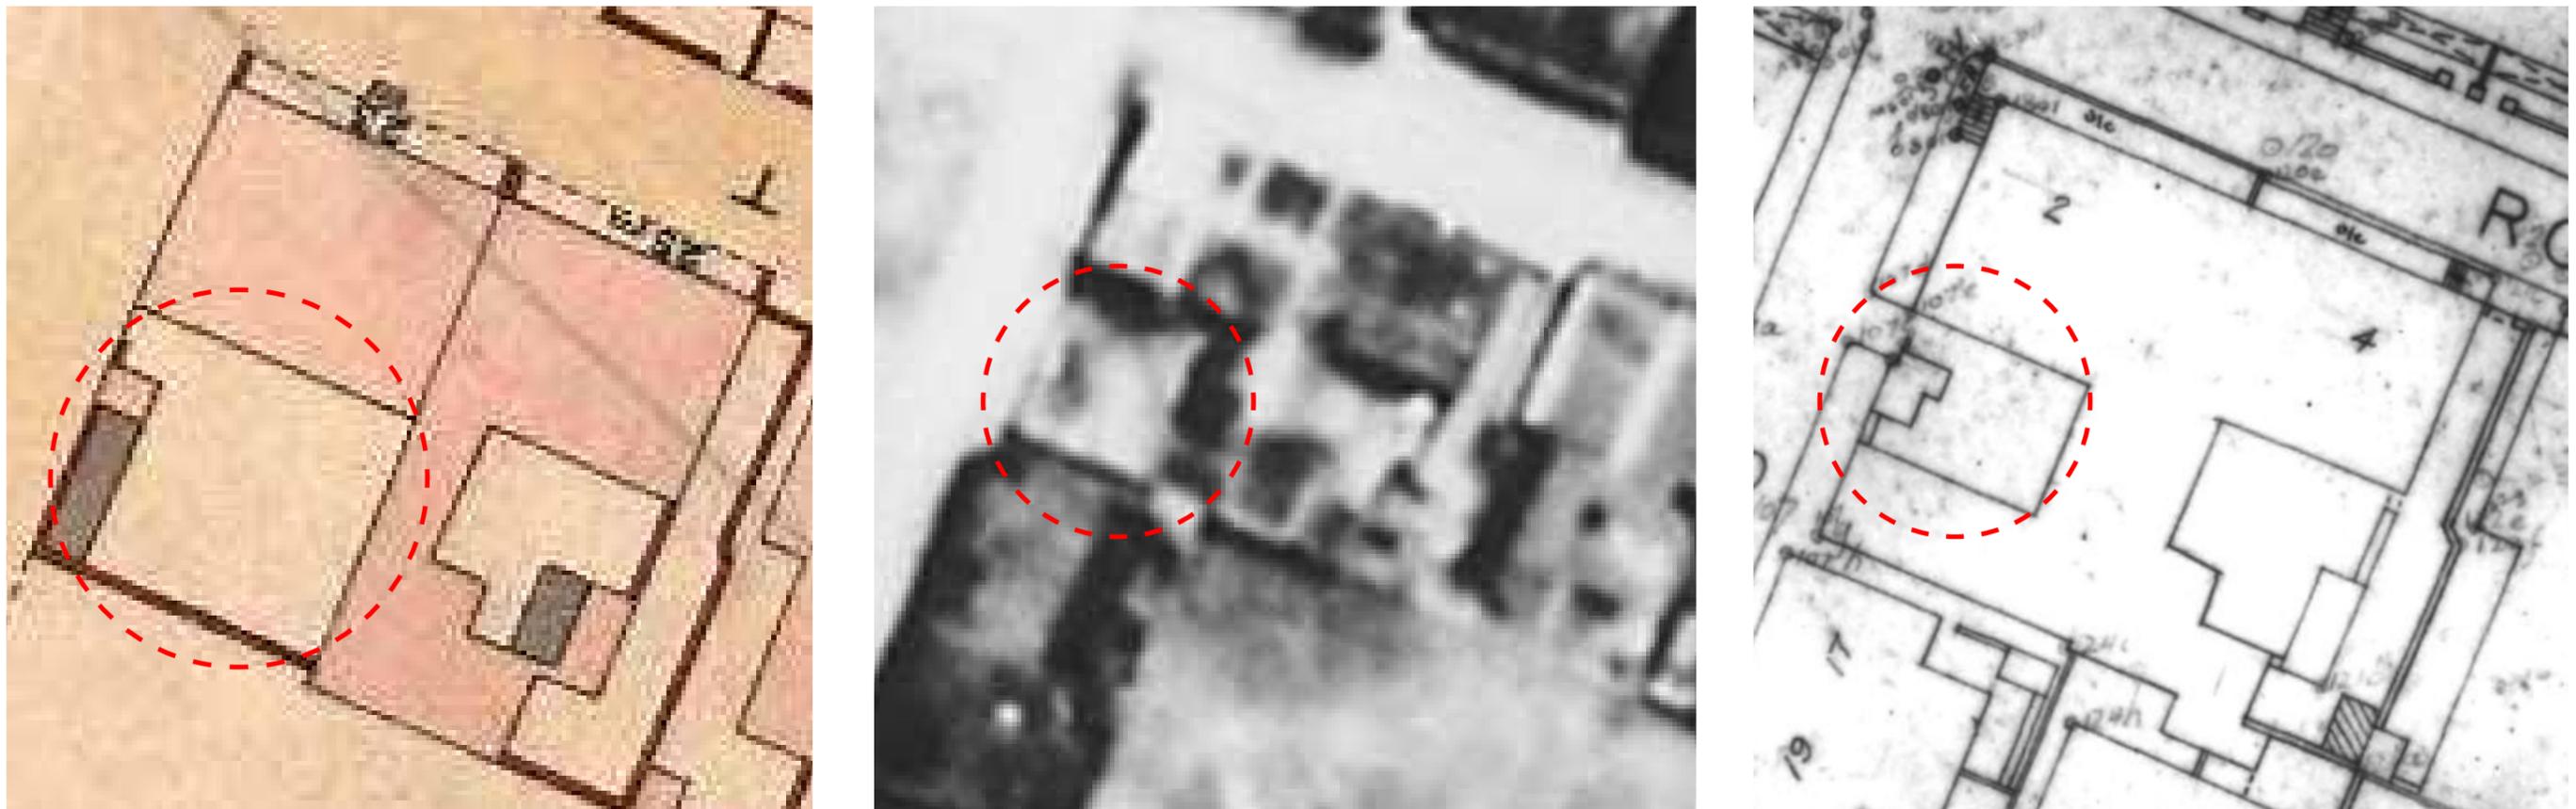
While little is known about this early property, its layout and development through time are clearly illustrated in the series of historic plans of the property (Figure 24). These plans show a structure fronting onto Roos, with access into the yard from Lewis; of interest is the depiction of the pavement on the Lewis Street side, where the pavement is wider, presumably to accommodate a different building line of that property than the surrounding, C20th buildings.

Figure 24. The development of the site as illustrated in the 1895 Thom survey (l), the 1926 aerial photograph (c) and the 1957 City survey (r); the courtyard is indicated in red (RSA, 2020).

- Archaeological excavation at the site of 2 Roos Street should be carried forward as a recommendation of the HIA process.
 - If the site cannot be retained as a feature in the new development, excavation must take place as mitigation;

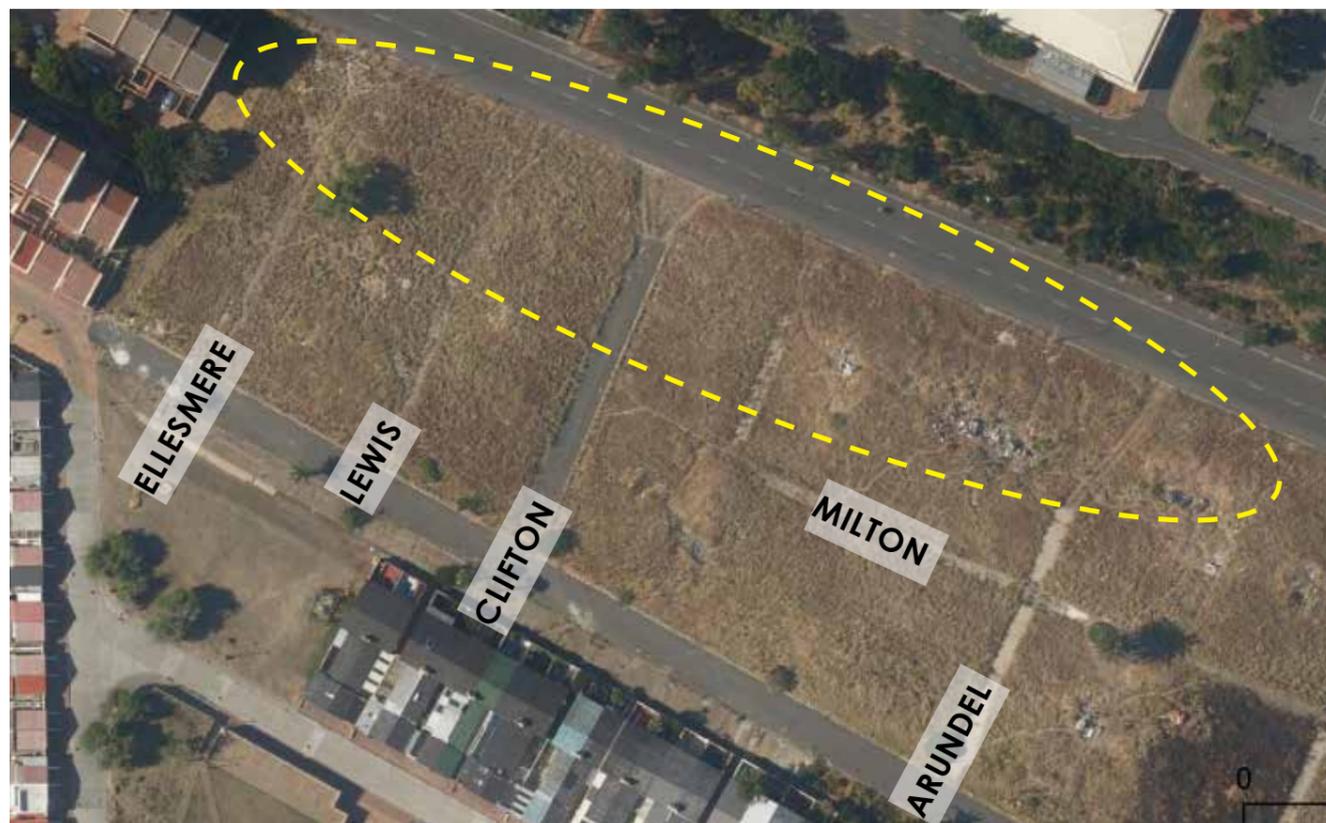
The northern extent of all streets had been truncated across Parcel N, with the extent of truncation greater in the western half of the site (Figure 25). As such, no road surfaces were encountered at the northern extent of any of the north-south streets, and almost no remnant of Roos Street was encountered. While this could relate to that area of site not being excavated to the same levels as the rest of Parcel N to retain a soil berm there for storm water management, however, in several instances, the northern extent of north-south streets dipped dramatically in near to Constitution Street, and large sandstone boulders were encountered in the road alignments there (see Arundel Street, bottom left Figure 26). This would seem to indicate that some earthmoving took place previously between Albert and Arundel Streets along the alignment of the newly built Constitution Street, presumably at the time of the demolitions in the 1960s and 1970s.

Figure 25. Google Earth image showing the truncation of all streets at the north eastern extent of Parcel N (RSA, 2020)

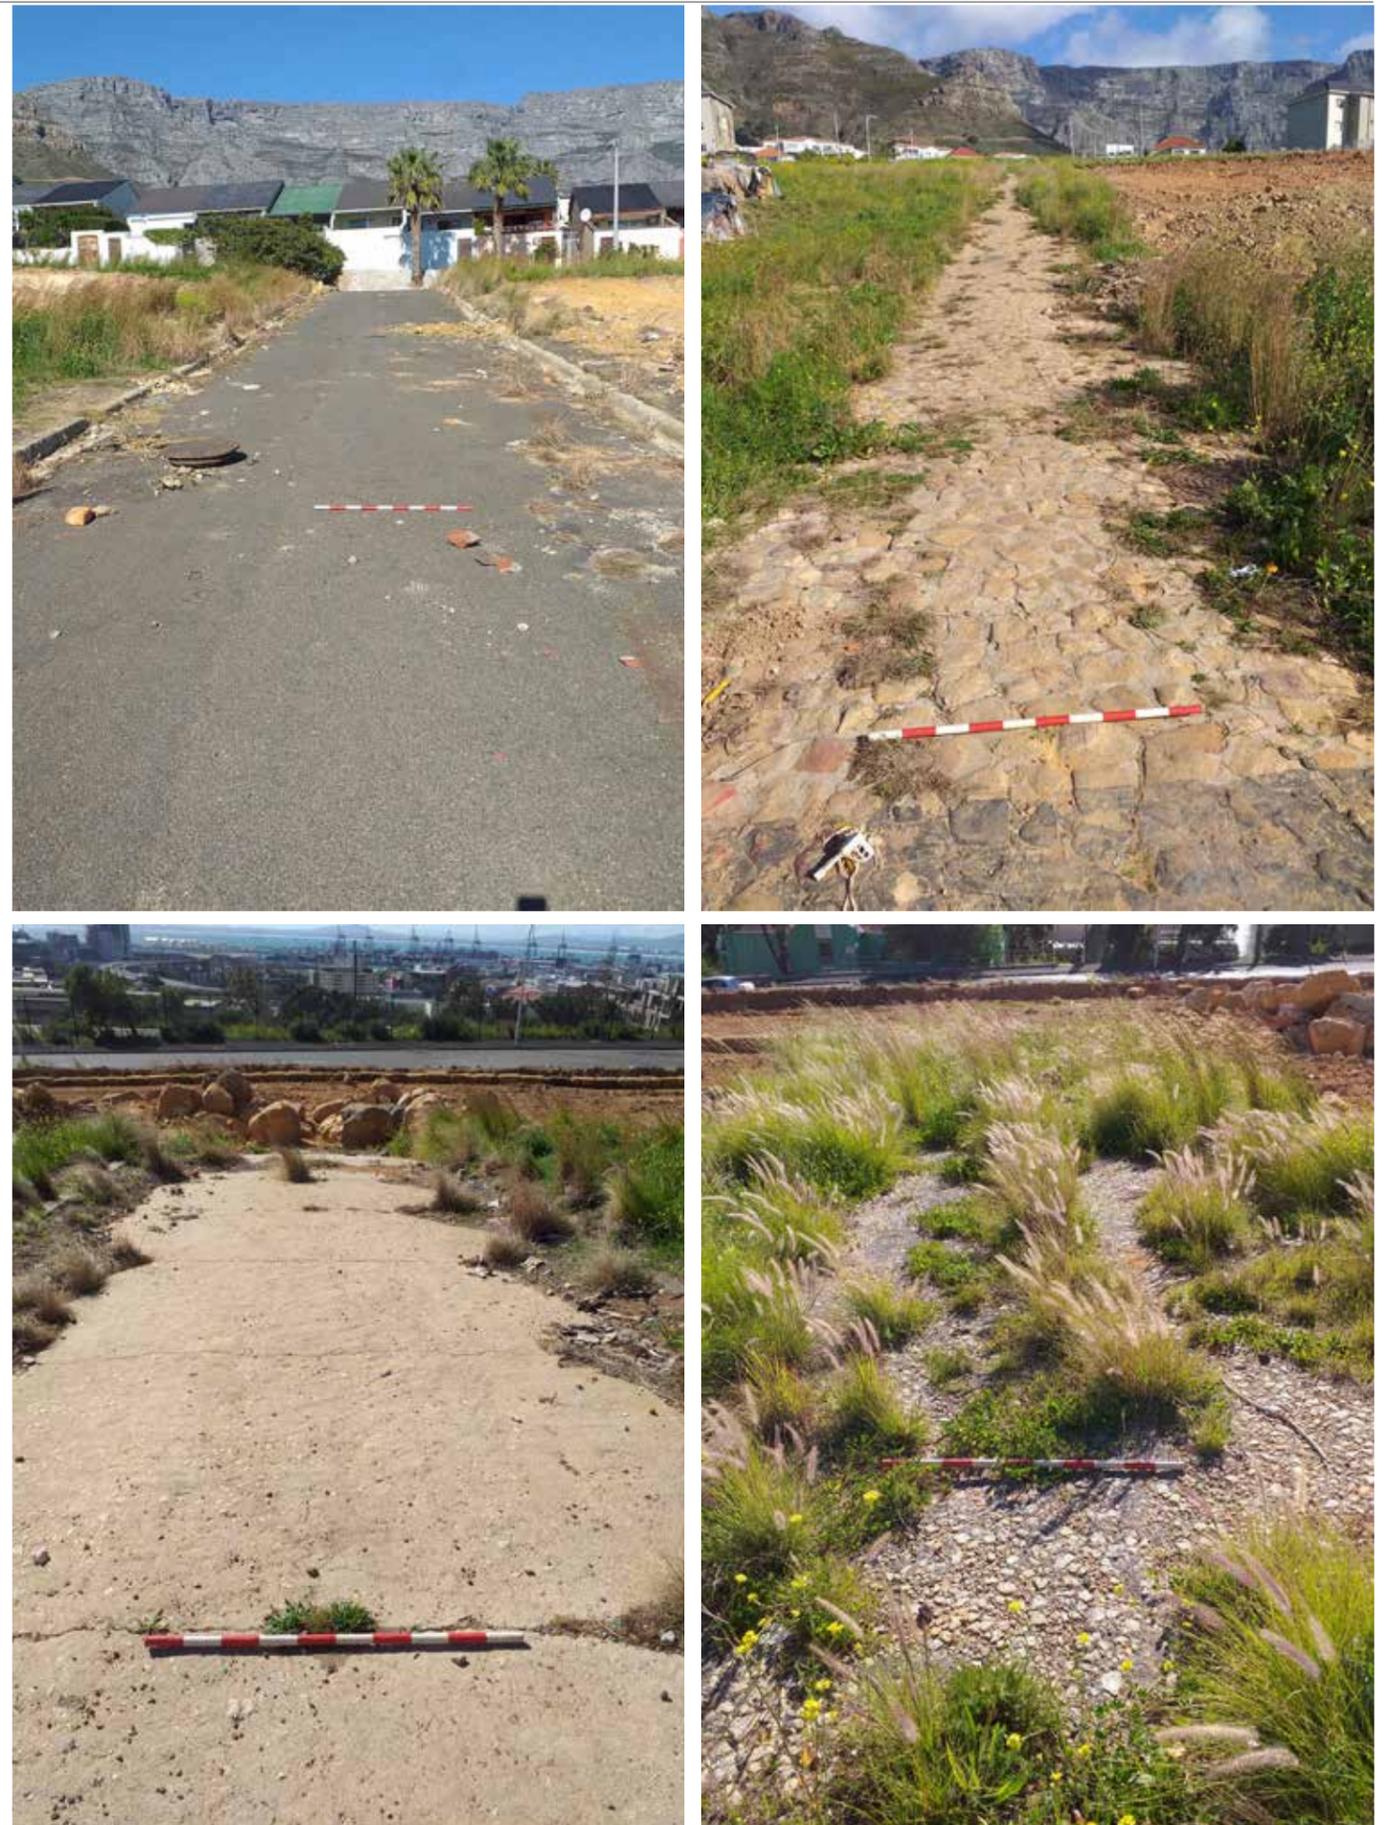
Figure 26. Variety of road surfaces, and relative preservation of surfaces across site: Clifton Street (top left), tarred, Upper Horstley Street (top right), cobbled, Arundel Street (bottom left), cement, Albert Street (bottom right), aggregate (RSA, 2020).

Milton, the only east-west street in Parcel N was present for its entire length, while Upper Horstley and Richmond Streets were the best-preserved and most intact north-south streets. Arundel, Lewis, Clifton, Ellesmere and Albert were all truncated at their northern extent, by 25m, 15m, 11m, 25m and 28m respectively. Albert and Ellesmere were in poor condition and their alignment and features, including kerb stones, not as clearly preserved or retained.

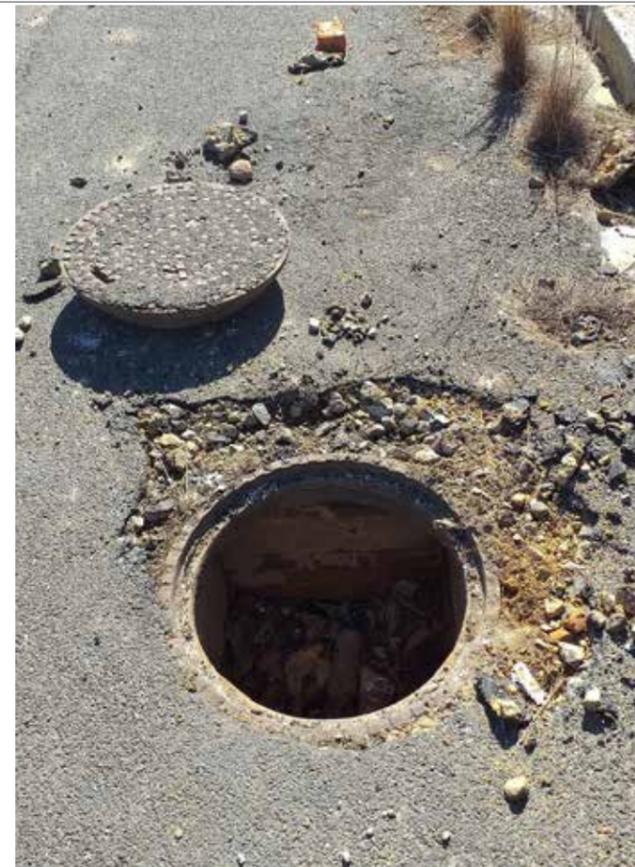
In addition to road surfaces and kerb stones, several cast iron sewer covers, manhole covers and similar were also noted. Most of these heavy objects had been lifted out of the ground, although not removed from site (Figure 27). In places, road surfaces have been damaged to extract metal from below the street surface (Figure 27), and it cannot be discounted that the manholes were shifted with the intention of removing them to sell for scrap. However, it is clear in several instances, that the spaces below afforded shelter and/or storage spaces for those living on the site currently.

Figure 27. Manhole shifted on Clifton Street (RSA, 2020).

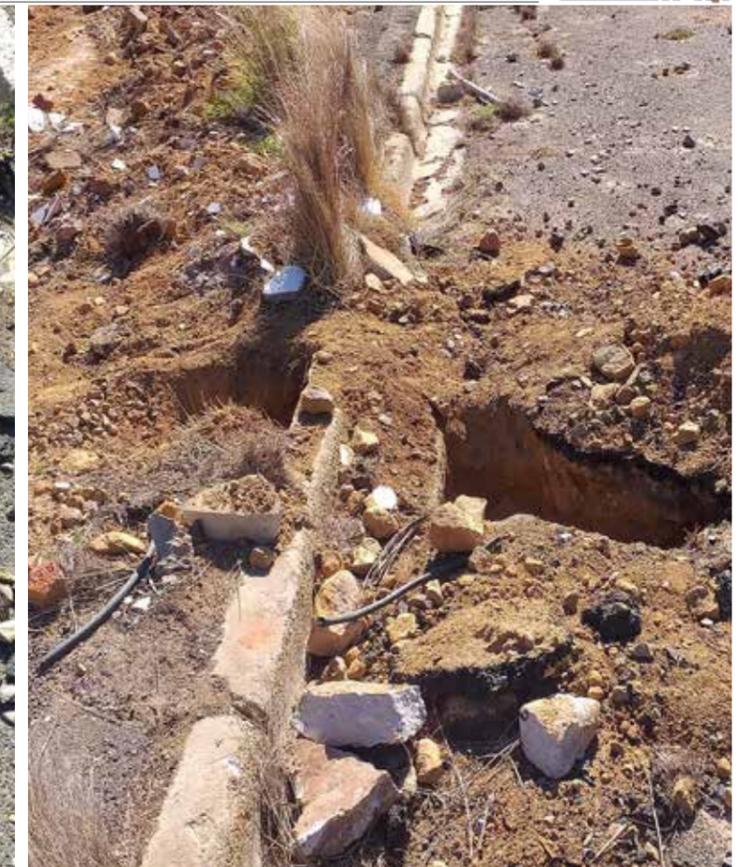
Figure 28. Excavations into Clifton Street to remove scrap metal (RSA, 2020).

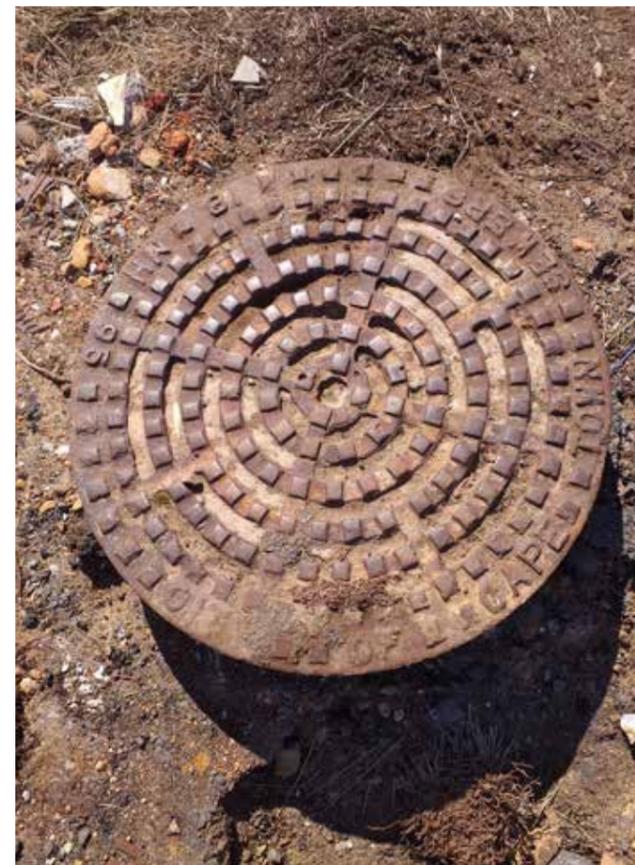
Figure 29. Cast Iron manhole cover retrieved from site (RSA,2020).

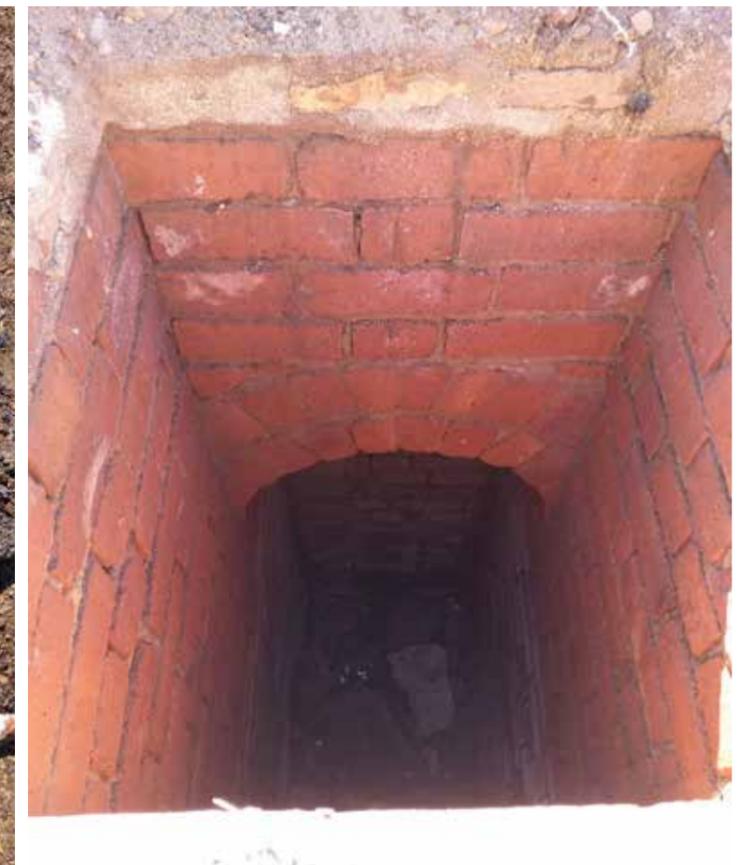
The manhole at the intersection of Milton and Arundel, which had been shifted, was retrieved from site for safe storage (Figure 30), revealed a robustly built sewerage tunnel below, that had been bricked up (Figure 30). Elsewhere, such as on Clifton, these subsurface spaces were likely more recent and related to more modern services than sewerage or water.

Figure 30. Tunnel below Arundel Street (RSA, 2020).
