REPORT ON ARCHAEOLOGICAL MONITORING OF RUBBLE REMOVAL

submitted in terms of Section 35 of the NHRA (1999) for
DISTRICT SIX PHASE FOUR DEVELOPMENT ON PARCEL N,
DISTRICT SIX, CAPE TOWN,
ERVEN 177646, 10010 AND 117891-117898

Prepared by Katie Smuts, Archaeologist at Rennie Scurr Adendorff for Delta BEC
on behalf of the Department of Land Reform and Rural Development

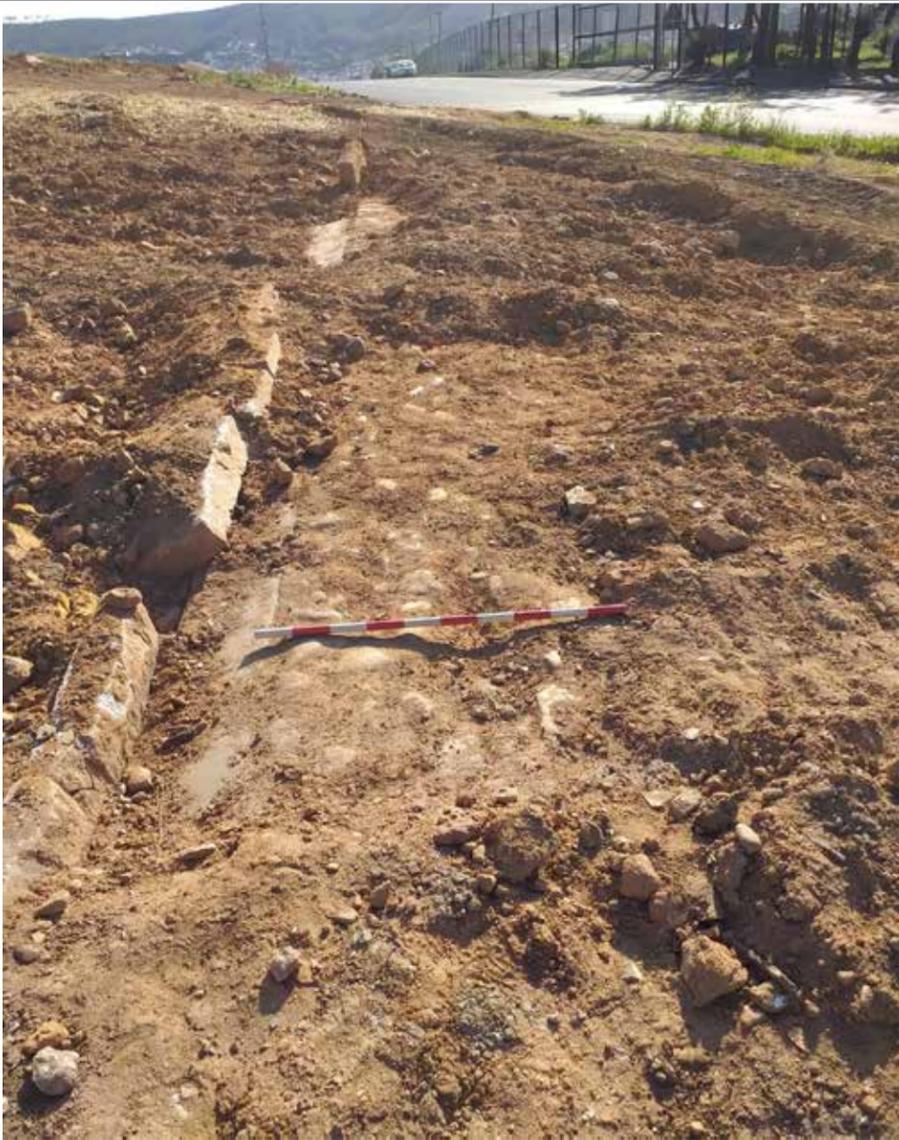
A portion of Roos Street was uncovered, intact in the north eastern extent of Parcel N. Here the street was revealed to be narrow, cobbled and lined on either side with granite kerb stones (Figure 31). This portion of Roos correlates precisely with the angle, width and alignment of the north east of Roos Street as indicated on Thom's 1895 survey (Figure 24) and the aerial photograph of the area from 1945 (Figure 25).

Figure 31. Roos Street remnant at north east of Parcel N (RSA, 2020).

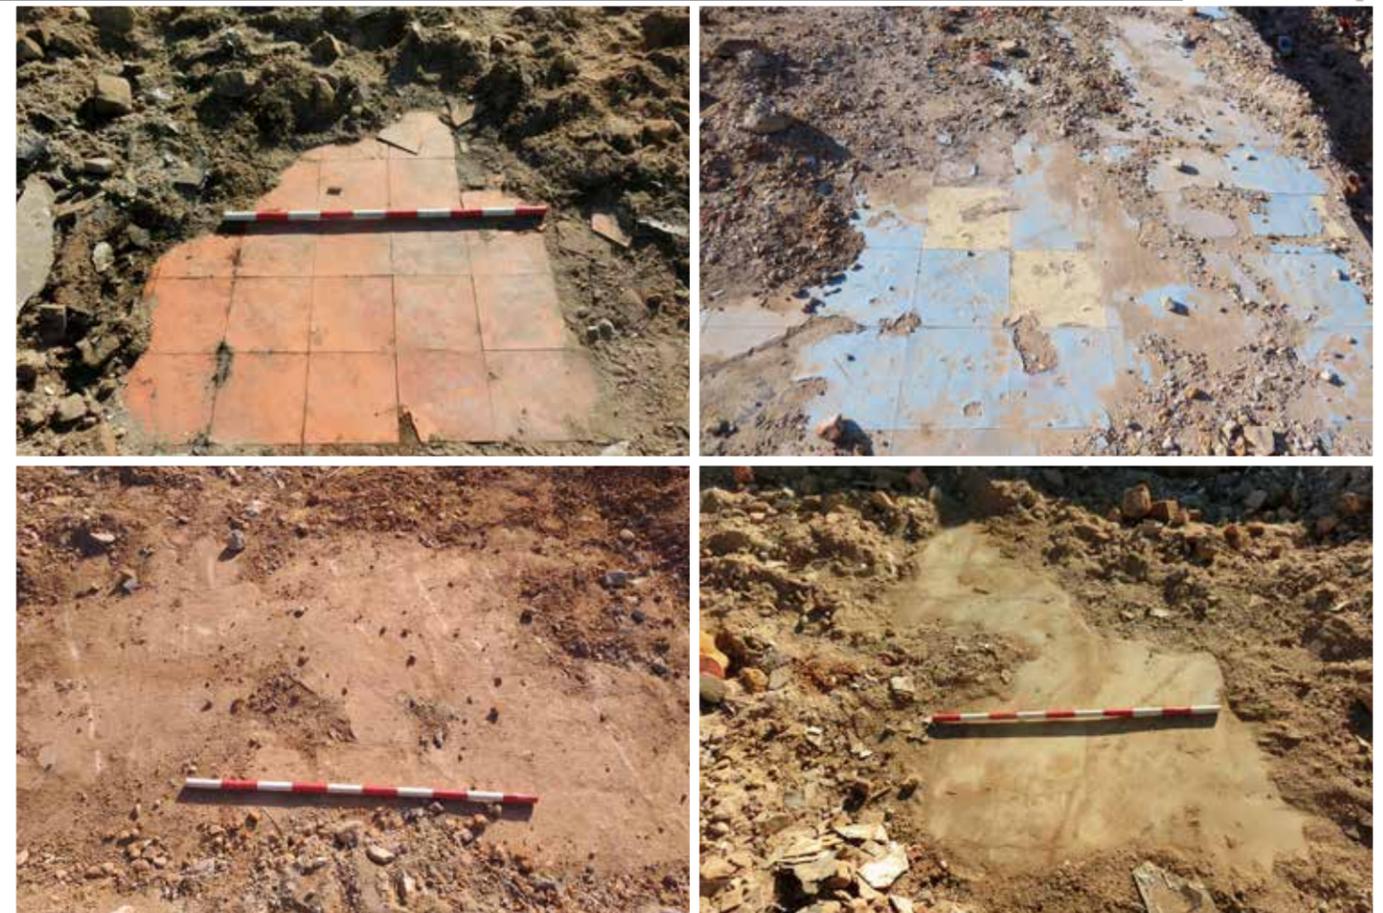
Most areas revealed foundation levels intact across site, with floor levels and even floor surfaces still intact. (Figure 35) In some instances, foundations and lower courses of walling remained, but floors were absent, in still others vertical walling remained standing to some height above ground level (Figure 36).

In keeping with the relatively recent age of the buildings, most structures were found to have brick foundations, with brick superstructures, and extensive use of cement and concrete for floor surfaces and plaster. It is likely that those structure with no remnant floor surfaces would have had timber flooring, and these structures were predominantly found along Lewis and Upper Horstley Street, where structures were older, and more likely to have had wooden floors. Brick fabric ranged from soft, bright red, friable bricks, through well made, dull red bricks with clear frogs, to high-fired purple-red facebricks.

Figure 35. Different flooring materials found across site (RSA, 2020).

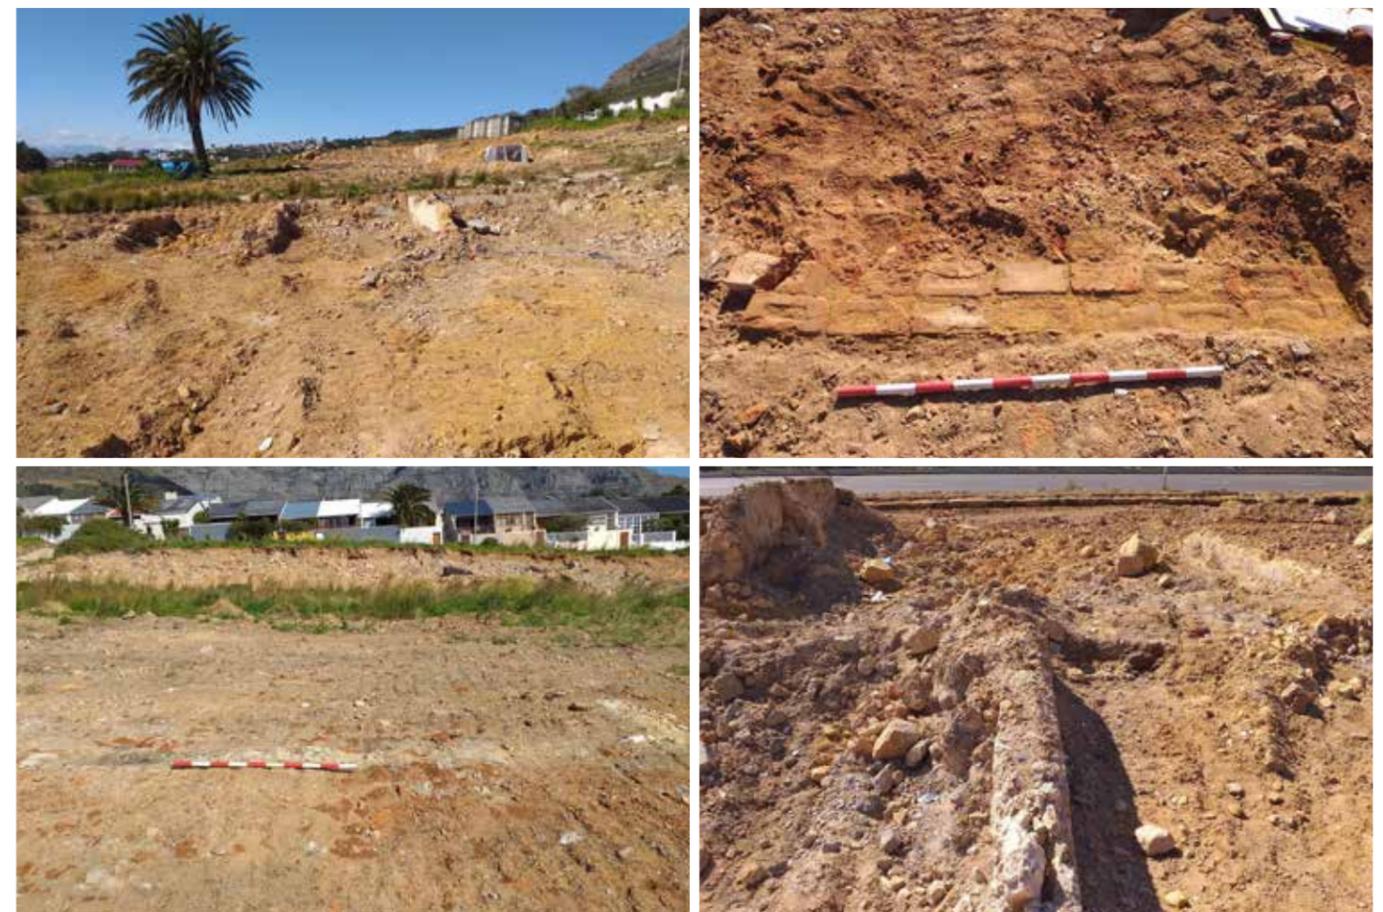
Figure 36. Different preservation, and different construction materials across site (RSA, 2020).

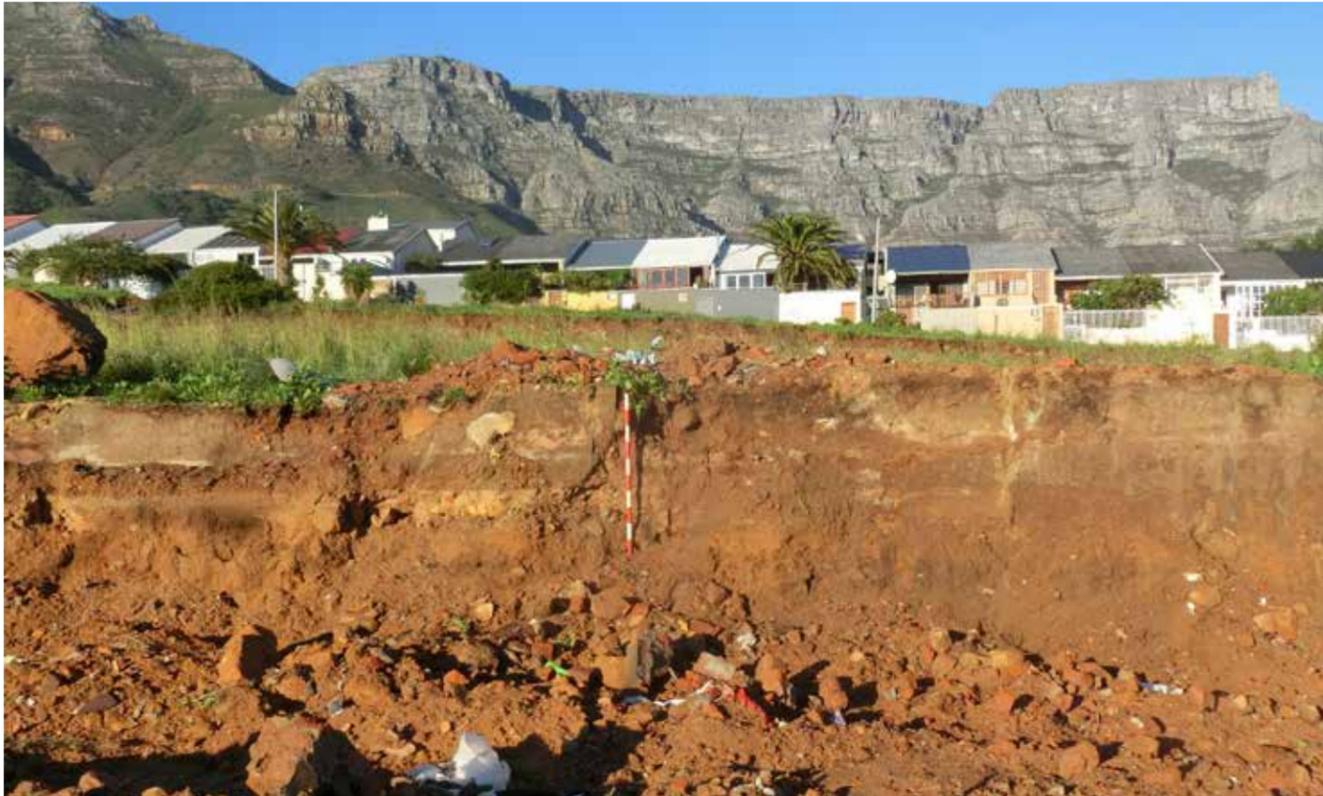
Most interesting, archaeologically, were the remnant walls located between Lewis and Arundel Streets (Figure 40 and Figure 41). These walls correlate with the rear yard walls of the houses at 6, 8 and 10 Roos and, as such, represent some of the few remains on Parcel N dating to the C19th (Figure 42).

Figure 40. Extensive standing walling between Lewis and Arundel, showing the north face of common wall between Roos and Milton Street properties, view to south (RSA, 2020).

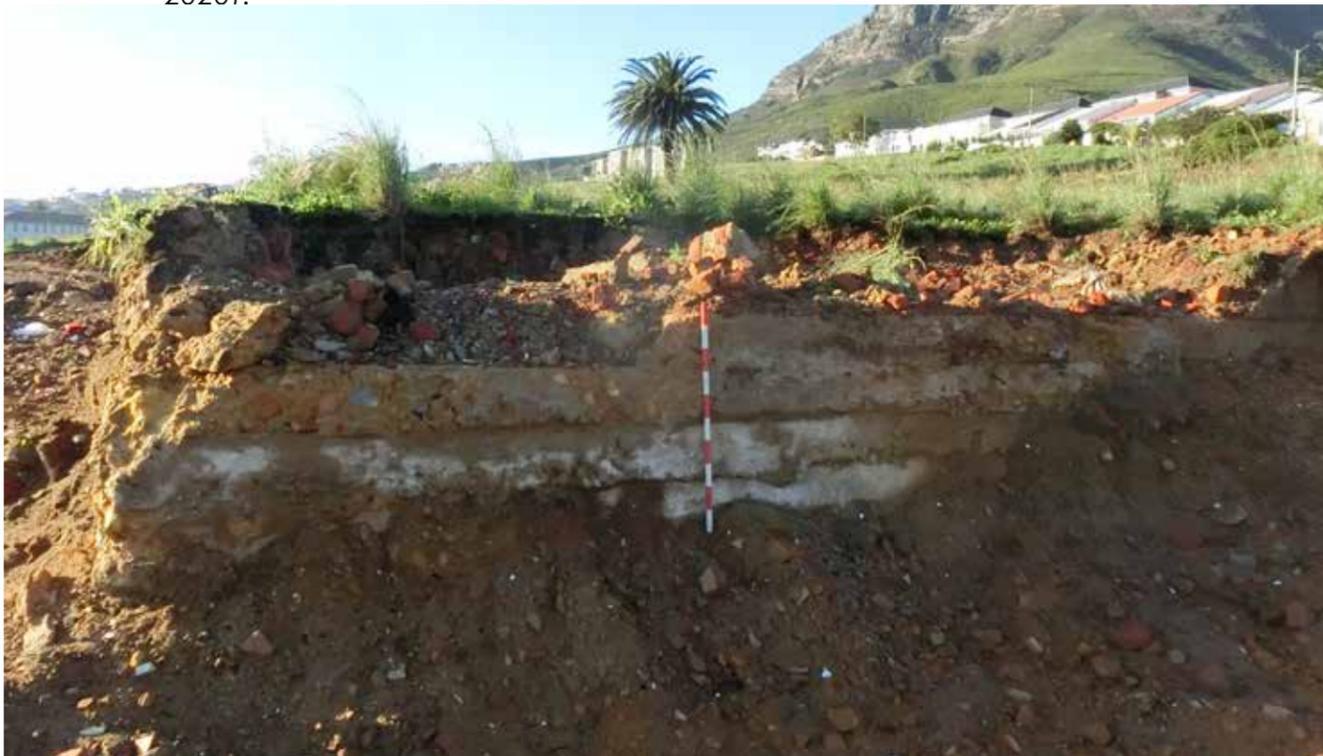
Figure 41. The return of the feature at its western extent, view to south east (RSA, 2020).

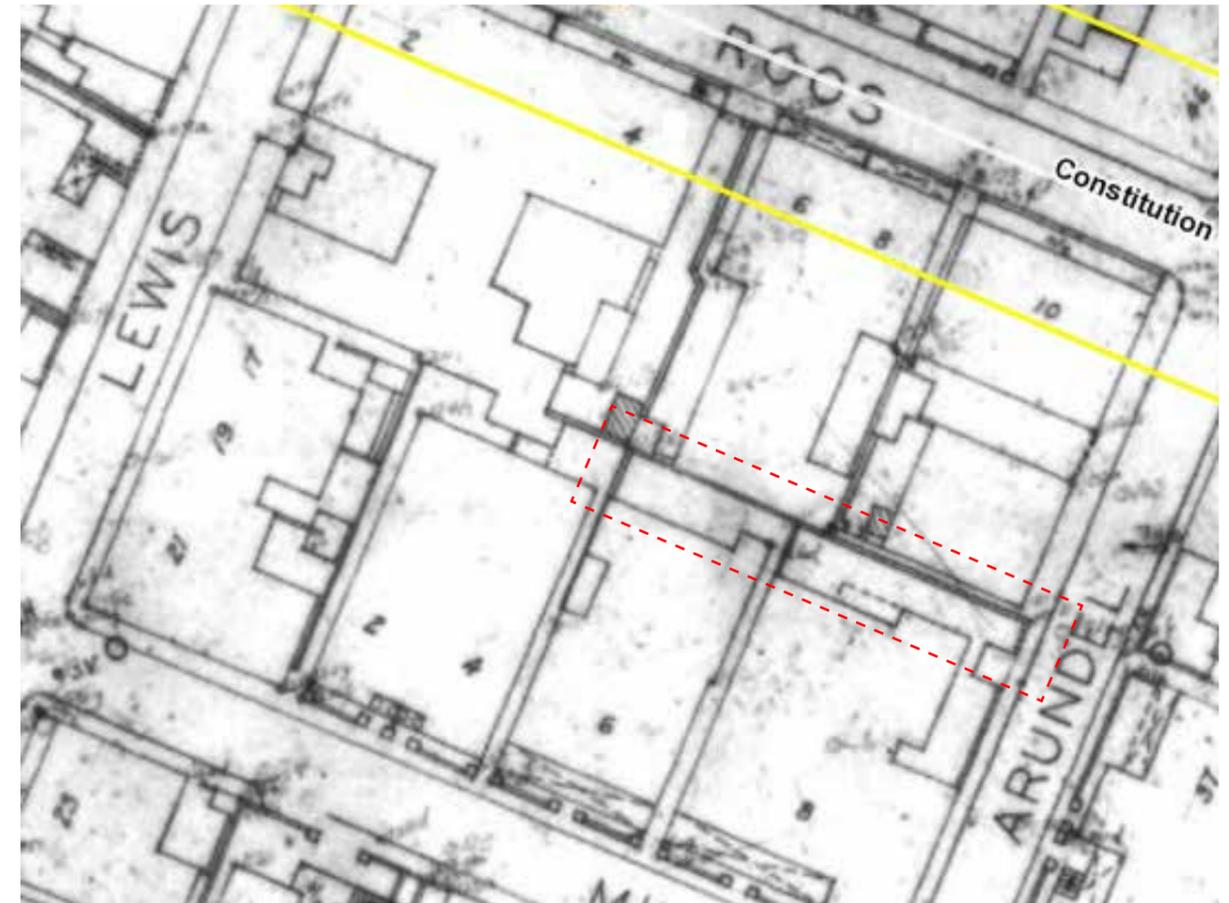
Figure 42. The location of the walling, indicated in red, on Thom's 1895 plan (top left insert), the 1945 aerial photo (above) and on the 1957 City plan (below); note the return of the wall clearly visible on both images at far left of highlighted area (RSA, 2020).

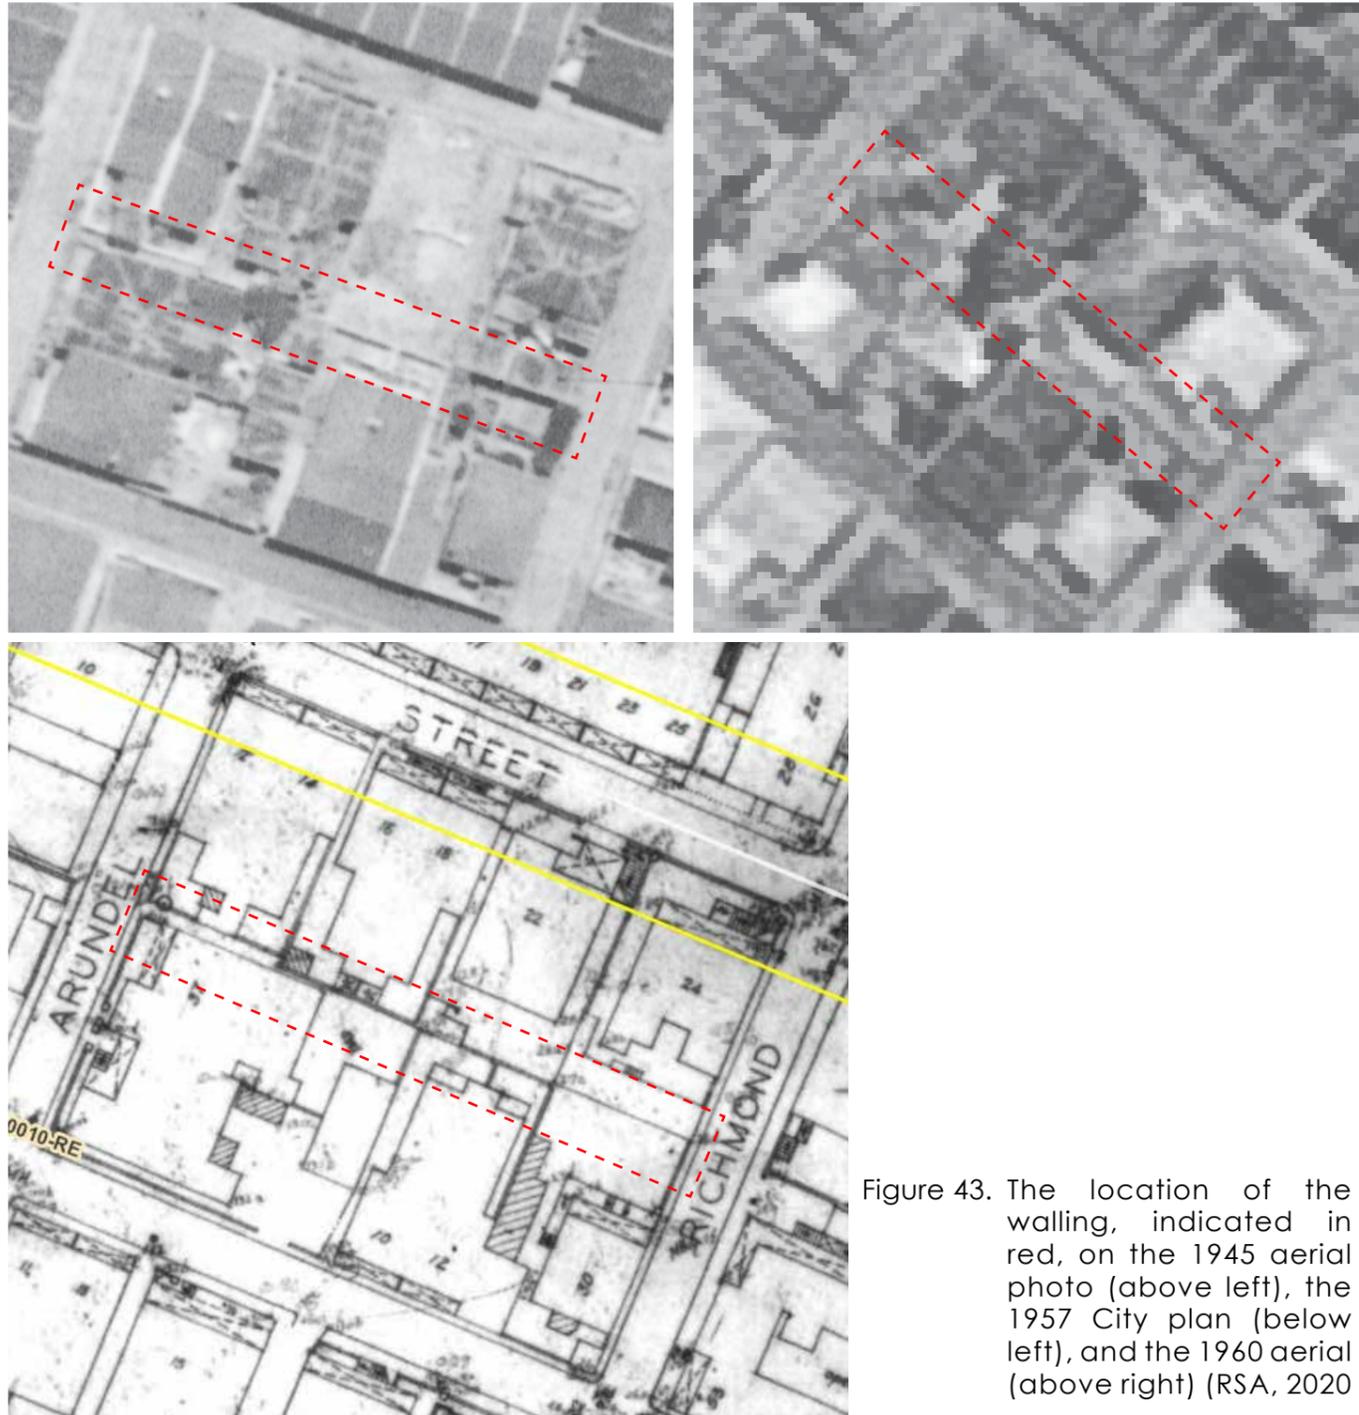
Excellent preservation of above ground material was recorded, as noted previously, in the centre of site between Arundel and Richmond, north of the central, elevated area of site (Figure 43). These features correlate with the rear courtyard walls of 16 and 18 Roos Street, just to the east of the last of the structures indicated along Roos on Thom's 1895 survey (Figure 44). The preservation of extensive above ground walling here would seem to result from terracing to accommodate the drop off of site from south to north and they were likely left intact to continue acting as retaining walls for upslope deposits.

Figure 43. The location of the walling, indicated in red, on the 1945 aerial photo (above left), the 1957 City plan (below left), and the 1960 aerial (above right) (RSA, 2020)

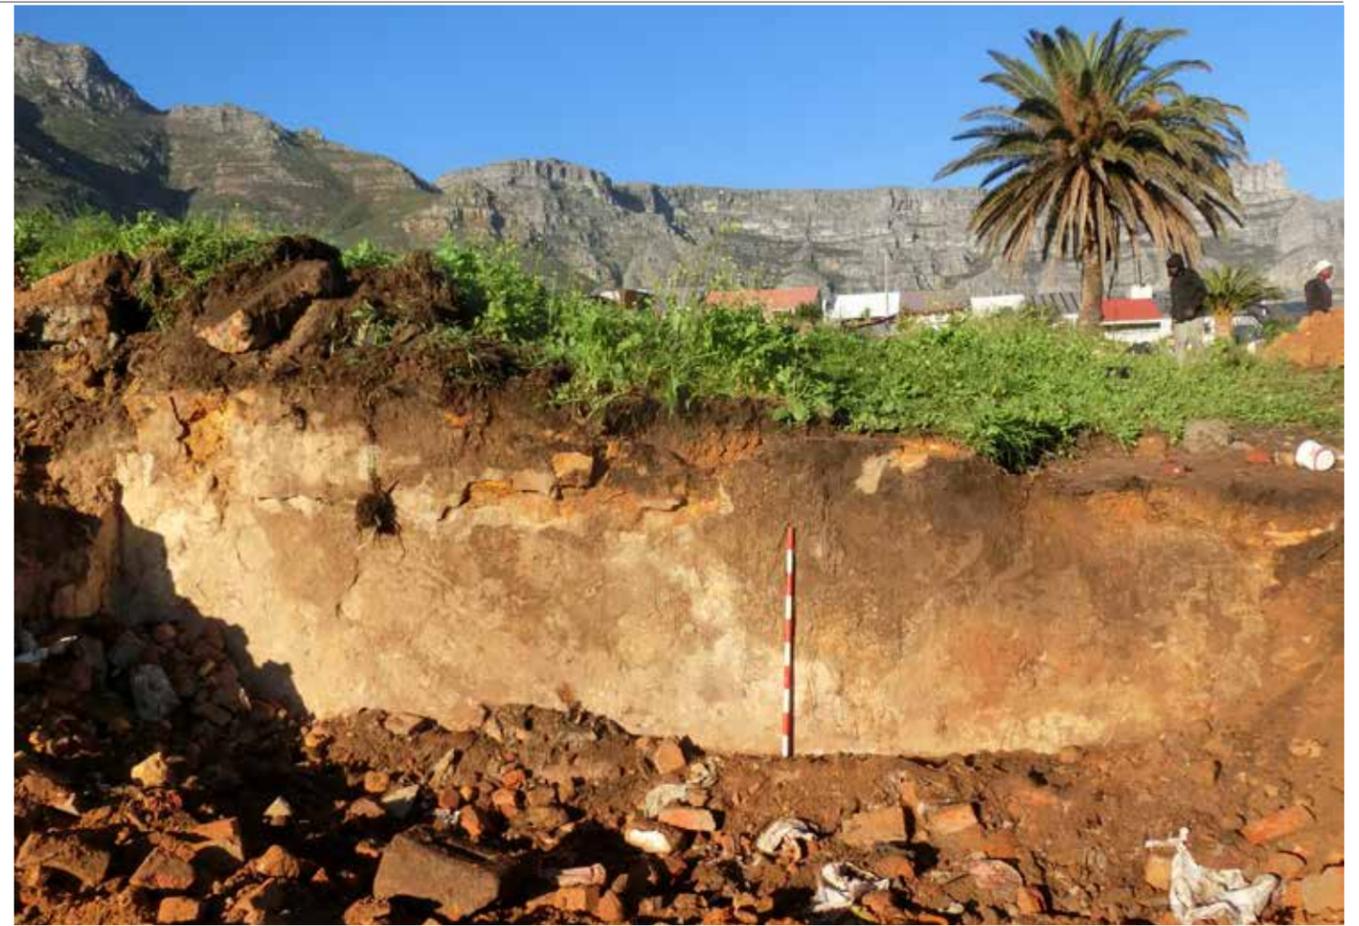
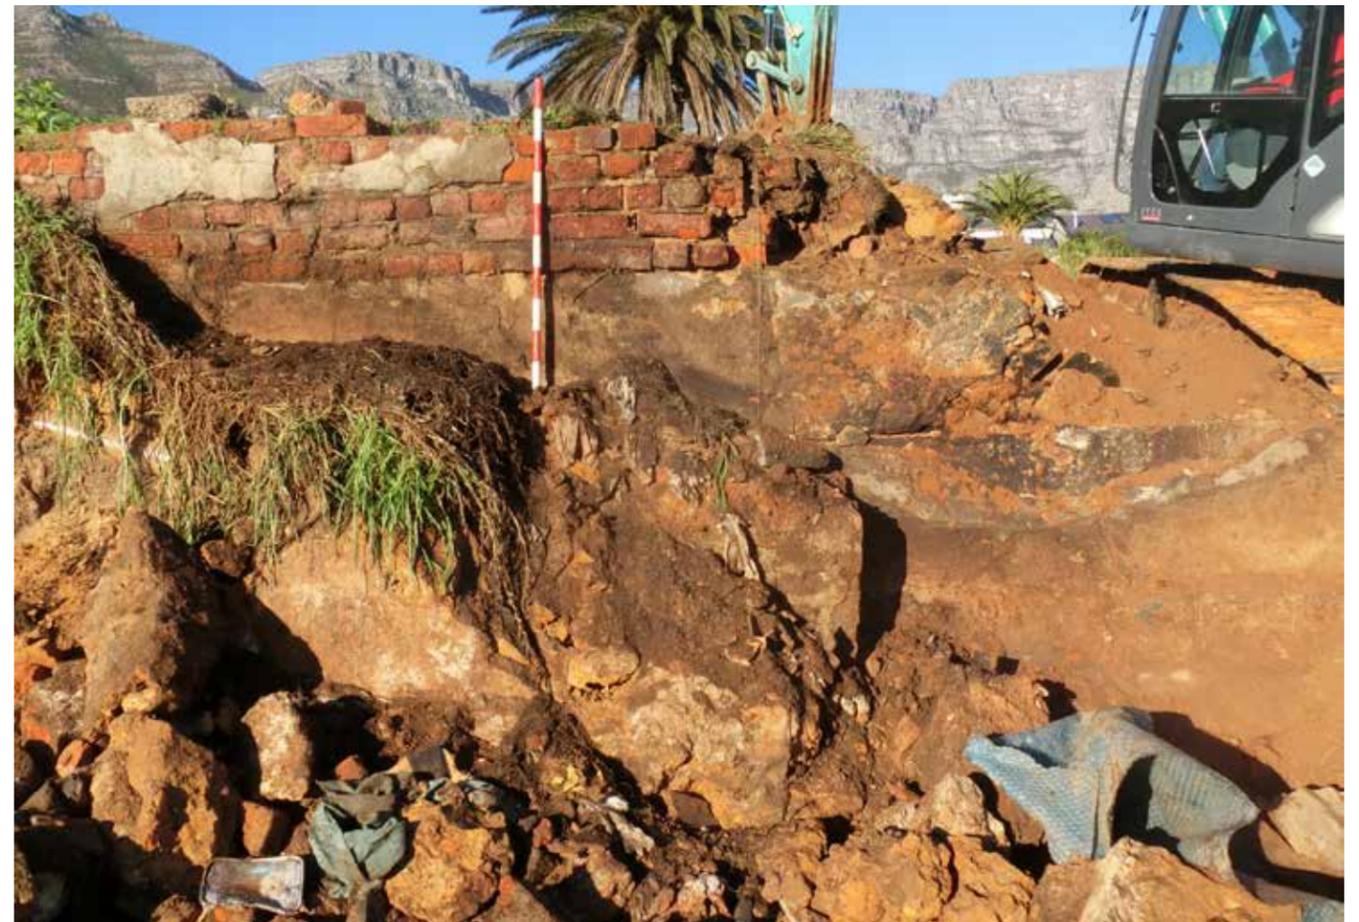
Figure 44. Standing walling north of Milton between Arundel and Richmond (RSA, 2020).

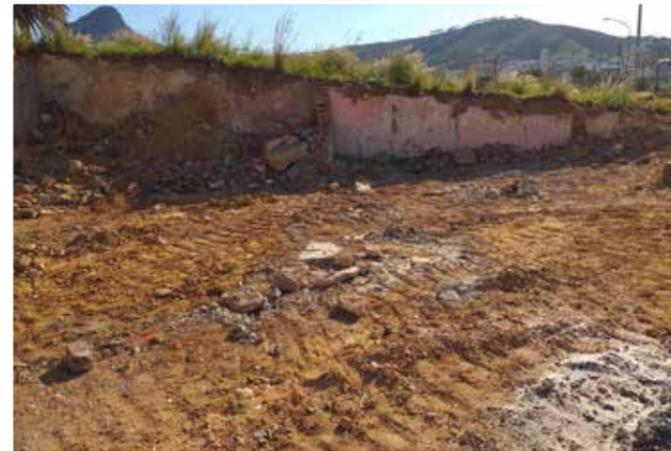
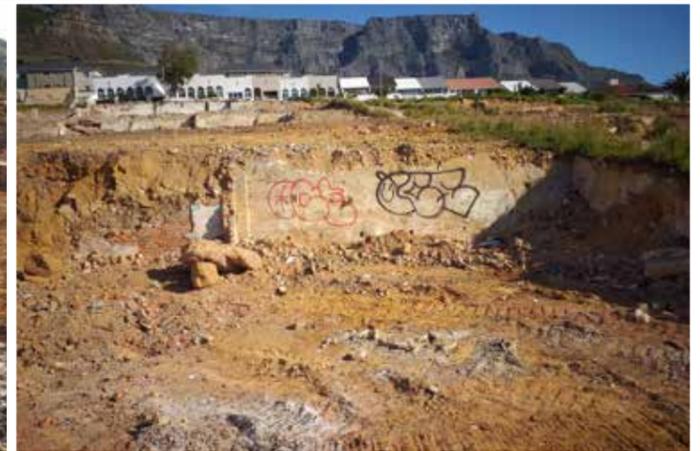
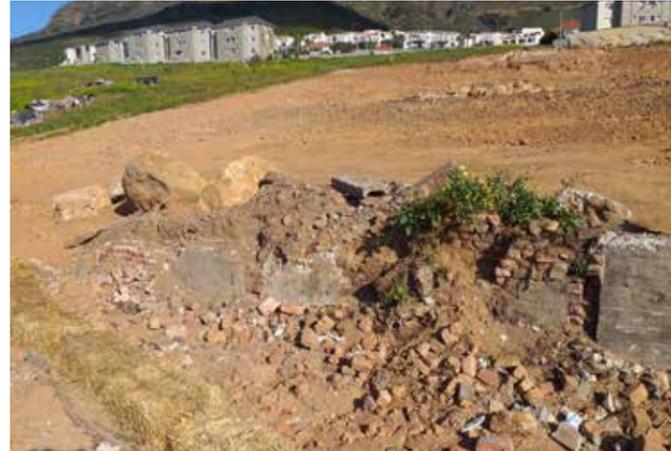
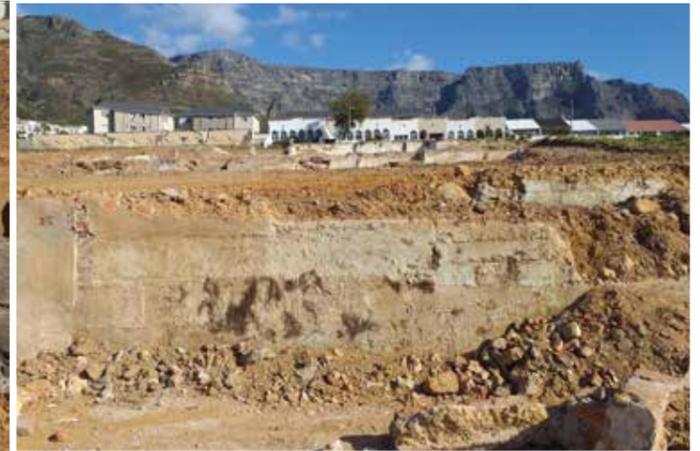
Further prominent standing walls were located east of Richmond Street. These features correlate with the structures at 26/28 Roos, and 30 Roos which stood adjacent to the open area at the eastern part of Parcel N (Figure 45). These remains included the painted, inner face of walls, with stubs of internal walling, concrete steps and vinyl floor tiles (Figure 46 and Figure 47).

Figure 46. Standing walling at corner of Richmond and historic Roos, clockwise from top left: view of western wall along Richmond, and rear wall from west to east (top right, bottom left, bottom right respectively) (RSA, 2020).

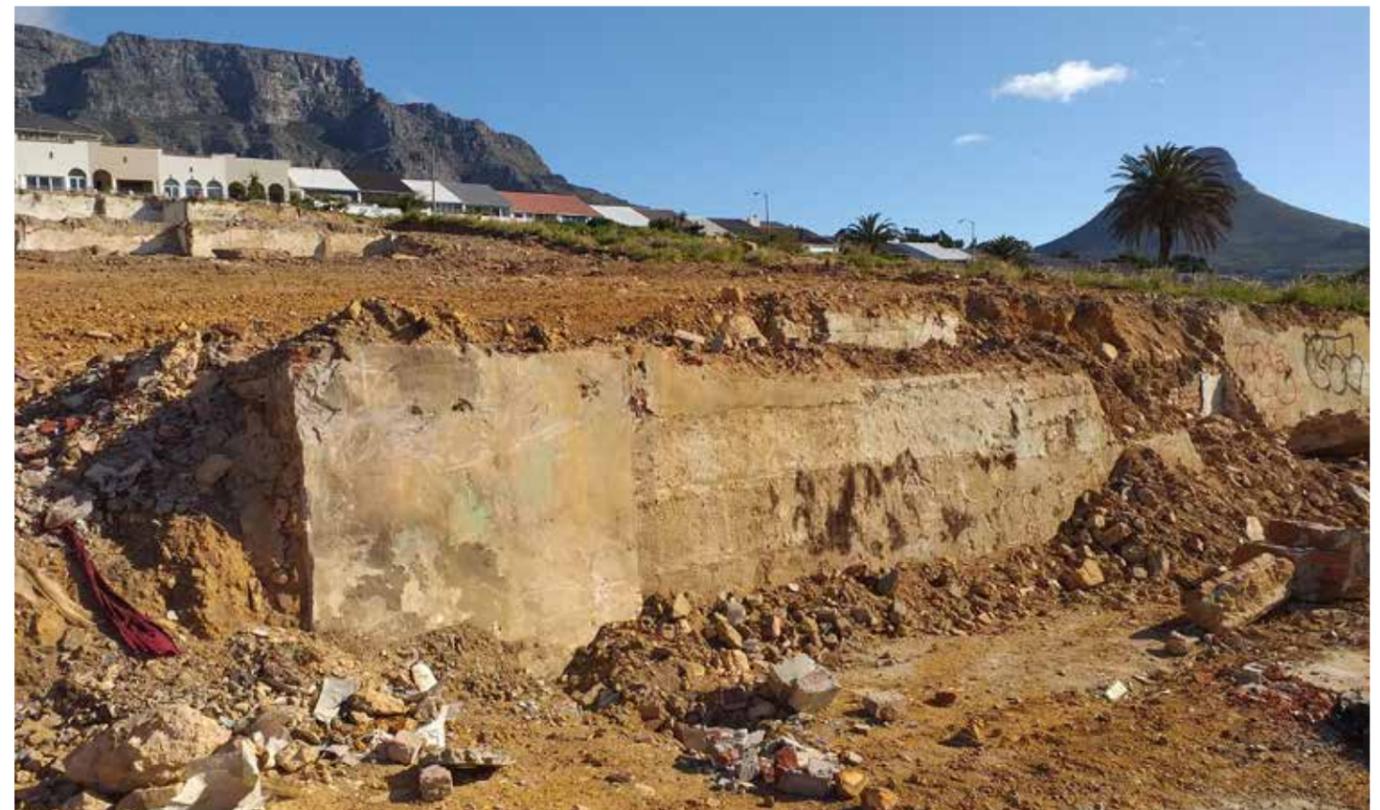
Figure 47. Detail of rear property wall; collapsed section at right was location of cement steps leading up between the two portions of wall (RSA, 2020).

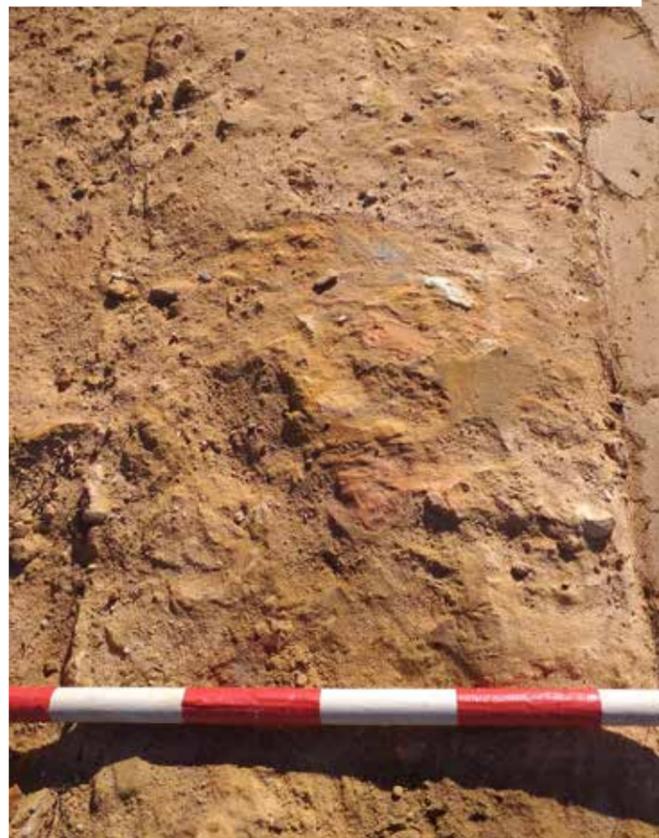
Figure 48. Wall footings and frogged bricks at 30 Albert Street (RSA, 2020).

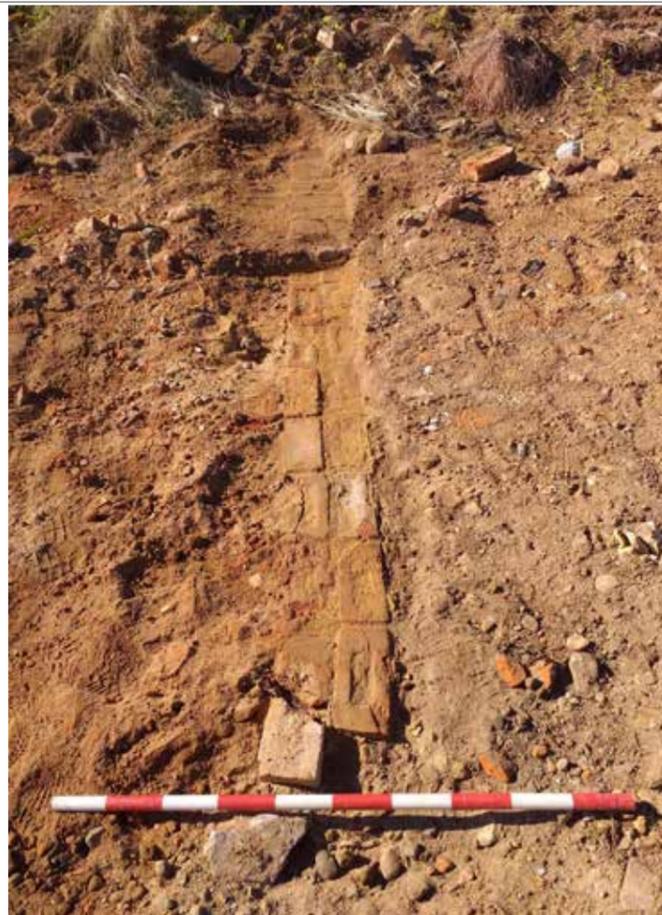
Figure 50. Brick thresholds off Milton Street at 2-4 Milton (top) and 9 Milton (below) (RSA, 2020).

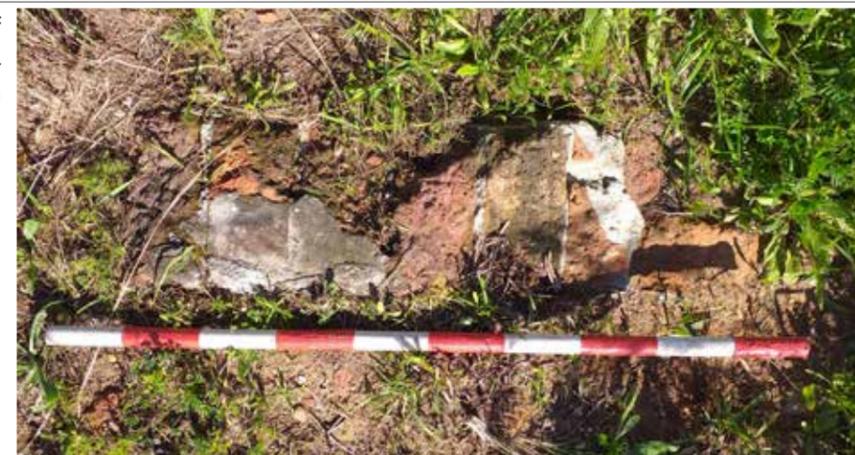
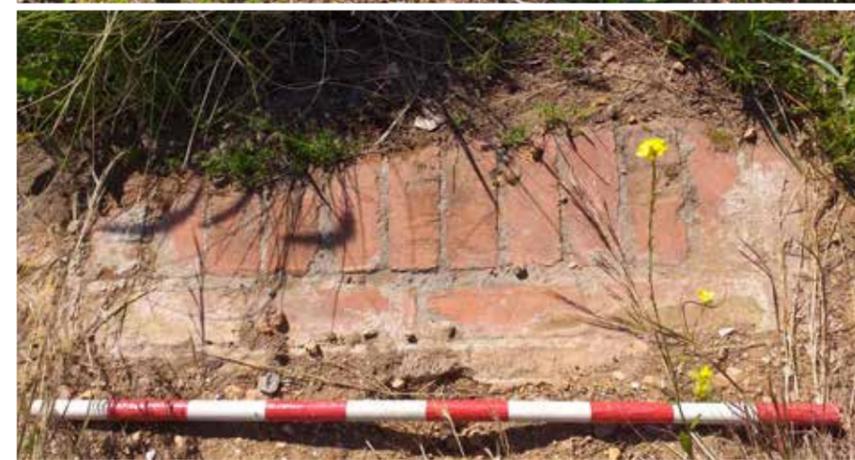
Figure 49. Retaining wall against Upper Constitution Street at 137 and 141 Upper Constitution (RSA, 2020).

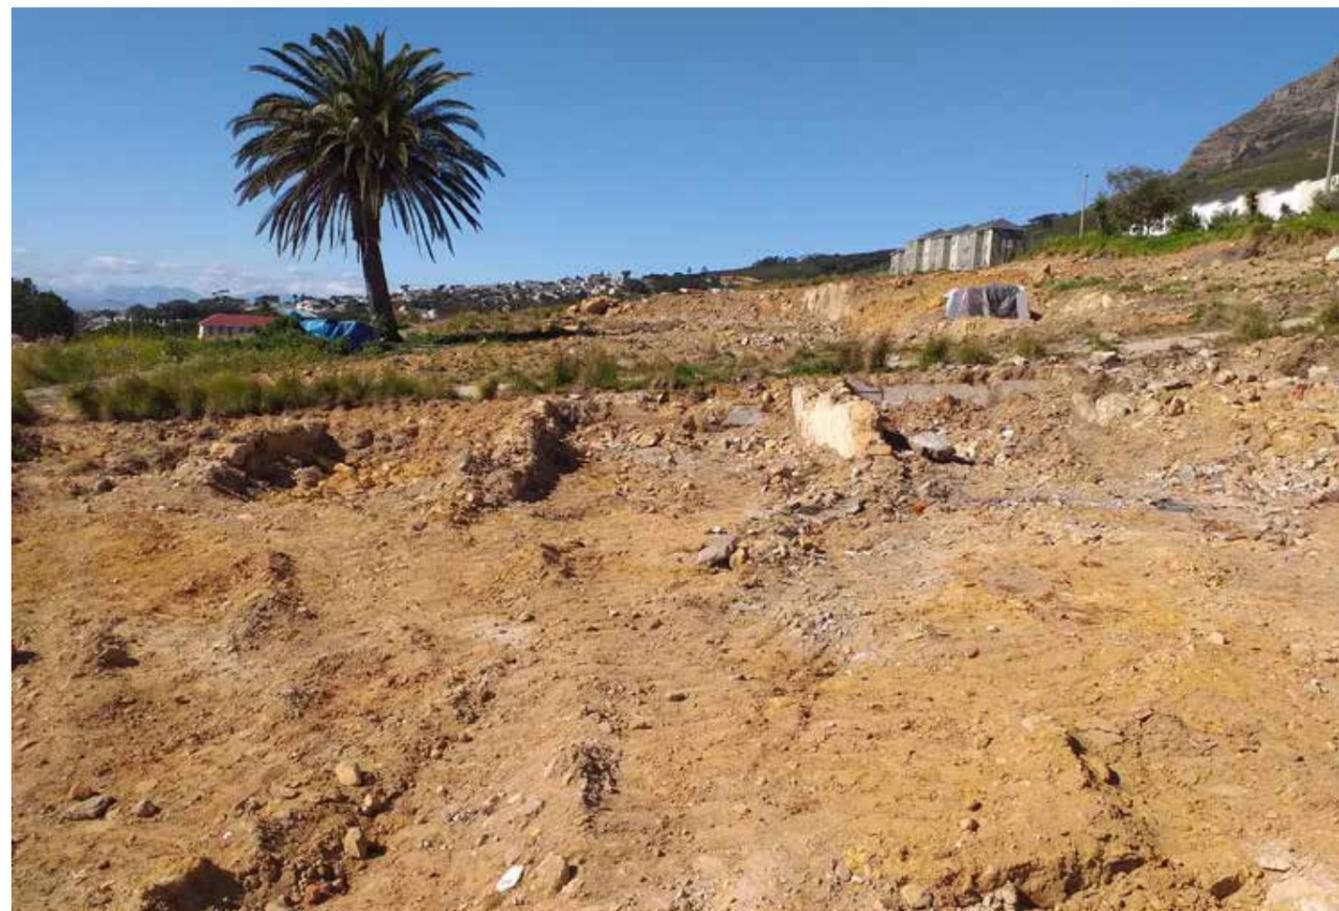
Figure 51. Internal east west walls of 9 Milton along Arundel Street (RSA, 2020).

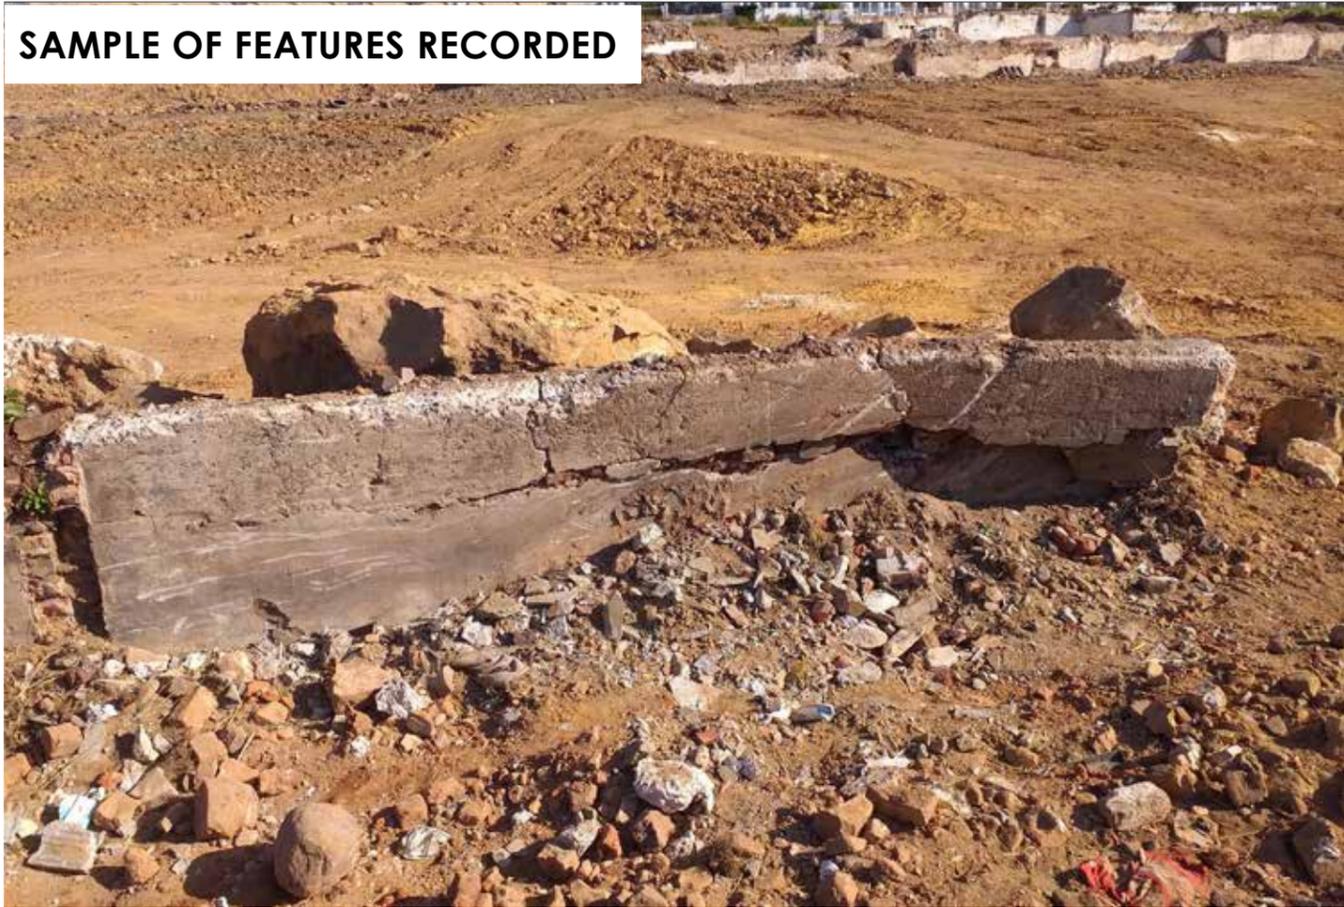
Figure 52. Rear walling at 44-52 Roos Street, view to south west (RSA, 2020).

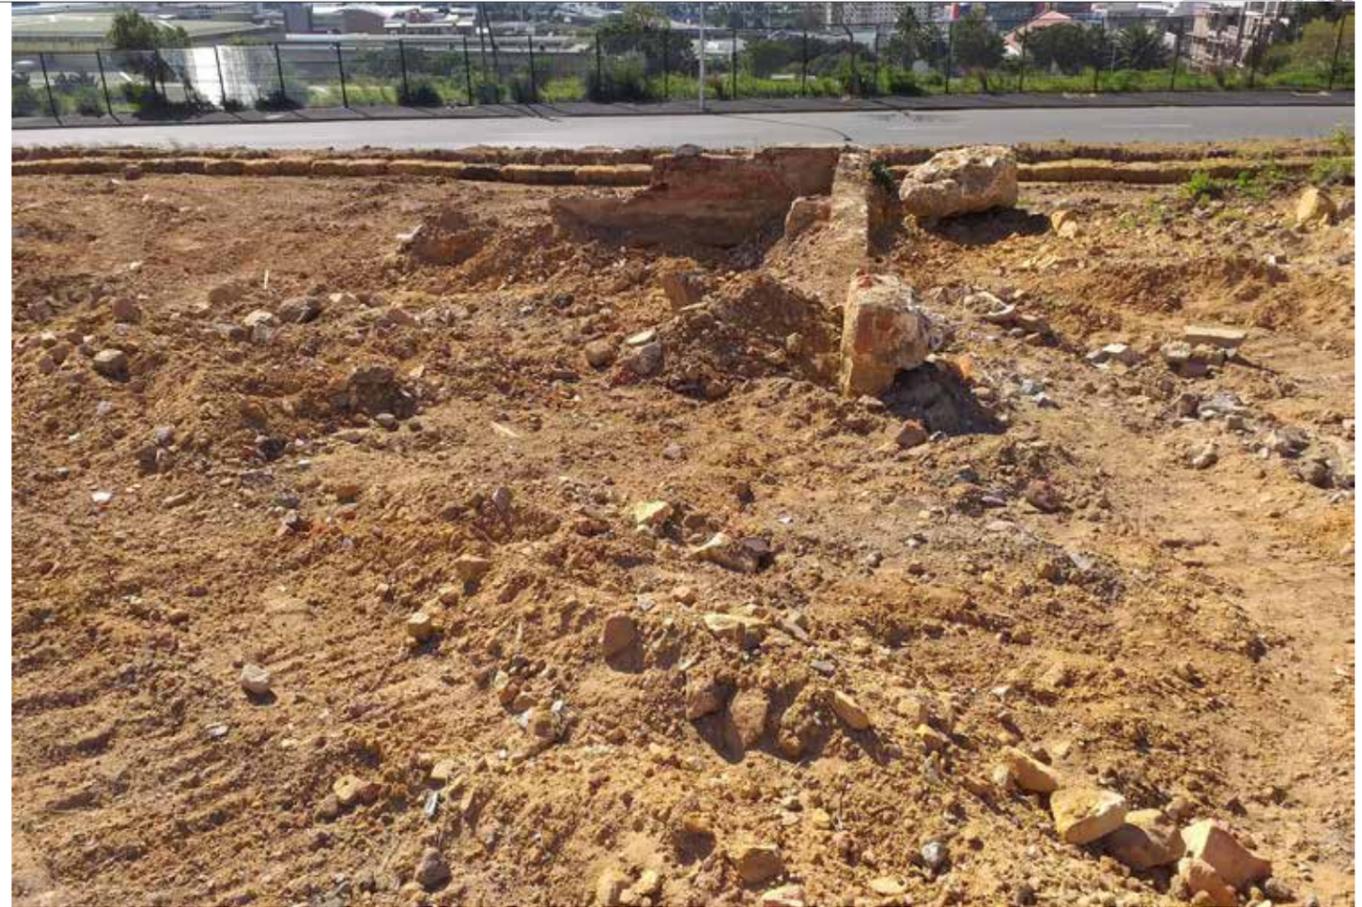
Figure 53. Evidence for nature of site fill south of walling at 37 Arundel Street, view to north

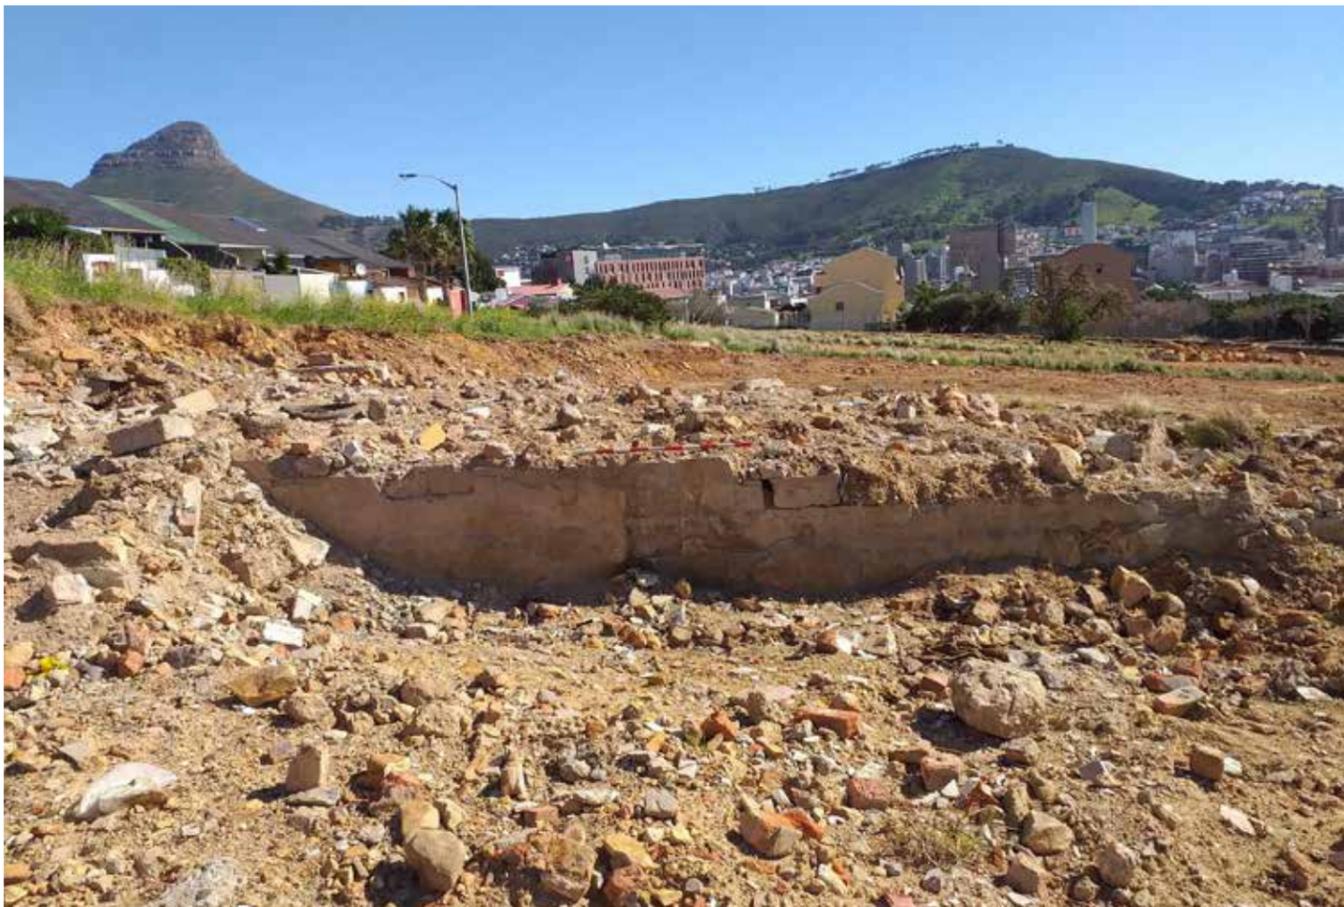
Figure 54. Remnant walling between the rear of properties 25-29 Lewis and 143 Upper Constitution, view to east (RSA, 2020).

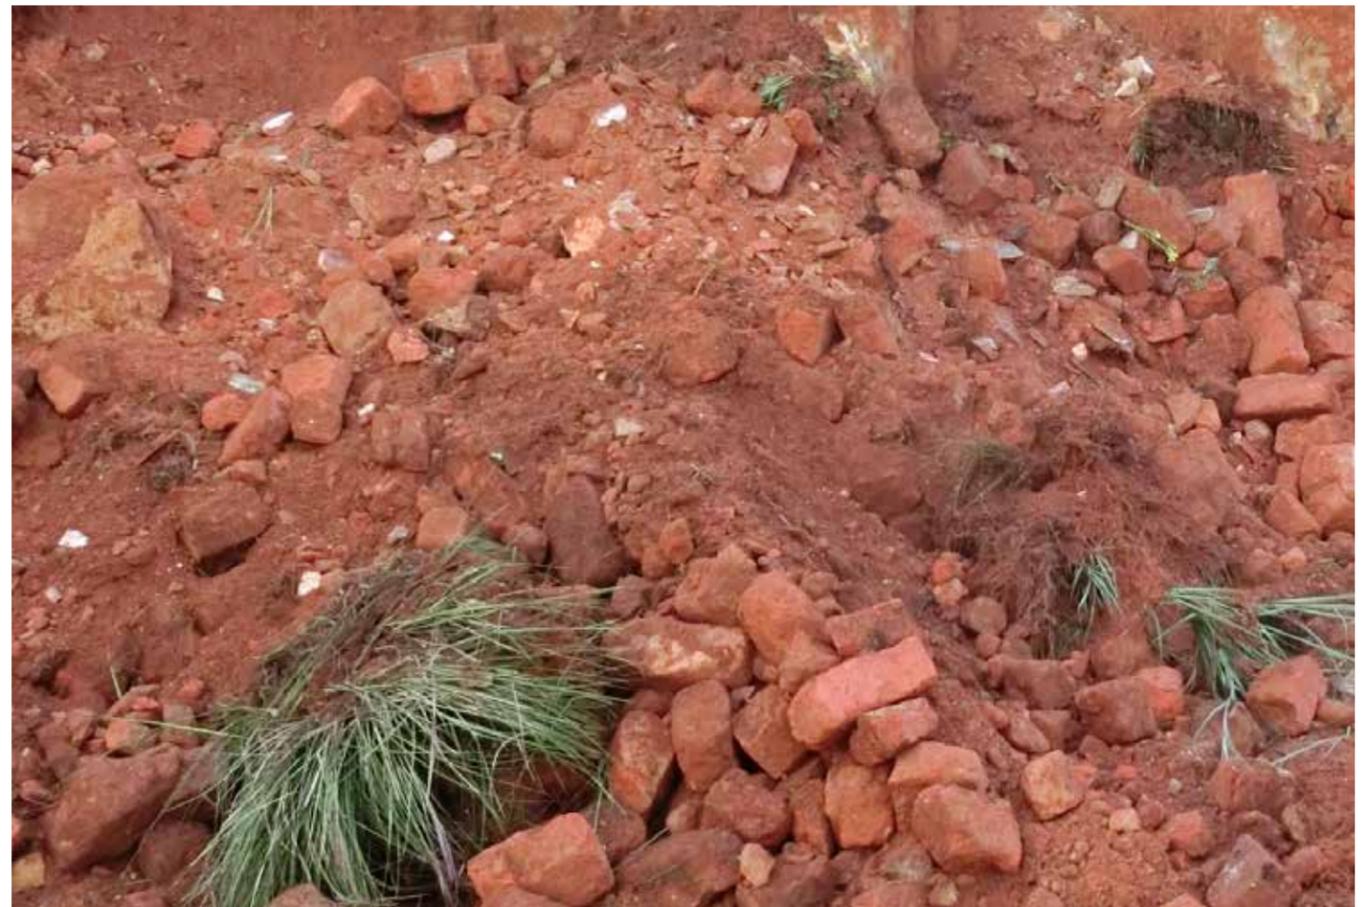
Figure 55. Evidence for nature of fill between Clifton and Lewis (RSA, 2020).
