REPORT ON ARCHAEOLOGICAL MONITORING OF RUBBLE REMOVAL

submitted in terms of Section 35 of the NHRA (1999) for
DISTRICT SIX PHASE FOUR DEVELOPMENT ON PARCEL N,
DISTRICT SIX, CAPE TOWN,
ERVEN 177646, 10010 AND 117891-117898

Prepared by Katie Smuts, Archaeologist at Rennie Scurr Adendorff for Delta BEC
on behalf of the Department of Land Reform and Rural Development

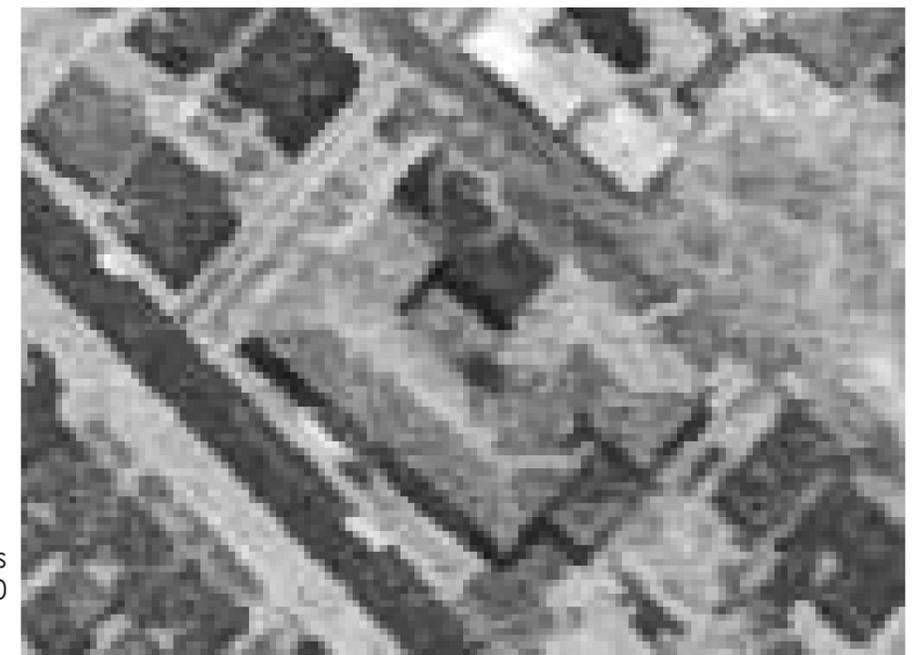
Figure 58. The building as captured in the 1960 aerial (NGI, 2020).

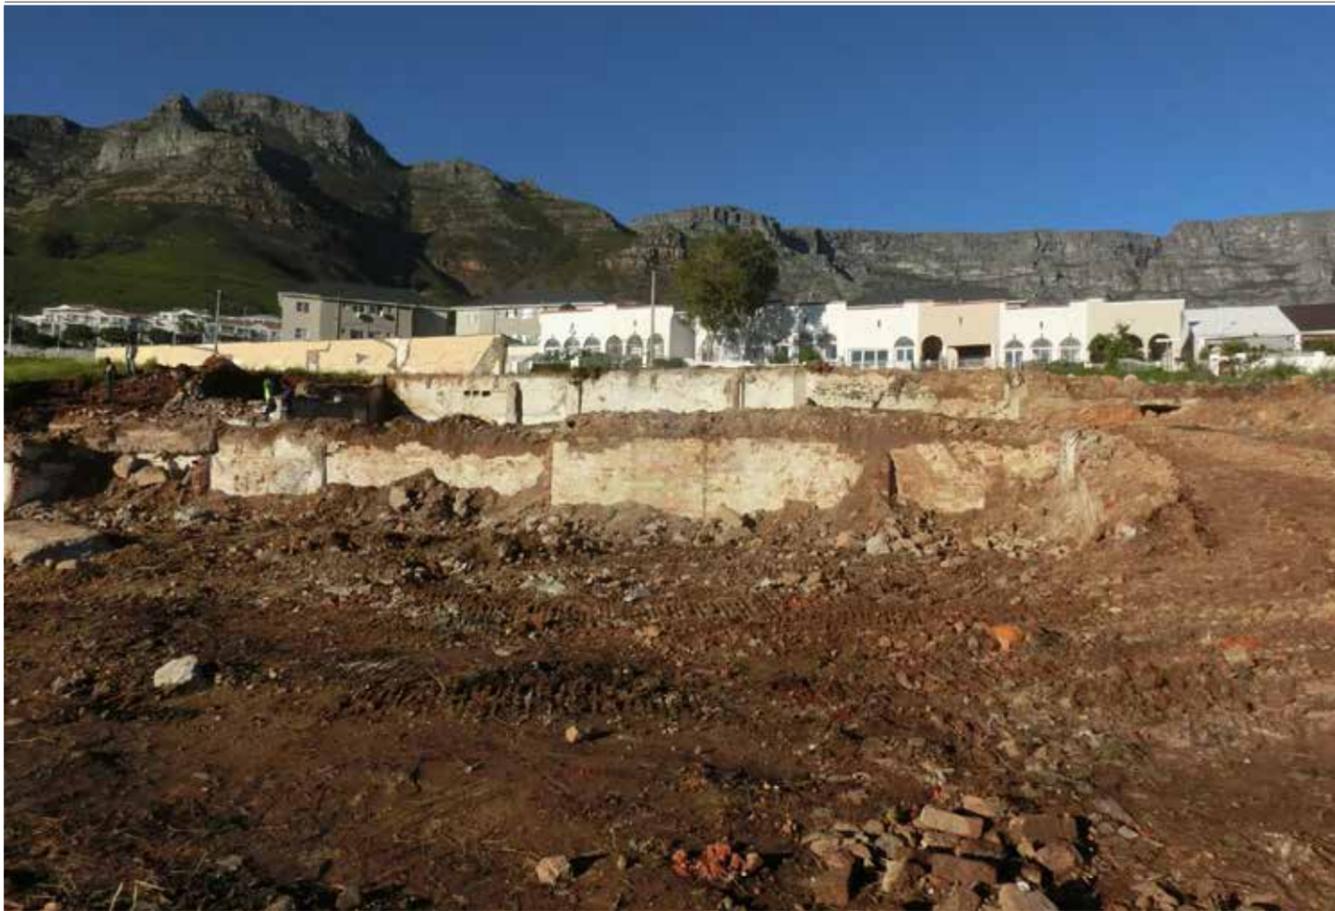
Figure 59. View of remains of Hotel Tafelberg, view to south (RSA, 2020).

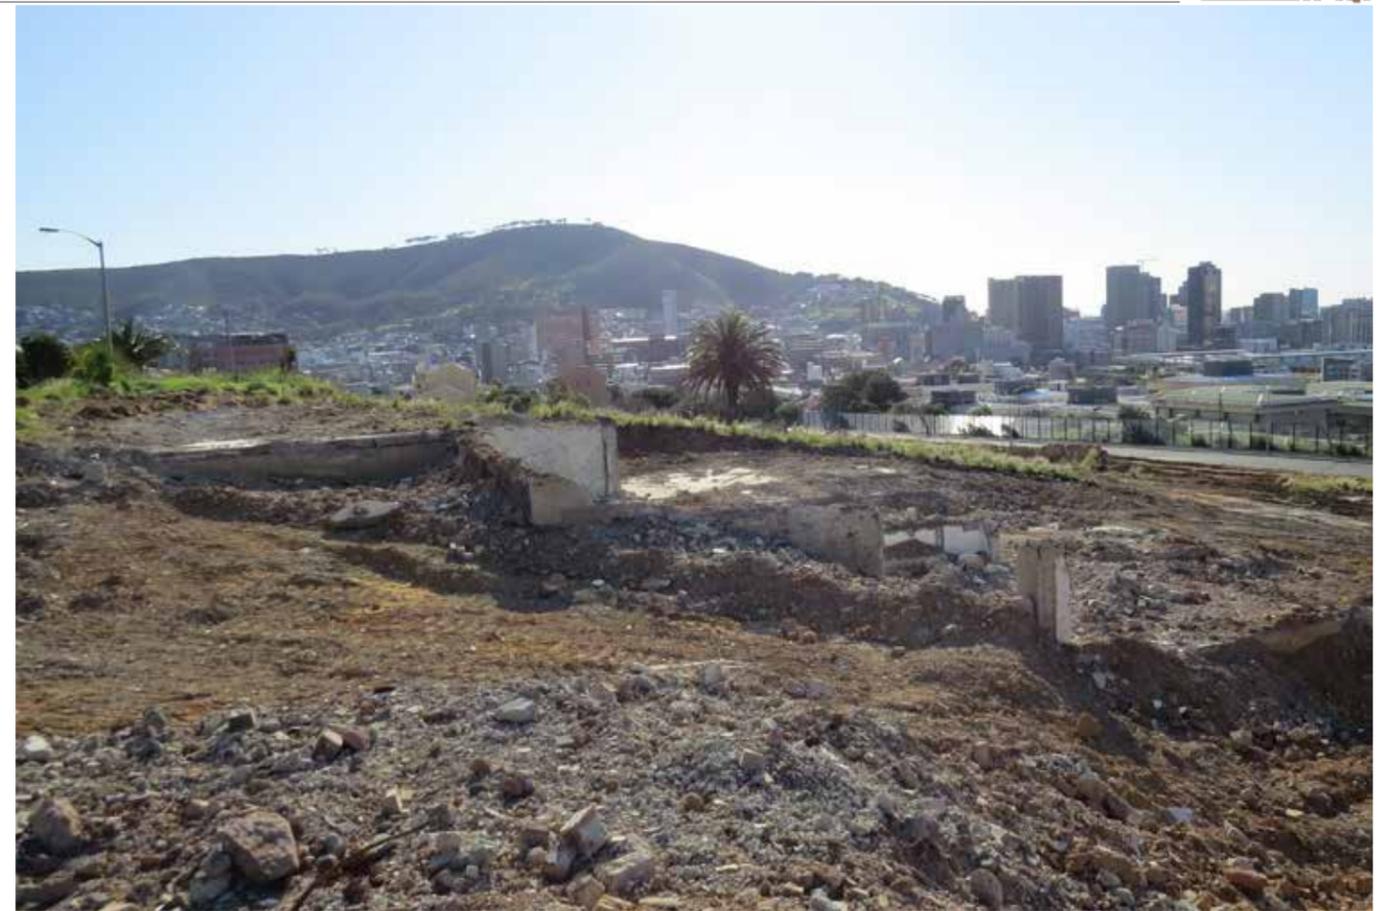
Figure 61. View of remains of Hotel Tafelberg, view to north west (RSA, 2020).

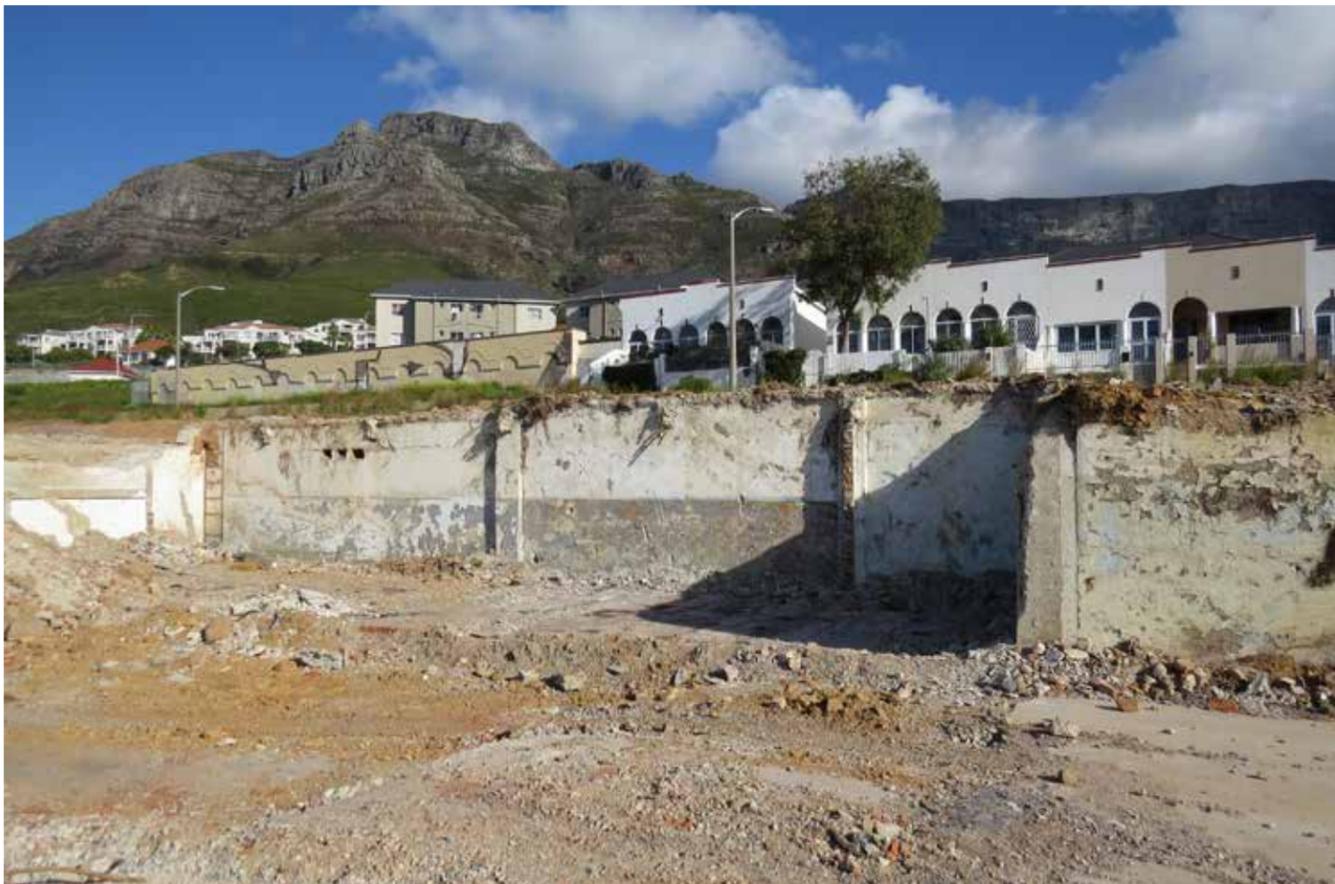
Figure 60. View of rear wall of Hotel Tafelberg; the entrance to the boiler room is below the spoil heaped at the extreme left of image, view to south west (RSA, 2020).

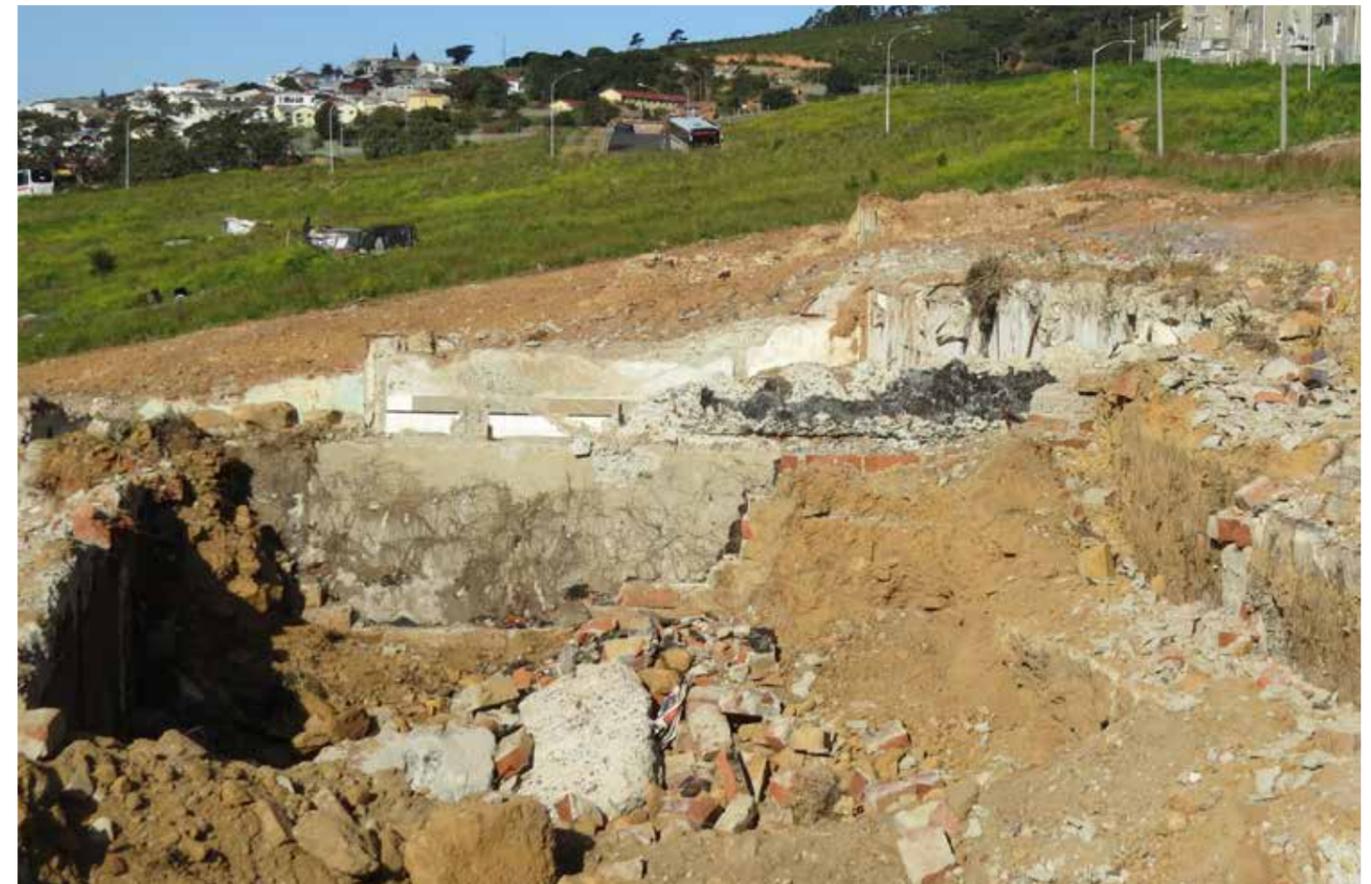
Figure 62. View of remains of Hotel Tafelberg, view to east; this image is taken from the raised area at right of Figure 60 (RSA, 2020). (RSA, 2020).

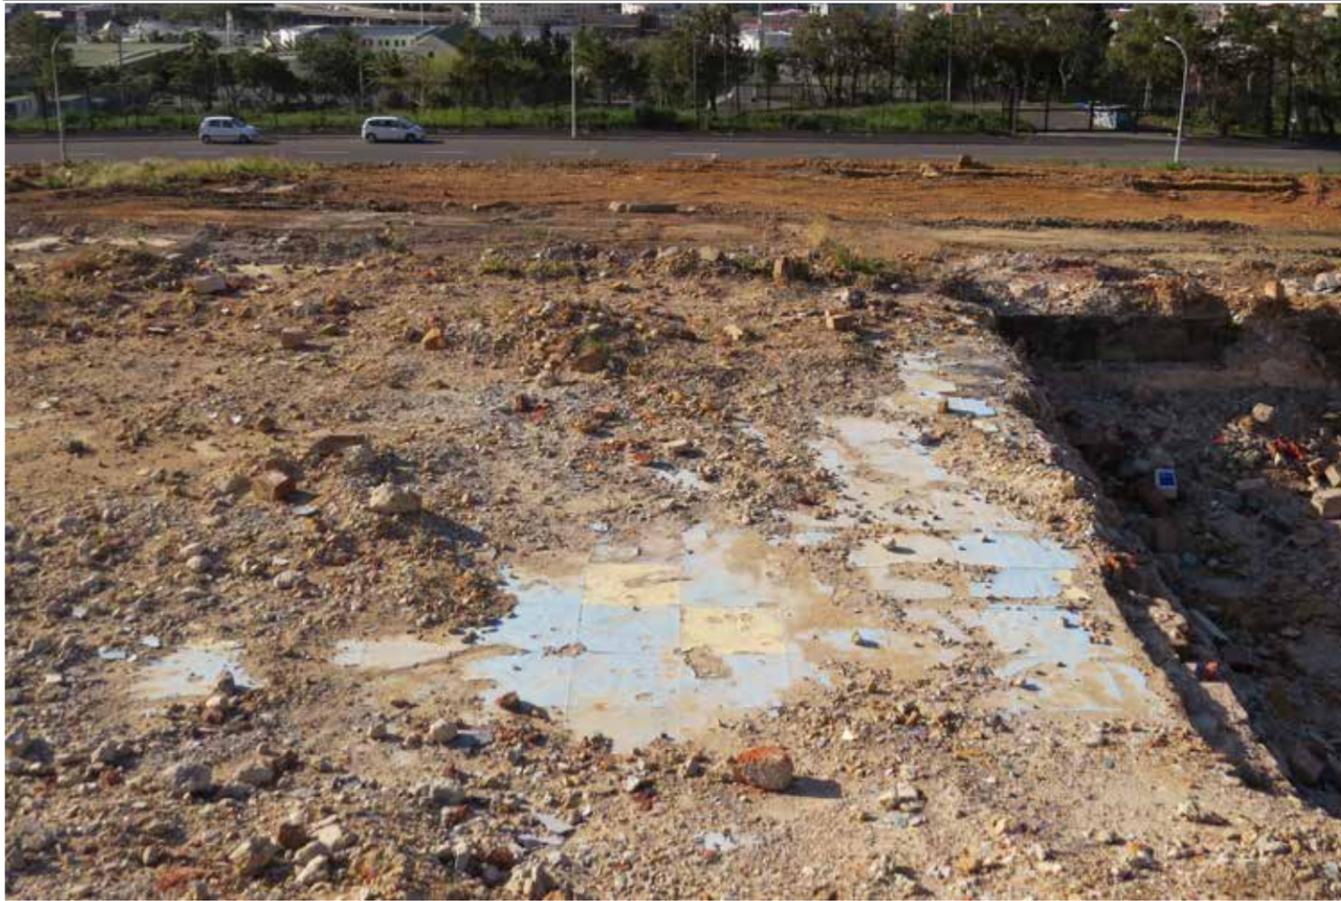
Figure 63. Remnant floor tiles at entrance to hotel off Richmond, view to north (RSA, 2020).

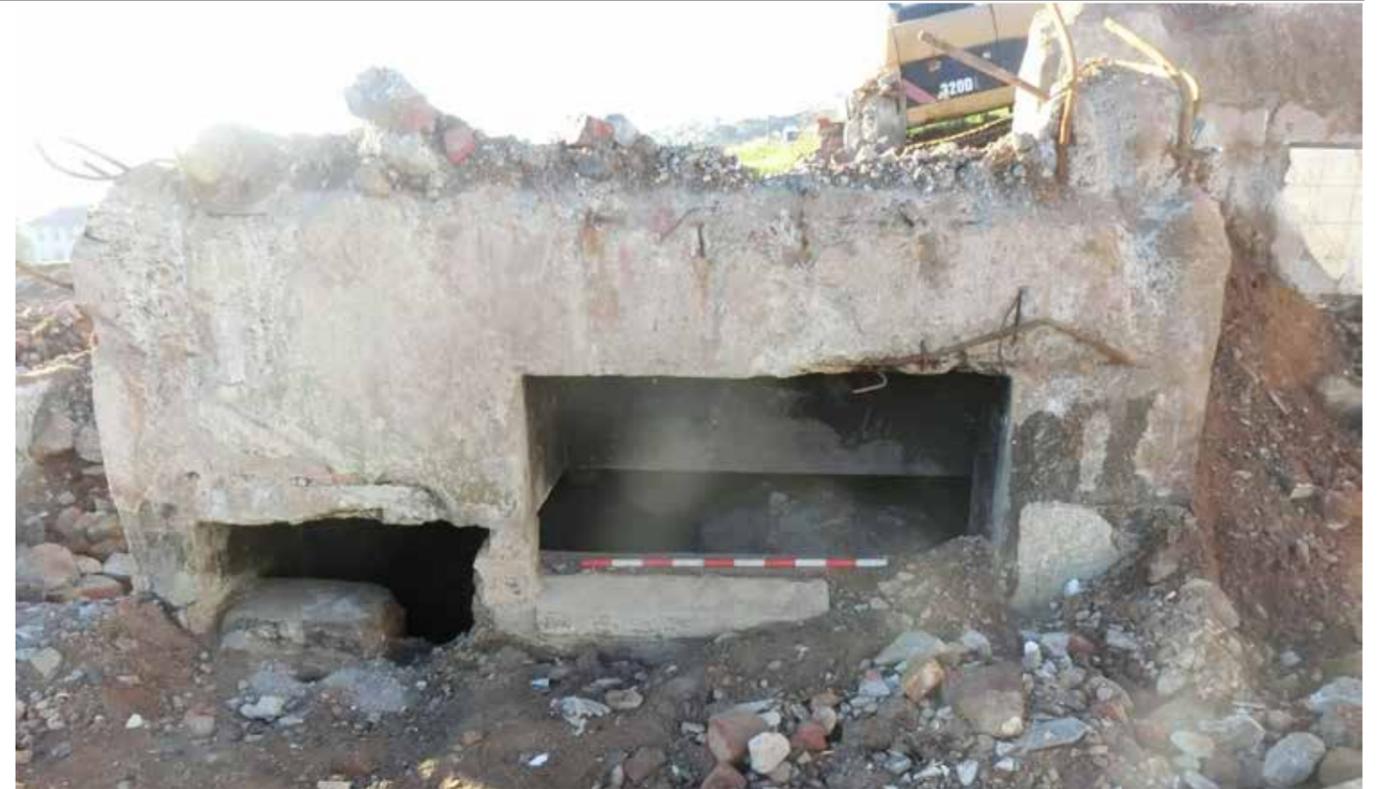
At least two interleading subterranean rooms were found at the south east of the structure, one of which contained a large hot water heater (Figure 65 and Figure 66). These features were directly adjacent to the areas of tiled walling, supporting the conclusion that this area of the site was the service area of the hotel, comprising either kitchens or bathrooms.

Figure 65. Entrance to subterranean room with boiler visible at right, view to east (RSA, 2020).

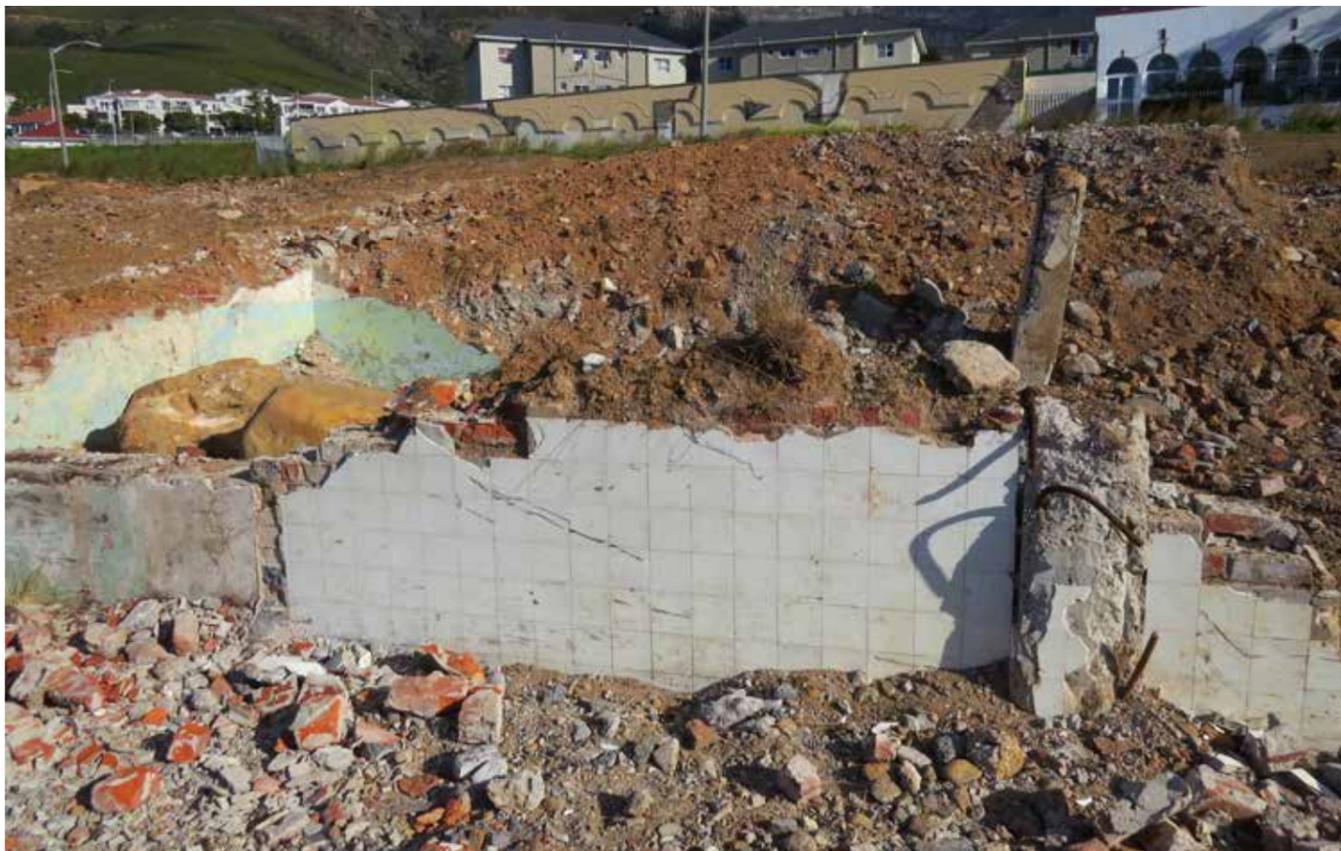
Figure 64. Tiled walling at eastern extent of structure, view to south (RSA, 2020).

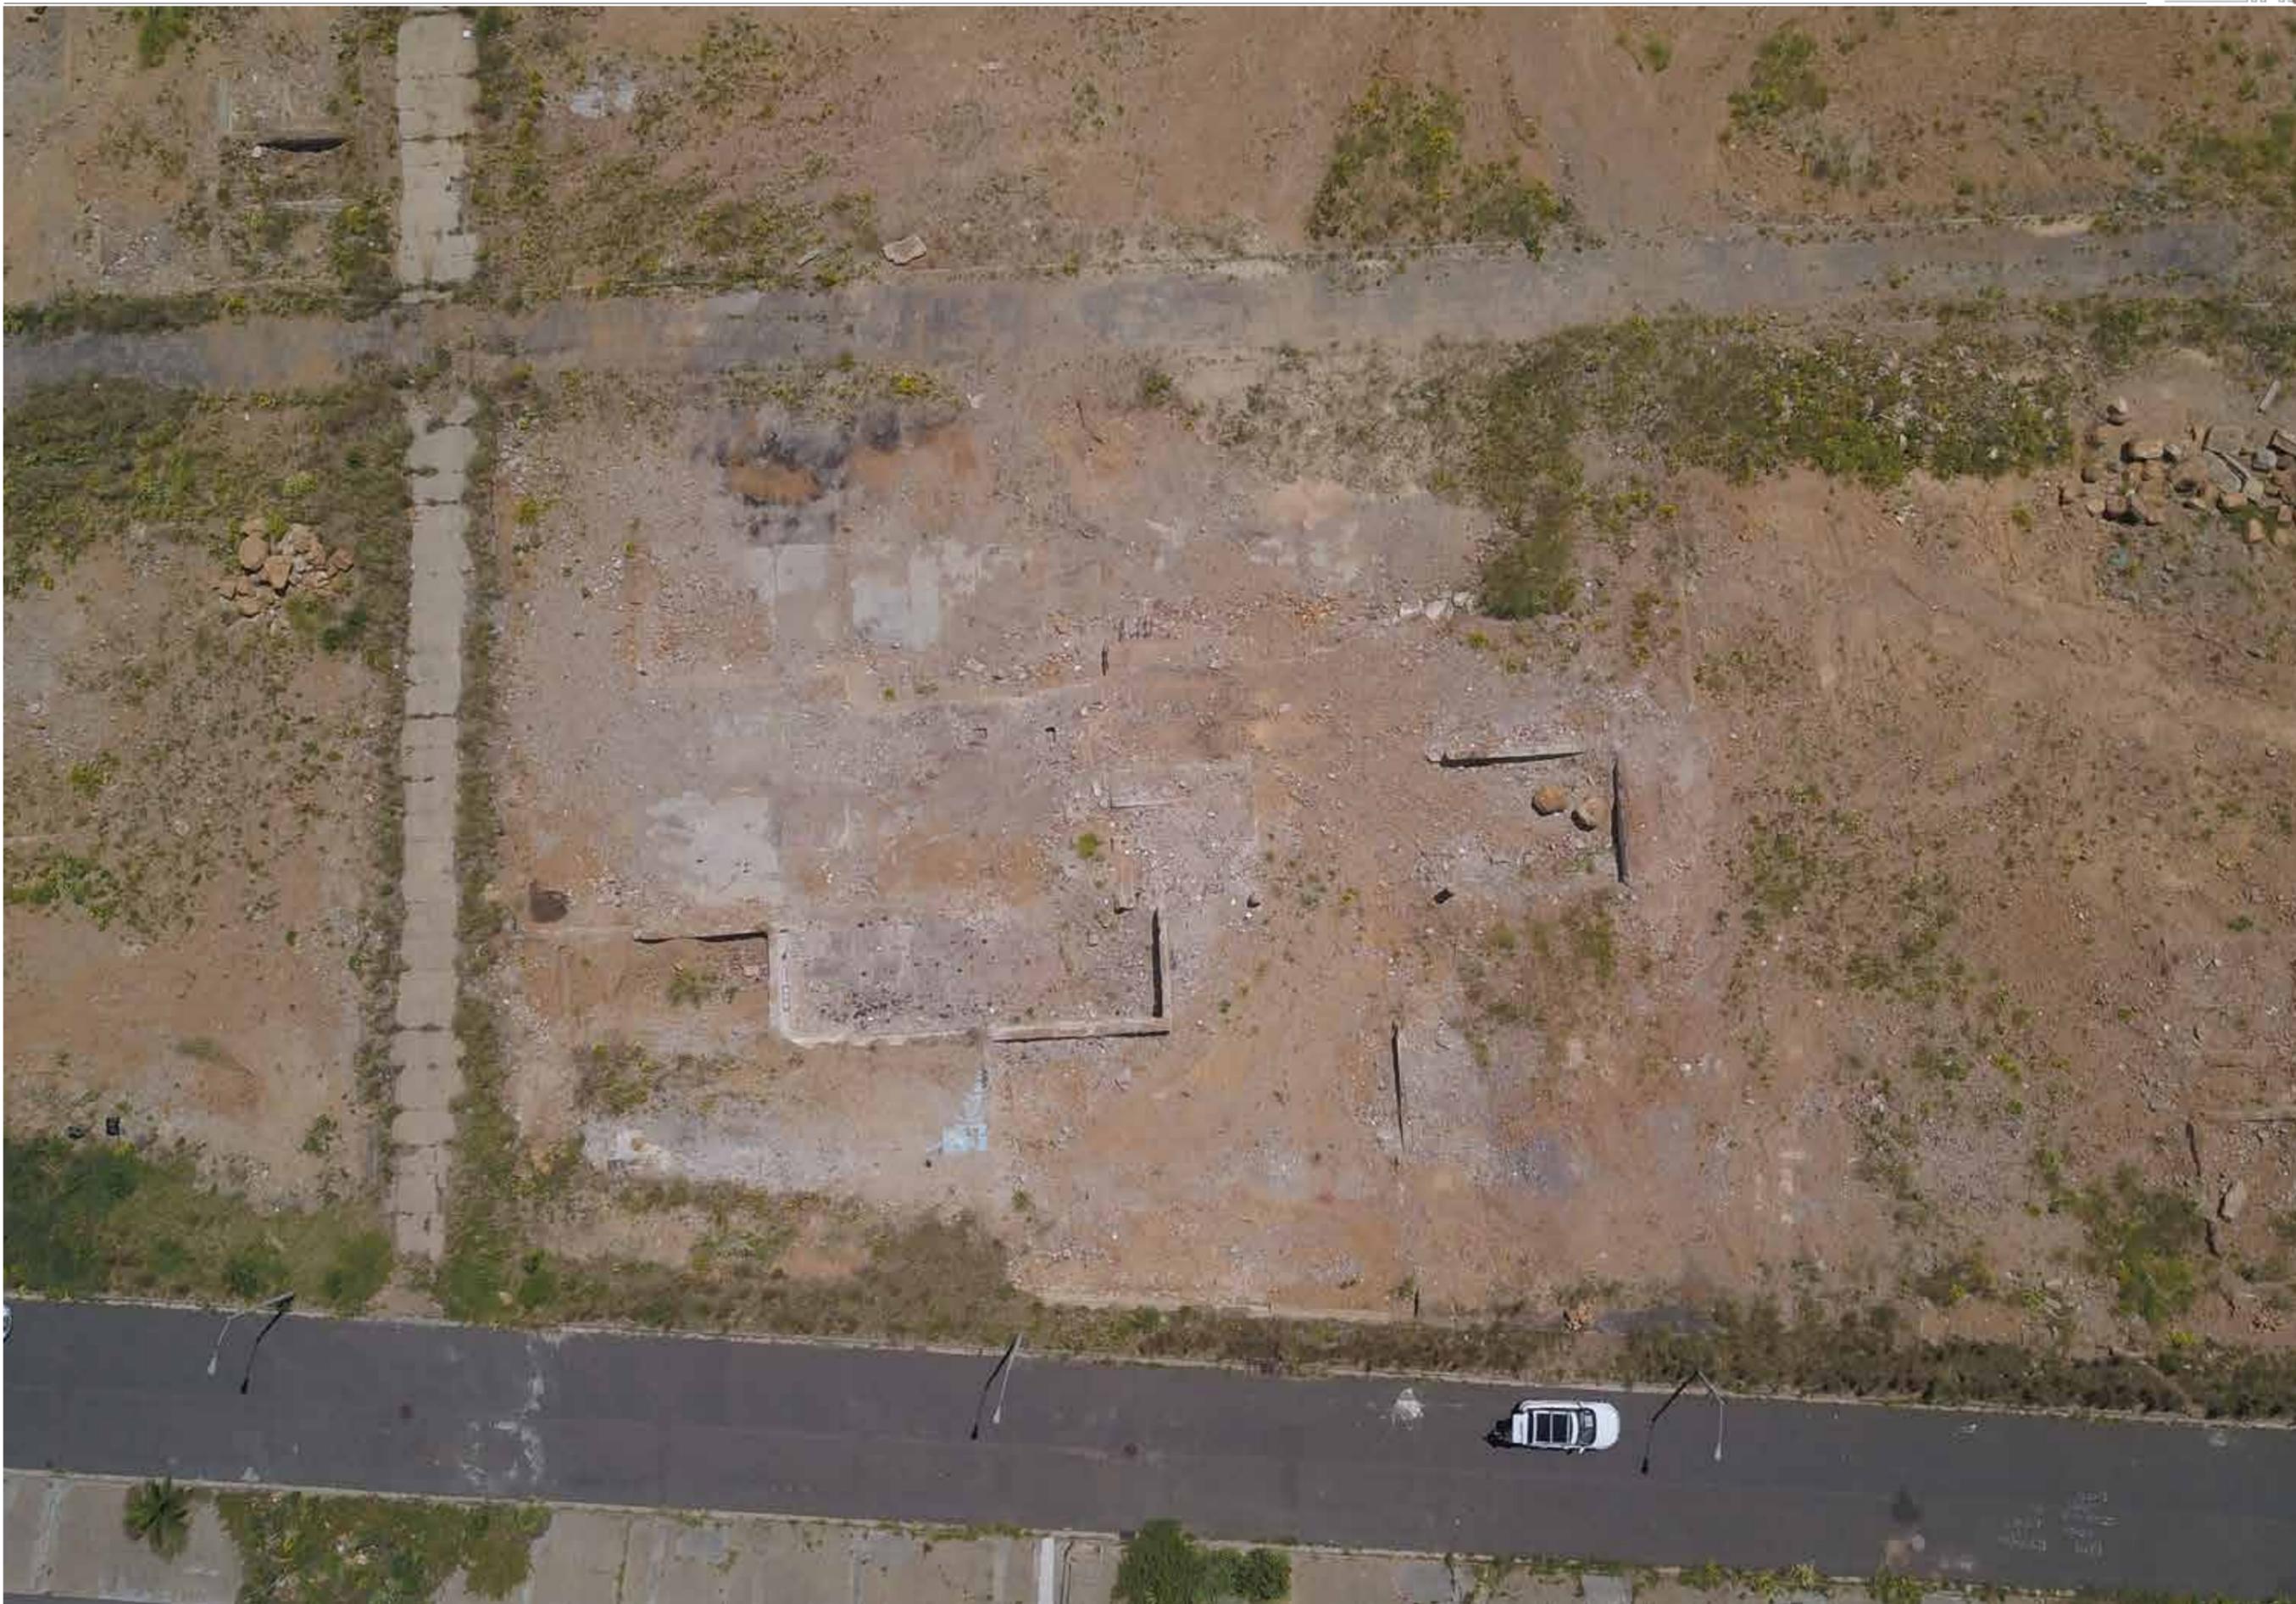
Figure 67. Aerial image of hotel site between present Justice Walk and Milton Street, east of Richmond Street (RSA, 2020).

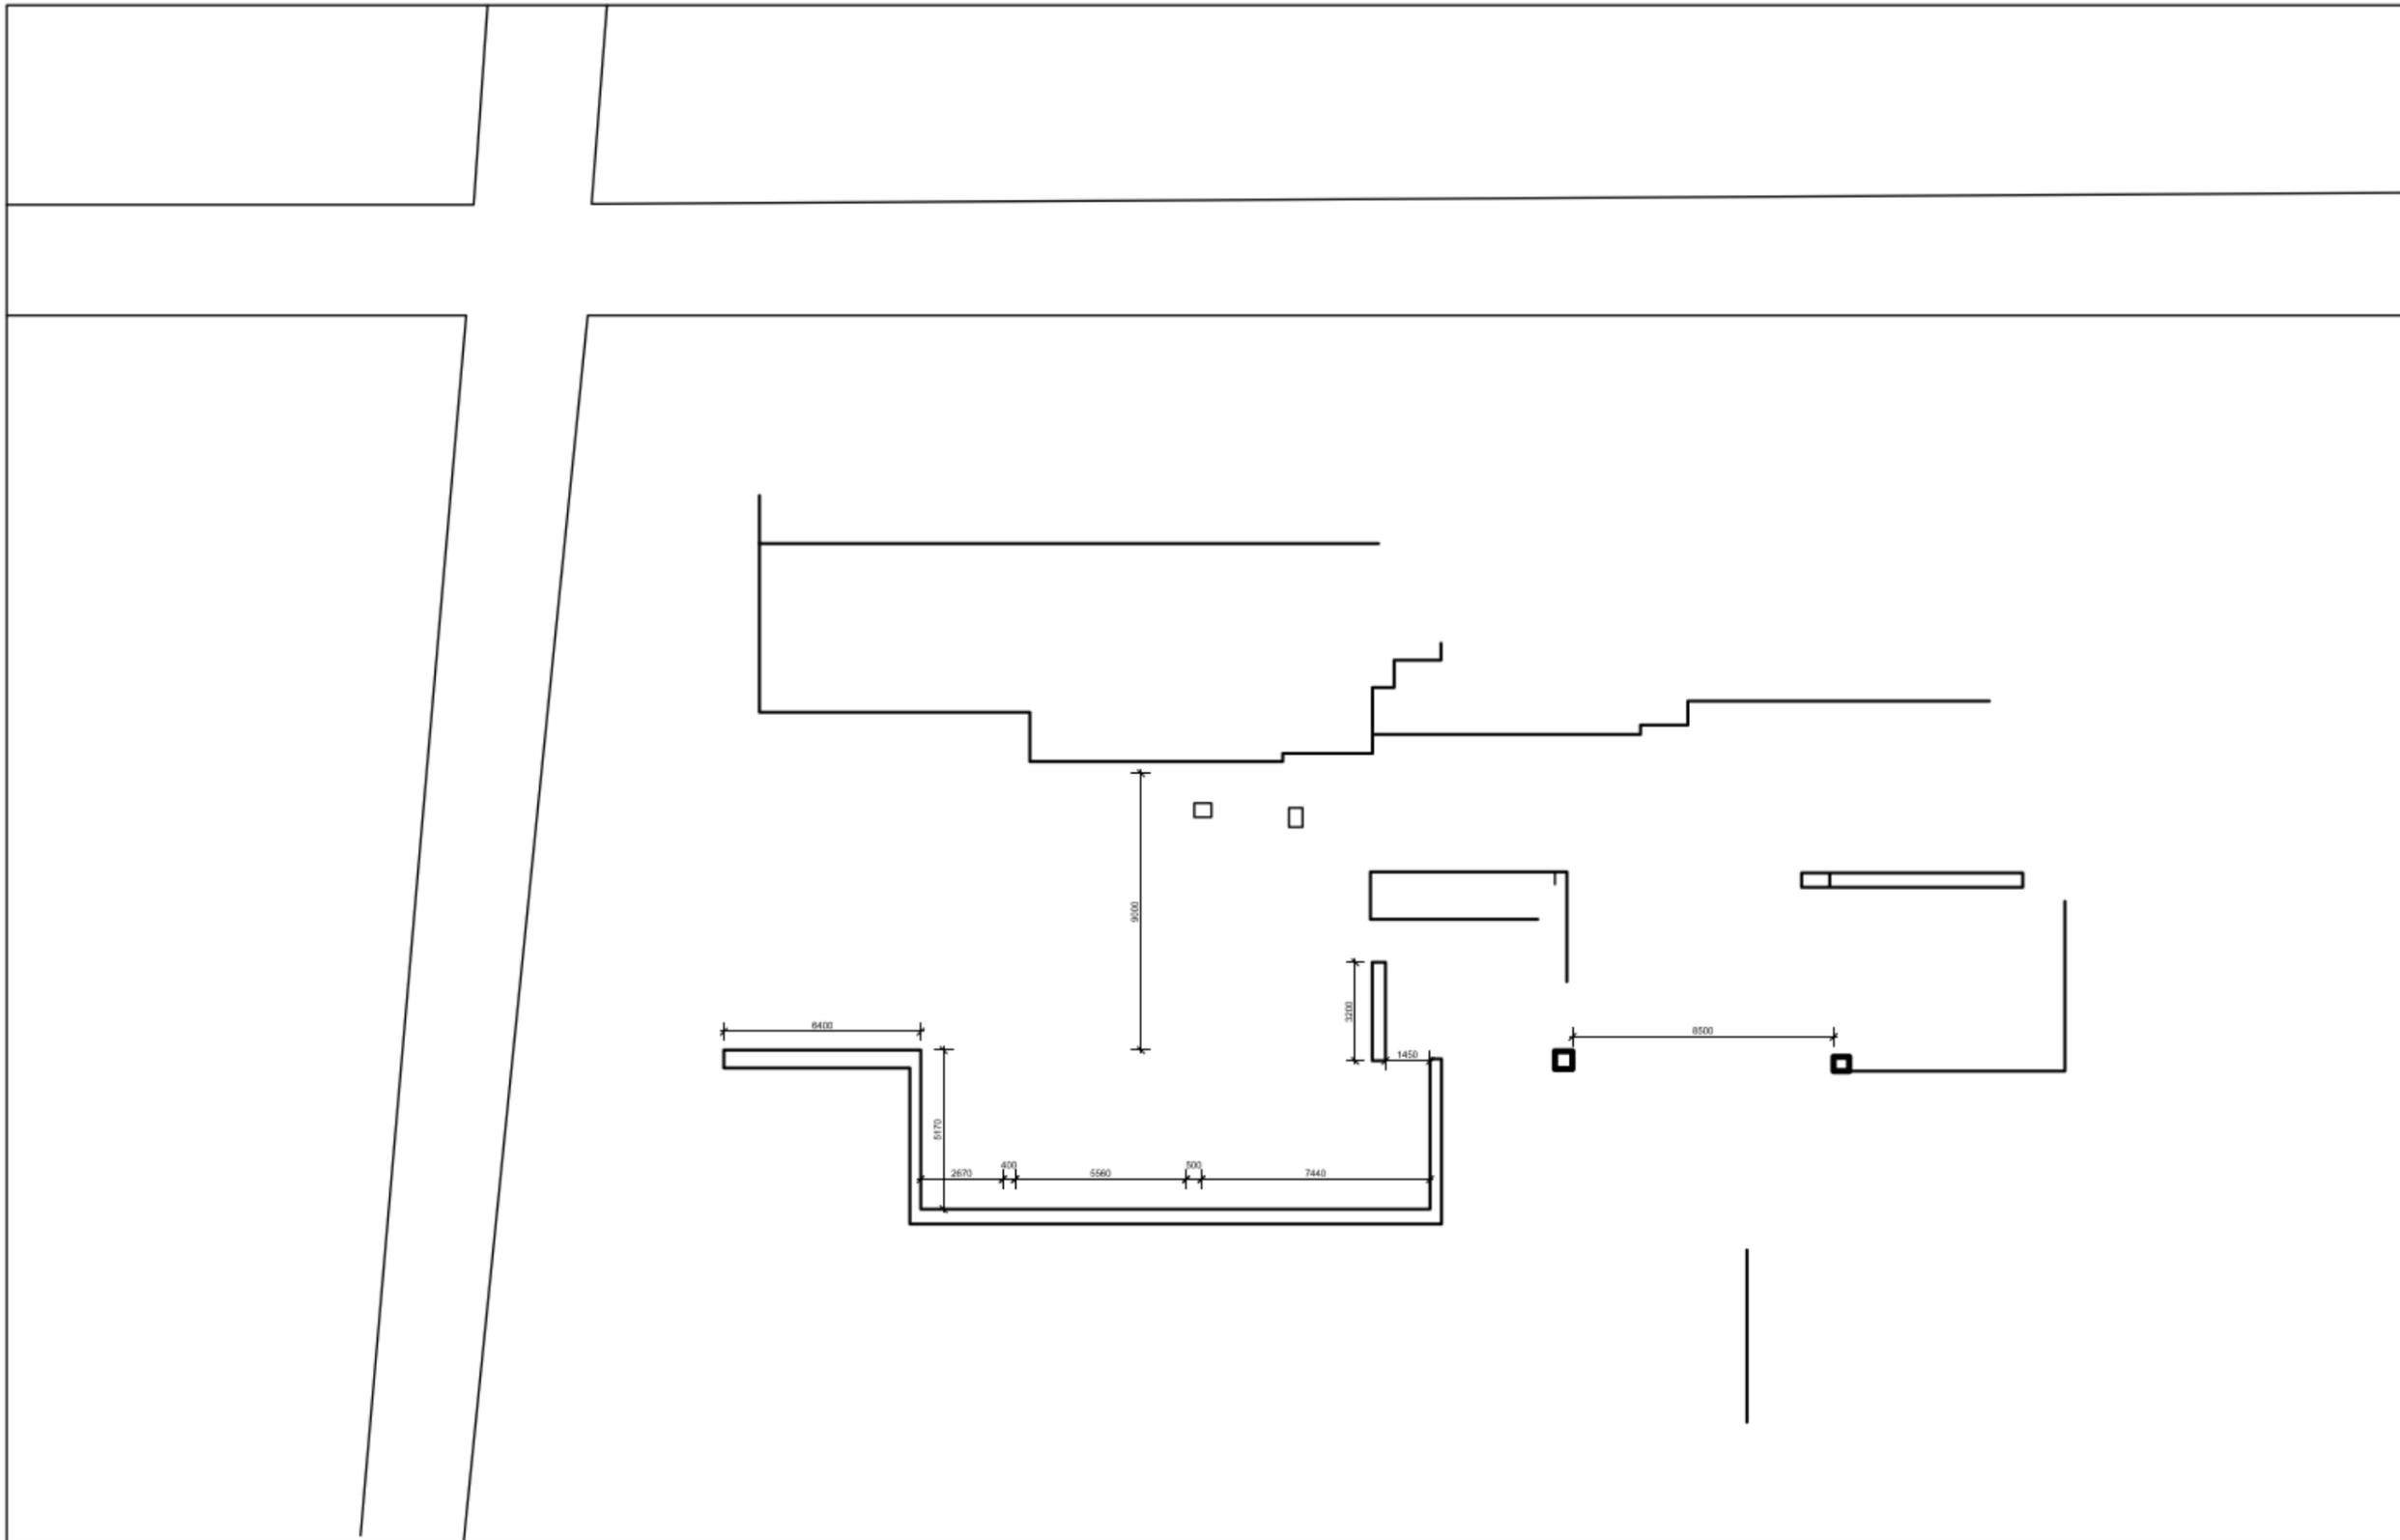
Figure 68. Plan of visible features of Hotel Tafelberg (RSA, 2020).

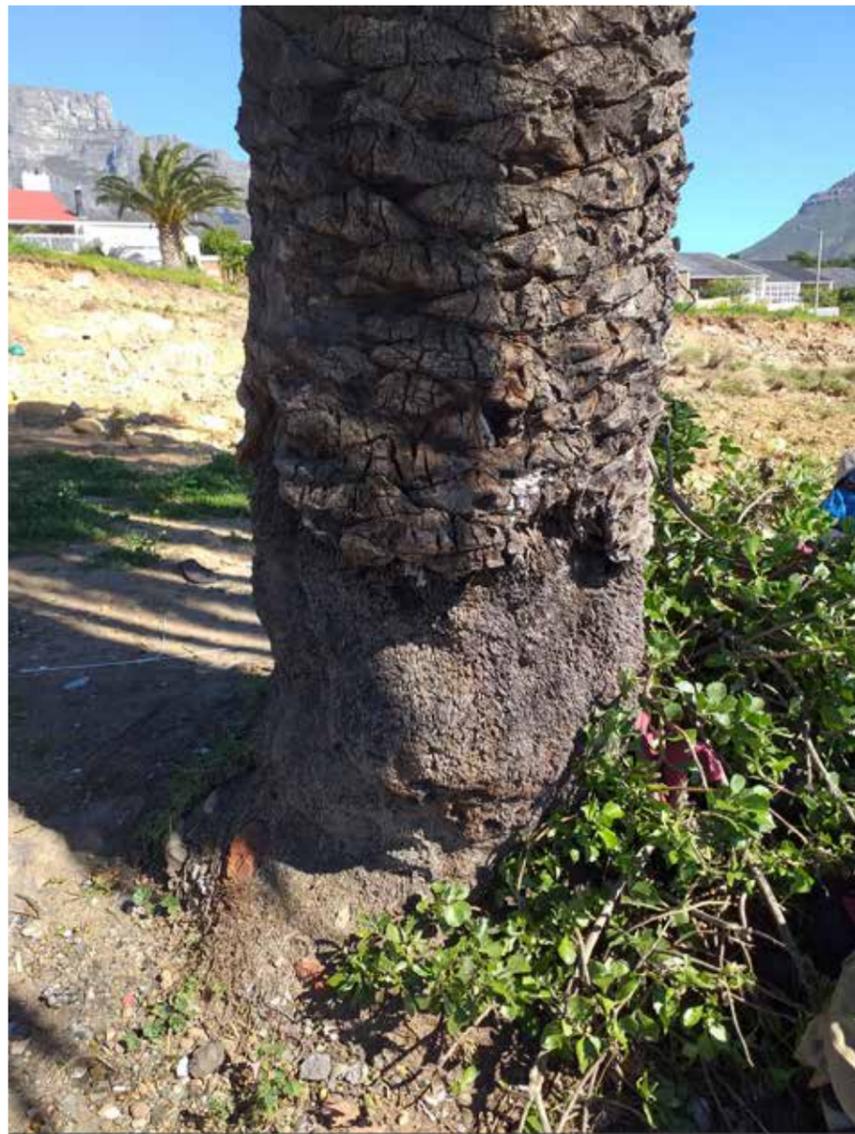
The palm tree is highly visible on the site, and is used for shelter by homeless people who have live under tarpaulin and tents at its base. While the tree looked healthy, it appears to exhibit some damage at the base of the trunk: this could reflect the attempts to uproot it during the forced removals, but could also reflect damage or disease from another source.

Figure 70. Base of palm tree showing apparent girdling, possibly arising from attempts to uproot it during the forced removals (RSA, 2020).

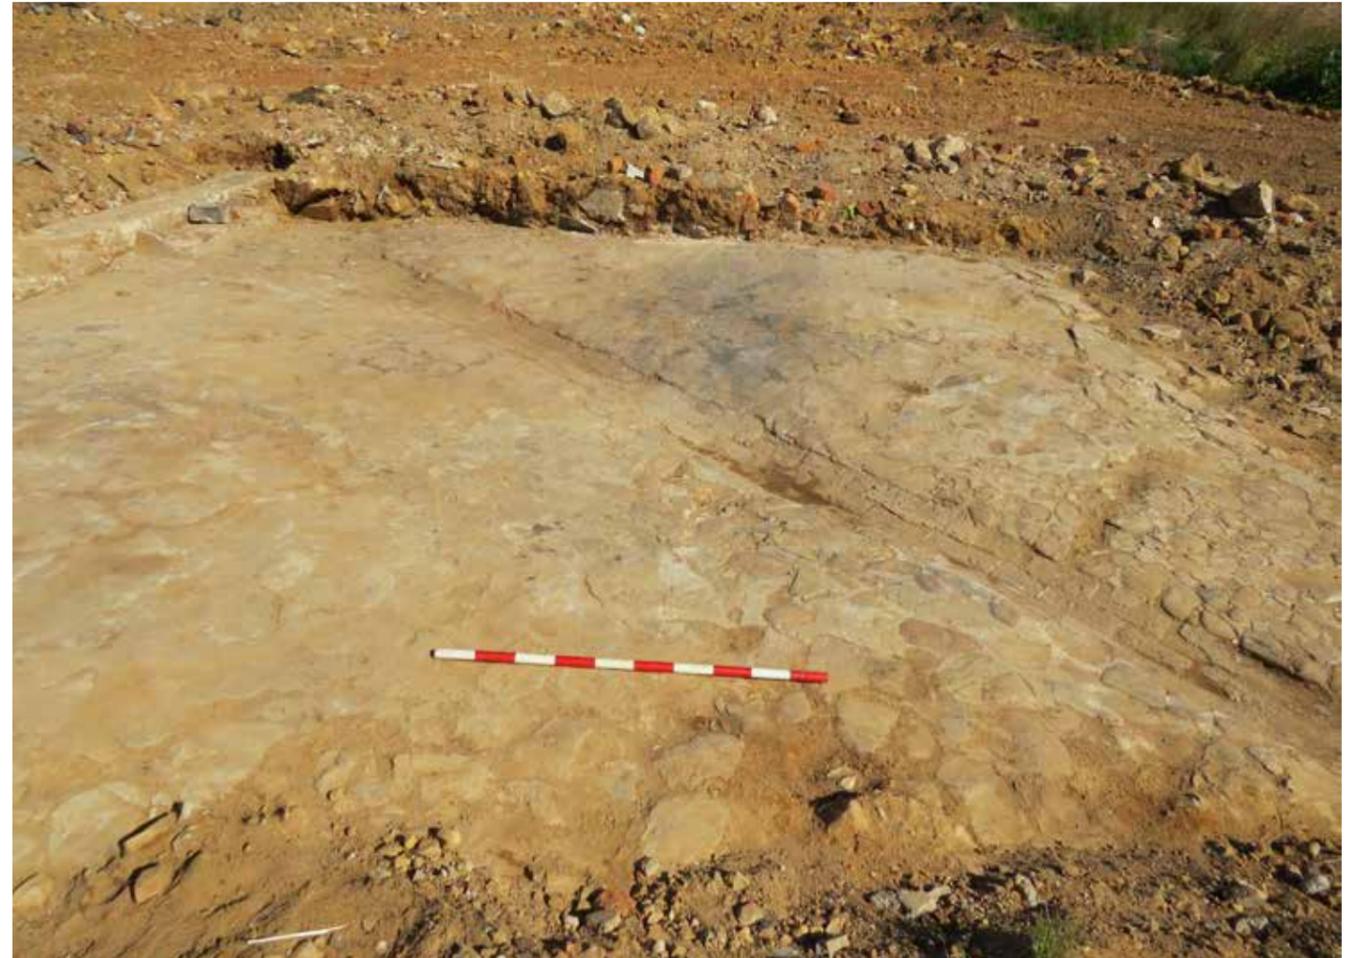
A cobbled surface was exposed by machine in the vicinity of Erf 7490, and mechanical excavation was halted in the area so that the feature could be cleaned by hand. Cleaning revealed an intact cobbled courtyard with a transverse, brick-lined drainage channel bisecting the cobbled area from south east to north west (Figure 71). Only surficial deposits were cleared for planning (Figure 72 to Figure 74), and no excavation was undertaken.

Figure 71. The cobbled yard of 2 Roos Street showing transverse brick-lined drainage channel; at far left of image is the eastern end wall of the yard (RSA, 2020).

This cobbled yard is depicted on Thom's plan of the property in 1895 (Figure 75). Given that we know there were stables on the property that were described as "old" in 1928 already (KAB 3/CT 4/2/1/3/329), the cobbled courtyard probably dates to this earlier use of the site, with the cobbles providing a firm surface that could be easily cleaned. Roofing over much of the yard is visible in the 1945 aerial. The extant cobbled area, reduced in size from that shown by Thom, is presented in the City's plan of 1957 (Figure 77). The reduction appears to relate to development along the south of the yard, and is possibly responsible for the truncation of the cobbles.

- Archaeological excavation at the site of 2 Roos Street should be carried forward as a recommendation of the HIA process.
 - If the site cannot be retained as a feature in the new development, excavation must take place as mitigation;
