REPORT ON ARCHAEOLOGICAL MONITORING OF RUBBLE REMOVAL

submitted in terms of Section 35 of the NHRA (1999) for
DISTRICT SIX PHASE FOUR DEVELOPMENT ON PARCEL N,
DISTRICT SIX, CAPE TOWN,
ERVEN 177646, 10010 AND 117891-117898

Prepared by Katie Smuts, Archaeologist at Rennie Scurr Adendorff for Delta BEC
on behalf of the Department of Land Reform and Rural Development

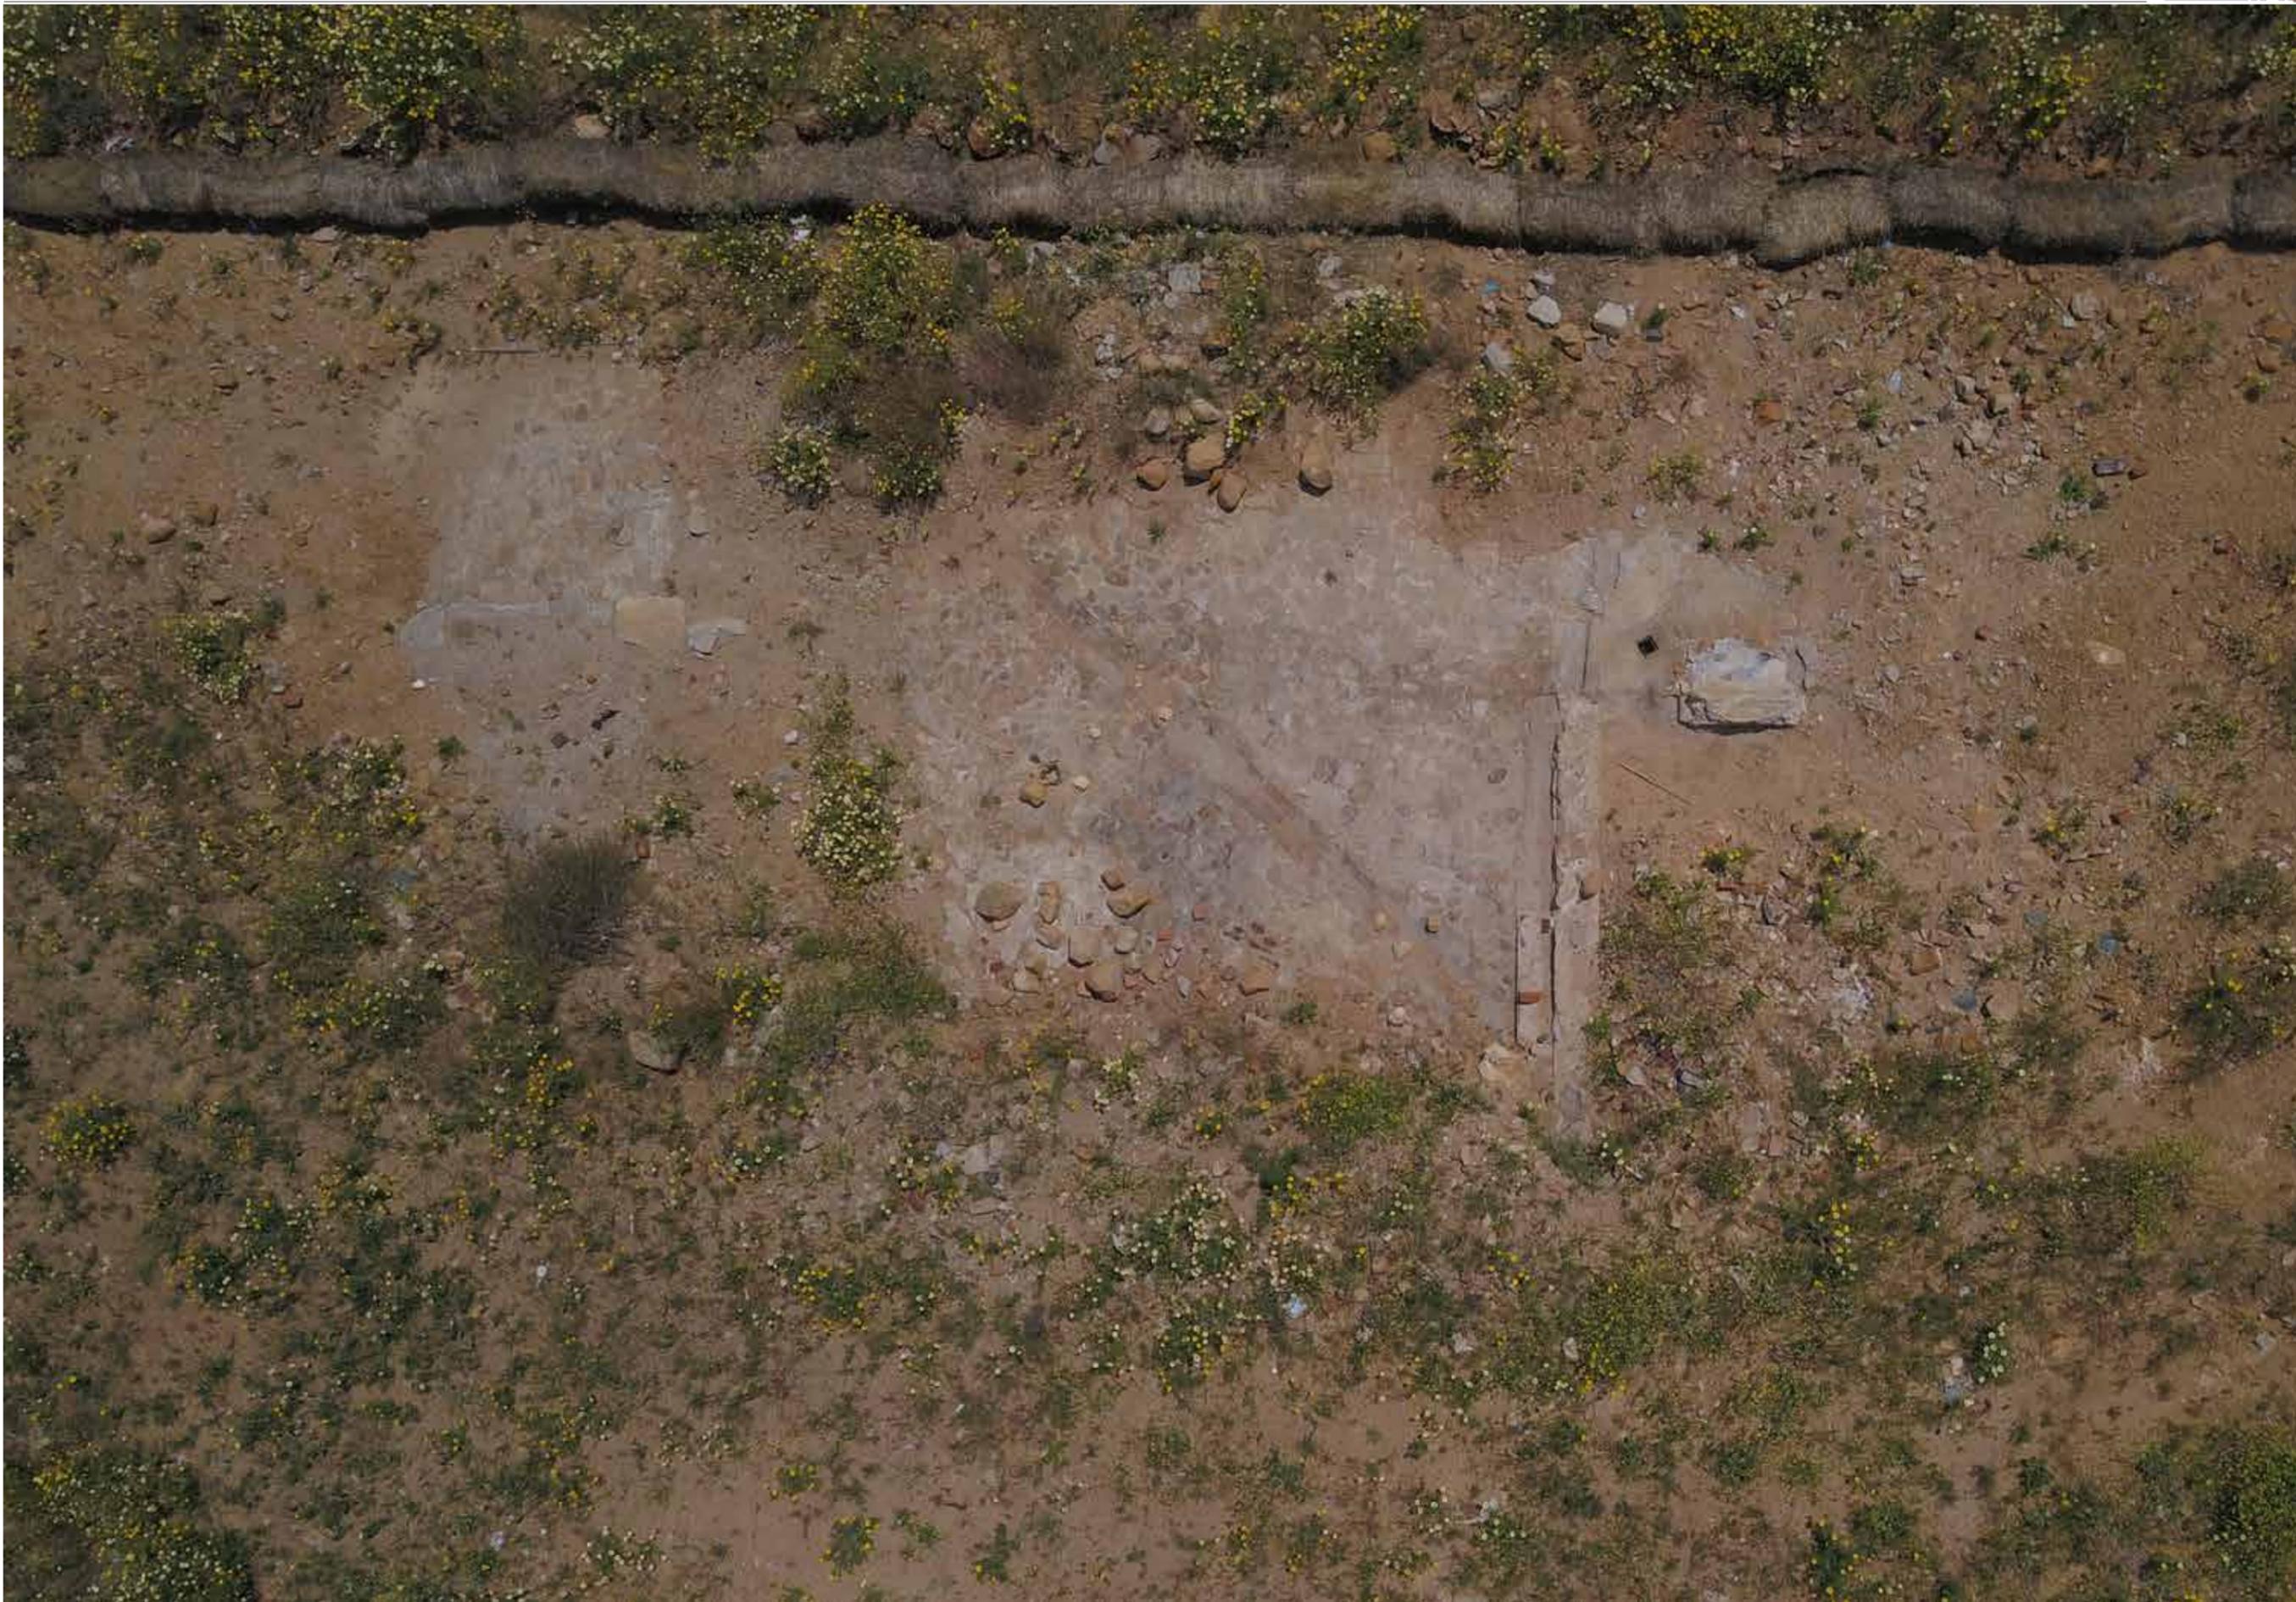
Figure 72. Aerial image of 2 Roos Street, (RSA, 2020).

- Archaeological excavation at the site of 2 Roos Street should be carried forward as a recommendation of the HIA process.
 - If the site cannot be retained as a feature in the new development, excavation must take place as mitigation;

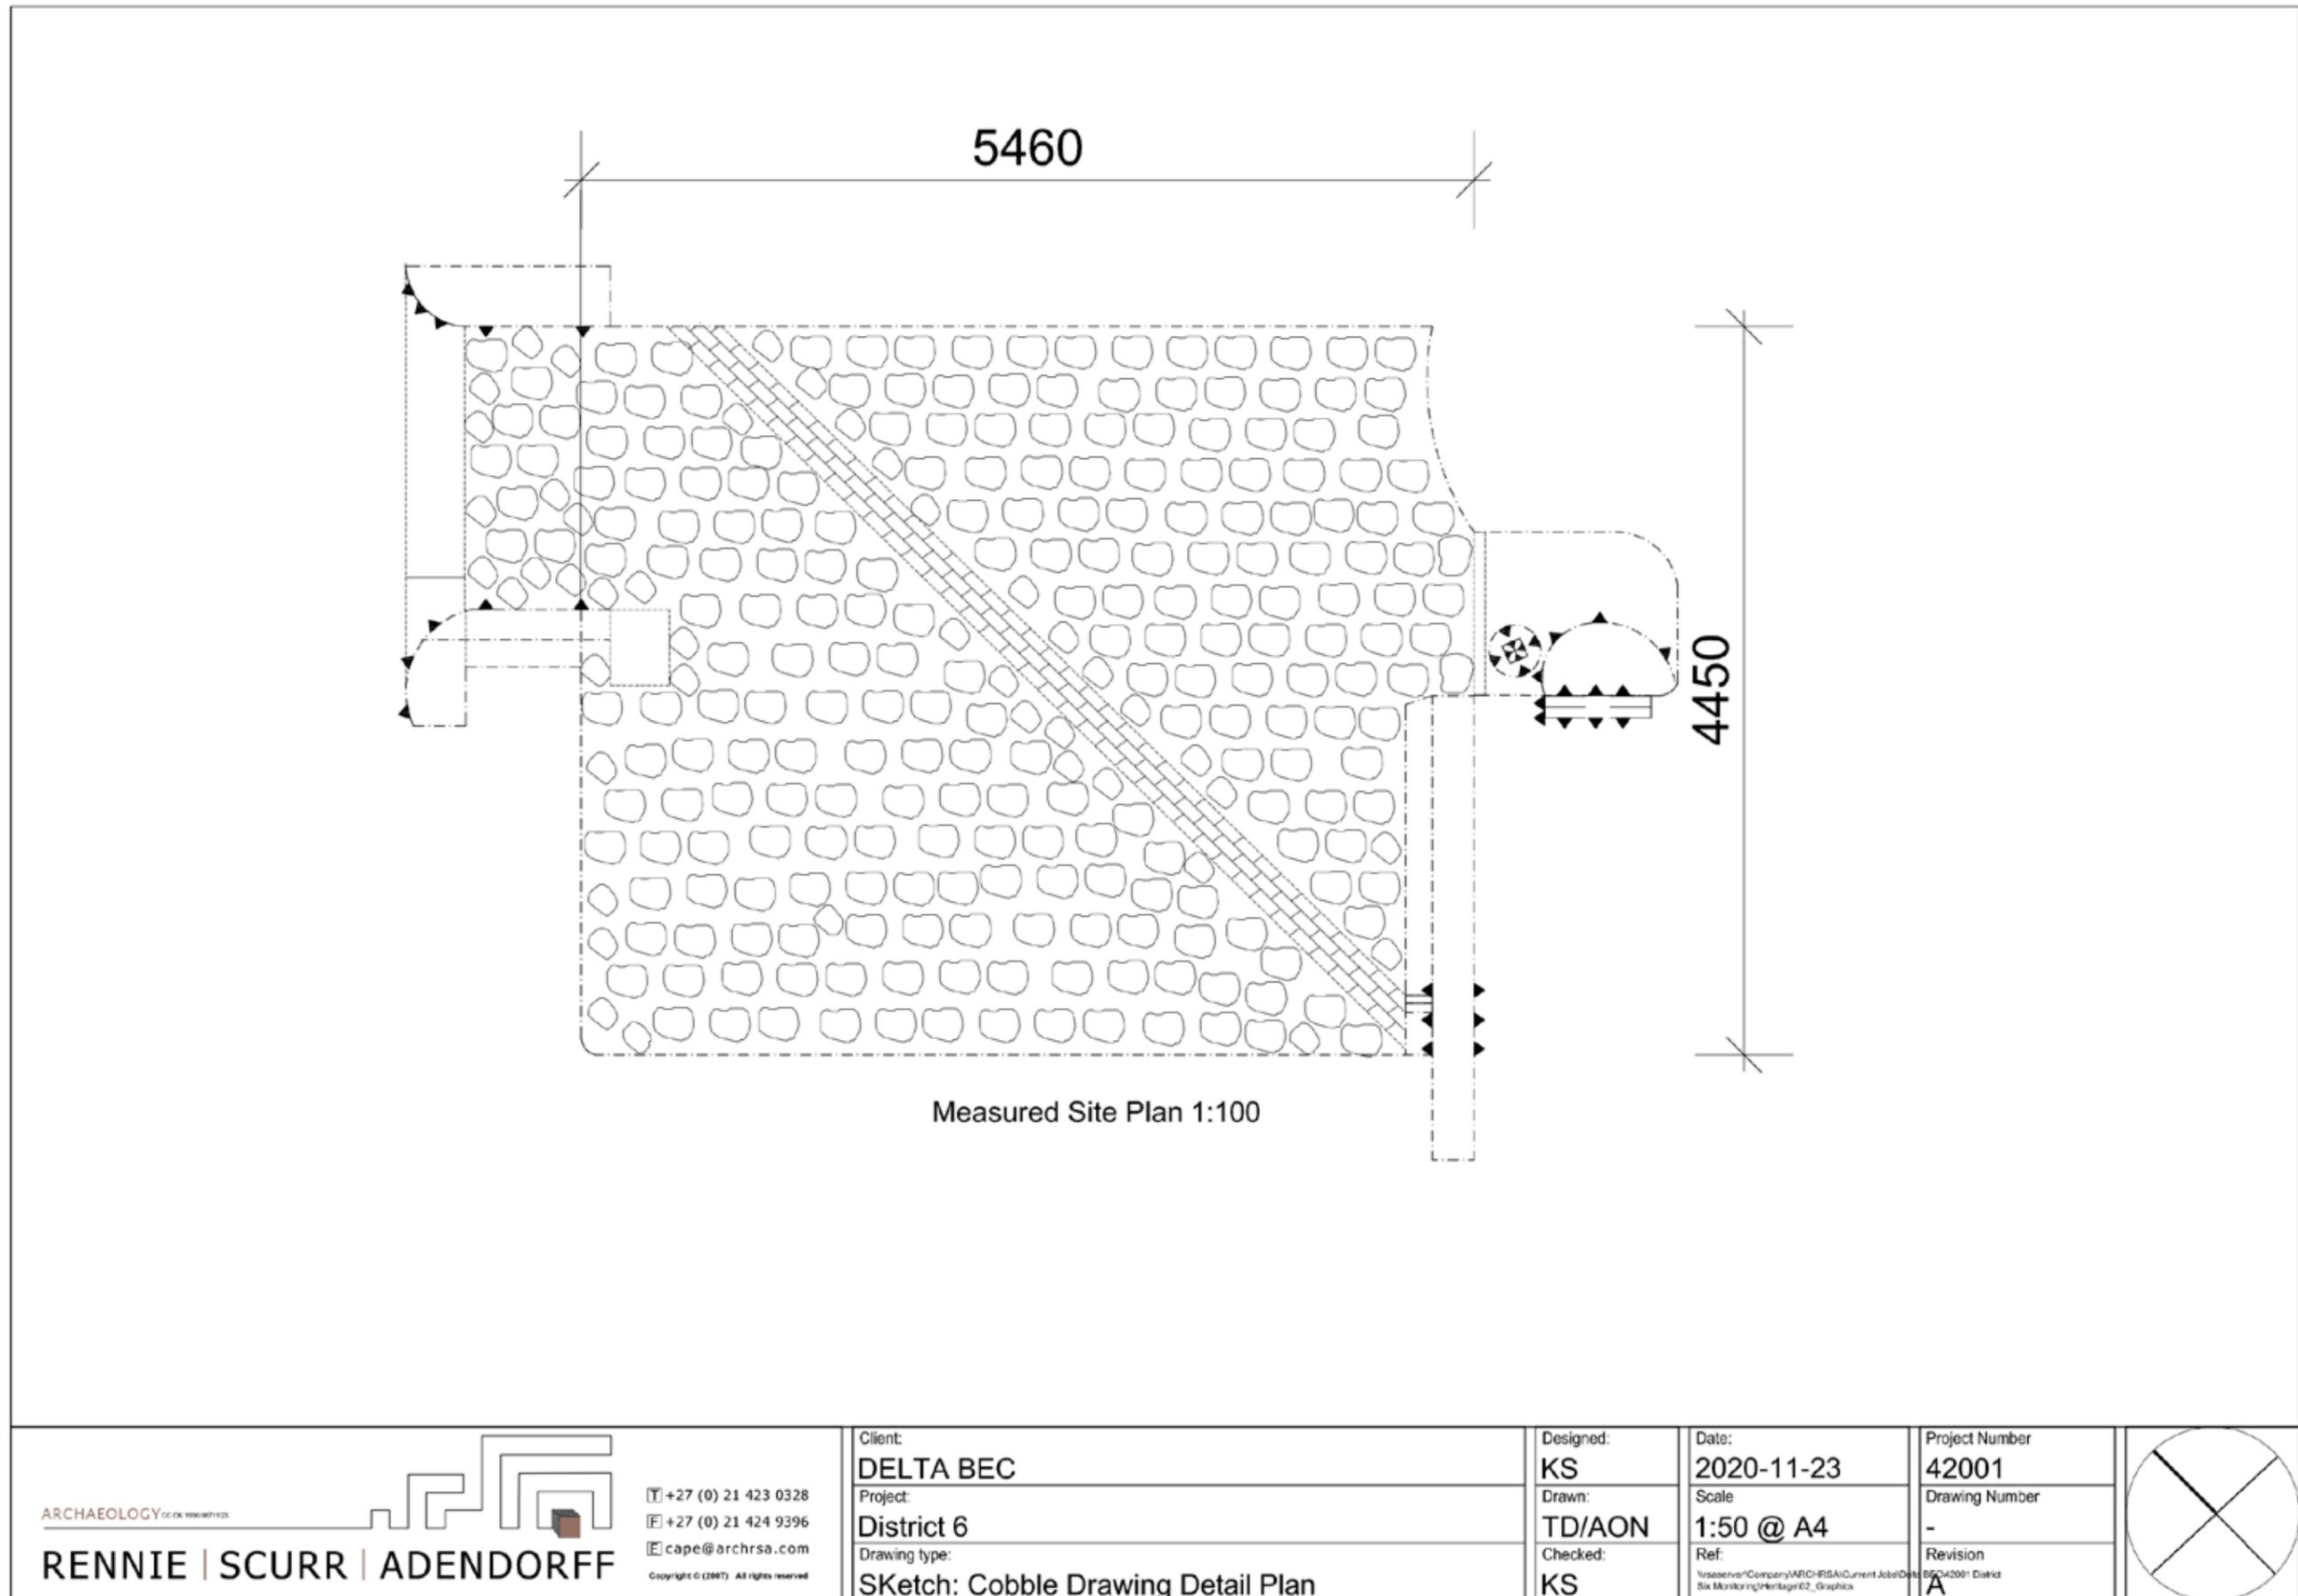
Figure 73. Plan of features recorded at 2 Roos Street (RSA, 2020).

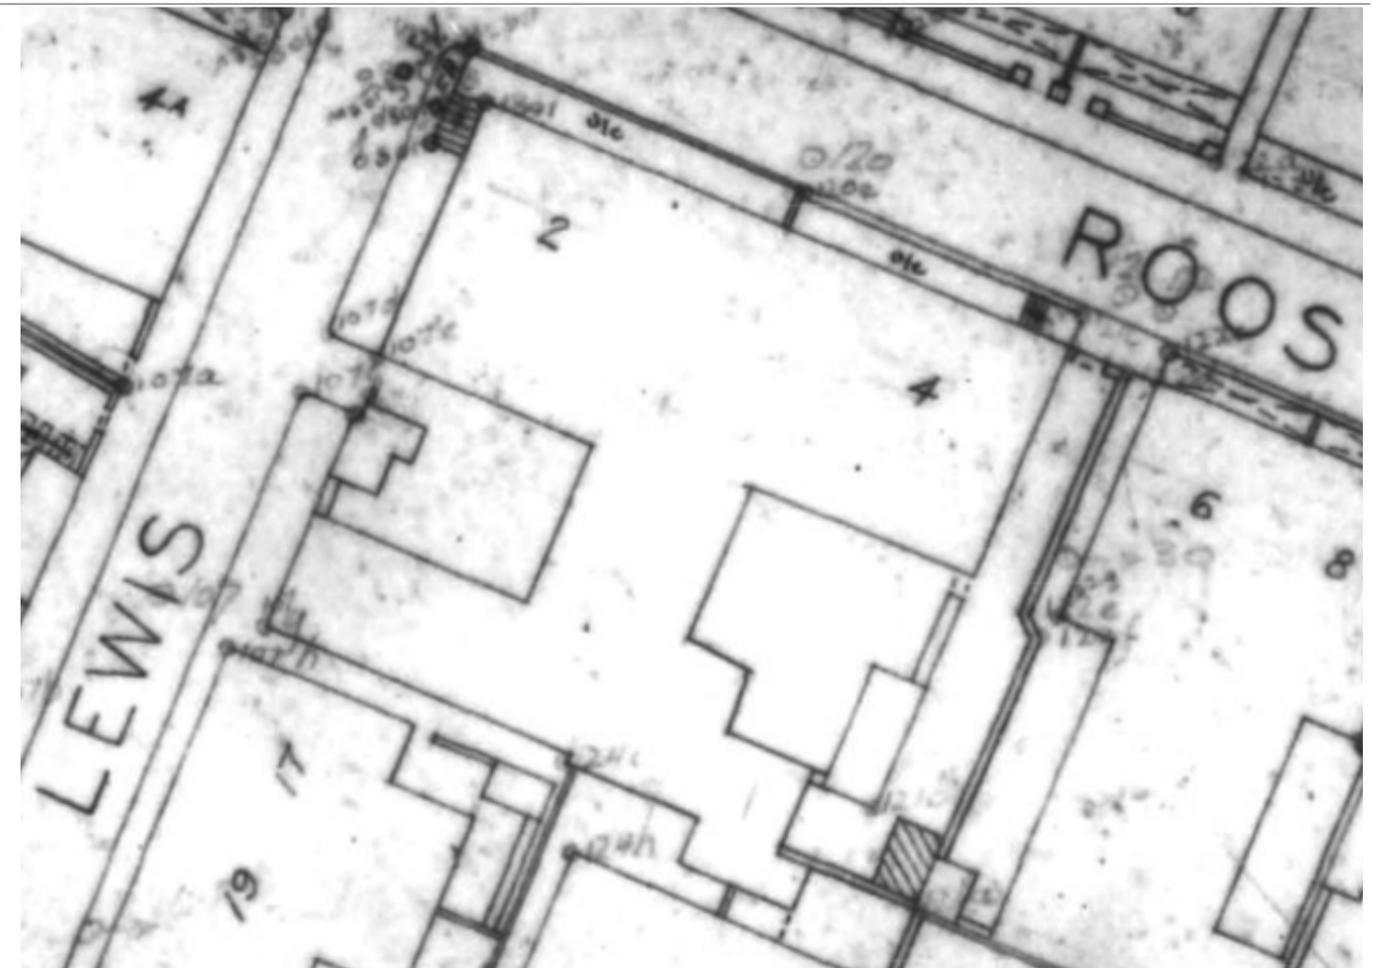
Figure 77. Detail of 1957 Plan, showing the reduced area of the yard; note the width of the pavement onto Lewis, west of 2 Roos (CoCT MapViewer, 2020).

The cobbled area was truncated to the north and south, possibly where the enclosing walls of the yard had stood prior to demolition during the forced removals. At west, the truncation appeared to relate to a 2m wide service trench, although this could not be confirmed without excavation. Beyond the 2m wide truncation, to the west of the cobbled yard, a further cobbled section was identified.

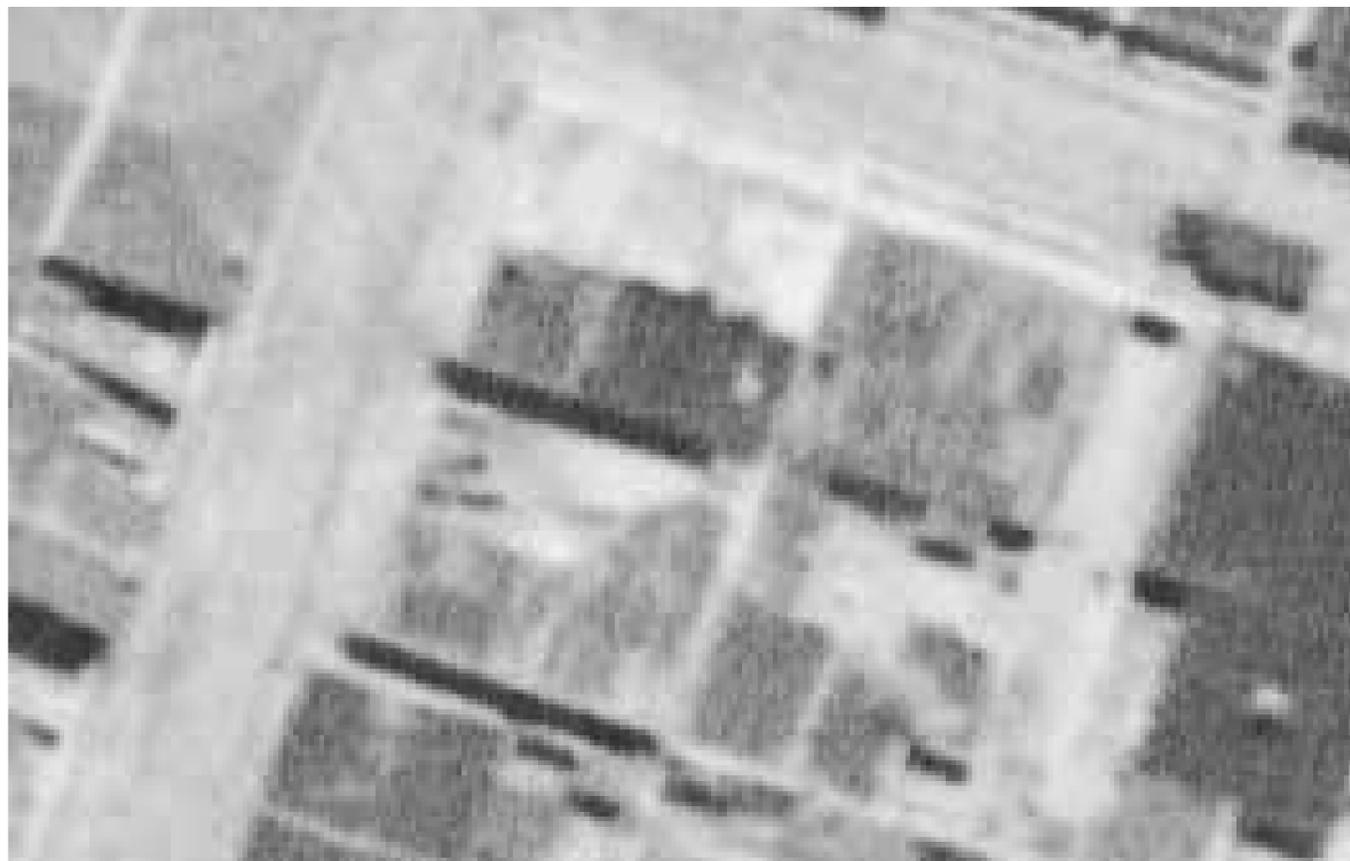
Figure 76. Detail of 1945 aerial showing 2 Roos Street (NGI, 2020).

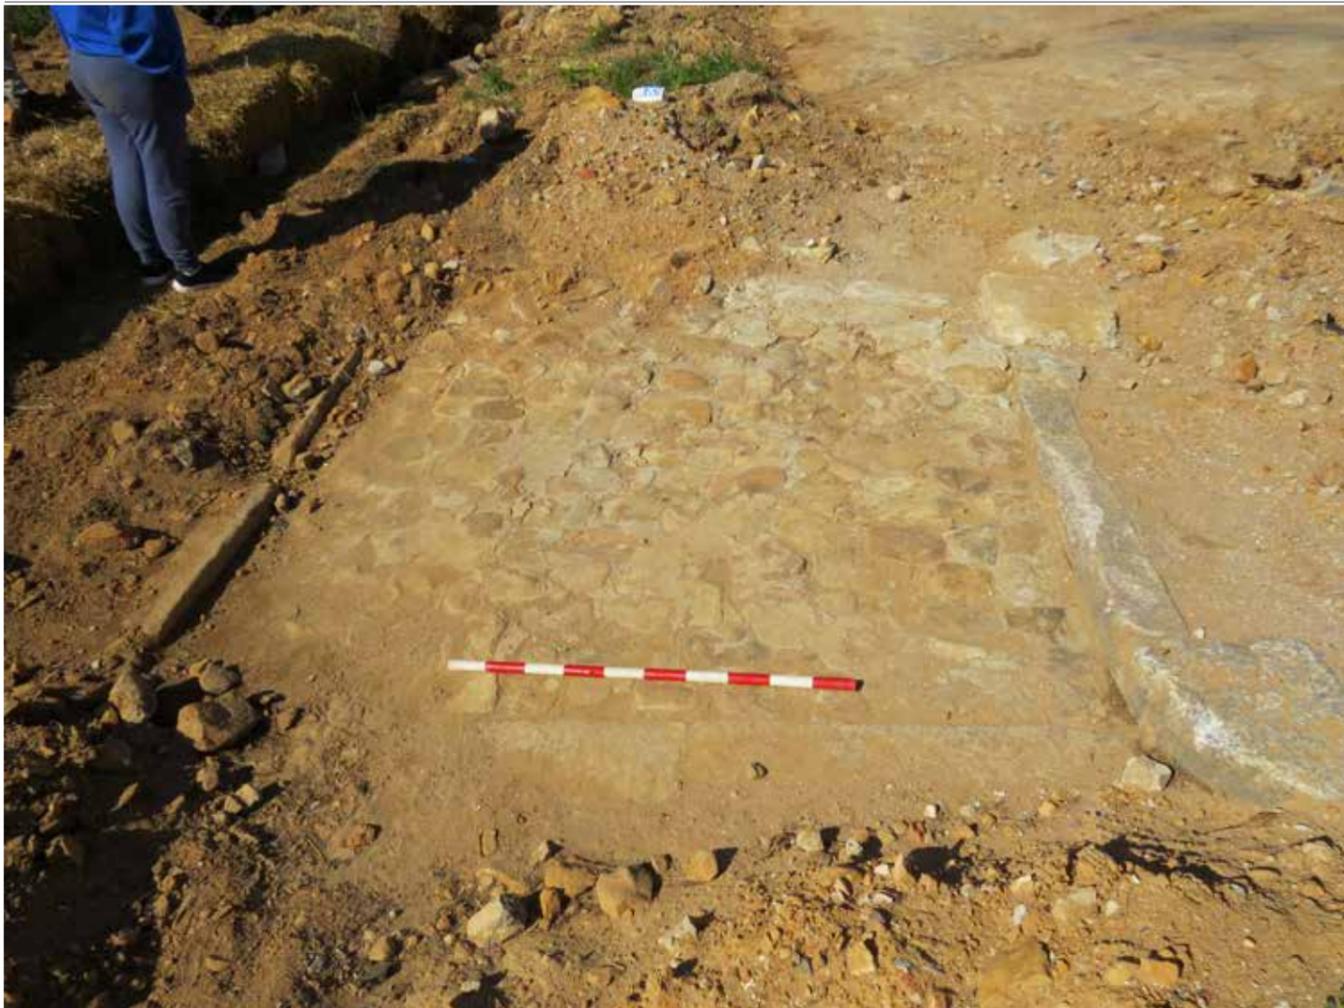
The 1957 plan of the property indicates curved kerb stones at this location, and a broad pavement adjacent to the property (Figure 79). The pavement at this point is significantly wider than the pavements elsewhere in the area, and this would seem to represent an accommodation necessary due to the different building line of the older structure. Lewis Street itself has been truncated this close to Constitution Street but would have run north-south at the western extent of the area exposed.

Figure 78. The access from Lewis into the yard at 2 Roos; note the granite kerb stones at left and right, and the curved kerb stone at right, view to east (RSA, 2020).

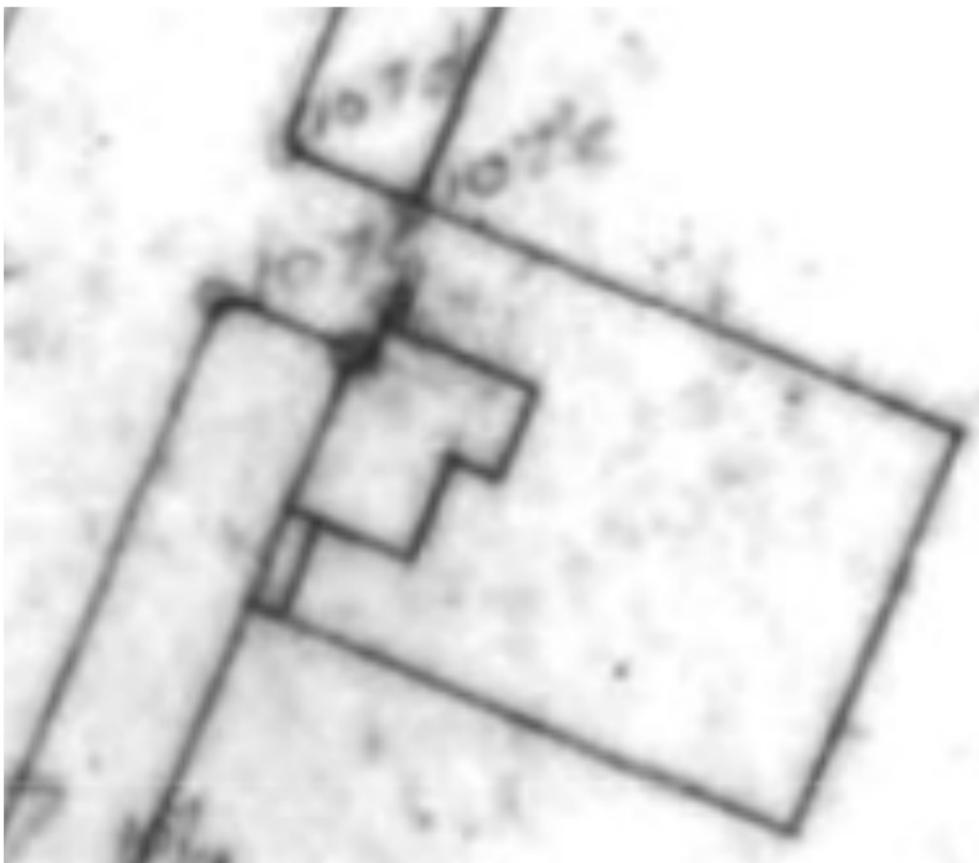
Figure 79. Detail of 1957 Plan, showing wide pavement west of 2 Roos, with curved pavement illustrated (RSA, 2020).

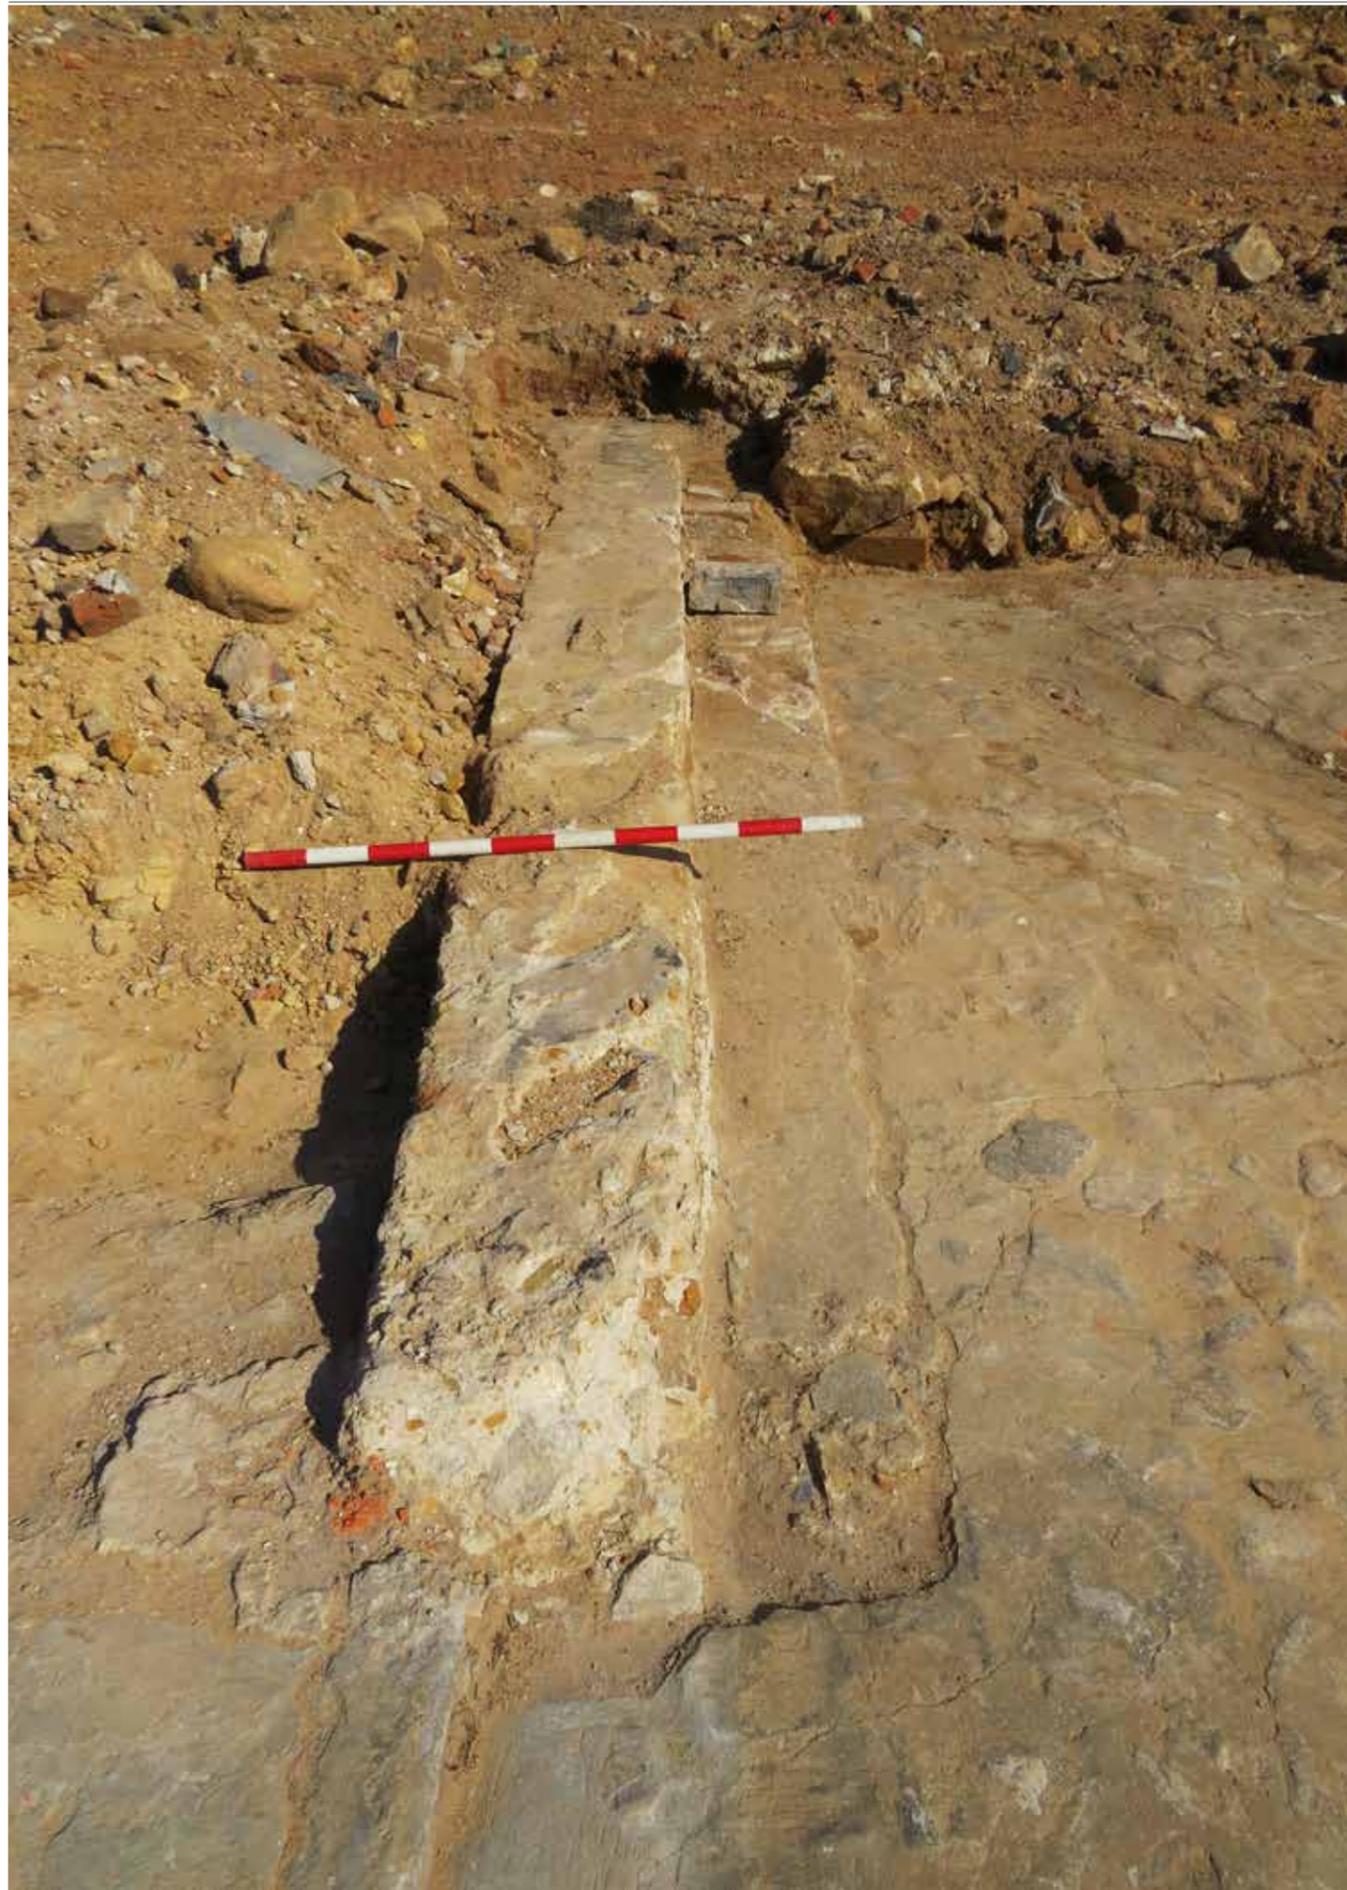
At the eastern end of the cobbled yard, the cobbles terminated at a low wall that represented the eastern end wall of the cobbled yard (Figure 81). Adjacent to the wall was a single Staffordshire Blue Brick, with a red brick next to it (Figure 81 and Figure 82). Staffordshire Blues are high-fired, hard-wearing brick ideally suited for high traffic areas. This brick is a stable paver, chamfered into four bars on one face, resembling a bar of chocolate, used in stable yards where the chamfered shape allowed for easy sluicing, drainage and cleaning. On the obverse face, the brick was stamped with a Star of David, the makers mark of P&S Wood, brickmakers in West Bromwich who were active from the 1880s (Sallery, 2020).

Figure 81. Wall footing at east of cobbled area, 2 Roos Street, view to south (RSA, 2020).

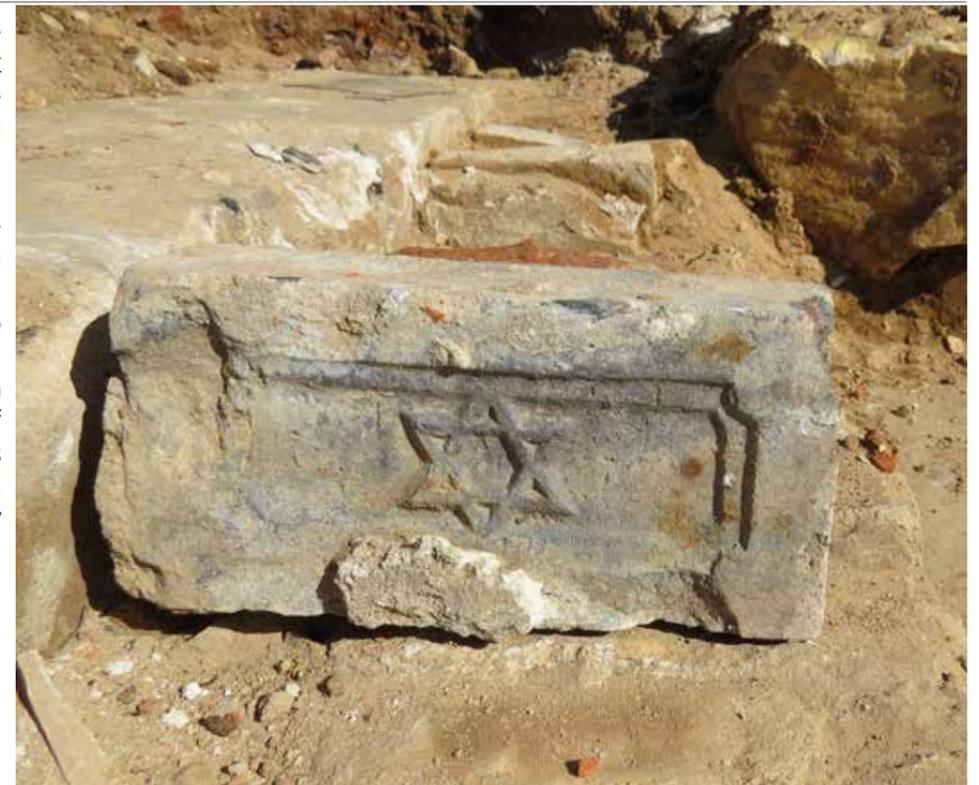
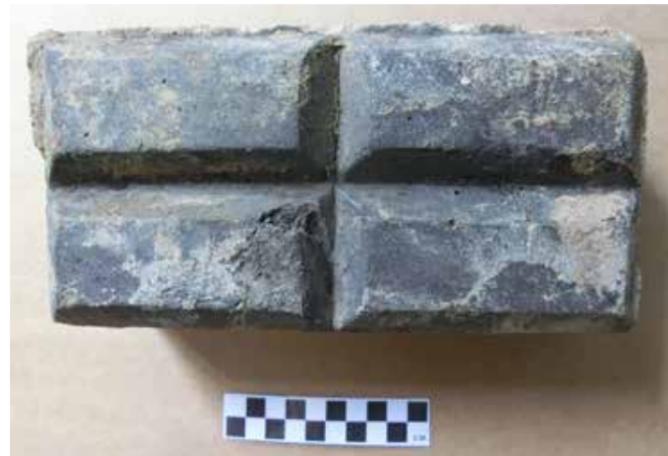
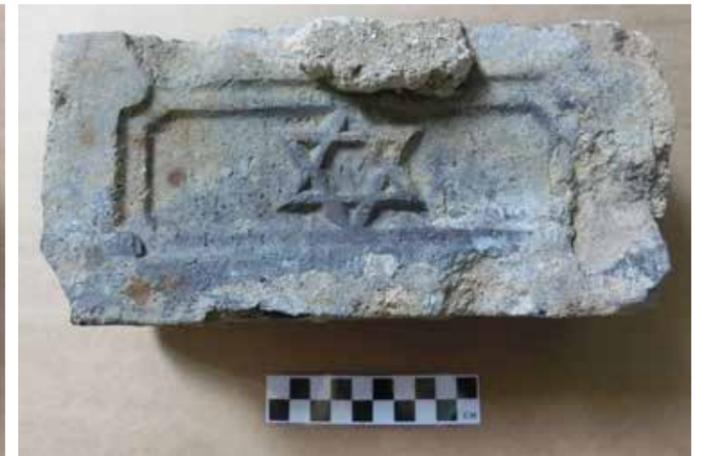
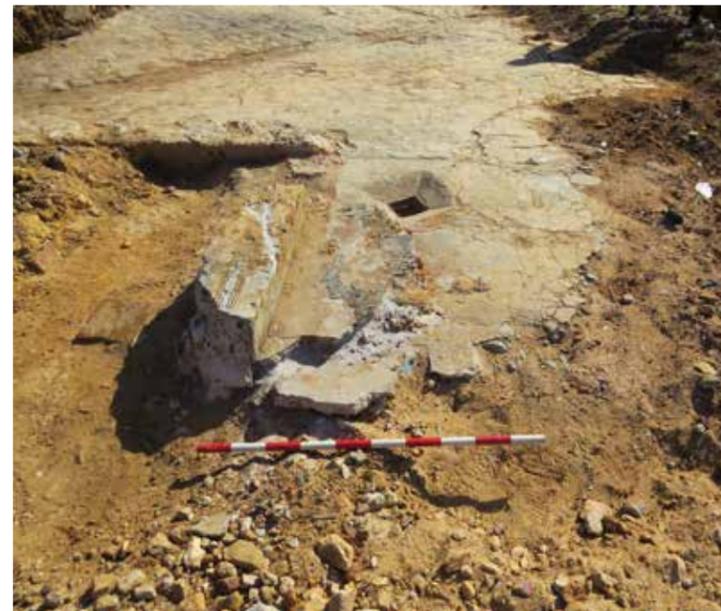
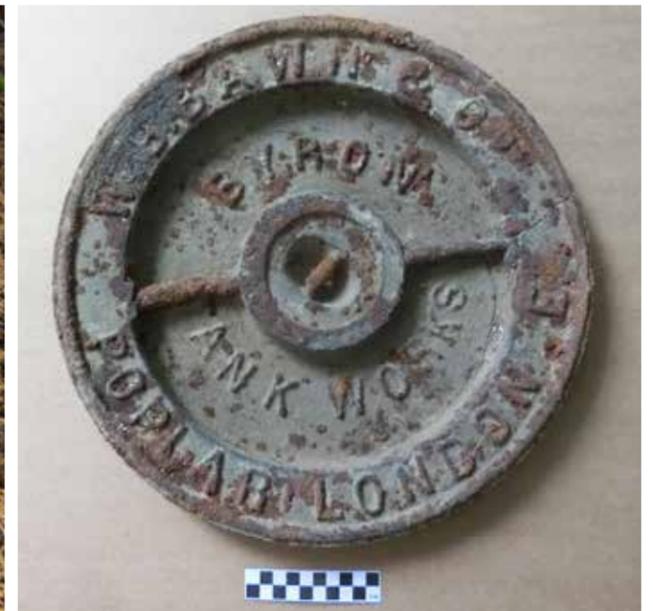
Central steps in the eastern end wall were marked by a stone threshold in the walling (Figure 81). The only feature beyond the wall was a small square opening set in concrete (Figure 83). The opening was covered with a round cast iron lid stamped with "Byron Tank Works". The lid was for an iron ship tank, which presumably was laid in the ground at that location. Whether the tank survives could not be established.

These square, riveted ship tanks were invented in 1808, and intended as a more durable alternative to conventional wooden barrels that maximised space, being square not round. They were originally intended for shipping dry goods and liquids, but since they were airtight, and could keep water fresh, they were predominantly used to transport water. William Byron Bawn had his tank works in the West India Dock in London from 1875 (Figure 80), and produced galvanised iron tanks and cisterns for liquid storage and transport (Helmsman, 2019).

In Australia, these tanks are recorded as being used on land from 1838 to store bread, sugar, clothes and other goods that were susceptible to insects, although primarily they were used for domestic water storage (Pearson, 1992). It is likely that this tank would also have been used to store water, although whether for domestic consumption, irrigation or watering horses, it cannot be known; its age and/or length of service is similarly unknown.

Figure 83. The feature east of the cobbled yard, with the access to the water tank (left) and the tank lid (right) (RSA, 2020).

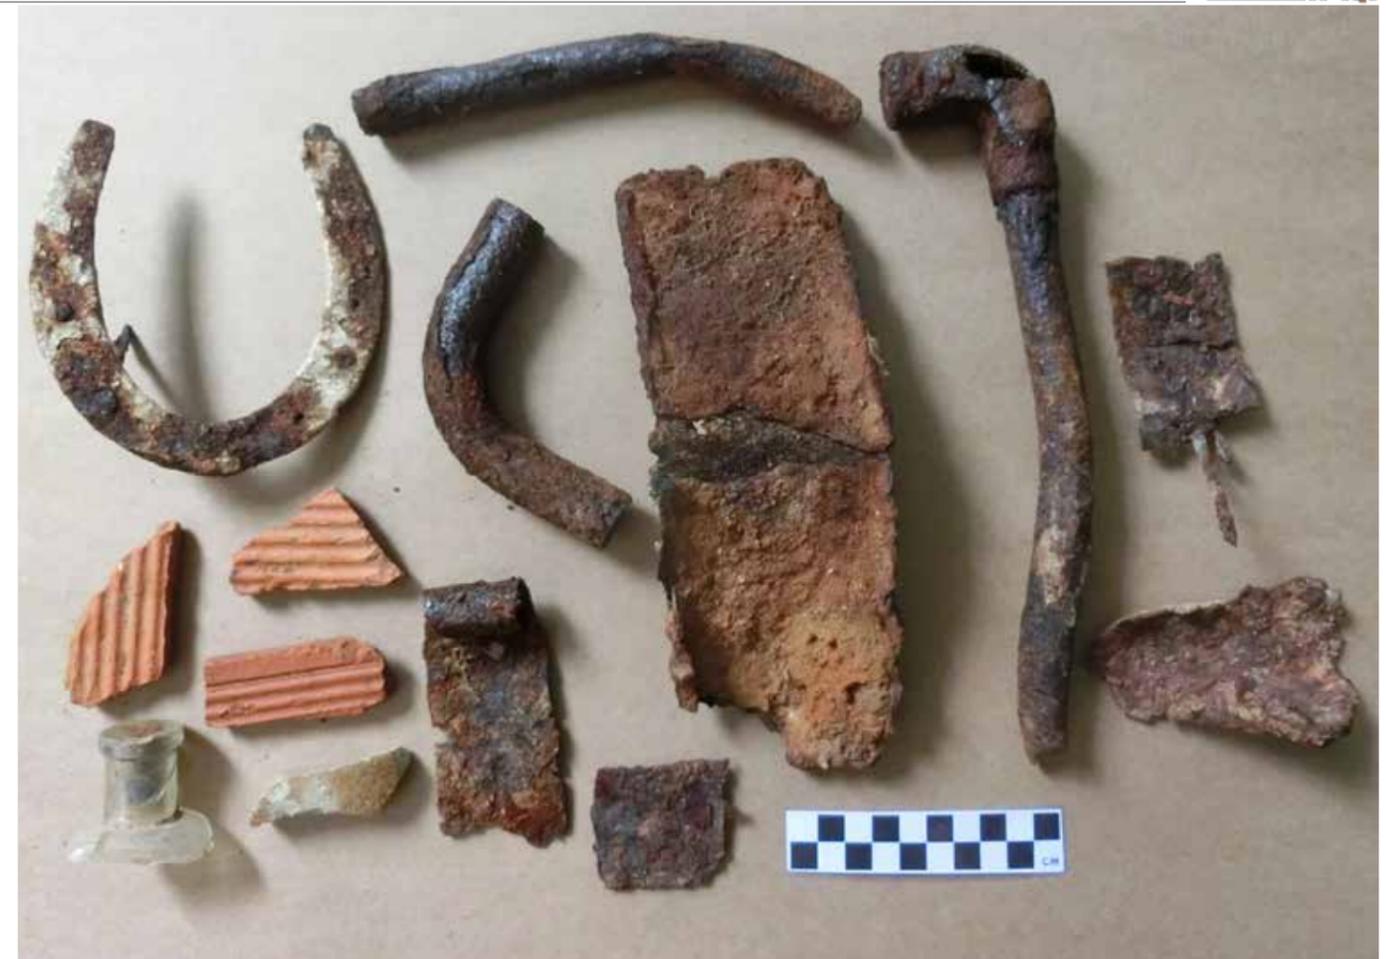
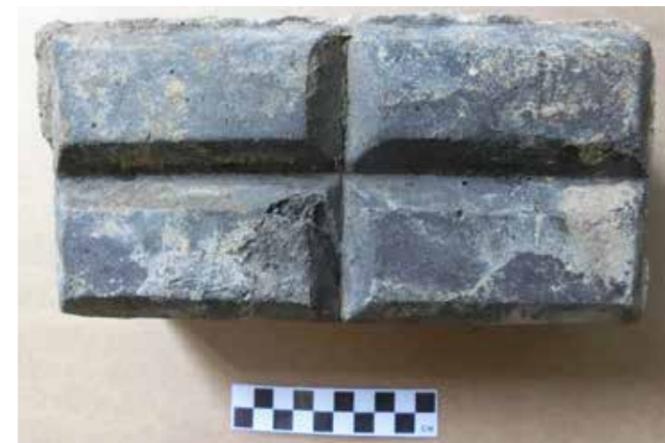
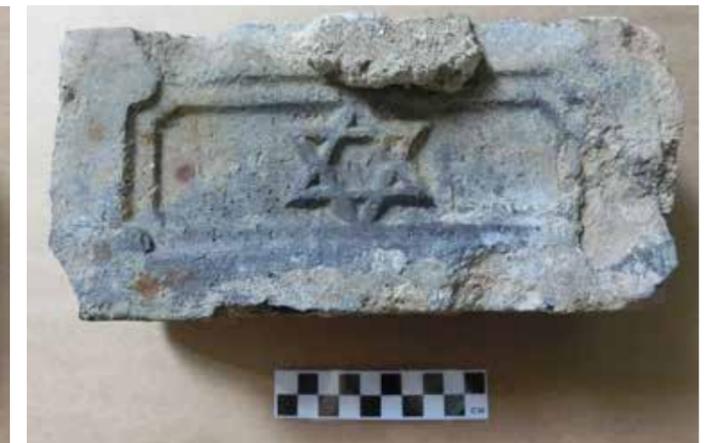
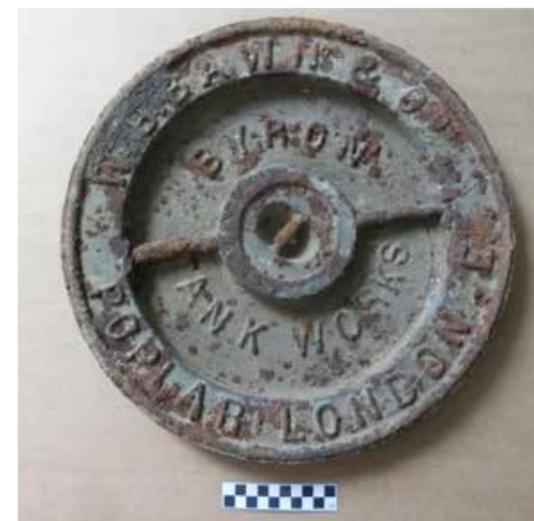
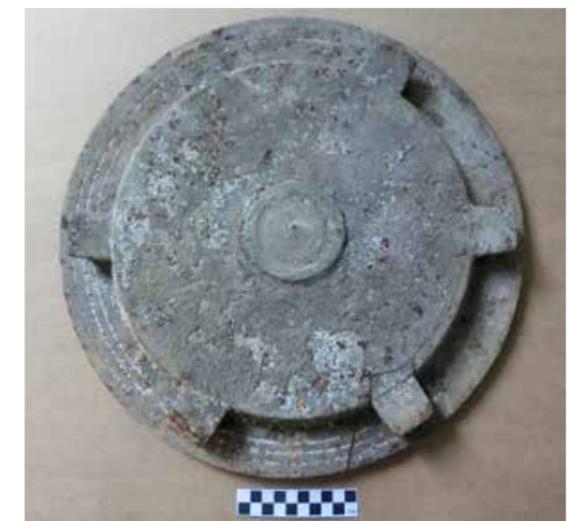
Figure 84. Finds recovered from the vicinity of 2 Roos Street during cleaning of the cobbled surface uncovered there. Various metal items including a horseshoe, ceramic files, clear glass bottle and fragment of salt glazed stone ware (top), the front and back of the stable paver (centre) and the front and back of the Byron Tank Works tank lid (RSA, 2020).

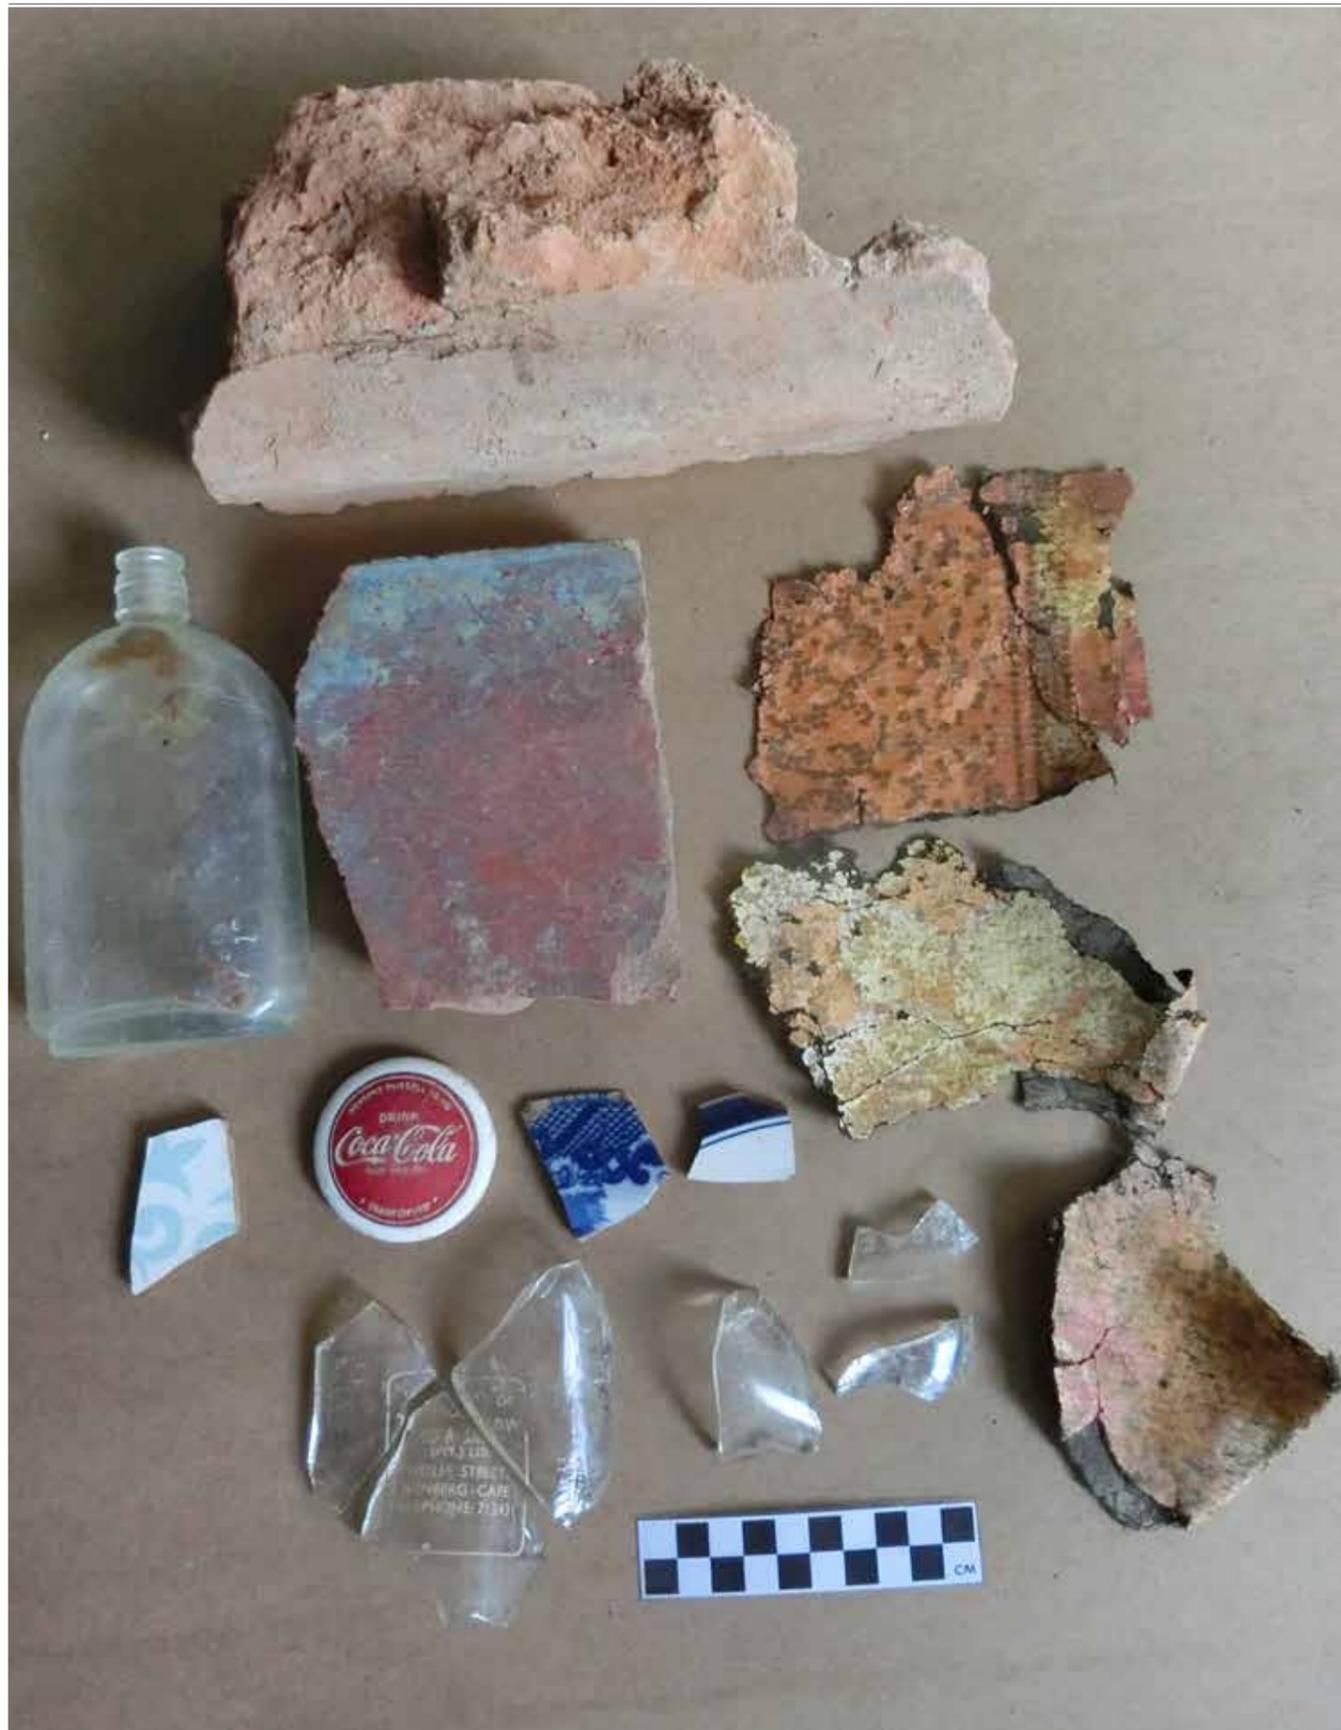
Figure 85. Find retrieved from vicinity of 12 to 24 Roos Street, including fragments of moulded tile, ceramic tile, wall tile and vinyl flooring, as well as ceramic and glass fragments, a glass bottle and a plastic yoyo. The conjoining glass fragments are printed with "David & Salkow (Pty) Ltd Wolfe Street Wynberg Cape Town Telephone 713431"; the company produced ginger beer and soda water from the C19th onwards (RSA, 2020).
