REPORT ON ARCHAEOLOGICAL MONITORING OF RUBBLE REMOVAL

submitted in terms of Section 35 of the NHRA (1999) for
DISTRICT SIX PHASE FOUR DEVELOPMENT ON PARCEL N,
DISTRICT SIX, CAPE TOWN,
ERVEN 177646, 10010 AND 117891-117898

Prepared by Katie Smuts, Archaeologist at Rennie Scurr Adendorff for Delta BEC
on behalf of the Department of Land Reform and Rural Development

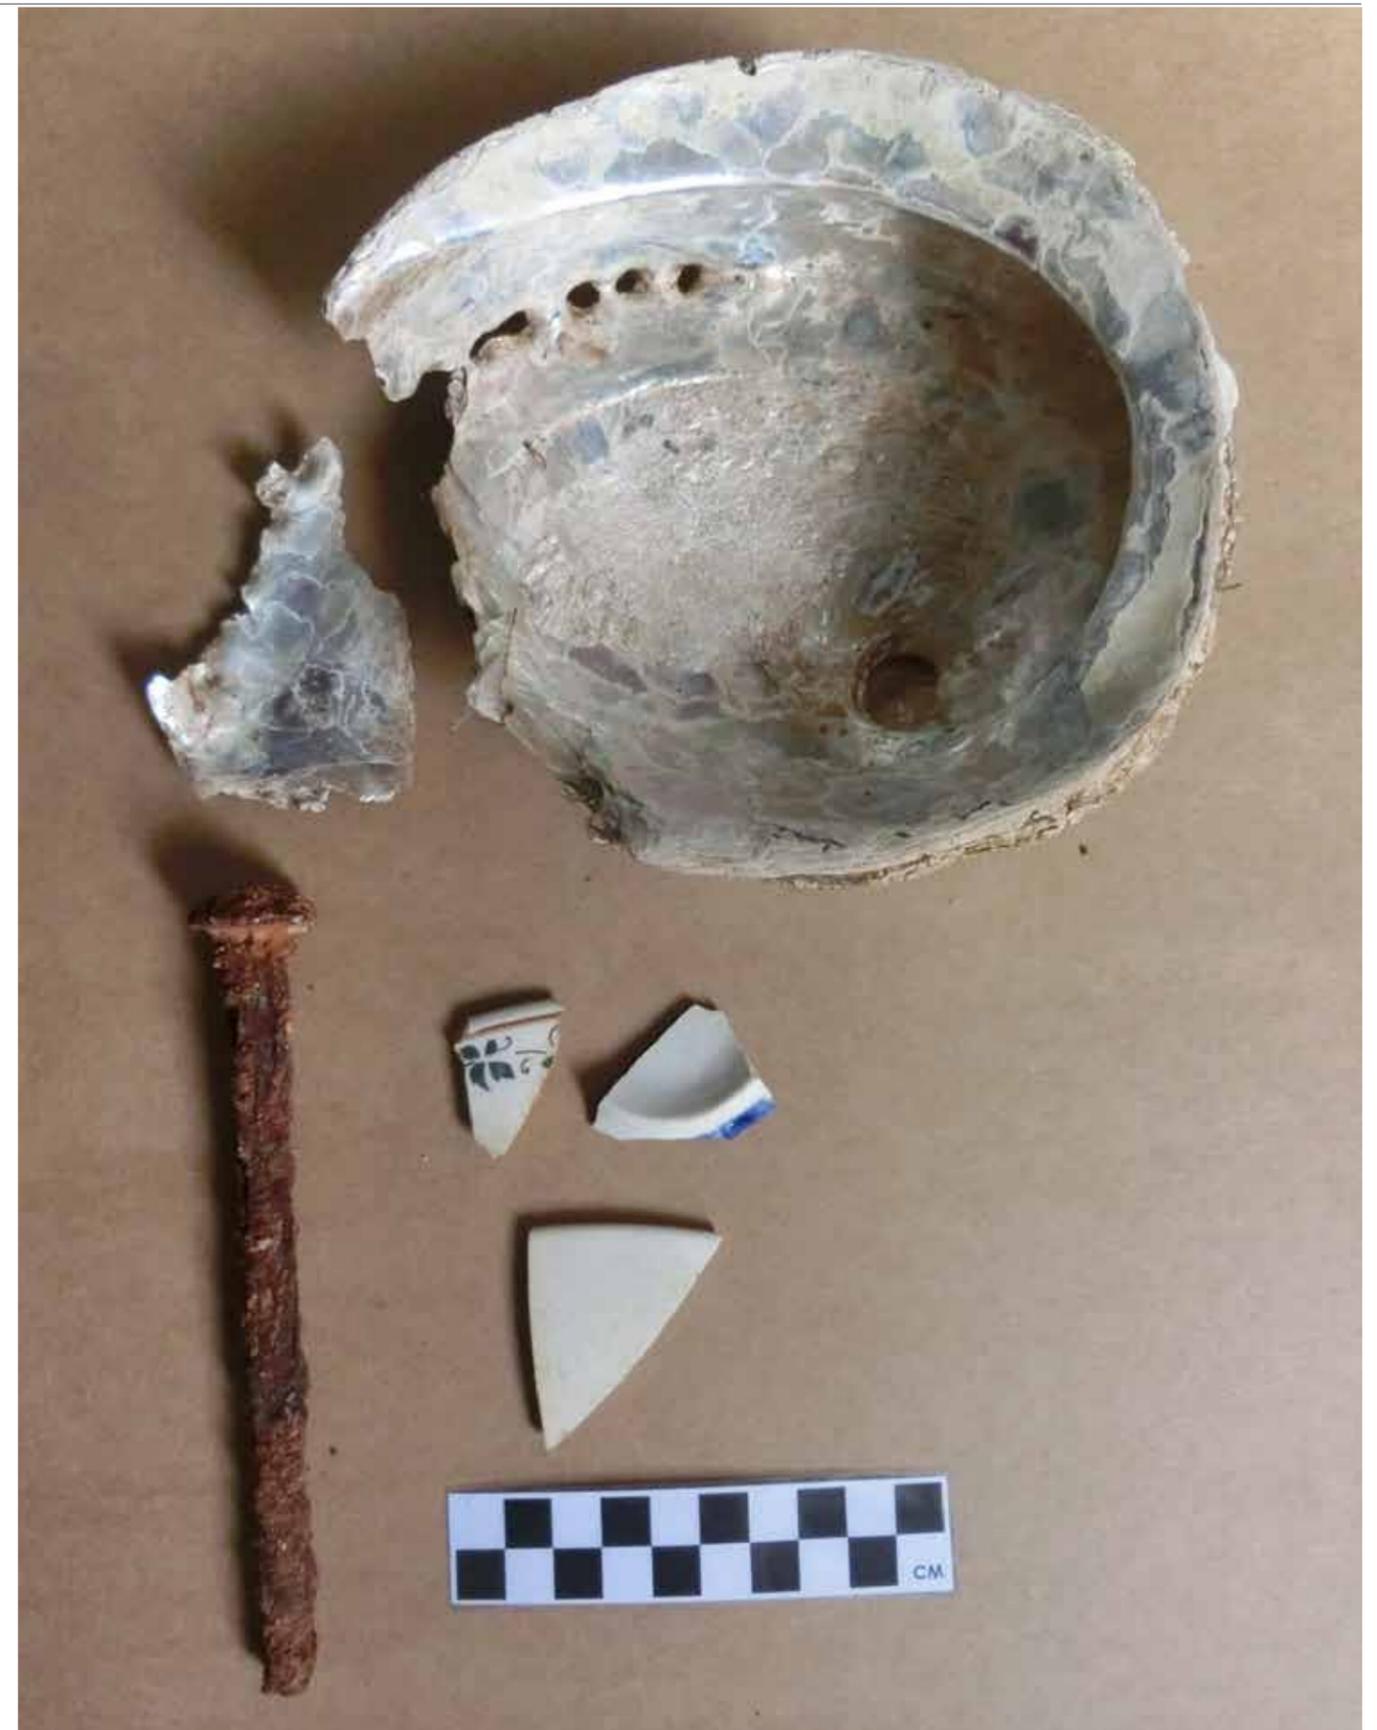
Figure 86. Finds recovered from the northern extent of Clifton Street, including a large perlemoen shell, a roof nail and ceramic fragments (RSA, 2020).

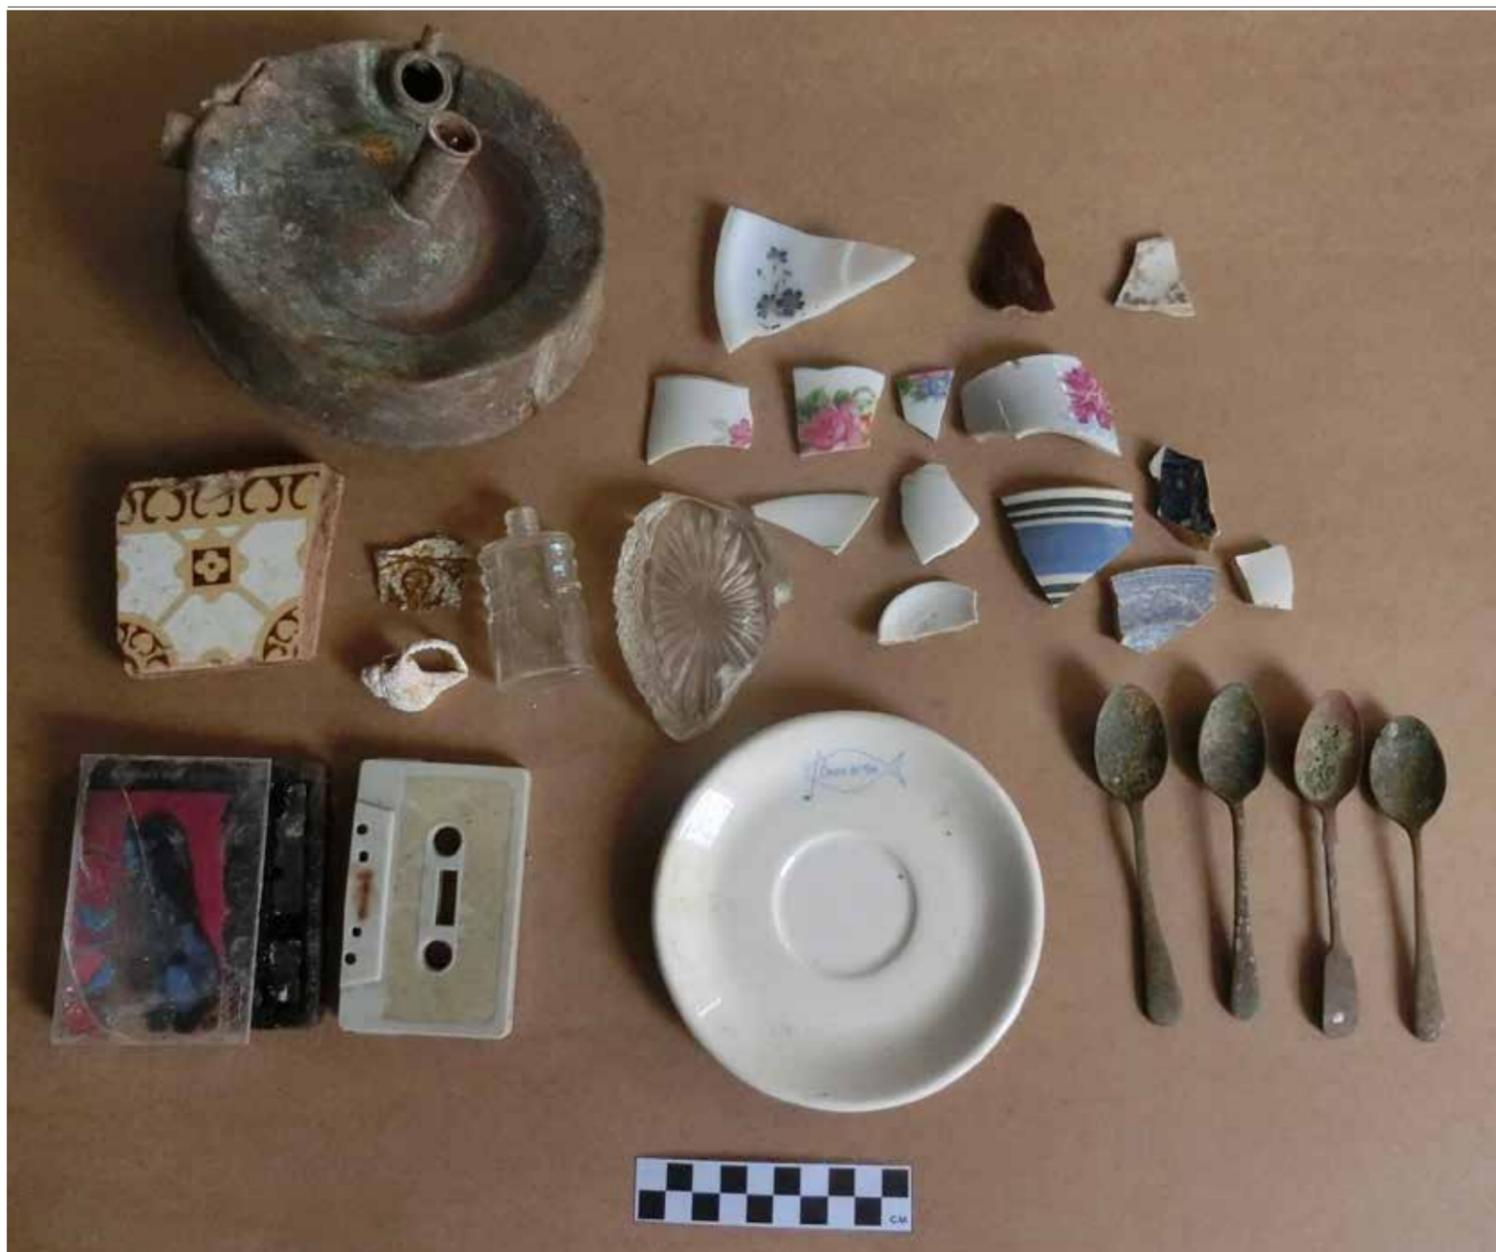
Figure 87. Various finds. Clockwise from top left: copper pump; ceramic sherds from a localised deposit east of Albert Street; various teaspoons; a ceramic saucer marked "Hotel Ware" on the reverse; two cassette tapes, one of which is "Dreamland" by Blackbox which was released in 1990; sherd of patterned tile; fragment of vinyl floor tiling; seashell; glass bottle and base of a decorative glass dish (RSA, 2020).

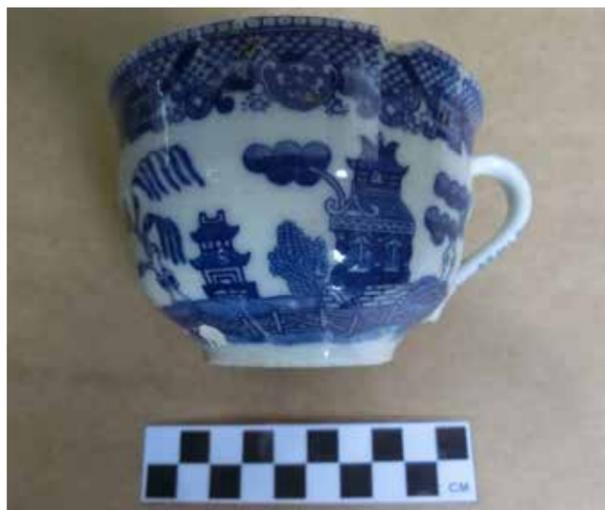
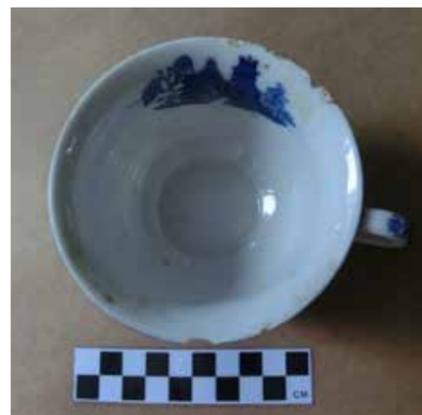
Figure 89. Single tea cup retrieved from site; likely of recent age (RSA, 2020).

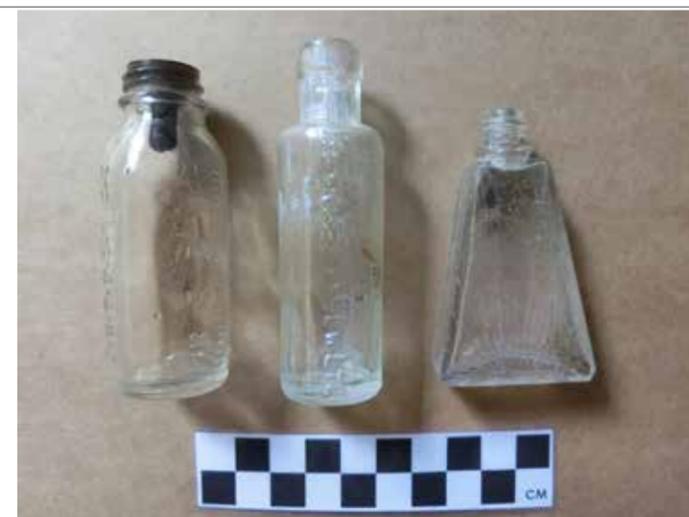
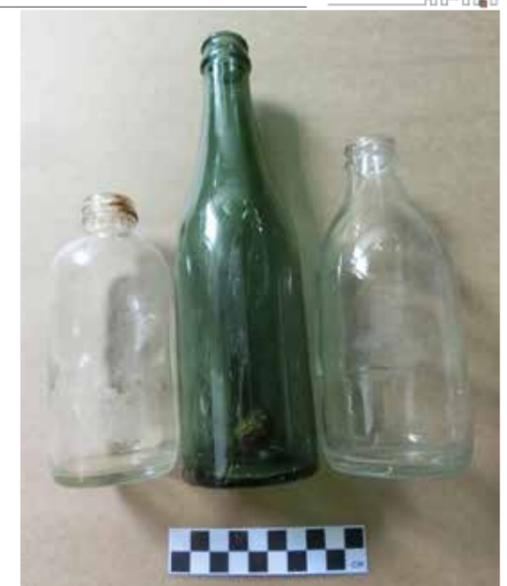
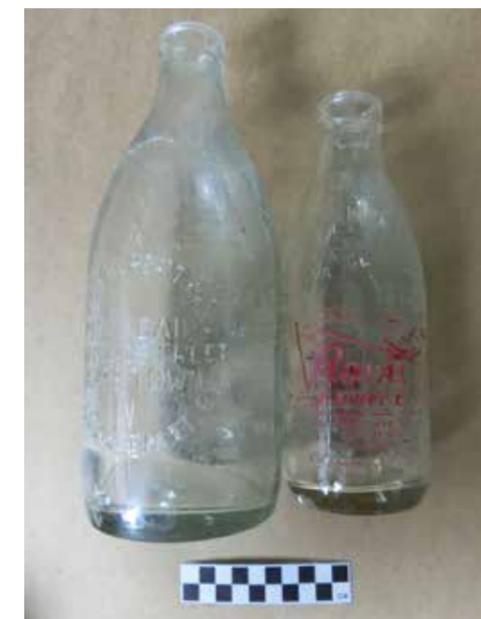
Figure 88. Glass bottles retrieved from site: two Royal Dairy milk bottles, one embossed with the Long Street address, one printed with Cochrane Avenue Epping (top left); two clear bottles and one green bottle (bottom left); three small bottles (top), at left with dropper and measurement markers, central embossed with Heynes Mathew Ltd, a prominent pharmaceuticals company established in the early C19th in Cape Town, and perfume bottle at right embossed with sunburst motif (RSA, 2020).

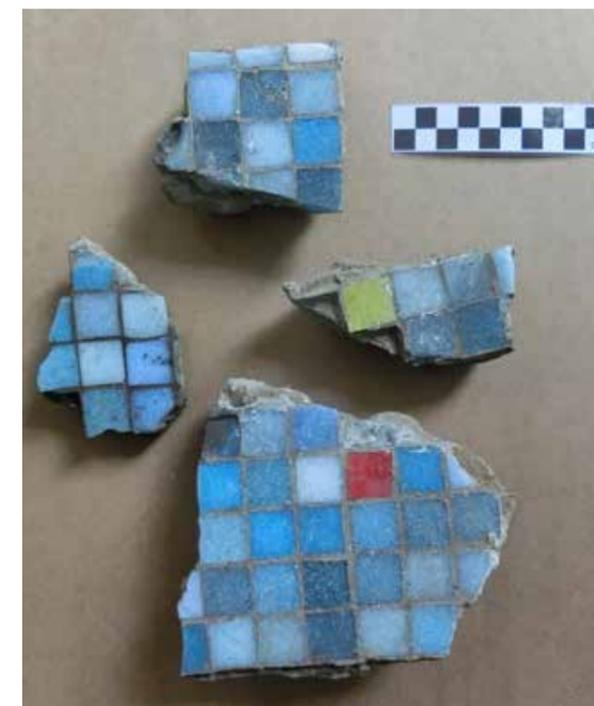
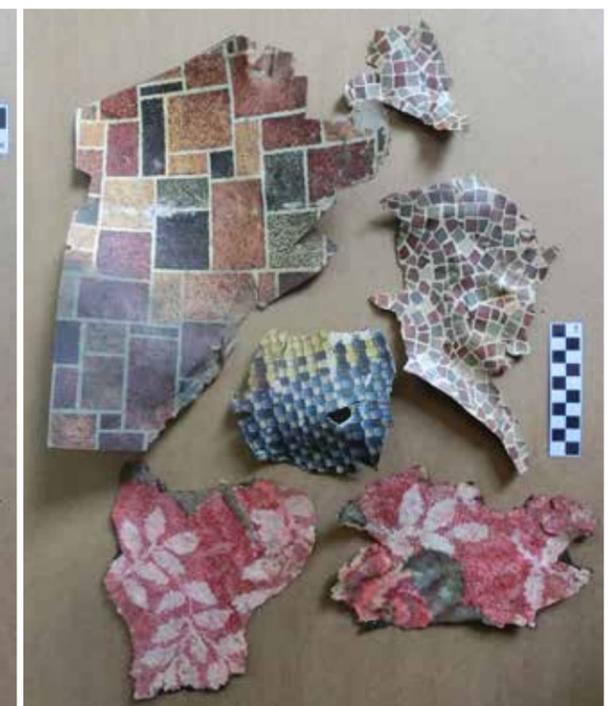
Figure 90. Fragments of bathroom tile retrieved in the vicinity of 59 to 65 Clifton Street (left) and various vinyl tile fragments from across site (RSA, 2020).

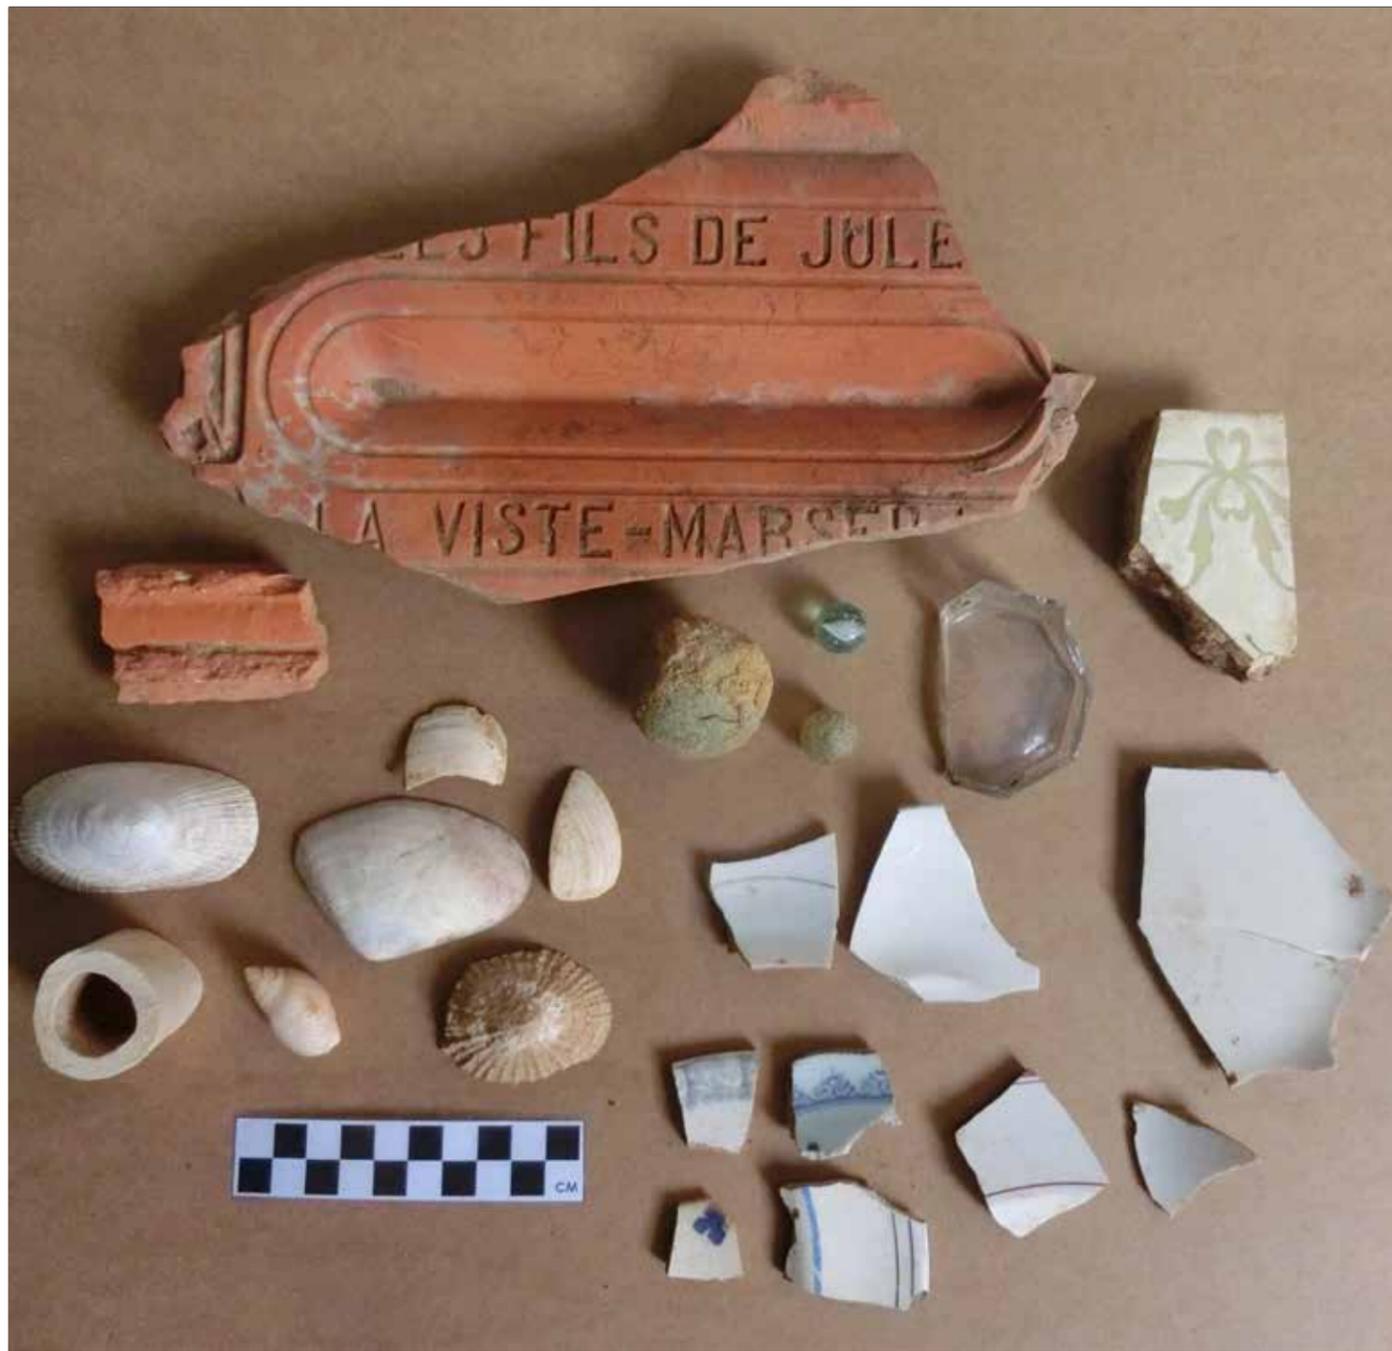
Figure 91. Various finds: at top, two fragments of roof tile, the larger reads "Les Fils de Jules Bonnet La Viste-Marseille"; bottom left, assortment of marine shells including white mussel, two limpets and a whelk as well as a mutton bone; centre of image remains of cricket ball and two marbles, top right base of decorative bottle or glass and fragment of wall tile; bottom right assortment of ceramic fragments (RSA, 2020).

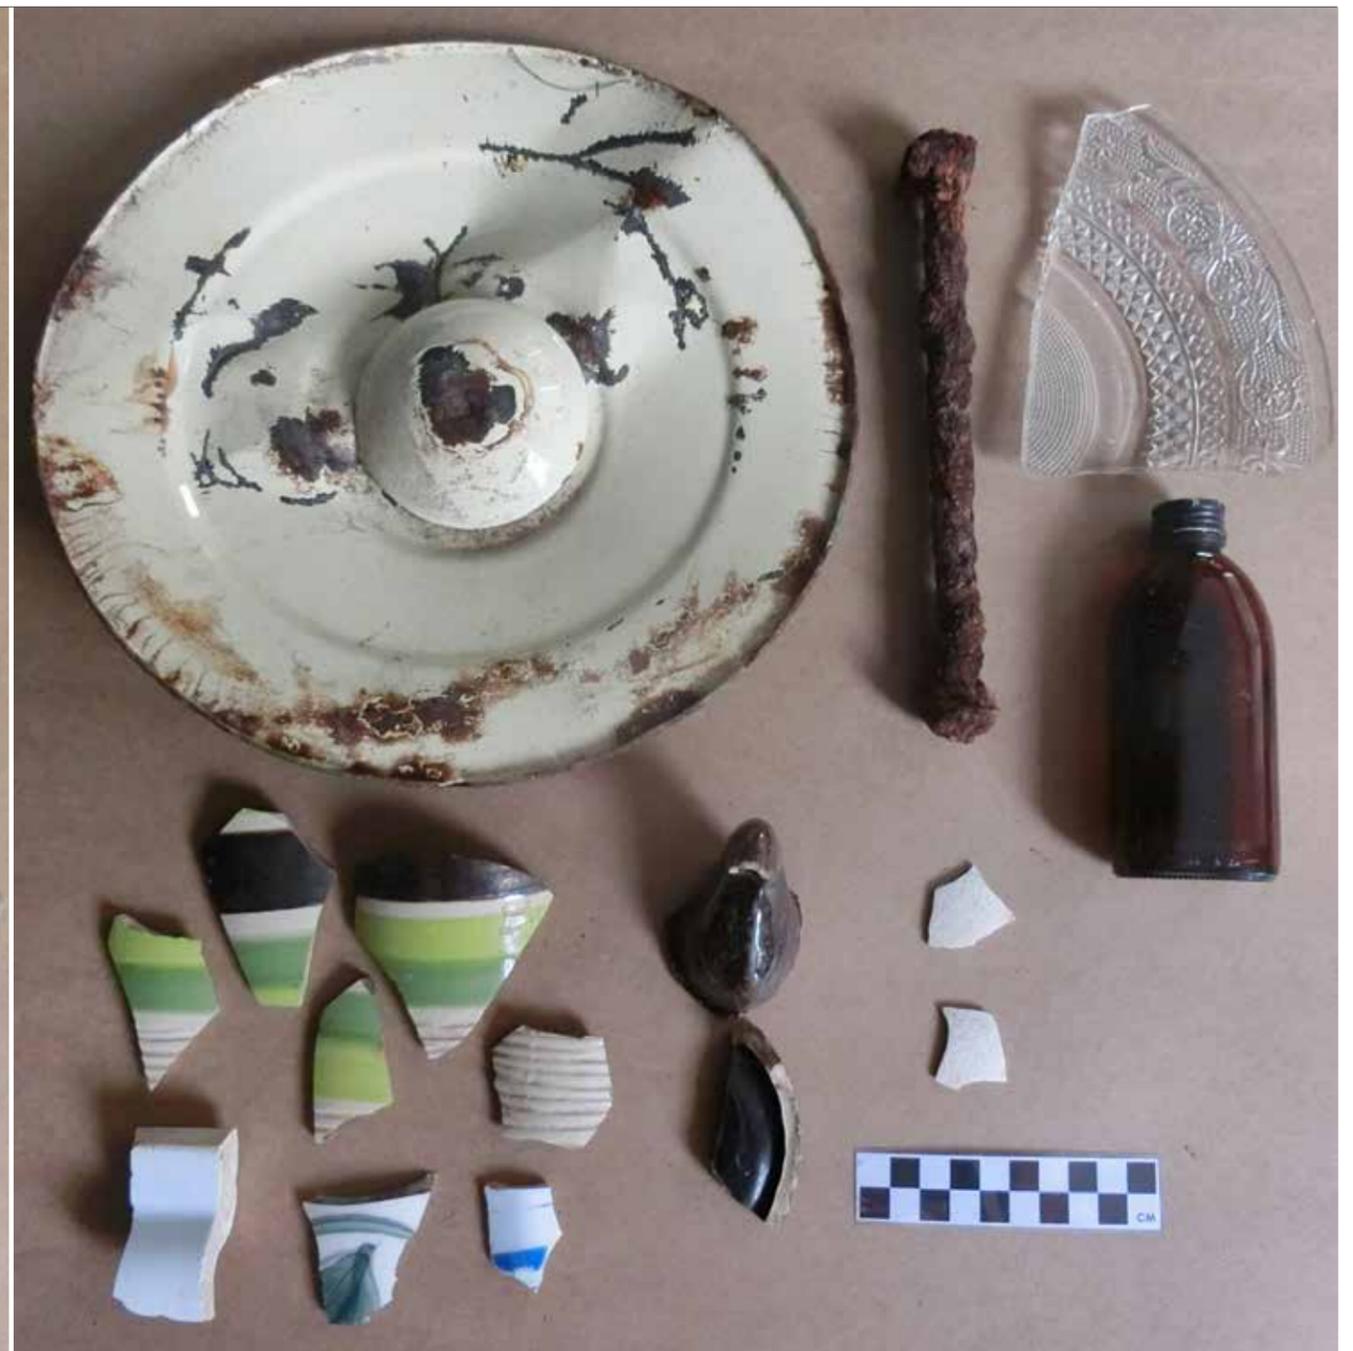
Figure 92. Various finds, clockwise from top left: enameled pot lid; iron bar; decorative glass plate; small medicine bottle; two sherds of ostrich egg shell; fragments of teapot spout; various ceramic fragments (RSA, 2020).
