TABLE OF CONTENTS

1.0. INTRODUCTION

1.1. Purpose of Report

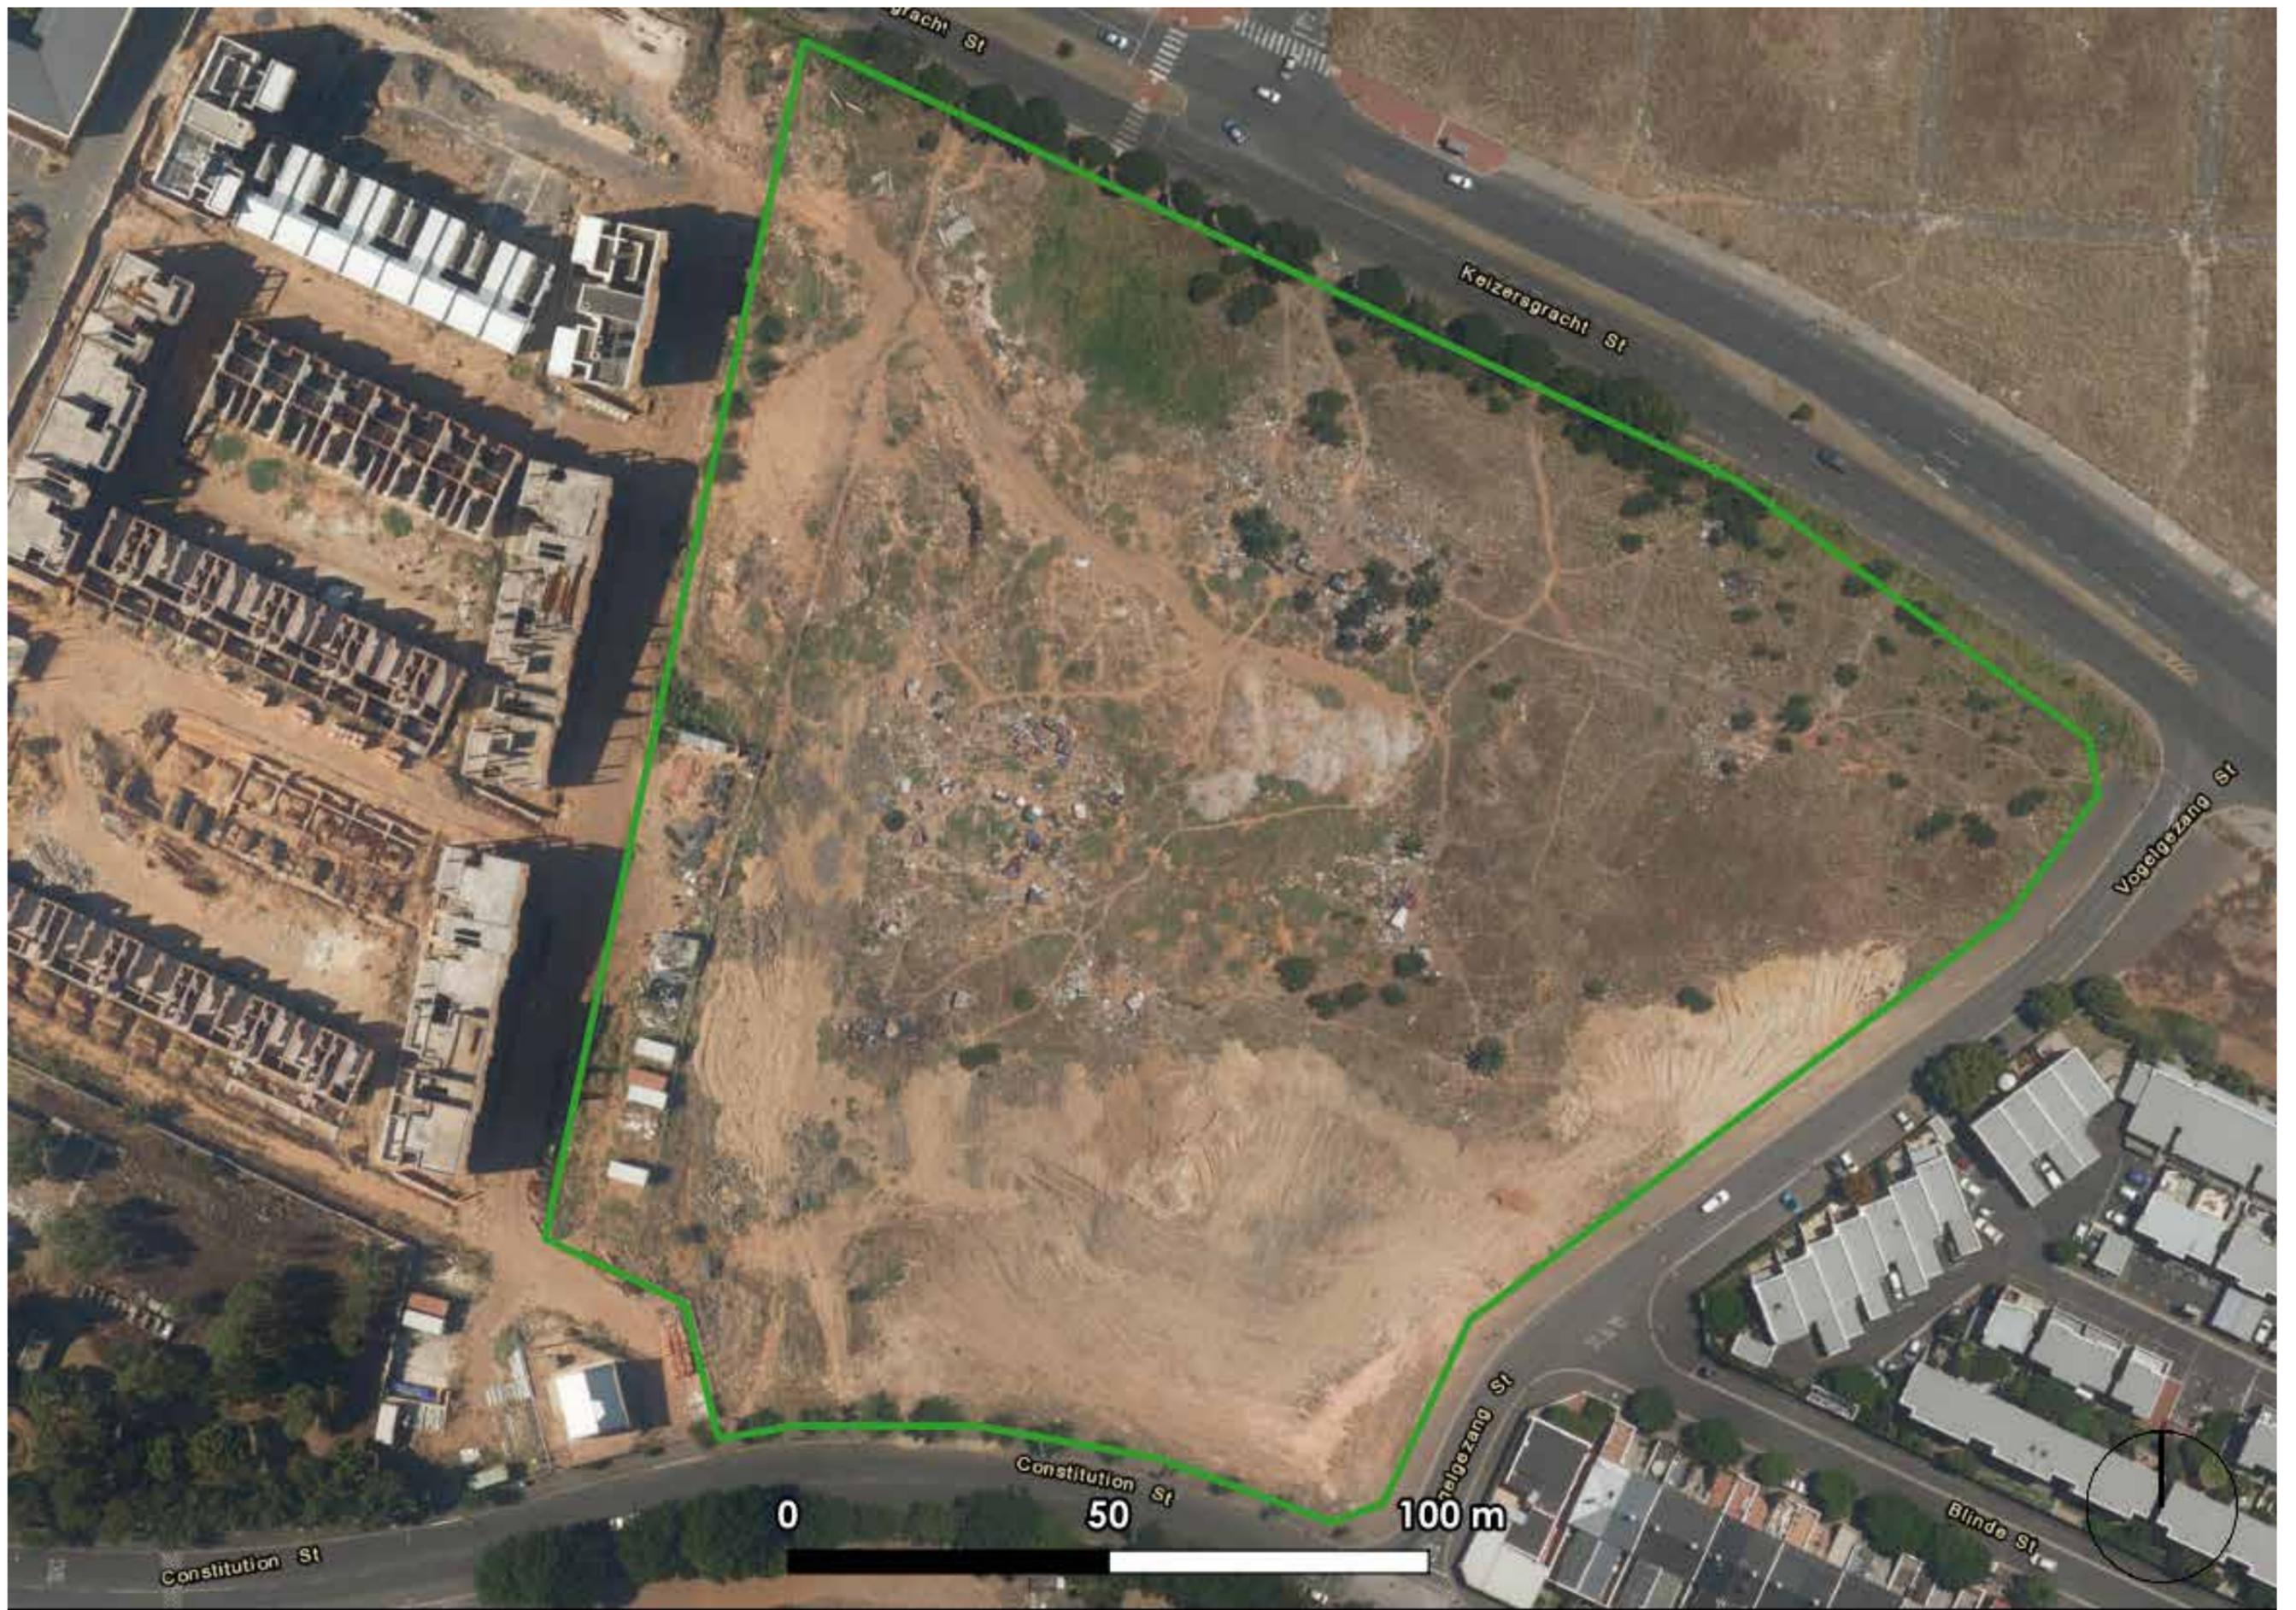
Figure 3. Parcel P, Erf 177646, in immediate context; note Phase 3 development of Block Q2 immediately to the west (RSA, 2020).

More recent development activities related to the development of Block Q2 as part of Phase 3 of District Six, has resulted in extensive disturbance across the majority of the site, particularly since mid-2018. This disturbance is related both to the activities of heavy machinery on site, as well as stockpiling of soils and redistribution of rubble across site, and represents the most recent layer of dumping, cut and fill on this portion of site (Figure 4 to Figure 12).

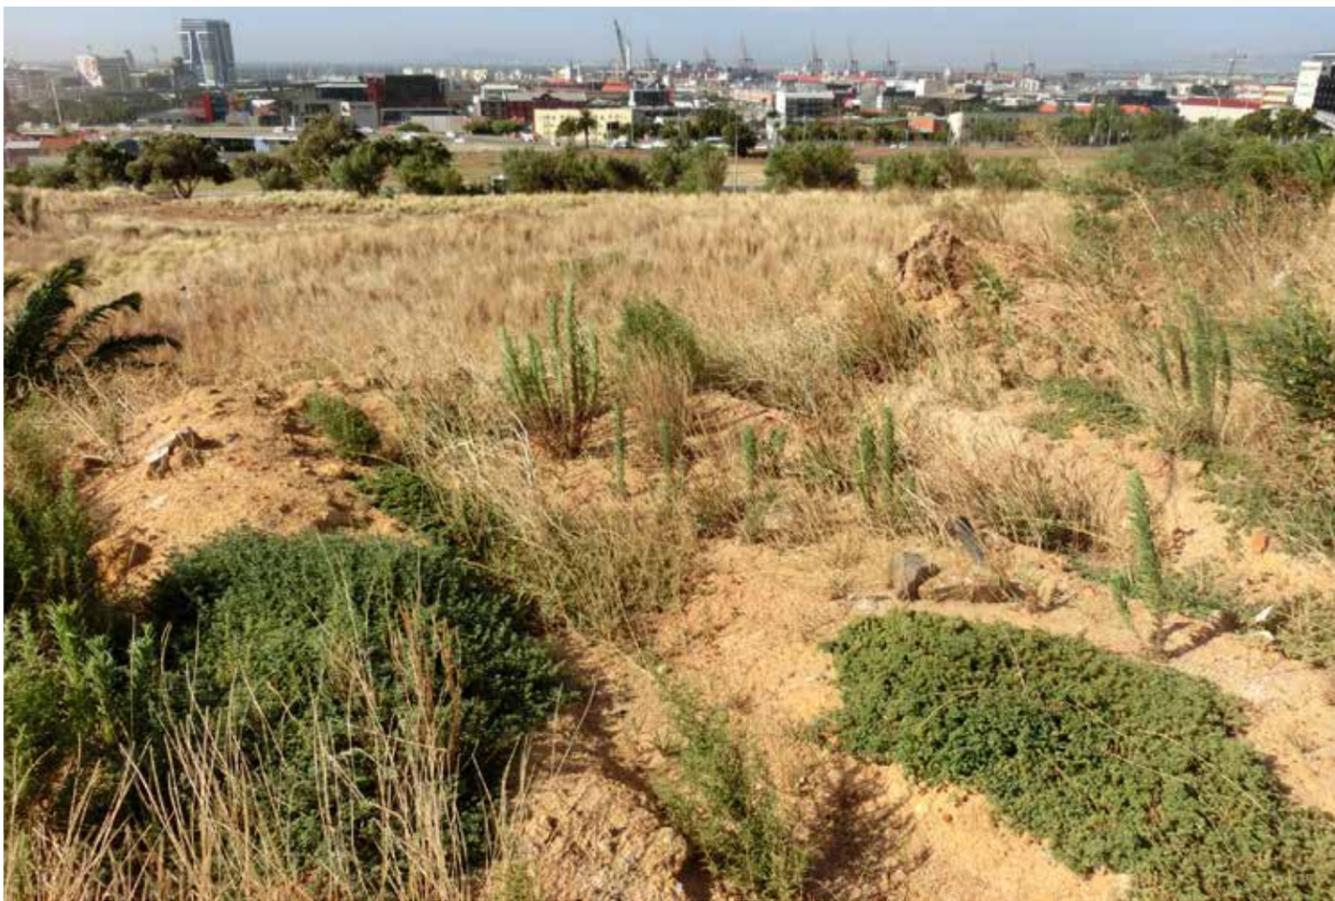
Figure 4. View across Parcel P from south east of site, view to north (RSA, 2020).

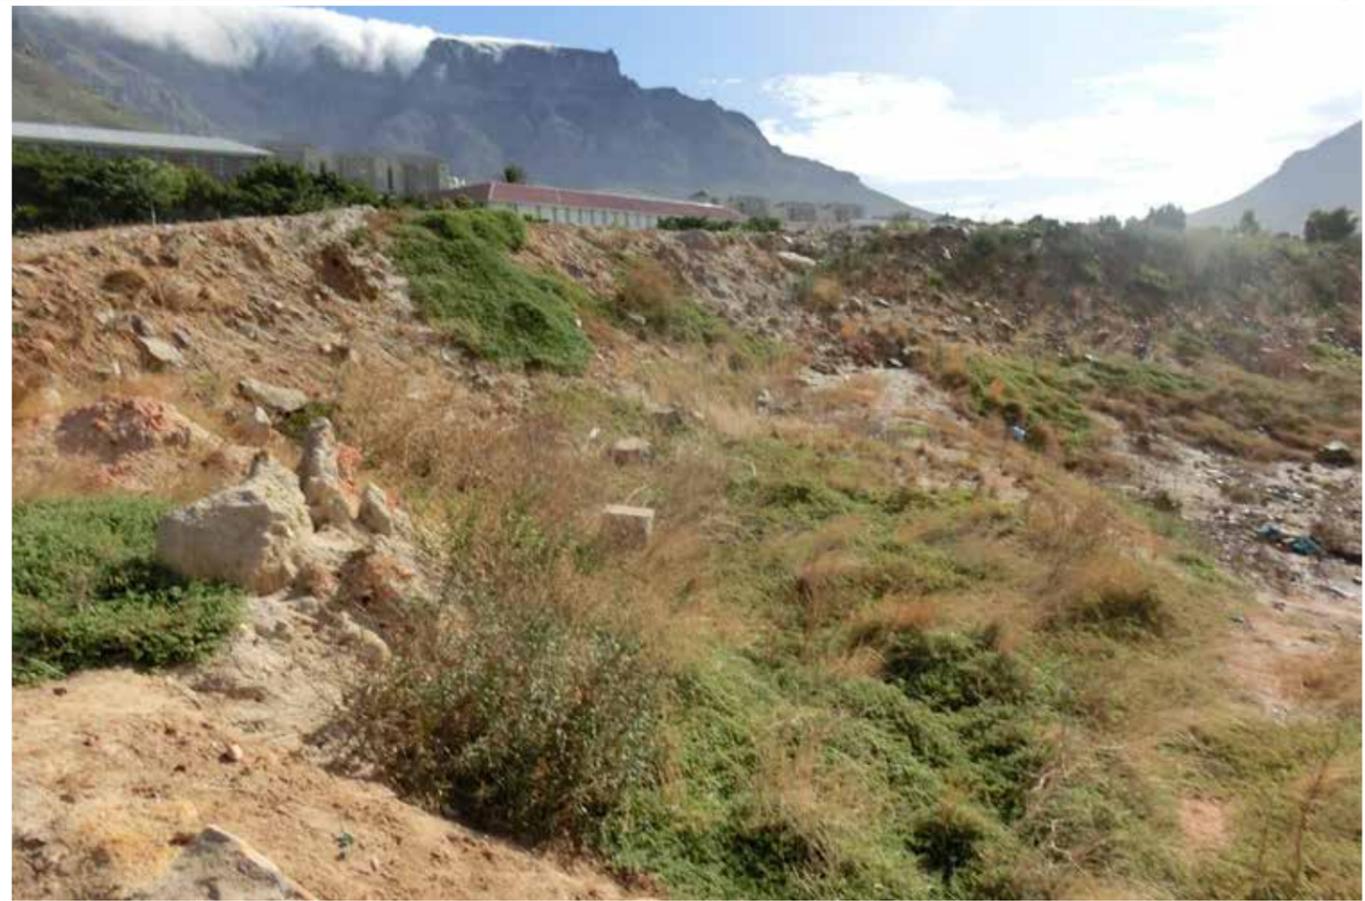
Figure 6. View across Parcel P from Vogelgezang Street showing recent changes in site levels (RSA, 2020).

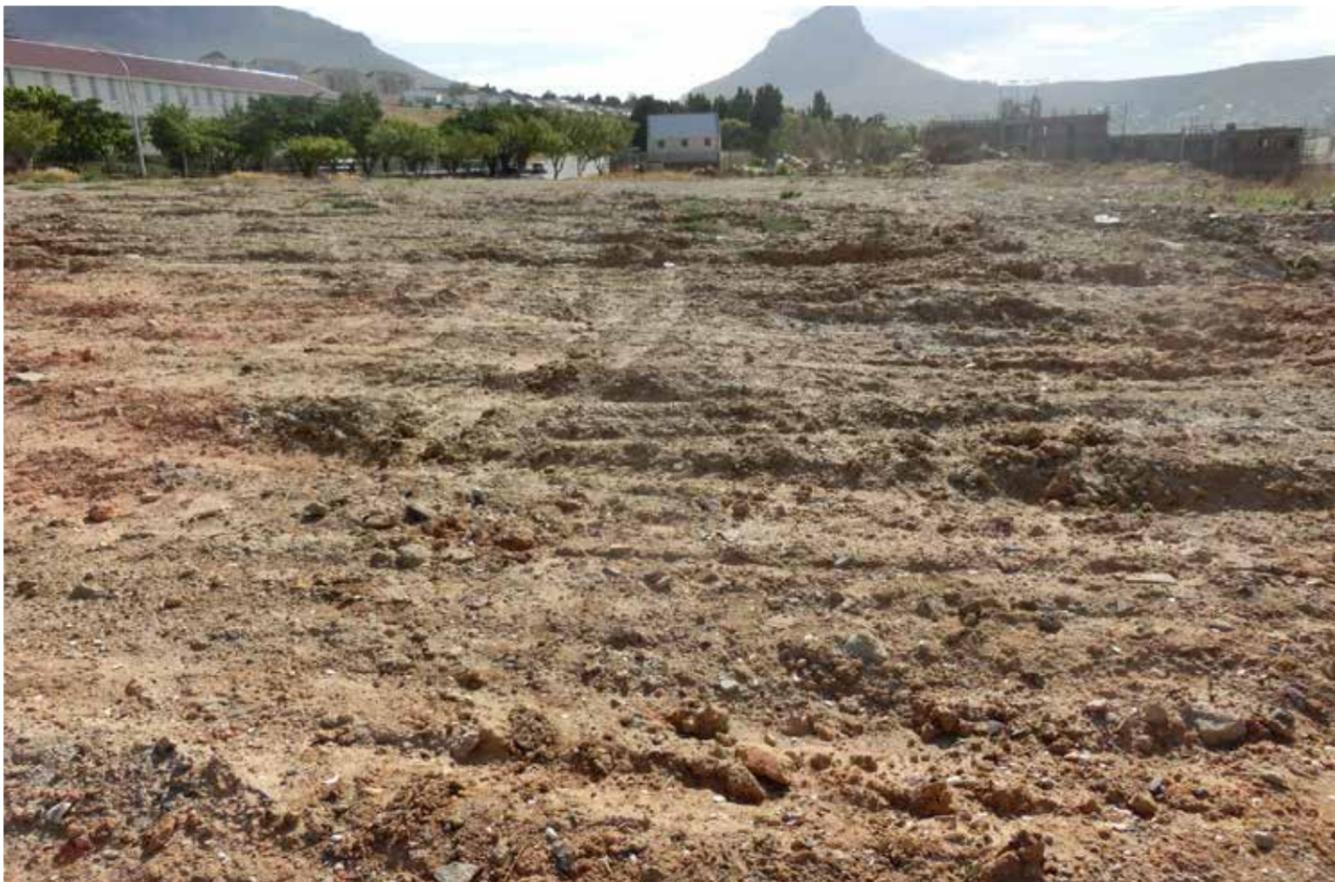
Figure 5. View across Parcel P from east of site showing recent earthmoving activity, view to west (RSA, 2020).

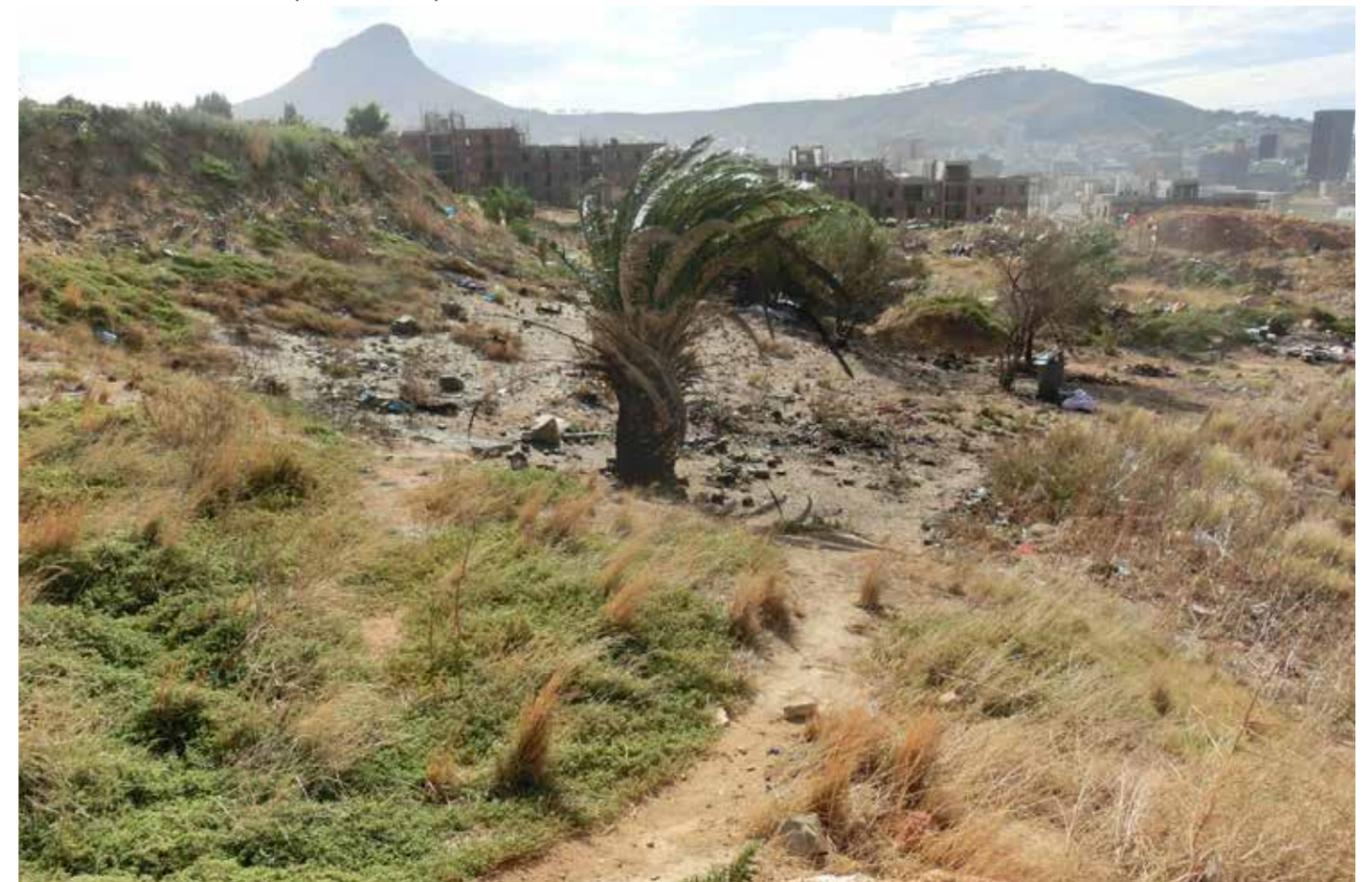
Figure 7. View across Parcel P from Vogelgezang Street, view to west (RSA, 2020).

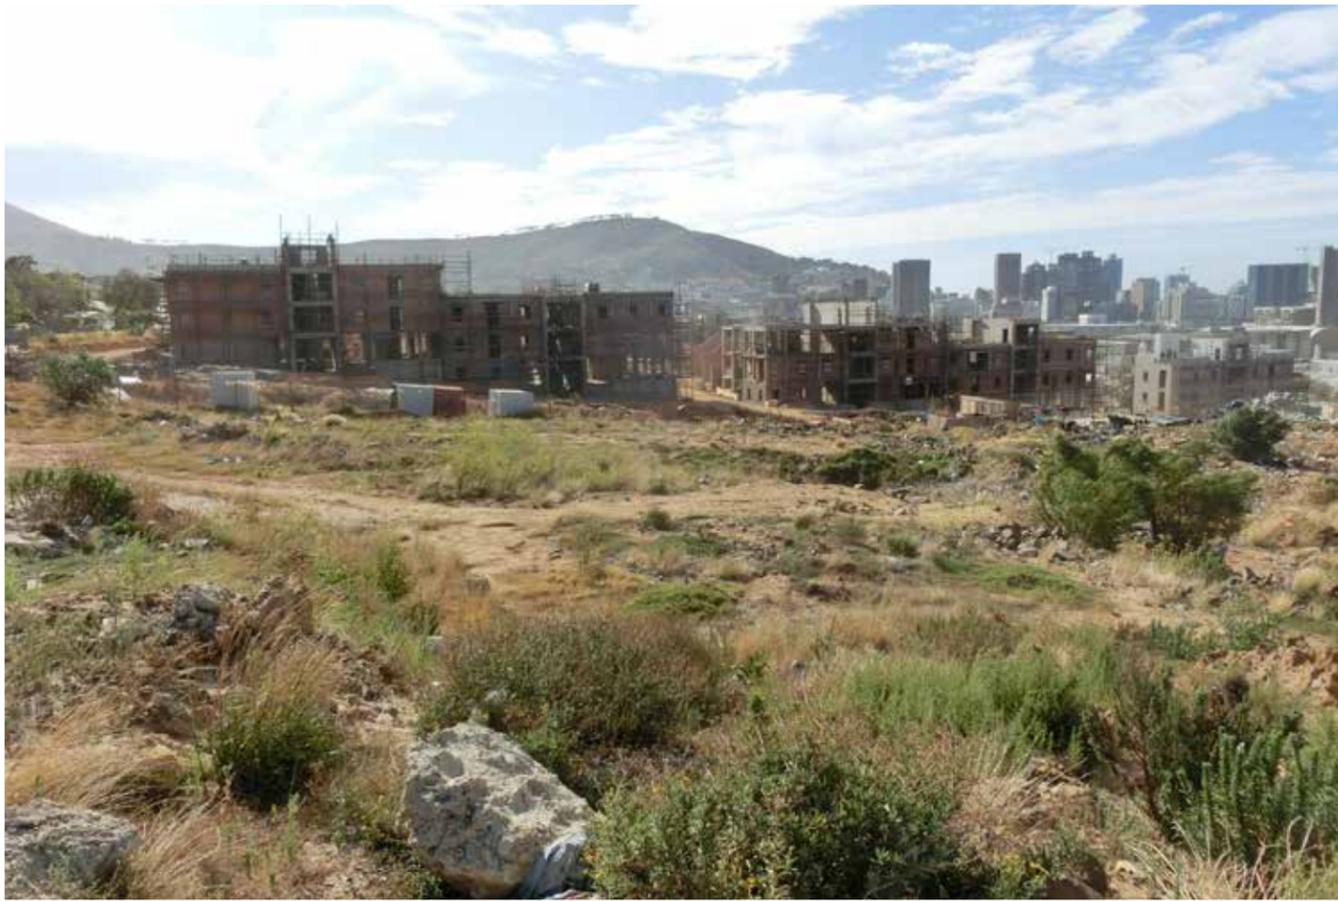
Figure 8. View of Phase 3 development beyond Parcel P, view to west (RSA, 2020).

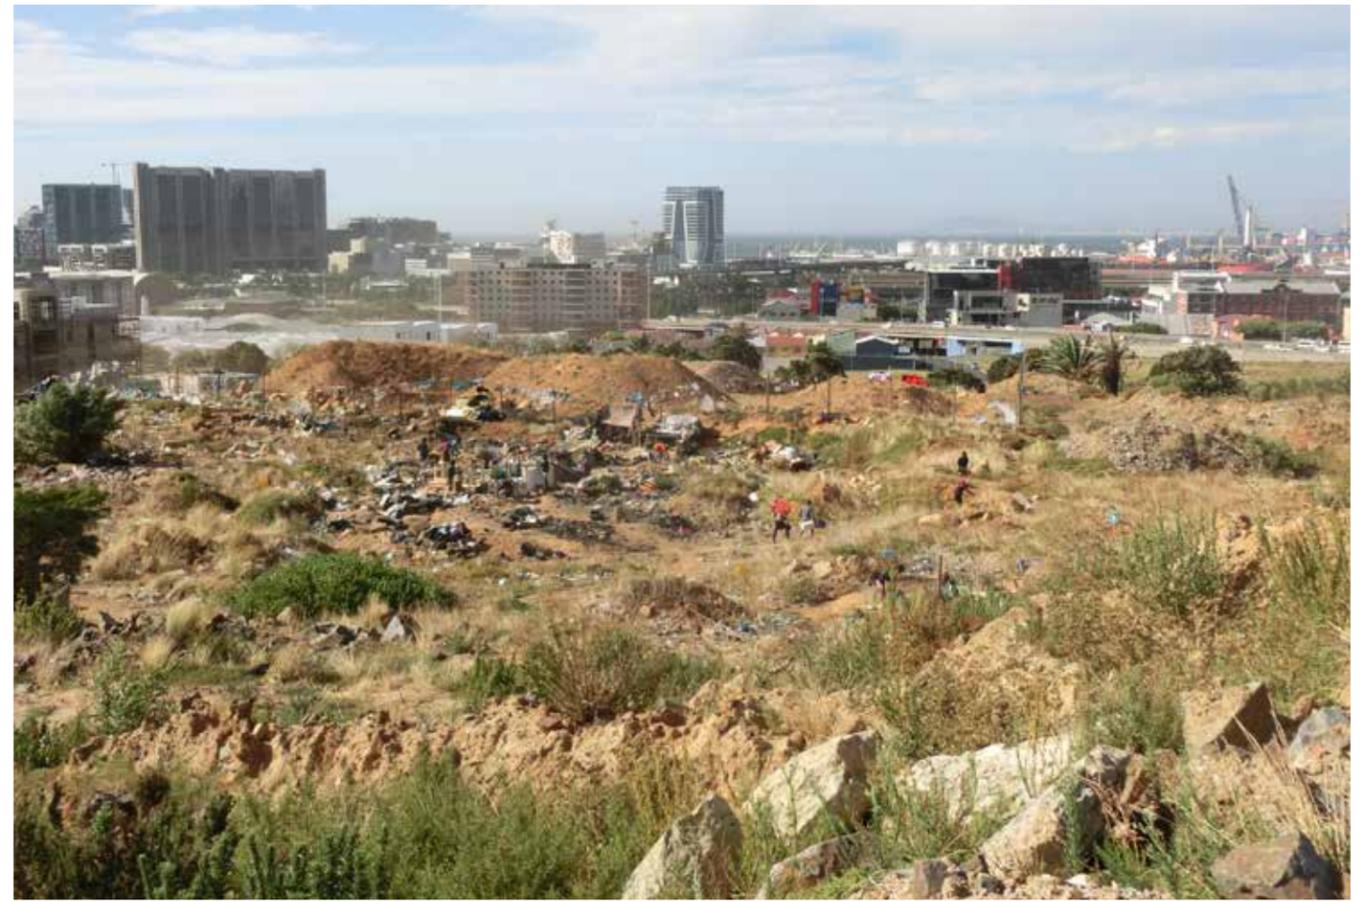
Figure 10. Disturbance across northern portion of Parcel P related to development of Phase 3, view to north west (RSA, 2020).

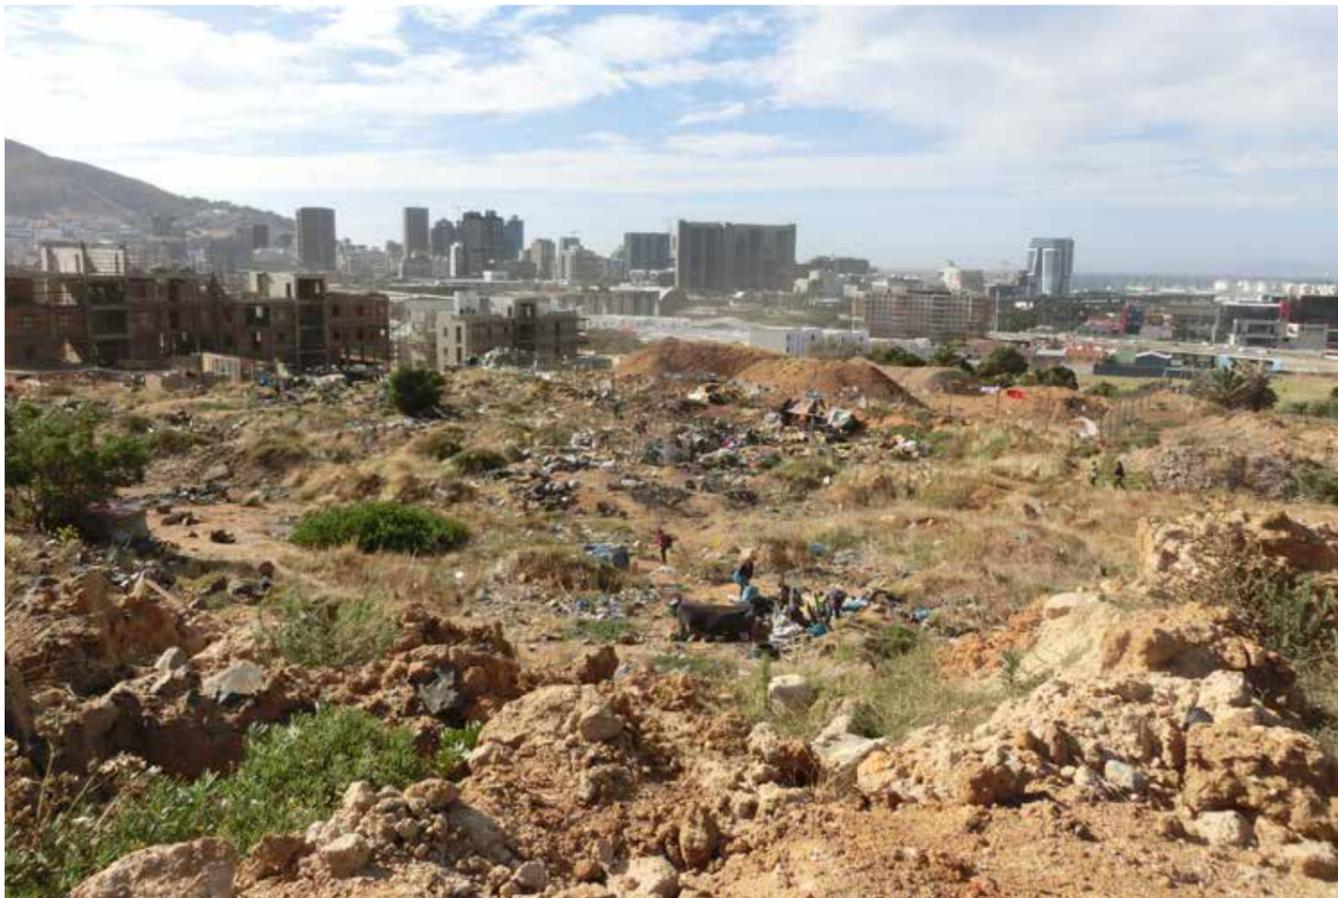
Figure 9. Evidence for extensive disturbance on Parcel P, view to north west (RSA, 2020)

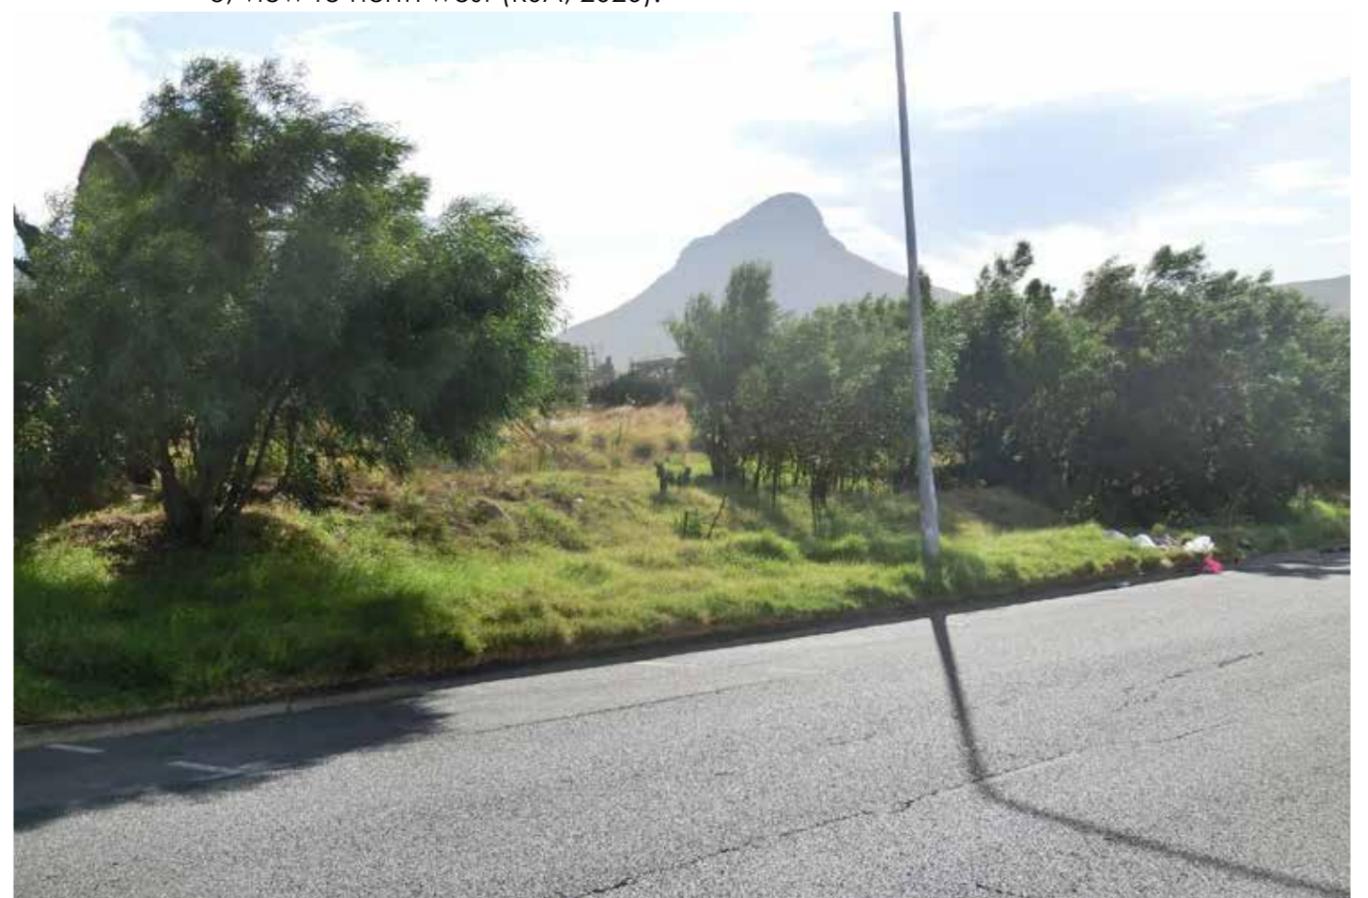
Figure 11. Embankment along what is now Hanover Street, view to south west (RSA, 2020).

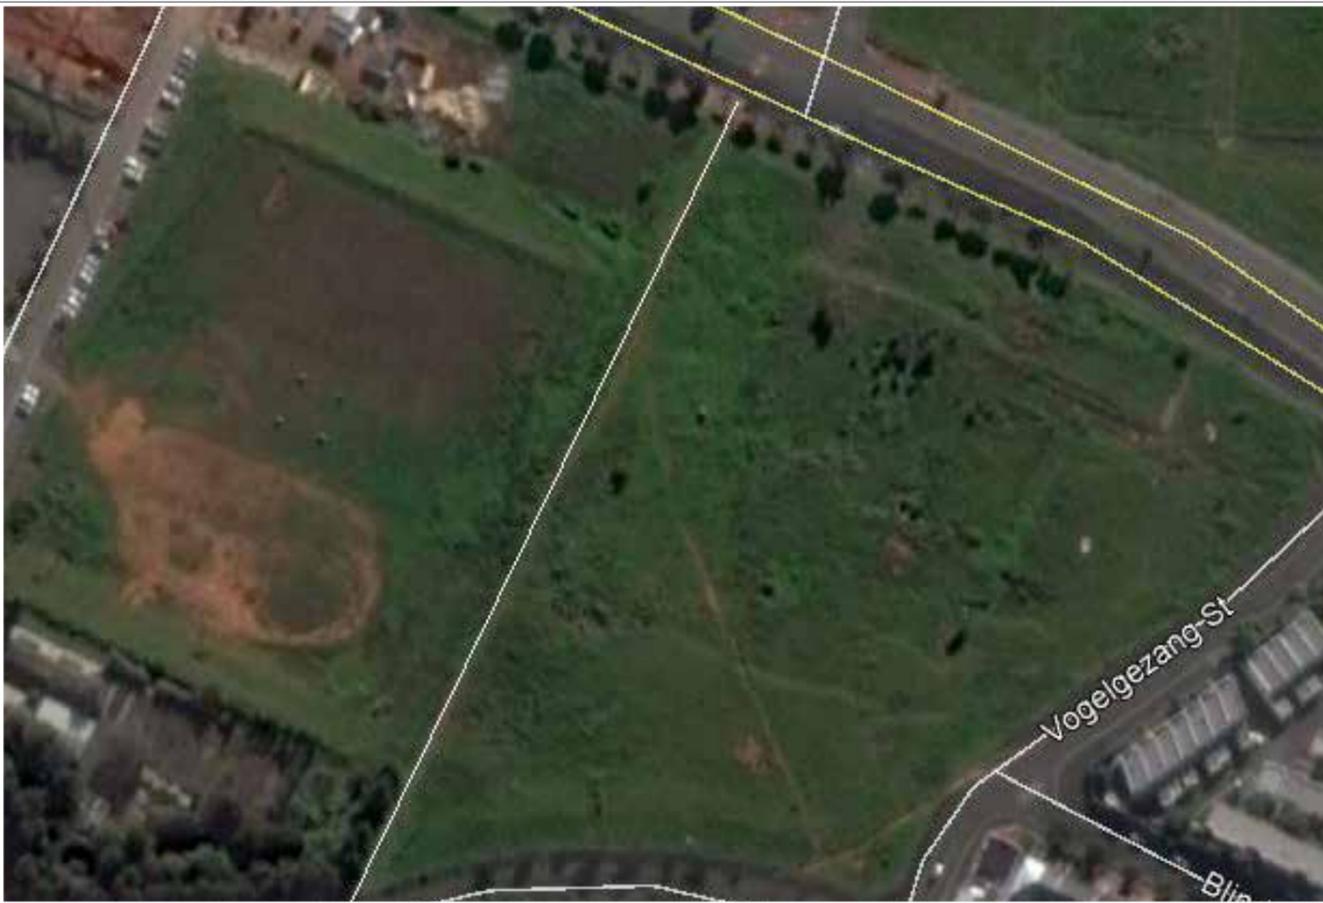
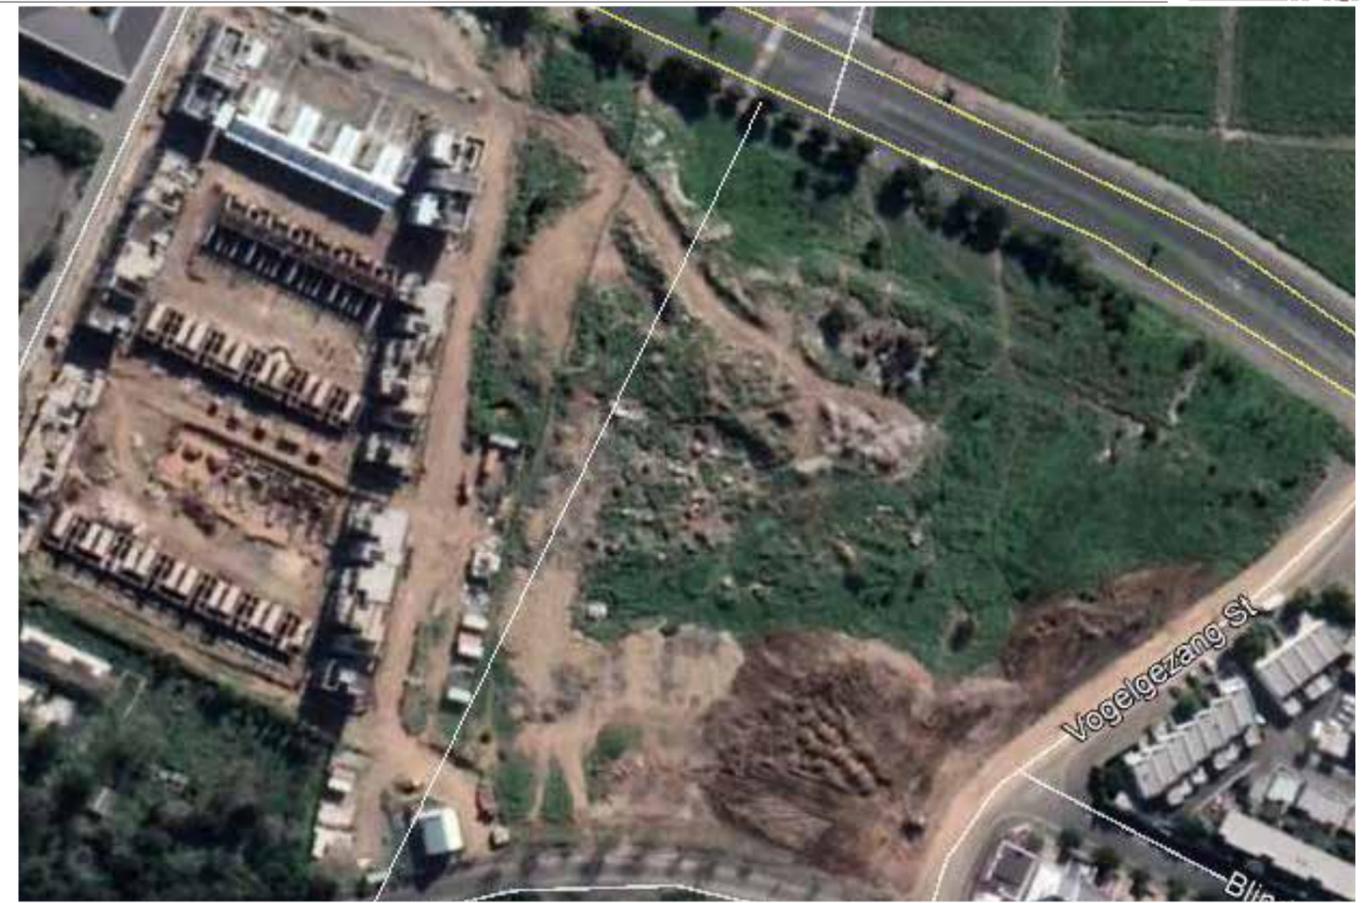
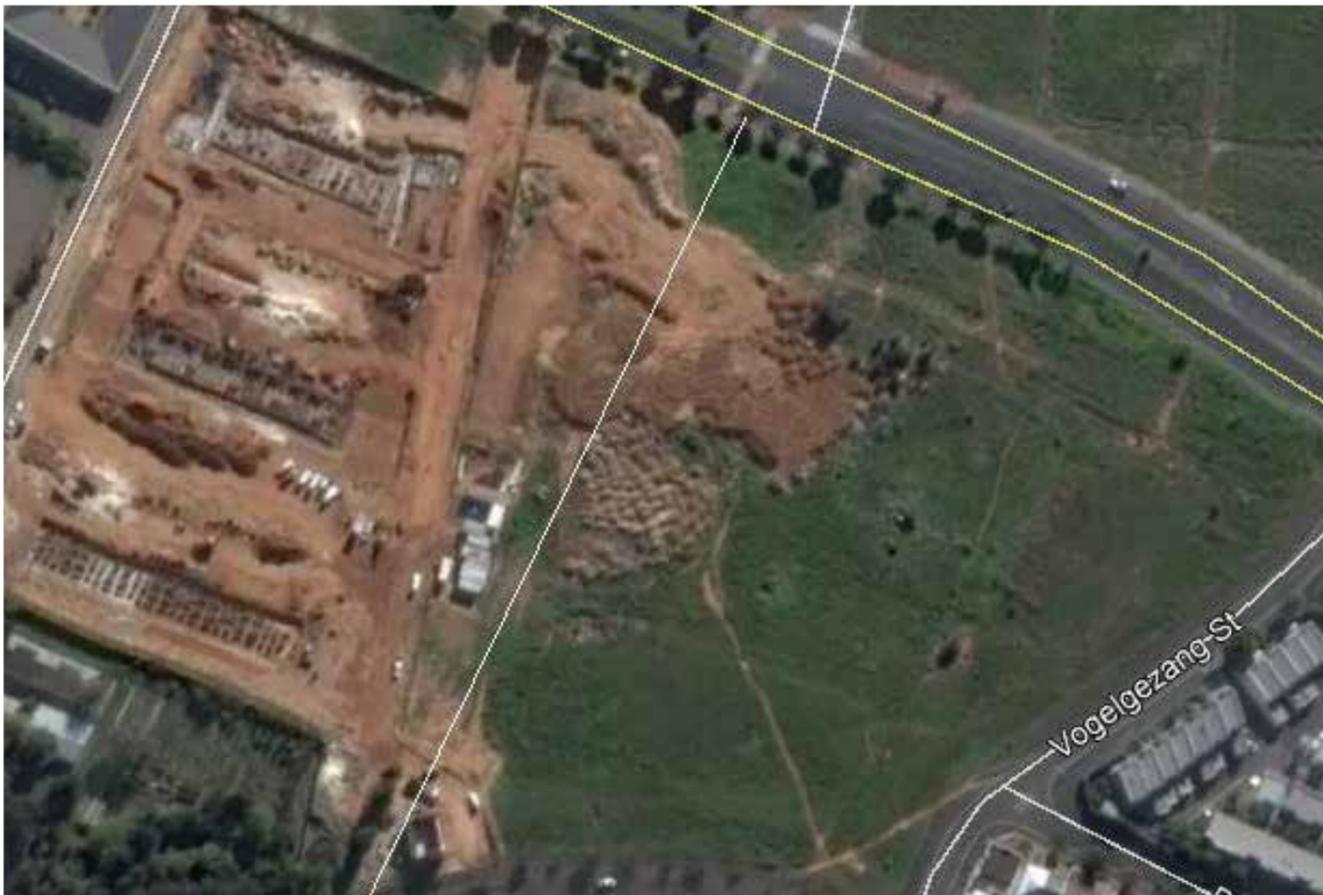
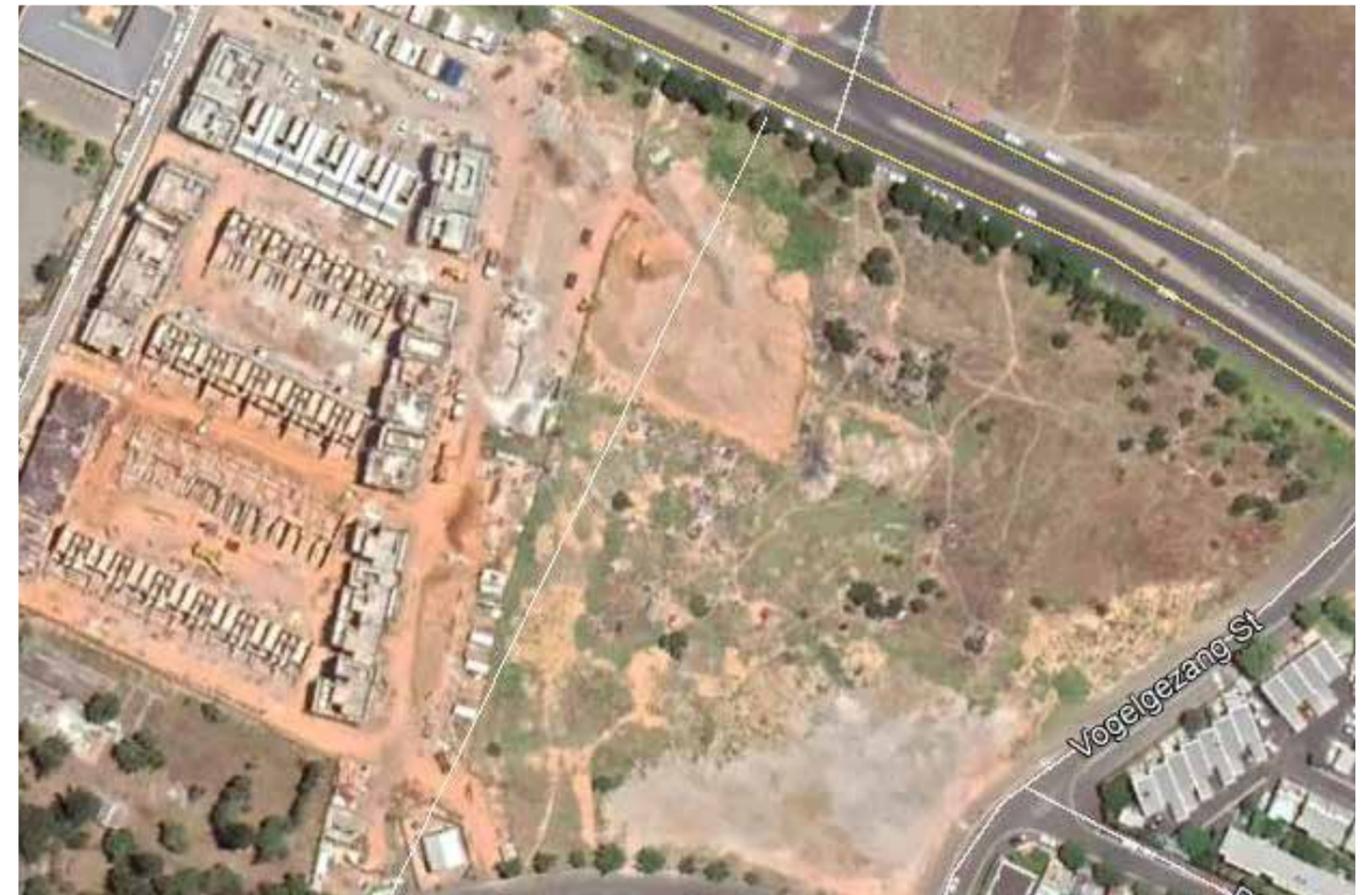
Figure 12. Evidence for disturbance of Parcel P through time as a result of development activity on the adjacent site, Block Q2.. Google Images are: top left, June 2014; bottom left June 2016; top right July 2018; bottom right, November 2019 (Google Earth, 2020)

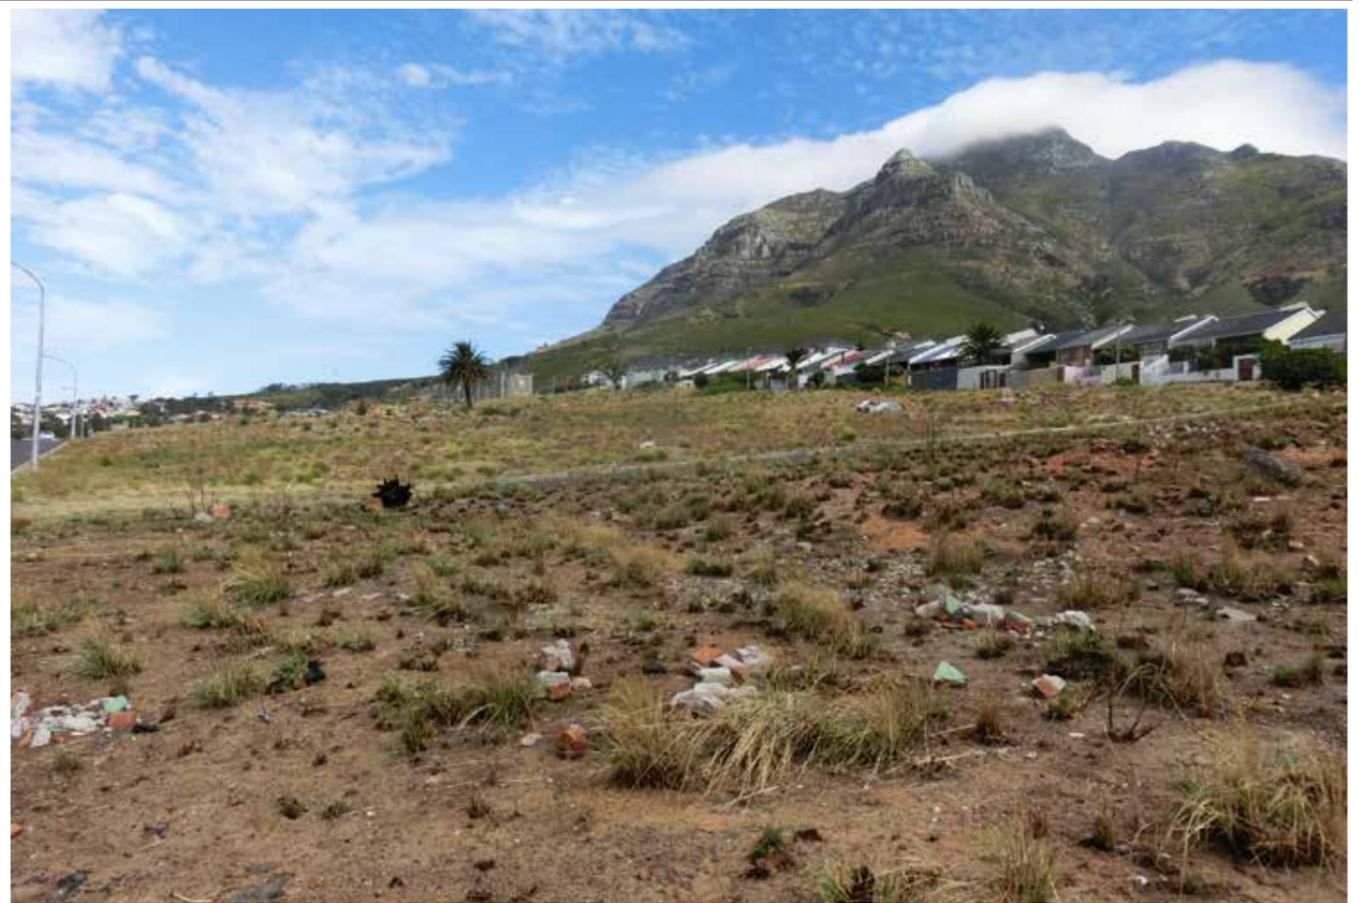
Figure 16. View across Parcel N from Constitution Street west of Clifton Street, view to south east (RSA, 2020).

Parcel N is a steeply sloping site, with variable evidence for preservation and some clear signs of disturbance, although it displays fairly good preservation of the historic street system throughout (Figure 16 to Figure 21). In some places, particularly the higher lying areas along the southern extent, have been scraped to below pavement level, revealing the natural substrate of ferruginous gravels. In other places, however, remnants of terracing, cement surfaces, wall foundations, floor slabs and kerb stones are all visible, showing greater retention of historic fabric and layers.

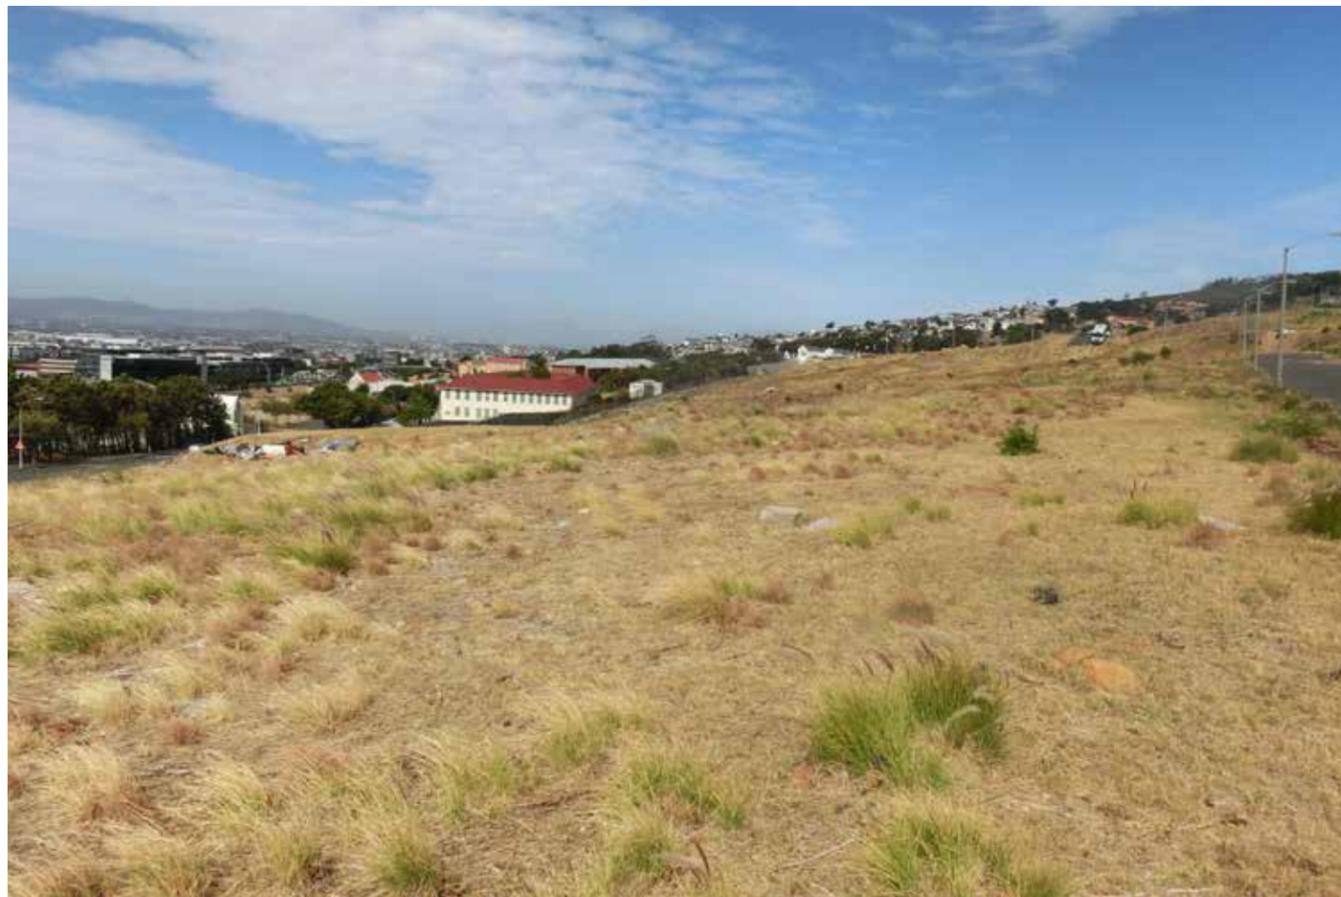
Figure 15. View across Parcel N from east of Richmond Street, view to east (RSA, 2020).

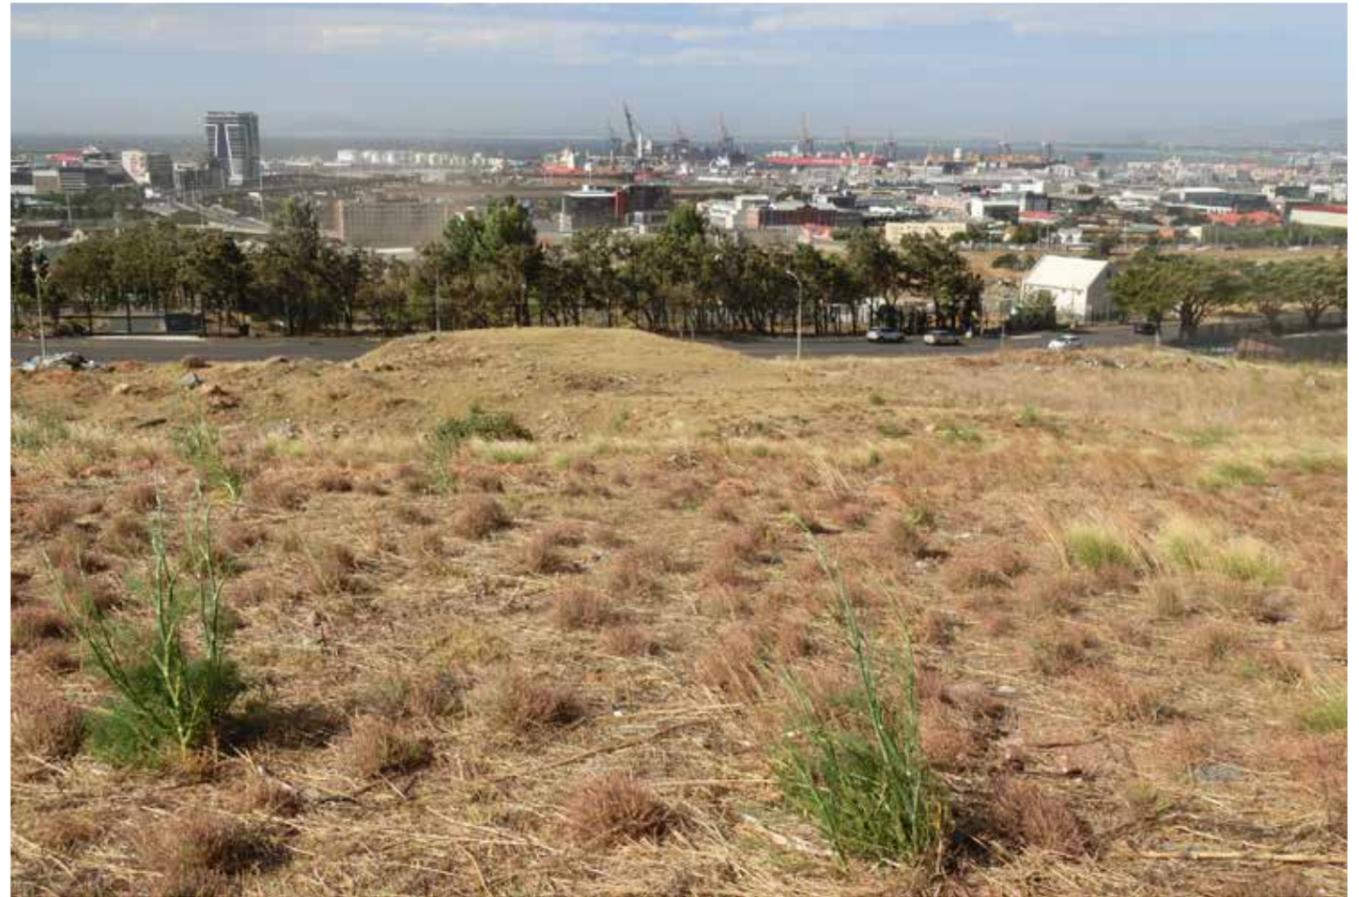
Figure 17. View across Parcel N from west of Horstley Street, view to north east (RSA, 2020).

The site retains evidence for past earthmoving activities, particularly to the east, near Horstley Street, where there is a large, regular mound that appears level on top as though it were utilised by dump trucks for depositing large quantities of rubble (Figure 17 and Figure 19). This could reflect 1960s activities related to clearance of the wider site, or be evidence for more recent activity. Squatters have erected shacks across the central portion of site (Figure 15 and Figure 18). Shacks are particularly erected where topography provides shelter from the southeaster, and it looks as though some digging activity has occurred to create such shelter where there was none.
