TABLE OF CONTENTS

1.0. INTRODUCTION

1.1. Purpose of Report

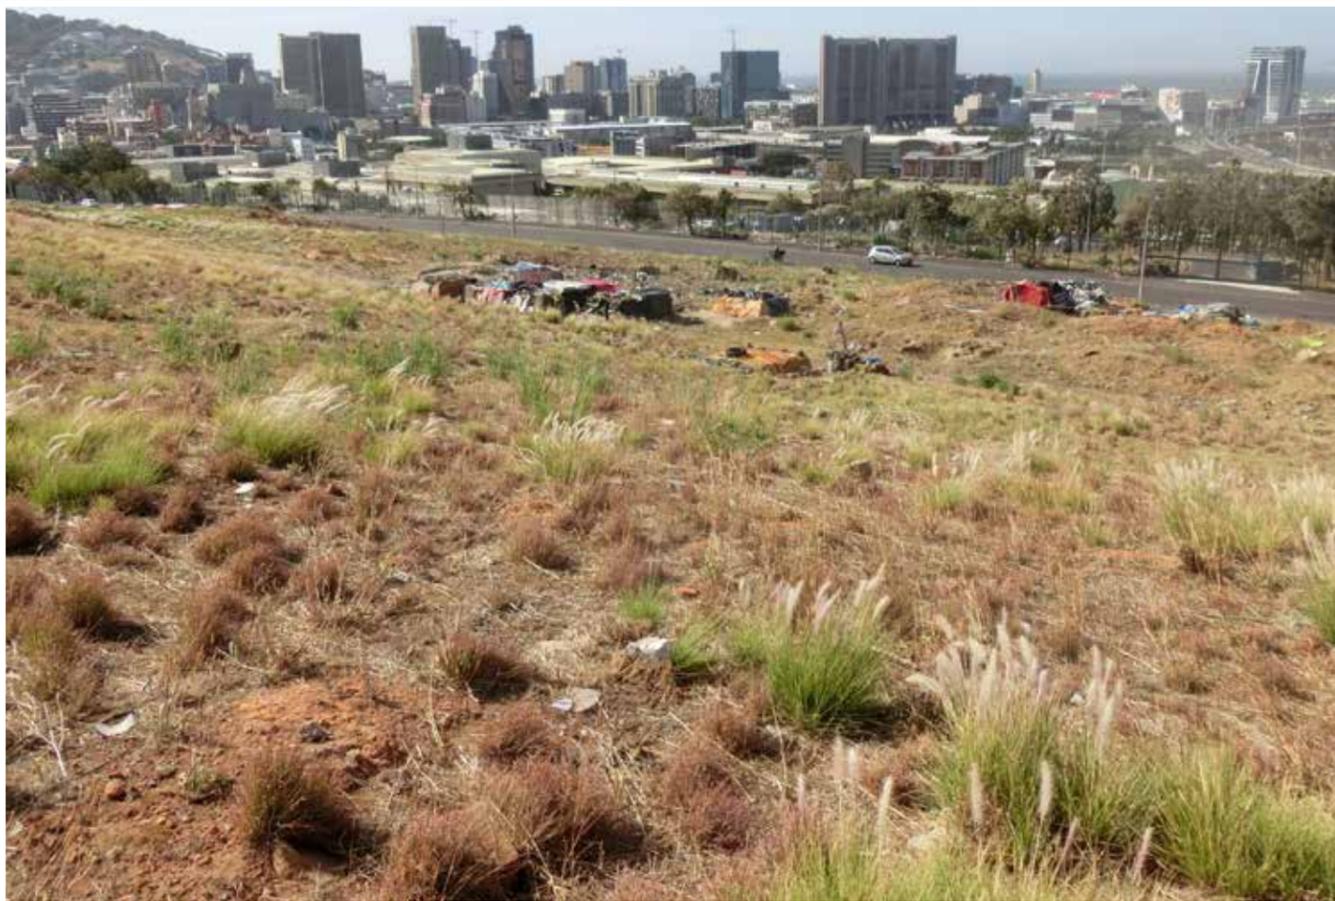
Figure 18. View across shacks erected on Parcel N, view to north (RSA, 2020).

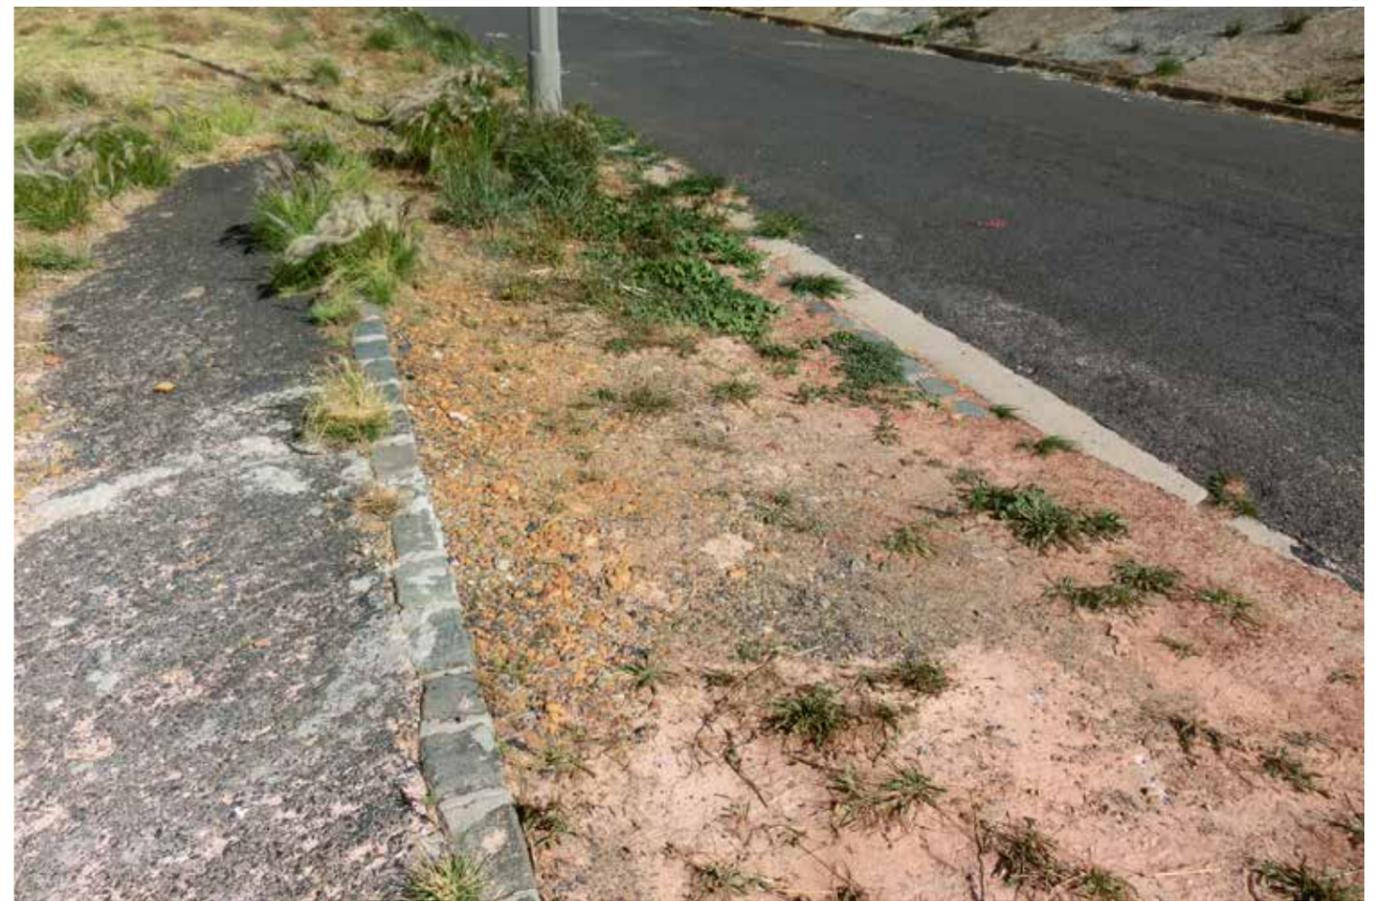
Figure 20. Old road edgings and alignments with preserved pavement levels, presumably of Upper Constitution Street, along Justice Walk, view to east (RSA, 2020).

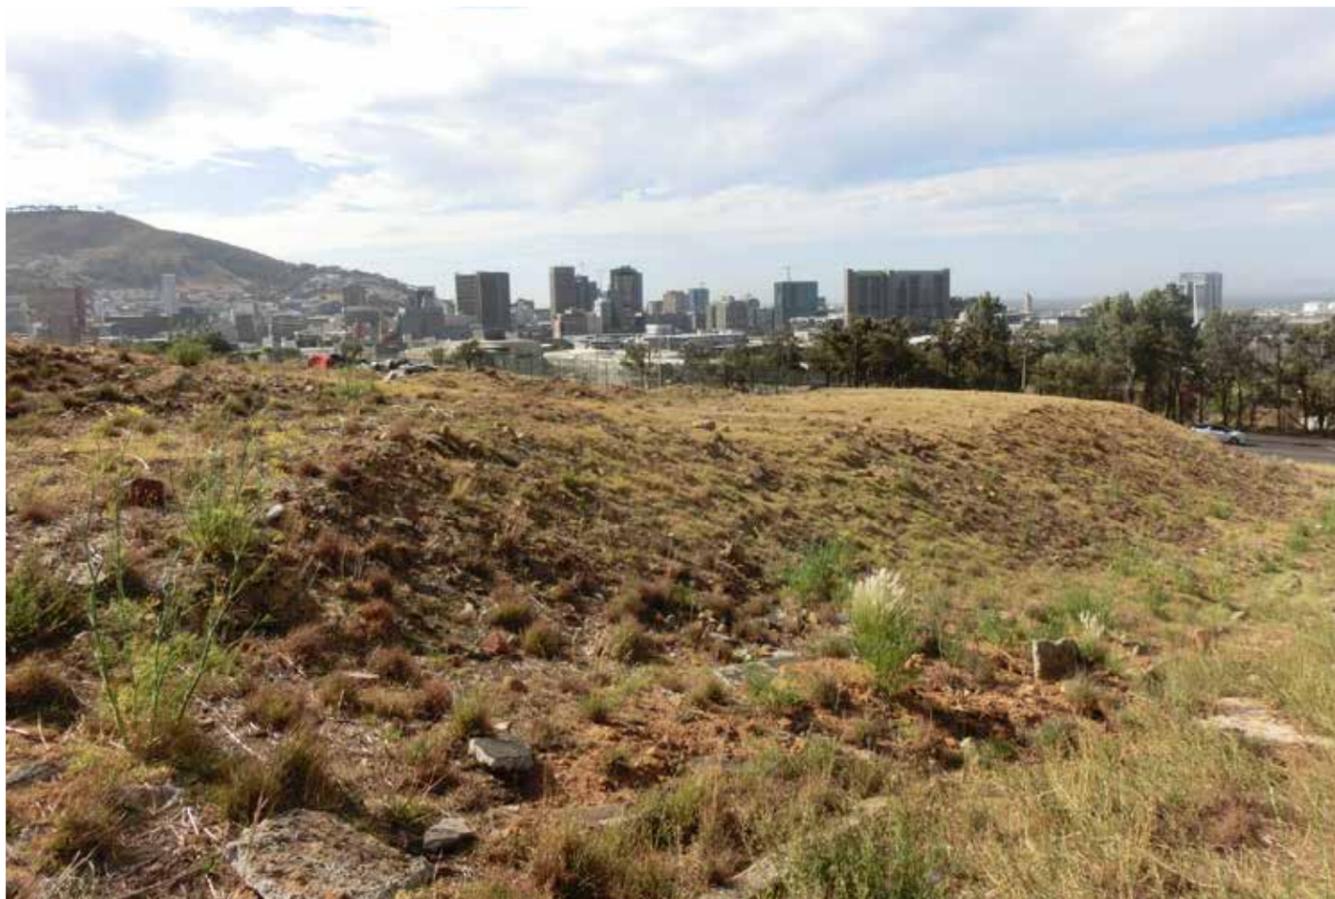
Figure 19. Evidence for past dumping and earthmoving across site (RSA, 2020).

The site retains evidence for past earthmoving activities, particularly to the east, near Horstley Street, where there is a large, regular mound that appears level on top as though it were utilised by dump trucks for depositing large quantities of rubble (Figure 17 and Figure 19). This could reflect 1960s activities related to clearance of the wider site, or be evidence for more recent activity. Squatters have erected shacks across the central portion of site (Figure 15 and Figure 18). Shacks are particularly erected where topography provides shelter from the southeaster, and it looks as though some digging activity has occurred to create such shelter where there was none.

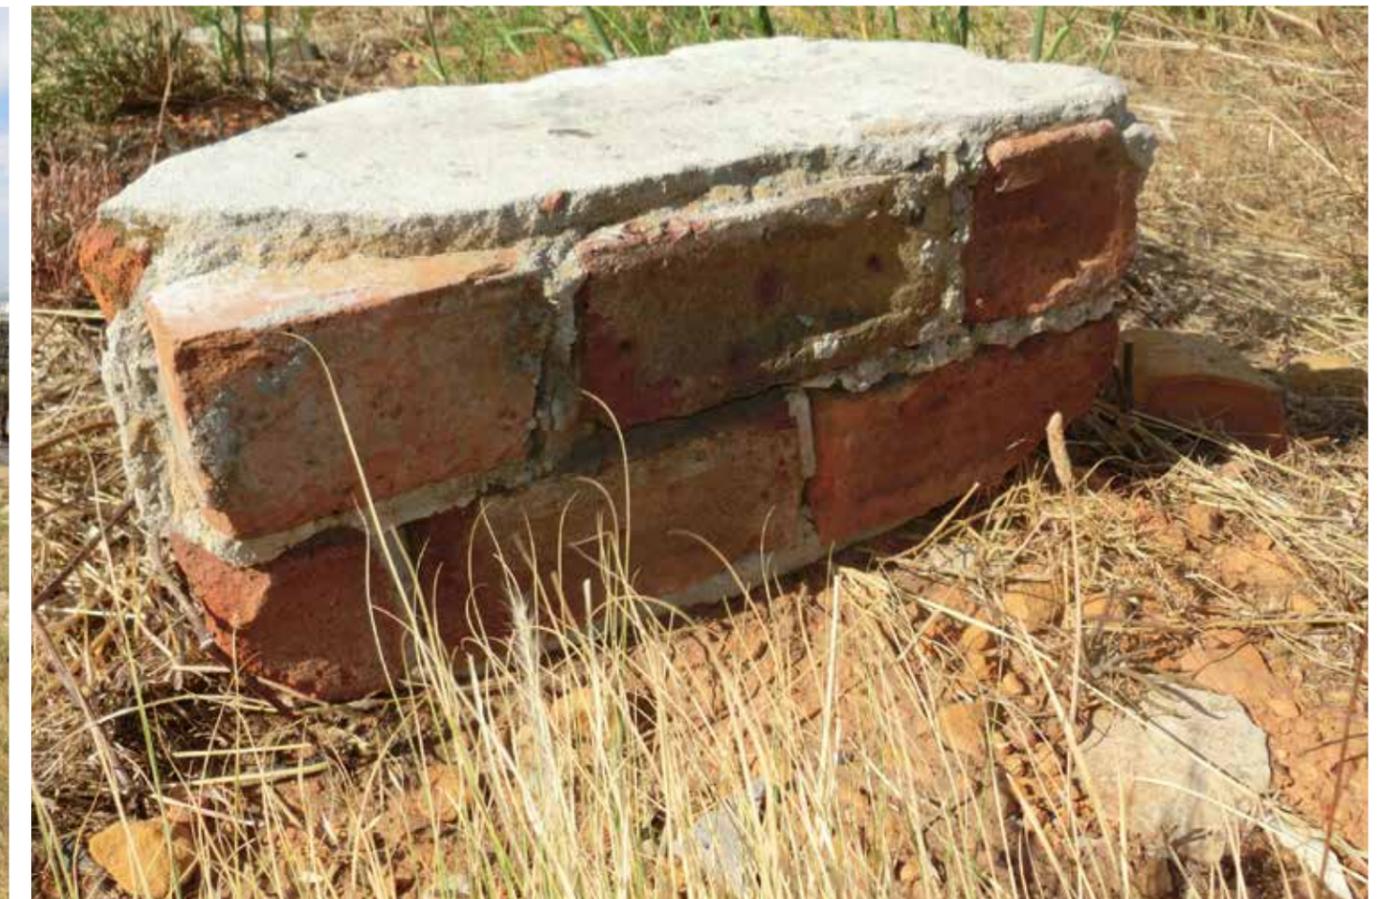
Figure 21. Historic building debris, with frogged bricks, likely early C20th (RSA, 2020).

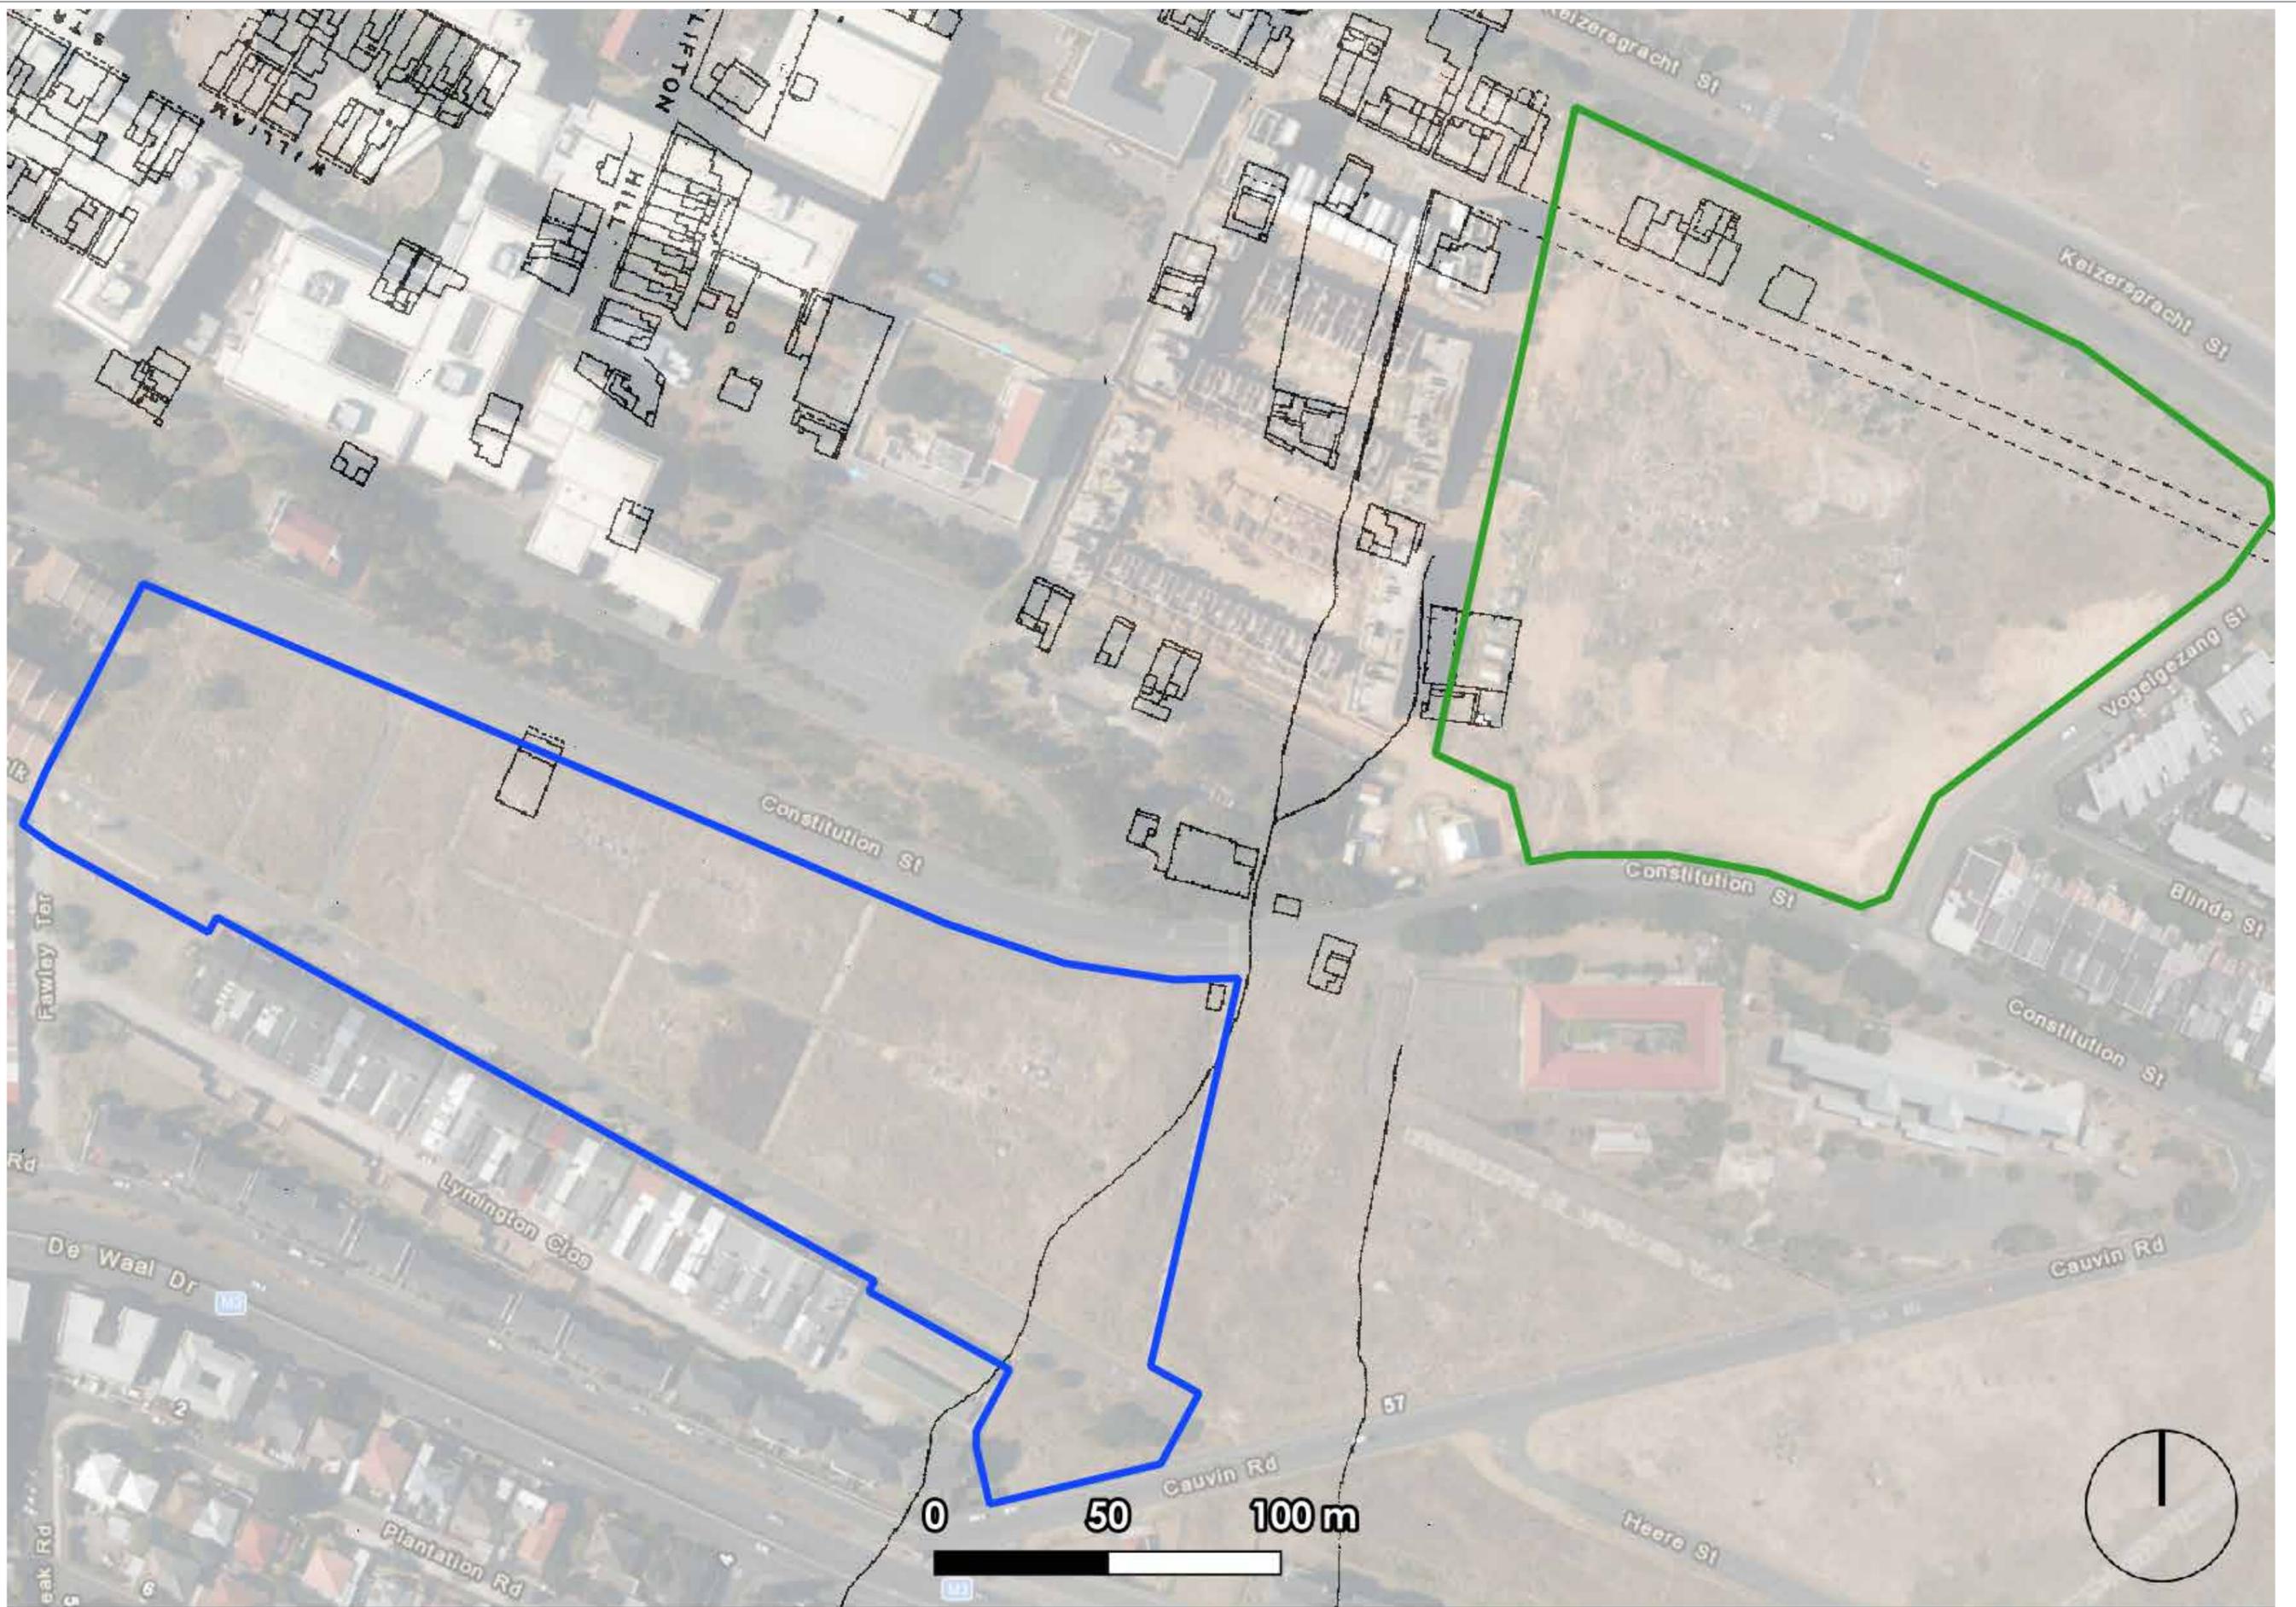
Figure 22. Overlay showing degree of development in and around the development areas at the time of Snow's survey in 1860 (RSA, 2020).

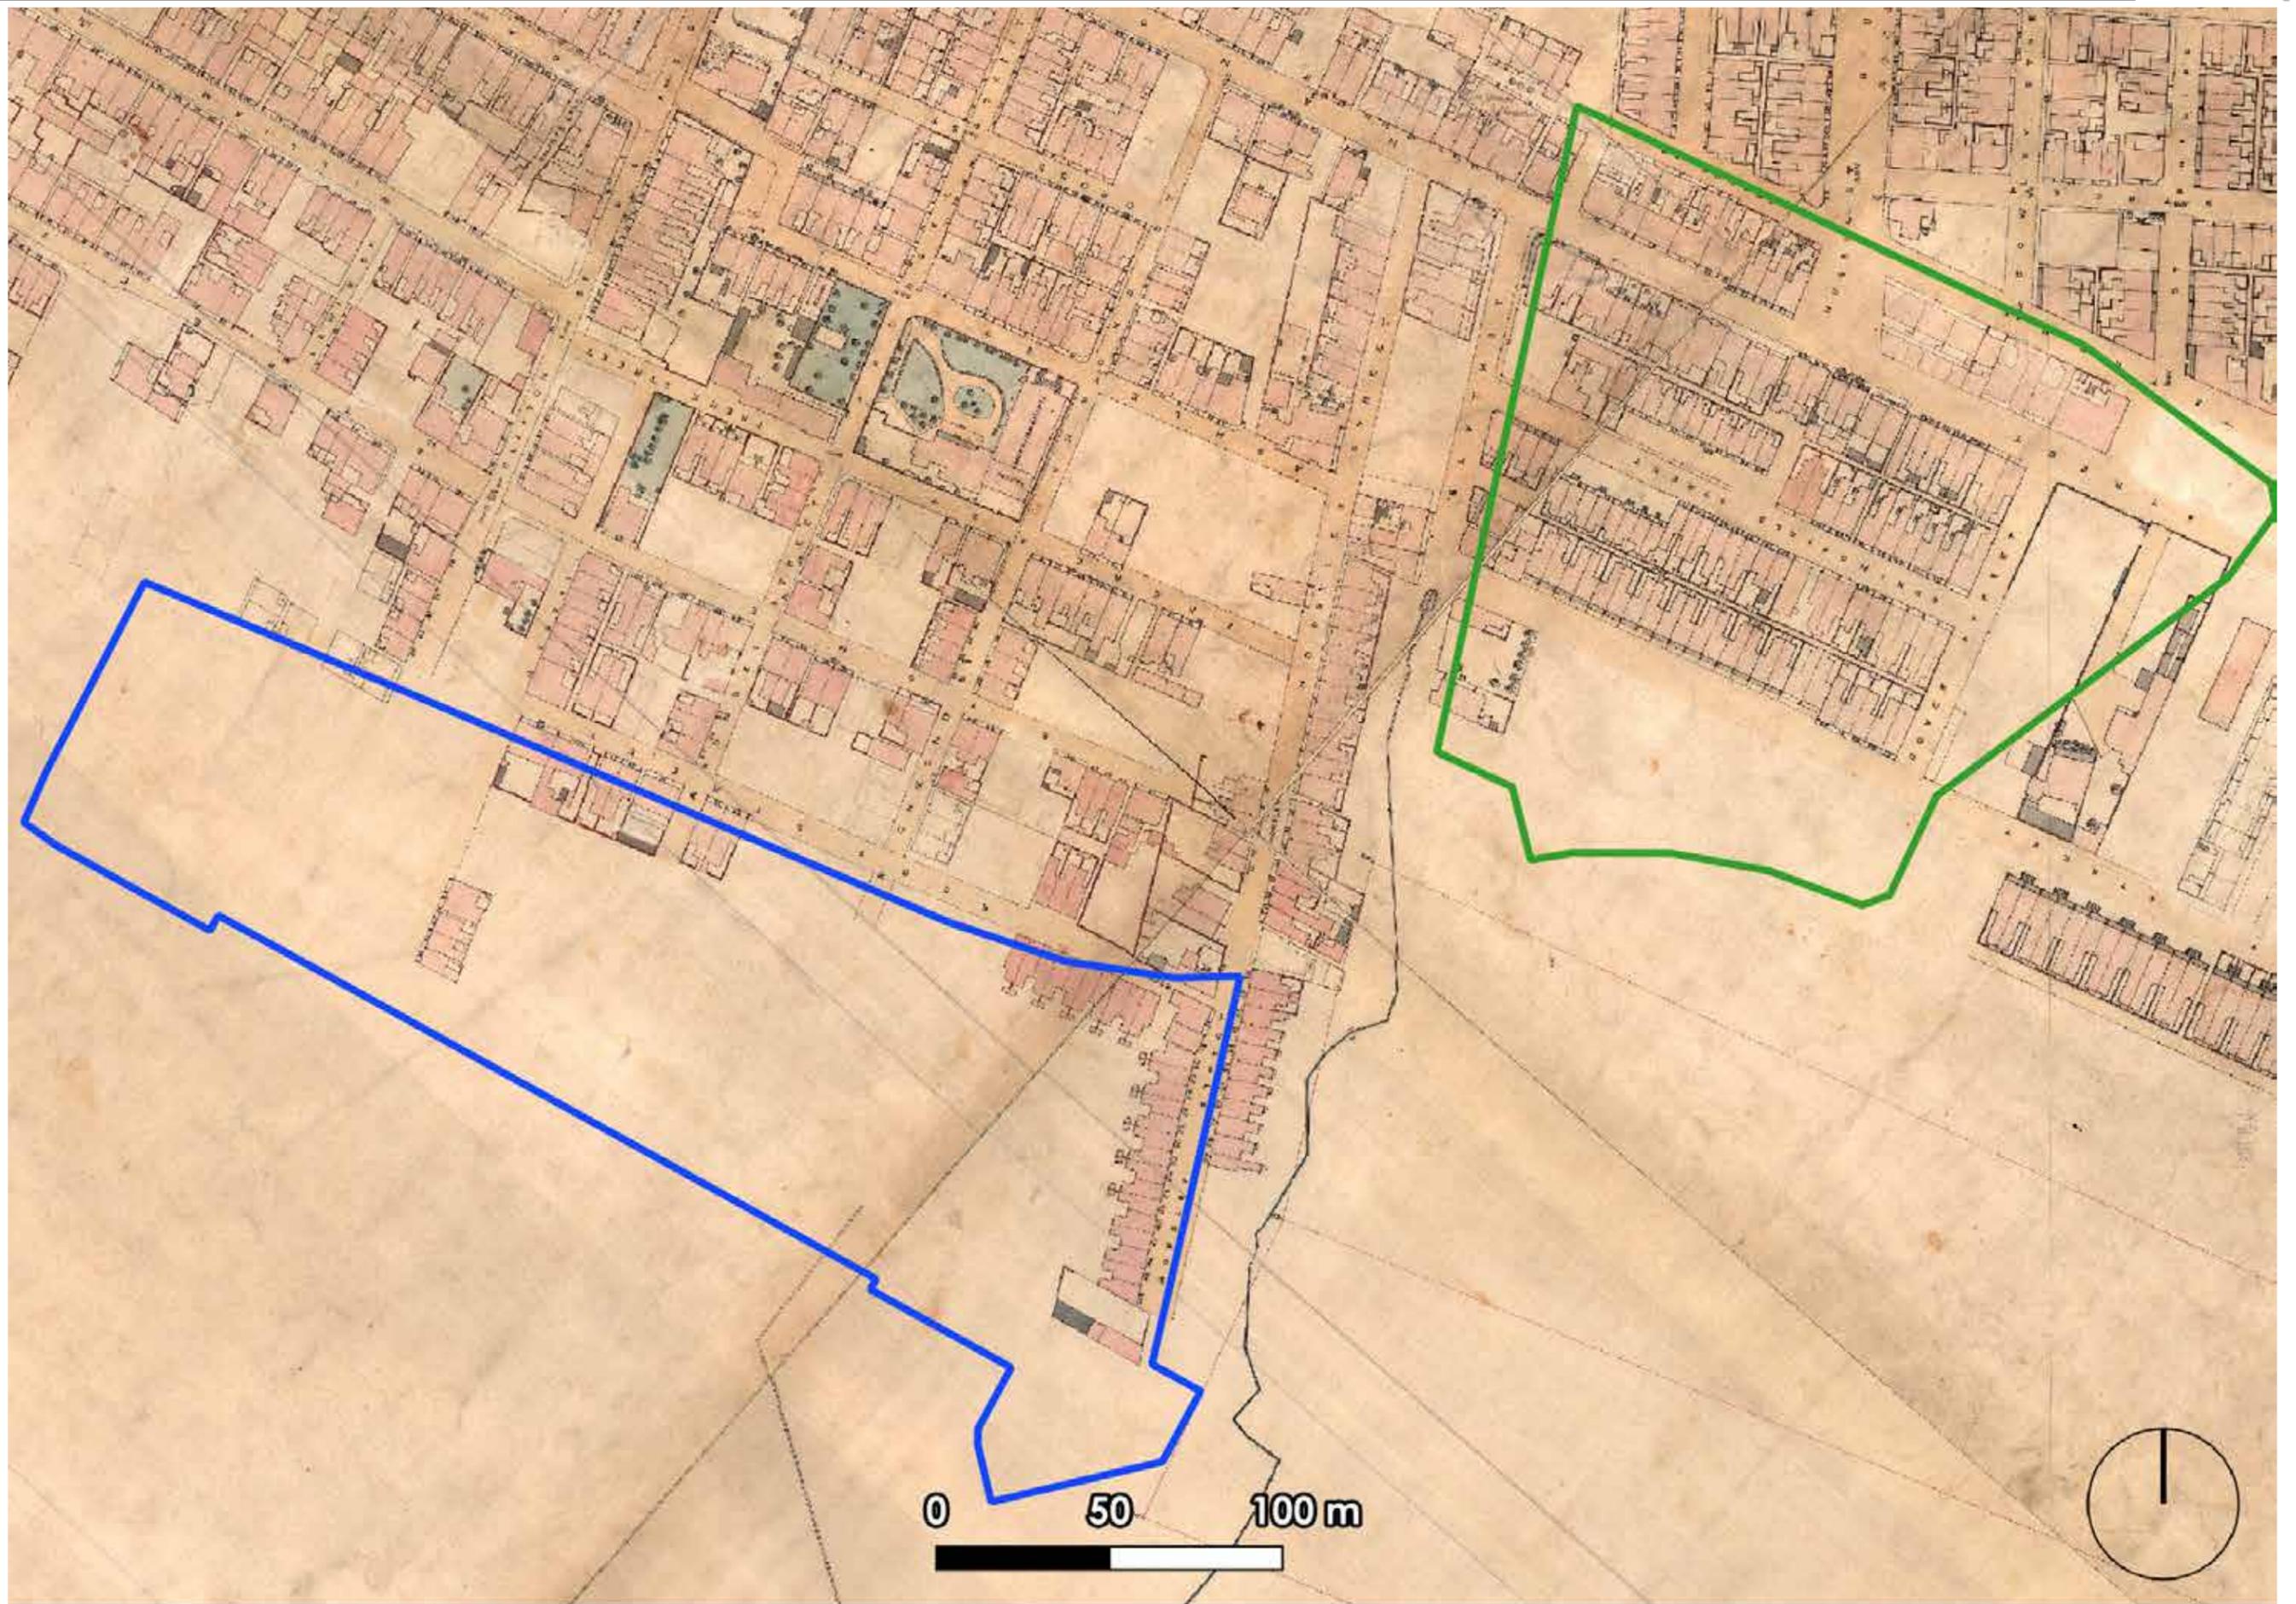
Figure 23. Overlay showing degree of development in and around the development areas at the time of Thom's survey in 1898 (RSA, 2020).

By the time of Thom's survey in 1898, rows of houses were aligned along Horstley, with clusters of development along Rose Street, in some places (Figure 23 and Figure 27). A further isolated cluster of houses was located above Rose Street along Lewis Street. This extent of development remained largely unchanged by 1926 (Figure 28).

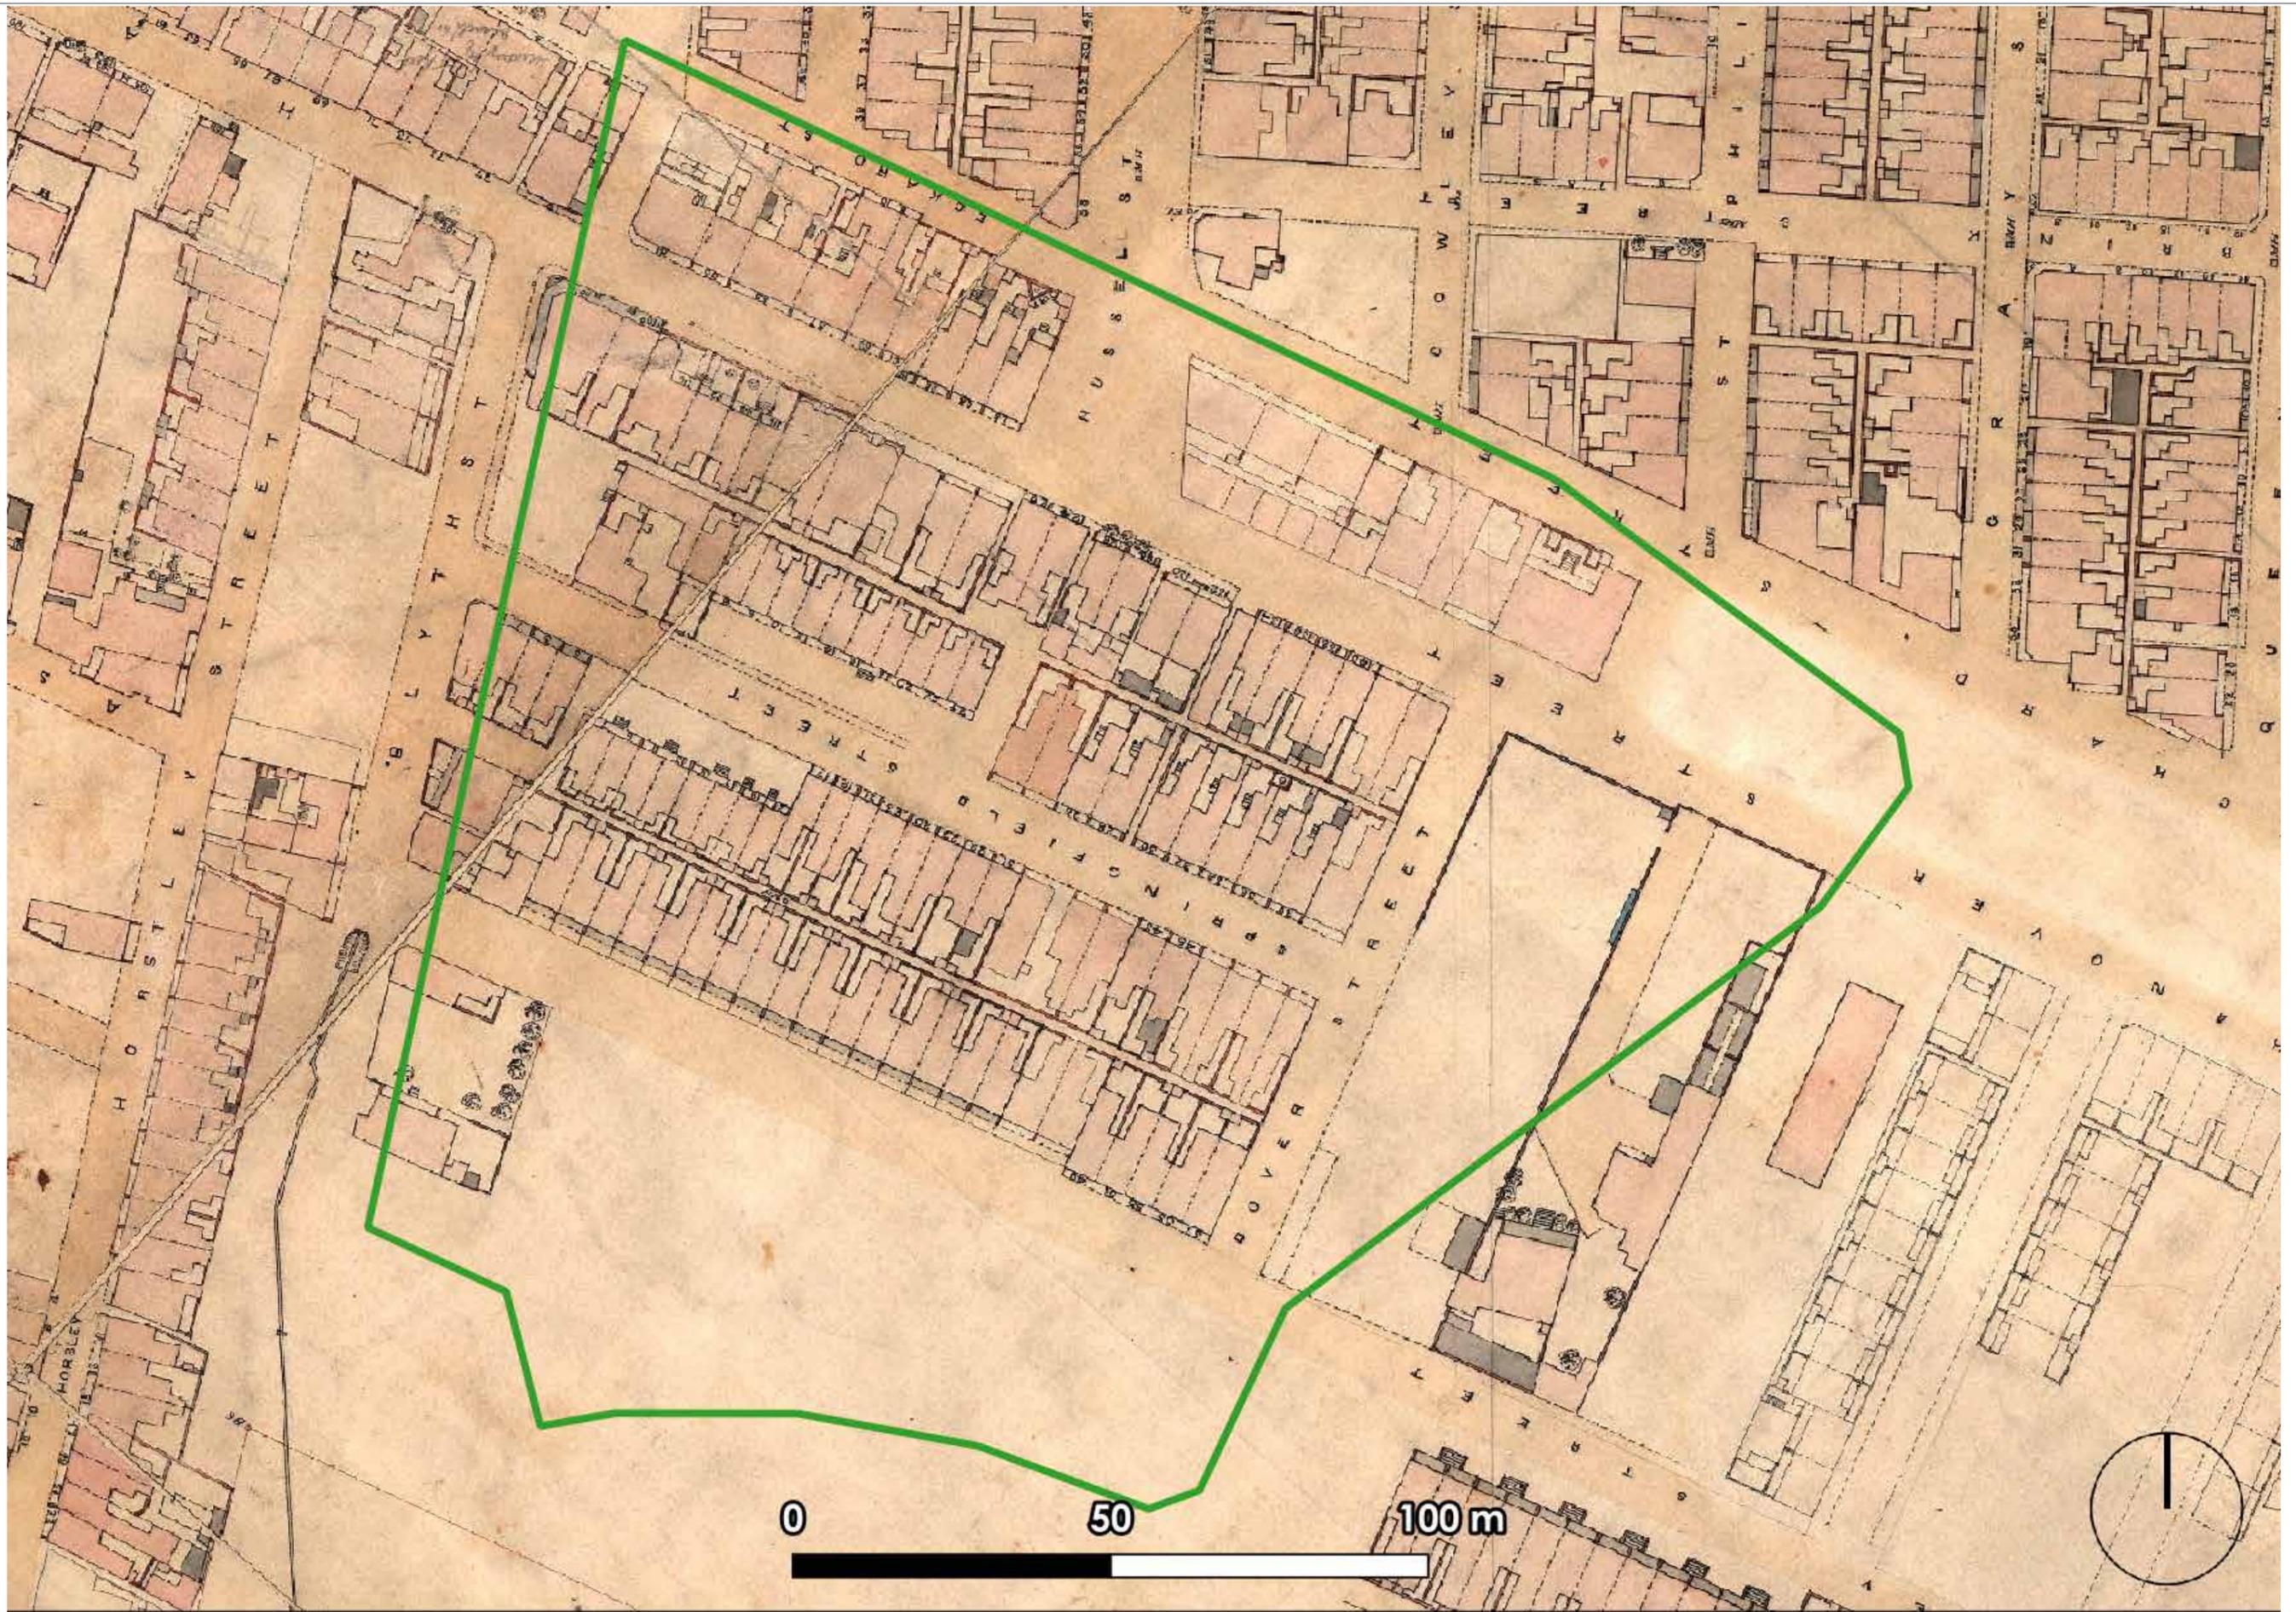
Figure 24. Detail of 1898 Thom survey showing the layout of structures and roads within Parcel P (RSA, 2020).

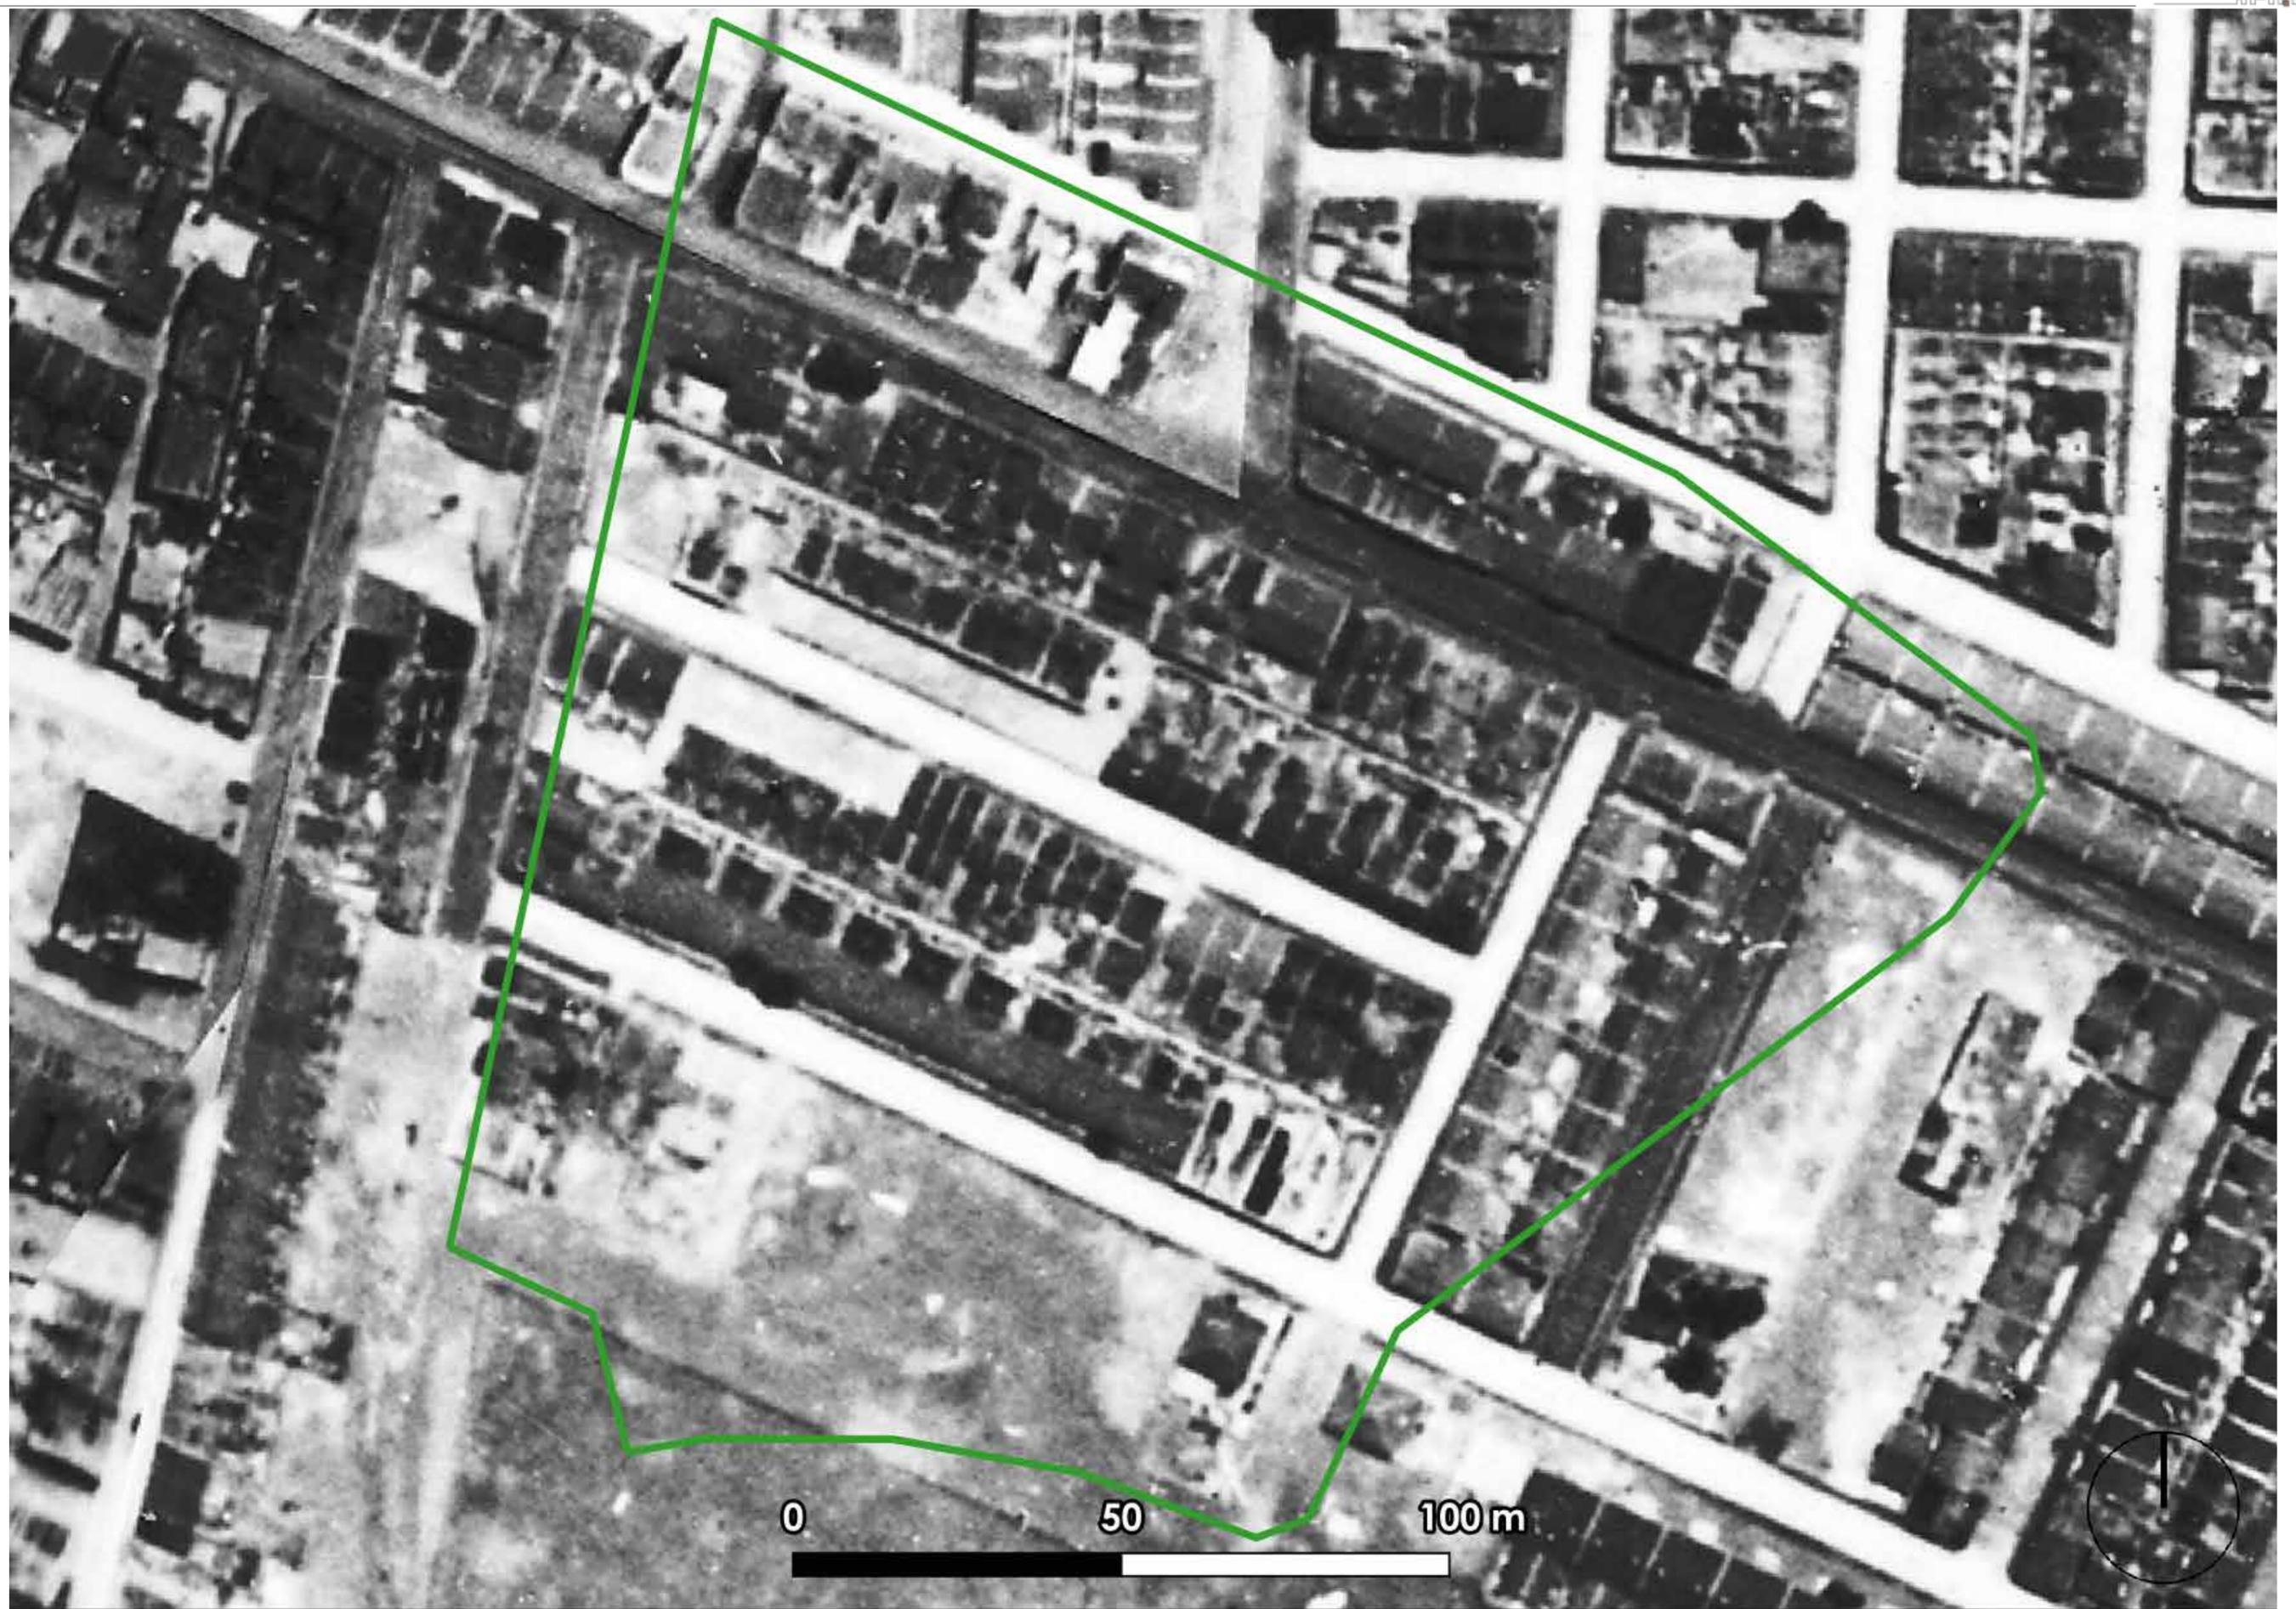
Figure 25. 1926 aerial photograph of the area of Parcel P showing the layout of structures and roads in the early part of the C20th (NGI, 2020; RSA, 2020).

By Thoms's survey in 1898, it is clear that the northern portion of site was densely built up, with two double rows of terraced houses, the northernmost of these fronting onto Hanover Street (Figure 23 and Figure 24). By this time, although a water course is still depicted to the west of Parcel P, it appears to have been diverted upstream, and enters a culvert or drain near the top of Blythe Street where it previously ran adjacent to the old houses there. The layout evident in 1898 appears largely unchanged in the aerial photograph of the area from 1926 (Figure 25)
