TABLE OF CONTENTS

1.0. INTRODUCTION

1.1. Purpose of Report

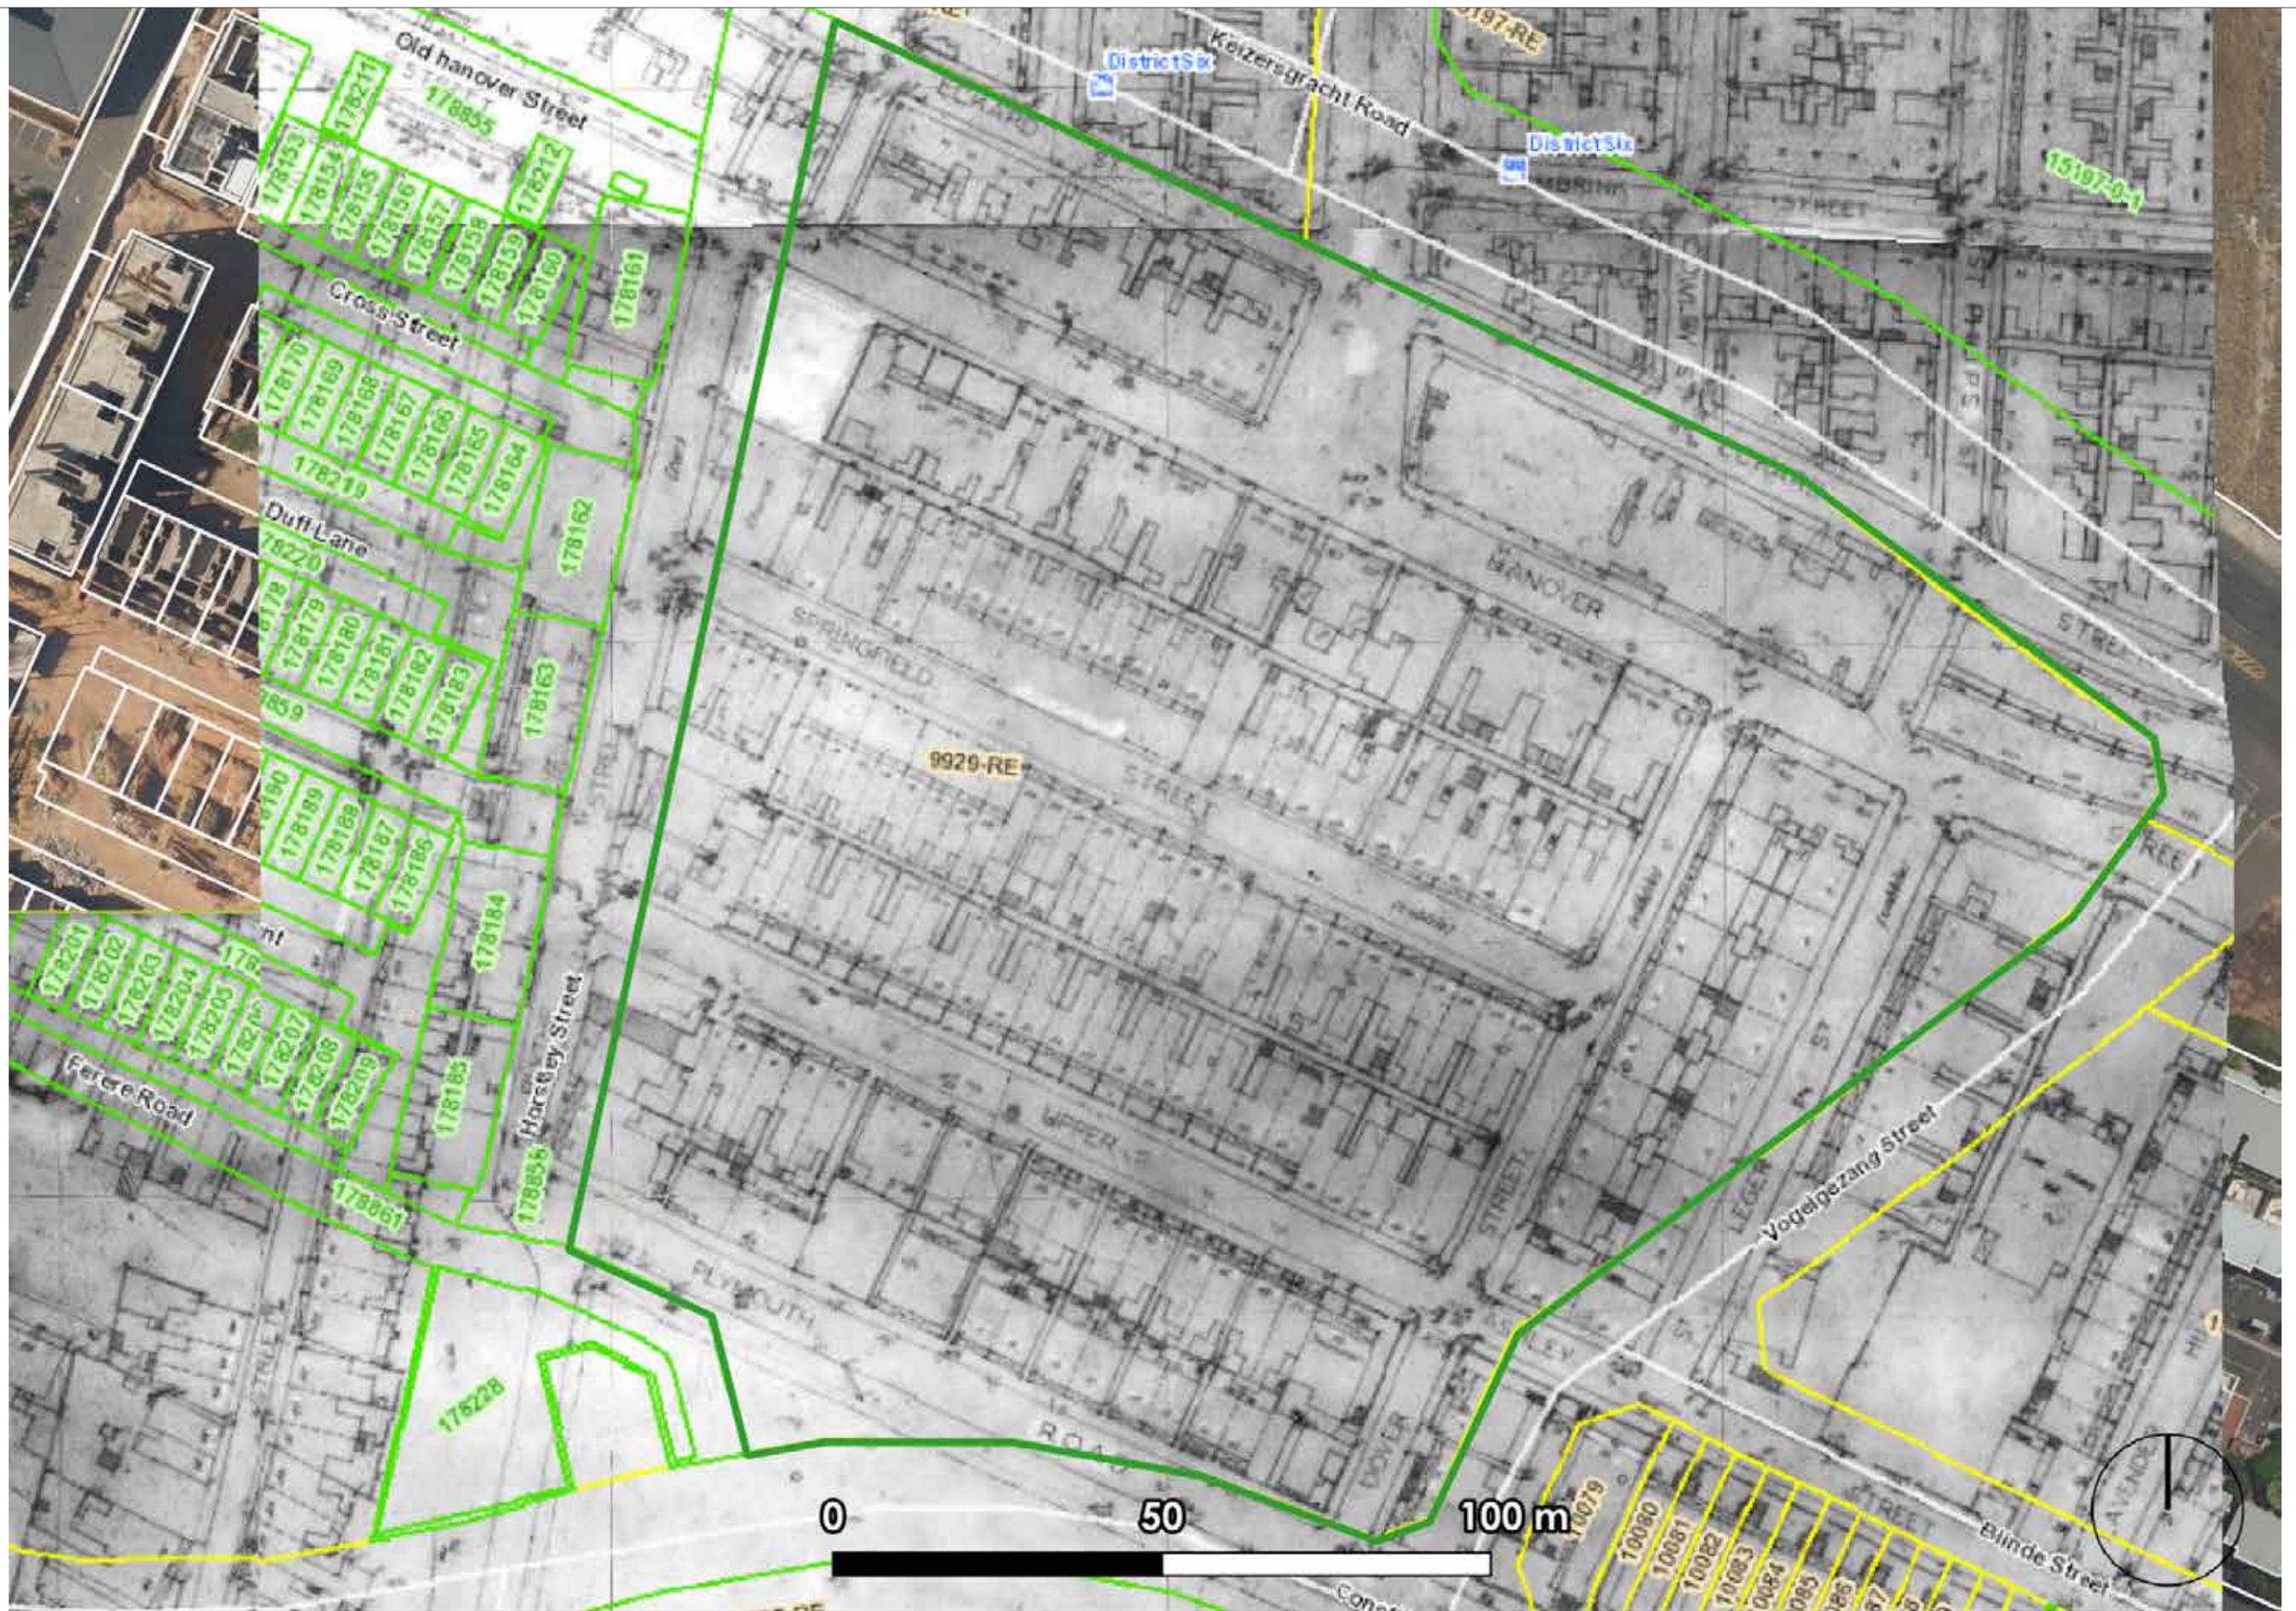
Figure 26. City of Cape Town survey of 1954 for Parcel P showing the layout of structures and roads prior to the forced removals of 1966 (CoCT, 2020; RSA, 2020).

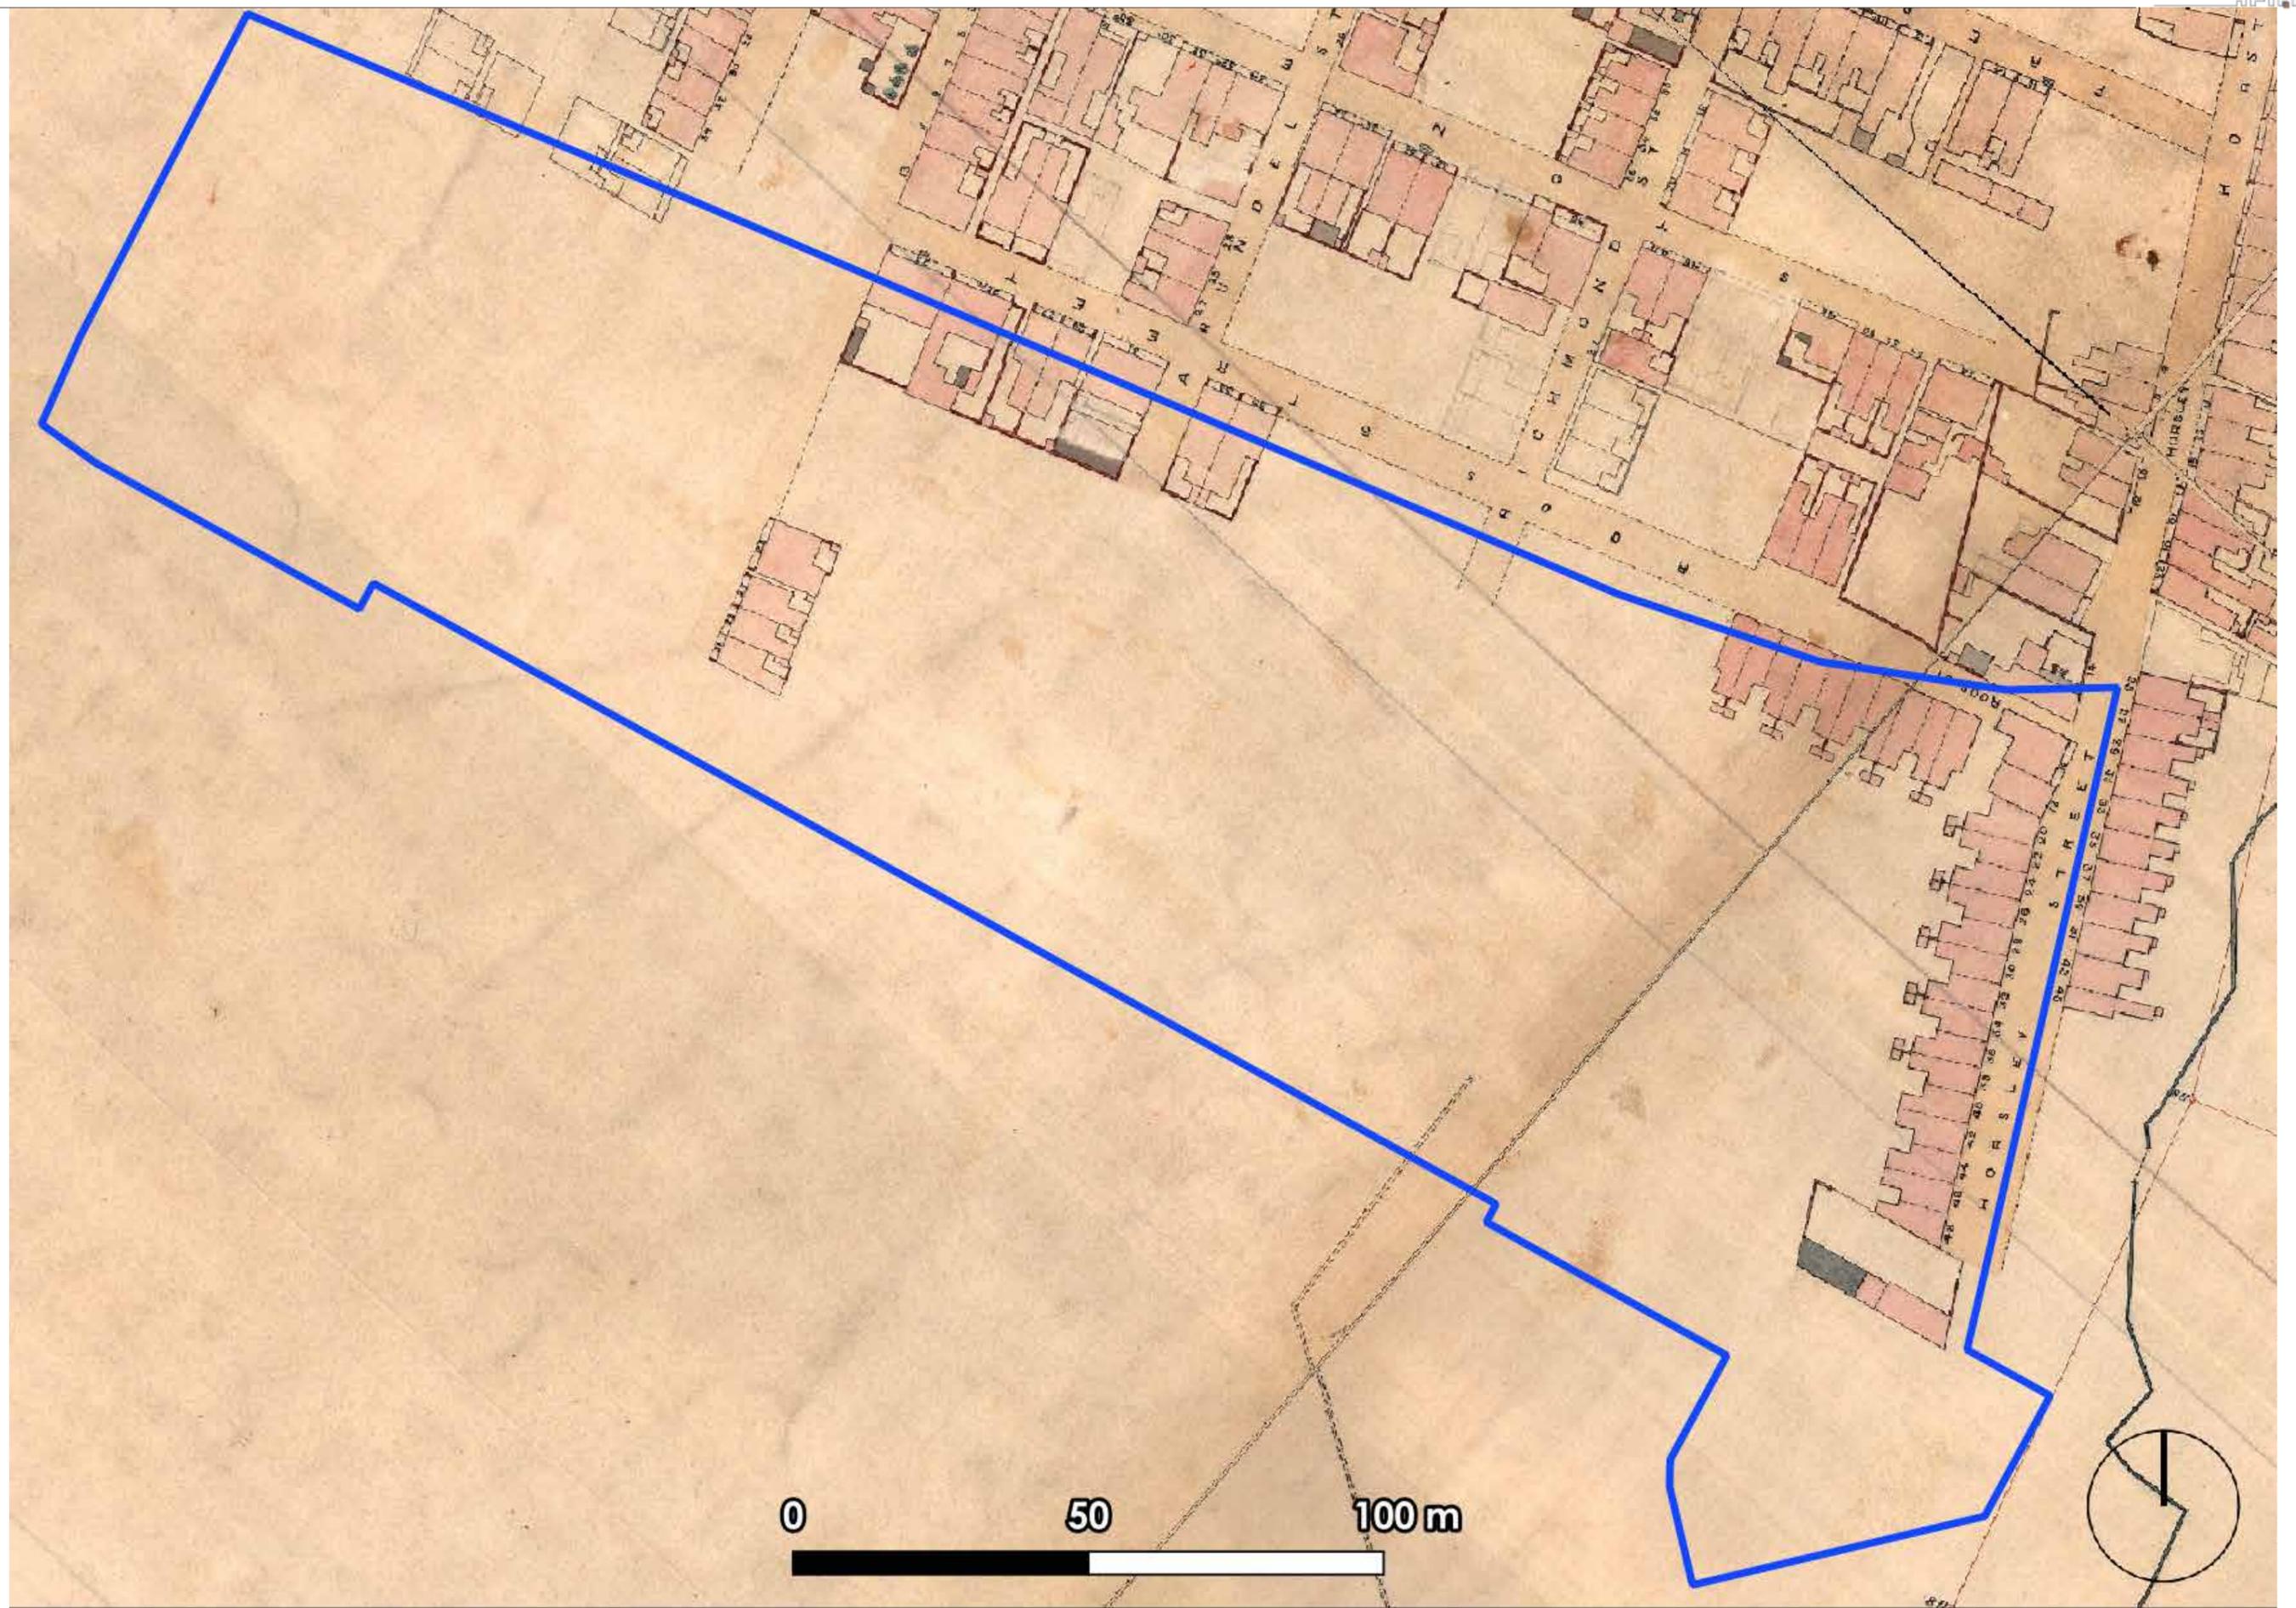
Figure 27. Detail of 1898 Thom survey showing the layout of structures and roads within Parcel N (RSA, 2020).

By the time of Thom's survey in 1898, rows of houses were aligned along Horstley, with clusters of development along Rose Street, in some places (Figure 23 and Figure 27). A further isolated cluster of houses was located above Rose Street along Lewis Street. This extent of development remained largely unchanged by 1926 (Figure 28).

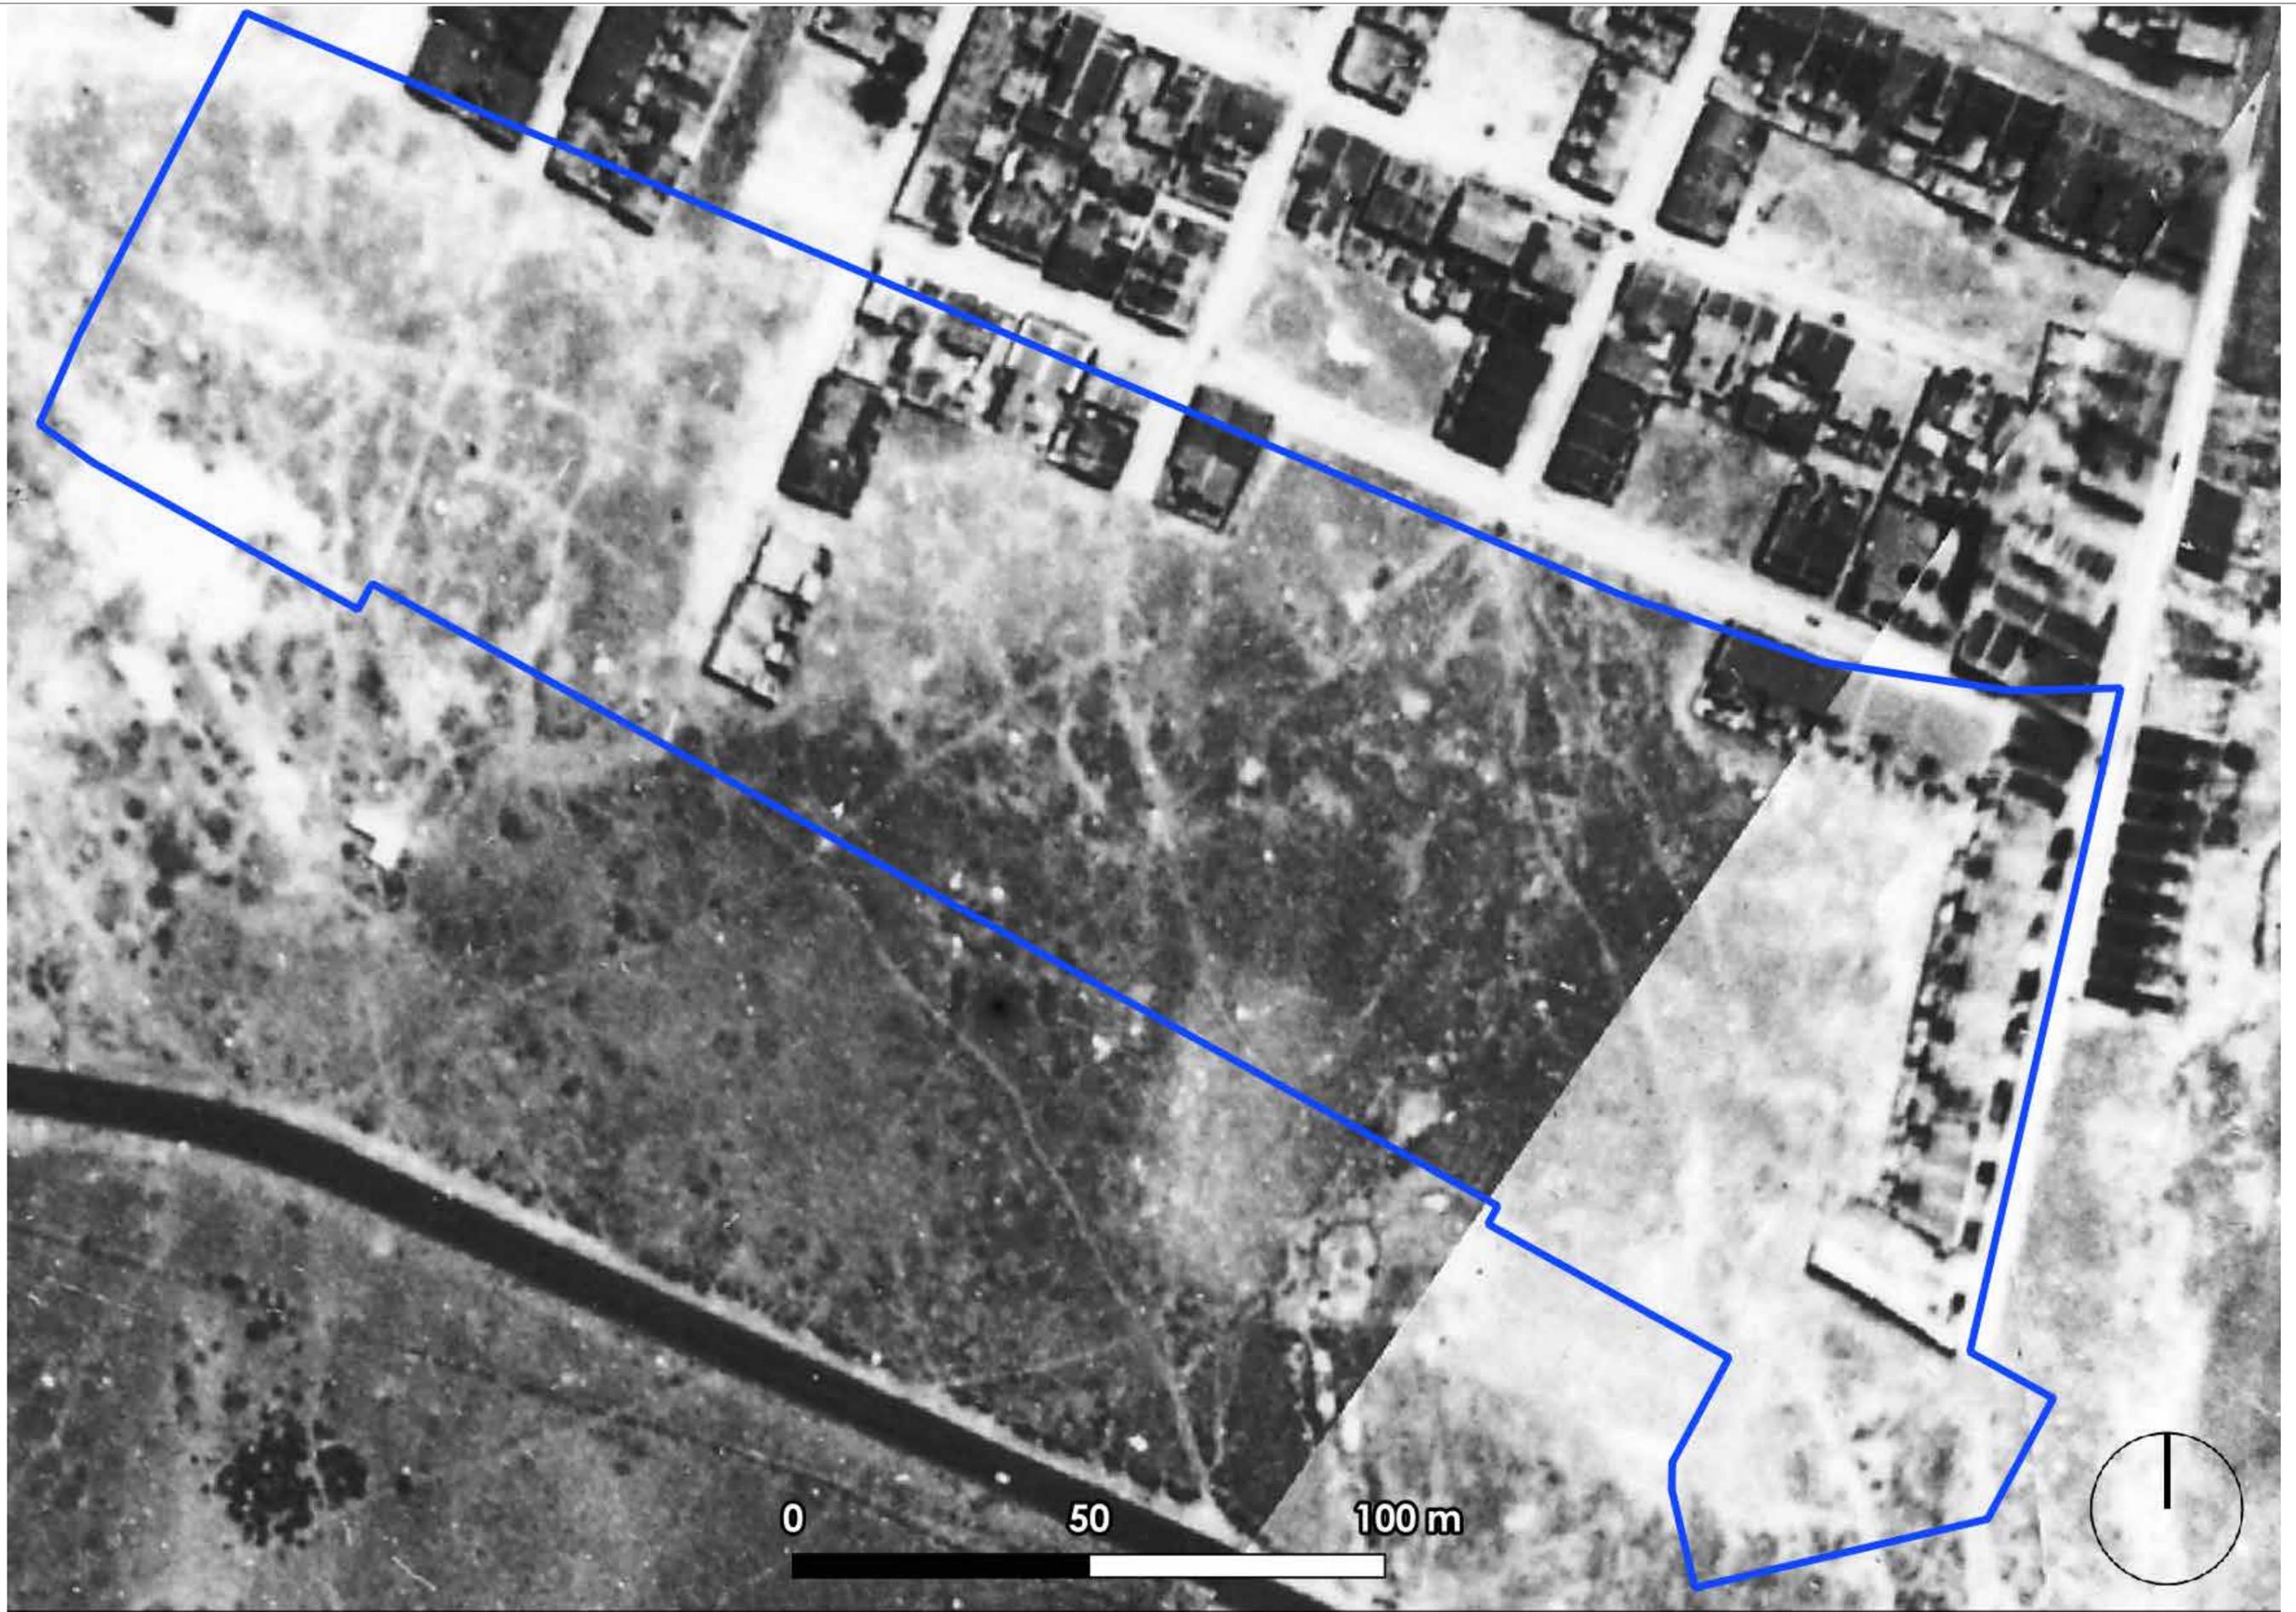
Figure 28. 1926 aerial photograph of the area of Parcel N showing the layout of structures and roads in the early part of the C20th (NGI, 2020; RSA, 2020).

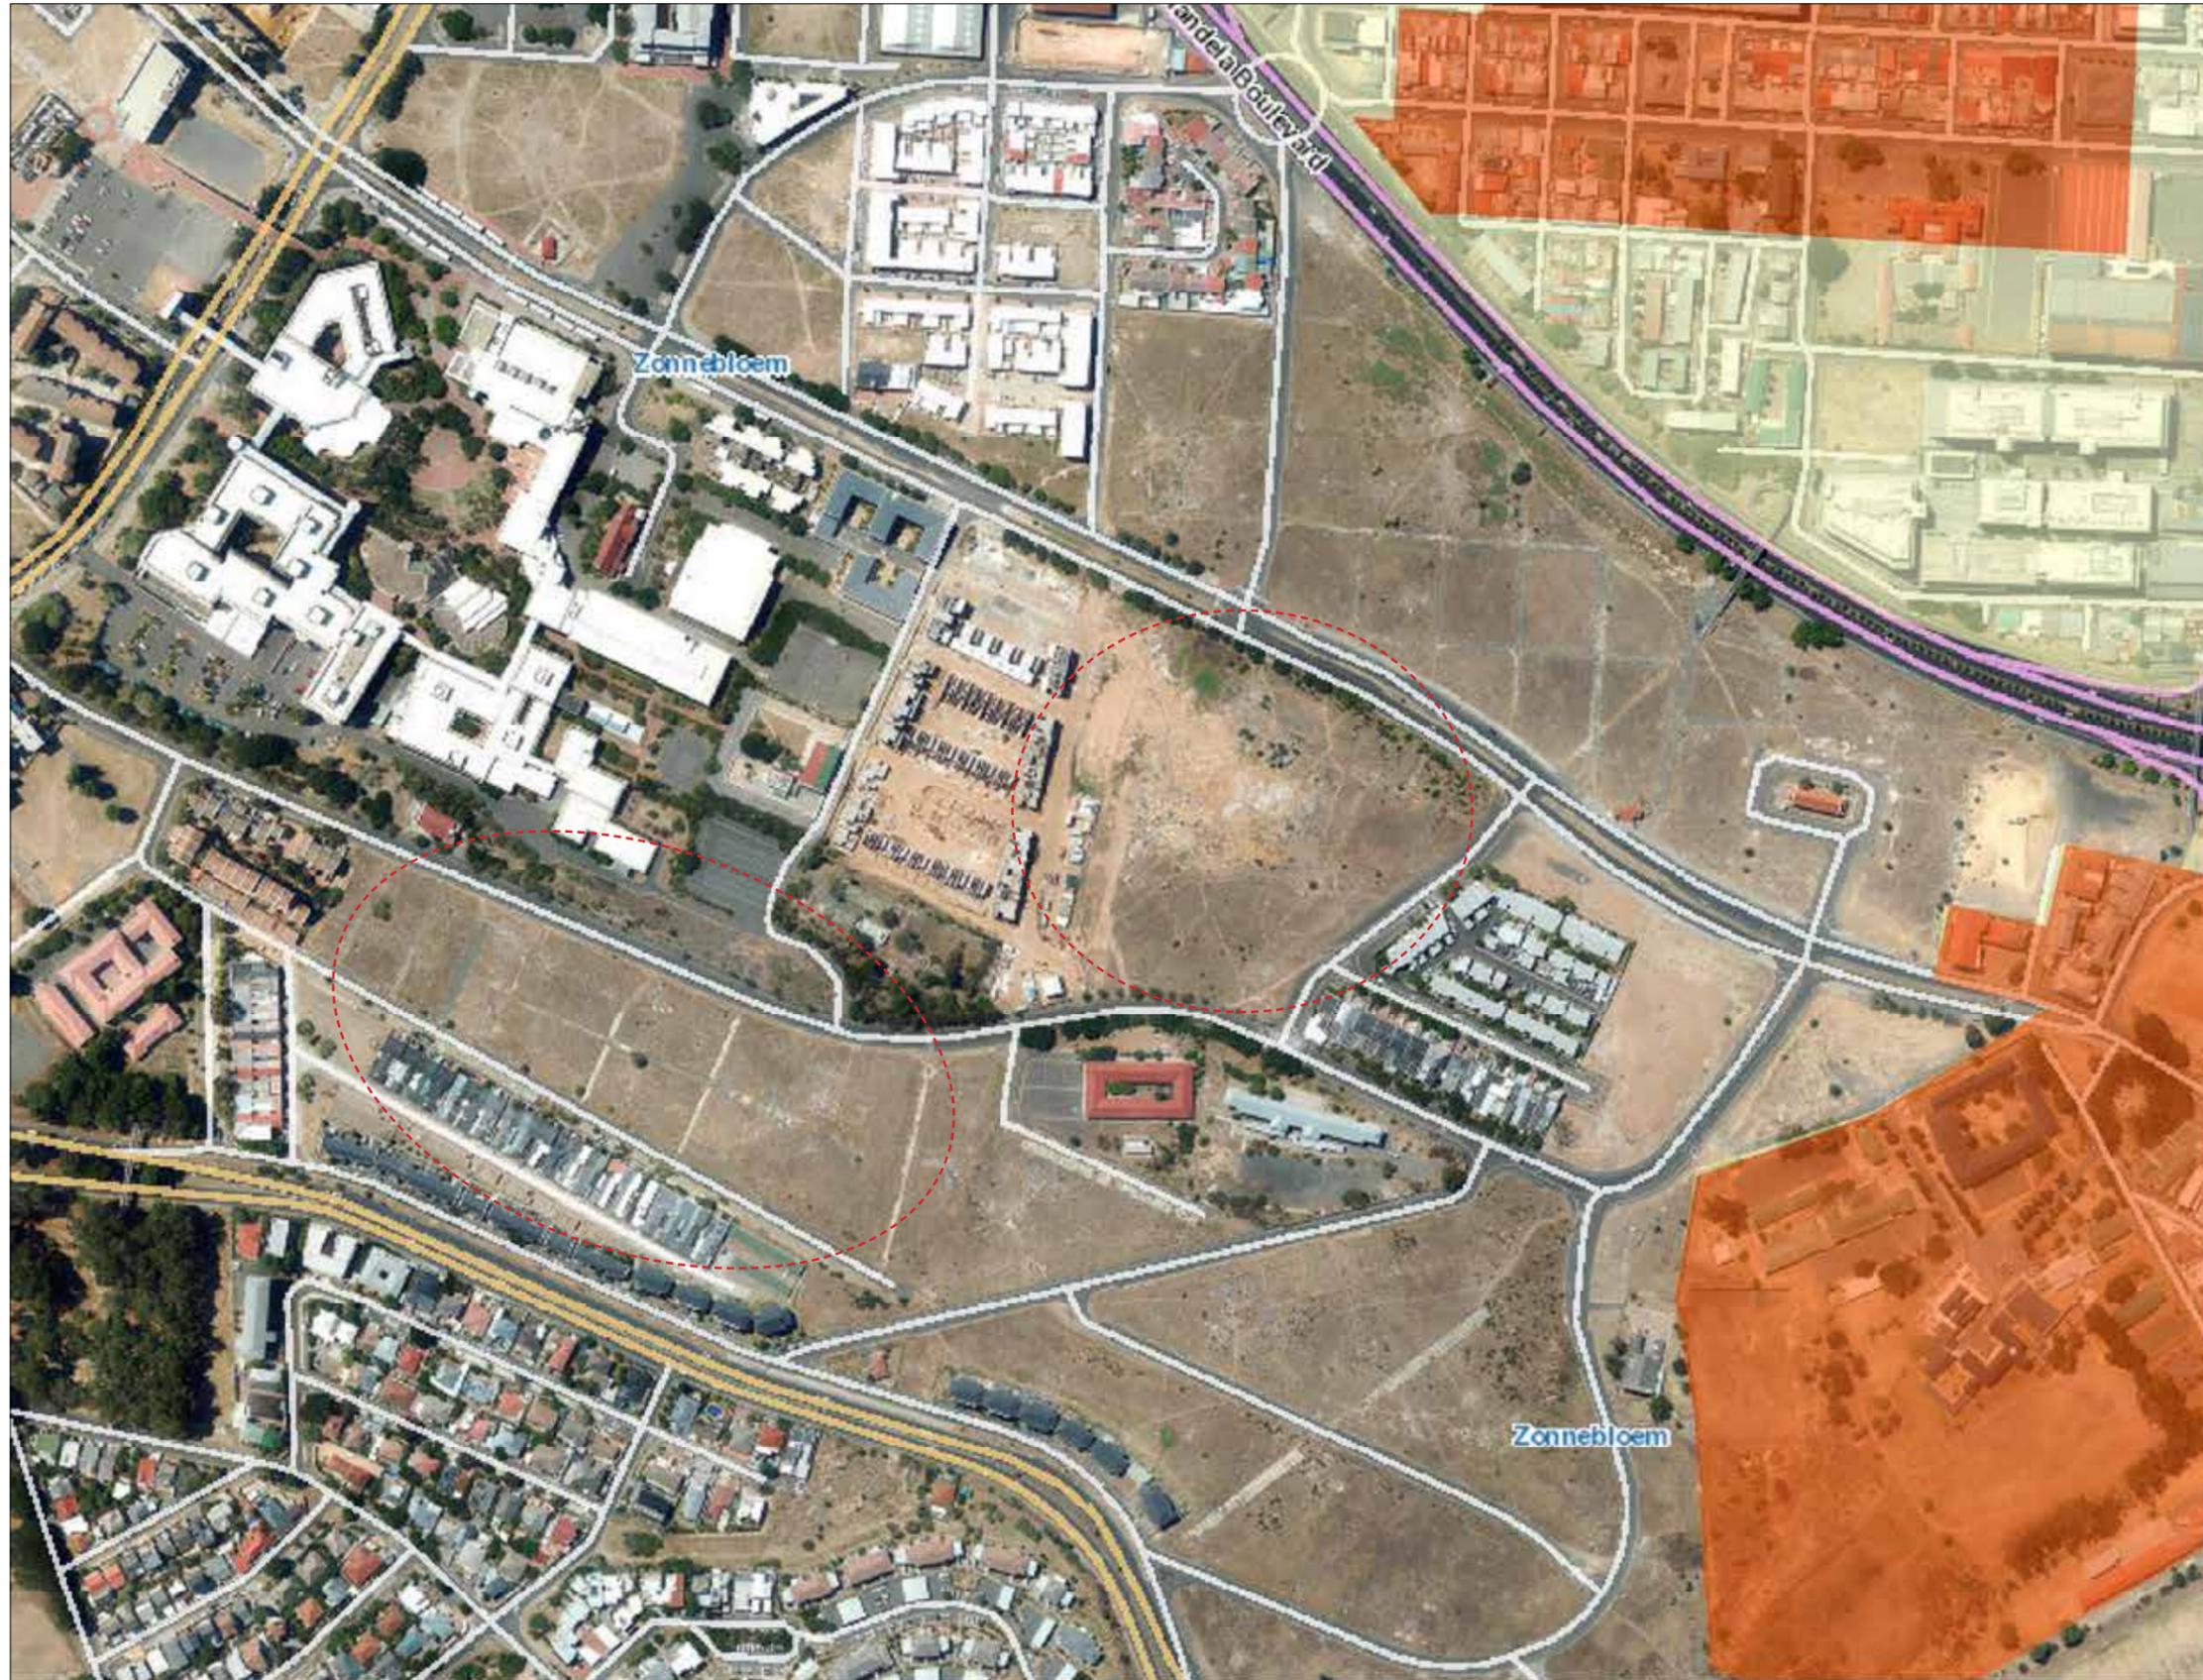
Figure 30. City of Cape Town Heritage Overlay Zone Map showing the proposed Upper Woodstock HPOZ and the Chapel Street (north) and Chester/Coronation Steet (south) HPOZs (Cityviewer, 2020).

While the area of District Six is identified as a Grade I area, there is currently no HPOZ in place in the area, nor are either of the sites in question graded (Figure 30 and Figure 31). Both of these factors reflect the wholesale destruction of fabric and tangible elements in the landscape. Nearby gradings are attached to standing buildings and remnant religious sites and structures, while HPOZs are linked to areas of well preserved historic fabric, namely the Chapel Street area of Upper Woodstock, itself a remnant of District Six, and the Chester/ Coronation area of Zonnebloem.

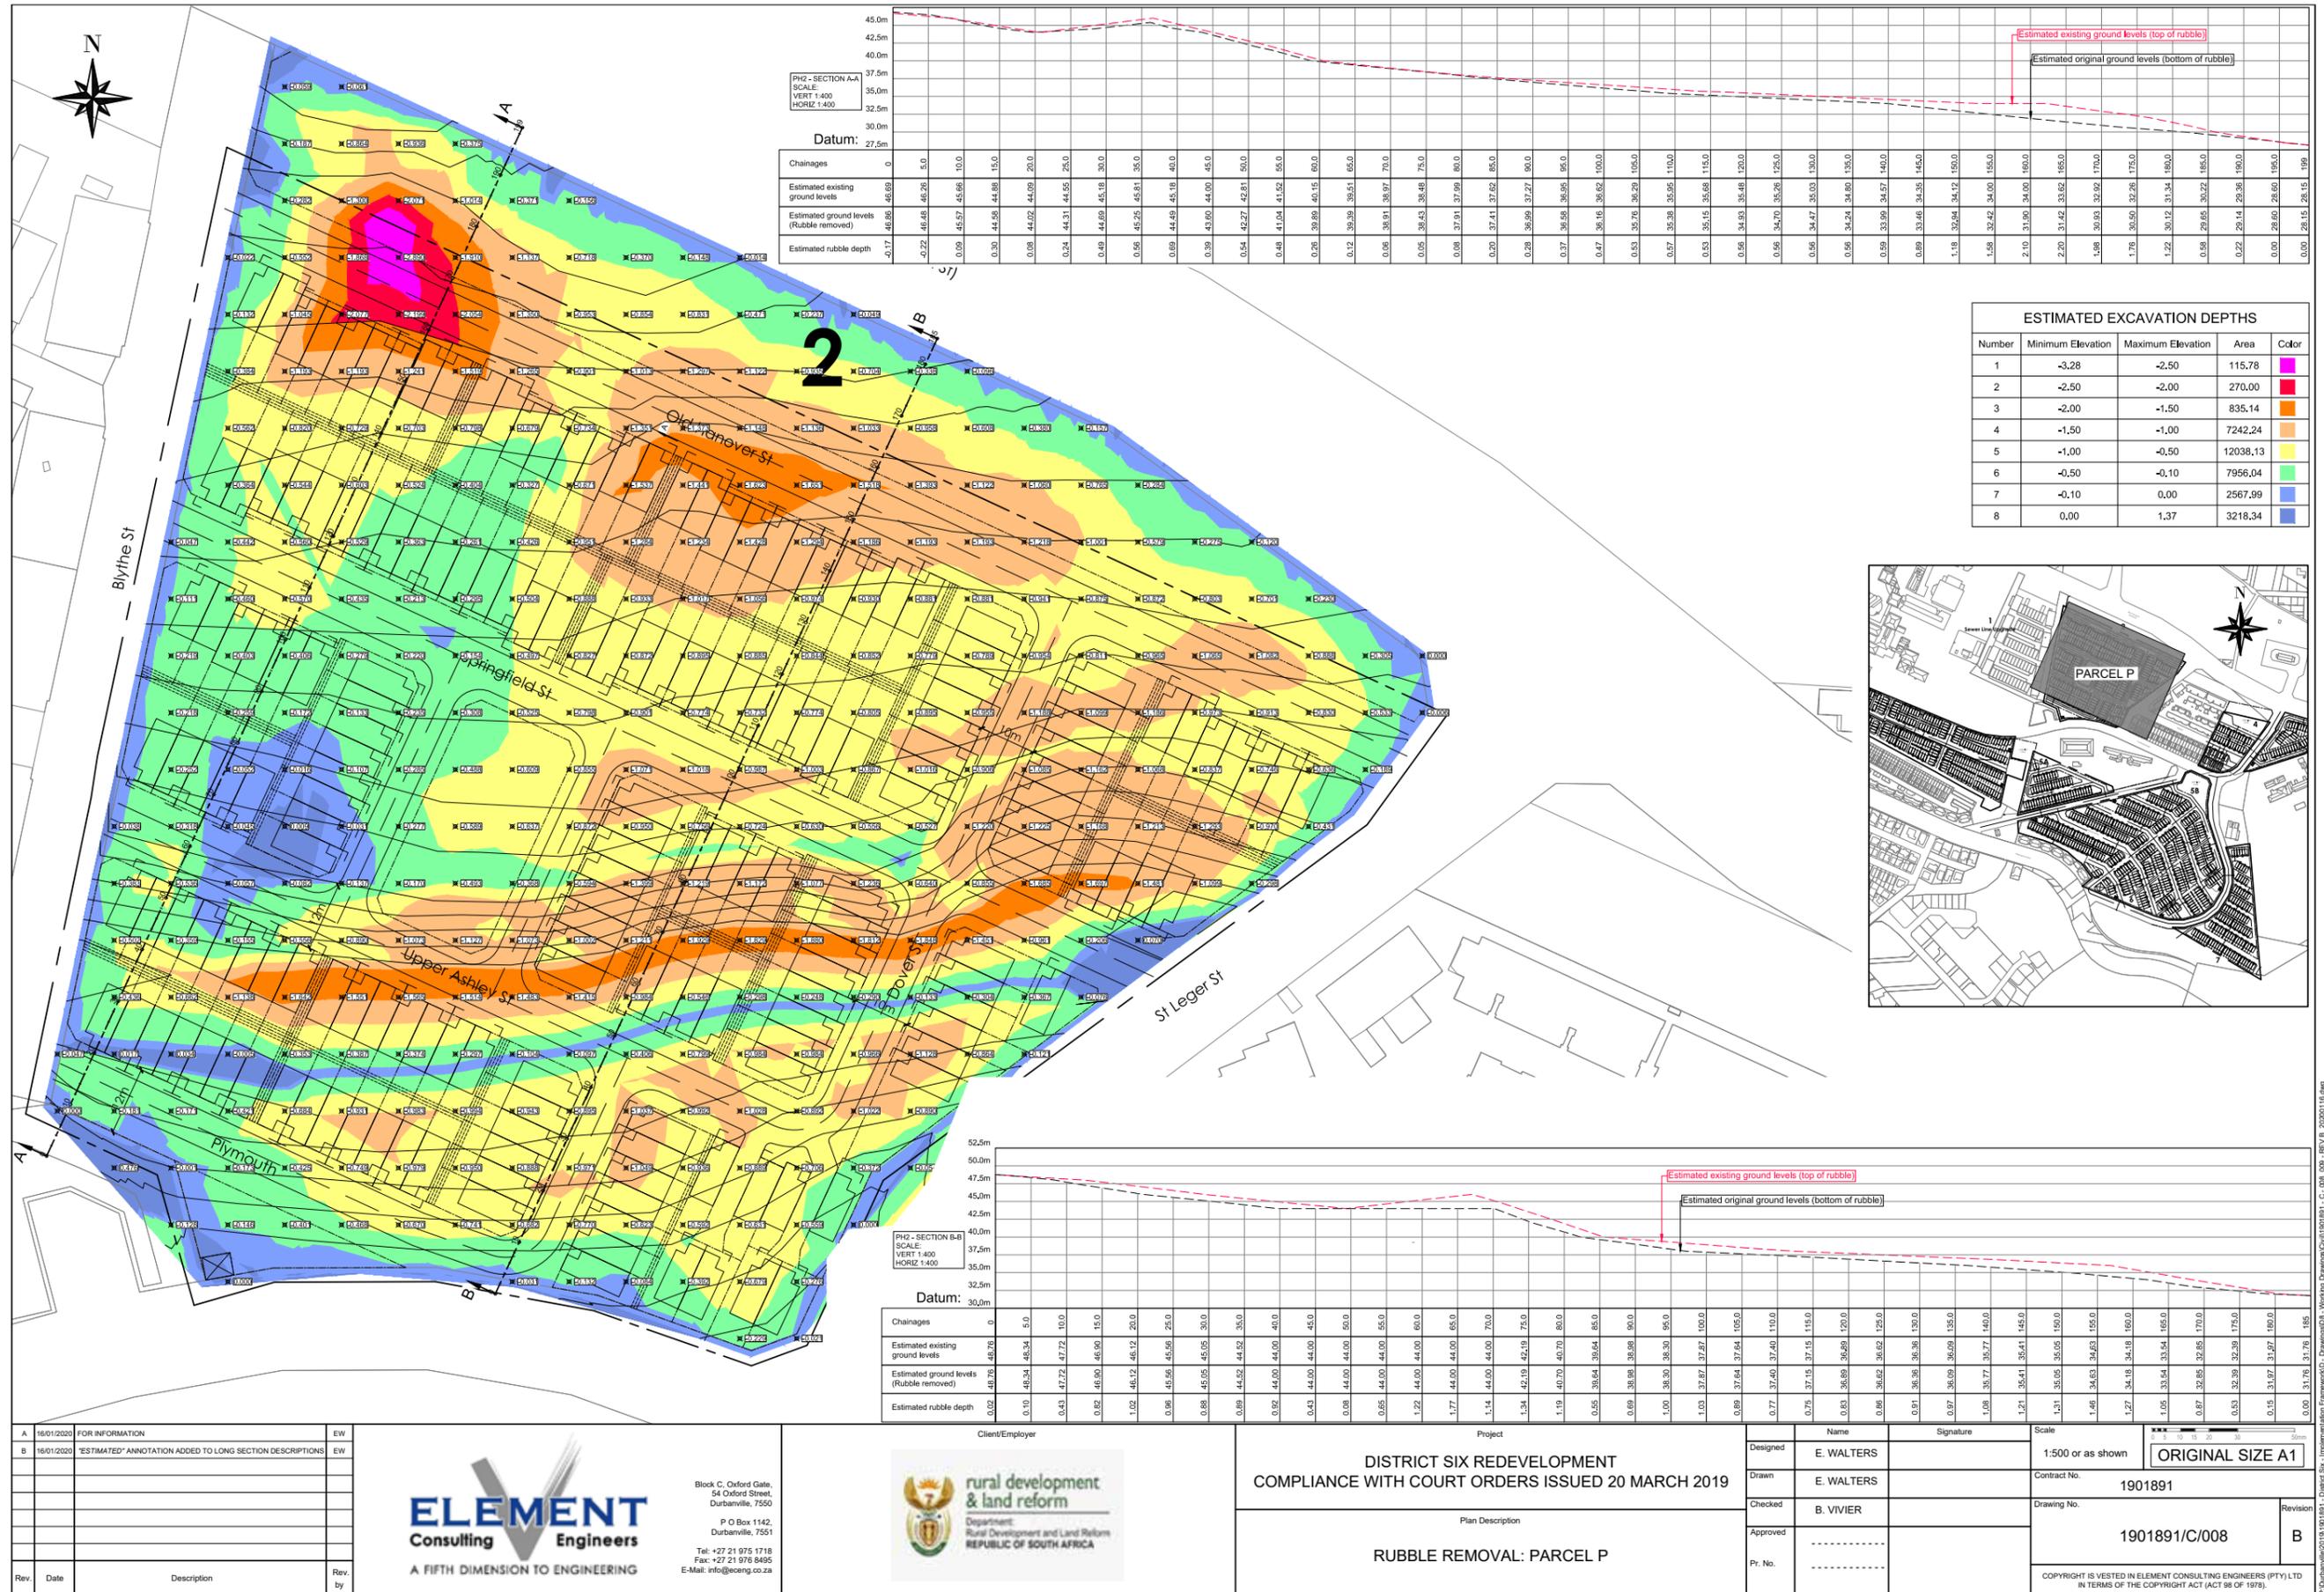
The activities proposed in terms of this application pertain only to above ground rubble clearance and removal of overburden (Figure 32 and Figure 33). It is anticipated that some 29 000m³ of rubble will be removed down to historic ground level. No other development related activities will take place on site, and all these will be subject to the HIA process in terms of Section 38 of the NHRA that is to follow this process.

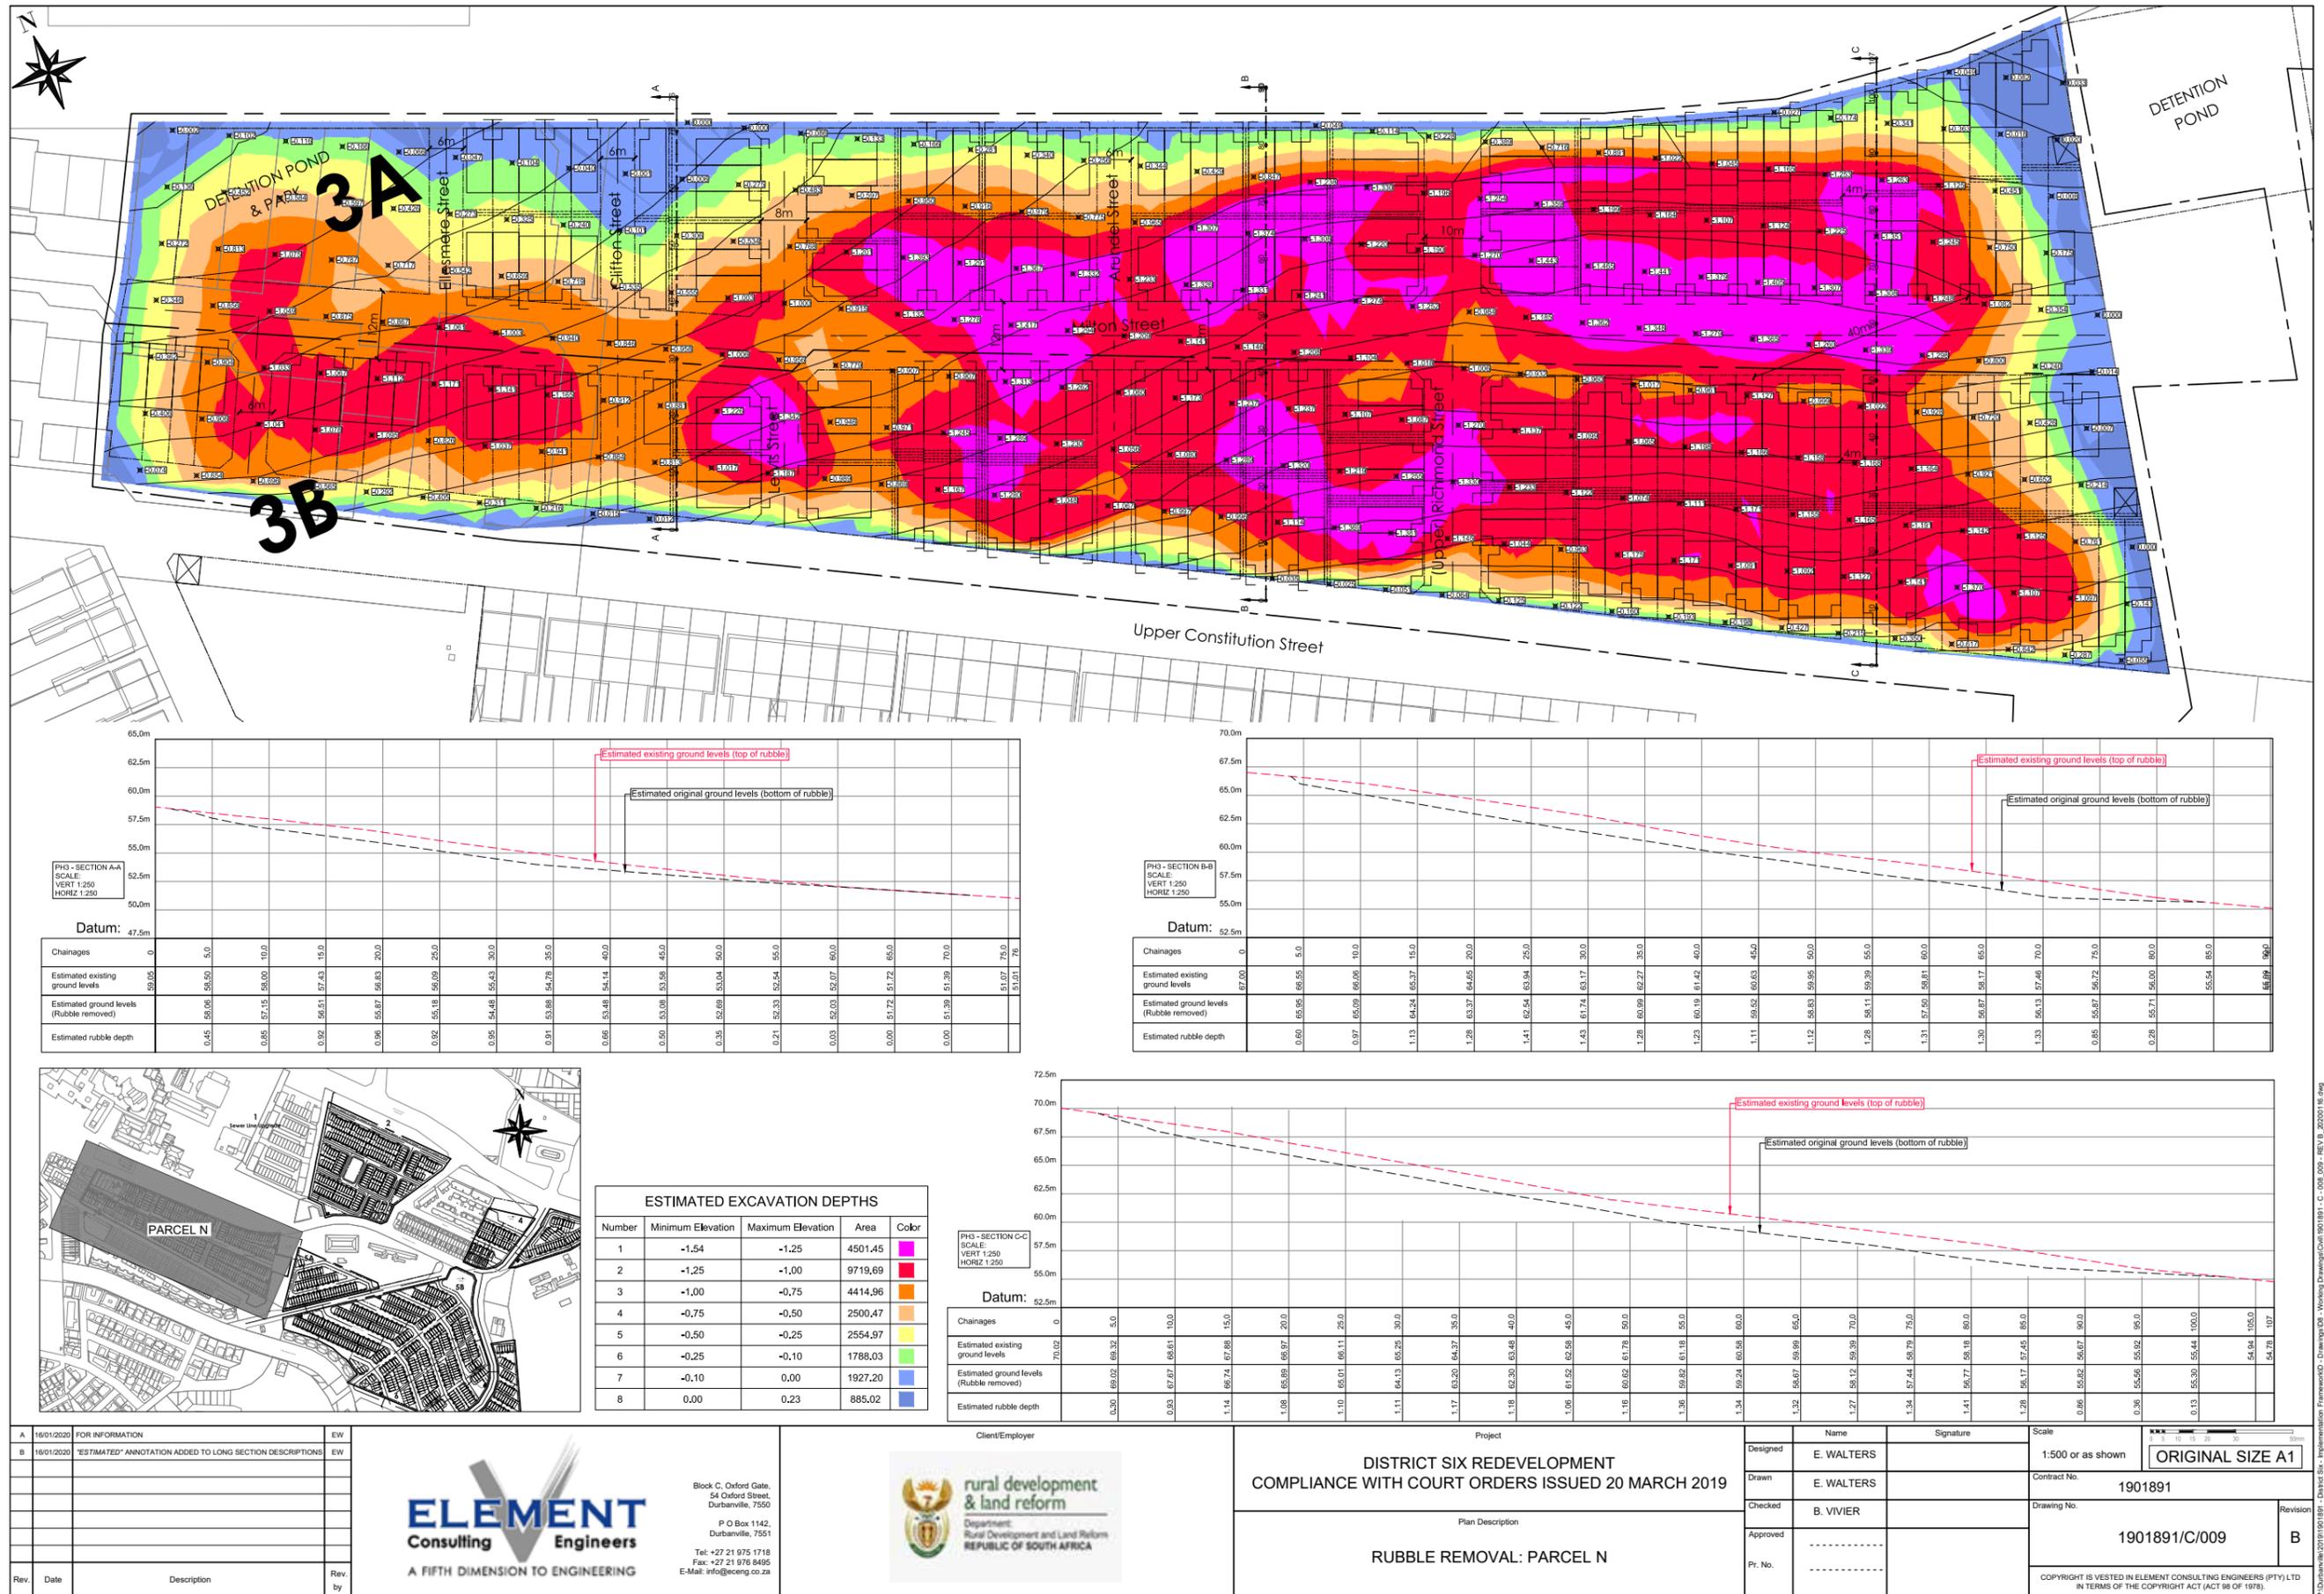
Figure 33. Proposed rubble removal plans for Parcel N (Element Consulting Engineers, 2019).
