# DISTRICT SIX PHASED REDEVELOPMENT: PERMIT CLOSE OUT REPORT FOR PREPARATORY WORKS

INVASIVE SITE PREPARATION WORKS ON SEVERAL PARCELS AND VARIOUS ERVEN AHEAD OF REDEVELOPMENT, DISTRICT SIX, CAPE TOWN

S35 PERMIT REPORT

Prepared by Rennie Scurr Adendorff for Delta BEC on behalf of Department of Agriculture, Land Reform and Rural Development

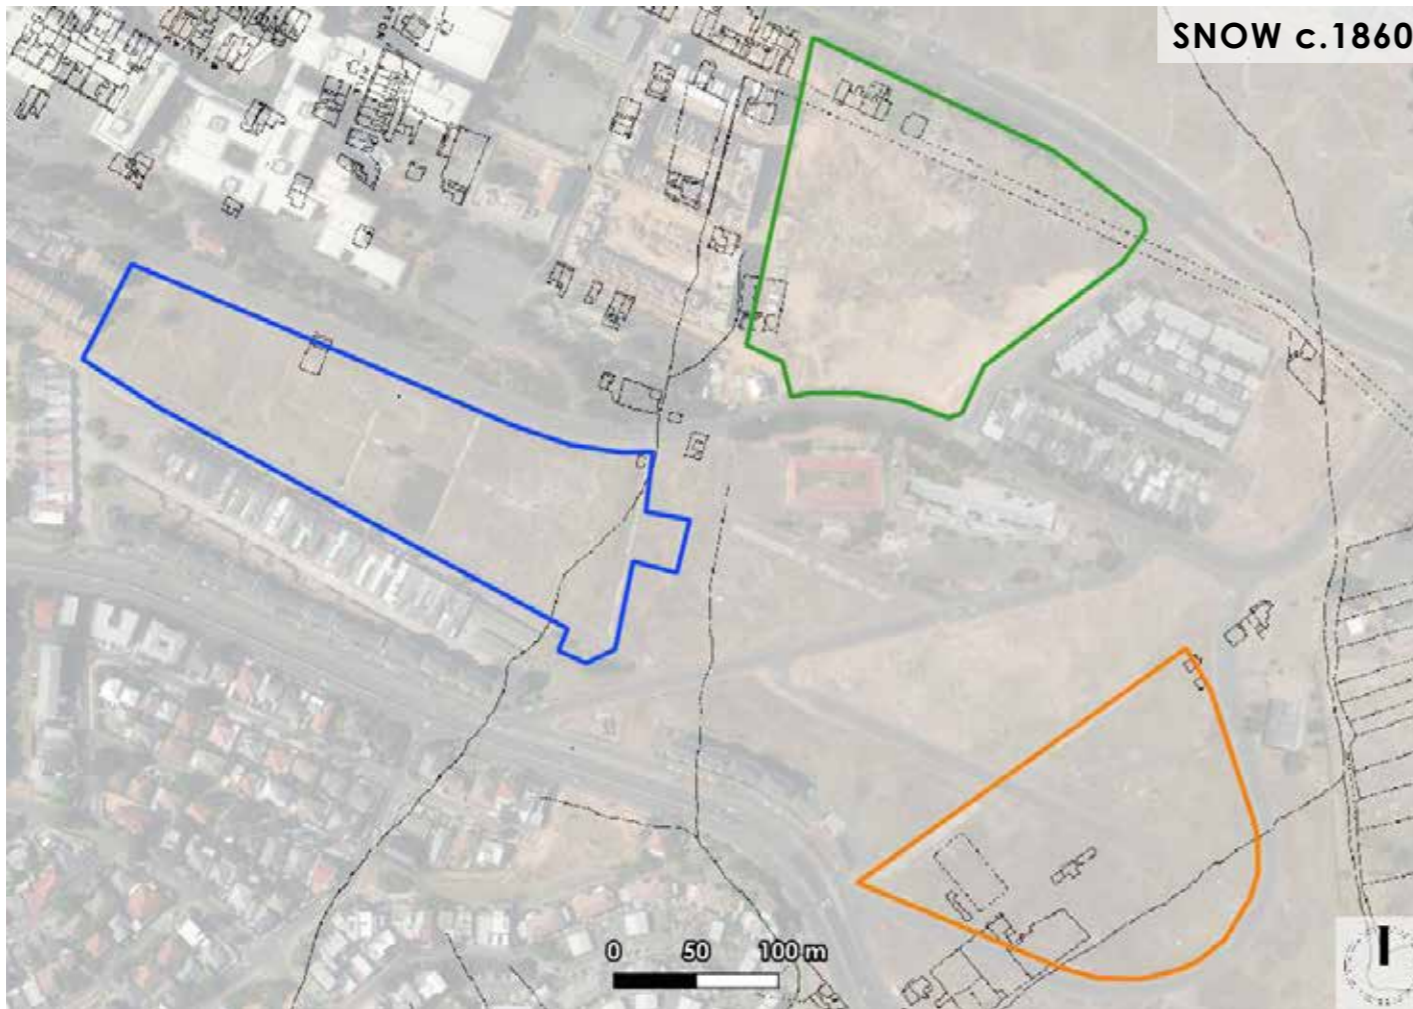
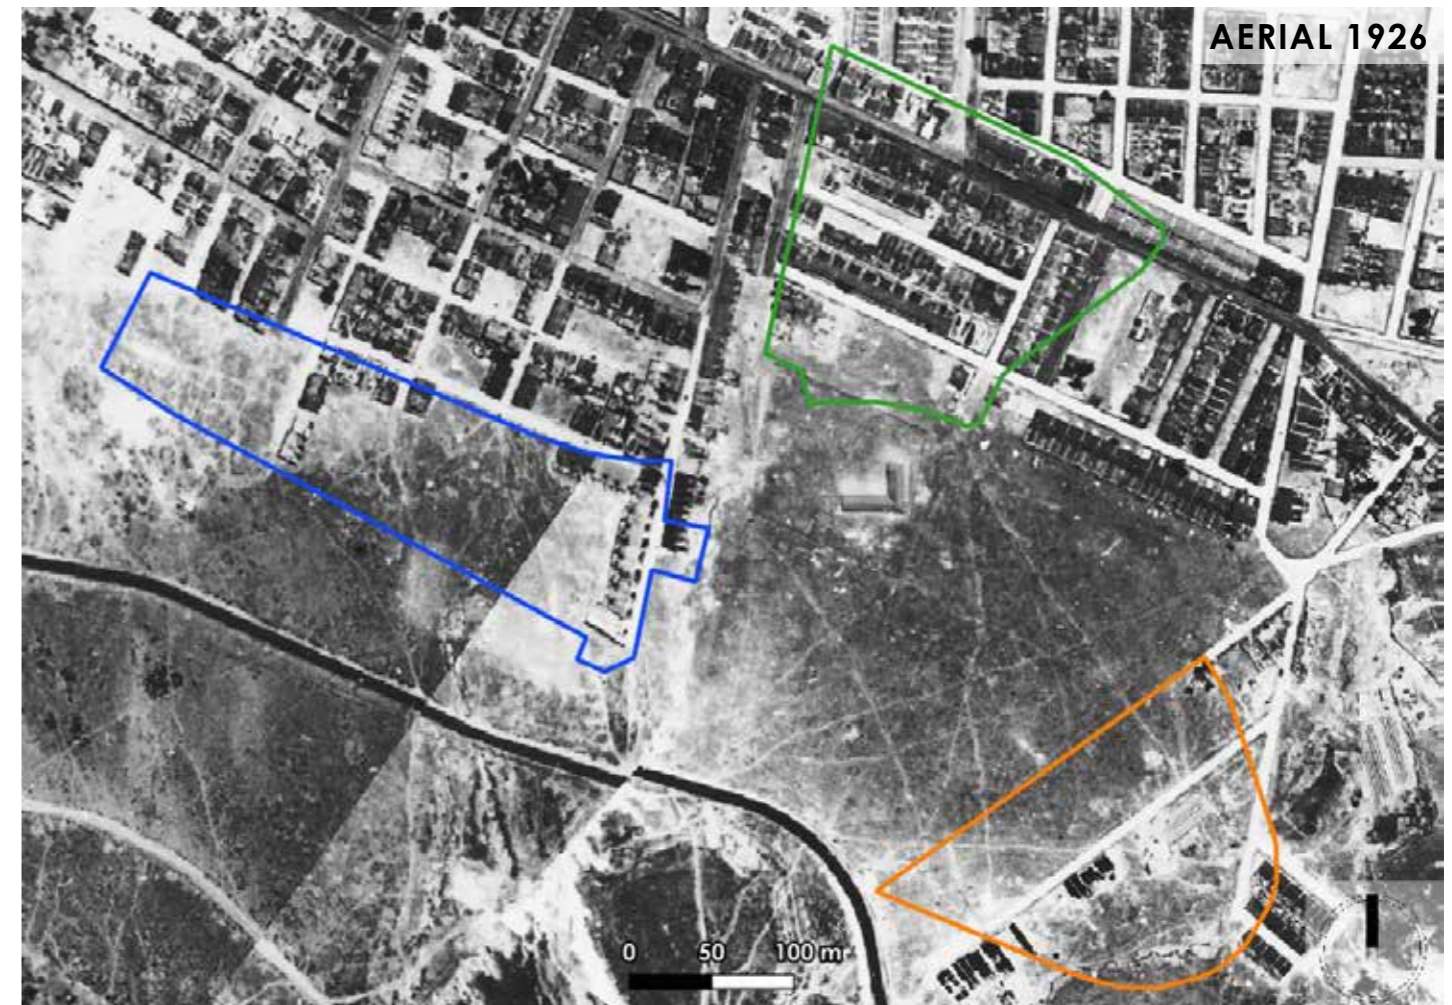
Figure 6. Overlays showing the development of the parcels through time: Snow c. 1860 (above), Thom c1895 (top right) and the 1926 aerial (bottom right) (RSA, 2022)

By the time of Thom's survey in 1895, this picture had changed dramatically, with the northern portion of Phase 4 entirely built up. Further up the slopes, development had proceeded on Phase 5 at the intersection of Upper Horstley and Roos, as well as along Lewis Street and at the intersection of Lewis and Roos. Some structures remain visible in Phase 6, though fewer than were evident on the Snow plan.

Aside from some infill along Lewis Street in Phase 5, this remains unchanged until the late 1920s, as evidenced in the 1926 aerial imagery of District 6. By the time of the municipal survey of the late 1950s, all sites were densely developed.

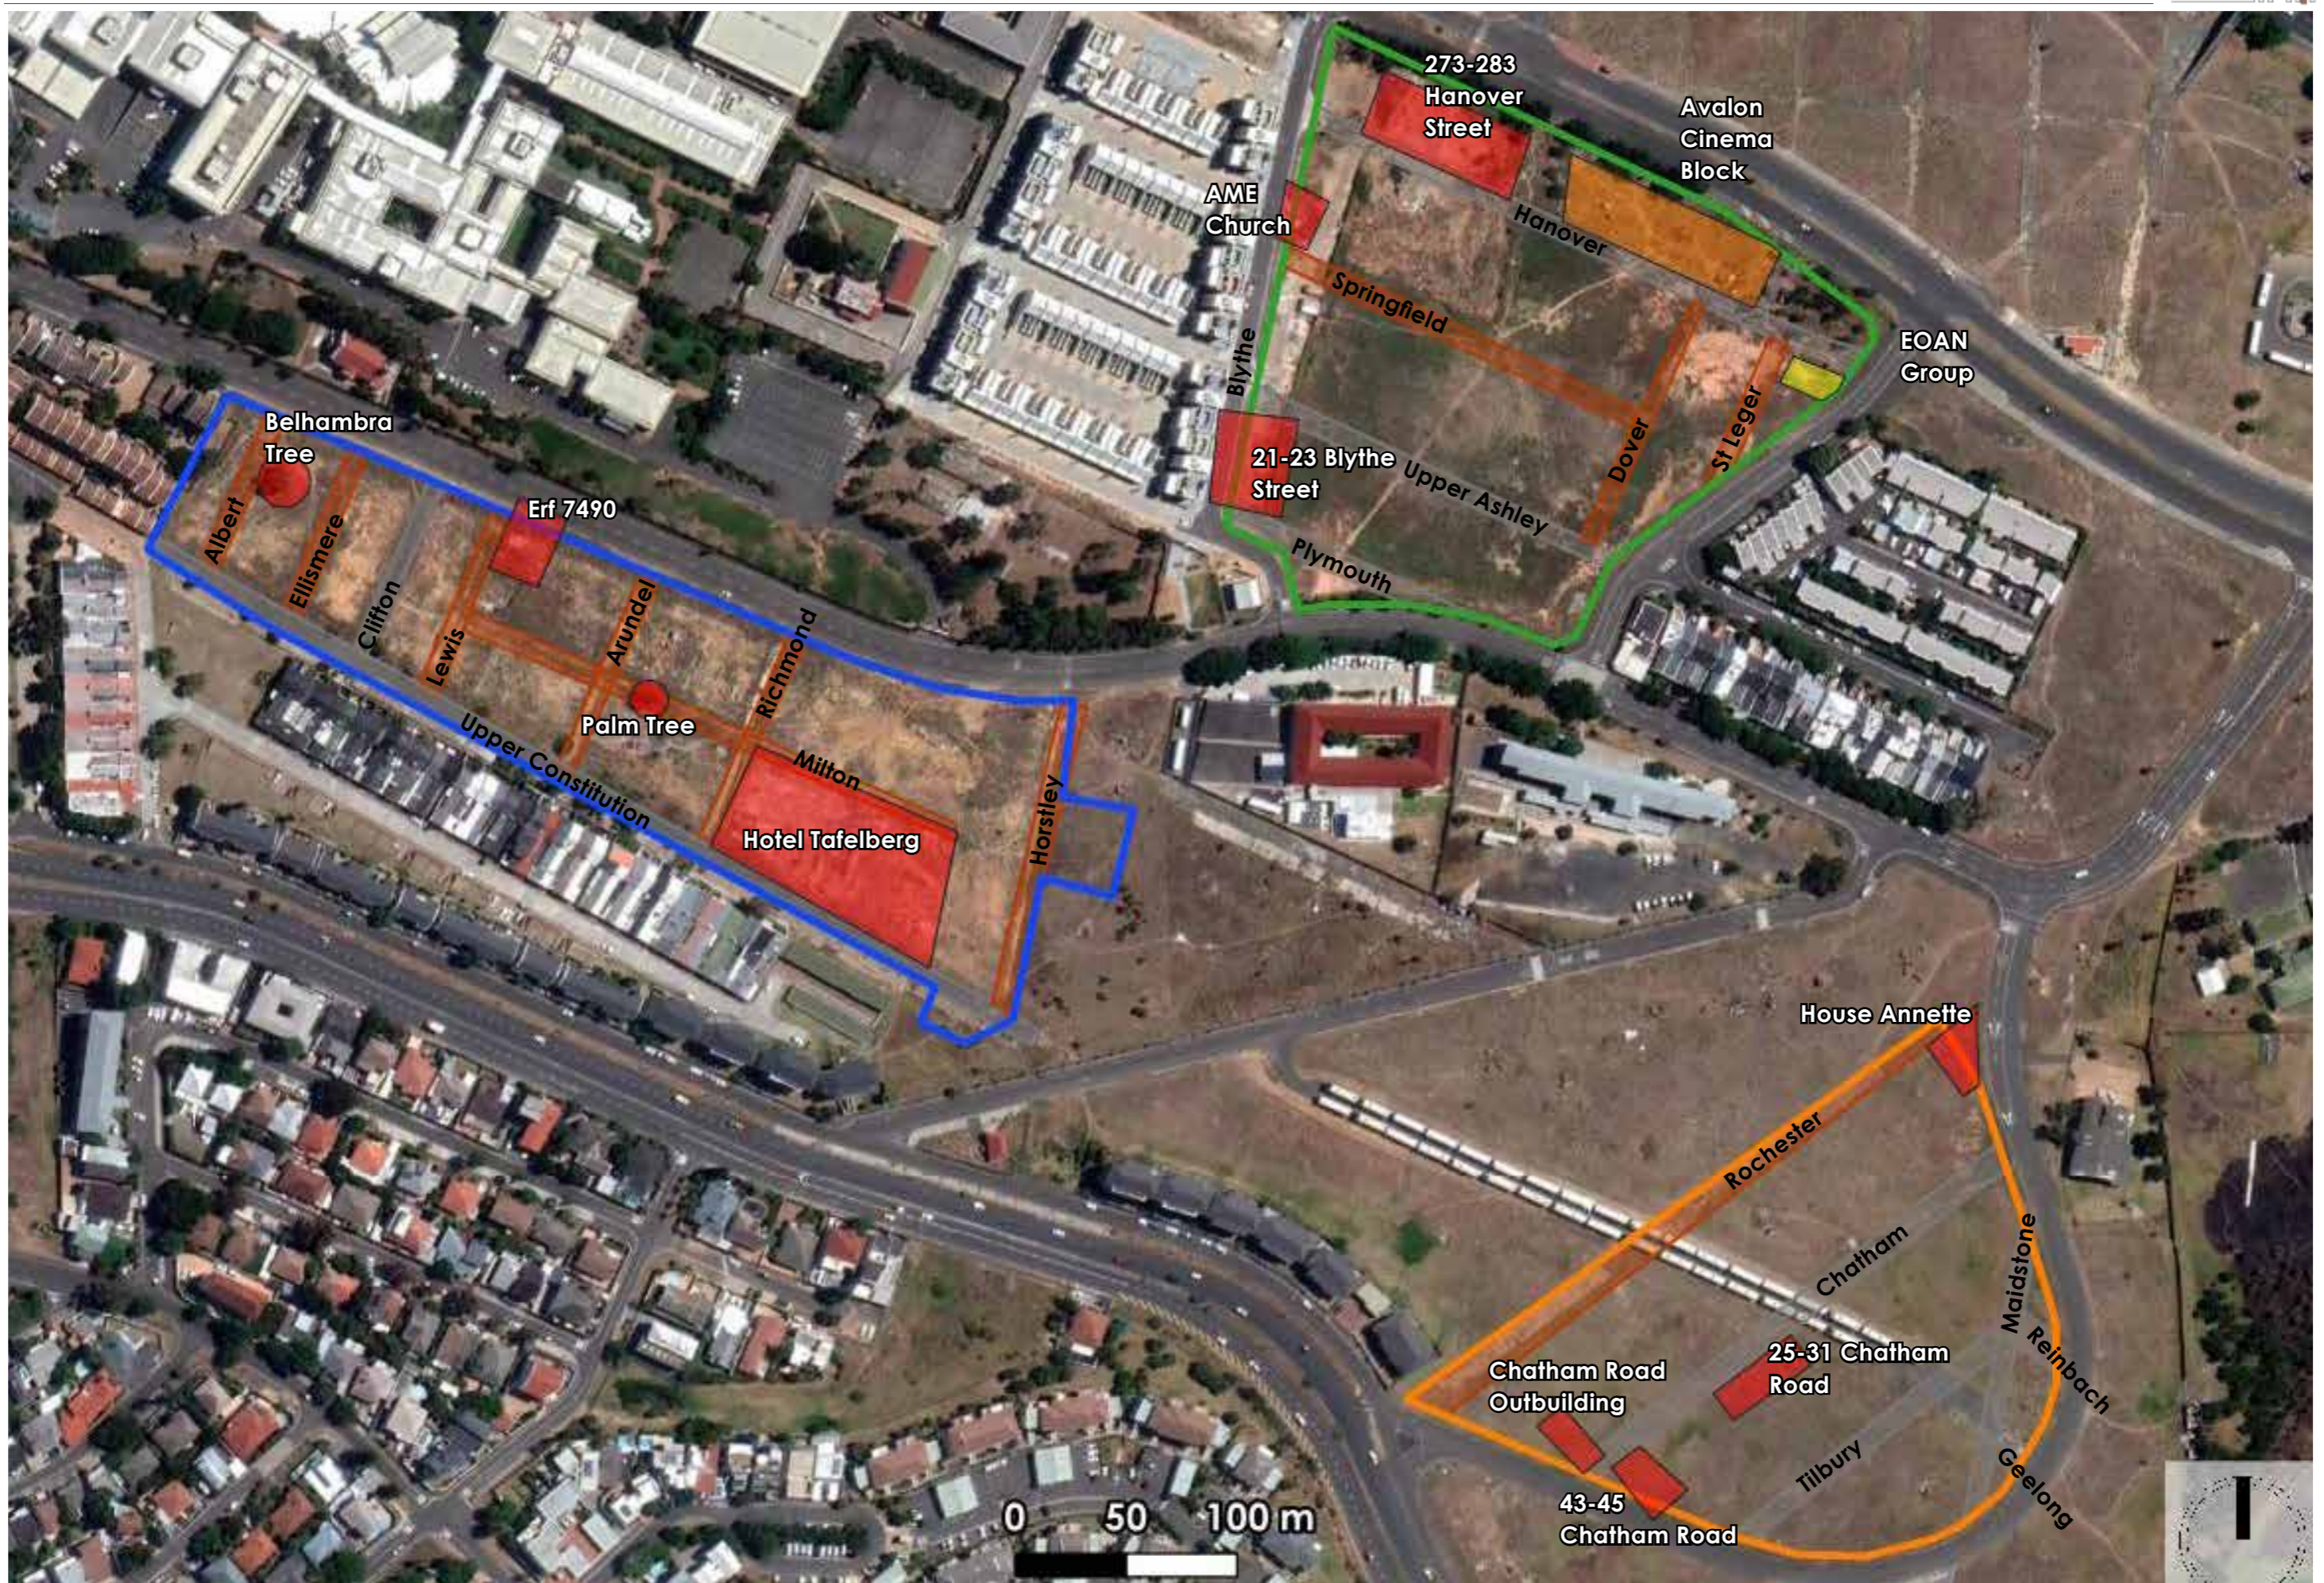
Figure 7. Sensitivity mapping of archaeological sensitivity derived from historic overlays, with sensitivities based on expected or known areas of old fabric or sites or features of social significance; red indicates areas of highest significance, orange moderate and yellow lowest. Historic road alignments are indicated, brown for concrete or cobbled surfaces, and grey for tar (RSA, 2022).

Known resources identified as highly significant were initially identified for the purposes of this work (Figure 7), and these were further refined during the research and compilation undertaken for the site levelling permit application and the wider redevelopment HIA.

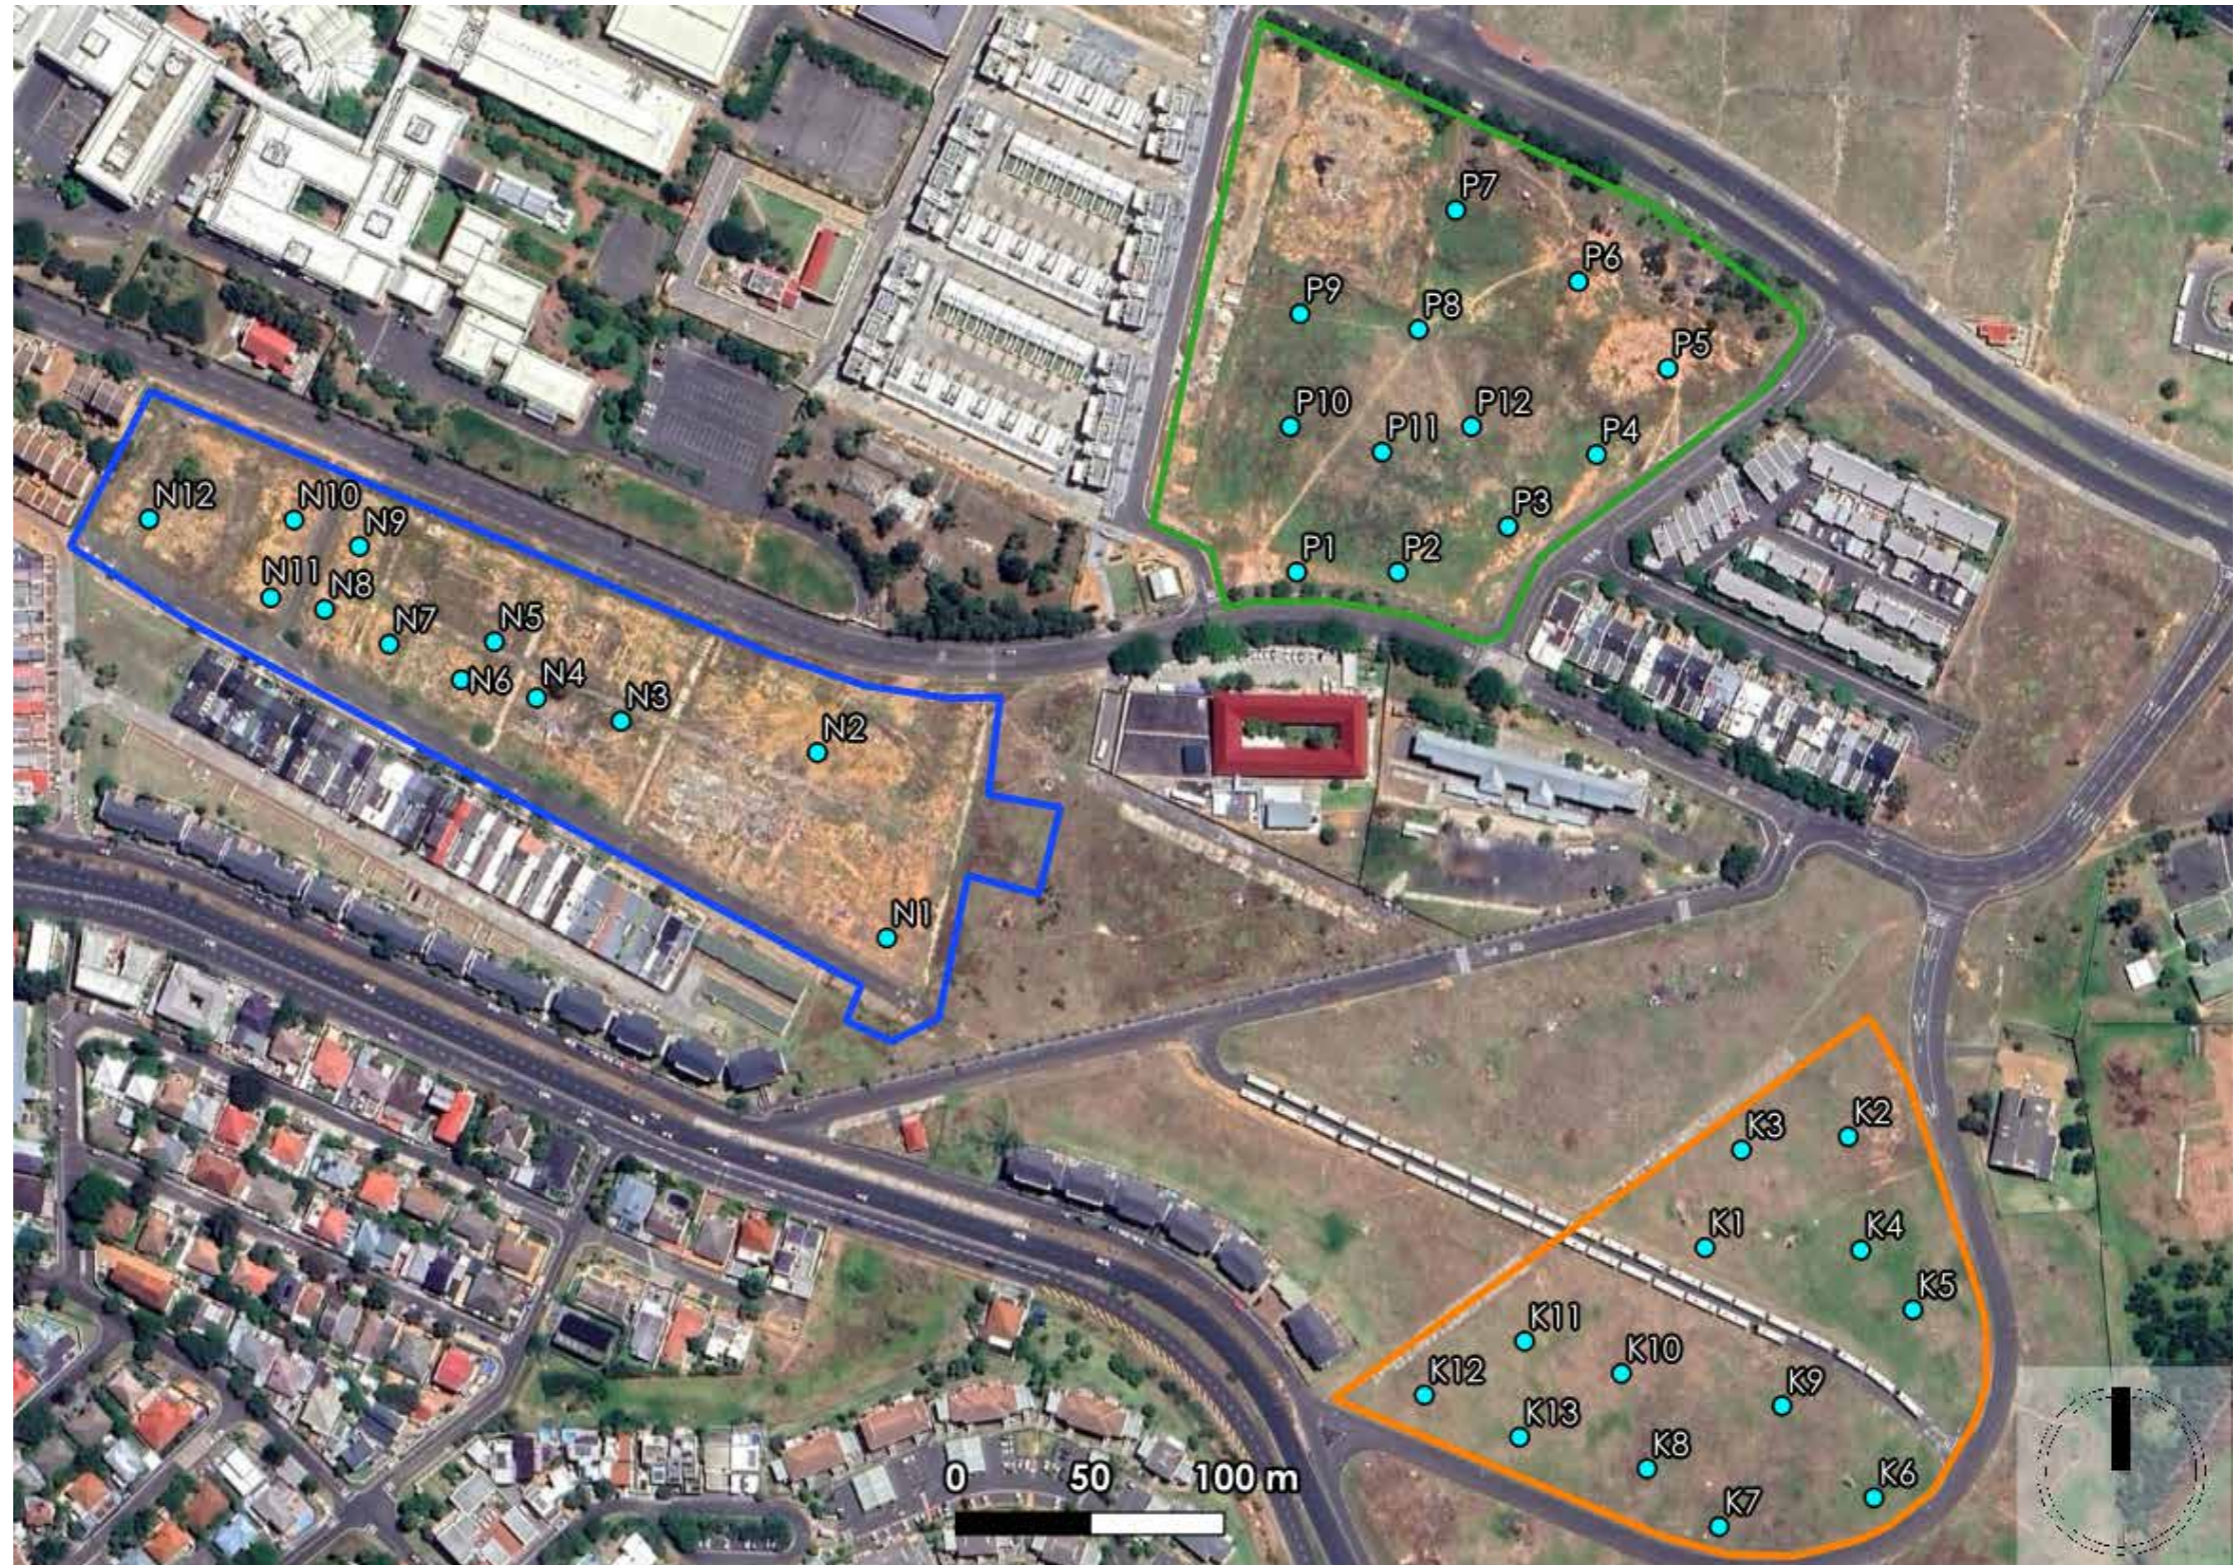
Figure 8. Location and distribution of test holes across all three parcels (RSA from SRK, 2022)

Fourteen test pits (N1 to N14) were excavated across Phase 5 (Figure 8, Figure 9 and Figure 11), generally terminating within boulder colluvial/talus material at a depth of less than about 2.5m below surface (excavation refusal).

Thirteen test pits (K2-1 to K2-13) were excavated across Phase 6 (Figure 8, Figure 9 and Figure 12), with excavation refusal generally occurring within boulder colluvial/talus material or within very stiff/very soft rock Malmesbury Group shale.

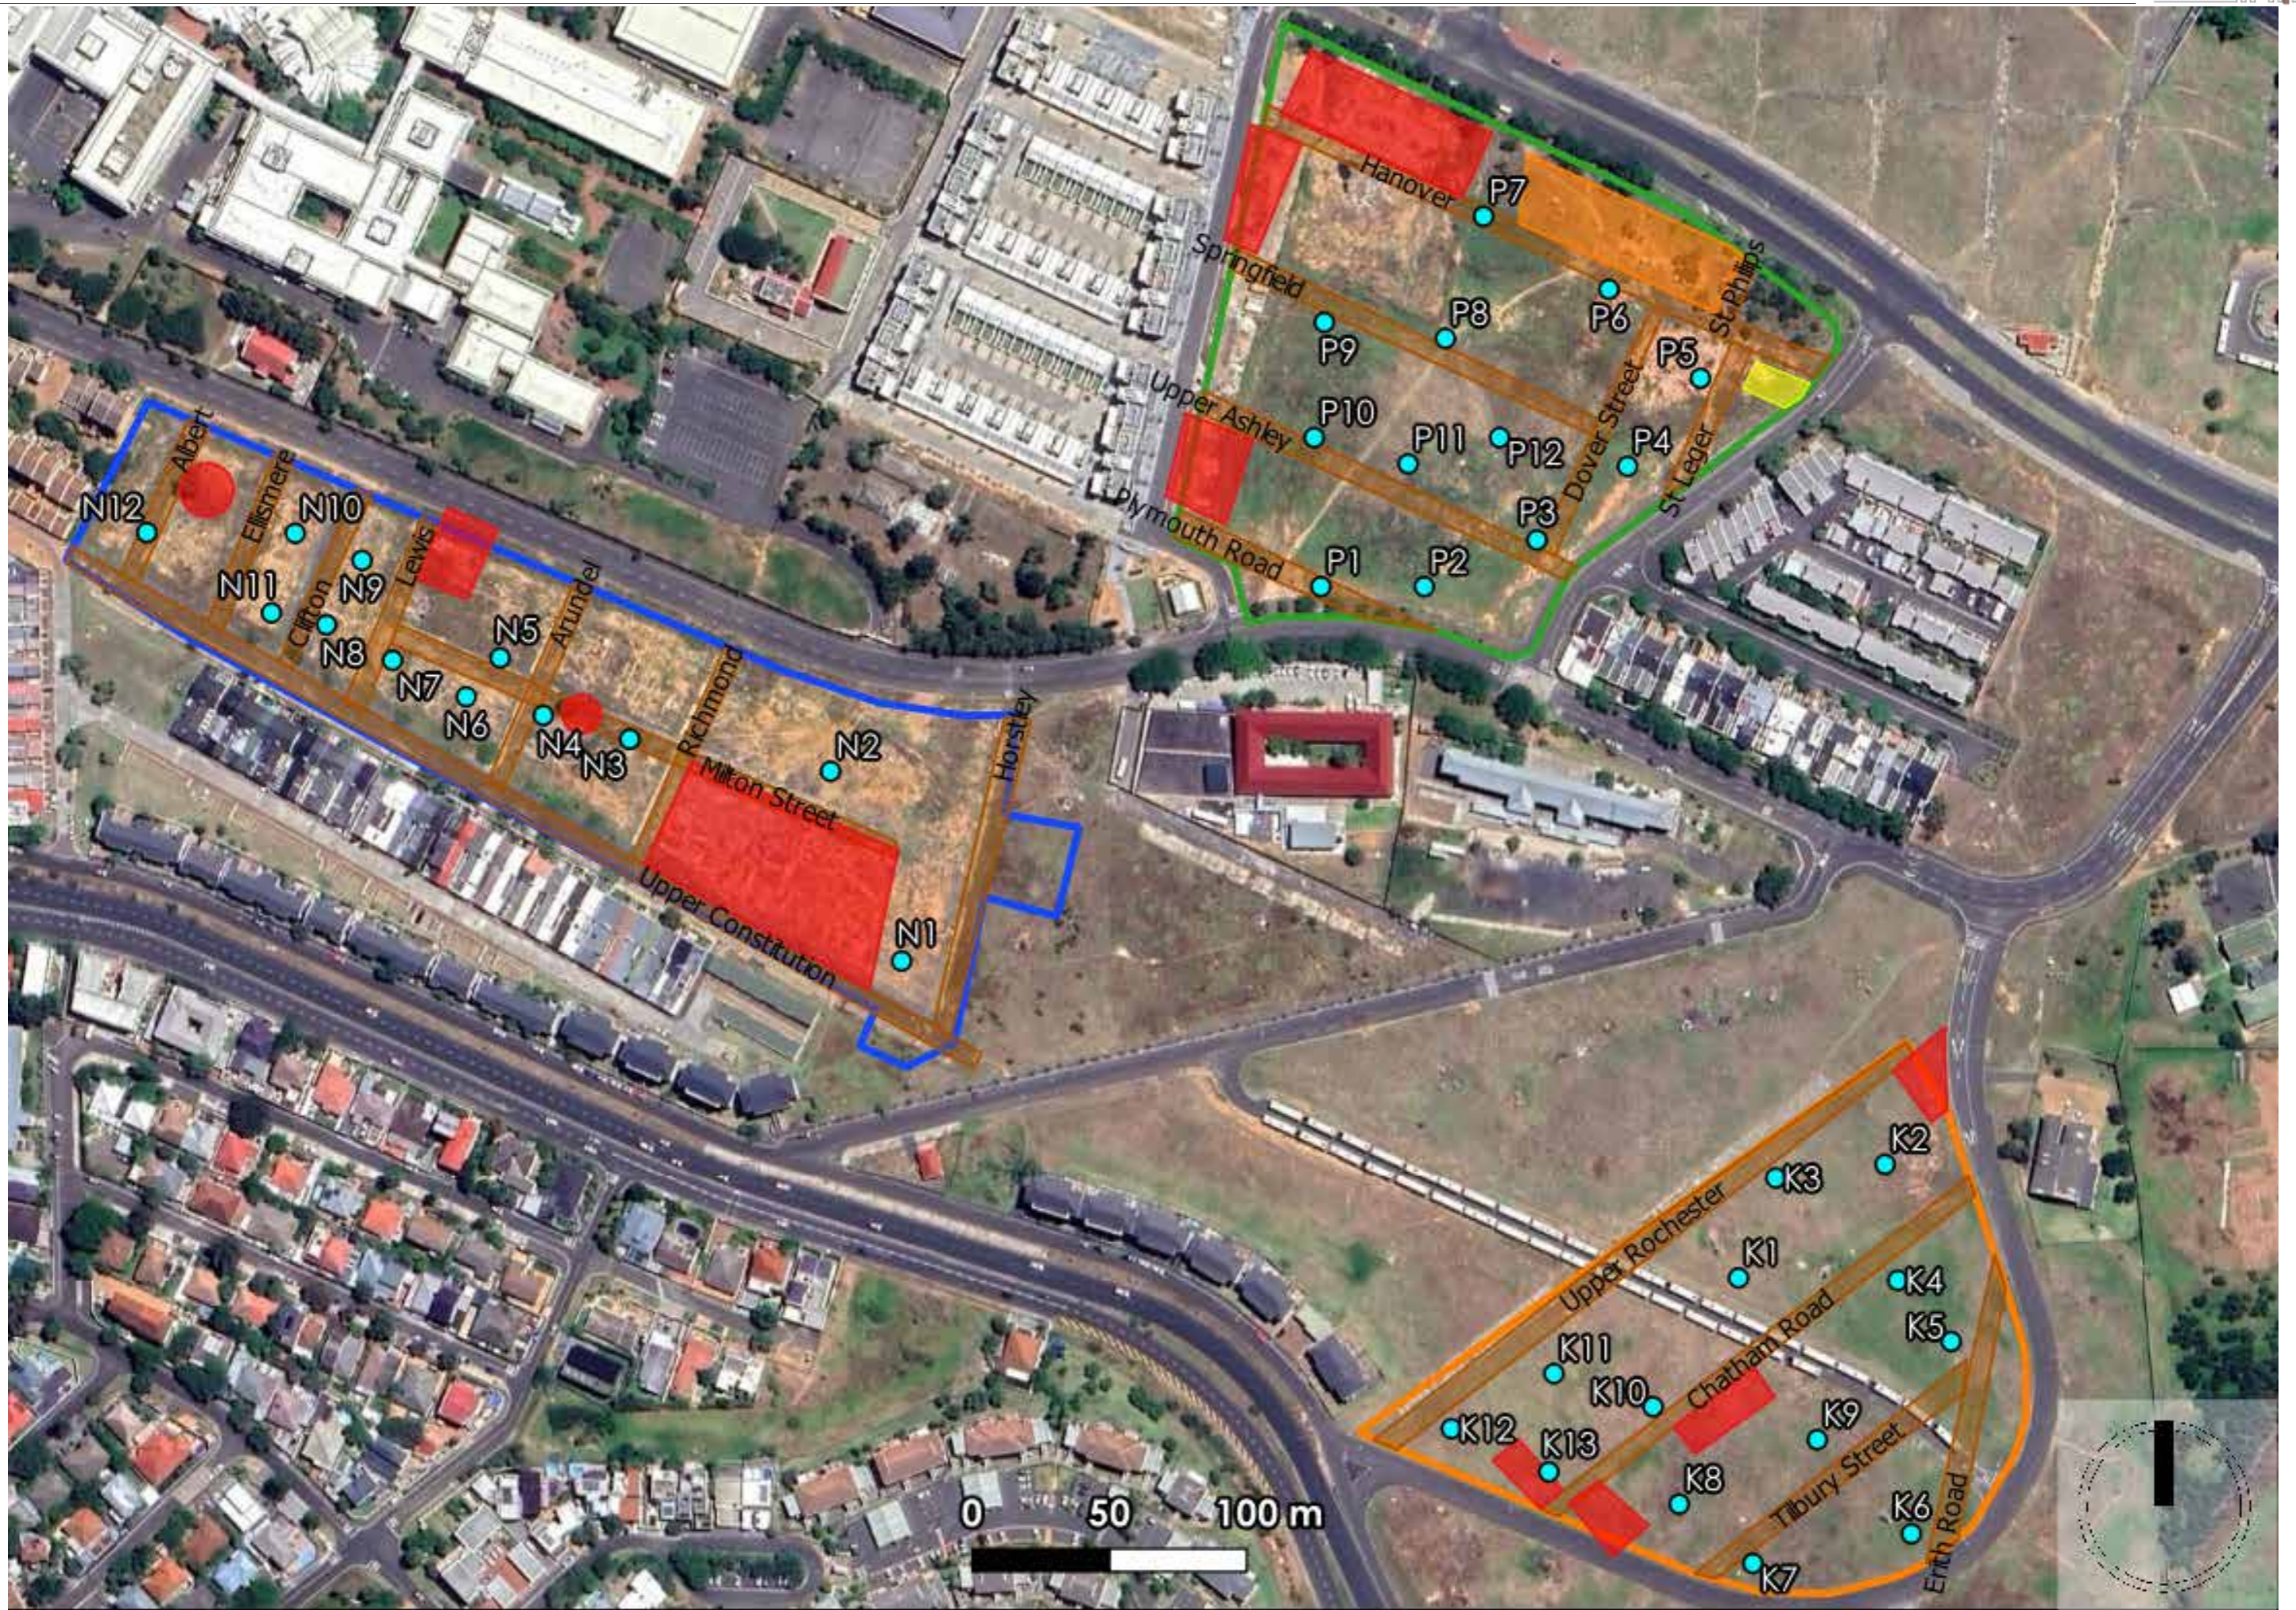
Figure 9. Overlay of geotechnical test holes on the sensitivity mapping for all three parcels (RSA, 2022)

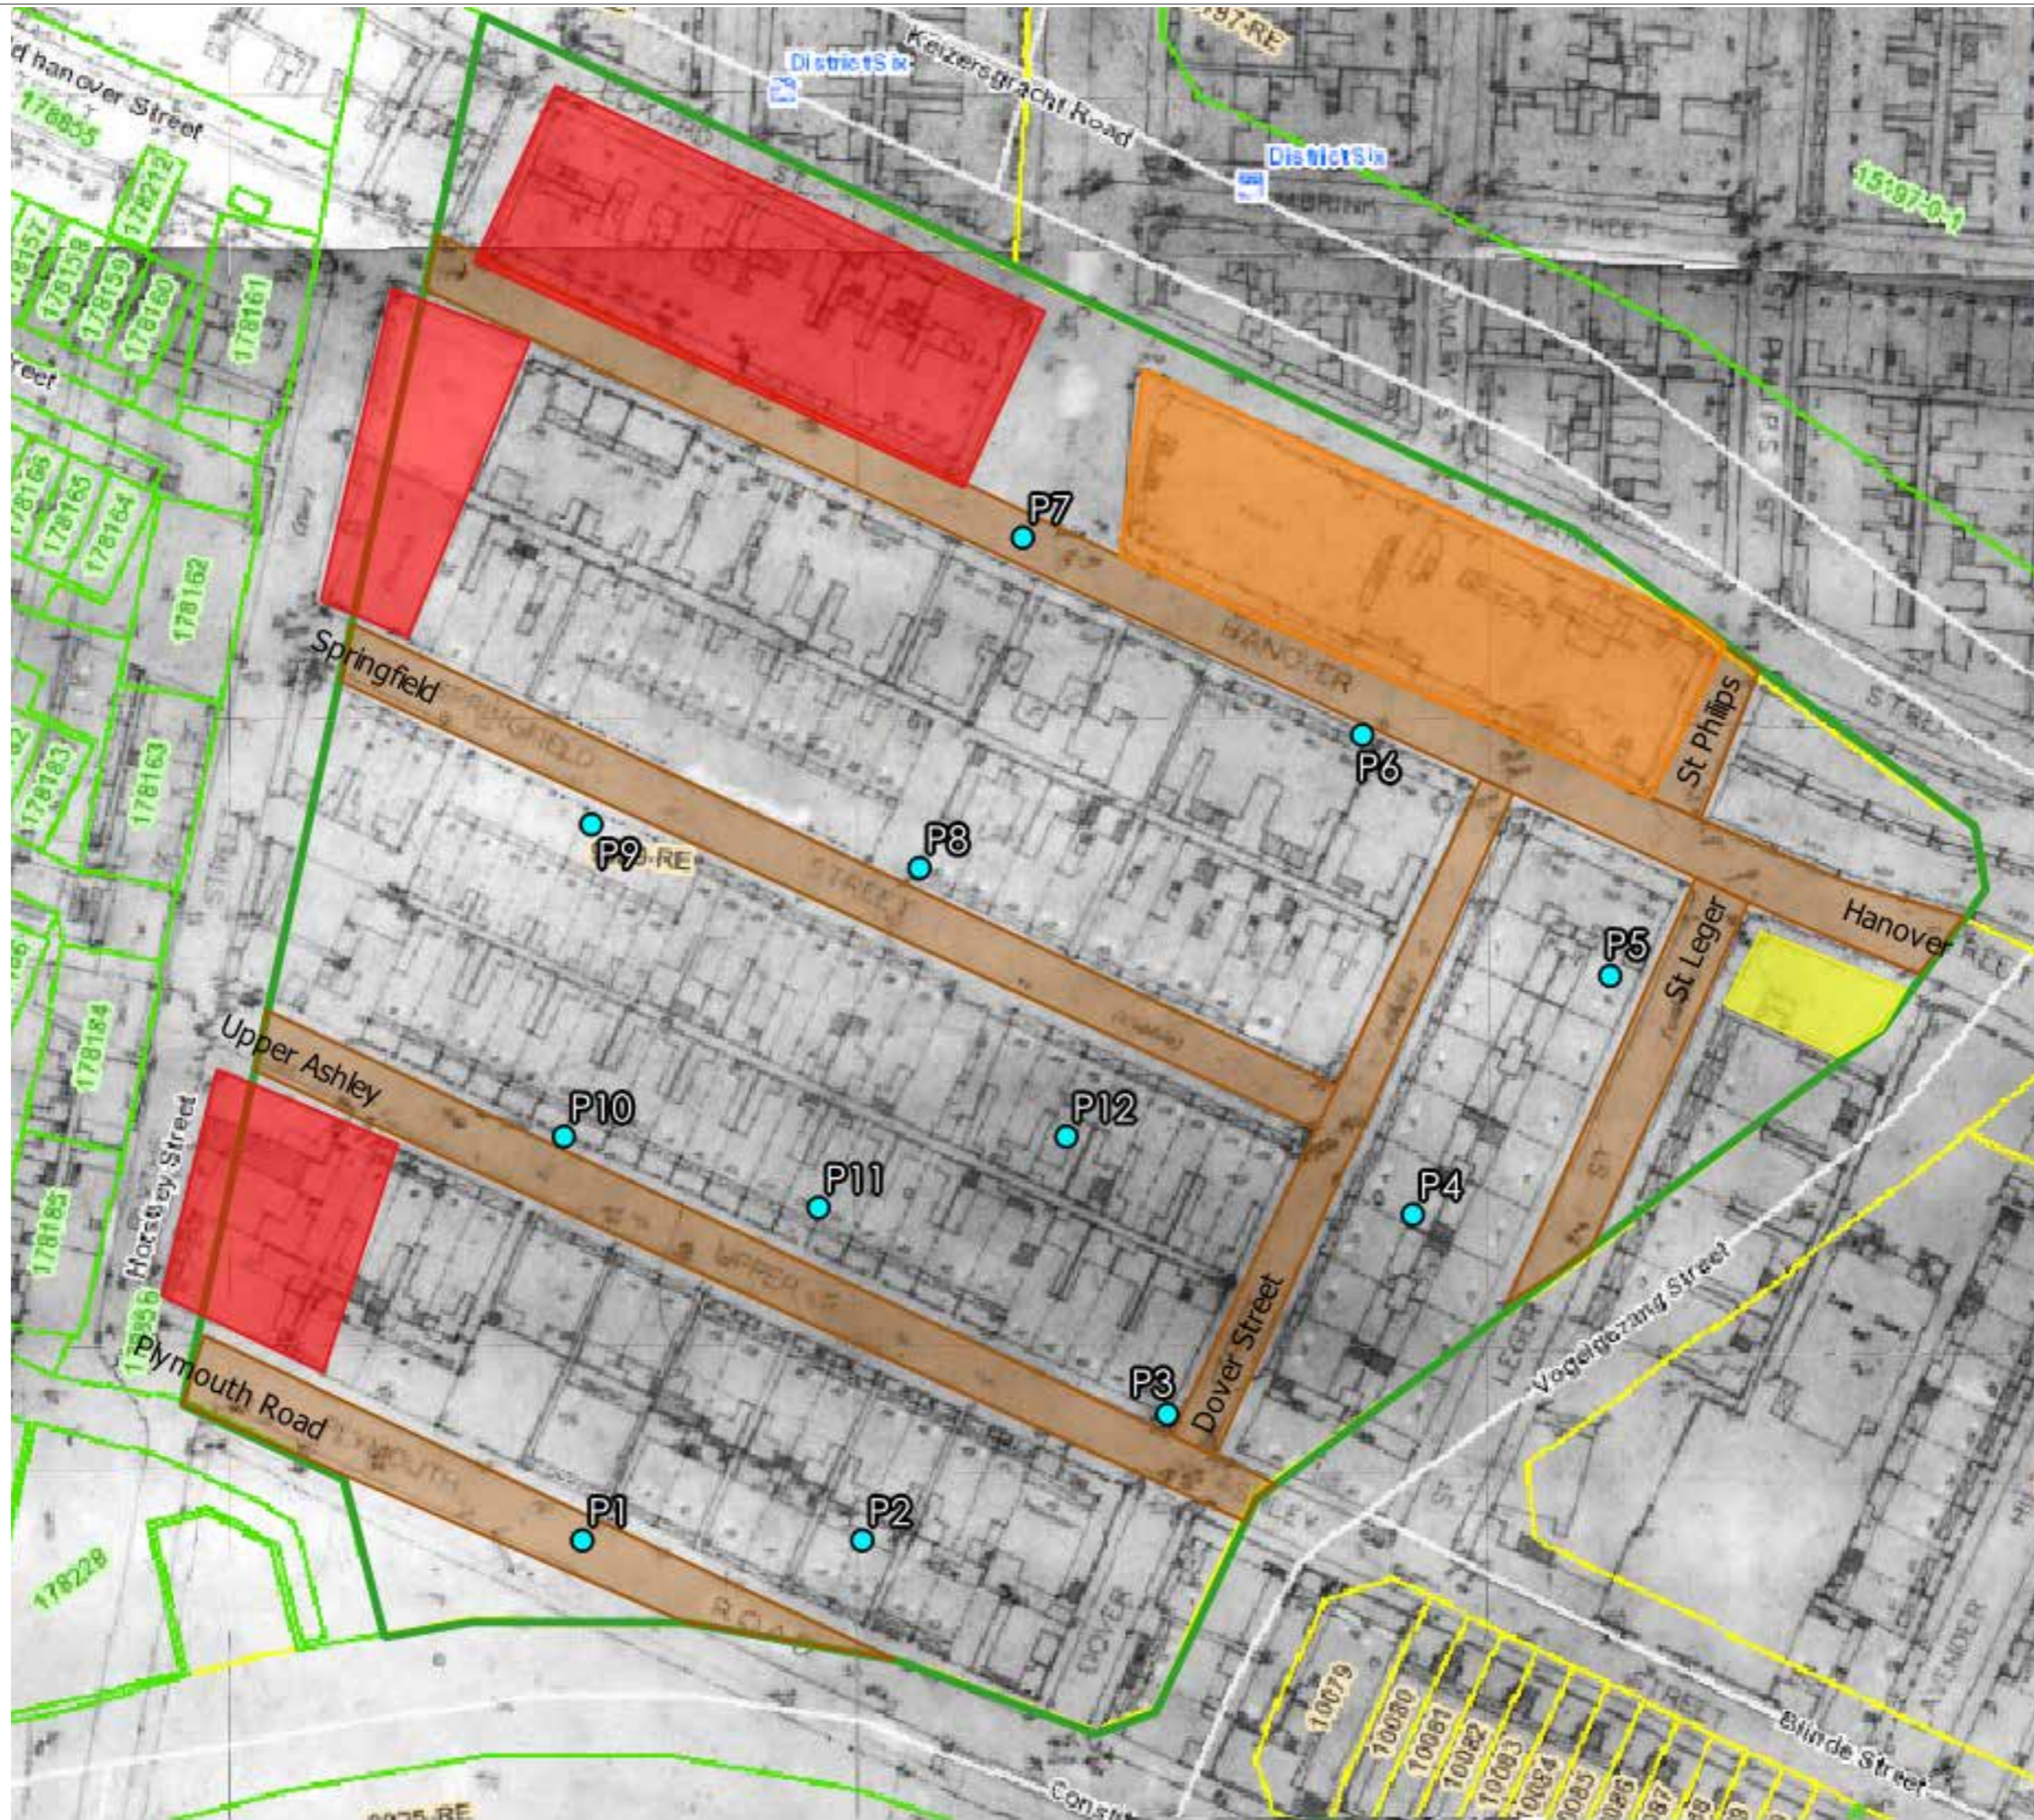
Figure 10. Location of geotechnical test holes and sensitivity mapping overlaid on 1957 City Survey Map for Phase 4 (RSA, 2022)

Twelve test pits (P1 to P12) were excavated across Erf 177646 using a 20 ton track excavator; the pits were excavated down to near refusal (i.e. deposit that cannot be excavated) or to the practical maximum reach of the excavator. Holes were excavated at selected and accessible locations across site, avoiding those areas identified and mapped as archaeologically sensitive (Figure 8, Figure 9 and Figure 10). The test pits were profiled according to accepted geotechnical practice and representative soil samples were recovered for soil classification purposes.

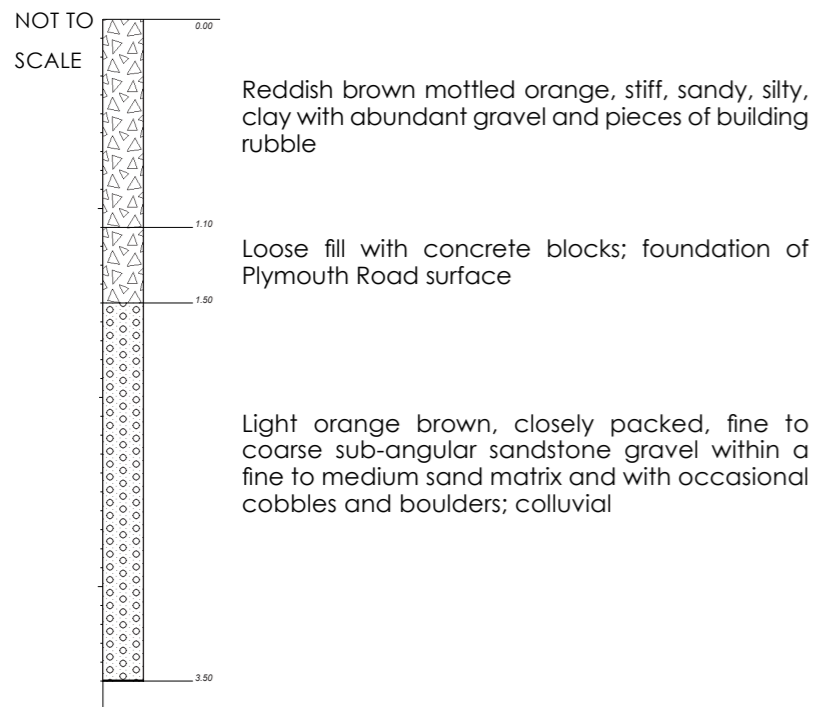
**P1**

P1 contained demolition rubble to a depth of 1.1m which overlay fill for Plymouth Road, although no evidence was recorded here for the tarred road surface itself.

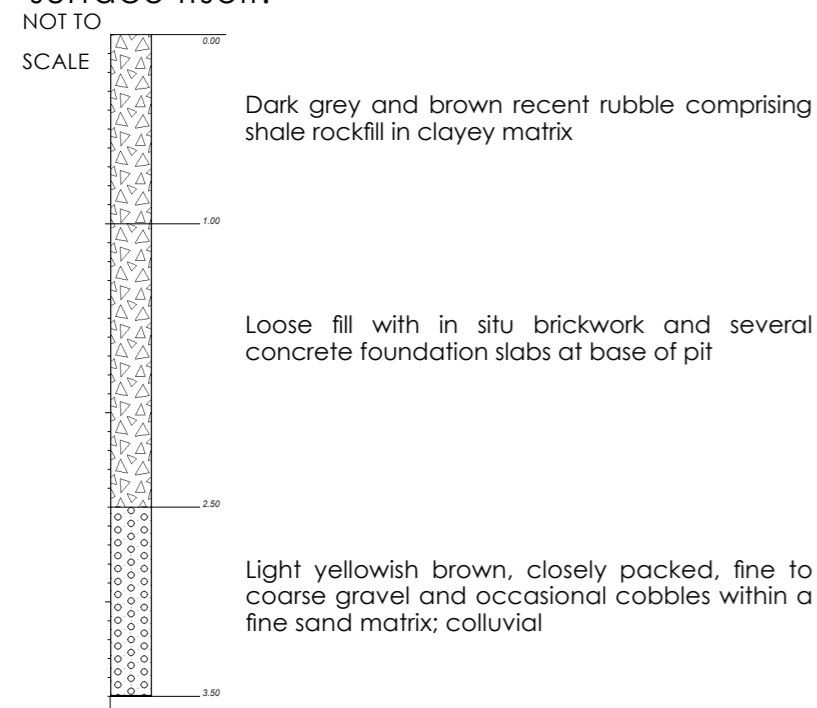
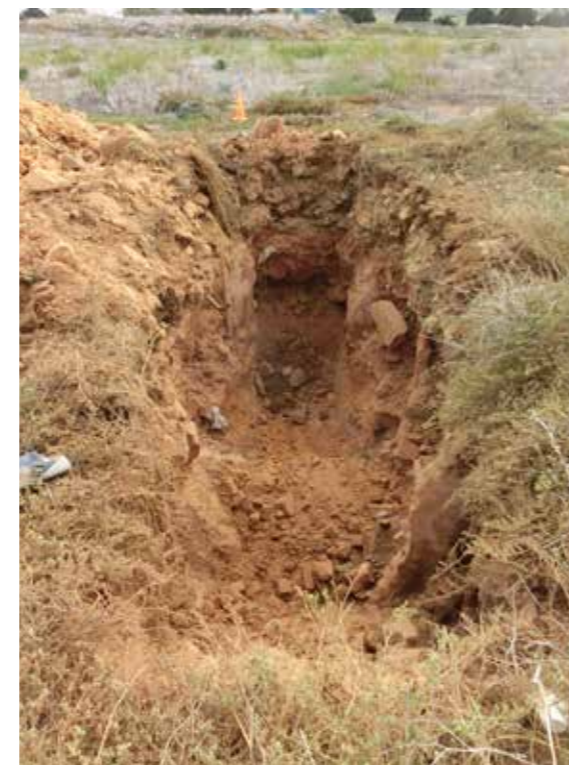
**P2**

P2 contained a recent rubble to a depth of 1m. Demolition rubble and intact structural elements, deriving from the northern extent of the dwelling at 19 Plymouth Road (brick walling and concrete foundation slabs), were encountered between 1m and 2.5m below surface level. This test pit possibly shows the demolition rubble truncated down to intact basement levels, with the subsequent fill being brought in from elsewhere.

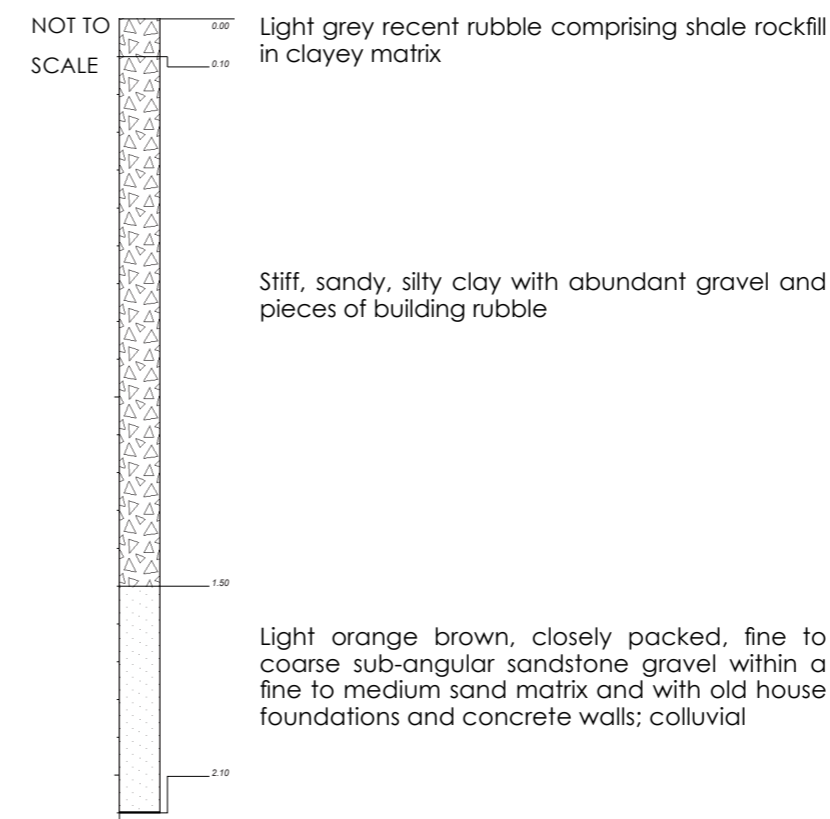
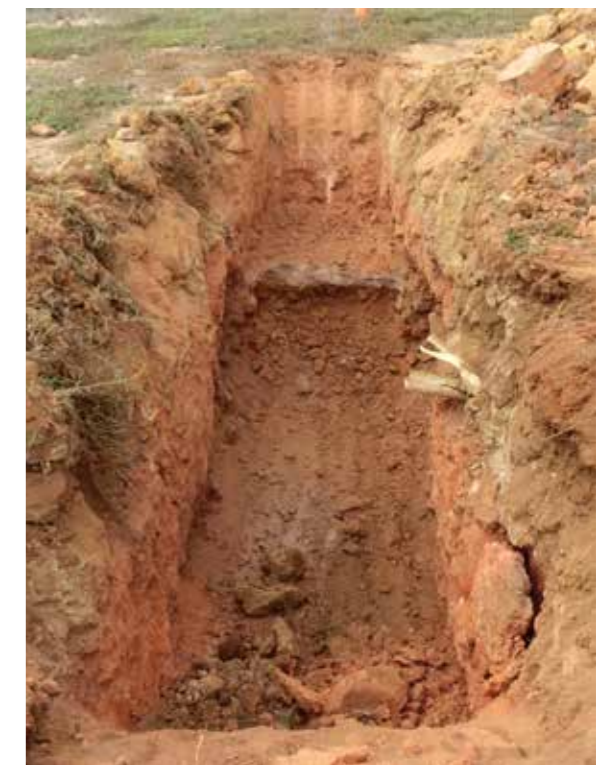
**P4**

P4 contained recent fill, to 0.1m, with a demolition layer extending some 1.4m below that. This deposit overlay foundation levels - southern extent of 9 Dover Street - and concrete walling, within a matrix of colluvial deposits.

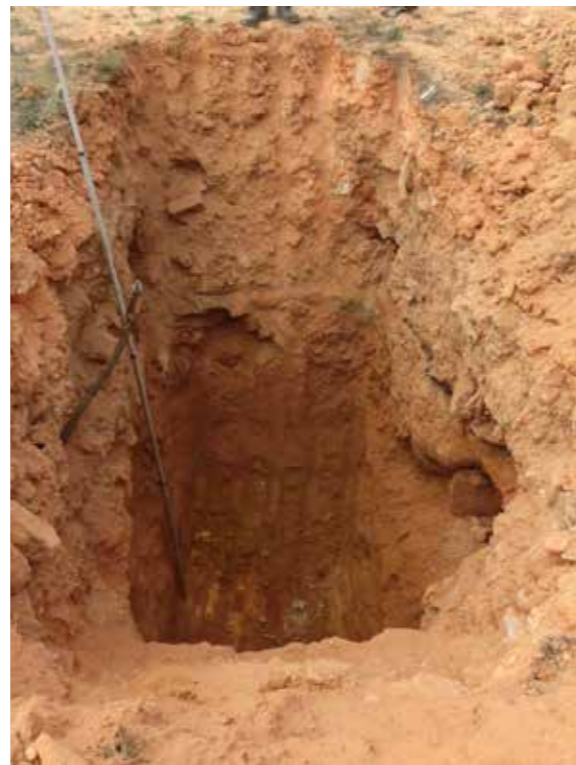
**P5**  
 This test pit revealed recent fill to 1.1m below surface with the concrete foundations either part of that transported fill or redeposited demolition rubble. A tarred surface (St Leger is cobbled, so possibly this represents a yard or similar) was present between 1.1m and 1.15m in the location of 2 St Leger, overlaying fill matrix laid on natural deposits.

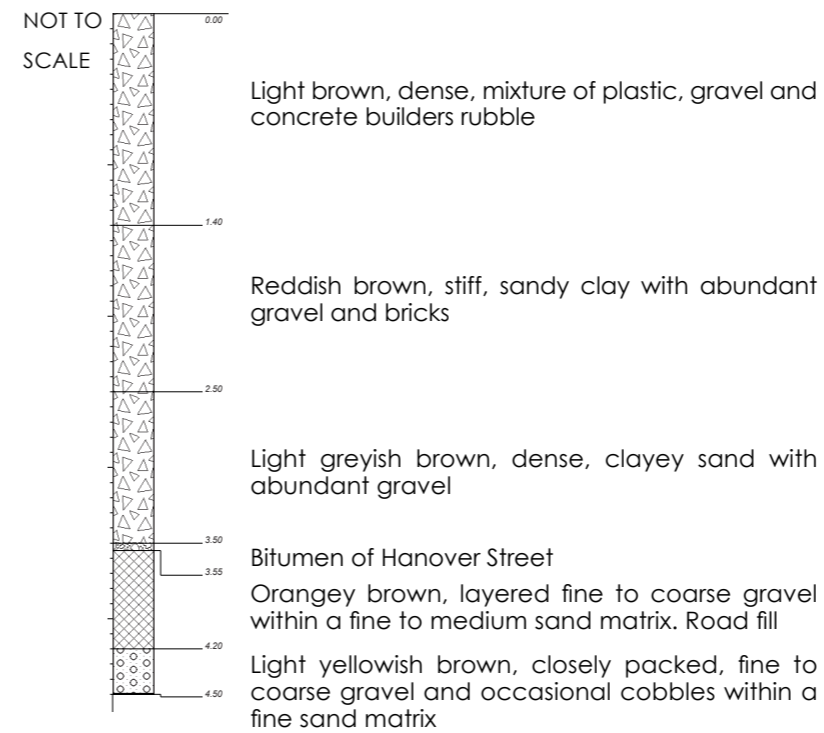
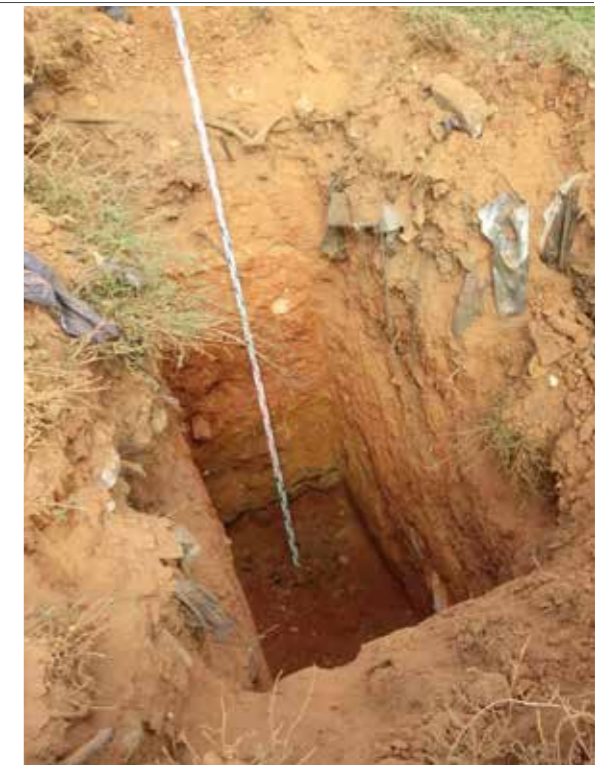
**P7**  
 This test pit revealed recent fill to 1.4m below surface, with further demolition rubble below that to a depth of 2.5m. Below the demolition rubble was a layer of sand and gravel overlaying the tarred surface of Hanover Street at 3.5m deep. A fill layer underlay Hanover Street at this point, extending to 4.2m deep, with colluvial deposit below that.
