# DISTRICT SIX PHASED REDEVELOPMENT: PERMIT CLOSE OUT REPORT FOR PREPARATORY WORKS

INVASIVE SITE PREPARATION WORKS ON SEVERAL PARCELS AND VARIOUS ERVEN AHEAD OF REDEVELOPMENT, DISTRICT SIX, CAPE TOWN

S35 PERMIT REPORT

Prepared by Rennie Scurr Adendorff for Delta BEC on behalf of Department of Agriculture, Land Reform and Rural Development

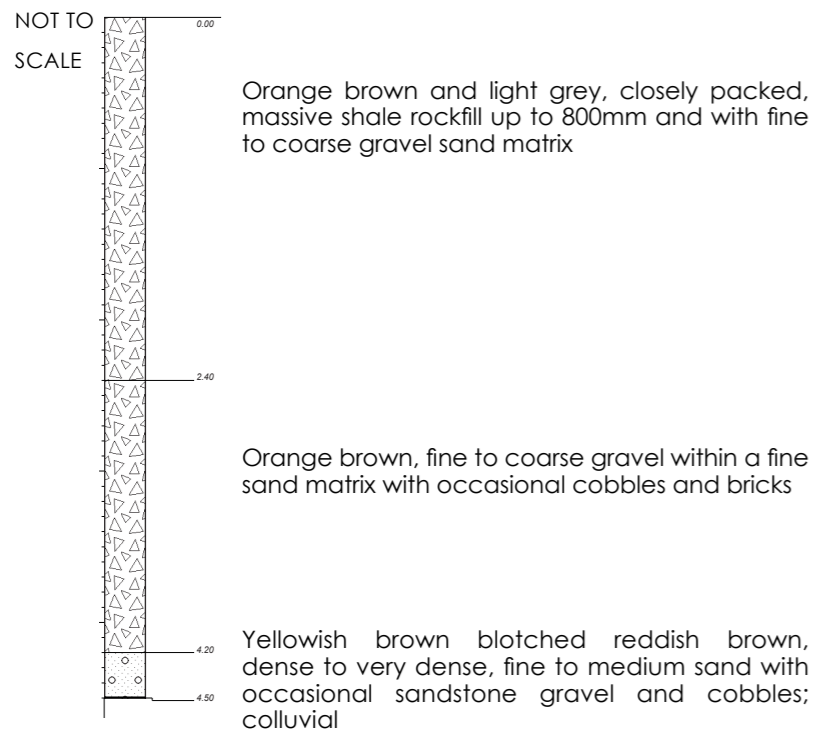
**P9**

This test pit revealed recent fill to 2.4m below the surface, with demolition rubble below that to 4.2m. The demolition layer directly overlay natural deposits.

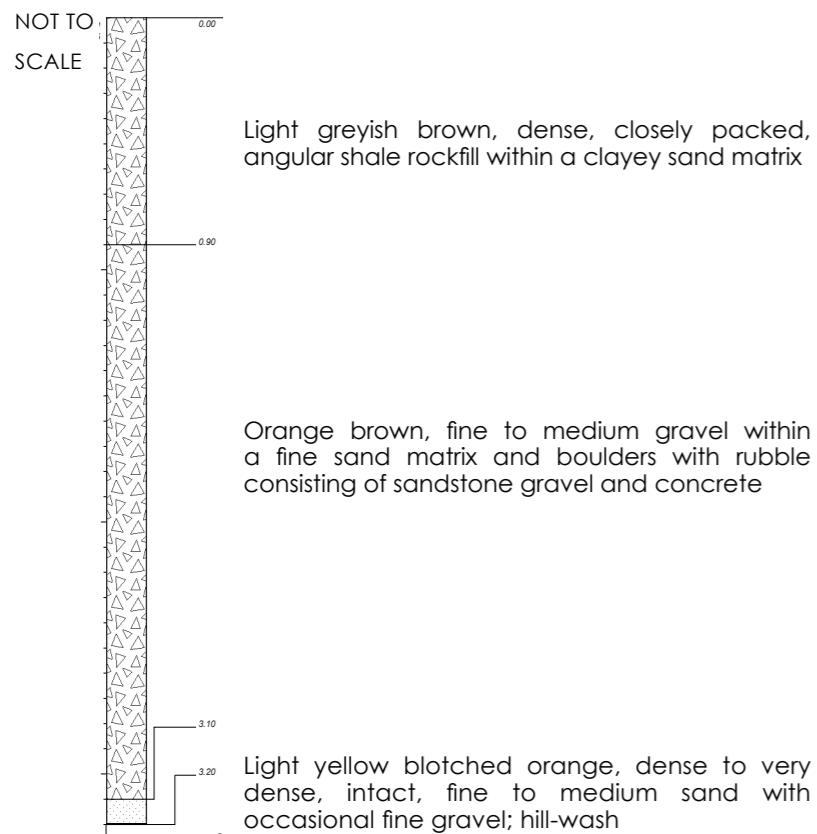
**P10**

P10 contained recent rubble down to 0.9m, with an extensive rubble layer below that contained frequent concrete chunks extending to 3.1m deep. Below this rubble layer was natural deposit.

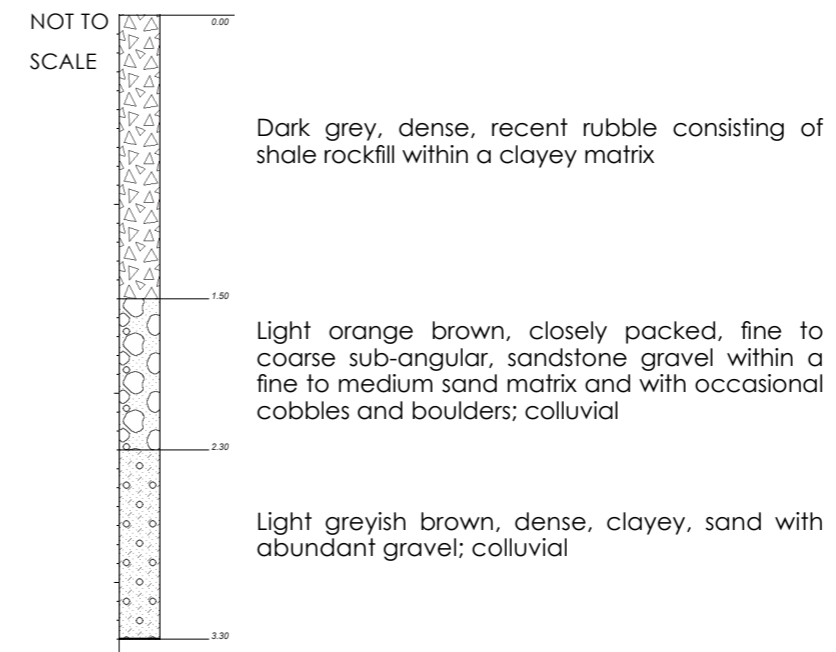
**P12**

P12 contained 1.5m of recent rubble overlaying natural levels.

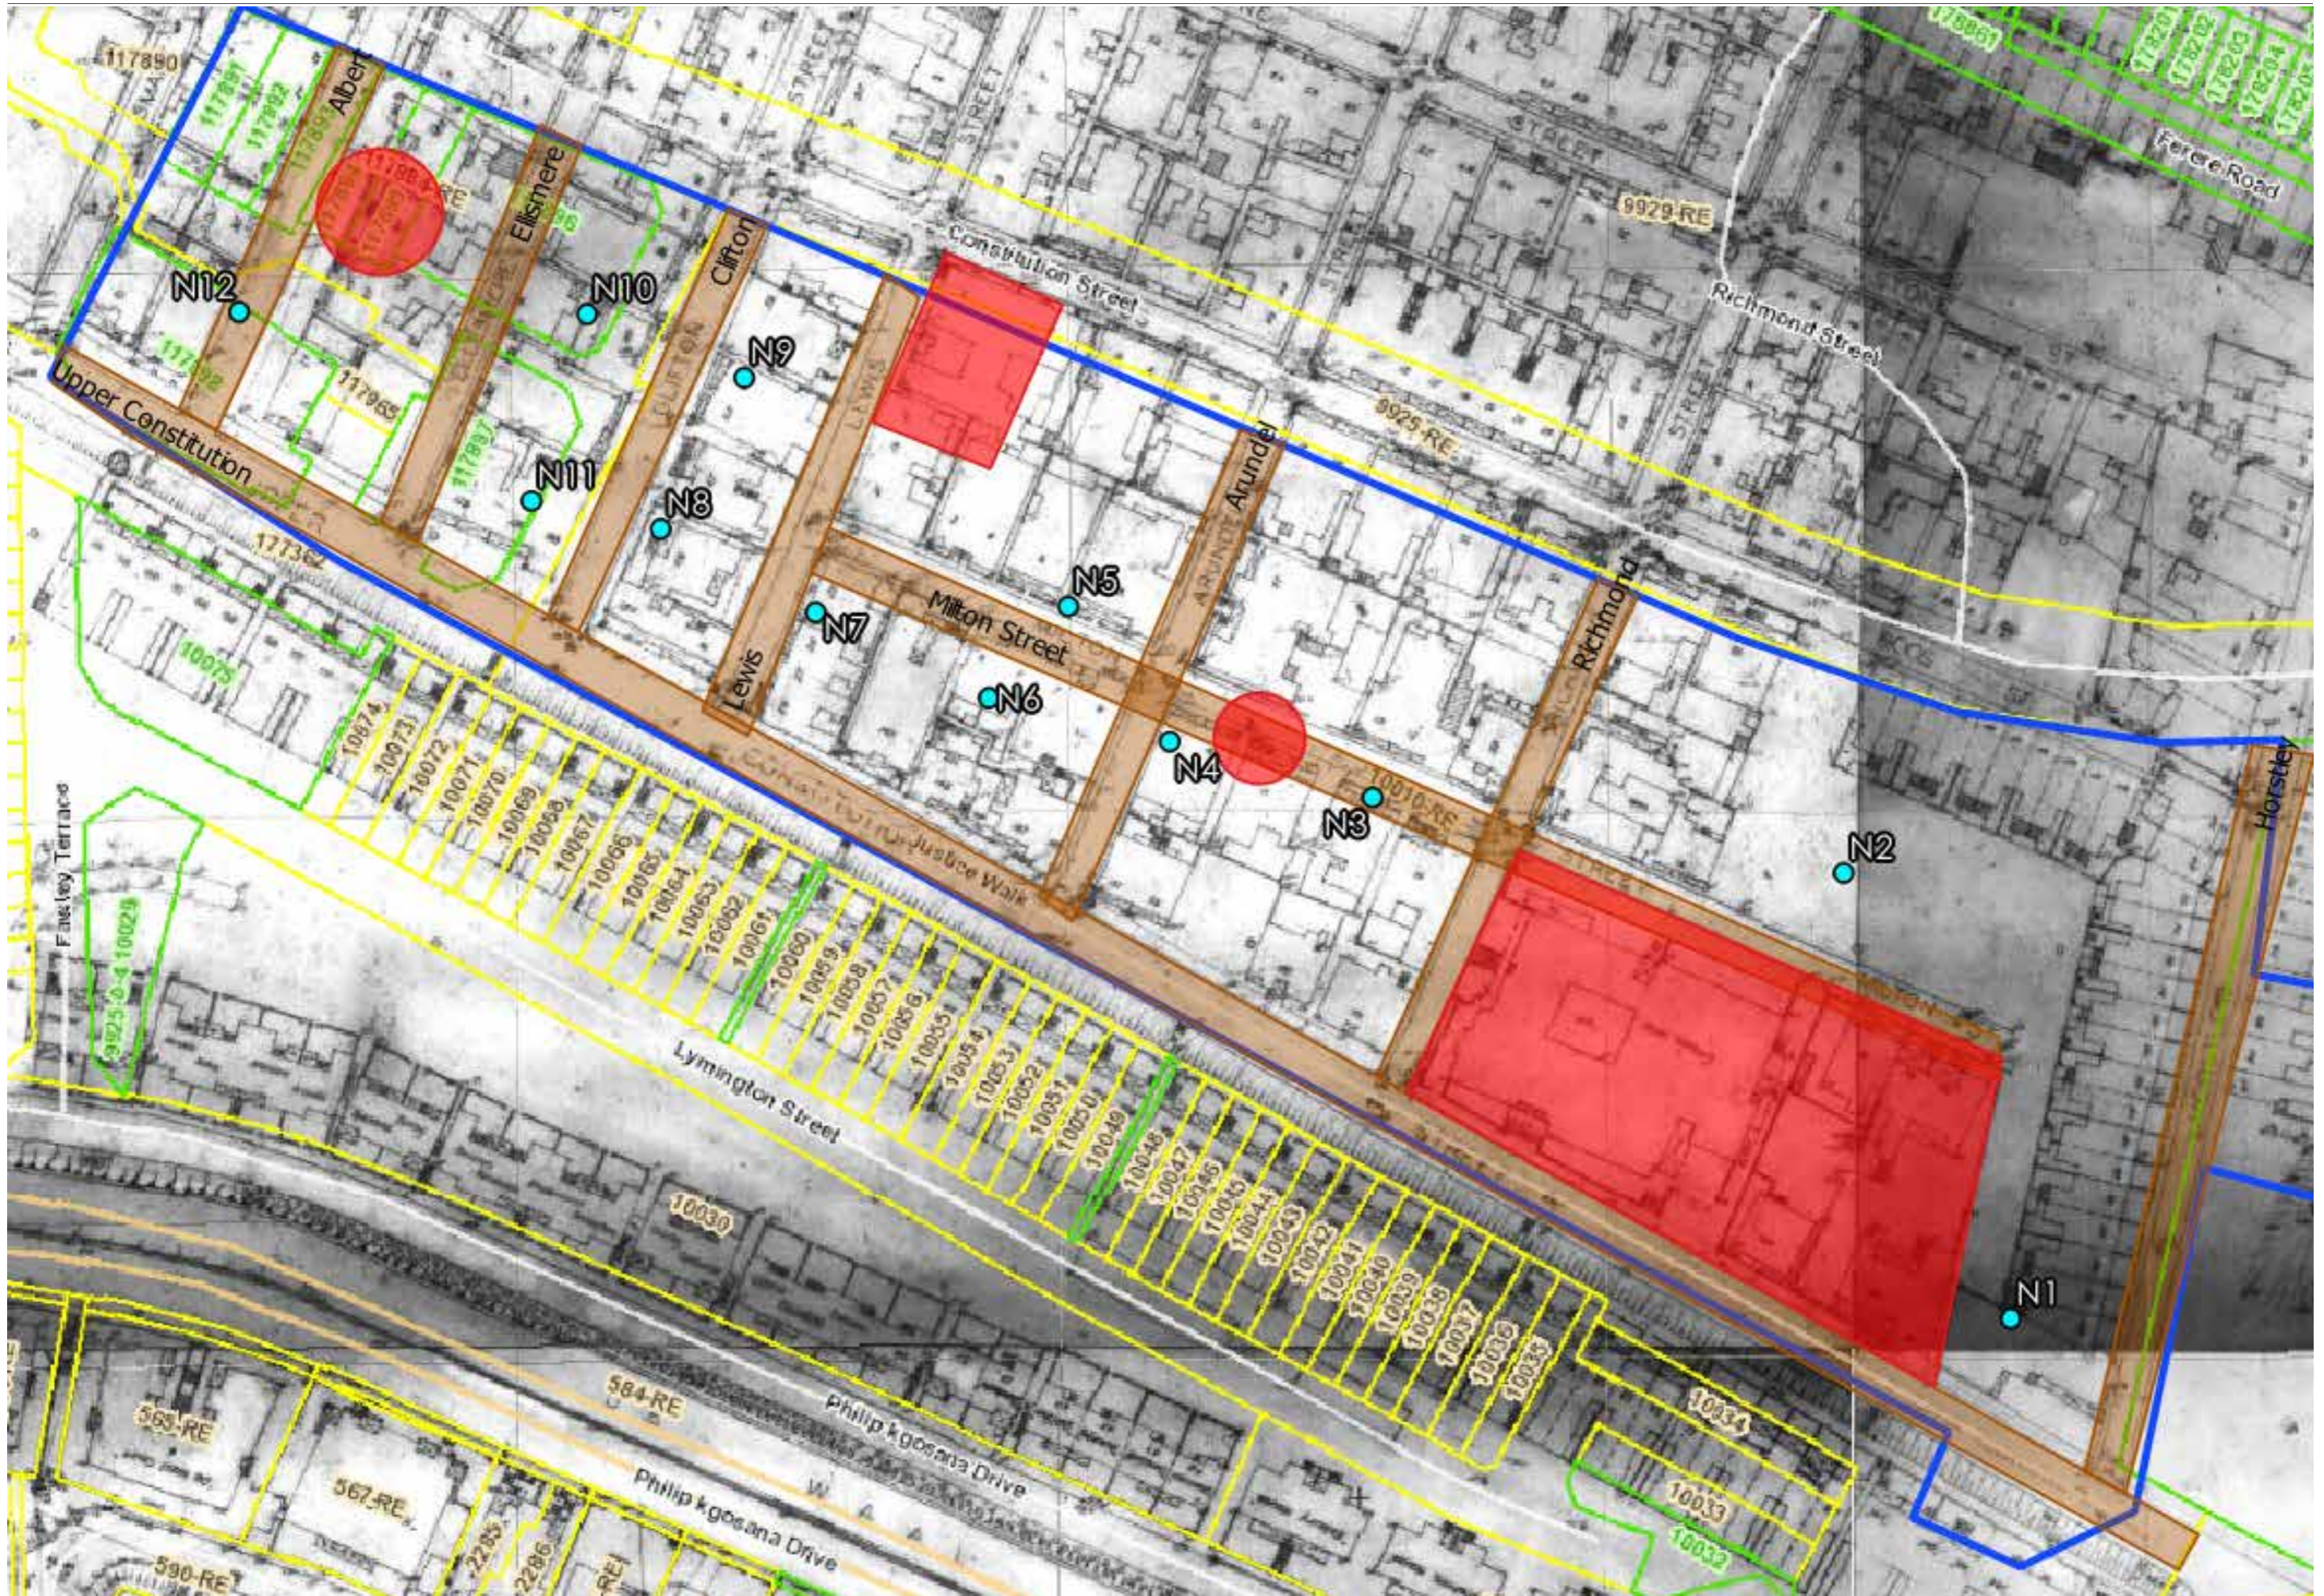
Figure 11. Location of geotechnical test holes and sensitivity mapping overlaid on 1957 City Survey Map for Phase 5 (RSA, 2022)

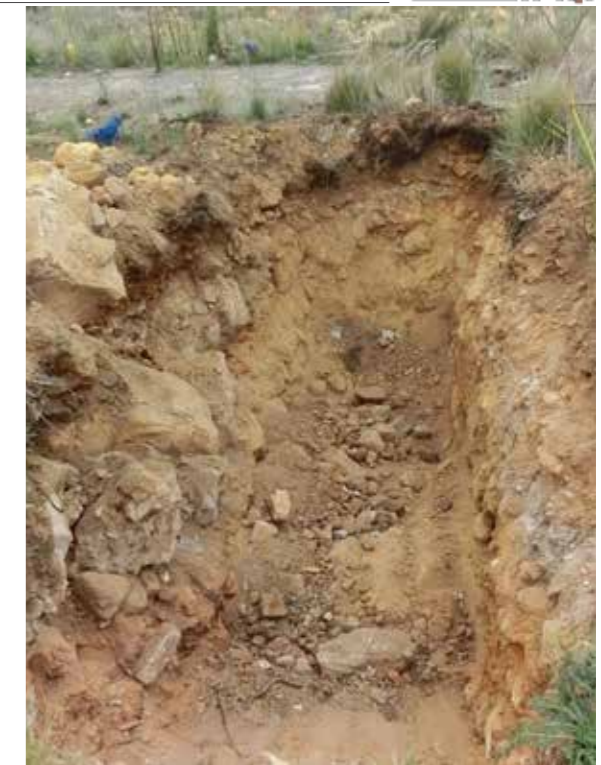
**N3**

N3 contained disturbed demolition rubble to a depth of 0.4m overlaying further rubble and in situ house foundations to a depth of 1m - at 17 Milton Street - below which were natural deposits.

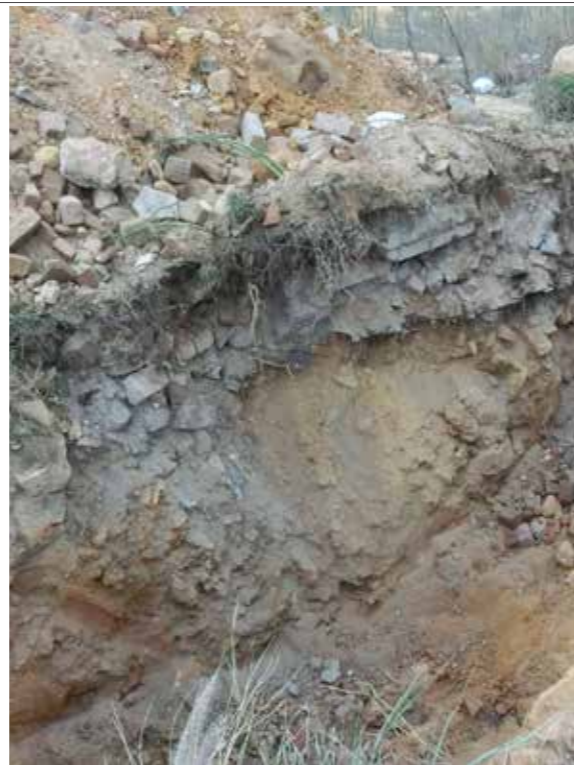
**N5**  
N5 contained disturbed demolition rubble, intact walling and house foundations to a depth of 1m - at 8 Milton - overlaying natural deposits.

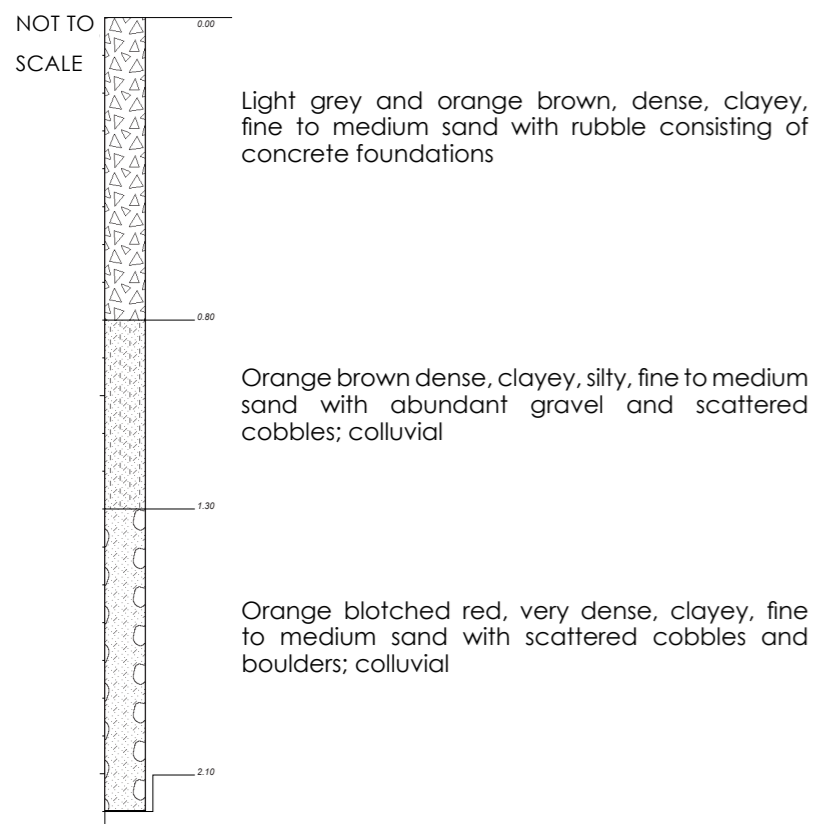
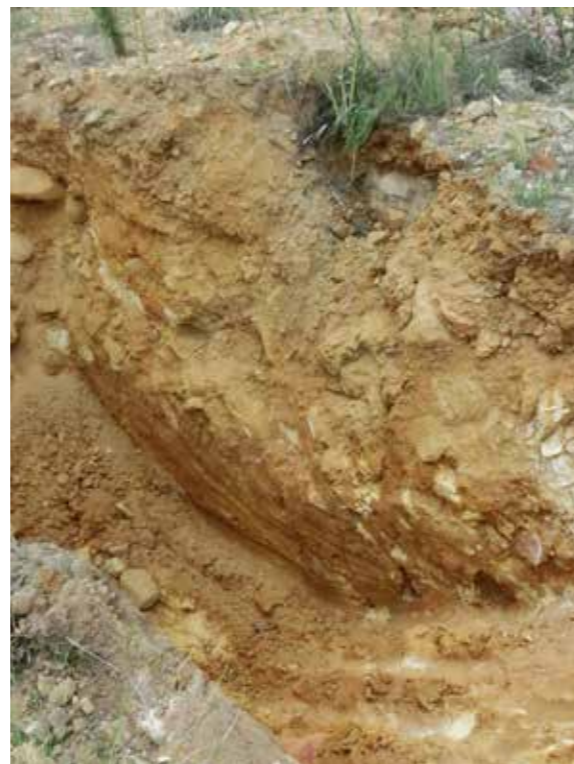
**N6**  
N6 contained disturbed demolition rubble and concrete foundations to a depth of 0.8m - at 3-5 Milton - overlaying natural deposits.

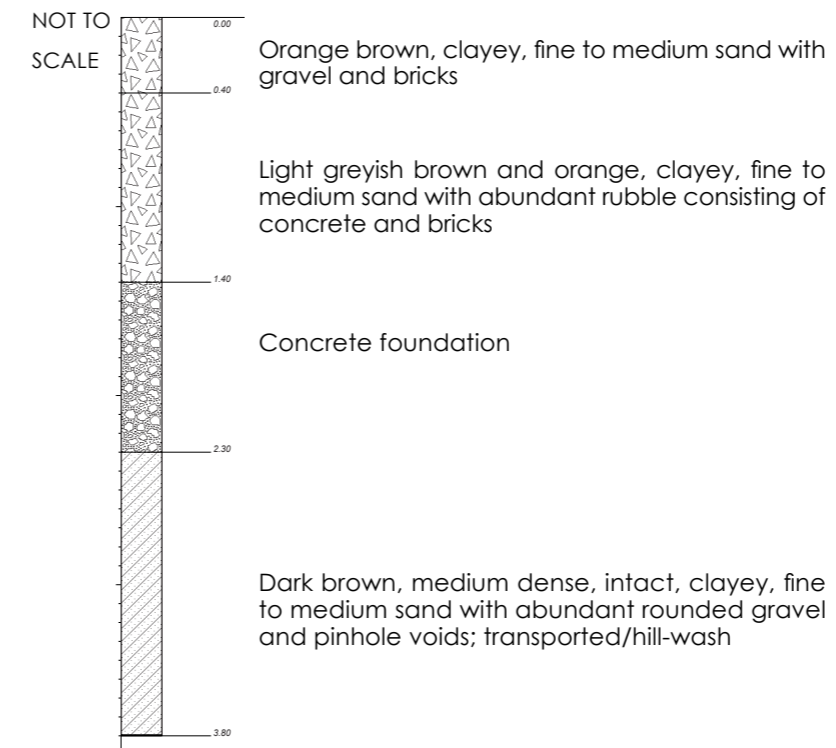
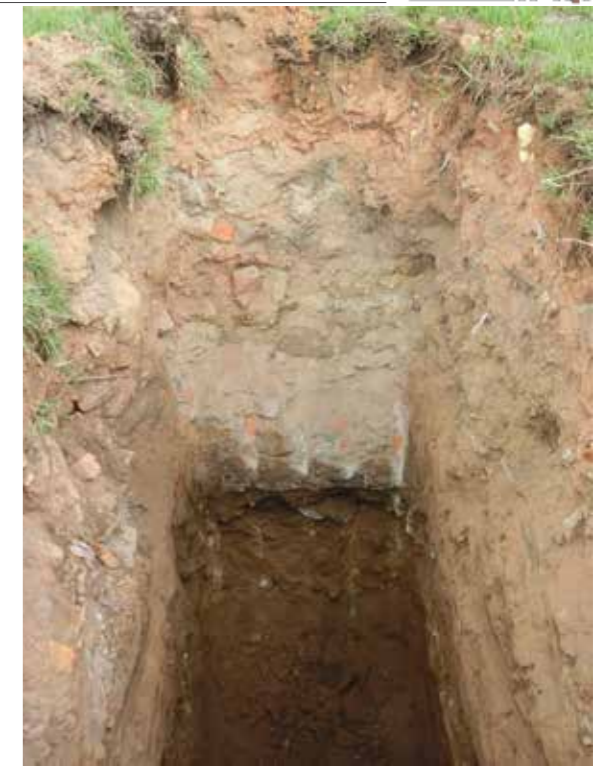
**K9**

K9 contained two demolition rubble layers measuring 0.4m and 1m each, with a thick concrete foundation between 1.4m and 2.3m - at Multe Red, Tilbury Street - overlaying natural deposits below.

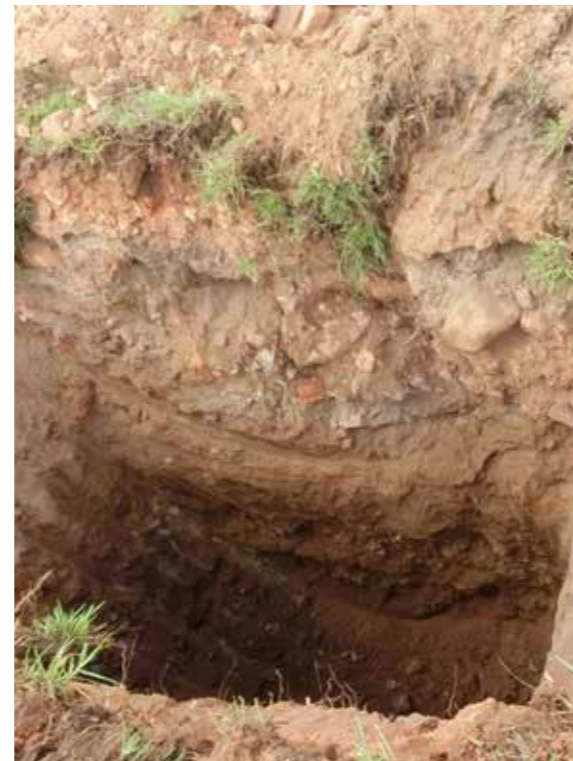
**K8**

K8 contained disturbed demolition rubble to a depth of 2.8m overlaying a further layer of demolition rubble to 3.6m with natural deposits below.

The test pits show how very deep the demolition and later dumping fill is across Phases 4 and 6, with demolished fabric as deep as 3.6m (K8), and intact road surfaces at 2.3m (P3, P11) in some places, and 3.5m in others (P7). In Phase 5, where nearly 20 000m<sup>3</sup> of overburden was removed in 2020, the impacts of this clearing is plainly apparent, with the overburden almost entirely truncated, and the upper deposits extensively disturbed.

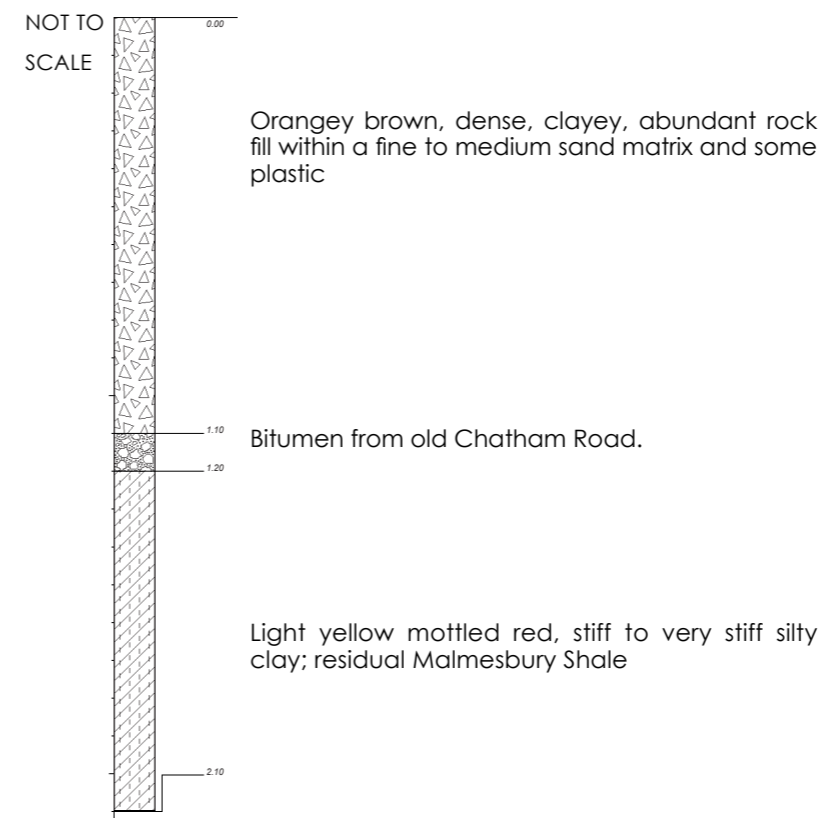
**K10**

K10 contained a disturbed demolition layer to 1.1m overlaying the tarred surface of Chatham Road; the road was laid directly on the natural clay below.
