**HERITAGE IMPACT ASSESSMENT: PROPOSED CONSTRUCTION
OF ENAMANDLA PV 1 SOLAR FACILITY ON THE REMAINING
EXTENT OF THE FARM HARTEBEEST VLEI 86, NEAR AGGENEYS,
NORTHERN CAPE**

CaseID: 10164

January 2017

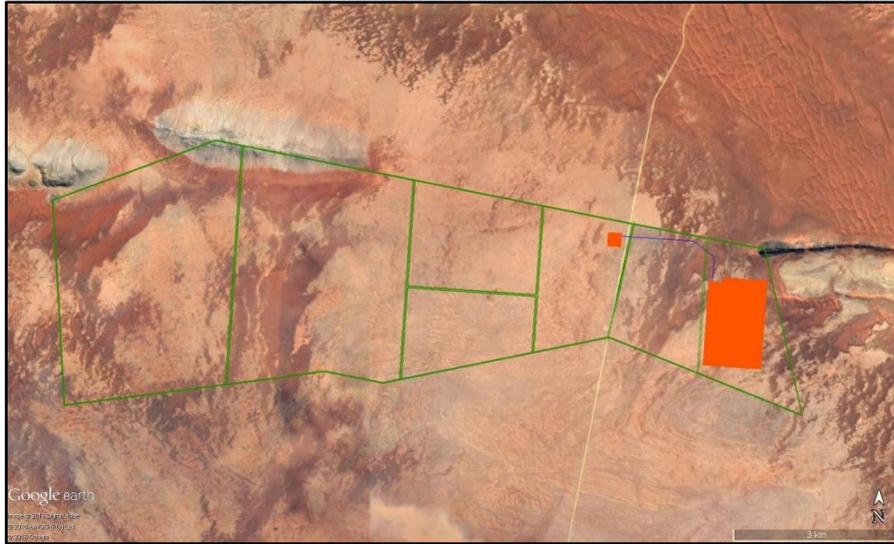
Figure 2: Layout Option 1.

This report assesses the PV 1 facility (**Figure 2**). There are three alternative layout options for Enamandla PV Site 1, namely Options 1, 2 and 3.

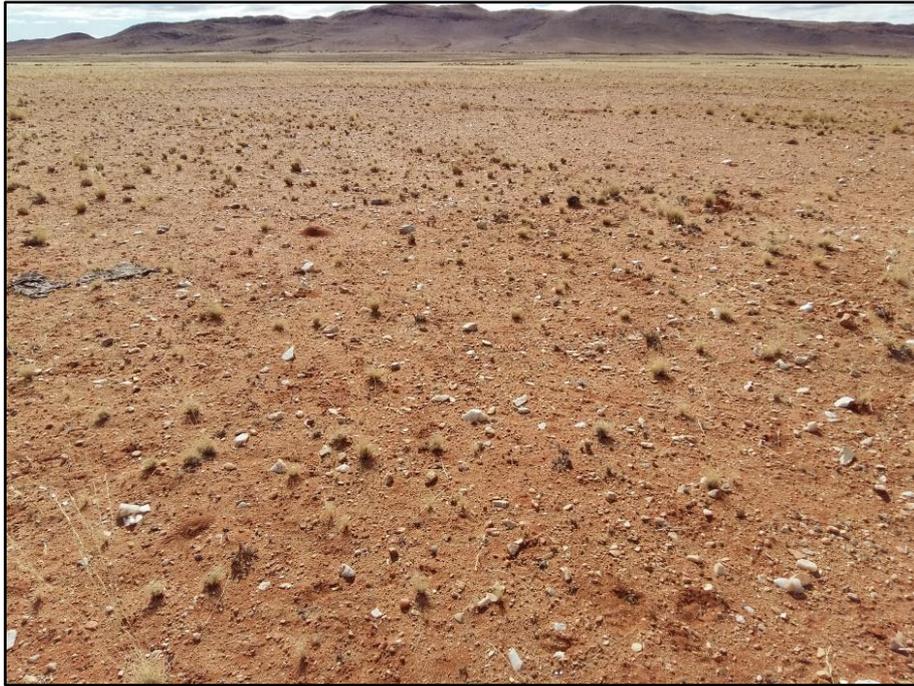
Plate 8: A typical distribution of quartz material recorded across the gravel areas of the study area. Most of the quartz in this photograph is non-artefactual, derived from occasional bedrock exposures.

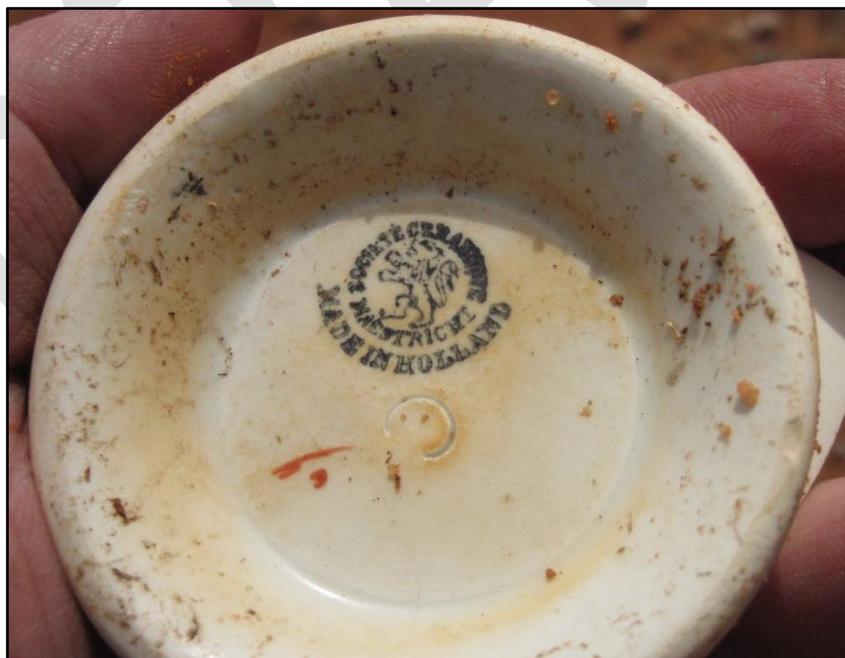
Plate 9: A base of a bowl with the inscription: “Société Ceramique, Maestricht, Made in Holland”. Recovered from a gravel area, together with MSA quartz artefacts, this fragment was dropped or discarded after 1900, when the words “Made in Holland” were added to the inscription.
