HERITAGE IMPACT ASSESSMENT

submitted in terms of section 38(8) of the National Heritage Resources Act

AURECON South Africa (Pty) Ltd

It is proposed to develop a borrow pit for road material at km 36.6 along DR 2308 approximately 40km south west of Beaufort West, Central Karoo District Municipality, Western Cape. The DR02308/36.6/0.05L borrow pit site is situated on an erosionally dissected Karoo landscape characterised by prominent ridges of Beaufort Group sandstones and intervening vlaktes and gentle slopes underlain by overbank mudrocks. Several south-flowing tributaries of the Gamka drainage system, including the Rietkuilsrivier 1 km to the east of the pit site, traverse the area. The site is located in a wide, very shallow, unsymmetrical, headwater valley of an ephemeral water course that heads downstream in a north-easterly direction. Farm Rietkuil is in private ownership of K. Mocke with borrow pit co-ordinates 32°24' 58" S, 22° 8' 25.29" E

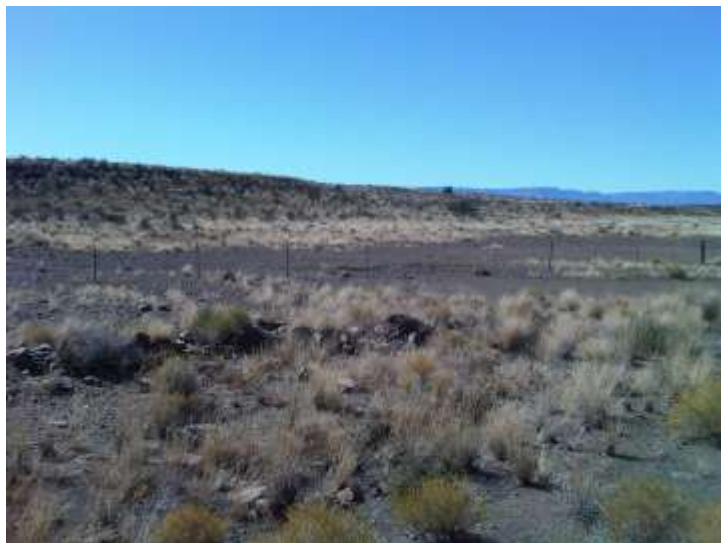
Figure 2: Looking northwest across the site of the proposed borrow pit, north of road DR02308 (April 2011)

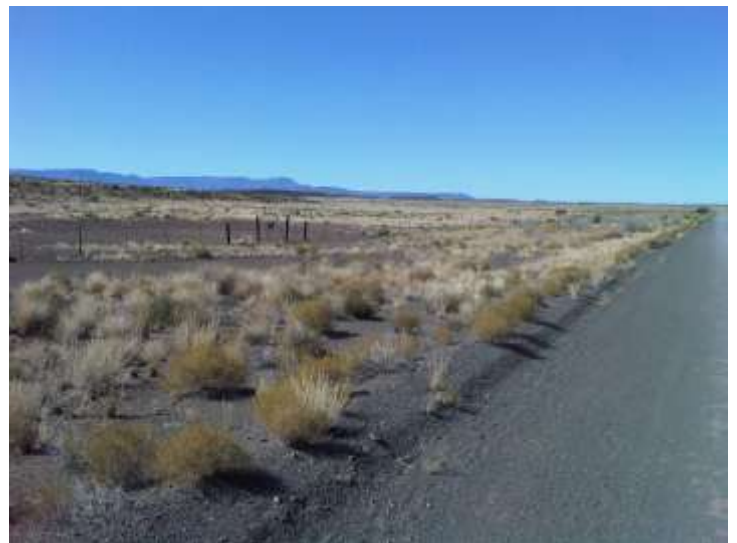
Figure 3: Looking northeast across the site of the proposed borrow pit, north of road DR02308 (April 2011)

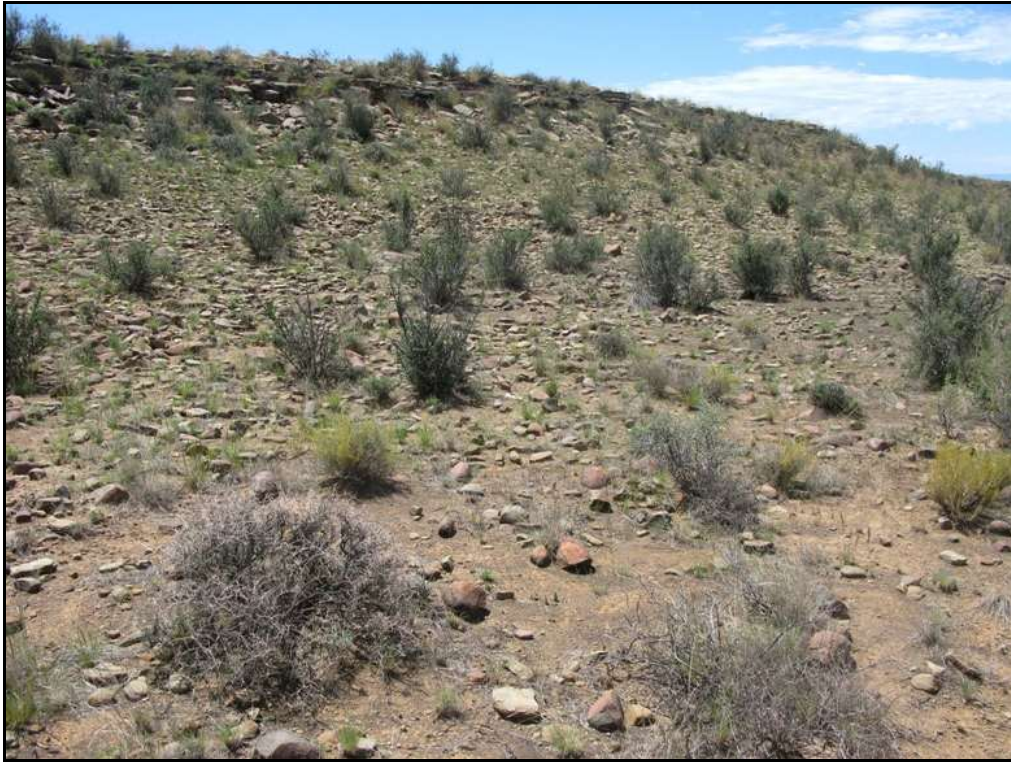
Fig. 3. View north-westwards towards the sandstone ridge bordering the pit study area. Scattered, reworked fossil bones occur among the coarse surface gravels in this region.

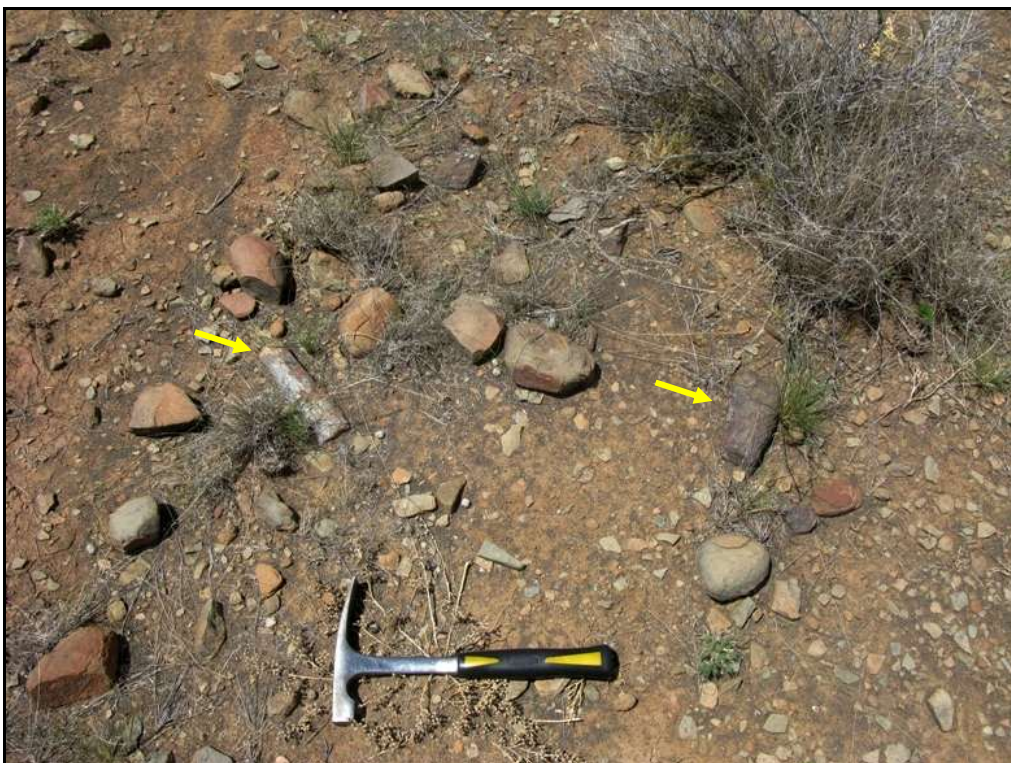
Fig. 4. Detail of poorly-sorted, coarse colluvial gravels seen in previous photo with two reworked fossil limb bone fragments arrowed (Hammer = 32 cm).

During the present field assessment a number of disarticulated fossil bone specimens, mostly sun-cracked, weathered and fragmentary, were recorded along the western edge of the borrow pit area (Figs. 4 to 6). Several show a distinctive lilac hue (Fig. 6). The bones were found among coarse surface gravels of sandstone (Fig. 3) and had clearly been reworked by sheetwash and gravity processes, and / or downwasted from above. No *in situ* or articulated skeletal material or petrified wood was seen. A single occurrence of fossil bone was observed on the sandstone plateau to the north of the ridge crest, well outside the study area (M. Tusenius, pers. Comm.). The postcranial fossil bones found clearly belong to large-bodied tetrapods, perhaps dinocephalian therapsids and / or pareiasaur reptiles, but have not been identified more precisely. A few of the bones might be fragments of cranial material; this still needs to be confirmed.

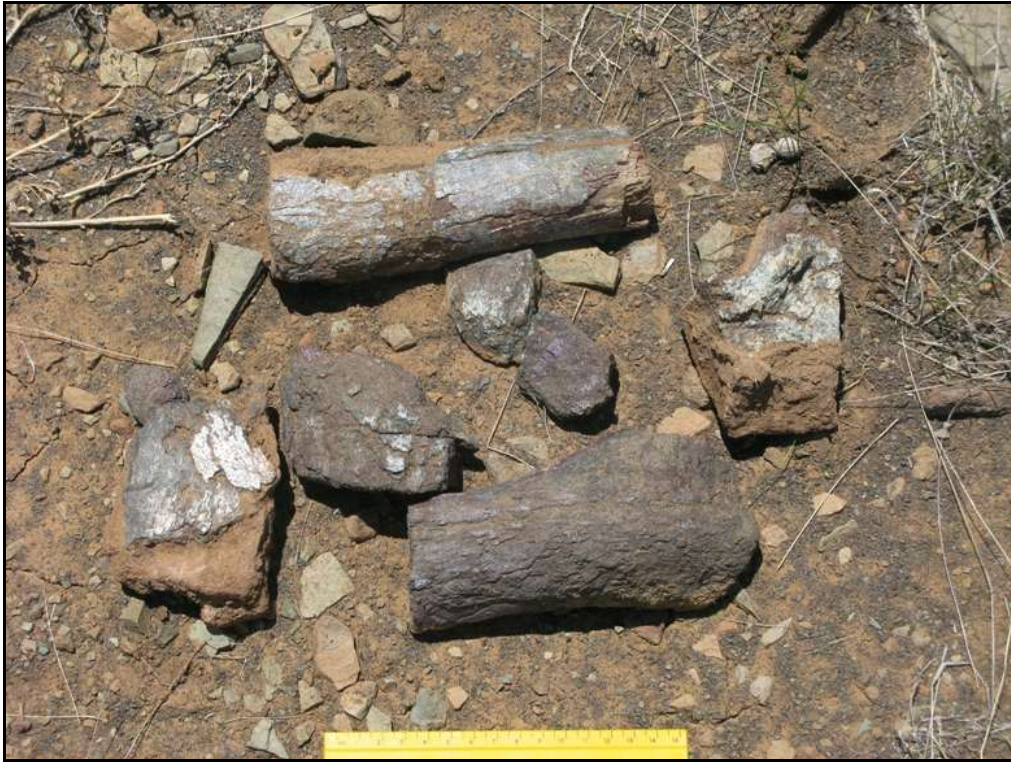
Fig. 5. Close-up of collection of fragmentary fossil bones made at the locality illustrated above. Note poor preservation suggests that these specimens have been exposed for a considerable length of time and also reworked by sheetwash or stream processes.

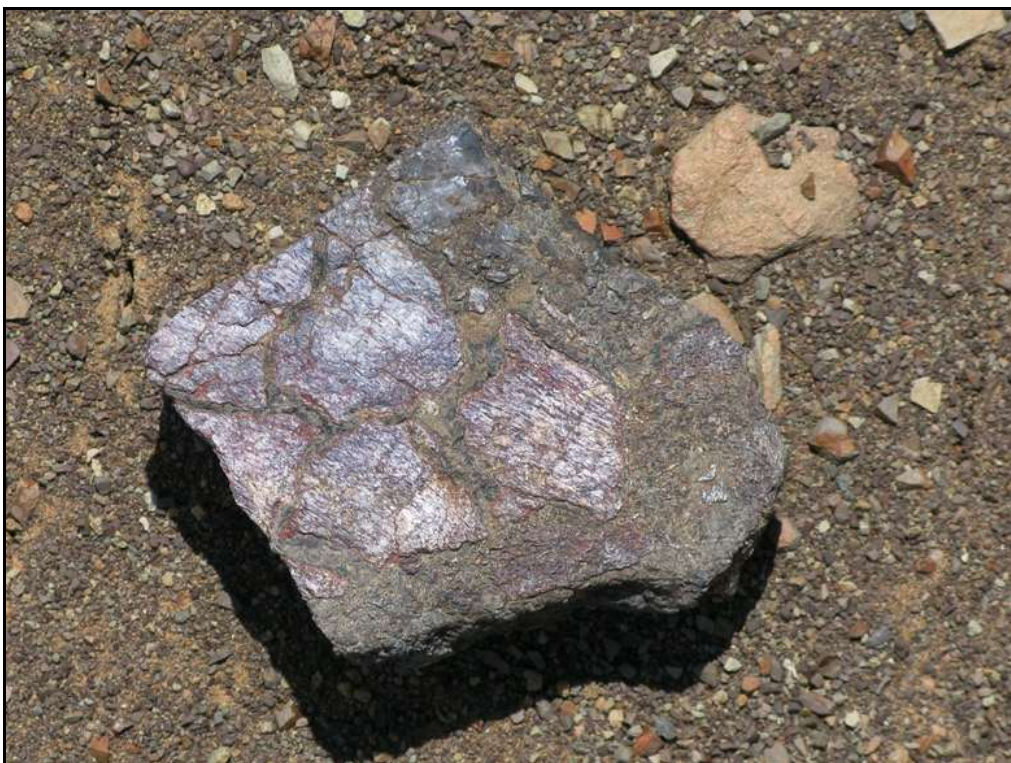
Fig. 6. Close-up of large fossil bone fragment (8 cm long) showing distinctive lilac hue and extensive surface cracking. The latter probably reflects protracted exposure of the bone on a semi-arid flood plain before original burial in Middle Permian times, as well as recent weathering.

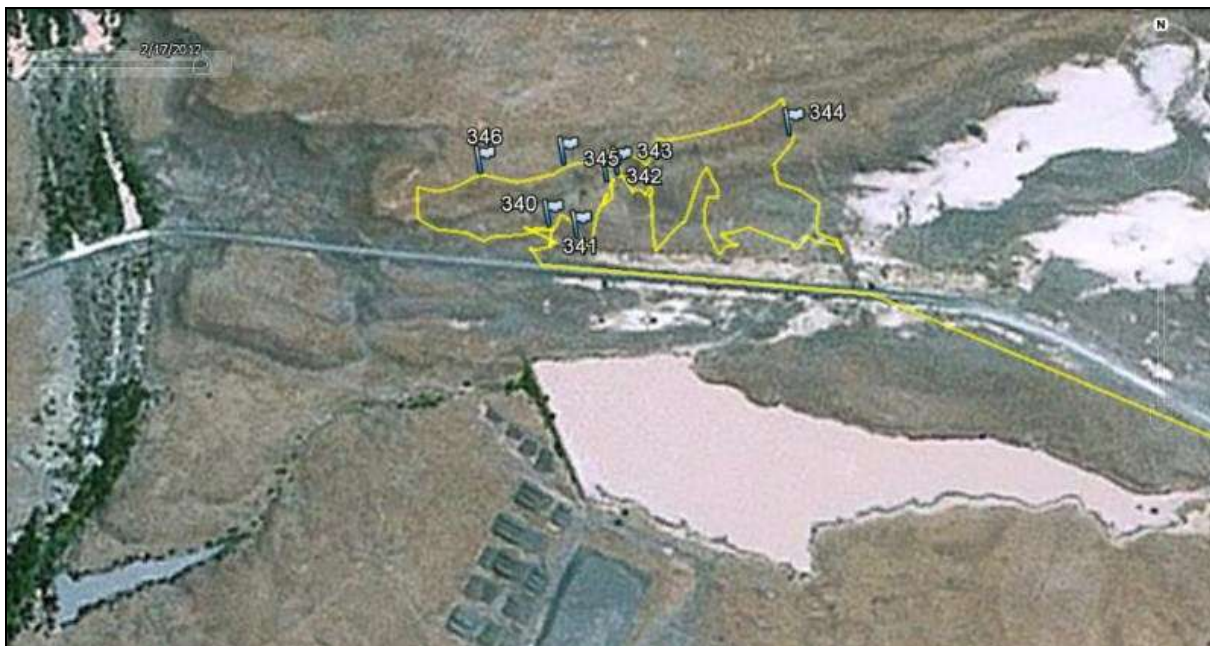
Figure 2: Google earth image showing the proposed new borrow pit 35 and tracks of the field survey. A small ridge lies to the north of the affected area. Rows of test pits and dumps from uranium exploration activities are visible to the south of the road and irrigation dam.

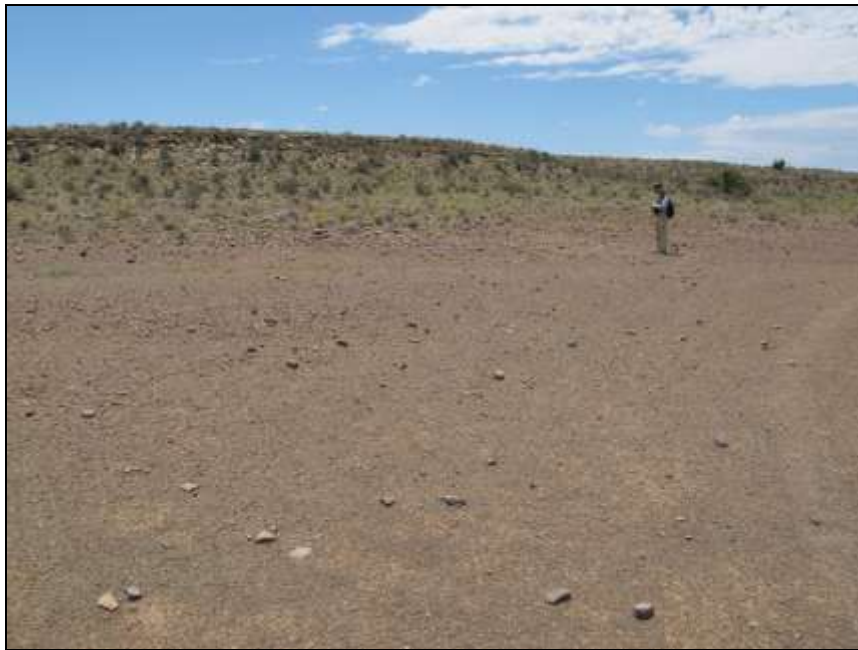
Figure 3: Northward view of the study area of pit 35 showing the extensive area affected by sheet wash in the foreground and the sandstone ridge in the background.

Environment: The proposed borrow pit is located in a wide, very shallow, unsymmetrical, headwater valley of an ephemeral water course that heads downstream in a north-easterly direction. There is a small, sandstone ridge to the northwest of the generally flat-lying terrain which forms the northern boundary of the study area (Figures 2, 3 and 6). The affected area is further bounded by the DR02308 to the south and an existing fence to the west. A breached low earth dam embankment which traverses the valley in a north-south direction was regarded as the eastern boundary for the purpose of the survey. Shallow colluvial and alluvial fine, gravelly, silty sand overlies weathered mudstone of the Abrahamskraal Formation of the Beaufort Group. An apron of coarse gravel, derived from the sandstone ridge, lies down the slope and at the foot of the ridge. A farm track from the southwestern corner of the proposed pit area runs close to the base of the rocky slope of this ridge. Visibility of archaeological material was good as the vegetation is either non-existent in some of the areas affected by sheet wash, or consists of widely dispersed, low karoo bushes. The tallest shrubs occur at the foot of the ridge.

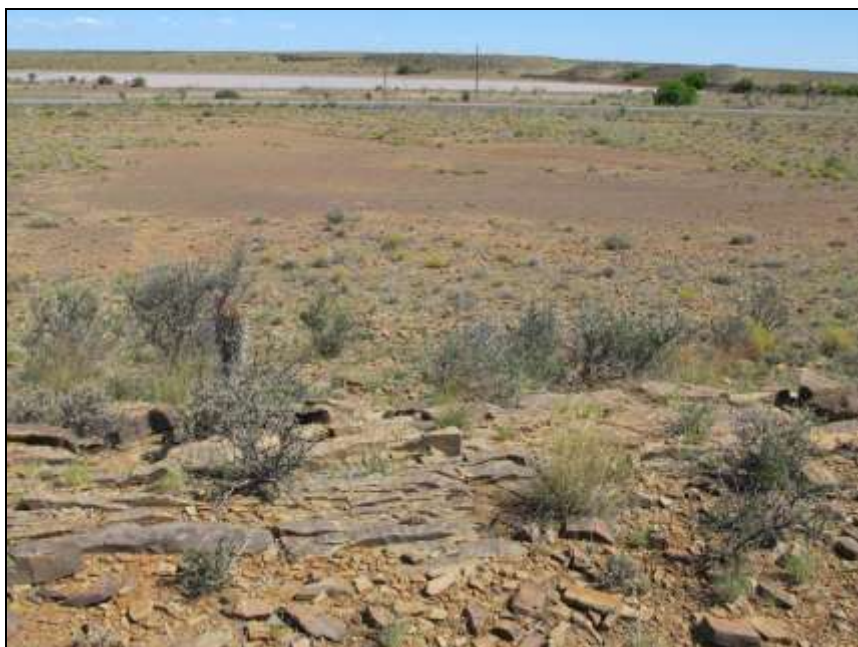
Figure 4: View towards the south taken from the top of the ridge to the north of the study area. The irrigation dam and the signs of the uranium exploration activities to the south of the DR02308 are visible in the background.

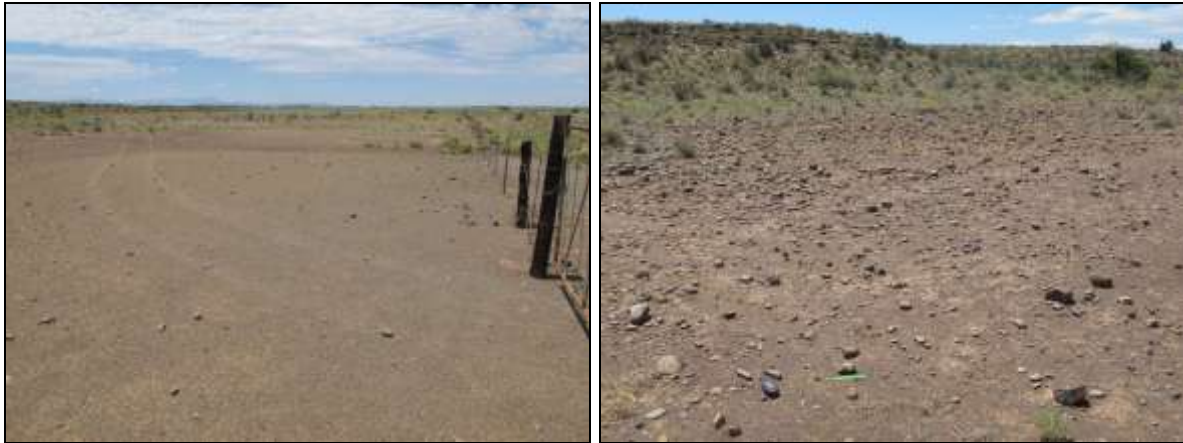
Figures 5 and 6: View towards the east of the affected area; view of scatter of the coarser gravels and dispersed artefacts close to the ridge, north-eastern view. The ruler is 15 cm in length.

Results of survey: Scatters of Stone Age artefacts were observed in most of the affected area, with the greater part of the material being concentrated in the low-lying area marked by waypoints 340 – 343 and 345 (Figure 2). The artefacts are obviously in a secondary context as evidence of sheet wash is ubiquitous and MSA and LSA artefacts are mixed together. Various degrees of weathering and patination on the surface of the specimens indicate that they have been transported by water and have lain on the surface of the landscape for varying lengths of time (Figures 7, 8 and 10). Hornfels is the predominant raw material used but quartzite and banded sandstone are also evident. The quartzite generally appears to be less weathered than the hornfels (Figures 7 and 13). Most of the artefacts are probably LSA but at least one typical MSA blade was observed (Figure 10). It is not certain to which period the relatively large, banded sandstone flakes and chunk belong (Figures 11 and 12). Further evidence of disturbance is provided by the occasional pieces of metal, glass and porcelain which are also found scattered amongst the gravels and flaked material (Figures 14 and 15). Scatters of artefacts and some of the more interesting isolated specimens were photographed and marked as waypoints (see the Appendix). No dolerite boulders suitable for rock engravings were found in or near the affected area of the proposed pit.

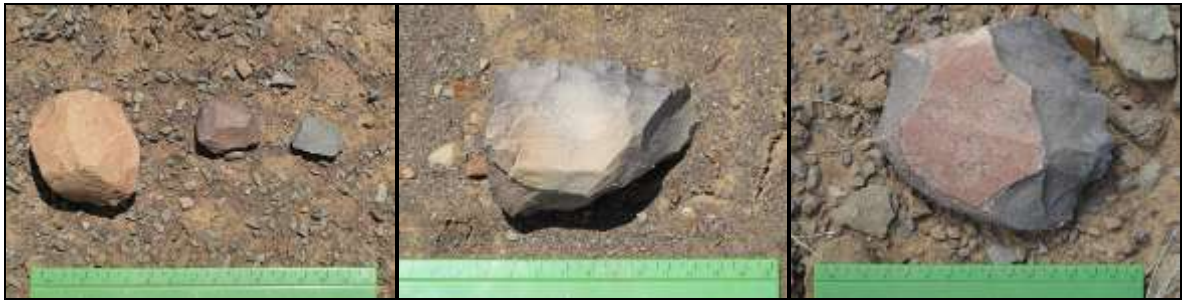
Figures 7, 8 and 9: Various degrees of weathering and patination of stone artefacts are evident in these photos. Hornfels flakes and fresh-looking quartzite flake on the left; fine-grained flaked quartzite cobble in the middle; hornfels core on the right. The scale is in cm.

Waypoint (MT)	South	East	Description of material found
340	32 24 59.7	22 08 05.5	Scatter of artefacts including the flaked fine-grained quartzite piece (Figure 8)
341	32 25 00.1	22 08 06.7	Cluster of weathered flakes, including possible snapped blade, pink glass fragment, hornfels core (Figure 7)
342	32 24 58.0	22 08 08.0	Scatter with banded sandstone flakes, metal plaque, glass and porcelain fragments (Figures 11, 12, 14)
343	32 24 57.8	22 08 08.5	Scatter including weathered MSA blade (Figure 10)
344	32 24 56.3	22 08 16.0	Isolated hornfels core (Figure 9)
345	32 24 57.4	22 08 06.2	Single very weathered circular flake on a cobble
346	32 24 57.7	22 08 02.5	Isolated fresh-looking quartzite flakes, coarse sandstone flake with cortex (Figure 13)

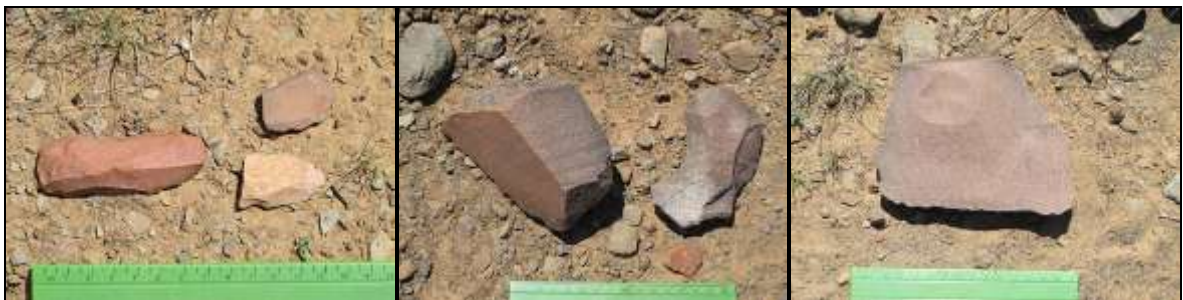
Figures 10, 11 and 12: A typical MSA blade is shown on the left. Banded sandstone artefacts are shown in the other two photos. The scale is in cm.

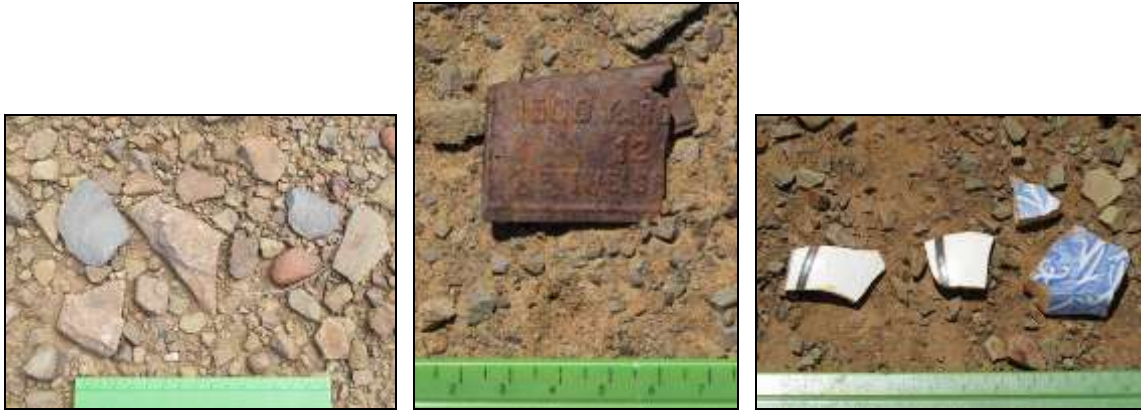
Figures 13, 14 and 15: Quartzite flakes found on top of the ridge; metal plaque with part of an inscription ('500 yard...12...'); isolated porcelain fragments observed amongst the surface gravels. The scale is in cm.
