NOTIFICATION OF INTENT TO DEVELOP

WESTERN CAPE BORROW PITS – INITIAL PALAEOONTOLOGICAL HERITAGE ASSESSMENT (August 2011 Second tranche)

Figure 2: Google earth image showing the proposed extension of the existing borrow pit 30 and tracks of the field survey. The existing quarry lies to the east of the road and the donga is located on the western side.

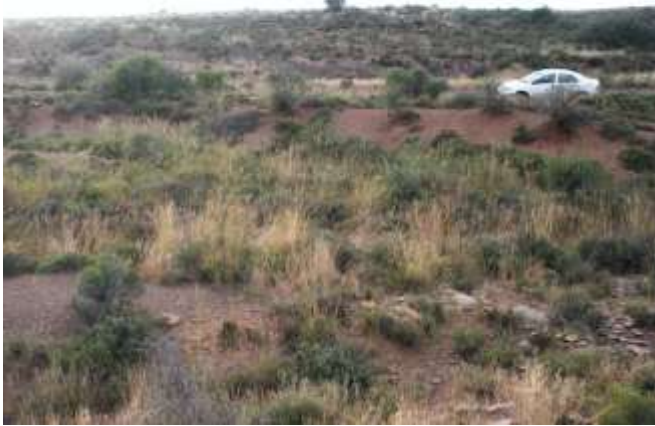
Looking east from the western edge of the existing borrow pit, located on either side of DR02404, situated where car is parked (April 2011).

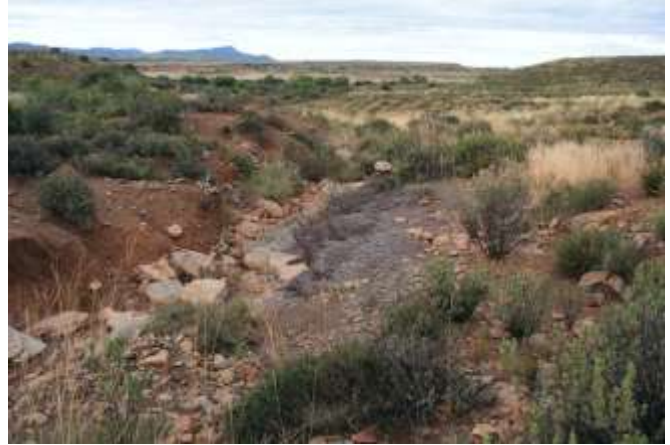
Looking south from western side of existing borrow pit (road is to the left). Purple siltstone is to be mined (April 2011).

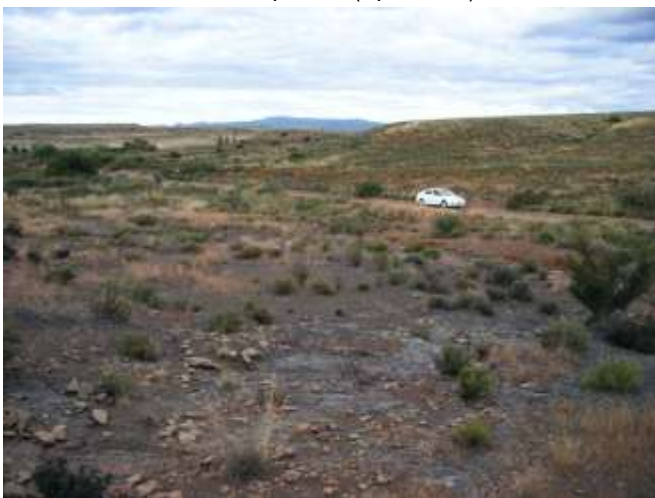
Looking southwest across existing borrow pit. Car is parked on DR02404 which runs through the centre of the pit (April 2011).

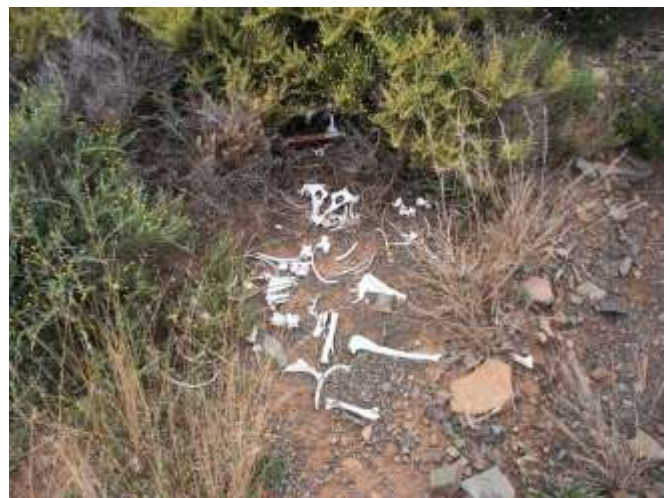
Ground cover on part of where the proposed pit will expand to. Vegetation consists of Karoo bushes, and there is evidence of small buck in the area (April 2011).

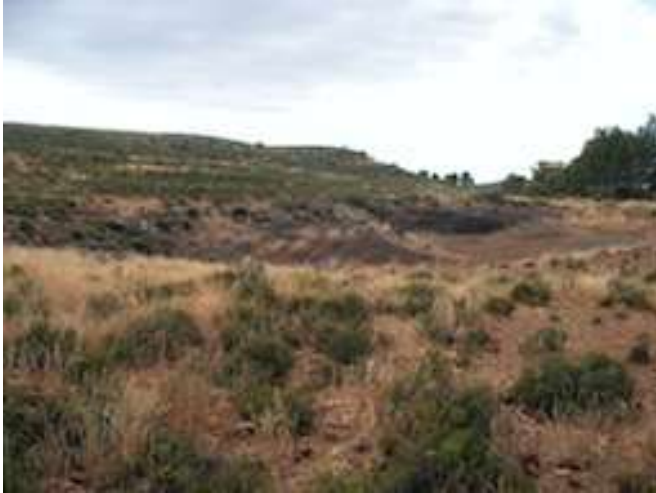
Looking north from the access point to the existing borrow pit (April 2011). The area in the foreground will fall within the expanded pit.

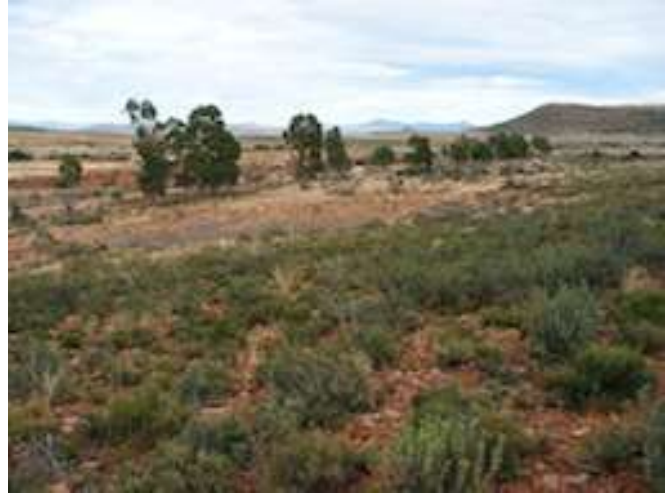
Looking southeast from northern-western edge of proposed expansion to the pit (April 2011).

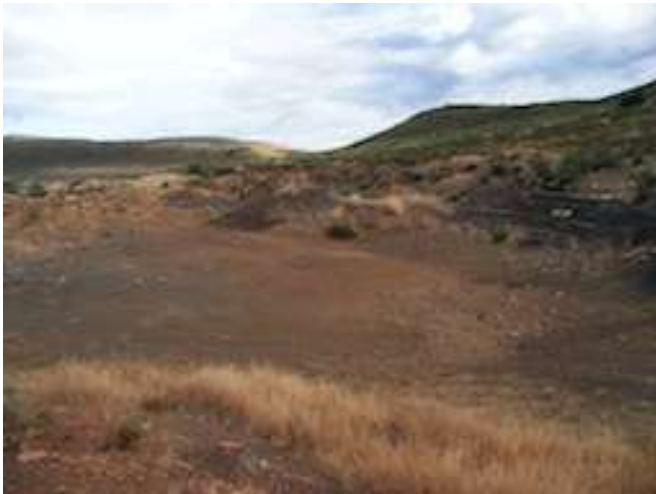
Looking southwest across existing pit illustrating the depth of suitable material present (April 2011).

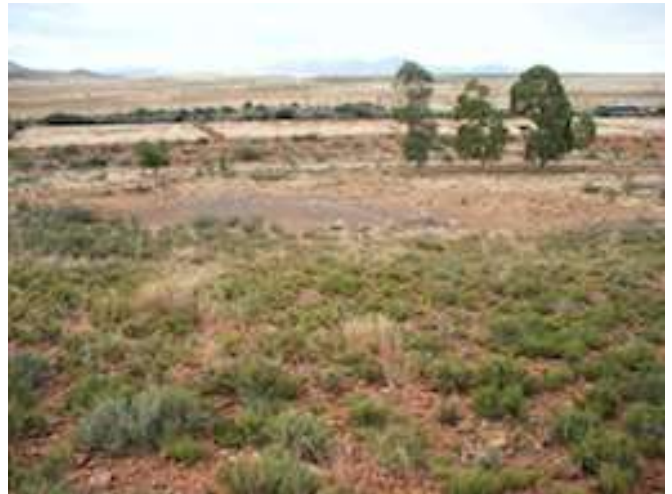
Looking east from the western edge of the proposed expansion (April 2011). DR02404 is located immediately beyond the trees in the background.

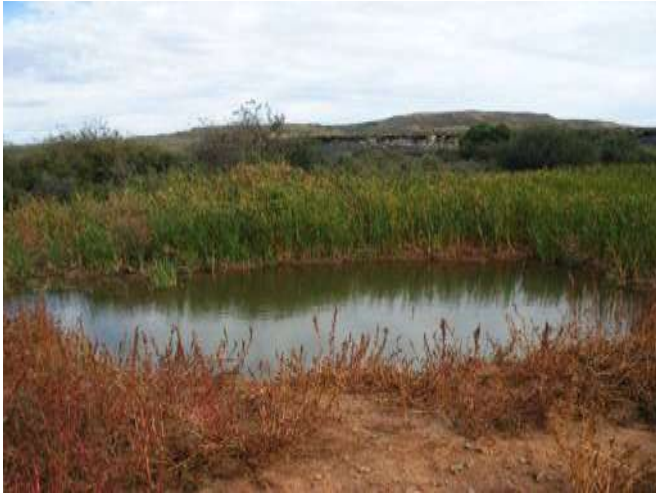
Looking north at existing pit to be expanded (April 2011). The pit holds water during the wet season and has promoted the establishment of bulrushes.

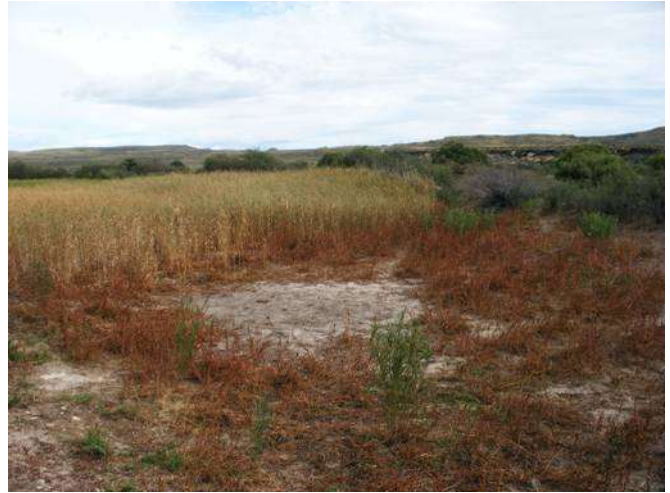
Looking northwest at existing pit to be expanded (April 2011). Cultivated lucerne fields are located to the north of the site.

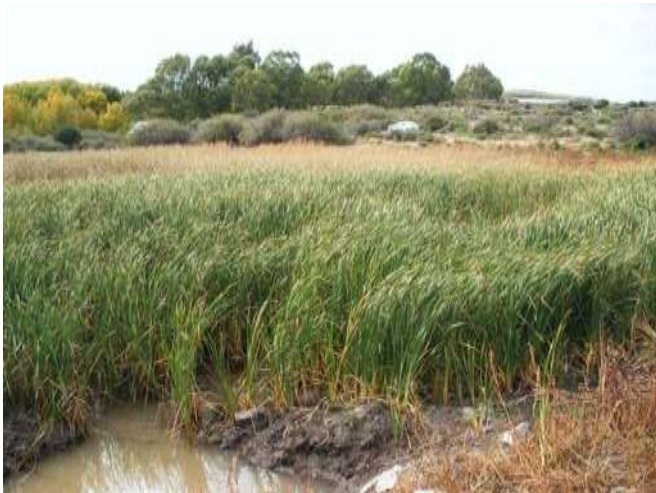
Looking east at existing site (April 2011). The car in the background is on DR02404.

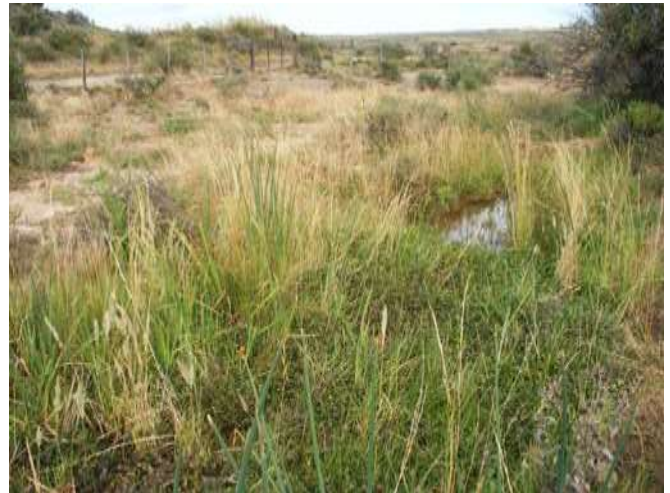
Looking west at upslope edge of existing pit (April 2011). Runoff water enters the existing pit before being fed to lucerne fields located downslope of the pit.

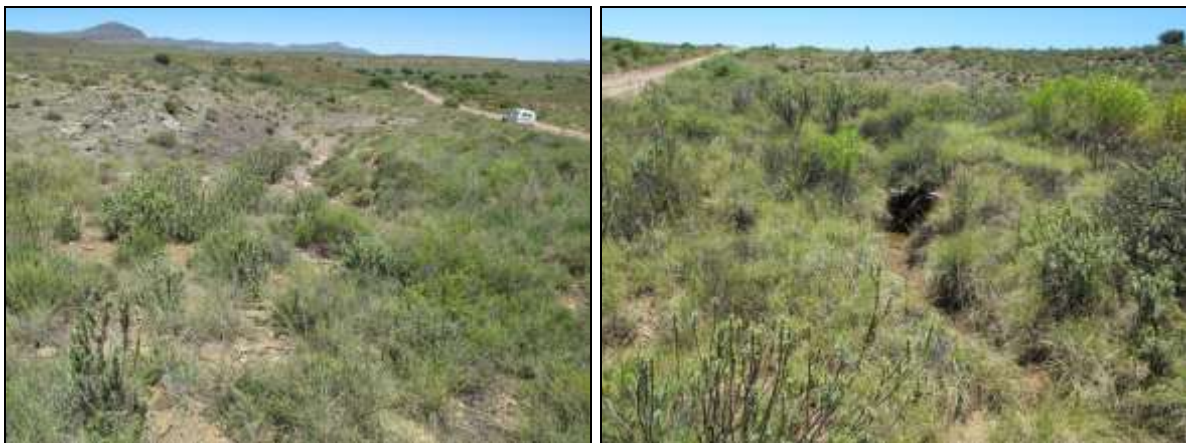
Figures 3 and 4: Pit 30 – view of the eastern side of the study area showing the existing quarry with exposed Beaufort Group siltstone (view towards the south) and disturbance caused by water erosion (view towards the north). The existing quarry lies towards the top of the slope in the photo to the right.

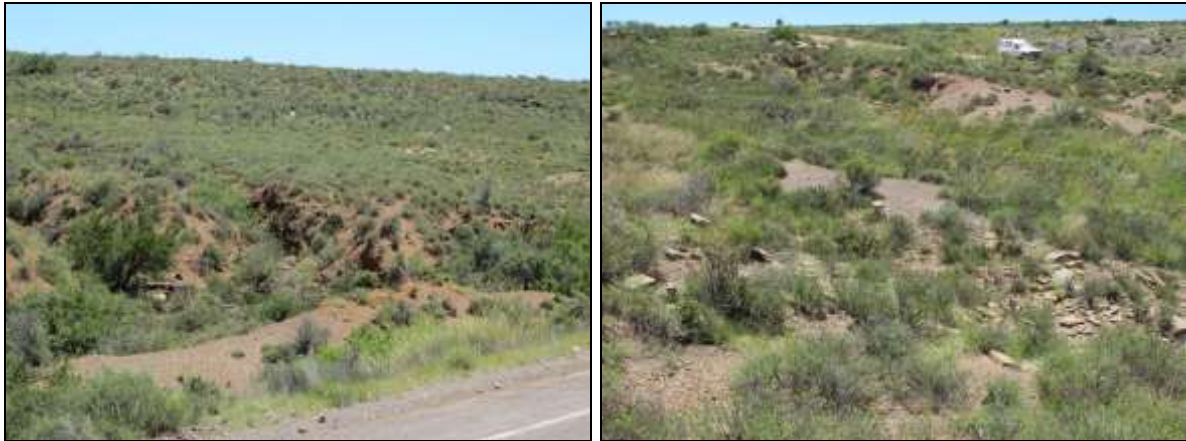
Figures 5 and 6: Pit 30 – views of the erosion gully on the western side of the road, looking towards the west and the northeast respectively.

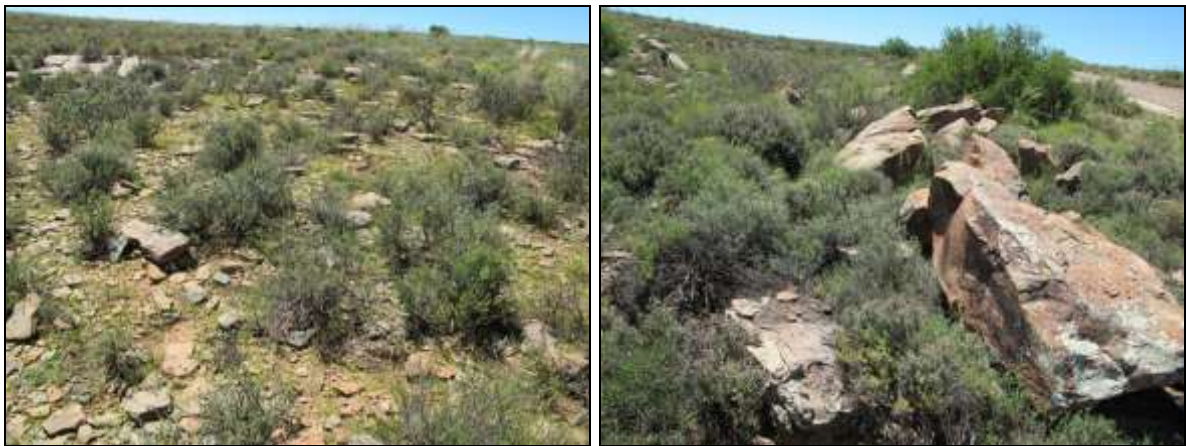
Figures 7 and 8: Pit 30 – views towards the north showing differing archaeological visibility across the study area: sparse vegetation and blocks of sandstone and dolerite scree; dense vegetation and large boulders.

Results of survey: Both sides of the road were surveyed and no archaeological remains were observed. Several heaps of stone used for anti-erosion purposes were examined and no artefacts were found. Due to the very disturbed nature of the terrain, any artefacts found would not have been in a primary context. One would expect to see the occasional flaked piece of stone washed into the study area if there were archaeological remains in the immediate vicinity. No dolerite boulders suitable for rock engravings were found in or near the affected area.

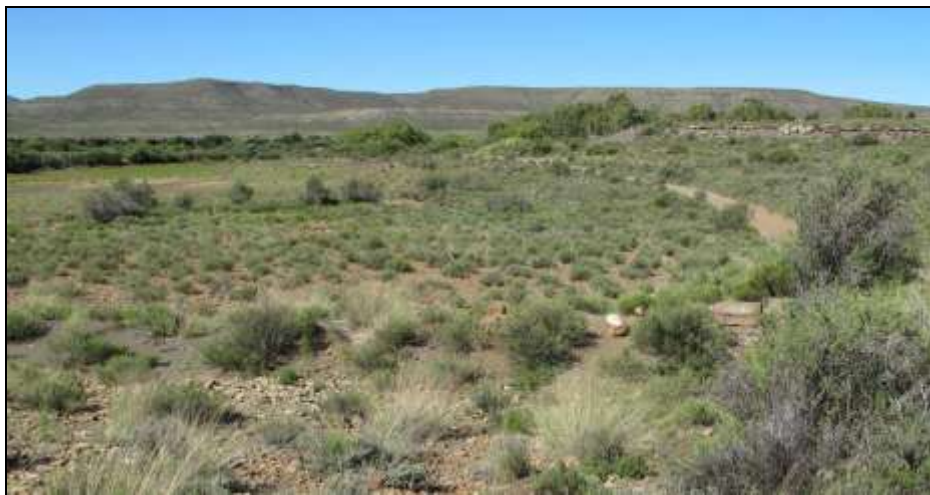
Figure 11: Pit 26 – view towards the east of the proposed pit which would be located in the basin of the existing irrigation dam. The farm buildings and stone kraal are located behind the tall trees and ridge in the back right corner of the photo.

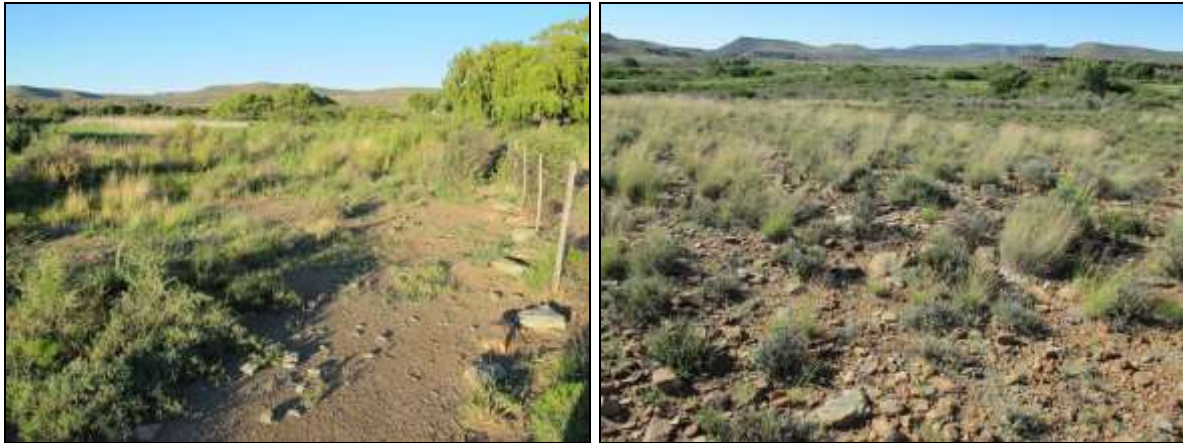
Figures 12 and 13: Pit 26 – view towards the east of the eastern part of the affected area which mainly consists of a dam filled with water and dense vegetation surrounding it; view towards the north taken from the undisturbed terrain beyond the western extent of pit 26. The windpump close to the cemetery lies approximately 200 m to the north of the pit.

Environment: The proposed pit is located in the basin of an irrigation dam that lies close to cultivated land to the west of the DR02404 and the Zwavelkrans farm buildings (Figures 9 and 10). According to the site plan, the pit could be extended towards an adjoining dam to the east (Figure 12). The generally flat-lying proposed area is bounded by a fence to the north and east, the access track on the south and by the dam wall to the west. The area of the dam, empty of water at present, is obviously disturbed but the raised area to the west of it appears to be relatively undisturbed as it is vegetated by a variety of karoo bushes. Archaeological visibility was generally good in this western part of the affected area, but poor in the eastern part where the full dam is surrounded by dense vegetation. Not much of this latter area could be surveyed.

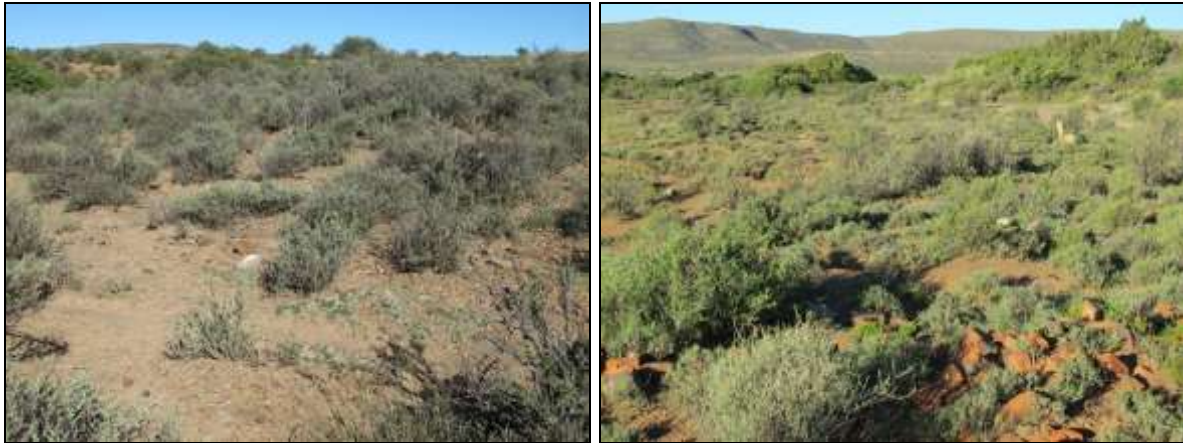
Figures 14 and 15: Pit 26 – view to the west showing typical scatters of flaked and unflaked stone to the west of the affected area; view to the east showing part of the heap of abandoned bricks in the foreground and two of several stone fence posts to the right.

Some historical background to the farm was provided by Mr Martin Hesselink of Hartbeesfontein, the neighbouring farm. This included the information that several upright stones observed (Figure 15) were fence posts which had marked one of the earlier roads to the northern Cape, and that some of the farm buildings were in existence at the time of the Anglo-Boer war. The heap of bricks noted (Figures 15, 24 and 25) was probably the remains of brick-making activities of 50 to 80 years ago.

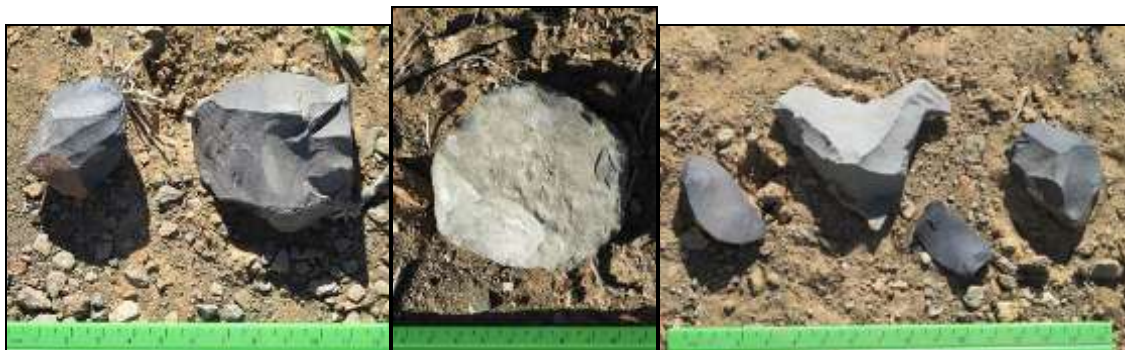
Figures 16, 17 and 18: Pit 26 – selection of hornfels LSA artefacts including a bladelet core and chunk from waypoint 331 and a circular, retouched piece from the scatter of material to the west of the study area. The scale is in cm.

Results of survey: The affected area and some of the surrounding ground was surveyed. Sparse surface scatters of LSA artefacts and a few isolated MSA blade fragments were observed, mainly outside the affected area of the proposed pit (See Table 1 in the Appendix and Figures 16 - 21). It is probable that these are not in a primary context as there is evidence of sheet wash throughout the area. The MSA material was very weathered and patinated in comparison with the fresher-looking hornfels of the LSA artefacts. A few quartzite flakes of indeterminate age were also found (Figure 19). No dolerite boulders suitable for rock engravings were found in or near the affected area.

Waypoint (MT)	South	East	Description of material found
331	31 46 55.0	23 58 00.9	Isolated hornfels core and chunk (Figure 16)
332	31 46 54.2	23 57 58.8	Scatter of artefacts including mainly hornfels LSA flakes & chunks, quartzite flakes, weathered MSA flakes/snapped blades, (Figures 14, 17, 18, 19, 20)
333	31 46 55.4	23 57 55.8	Approximate western extent of artefact scatter
334	31 46 54.7	23 57 59.3	Approximate southeastern extent of artefact scatter
335	31 46 53.6	23 58 00.6	Possible stone foundation wall (Figure 23)
336	31 46 55.8	23 58 04.5	Heap of bricks, probably dating 50 to 80 years ago (Figures 15, 24, 25)
337	31 46 51.2	23 50 11.7	Single snapped MSA blade
338=339	31 46 47.3	23 57 57.6	Cemetery of unmarked workers' graves (Figure 29)

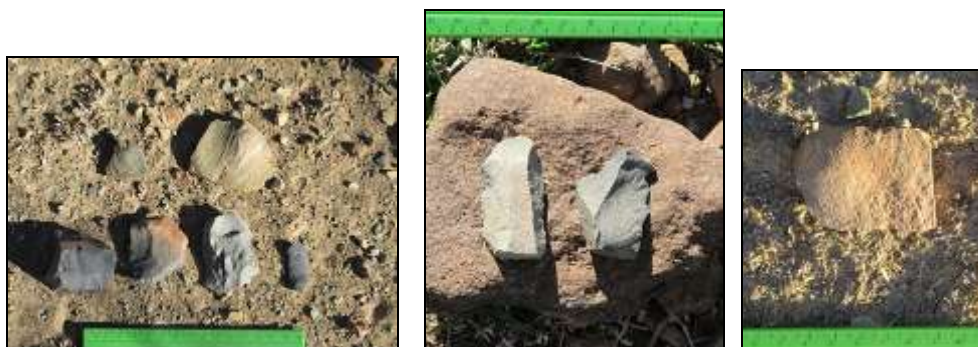
Figures 19, 20 and 21: Pit 26 – hornfels and quartzite flakes from the scatter to the west of the dam; one of the snapped MSA blades to the left in the middle photo; snapped, weathered MSA blade found at waypoint 337. The scale is in c

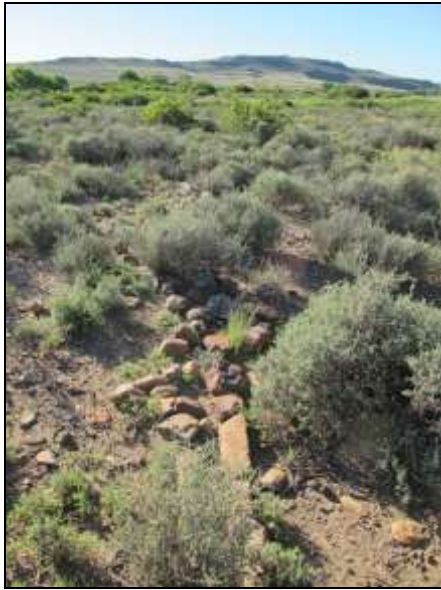
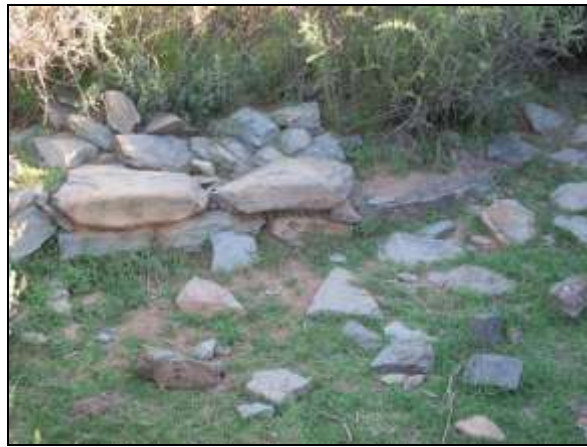
Figures 22 and 23: Pit 26 – view to the north of a typical line of heaped stone to prevent erosion; possible stone foundation wall to the northwest of the dam wall.

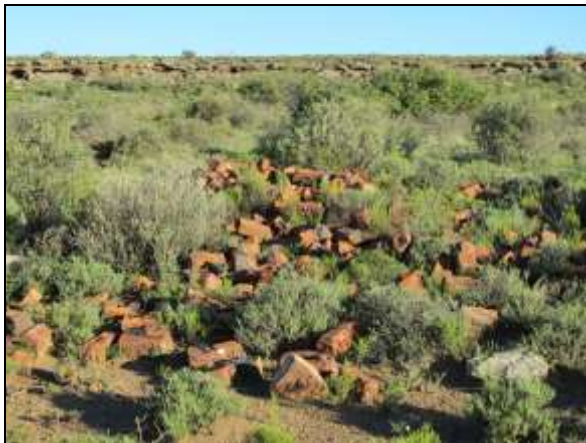
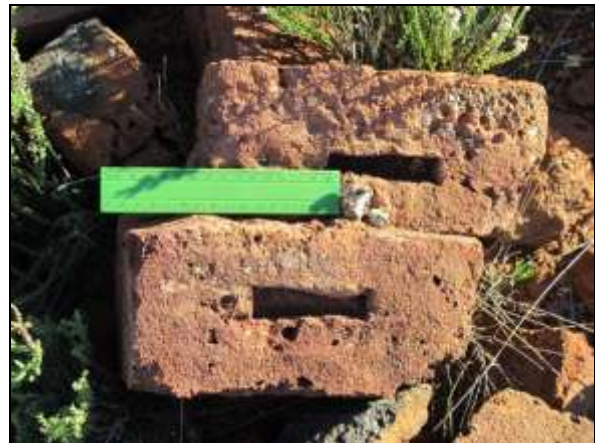
Figures 24 and 25: Pit 26 – the remains of brick-making 50 to 80 years ago. The ruler is 15 cm in length.

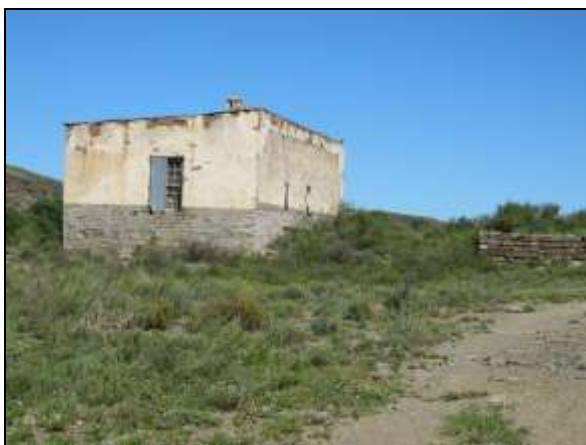
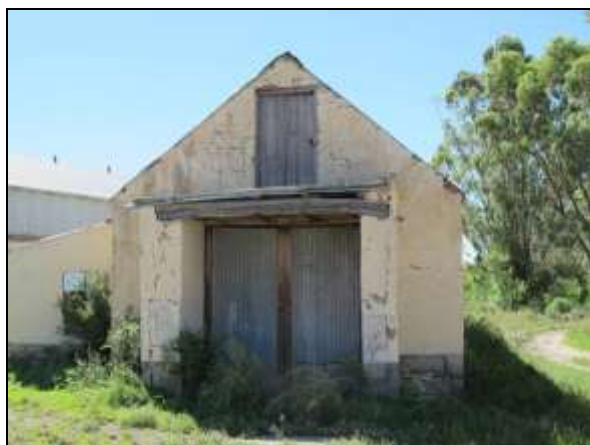
Figures 26 and 27: A couple of the stone farm buildings at Zwavelkrans at least 130 m to the east of the proposed pit.

Resources of historical interest were noted outside the affected area, namely: a stone kraal and stone farm buildings which are over sixty years old (Figures 26 and 27). Mr Martin Hesselink of the neighbouring farm informed us about a cemetery of unmarked farm workers' graves beyond the agricultural fields to the north of the proposed pit site. An inspection of the cemetery, located close to the water pump approximately 200 m north of the dam, revealed at least 17 graves marked by heaps of stone with or without headstones (Figure 29).

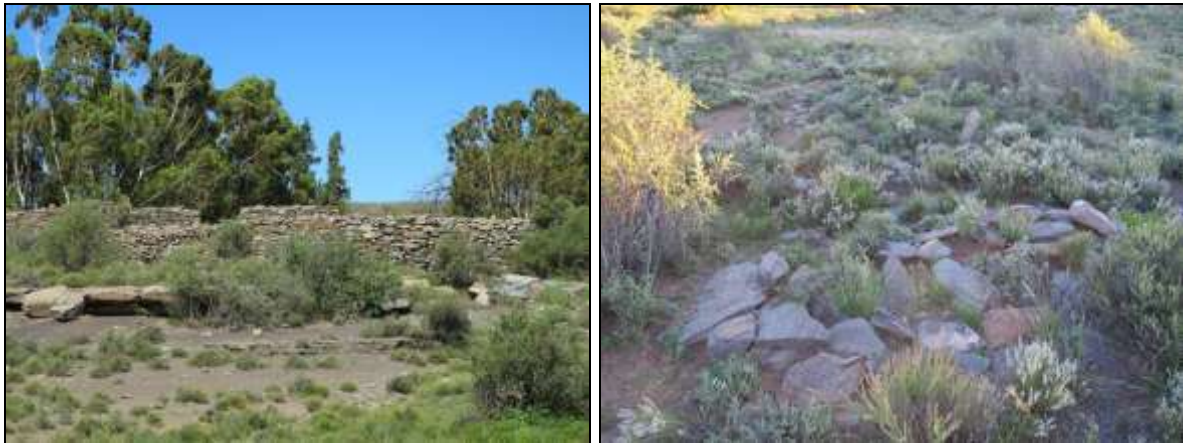
Figures 28 and 29: View of the stone kraal to the east of the DR02404; a few of the unmarked farm workers' graves at the cemetery to the north of the affected area.

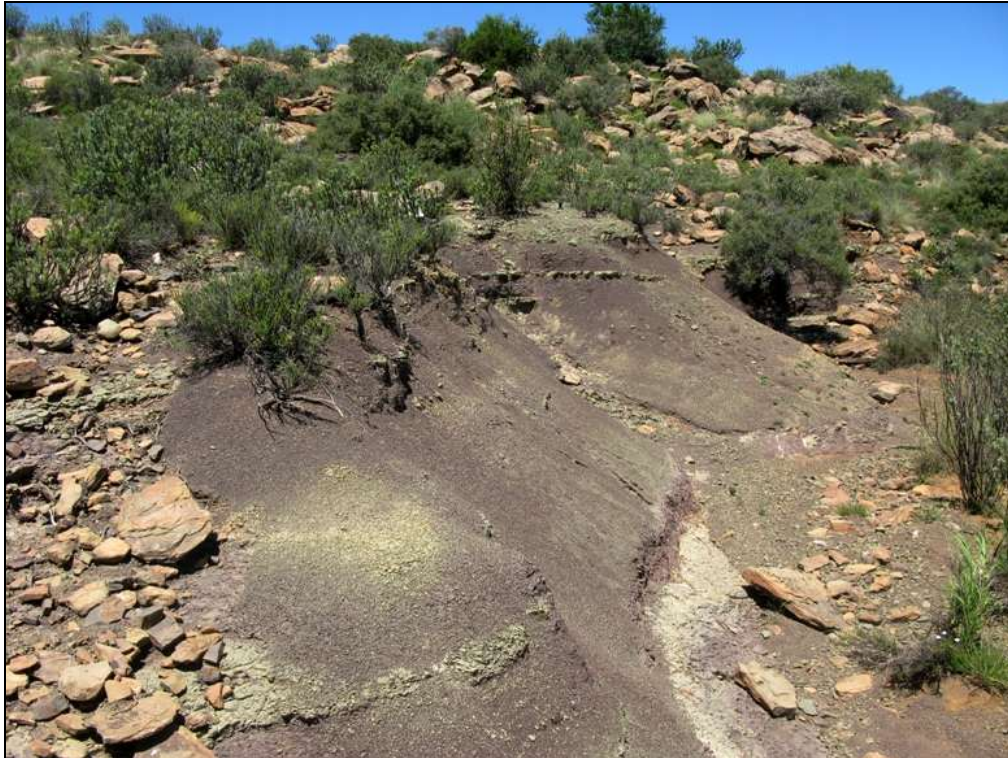
Fig. 3. Purplish-brown mudrocks and overlying channel sandstones (on the horizon) exposed on the south-eastern side of borrow pit site DR02404/8.5/0LR.

The Lower Beaufort succession exposed on the pit floor east of the road mainly comprises purple-brown, well-consolidated siltstones with horizons of rusty-weathering pedogenic calcrete nodules associated with scattered fossil bones (Fig. 4; Section 4.1). The siltstones are overlain by purplish, hackly-weathering mudrocks capped by a multi-storey channel sandstones (Fig. 3). The latter are variously flaggy to cross-bedded and ripple cross-laminated, and contain concentrations of transported plant material. On the west side of the road the Beaufort Group sediments are mantled by a thick layer of gravelly alluvium and soils, incised by the modern stream gully here (Fig. 5). The edge of a dolerite intrusion and adjacent baked Beaufort rocks are exposed in the stream bed on the south-western side of the study area.

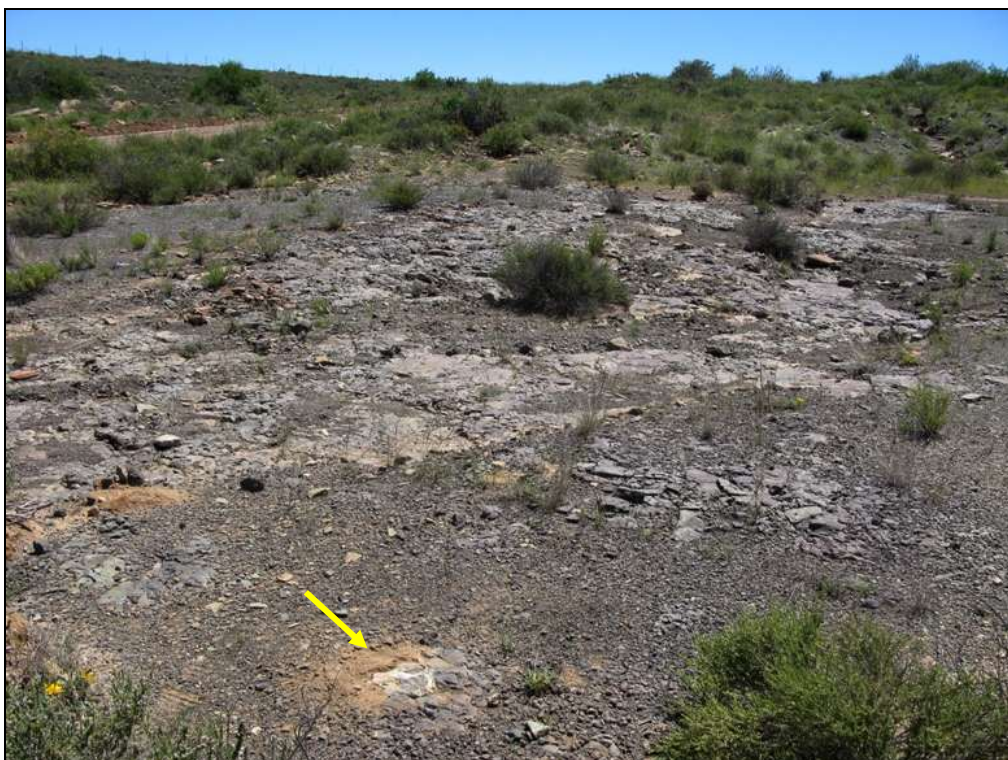
Fig. 4. Purplish siltstones exposed on the floor of borrow pit site DR02404/8.5/0LR, looking towards the northwest. A partially-exposed fossil specimen is arrowed.

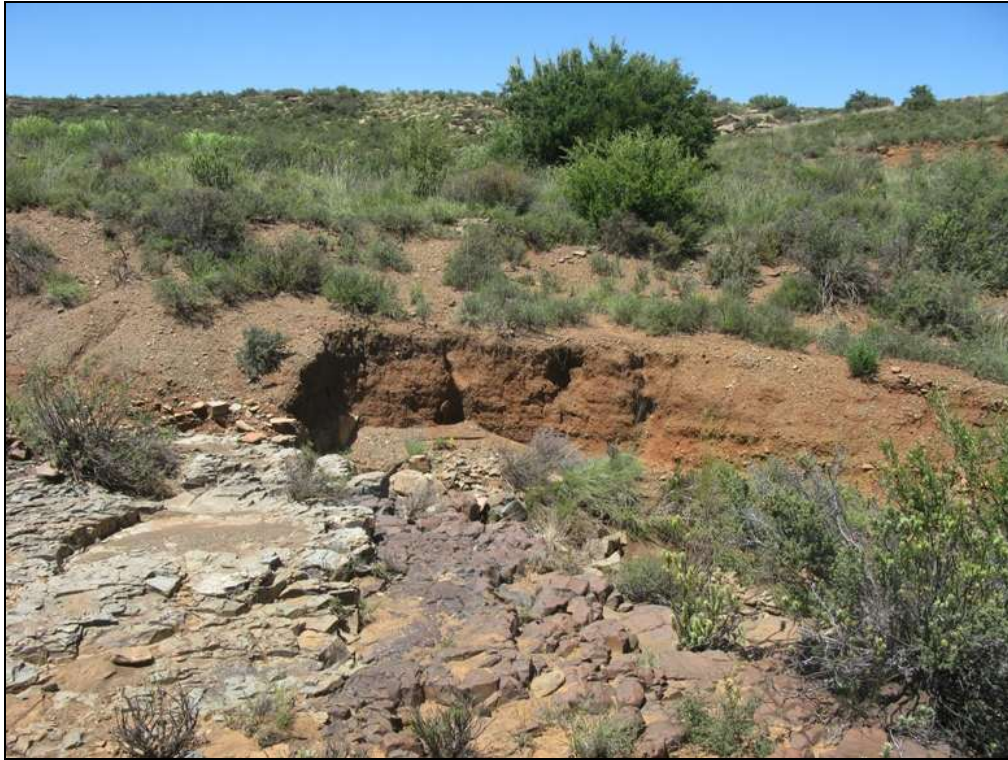
Fig. 5. Contact between a dolerite intrusion (rusty brown) and adjacent baked Beaufort Group sediments (grey-green) in the south-western portion of the study area. The bedrocks are mantled with well-bedded, fine gravelly alluvium here.

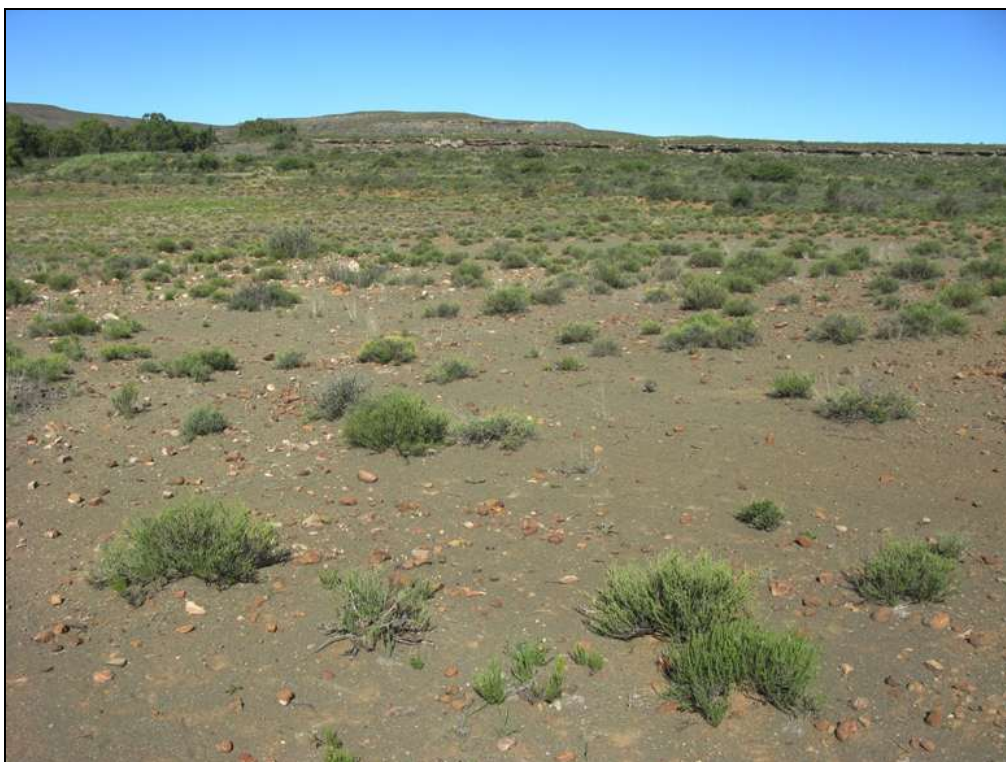
Fig. 6. View south-eastwards across borrow pit site DR02404/29.3/0.5L showing mantle of fine-grained alluvium and sheetwash gravels in the dam area in the foreground and the low sandstone-capped ridge towards the south where several fossil sites are located.

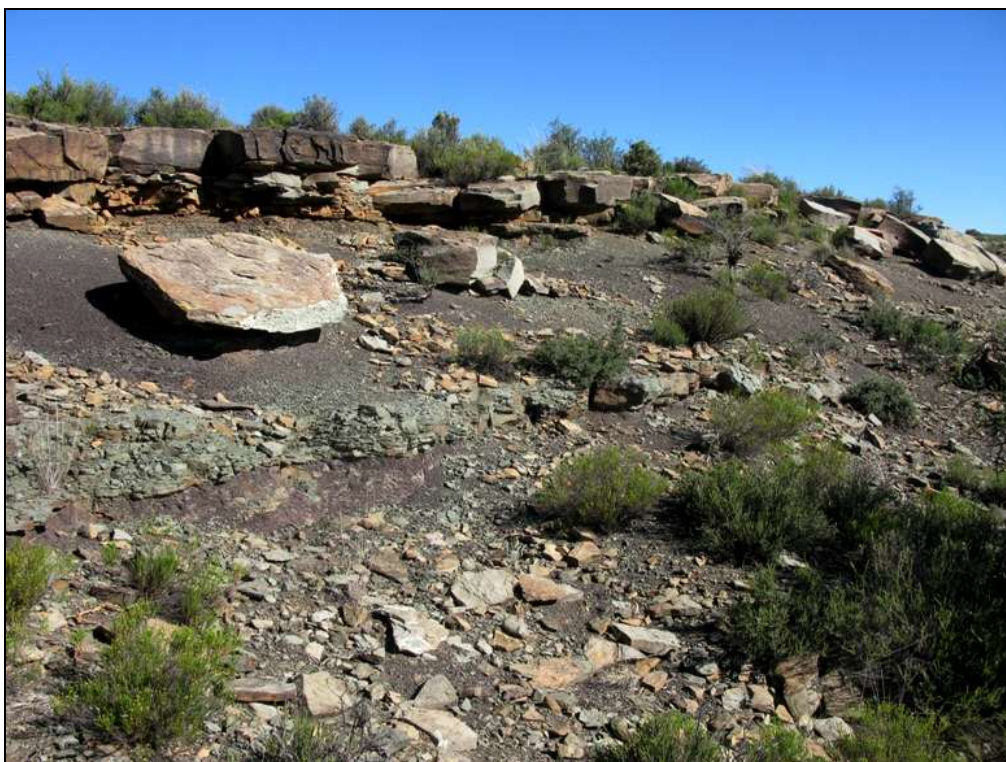
Fig. 7. View along the sandstone-capped ridge showing good exposure of fossiliferous Lower Beaufort mudrocks just south of the DR02404/29.3/0.5L borrow pit study area.

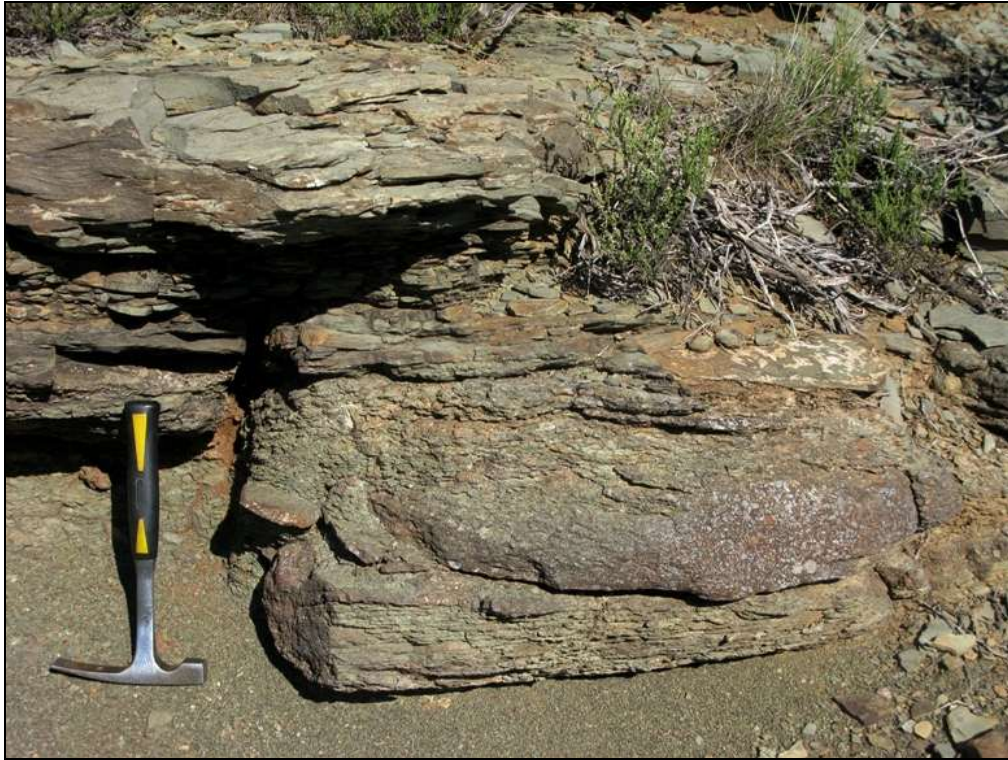
Fig. 8. Pinkish-brown, speckled lens of calcrete conglomerate at the base of the channel sandstone shown in the previous photograph (Hammer = 32 cm). These basal conglomerates often contain rolled fossil bone fragments.

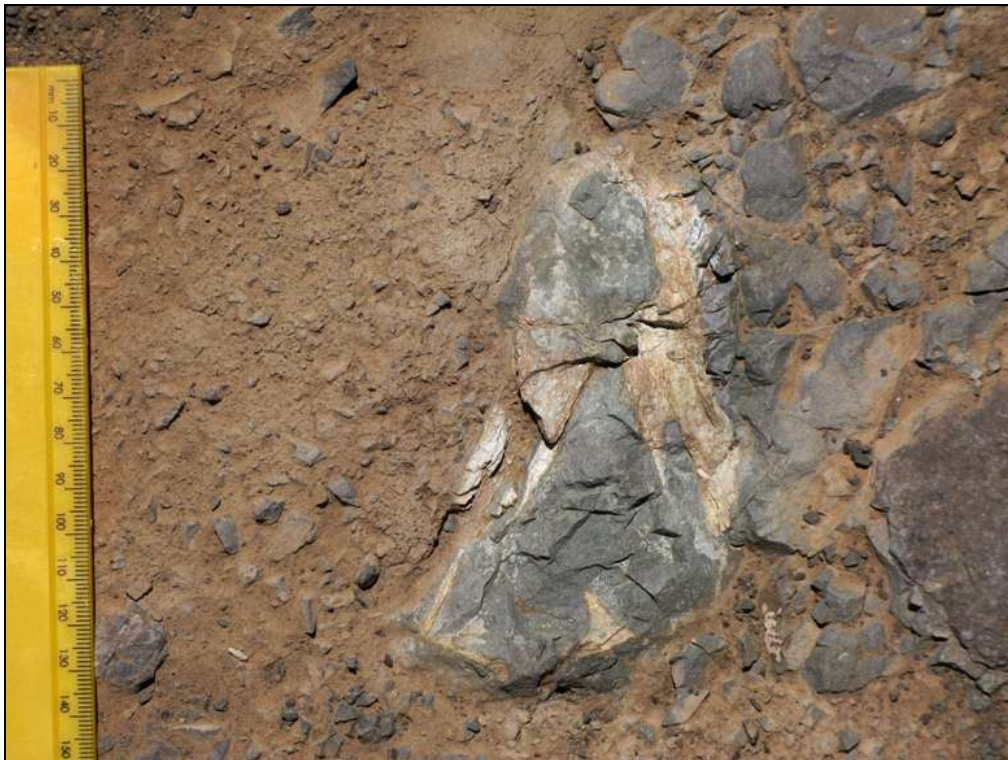
Fig. 9. Lower jaw (mandible) of a medium-sized dicynodont therapsid exposed on the floor of borrow pit site DR02404/8.5/0LR.

A scatter of nine fossil vertebrate sites was recorded *within* the DR02404/8.5/0LR borrow pit site on the east side of the road (Fig. 4). The fossil bones are exposed in the quarry floor and are mostly disarticulated, although they include some articulated lower limb bones (Figs. 9 to 12). They are largely embedded in grey-green to purplish siltstone and are associated with a palaeosol (fossil soil) horizon, as indicated by abundant pedogenic calcrete nodules at this level. A few bone fragments were also noted within the overlying purple-brown mudrocks. Most of the remains observed are postcranial, but at least one lower jaw (Fig. 7) and skull (Fig. 9) are present. The fossils have not yet been firmly identified, but at least some of them probably belong to a medium-sized dicynodont therapsid such as *Aulacephalodon*. It is possible that several of the fossils are parts of the same animal whose skeletal remains were dispersed on the floodplain surface after death. However, floods may also have concentrated the bones of several different animals here.

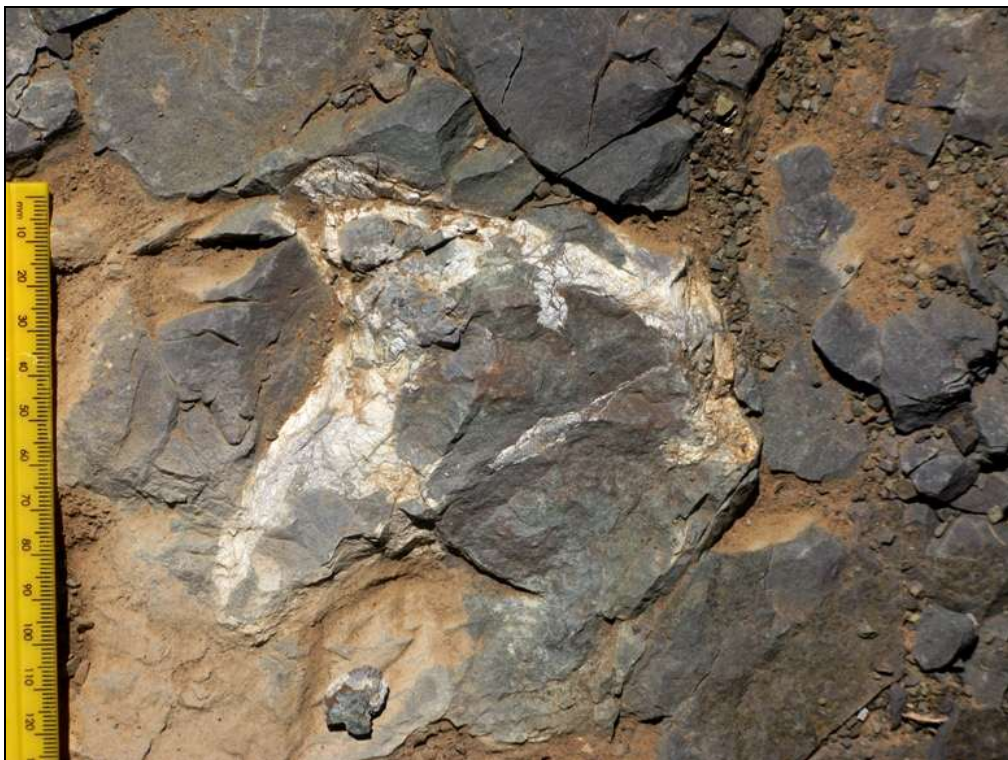
Fig. 10. Unidentified fossil bone exposed on the floor of borrow pit site DR02404/8.5/0LR.

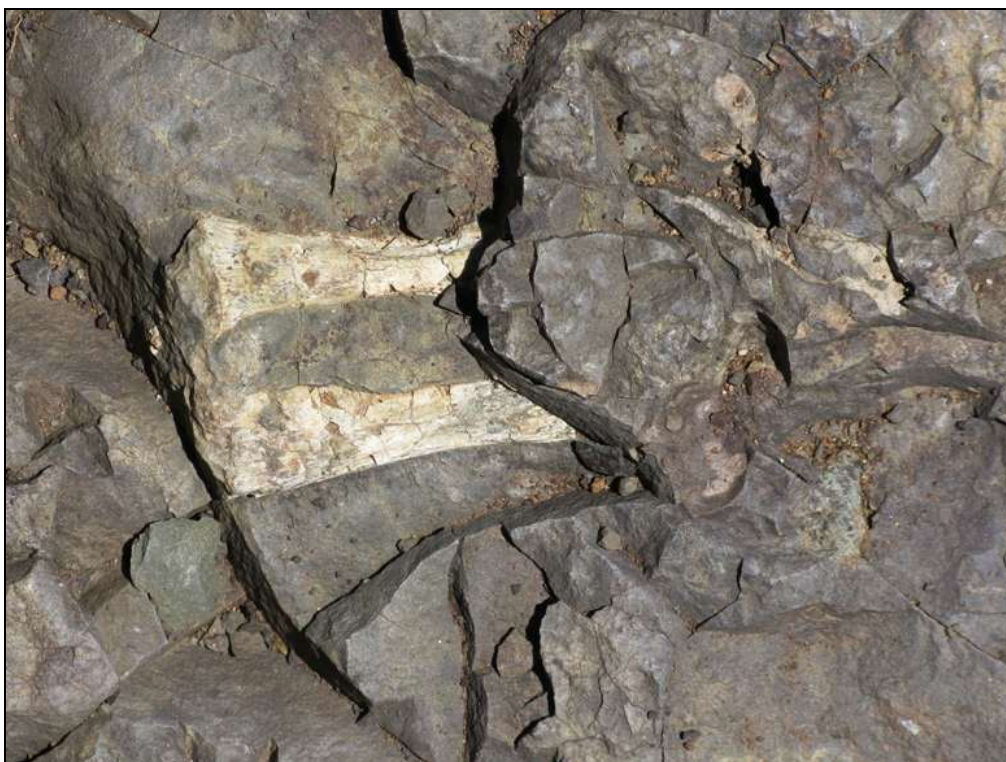
Fig. 11. Articulated lower limb bones of a medium-sized therapsid exposed on the floor of borrow pit site DR02404/8.5/0LR.

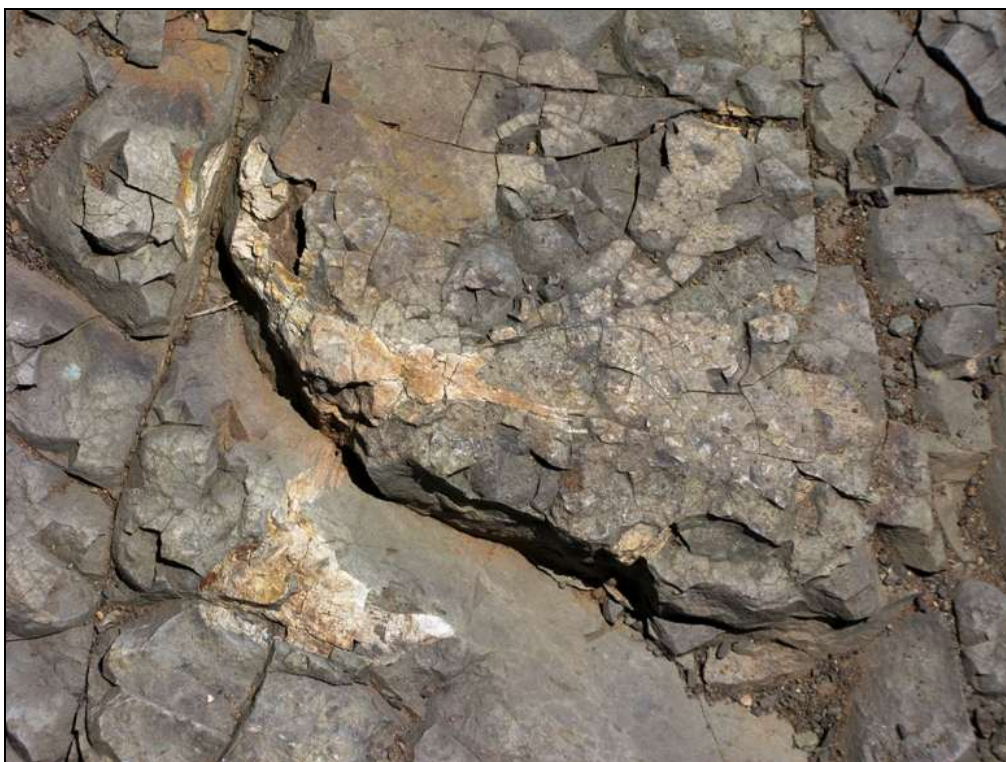
Fig. 12. Palatal (ventral) view of the skull of a medium-sized dicynodont, possibly *Aulacephalodon*, exposed on the floor of borrow pit site DR02404/8.5/0LR.

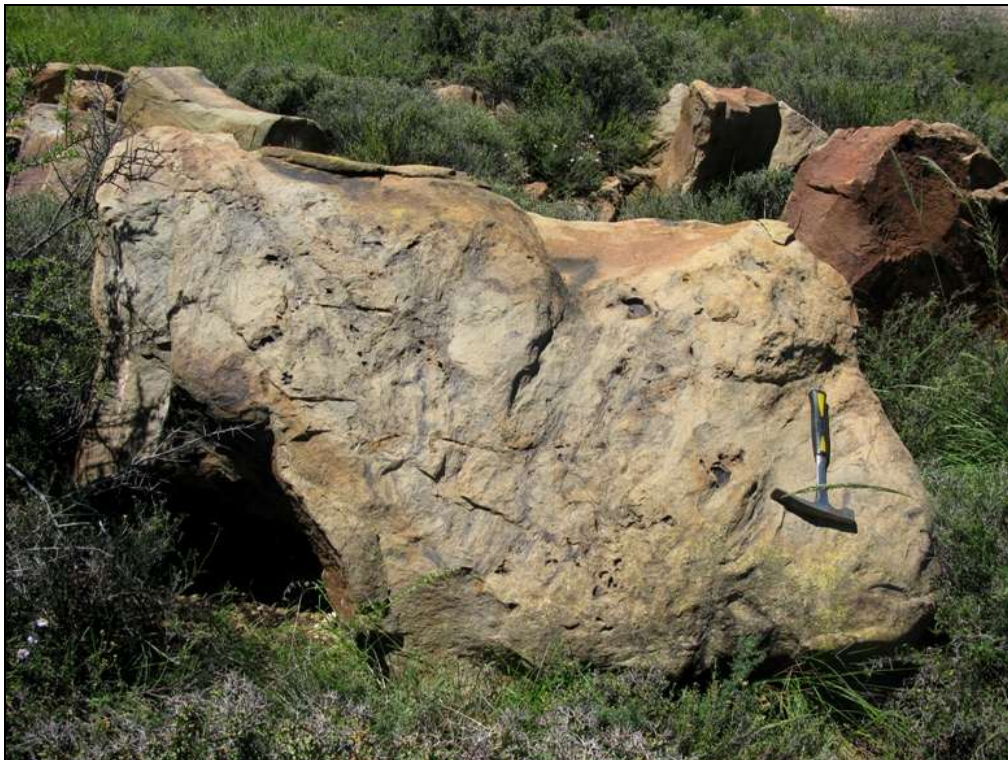
Fig. 13. Large displaced slab of channel sandstone showing current-orientated plant material associated with mudflakes and reworked bone fragments on the sole surface (Hammer = 32 cm).

In situ channel sandstones on the south-eastern edge of the pit site, and even more so displaced blocks of sandstone on the west side of the road, contain compressions and moulds of reworked plant material, possibly stems or large branches (Fig. 10). Mudflake conglomerates on the soles of these sandstones contain further fossil plant material as well as scattered bone fragments and moulds of small intact bones.

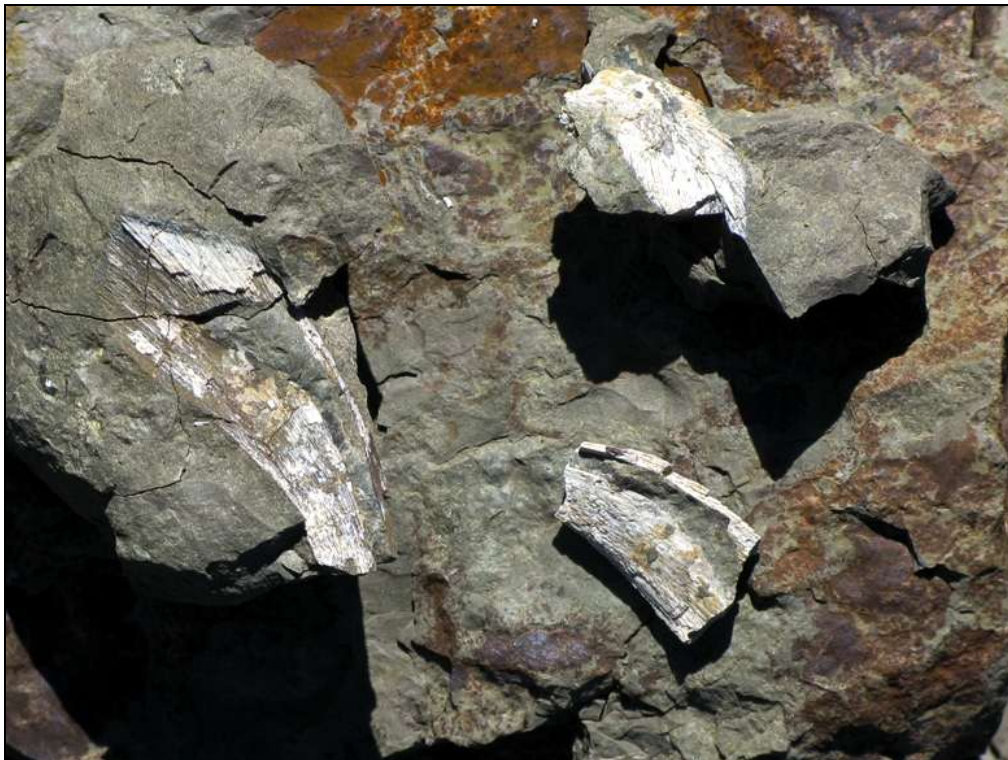
Fig. 14. Bone fragments embedded in grey-green Beaufort mudrocks excavated from a test pit in the western part of the dam area.
