NOTIFICATION OF INTENT TO DEVELOP

WESTERN CAPE BORROW PITS – INITIAL PALAEOONTOLOGICAL HERITAGE ASSESSMENT (August 2011 Second tranche)

Figure 2: Google earth image showing the proposed extension of the existing borrow pit 30 and tracks of the field survey. The existing quarry lies to the east of the road and the donga is located on the western side.

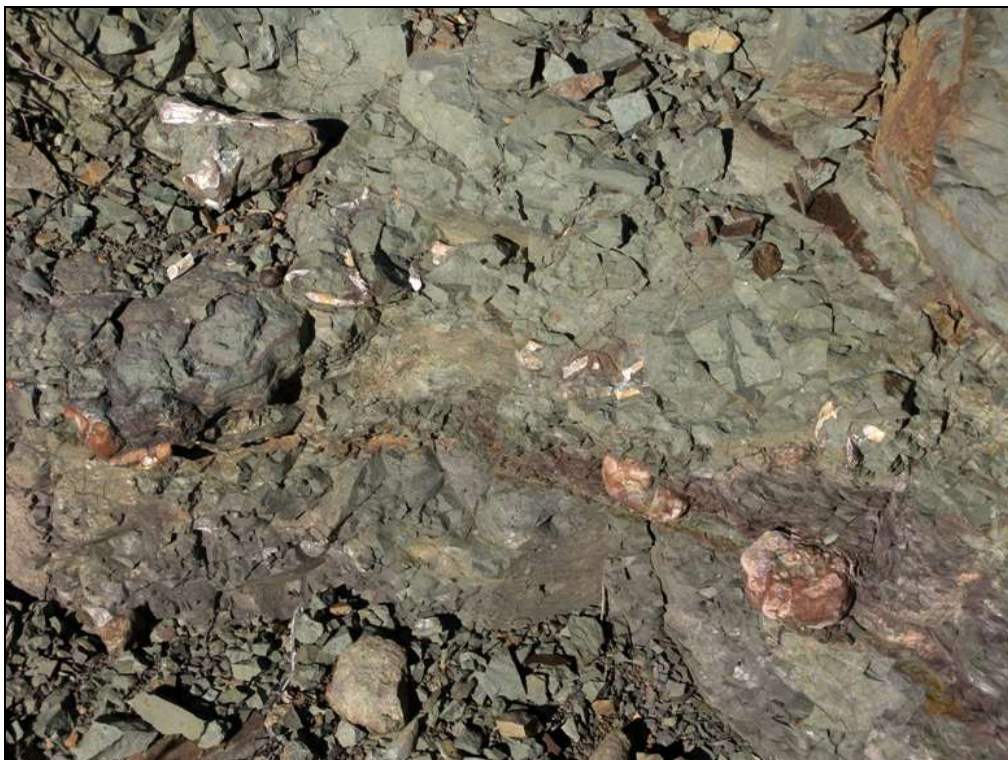
Fig. 15. Ancient soil horizon marked by pinkish calcrete nodules. Note concentration of disarticulated fossil bone a few cm above the calcrete zone.

The low ridge to the south of the study area is capped by a c. 1.5 m thick channel sandstone showing cross-bedding, subordinate channels, ripple cross-lamination and other sedimentary features (Figs. 7, 8). The sole of the sandstone body often features a well-developed ferruginous basal conglomerate dominated by reworked calcrete glaebules with occasional fragments of fossil bone. The underlying grey-green mudrocks contain several horizons of pedogenic calcrete nodules, some of which are richly fossiliferous (Fig. 15).

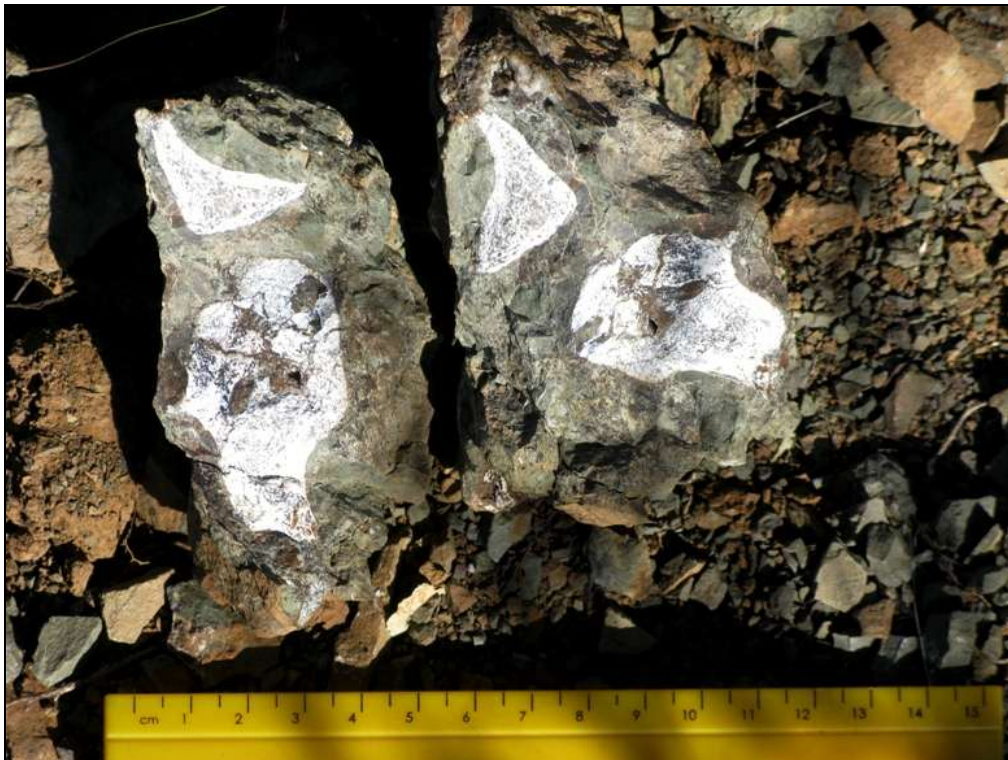
Fig. 16. Freshly broken calcrete nodule showing white fossil bones embedded inside (Scale in cm).

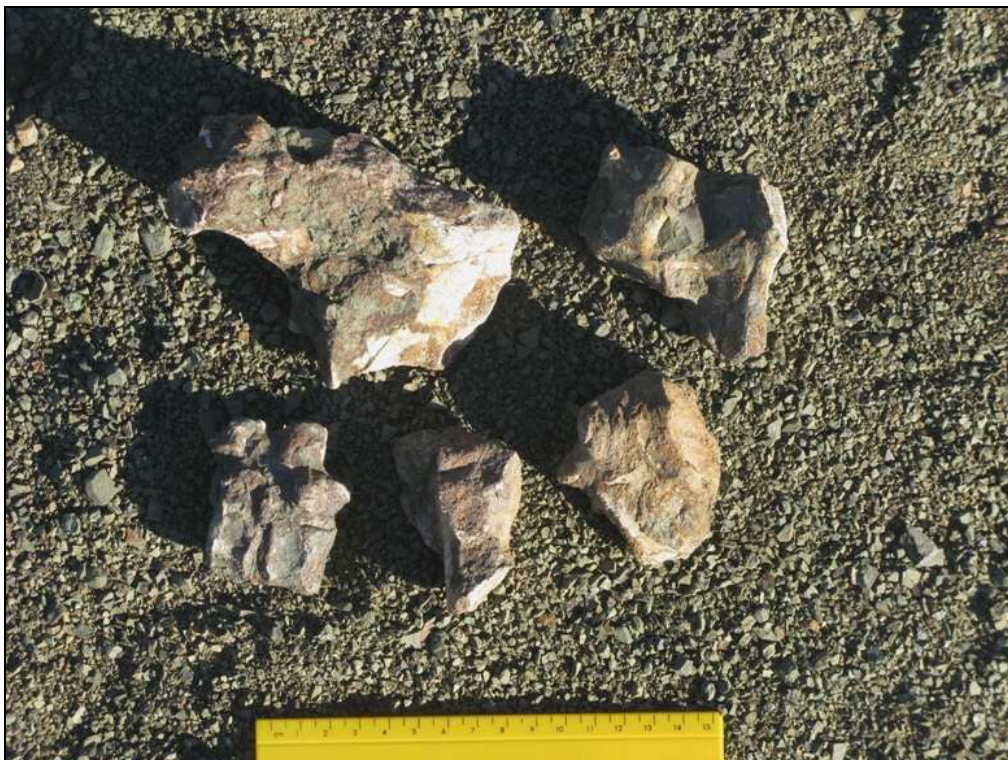
Fig. 17. Disarticulated or semi-articulated vertebrae of a medium-sized reptile or therapsid that have eroded out of the Beaufort mudrocks and been concentrated in gullies (Scale in cm).
