# HERITAGE IMPACT ASSESSMENT

25 April 2012

DR 01445 Central Karoo

Laingsburg – Central Karoo District Municipality, Western Cape

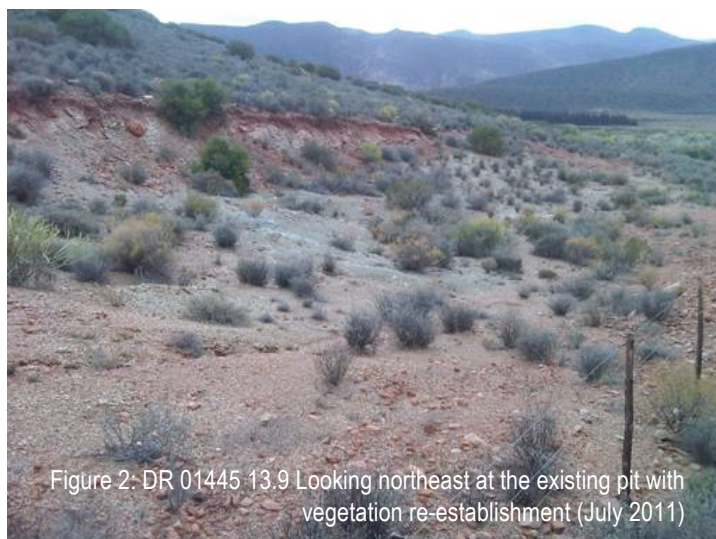
Figure 2: DR 01445 13.9 Looking northeast at the existing pit with vegetation re-establishment (July 2011)

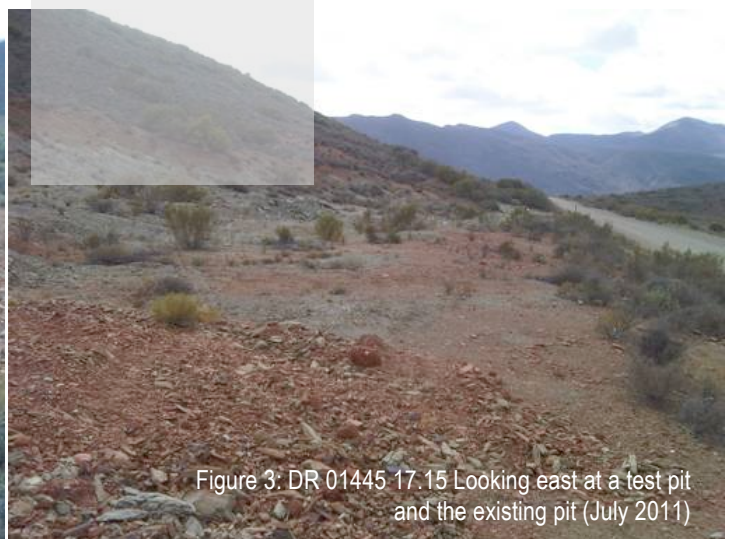
Figure 3: DR 01445 17.15 Looking east at a test pit and the existing pit (July 2011)

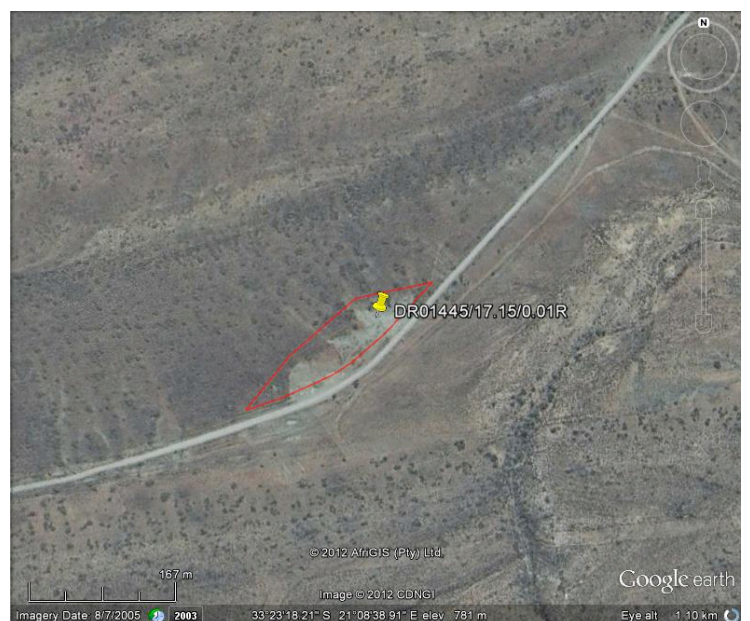
Figure 6: Aerial view of existing borrow pit at km 17.15 (Google earth image, April 2012)

The site is considered to possess intrinsic heritage value. Palaeontological sensitivity of the uncleaved Gydo Formation mudrocks at pit DR01445/17.15/0.01R is high and it is recommended that fossil material from the pit should be recorded and sampled during early stages of excavation.
