# **PRECONSTRUCTION ARCHAEOLOGICAL SURVEY OF THE MAINSTREAM KENTANI SUITE PV PROJECTS (KLIPFONTEIN 2), DEALESVILLE, FREE STATE**

Required as a condition of authorisation.

1<sup>st</sup> draft: 19 May 2021  
Final report: 13 August 2022

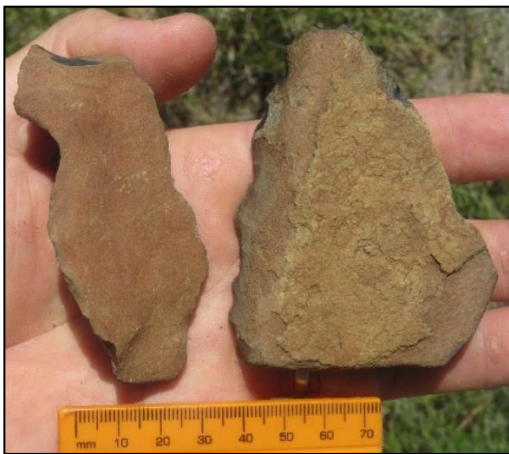
An area with background scatter hornfels artefacts was seen in the south-western part of the Klipfontein 2 PV site (Figure 13 to Figure 15). The artefacts were associated with gravel with the exposure at waypoint 713 being dense gravel (Figure 16). Very low-density scatter was also seen in the northwest. In the northeast a single dolerite boulder with recent/historical scratched graffiti was noted (Figure 17 and Figure 18). This is very likely connected to recent use of the area and would then not be heritage.

**Figure 13: Stone artefacts from waypoint 712. Scale in cm/mm.**

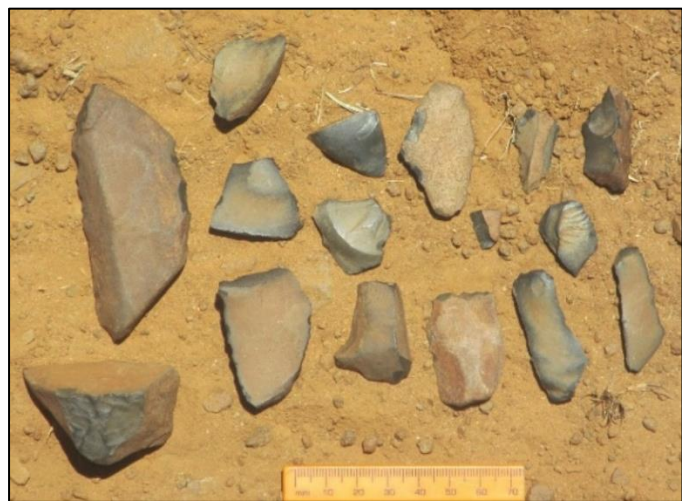
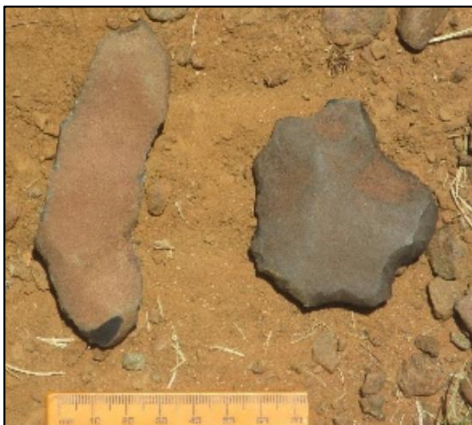
**Figure 14: Stone artefacts from waypoint 713. Scale in cm/mm.**

**Figure 15: Stone artefacts from waypoint 713. Scale in cm/mm.**

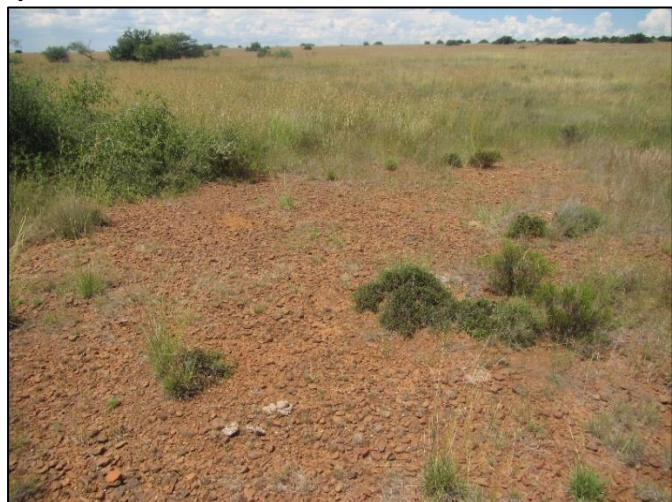
**Figure 16: The gravel patch at waypoint 713.**

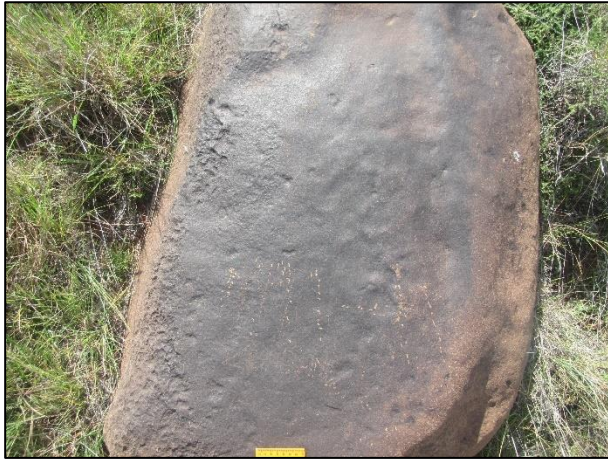
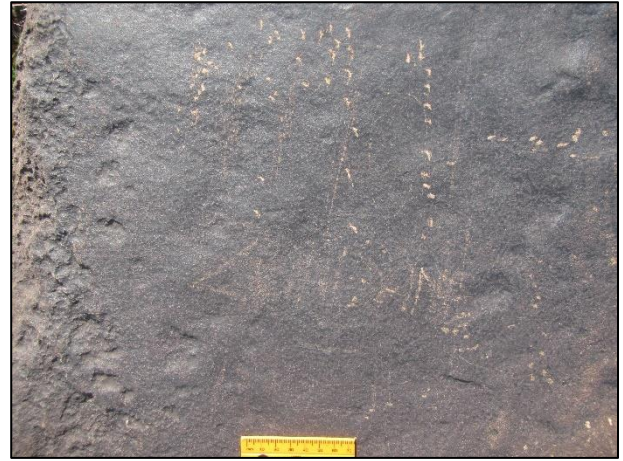
**Figure 17: Historical/recent scratched engraving from waypoint 715. Scale = 7 cm.**

**Figure 18: Historical/recent scratched engraving from waypoint 715. Scale in cm/mm.**

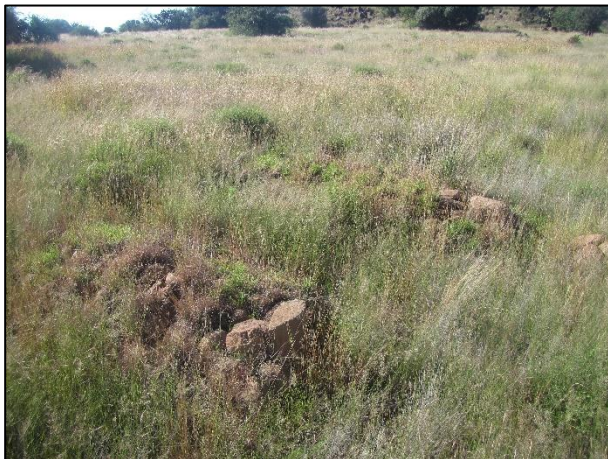
Klipfontein 2	721	S28 42 15.7 E25 43 16.3	A set of about 12 farm workers' graves located a short way outside of the Klipfontein 2 study area. They are very overgrown with grass and contain some graves with dolerite mounds, some with low and seemingly very narrow packed calcrete stones and one with an informal cement slab with a small dolerite headstone at the western end of the grave.	IIIA
Klipfontein 2	579	S28 40 57.7 E25 43 43.1	Low density background scatter of weathered MSA hornfels artefacts.	GPC
Powerline & substation	719	S28 37 23.1 E25 45 12.1	Modern face brick house on the northern edge of the substation site. <u>Not heritage.</u>	---
Powerline & substation	720	S28 39 16.2 E25 44 21.1	Historical ruin with brick and stone (dolerite and calcrete) walls using mud mortar throughout. Most joinery and the roof are gone. The main section is a farm shed and is built of brick. It has a more recent concrete floor. A smaller room to the northwest is probably older. It is built from a mixture of bricks, dolerite and calcrete and its floor is covered with mud and grass.	GPA

Martin Nel of Leliehoek had recently been working on Doornrandjes 546/rem when he stumbled over some graves in the long grass. The site was revisited and found to be a small farm workers' graveyard with about 12 graves (Figure 19 to Figure 21). The graves are not within the Klipfontein 2 PV study area but are less than 200 m from its edge.

**Figure 19: Dolerite grave mounds at waypoint 721.**

Graves are deemed to have high cultural significance at the local level for their social value. They are allocated a grade of IIIA.

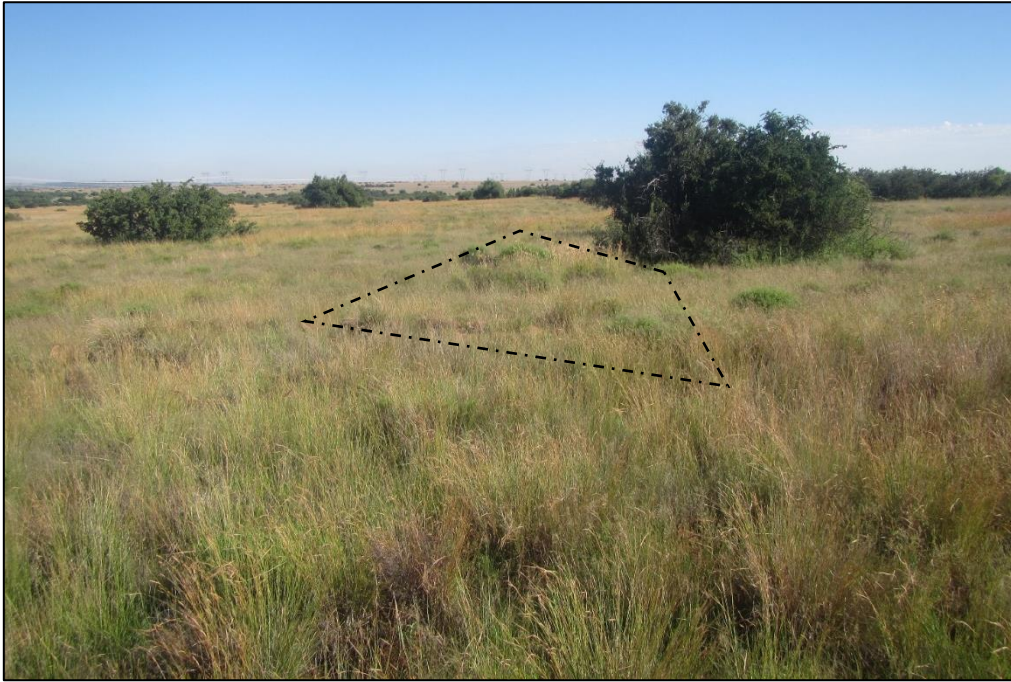
**Figure 21: View towards the north showing the approximate location of the graves at waypoint 721. In this view, the dolerite mounds are in the back left corner of the dashed polygon, the cement-topped grave is in the front left corner and the calcrete-covered graves are towards the right.**

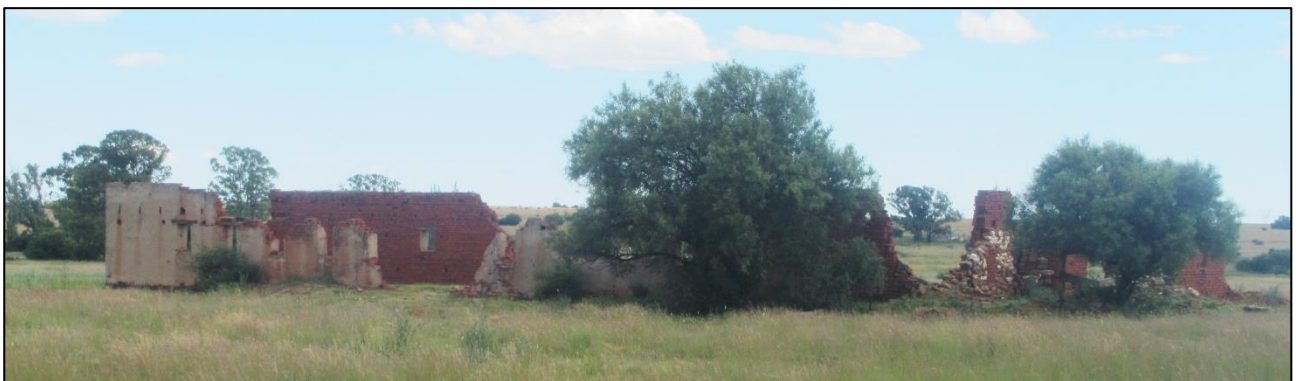
The most important sites were located along the powerline route and consist of historical ruins. None are likely to be older than the late 19<sup>th</sup> century. In the north an old, ruined farm shed, and small attached room were seen (Figure 22 to Figure 24). Built with a combination of bricks and stones with mud mortar, these ruins are typical of the older ruins in the area as previously documented (Orton 2015, 2021). Not far away was the ephemeral remnants of a foundation (Figure 25). A little further south a livestock dip (Figure 26) and a tall brick and cement silo or kiln with a small metal entrance was seen (Figure 27). These features could be seen as structures but given they are derelict and in a state of disuse they can be considered under the definition of archaeology as per the NHRA. The only Stone Age material along the route was a background scatter of variably weathered hornfels artefacts associated with an exposed calcrete outcrop in the far south (Figure 28).

**Figure 22: View towards the west showing the ruined farm shed at waypoint 720. The main shed is to the left with the smaller room being to the right.**

The Stone Age archaeological resources are deemed to have low cultural significance at the local level for their scientific value and can be graded GPC. The ruins, however, are ascribed greater value and are seen as of medium significance at the local level for their architectural, historical and social values and are considered to be GPA.

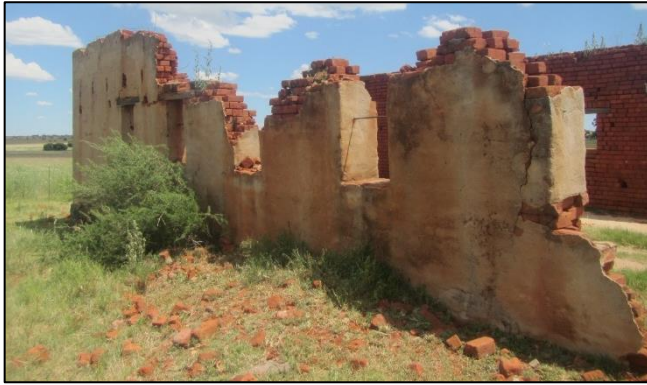
**Figure 23:** View of the main shed section of the ruined structure at waypoint 720. The smaller section lies to the right of this view.

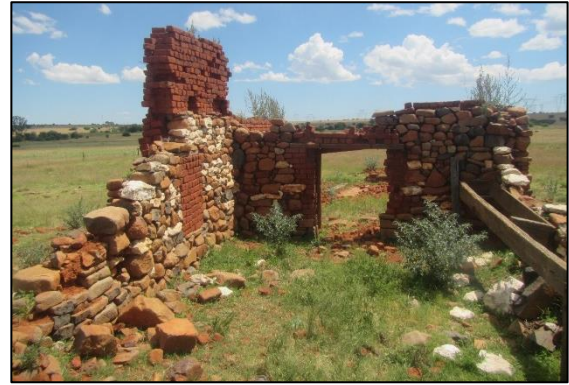
**Figure 24:** View of the smaller room of the ruined structure at waypoint 720.

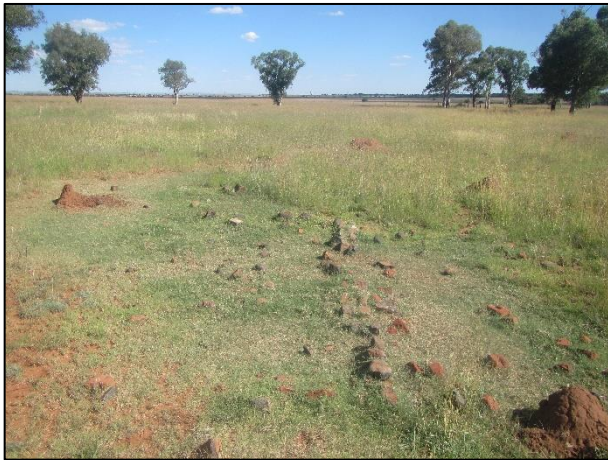
**Figure 25:** Remnant of a foundation at waypoint 733.

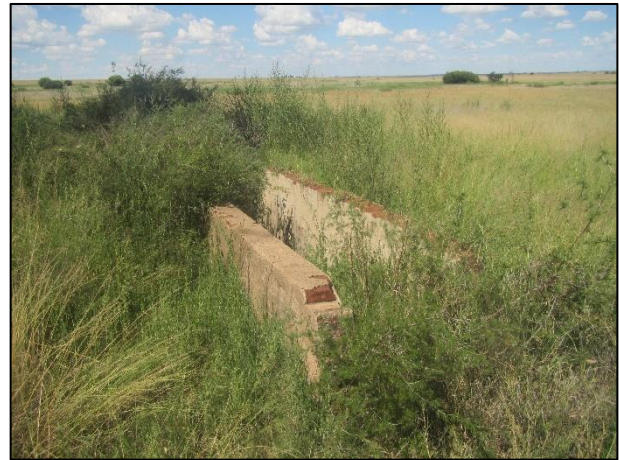
a small metal opening at about 1.4 m. The base is about 1.8 m diameter, but it narrows to about 1.2 m at the top.	
Powerline & substation	729	S28 39 31.4 E25 44 16.8	A brick and cement livestock dip, now partly filled in.	GPC

**Figure 26:** An old livestock dip at waypoint 729.

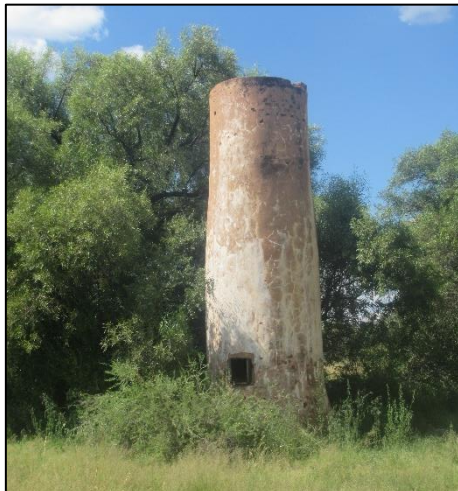
**Figure 27:** Ruined structure at waypoint 728.

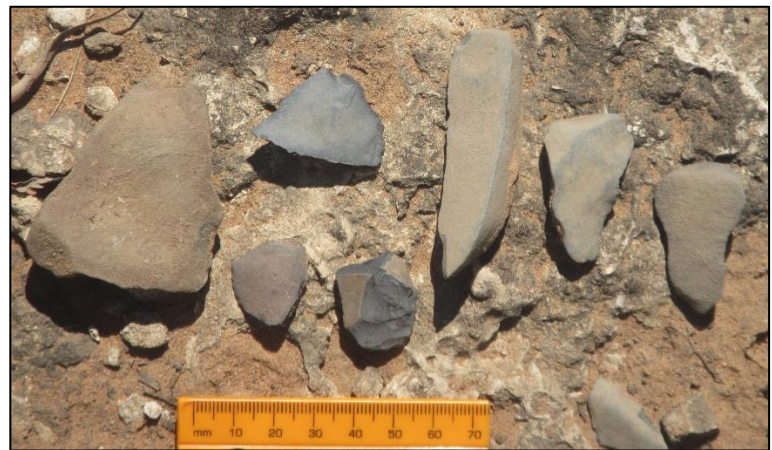
Powerline & substation	722	S28 43 22.8 E25 42 40.5	Light background scatter with variable weathering and hence probably variable age. The scatter was associated with a very small area of exposed calcrete.	GPC
Powerline & substation	723	S28 43 38.7 E25 42 37.1	An area that has been informally 'paved' with calcrete and dolerite stones. It is close to a wind pump and dam (c. 230 m away) so must be connected to farming activities.	GPC
Powerline & substation	728	S28 39 30.3 E25 44 15.7	A brick and cement silo or kiln (original function cannot be determined) of about 6 m high and with	GPA

**Figure 28:** Stone artefacts at waypoint 722. Scale in cm/mm.
