DESKTOP HERITAGE ASSESSMENT

**SAPPI SAICCOR FLOOD PROTECTION BERM,
UMKHOMAZI, KWAZULU-NATAL**

September 2020

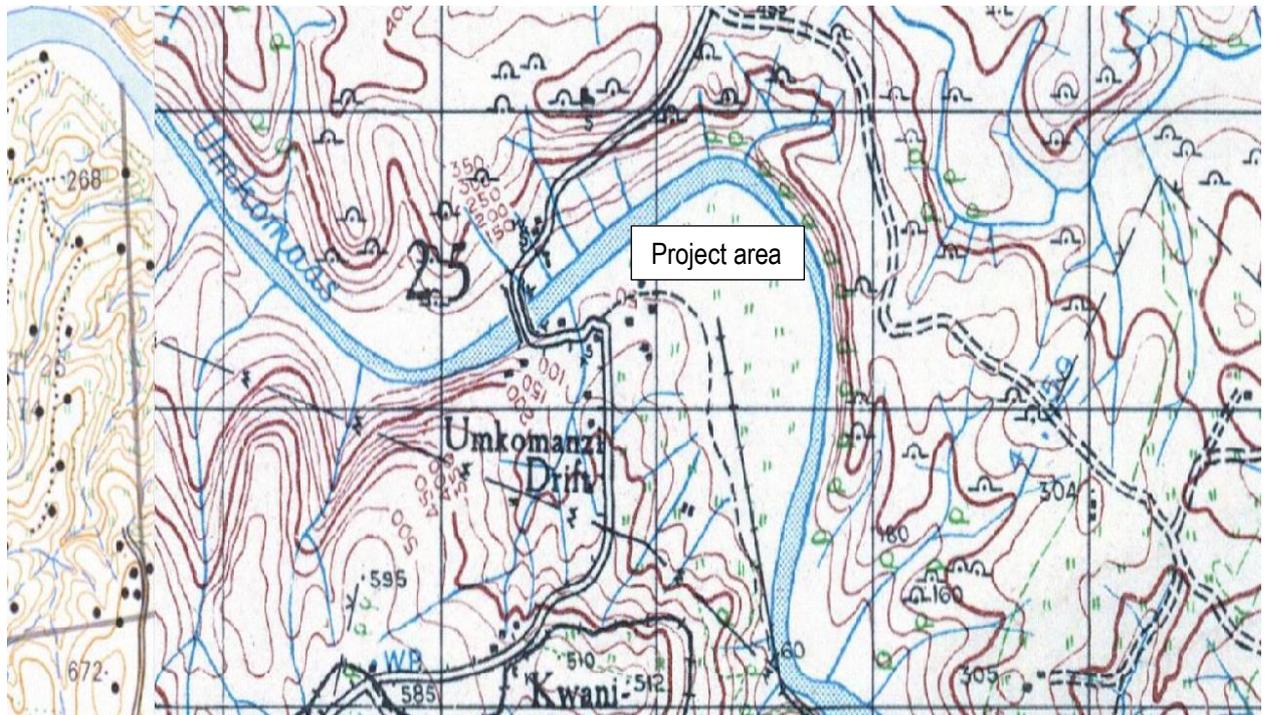
Figure 3: Old map of project area prior to the development of the mill

A section of an undated topographical map, dated possibly prior to the construction of the Mill, clearly shows farming of the project area.

Scrutiny of old maps (see **Figures 3, 4 and 5** below) of the area between the uMkhomazi River and the Saiccor Mill shows that, over the years, the area has been disturbed by farming, as well as the extension of the Mill and, more recently, what appears to be sand quarrying. In addition, a gravel road also crosses the area between the proposed protection berm and river.

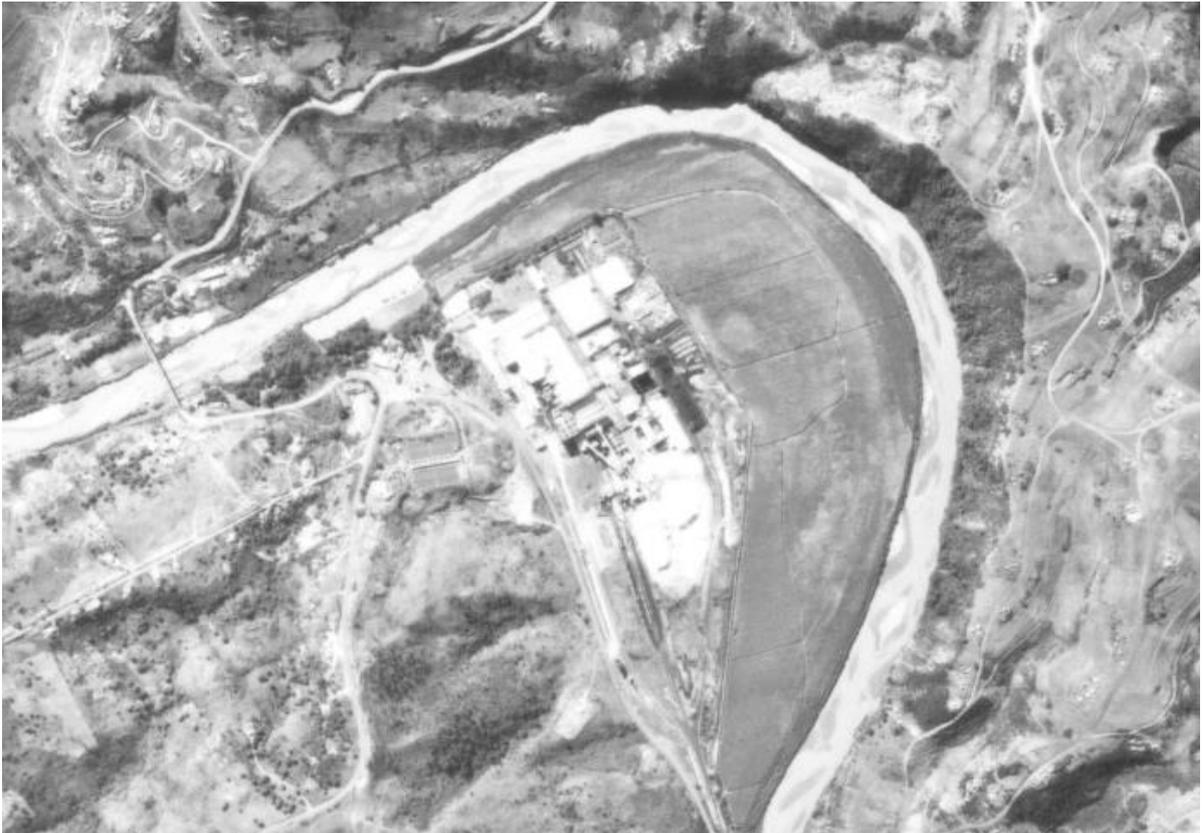
Figure 4: Farming of area between mill and river (1974)

Aerial images below (Figure 4 and 5) of the project site from the 1970s and 1980s show continued farming of the area east and south-east of the Mill with what appears to be sugar cane. The 2005 Google Earth image of the project area also shows farming of the area. The continuous use of the area for farming purpose would have resulted in the destruction of any heritage resources in

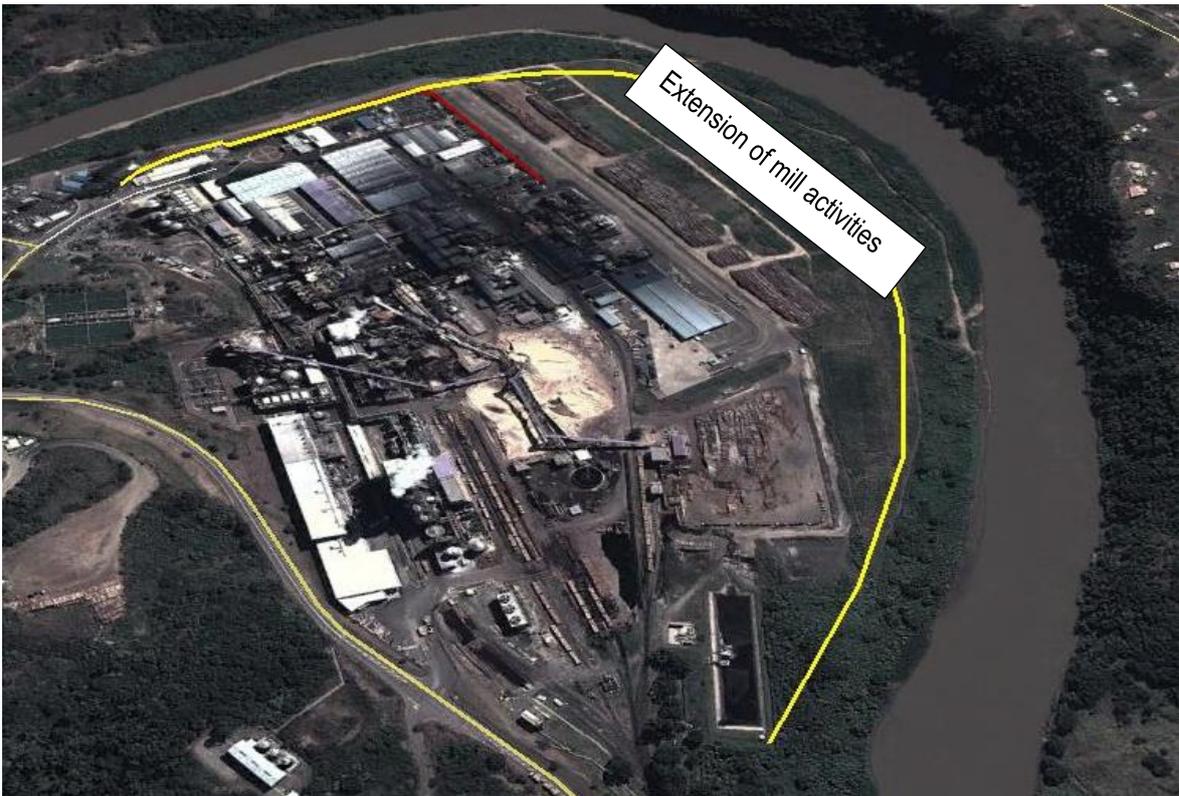
Figure 6: Google earth image (2011)

Figures 6 and 7 below show the extension of the Mill eastwards (2011) as well as showing a road running alongside the river. As noted earlier in Chapter 1 of this report, existing flood protection measures on the Mill's western and northern boundaries have also led to disturbance of the area. The 2018 Google Earth image shows possible sand quarrying along the banks of the uMkhomazi River leading to even more disturbance of the area.

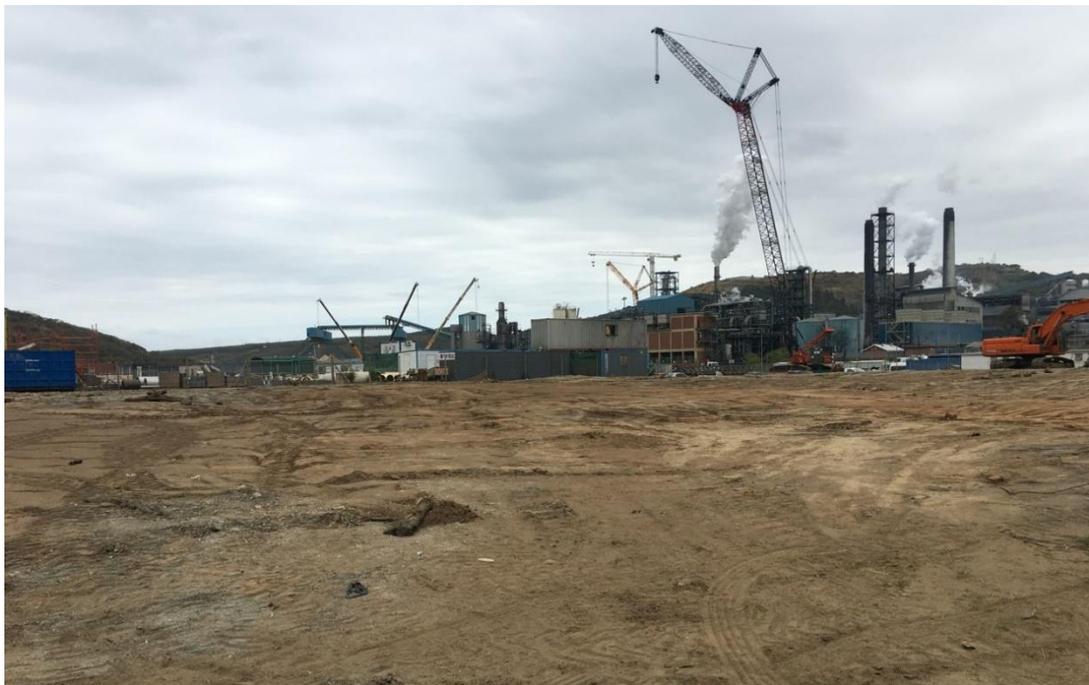
Photographs of the project area taken in September 2020 by WSP confirm the current disturbance of the area between the river and the Mill.

Figure 8: Looking towards mill across cleared area

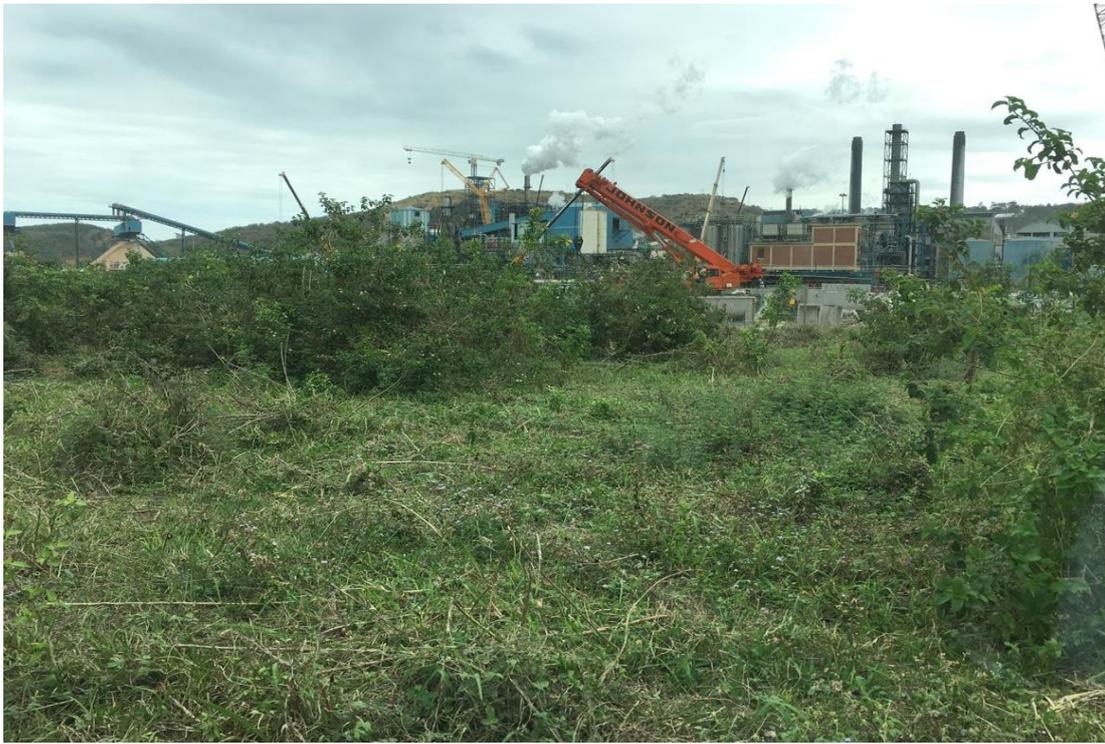
Figure 9: Area between mill and river overgrown with invasive plants

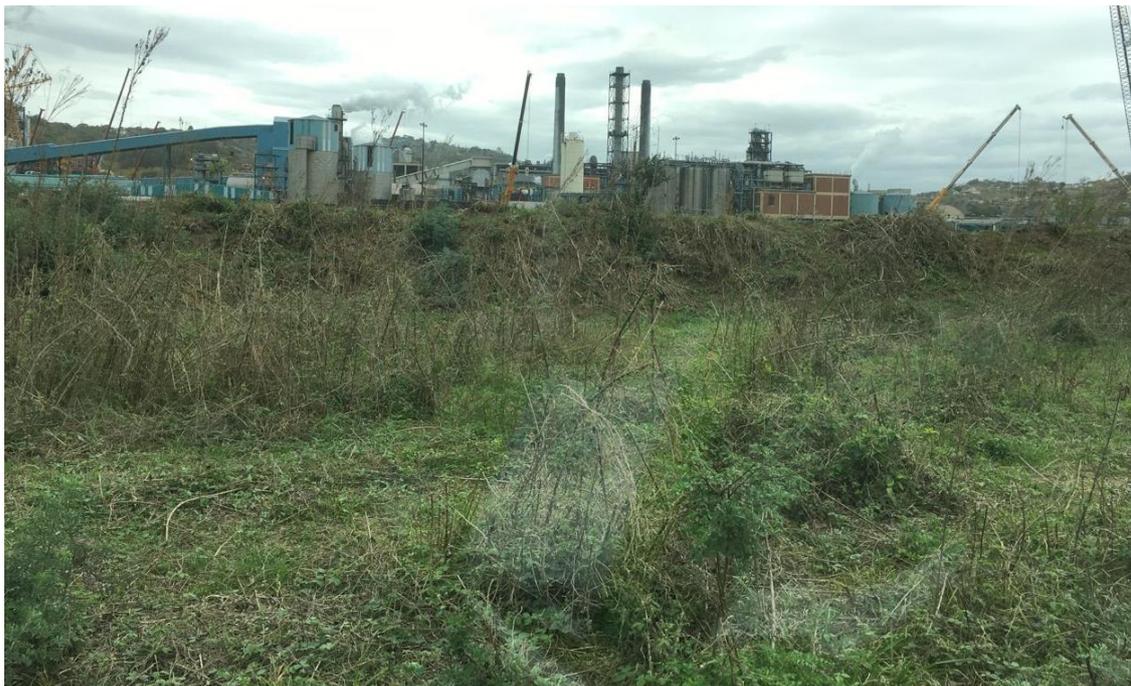
Figure 10: Disturbed area

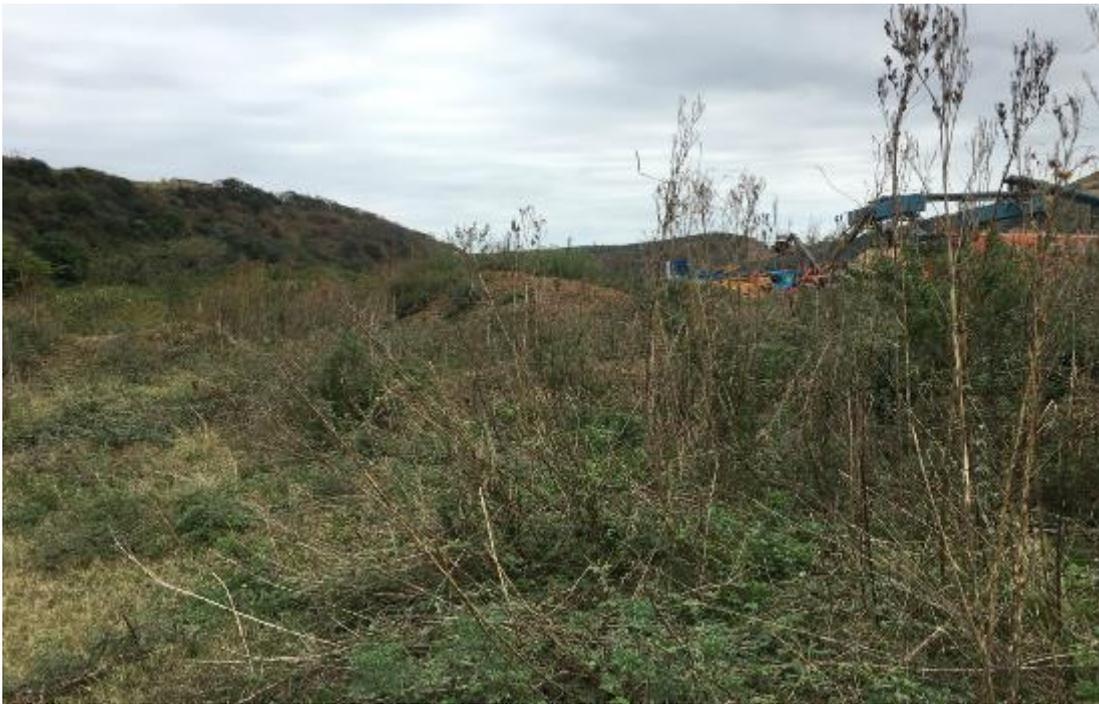
Figure 11: Existing disturbance

Due to the disturbed and transformed nature of the area where the proposed flood protection berm is to be constructed, it is highly unlikely that intact heritage resources will be found on the site. Continual use of the area over many years has resulted in a highly disturbed environment. Therefore, it is recommended that from a heritage perspective the construction of the flood protection berm may proceed as long as the mitigation measures provided below as well as those in the desktop palaeontological report are applied where necessary.
