Phase 2 Cultural Heritage Documentation:

THE PROPOSED DEMOLISHING OF AN OLD CONCRETE ROAD BRIDGE ACROSS THE MBOKOTWANA RIVER, N2 NATIONAL ROAD, TSOLO, EASTERN CAPE PROVINCE

Report No: 2018/JvS/069

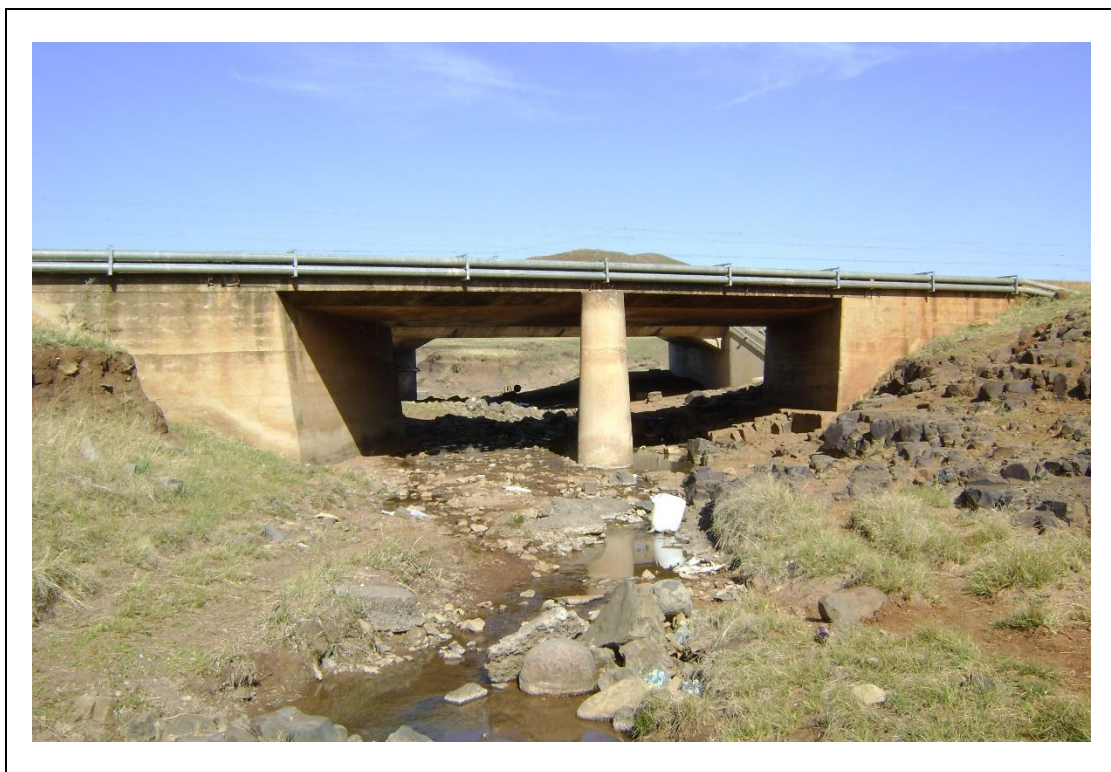
The Mbokotwana River bridge is classified as a **two-span** bridge as the spanning superstructure extends from one vertical support, called abutment, to another, being supported by a single column (Fig. 1).

Figure 1. Side view of the Mbokotwana River Bridge
(Eastern aspect)

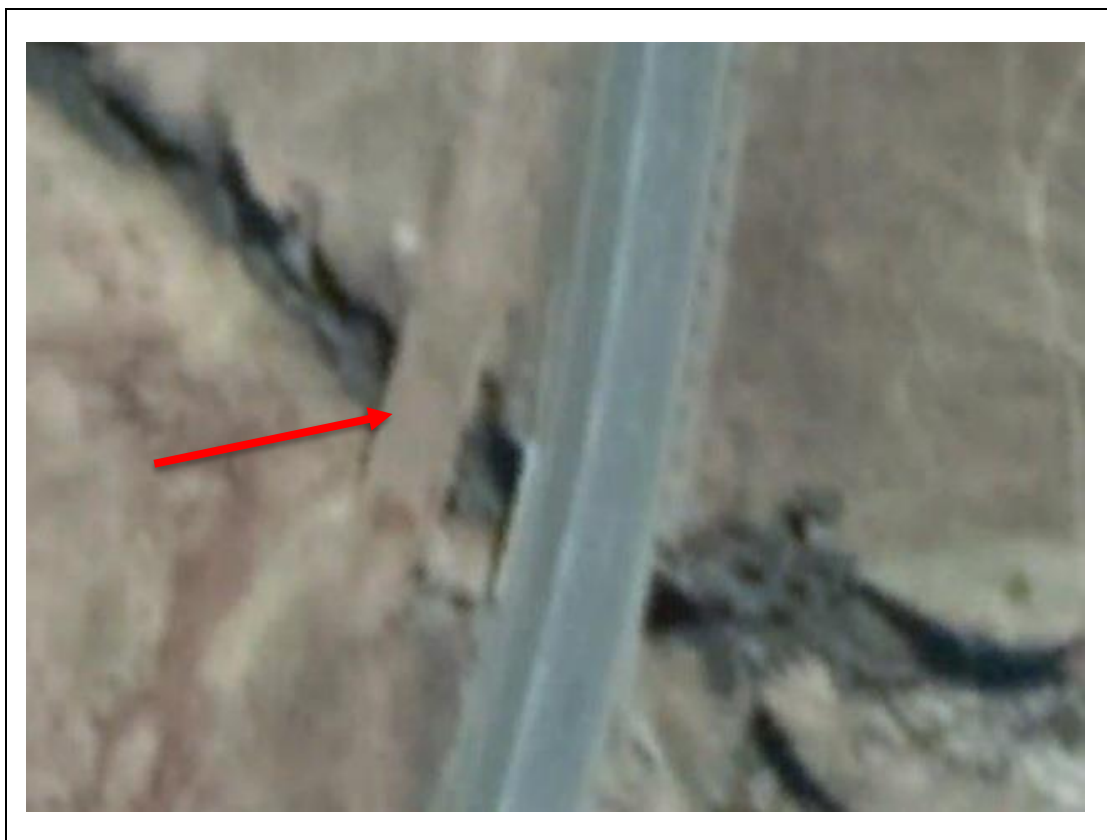
The bridge under discussion is located approximately 5,8 km northeast of the town of Tsolo in the Mhlonlo local district municipality of Eastern Cape Province (Fig. 2). It is located on the western side of the current N2 road at Km reading: N2-19; 37,8E, and falls inside the existing road reserve (Fig. 3).

Figure 3. The old bridge (arrowed) in relation to the current bridge
(Image: Google Earth)

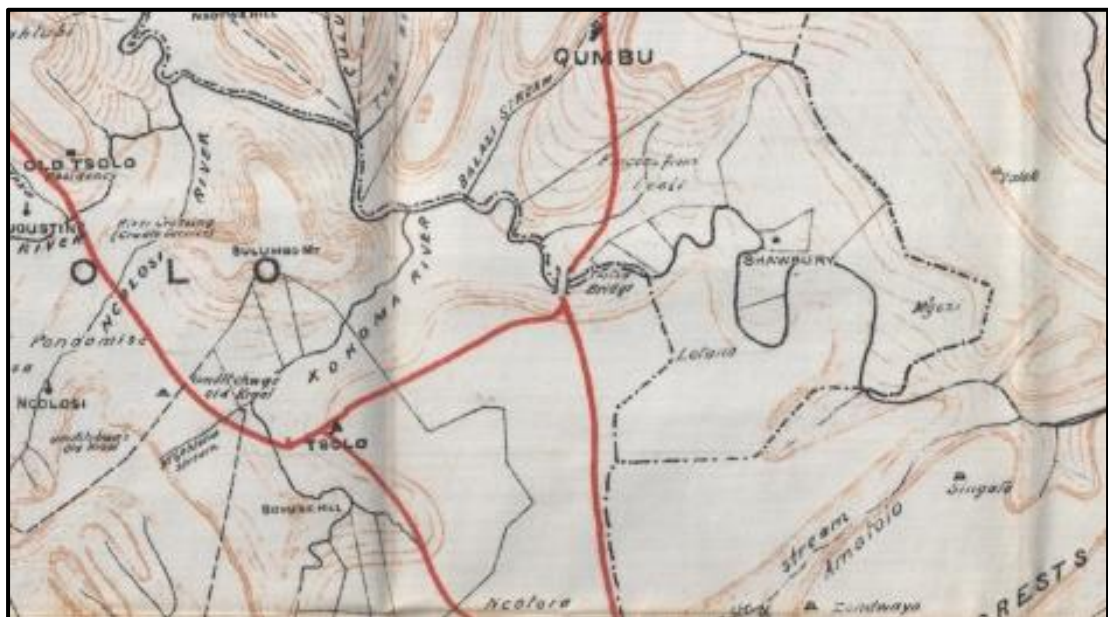
Figure 4. Imperial War Map of the region, dating to 1902

One of the oldest maps of the region, showing the development of infrastructure in the region, such as roads and bridges, is the Imperial War Map dating to 1902 (Fig. 4). However, with reference to the road under discussion, this is very unspecific. One point of reference that is taken as approximately correct, is the Tsitsa River Bridge to the south of Qumbu.

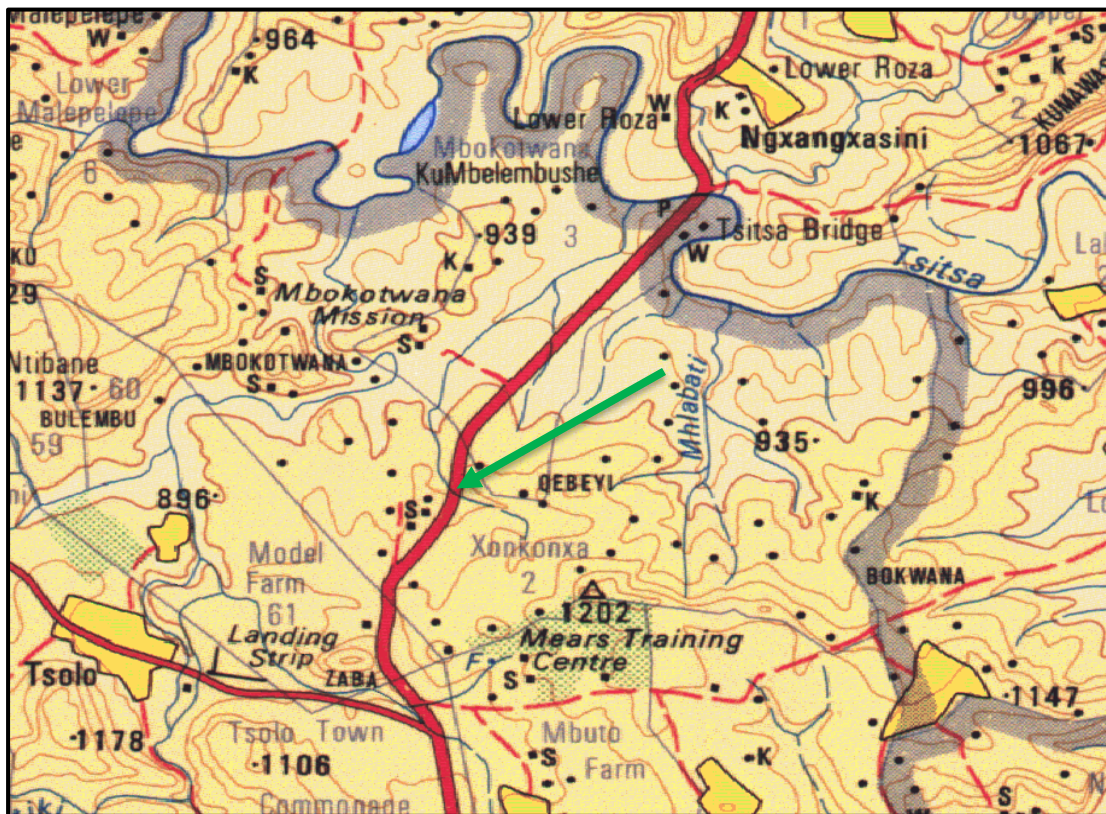
Figure 5. The 1:250 000 map showing the modern roads in relation to the Imperial War Map (above)

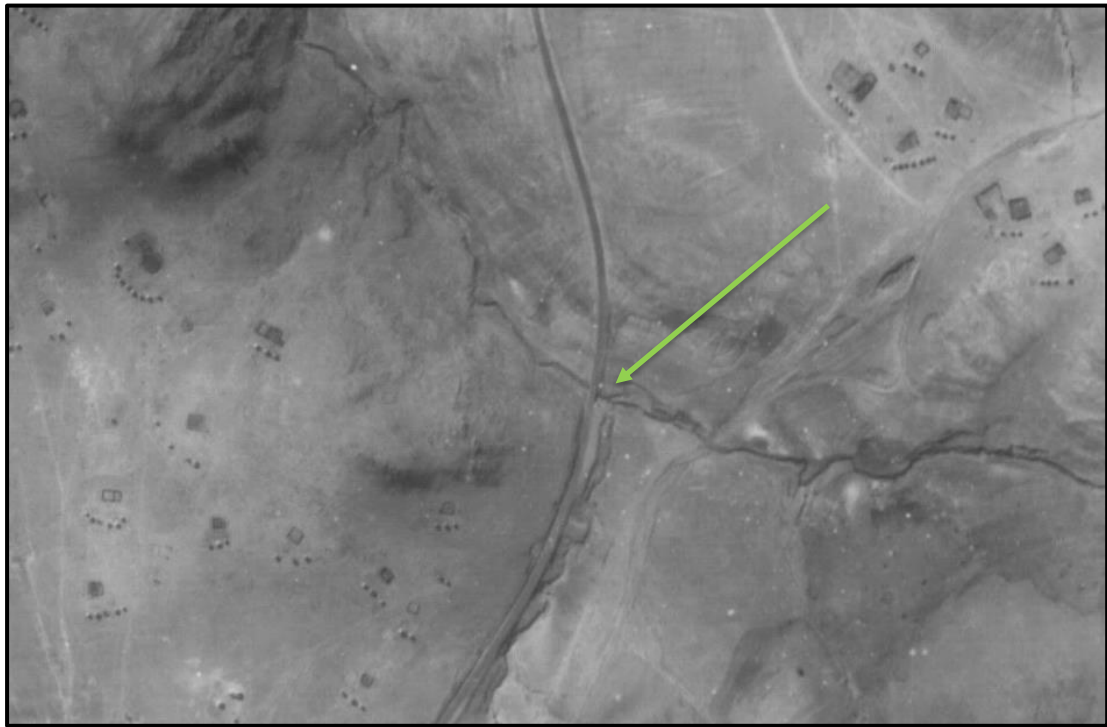
From the aerial photograph dating to 1948 (Fig. 6), the road can be seen to approximately follow the current alignment. From this it is deduced that, when the current N2 was constructed, the road alignment was adapted to bypass the old bridge. In all probability the old bridge was still used to carry traffic up to the completion of the new bridge.

Figure 6. Aerial photograph of the relevant section the road and the bridge location, dating to 1948 (Photo: 207_031_12543)

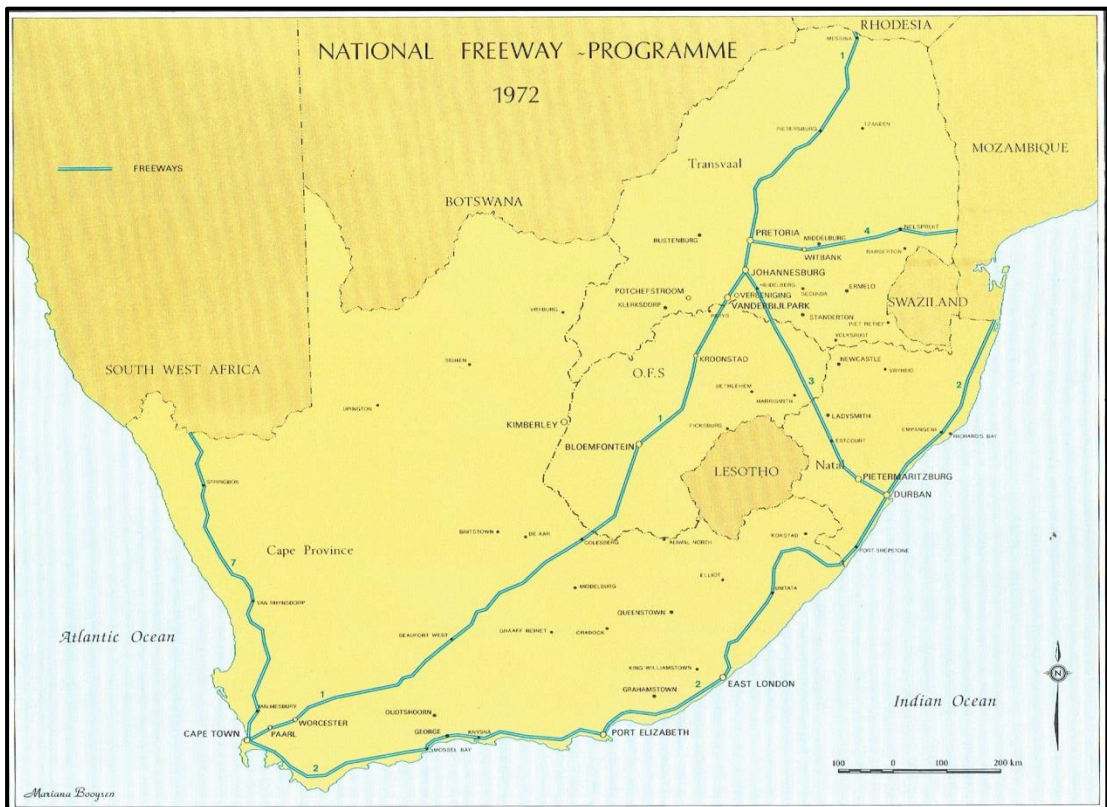
Figure 7. Development of the National Freeways by 1972 (Floor 1985)

The current alignment was probably completed during the 1970s, as this was a period when the National Roads (N roads) were developed over long distances in the country as a whole (Floor 1985) (Fig. 7).

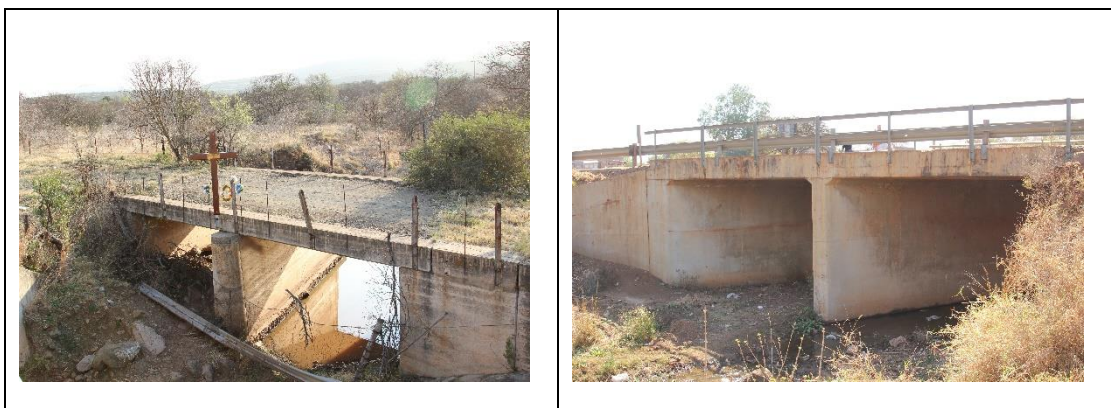
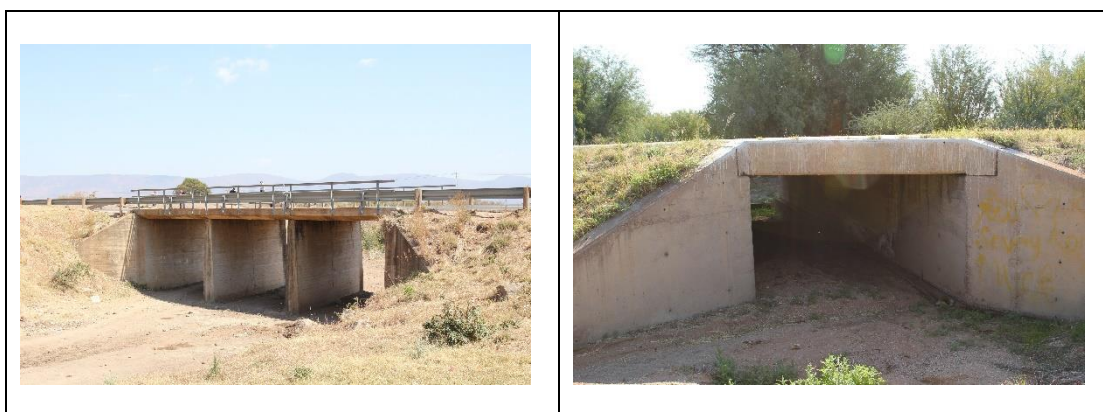
It seems, statistically speaking, that this type of concrete bridge was mostly used for roads. Depending on the length of the obstacle that had to be spanned, any number of columns (vertical support structures) can be added (Fig. 9).

Figure 9. Examples of bridges of similar material and construction

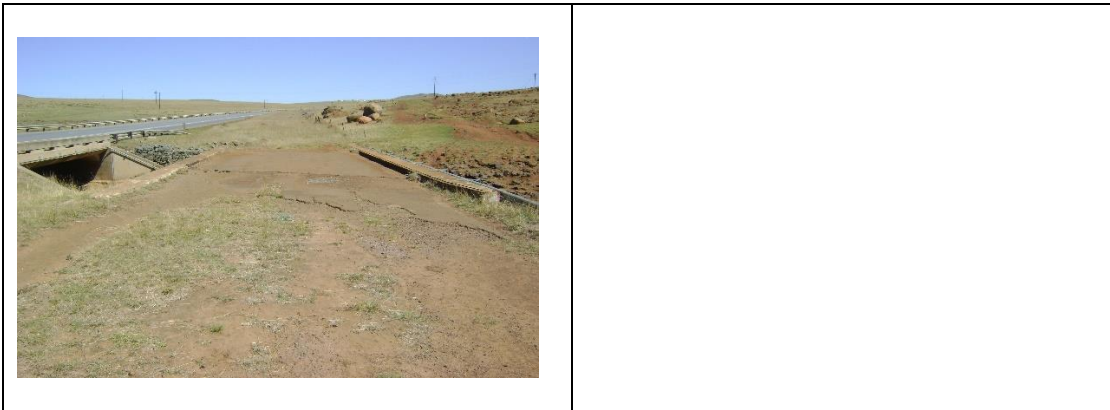
Approach road:

- The road leading up to the bridge on both sides.

This is currently a dirt road, but presumable was tarmac in the past.

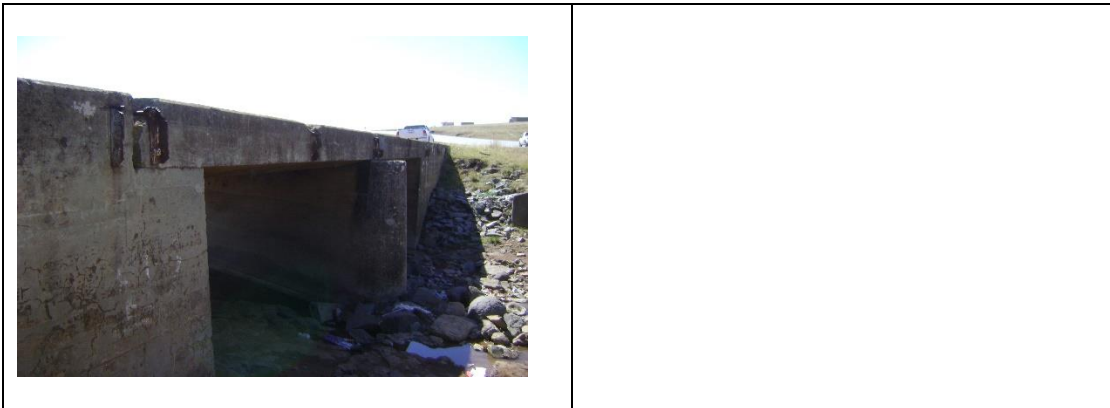
Bridge deck:

- The roadway portion of a bridge that supports the traffic.

This consists of a flat cast concrete superstructure and is commonly re-enforced with steel.

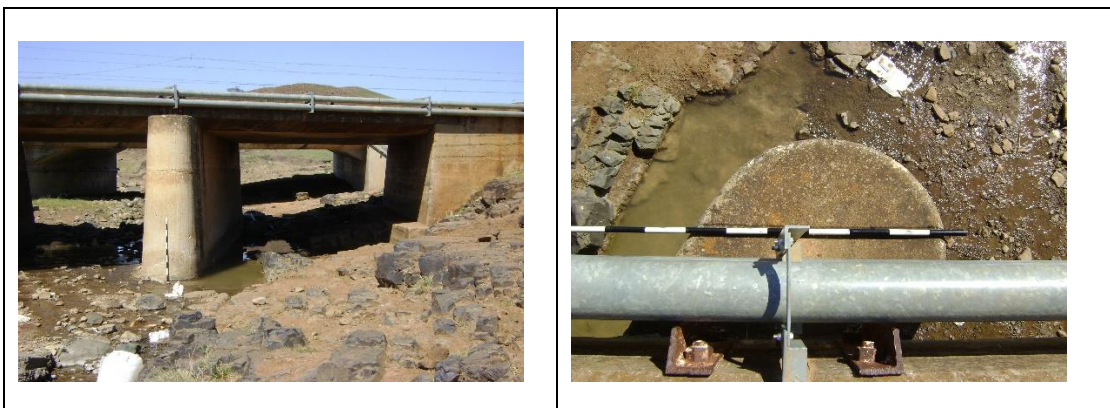
Columns:

- Vertical structure member used to support the load of the bridge deck.

A single column supports the bridge deck. It is from cast concrete and is set at a slight angle to the bridge deck in order to be parallel to the stream bed. Currently, this is used to house a pipeline, probably carrying water.

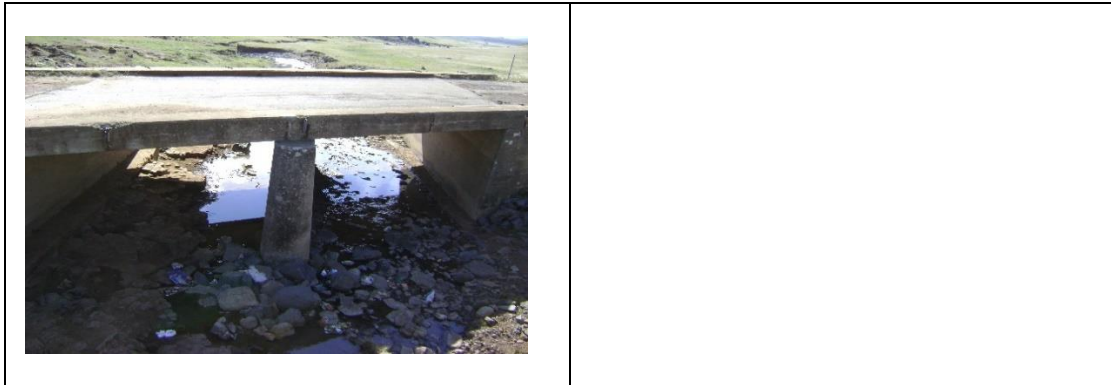
Deck floor:

- The top layer on which the traffic crosses.

This consists of a layer of re-enforced concrete. The concrete layer also served as part of the construction of the bridge deck.

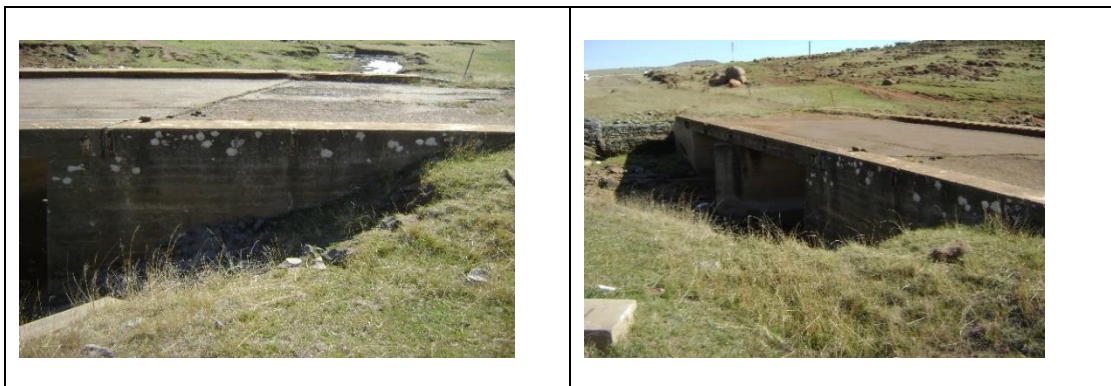
*Embankment:*

- Angled grading of the ground, leading up to the bridge.

Due to the low level of the bridge as well as the steep, nearly perpendicular river banks, the latter was cut away to accommodate the bridge. In some cases, erosion started to take place, cutting away the soil. This was prevented by installing gabions.

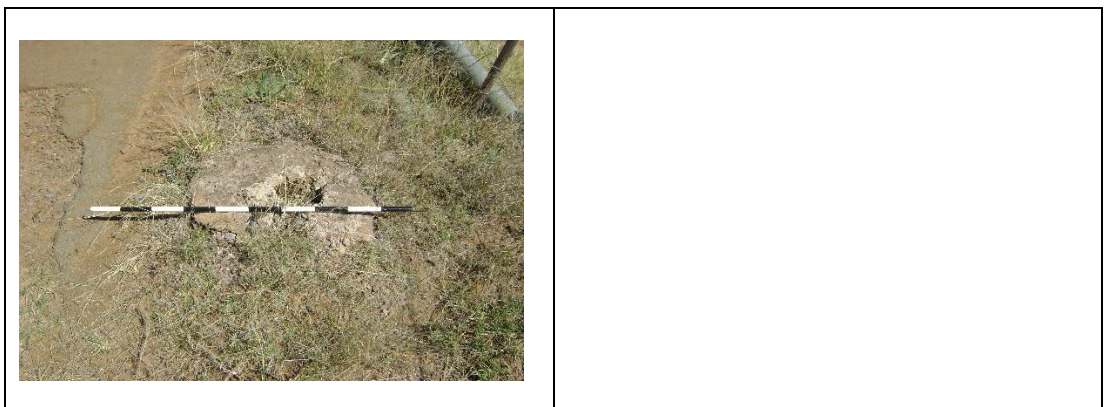
Pylon:

- A monumental vertical structure marking the entrance to a bridge or forming part of a gateway.

No pylons were identified. However, a round concrete foundation with a hole that probably housed a pole of some sort were identified in the location where pylons are usually found – the left-hand entrance, irrespective of the approach, south or north, of the bridge.

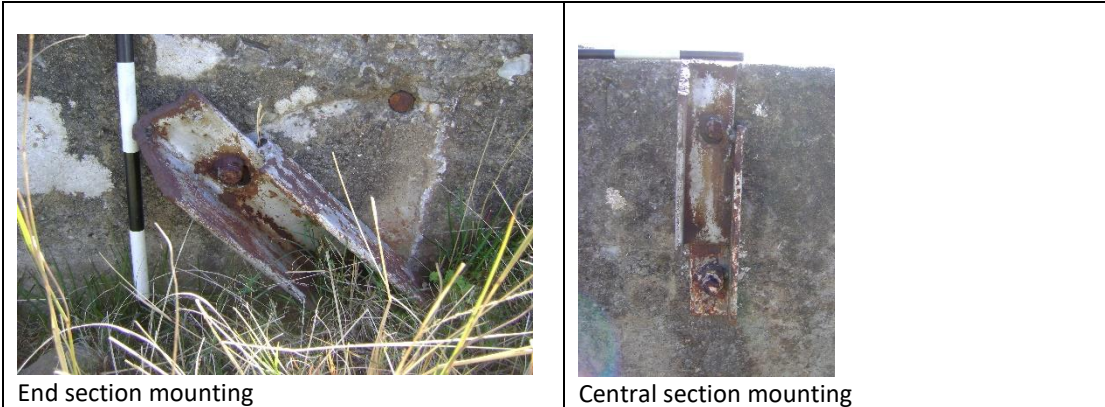
Railings:

- Consists of steel structure made up of a number of upright sections or stanchions, on which horizontal railings are suspended.

The original handrails were removed some time ago and only the fittings embedded into the concrete bridge deck remains.

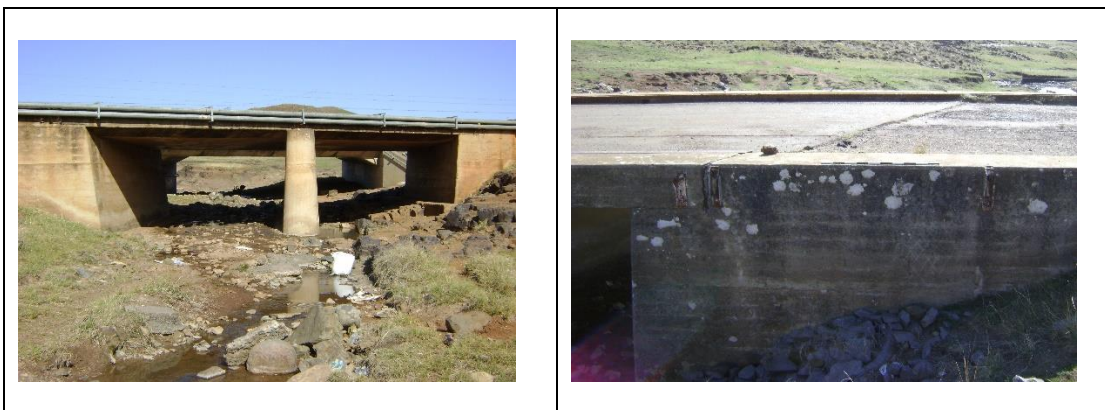
Superstructure:

- The part of the bridge that spans the obstacle, e.g. river.

The concrete deck was cast in-situ and has a slightly skew angle (c. 12°).
