**HERITAGE IMPACT ASSESSMENT:  
PROPOSED 132 kV POWERLINES FOR DU PLESSIS DAM  
PV1 & PV2 AT DE AAR, DE AAR MAGISTERIAL DISTRICT,  
NORTHERN CAPE**

Required under Section 38(8) of the National Heritage Resources Act (No. 25 of 1999)  
as part of a Heritage Impact Assessment

24 April 2022

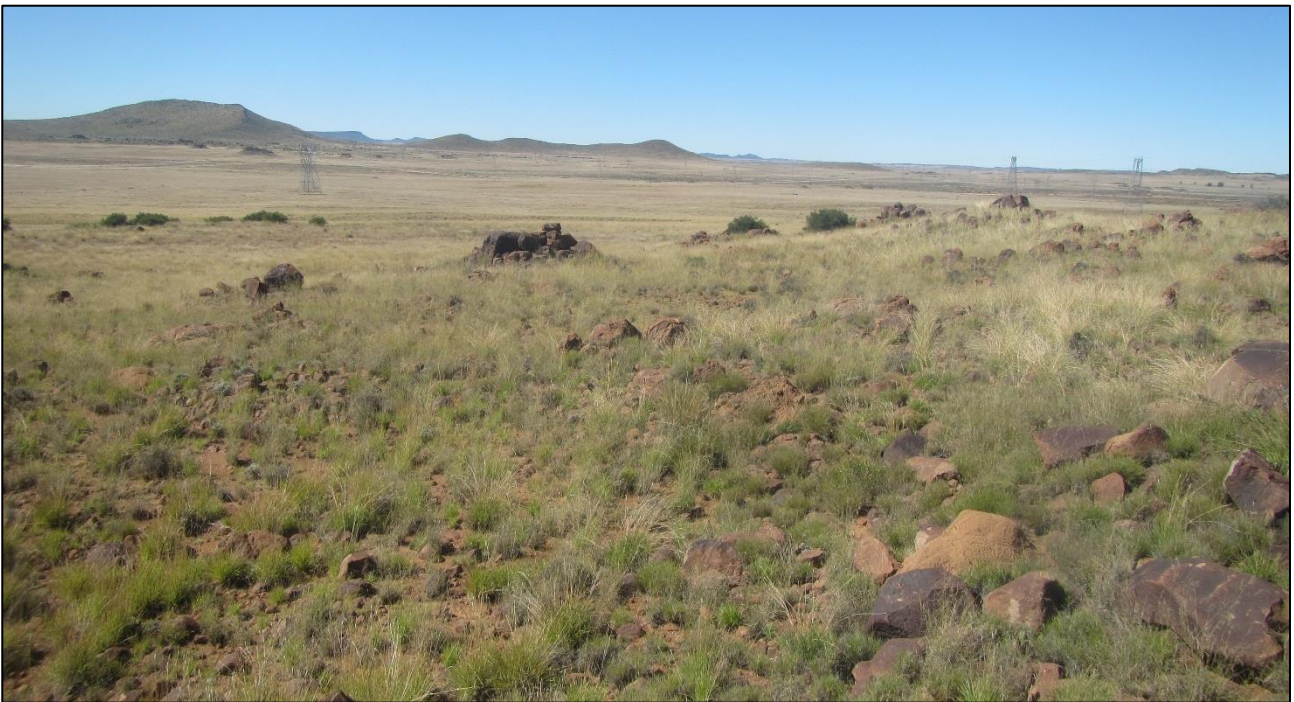
*Figure 16: Looking towards the east across the south-easternmost part of the PV2 powerline corridor. The Vetlaagte Substation will be located on the flat ground between the foreground rocky hill and the powerline in the background.*

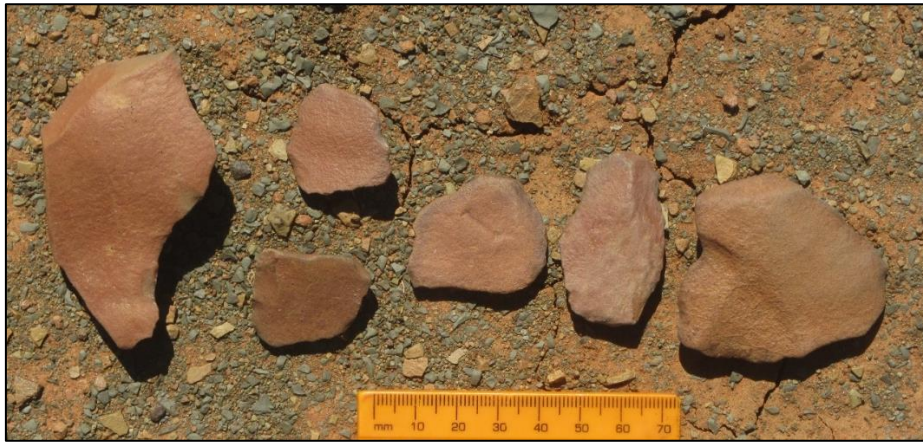
**Figure 21:** Well-patinated MSA artefacts from waypoint 933 in the eastern part of the study area.

Stone artefacts were seen in a number of areas but generally in association with open mudflats and denuded areas. All of the archaeological occurrences seen were of very low density. The majority are what could be described as background scatter – either artefacts that have been lying on the surface for a long time and do not have spatial integrity, or isolated artefacts that do not relate to any specific site (essentially precolonial litter). They have often been moved by erosion and sheetwash. All artefacts were made on hornfels. These artefacts were often well-patinated which indicates great age (Figures 22 to 24), and almost certainly an origin in the MSA. Some artefacts were somewhat darker in colour with less patination (Figures 23 & 24). Rare, isolated artefacts had fresh edges and still retained the typical dark colour of freshly broken hornfels. These latter artefacts relate to the LSA. Two ephemeral scatters of such LSA artefacts were noted in the southeast, close to the proposed Vetlaagte MTS and at the foot of a dolerite hill (Figure 25). It was not possible to tell how extensive these scatters were due to the dense grass, but they are likely larger than what was seen. They would relate to spots where LSA people camped.

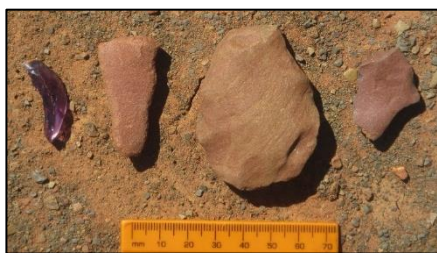
**Figure 22:** Well-patinated MSA artefacts and a historical pink glass fragment from waypoint 940 in the eastern part of the study area.

Just one historical artefact – a piece of pink glass – was seen (Figure 22).

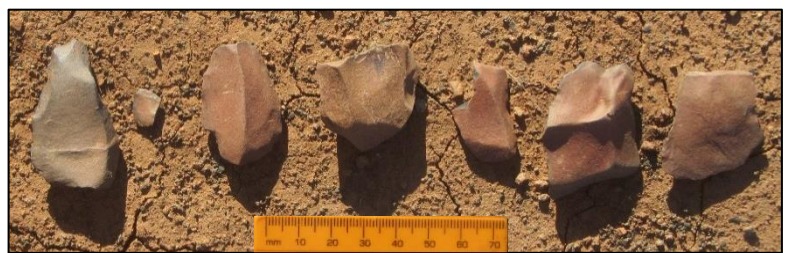
**Figure 23:** Well-patinated MSA artefacts from waypoint 927 in the western part of the study area. The one on the left is younger than the rest, as evidenced by its grey colour.

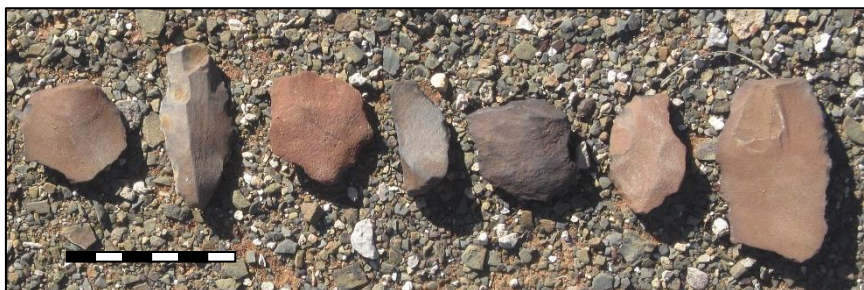
**Figure 24:** Artefacts with variable patination from waypoint 928 in the northern part of the study area. Scale in cm.

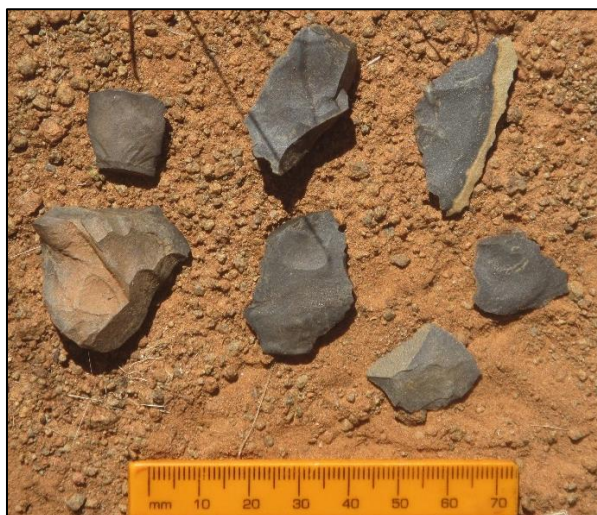
**Figure 25:** *Very lightly patinated LSA hornfels artefacts from waypoint 936 in the south-eastern part of the study area. The lower left artefact is somewhat older than the rest as evidenced by its slight orange patina.*

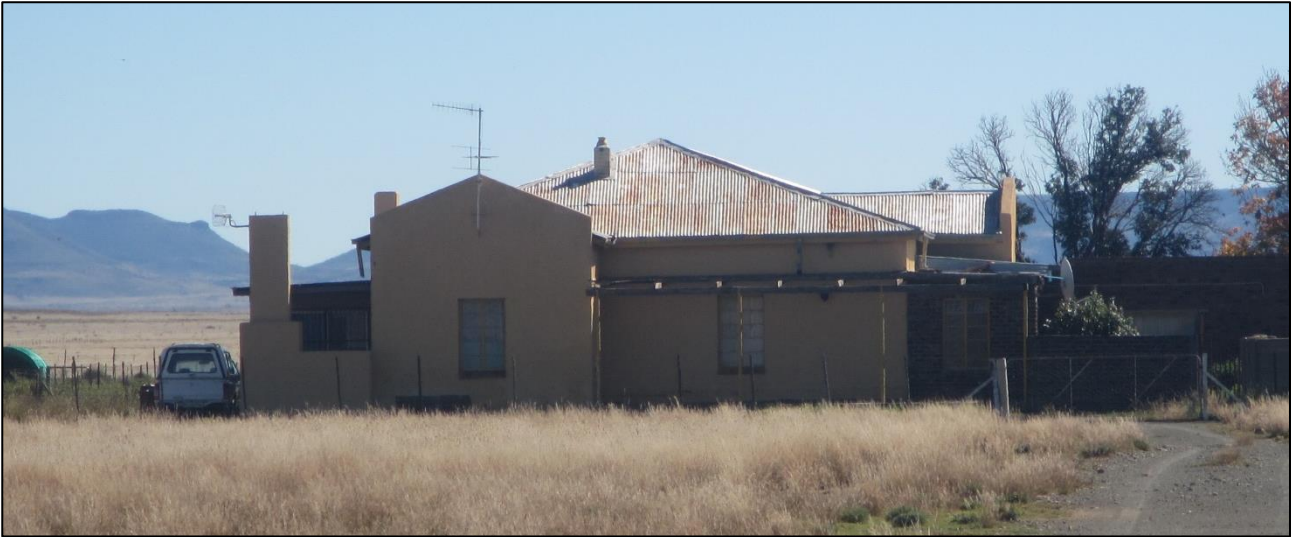
**Figure 28:** Farmhouse at waypoint 932.

The only historical resources seen near the study area are two farmhouses. One lies along a road in the central part of the study area on Portion 5 of the farm De Aar 180 and looks to date to the early-mid-20<sup>th</sup> century (Figure 28). The other lies on the remainder of Vetlaagte 4 and, although not visited, looks like an early 20<sup>th</sup> century house (Figure 29). The latter was recorded by Kruger (2012) as HP01.

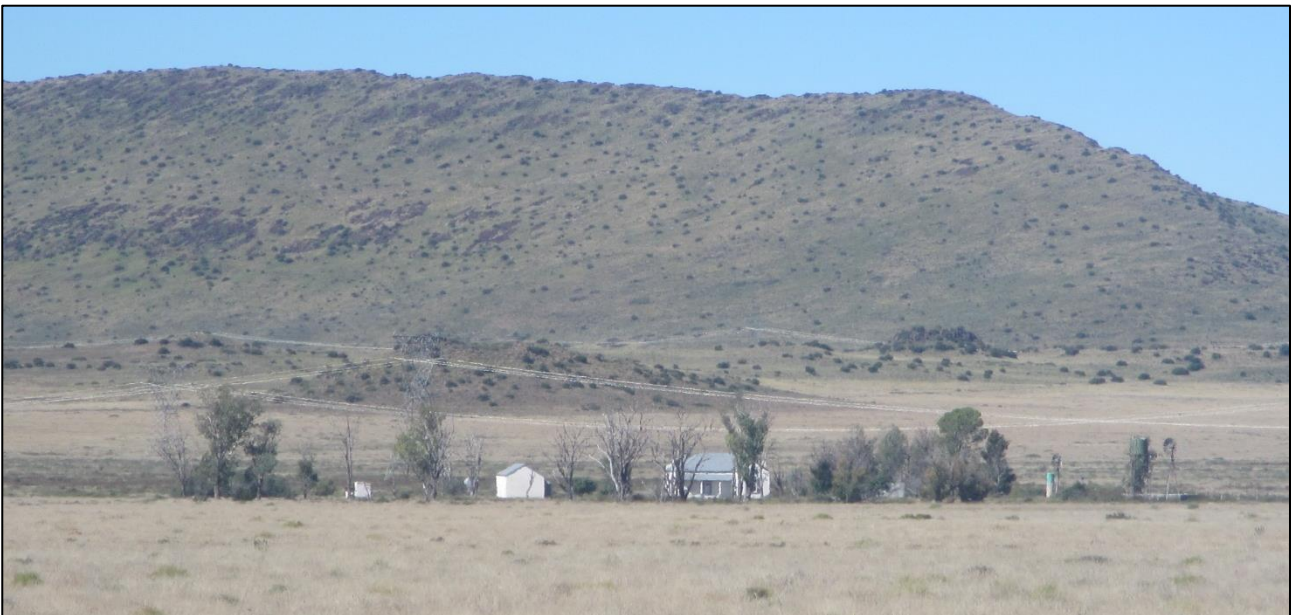
**Figure 29:** Farmhouse at waypoint 939.
