**Phase 1 Heritage Impact Assessment for the Proposed
Development of the ERPM Mine Village, Boksburg, Gauteng.**

VERSION 1.1

23 MAY 2012

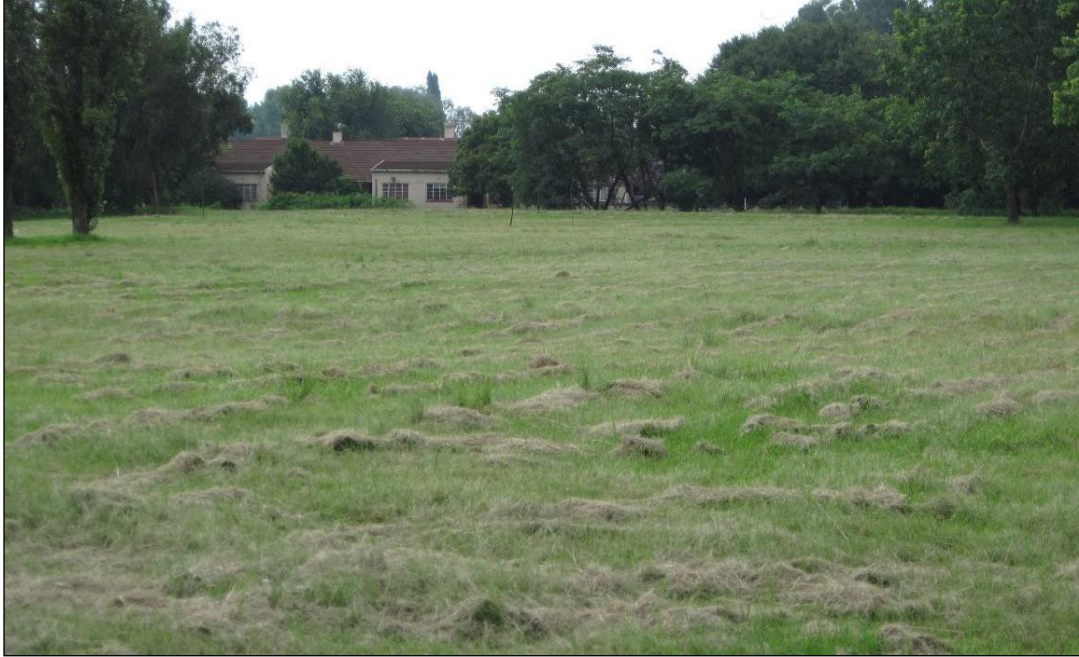
Figure 5: A section of the old married quarters is visible in the back with the open space in front.

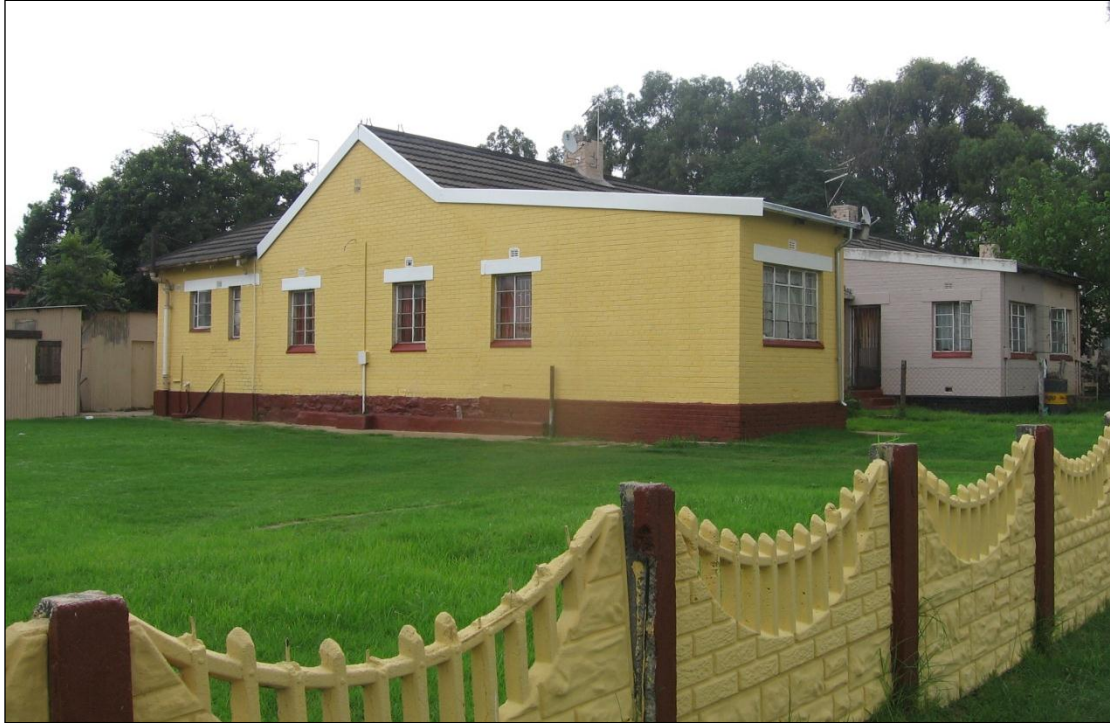
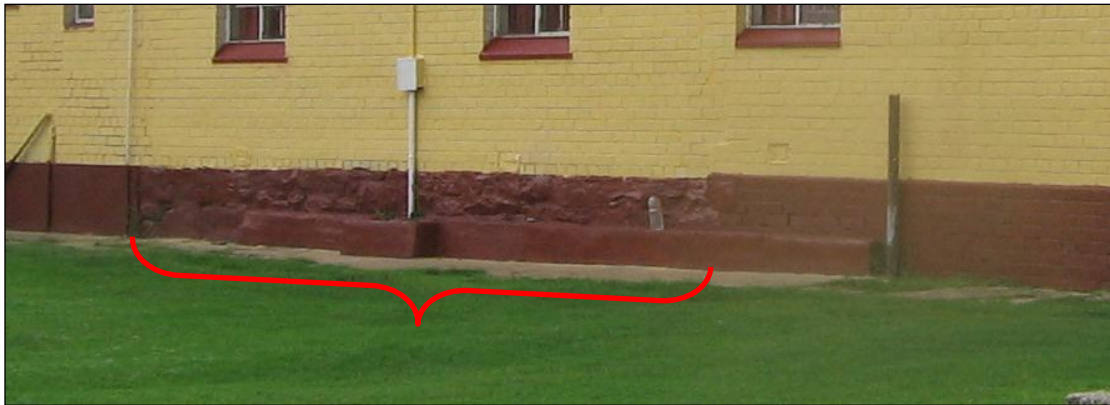
The original units had stone foundations with a plinth elevated to a height of about 500-600mm above the ground and were probably not painted at first. During the later extensions the same architectural solution was discarded in favour of more commercial foundations that were subterranean.

Figure 8: Side elevation of one of the existing buildings from the old married quarters. The enlarged image (bottom) clearly shows the original stone foundation. The stone foundation is marked in red.

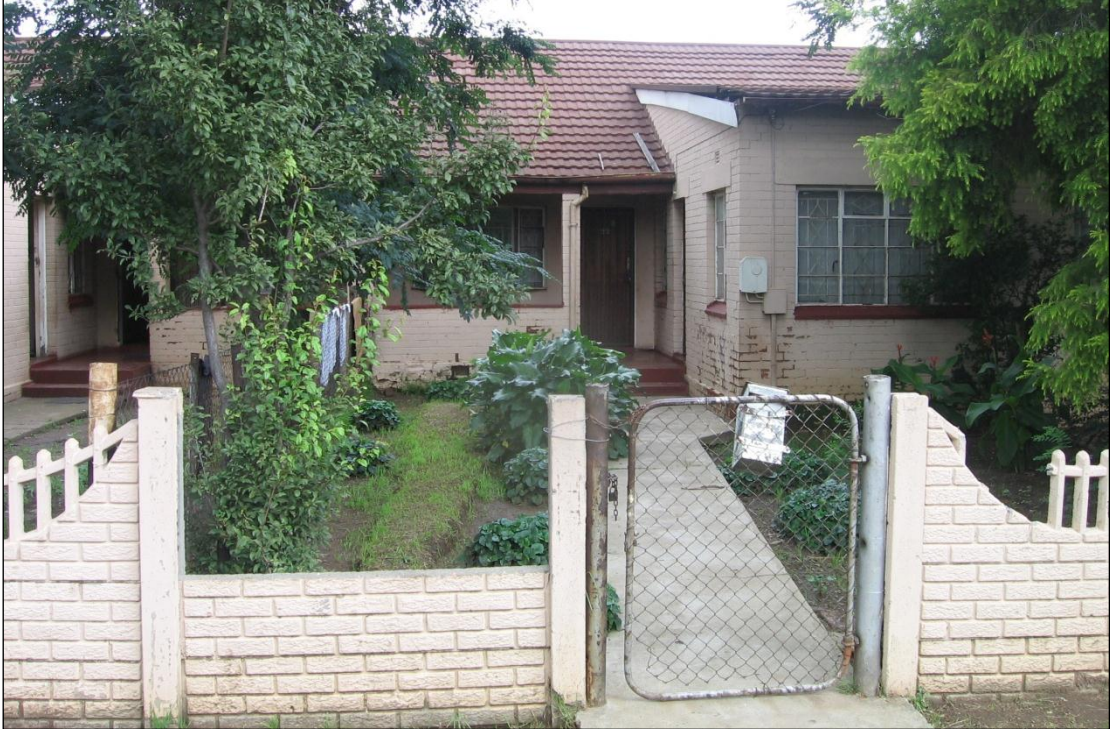
Figure 9: The front elevation and garden of one of the existing units from the old married quarters. This unit is number 22.

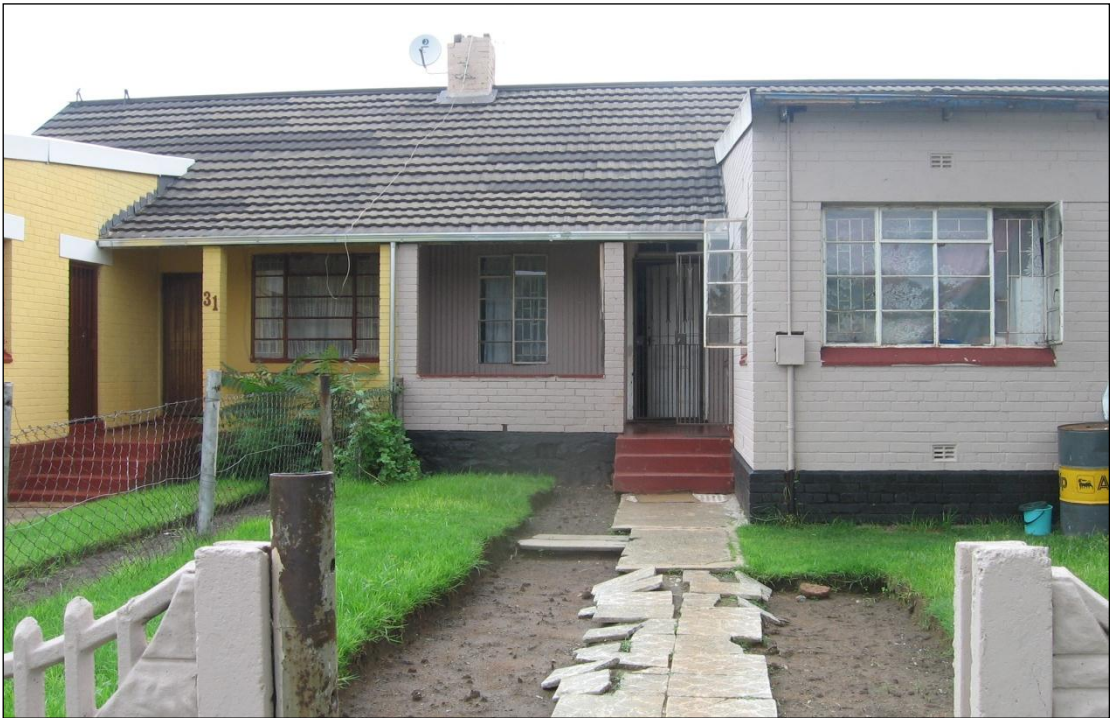
Figure 10: The front elevation and garden of another one of the existing units from the old married quarters. This unit is number 32, with unit 31 to the left.

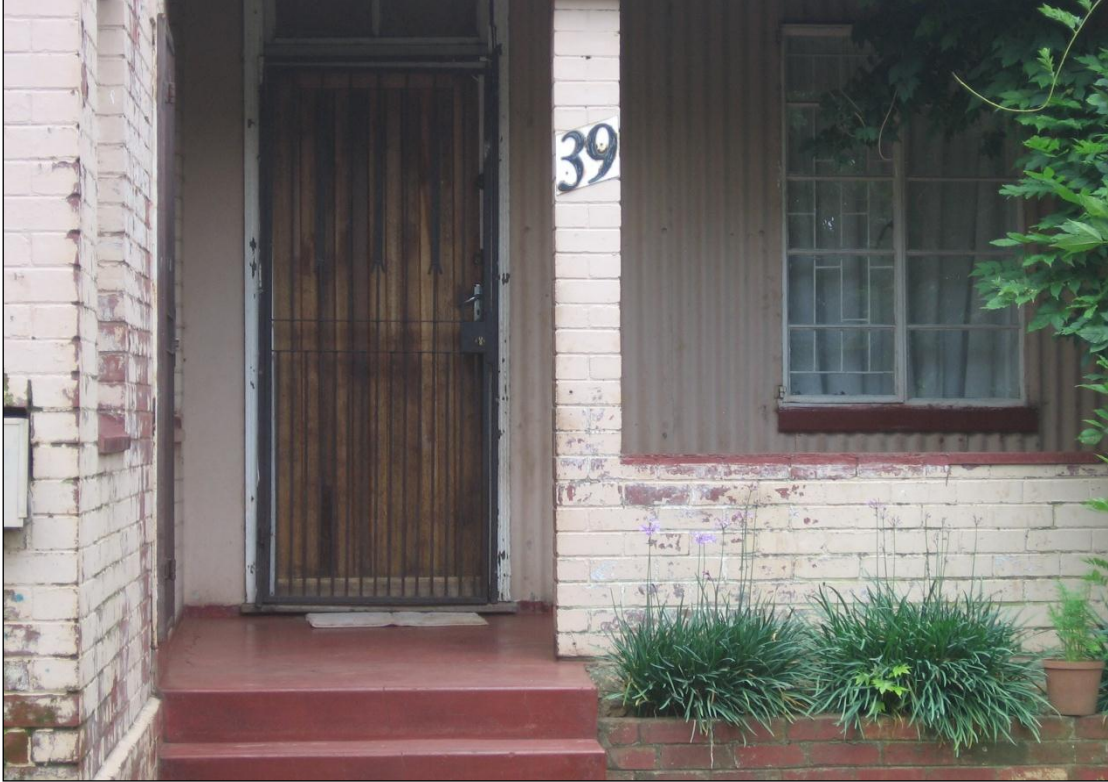
Some of the units found to the west of Rondebult Road still have corrugated sheets on its walls. The use of corrugated iron at first is supported by an archival map which depicts the old married quarters as brick-lined iron buildings. At a later stage the walls of the dwellings were constructed with face brick and left unpainted. This rule of thumb was altered over time and all the buildings were covered with paint without plastering the original brick exterior walling.

Figure 11: The front veranda of one of the existing units from the old married quarters. This unit is number 39. The corrugated iron sheeting on the walling next to the door can clearly be seen. As discussed elsewhere the corrugated sheeting must have formed part of the original structure.

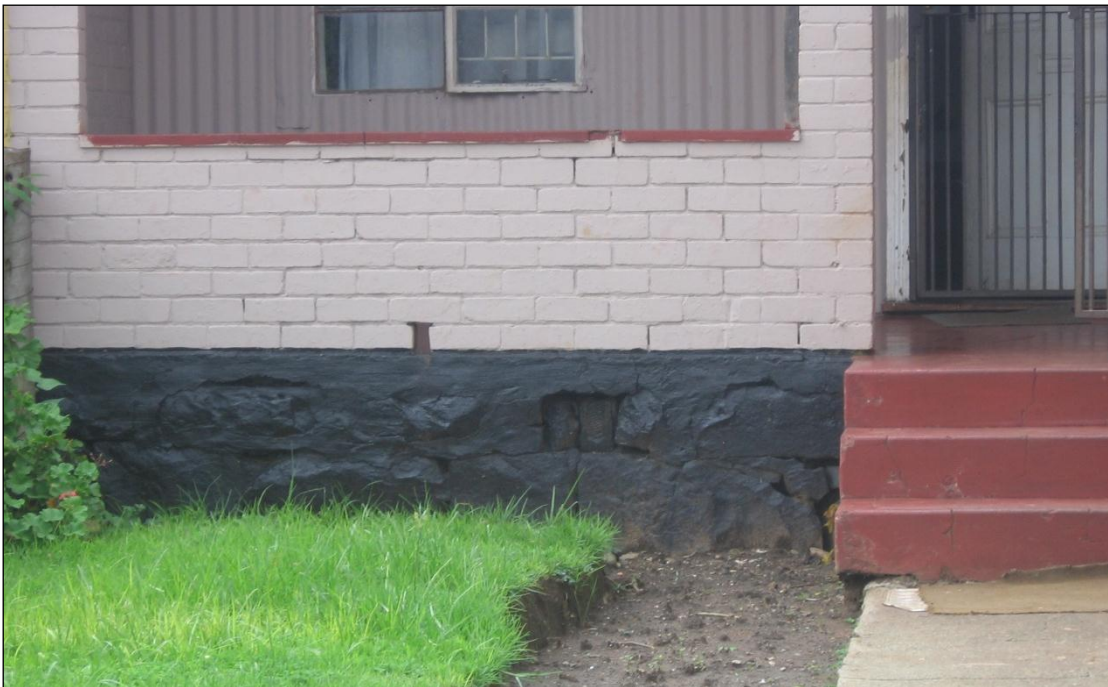
Figure 12: A section of the front elevation of another existing unit from the old married quarters. The original structure's corrugated iron sheeting and stone foundation can clearly be seen.

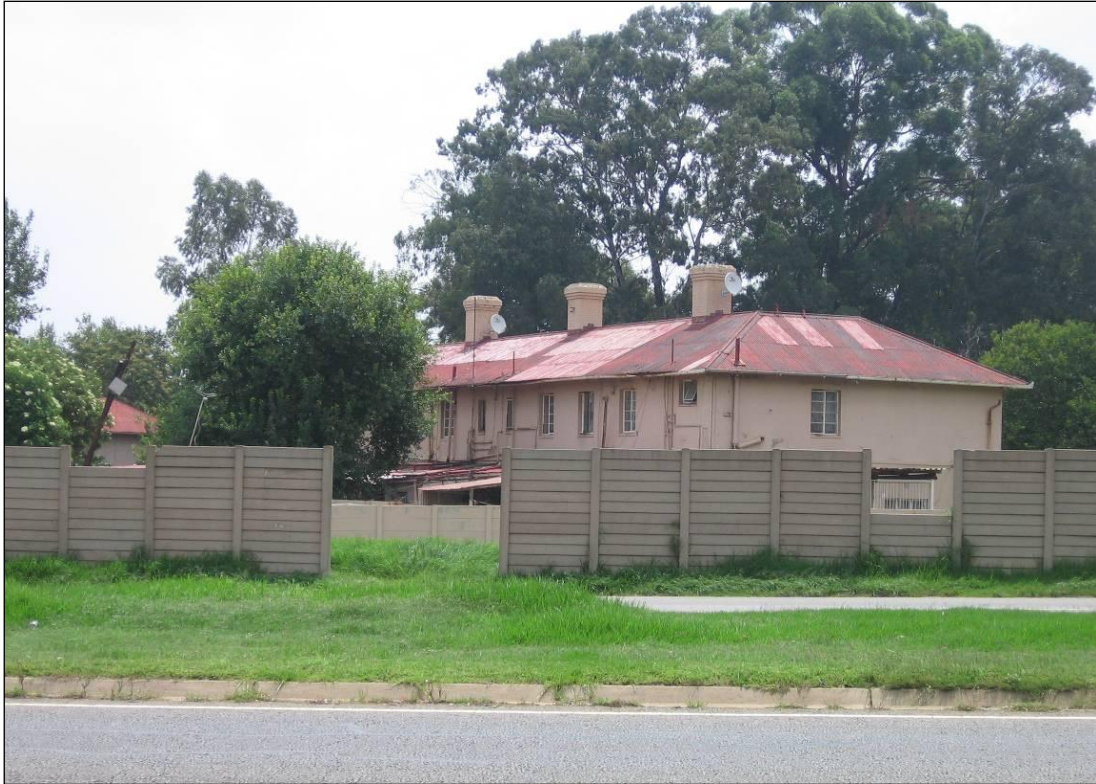
Figure 16: View from Rondebult Road towards the southern elevation (back elevation) of one of terrace buildings located to the west of the aforementioned road.

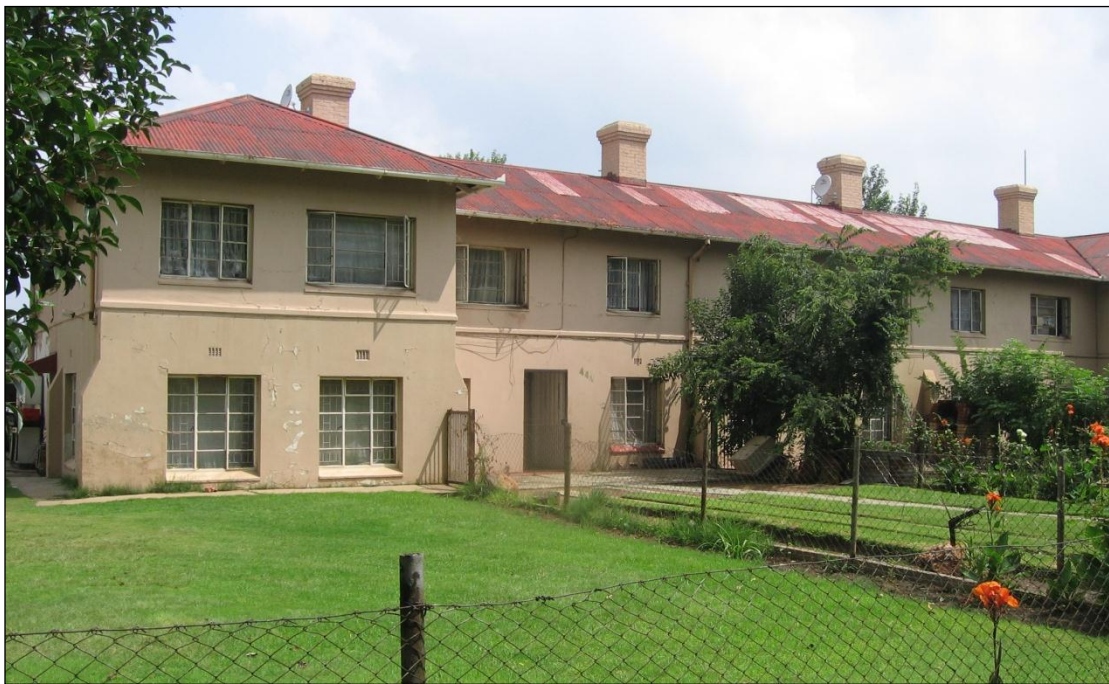
Figure 17: General view of the northern elevation of one of the units indicating the new steel frame windows that replaced the casement windows of Baker.

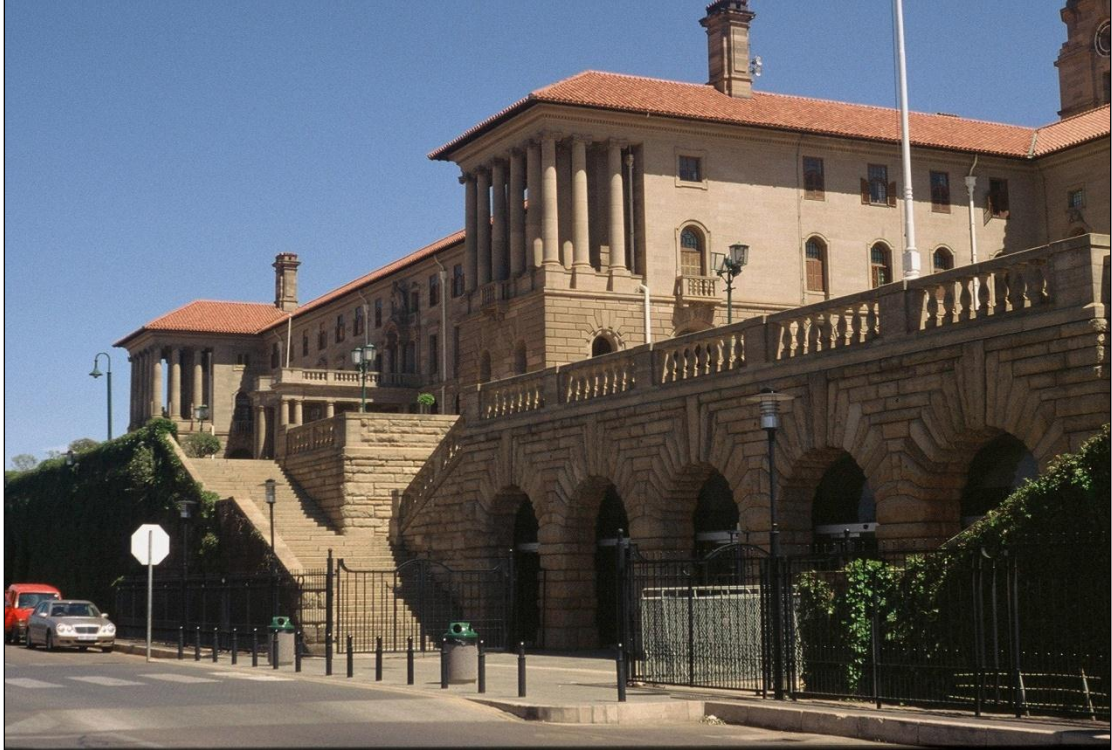
Figure 18: A similar pattern emerges in Baker's work with the simple rectangular floor plan pushed backwards by adding a pavilion at each side of the front elevation - here applied at the Union Buildings but also applied at the ERPM housing units in minute scale.

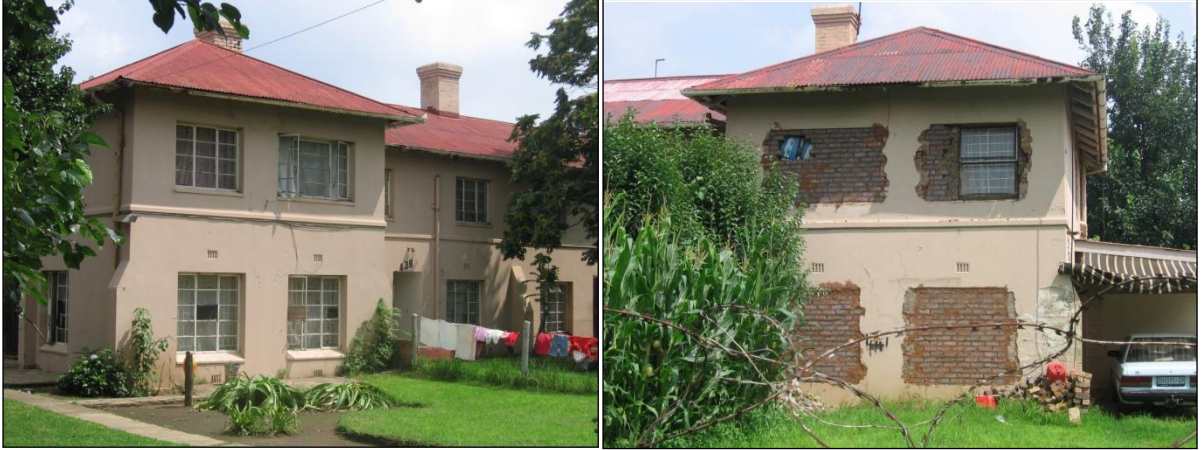
Figure 20: Second generation steel frame windows (left) are replaced by the current residents.

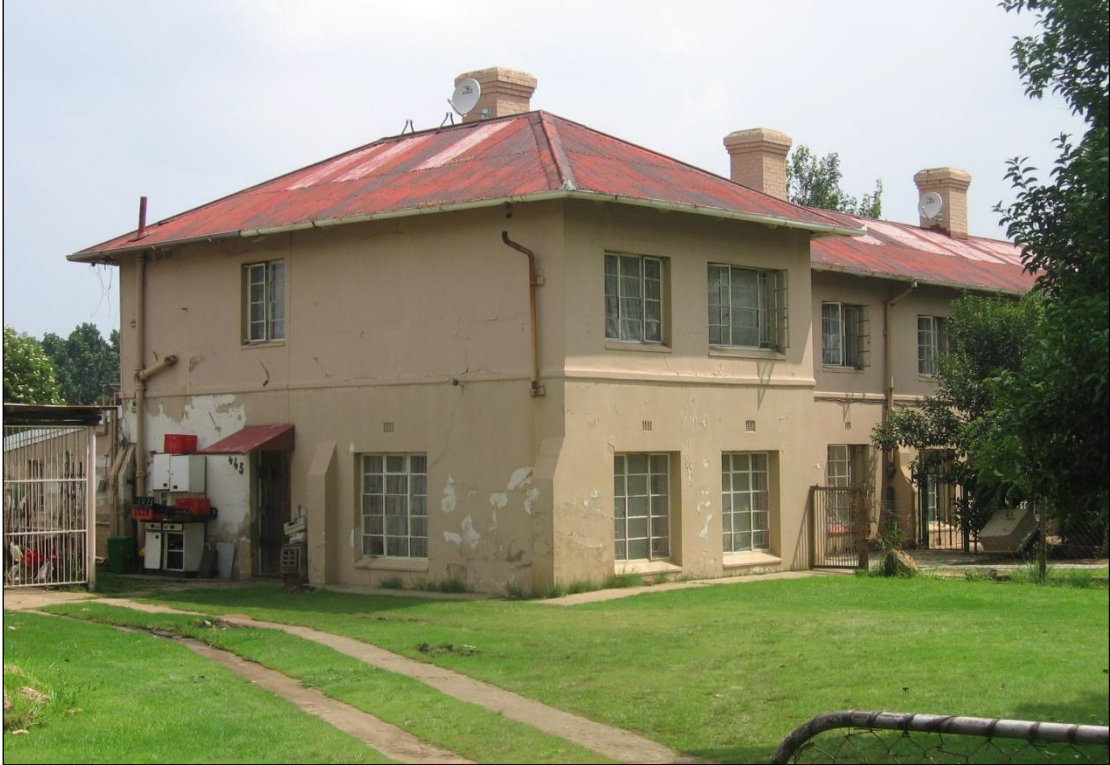
Figure 22: Corner elevation of one of the terrace buildings at ERPm with a slightly protruding pavilion and small buttressing element at its corner.

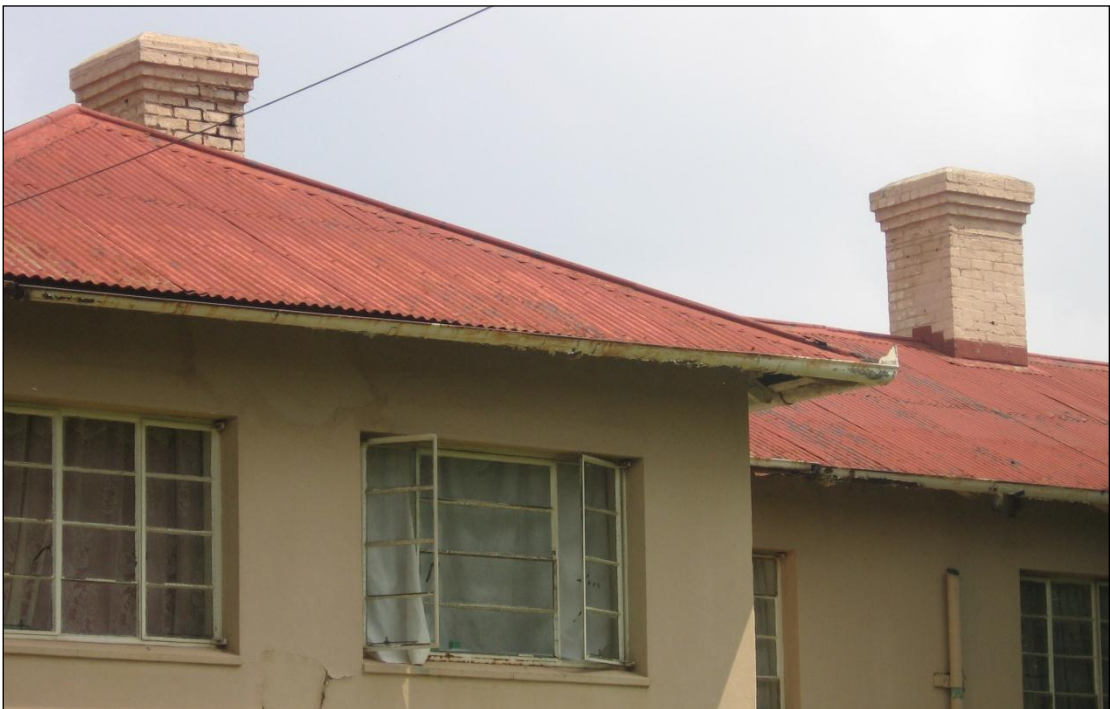
Radford also mentioned the occurrence of the chimneys as they tend to be a trademark element on the terrace and single storey units. They were used both as functional and aesthetic elements in order to fit the balance and symmetry of the design and to add some aesthetic value to an otherwise functional element.

Figure 23: Simple though stylish chimneys as seen at the terrace housing from ERPm are typical of the design of the architectural firm of Baker & Masey.

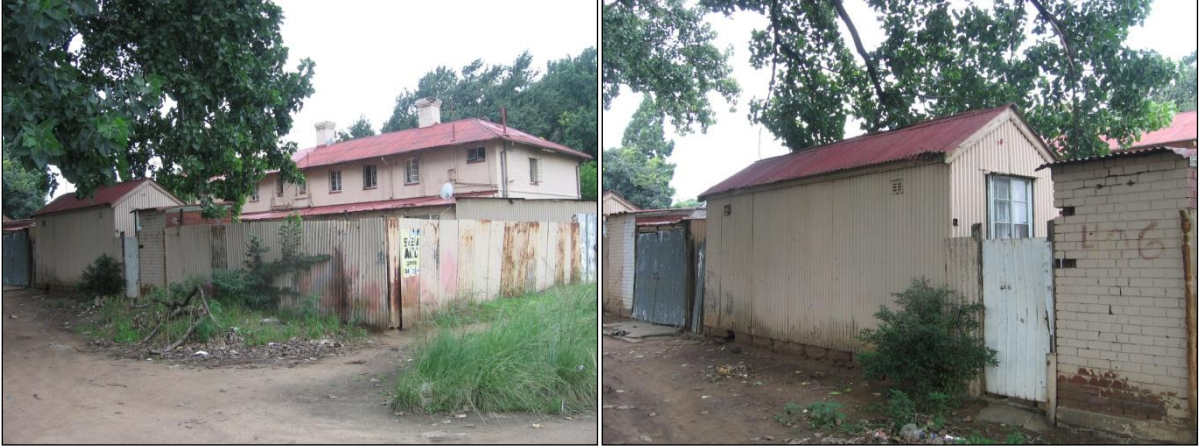
Figure 25: Exterior of backyard walling and small timber and iron outbuilding.

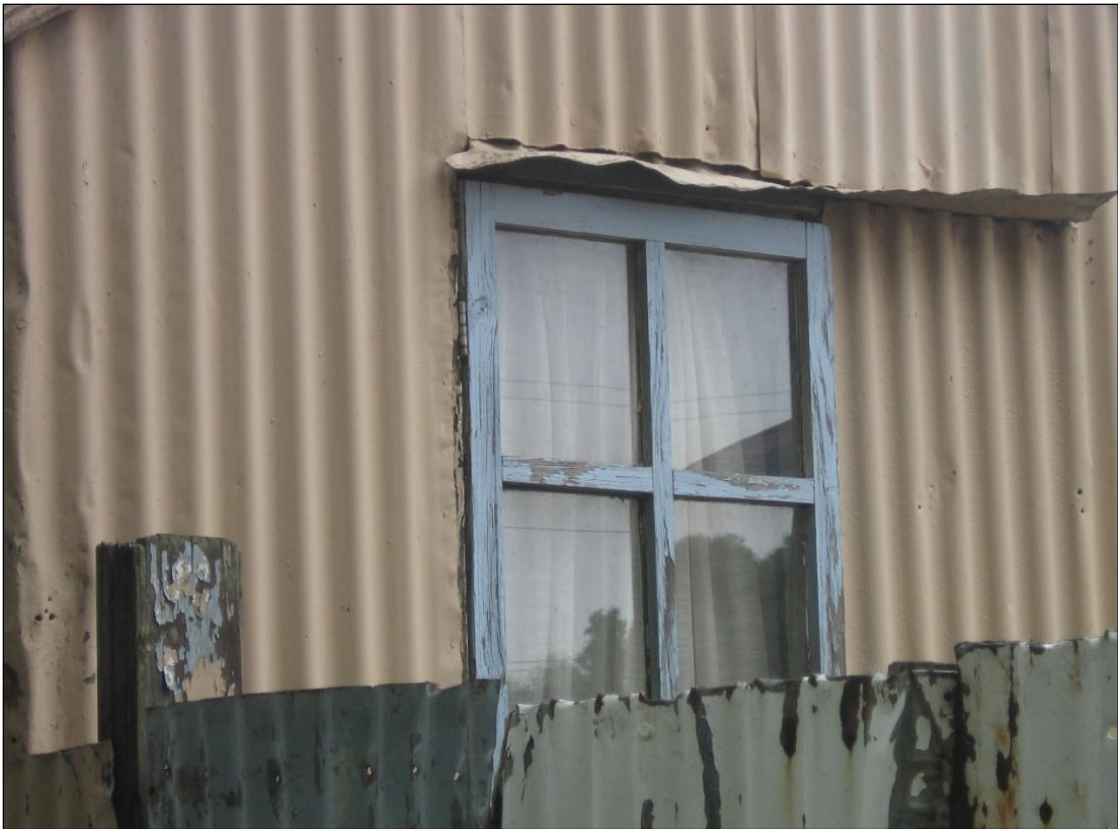
Figure 26: The original wooden window from an old corrugated iron outbuilding.

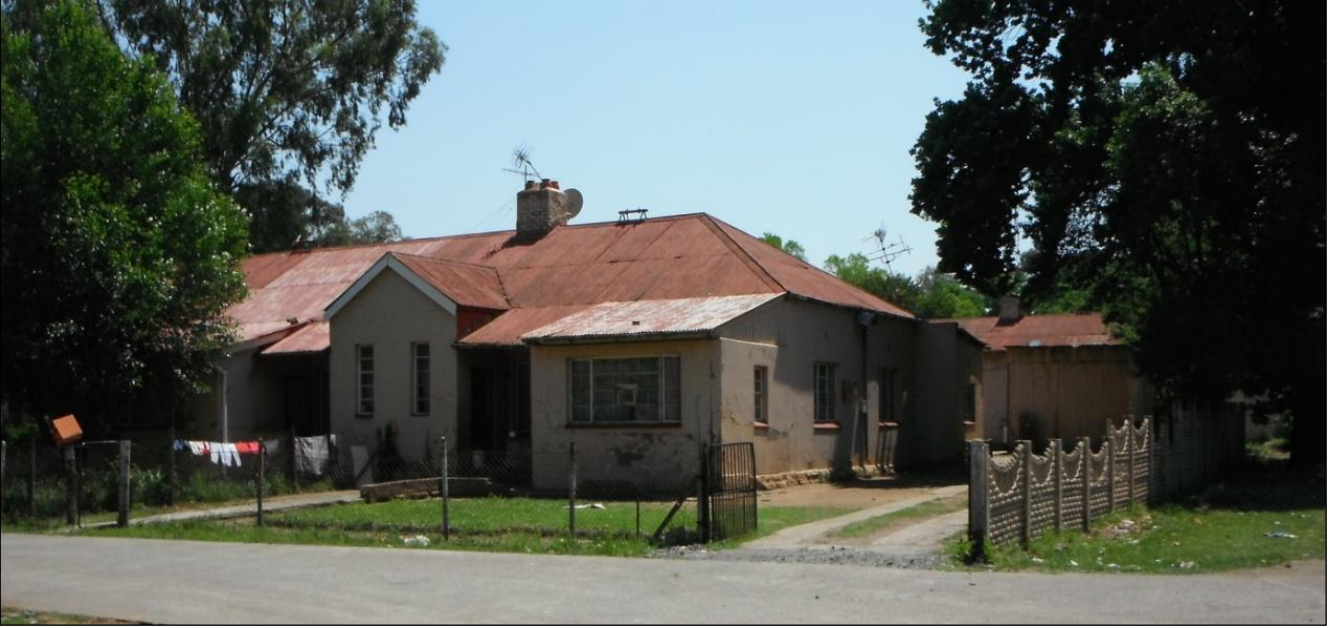
Figure 28: General view of the front and side facades of the first type of dwelling building in Precinct 2.

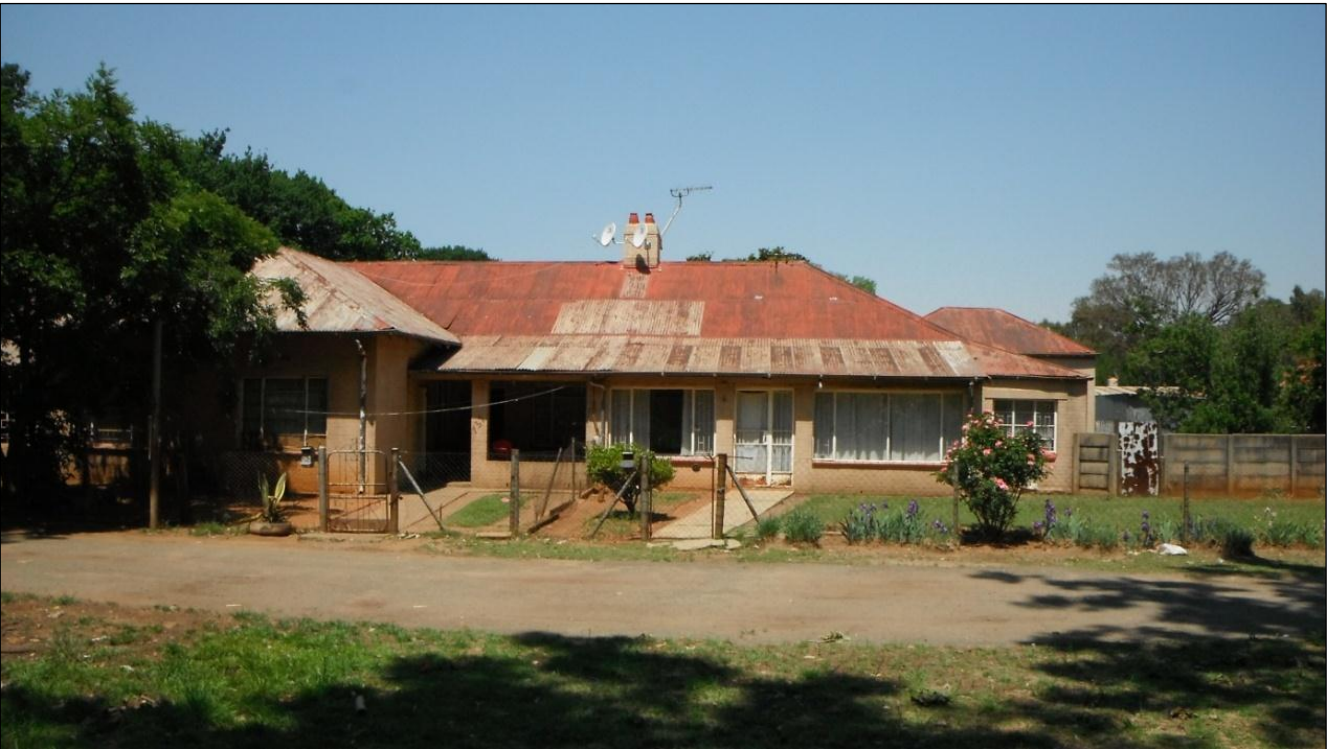
Figure 29: General view of the front and façade of the second type of dwelling building in Precinct 2.

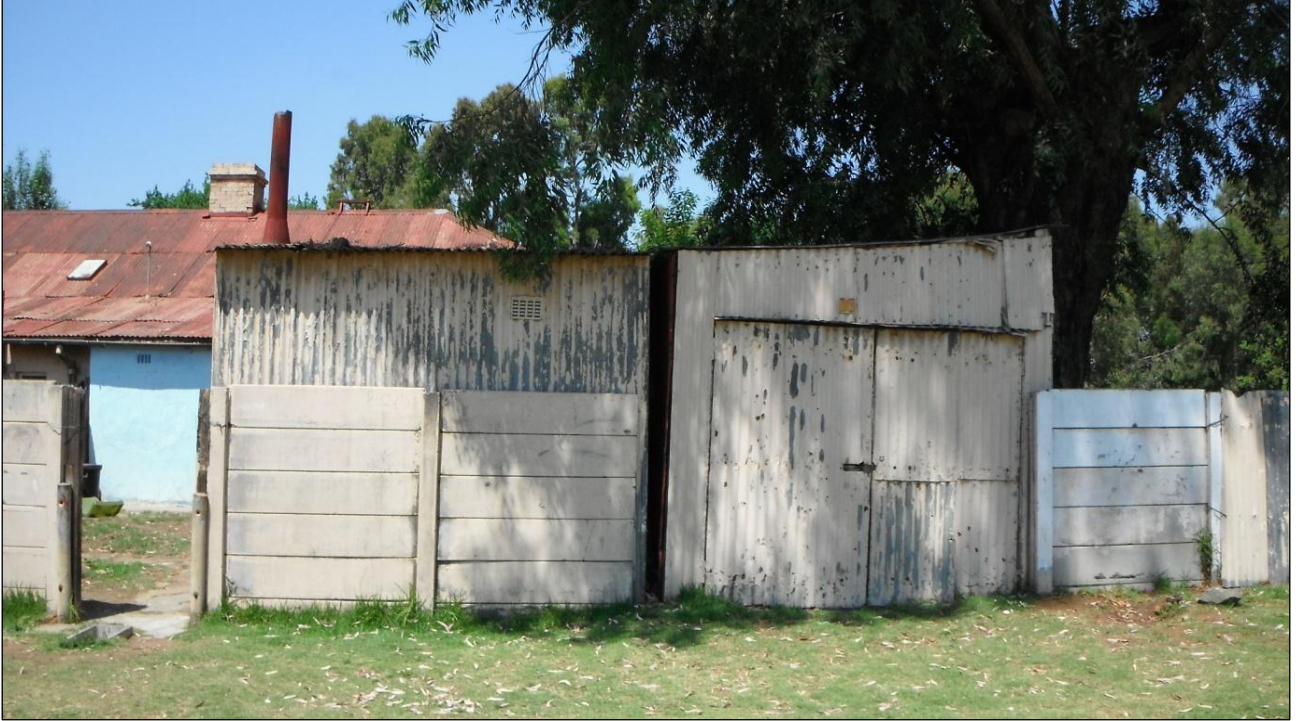
Figure 30: Some of the outbuildings from Precinct 2.

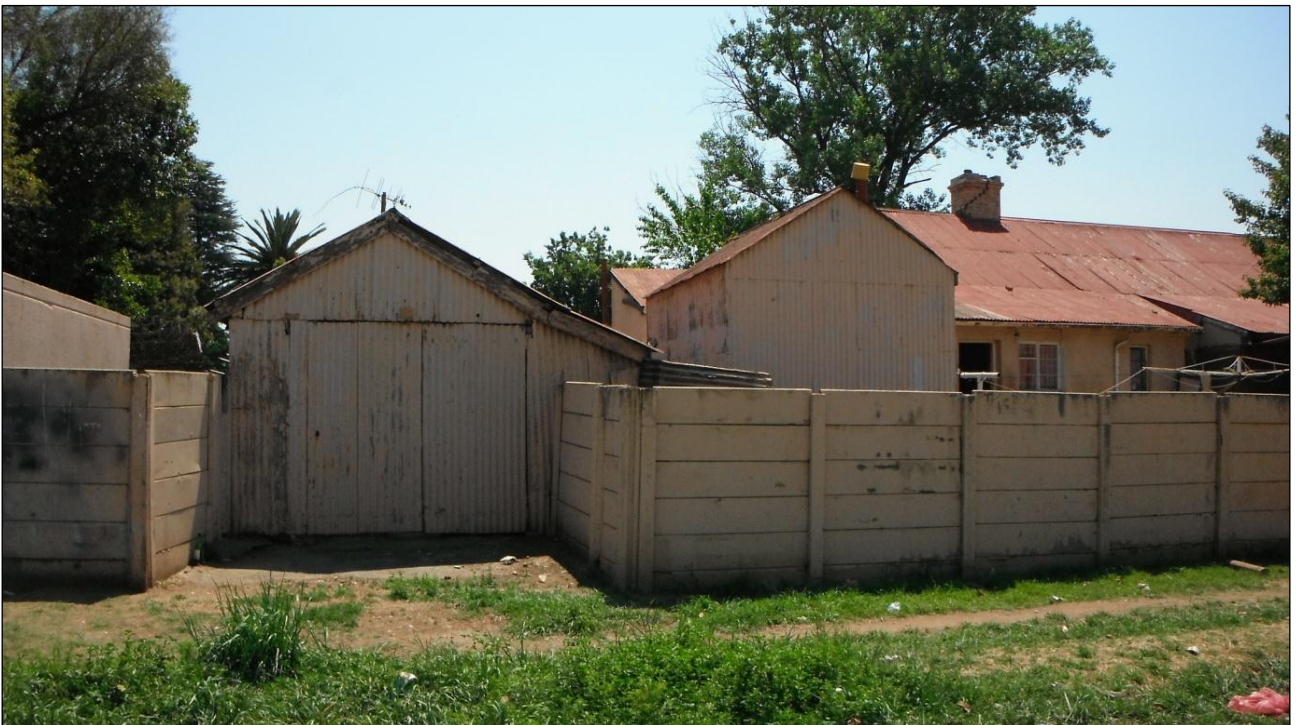
Figure 31: Another view of more outbuildings from Precinct 2.

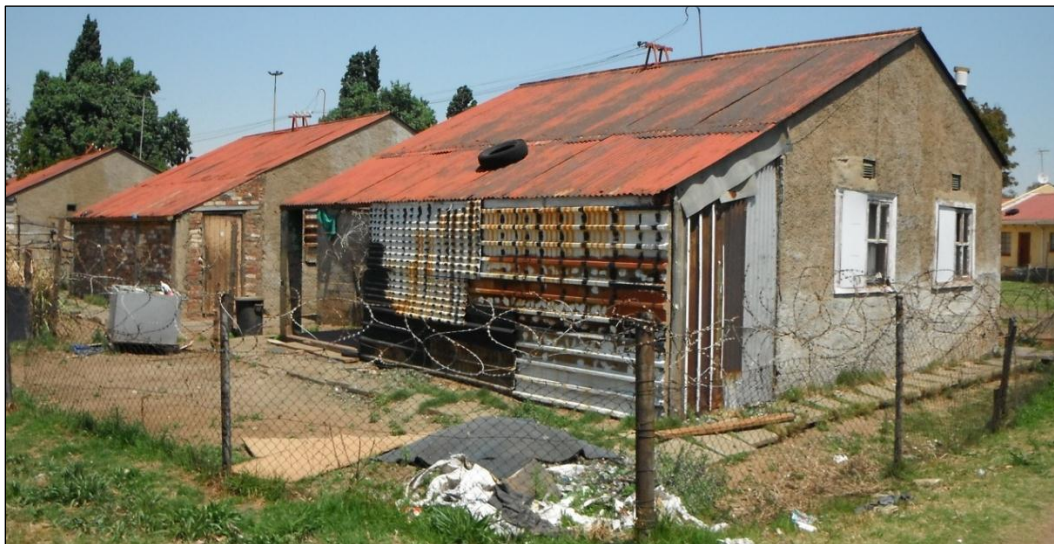
Figure 33:

One of the two dwelling types representing some of the earliest buildings from Precinct 3. This type comprises a corrugated iron core over which a cement mixture was plastered.

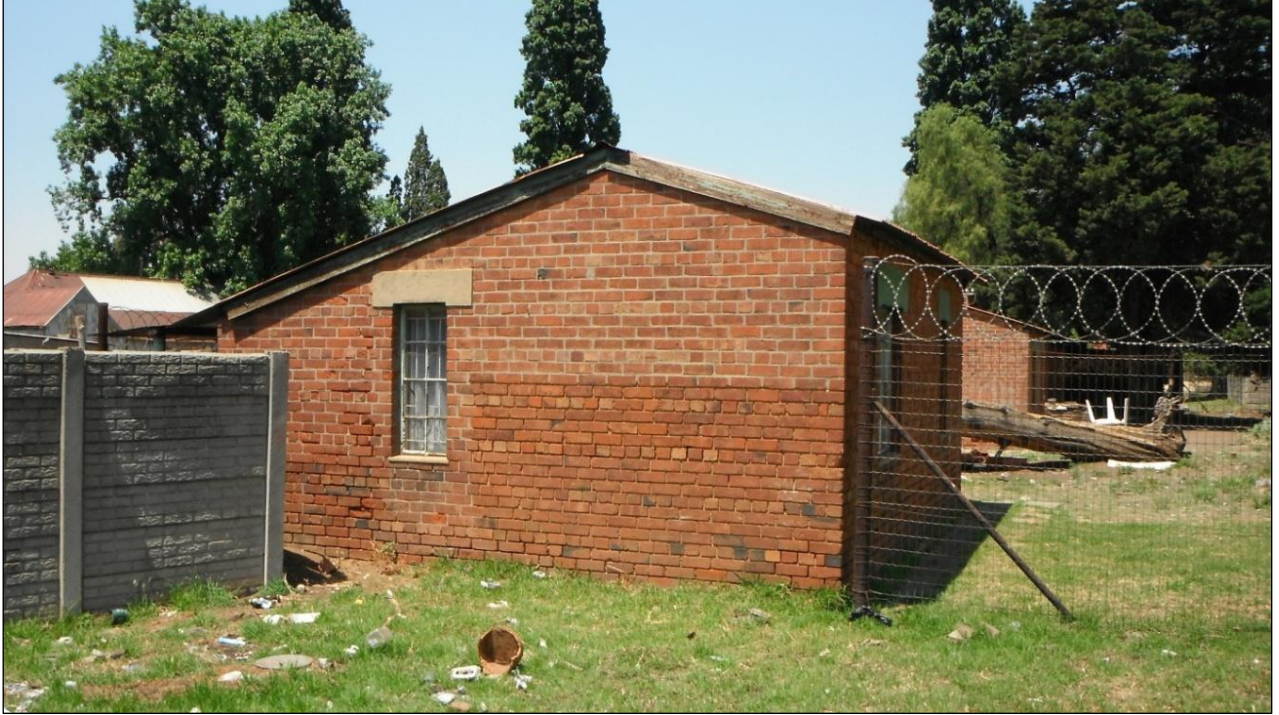
Figure 34: One of the two dwelling types representing some of the earliest buildings from Precinct 3. This type comprises unplastered red face-brick walls.

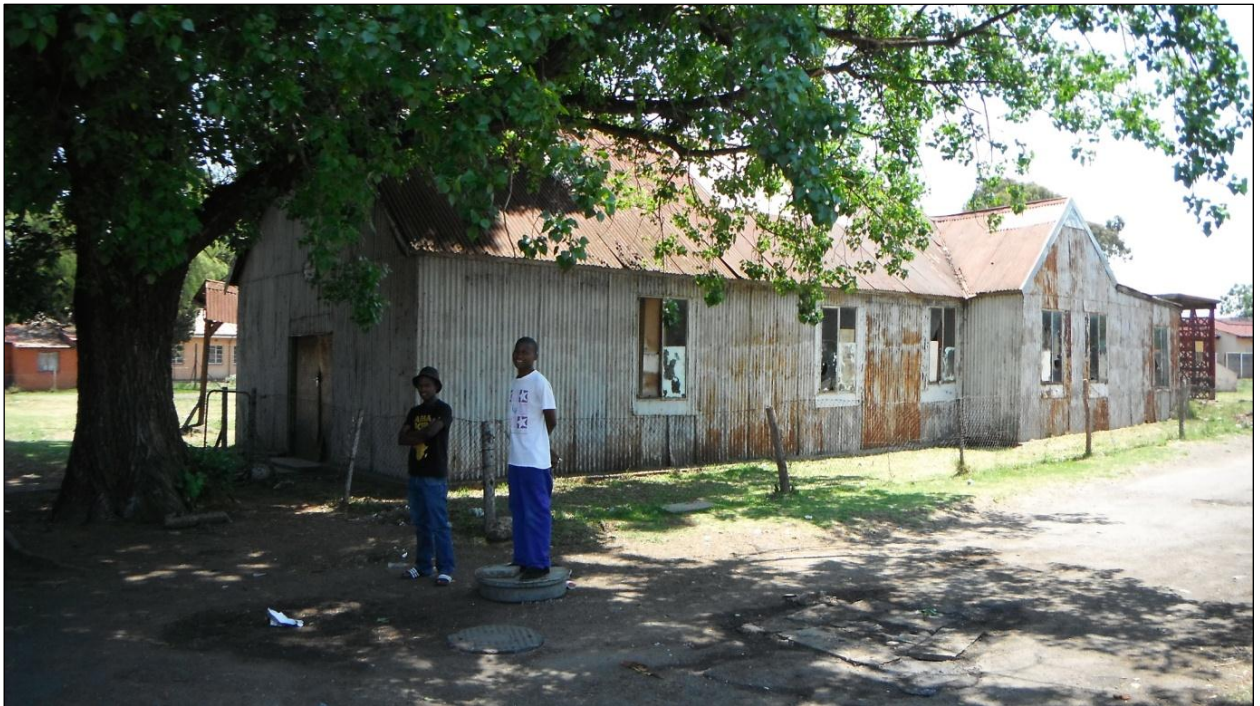
Figure 35: The Comet Methodist Church, which is also one of the earlier buildings from Precinct 3 and is certainly older than 60 years and may even be older than that.

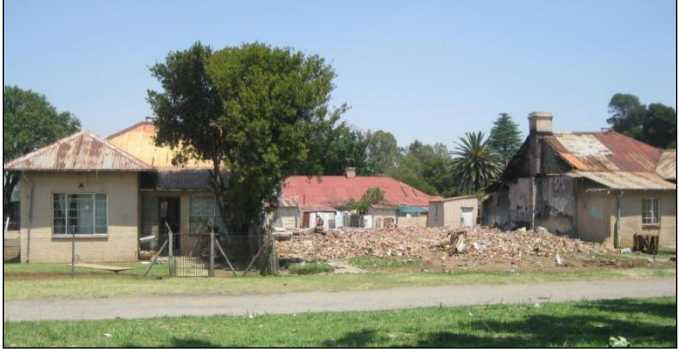
Nr	Type	Photograph	Rating
1.	<p>Single storey semi-detached dwelling units. These units were designed and built for the married white mine employees and their families.</p> <p>Five examples of this type were identified within the precinct.</p>

medium
2.	<p>Double storey semi-detached married quarters for white married staff, now inhabited by black tenants. These units were designed by the architectural firm of Baker & Masey.</p> <p>Eight examples of this type were identified within the precinct.</p>

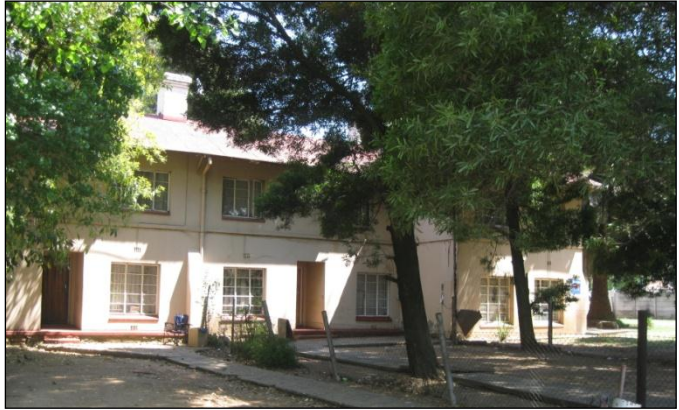
high

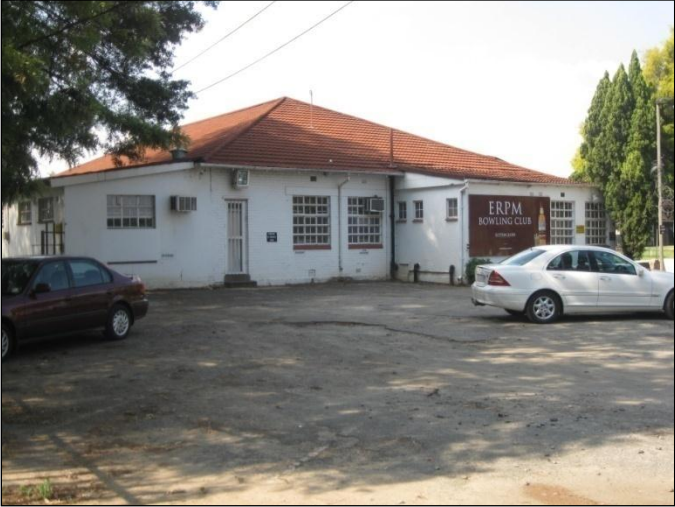
<p>3.</p>	<p>Club house and grounds that are still used for cricket and bowling and are secured from the remaining portion of the village by fences and electric gates.</p> <p>One example of this type was identified within the precinct.</p>

<p>medium</p>

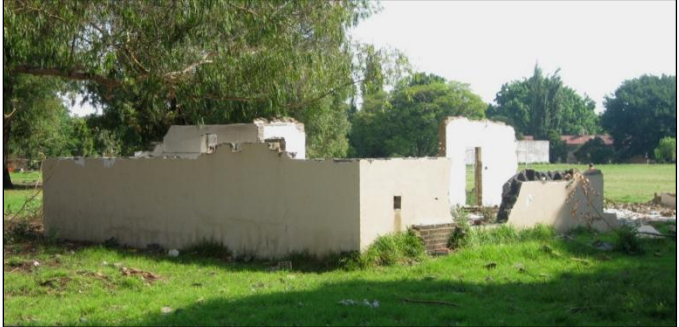
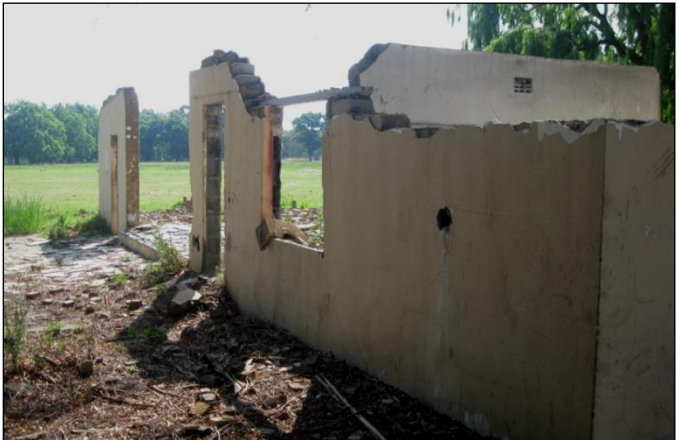
4.	<p>Ruins of ablution facilities located directly adjacent to the soccer field and clubhouse. All doors, windows as well as the roof have been removed and vandalized.</p> <p>One example of this type was identified within the precinct.</p>

low

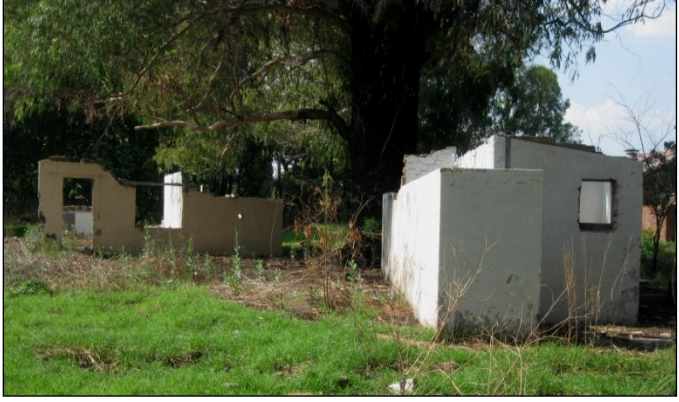
<p>A photograph showing the remains of a small, rectangular concrete structure. The walls are partially standing, but the roof and openings are missing. The structure is situated in a grassy area with trees in the background.</p>	<p>low</p>
<p>6.</p>	<p>Red face brick transformer building with cast concrete roof. The building is still used for this purpose.</p> <p>One example of this type was identified within the precinct.</p>

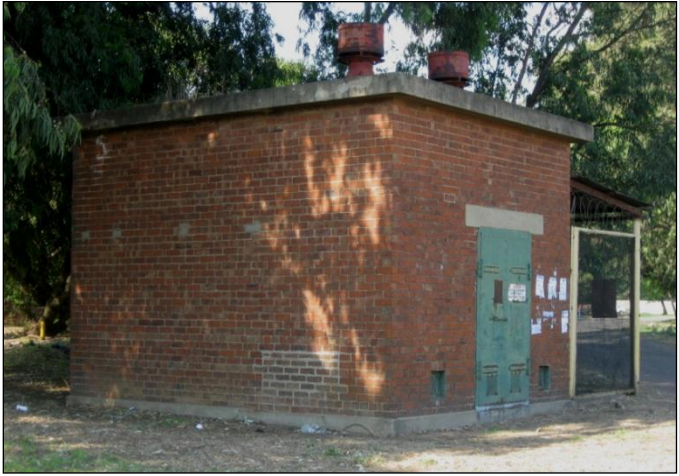
<p>A photograph of a small, square brick building with a flat concrete roof. The walls are made of red bricks. There is a green door on the side and a small window. The building is surrounded by trees and a fence.</p>	<p>low</p>

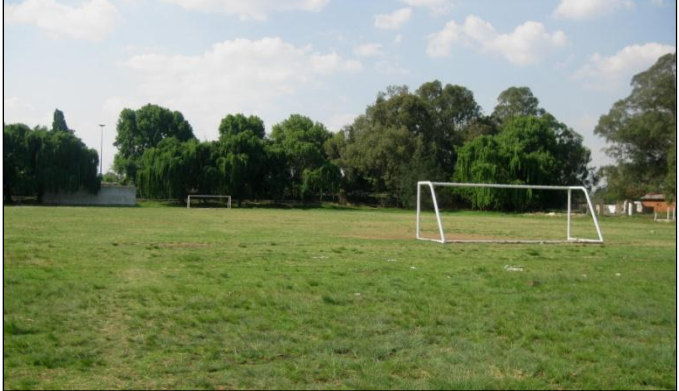
<p>7.</p>	<p>Original soccer field still used by local residents of the village.</p> <p>One example of this type was identified within the precinct.</p>

<p>A wide-angle photograph of a large, open grassy field. In the foreground, there is a white soccer goal. The field is surrounded by trees and a fence in the background.</p>	<p>low</p>

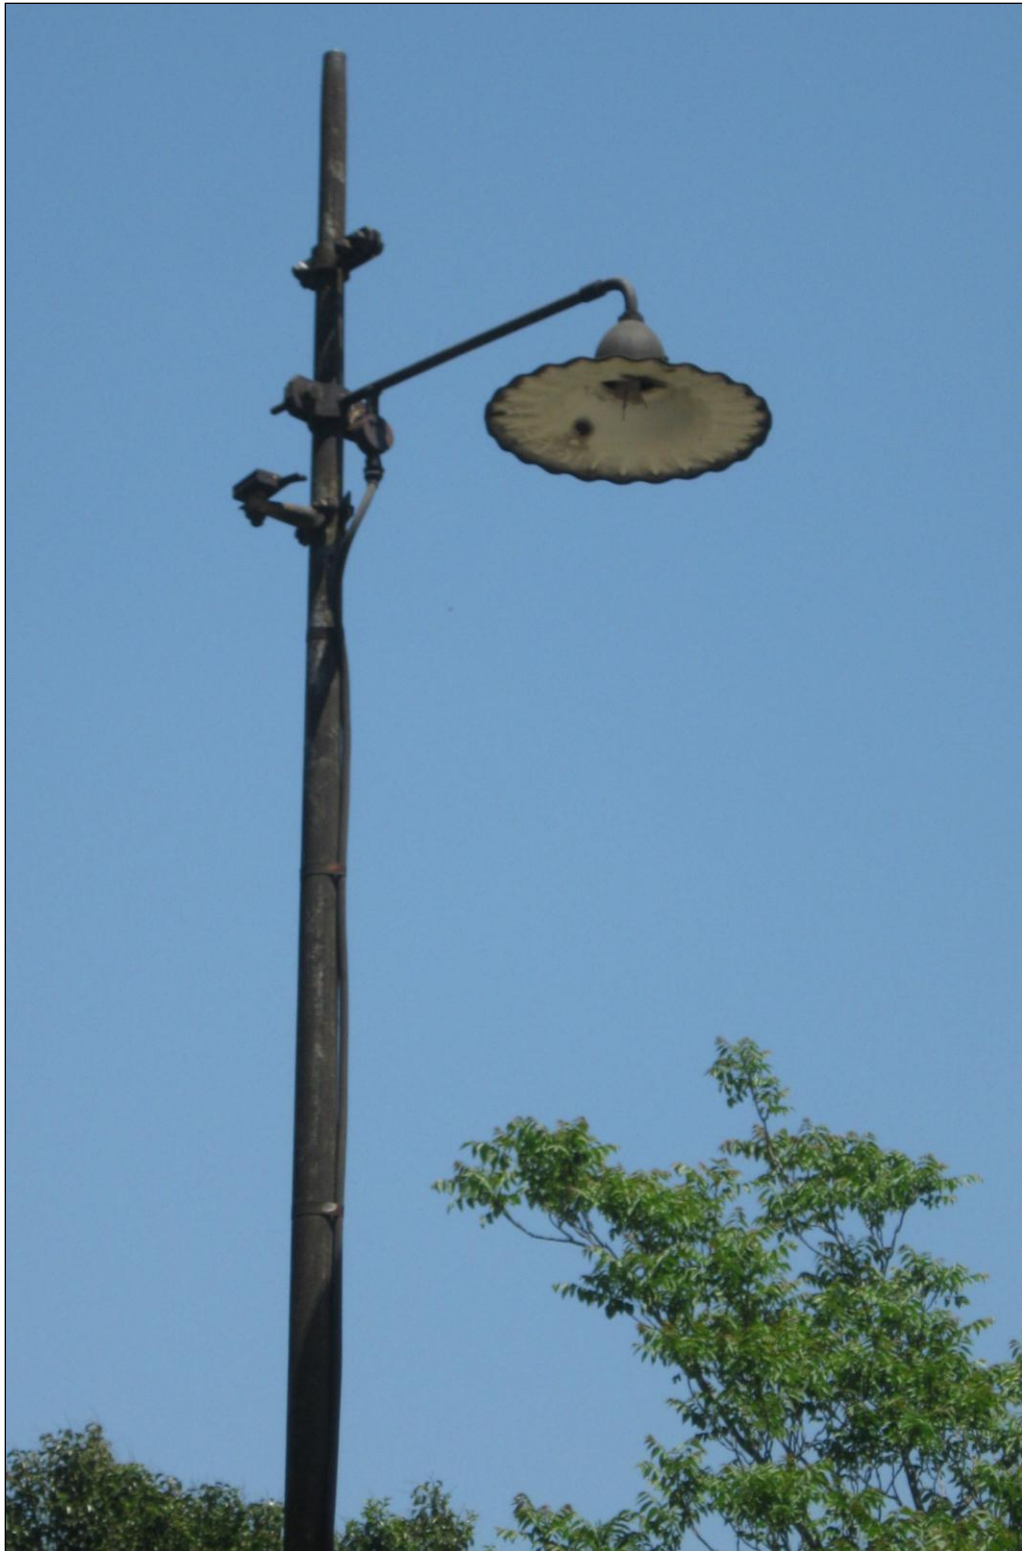
This is the only precinct where some of the older street lighting structures have remained in situ. Refer Figure 37 for a photograph of one of the remaining street lamps. This is a unique occurrence as most mining villages have been stripped of this type of service providing installations.

Figure 43: One of the old street lamps still preserved in Precinct 1.
