**Phase 1 Heritage Impact Assessment for the Proposed
Development of the ERPM Mine Village, Boksburg, Gauteng.**

VERSION 1.1

23 MAY 2012

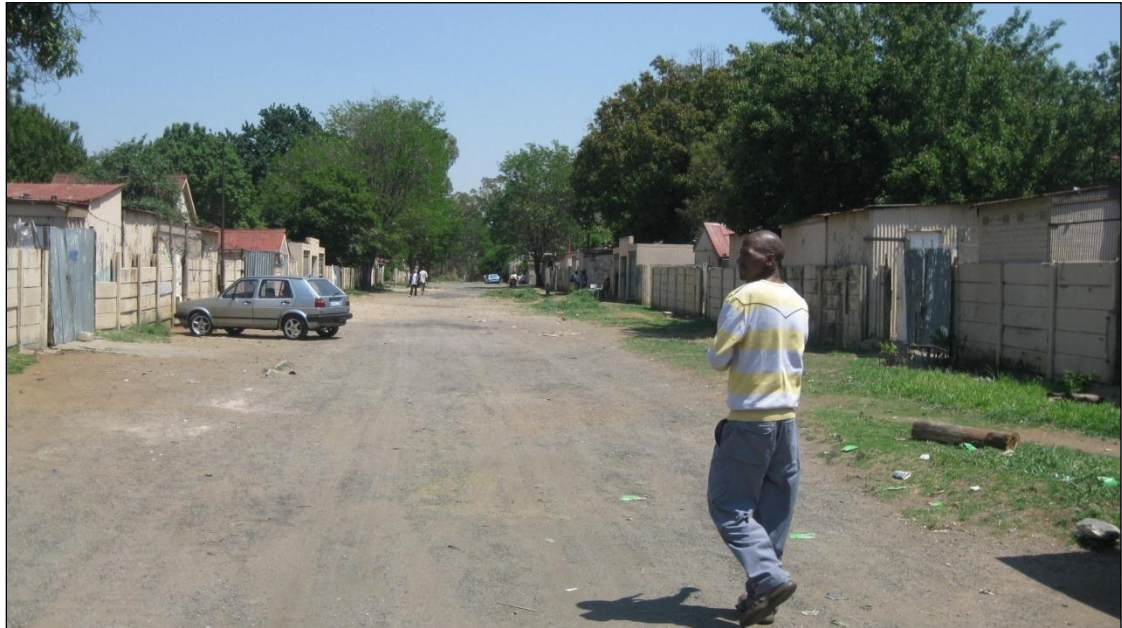
Figure 44: General view along service street running between backyards of residential units.

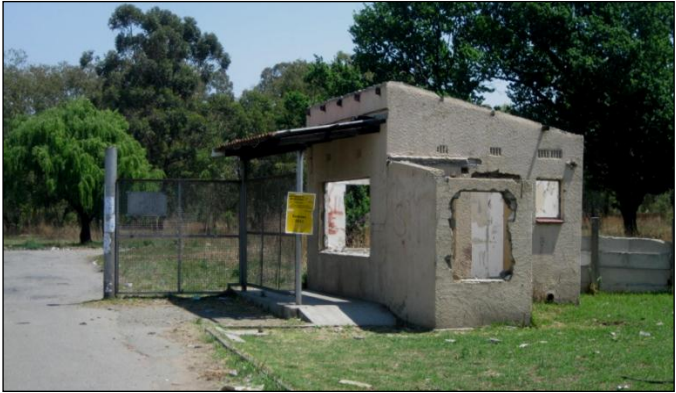
Nr	Type	Photograph	Rating
1.	<p>Old entrance building used as control point for residents leaving and entering this section of the housing complex. Constructed with plastered brick with flat corrugated iron roof – now vandalized with all window and door frames removed. The building is not used anymore.</p> <p>One example of this type was identified within the precinct.</p>

low

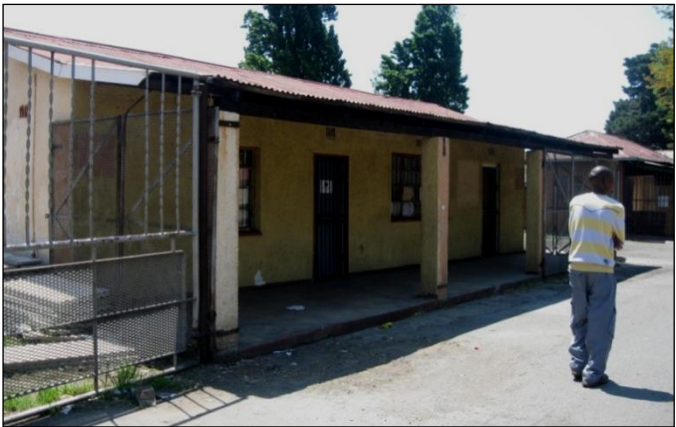
2.	<p>Single storey building resembling the general characteristics of a small shop with verandah supported by plastered brick columns. The building is constructed with plastered brick with low pitch corrugated iron roof.</p> <p>One example of this type was identified within the precinct.</p>

low

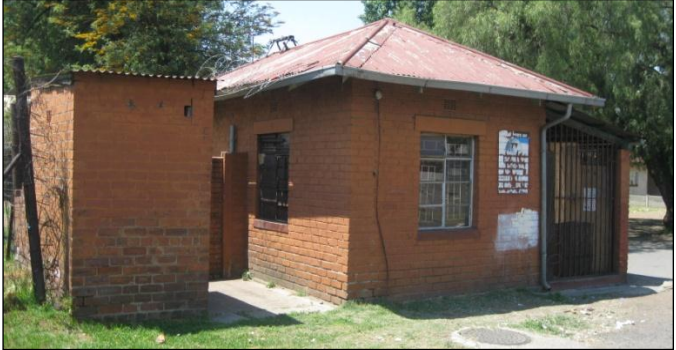
3.	<p>Single storey building with hipped corrugated iron roof used as annex to the small shop building across the street. The building is locked but still intact. It is a plastered brick building with closed front stoep.</p> <p>One example of this type was identified within the precinct.</p>

low

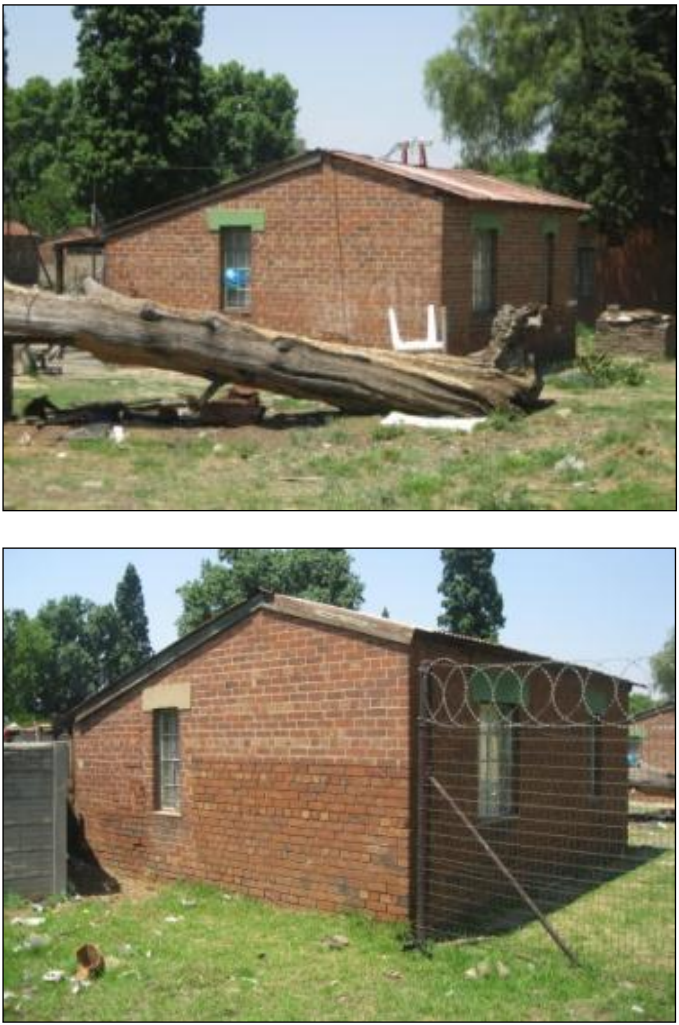
<p>4.</p>	<p>Single storey face brick building with low pitched corrugated iron roof forming part of the school grounds. The original function is unknown but could have been used as a tuck shop or office.</p> <p>Three examples of this type were identified within the precinct.</p>

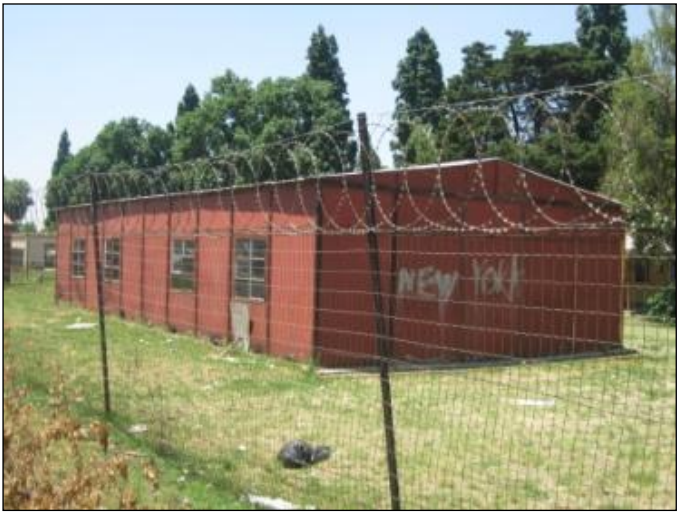
<p>low</p>
<p>5.</p>	<p>Pitched roof prefabricated asbestos cement building forming part of the school grounds.</p> <p>One example of this type was identified within the precinct.</p>

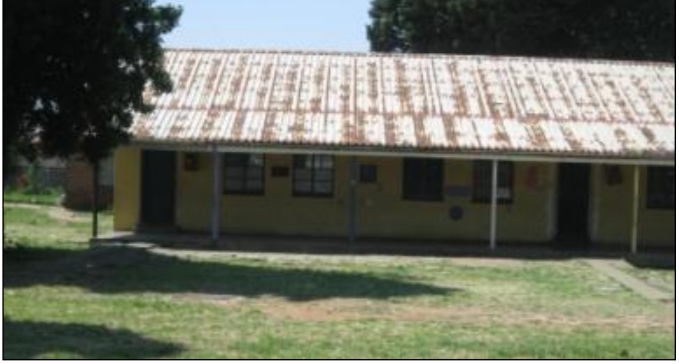
6.	<p>Single storey plastered brick school building with pitched saddle roof covered with corrugated iron sheets.</p> <p>One example of this type was identified within the precinct.</p>

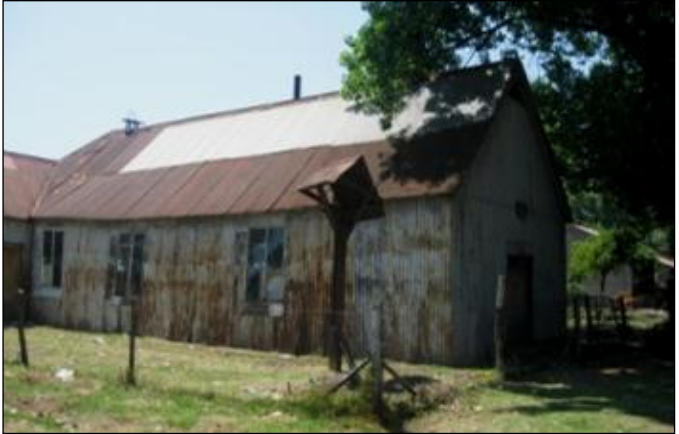
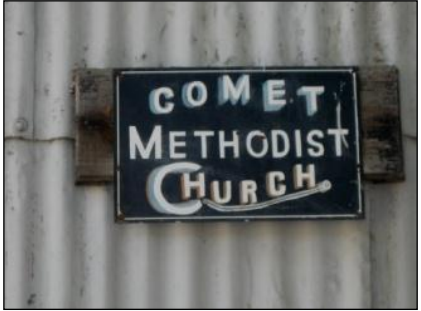
low
7.	<p>Comet Methodist Church building. It is a single storey timber frame with corrugated iron clad building facing north-south. Contrary to the other corrugated iron buildings in the village it has a forty-five degree pitched corrugated roof.</p> <p>The remains of a small timber structure originally used for the church bell is still in situ but the bell has since been removed.</p> <p>One example of this type was identified within the precinct.</p>

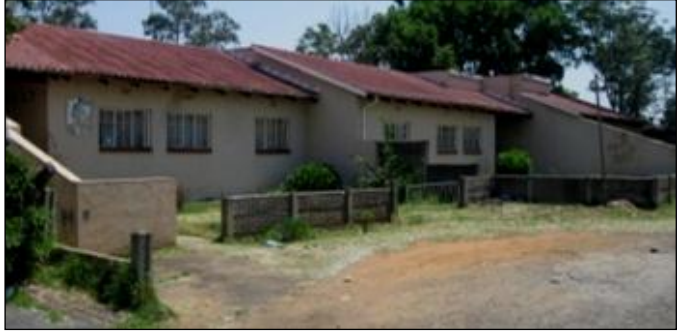
high
8.	<p>Semi-detached single storey dwelling units with staggered facades</p> <p>Twelve examples of this type were identified within the precinct.</p>

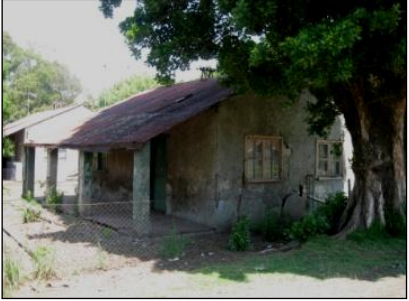
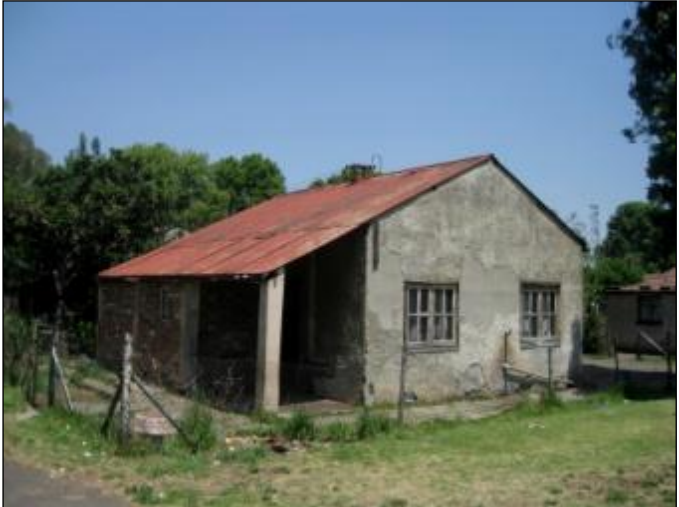
<p>9.</p>	<p>Semi-detached single storey dwelling units probably erected between 1985 and 1995.</p> <p>Nine examples of this type were identified within the precinct.</p>	 	<p>low</p>
<p>10.</p>	<p>Original old square dwelling units constructed with corrugated iron and timber frames, covered with chicken wire mesh and then sprayed with cement mixture leaving a coarse cement plaster and left unpainted.</p> <p>Forty-three examples of this type were identified within the precinct.</p>

5.	<p><i>Are there any buildings or structures that are important examples of an industrial, technological or engineering development.</i></p> <p>None of the buildings are exceptional examples of an industrial, technological or engineering development.</p> <p>Precinct 3: However the oldest dwellings in Precinct 3 are unique as they have been constructed with corrugated iron sheets and covered with cement clad sprayed over the corrugated iron. The use of corrugated iron itself is not unique and has become a common building material for individual units and shacks commonly found in industrial areas, industrial villages and squatter shack building. In all these cases the corrugated iron is mounted to a vertical frame or superstructure of timber with the sheets mounted vertically and the fluting in the same direction. At this site the sheets were mounted horizontally. The sheets were then covered with wire mesh and finally covered by spraying cement over both the interior and exterior sides. The wire mesh served as reinforcing and also allowed the cement to cling to the otherwise smooth and slippery sides of the corrugated iron.</p>	<p>Rating</p> <p>high</p>

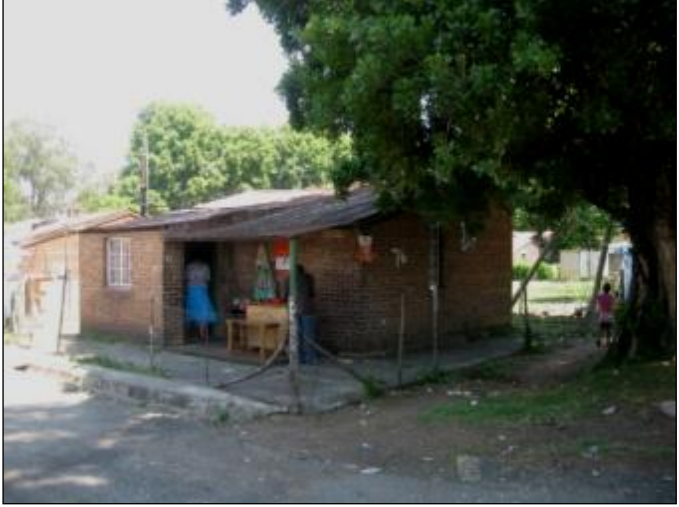
11.	<p>Small independent (detached) housing unit constructed the same as the other dwellings of this cluster but with red face bricks.</p> <p>Four examples of this type were identified within the precinct.</p>

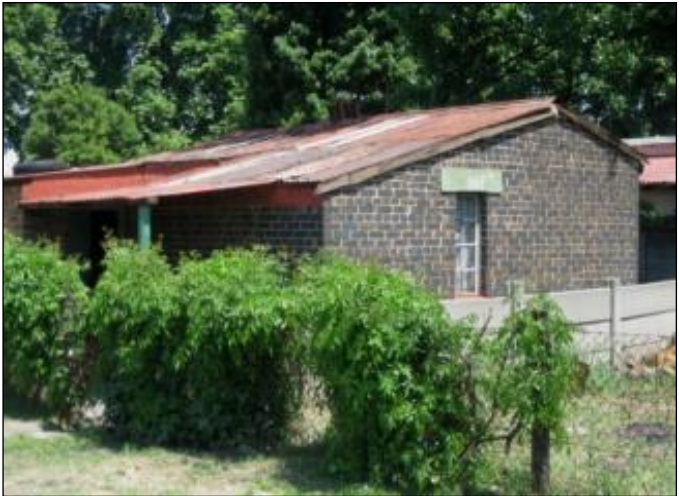
medium
12.	<p>Small independent (detached) housing unit constructed the same as other dwellings in this cluster but with unplastered grey-blue face bricks.</p> <p>Three example of this type were identified within the precinct.</p>

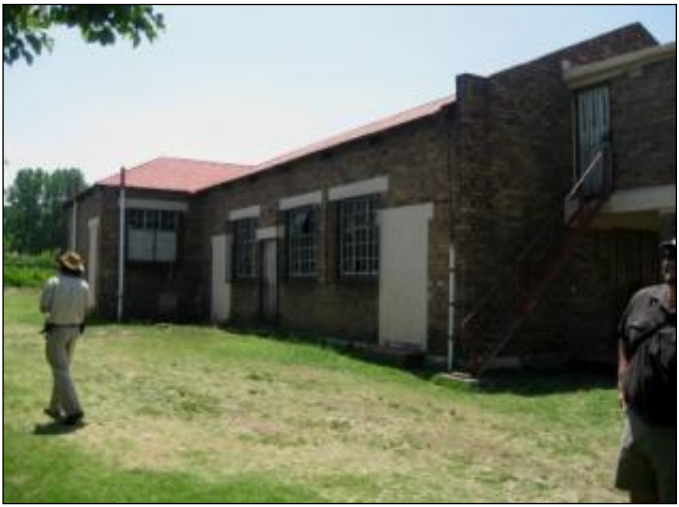
medium
13.	<p>Community centre functioning as concert hall, clinic and any other functions associated with the community. One-and-a-half storey building constructed with face bricks and corrugated iron roof, steel frame windows with typical industrial exposed concrete window and door lintels quite common of mining architecture.</p> <p>One example of this type was identified within the precinct.</p>

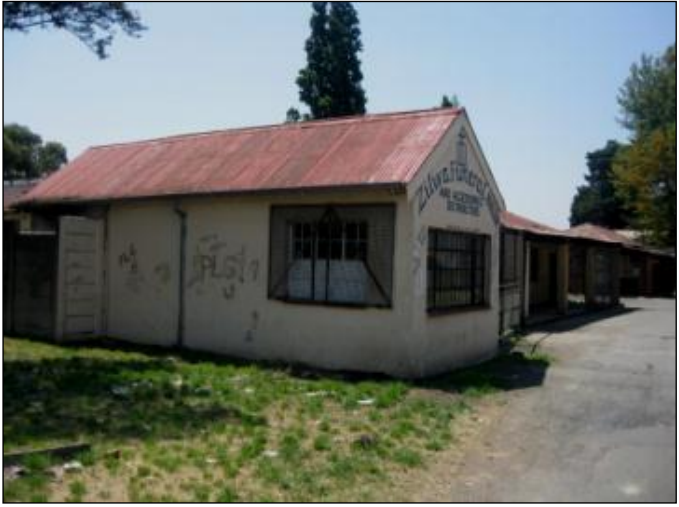
<p>low</p>
<p>17.</p>	<p>Building used as a shop serving the existing and remaining residents of the village.</p> <p>One example of this type was identified within the precinct.</p>

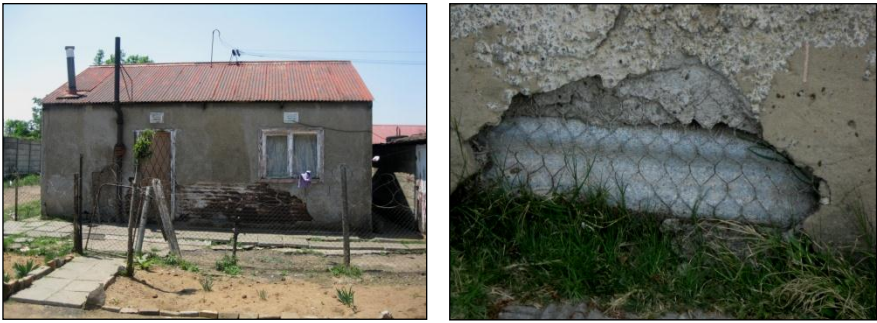
<p>This is a unique building method and the project architectural historian has not seen this anywhere at a mining housing site before.</p>
