## Environmental Management Plan for the Approved Lambda Substation and Associated 400/765kV Transmission Lines

### Heritage Walk-Down Report

ESK3420

October 2015

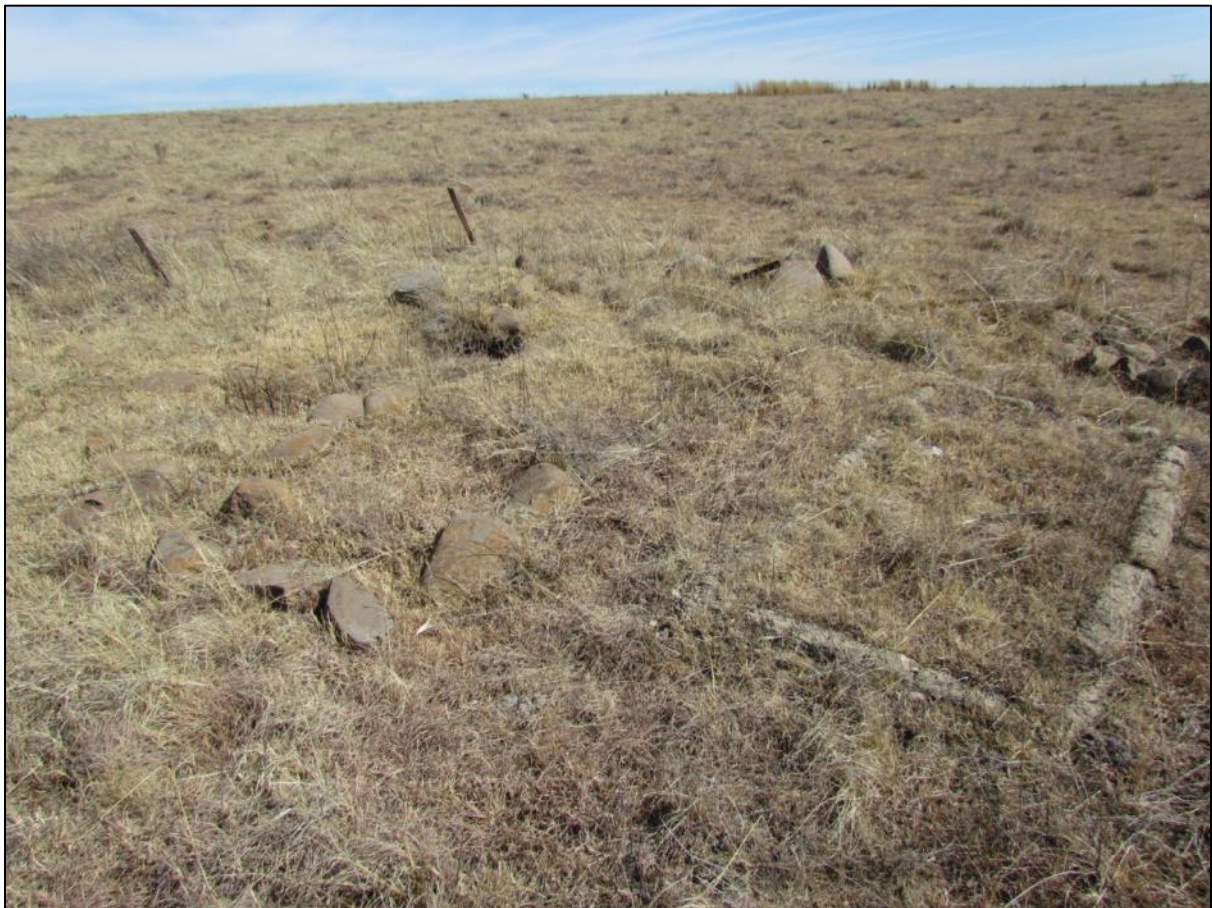
**Figure 4-3: Burial ground at BGG-001**

An unregistered burial ground containing approximately 12 burials was identified below the approved transmission line route and 170 m from tower TUT/LAM 0010 (See Figure 4-3 below). The burial ground is unfenced and unkempt, and next to a farm access road.

No features to date the graves were noted, however, the site is assumed to be older than 60 years and therefore under general protection in accordance with section 36 of the NHRA.

- All identified heritage resources are to be conserved in-situ. The following mitigation measures must be implemented as minimum requirements:
  - Fencing off of burial grounds and heritage sites;

- Establishing a 50 m buffer around the burial grounds and heritage sites ; and
  - Where applicable, construct temporary protective scaffolds over burial grounds and archaeological sites to shield from accidental damage during construction, and repairs and maintenance during the operational phase; and

- On-site supervision of the stringing of the electrical cables over sites BGG-001, St-005 and BGG-006;
  - Should any sub-surface heritage resources be uncovered, the archaeologist will assess the find and recommend further mitigation measures.

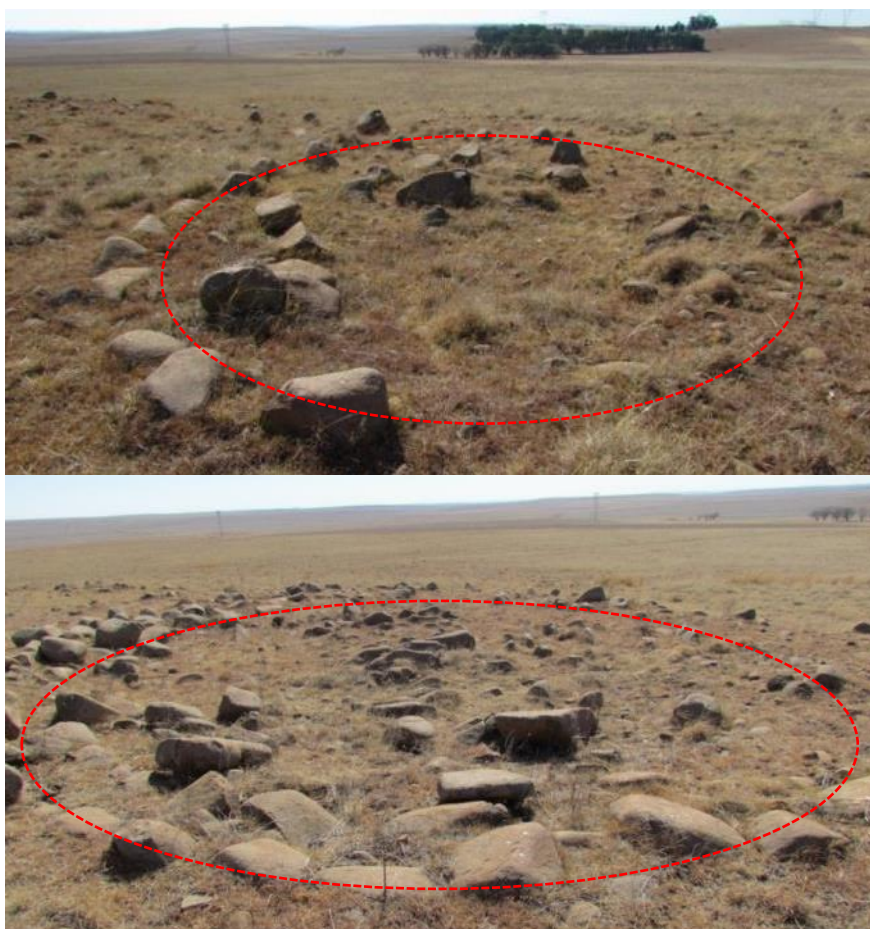
**Figure 4-4: Stone walled settlement located at St-002**

A stone-walled settlement approximately 140 m x 190 m in extent, located at pylon tower TUT/LAM0011 (See Figure 4-4 below). The settlement consists of several circular structures that may represent housing units or stock enclosures, located on a low kopie.

No material culture was identified to provide a relative date and it does not appear to be associated with any historical farmsteads. A similar site (St-003) is visible on DATE aerial imagery, indicating a relative age older than 60 years. In general, these types of sites are associated with Late Farming Communities (LFC) or early historical periods and under general protection in terms of sections 34 (historical resources older than 60 years) and 35 (archaeological resources older than 100 years).

- The Watching Brief must be conducted by an accredited qualified Archaeologist;
  - It will entail the on-site supervision of earthworks by the archaeologist at sites St-002, St-003 and BGG-004;

TUT/LAM 0011	St-002 – Stone walled settlement located at proposed location for TUT/LAM 0011	Direct impact to stone walled settlement. Digging the foundation for the pylon tower will damage the settlement and possible burials located sub-surface	<p>St-002 is to be conserved in-situ. Mitigation measures include the following pre-construction actions as a minimum requirement:</p> <ul style="list-style-type: none"> <li>▪ A 50 m buffer must be maintained from the edge of the settlement;</li> <li>▪ A Watching Brief to be implemented during construction</li> </ul> <p>■ Should this not be possible, a Watching Brief must be conducted during the construction phase to monitor the earthworks for the tower foundations.</p>	Section 35 of the NHRA and Chapter 2 and 3 of the NHRA Regulations
TUT/LAM 0056	St-003 – Stone walled settlement located at proposed location for TUT/LAM 0056	Direct impact to stone walled settlement. Digging the foundation for the pylon tower will damage the settlement and possible burials located sub-surface	<p>St-003 is to be conserved in-situ. Mitigation measures include the following pre-construction actions as a minimum requirement:</p> <ul style="list-style-type: none"> <li>▪ A 50 m buffer must be maintained from the edge of the settlement.</li> </ul> <p>■ Should this not be possible, a Watching Brief must be conducted during the construction phase to monitor the earthworks for the tower foundations.</p>	Section 35 of the NHRA and Chapter 2 and 3 of the NHRA Regulations

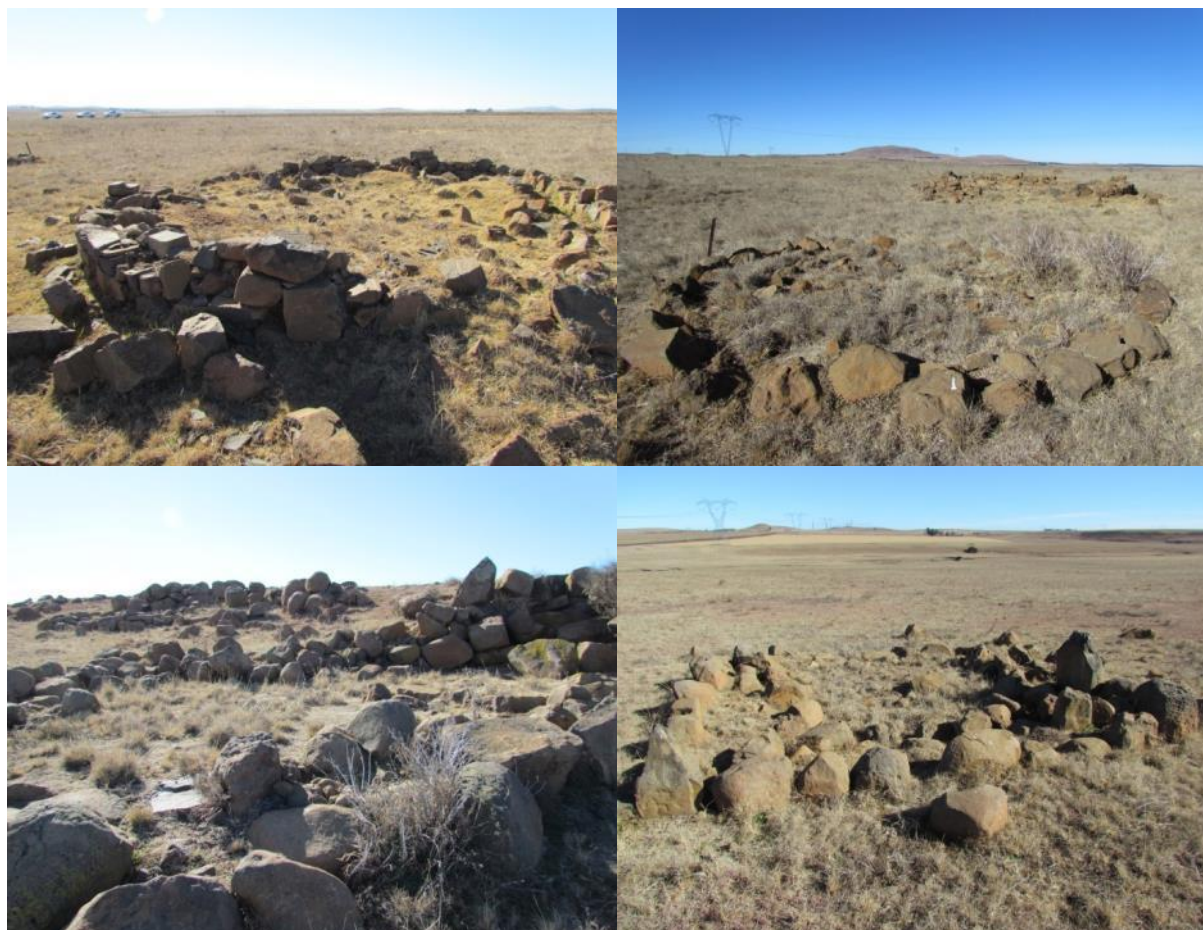
**Figure 4-6: Top row of photos depict the stone-walled units identified in the 2012 HIA. The bottom row shows a cattle kraal and rectangular structure identified during the walk-down at St-003.**

A large stone-walled settlement measuring approximately 380 m x 180 m is located at pylon TUT/LAM 0056. This stone-walled settlement was identified as part of the 2012 HIA. The 2012 HIA mentions two stone-walled units, however, under further investigation, several additional stonewalled units were identified on a slope to the west of the two previously identified units. Other features included cattle kraals and small rectangular stone walled features. In the 2012 HIA, this site was estimated to be less than 60 years old, however aerial photographs from 1957 show St-003 as an established site. The site must therefore be considered to be older than 60 years and consequently under general protection in terms of either section 34 or 35 of the NHRA (See Figure 4-7).

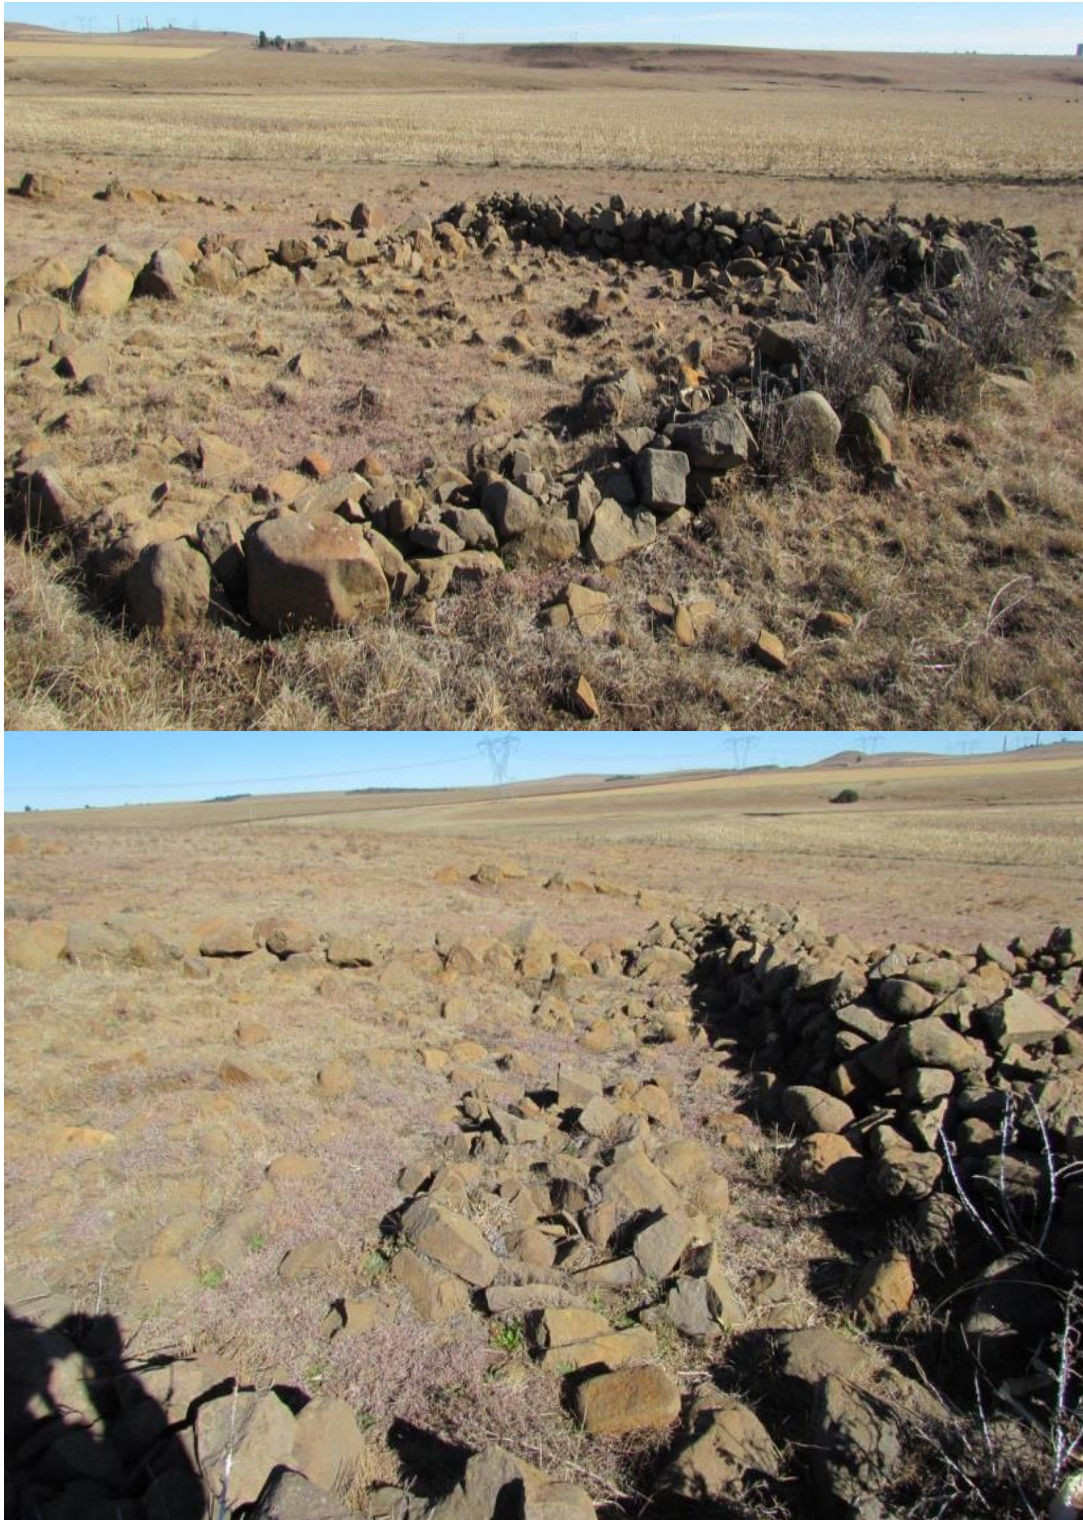
**Figure 4-8: Burial ground at BGG-004**

A burial ground containing at least 15 graves was identified approximately 65 m from the proposed position of pylon MAJ/LAM 032 (See Figure 4-8 below). The burial ground is unfenced and unkempt. This burial could possibly be associated with the stone walled settlement at St-003 as it is only 190 m from the settlement.

No features to date the graves were noted, however, the site is assumed to be older than 60 years and therefore under general protection in accordance with section 36 of the NHRA.

MAJ/LAM 032	BGG-004 – Burial ground located 65 m from proposed location of MAJ/LAM 032	Potential impact to burial ground due to possible vandalism of burial ground by workers.	<p>BGG-004 is to be conserved in situ. Mitigation measures include the following pre-construction actions as a minimum requirement</p> <ul style="list-style-type: none"> <li>▪ Fencing off of burial ground; and</li> <li>▪ Establishing a 50 m buffer around the burial ground.</li> </ul> <p>■ A Watching Brief must be undertaken for the burial ground during construction.</p>	Section 36 of the NHRA and Chapter 9 of the NHRA Regulations

Unplanned event	Potential impact	Mitigation/ Management/ Monitoring
Accidental damage to burial ground BGG-004 located near tower Maj/Lam 032	Damage and/or destruction of heritage resources generally protected under section 36 of the NHRA	<ul style="list-style-type: none"> <li>■ Fencing off of burial ground;</li> <li>■ Establish 50 m around the burial ground;</li> <li>■ Monitoring of the heritage resources must be conducted during the construction phase, and</li> <li>■ Should damage occur during construction, SAHRA is to be informed and corrective measures are to be implemented such as repair and rehabilitation.</li> </ul>
Accidental exposure of unidentified heritage resources	Damage and/or destruction of heritage resources generally protected under section 34, 35 and 36 of the NHRA	Chance Finds Procedures (CFPs) must be included as a condition of authorisation that clearly describes the reporting process and appropriate management of the exposure of previously unidentified heritage resources. The established and defined CFPs must be implemented prior to any construction/development taking place.

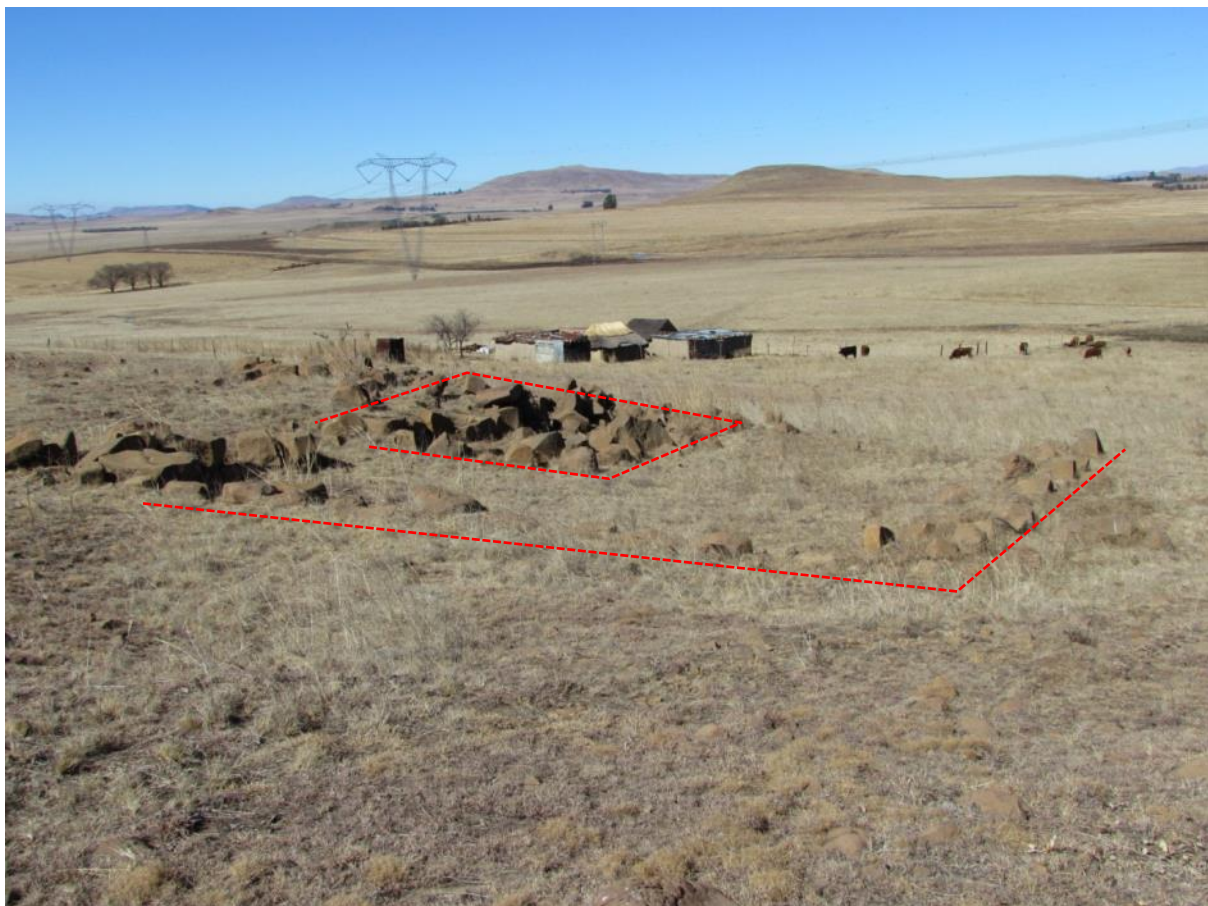
**Figure 4-10: Stone feature located at St-005**

A rectangular stone feature was identified between the pylons MAJ/LAM 023 & 024 (See Figure 4-10 below). The feature's extent is 10 m x 12 m. Given the rectangular construction, the feature is probably historical and not archaeological and therefore under general protection in terms of section 34 of the NHRA.

Tower number	Aspect	Identified potential impact	Action to be taken / mitigation measures	Relevant legislation
MAJ/LAM 023 & 024	St-005 – Stone-walled feature located below the transmission line between MAJ/LAM 023 & 024	A potential impact has been identified if the activity (stringing) is not managed. The transmission cables will be strung across St-005 which may result in a direct impact if, for instance, the cable is dropped during stringing, or dragged across St-005.	<p>St-005 is to be conserved in-situ. Mitigation measures include the following pre-construction actions as a minimum requirement:</p> <ul style="list-style-type: none"> <li>▪ Fencing off the site;</li> <li>▪ Establishing a 50 m buffer around the site; and</li> <li>▪ Where applicable, construct temporary protective scaffolds over the site to shield from accidental damage during construction and repairs and maintenance during the operational phase.</li> </ul> <p>■ A Watching Brief must be undertaken for the burial ground during construction.</p>	Section 35 of the NHRA and Chapter 2 and 3 of the NHRA Regulations

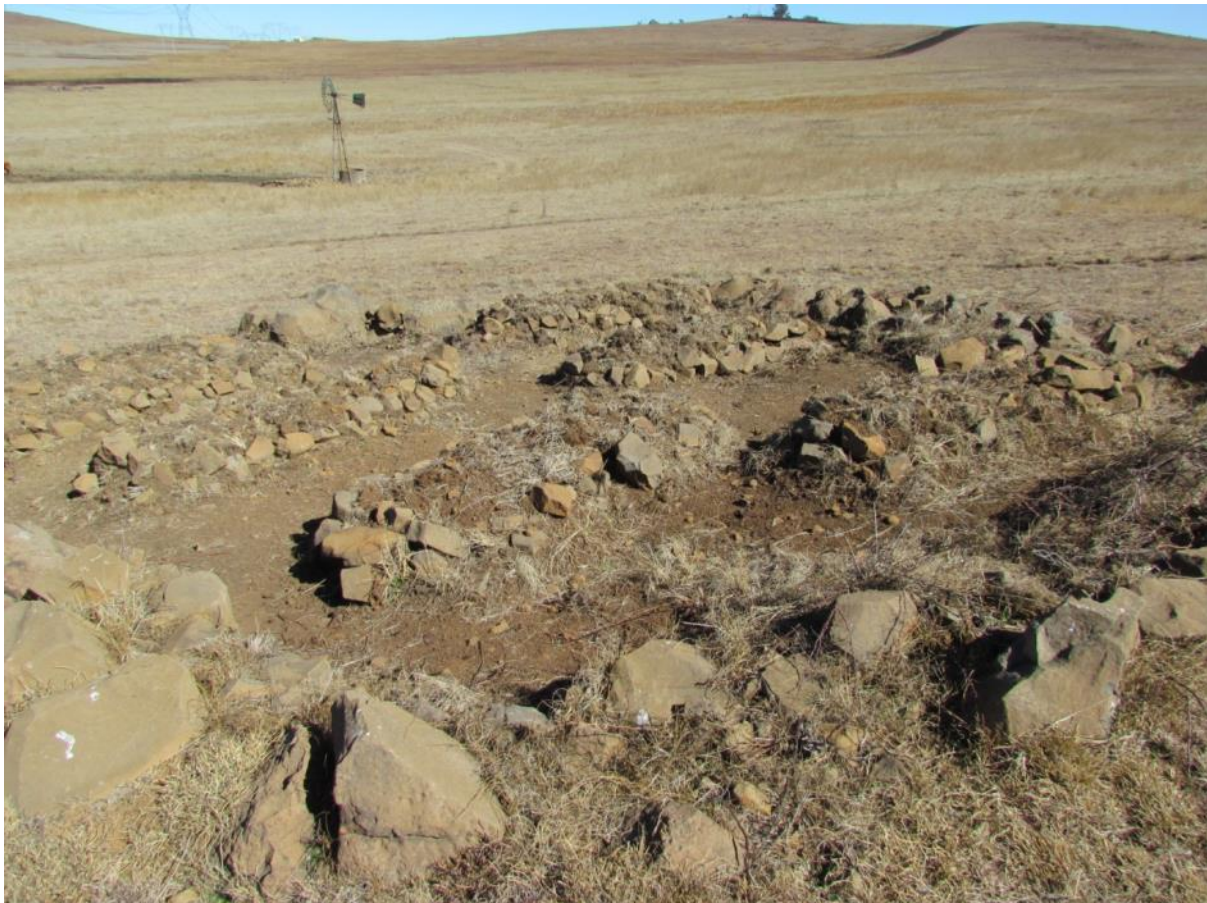
Figure 4-11: Burial ground at BGG-006

A burial ground containing seven graves located between pylon towers TUT/LAM 0047 & 0048 (See Figure 4-11 below). The graves are characterised by stone cairns, surrounded by a rectangular low stone wall. No features to date the graves were noted, however, the site is assumed to be older than 60 years and therefore under general protection in accordance with section 36 of the NHRA.

TUT/LAM 0047 & 0048	BGG-006 – Burial ground located below the transmission line between TUT/LAM 0047 & 0048	A potential impact has been identified if the activity (stringing) is not managed. The transmission cables will be strung across burial ground BGG-006 which may result in a direct impact if, for instance, the cable is dropped during stringing, or dragged across BGG-006.	<p>BGG-004 is to be conserved in situ. Mitigation measures include the following pre-construction actions as a minimum requirement:</p> <ul style="list-style-type: none"> <li>▪ Fencing off of burial ground;</li> <li>▪ Establishing a 50 m buffer around the burial ground; and</li> <li>▪ Where applicable, construct temporary protective scaffolds over burial grounds to shield from accidental damage during construction and repairs and maintenance during the operational phase.</li> </ul> <p>■ A Watching Brief must be undertaken for the burial ground during construction.</p>	Section 36 of the NHRA and Chapter 9 of the NHRA Regulations
