# A CONSERVATION PLAN FOR EAST FORT, HOUT BAY

First Draft May 2003  
Revised January 2004

Prepared by  
Tim Hart

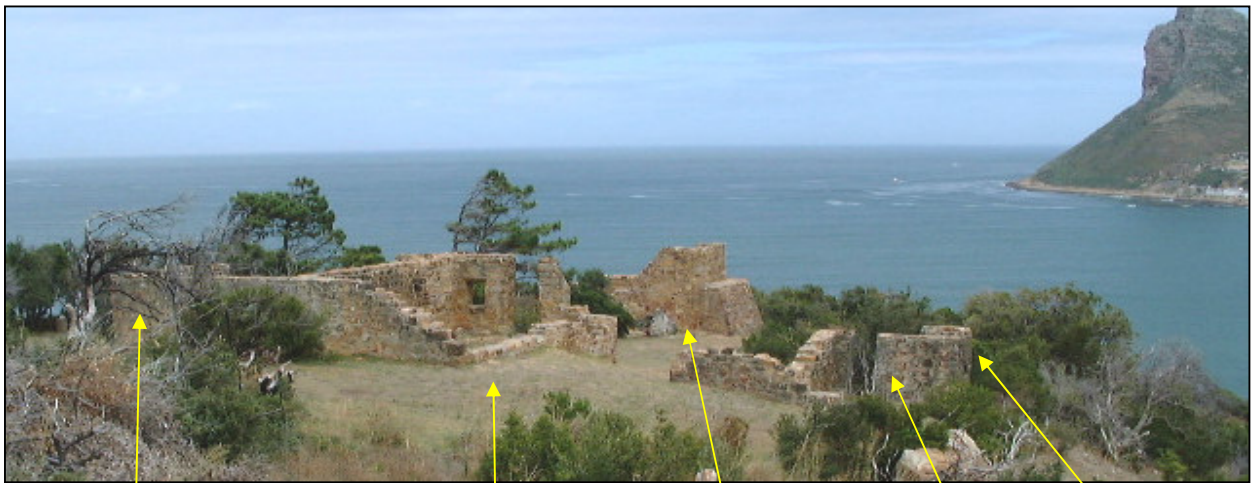
**EAST FORT  
UPPER AREA**  
(after Finlayson, existing site plan for HLHT)

This consists of a collection of ruins. Laid out paths and interpretive signs identify the various structures while the well maintained flat open areas in between the various features provide sheltered areas used by picnickers on rare occasions. The British forces built this upper part of East Fort after the first occupation of the Cape in 1795. The surviving elements that make up the upper part of the site are listed below. The site of wooden barracks mentioned in historic documents remains unknown.

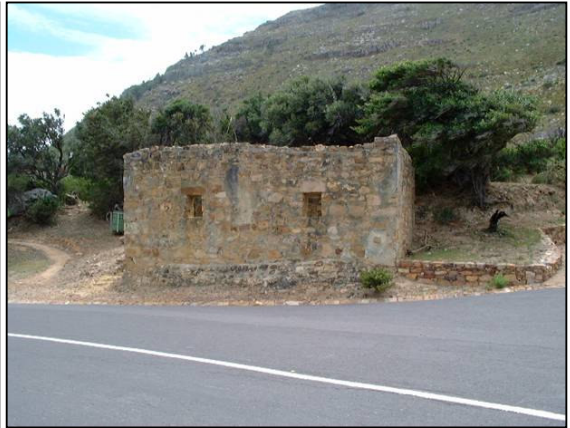
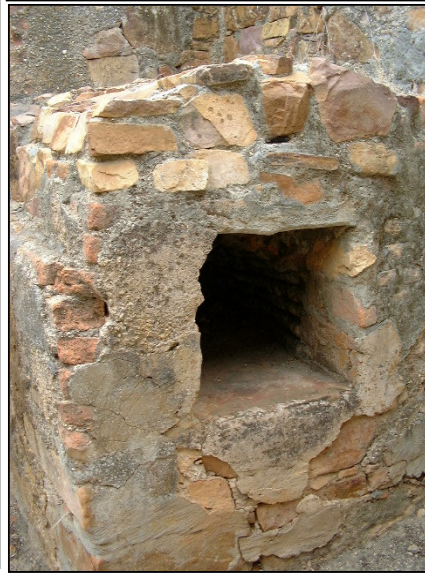
## Cook House

Description: A two roomed stone structure without a roof. A Dutch oven is present in the western room. No joinery has survived.

The building shows that many years of conservations measures have altered the appearance of the fabric – Portland cement has been used and loose available stone has been used to repair walls.

The Dutch oven has deteriorated in since Seeman photographed it 12 years ago. Much of the original plasterwork has been lost and the opening is now square (as opposed to vaulted in 1992). The plan of 1935 indicates that the oven door was still present. There is no evidence of it today.

The short flight of stairs up to the doors of the building is not indicated as being present in 1935. It is not clear from the plan drawn in 1935 whether these existed at the time or were built to facilitate visitor access in preparation for declaration of the site as a Historic Monument.

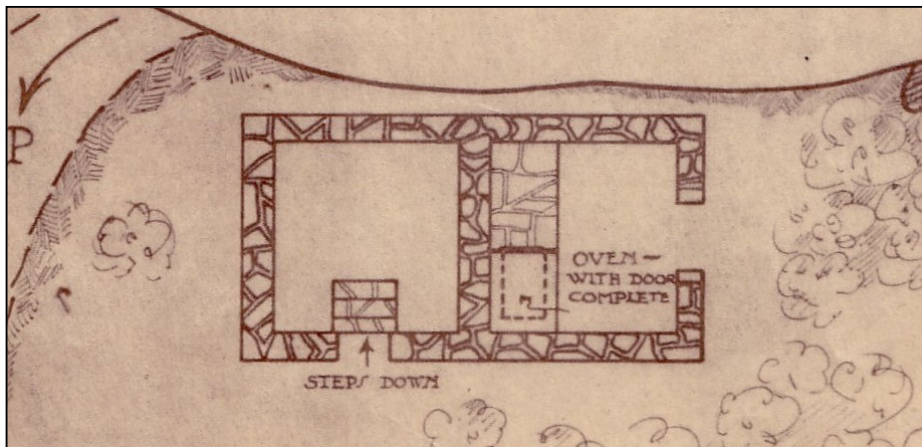
Plan view of the Cook House as it appeared in 1935.

The door of the oven is indicated to be complete.

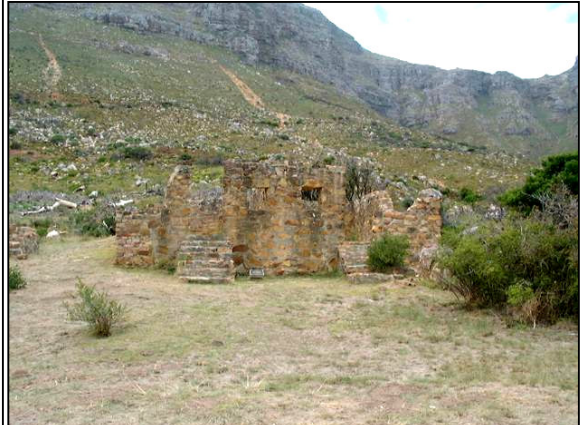
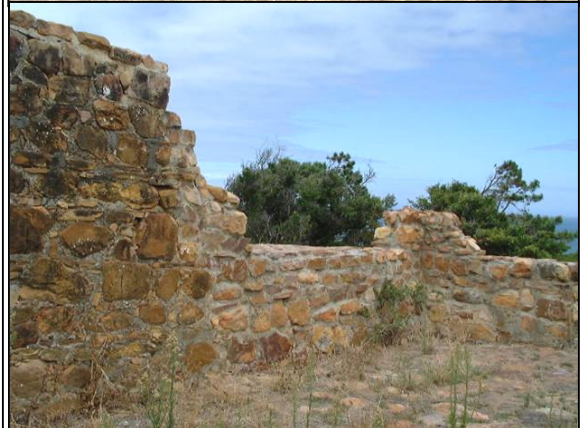
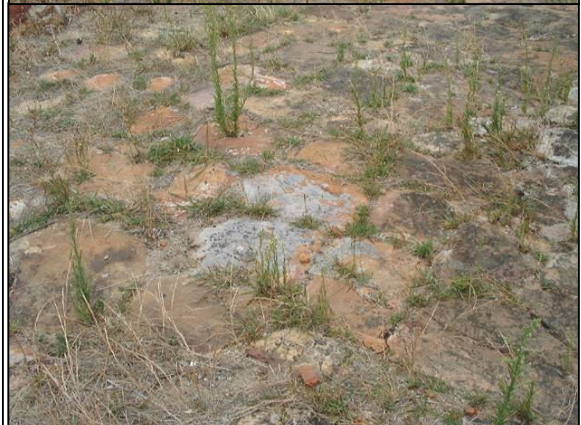
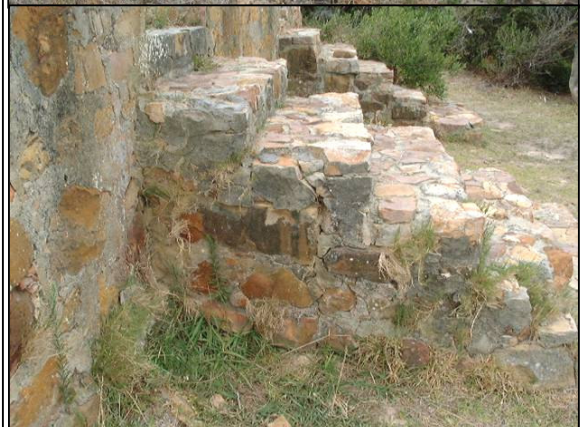
A patch of Portland cement on the flagstone floor of the southern room of the soldiers quarters are testimony to the *ad hoc* nature of repairs done in the interest of conservation during the 20<sup>th</sup> century.

Stone stairs leading up to the doorways of the two rooms showing evidence of modification and layering. A layer of late 20<sup>th</sup> century stonework and mortar is clearly visible overlying an earlier set of stairs. The existing stairs are steep and difficult to negotiate for an infirm or disabled person.

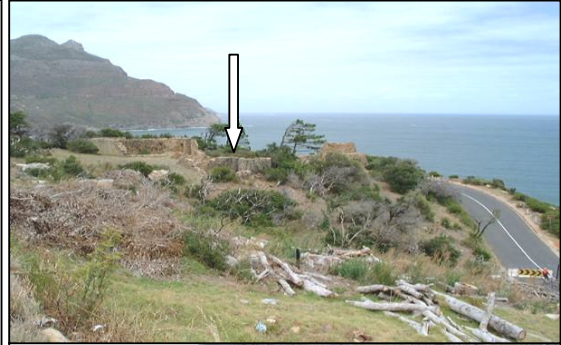
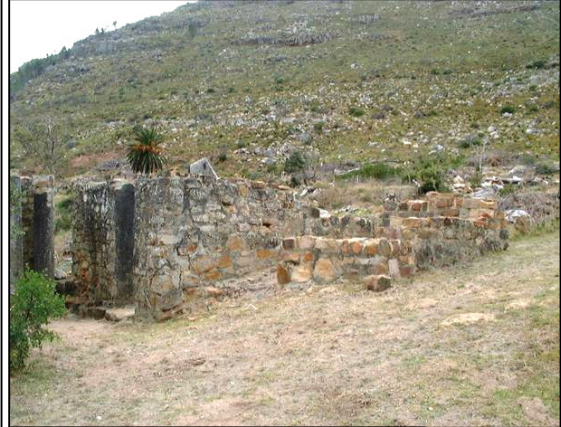
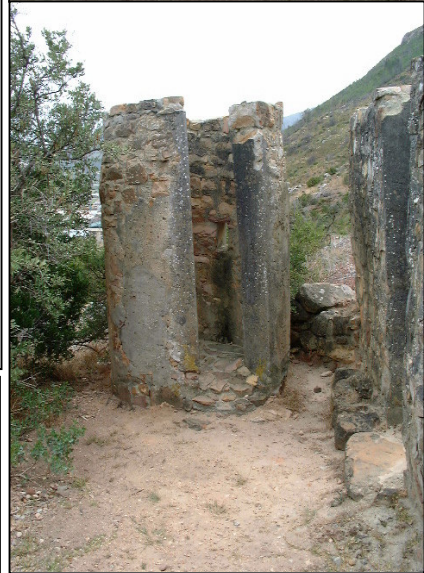
### Officer's quarters and sentry box

When photographed by Seeman in 1990, most of the front walls stood at full height. The loss of fabric from the two rooms of the Officers quarters in recent years is alarming (see Seeman). As with other structures, no joinery has survived, however early plasterwork still adheres to the areas around the doorways. Modern conservation measures are evident.

The sentry box appears to have withstood the elements comparatively well with substantial amounts of early plaster in evidence. Tops of the wall have been capped with modern fabric to retard erosion of the plaster. Bush growth around the area may have assisted in retarding the erosion of plaster by driving winter rain.

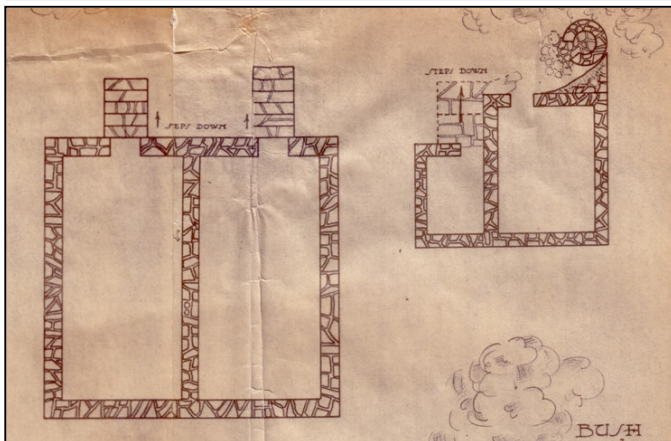
Plan of the soldier's quarters (left) and officer's quarters and sentry box as they appeared in 1935.

Note steps to the soldier's quarters but the paved floors are not indicated.

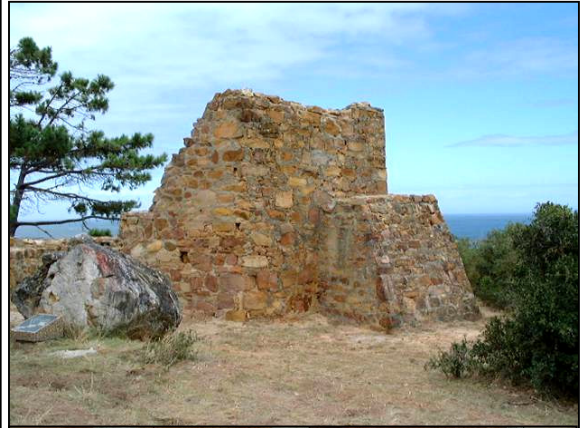
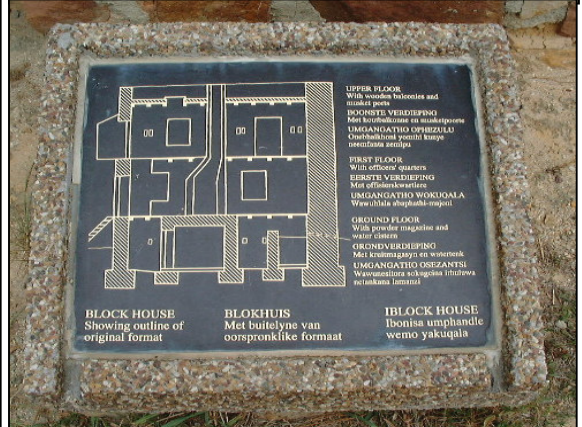
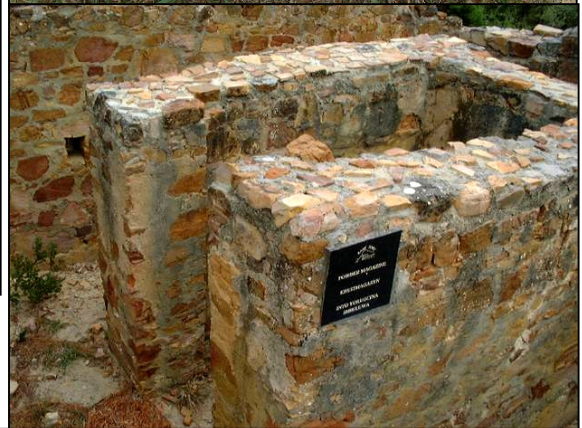
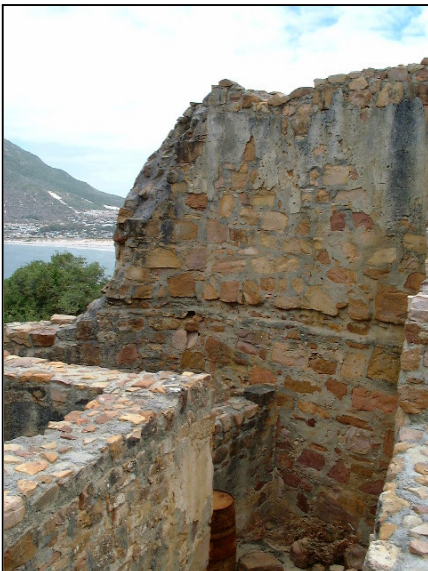
The original form of the blockhouse is well known and has been recorded by a number of 19<sup>th</sup> century artists. The original plans drawn by the Royal Engineers are housed in the Cape Archives. These form the basis of a very useful information sign that adds value to the site by assisting in the interpretation of what is a complicated structure. The blockhouse had 3 floors with wooden parapets erected around the top floor.

Remains of the powder magazine and cistern in the basement have survived well but have been conserved by liberally adding stonework and modern mortar to the top of the walls. This has retarded erosion. The interior of the structure has been cleared of rubble (and archaeological material) on a number of occasions.

- This was a unique building and makes for an interesting ruin. The HBHT has expressed an interest in “restoring” the blockhouse, however, if funding were to be obtained for a venture of this magnitude, reconstruction in modern media utilizing the principals of the Burra Charter would be preferred. Plans of the original structure do exist so it would be possible to build it accurately in scale and form. It must be noted that reconstruction of this building will be considered controversial in heritage circles, will alter the ambience of the site and tend to be a dominant visual feature. On the other hand it has the potential to illustrate the military history of the site, serve as a venue for static or multi-media displays and generally enhance educational and tourism significance.

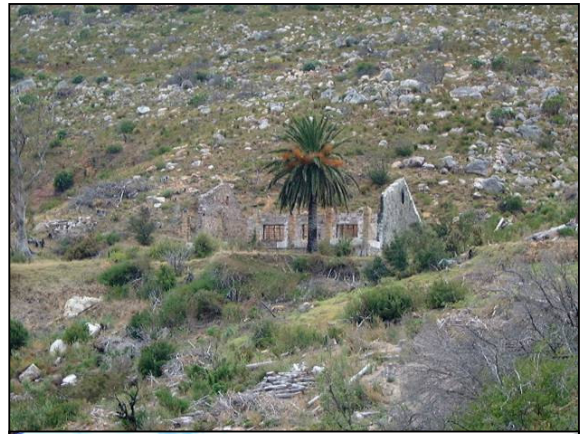
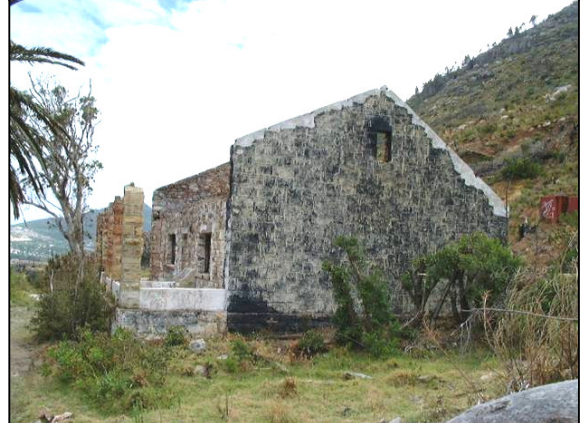
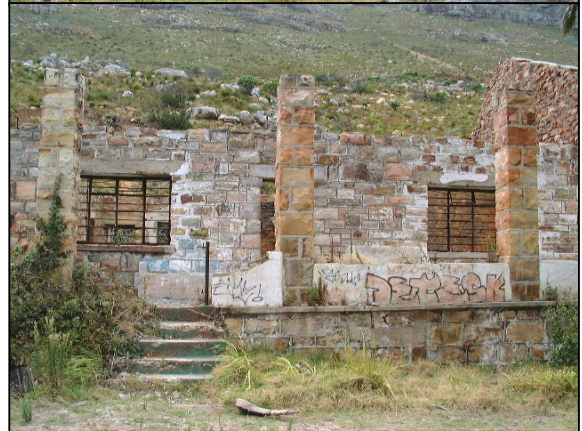
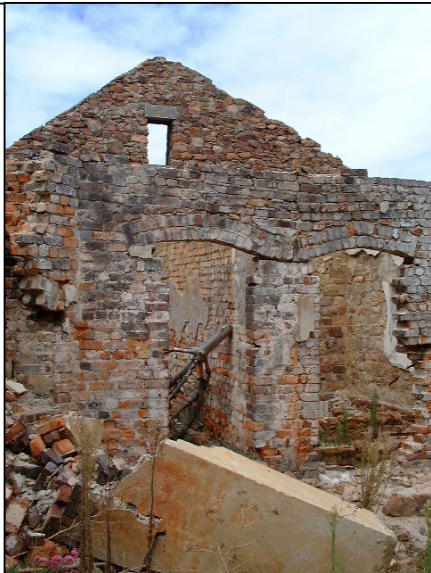
## Forester's cottage

The abandoned cottage, despite being technically unsafe has attracted graffiti and appears to have served as a "hangout" for persons intent on social mischief.

The forester's cottage is in poor condition since it was gutted by fire in the year 2000. Water damage has weakened the mortar and walls have collapsed in places.

The cost of making good this structure will be considerable and an analysis of the costs of demolishing it versus building an entirely new, but sympathetic structure should be considered.

- Development of this element presents the least impact to the actual fort buildings therefore its adaptive reuse is desirable over other ruins on the site. There is an opportunity to convert the cottage into a funds generating facility such as a small restaurant, lodge or even an alternative audio-visual presentation area. It enjoys superb views, and on this account is almost guaranteed to enjoy patronage. There is an opportunity to create more parking close to the cottage by clearing away disused foundations and tidying up the terrace.

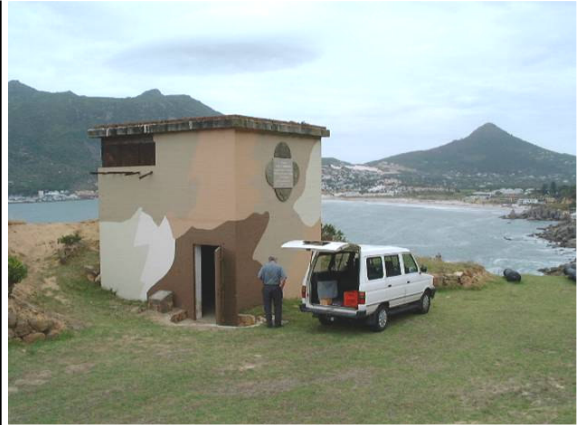
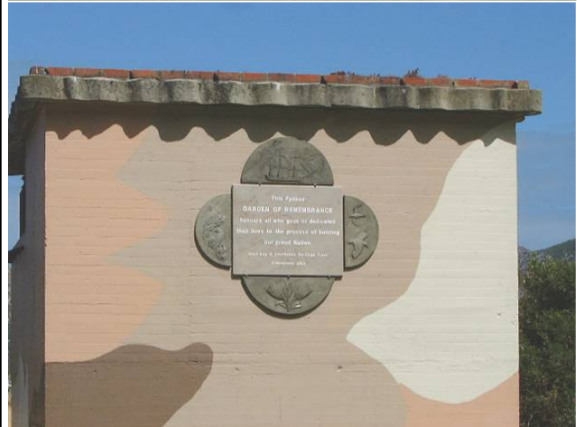
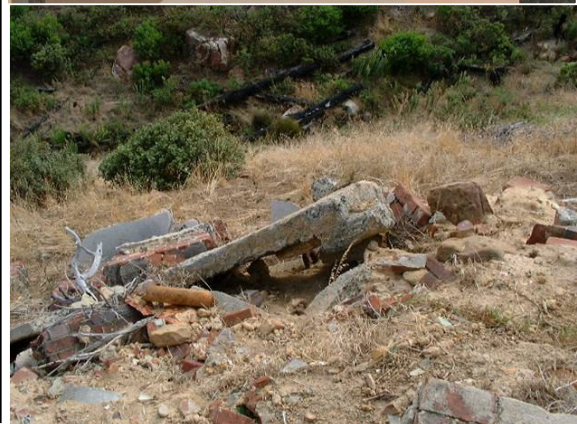
## Forward Observation Post

The FOP itself is typical of a number built round the coast of South Africa. The irregular edged concrete roof was a method of breaking up the visual profile of the structure.

The “quarters” which were built in 1940 immediately behind the FOP was demolished to discourage squatters. Its remains lie scattered on the slope below the blockhouse. A toilet, is all that remains. The site of the “quarters” is now grassed over. A working 18 pounder which is fired to commemorate events, has been mounted in this area.

- The FOP is made of cast concrete and is therefore stable. Corrosion is affecting the steel shuttering over the observation ports on the upper floor of the FOP.

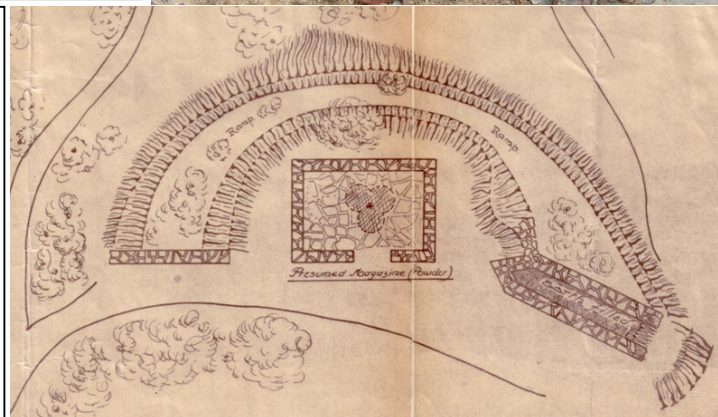
The 1935 plan of the site shows the area before the FOP was built. This was the site of the gun powder magazine, which was demolished in 1940.

The earthworks in front of the magazine have survived, however the stone walled sections of the earthworks have degenerated.

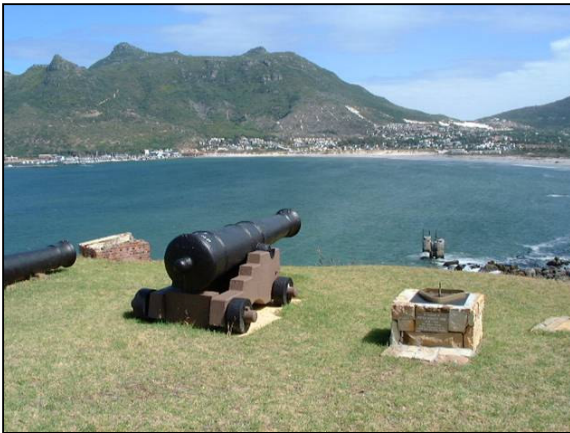
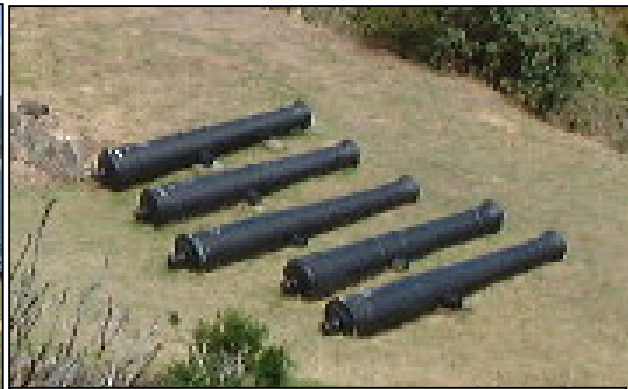
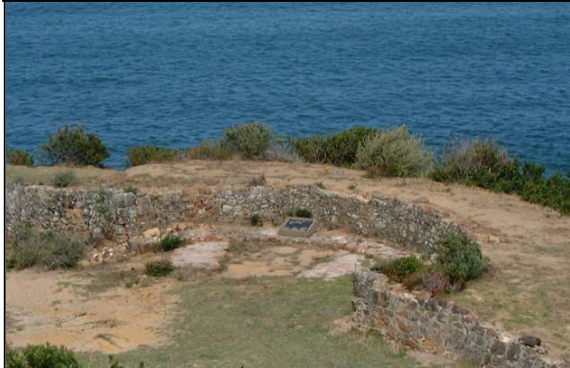
**7. Battery and armaments**

Eight 18<sup>th</sup> century Swedish muzzle loading cannons (18 pounders) have survived. One of these has been mounted on a concrete carriage after being moved from the battery to FOP (above left). It is fired from time to time commemorate various events. The other 7 cannons have been cleaned, painted, proof fired and are now licensed. The two longer cannons probably belonged in the 360° traversing mountings at the battery (left).

The iron cannons are unique in terms of the fact that they are in good enough condition to function and are considered to be one of the most significant elements of the site. The wooden mountings (made in the 1970's) burned in the fire of 2000.

- The eight muzzle loading iron cannons are one of the most significant elements of the site. They are in such good conditions that they are still able to fire, which makes them unique.
- The proposal to remount them on restored traversing gun platforms so as to create a complete working battery would impart exceptional significance and really contribute to the concept of a living museum. Again, the principles of the Burra Charter are applicable – use good safe modern materials, acknowledge what is reconstructed.
- Archival research and archaeological excavation will be needed to obtain information on mounting details if the reconstructions are to be true to scale.

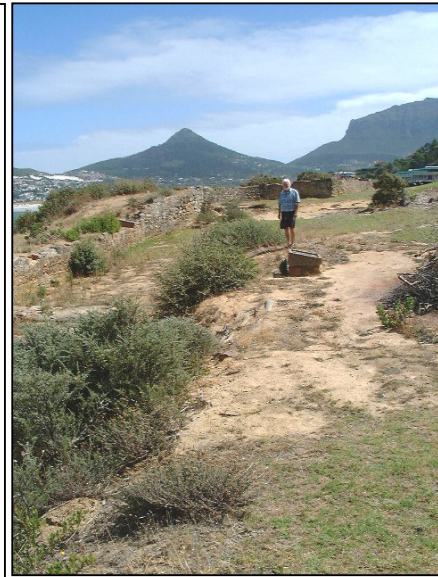
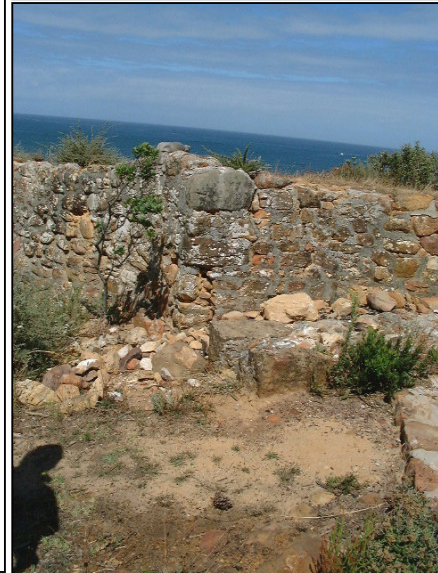
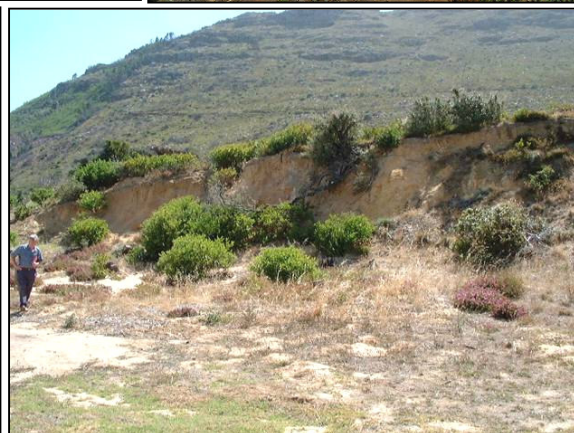
## 8. Battery walls and earthworks

The battery itself is built with a combination of earthworks and low retaining walls.

Lack of maintenance, vegetation growth and erosion is impacting the stone walls – illustrated (right) is a corner of the remaining circular gun emplacement where fabric has loosened and collapsed out of the wall. The tops of the walls will need to be capped with modern good quality materials, and plant growth in the stonework will have to be controlled.

The battery has been incised in to the side of the mountain – a level area has been created by cutting away the soft earth as slumped substantially over the years h slope. The cutting at the back of east fort h with eroded material settling behind the battery walls. Substantial archaeological work is needed to remove the slumped deposits and bring the surface back down to "original" levels. The cutting could thereafter be re-landscaped and stabilised.

- The battery itself is an area of concern - there is visible deterioration of stone walling. This has been caused by erosion by water of mortar in the stone walling, people walking on the stonework, the action of plant roots loosening fabric.

- The walling of the battery is relatively unaltered but is deteriorating. The tops of the walls need to be built up by the equivalent of one course of stonework in places, while collapsed areas and missing stones need to be made good with distinguishable modern materials. There are good plans and some photos of the battery, which can be used as guides. Reconstructive work required throughout is comparatively small and will not dominate or obscure original fabric. The stone bases to the traversing platforms will need to be exposed by an archaeologist and strengthened to support the weight of the cannons.
