**PROPOSED EMATHENDENI SPORTS FIELD, WARD
29, LADYSMITH, KWAZULU-NATAL**

Phase 1 Heritage Impact Assessment

November 2018

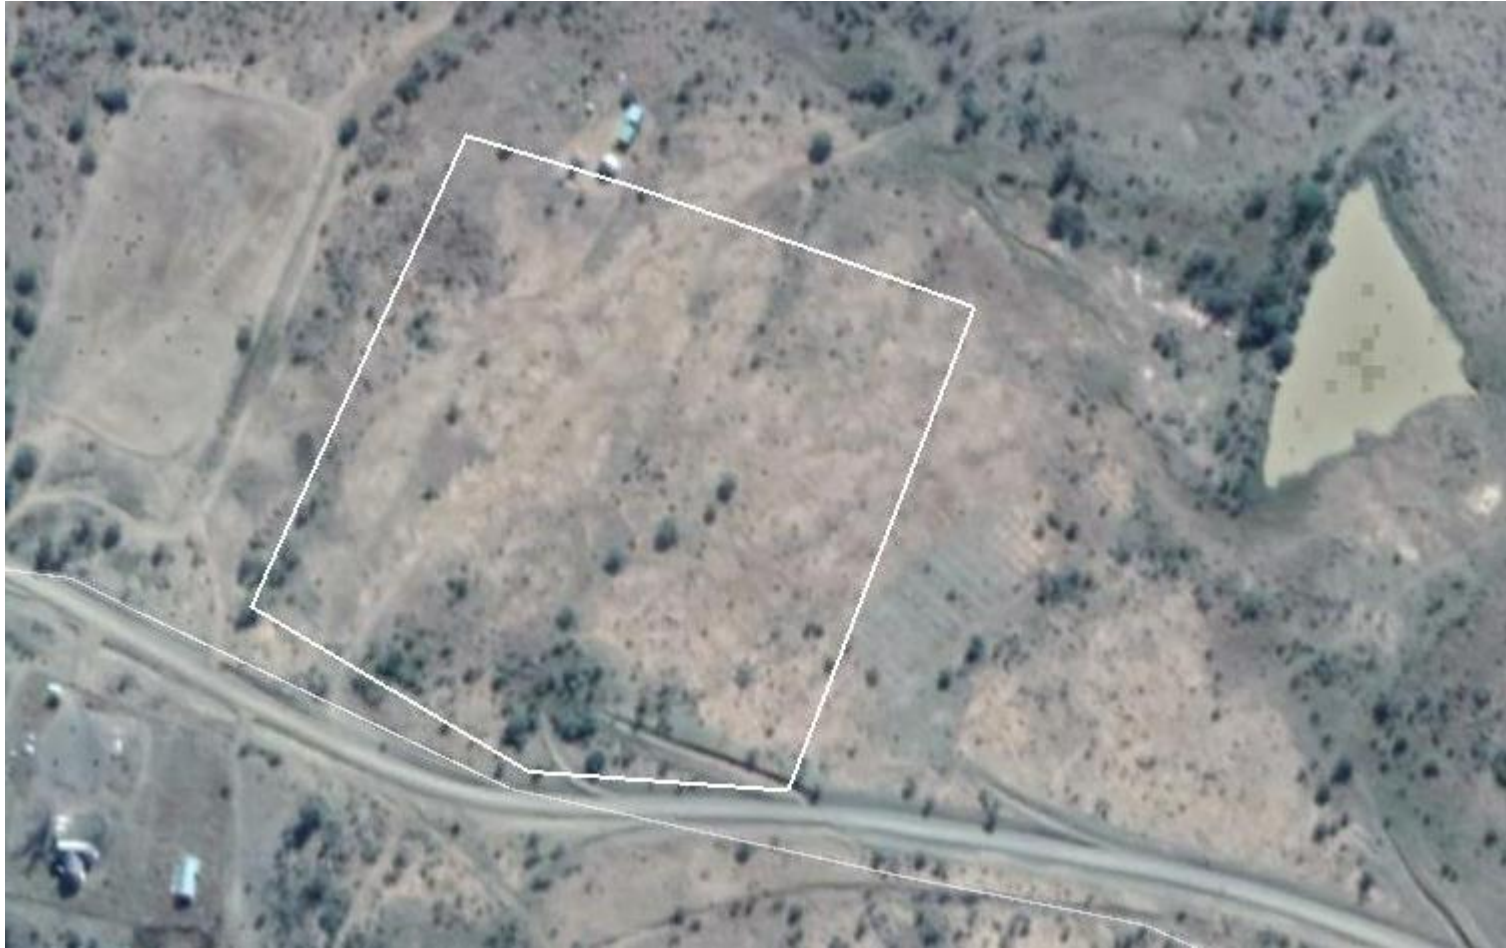
Figure 1: Wider view showing surrounding settlements

The Emathendeni sports field is located at: 28°38'46.0"S 30°07'05.0"E. It is situated approximately 23 km north of Weenen; 900 m north of the centre of the settlement of Mjinti and approximately 2.6 km south-east of the settlement of Potsdam. The project area is rural in nature with settlements, gravel roads, subsistence farming including the keeping of cattle and goats (see **Figures 1 and 2** below).

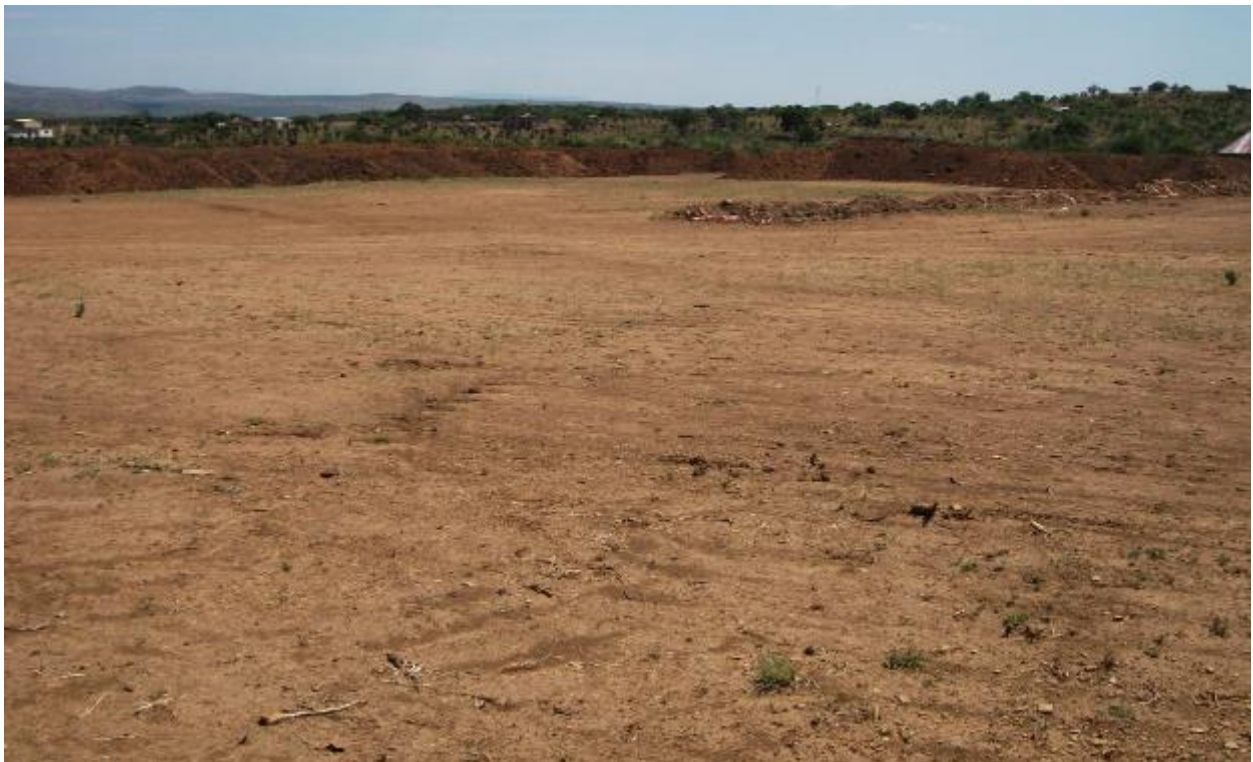
The project site was inspected on foot in the company of Messrs. Mthethwa and Bhengu, the project site agent and senior foreman respectively. As stated, prior to the site inspection, the project area had already been cleared in preparation for the construction of the components of the sports field. See photographs below.

Figure 3: Cleared section of sports field looking north-west

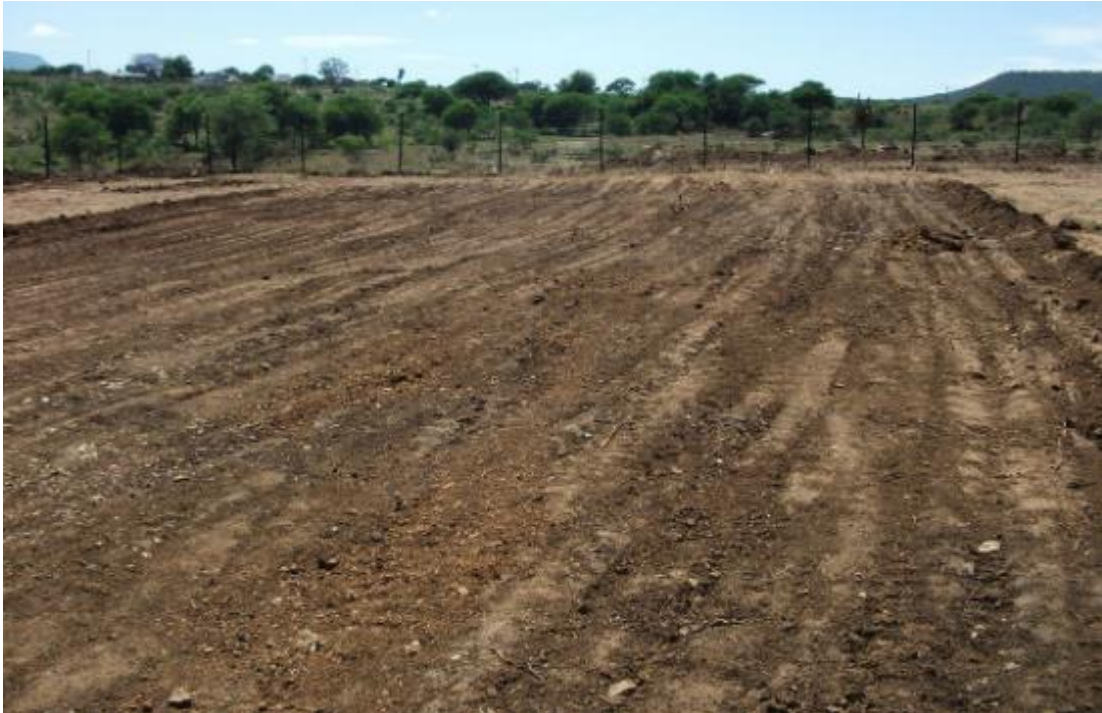
Figure 4: Cleared section of proposed sports field

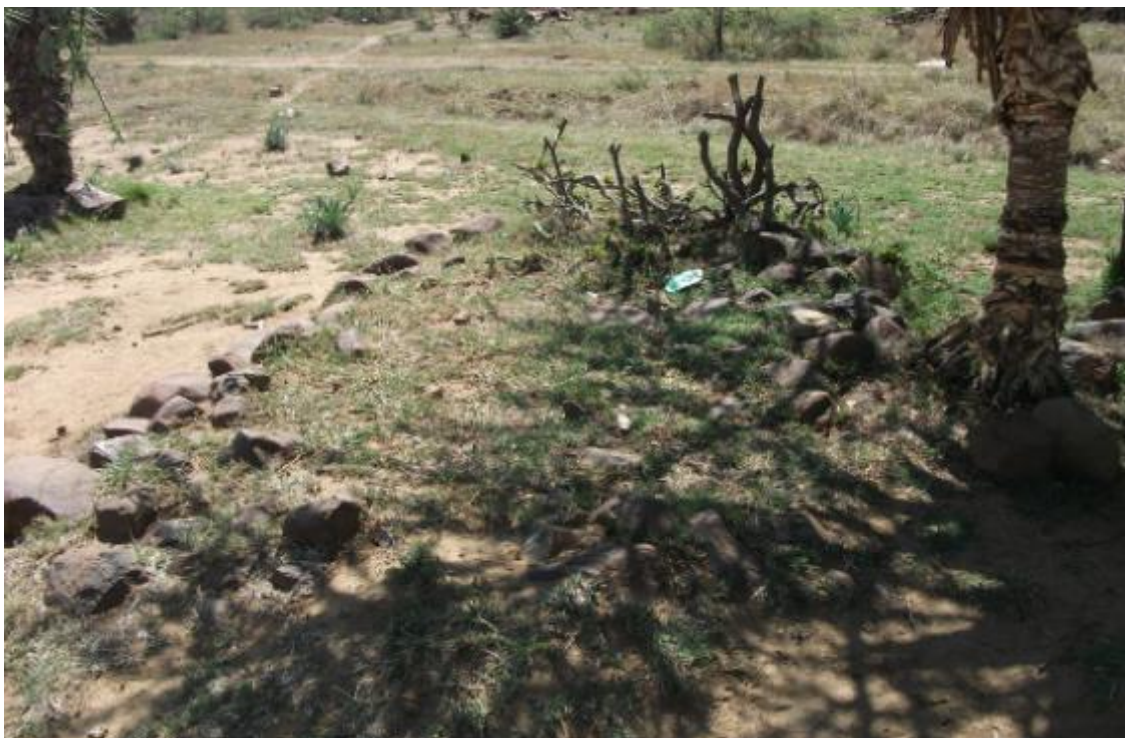
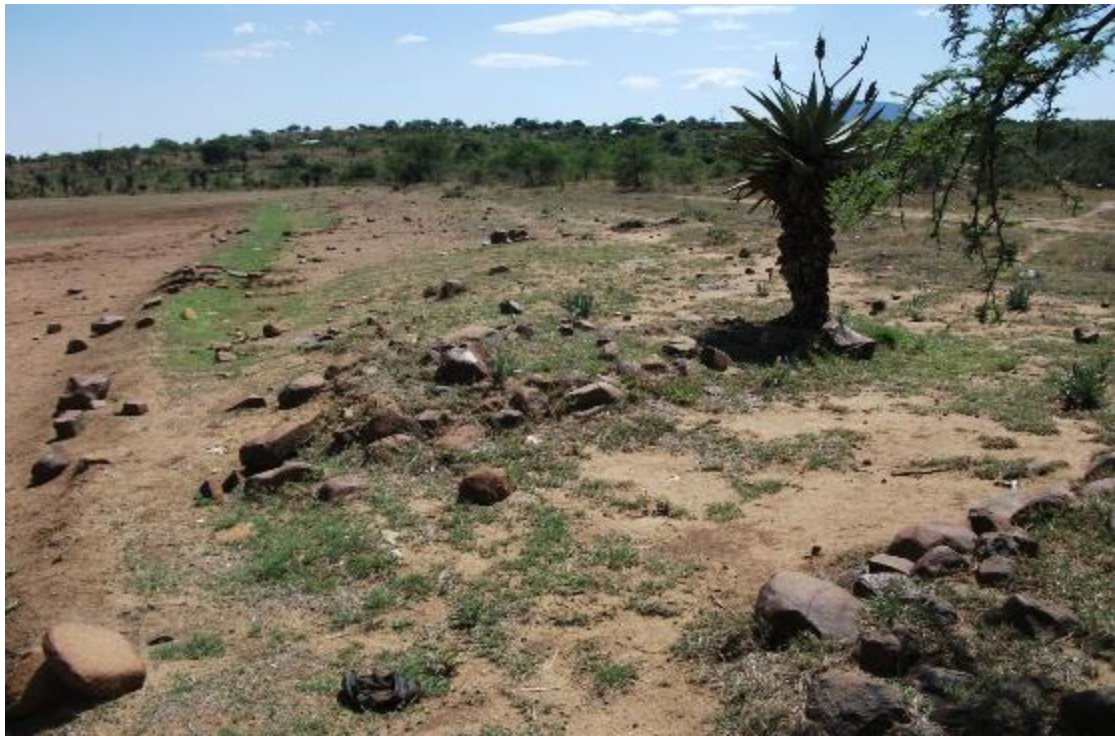
Two grave sites were encountered just outside the project area. The one site, situated furthest from the proposed sports field, contains 3 graves that belong to the Mthethwa clan and is located at: 28°38'43.5"S 30°07'04.8"E. The graves are made from packed rocks/stones and are situated approximately 40 m west of the boundary of the sports field.

Figure 5: One of three Mthethwa graves

Figure 6: Mthethwa graves

Due to the proximity of the proposed Emathendeni sports field to the two grave sites, it is recommended that both grave sites are permanently fenced to avoid any damage to them during the construction and operation/use of the sports field. The fencing should be of sturdy / strong and durable material and must be highly visible to the construction crew. The fencing must incorporate a buffer of 2 m which means that there should be 2 m between the graves and the fence in which no construction can take place.

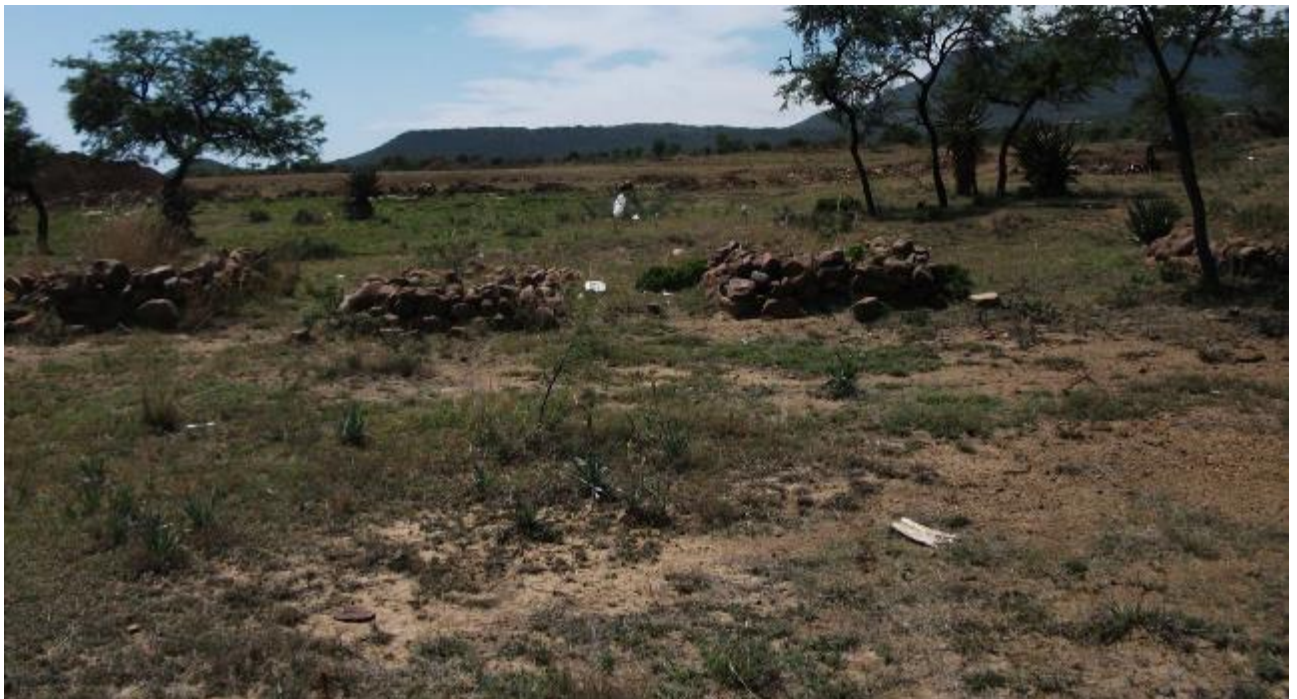
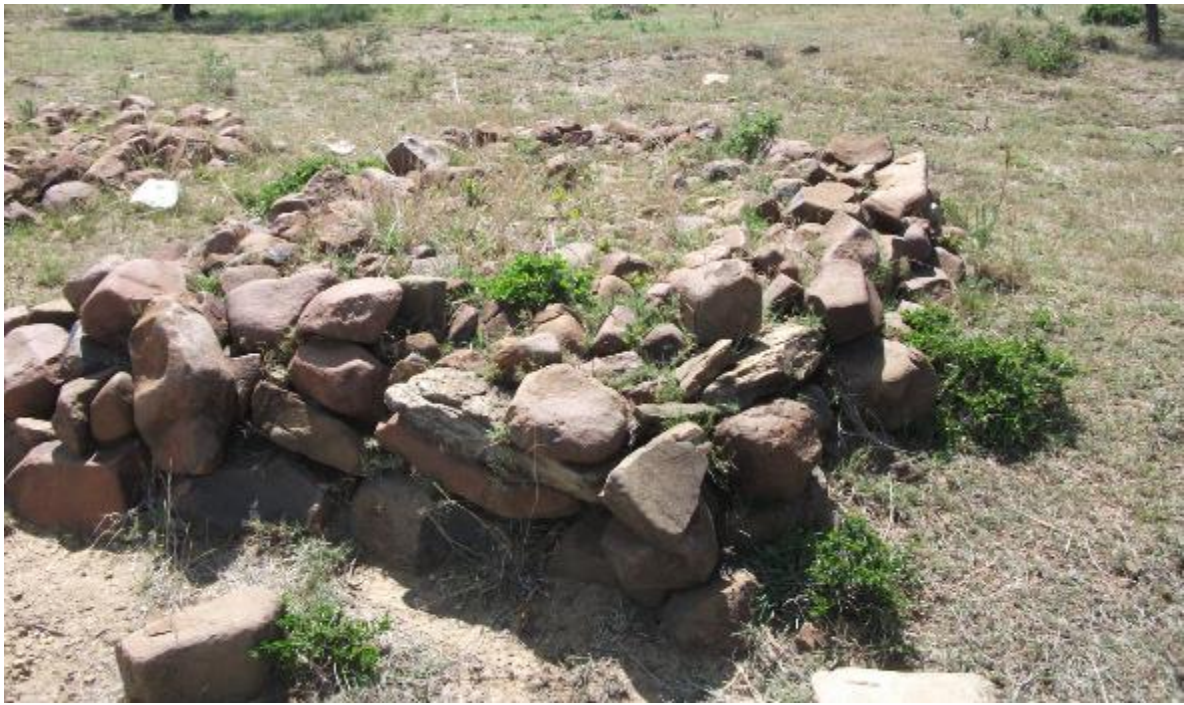
The other grave site contain 5 graves and those buried there, according to the security guard at the sports field, were killed during violence some years back and come from different families. The grave site is located at: 28°38'45.6"S 30°07'05.1"E and is situated 10 m west of the proposed sports field. These graves are also made from packed rock/stone.

Figure 7: Grave site with five graves

Figure 8: Two of five graves located close to sports field

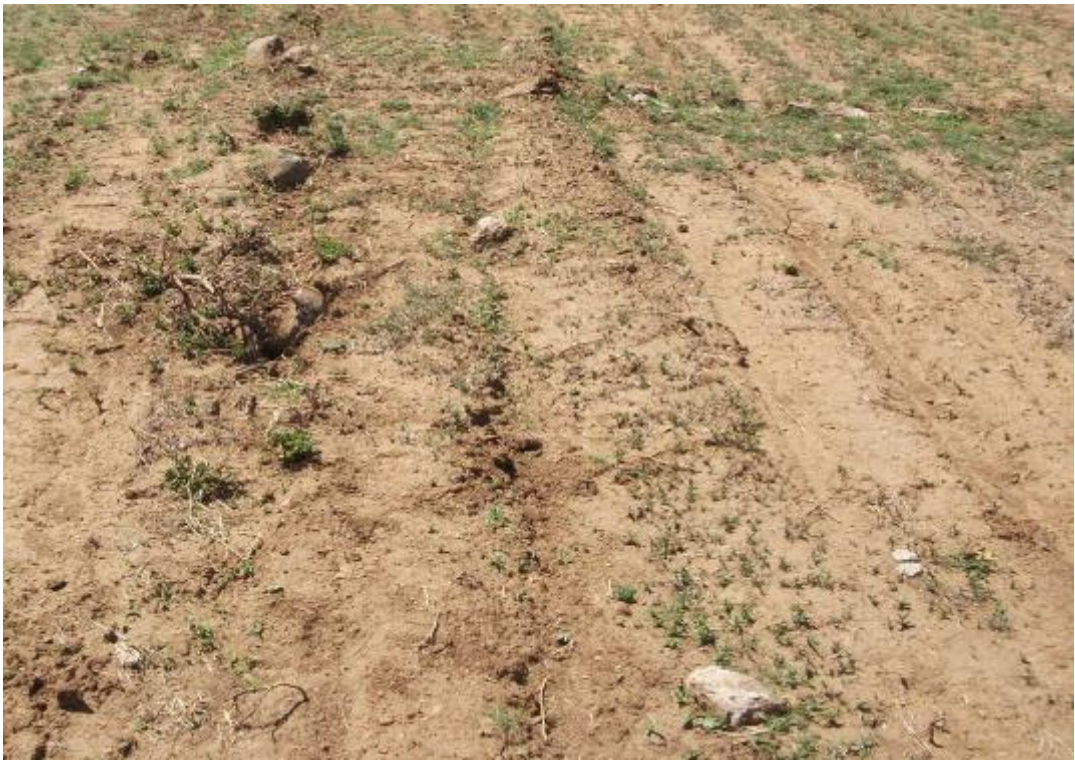
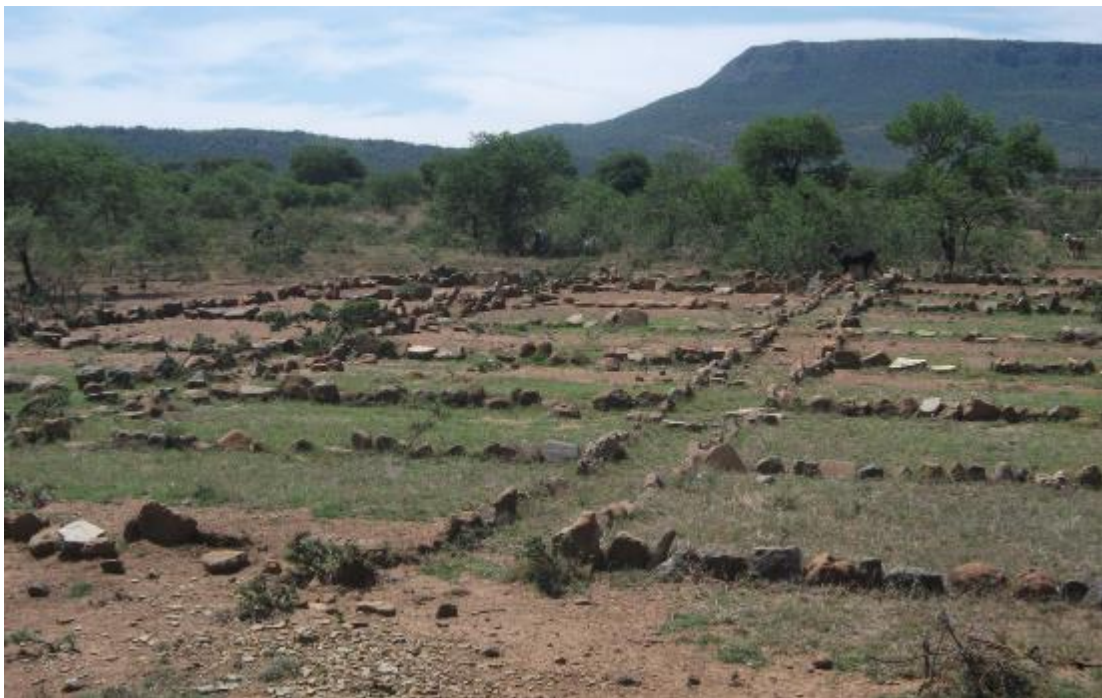
Inside the sport field and near its eastern boundary, the remains of small sections of stone walling were found that, according to Mr. Mthethwa, were subdivided subsistence gardens of which the remaining gardens can still be found immediately outside the boundary of the sports field. The gardens have been fallow for several years. Mr Mthethwa stated that in consultation with the Ward Councillor and the local Induna, it was agreed that some of the gardens could be incorporated into the sports field which led to their subsequent destruction. The age of the gardens could not be established.

Figure 9: Remains of stone walls between gardens

Figure 10: Small subsistence gardens on eastern edge of project area
