**HERITAGE SURVEY OF THE PROPOSED FAIRBREEZE
MINE**

FOR EXXARO SANDS

DATE: 5 MARCH 2010

**Umlando: Archaeological Tourism and Resource
Management**

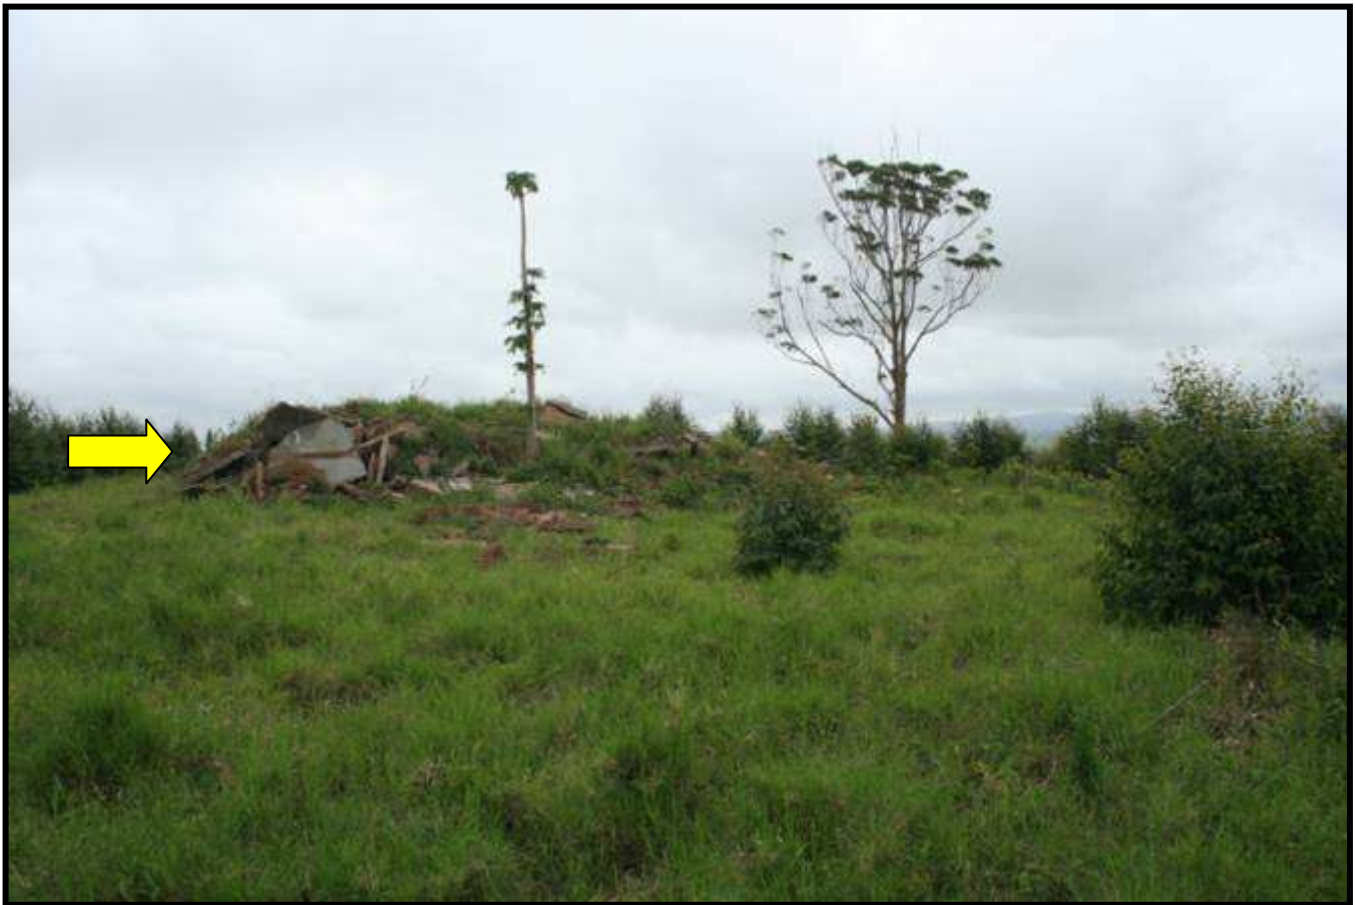
FIG.7: CURRENT STATUS OF 2931BA 022¹

This site was initially recorded in 1995. It is not an archaeological site per se, but does have human remains. The site occurs in the middle of the afforested area (fig.'s 5 - 6). It was noted as having several unmarked graves of farm labourers. These graves probably relate to 'Compound 8' discussed below. No photos were taken in 1995 of these graves. However, the 1964 1:50 000 topographical map clearly show this site and the related 'compound'

¹ Yellow arrow indicates building rubble.

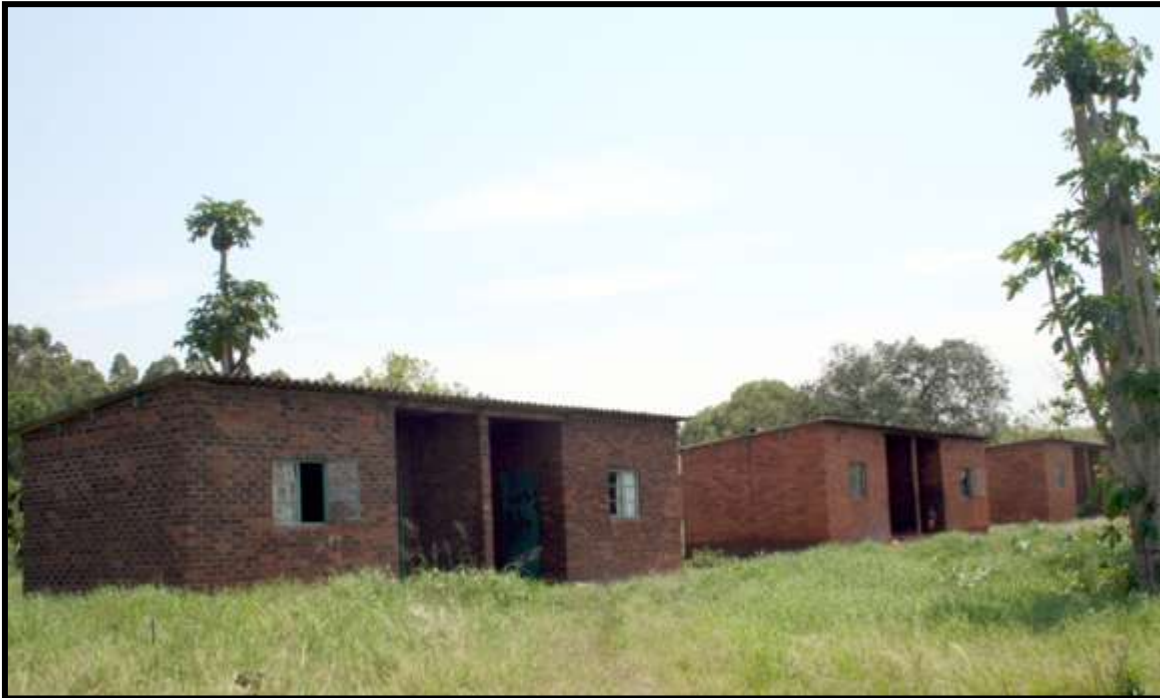
FIG. 9: 'COMPOUND' 9

While the compounds are not protected by legislation in terms of built structures, they are historically significant, in terms of apartheid socio-economy. They should be recorded as part of the country's recent history. CM8 still has several foundations even though they have been bulldozed. CM6 has not been bulldozed and original foundations may exist. CM6, CM11 and possibly CM12 occur on the 1937 aerial photographs, although these have been much modified (or destroyed) by 2010. Nonetheless, these older compounds would have left middens and structural features.

Mitigation: If building plans for the compounds can be obtained, then the buildings would be partly mitigated. However, buildings were modified by the inhabitants and these would not be recorded. I suggest that a few compounds are selected and the foundations and any anomalies are recorded by a survey. The older compounds should have some form of excavations around the middens. The Deeds Office maps may indicate where the earlier structures occur, and in this way direct the areas for excavations.

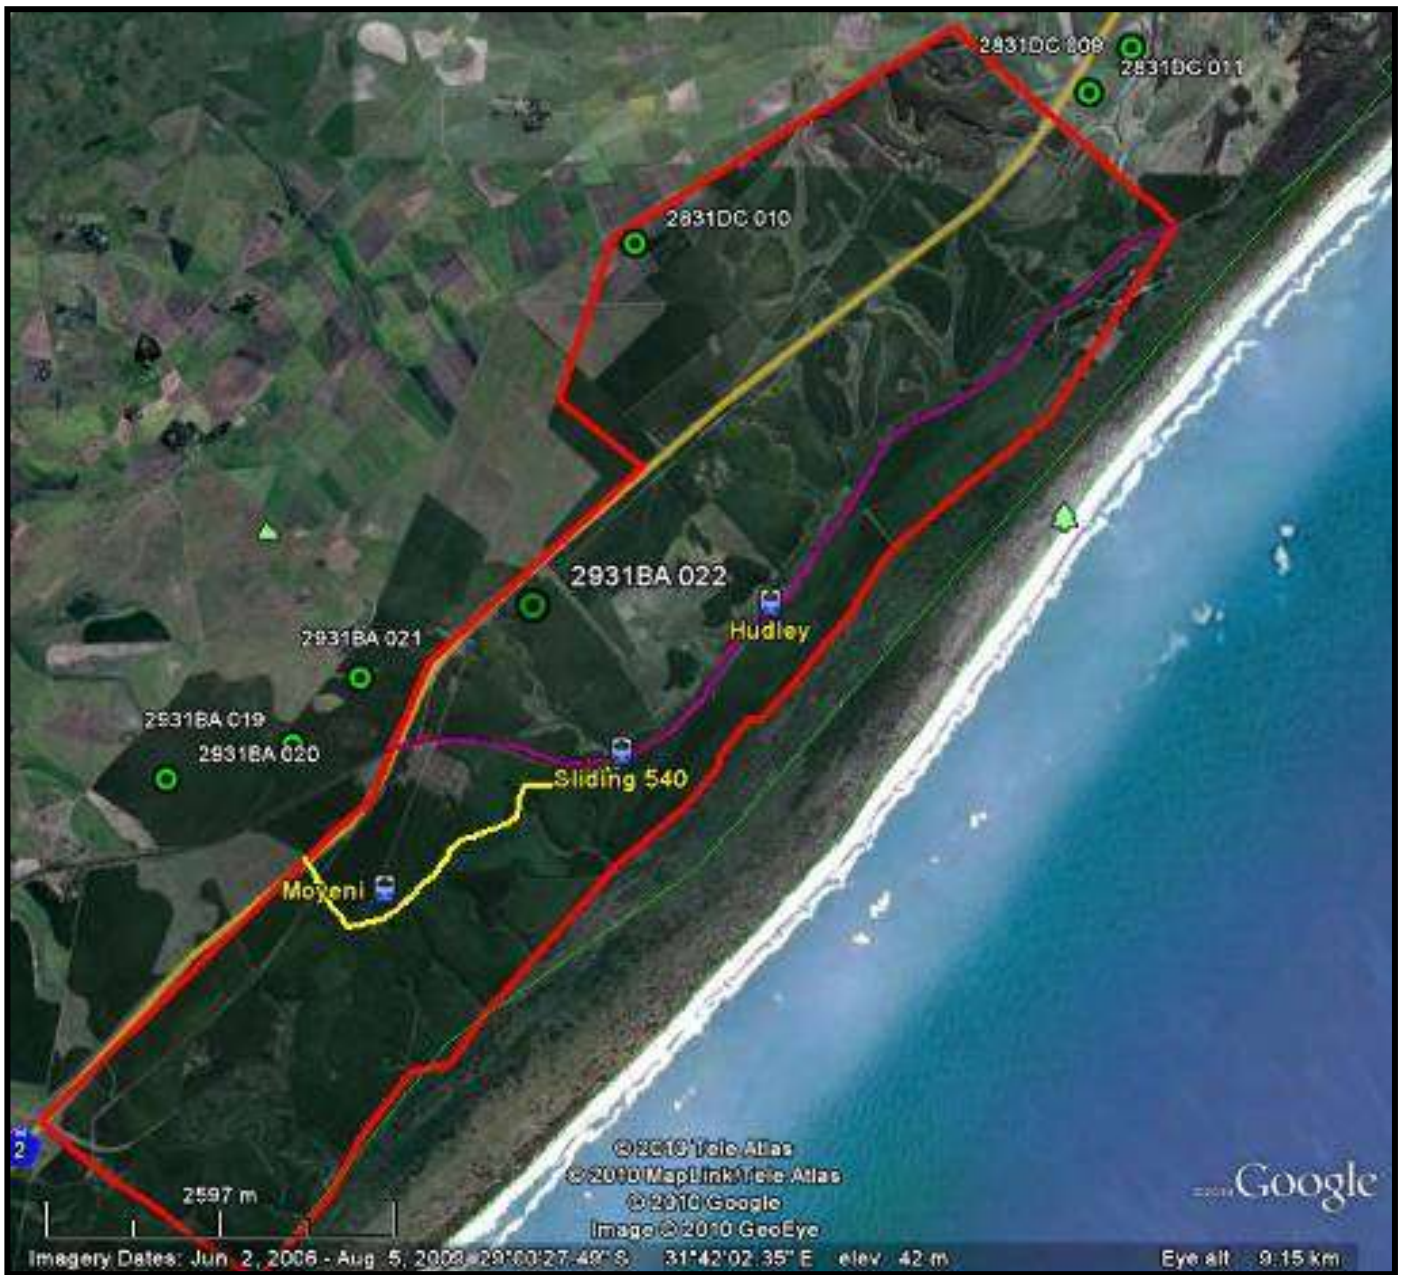
FIG. 11: LOCATION OF ORIGINAL AND CURRENT RAILWAY LINE⁴

The railway line running through the mining lease was in operation before 1937. Sections of the line have changed position after 1964, probably the late 1980s judging by the architecture. This would explain why there was a station near Carlyle farm, called Moyeni. The railway lines and the related stations and slidings are shown in fig. 11. The stations have been revamped recently (last 20-30 years and none of the original railway line exists).

⁴ Original railway = yellow, current railway = purple

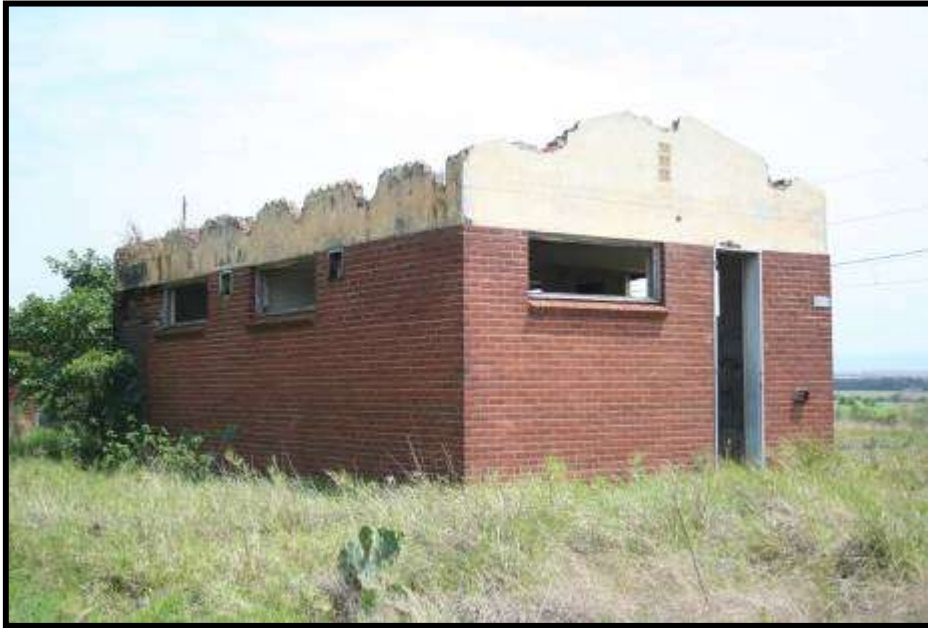
FIG 6: SHOWING REMAINS OF STATION BUILDING (PHOTO: SUPPLIED)

The structure is a roofless utilitarian building, possibly a station for the 1986 expropriation. This suggests that the building was constructed at this time, reinforced by the stretcher bond face brickwork and windows made to hold steel- framed windows. It has little architectural merit, and limited historical, social or technical value.

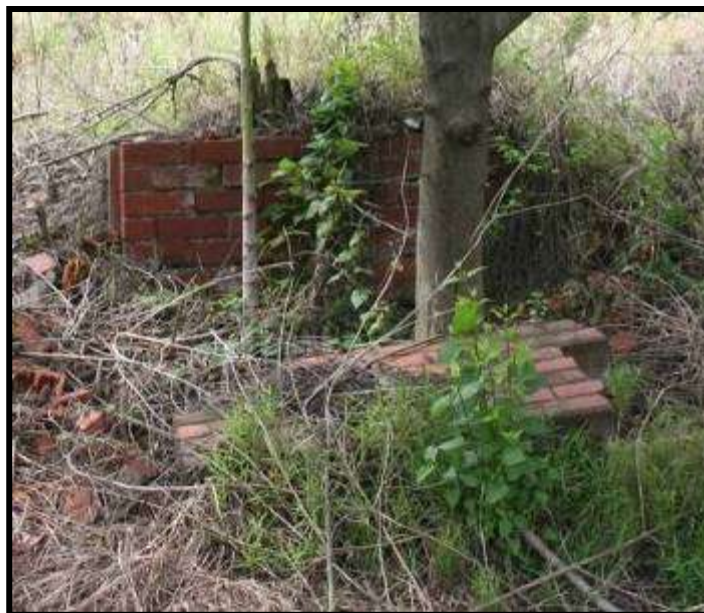
FIG 12: REMAINS OF CONTEMPORARY STRUCTURE ON LOT 98 UMLALAZI 9667 (PHOTO: SUPPLIED)

The 'structure' on lot 98 is the remains of a ruin, possibly a victim of the Mondi policy of destruction. However, the brickwork is indicative of recent construction, and would not be protected in terms of the KwaZulu-Natal Heritage Act no 4 of 2008.

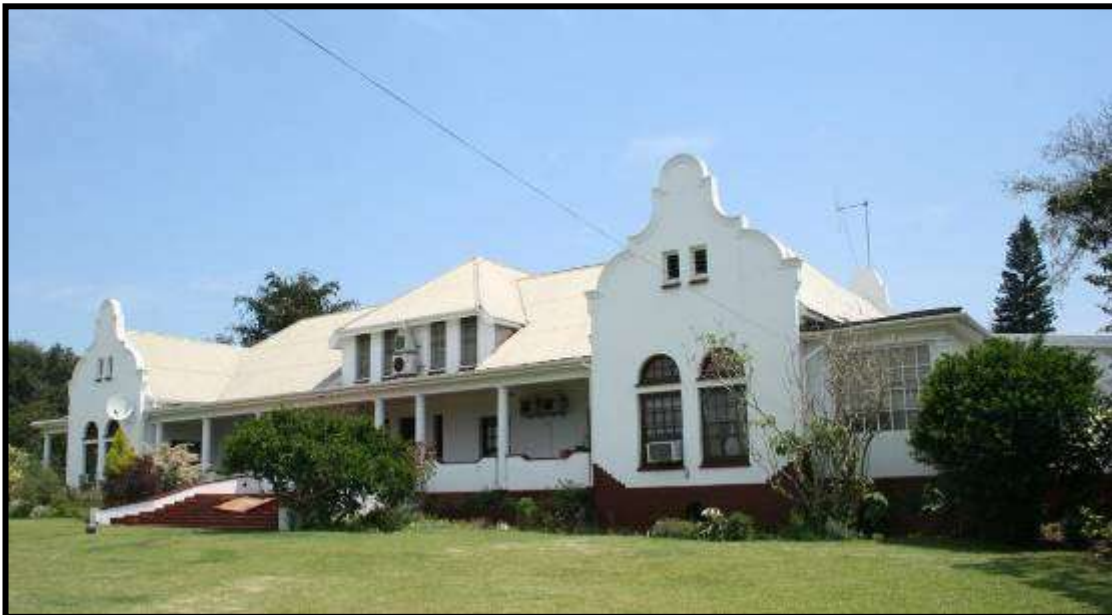
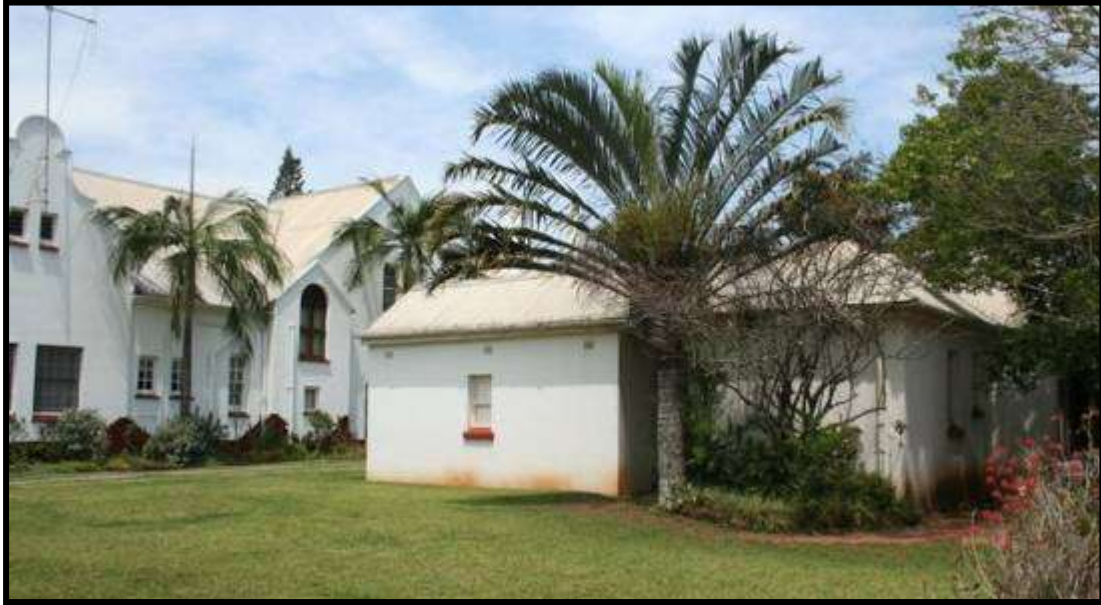
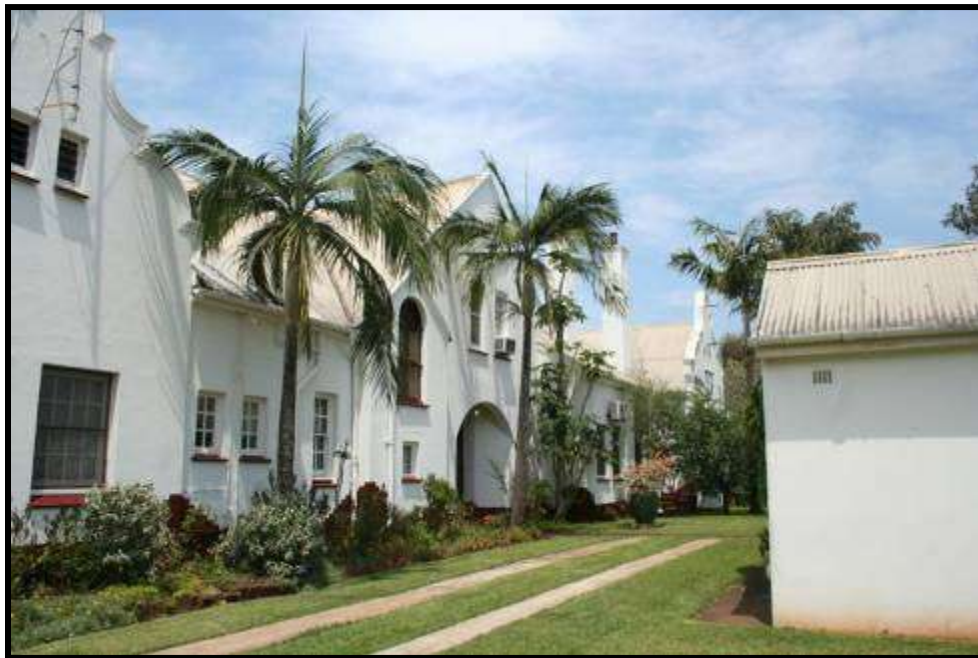
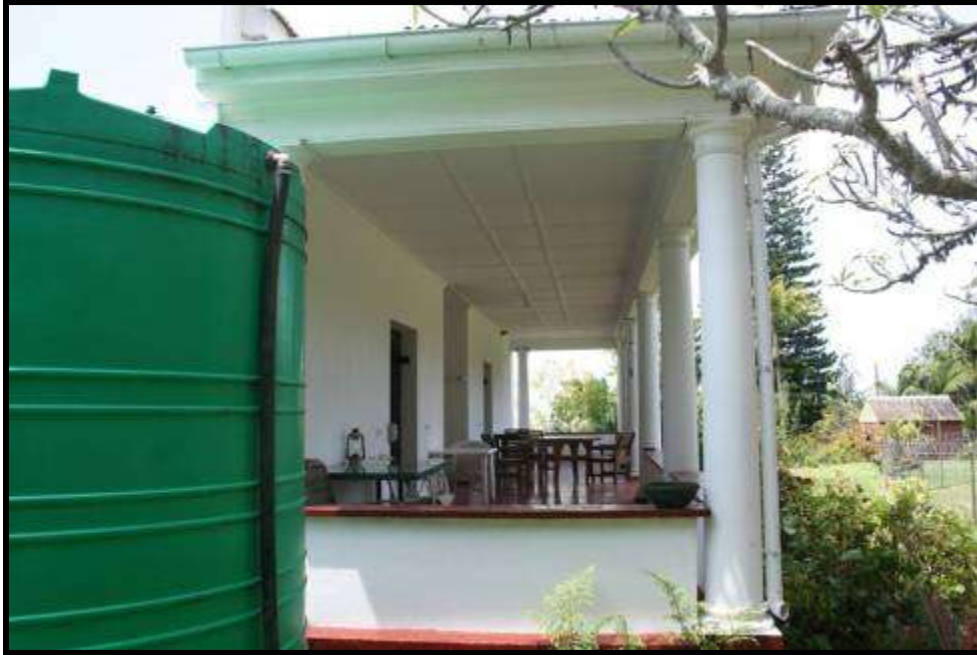
**FIG 14: SHOWING FRONT ELEVATION OF HIGHFIELD COUNTRY HOUSE
(PHOTO: SUPPLIED)**

sheeting, in a Cape Dutch Revival Style. It was allegedly constructed after the fashion of Groote Schuur (Pers.comm Sarco le Roux). A central stair leads to a wide veranda. A hipped second story reinforces the symmetry which is then supported by matching wings topped with simple Cape Dutch gables, with typically Union period windows below. It is also noted that this building is positioned in a well established garden. Highfields was constructed in 1929 by Roelf van Rooyen for his second wife. The original first house was demolished by Mondi many years ago (Sarco Le Roux, pers comm.). Willem le Roux, a partner in the farm with Ackerman, moved into the house and it has been occupied by the Le Roux family ever since.

House 1: Lot 89 Umlalazi	Local	Regional	National	International
Architectural importance	high	low	low	low
Historical importance	unknown	low	low	low
Technical importance	low	low	low	low
Social importance	unknown	low	low	low
Scientific importance	low	low	low	low

“This structure falls within the 60 year clause and is thus protected in terms of the KwaZulu-Natal Heritage Act no 4 of 2008. Moving the house and reconstructing it on a separate site is meaningless since the quality of the site and the existing garden will be lost. Demolition is NOT recommended as:

- The property is substantial*
- The house and associated building form a tight complex*
- The property has close proximity to the road and has been operating as a guest house for many years*
- The buildings are little altered and are in excellent condition*
- There is a strong topophilia suggested by the site, the house and its associated garden.*
- This is an excellent example of Union Period architecture in Zululand.*

It is strongly recommended that Highfield House be adopted by Exxaro KZN Sands as corporate headquarters, given its proximity to the main road and easy public access. The siting, topophilia and integrity of the building add up to an architecturally interesting structure. Recycling this building in a responsible and appropriate fashion is an opportunity for corporate responsibility.”

Management Plan: The house should be viewed as a red flag as it is of high architectural significance and demolition is not recommended. The general area would also have early rubbish middens and these would need to be monitored and sampled during any earthmoving activity. Exxaro will need to approach KZN Heritage if they want to demolish this building.

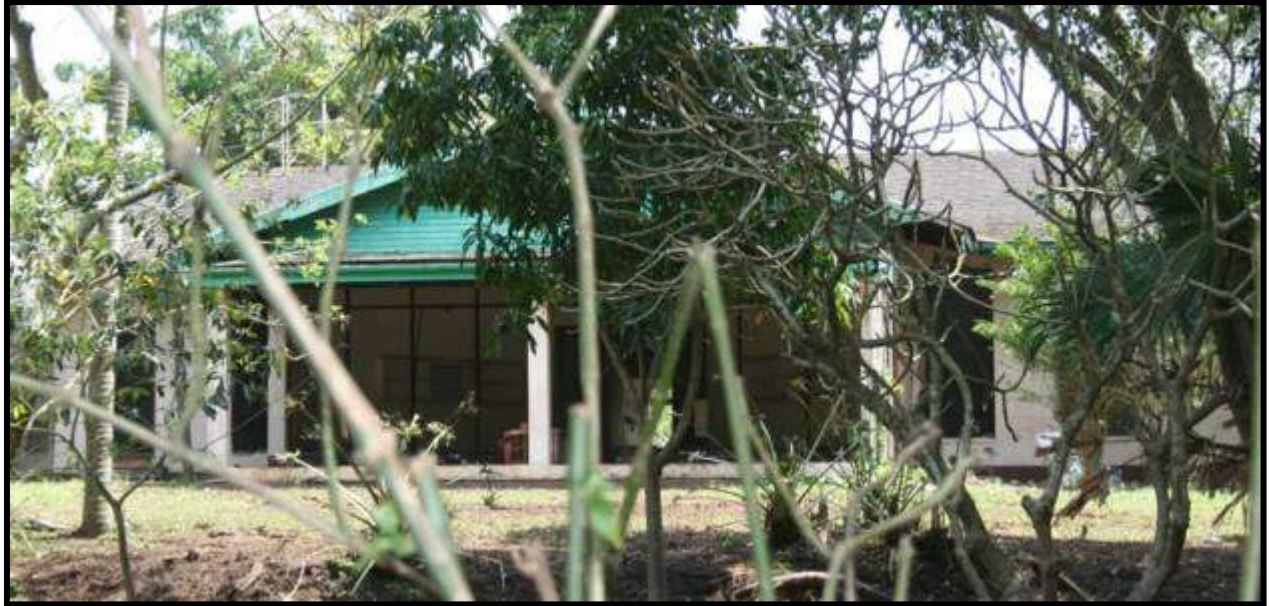
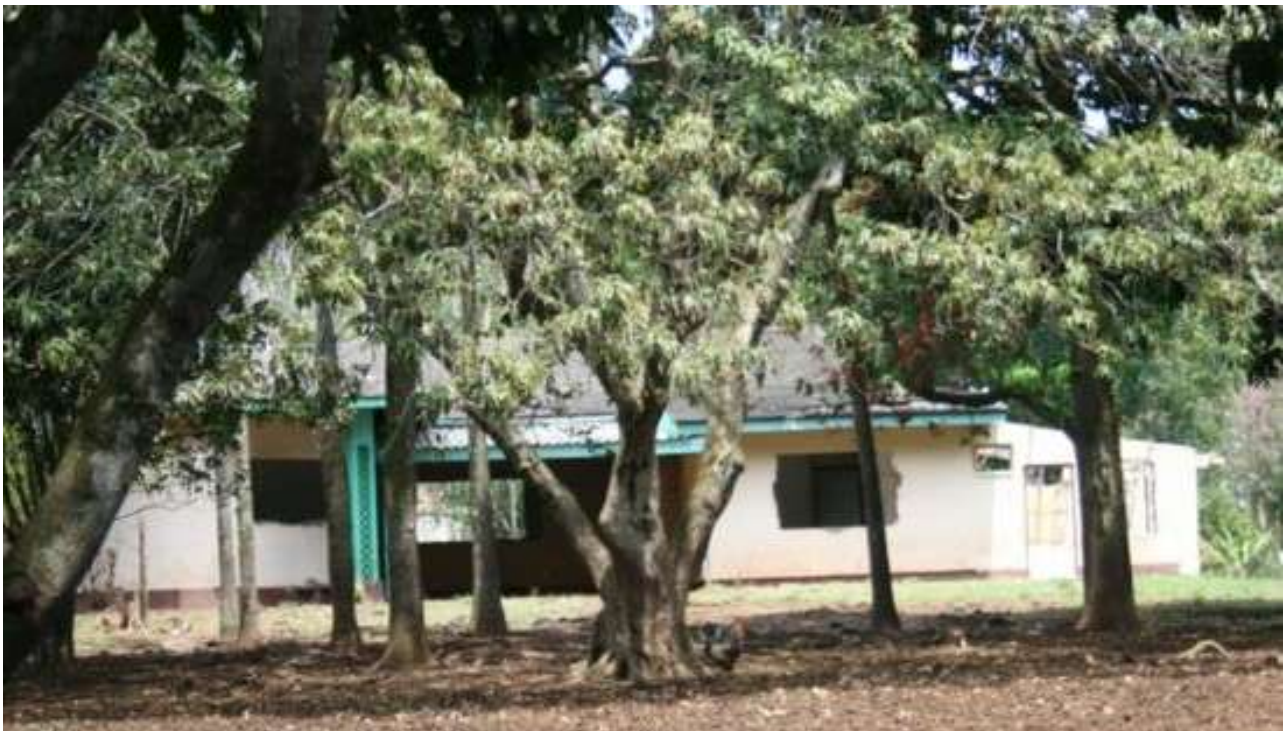
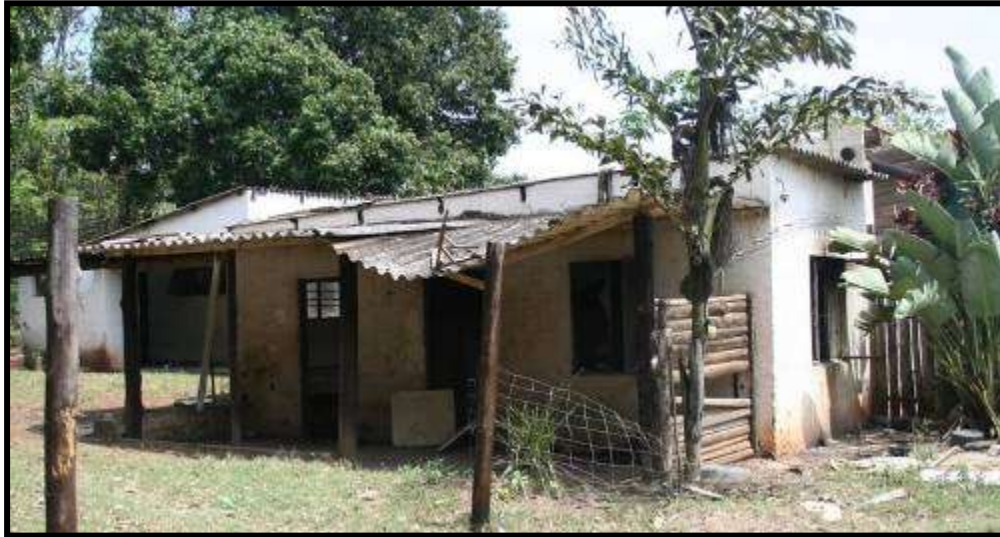
FIG 18: HOUSE 2 (PHOTO: SUPPLIED)

window frames. There is little of architectural, social or historical merit in these structures.

House 2: Lot 89 Umlalazi	Local	Regional	National	International
Architectural importance	low	low	low	low
Historical importance	low	low	low	low
Technical importance	low	low	low	low
Social importance	low	low	low	low
Scientific importance	low	low	low	low

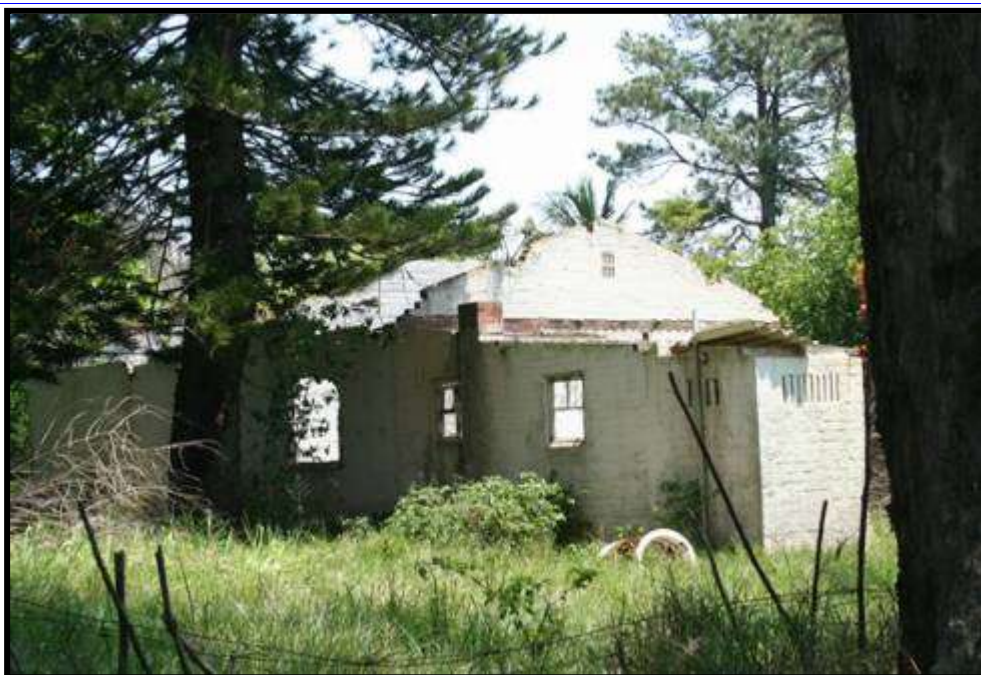
Fig 21: house at Adomay (photo: supplied)

Adomay was the name given to the 1969 subdivision which dates the house to the late 1960s. The house is semi- demolished.

House 3: Lot 89 Umlalazi	Local	Regional	National	International
Architectural importance	low	low	low	low
Historical importance	low	low	low	low
Technical importance	low	low	low	low
Social importance	low	low	low	low
Scientific importance	low	low	low	low

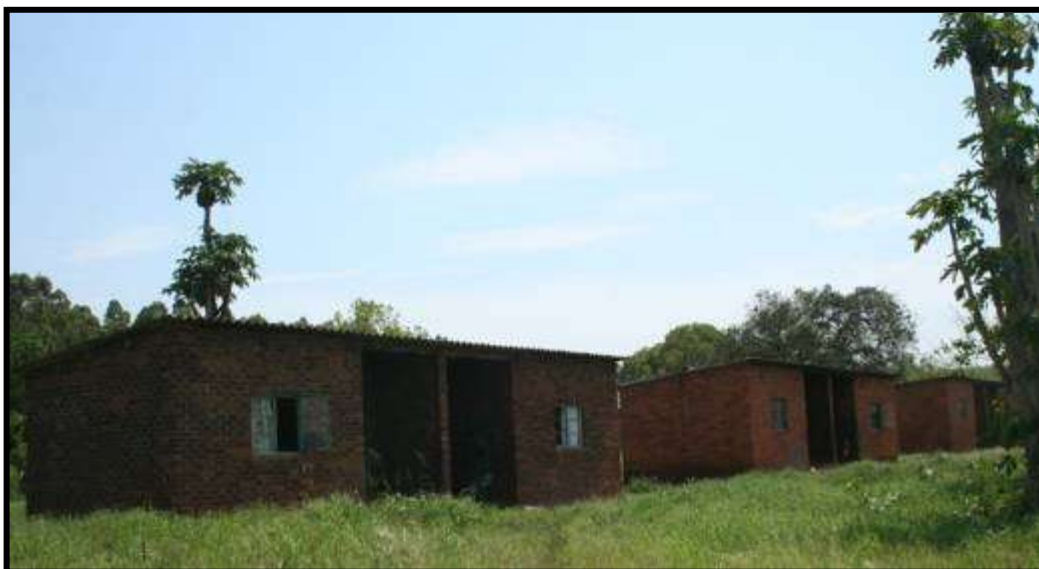
FIG 23: CANEFIELDS COMPOUNDS (PHOTO: SUPPLIED)

The only pictures of structures received were the labourer's compounds at Canelands, near Hudley Station. These are of recent construction and have little merit.

Hudley: Lot 100 Umlalazi	Local	Regional	National	International
Architectural importance	low	low	low	low
Historical importance	low	low	low	low
Technical importance	low	low	low	low
Social importance	low	low	low	low
Scientific importance	low	low	low	low

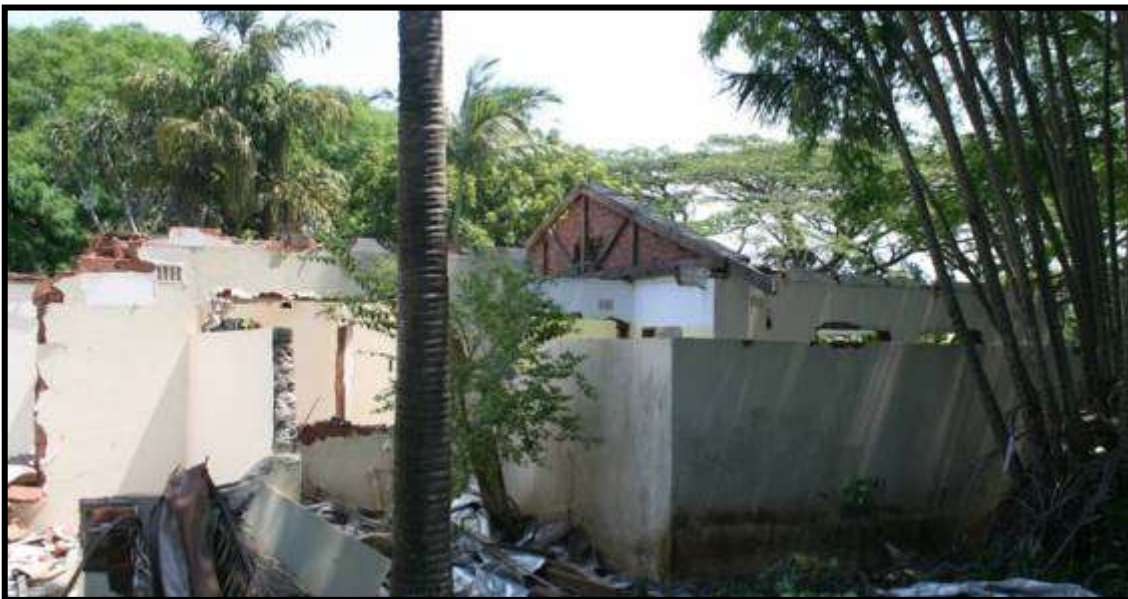
FIG 25: 'PENNYWERN ROAD' (PHOTO: SUPPLIED)

The structure, described as 'Pennywern Road' is largely demolished. It is of recent and common construction. However, the established garden points at earlier settlement and remnants of any earlier structures may still be visible.

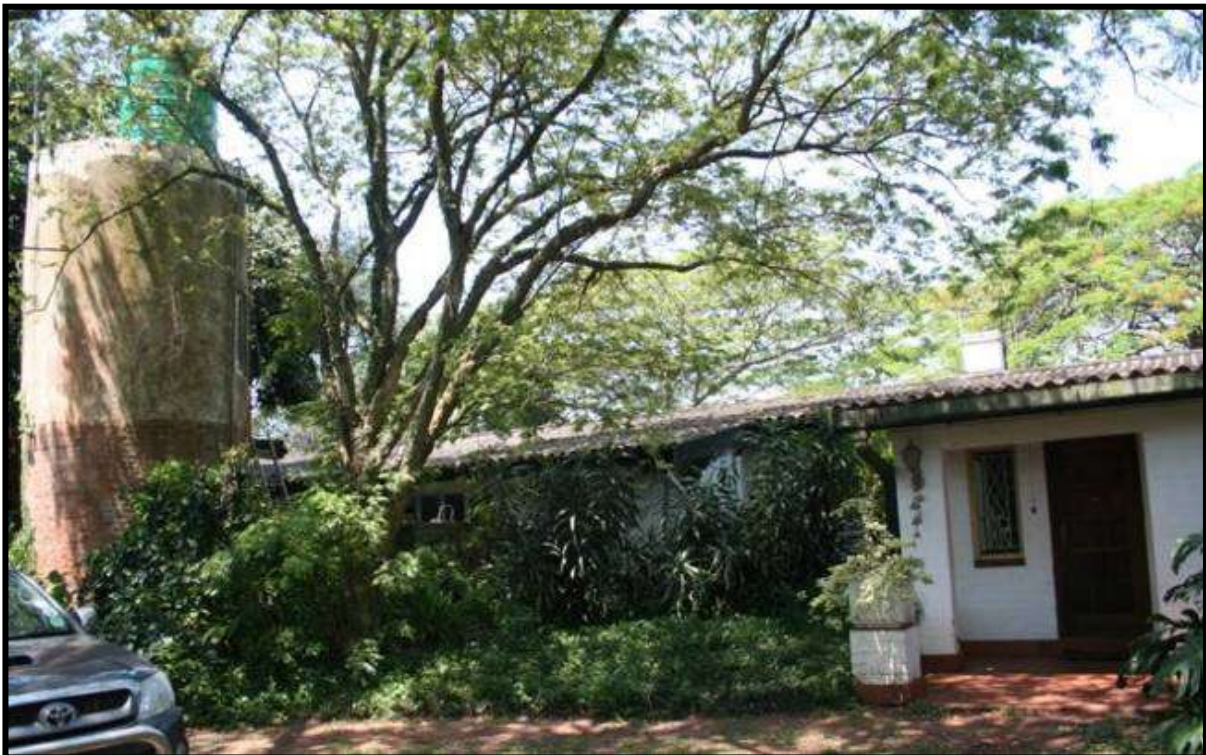
FIG 27: OUTBUILDING (PHOTO: SUPPLIED)

The buildings are of recent construction of brick and mortar under a Roman tile roof. The garden is established. The buildings have little architectural merit.

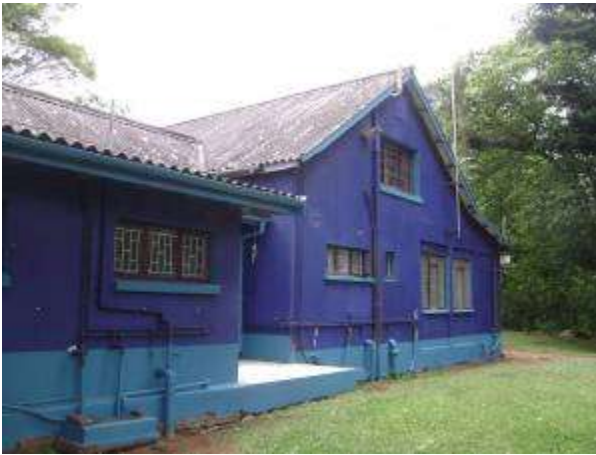
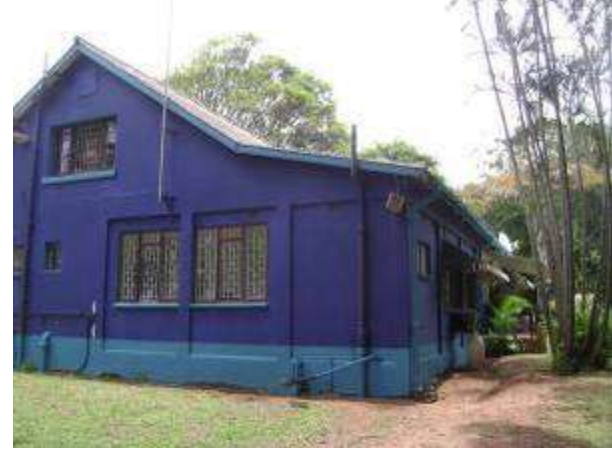
Fig 3.1 Main house east elevation

The main house is of conventional masonry construction under a corrugated fibre-cement (asbestos) roof. The windows and doors are all recent meranti standard issue and there are few diagnostic features which reveal its origin in the 1930. the house is painted a striking blue, and has limited views of the ocean, facing rather into the plantation.

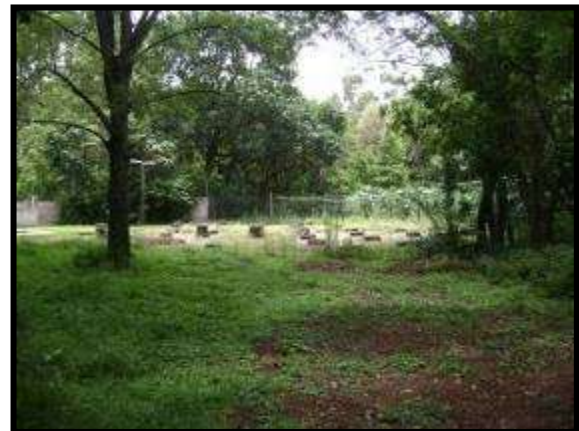
Fig 3.4 Old tennis court (author 2010)

The surrounding garden is established and typical of the area, but is not a striking example of horticultural expertise. There is a story that Talmage family members were buried under the tennis court.

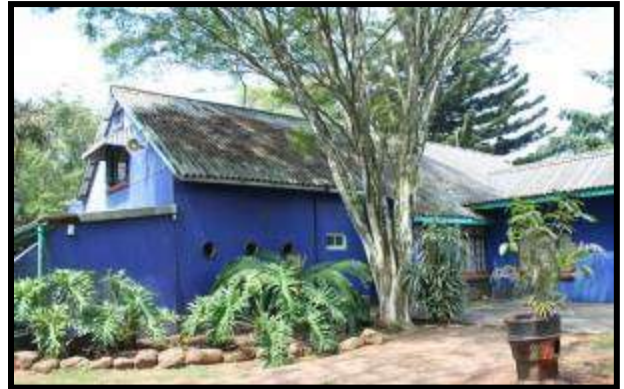
Fig 3.6: south west elevation

The original homestead apparently burnt down in the 1930s. The house which stands today has some period doors and fittings inside it which were rescued from the original house. Little else of the house is original, except for the staircase handrail and the kitchen. Elements have been added on over the years to create a rambling utilitarian homestead with little architectural merit.

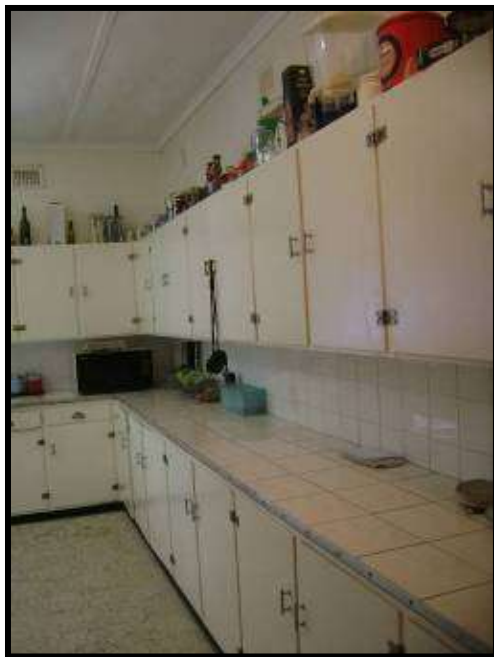
Fig 3.11: Kitchen with fittings—possibly original

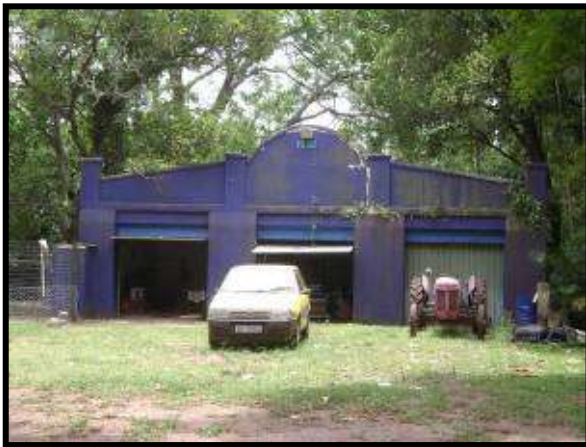
Possibly the oldest structural remnant on the site is the elegantly gabled garage/shed, which is also of conventional construction under corrugated asbestos. It has a date in the centre of the gable declaring that it was constructed in 1921. Its only relationship with the main house is its blue colour.

Fig 3.13: garage/ shed constructed in 1921.

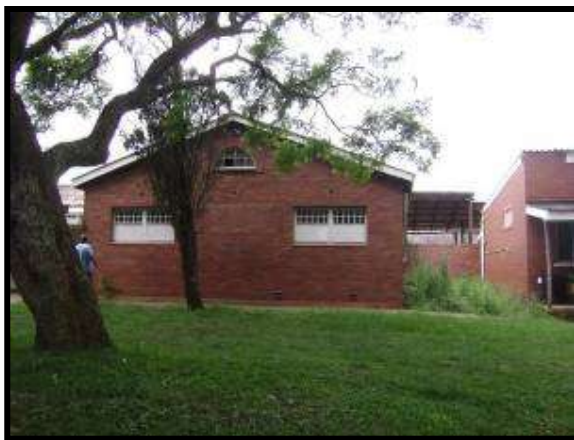
Fig 3.15: trading store and butchery, 1951.

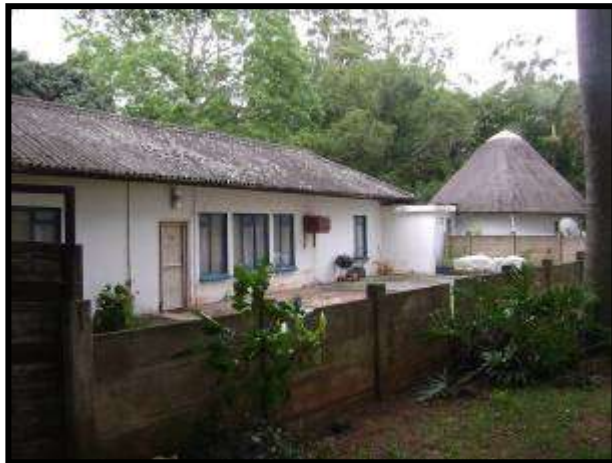
Fig 3.17: second dwelling, 1950's 1960's conventional materials under corrugated asbestos sheeting

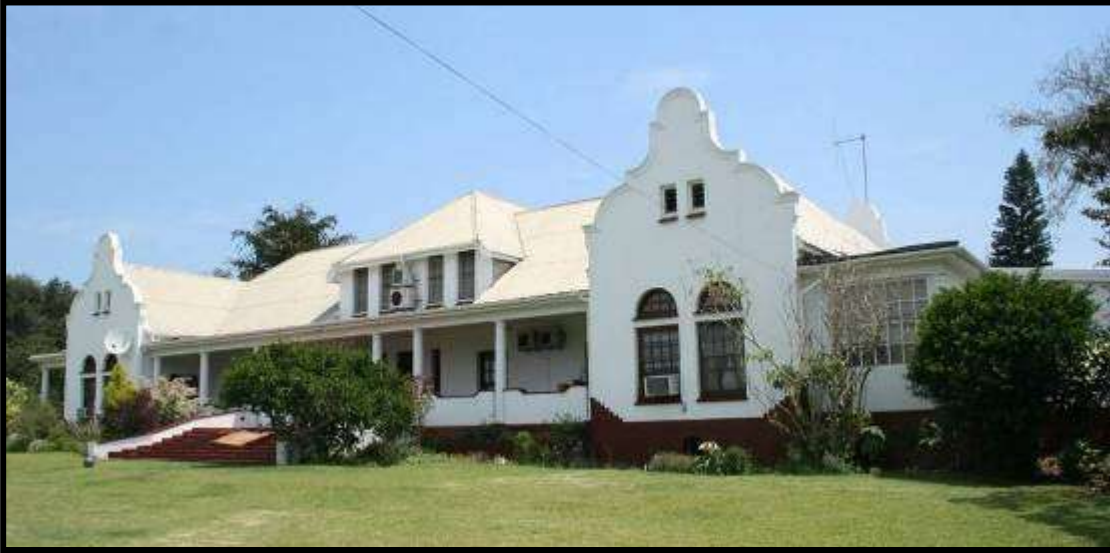
Fig 4.1: Showing front elevation of Highfield Country House (photo: supplied)

'This building is currently operating as a Bed and Breakfast under the name Highfield Country Home. It is a substantial structure, of plastered masonry under corrugated iron sheeting, in a Cape Dutch Revival Style. It was allegedly constructed after the fashion of Groote Schuur (Pers.comm Sarco le Roux). A central stair leads to a wide veranda. A hipped second story reinforces the symmetry which is then supported by matching wings topped with simple Cape Dutch gables, with typically Union period windows below. It is also noted that this building is positioned in a well-established garden. Highfields was constructed in 1929 by Roelf van Rooyen for his second wife. The original first house was demolished by Mondi many years ago (Sarco Le Roux, pers comm.). Willem le Roux, a partner in the farm with Ackerman, moved into the house and it has been occupied by the Le Roux family ever since.'

On inspection, the following was noted. Highfield consists of a number of buildings situated in close proximity. These consist of the substantial main house, which has views across an established and notable garden towards the sea. The house and the garden are intimately connected and together they demonstrate an extraordinary *topophilia*. Close to the house are the combined conservatory (perhaps a name much smarter than its function) and the garages. Labourers cottages exist on the property but these are both distant and modest and not worthy of retention. Adjacent to the garage is a water tower of mixed construction and uncertain date. It is however, both nostalgic and monumental. The house and grounds are in immaculate condition, and the building is structurally sound.

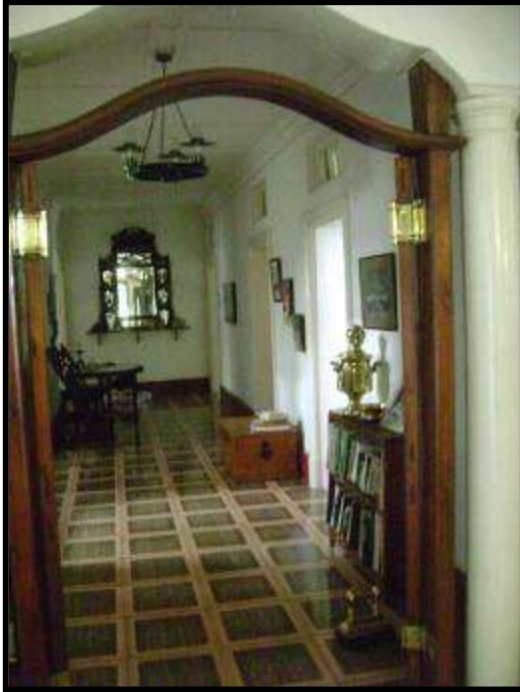
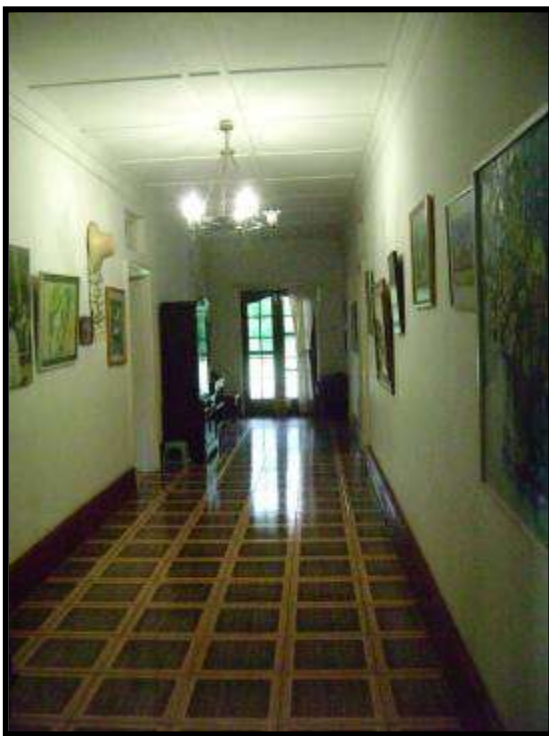
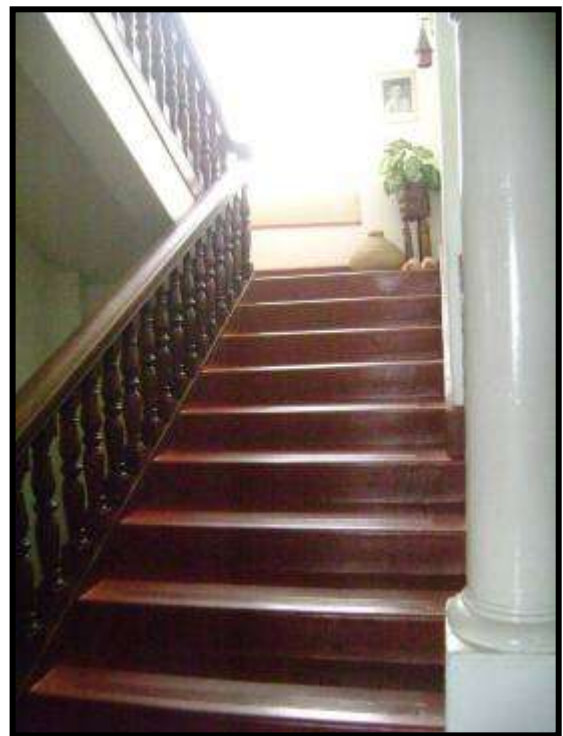
Fig 4.7: view along hallway

The plan of the house is characterized by a double-loaded wide hallway. Intersecting this hall at the entrance is a cross-passage which creates the symmetry of the building and enhances the focus of the views out across the garden towards the ocean. The timber internally is teak and mahogany, and the Union Period theme revisits the architecture of Groote Schuur. Downstairs has bedrooms, all with basins, a pristine bathroom and reception rooms and dining and cooking areas. One gains access to the second floor up an elaborate staircase. The second floor has much smaller spaces and is much less grand than downstairs.

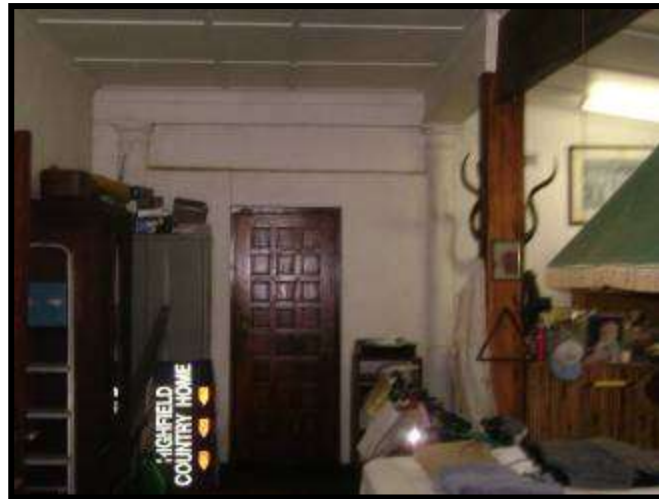
Fig 4.9: The enclosed veranda to the north forming a games room.

Alterations: The hallway floor has been covered with an unfortunate ceramic tile, which could possibly be replaced. The other changes are minor; the short veranda to the north has been enclosed to form a games room, and two *en-suites* have been constructed in the attic space upstairs in each of the short elevations. The effort of the owners according to Mrs. Le Roux, was to interfere as little as possible with the authenticity of the building.

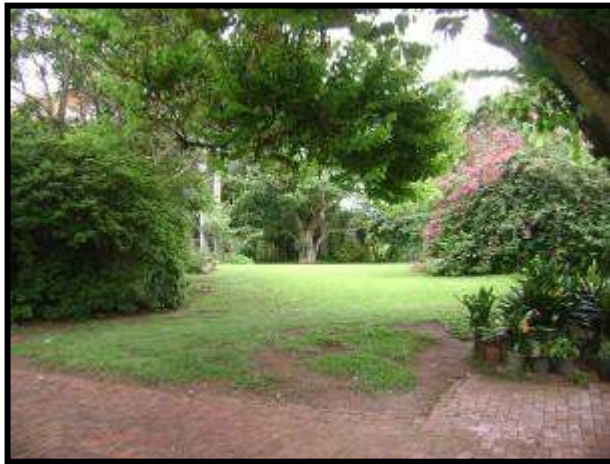
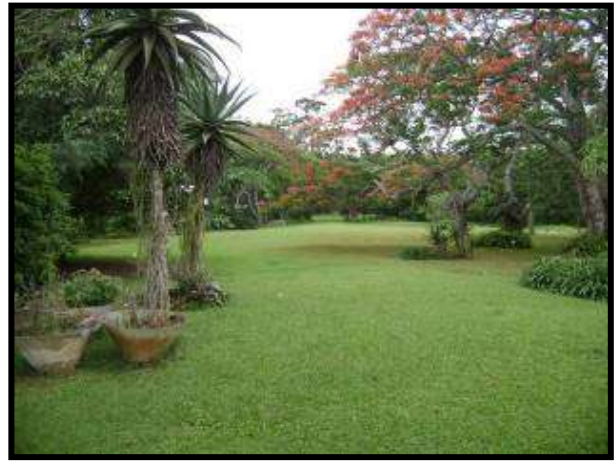
Fig 4.12 and 4.13 garden views

As mentioned earlier in this report, this garden is noteworthy and forms part of the sense of place created by the main house. The plant material is not solely indigenous, but the

creation of separate spaces with their own identity and the views across the ocean are commendable.

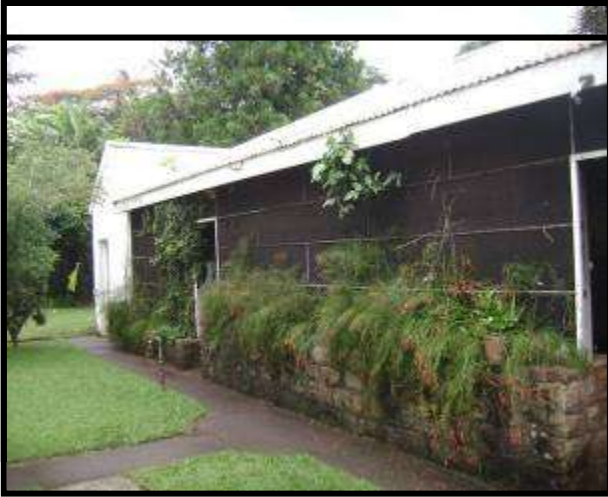
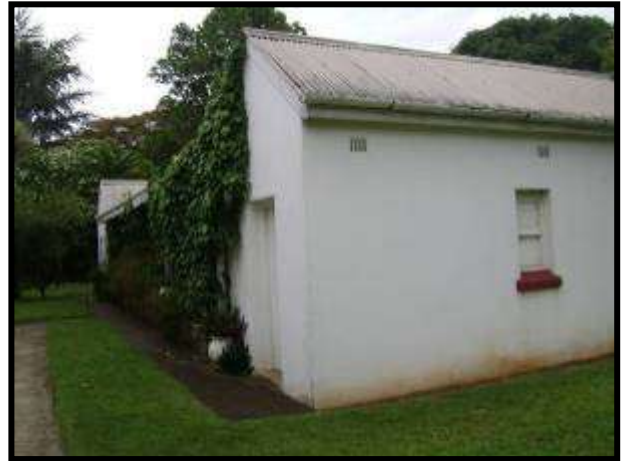
Figs 4.19, 4.20 and 4.21: The conservatory/ garage

This is a smaller, modest and elongated orthogonal structure which is situated at the rear of the house, where one arrives on the property. It is of conventional construction under a ridged corrugated sheeting and would appear to date to the construction of the main house.

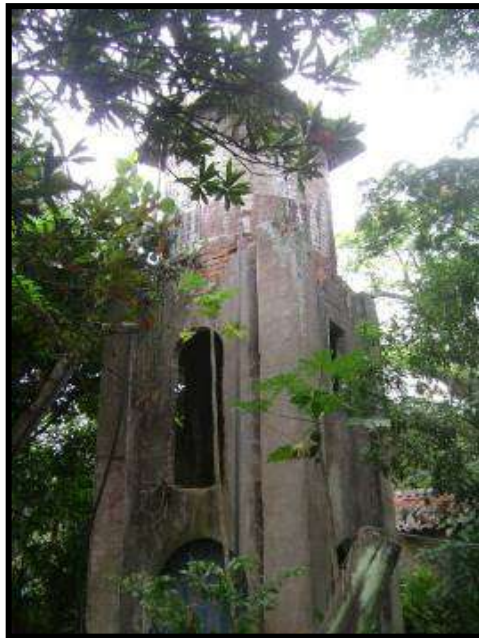
Fig 4.21: Water tower

This is monumental and of such mixed construction that it is difficult to date as it is suspected that it was also built out of rubble and second- hand bricks. As noted, it has nostalgia value rather than any serious architectural merit.

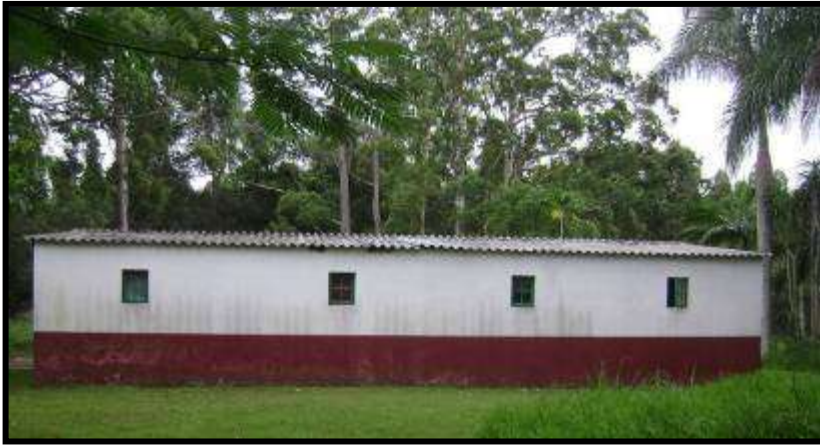
**Fig 4.22: Labourers quarters**

These are situated distant from the house, have little or no architectural merit, are on the edge of the garden and their demolition could be condoned.
