**INTEGRATED HERITAGE IMPACT ASSESSMENT IN TERMS OF SECTION  
38(8) OF THE NATIONAL HERITAGE RESOURCES ACT, 1999 (ACT 25 OF  
1999)**

**PROPOSED RESORT DEVELOPMENT: KRAAIBOSCH 195/64, GEORGE  
DISTRICT**

**APRIL 2012**

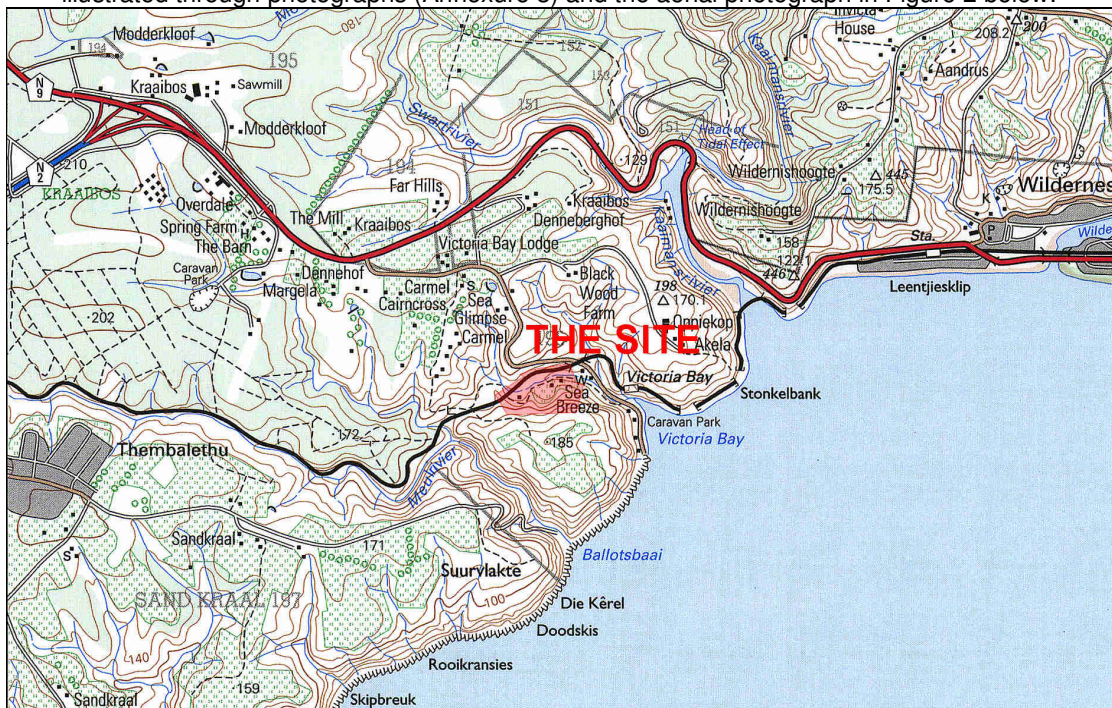
**Figure 1:** Locality of property in relation to Thembalethu, Wilderness and the N2 National road (Source: 1:50,000 Topo-cadastral series, 3422AB & 3322DC, 3422BA George, CDSM)

The subject property (15,4176ha in extent) is approximately 11km southeast of George, 8km west of Wilderness and south of the N2 National road as shown with the locality plan below. The property is located within a closed-off valley, directly northwest of the coastal hamlet Victoria Bay and bounds onto an existing high-density holiday resort named “Seabreeze”, as illustrated through photographs (Annexure 3) and the aerial photograph in Figure 2 below.

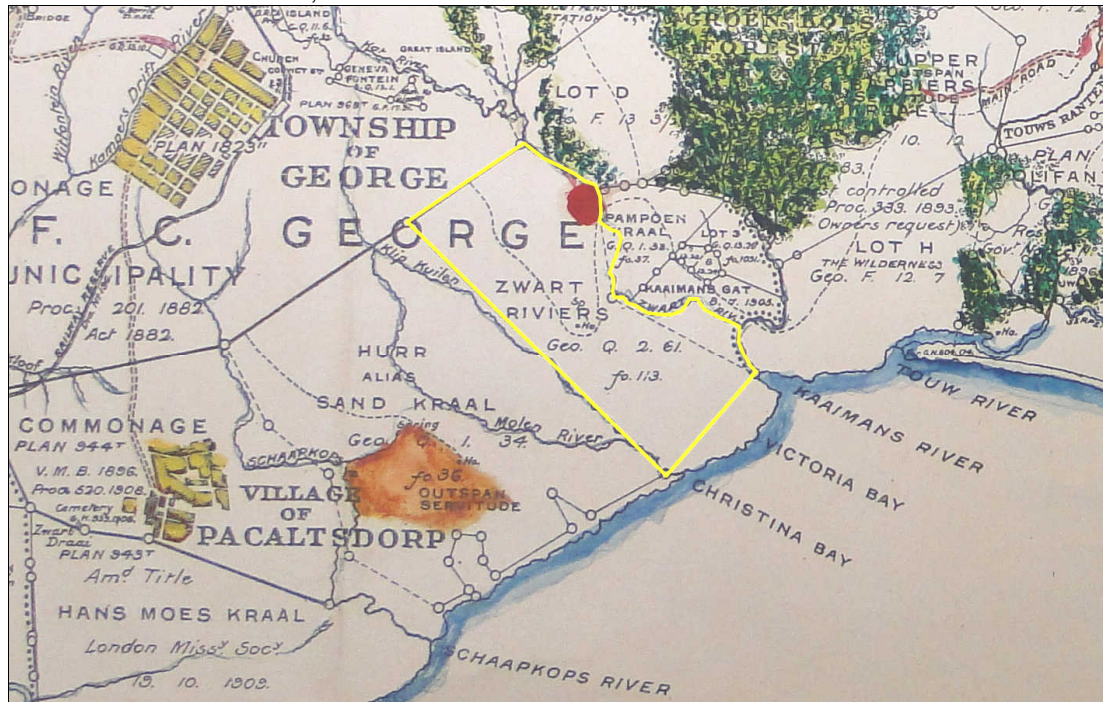
**Figure 4:** Original boundaries of farm Zwart Rivier transposed onto compilation of 1880-1890 SG Map. The farm name Kraaibosch appears on maps from c. 1903 onwards (Source: George Museum Archives)

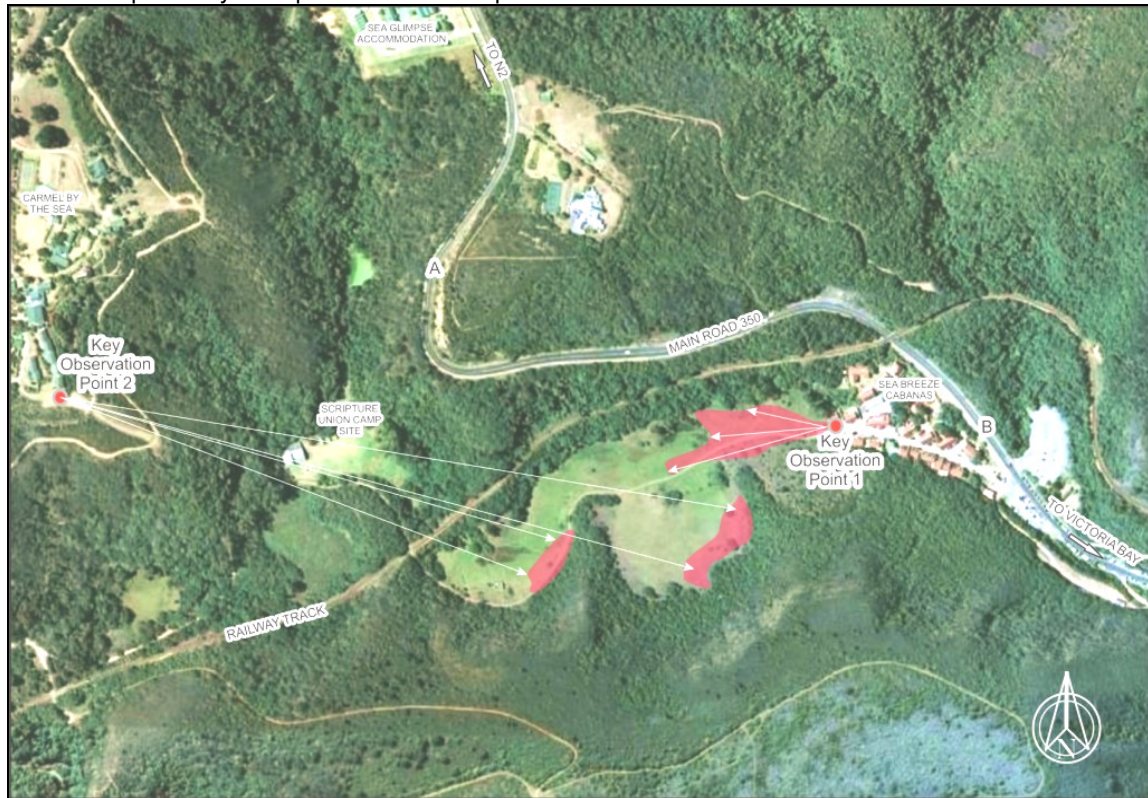
**Figure 10:** Potential visual impact from Key Observation Points (KOP's) (Source: Google Earth)

The main access road (Main Road 350) to Victoria Bay runs along the hillside just north of the northern property boundary. However, during visual inspection along the entire route between points "A" and "B" (refer Figure 10) it was found that due to (a) the vertical and horizontal alignment of the road in relation to the property and (b) occurrence of embankments and indigenous vegetation along the southern road boundary, it is not visible from this road in both directions. To illustrate this, please refer to the series of photographs attached providing sequenced views from the Main Road 350, railway tracks and site itself (Annexure 10).

During fieldwork, the Carmel Guest Farm was identified as a second KOP and views from here towards the subject property are illustrated through photographs attached as Annexure 10. As further shown with Figure 10, only relatively small portions of “potentially developable” areas would be visible from the easternmost boundary of KOP 2 over a long distance – primarily due to the geographic location of these areas within the narrow valley as well as the two ridgelines, which obscures portions of the site from view. Future development of the subject property may therefore have a moderate visual impact (long distance, east-facing views) from Carmel Guest Farm’s east-facing holiday accommodation units located along the natural ridgeline.
