**PROPOSED UPGRADE OF D1867 ROAD SITUATED
WITHIN THE PHONGOLA MUNICIPALITY, KWAZULU-
NATAL AND MPUMALANGA PROVINCES**

Phase 1 Heritage Impact Assessment

19 July 2019

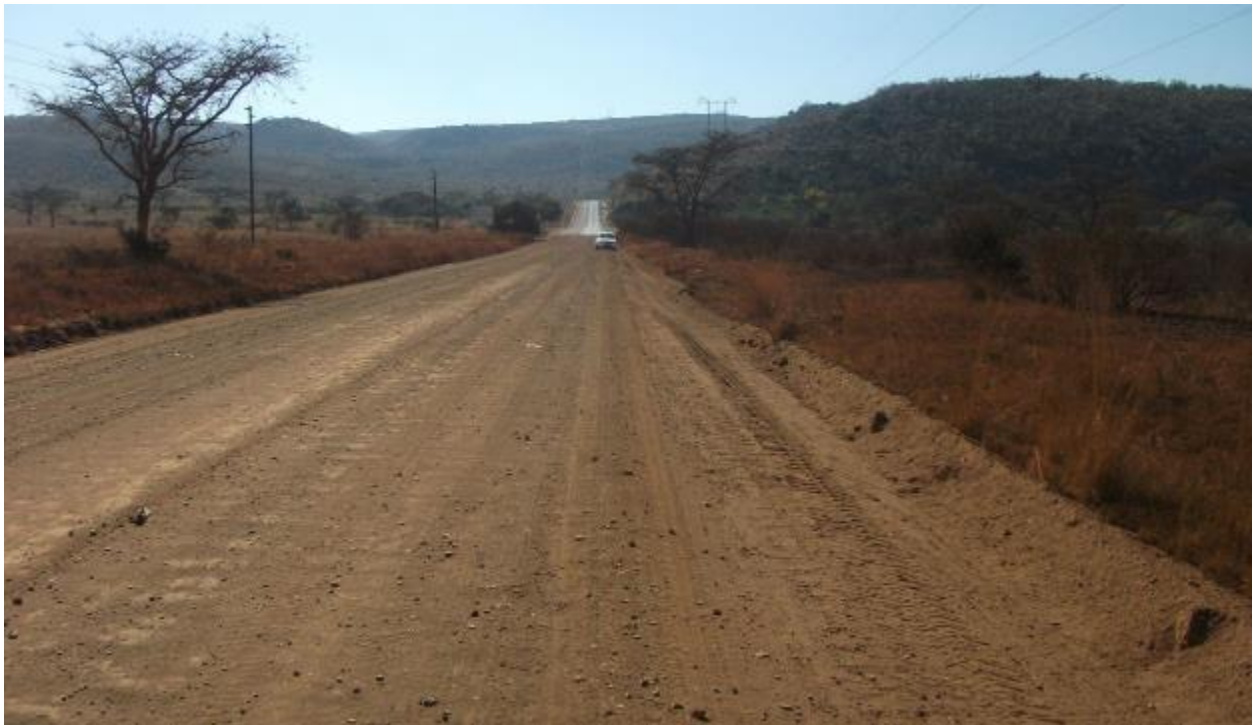
The site inspection started at the end point (north-eastern end) of the proposed upgrade and proceeded southwards to the start point of the upgrade. There is existing infrastructure along the D1867 including power lines as well as a new water pipeline on the western side of the road. This pipeline runs the entire length of the proposed road upgrade.

Figure 2: View towards end point of road upgrade

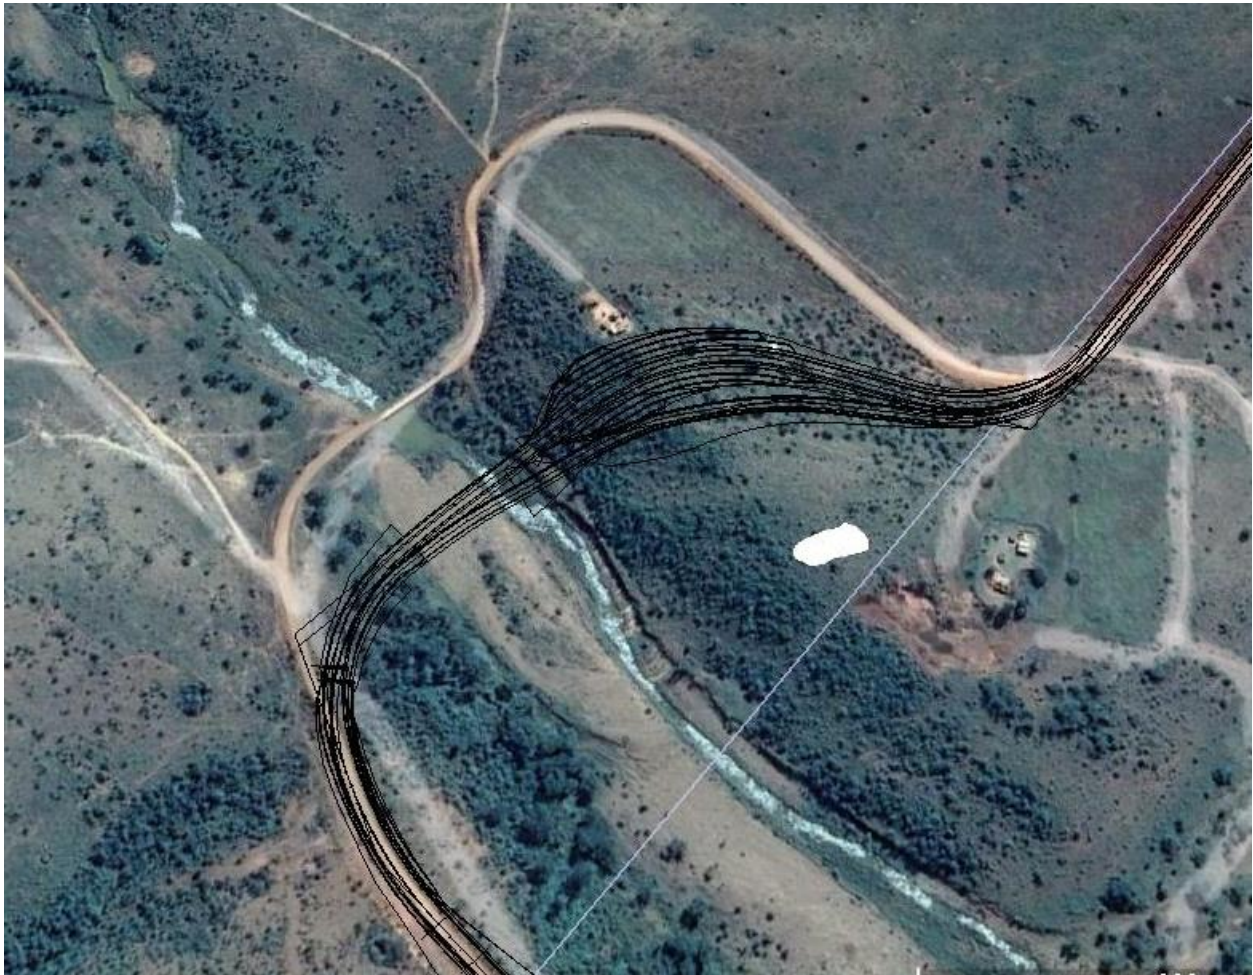
A diversion of the current alignment of the D1867 is proposed where the road loops into the Mozana River valley before crossing the river (see **Figure 3** below). Diversion alternatives 4 and

Two homesteads are situated south-east of the existing road as well as a burial site consisting of at least 16 graves that were pointed out by those residing at the homestead. The graves between the two homesteads are located about 80m from the proposed road diversion. The graves are made from packed rock and earth, and some appear to be well over 60 years of age

Figure 3: Burial site shaded in white with road diversion indicated in black

An assessment of the significance of impacts of the upgrade of the road on graves indicated that both pre- and post-mitigation, the impact would be a low impact due to the distance between the burial site and the proposed road upgrade. It is recommended that the burial site is clearly demarcated to avoid any impacts to the graves during the construction phase of the project. Of the two deviation alternatives, alternative 5 is the preferred option from a heritage perspective as it is located some distance from the burial site as well as from the two homesteads.

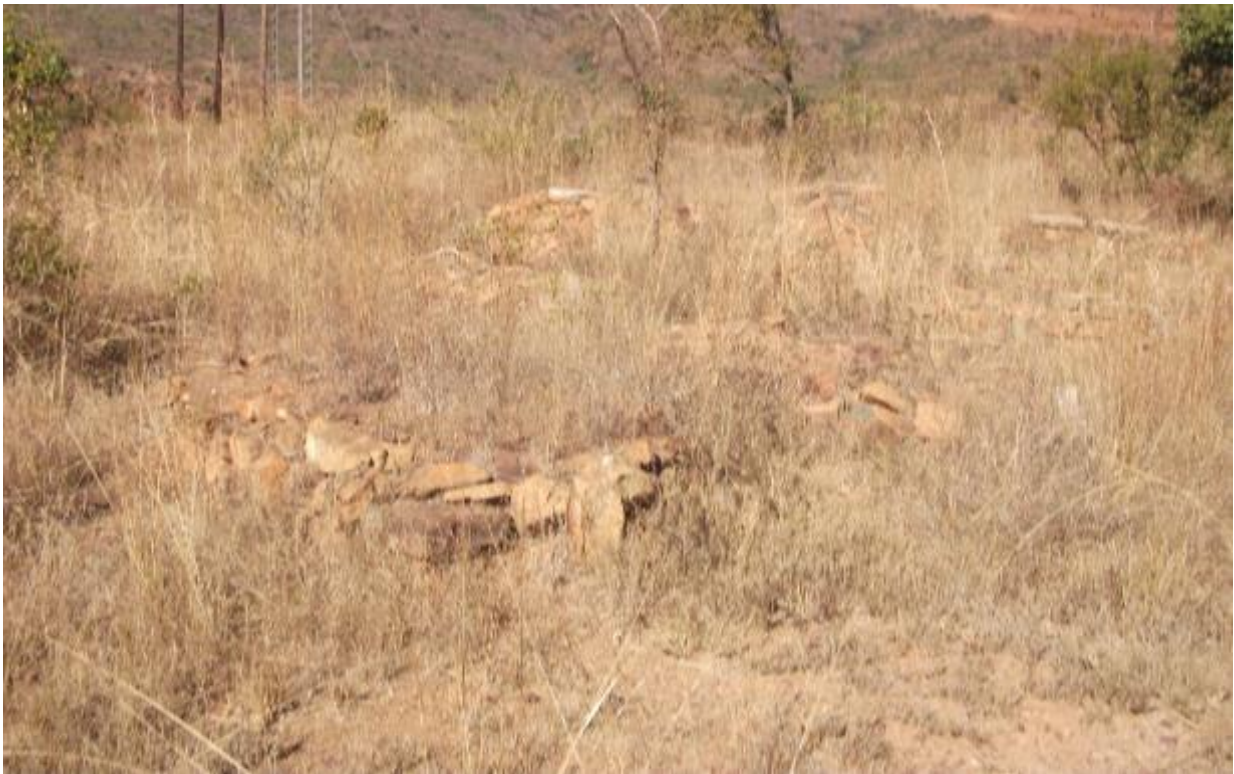
Between the graves and the homestead are the remains of several homesteads. The residents of the homestead explained that family members had lived in this area and when they died, the structures were dismantled. According to these residents, all associated graves are located in the burial site mentioned above.

Figure 4: Graves made from packed rock

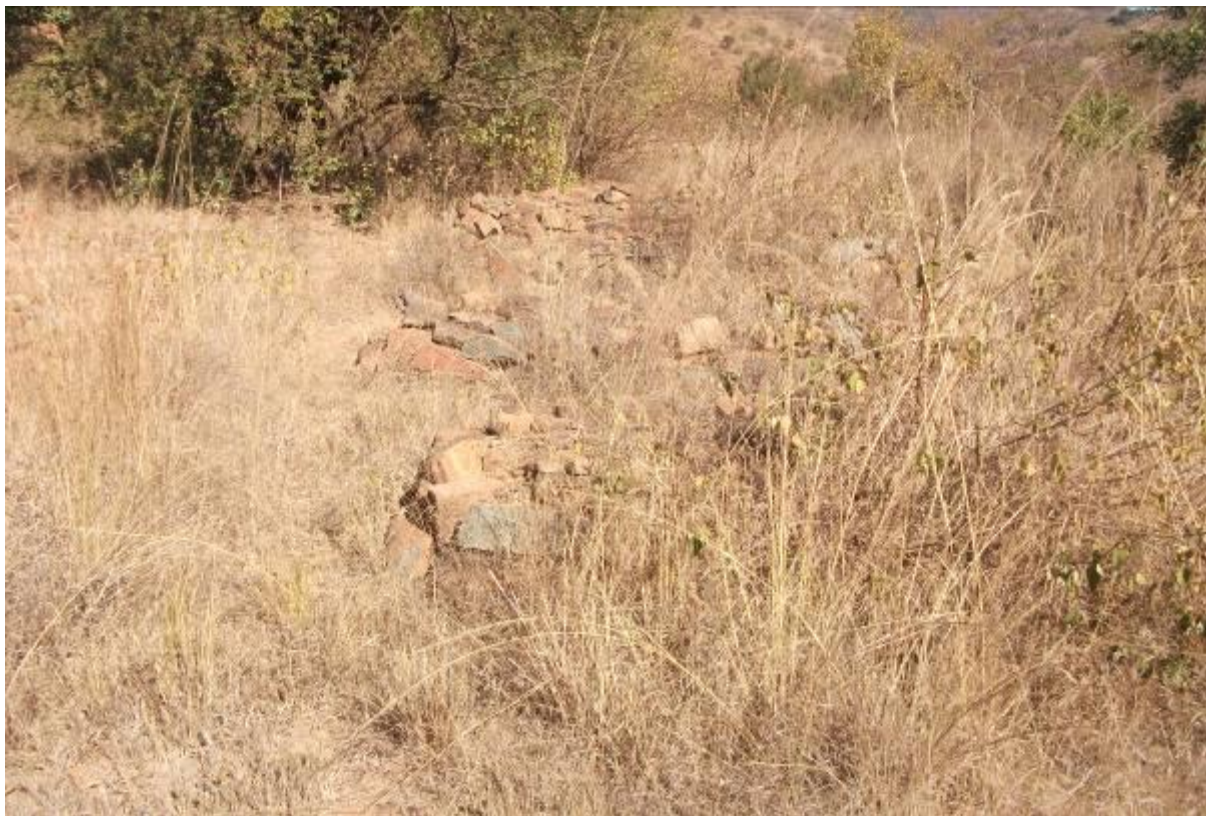
Figure 5: Graves forming part of the burial site

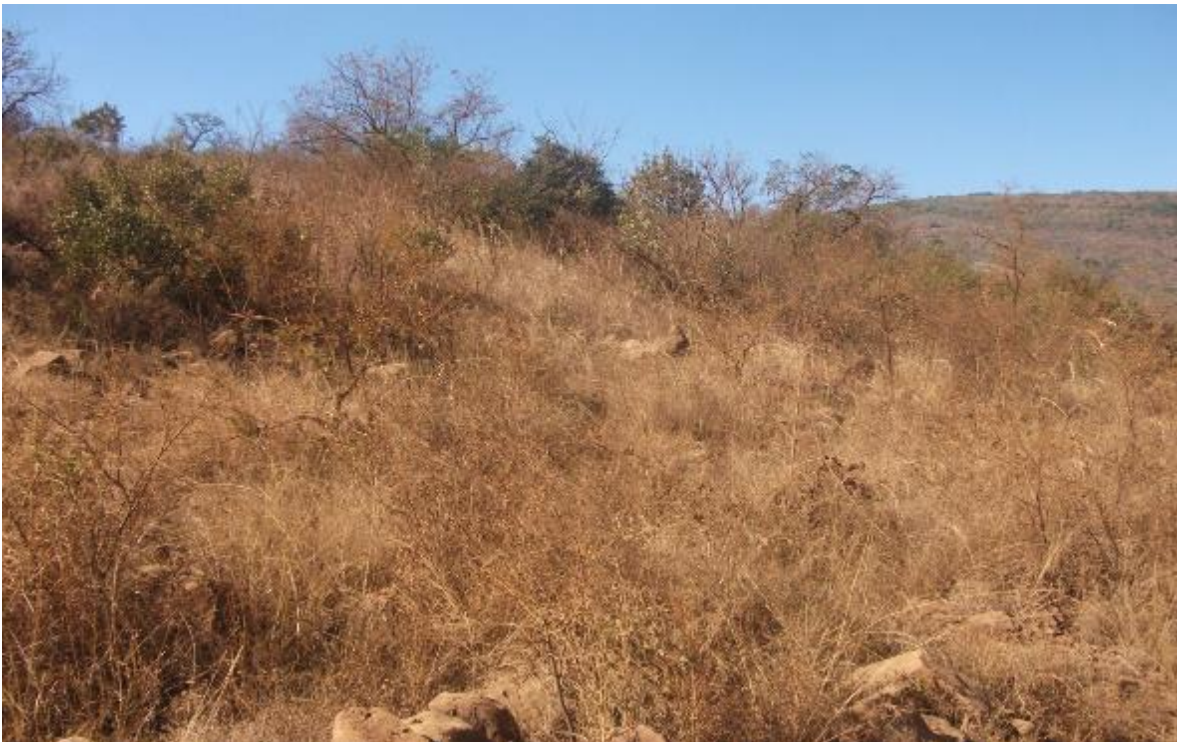
The proposed diversion crosses a rocky outcrop that is situated above the river. The outcrop is in pristine condition and should be avoided by the proposed road upgrade as such areas can be archaeologically sensitive, although nothing was found during the site inspection.

Figure 6: Rocky outcrop

The proposed road diversion also crosses a rocky outcrop which is in pristine condition. It should be avoided by the proposed upgrade as such areas are often archaeologically sensitive.

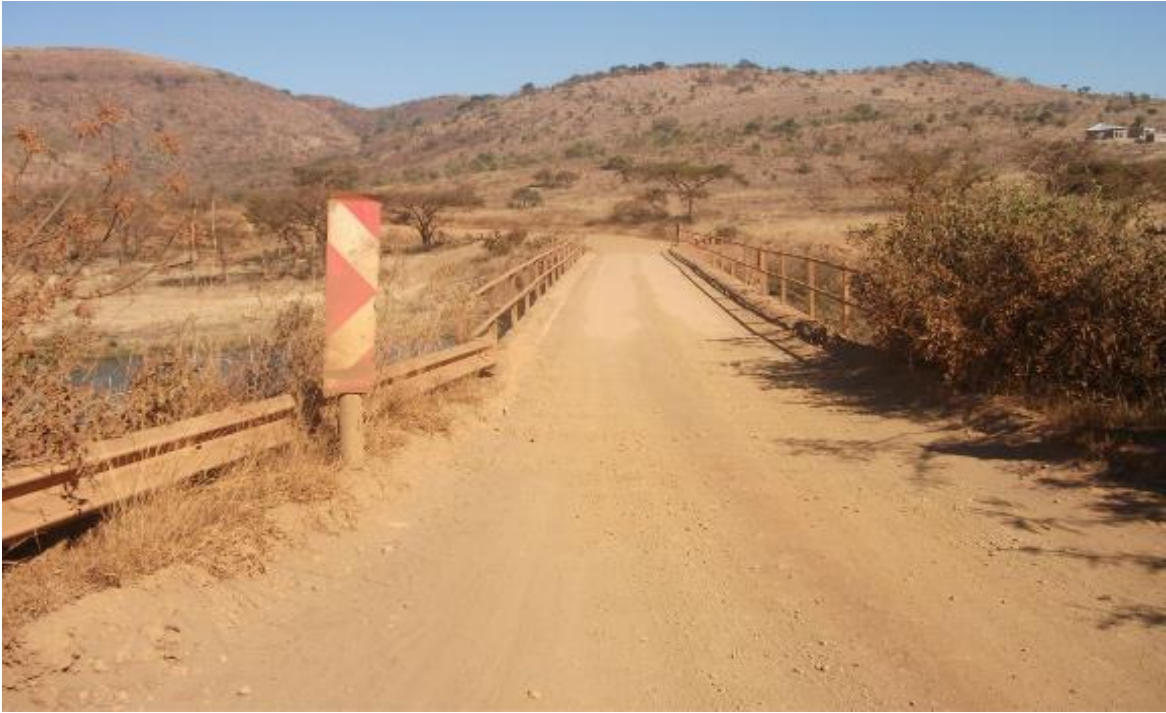
The bridge crossing the Mozana River is a single vehicle bridge as can be seen in **Figure 6** below. The age of the bridge appears to be around 20-30 years old.

Figure 7: Existing bridge crossing Mozana River

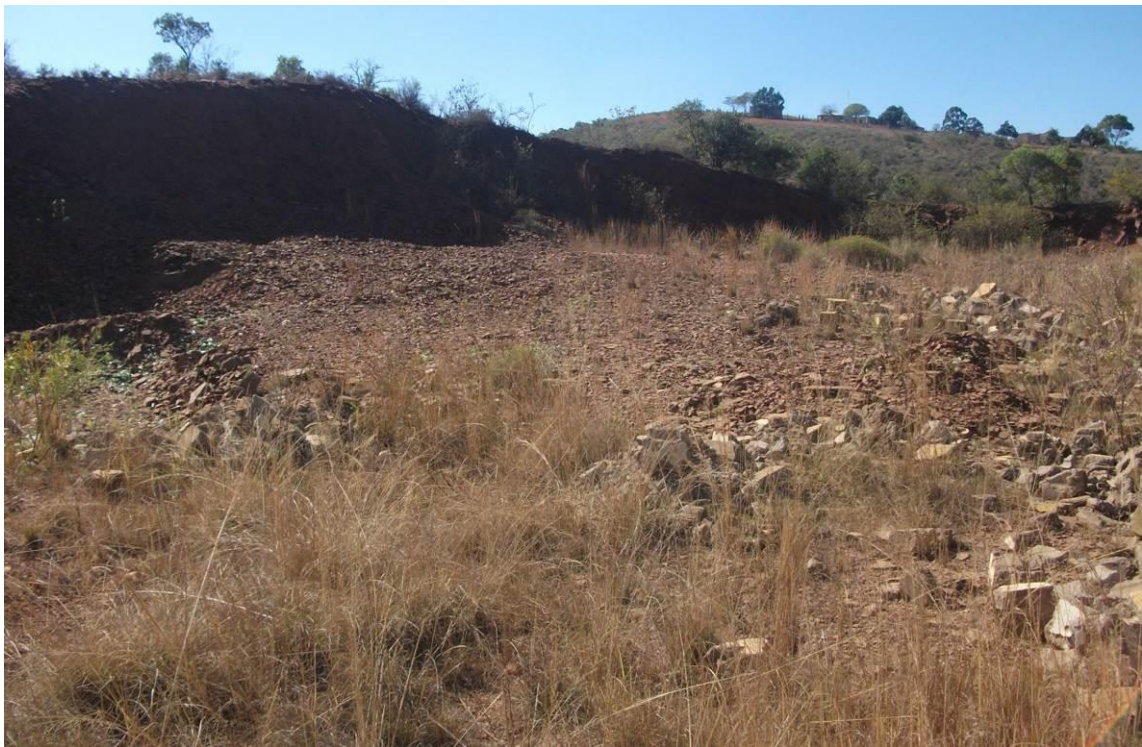
The site of the first borrow pit (coordinates: 27°17'42.00" S; 31°13'58.50" E) is situated above the valley after crossing the Mozana River. It is an existing borrow pit which has been previously mined. The area is highly disturbed and is currently used to dump building rubble and other waste (see **Figure 7** below). No heritage resources were found in and around the borrow pit.

Figure 8: Borrow pit 1 showing disturbance and dumping

The three proposed borrow pit sites were inspected and all were found to have been previously mined. Due to the highly disturbed nature of the sites, no heritage resources were found therefore, any of the sites can be utilised.

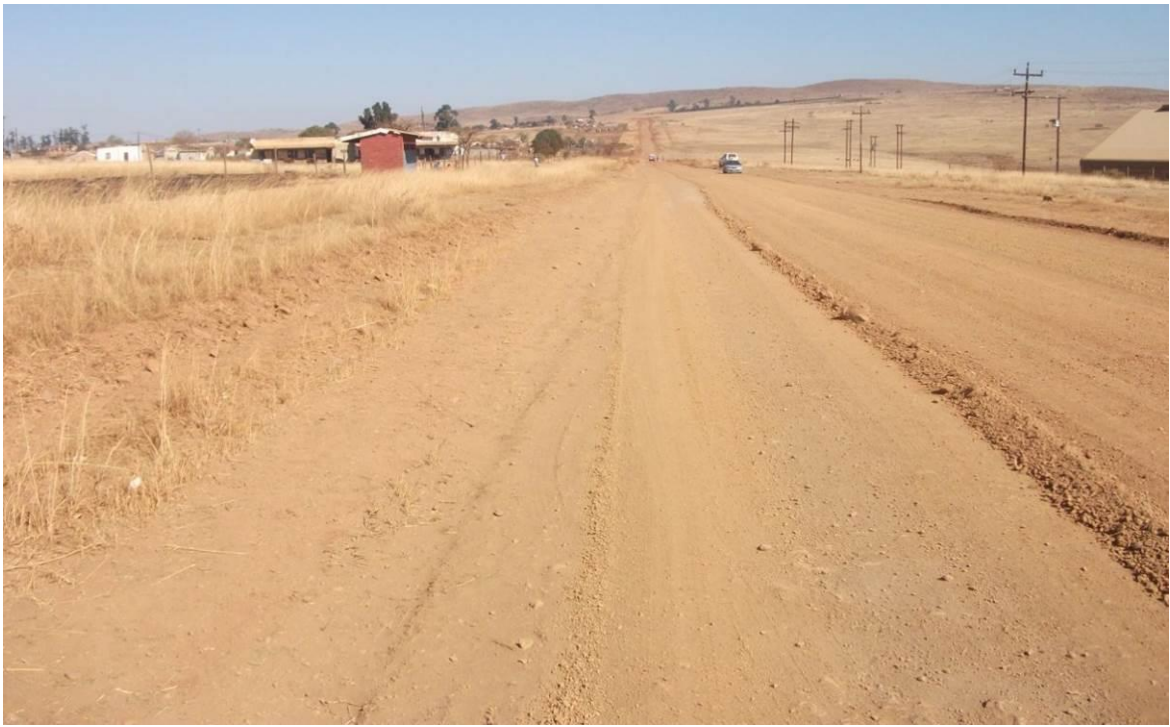
Moving south from borrow pit 1, homesteads and other structures were found to be situated some distance from the D1867. A number of graves were noted that are situated within homestead boundaries hence at no risk by the proposed upgrade.

Figure 9: D1867 looking southwards

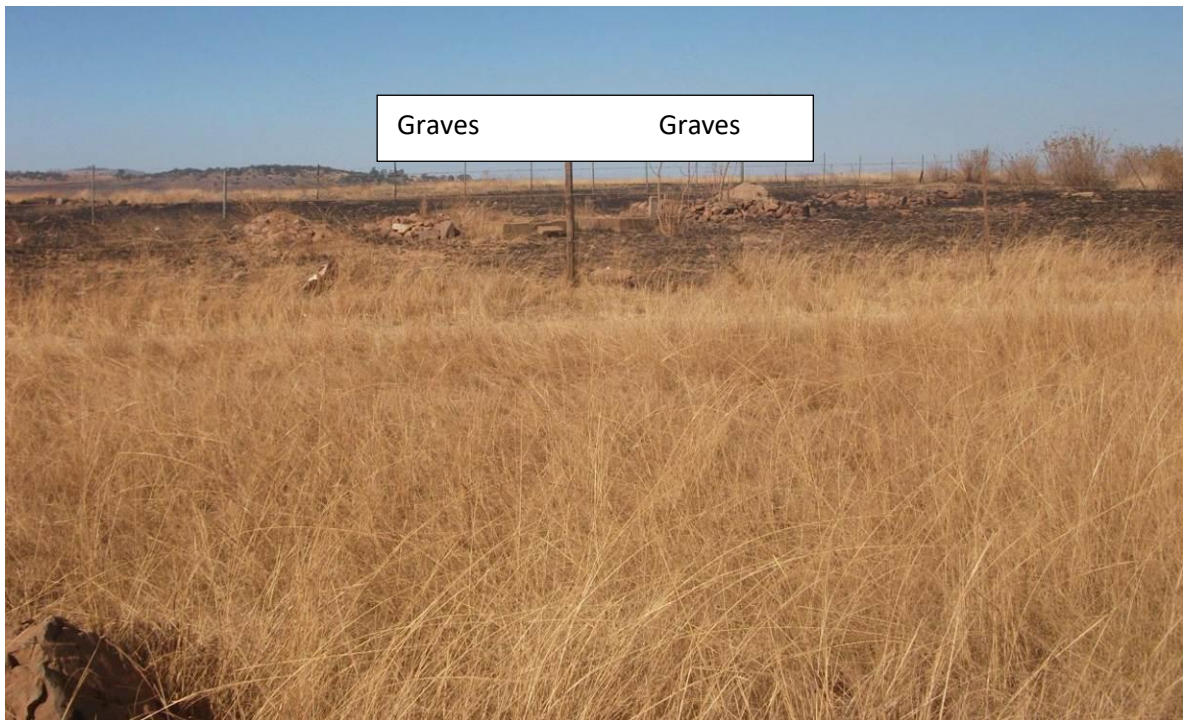
Figure 10: Graves within fence around homestead

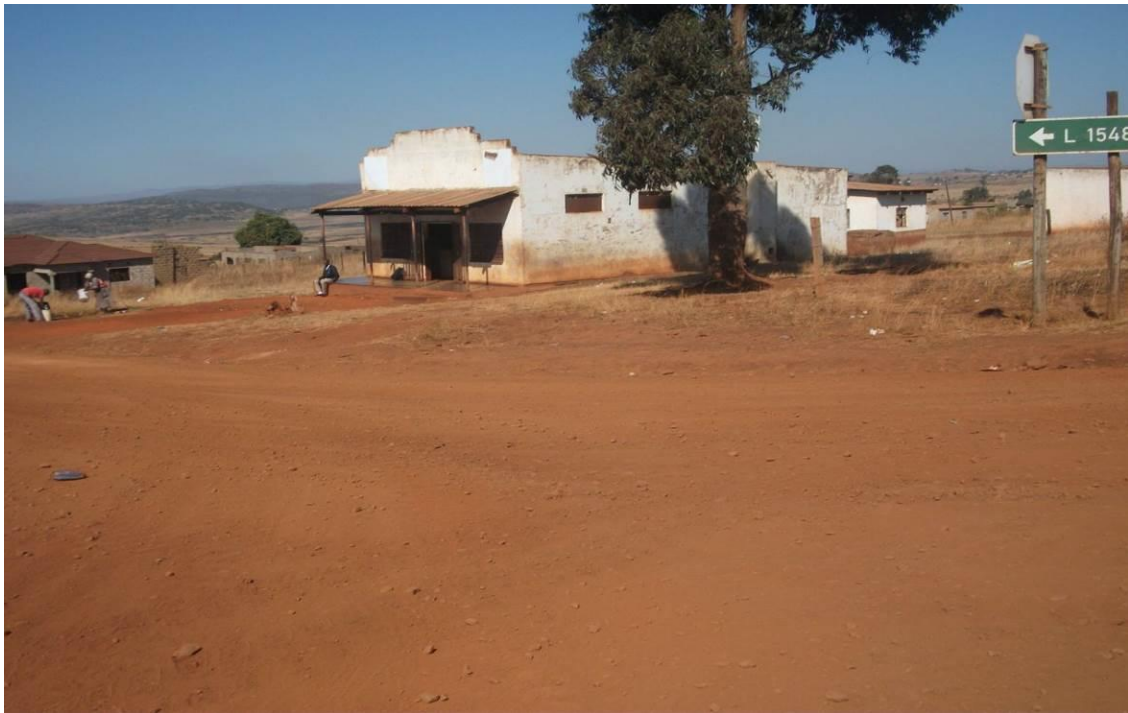
Some structures situated along the road could be protected structures (structures older than 60 years) including a shop that is situated at the intersection of the D1867 and L1548 roads. However, the structures are situated far away enough not to be impacted by the road upgrade.

Figure 11: Potential protected structure

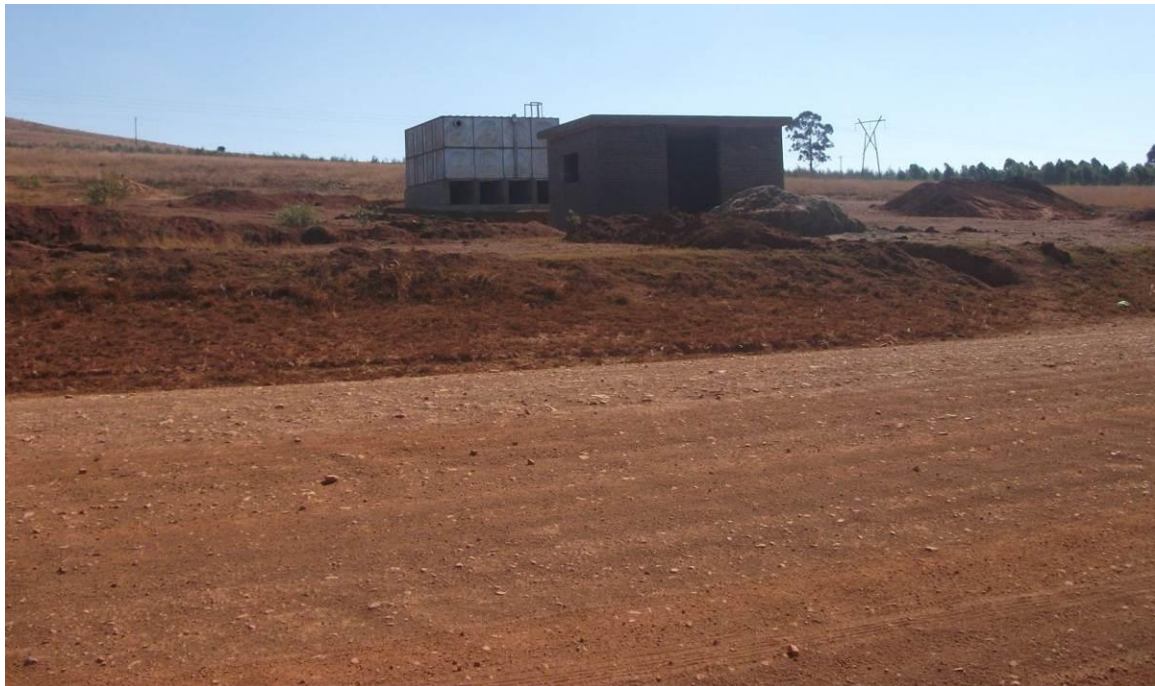
New structures have been built close to the road including a water reservoir and associated building, but these should not be impacted by the proposed upgrade.

Figure 12: Reservoir and associated building

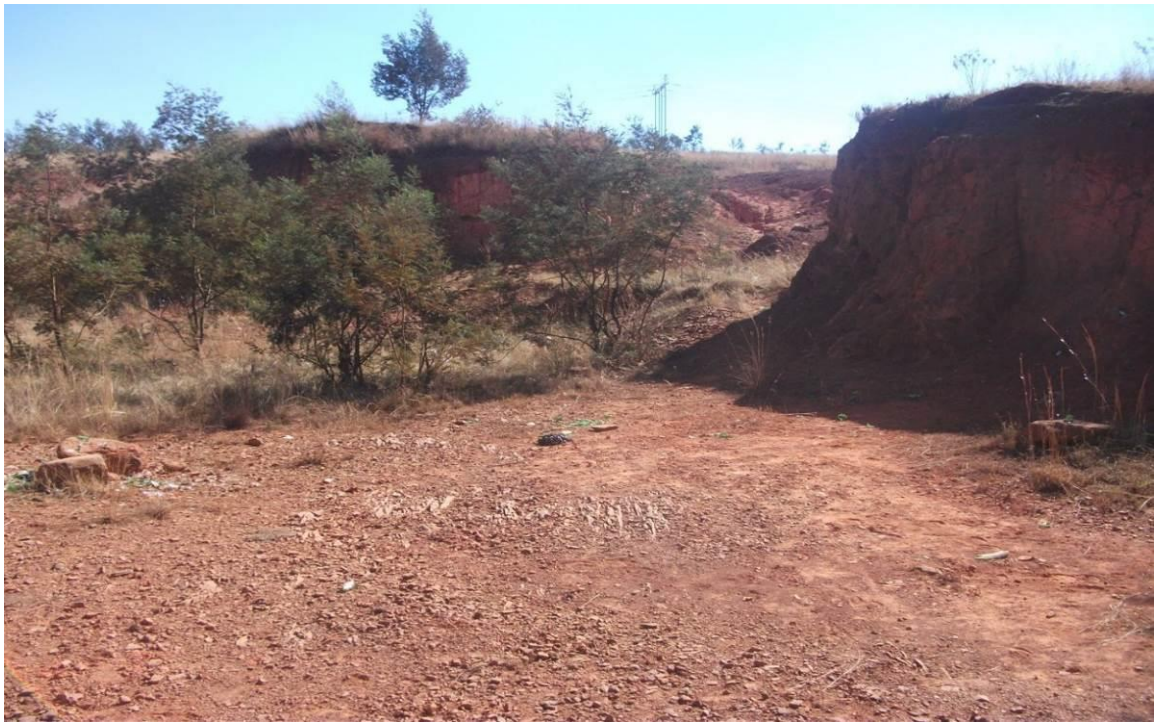
Borrow pit 3 (coordinates: 27°18'50.60" S; 31°12'41.37" E) was inspected. It is an existing borrow pit that has been previously mined and is therefore highly disturbed. No heritage resources were found during the inspection.

Figure 13: Borrow pit 3

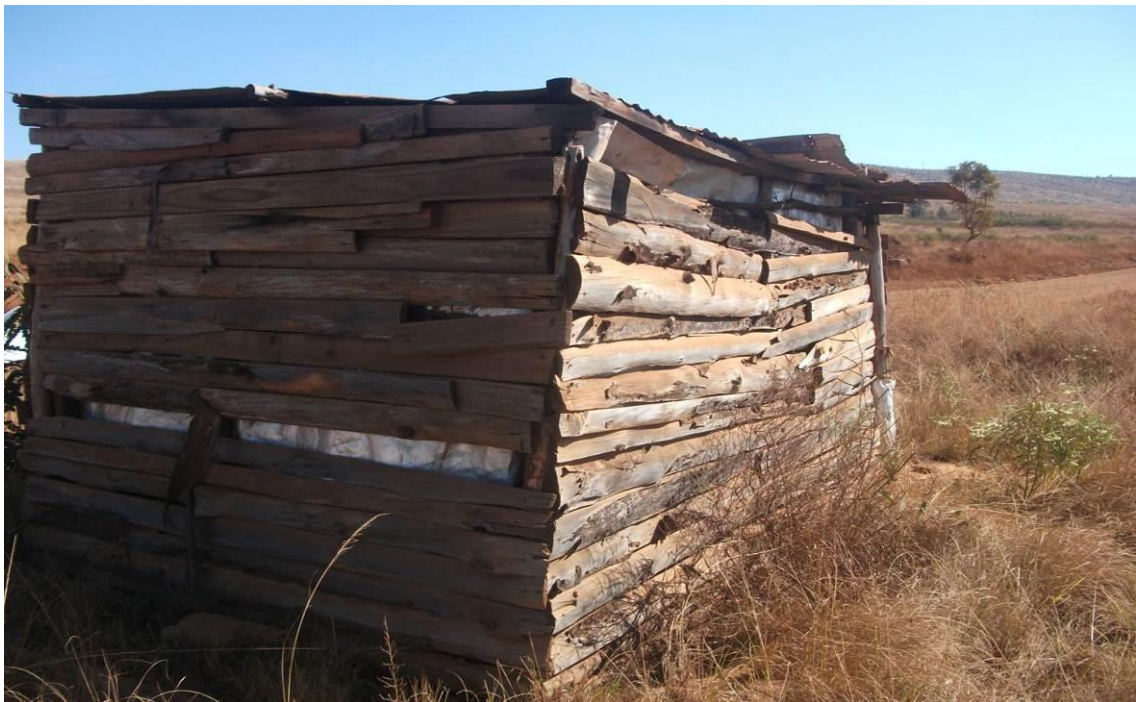
Moving south from borrow pit 3, a wooden temporary structure was found close to the road at 27°19'17.06" S; 31°12'48.00" E. The CLO explained that the house was used by Shembe followers when they came to the area to worship. It is within 6m of the road and could be impacted by the upgrade of the D1867. The structure is significant because of its association with the Shembe religion and its potential importance or use to the local Shembe community.

Figure 14: Shembe temporary structure

It is recommended that, in discussion with the Shembe leaders in the community the temporary Shembe structure is moved away from the road and that the immovable structure is protected by a buffer to avoid damage to it during the upgrade of the road.

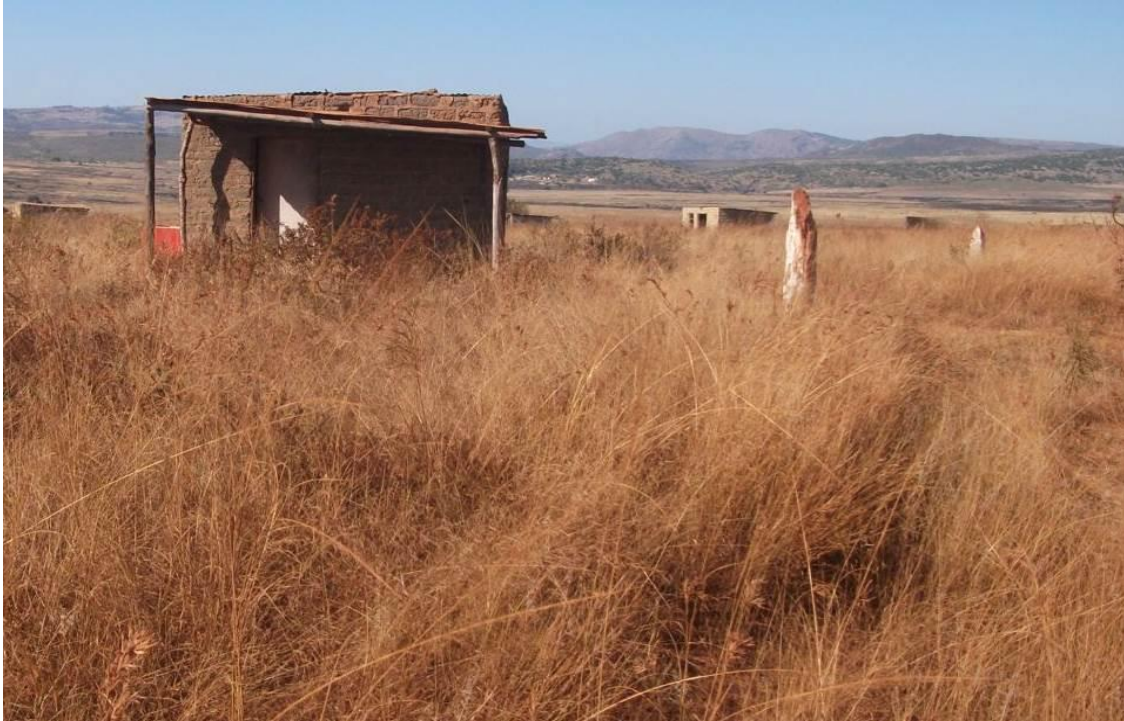
Another structure made of stone was found not far from the wooden structure which the CLO said was also used by the Shembe followers when they were in the area to worship. It is situated at 27°19'20.55" S; 31°12'50.39" E. The structure is significant again for its association with the Shembe religion. It is situated about 5m from the road and could be impacted by the proposed road upgrade.

Figure 15: Shembe structure close to road

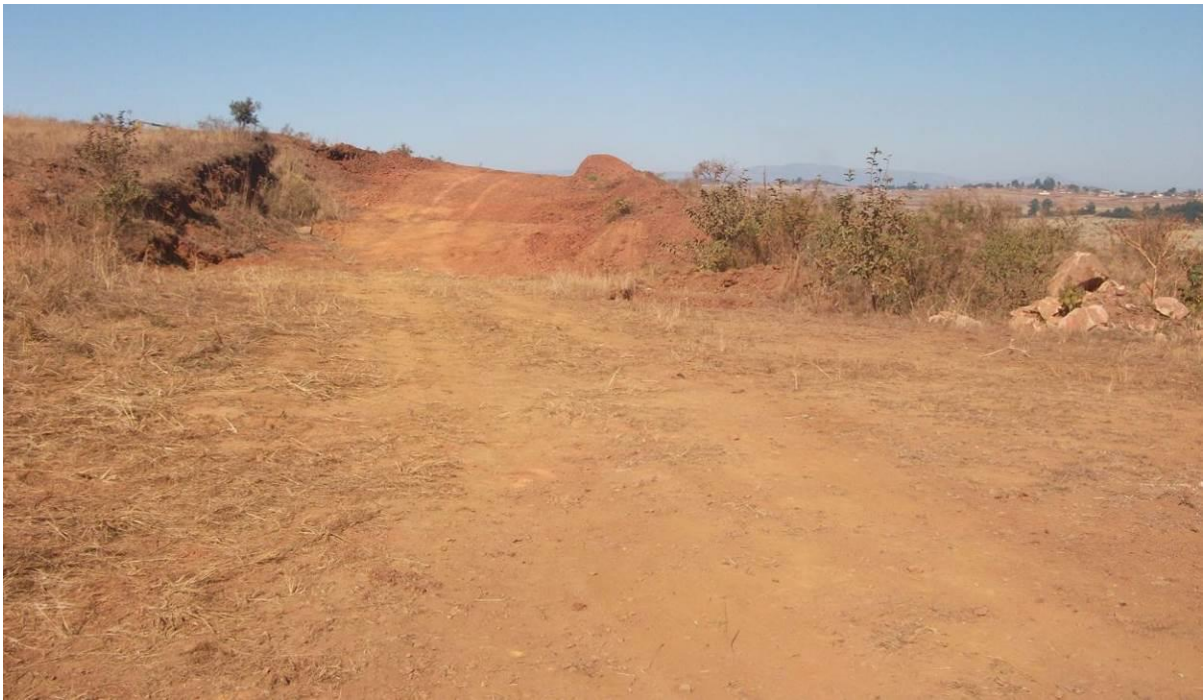
Between the Shembe sites mentioned above and borrow pit 2, areas cultivated with maize were noted. Borrow pit 2 is an existing borrow pit. The area is highly disturbed by previous and current mining and no heritage sites were found.

Figure 16: Borrow pit 2

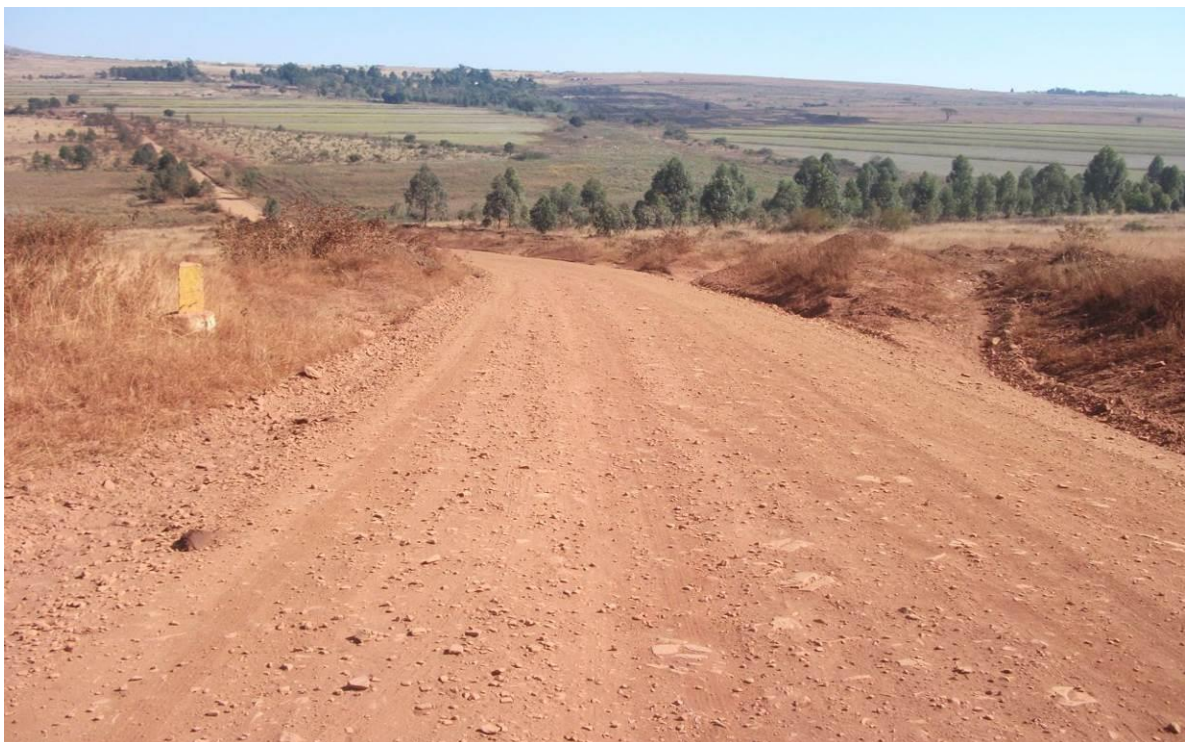
From borrow pit 2 until the start point of the proposed upgrade no further heritage resources were found. Graves were seen within homesteads some distance from the road and will not be impacted by the upgrade.

Figure 17: View of road looking south from borrow pit 2

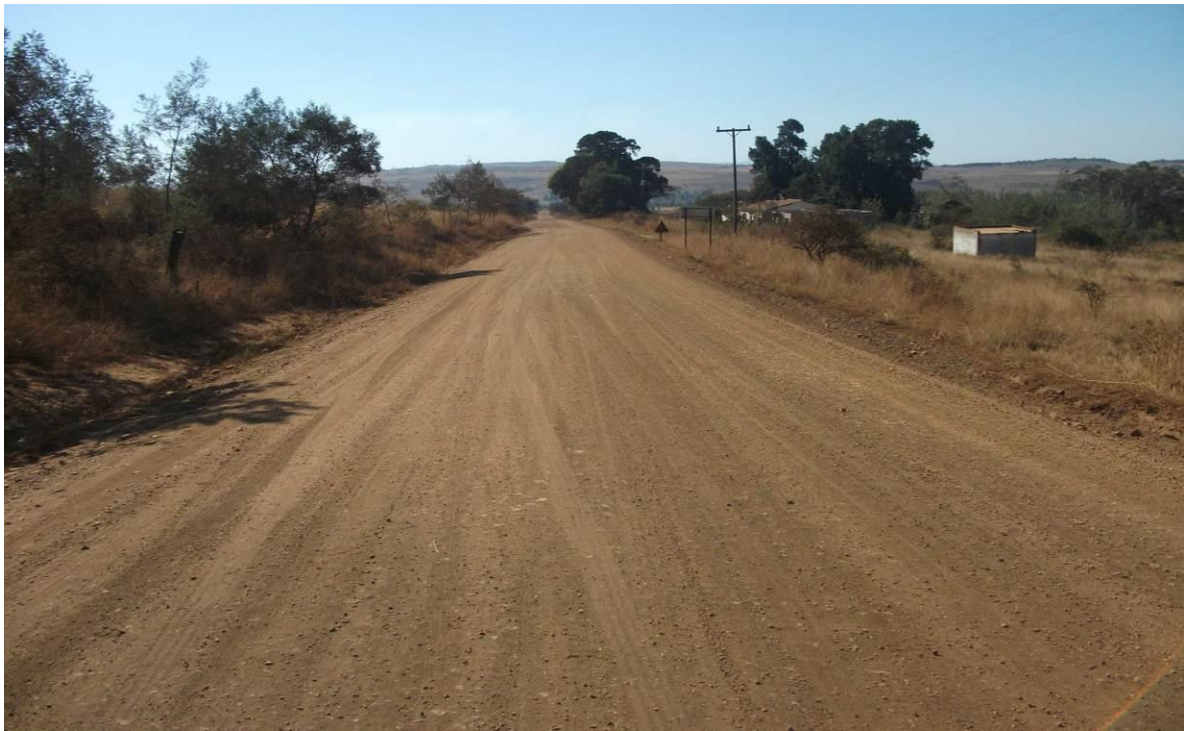
Figure 18: View of D1867 looking northwards from starting point of upgrade
