PRELIMINARY REPORT ON GEOTECHNICAL INVESTIGATION OF THE FRANKFORT LANDFILLS Free State PROVINCE

GEOTECHNICAL INVESTIGATION REPORT FOR THE LANDFILL

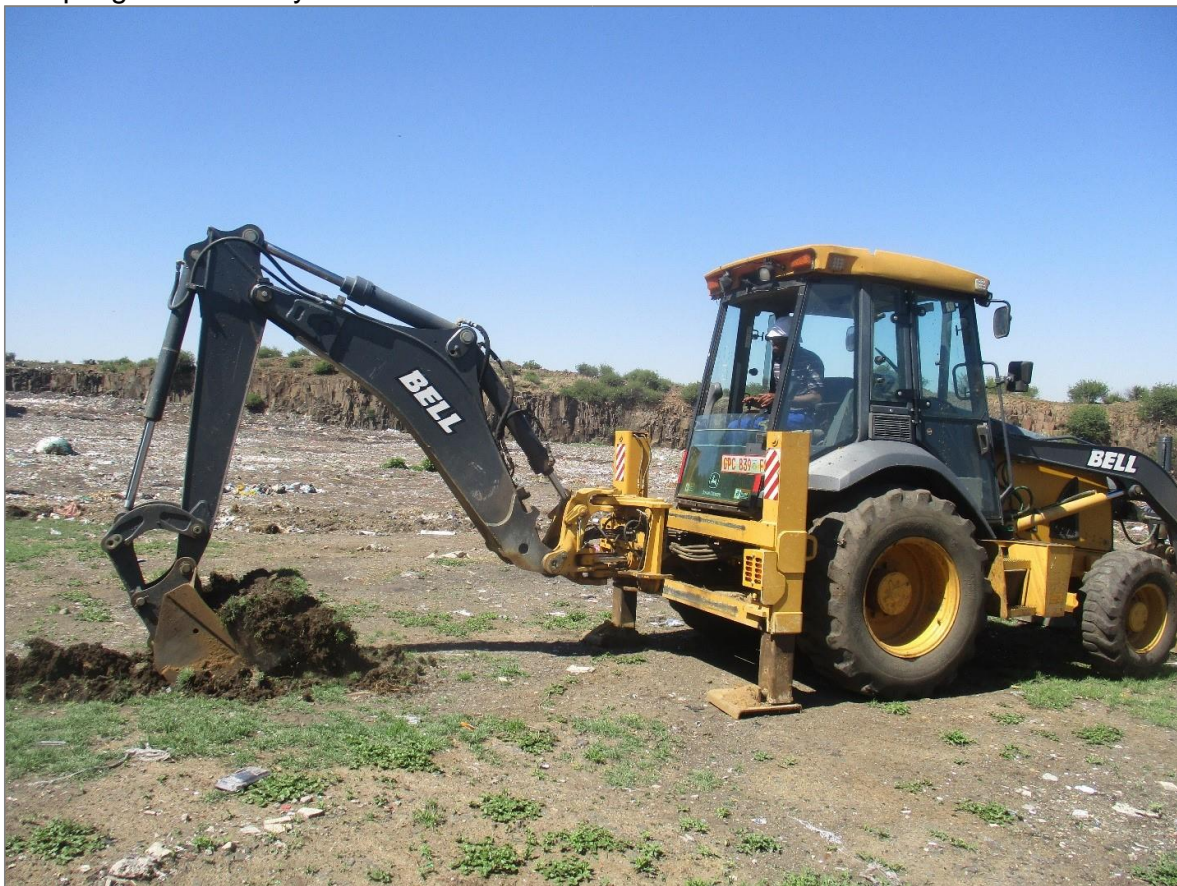
FIGURE 3: BELL TLB USED FOR INVESTIGATION

Sampling was done by a BELL Backhoe Loader 4 x 2 75Kw

5.1 A 75Kw Bell Backhoe Loader (TLB) was used to excavate test pits at agreed Location

Eight (9) test pits were investigated by means of a BELL 75kw TLB.

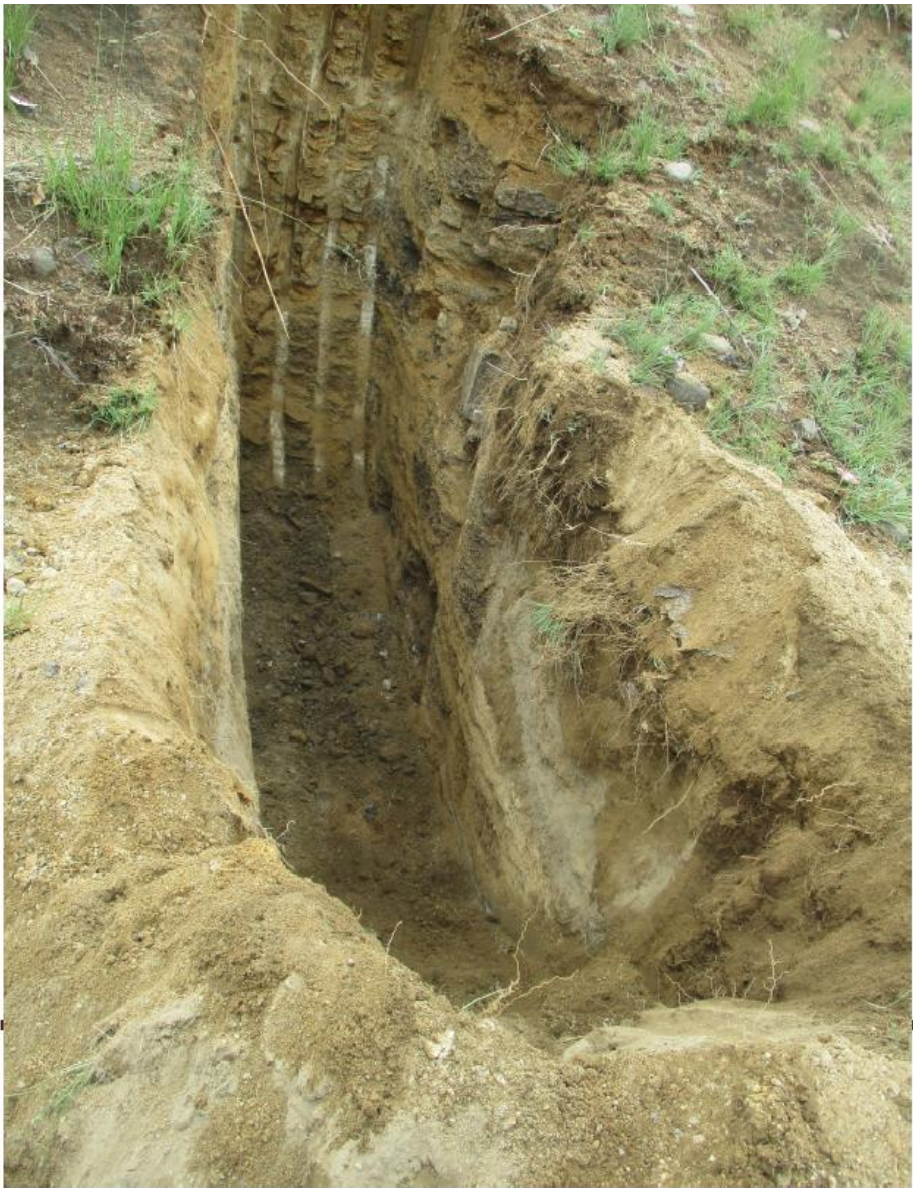
Test Pit	Test Pit		Refusal on	Coordinates		Material Description
	Depth(m)			LATITUDE	LONGITUDE	
TP01	0- 0.75m	0.75-1.71m	Maximum Reach of TLB Machine	27°17'8,69" S	28°29'24,82" E	Brownish Grey Black Firm sandy gravel/Light Brownish Sand gravel soil with a dense sand
TP02	0.0-0.35m	0.35m-0.9m	Maximum Reach of TLB Machine	27°17'40,96" S	28°29'44,55" E	Light Brownish Sand gravel soil with a dense sand/Brownish Sandy stone with

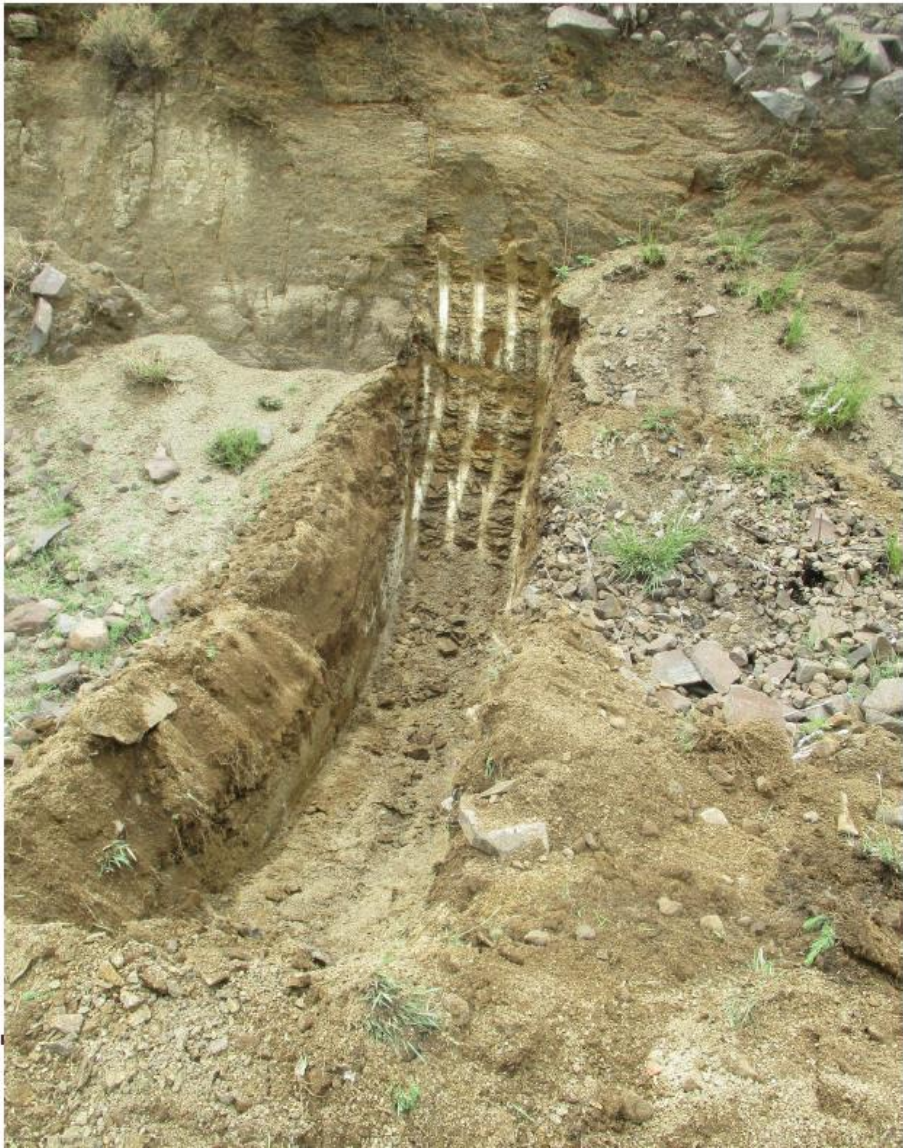
TP02

a very dense intact sandy soil
TP03	0.0-0.910m 0.91-2.7m	Maximum Reach of TLB Machine	27°17'36,61" S	28°29'45,41" E	Brownish Firm sandy gravel/Brownish Black Sandy Material
TP04	0.35-0.9m 0.9-1.76m	Maximum Reach of TLB Machine	27°17'25,53" S	28°29'14,31" E	Brownish Firm sandy gravel/Brownish Black Sandy Material
TP05	0.3-1.2m 1.2-1.51m	Maximum Reach of TLB Machine	27°17'5,94" S	28°29'43,45" E	Brownish Firm sandy gravel/Greyish brown Sandy stone Material
TP06	0.25-0.81m 0.81-1.56m	Maximum Reach of TLB Machine	27°17'37,03" S	28°29'53,04" E	Light Greyish Sandy stone with slight moist/Brownish
					Black,sand stone (mudstone) with slight gravel.
TP07	0.2-0.95m 0.95-1.92m	Maximum Reach of TLB Machine	25°17'36,60" S	28°29'50,98" E	Light Greyish Sandstone with slight ease/Brownish black sandstone mudstone with slight grave

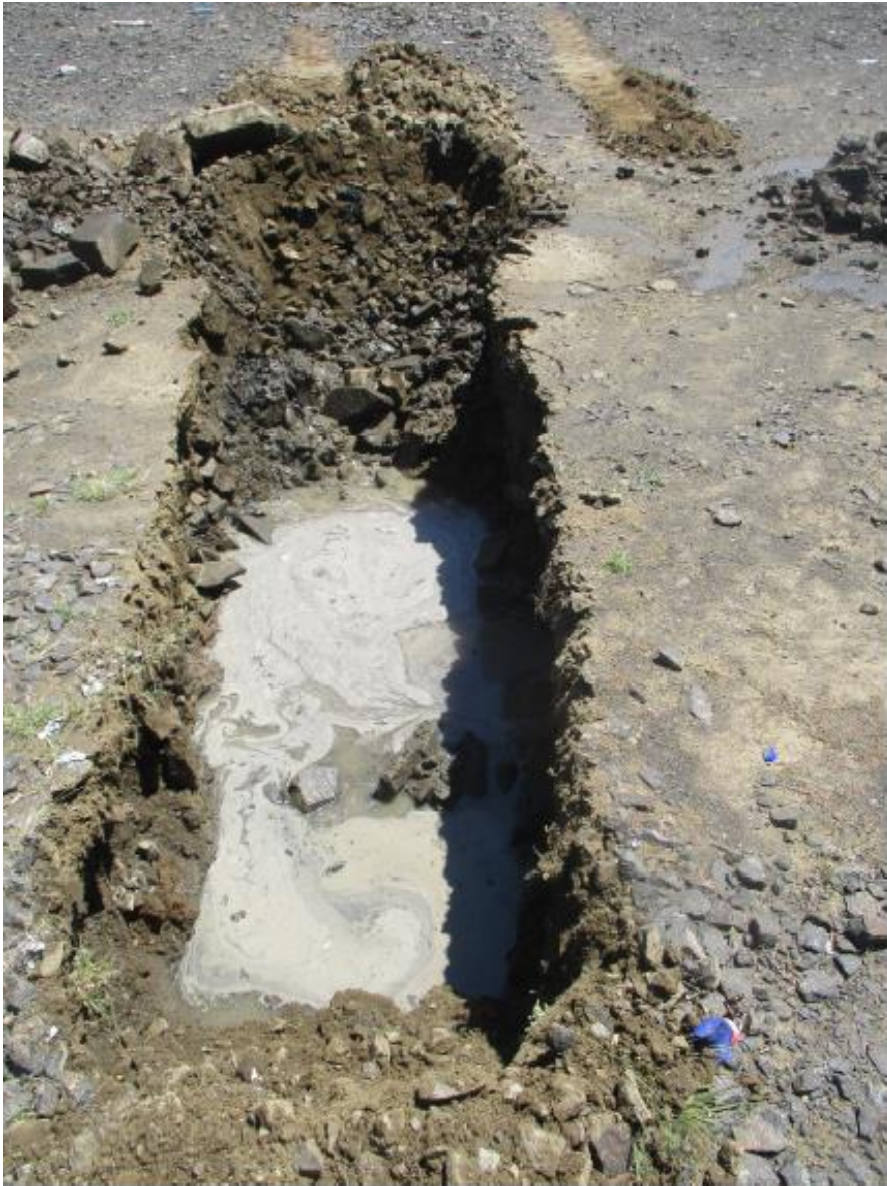
TP06

TP6 encountered groundwater however.

- Proper Lining measures will be required. Service trenches may also have to be dewatered during construction.

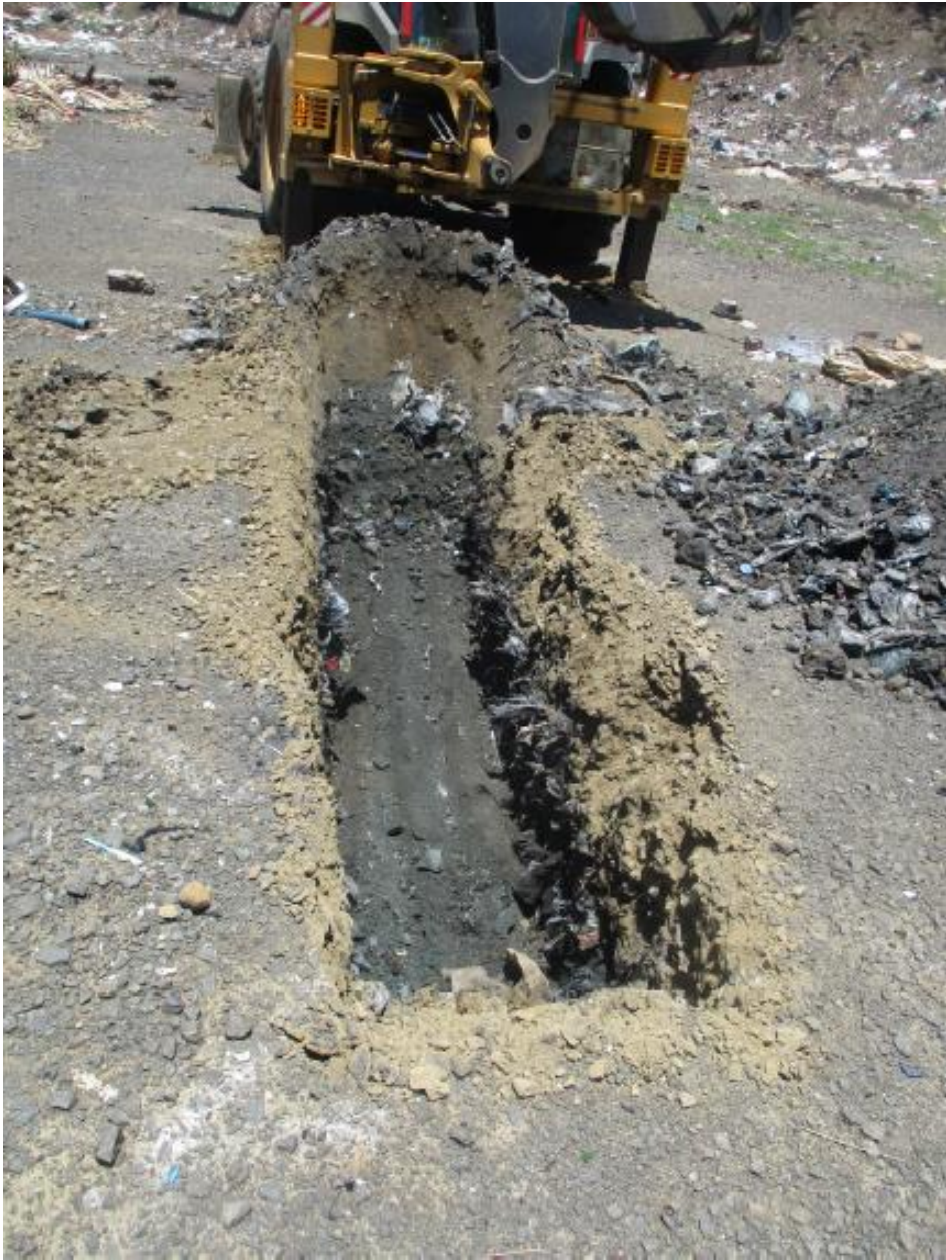
TP08	0.25-0.8m 0.8-0.95m	Maximum Reach of TLB Machine	27°17'37,67" S	28°29'49,45" E	Light Sandstone with slight ease/Brownish black sandstone mudstone with slight grave	Greyish with
TP09- ROAD	0-1.10m 1.10-3.1m	Maximum Reach of TLB Machine	TBC		Yellowish sandy soil with firm consistency/Light Grey sandy soil mater with loose intact material	Brown soil with
