HERITAGE COMMENT

The Proposed Rectification in terms of Section 24G of NEMA for the Unauthorised Establishment of a Private Staging Facility on a Portion of the Property Rem of Portion 55 of the Farm Langewacht No. 2168 near Mooi River, KwaZulu-Natal.

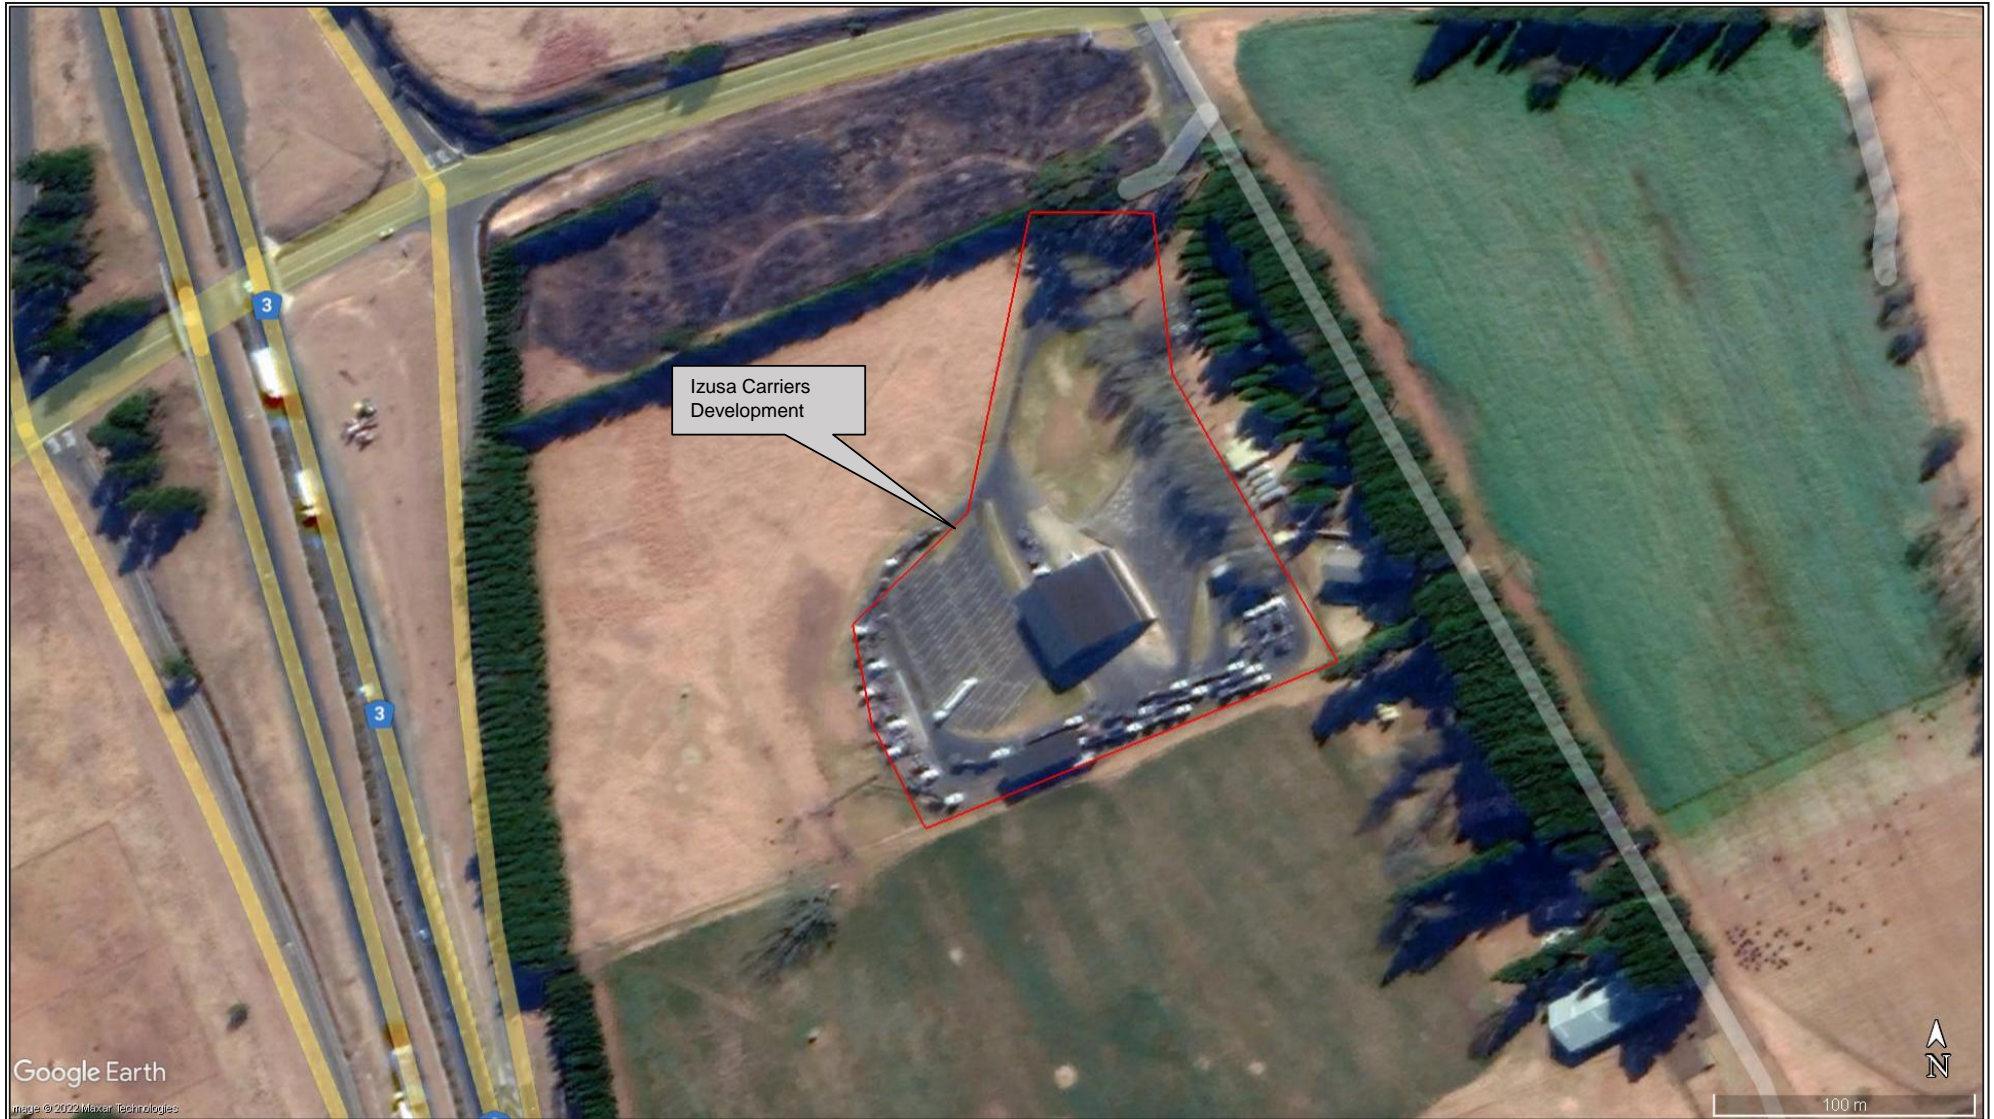
Figure 2: Izusa Carriers Staging Facility Development Footprint.

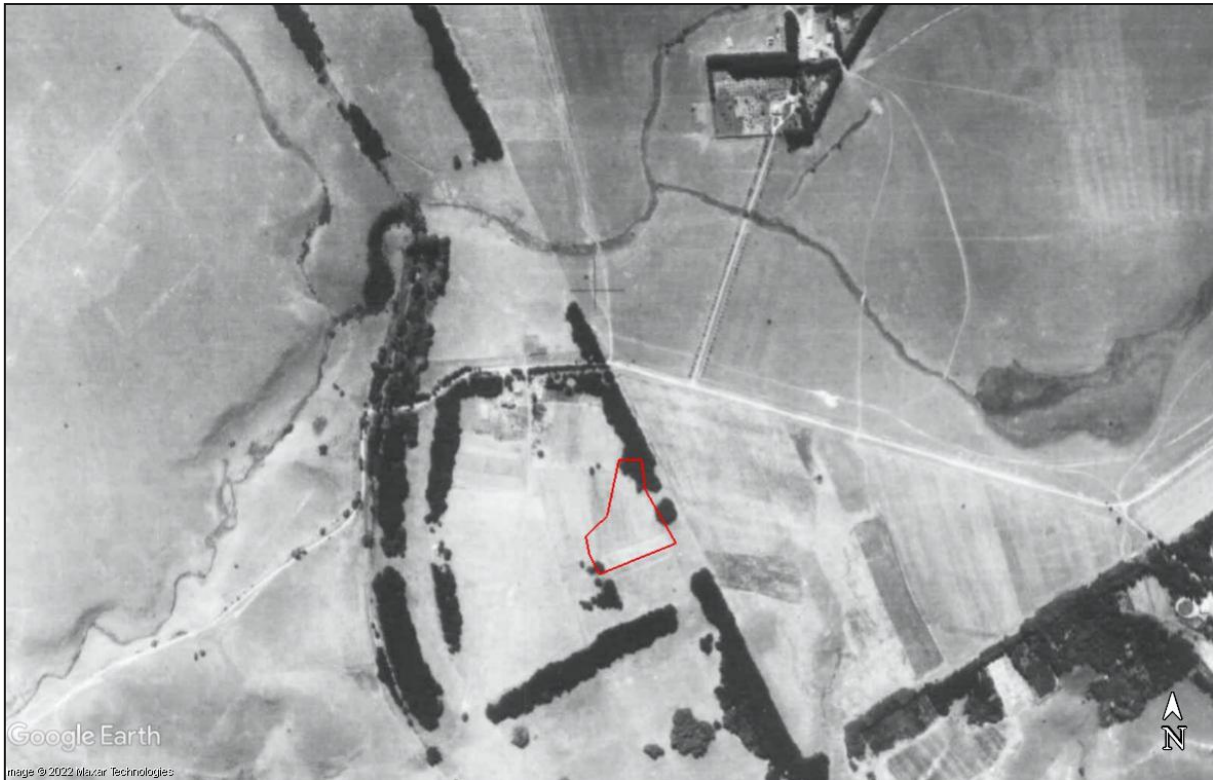
Aerial imagery from 1944 (Figure 4) shows the site and immediate surrounds as undeveloped, comprising grassland vegetation, with a row of trees along the eastern boundary of the site. There are no built structures present on the site in the 1944 aerial imagery. Aerial imagery from 1978 (Figure 5) shows little change to the site, with the site remaining undeveloped. The encroachment of trees onto the site is however evident, and the newly built section of N3 Highway is now also evident adjacent to the site in the 1978 imagery. There are no built structures present on or directly adjacent to the site.

Figure 4: Historic aerial imagery of the development site from 1944 shows the site as undeveloped, comprising grassland, with trees and a dirt road adjacent to the eastern boundary. There are no buildings or other structures present on or directly adjacent to the site.

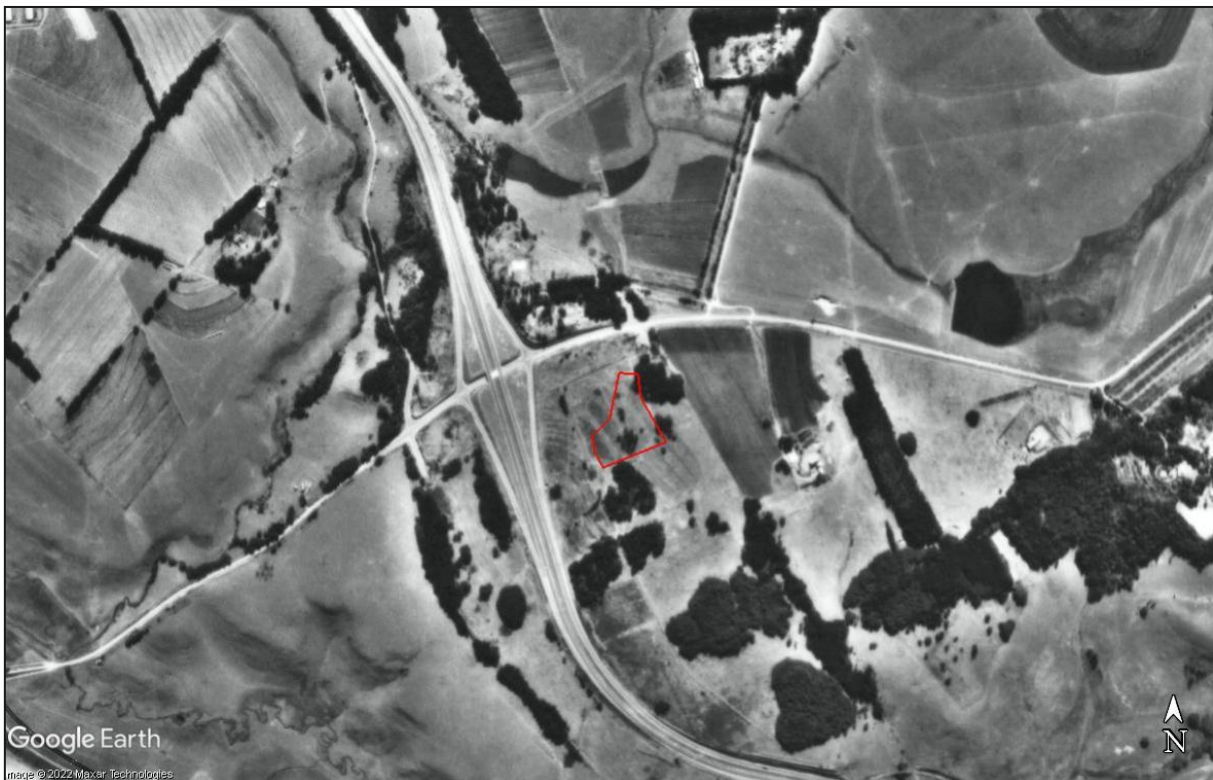
Figure 5: Aerial imagery from 1978 shows little change to the site, with the site remaining undeveloped. There are no built structures present on or directly adjacent to the site.

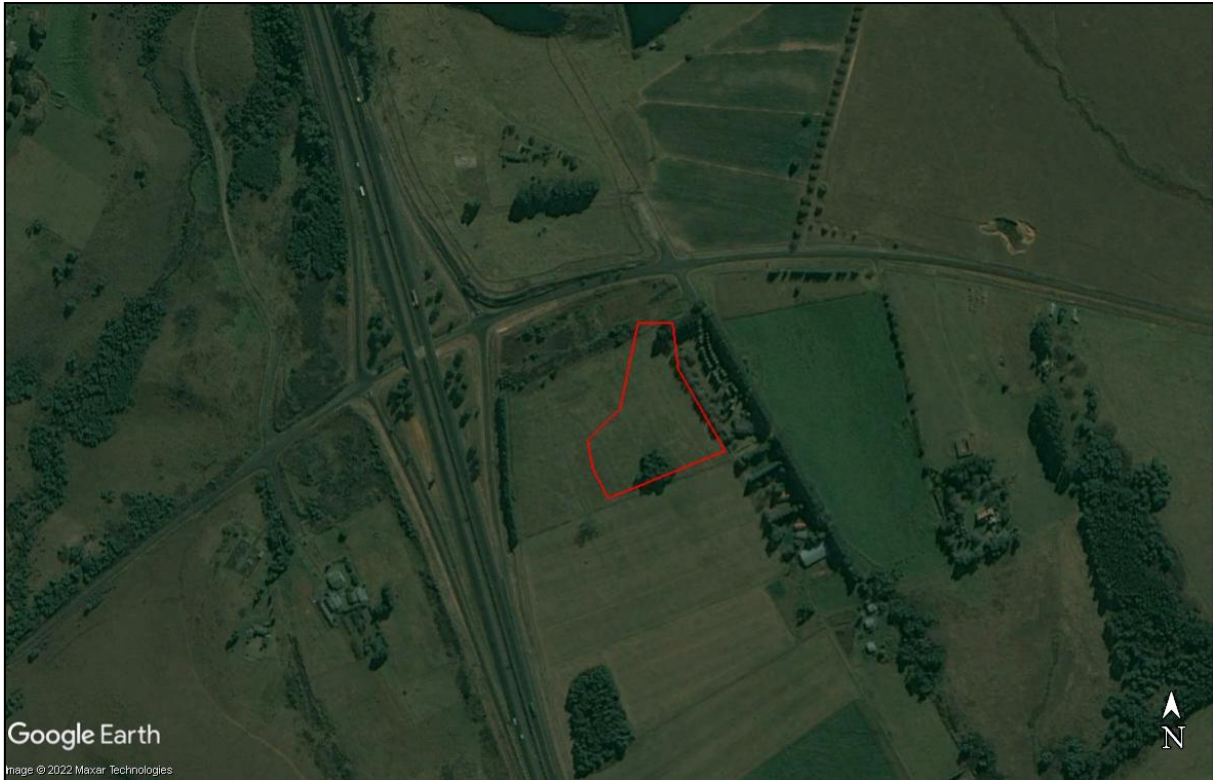
Aerial imagery from 2008 (Figure 6) shows no significant land use change to the site, with the site still comprising grassland. Buildings are now evident to the east and south east of the site. Lastly, current Google Earth imagery from 2022 (Figure 7) shows the complete transformation of the site from grassland to hardened surfaces has occurred.

Figure 6: Aerial imagery from 2008 shows no significant land use change to the site, with the site still comprising undeveloped grassland. Built structures are now evident to the east of the site.

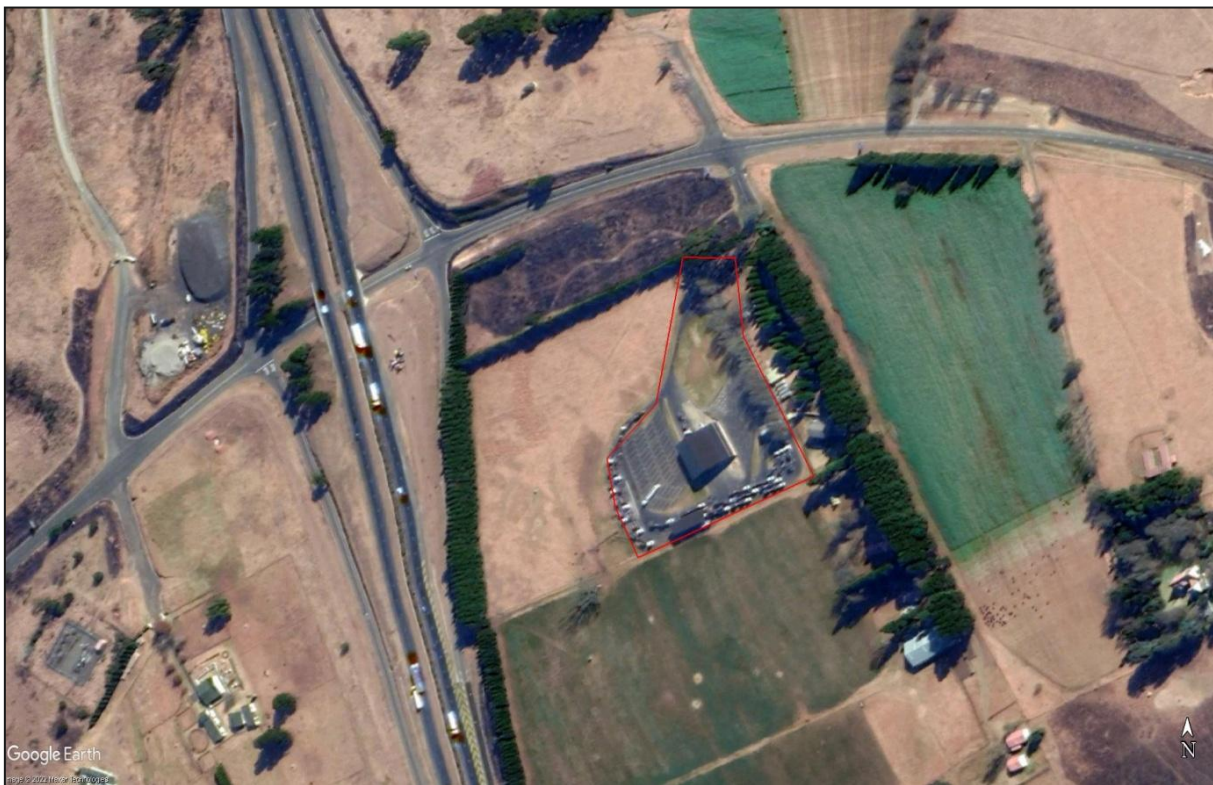
Figure 7: Current imagery of the site (2022) shows the complete transformation of the site from grassland to hardened surfaces.
