**HERITAGE IMPACT ASSESSMENT FOR THE
PROPOSED GESSLA ECO ESTATE DEVELOPMENT**

FOR TRIPLO4

DATE: 17 NOVEMBER 2014

**Umlando: Archaeological Surveys and Heritage
Management**

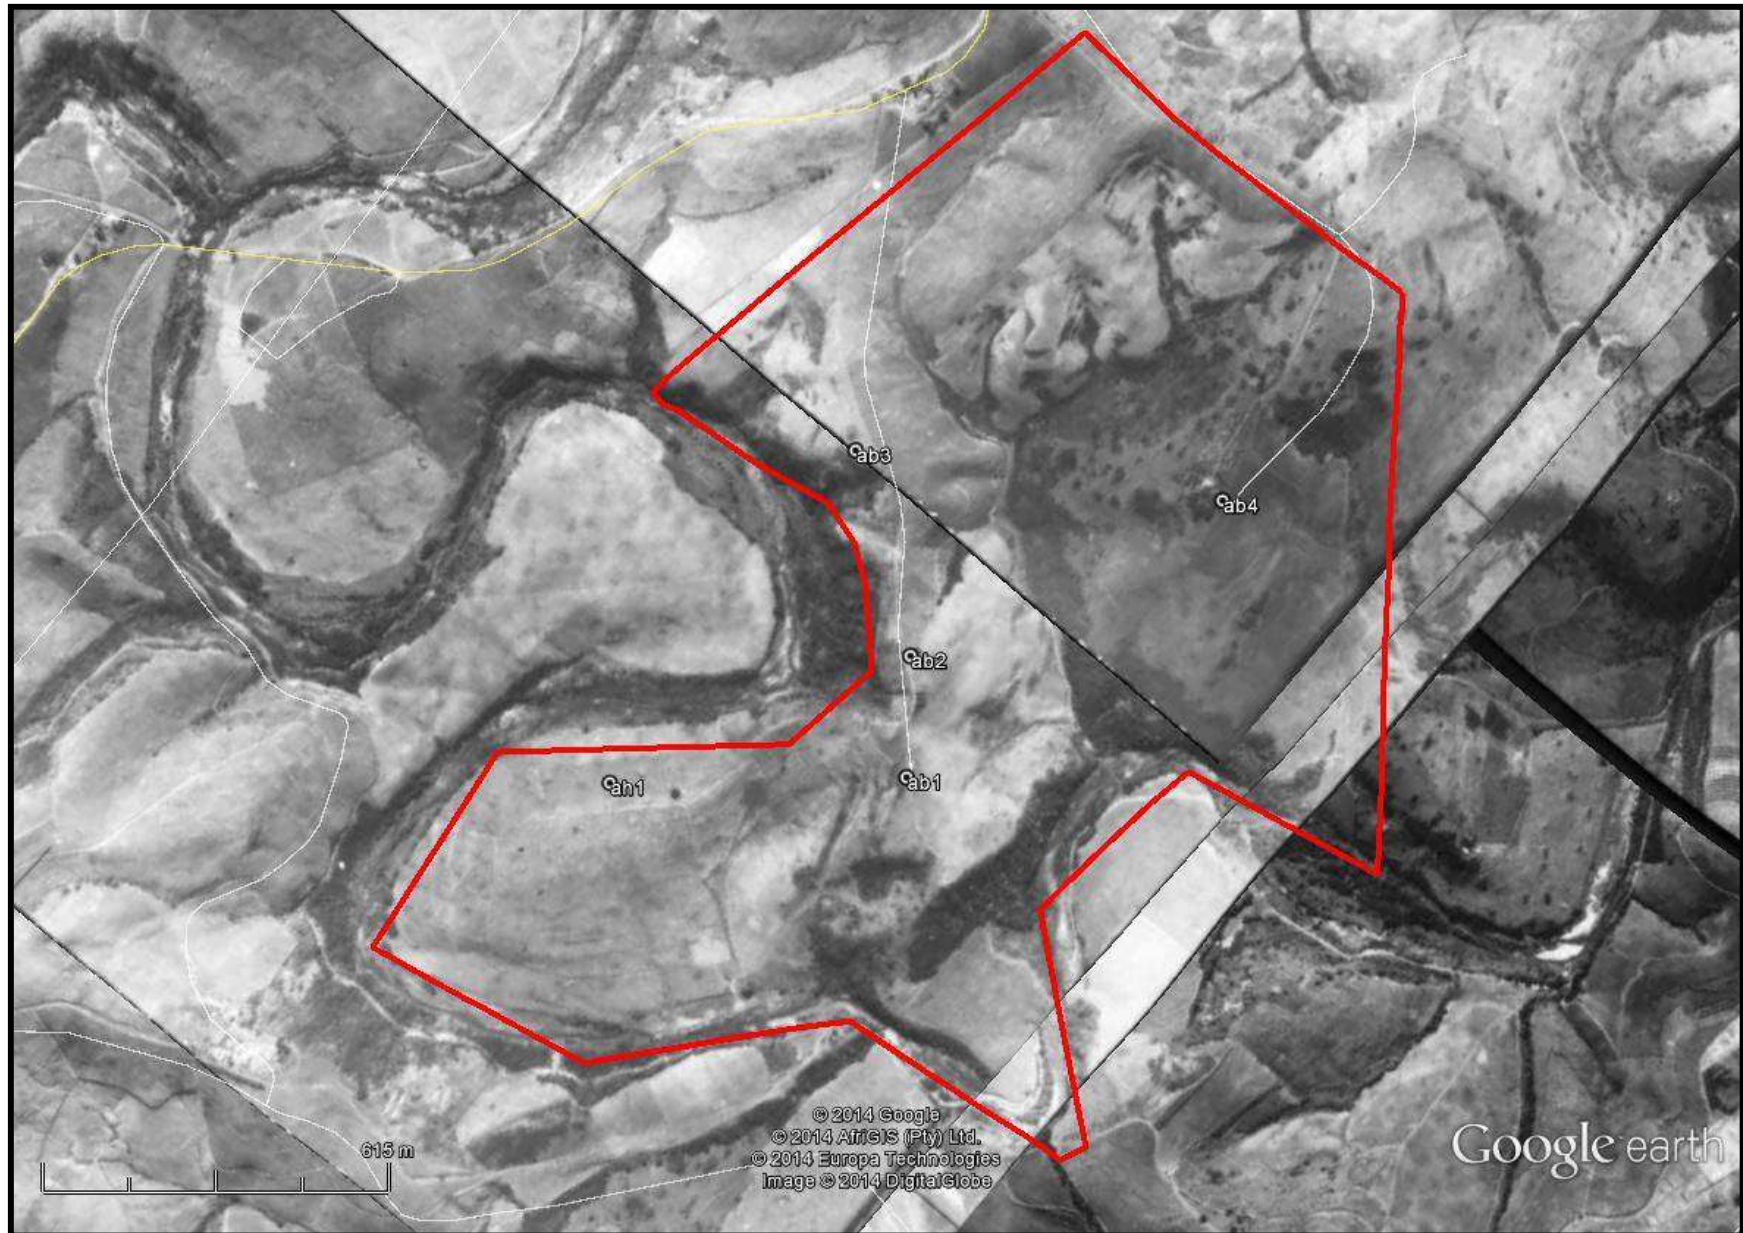
FIG. 6: STUDY AREA IN 1937

The Surveyor General's Diagram indicates that the land was first surveyed in 1849, possibly 1853 (fig. 5). No buildings were noted on the land. The 1937 aerial photographs indicate that the main farmhouse and three other buildings exist on the property, as well as a settlement (fig. 6, Table 1).

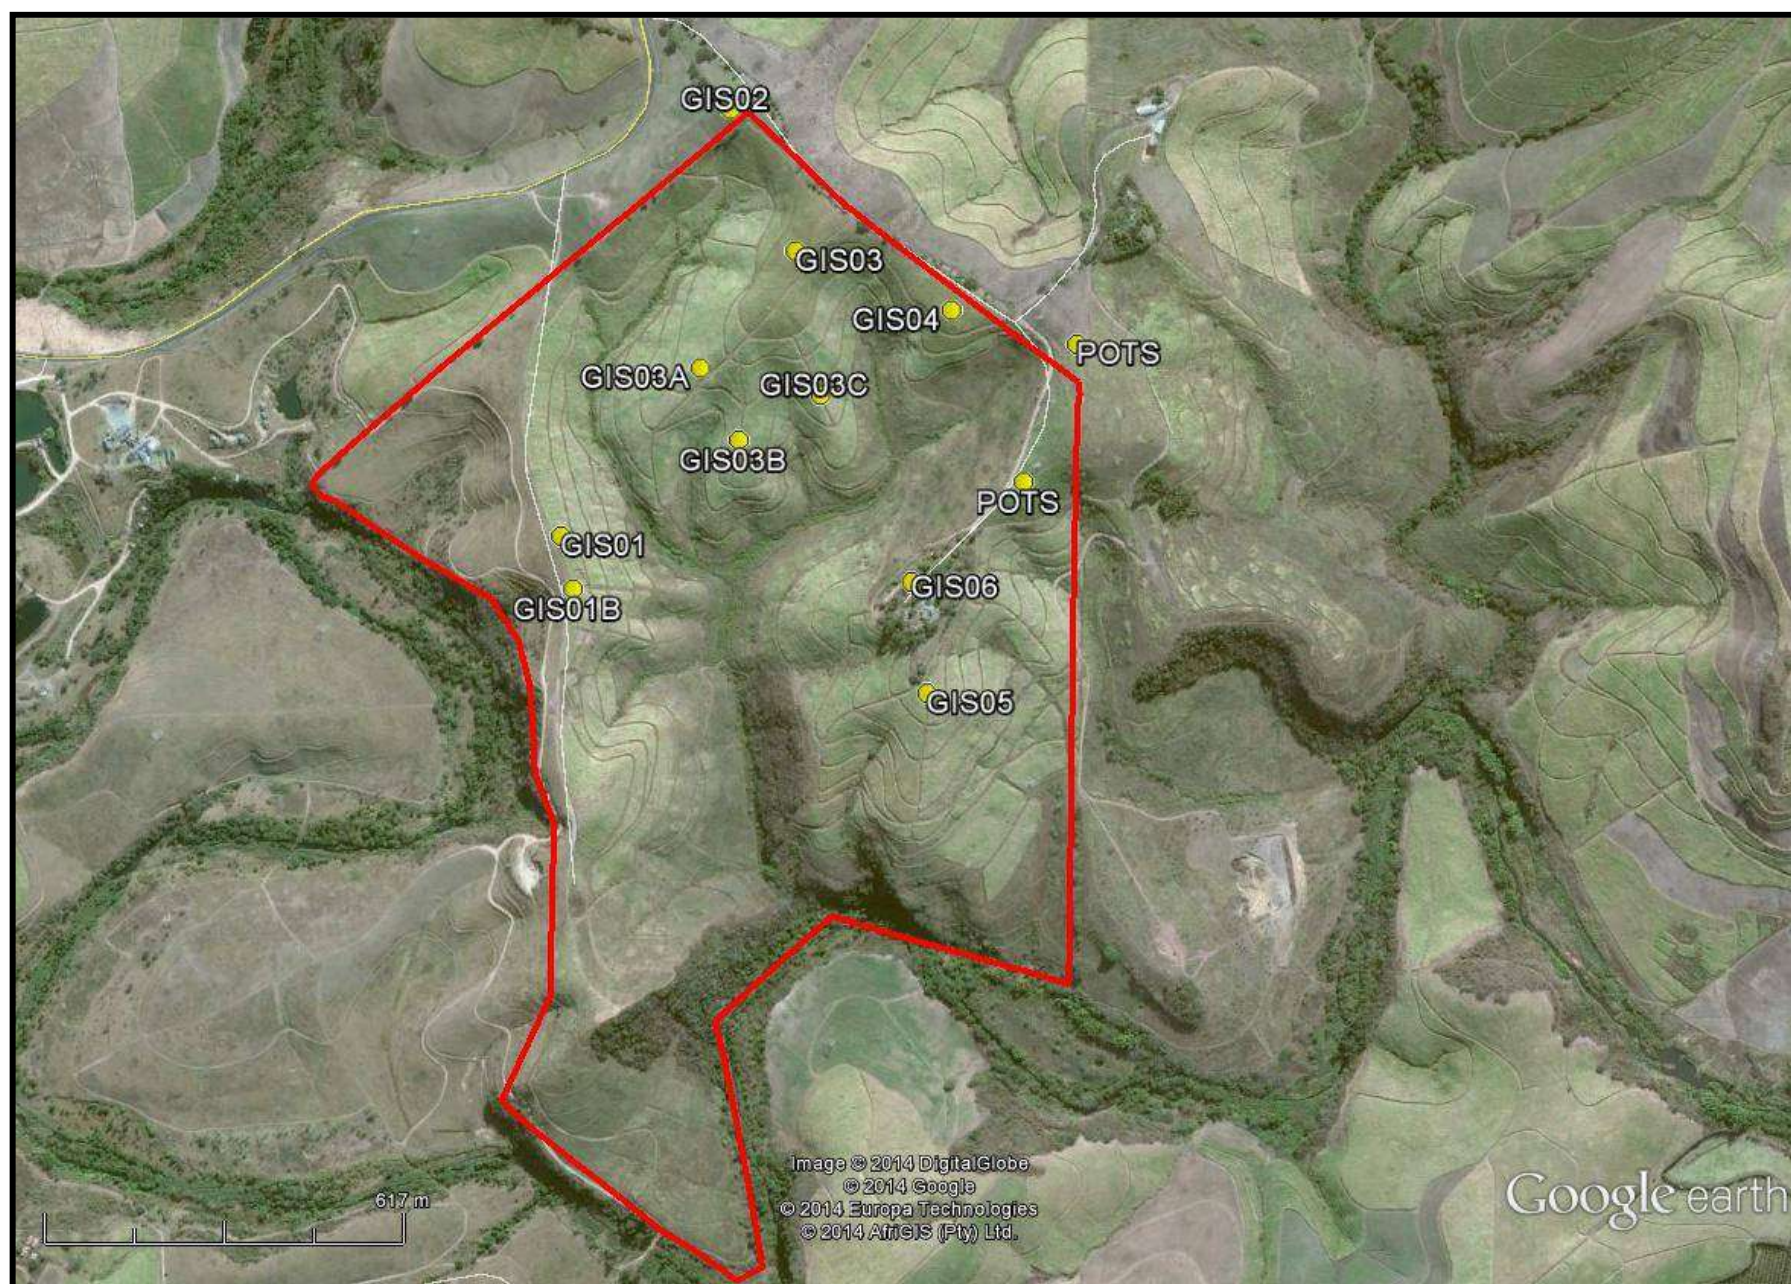
FIG. 9: LOCATION OF RECORDED SITES.

The area consists of mostly shallow soils that have been ploughed for sugar cane farming for more than 80 years. None of the original buildings, with the exception of River View farmhouse no longer exists. These have been demolished, with only the foundations remaining at one area near the main farmhouse. Figure 9 shows the location of the recorded sites.

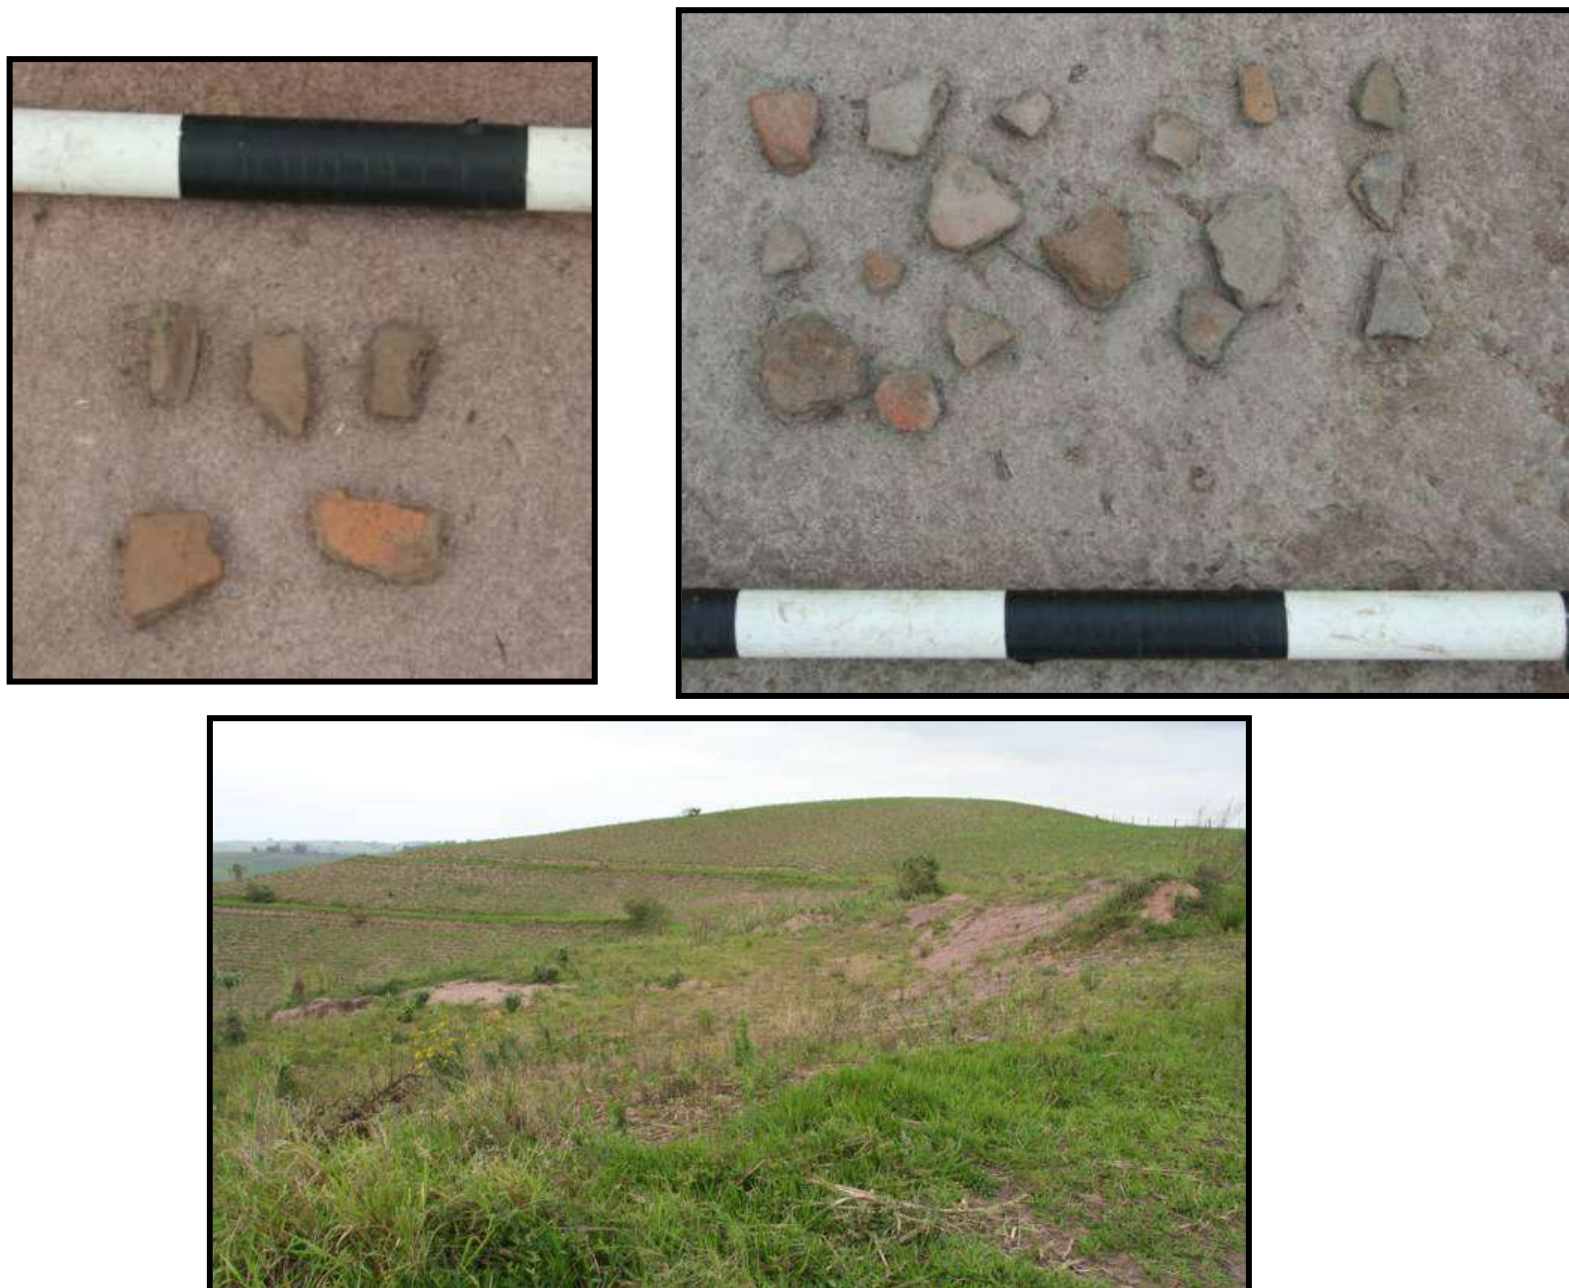
FIG. 10: ARTEFACTS AT GIS01

GIS01 is located on the top of the hill. The hill is narrow and overlooks the Umhlali River on the north. The site extends for ~100m in length. GIS01 consists of a scatter of various pottery sherds of various colours (fig. 10). No decorated sherds occur on the site. Most of the sherds probably date to the Historical Period, however some are more sand blasted and may date to the Late Iron Age. Two sherds would be related to the “compound” that existed here.

The soil is very shallow on the top of the ridge, and it is unlikely to yield any deposit. The soil towards GIS01B is deeper; however, this has been ploughed and bulldozed.

The area will be directly affected by one of the projects.

Significance: The site is of low significance.

Mitigation: No further mitigation is required; however, a permit for its destruction is needed.

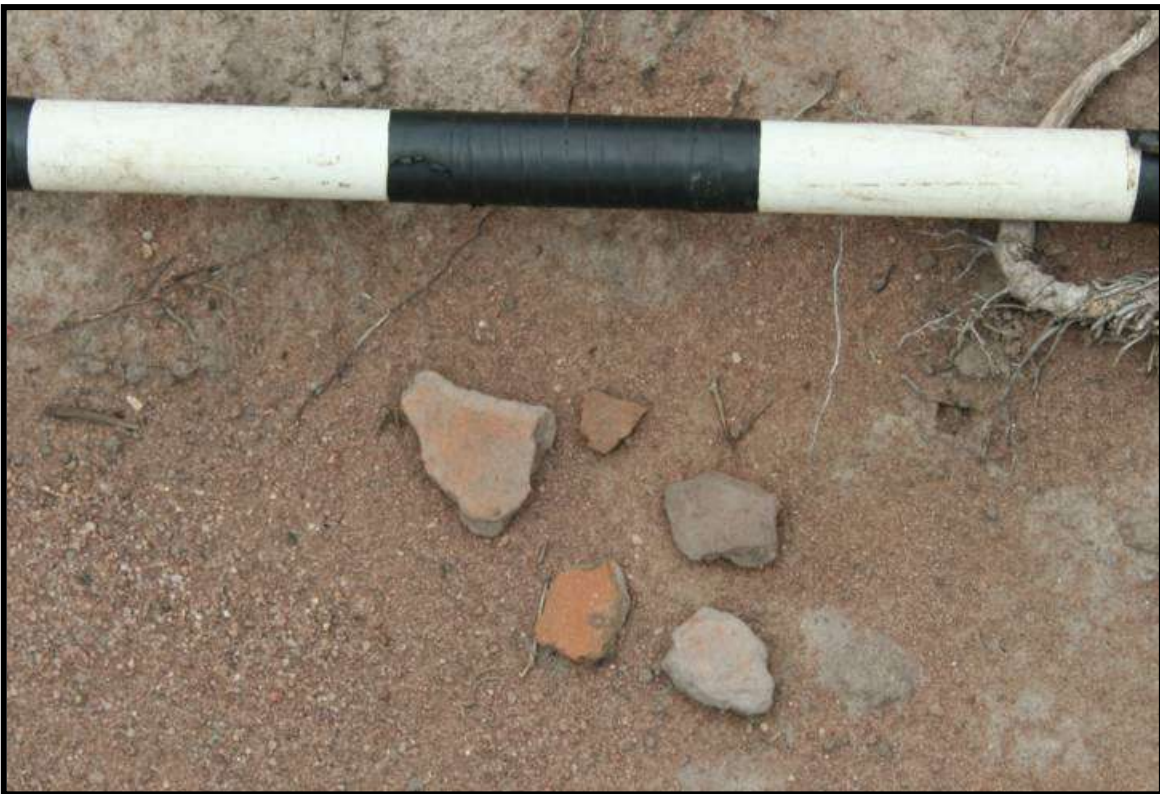
FIG. 11: ARTEFACTS AT GIS02

GIS02 occurs on the top of a hill on the northern boundary of the development. The site consists of an ephemeral scatter of pottery on the crest of the hill (fig. 11). The road to the farmhouse would have removed much of the site. The sherds are orange to brown in colour and are undecorated. They could date to the late Iron Age or Historical Period.

Significance: The site is of low significance.

Mitigation: No further mitigation is required; however, a permit for its destruction is needed.

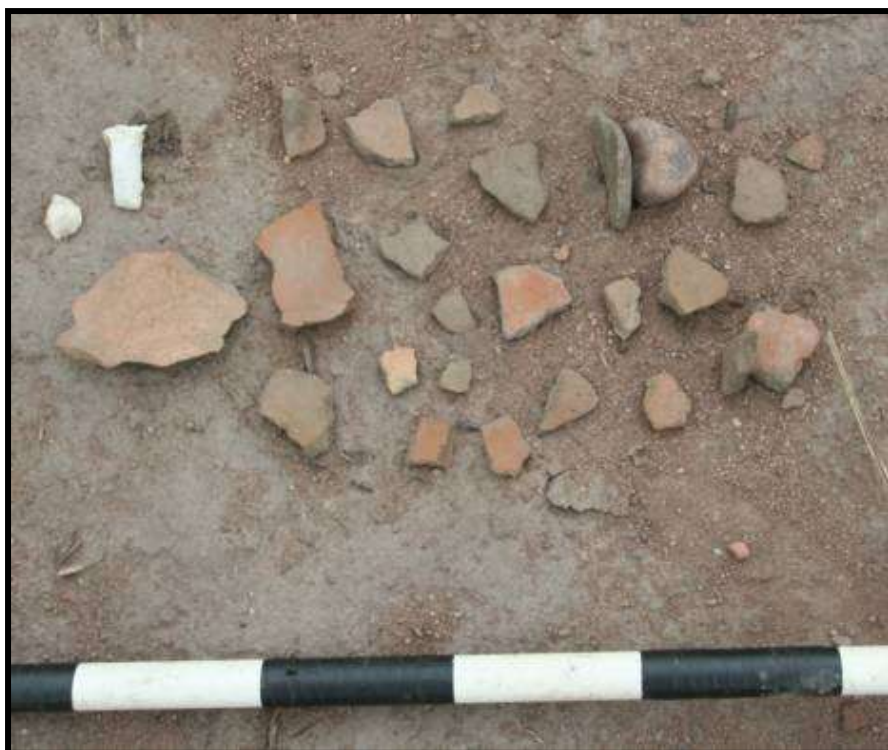
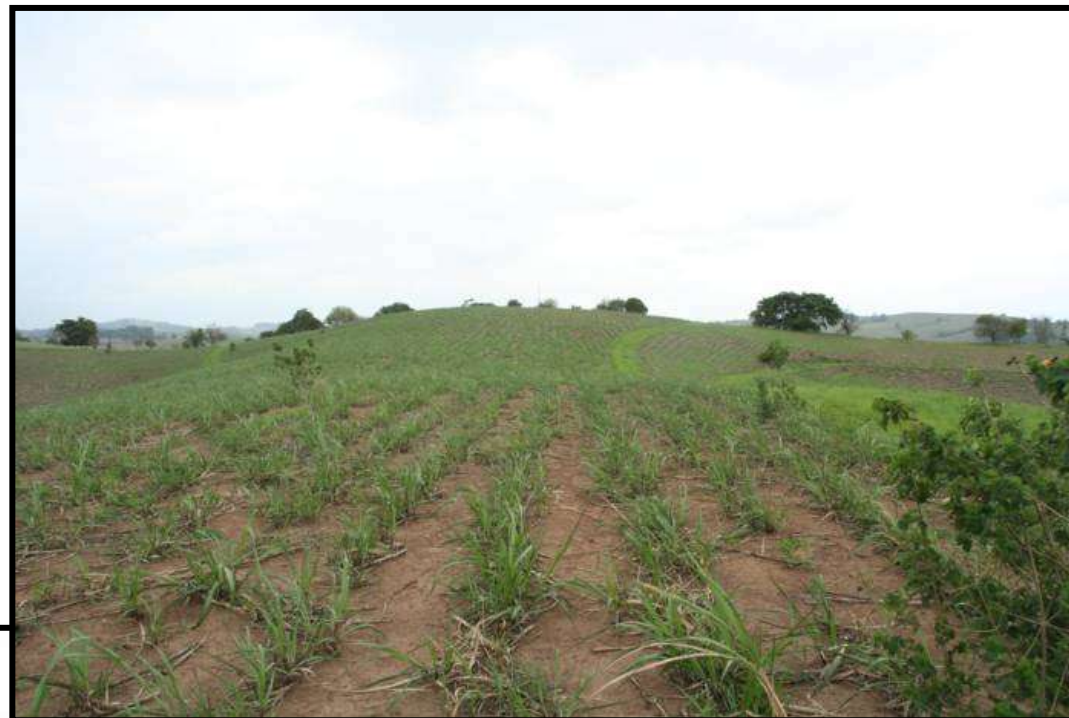
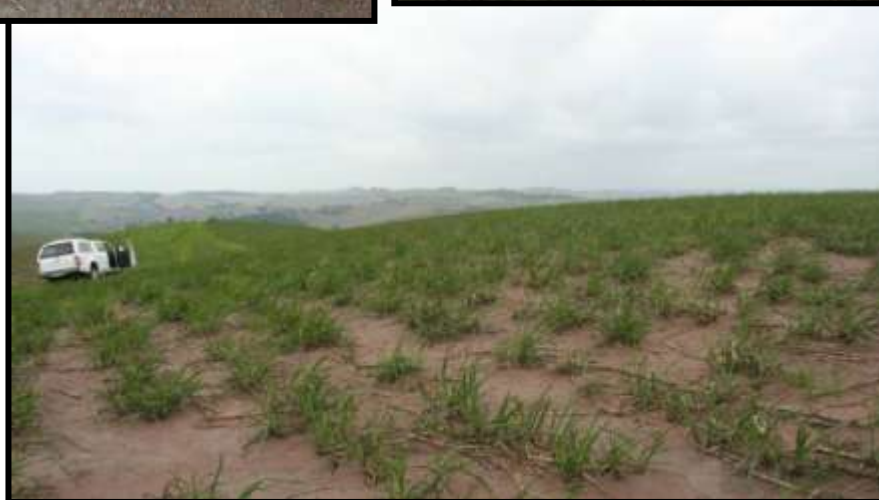
FIG. 12: GIS03 AND ARTEFACTS

GIS3 occurs on the main hill of the study area, and will have the main development. The site consists of a large hill with three spurs lower down. The main hill, GIS03, has a medium density of pottery sherds. The sherds vary in colour and size and come from many different pots (fig. 12). One sherd has lip notching on a slightly everted rim. Two small grinding stones were noted. The sherds extend over the southern/south-eastern side of the hill, and rarely on the northern side. One MSA flake and a LSA adze 'blank' was noted on the hill.

GIS03a, GIS03b and GIS03c are ephemeral scatters of pottery sherds that could be linked to the main site. They are probably the remains of smaller settlements

The soil is not deep in this area and any deposit would have been heavily disturbed by ploughing activity. Most of the site would probably occur on the hill opposite the road.

Significance: The site is of low significance.

Mitigation: No further mitigation is required; however, a permit for its destruction is needed.

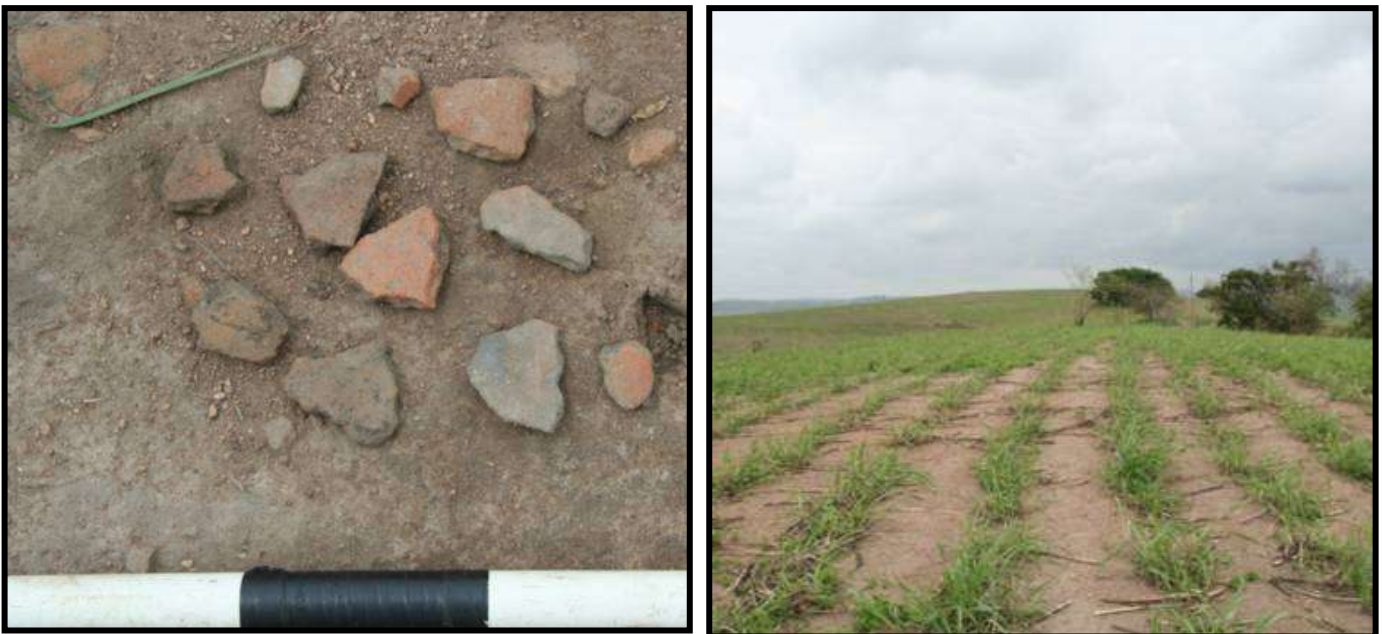
FIG. 13: GIS04 AND ARTEFACTS

GIS04 is located ~175m to the southeast of GIS03. GIS03 is still on the same hill; however, there is a clear break in the occurrence of artefacts between the two sites. The site is located on shallow soils. The artefacts included an ephemeral scatter of pottery sherds, an upper grinding stone, and a broken lower grinding stone (fig. 13). The sherds are undecorated and similar to those at GIS03.

Significance: The site is of low significance.

Mitigation: No further mitigation is required; however, a permit for its destruction is needed.

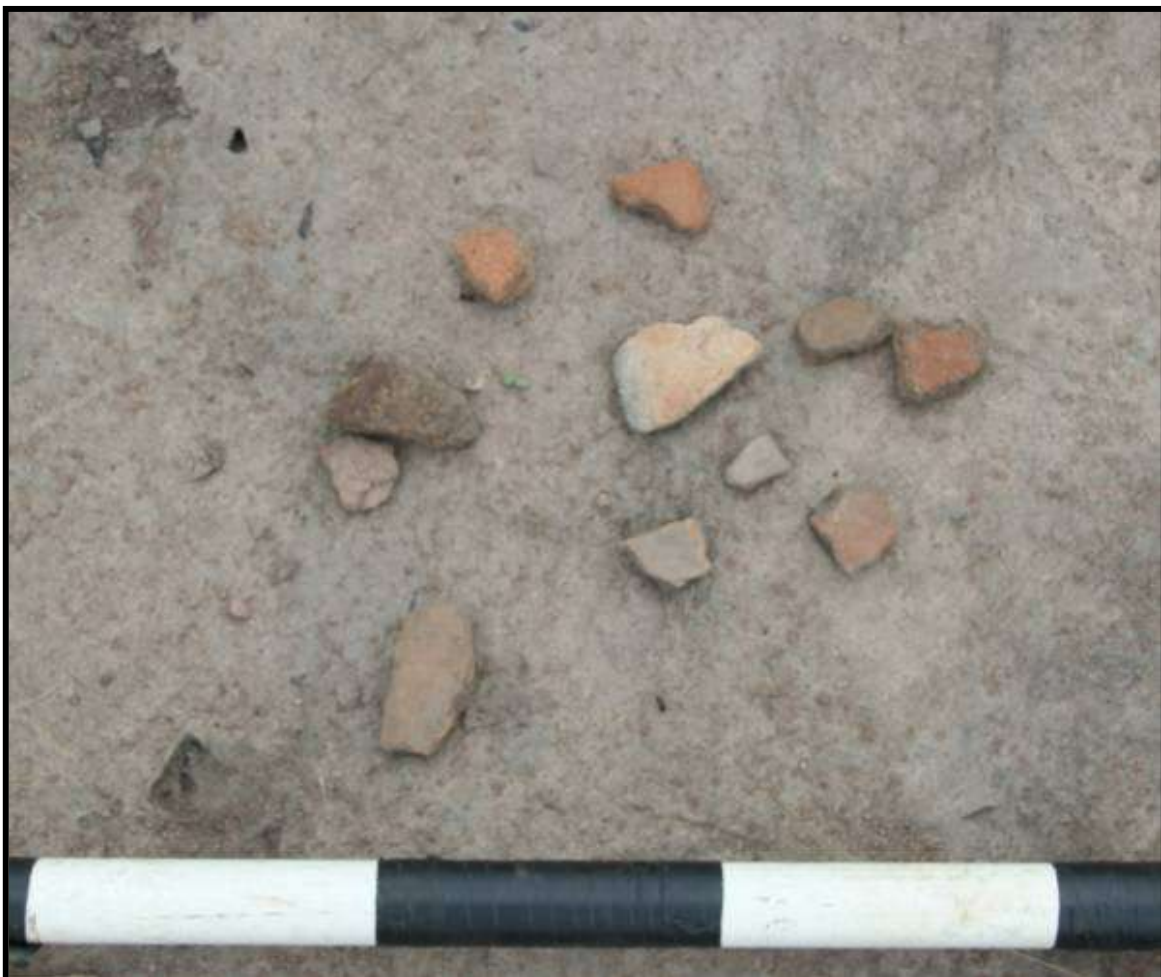
FIG. 14: POTTERY SHERDS FROM GIS05

GIS05 is located on the hill around the buildings of River View. The site consists of an ephemeral scatter of pottery around the southern and (south-) eastern sides of the hill. The pottery is similar to that of GIS03 (fig. 14). The site is shown in Figure 8 (bottom right).

Significance: The site is of low significance.

Mitigation: No further mitigation is required; however, a permit for its destruction is needed.

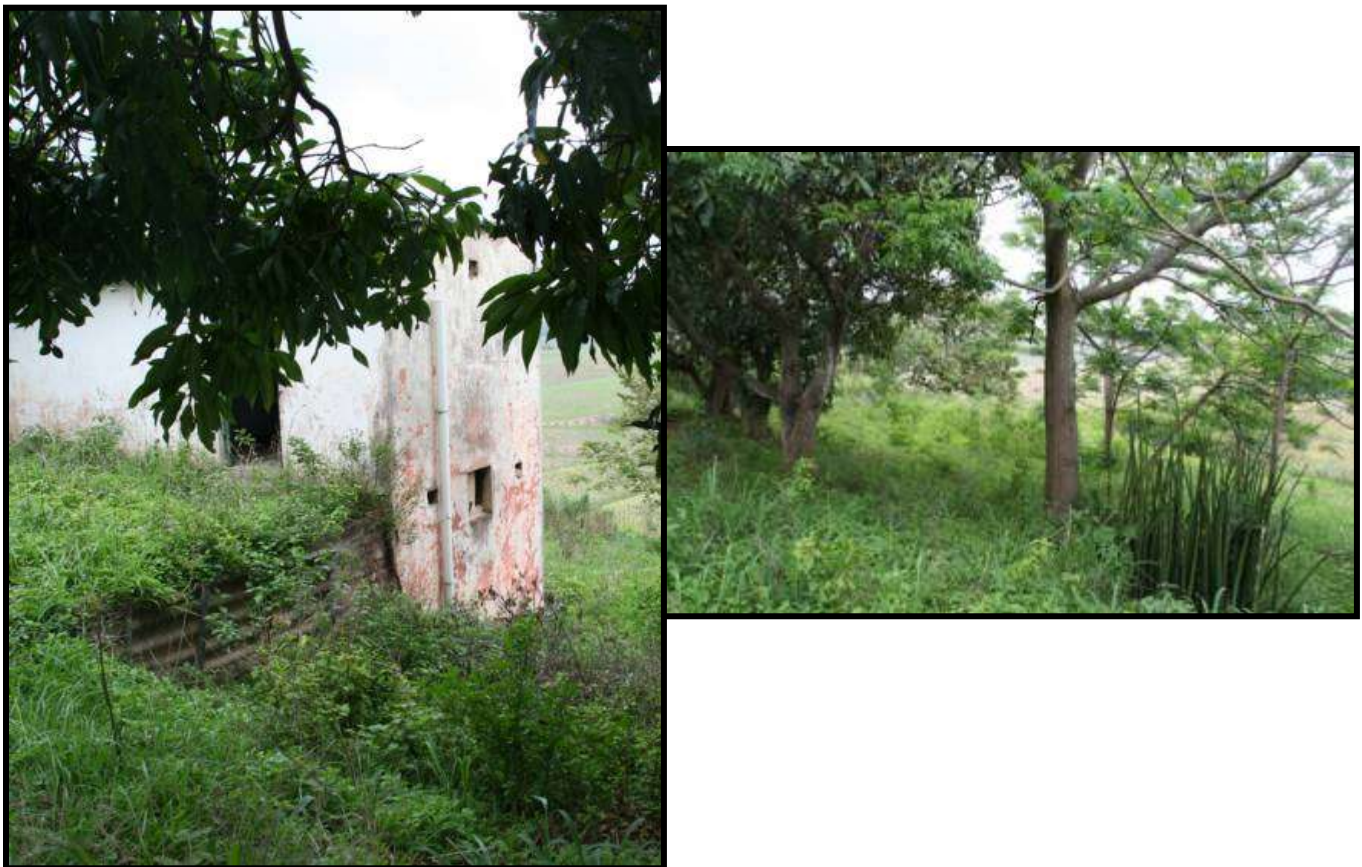
FIG. 15: BUILDINGS AT GIS06

GIS06 occurs on the top of the hill, and is the original farmhouse called River View. The farm buildings occur on the 1968 topographical map, and the 1937 aerial photographs. The main farm building is appears more recent i.e. from the ~1960s onwards. Many of the older buildings only have the foundations remaining and/or have been built over (fig. 15). These buildings will not be affected by the development.

Significance: The significance of the buildings, and ruins, would need to be assessed by an architect historian if they are to be impacted in any manner.

Mitigation: No further mitigation is currently required.
