**INTEGRATED HERITAGE IMPACT ASSESSMENT IN TERMS OF SECTION
38(8) OF THE NATIONAL HERITAGE RESOURCES ACT, 1999 (ACT 25 OF
1999)**

**PROPOSED GOERREESOE WIND ENERGY FACILITY: PORTIONS OF THE
FARMS GOERREESOE 432/ REM, 2, 4 & 5, SWELLENDAM DISTRICT**

APRIL 2013

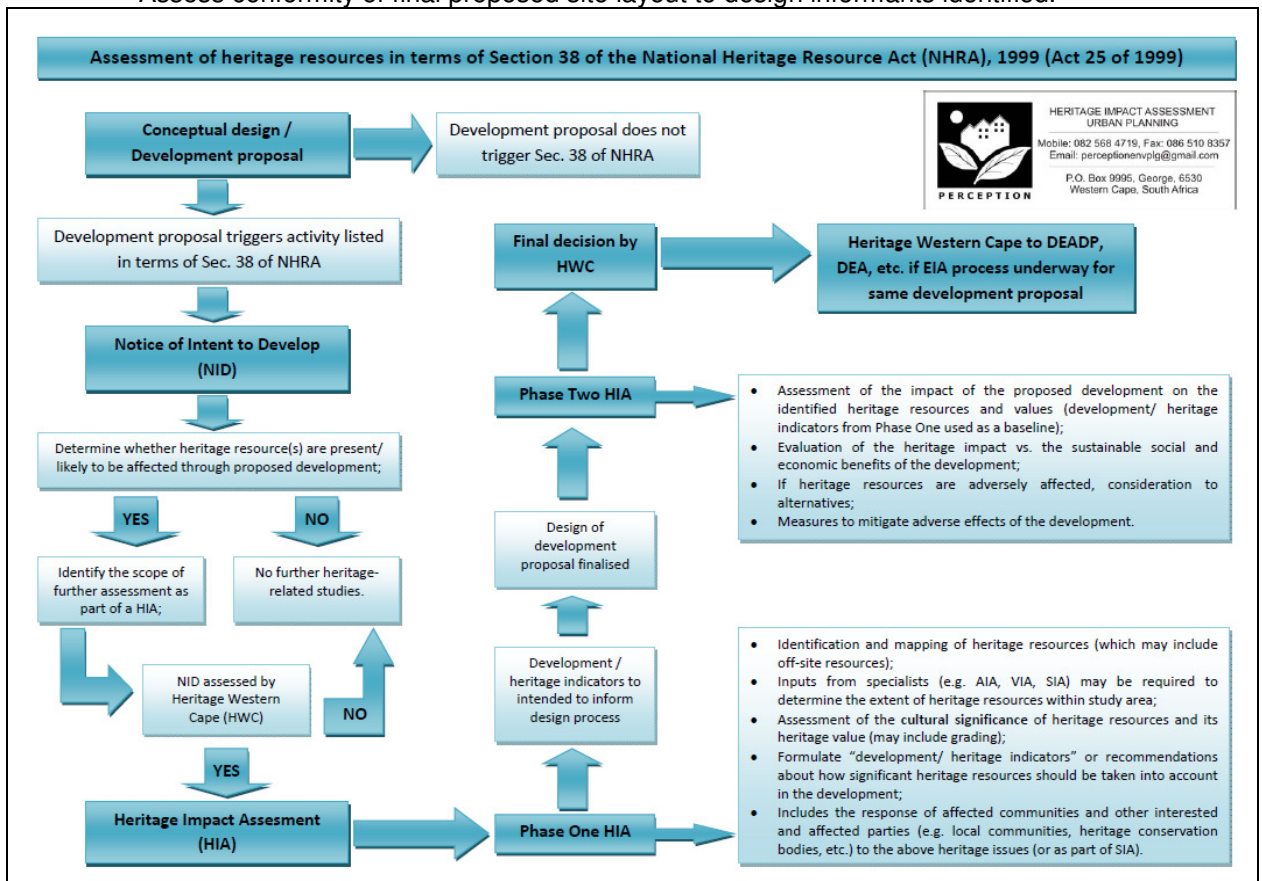
Figure 1: Flowchart describing the HIA process in terms of Section 38 of the NHRA (Act 25 of 1999). The HIA process is now at its final stage, prior to submission to HWC

As part of the compilation of this Integrated HIA report the author has studied, visited, photographed and assessed the subject site and its environs, which more specifically involved the following (also refer to Figure 1):

Aspects to be dealt with in the Final HIA will include (refer Figure 1):

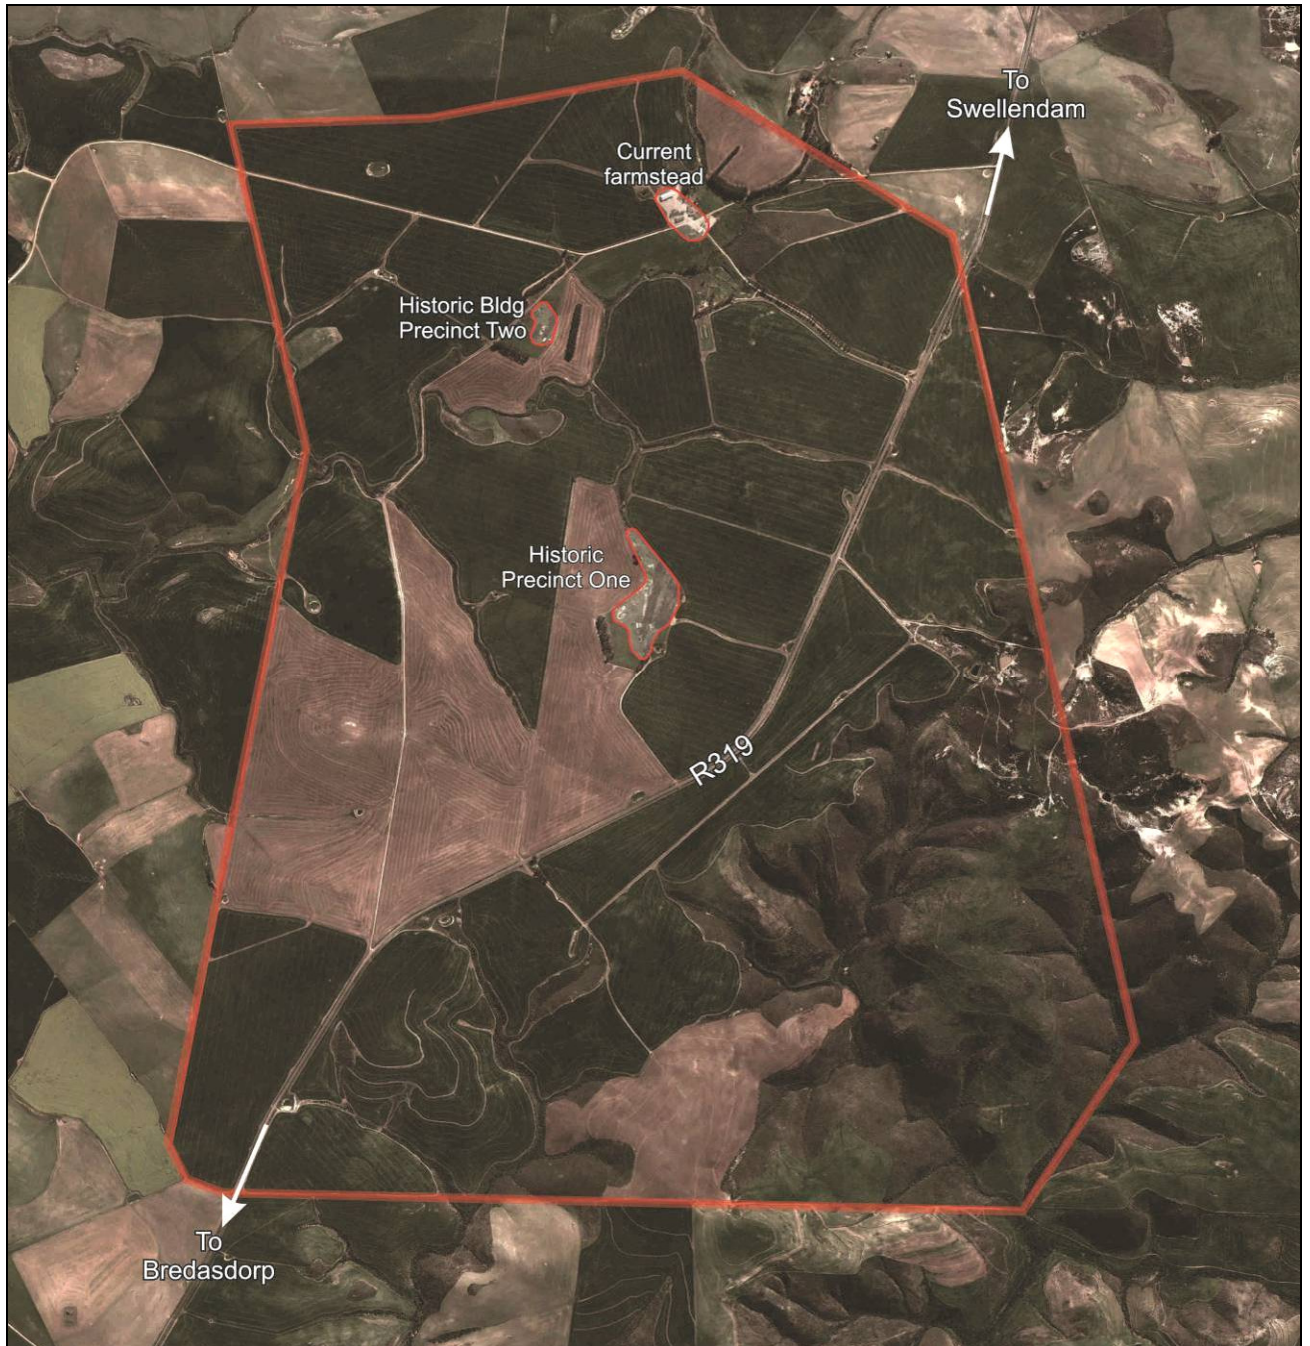
Figure 3: Study area imposed on recent aerial image of surrounding areas (Source: Google Earth, 2011)

No gravesites/ burial grounds were noted anywhere on the site. Various farm roads, the alignment of which seems to correspond with that of roads noted on early mapping, we noted. Also refer to recent aerial photography for the study area (Figure 3).

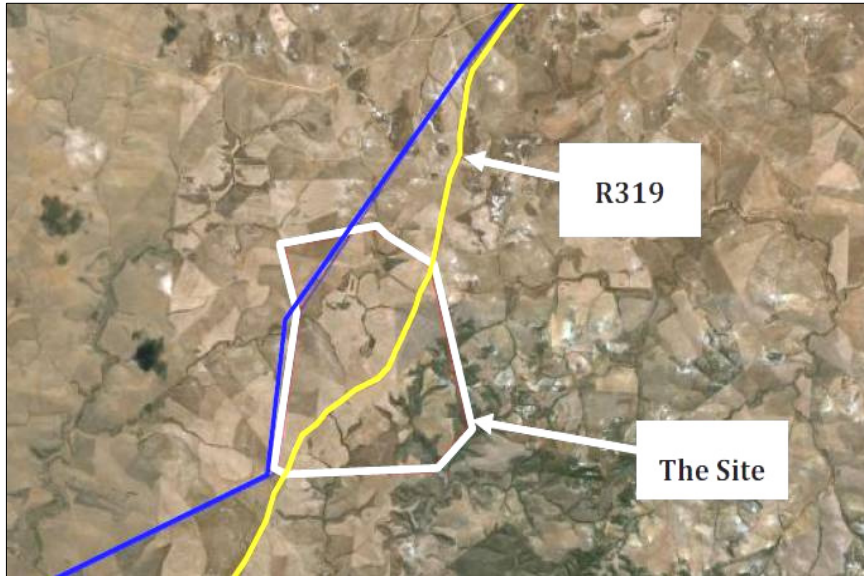
Figure 4: Alignment of existing 66kV Eskom power line (blue) in relation to site boundaries (white) and R319 road (yellow) (Source: NID Submission, August 2011)

Put forward as part of NID submission during August 2011, initial proposal was for a wind energy facility allows for 30MW to be joined to an existing 66KV Eskom line traversing the northwest quadrant of the site and following its western boundary as illustrated (blue line) with Figure 4 below. The number of turbines envisaged at that stage would depend on whether 1.5MW or 3MW turbines were to be used (Estimated height of 80m – 100m). The maximum number of wind turbines envisaged would be between 10 (all 3MW turbines) – 20 (all 1.5 MW turbines) turbines, depending on a number of factors e.g. wind strength at the specific point of location of each turbine. See layout, Annexure 4.1.

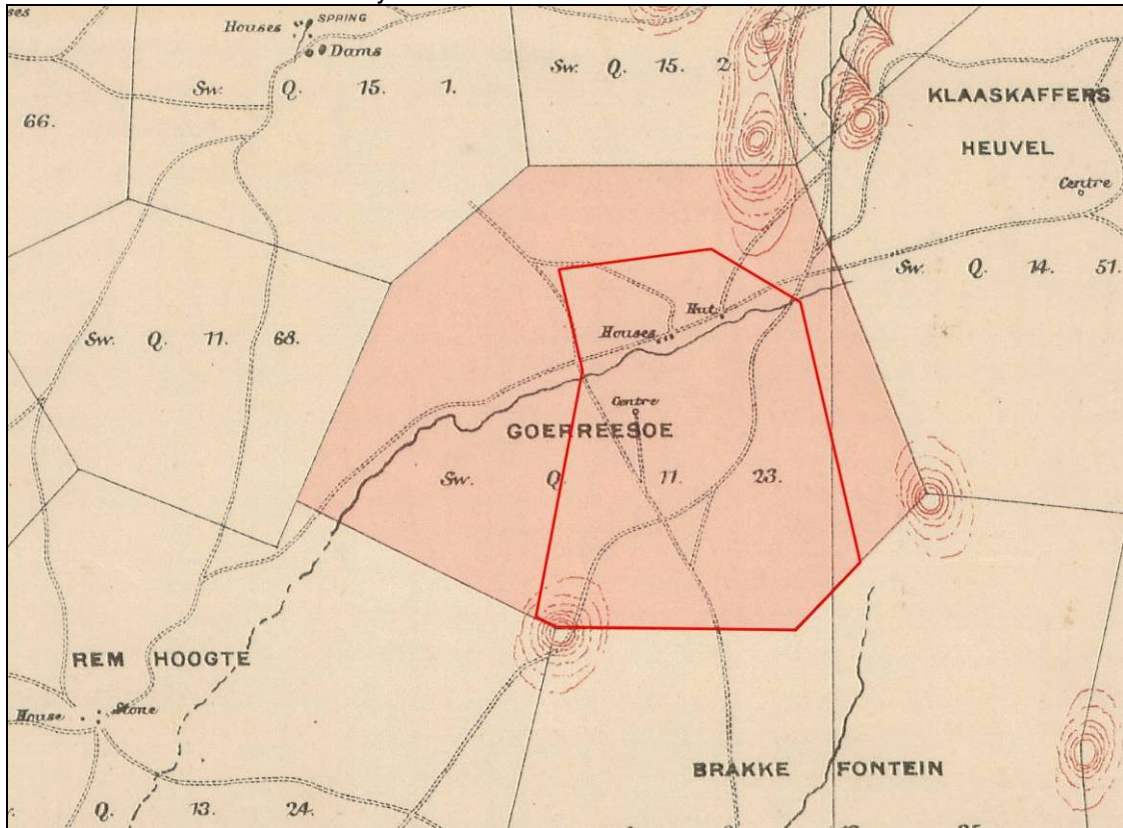
Figure 5: Location of the site in relation to early (1880-1900) farm boundaries for the farm Goereesoe, Swellendam. Note annotations referring to built environment, roads/ tracks shown (Source: CDSM)

From Surveyor General diagrams it would appear that an historic road from Swellendam traversed the property east to west and north of the ravine. The first diagram dated 1836 shows three dwelling houses along the historic road on the northern side of the ravine as well as a hut, north east of the homesteads. The location of these three homesteads appears to correlate with the location of the current ‘modern’ farmstead used by the land owner (Figure 4). The remains of the hut were not located during field work investigation. No buildings were found on diagrams for the remaining portions, but this does not mean that buildings did not exist.

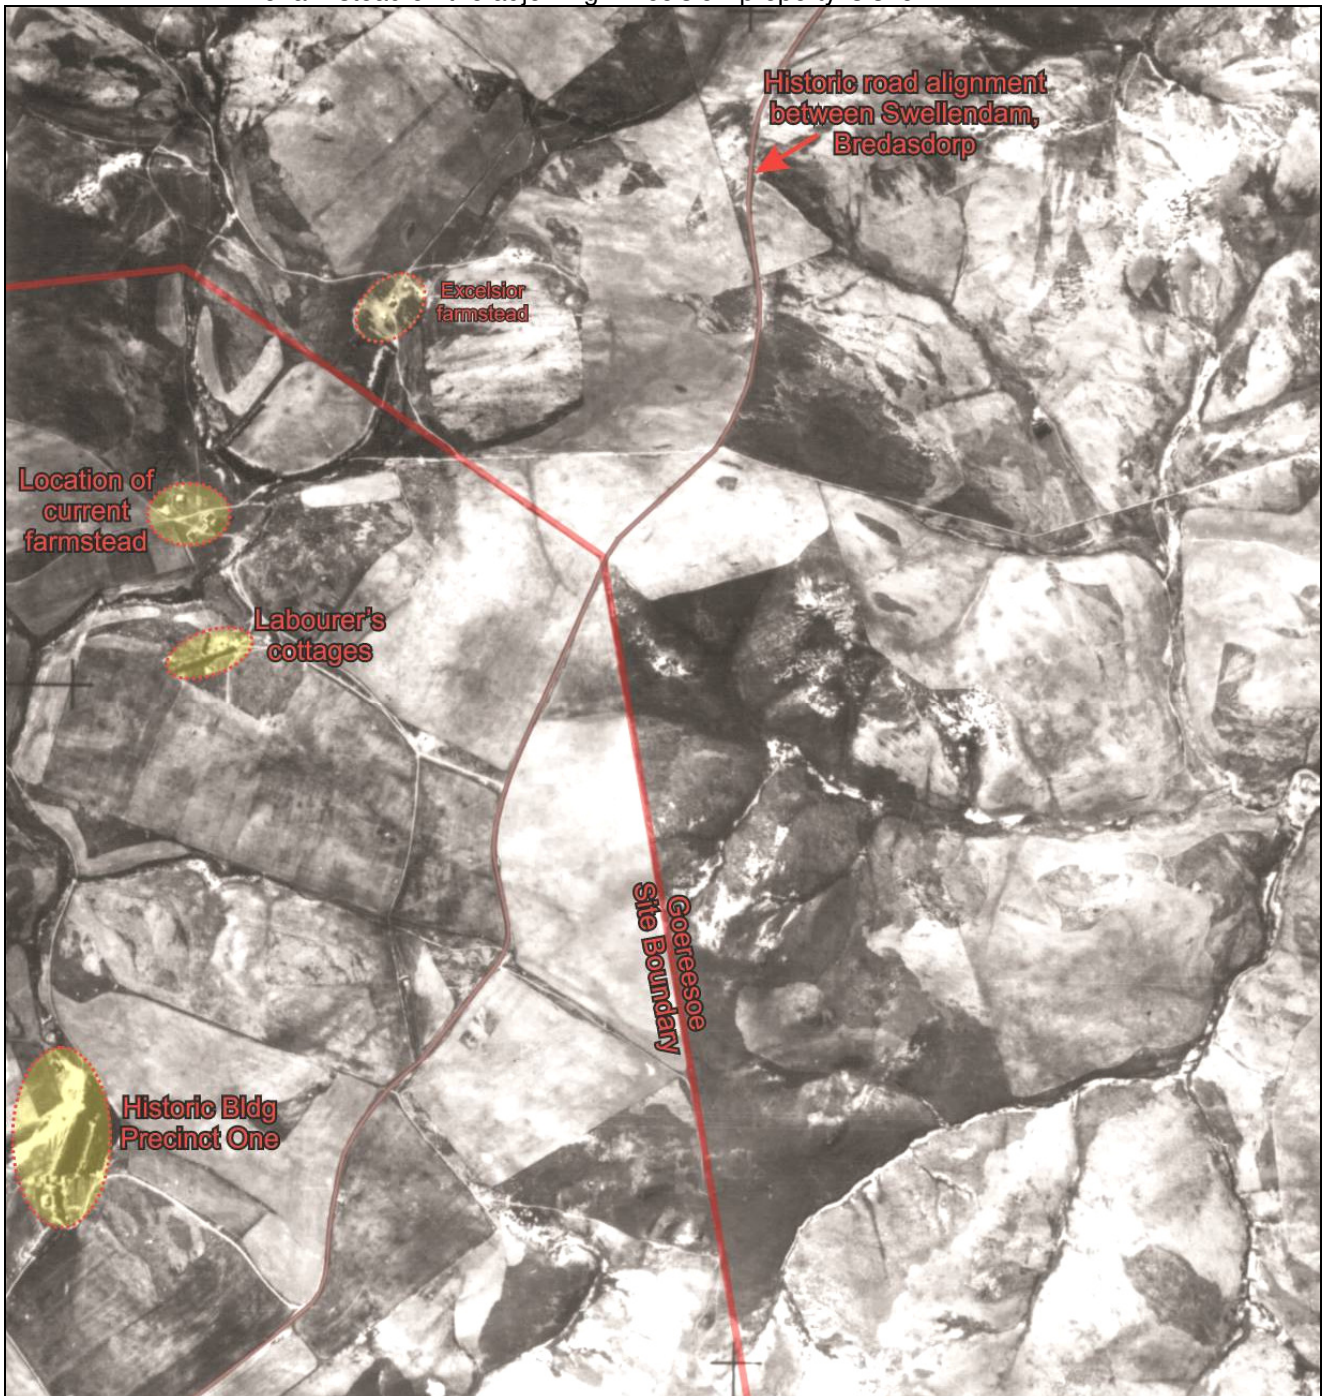
Figure 7: Only available early aerial only covering northeast portion of Goereesoe site. Note alignment of early roads and building precincts (Source: Aerial survey 170 of 1942, Flight strip 15, Image 42493, CDSM)

- While a group of buildings are visible within the proximity of the current primary farmstead and large outbuildings, these are all modern structures except for the old outbuilding (#081) described elsewhere in this report;

- An old labourer's cottage (#080), as well as several other small structures, which no longer remain, are visible;
- All historic structures recorded as part of "Historic Bldg Precinct One" are present;
- The farmstead on the adjoining "Excelsior" property is shown.

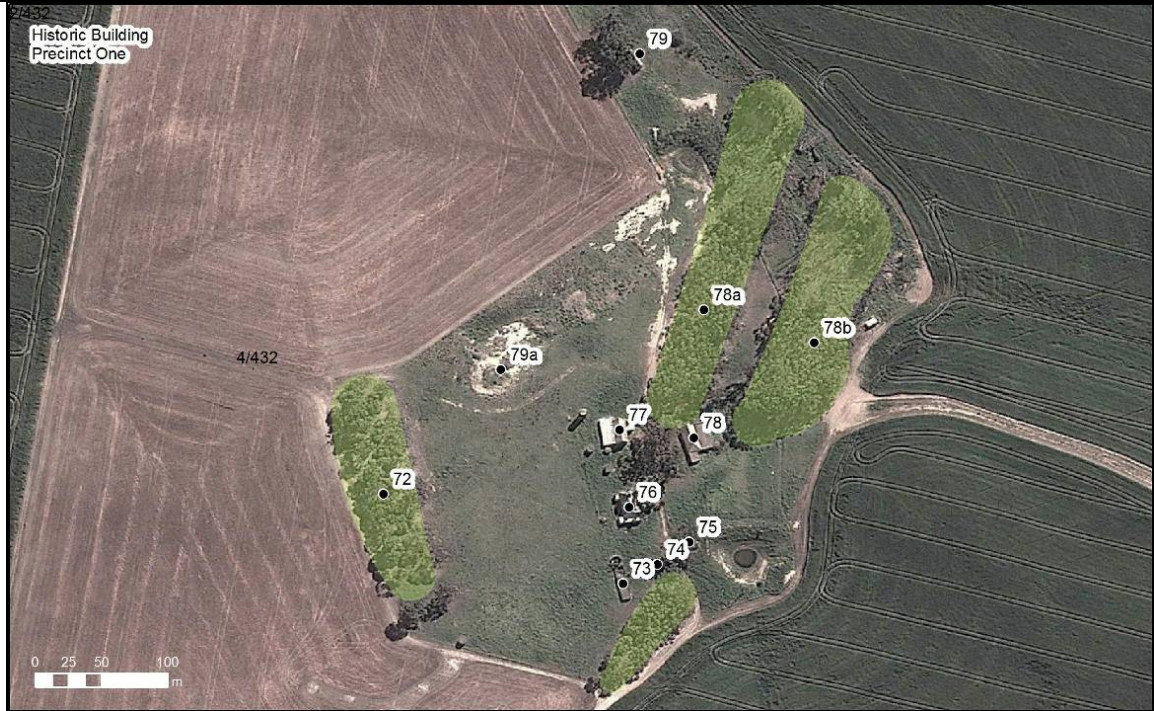
Figure 8: Mapping of heritage resources in Historic Bldg Precinct One (Source: GoogleEarth)

78	Agricultural outbuilding with pitched roof and flat-roofed extensions to side. More recent but >60 yrs with corrugated iron roofing. North-facing gable replaced in same style and (most likely) during same period as for #77 above.	14, 15, 16
	78 a	Copse of blue gum trees	-
	78 b	Copse of blue gum trees	-
	79	Derelict labourer's cottage (mud brick)	18, 19
	80	Labourer's cottage older than 60 years in picturesque setting along slope and amongst row of bluegums and small dam. Pitched roof with attic and corrugated iron roofing and lean-to addition – also of corrugated iron sheeting. Small addition (bathroom) to side and previously fitted with water, electricity though now abandoned. In fair condition though requiring urgent maintenance.	20, 21, 22
	80 a	Row of blue gum trees lining approach road from R319	17
	80 b	Linear-planted blue gum trees (Y-shaped wind breaks)	-
	81	Agricultural store with kraal directly south. Mud brick construction, corrugate iron roofing, reed ceiling, still in use though in poor condition requiring urgent maintenance.	23, 24, 25

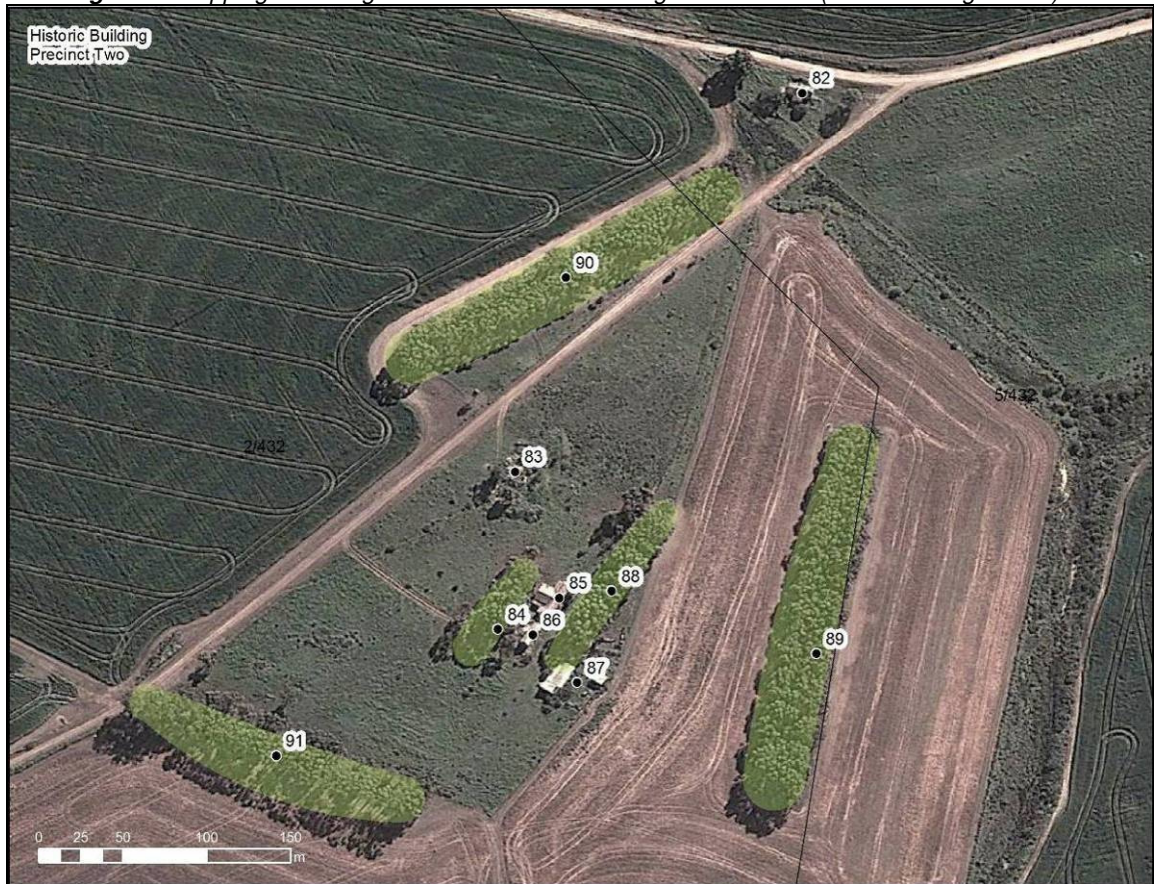
Figure 9: Mapping of heritage resources in Historic Bldg Precinct Two (Source: GoogleEarth)

Building Precinct Two	82	Labourer's cottage, age uncertain	28
	83	Building rubble dumped on top of foundations. Location corresponds with that of former structure visible on 1942 aerial photography.	29
	84	Small ruined outbuilding set within copse of bluegum trees (mud brick construction, square with simple but quaint northeast-facing gable)	30
	85	Ruin of substantial single-storey farmstead. U-shaped but with centrally-orientated flank to rear. Stoep to front (east-facing) elevation as well as two stoeps to rear elevation. Two entrances to attic along front facade. Mud brick construction with pitched (corrugated iron) roofing. Former sash windows, timber flooring and timber ceilings sadly removed and building allowed to deteriorate significantly – restoration probably no longer feasible. Interior of building not accessible due to presence of bee colony.	33 – 36
	86	Derelict secondary homestead of simpler but similar mud-brick construction as #85. Corrugated iron roofing and attic. Poor condition though presently used as storage.	31, 32

87	Two ruined agricultural outbuildings (mud brick construction, corrugated iron roofing) set to side of stonewalled kraal. Restoration probably no longer feasible.	37
	88	Linear-planted blue gum trees (wind break)	-
	89	Linear-planted blue gum trees (wind break)	-
	90	Linear-planted blue gum trees (wind break)	-
	91	Linear-planted blue gum trees (wind break)	-
