A REPORT ON THE ARCHAEOLOGICAL MONITORING OF THE LAYING OF THE 132 KV ELECTRICITY CABLES FROM THE FORESHORE SWITCHING STATION TO THE NEW GREEN POINT STADIUM

Prepared for

Jeffares & Green (Pty) Ltd

November 2009

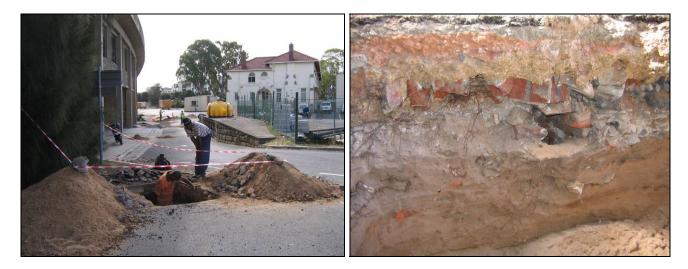
(I) Contractors test holes along the cable route in the Council Roads Depot off Ebenezer Road (r) Large amounts of rubble fill were noted in the upper parts of the holes overlying in situ sandy deposits.

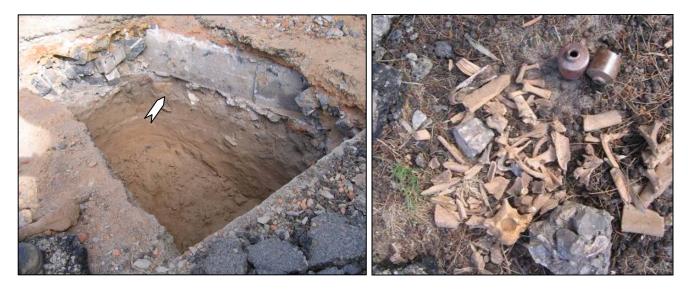
(I) Undisturbed sandy matrix seen in one of the test holes in the Council Roads Depot. Artefactual material was located just below the rubble as indicated. The content suggests that it emanated from a household/s dump (r) 19th century artefactual material recovered from spoil heaps of one of the test holes in the roads depot. Bones are all those of domesticates and fish, while glass and refined earthenware ceramics were also present. Two salt glazed earthenware ink pots can be seen at upper right. This was the only dense (though spatially limited) scatter of material observed during the entire monitoring exercise.

Largely undisturbed sandy deposit were also observed in the test holes to the west of the entrance to the Roads Depot off Ebenezer Road. A variety of 19th century artefactual material found in one of the holes appeared to have come from a refuse dump. Quite a lot of bone was present, and after some initially anxious moments, closer inspection identified them as the remains of sheep, fish and cattle resulting from human consumption (see photo). Most of

what was found was immediately collected to pre-empt any unnecessary misidentification as human remains. This turned out to be the only dense scatter of material observed during the entire project and only a handful of isolated artefacts were observed elsewhere. The thickness of the sand strata here was cause for concern as this appeared to most resemble the deposits found in the burial grounds adjacent to Prestwich and Cobern Streets excavated some years before.

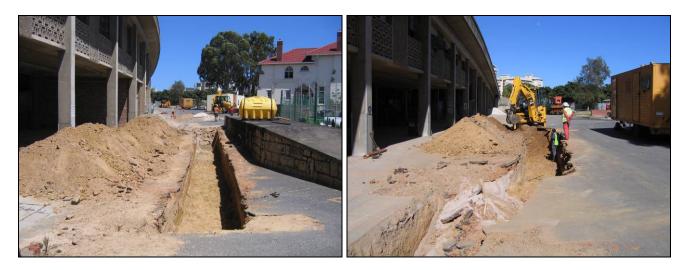
(I&r) Trenches alongside the elevated freeway in the Council's Ebenezer Roads Depot

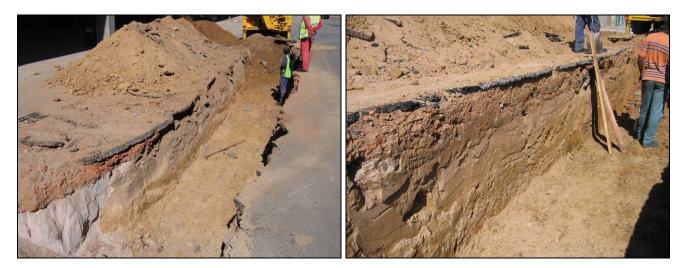
(I&r) Trenches alongside the elevated freeway in the Ebenezer Roads Depot

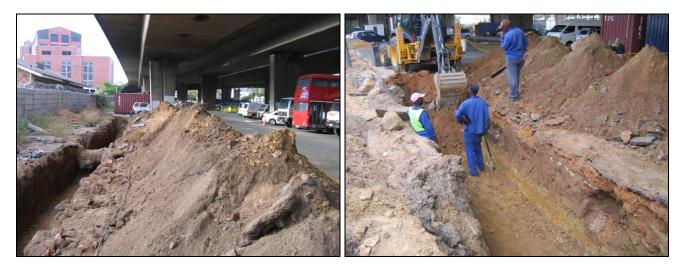
(I&r) Trenches below the elevated freeway to the west of Port Road

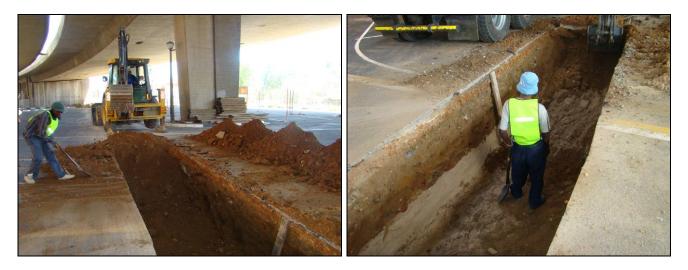
(I&r) Trenches below the elevated freeway in the Traffic Department Drivers Testing facility on the corner of Port and Ebenezer Roads.

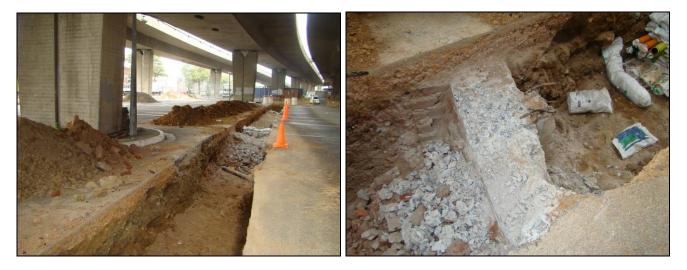
(I&r) A substantial re-inforced concrete foundation was encountered along the route. No similar features were observed elsewhere in the area suggesting that it was not part of a building but, more likely to have been a linear feature such as a wall or supporting structure of some kind.

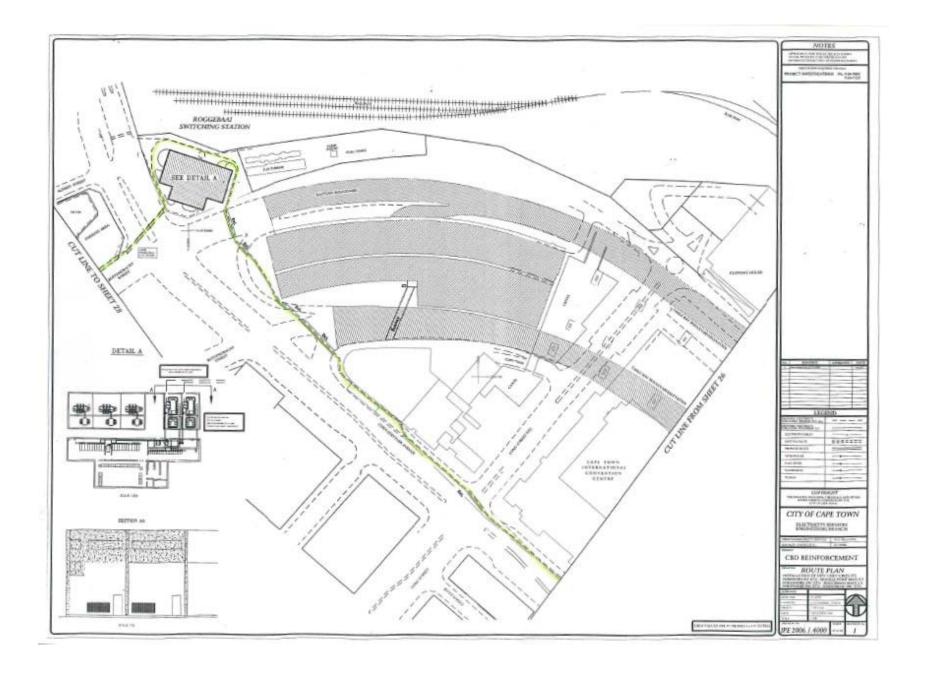
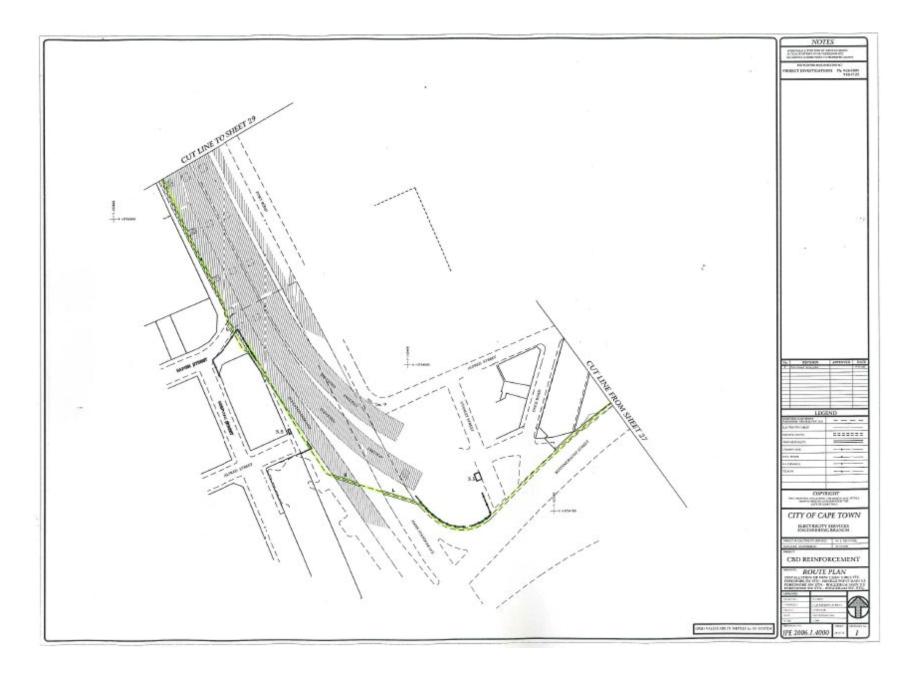
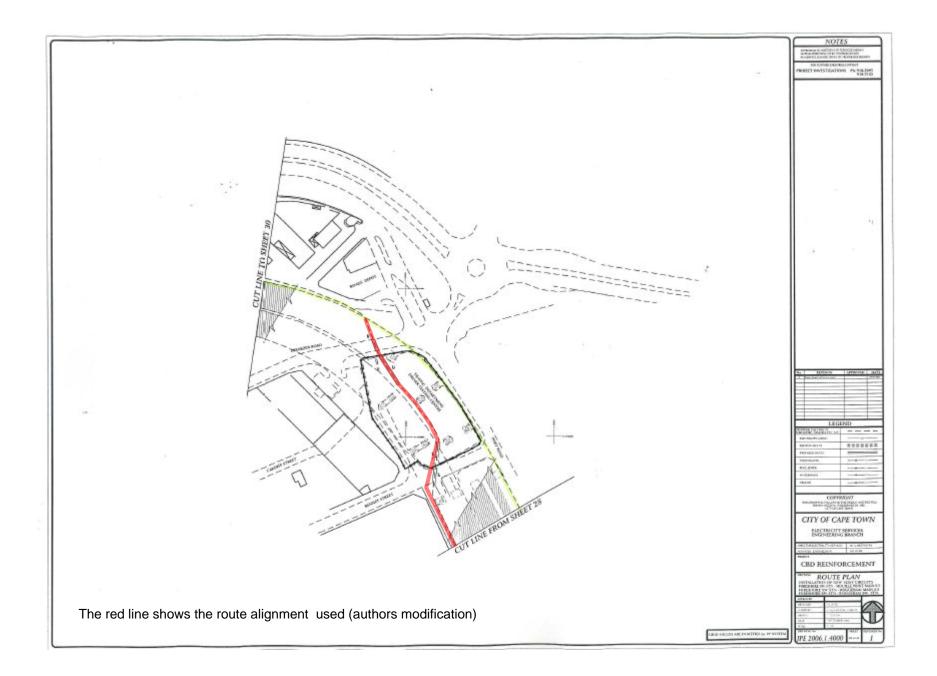
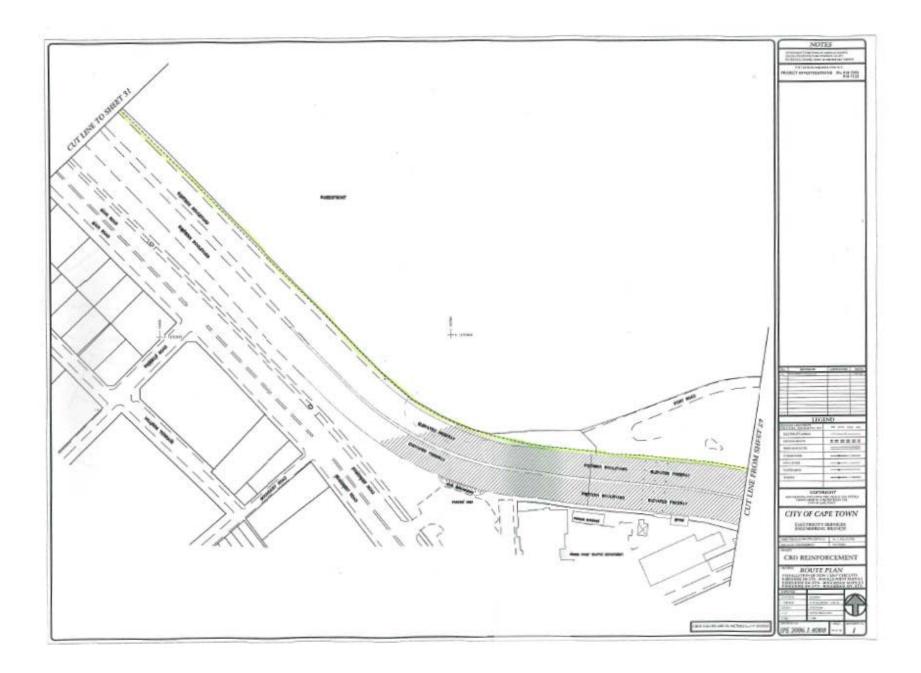
ANNEXURE 1: CABLE ROUTE

The project consists of the installation of a new 132kV switching station to be constructed behind the existing Foreshore main substation to reinforce the electricity supply to the CBD and to the new main substation to be constructed in conjunction with the 2010 Green Point Stadium. The footprint of the switching station is approximately 352m². Transformers within the existing Foreshore main substation will be replaced with two 132/11/66 kV 50 MVA units. New underground 132 kV cables will be installed in Oswald Pirow Street and Table Bay Boulevard to serve the new switching station. From there, underground cables will be laid through to the stadium along a circuitous route along Coen Steytler Avenue and the Roggebaai switching station, then up lower Buitengracht Street then in a westerly direction below the existing overhead freeway, through the Traffic Department Driver Testing Centre, the City Council's Ebenezer Road depot, then again alongside Western Boulevard towards the stadium. The cable route is shown in Annexure 1.
