A DESKTOP SPECIALIST ARCHAEOLOGICAL STUDY OF THE REMAINDER ERF 1056 GREEN POINT: CAPE TOWN STADIUM AND GRANGER BAY PRECINCT

(In terms of Section 38 of the NHRA of 1999)

Dave Halkett

ACO Associates cc

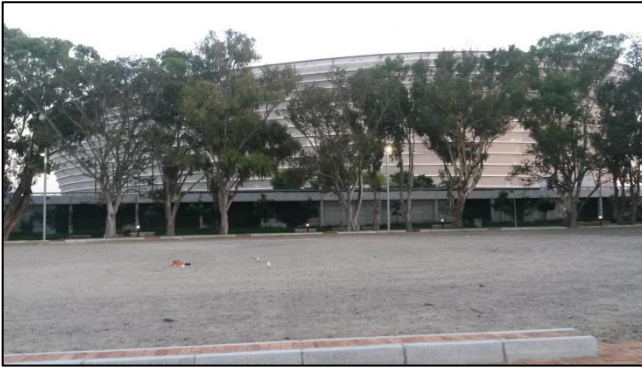
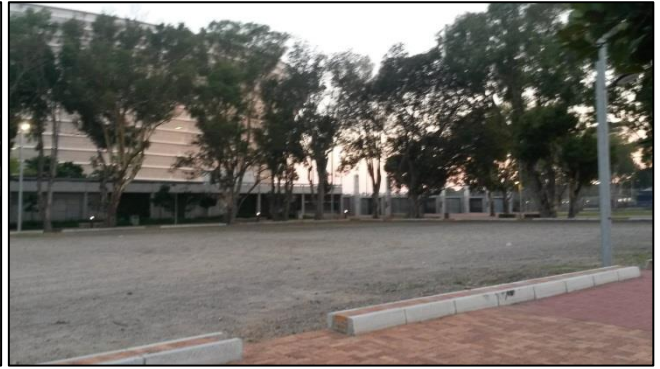
Plate 1 & 2: Looking north across the parking area that is the present configuration of the Granger Bay Boulevard Precinct.

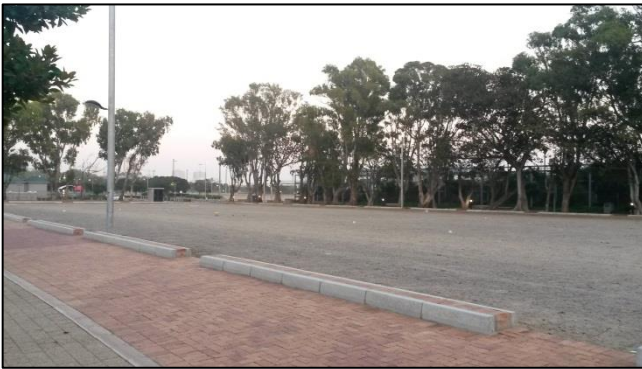
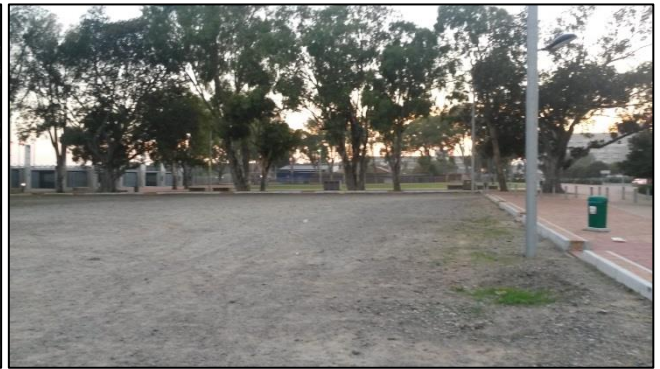
Plate 3: Looking to the north west across the parking. **Plate 4:** Looking north east towards Fort Wynyard.

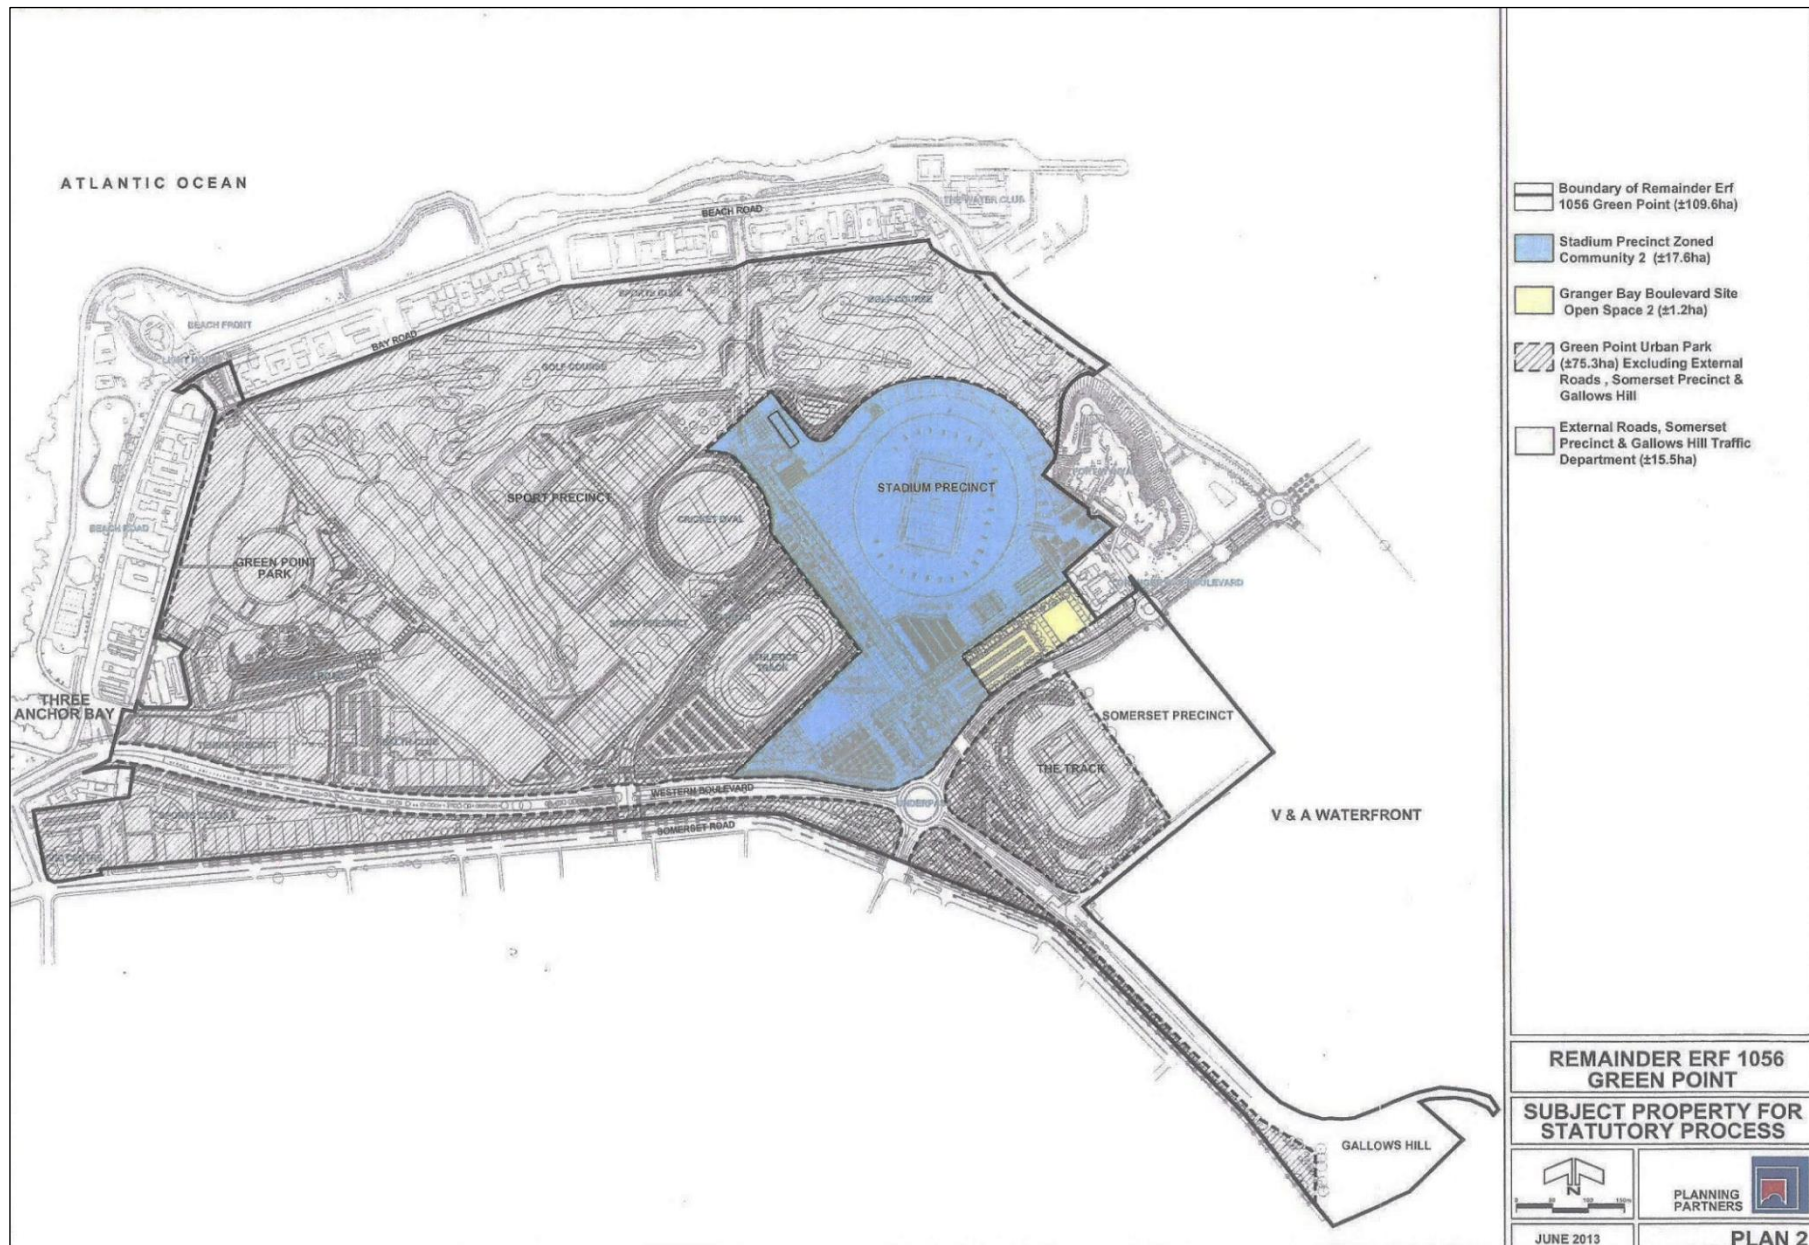
Figure 2: The outline of the broader Erf 1056 and the various sub-components.

The formal application includes the following (see Figure 2 for the various sites discussed below):

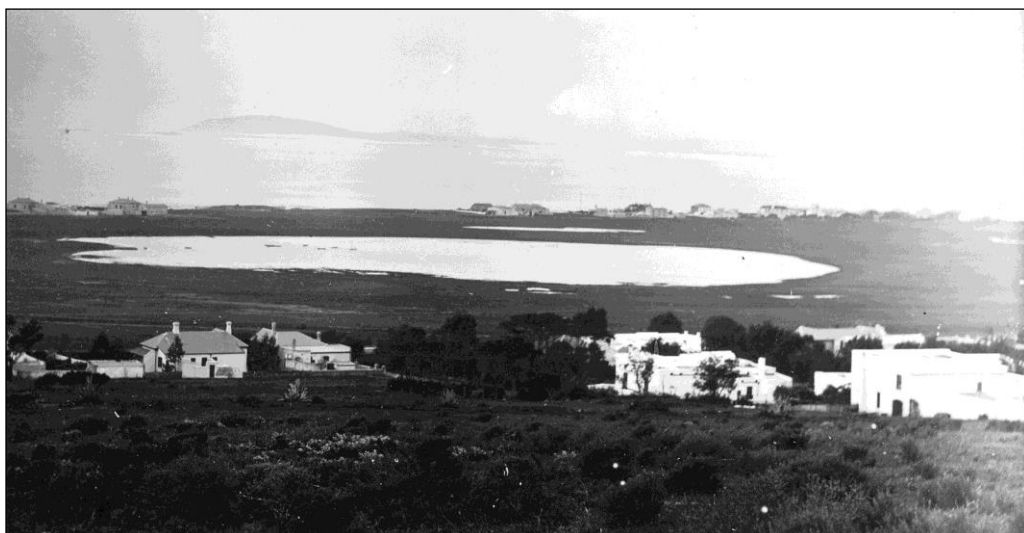
Plate 9: A photograph c1889 showing the vlei and surrounding houses along Beach Road in the background and Main Road in the foreground (CA Dr J 250).

Green Point consisted of a flat coastal plain in front of Signal Hill, punctuated by some prominent dunes. A large vlei existed close to the present site of Green Point Stadium, while seasonal swamps characterized much of the Common (Plate 9). The granite and malmsbury shale geological substrates of the area would have provided trace elements necessary for the raising of domestic animals. Early maps describe Green Point as being the location of a "hottentot village" on the outskirts of Cape Town². These people were probably the remnants of indigenous groups who would have grazed their herds on the Common before being displaced by European settlement. In 1997 the remains of 4 human individuals displaying Khoi Khoi characteristics were found buried in traditional style (with pot and broken grindstones) under 19th century houses in Cobern Street, Green Point (Cox 1999). Dated to about 1000 years before present, these archaeological finds testify to a long history of use of the area.

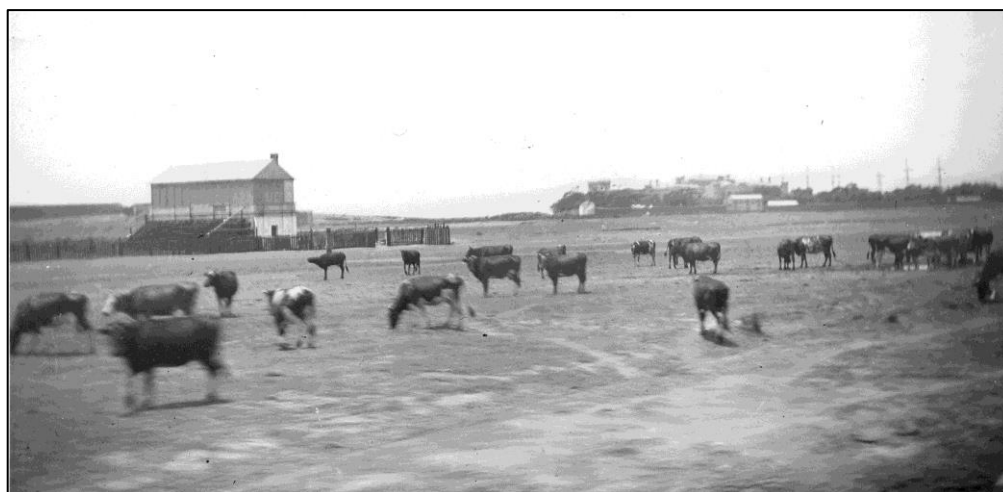
Plate 10: C1895 showing the race stand, with the (new) Somerset Hospital in the background (CA Dr J 723).

Horse racing on the Common was made popular by the British. Soon after their occupation of the Cape in 1795, regular horse racing became an institution on the western end of the Common and by 1797 the African Turf Club was established (Kagan 1975). The Stand was built in 1851 for the South African Turf Club, after a design by G McDougall. It was reused as a club house in the early days of the Metropolitan Golf Club, and was also used as an art centre. It presently serves as a McDonalds outlet. According to Fransen (2004:78), although the building has been altered, the late Georgian two storey five-bay core is still intact and has been a familiar landmark on the Green Point Common since the mid-19th century.

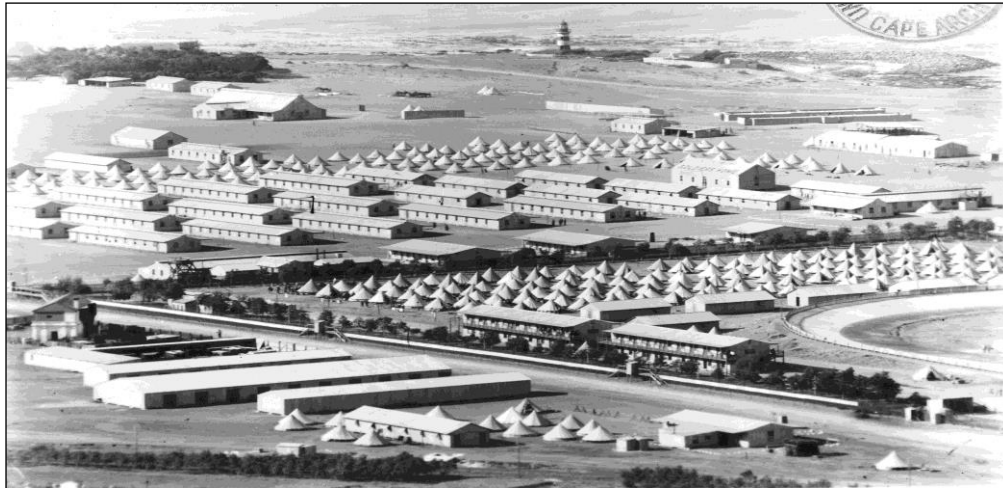
Plate 11: Military and Prisoner of War camp on the Common. The Cycle Track can be seen at right and the Race Stand at extreme left. (CA E9356)

During the South African War, Green Point common was, due to its proximity to the Victoria and Alfred Basins, used as a military transit camp for British and Colonial troops who were housed in temporary bungalows⁵. Of particular interest is that the Green Point Track was used as a Prisoner of War Camp for Boer captives who were housed in tents⁶ while waiting to be shipped out to St Helena, Ceylon and Bermuda. Photographer Arthur Eliot's earliest images include several taken at the Green Point Camp⁷. The monitoring reports produced by Patrick and Mutti (2009a) and document a number of military artefacts that were found during the construction of the stadium that can be associated with the camp.

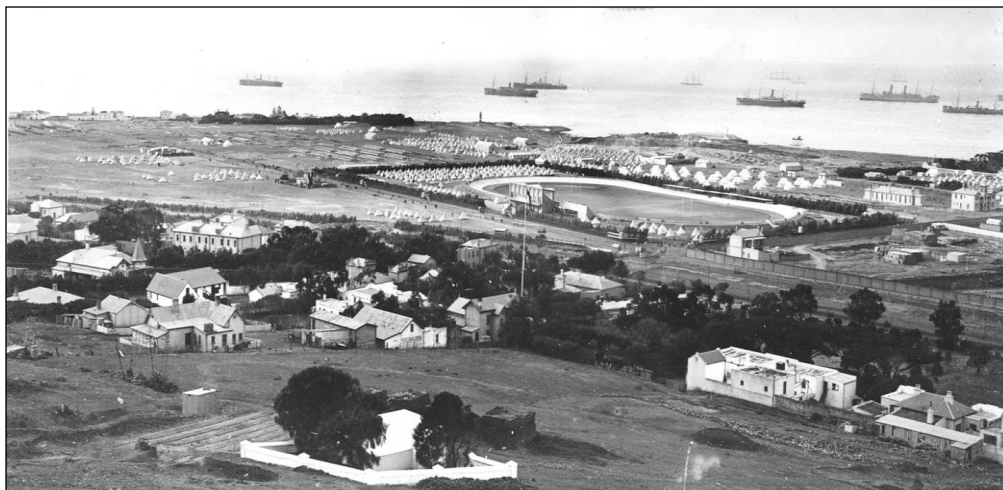
Plate 12: Military and Prisoner of War camp on the Common. The Cycle Track is clearly visible. (CA E9342)

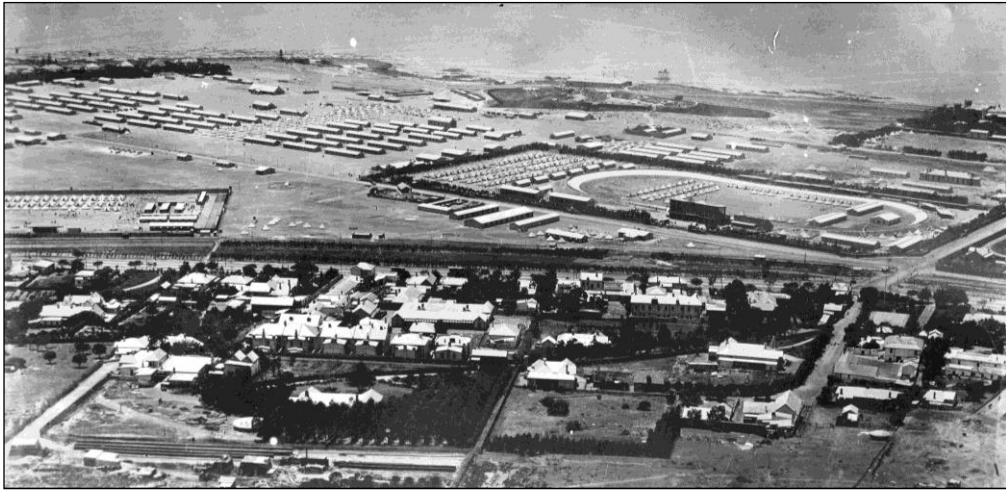
Plate 13: The extent of the encampments on the Common during the Anglo Boer War are clear in this photo. The Boer prisoners were confined to the Green Point Track (CA R1443). This image is also presented in Figure 7 to show the positions of the Stadium and GBB precincts and the Laboratory and Fort Wynyard.

Garrison Artillery³. Kyk in de Pot and the remodelled Fort Wynyard are shown on various maps and plans i.e. Figures 3, 4, 6, 7 (also Plate 13) and 8.

Figure 7: A photograph (CA R1443) showing the extent of the encampments on the Common during the Anglo Boer War. Boer prisoners were confined to the Green Point Cycle Track. The Stadium (blue) and Granger Bay Boulevard (yellow) precincts are superimposed for reference. Fort Wynyard and the associated Laboratory are shown in orange. The position of modern roads (Fritz Sonnenberg (yellow) and Portswood Road (green)) corresponds largely to those on the older layout (Green Point Road).

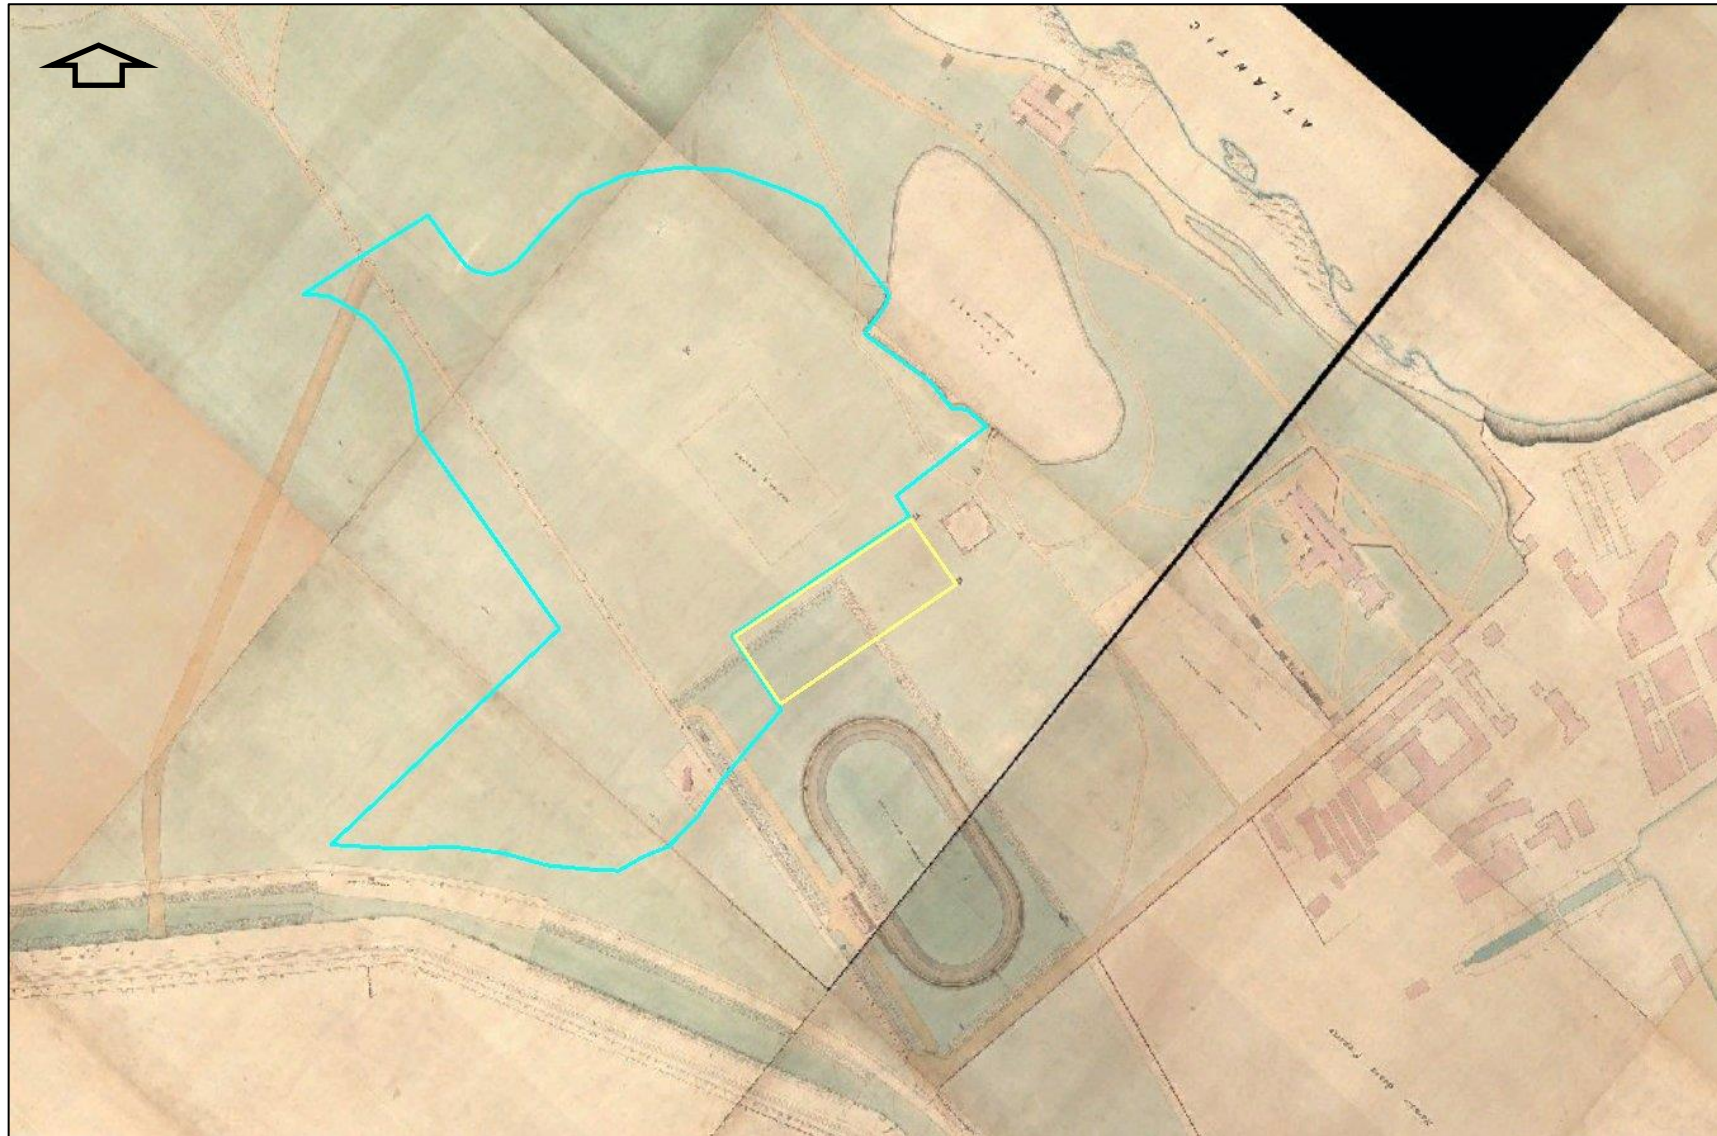
Figure 6: Thom's map of Cape Town c1898 (Jordan 2003). The outlines of the Stadium and Granger Bay precincts are shown by the blue and yellow polygons. The Cycle Track is a new addition to the landscape while a football ground is indicated at a position which is now partially covered by the new stadium. The track, race stand, laboratory and Fort Wynyard are key landmarks which remain until today. Parts of the Cycle Track site extended into the Stadium and Granger Bay Boulevard precincts.

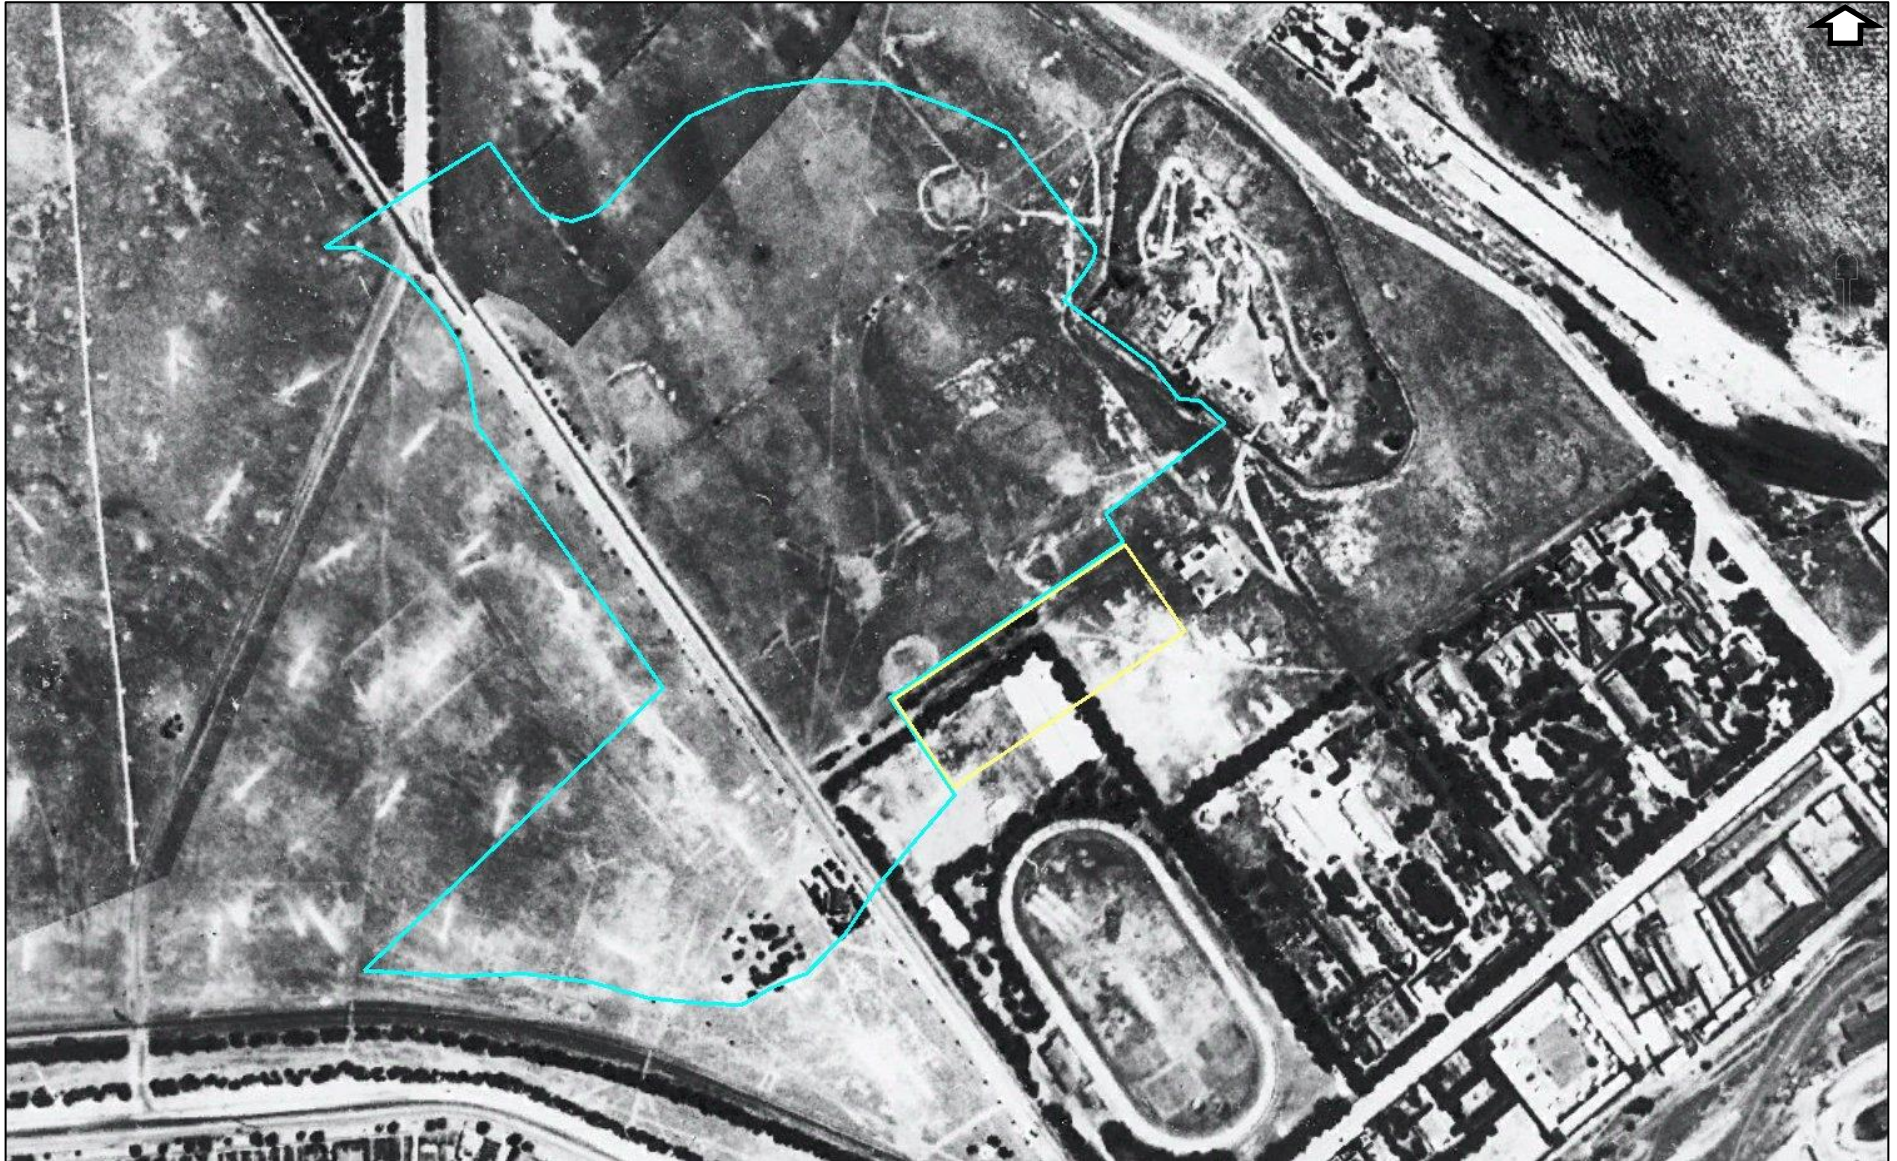
Figure 8: A portion of the 1926 aerial photograph showing development on the common at that time with the outlines of the Stadium and Granger Bay precincts shown by the blue and yellow polygons. Fort Wynyard, the Laboratory, Cycle Track and Race stand are all clearly visible (Jordan 2003).

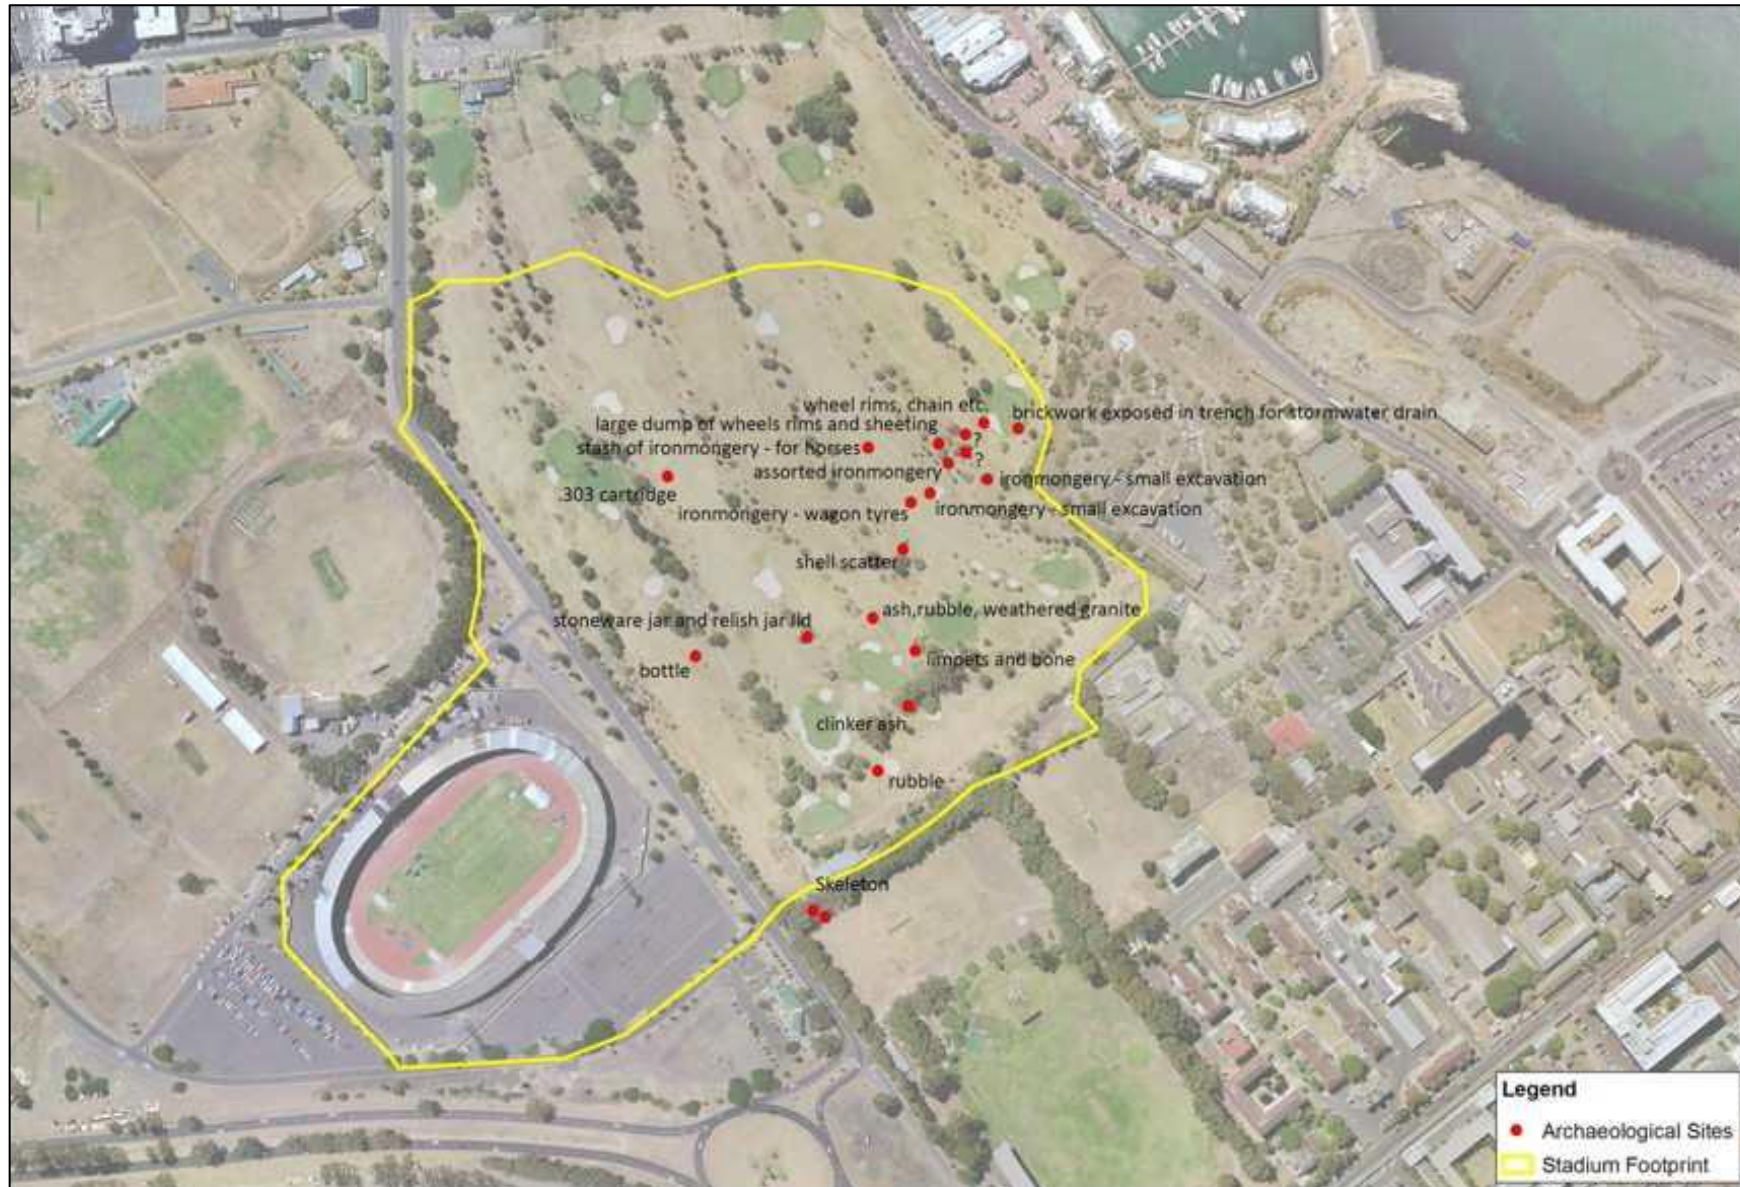
Figure 12: Position of identified archaeological features and artifacts (GIS work by Beuster, Clarke & Associates (2009) superimposed on 2001 aerial photograph) (After Patrick 2006a)

According to Patrick, the north-east and south-east quadrants lying to the north of Fort Wynyard yielded the largest number of archaeological features and artefacts (Figure 12). An analysis of these finds indicates that cultural material associated with the Anglo Boer war (1880-1881, 1899-1902) remained in-situ under the current land surface. Several wheel rims and gun carriage artefacts associated with Prince Albert's Own Royal Artillery at the Cape were identified, as well as live ammunition associated with the same period. Pockets of ash, horse shoes and nails were found in the same location which suggests that a blacksmiths workshop had been located in the area. An ephemeral scatter of shell and prehistoric stone tools was found in the south west quadrant, indicating the presence of a prehistoric footprint, however ephemeral, confirms that the rocky promontory which became known as Green Point was occupied by the earliest inhabitants of the Cape.

Human remains consisting of the fragmentary distal end of a single tibia were noted in the south-east quadrant. The area in which the remains were located was searched for evidence of a burial shaft but none was found¹². This suggested that the burial was in secondary (possibly disturbed) context. Additional human remains including post-cranial and cranial elements were found outside the stadium footprint at the contractors site offices (Camp One) opposite McDonalds restaurant (Figure 12). This latter find is close to the GBB Precinct.
