SOCIAL MONITORING PROGRAMME FOR THE ARIADNE-EROS 400KV MULTI
CIRCUIT LINES, KWAZULU-NATAL PROVINCE

12 SEPTEMBER 2018

**Grave Assessment as Part of Ariadne-Eros 400kv
Multi Circuit Lines Social Monitoring Programme**

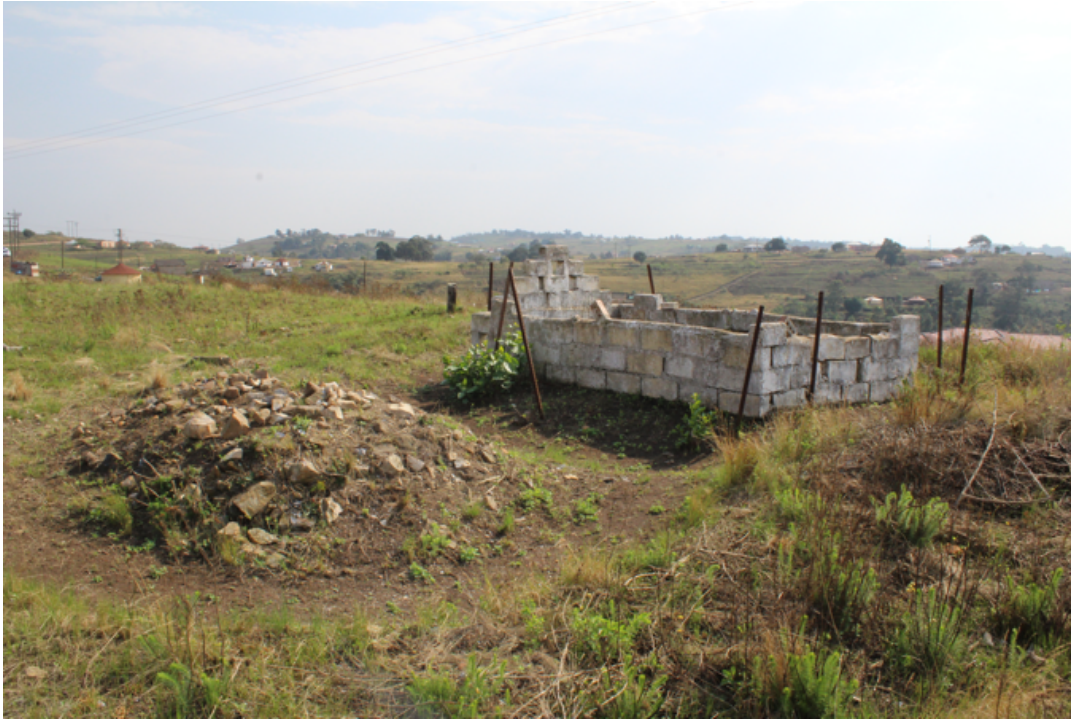
- Near Tower 147 there are 2 graves that belong to the parents of Inkosi LD Mkhize (*Figure 2*). The graves will not be directly impacted by the tower construction. There are situated 20m away from the tower's centre position. The tower near this cemetery site has been move to a new location and away from the grave site.

Figure 2-Inkosi LD Mkhize family graves

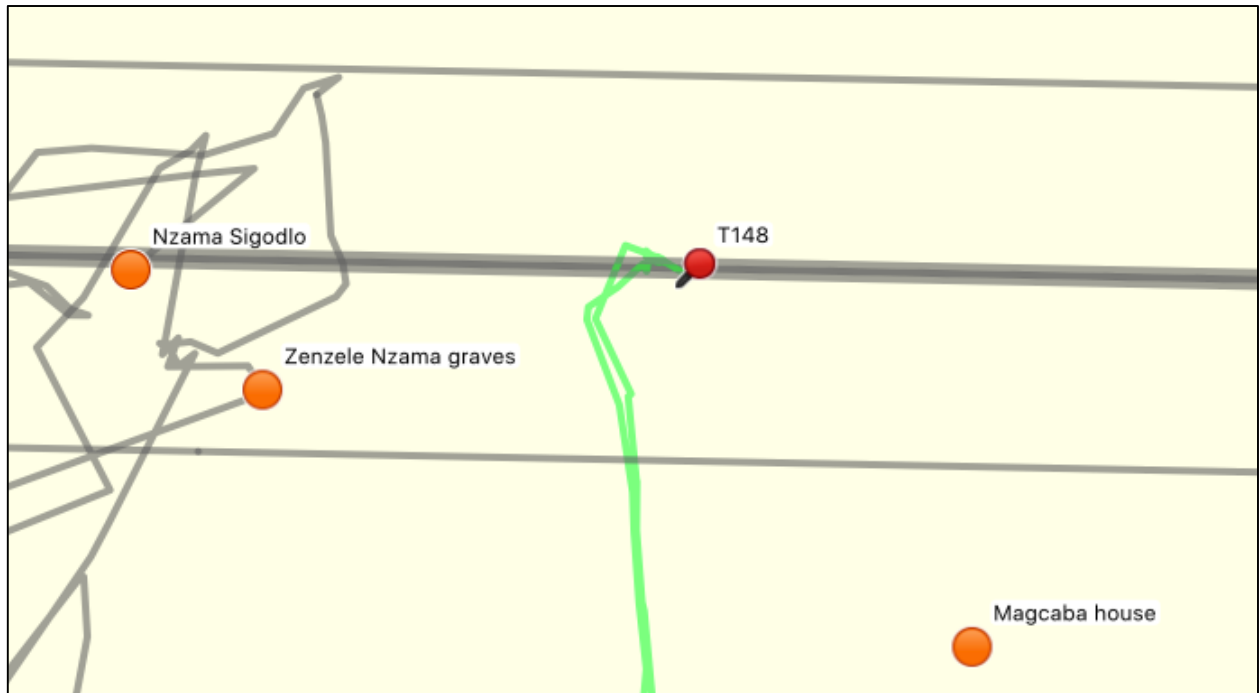
- The tower has no graves. It is situated in an open area with no ruins or foundations of former homesteads. However, north and south of the tower there are households known to contain graves (*Figure 3*).

Figure 3-Tower 148 with no graves

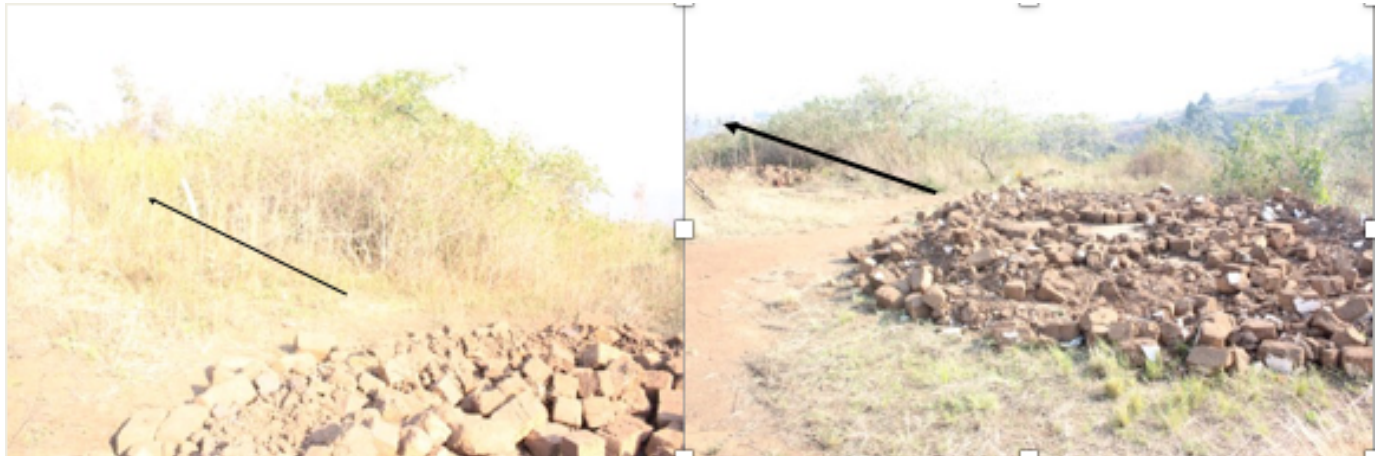
- The tower is located in the Mthembu homestead and south of the Maphumulo homestead. There are approximately 9 graves in the homestead. They are situated approximately 12m from the current tower position and to the south of the tower (*Figure 5*). The tower has been moved to the area where the family built old three rondavels. The rondavels have since been demolished to make space for the tower (*Figure 4*)

Figure 4-Mthembu family ruins. Here there we three rondavels that have since been demolished to make way for the tower. Arrows show position of graves

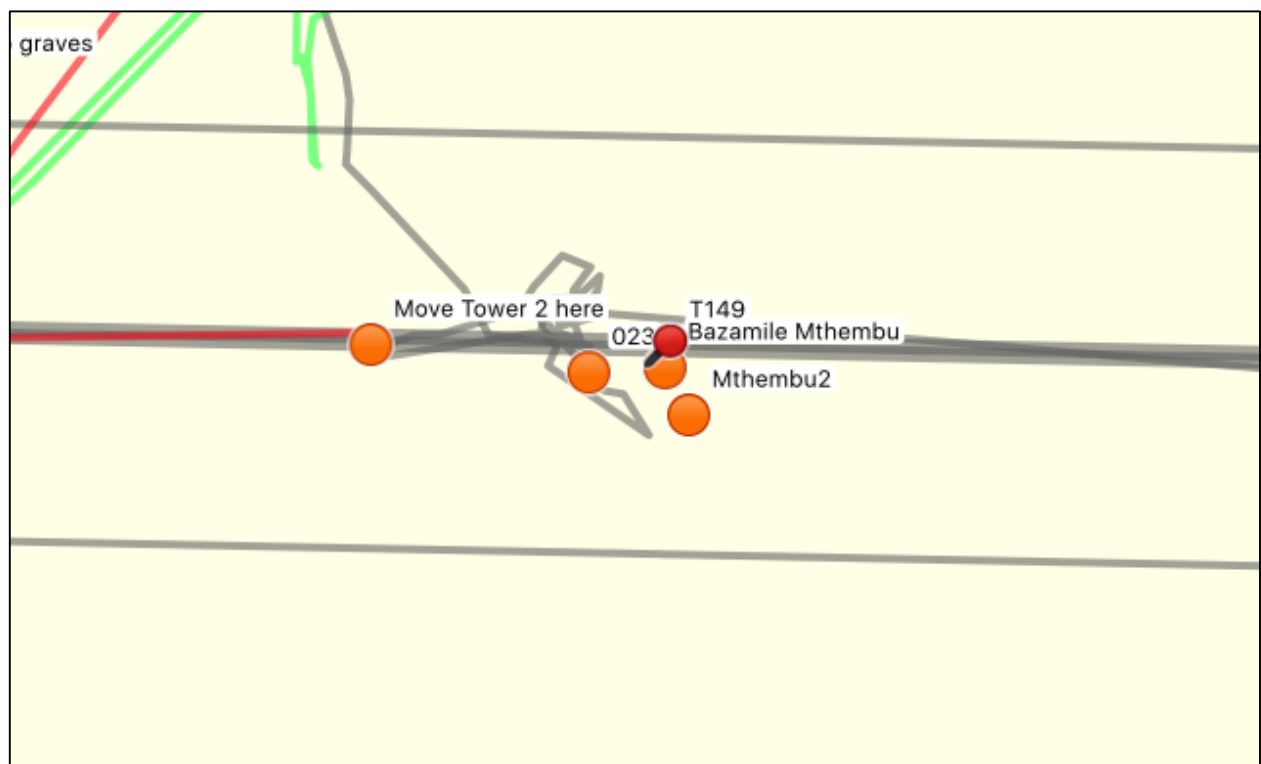
Figure 5-Mthembu family ruins. Here there we three rondavels that have since been demolished to make way for the tower

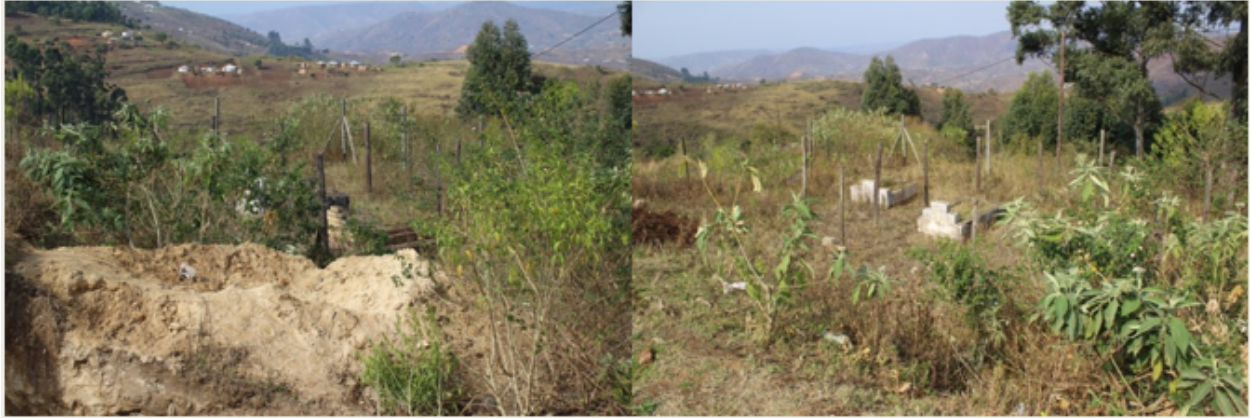
- The tower is situated in the former Koyama family homestead. Here construction activities are underway. The graves are situated south of the tower (*Figure 6 and Figure 7*).

Figure 6-Sifiso Koyama family graves situated south of tower 150 whose foundations are nearly complete.

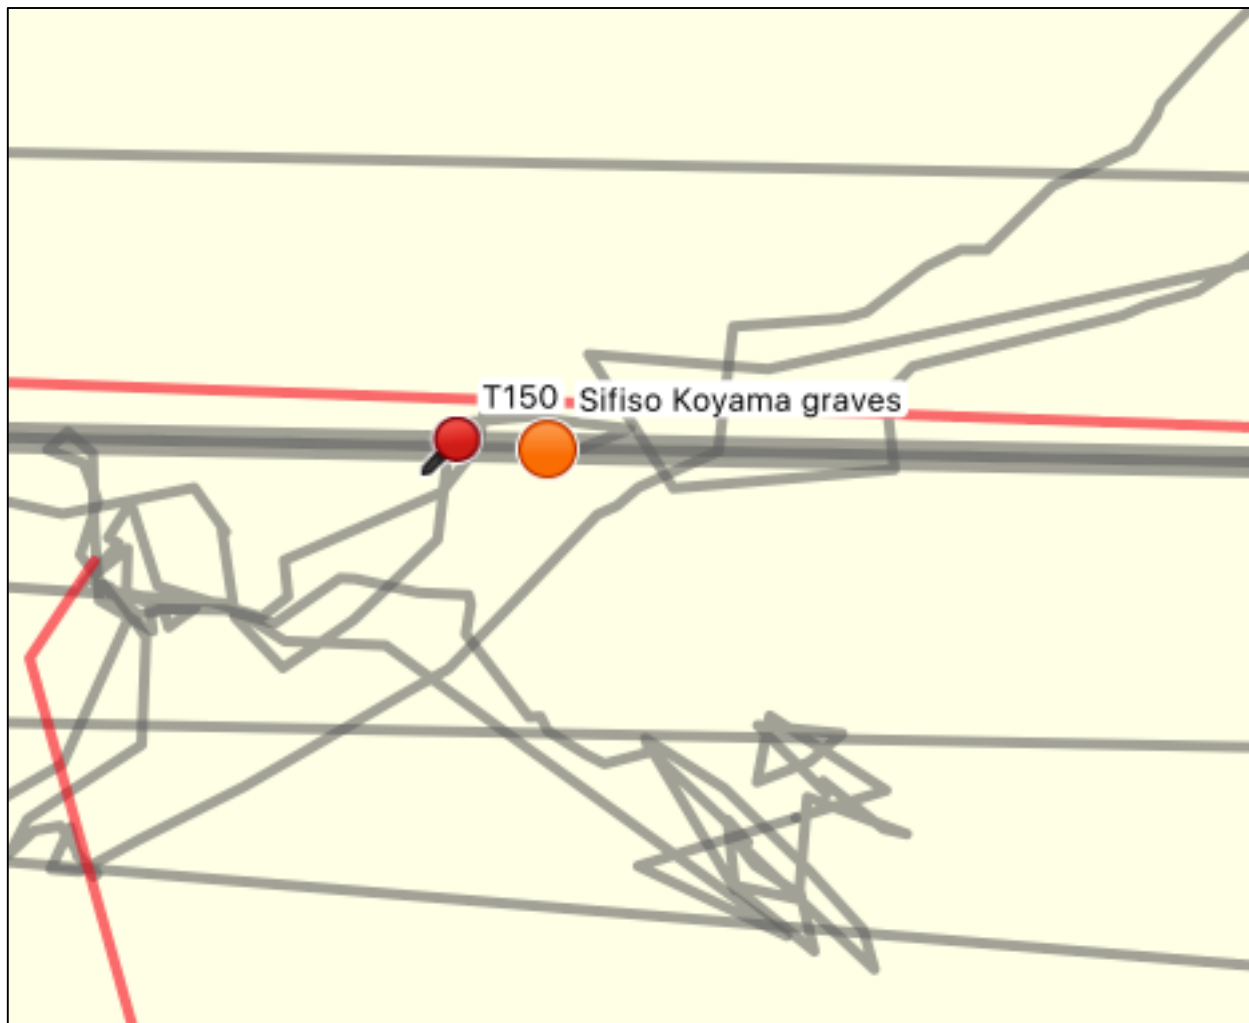
Figure 7-Sifiso Koyama family graves in relation to the tower position.

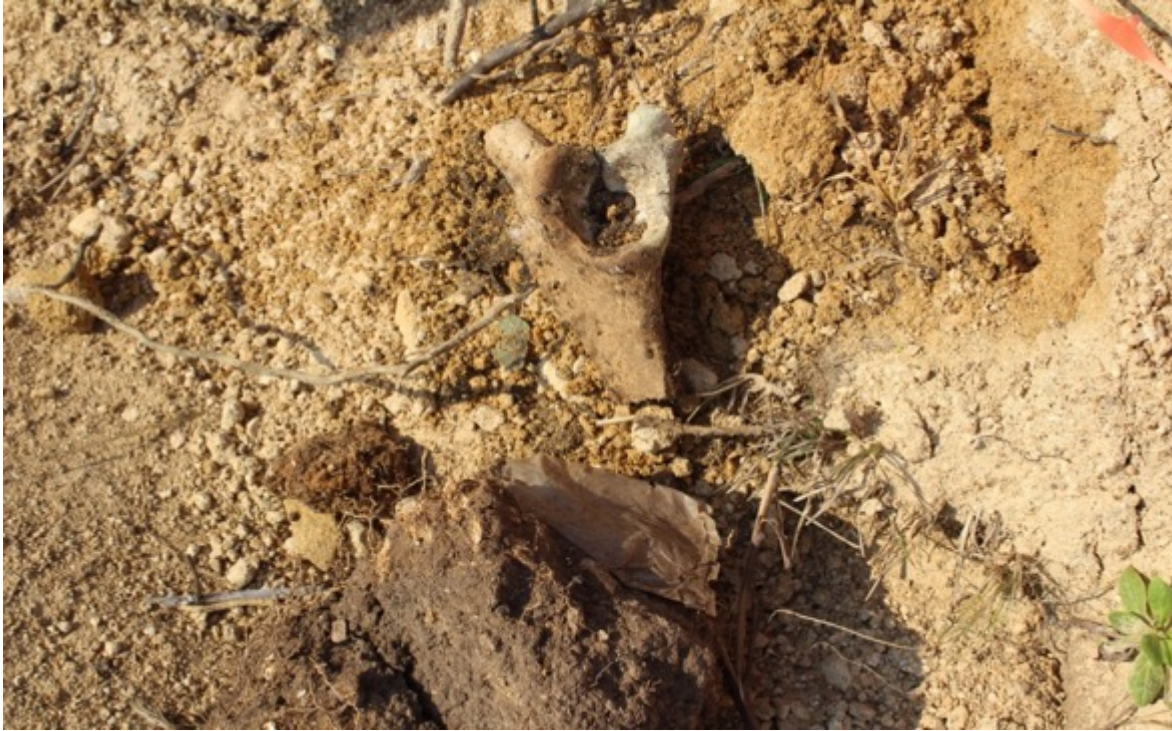
- A human os coxa (Pelvis bone) was found (*Figure 8*)
- There were also stained clothes found in the soil –during the burial decomposition process clothes are often stained (*Figure 9*)
- A metal zinc was also found on the soil dump – this is another indicator of grave disturbance since metal zincs are often place above the casket in burial processes (*Figure 10*)

Figure 8-Part of human pelvis bone found in the excavated soil

- The detailed survey conducted on this site yielded a fractured **os coxa** (pelvis bone) of a human. Other grave indicators include stained clothes which could have been associated with the burial as well as plastic material that remains in the grave when a casket decomposes (*Figures 7 to 9*).

- It is recommended that construction activities should be stopped in Tower 152 until NGT obtain a grave rescue permit from Amafa KwaZulu-Natali.
- The graves on the road to Tower 153 should be immediately fenced off to avoid them be disturbed by trucks/graders working on Tower 153. An instruction has also been issued to the family and they will commence with the fence from Monday 27 August 2018.

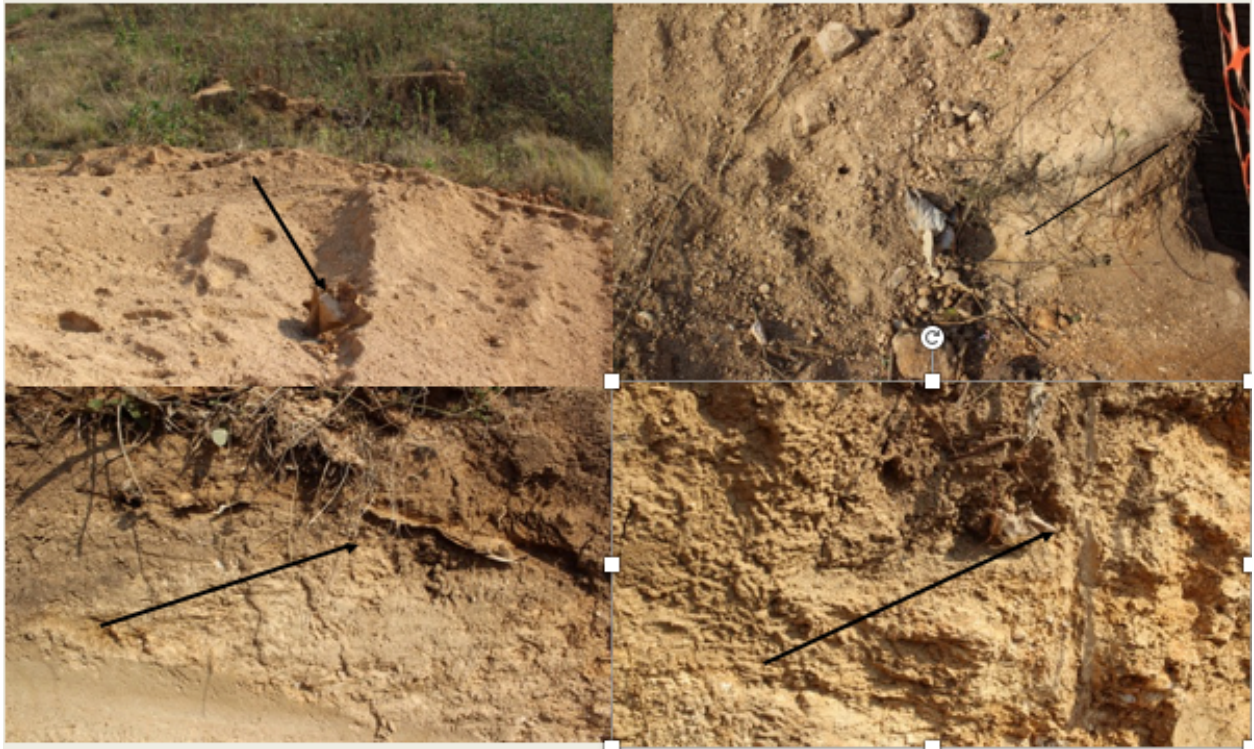
Figure 9-Grave indicators

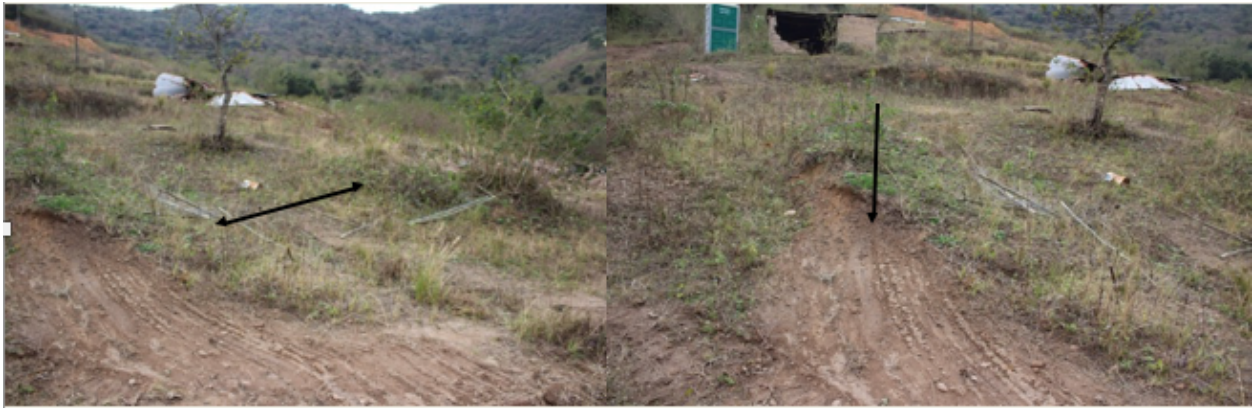
- The tower has no graves. However, south-east of the tower and on the road that has been created to access the tower two graves have been found (*Figure 11 and Figure 12*). One of the graves is slightly scraped by the grader.

Figure 11- Two graves located next to a road used to access tower 153

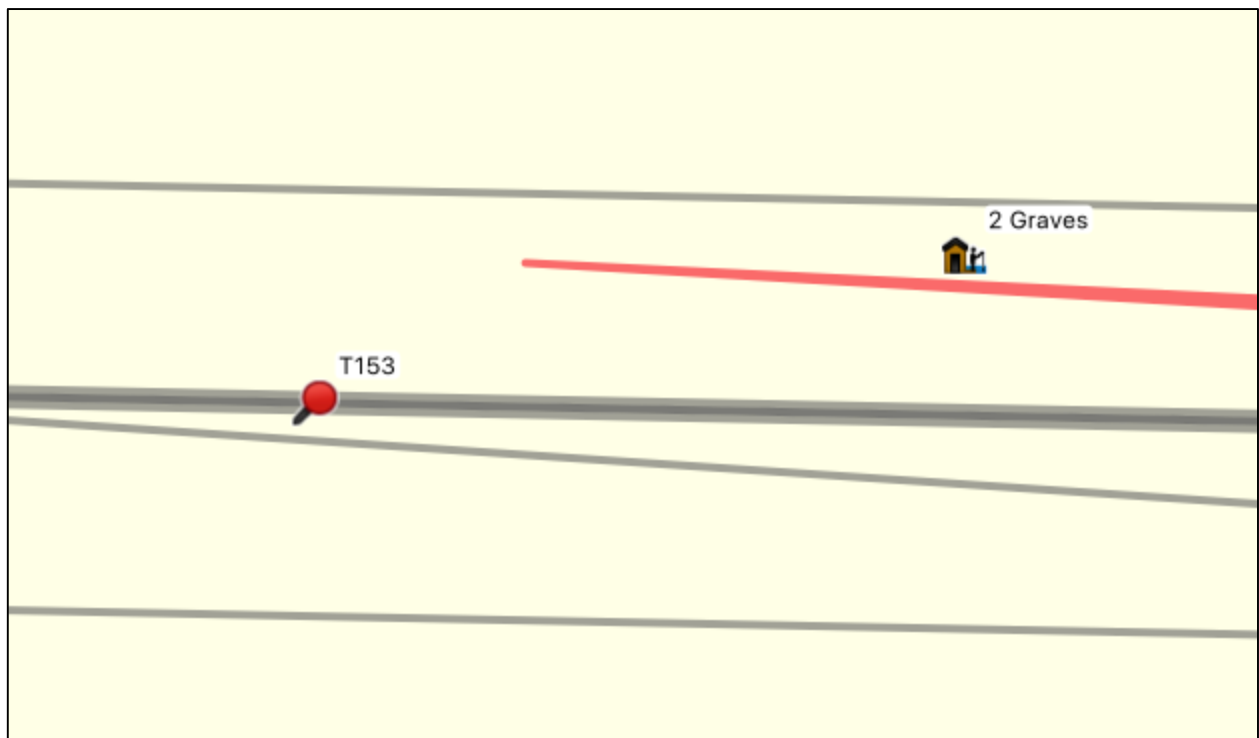
Figure 12-Location of the two graves in relation to tower 153

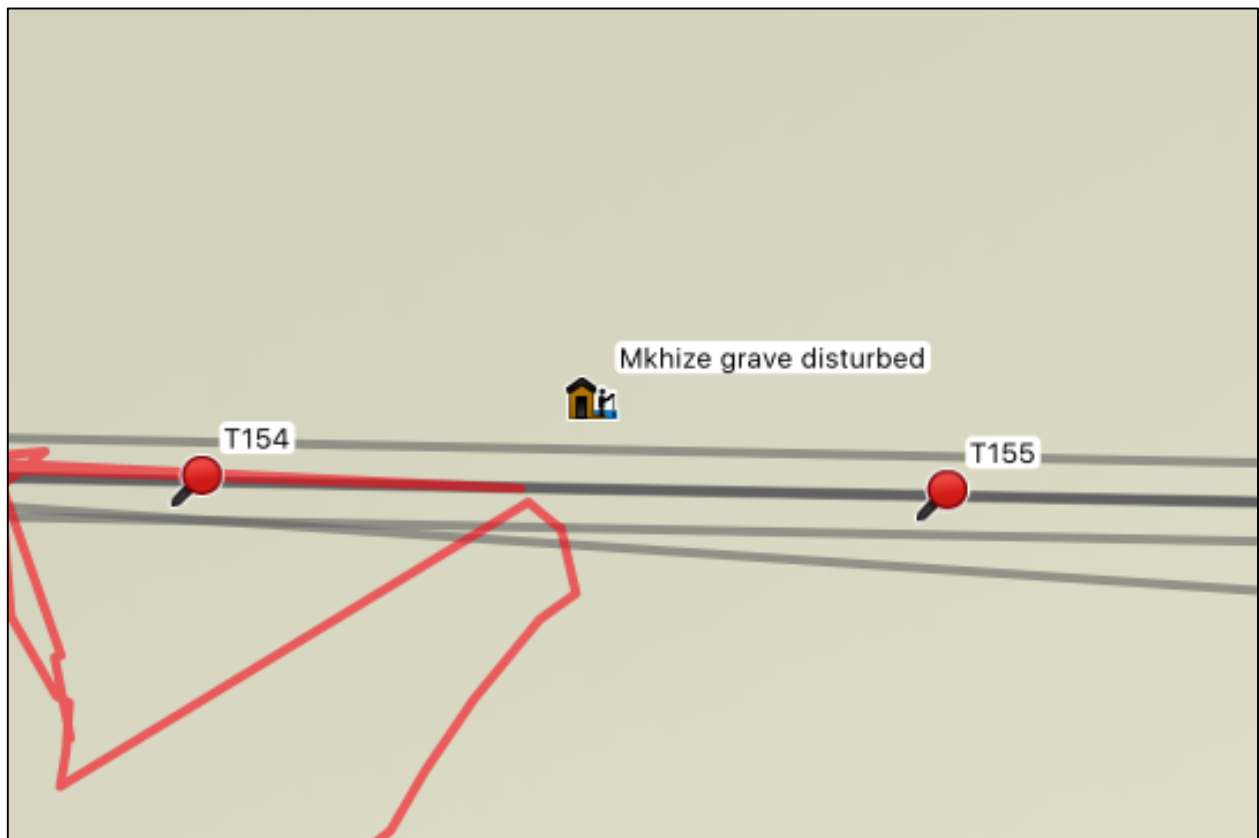
- There are no issues in terms of Tower 154. There is, however, a challenge between Towers 154 and 155. When the road to access Tower 155 was initially constructed, it disturbed a grave belonging to the Mkhize family. The road has since been diverted to a new location, but the grave issue still stands as it has not yet been addressed. The figure below shows the location of the grave in relation to Tower 154 and Tower 155 (Figure 13).

Figure 13-Location of the Mkhize family grave that was disturbed through road construction activity

- The issue of the Mkhize grave should be attended to with immediate effect – Induna Meyiwa has reported the issue to the contractor and the social team on site which was represented by Ms Snenhlanhla Mngadi. However, nothing has been done to date and this has posed social risks to the project – the Ngcobo family whose graves are located near the ruins close to Tower 155 are concerned that the contractor might desecrate their family graves.

- The issue of the Mkhize grave should also be attended to so that the Ngcobo family which have graves near Tower 155 may be at ease and allow construction activities to proceed on Tower 155.
