# HERITAGE IMPACT ASSESSMENT: PROPOSED GAMMA GRIDLINE CORRIDOR, WESTERN AND NORTHERN CAPE

Required under Section 38(8) of the National Heritage Resources Act (No. 25 of 1999)

Gamma gridline corridor

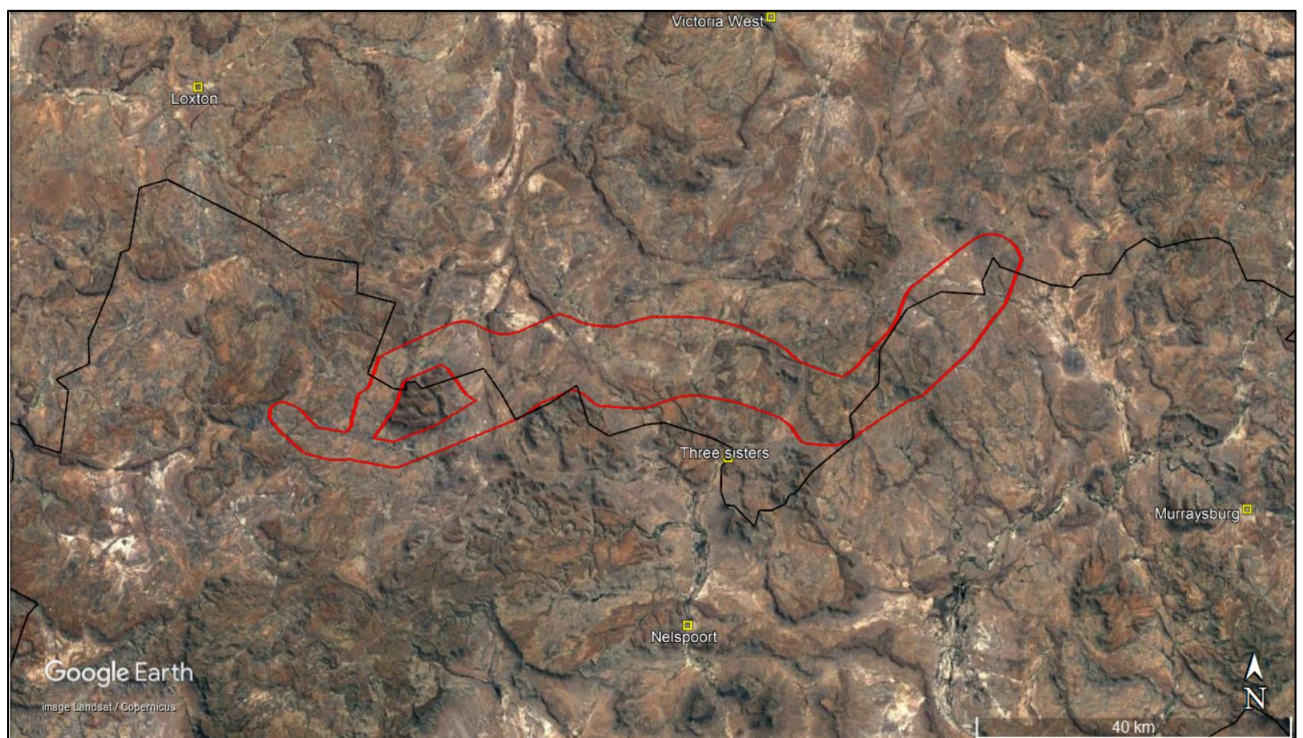
**Figure 2:** Proposed corridor for Gamma Grid Connection.

Following an initial specialist assessment and landowner negotiations, a refined grid connection corridor, within which the line will be built, has been established – see Figure 2. This report deals specifically with impacts on archaeological/cultural heritage resources within the refined Corridor to enable the identification of a preferred servitude and gridline route.

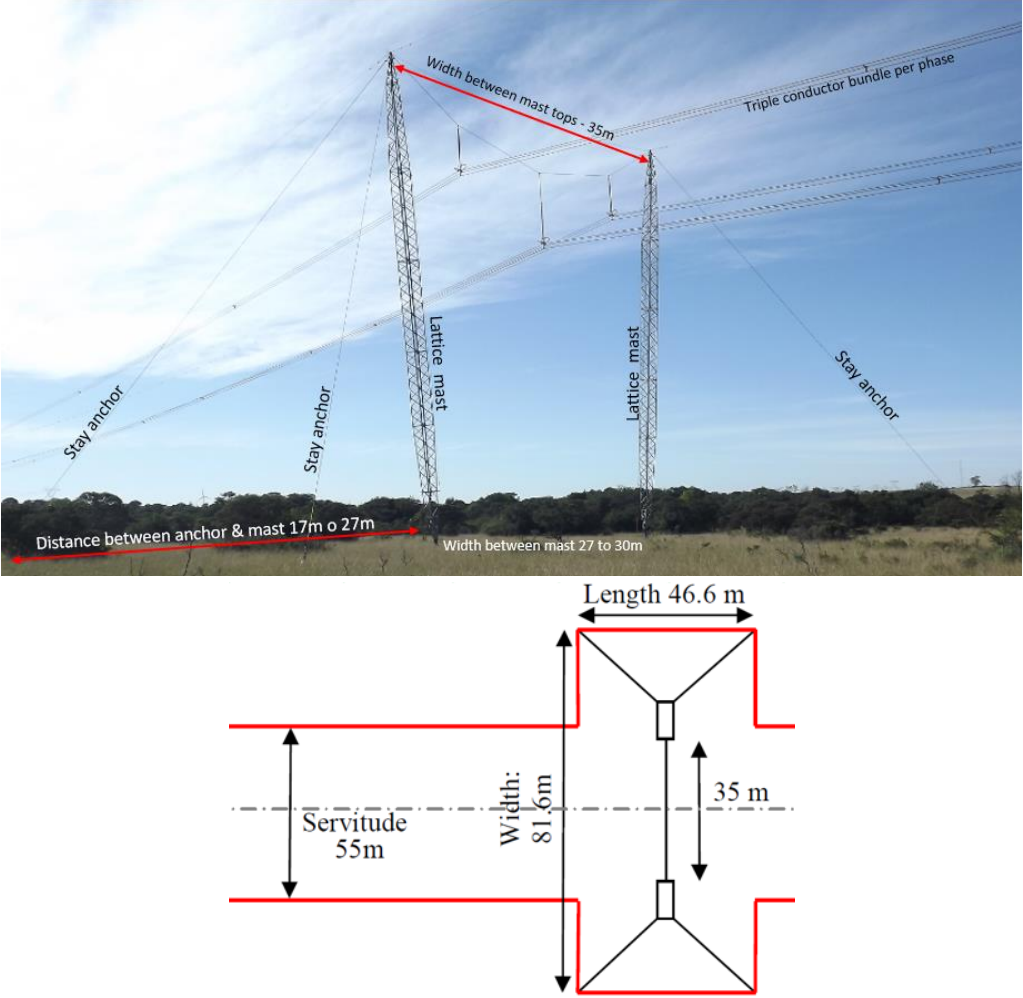
Tower Type	Description and purpose	Illustration
<p><b>Option 1:</b> Cross-Rope Suspension Tower (Continue)</p>	<p>Tower heights: 27m to 50 m Tower width: 28m to 35m</p> <p>Tower footprint: The footprint of the tower is determined by the distances between the outer anchors supporting the structure – in general the stays positioned 17m to 27m from the tower masts at an angle. This forms a square with estimated distances as per the illustration.</p> <p>Typical Foundation sizes:</p> <p>1) Typical Tower mast foundation</p>

<p>The illustration consists of a photograph and a technical diagram. The photograph shows a cross-roped suspension tower with two lattice masts. Stay anchors are positioned at an angle from the masts. Red arrows and text labels indicate key dimensions: 'Width between mast tops - 35m', 'Distance between anchor &amp; mast 17m o 27m', and 'Width between mast 27 to 30m'. The diagram below the photograph shows a cross-section of the tower footprint. It is a rectangular shape with a width of 81.6m and a length of 46.6m. A horizontal dashed line indicates a 'Servitude 55m'. A vertical dimension of 35m is shown for the upper section of the tower.</p>

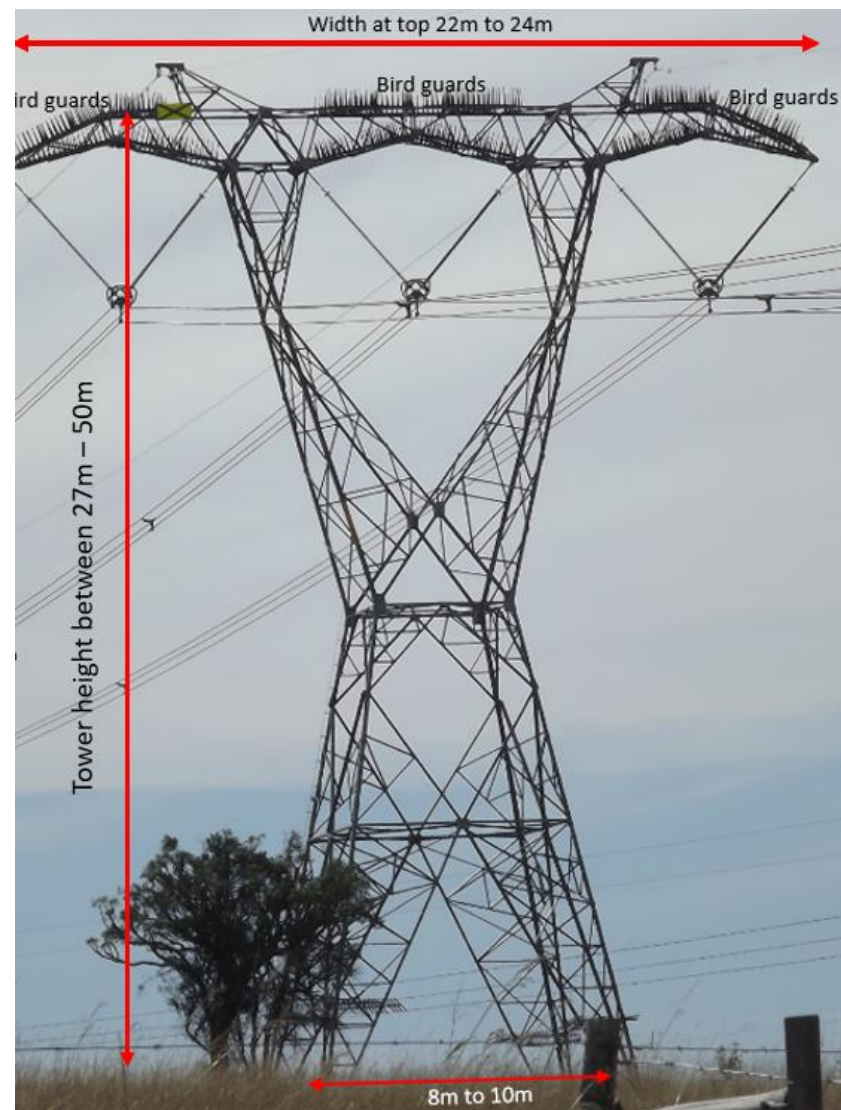
**Front View of the tower:**

2	400kV Intermediate or Suspension Tower.	<p>The tower consists of a self-supporting lattice structure design with 4 x tower legs. The insulators are supported from a steel lattice cross-arm as indicated in the illustration.</p> <p>The tower is fully supported by the 4 x leg foundations and do not have any guyed anchors.</p> <p>The structure is design to support the conductor weight as well as the wind loading specifications.</p>
	<b>Option 2:</b> Self-Supporting Suspension Tower.

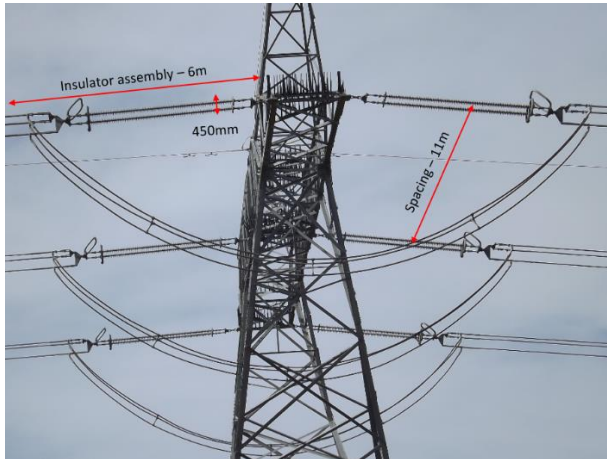
The tower consists of a self-supporting lattice structure design with 4 x tower legs. The insulators are supported from a steel lattice cross-arm as indicated below:

The tower is fully supported by the 4 x leg foundations and do not have any guyed anchors.

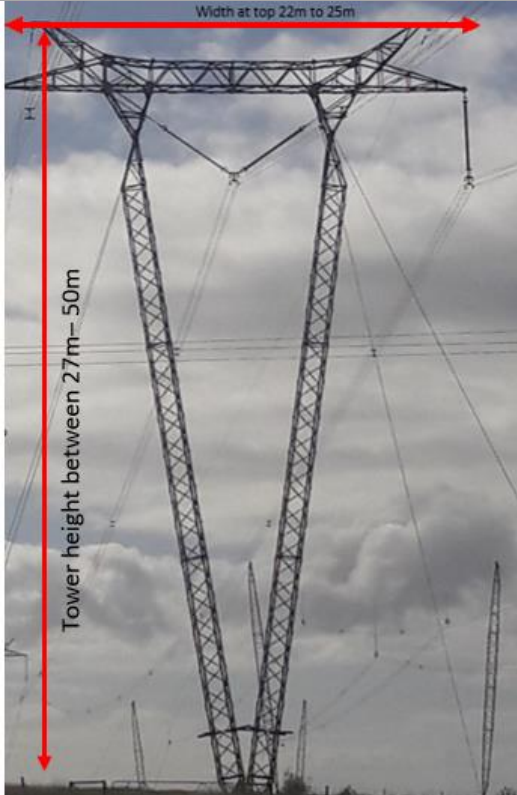
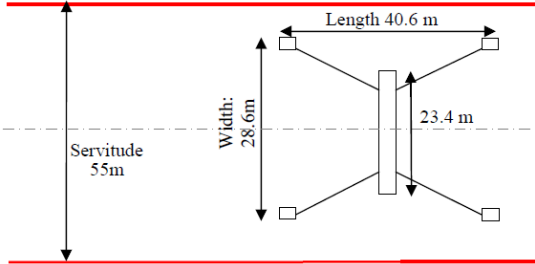
4	<p>400kV Intermediate or Suspension Tower.</p> <p>Guyed V-Type Tower</p>	<p>The tower consists of a main lattice triangle shape steel support tower that is installed on a centre foundation and supported by 4 x guyed anchors on the side.</p> <p>The structure is design to support heavier conductor weights and can be used where longer spans are required. Also have a smaller footprint than the intermediate cross rope tower.</p> <p>Tower centre foundations and 4 x guy anchor foundations similar to the cross rope tower foundations illustrated under Item 1.</p>

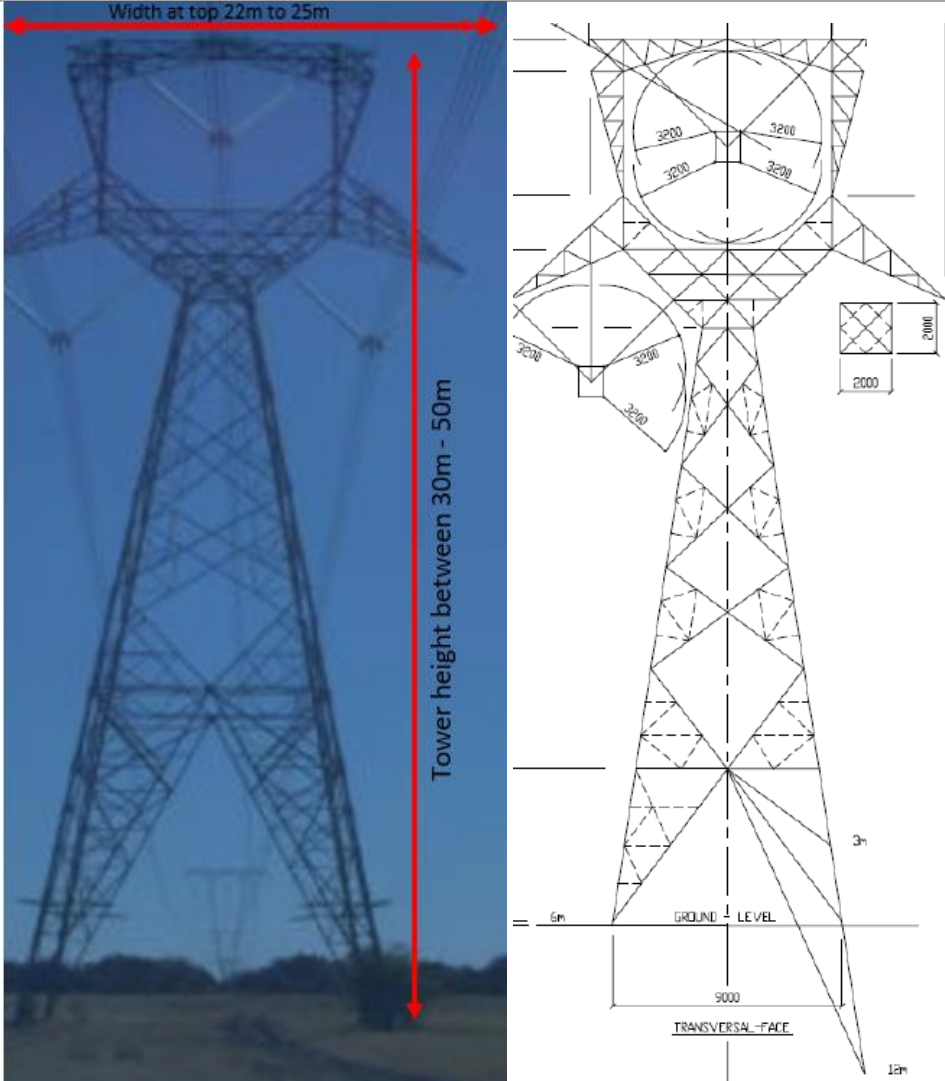
5	<p>Transposition Tower.</p> <p>Required in the case where phasing needs to be swopped along the line.</p>	<p>The tower consists of a self-supporting lattice structure with 4 x tower legs. The insulators are supported from a steel lattice delta type cross-arm/beam as indicated in the illustration. The tower is supported by the 4 x legs with foundations and do not have any guyed anchors.</p> <p>The tower is only used in the case where conductor phasing needs to be swopped around. Normally maximum of 3 x towers required across a distance &gt;100km.</p> <p>Tower foundations similar to the strain lattice tower foundations illustrated under Item 3 above.</p>

<p>The image consists of two parts. On the left is a photograph of a transposition tower, a self-supporting lattice structure with four legs. Red dimension lines are overlaid on the photo, indicating a 'Width at top 22m to 25m' and a 'Tower height between 30m - 50m'. On the right is a technical cross-section diagram of the tower. It shows a lattice structure with a top width of 22m to 25m and a height of 30m to 50m. The diagram includes a ground level line and a transversal face. Dimensions shown in the diagram include 3200, 3200, 3200, 3200, 2000, 2000, 3000, 9000, and 12m.</p>

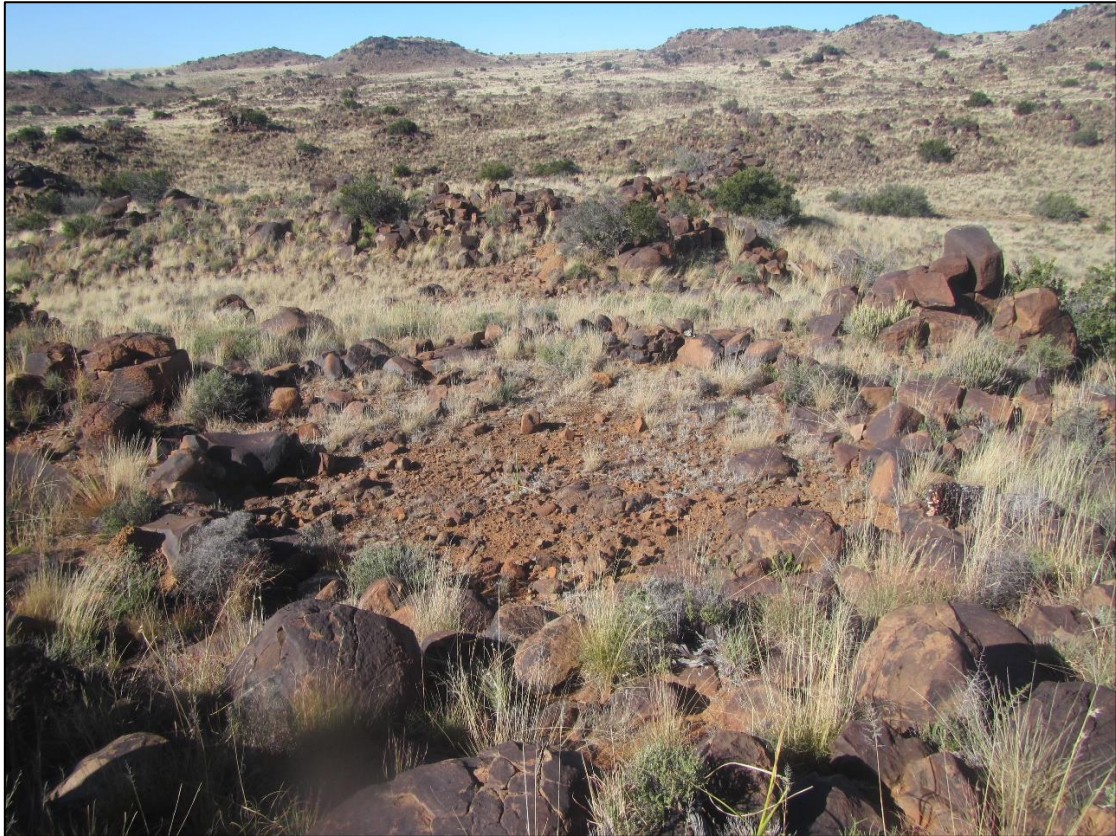
**Figure 38:** A faint, 5 m diameter stone-walled enclosure at waypoint 1360 in Northern Cape. The walling is very ephemeral and seems more like it was created purely by moving stones to the edge of the circle.

One potential example of a Stone Age stone-walled enclosure was seen at waypoint 1360 in Northern Cape (Figure 38). It was very 'informal' in appearance and this could be due to its walling having tumbled over time. Alternatively, it was simply made by moving stones to the side to create a clearing rather than a walled enclosure. Without any associated finds it is not possible to be sure whether this is a Stone Age or historical feature.

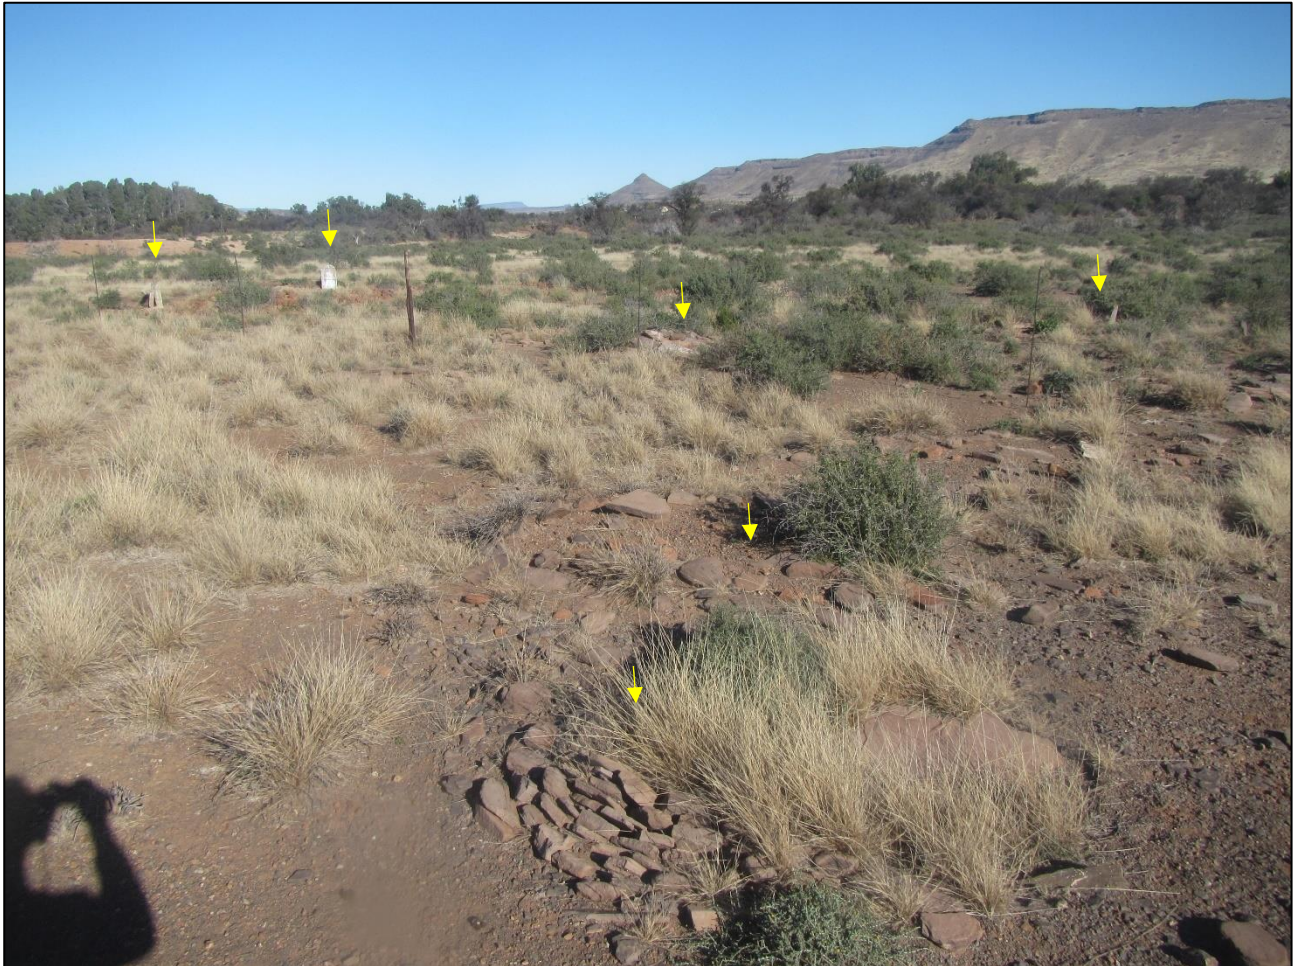
**Figure 61:** A farm graveyard at waypoint 1339 in Northern Cape. Visible graves are arrowed.

Graveyards were found on two farms in Northern Cape, but many more are expected to occur in association with farmsteads. One was alongside a gravel road at waypoint 1339 in Northern Cape. The farm fence alongside the road ran through the graves (Figure 61). The graves varied in style with some being simple stone mounds and others including a formal headstone. They were not in regular rows. The graveyard is assumed to be a farm workers' graveyard.

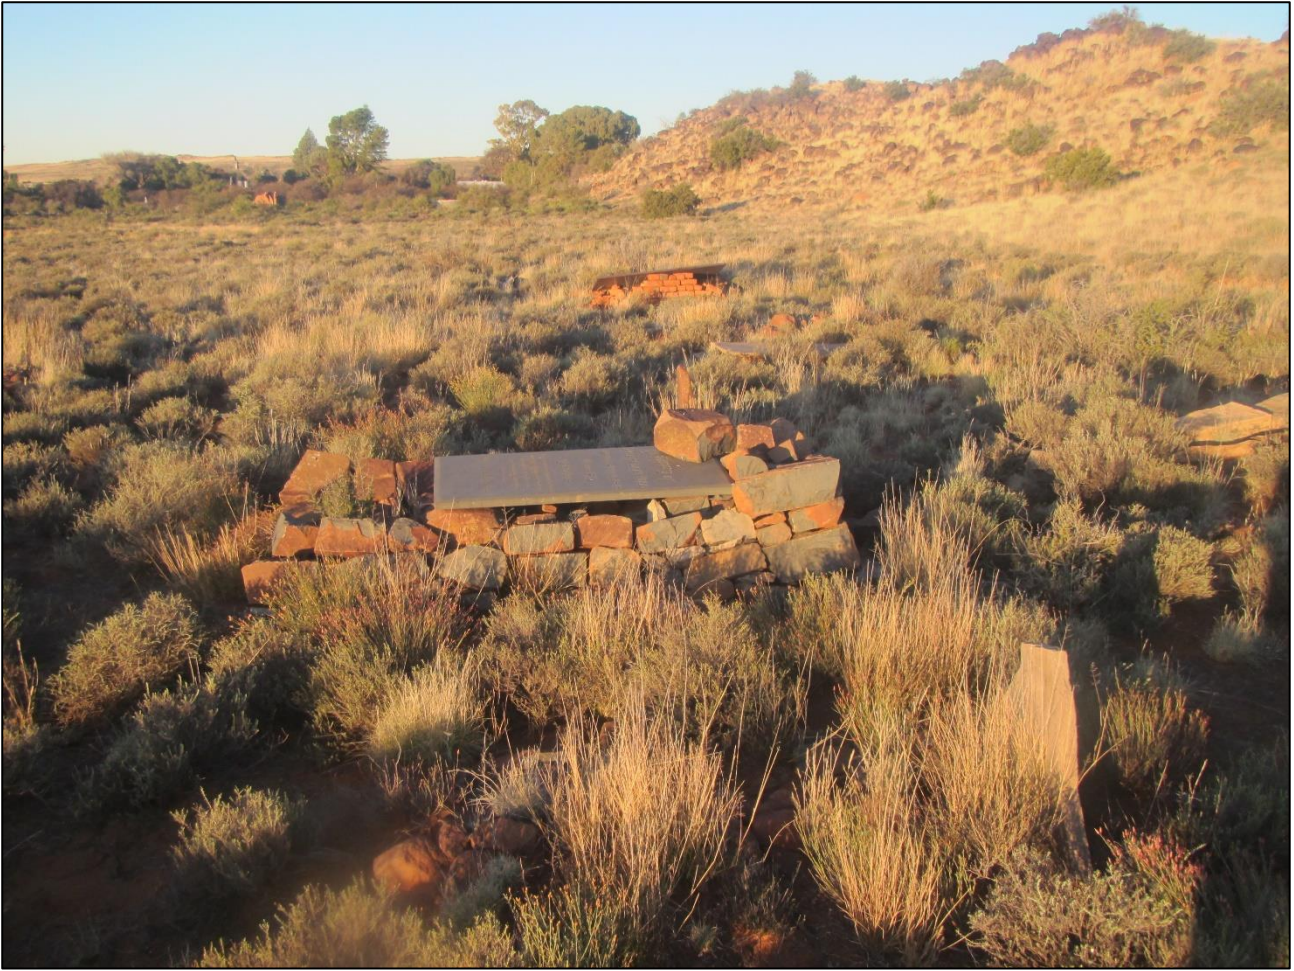
**Figure 62:** *An old farm graveyard at waypoint 1384 on the farm Wagenaar's Kraal in Northern Cape.*

Another graveyard was recorded at waypoint 1384 on Wagenaarskraal in Northern Cape (Figure 62). This graveyard contains graves related to the previous family to own the farm before it was acquired by the MacRoberts family in 1870. It lies 380 m west of the farmstead and is in relatively poor condition having not been used at all since 1875. Presumably the last burial relates to someone who used to live on the farm and whose body was returned there for burial. The other two dated graves are from 1852 and 1856. Also on the farm and located just east of the house is the current family graveyard. It was not visited.
