**DESKTOP HERITAGE SURVEY OF THE PROPOSED  
GINGINDLOVU POLICE STATION**

**FOR DE MELLO MACHADO ARCHITECTS**

**DATE: 18 AUGUST 2017**

**GINGINDLOVU: SOUTH AFRICAN POLICE SERVICES: PROJECT FIVE STAR: UPGRADING OF POLICE CELLS AND COMPLETE REPAIRS AND RENOVATIONS TO STATION: APPLICATION FOR THE DEMOLITION OF STATE OWNED BUILDINGS: UPDATED FROM 2012**

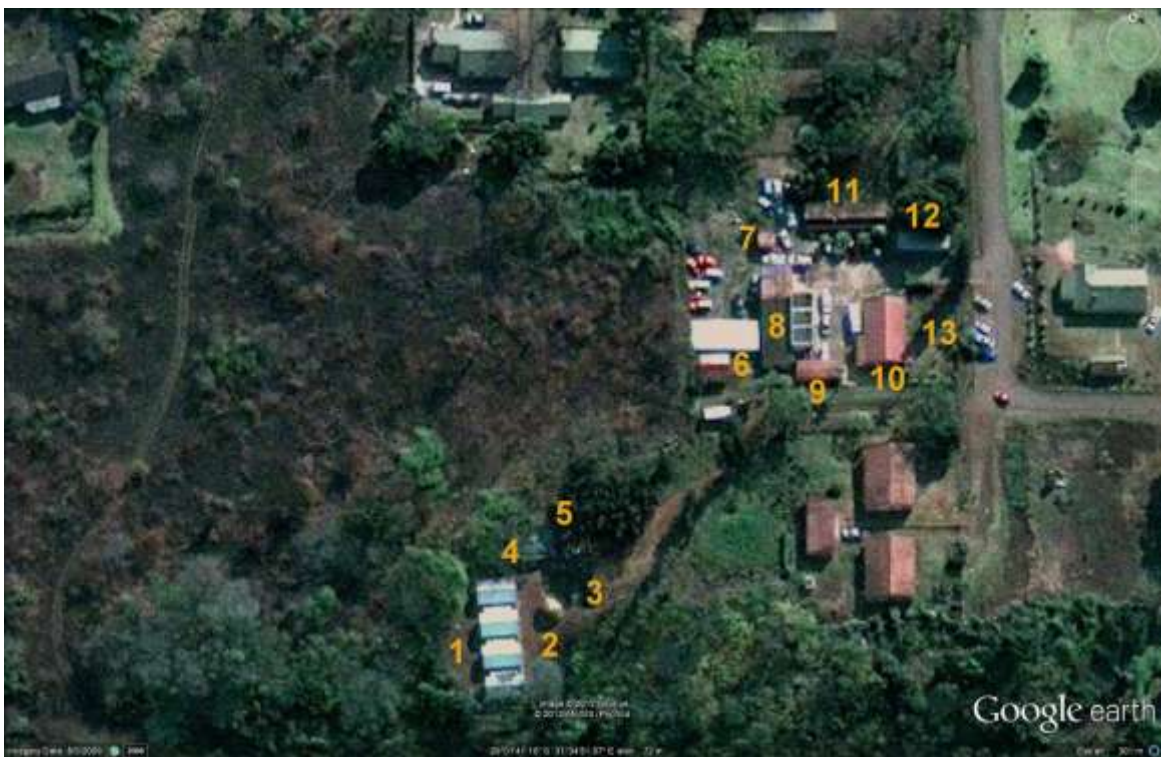
FIG. 4: LOCATION OF BUILDINGS MARKED FOR DEMOLITION

The desktop study consisted of analysing various maps for evidence of prior buildings in the study area, as well as for previous archaeological surveys. This was compared with the application for demolition (Appendix A) that lists the buildings that will be demolished. Fig. 4 shows the buildings.

Debbie Whelan was requested to comment on these two buildings (Appendix B). She states that they are of indefinite age and of very low value. She concludes that they can be demolished without further mitigation.

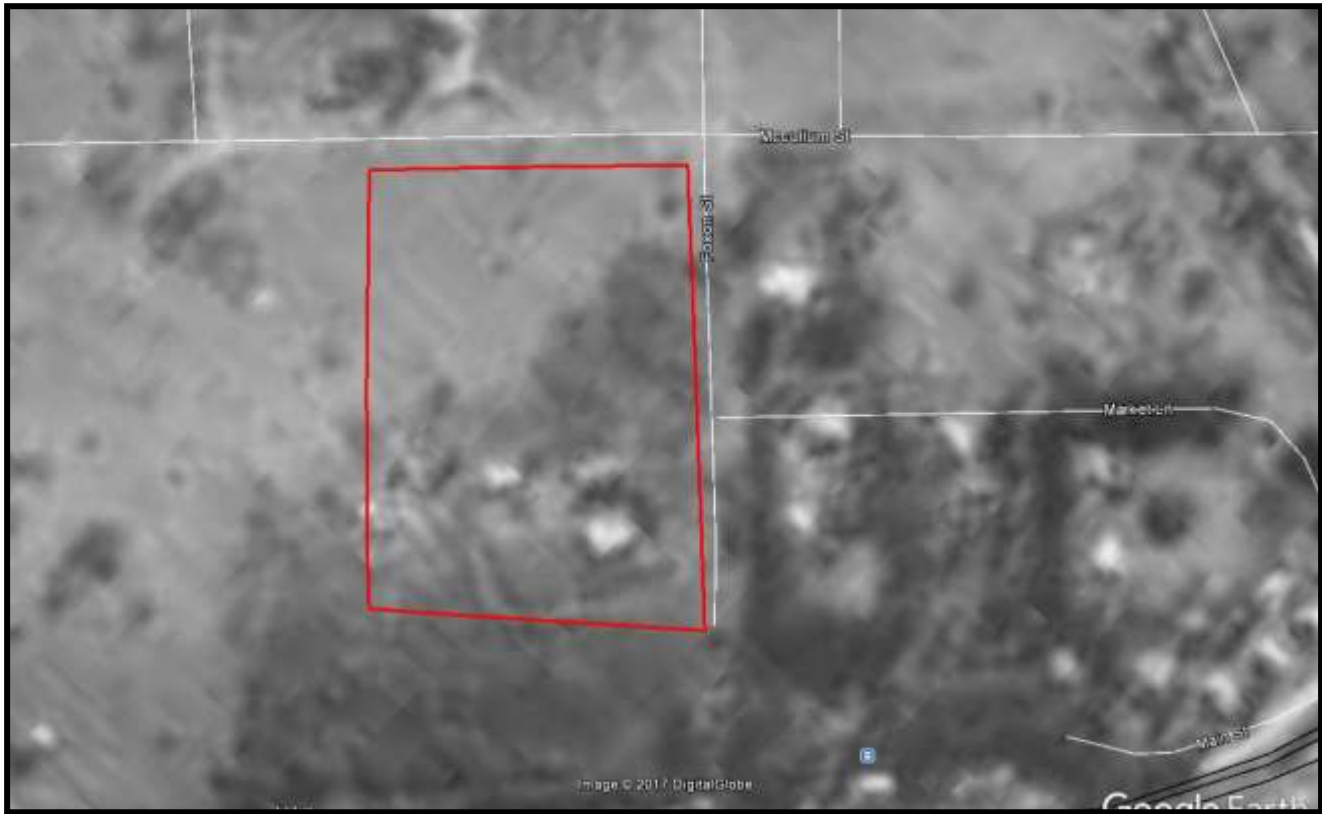
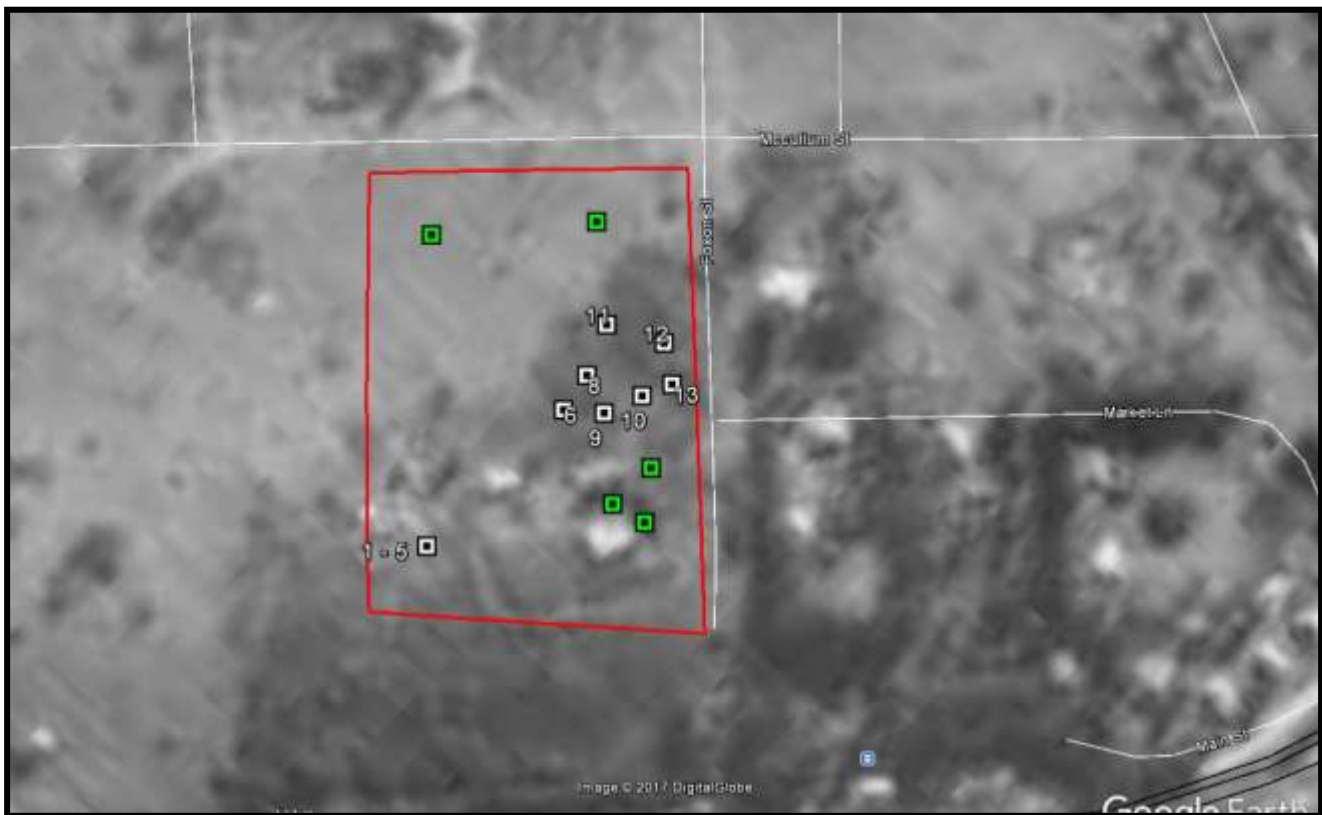
FIG. 6: STUDY AREA IN 1937 WITH(OUT) PROPOSED BUILDINGS<sup>2</sup>

The 1937 aerial photographs indicate that there are buildings on the study area; however, they will not be demolished. In Figure 6 (lower), the white squares indicate buildings to be demolished. While buildings 1 – 5 do have buildings, these were demolished at some stage and no longer occur today.

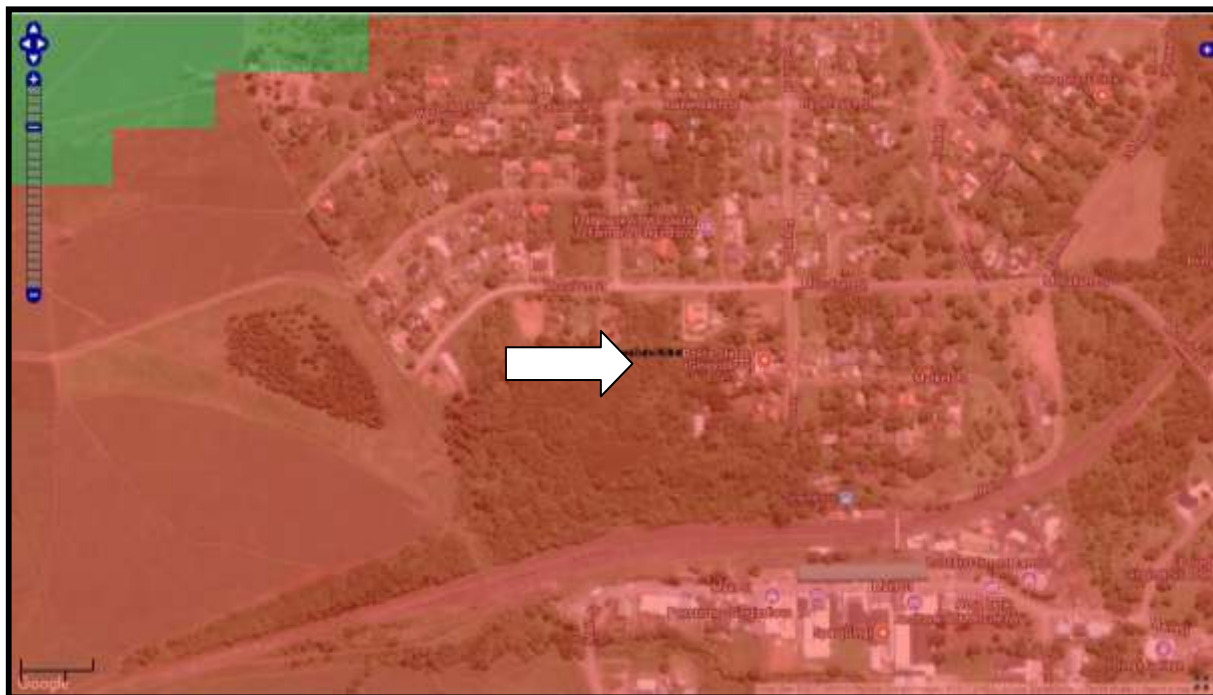
**FIG. 8: PALAEONTOLOGICAL SENSITIVITY OF THE STUDY AREA**

The area is of very high palaeontological sensitivity (fig. 8). However, the demolition of the buildings will not affect any palaeontological horizons. The existing and previous buildings would have already disturbed the upper 1.5m – 2m of deposit and thus new buildings are unlikely to impact on undisturbed horizons.

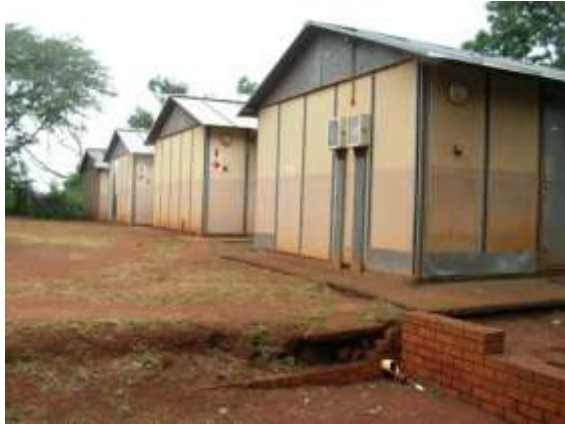
**BUILDING(S) # 1**

<b>Details:</b>	Type:	4 Prefabricated structures
	Address:	Foxon Street, Gingindlovu
	No. of floors:	Single storey
	Total area of building(s):	4 units x 39.31m <sup>2</sup> = 157.24m <sup>2</sup>
	Total area of land:	3,7108 ha
	Utilization:	Single staff quarters
	Current status:	Occupied

Reasons for demolition	Earmarked for demolition as per SAPS Needs Assessment document. These units are to be replaced with 20 new single staff quarters as per SAPS requirements.
Present value of building(s)	R268 789
Present market value of building(s)	R67 196
Present market value of land:	N/A – Government Land
Present replacement value of building(s)	R1 415 160
Estimated cost of repair of building(s)	Irreparable
Present value of material to be recovered	R10 000
Manner in which recovered material will be disposed	By contractor appropriately
Can land and building(s) be sold by auction	N/A – Government Land
Is land needed for other purposes	Yes - New SAPS Facility to be provided
Will some other building(s) be erected on land	Yes
Can building(s) perhaps be utilised for some purposes	No
Estimated age	Less than 60 years
Confirmation that funds are available for demolition	WCS 035880
Who will carry out demolition work	Recommended contractor by tender process

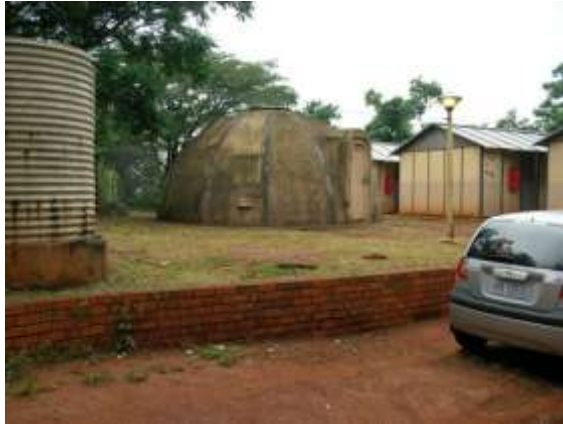
**BUILDING(S) # 2**

**Details:** Type: Prefabricated structure - Igloo  
 Address: Foxon Street, Gingindlovu  
 No. of floors: Single storey  
 Total area of building(s): 30.25m<sup>2</sup>  
 Total area of land: 3,7108 ha  
 Utilization: Store  
 Current status: Unoccupied

Reasons for demolition	Earmarked for demolition as per SAPS Needs Assessment document.
Present value of building(s)	R43 478
Present market value of building(s)	R15 125
Present market value of land:	N/A – Government Land
Present replacement value of building(s)	R151 250
Estimated cost of repair of building(s)	Irreparable
Present value of material to be recovered	R2 500
Manner in which recovered material will be disposed	By contractor appropriately
Can land and building(s) be sold by auction	N/A – Government Land
Is land needed for other purposes	Yes - New SAPS Facility to be provided
Will some other building(s) be erected on land	Yes
Can building(s) perhaps be utilised for some purposes	No
Estimated age	Less than 60 years
Confirmation that funds are available for demolition	WCS 035880
Who will carry out demolition work	Recommended contractor by tender process
Estimated cost of demolition	R6 050
Demolition by implosion / use of explosives	No

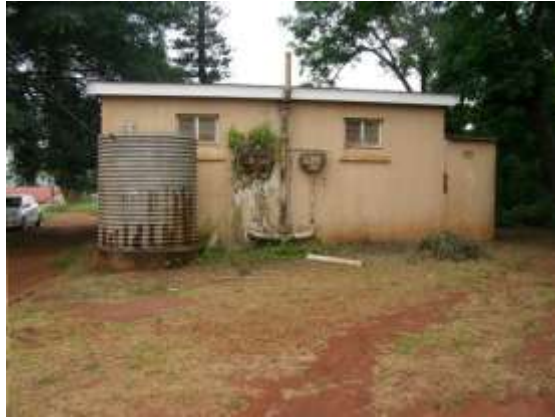
**BUILDING(S) # 3**

<b>Details:</b>	Type:	Brick with asbestos roof sheeting
	Address:	Foxon Street, Gingindlovu
	No. of floors:	Single storey
	Total area of building(s):	27.09m <sup>2</sup>
	Total area of land:	3,7108 ha
	Utilization:	Ablution
	Current status:	Unoccupied

Reasons for demolition	Earmarked for demolition as per SAPS Needs Assessment document. Building not in use.
Present value of building(s)	R101 271
Present market value of building(s)	R88 612
Present market value of land:	N/A – Government Land
Present replacement value of building(s)	R190 000
Estimated cost of repair of building(s)	R108 360
Present value of material to be recovered	R10 000
Manner in which recovered material will be disposed	By contractor appropriately
Can land and building(s) be sold by auction	N/A – Government Land
Is land needed for other purposes	Yes - New SAPS Facility to be provided
Will some other building(s) be erected on land	Yes
Can building(s) perhaps be utilised for some purposes	No
Estimated age	Circa 40 years – not significant – under 60 years therefore exempt from heritage application.
Confirmation that funds are available for demolition	WCS 035880
Who will carry out demolition work	Recommended contractor by tender process

Estimated cost of demolition	R25 000 (including asbestos removal)
Demolition by implosion / use of explosives	No
Implosion / explosive guidelines to be complied with.	N/A

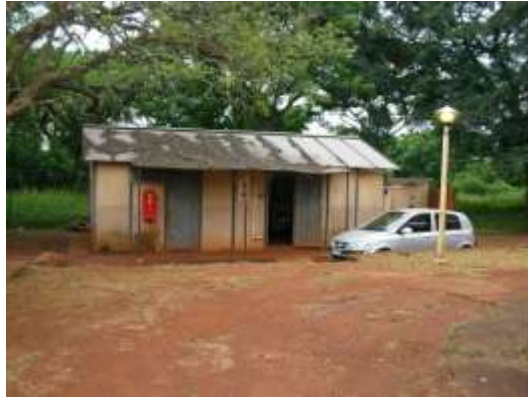
**BUILDING(S) # 4**

<b>Details:</b>	Type:	Prefabricated structure
	Address:	Foxon Street, Gingindlovu
	No. of floors:	Single storey
	Total area of building(s):	38.67m <sup>2</sup>
	Total area of land:	3,7108 ha
	Utilization:	Ablution
	Current status:	Occupied

Reasons for demolition	Earmarked for demolition as per SAPS Needs Assessment document. New single staff quarters will include ablution facilities as per SAPS requirements.
Present value of building(s)	R72 280
Present market value of building(s)	R105 463
Present market value of land:	N/A – Government Land
Present replacement value of building(s)	R309 360
Estimated cost of repair of building(s)	Irreparable
Present value of material to be recovered	R5 000
Manner in which recovered material will be disposed	By contractor appropriately
Can land and building(s) be sold by auction	N/A – Government Land
Is land needed for other purposes	No
Will some other building(s) be erected on land	No
Can building(s) perhaps be utilised for some purposes	No
Estimated age	Less than 60 years
Confirmation that funds are available for demolition	WCS 035880
Who will carry out demolition work	Recommended contractor by tender process

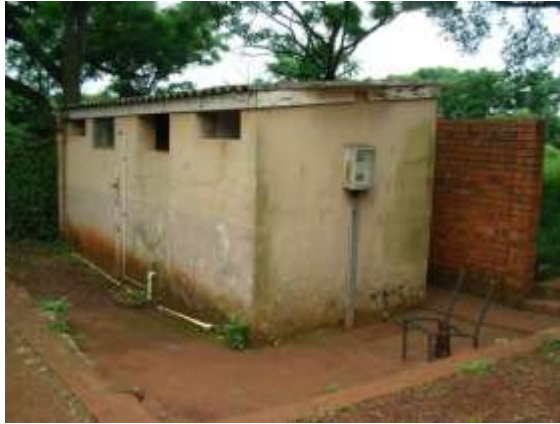
**BUILDING(S) # 5**

<b>Details:</b>	Type:	Brick with asbestos roof sheeting
	Address:	Foxon Street, Gingindlovu
	No. of floors:	Single storey
	Total area of building(s):	13.50m <sup>2</sup>
	Total area of land:	3,7108 ha
	Utilization:	Ablution
	Current status:	Unoccupied

Reasons for demolition	Earmarked for demolition as per SAPS Needs Assessment document. Building not in use.
Present value of building(s)	R50 467
Present market value of building(s)	R37 850
Present market value of land:	N/A – Government Land
Present replacement value of building(s)	R94 500
Estimated cost of repair of building(s)	R71 550
Present value of material to be recovered	R2 000
Manner in which recovered material will be disposed	By contractor appropriately
Can land and building(s) be sold by auction	N/A – Government Land
Is land needed for other purposes	Yes
Will some other building(s) be erected on land	No
Can building(s) perhaps be utilised for some purposes	No
Estimated age	Circa 40 years - not significant – under 60 years therefore exempt from heritage application.
Confirmation that funds are available for demolition	WCS 035880
Who will carry out demolition work	Recommended contractor by tender process

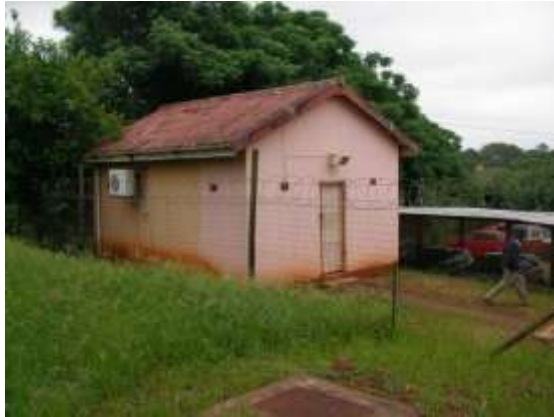
**BUILDING(S) # 6**

<b>Details:</b>	Type:	Brick with asbestos roof sheeting
	Address:	Foxon Street, Gingindlovu
	No. of floors:	Single storey
	Total area of building(s):	33.14m <sup>2</sup>
	Total area of land:	3,7108 ha
	Utilization:	Docket Filing Room
	Current status:	Occupied

Reasons for demolition	Earmarked for demolition as per SAPS Needs Assessment document. A new docket storing facility will be accommodated in the new CSC building as per SAPS requirements.
Present value of building(s)	R92 915
Present market value of building(s)	R77 429
Present market value of land:	N/A – Government Land
Present replacement value of building(s)	R265 120
Estimated cost of repair of building(s)	R132 560
Present value of material to be recovered	R5 000
Manner in which recovered material will be disposed	By contractor appropriately
Can land and building(s) be sold by auction	N/A – Government Land
Is land needed for other purposes	Yes - New SAPS Facility to be provided
Will some other building(s) be erected on land	Yes
Can building(s) perhaps be utilised for some purposes	No
Estimated age	Circa 40 years - not significant – under 60 years therefore exempt from heritage application.
Confirmation that funds are available for demolition	WCS 035880

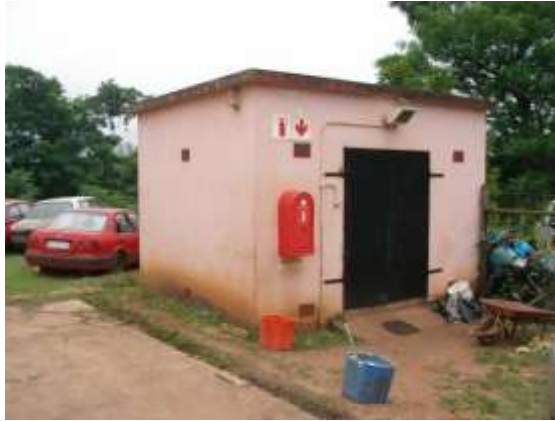
**BUILDING(S) # 7**

**Details:** Type: Brick with concrete roof slab  
 Address: Foxon Street, Gingindlovu  
 No. of floors: Single storey  
 Total area of building(s): 17.27m<sup>2</sup>  
 Total area of land: 3,7108 ha  
 Utilization: Store  
 Current status: Occupied

Reasons for demolition	Earmarked for demolition as per SAPS Needs Assessment document. New and appropriate storing facilities will be accommodated in the new project as per SAPS requirements.
Present value of building(s)	R21 810
Present market value of building(s)	R15 000
Present market value of land:	N/A – Government Land
Present replacement value of building(s)	R60 445
Estimated cost of repair of building(s)	R29 080
Present value of material to be recovered	R2 000
Manner in which recovered material will be disposed	By contractor appropriately
Can land and building(s) be sold by auction	N/A – Government Land
Is land needed for other purposes	Yes - New SAPS Facility to be provided
Will some other building(s) be erected on land	Yes
Can building(s) perhaps be utilised for some purposes	No
Estimated age	Circa 40 years - not significant – under 60 years therefore exempt from heritage application. -
Confirmation that funds are available for demolition	WCS 035880

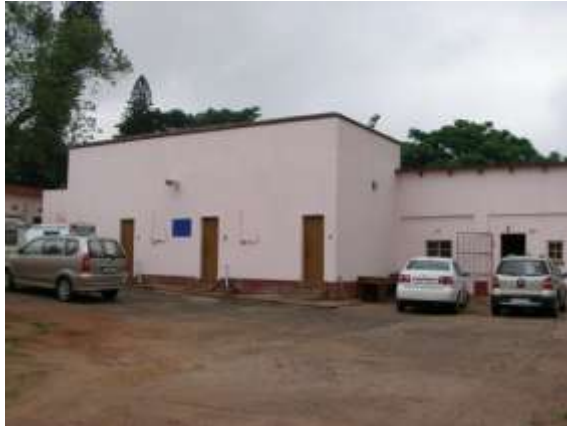
**BUILDING(S) # 8**

<b>Details:</b>	Type:	Brick, concrete roof slab and secured courtyards
	Address:	Foxon Street, Gingindlovu
	No. of floors:	Single storey
	Total area of building(s):	209.46m <sup>2</sup>
	Total area of land:	3,7108 ha
	Utilization:	Cell Block
	Current status:	Occupied

Reasons for demolition	Earmarked for demolition as per SAPS Needs Assessment document as it does not conform to Project 5 Star specifications. New Project 5 Star Cell Block to be erected.
Present value of building(s)	R783 028
Present market value of building(s)	R685 149
Present market value of land:	N/A – Government Land
Present replacement value of building(s)	R2 513 520
Estimated cost of repair of building(s)	R2 722 980
Present value of material to be recovered	R10 000
Manner in which recovered material will be disposed	By contractor appropriately
Can land and building(s) be sold by auction	N/A – Government Land
Is land needed for other purposes	Yes - New SAPS Facility to be provided
Will some other building(s) be erected on land	Yes
Can building(s) perhaps be utilised for some purposes	No
Estimated age	Circa 40 years - not significant – under 60 years therefore exempt from heritage application.
Confirmation that funds are available for demolition	WCS 035880

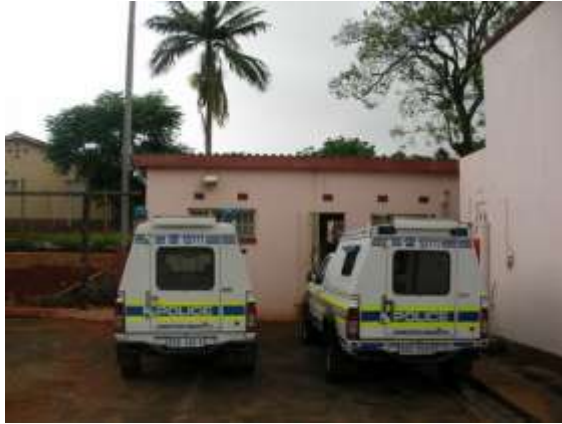
**BUILDING(S) # 9**

<b>Details:</b>	Type:	Brick with asbestos roof sheeting
	Address:	Foxon Street, Gingindlovu
	No. of floors:	Single storey
	Total area of building(s):	35.33m <sup>2</sup>
	Total area of land:	3,7108 ha
	Utilization:	Kitchen serving Cell Block + Staff Toilets
	Current status:	Occupied

Reasons for demolition	Earmarked for demolition as per SAPS Needs Assessment document. A new kitchen facility servicing detainees will be accommodated in the new Project 5 Star Cell Block.
Present value of building(s)	R132 074
Present market value of building(s)	R123 655
Present market value of land:	N/A – Government Land
Present replacement value of building(s)	R335 635
Estimated cost of repair of building(s)	R247 310
Present value of material to be recovered	R5 000
Manner in which recovered material will be disposed	By contractor appropriately
Can land and building(s) be sold by auction	N/A – Government Land
Is land needed for other purposes	Yes - New SAPS Facility to be provided
Will some other building(s) be erected on land	Yes
Can building(s) perhaps be utilised for some purposes	No
Estimated age	Circa 40 years - not significant – under 60 years therefore exempt from heritage application.
Confirmation that funds are available for demolition	WCS 035880

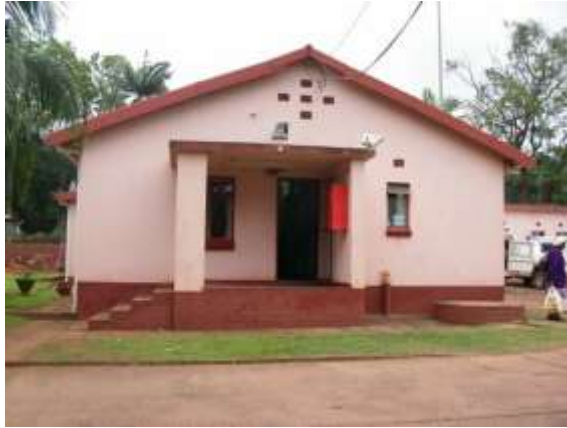
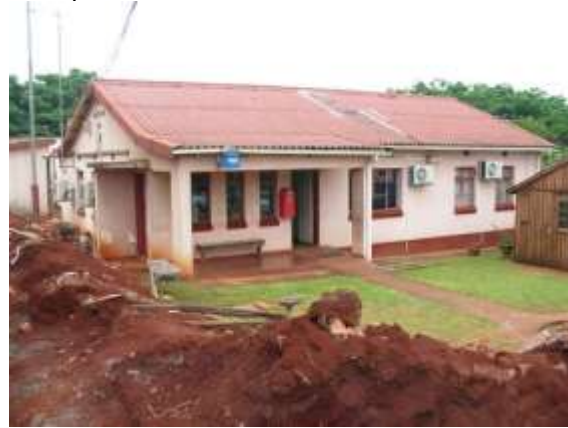
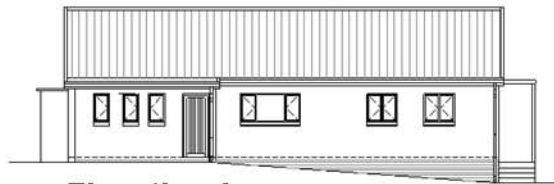
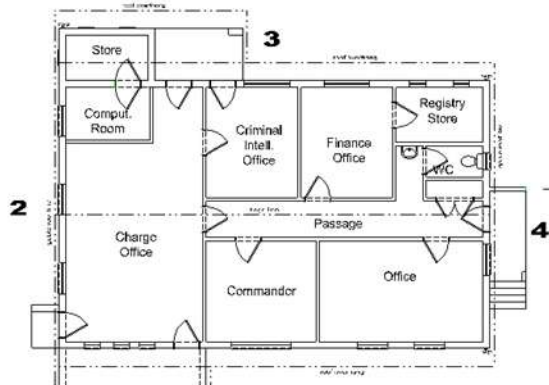
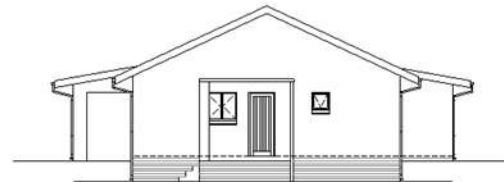
**BUILDING(S) # 10**

**Details:** Type: Brick with asbestos roof sheeting  
 Address: Foxon Street, Gingindlovu  
 No. of floors: Single storey  
 Total area of building(s): 133.33m<sup>2</sup>  
 Total area of land: 3,7108 ha  
 Utilization: Community Service Centre (CSC)  
 Current status: Occupied

Reasons for demolition	<ul style="list-style-type: none"> <li>• Condition: Sub-standard and overcrowded</li> <li>• CSC is currently accommodated in a dwelling</li> <li>• Current layout cannot accommodate SAPS needs.</li> <li>• Conversion impractical due to the following reasons: <ul style="list-style-type: none"> <li>• all internal walls to be removed</li> <li>• windows positions altered</li> <li>• roof to be replaced</li> <li>• plastered external walls not fitting overall aesthetic value of project and proposed general facebrick finish</li> <li>• negative impact on planning and functional circulation</li> </ul> </li> </ul>
Present value of building(s)	R560 733
Present market value of building(s)	R733 315
Present market value of land:	N/A – Government Land
Present replacement value of building(s)	R1 199 970
Estimated cost of repair of building(s)	R399 990
Present value of material to be recovered	R15 000

Manner in which recovered material will be disposed	By contractor appropriately
Can land and building(s) be sold by auction	N/A – Government Land
Is land needed for other purposes	Yes - New SAPS Facility to be provided
Will some other building(s) be erected on land	Yes
Can building(s) perhaps be utilised for some purposes	No
Estimated age	Circa 40 years - not significant – under 60 years therefore exempt from heritage application.
Confirmation that funds are available for demolition	WCS 035880
Who will carry out demolition work	Recommended contractor by tender process
Estimated cost of demolition	R50 000
Demolition by implosion / use of explosives	No
Implosion / explosive guidelines to be complied with.	N/A

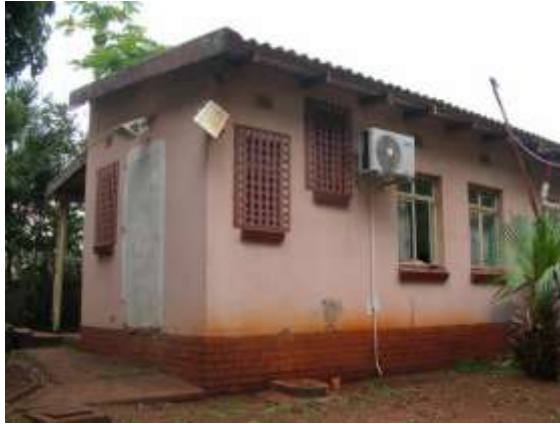
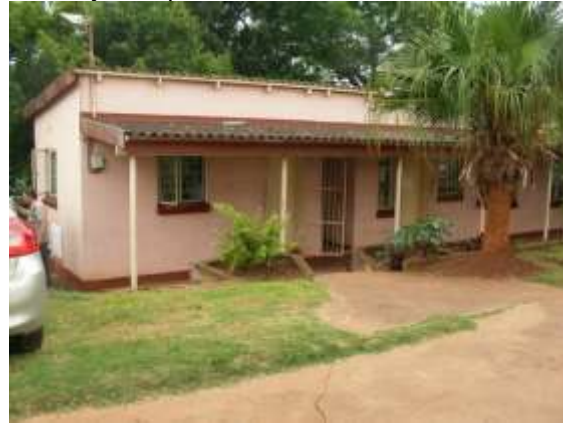
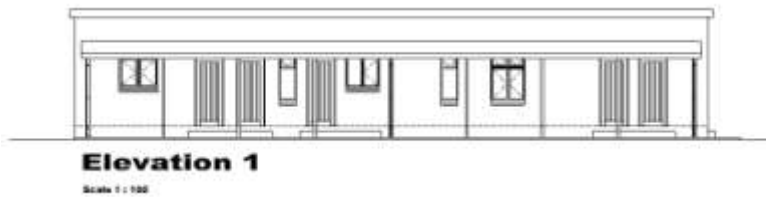
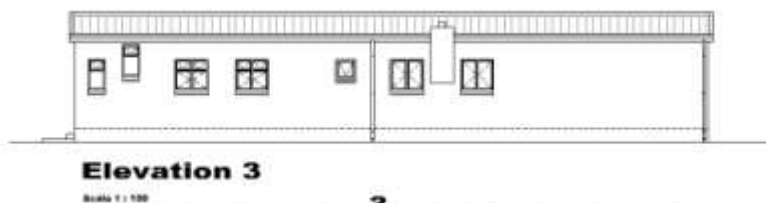
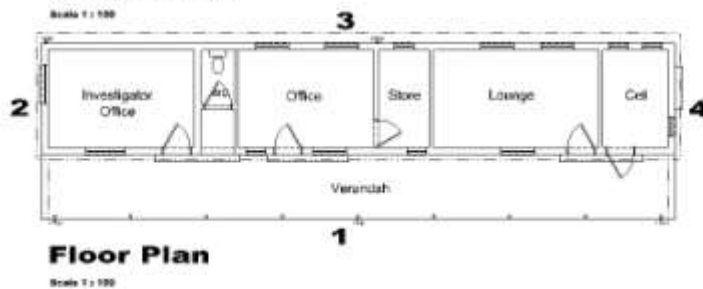
**BUILDING(S) # 11**

<b>Details:</b>	Type:	Brick with asbestos roof sheeting
	Address:	Foxon Street, Gingindlovu
	No. of floors:	Single storey
	Total area of building(s):	66.66m <sup>2</sup>
	Total area of land:	3,7108 ha
	Utilization:	Office Block
	Current status:	Partially occupied

Reasons for demolition	<ul style="list-style-type: none"> <li>• Condition: sub-standard</li> <li>• Office block currently accommodated in an outbuilding</li> <li>• Current layout cannot accommodate SAPS needs both in size and planning</li> <li>• Existing position on site impacts negatively with accommodation and circulation planning of other facilities as per SAPS requirements</li> </ul>
Present value of building(s)	R280 345
Present market value of building(s)	R399 960
Present market value of land:	N/A – Government Land
Present replacement value of building(s)	R599 940
Estimated cost of repair of building(s)	R199 980
Present value of material to be recovered	R5 000
Manner in which recovered material will be disposed	By contractor appropriately
Can land and building(s) be sold by auction	N/A – Government Land
Is land needed for other purposes	Yes - New SAPS Facility to be provided
Will some other building(s) be erected on land	Yes

Can building(s) perhaps be utilised for some purposes	No
Estimated age	Circa 40 years - not significant – under 60 years therefore exempt from heritage application.
Confirmation that funds are available for demolition	WCS 035880
Who will carry out demolition work	Recommended contractor by tender process
Estimated cost of demolition	R20 000
Demolition by implosion / use of explosives	No
Implosion / explosive guidelines to be complied with.	N/A

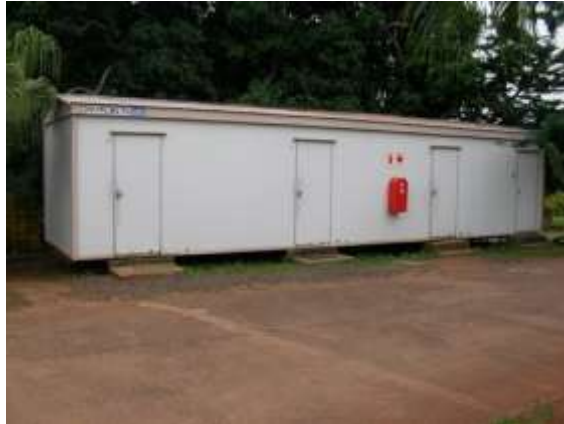
Type:	Prefabricated mobile structure
Address:	Foxon Street, Gingindlovu
No. of floors:	Single storey
Total area of building(s):	37.48m <sup>2</sup>
Total area of land:	3,7108 ha
Utilization:	Offices for Investigators
Current status:	Occupied

Reasons for demolition	Earmarked for removal/demolition as per SAPS requirements
Present value of building(s)	R72 076
Present market value of building(s)	R18 740
Present market value of land:	N/A – Government Land
Present replacement value of building(s)	R262 360
Estimated cost of repair of building(s)	Irreparable
Present value of material to be recovered	R5 000
Manner in which recovered material will be disposed	By contractor appropriately
Can land and building(s) be sold by auction	N/A – Government Land
Is land needed for other purposes	Yes - New SAPS Facility to be provided
Will some other building(s) be erected on land	Yes
Can building(s) perhaps be utilised for some purposes	No
Estimated age	Recent
Confirmation that funds are available for demolition	WCS 035880
Who will carry out demolition work	Recommended contractor by tender process
Estimated cost of demolition	R10 000
Demolition by implosion / use of explosives	No

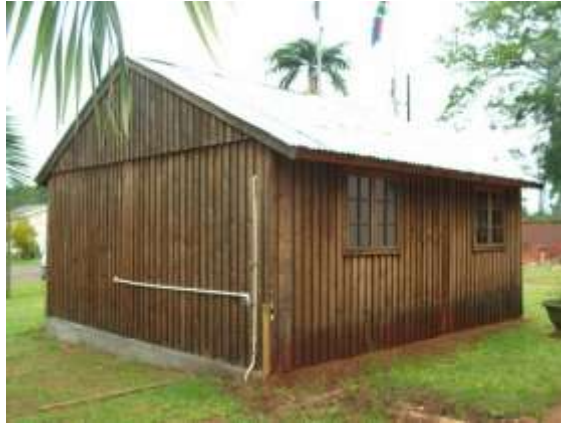
**BUILDING(S) # 13**

**Details:** Type: Prefabricated timber structure  
 Address: Foxon Street, Gingindlovu  
 No. of floors: Single storey  
 Total area of building(s): 24.09m<sup>2</sup>  
 Total area of land: 3,7108 ha  
 Utilization: Office/Store  
 Current status: Occupied

Reasons for demolition	Earmarked for demolition as per SAPS requirements
Present value of building(s)	R45 452
Present market value of building(s)	R68 179
Present market value of land:	N/A – Government Land
Present replacement value of building(s)	R192 720
Estimated cost of repair of building(s)	Irreparable
Present value of material to be recovered	R5 000
Manner in which recovered material will be disposed	By contractor appropriately
Can land and building(s) be sold by auction	N/A – Government Land
Is land needed for other purposes	Yes - New SAPS Facility to be provided
Will some other building(s) be erected on land	Yes
Can building(s) perhaps be utilised for some purposes	No
Estimated age	Recent
Confirmation that funds are available for demolition	WCS 035880
Who will carry out demolition work	Recommended contractor by tender process
Estimated cost of demolition	R10 000
Demolition by implosion / use of explosives	No

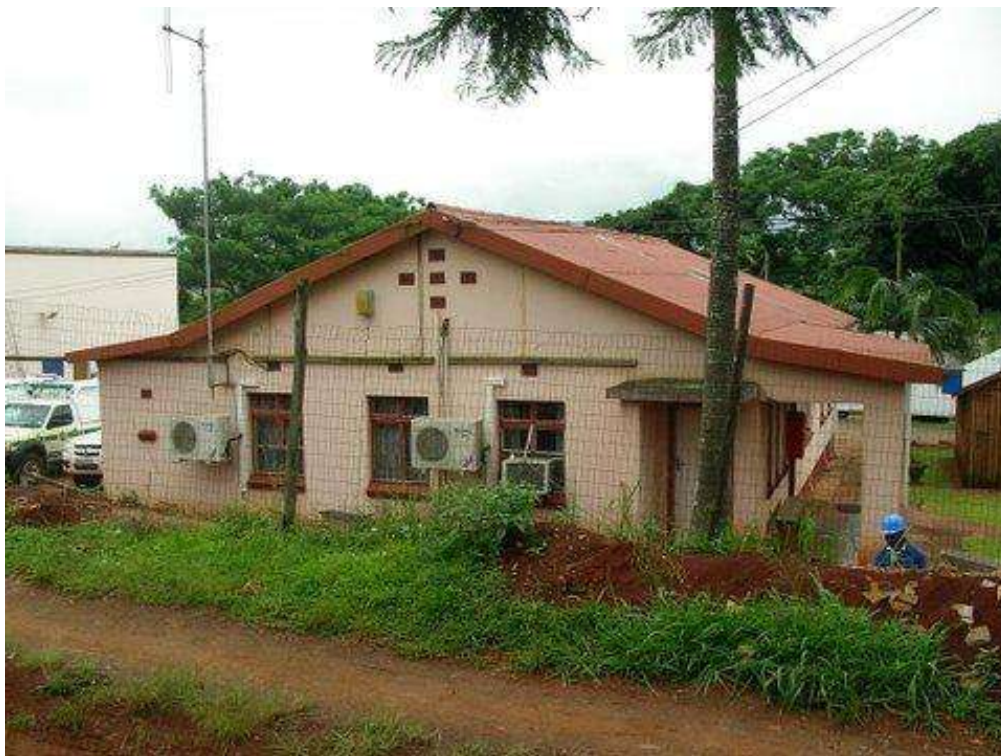
Both are utilitarian and functional buildings constructed of conventional brick and mortar, plastered and painted, on a low painted brick dado. Both roofs are double pitched corrugated asbestos sheeting; the house as a modest veranda with a painted stoep. Both have brick on edge cills, and painted standard section steel windows. The condition of both of these buildings is relatively good.

Fig 1: Side view of dwelling

**Conclusions: Whilst the dwelling does show some consideration in the treatment of the elevations, there is little of other merit to recommend its retention. It has little in the way of architectural, historical, technical or scientific merit, and may have low social associations for police staff that have stayed there in the past. The store has similar limited value: these buildings would be lost and**

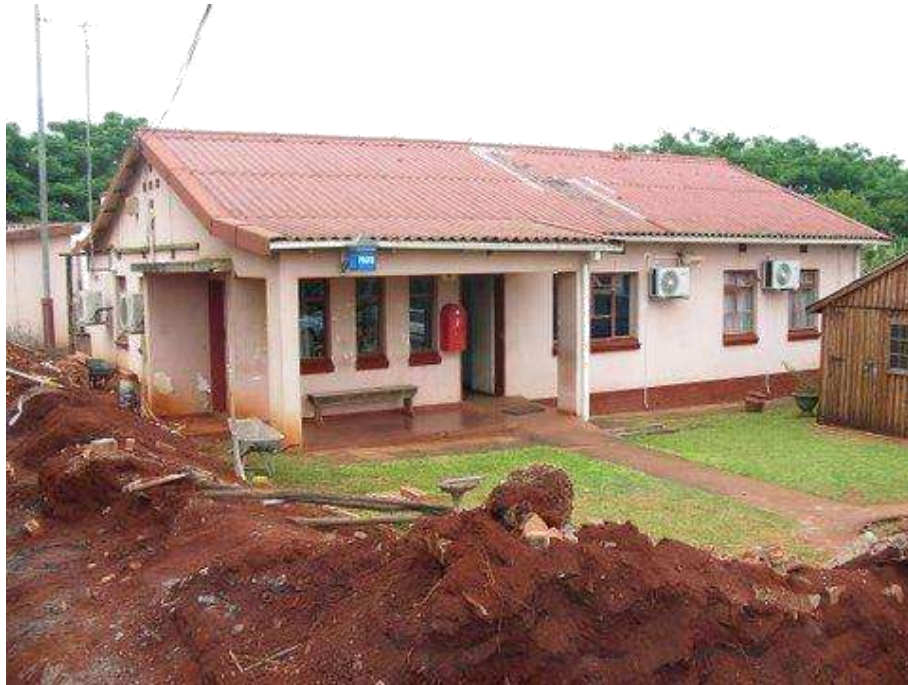
Fig 2: Front view of dwelling

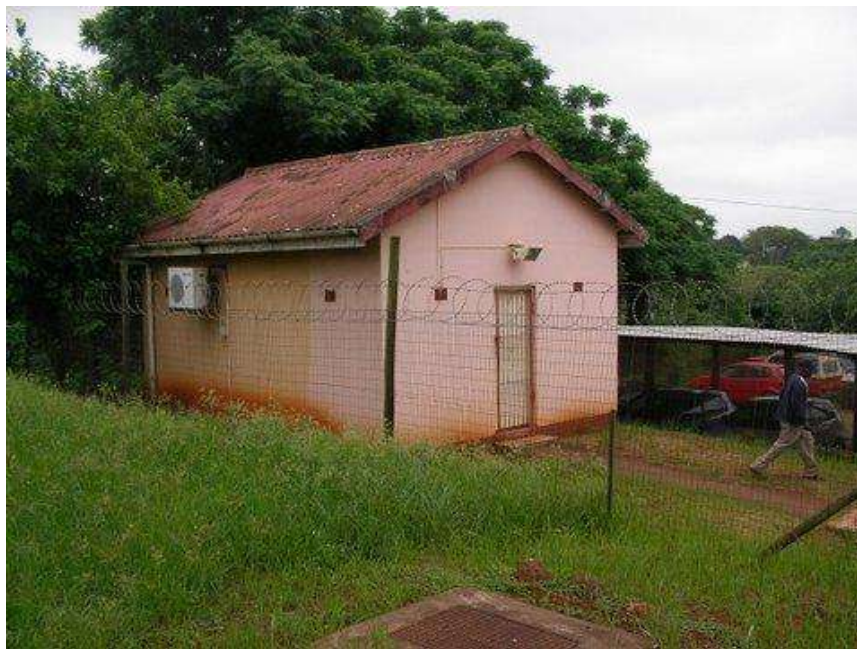
Fig 3: View of store
