**GLENWOOD SOUTH EAST SECTOR HOUSING
PROJECT, UMSUNDUZI LOCAL MUNICIPALITY,
KWAZULU-NATAL**

Phase 1 Heritage Impact Assessment

March 2022

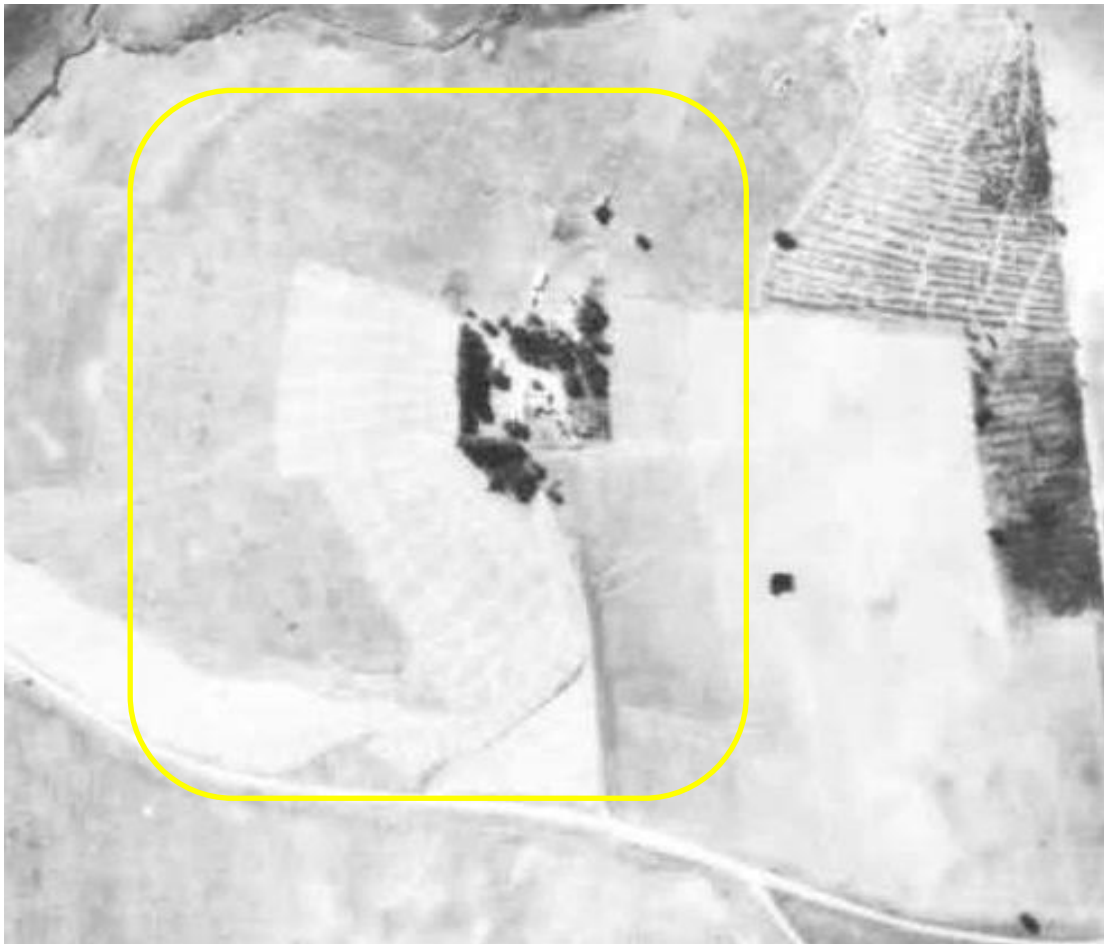
Figure 3: 1944 aerial image with project area outlined in yellow

The 1944 aerial photograph of the project area shows a large homestead/farmstead and associated buildings in the project area and cultivation on either side of the road to the homestead. The road running along the southern boundary of the project is visible.

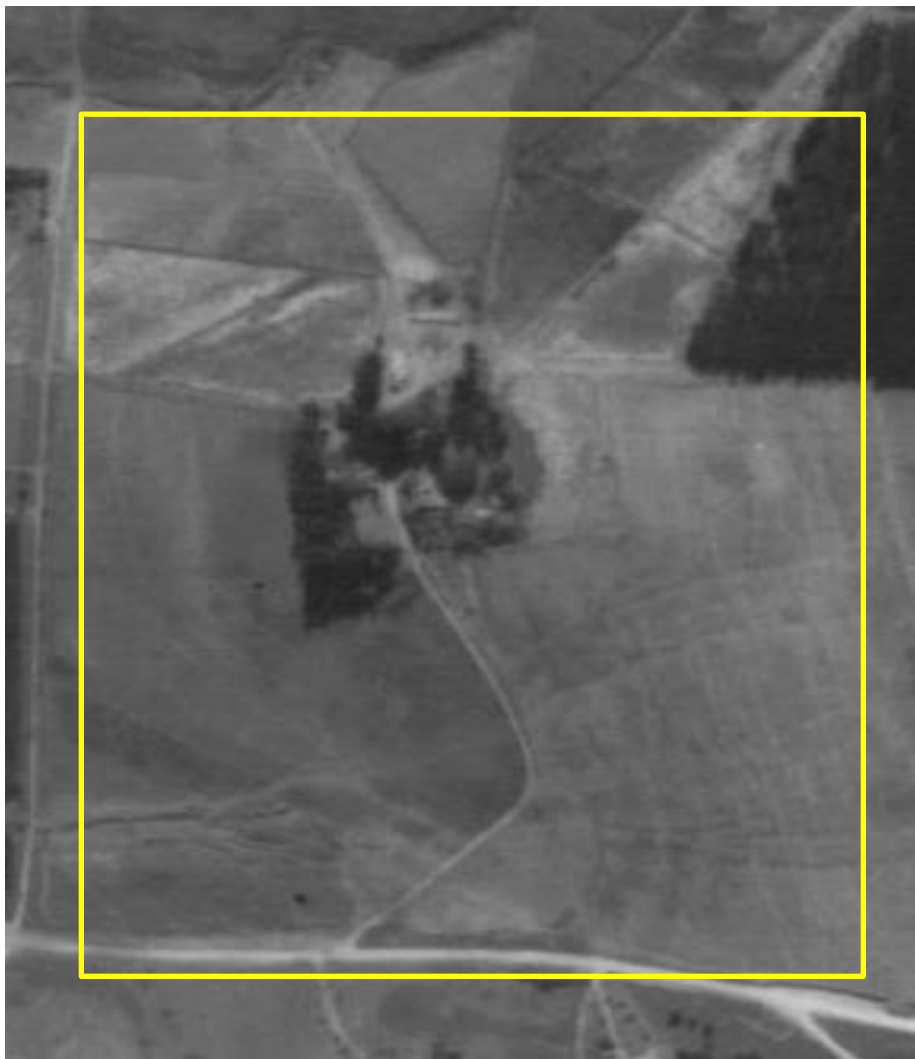
Figure 4: 1968 aerial image of project area

In the 1968 aerial image (**Fig. 4**), the homestead appears slightly reduced in size and there is additional cultivation immediately north of the homestead and associated buildings.

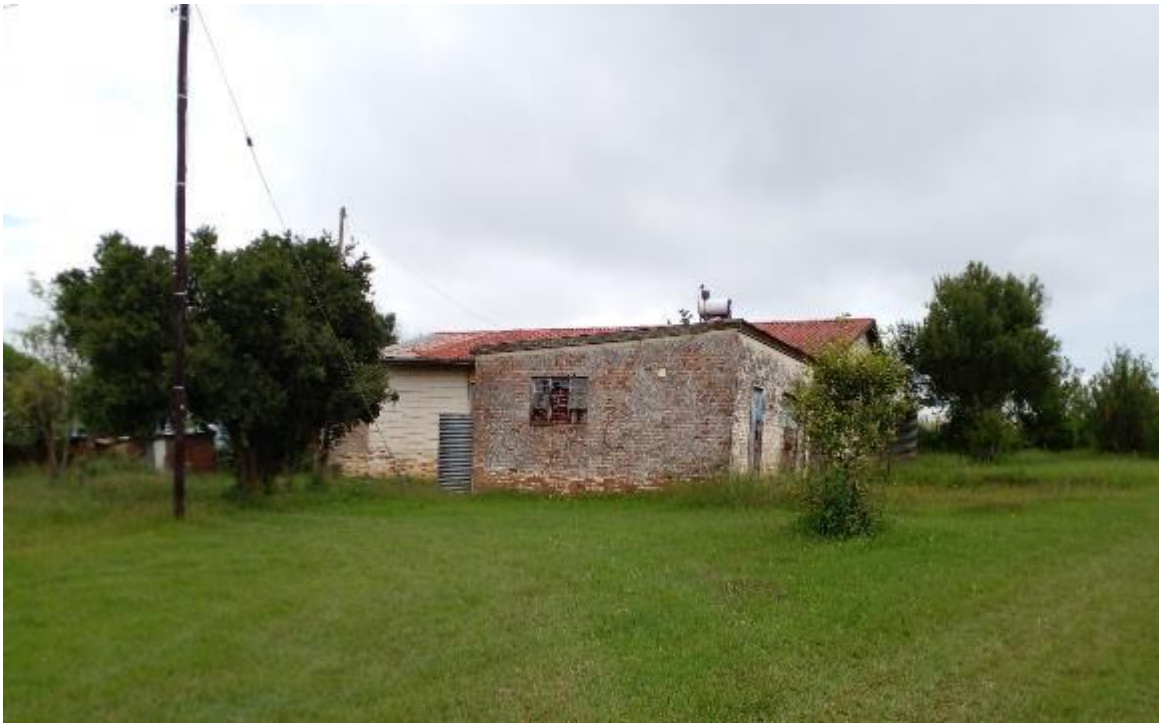
There is a dwelling with associated buildings in the south-eastern corner of the project site. The dwelling starts to appear on maps from the 1980s so it is not a protected structure. The dwelling is currently occupied. An inspection around the dwelling revealed no graves or other heritage sites. The dwelling is located 60m west of the eastern boundary of the project area. Sugar cane is growing along the eastern boundary.

Figure 5: Dwelling and associated building / garage

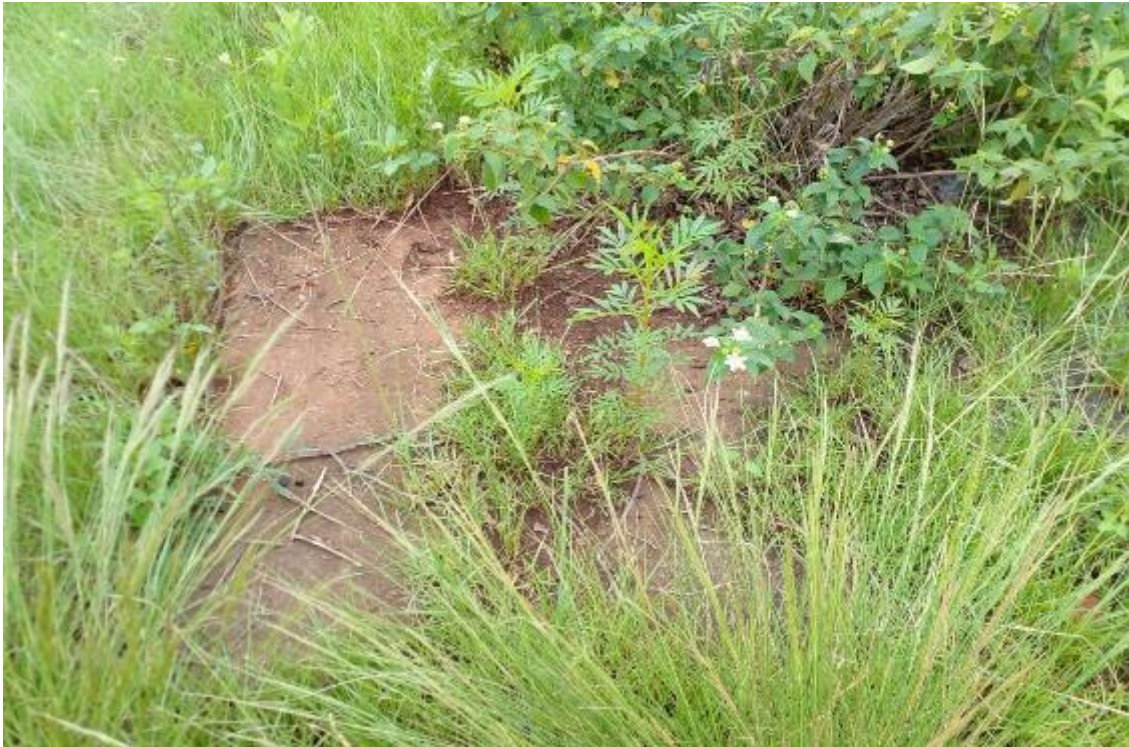
Behind or south-east of the business and other structures is an area which is most likely the site of the remains of the homestead discussed in Chapter 6 of this report. There are the remains of a concrete floor/foundation or platform as well as drains and a line of trees that may indicate an access road. Due to very dense vegetation around the site, it could not be determined if there

are graves associated with the homestead or any other heritage resources. The access road from the south which is visible in **Figs. 3 – 4** is still faintly visible.

Figure 17: Remains of concrete floor or platform

The site of the homestead needs to be cleared of vegetation in order to determine whether there are any graves related to the site. A polygon of the area to be cleared has been provided to the Environmental Assessment Practitioner (EAP), Sphe Consulting Services. The clearing and inspection of the site must be undertaken prior to any excavations been undertaken in that particular area.

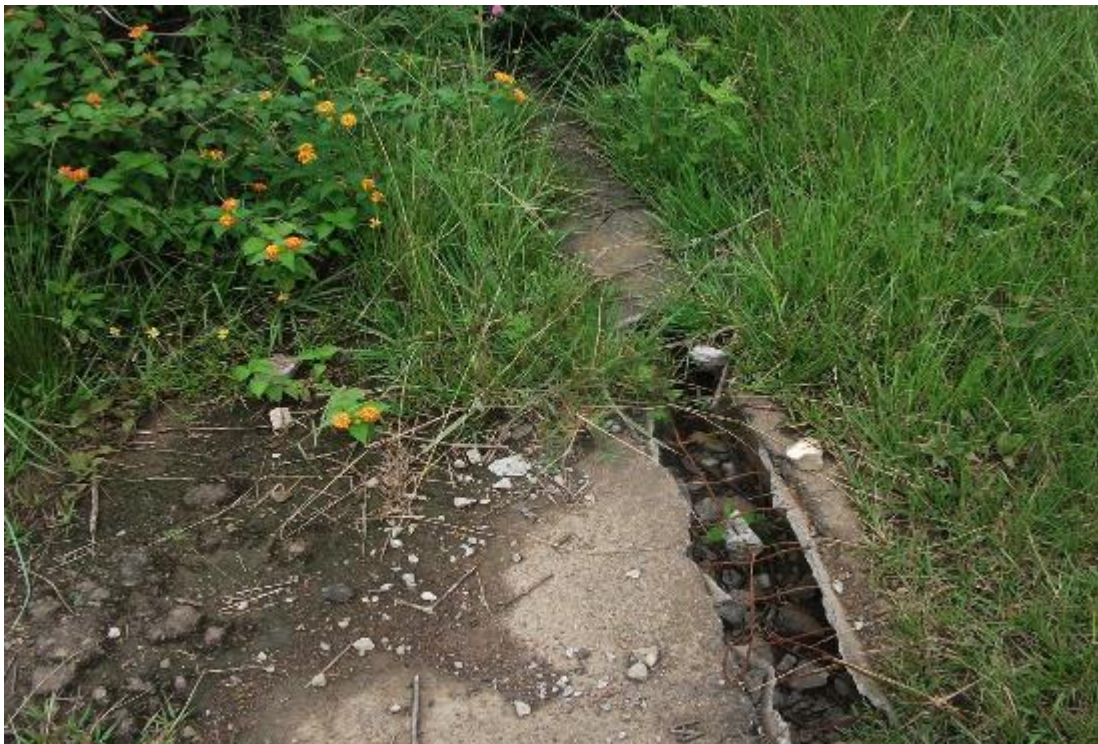
Figure 18: Remains of drain

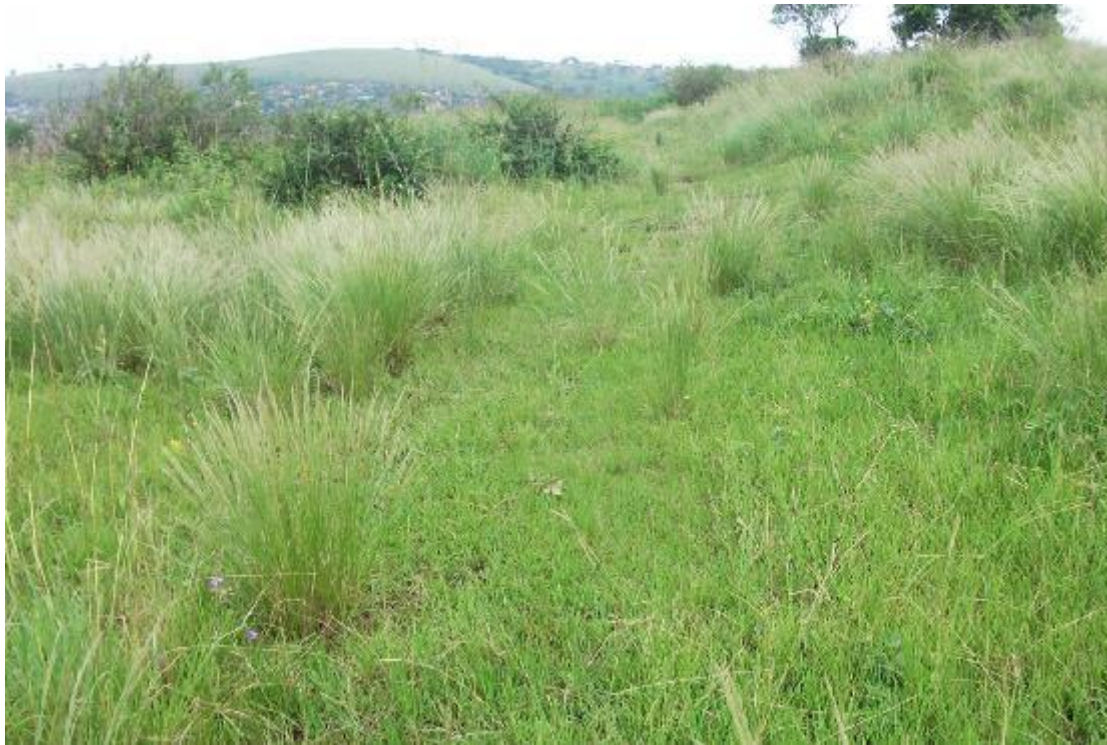
Figure 19: Original access road still visible
