**HERITAGE IMPACT ASSESSMENT OF THE  
PROPOSED DAMS AND ORCHARDS FOR THE  
GUBENXA VALLEY, E. CAPE**

**FOR INDWE ENVIRONMENTAL CONSULTING CC**

**DATE: 25 FEBRUARY 2021**

**By Gavin Anderson**

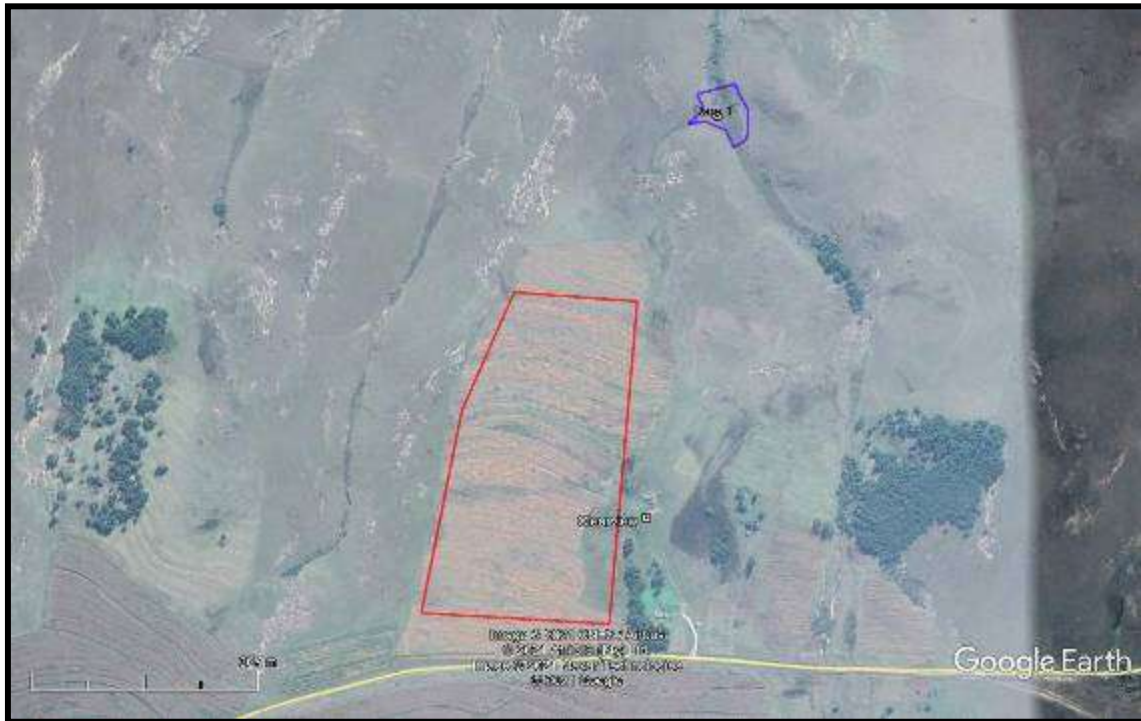
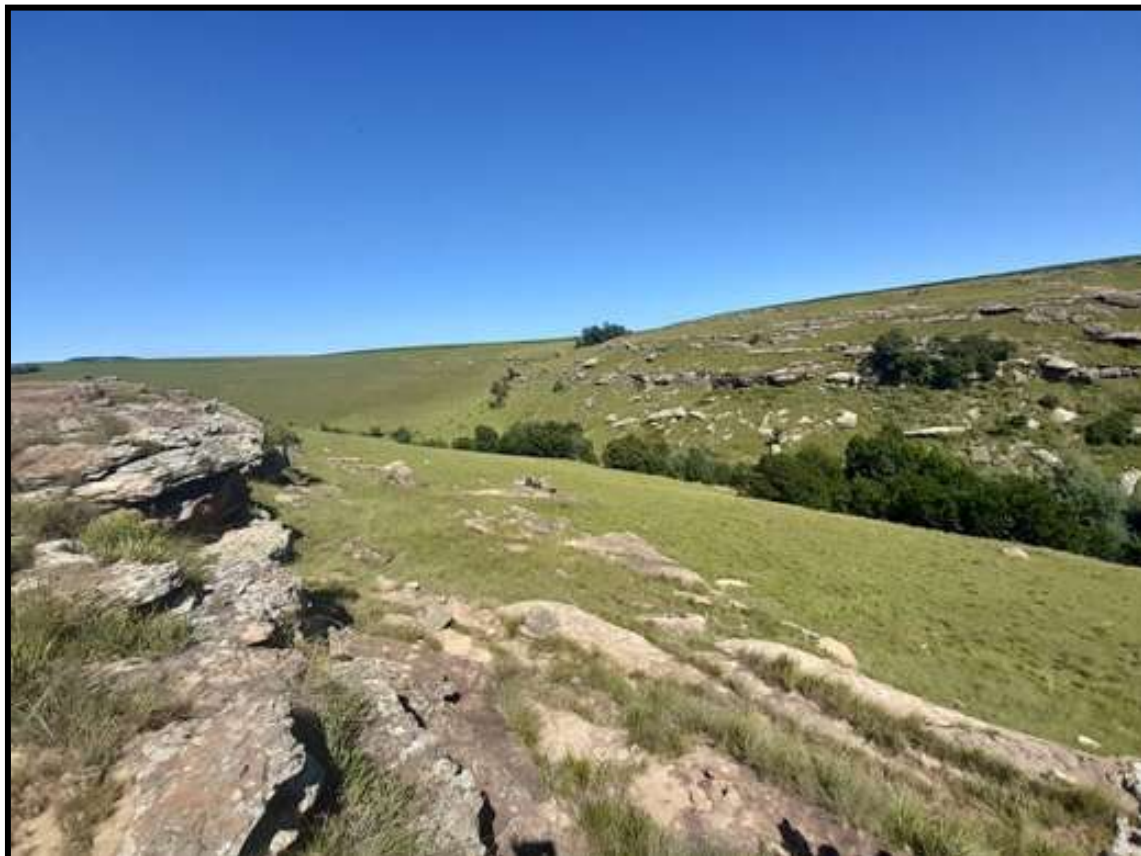
FIG. 20: DAM 1

No heritage sites were noted within the dam or orchard areas (fig. 20). The farm Clearwater occurs outside of the orchard.

Significance: None

Mitigation: None

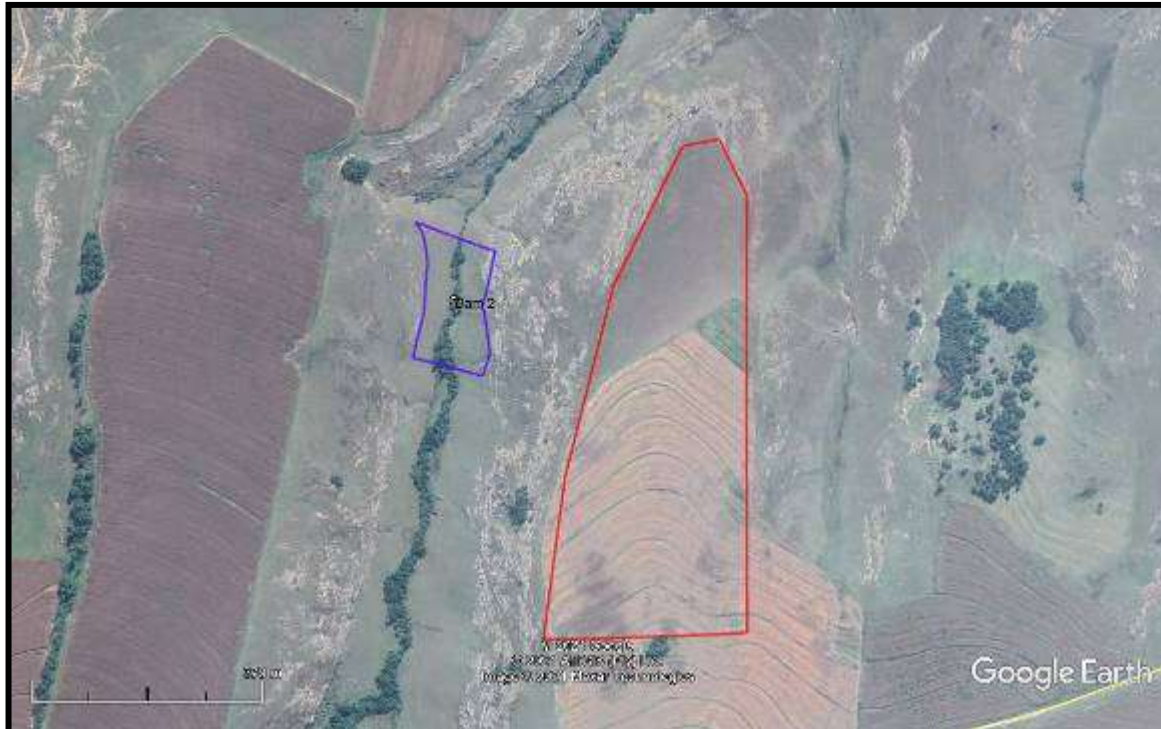
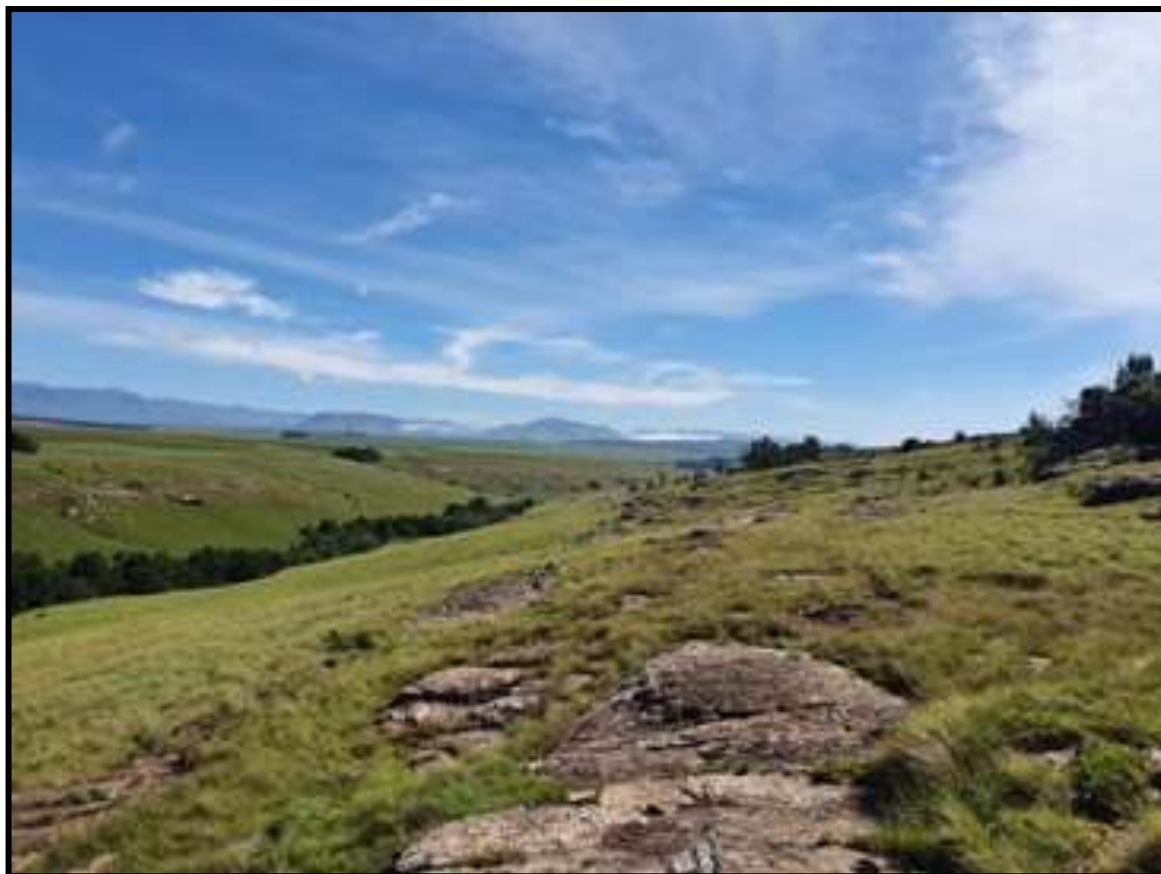
FIG. 21: DAM 2

No heritage sites were noted within the dam or orchard areas (fig. 21). The orchard is in an existing maize field.

Significance: None

Mitigation: None

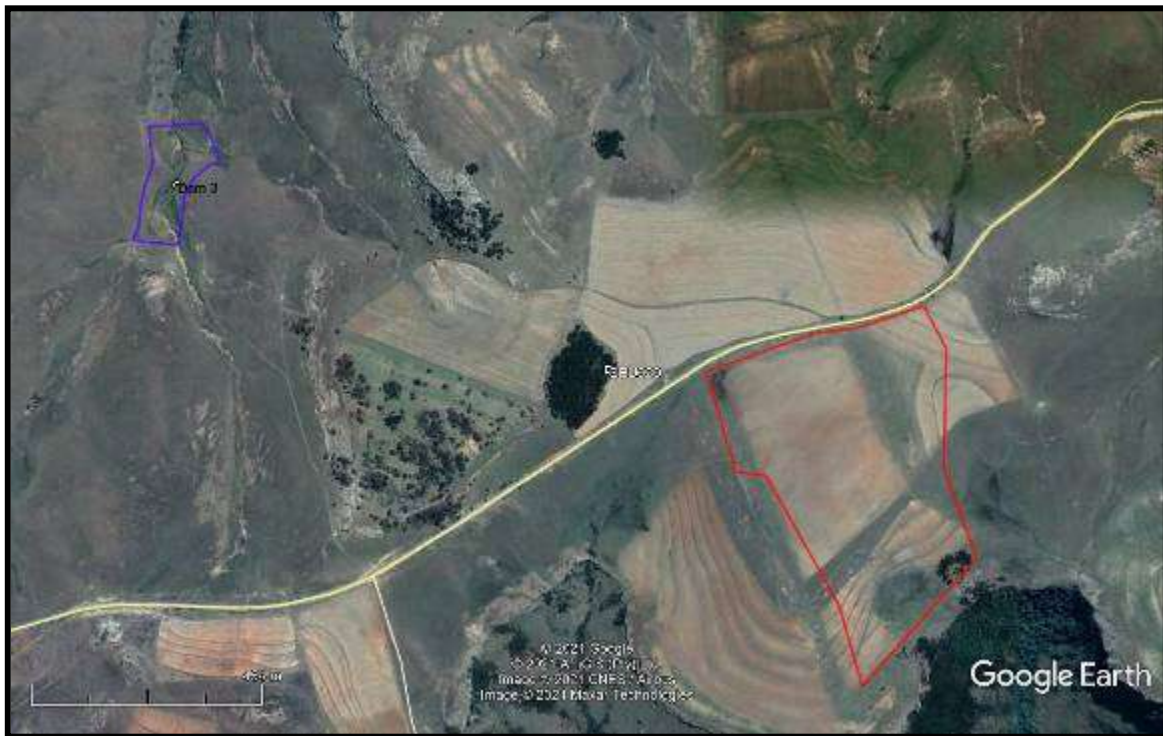
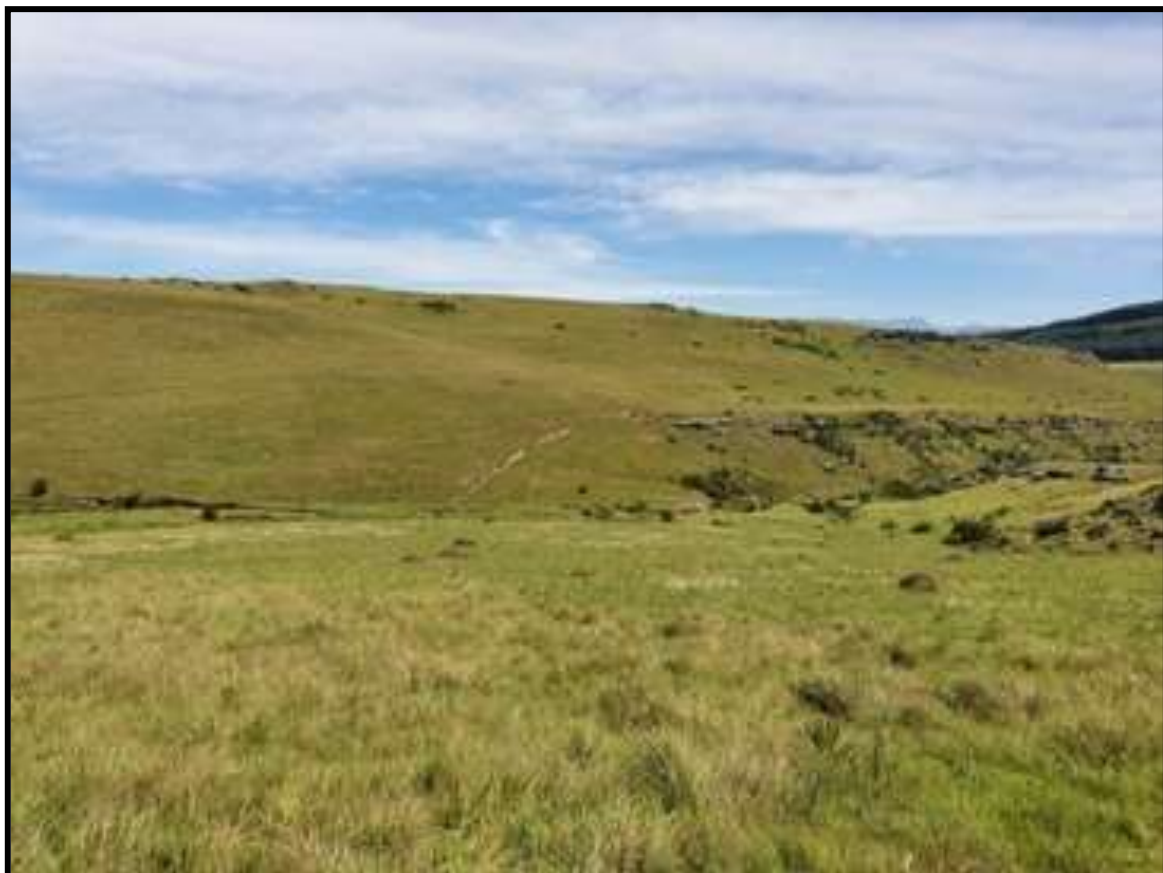
FIG. 22: DAM 3

No heritage sites were noted within the dam or orchard areas (fig. 22). A historical building occurs in the one woodlot but this will not be affected.

Significance: None

Mitigation: None

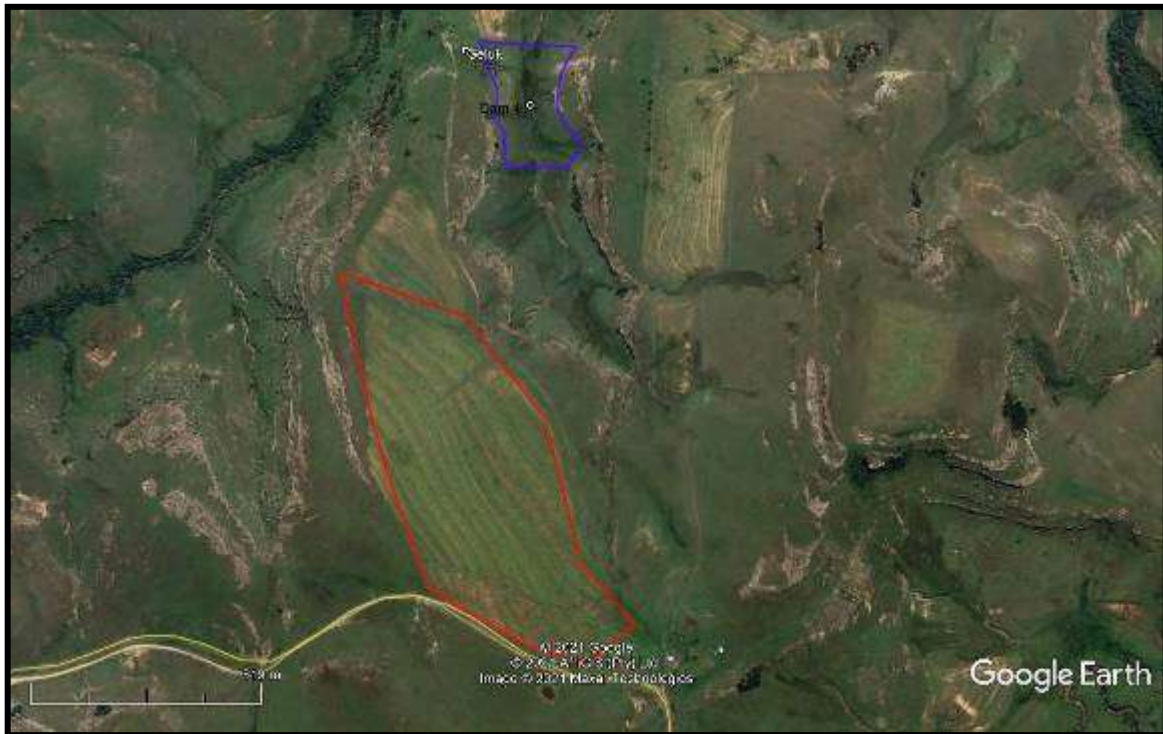
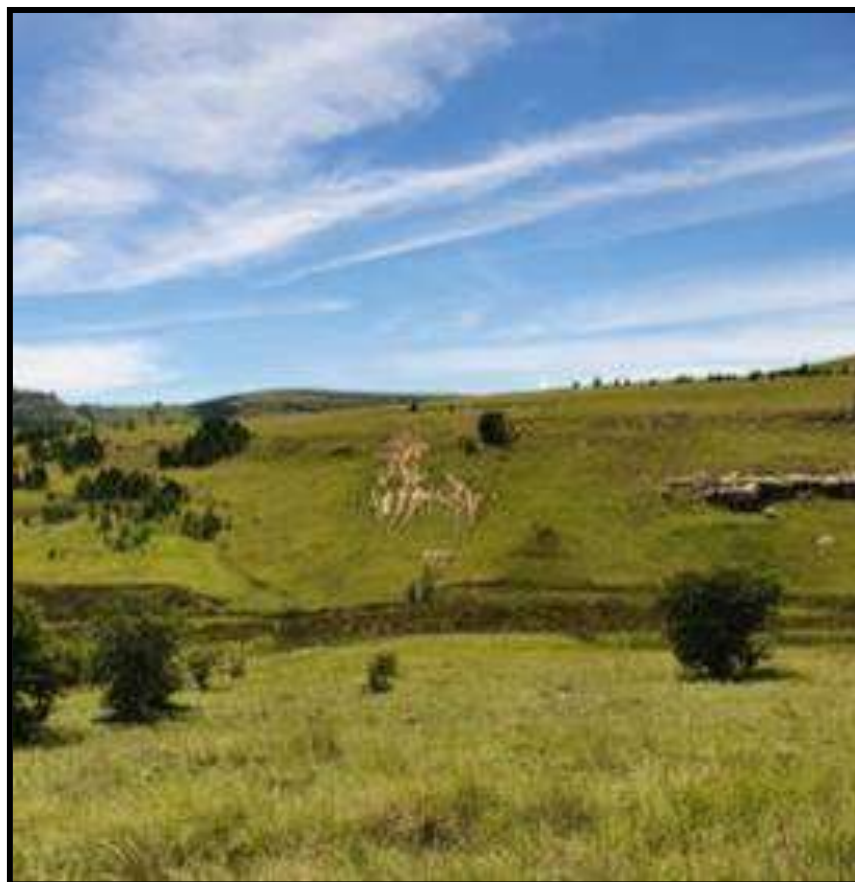
FIG. 23: DAM 4

No heritage sites were noted within the dam or orchard areas (fig. 23). The ruins of the Farm Geluk (fig. 24) occur 35m from the high-water mark. No graves were noticed at this farm. The stone stellae that formed the farm boundary will be flooded. The farmhouse appears to be the original farmhouse with several additions. The original fruit orchards still occur next to the house.

Significance: None, while the farmhouse and stellae are of low significance.

Mitigation: None

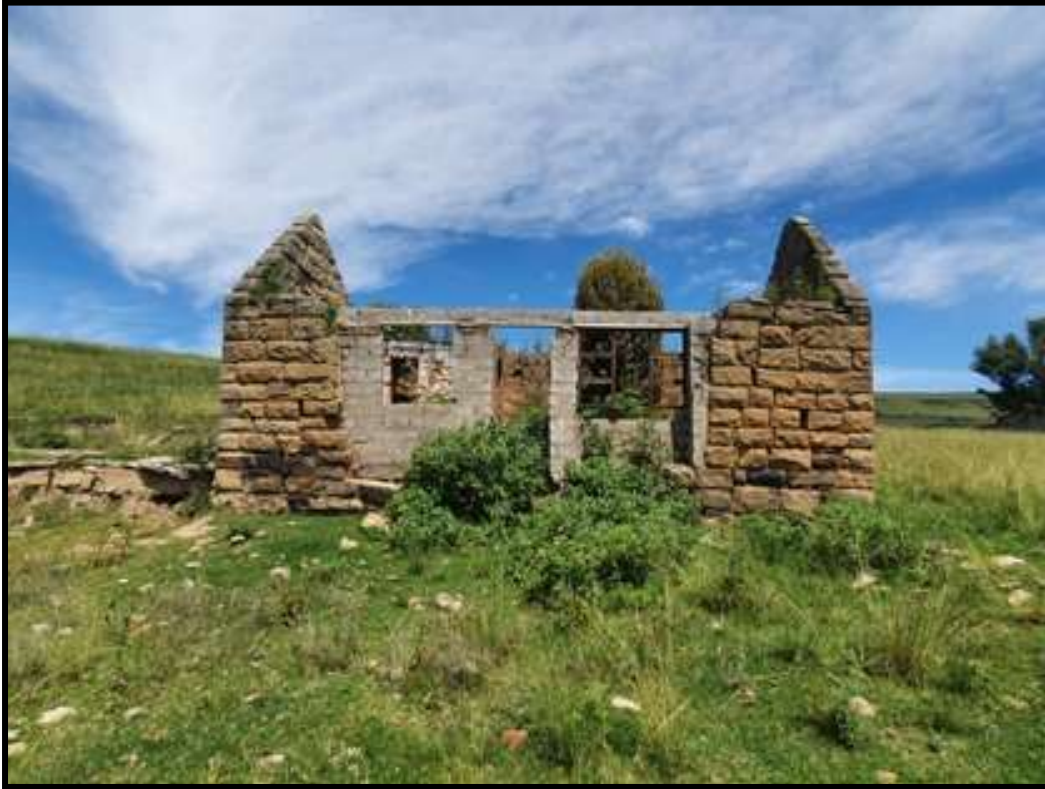
FIG. 24: GELUK FARMHOUSE

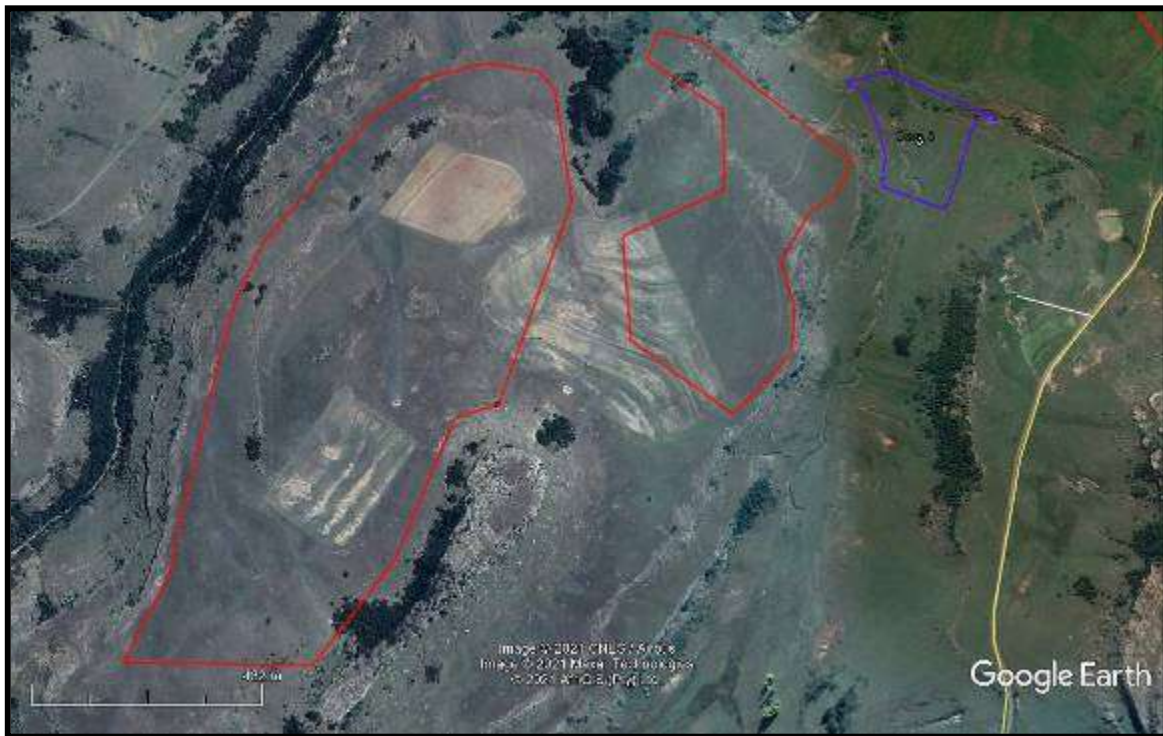
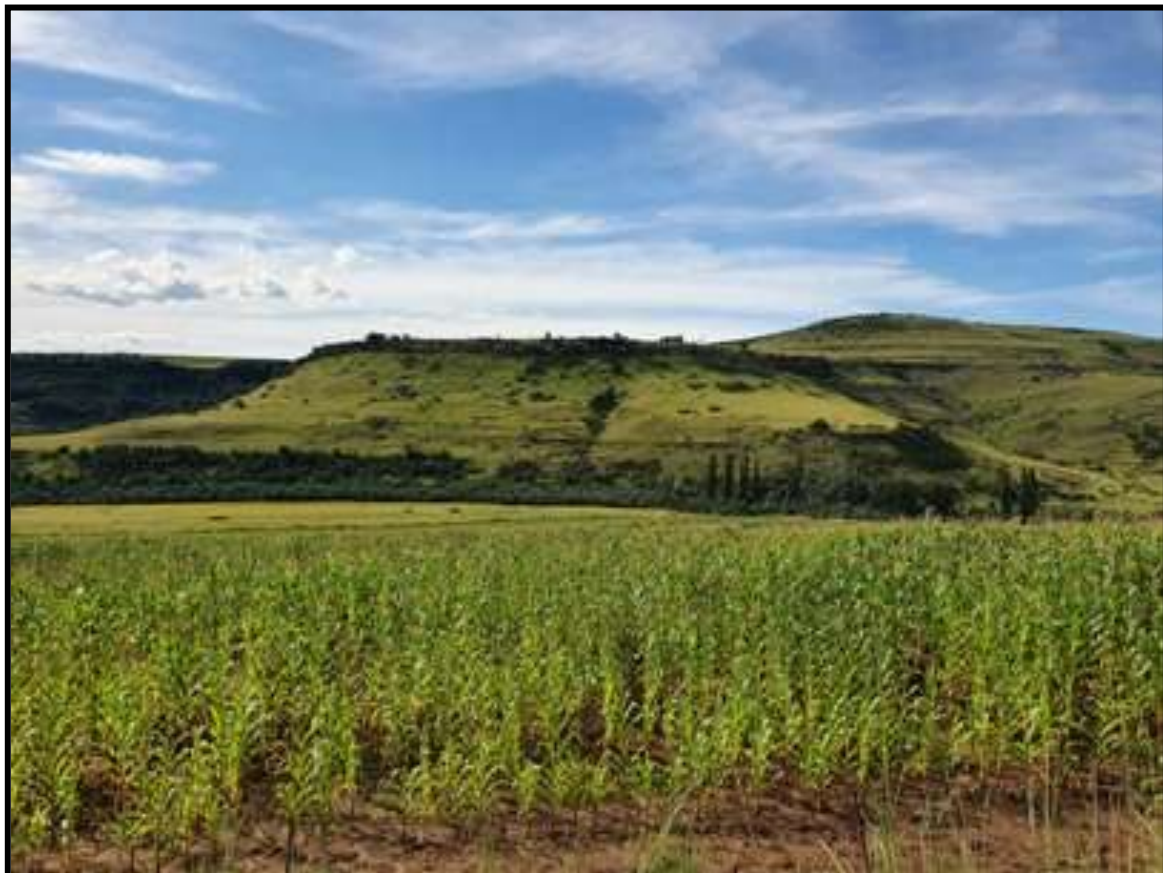
FIG. 25: DAM 5

No heritage sites were noted within the dam or orchard areas (fig. 25).

Significance: None

Mitigation: None

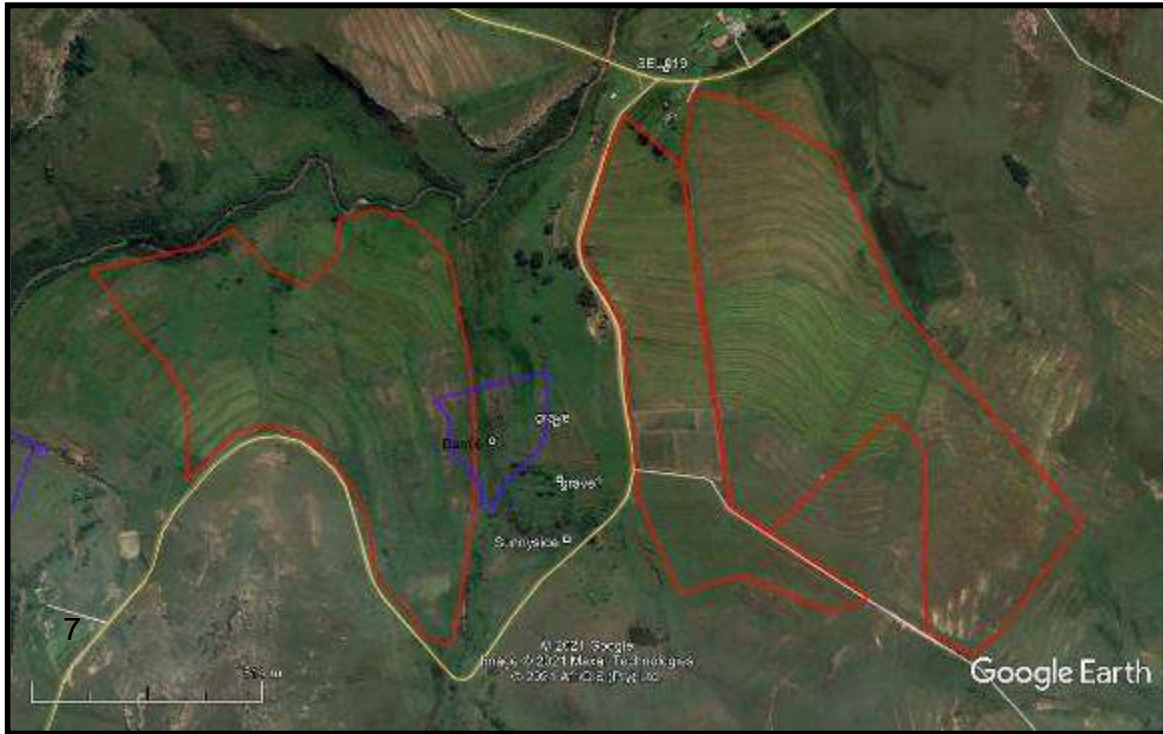
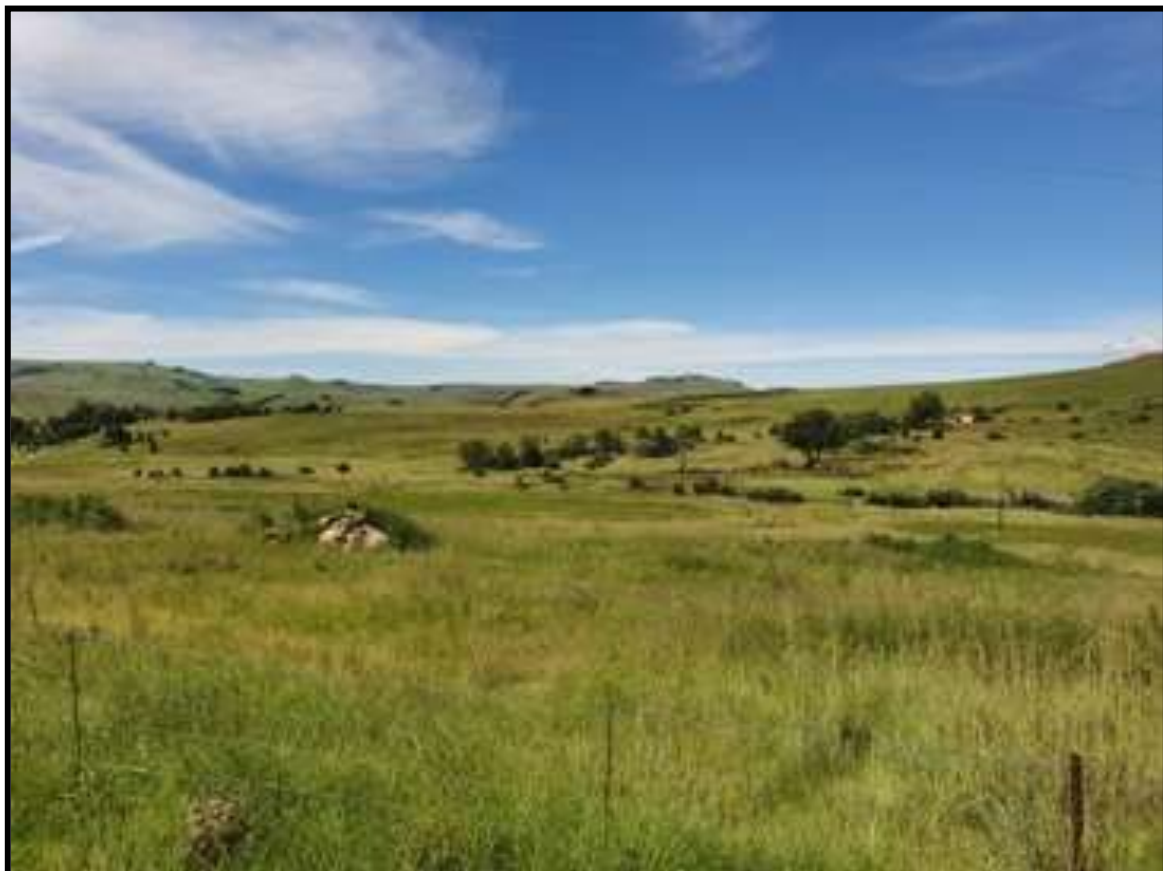
FIG. 26: DAM 6

No heritage sites were noted within the dam or orchard areas (fig. 26). The Ruins of the Farm Sunnyside occur out of the dam high-water mark, as do the associated buildings and walls, all which are demolished (fig. 27). The 1966 1:50 000 topographical map has a grave marked just outside of the dam boundaries. This grave could not be located in the general area. The vegetation was very thick in the area closer to the house. If a grave occurs within the farmhouse perimeter, then it will not be affected by the dam. The grave on the map could also be a cartographer error, as it omitted a family cemetery 1.4km northeast at Farm Gubenxa.

The proposed orchards have been ploughed for several decades.

Significance: None

Mitigation: None

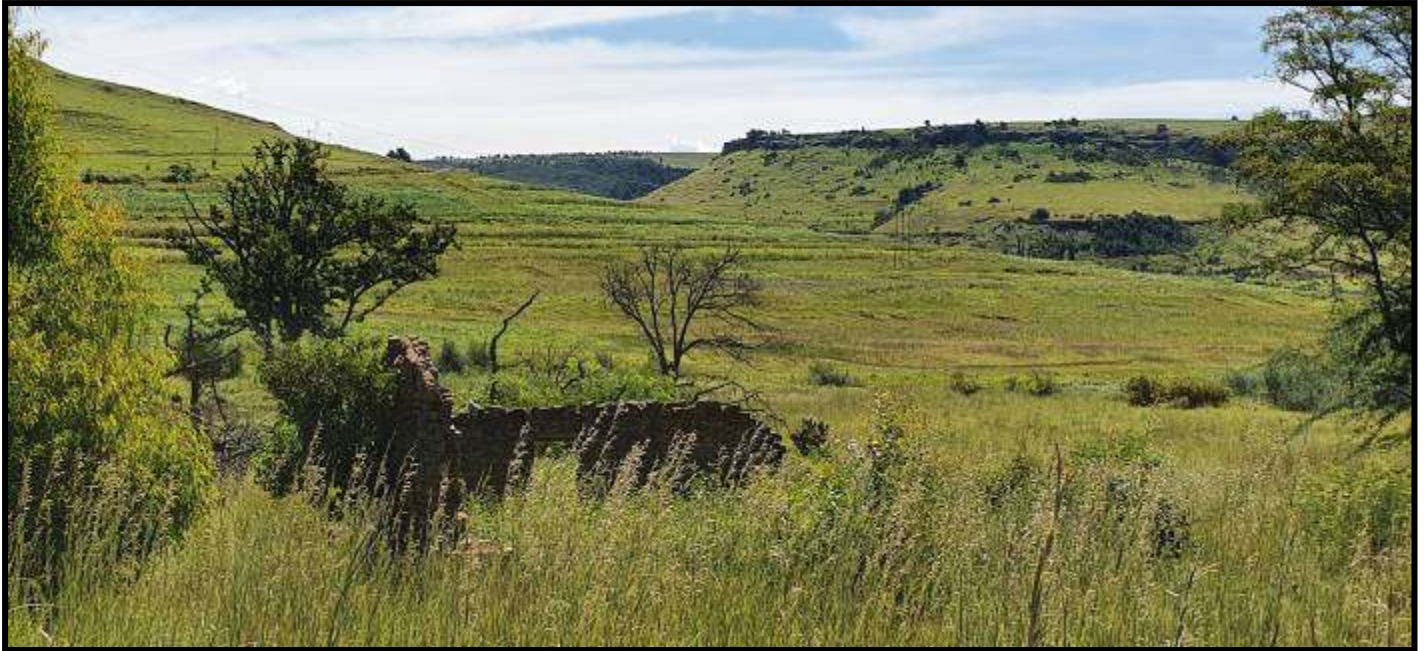
**FIG. 27: SUNNYSIDE FARM BUILDINGS**

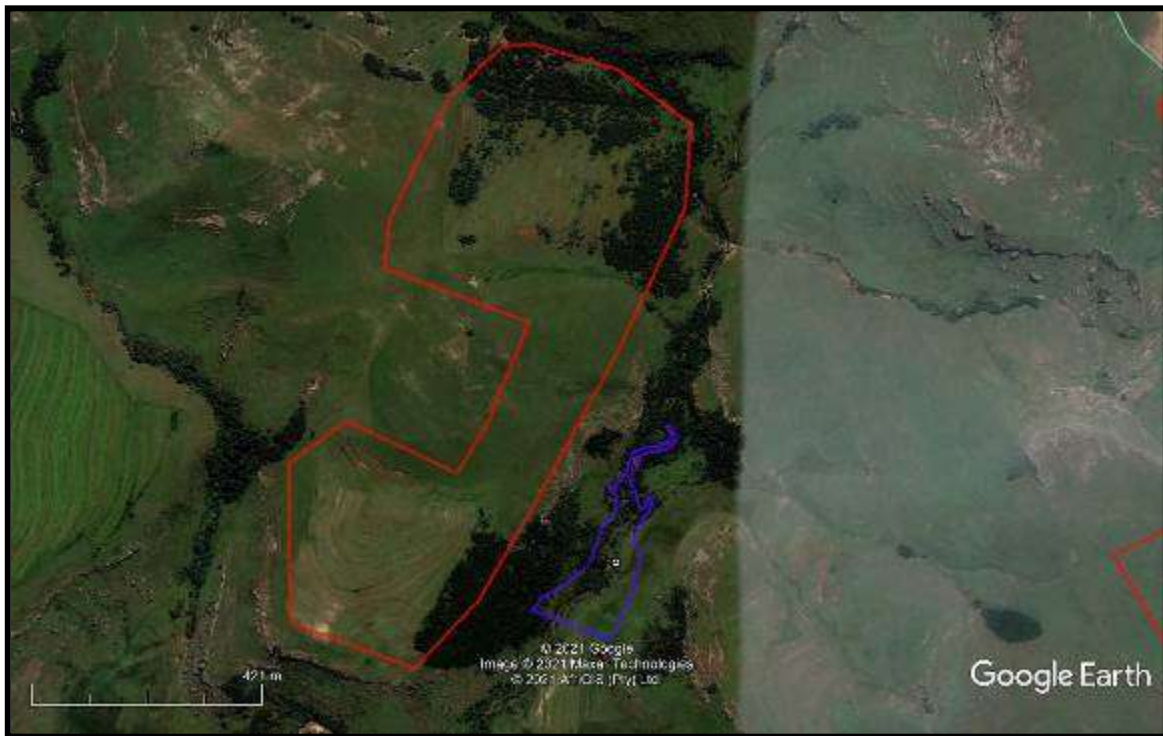
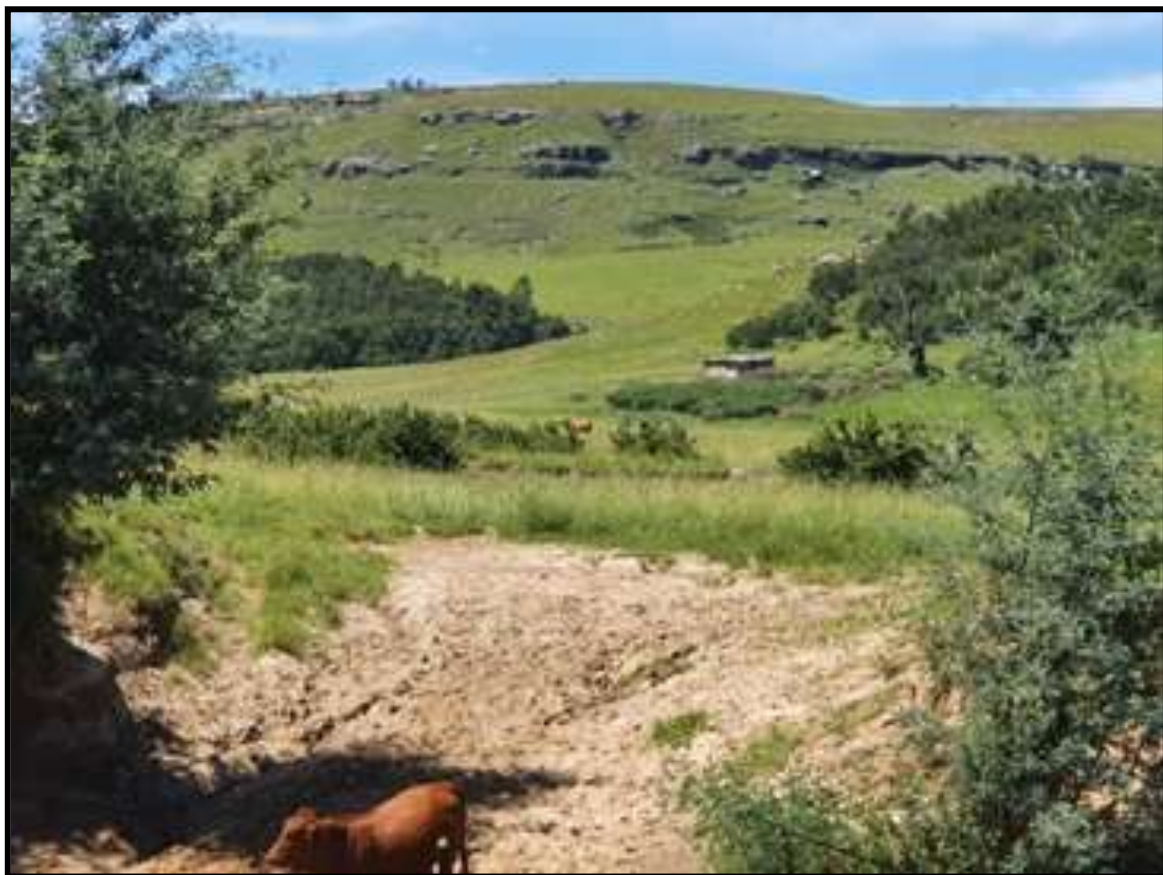
FIG. 28: DAM 7

No heritage sites were noted within the dam or orchard areas (fig. 28).

The orchards have been ploughed for several decades.

Significance: None

Mitigation: None

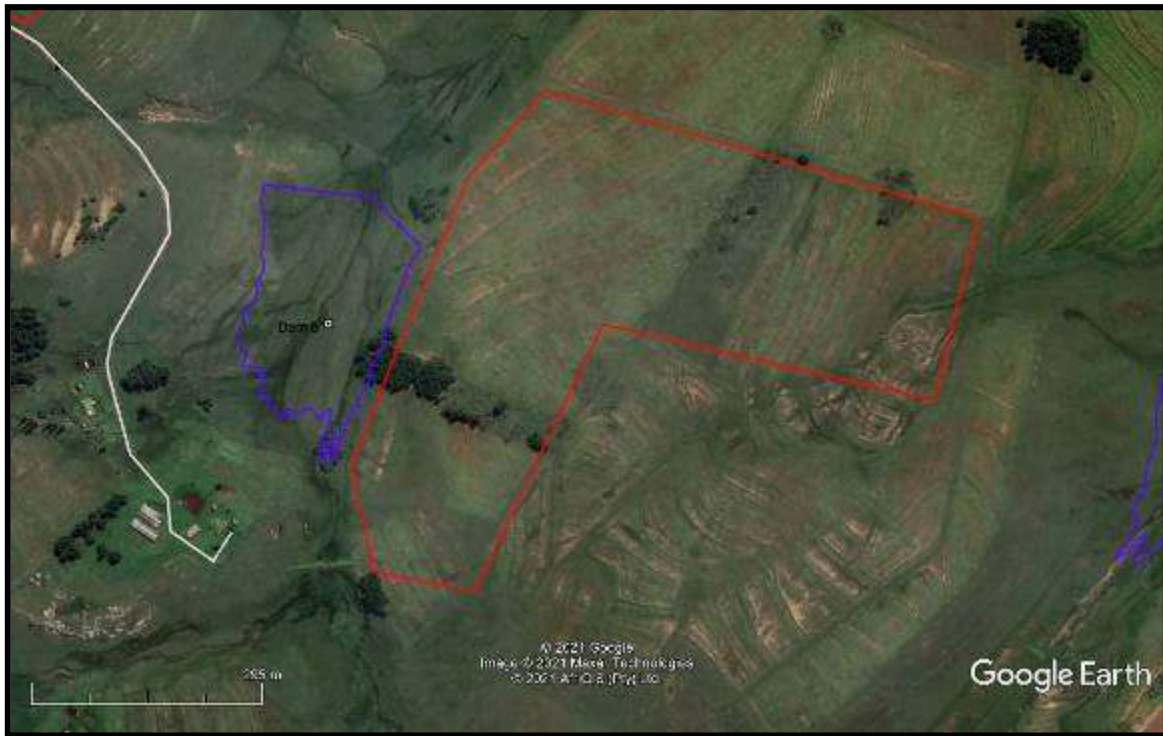
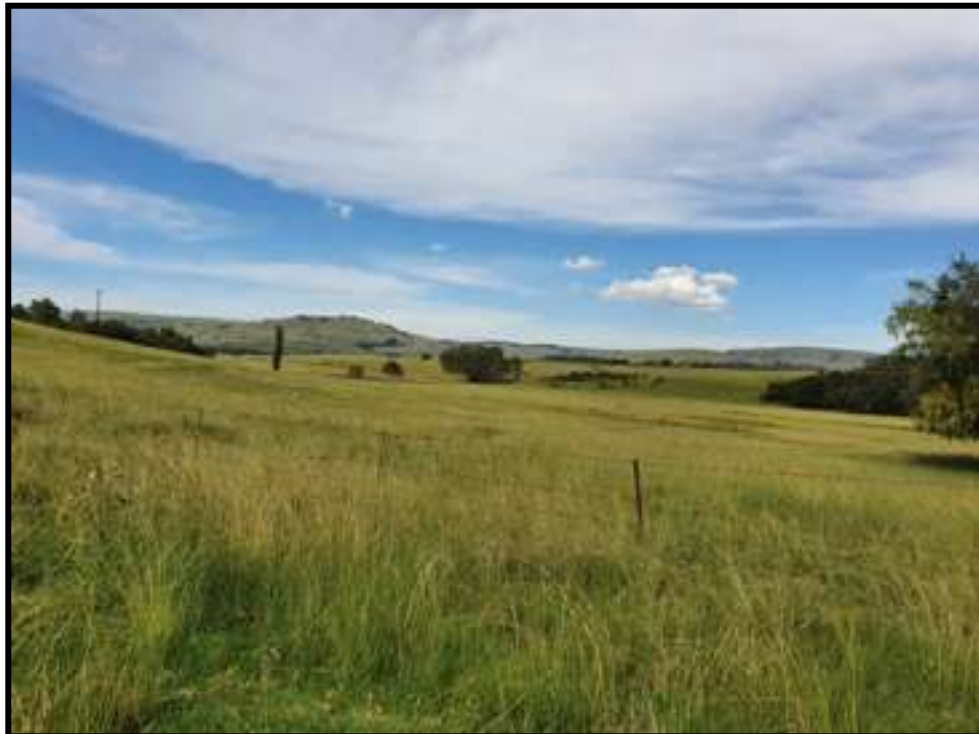
FIG. 29: DAM 8

No heritage sites were noted within the dam or orchard areas (fig. 29).

The orchards have been ploughed for several decades.

Significance: None

Mitigation: None

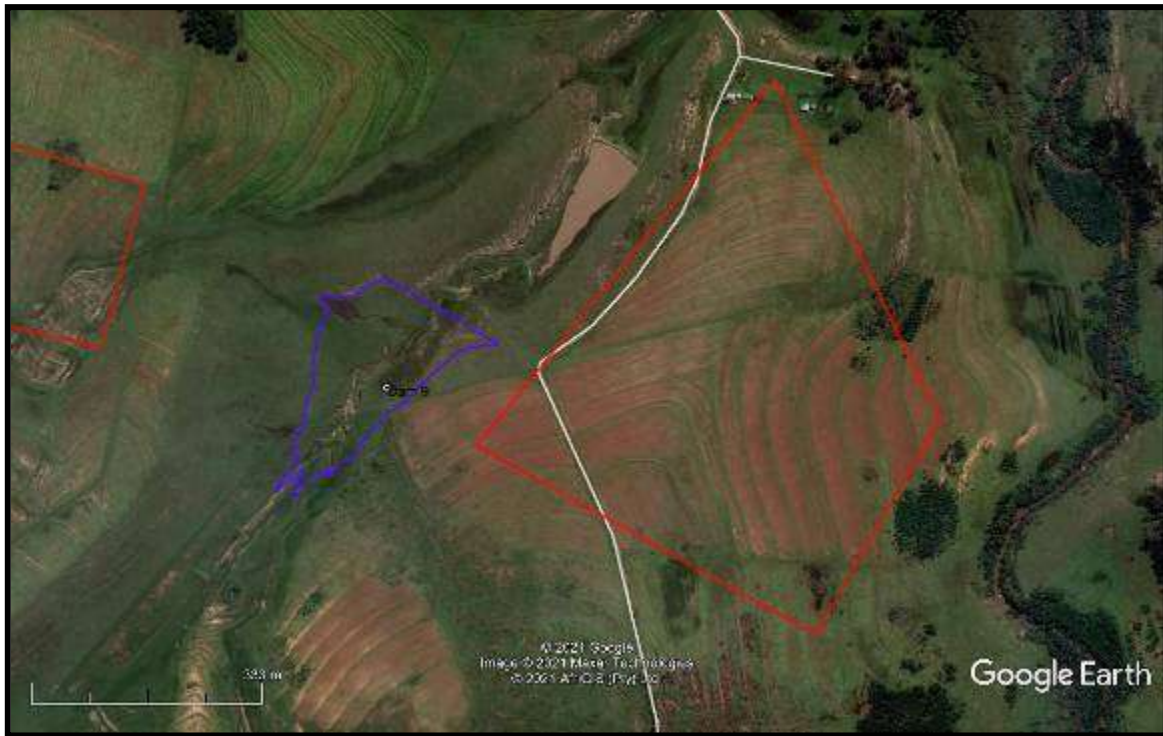
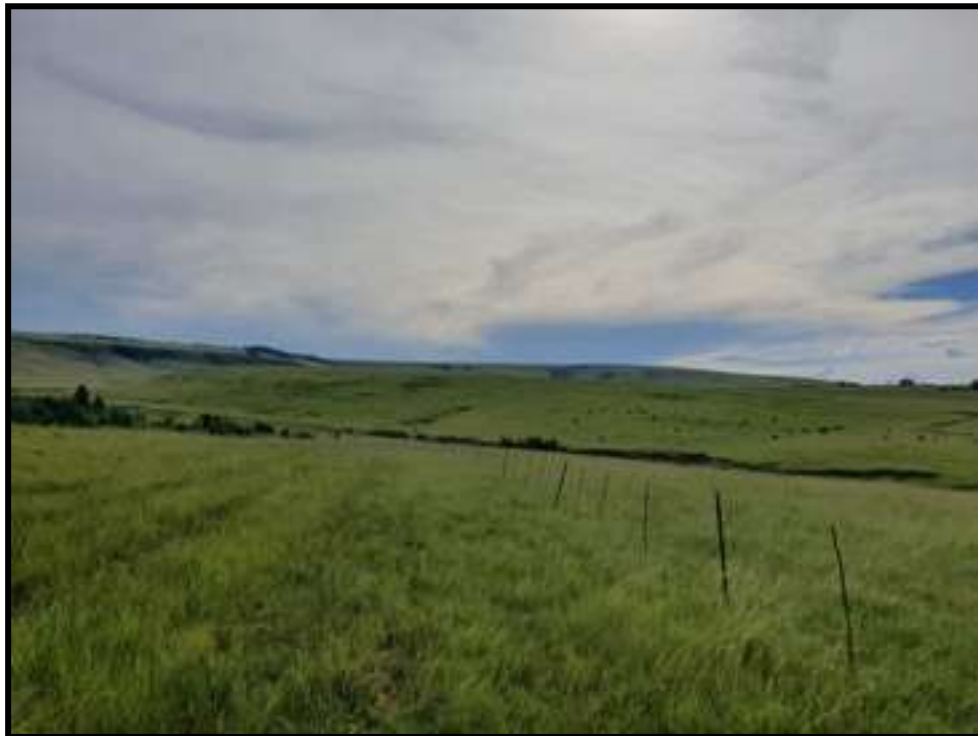
FIG.30: DAM 9

No heritage sites were noted within the dam or orchard areas (fig. 30).

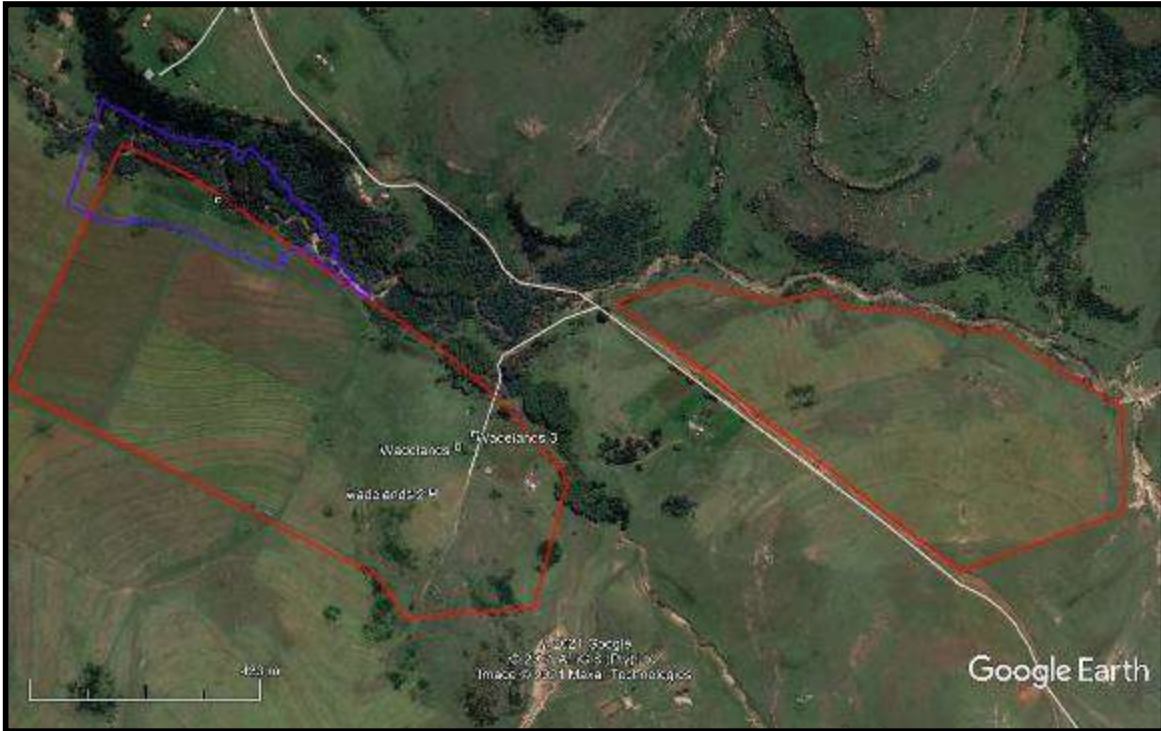
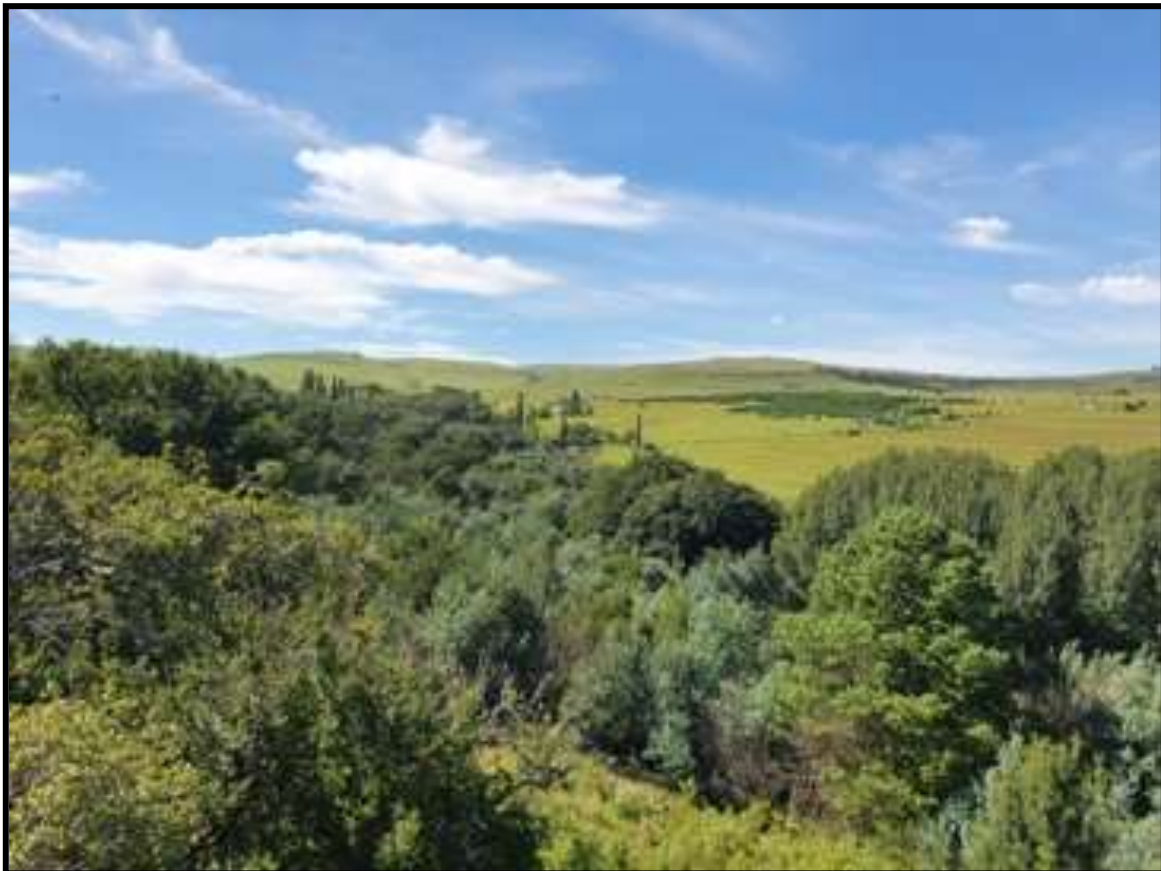
FIG. 31: DAM 10

No heritage sites were noted within the dam area (fig. 31). The dam area occurs in an area of dense alien invasive tree species. In Wadelands 2 Orchard, there are four currently used buildings and three ruins (fig. 32; Table 4). The ruins belong to the original Wadelands farm buildings. The ruins will have historical middens associated with them and are thus protected by the NHRA. Wadelands probably dates to 1913/1914.

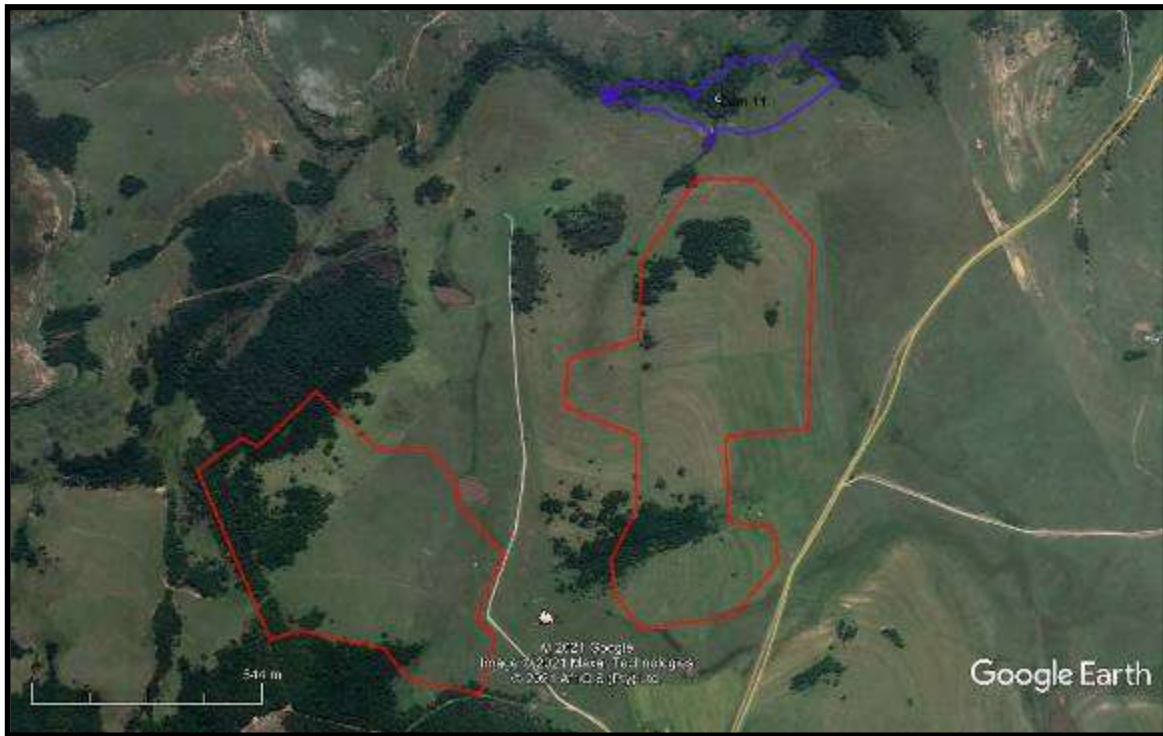
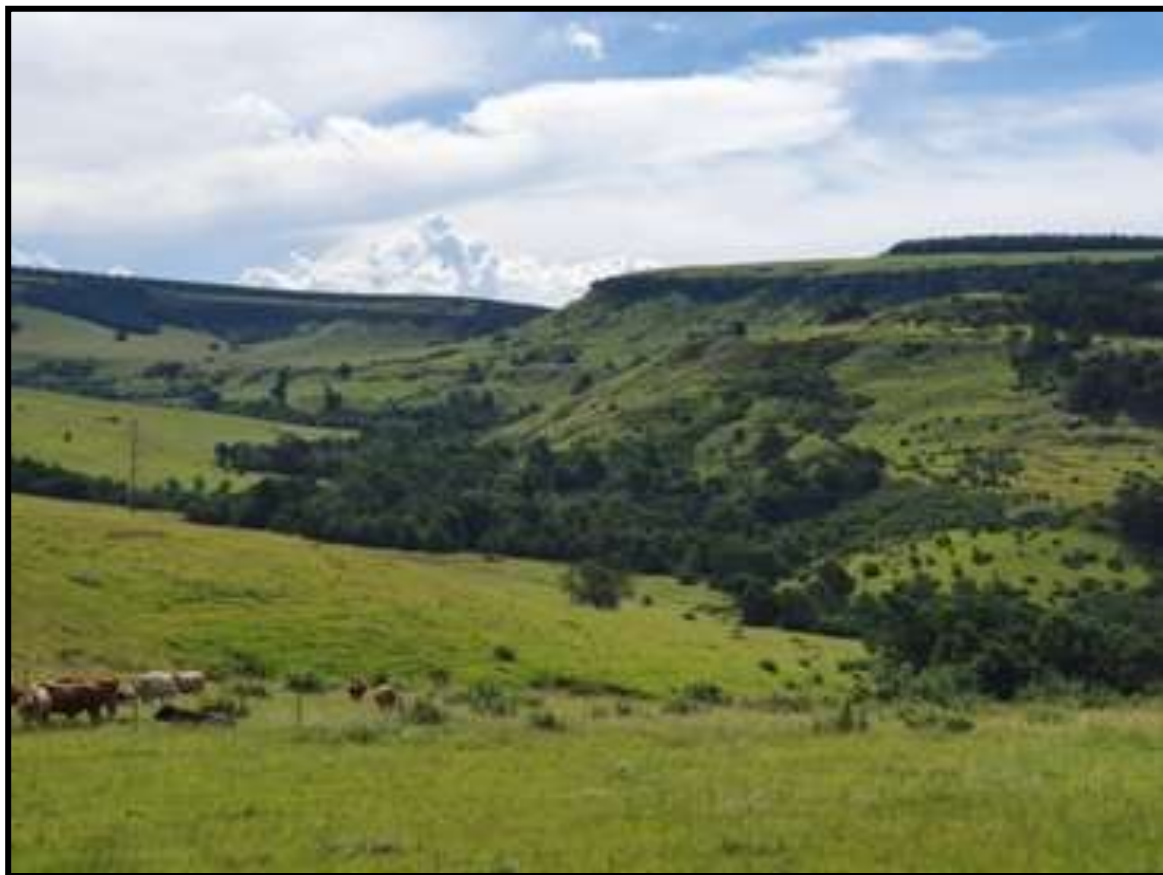
FIG. 33: DAM 11

No heritage sites were noted within the dam or orchard areas (fig. 33). The Greenfields Farm buildings are in ruin, but are not affected by the orchards.
